MONUMENT (& LADUE FRACTION)

SITE #47

MINFILE# 105M 007

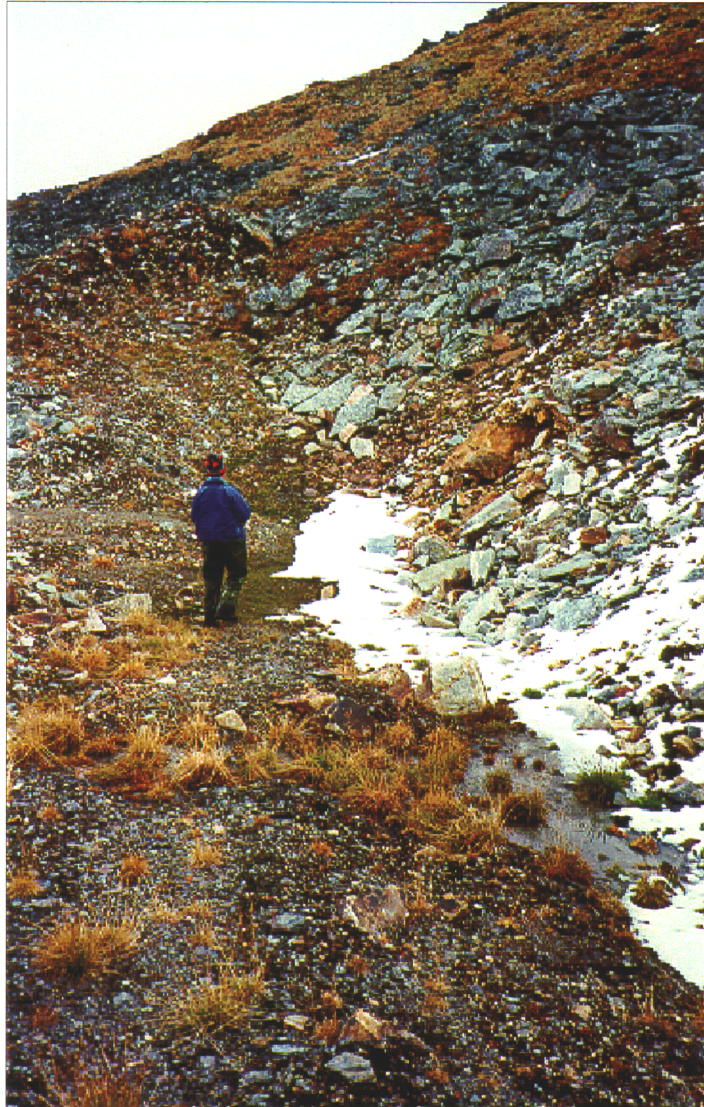
Trench #2 (photo 47-1)

Trench #2 is located between Trench #1 and the road, at the eastern end of the site. The southern side of the trench is a moderately steep talus slope. At the time of the site visit there was a small pool of water in the bottom of the trench. A section of mud at the east end of the trench is interpreted as a fault.

Condition: The talus slope on the south side is moderately steep, but appeared stable. The wall on the north side is very low and does not pose any stability concerns.

Photo 47-1 : Monument and Ladue Fraction. View of Trench #2, note small pool of water at bottom of the trench. (Azimuth 076°)

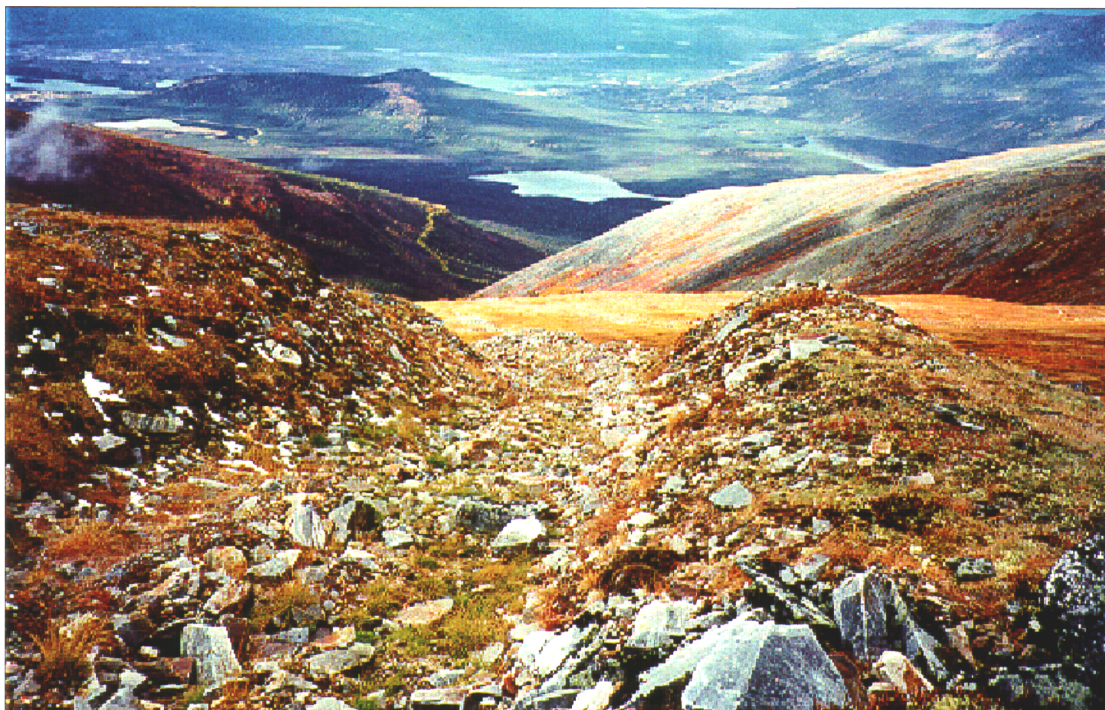
Trench #4 (photo 47-2)

Trench #4 is 400m to the west of Trench #3, 150m from Silver Basin Gulch Trail. There is a 1m wide band of quartzite at the northwest end. The trench is oriented from 318° at the northwest end and doglegs to 342° at the south end.

Condition: The low trench walls pose no stability concerns.

Photo 47-2 : Monument and Ladue Fraction. View of Trench #4, Gambler Lake is in the background. (Azimuth 318°)
