APEX (#48)
MINFILE# 105M 009

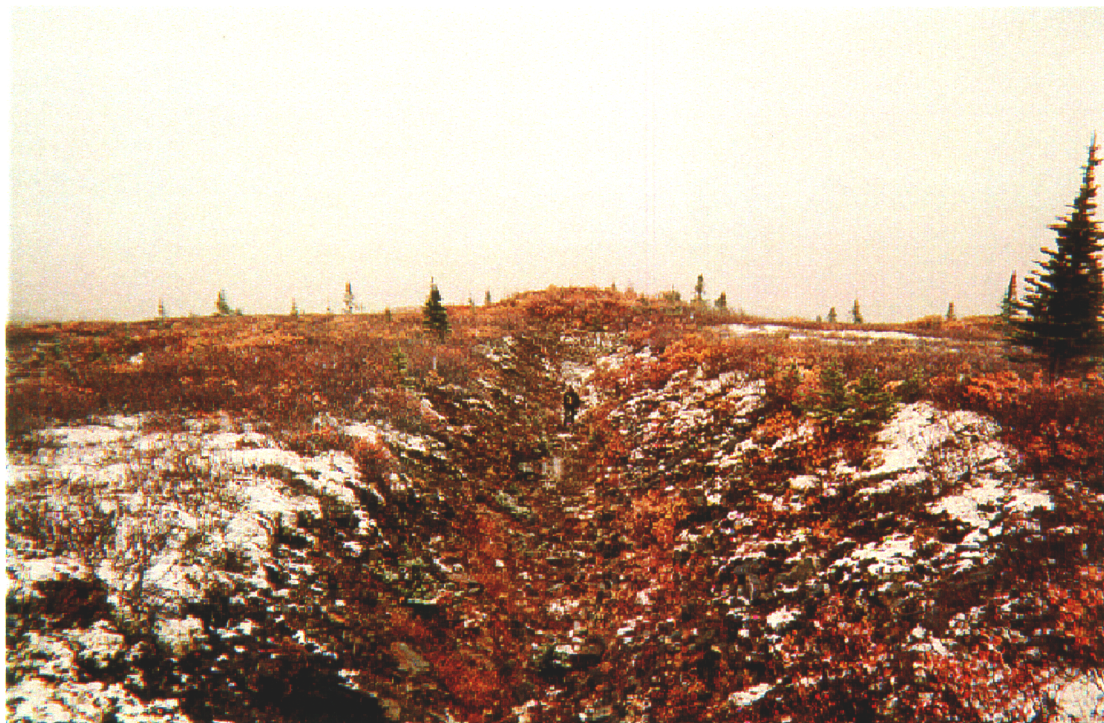
Trench 1 (photo 48-1)

Location: easternmost trench at the Apex site lying about 40 m west of Building 48A

Dimensions (L x W x H): 67 m x 4 m x 2 m - longitudinal bearing AZ 320

Condition: stable

Photo 48-1: View of Trench 1 at Apex site. (AZ 142)

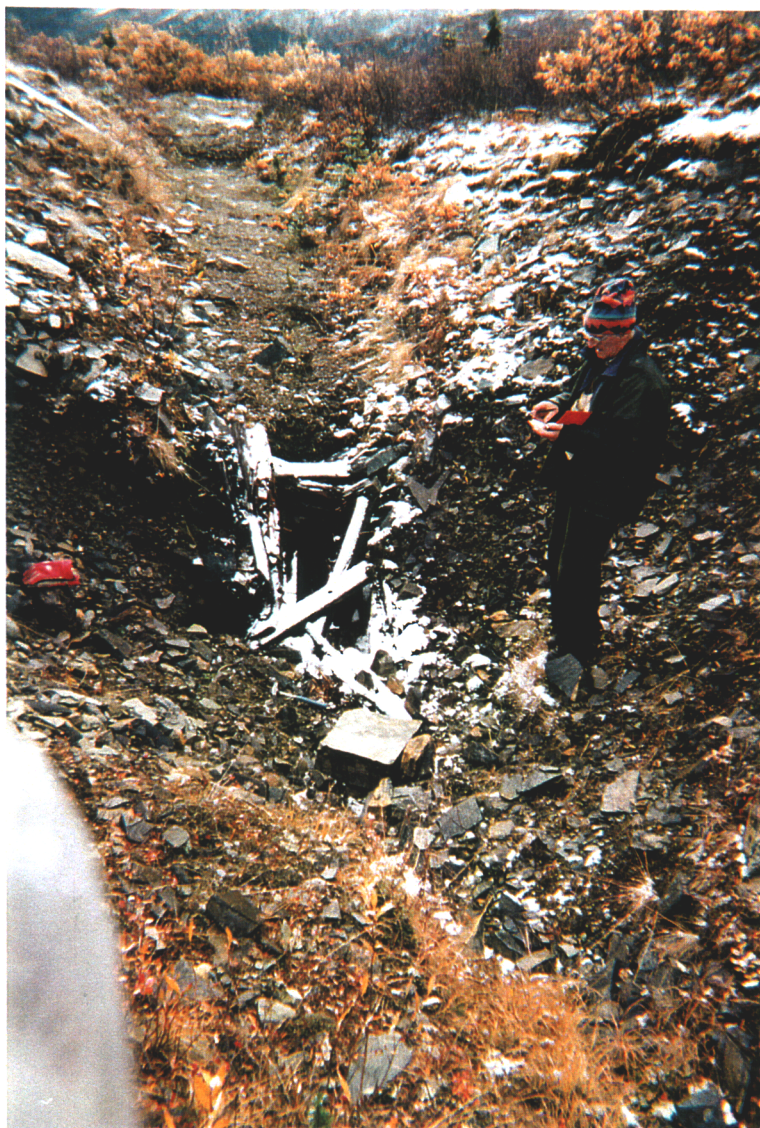
Shaft 1 (photo 48-2)

Old shaft filled in to within 5 m of surface

Location: in the bottom of Trench 3 (see description of Trench 3 below), 58 m from the waste rock dump at the south end of the trench

Dimensions (L x W): 2 m x 1.5 m

Condition: poor - caved in 5 m below surface

Accessibility: open

Photo 48-2: View of Shaft 1 in Trench 3 at Apex site. (AZ 132)

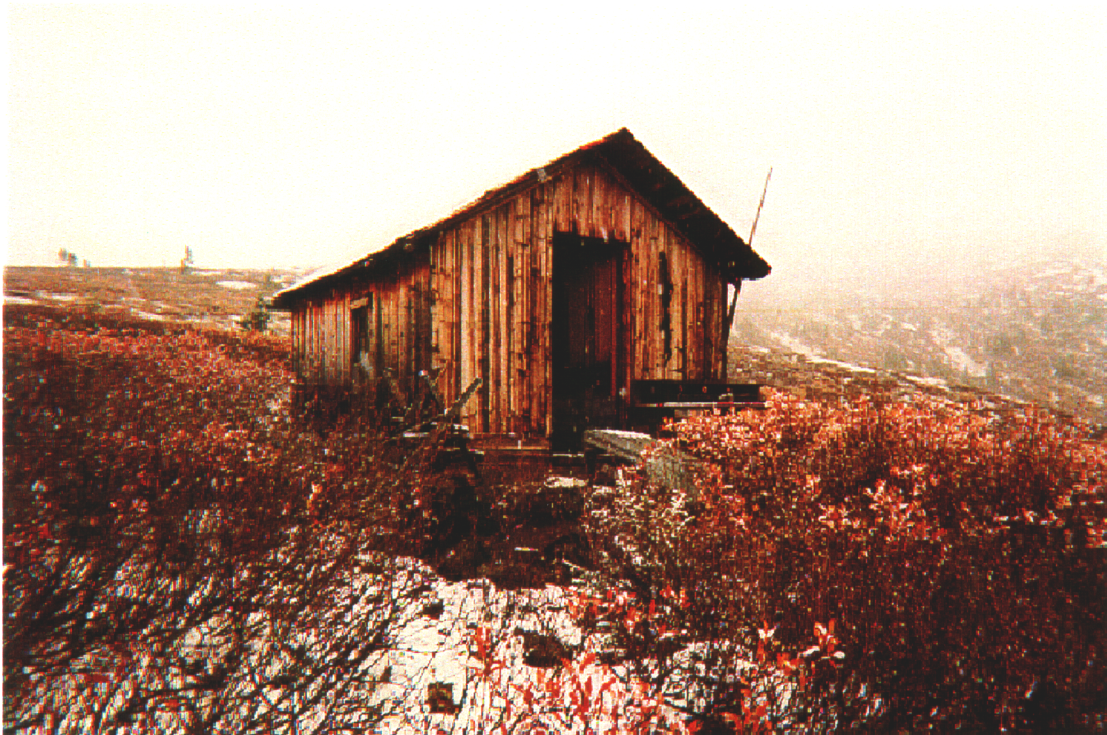
Building 48A (photo 48-3)

One level, single room freestanding wood cabin

Non-Hazardous Contents: 2 beds, utensils, firewood, and blankets are located inside. A fire pit, gas range (no fuel tank observed) and scattered debris (steel piping, cans) are located outside.

Photo48-3: View of abandoned wood cabin located at Apex site. (AZ 200)
