MO (#52)
(MINFILE# 105M 013)

Public Works and Government Services Canada Architectural & Engineering Services Western Region	designed by: conçu par: drawn by: dessiné par: approved by: approuvé par:	date: Nov. /99
Drawing title: Mo Site #52 Site Assessment Yukon Territory		project no. no. du projet: 125-12.01	draw. no. dessin no. 1 of 1

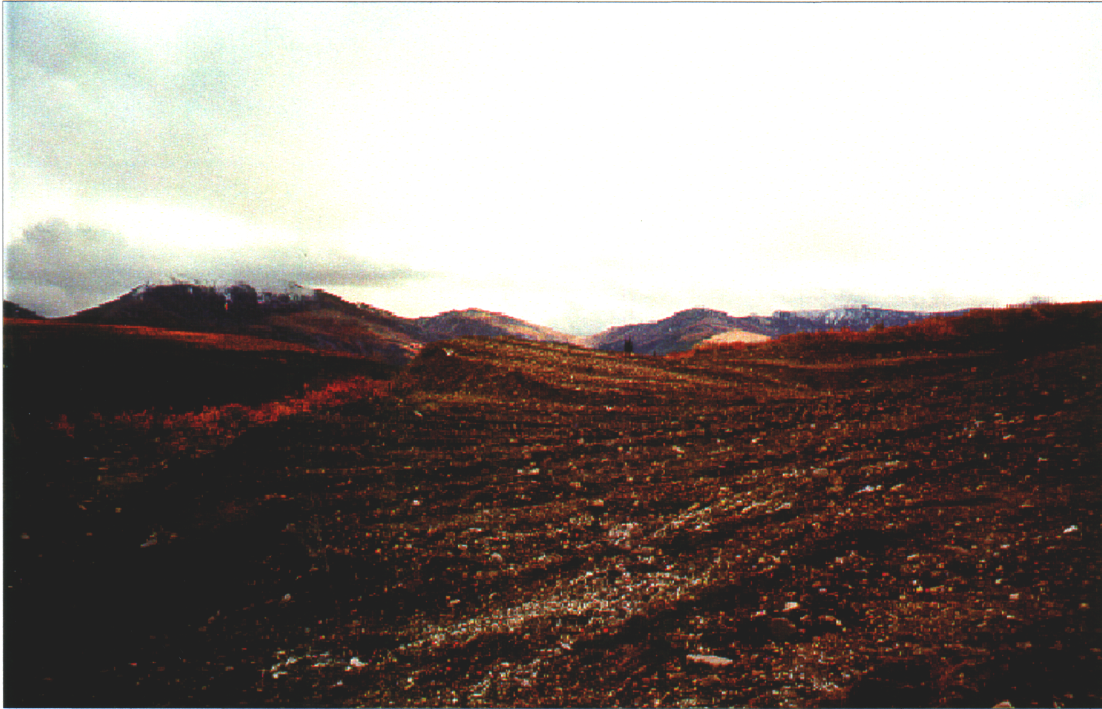
The major displacement of material from the trenching in this area has made it difficult to distinguish waste rock from overburden. Material has been piled and graded in several places to make level areas and roads (photo 52-1). Significant revegetation has occurred in the area. The extent of natural reclamation ranges from 20 to 60 percent depending on the quality of the soils.

Photo 52-1: Large area of displaced material at south end of Windy and Casy workings.

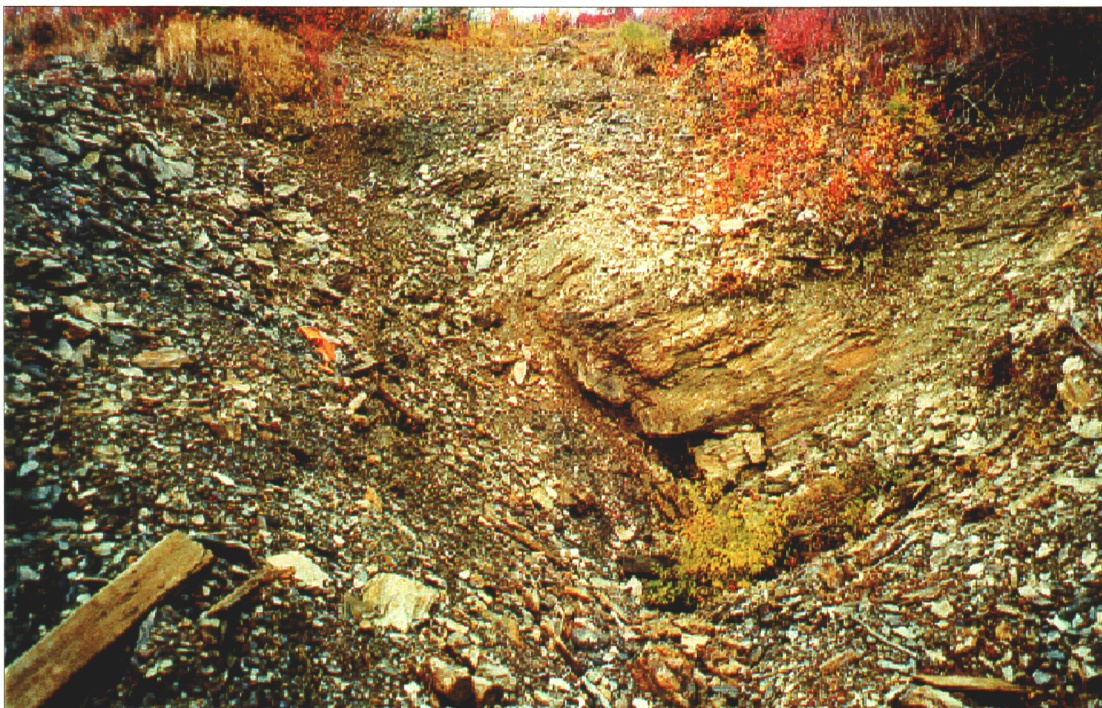
Pit 1 (photo 52-2)

Location: at south end of Windy and Casy trenching at side of road running through area (see figure 1)

Dimensions: 4 m x 3 m x 2 m

Condition: stable

Comment: potential site of former adit

Photo 52-2: View of Pit1 at Windy and Casy workings.

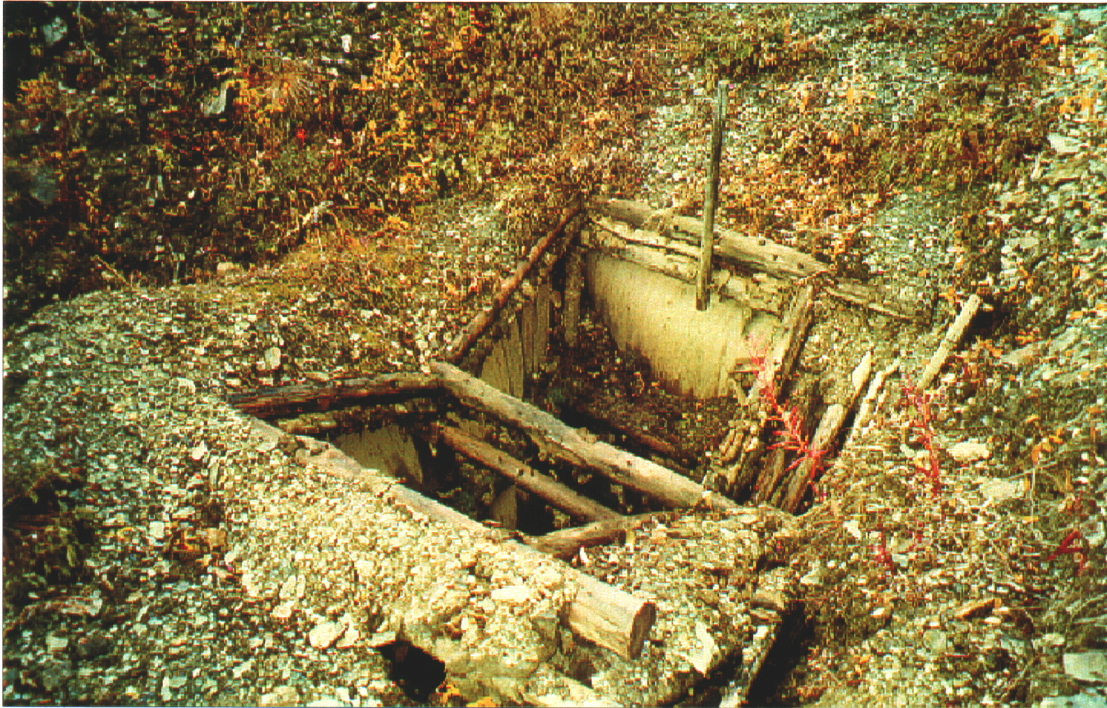
Shaft 1 (photo 52-3)

Two compartment shaft

Location: in a trench at south end of Windy and Casy trenching about 22 m east of Pit 1 (see map).

Dimensions: 2.5 m x 2.5 m – filled to within 2 metres of trench floor

Condition: the shaft has either been filled or it has collapsed

Photo 52-3: View of Shaft 1 at Windy and Casy workings.

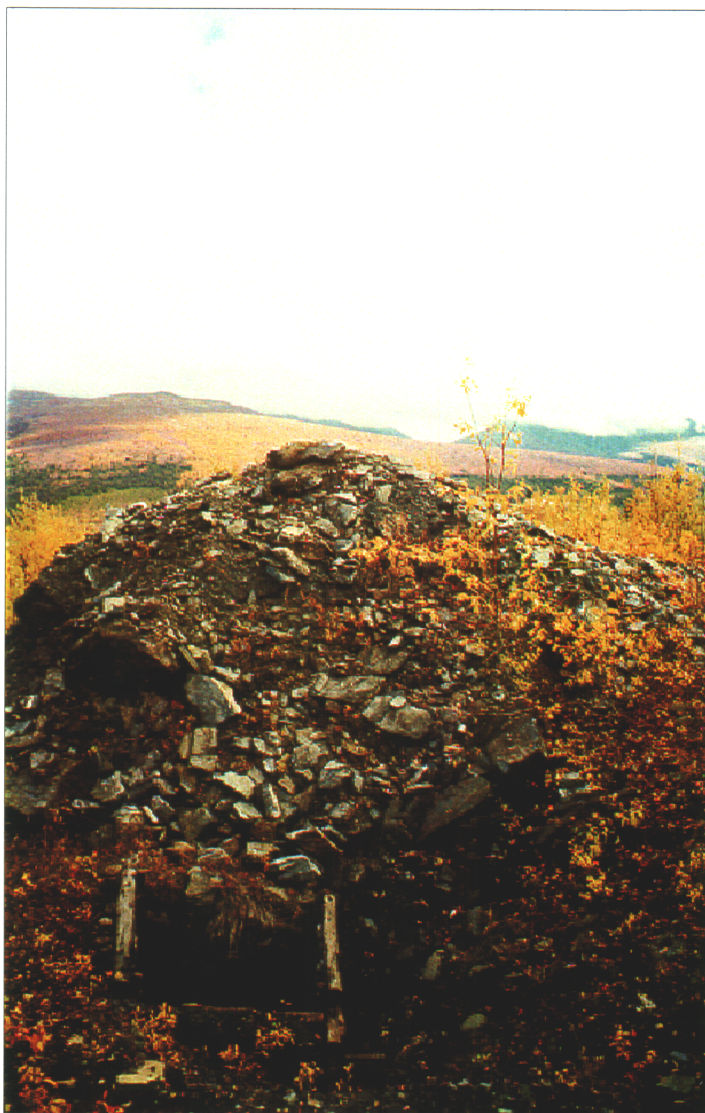
Shaft 2 (photo 52-4)

Small shaft

Location: in a trench at site of Windy and Casy trenching about 15 m south of a small shack (Building 52A)(see map).

Dimensions: 1.3 m x 1.5 m – filled to within 3 metres of trench floor

Condition: the shaft has either been filled or it has collapsed

Photo 52-4: View of Shaft 2 at Windy and Casy workings.

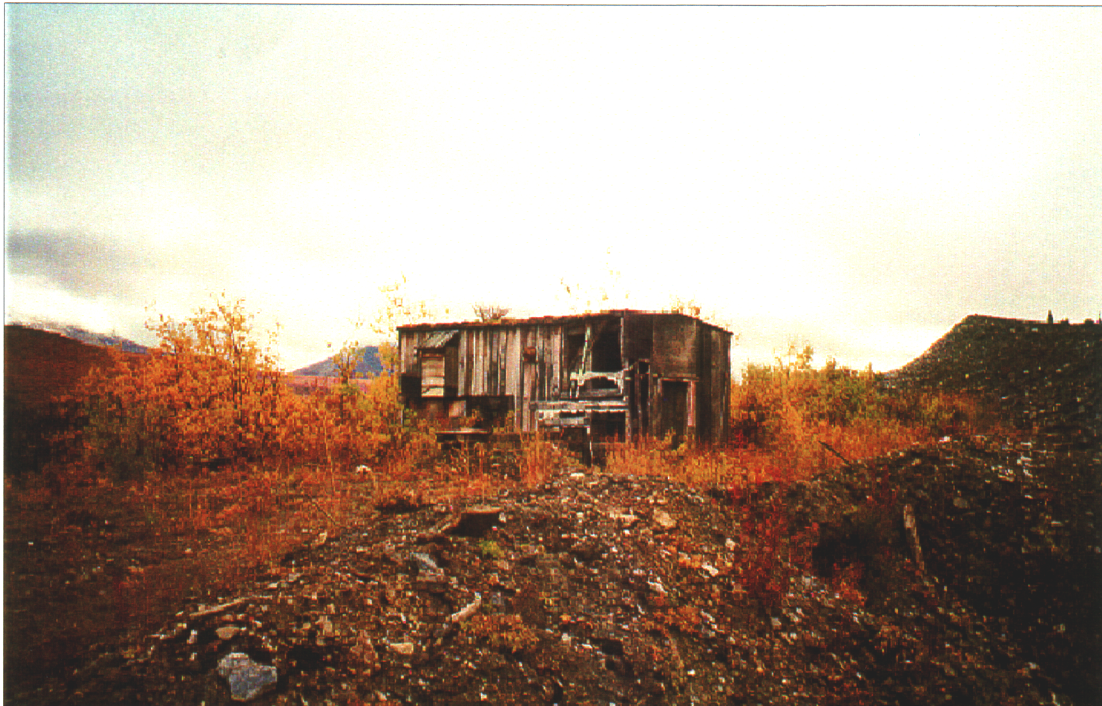
Building 52A (photo 52-5)

Wooden shack

Location: at Windy and Casy trenches (see Figure 1)

Dimensions (L x W x H): 5 m x 3 m x 2.5 m

Construction: wood

Paint: none observed

Asbestos: none observed

Foundation: none

Non-Hazardous Contents: woodstove, bed, cookware, clothing, magazines

Hazardous Contents: none observed

Photo 52-5: Abandoned wood shack near north end of Windy and Casy workings.

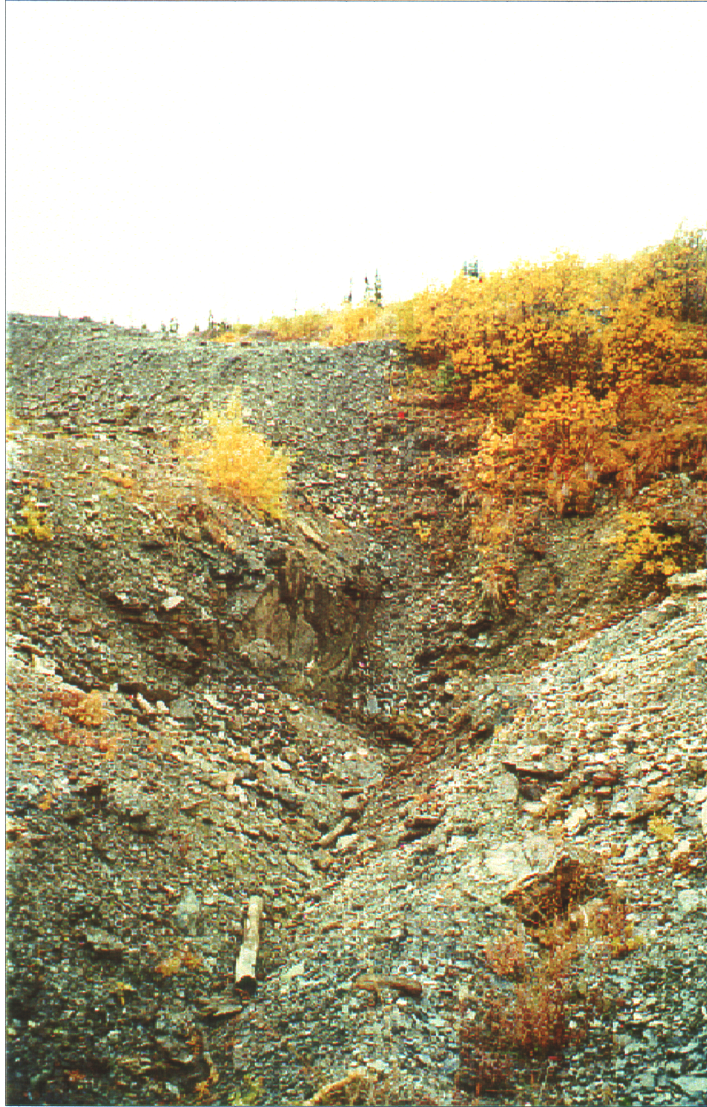
The Windy and Casy Trenches are located just off of the Sourdough Hill Trail on the Windy and Casy claims. This is a large area of trenching with small pits and two small shafts. The trenches can be accessed on foot from the Sourdough Hill Trail. One trench of particular interest shows an example of the bedrock in the area (Photo 52-6).

Photo 52-6: Deep trench showing bedrock just west of shack at Windy and Casy workings.

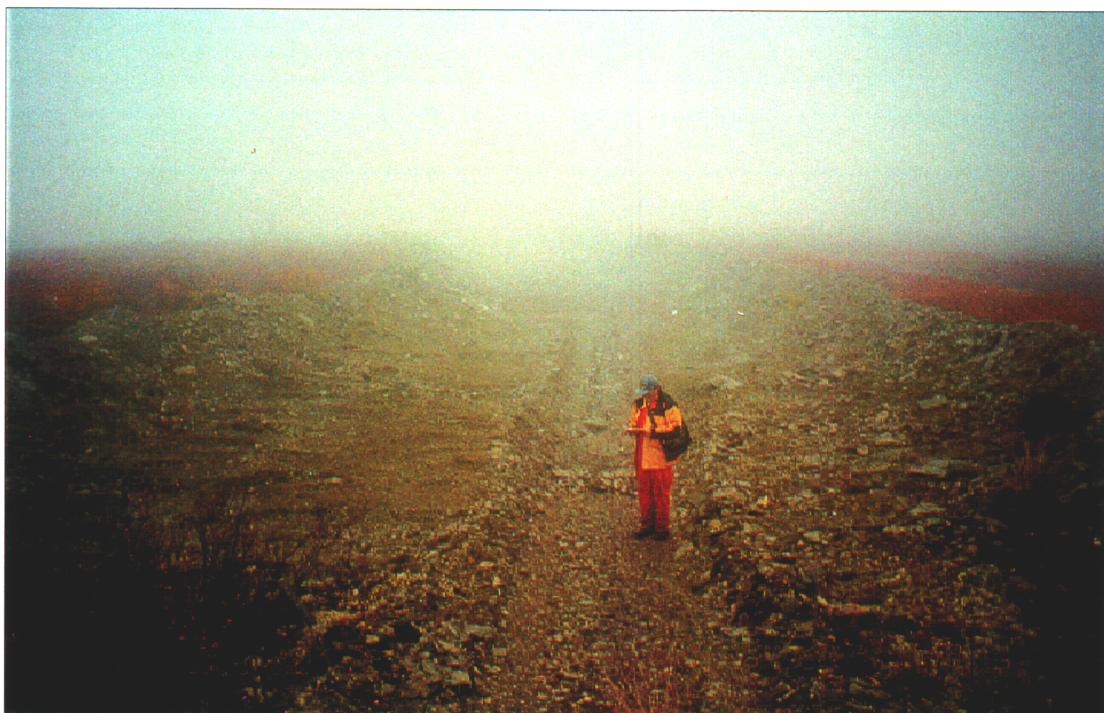
Trench 1 (photo 52-7)

Large shallow trench

Location: on the Bob claim

Dimensions: 83 m x 12 m x 1.5 m – longitudinal bearing AZ 138

Condition: stable – no revegetation

Photo 52-7: View along length of large trench (Trench 1) located 2 km south of Windy and Casy workings on Bob claim. (AZ 138°)

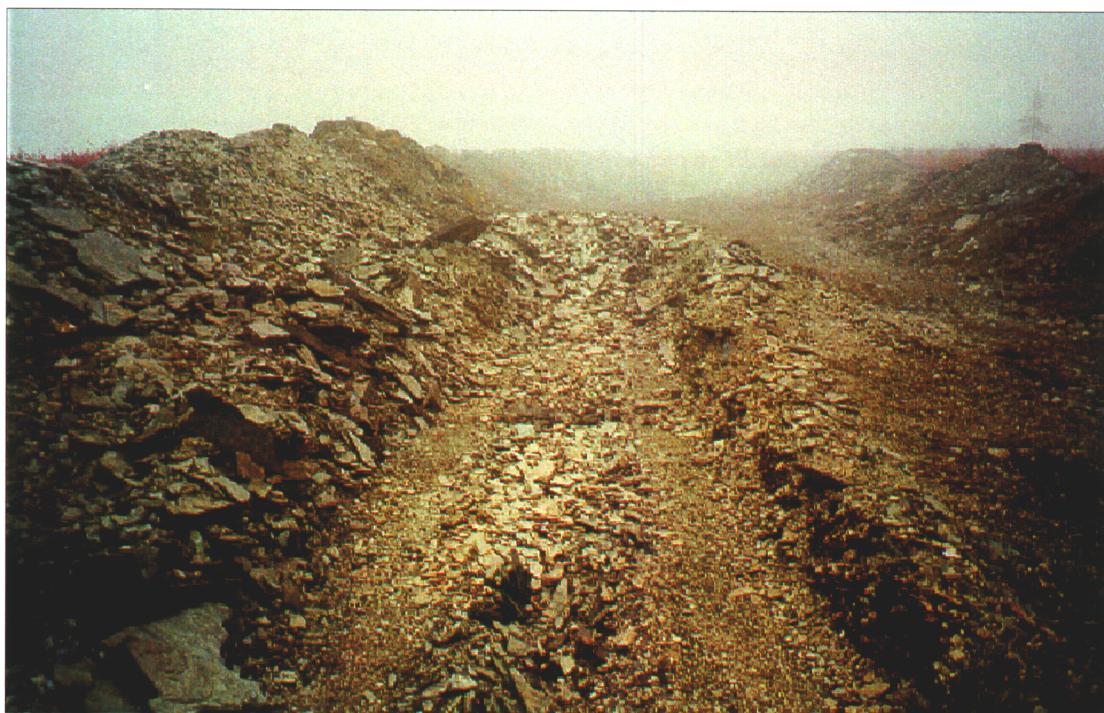
Photo 52-8: Area of digging at the bottom of Trench 1.

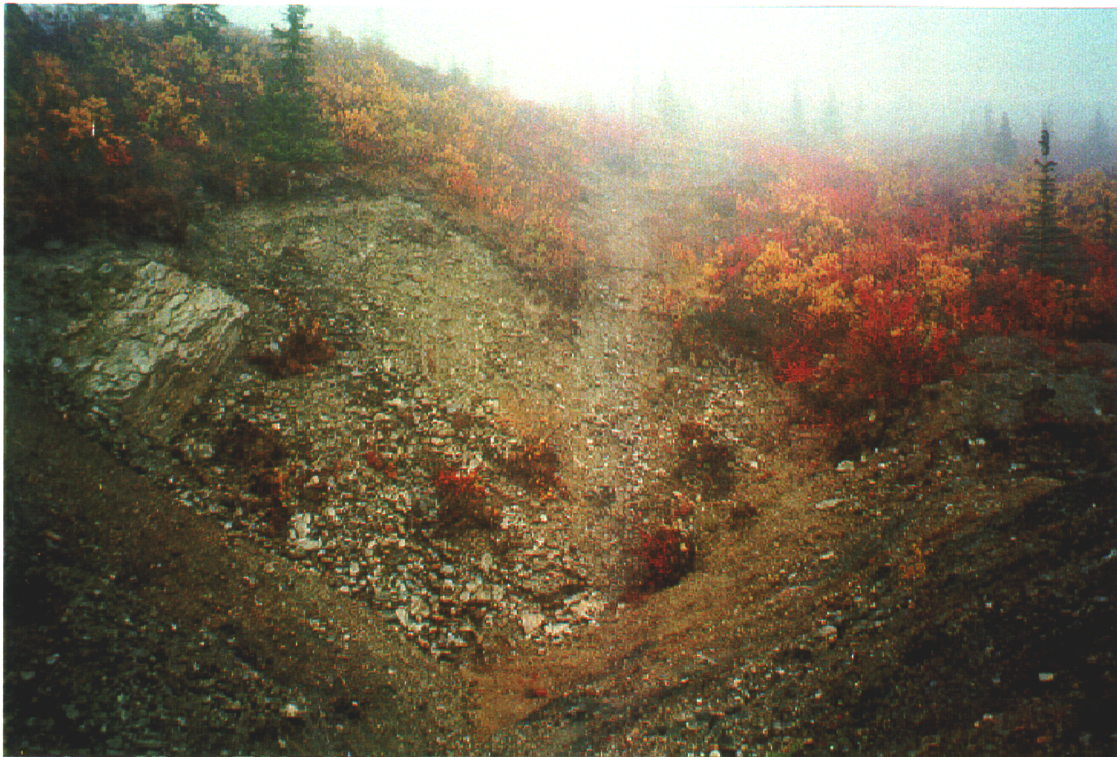
Pit 2 (photo 52-9)

Pit 2 is a deep pit with vehicle access from either side. Bedrock and overburden is dumped on the downhill side in two large piles. Bedrock is showing on the north slope of the pit.

Location: on Boogla claim

Dimensions: 30 m x 20 m x 7 m

Condition: stable

Photo 52-9: View of Pit 2 at Boogla claim located 2.4km south of Windy and Casy workings showing exposed bedrock. (AZ 070°)

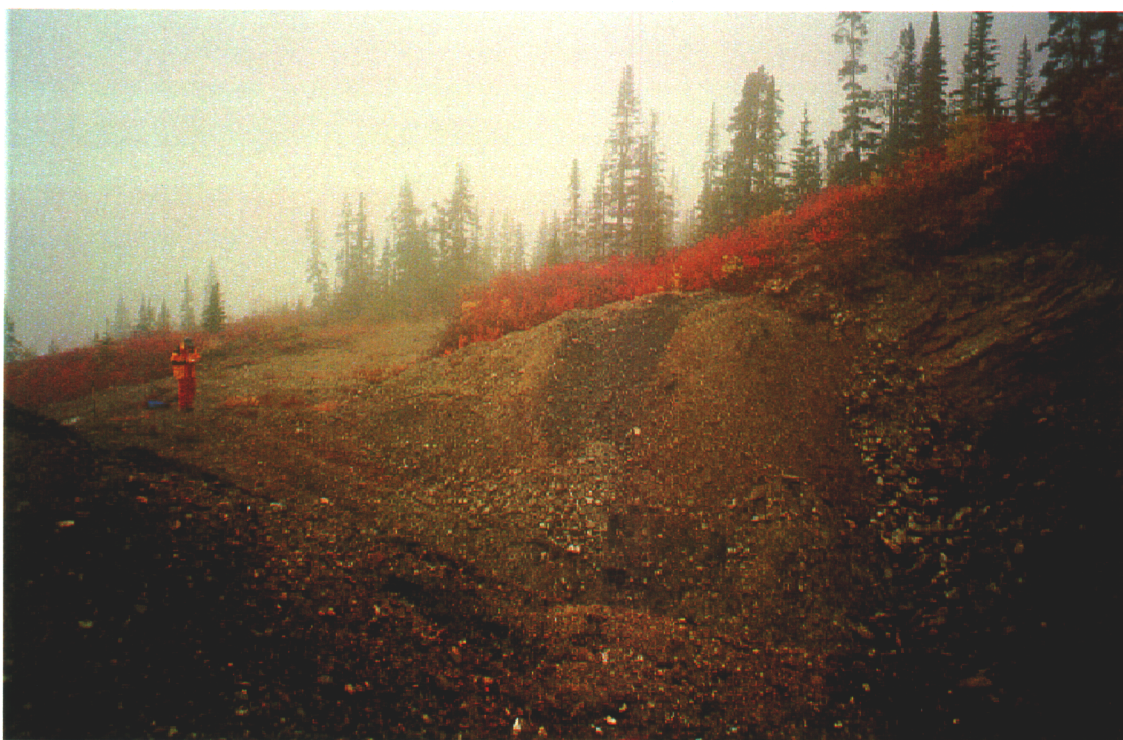
Pit 2 waste rock piles (photo 52-10)

There are two large waste rock piles located at Pit 2. They are composed of pale green and black phyllite that originated from the pit. The dimensions of the piles are 35 m x 4 m x 4 m and 10 m x 4 m x 7 m. Both waste rock piles are stable. No significant revegetation of these waste piles has occurred.

Photo 52-10: Example of waste rock piles surrounding Pit2
