FORMO (# 57)
(MINFILE# 105M 018)

1. LOCATION AND ACCESS

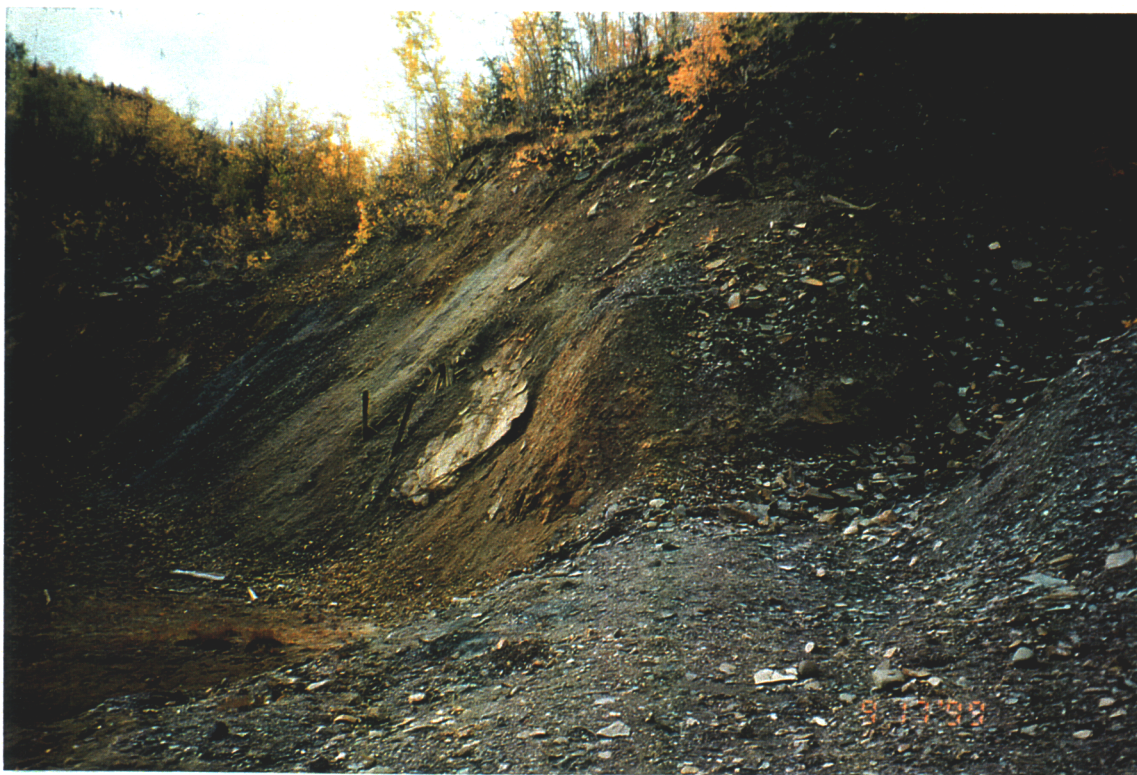
Upper shaft (photo 57-1)

Demolished during upper workings trenching. Only timbers remain at surface of site.

Photo 57-1: Remains of shaft on slope at upper workings.

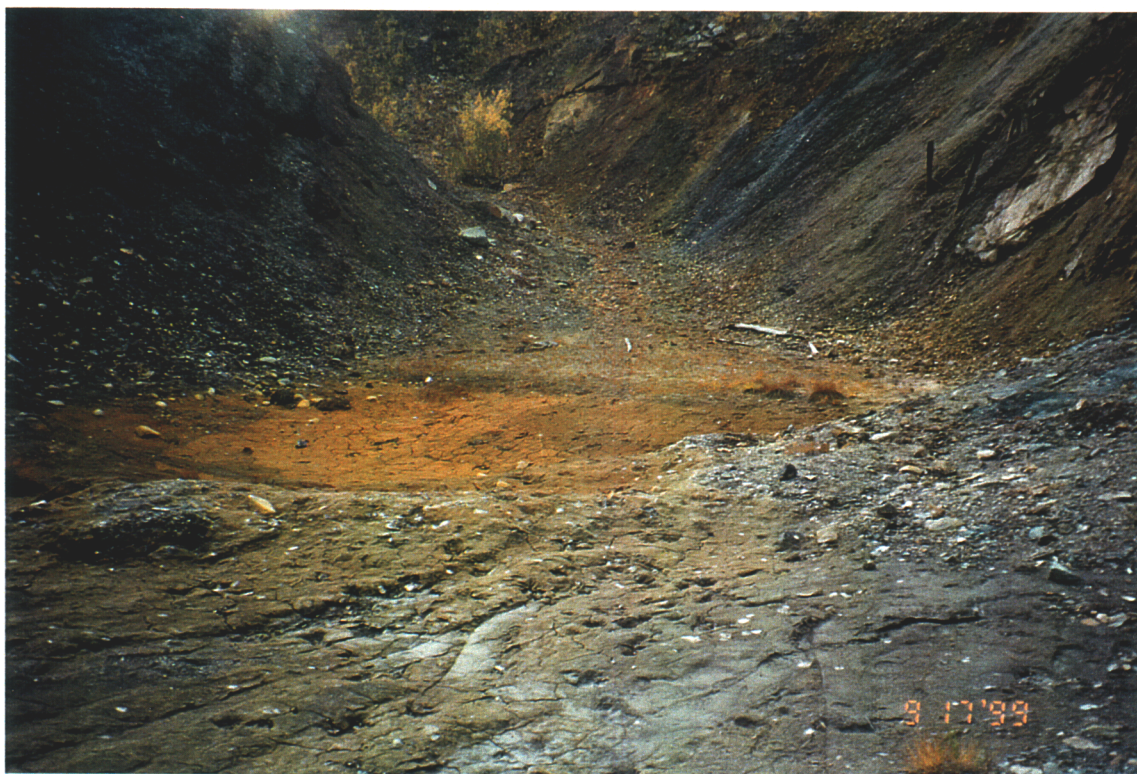
Condition: Minor revegetation of the trenches, particularly at the bottom; staining at bottom of main trench appears to be result of seasonal ponding water (none at time of site visit); material sloughing off trench walls at a number of locations.

Photo 57-2: Bottom of slope at upper workings where water has ponded in past.

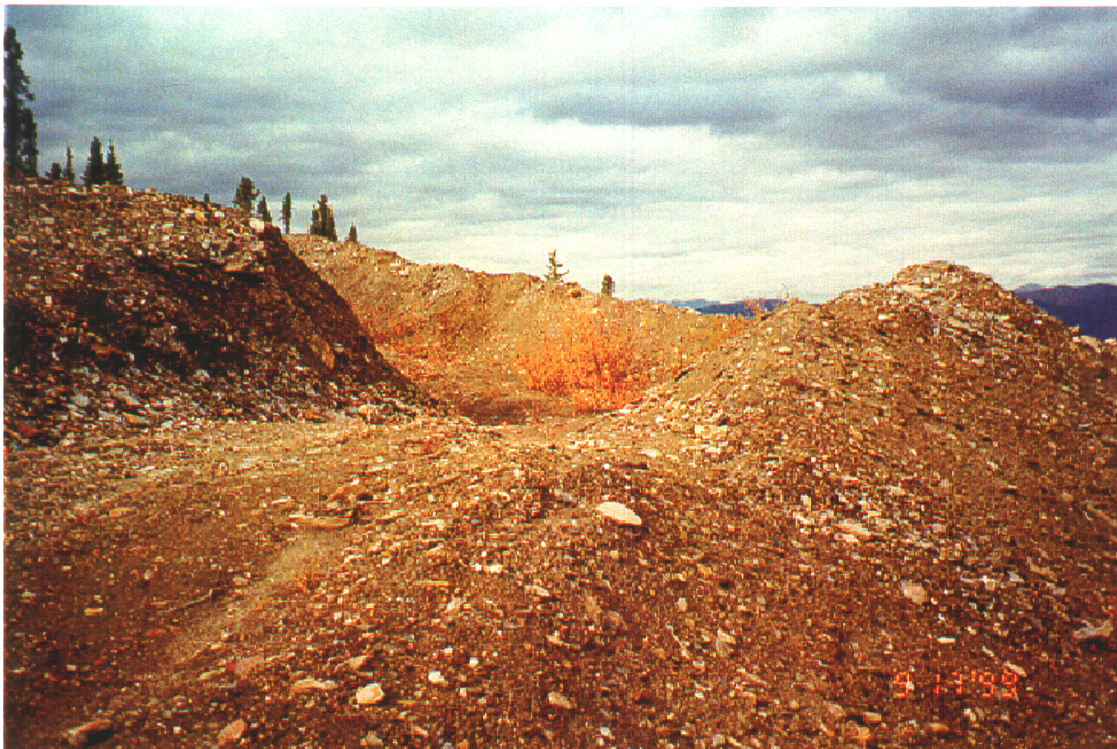
Over 6900 m³ of rock was removed from upper workings site and the waste rock was deposited on either side of the adjacent to the trenches.

Photo 57-3: Site road formed in waste rock at upper workings.

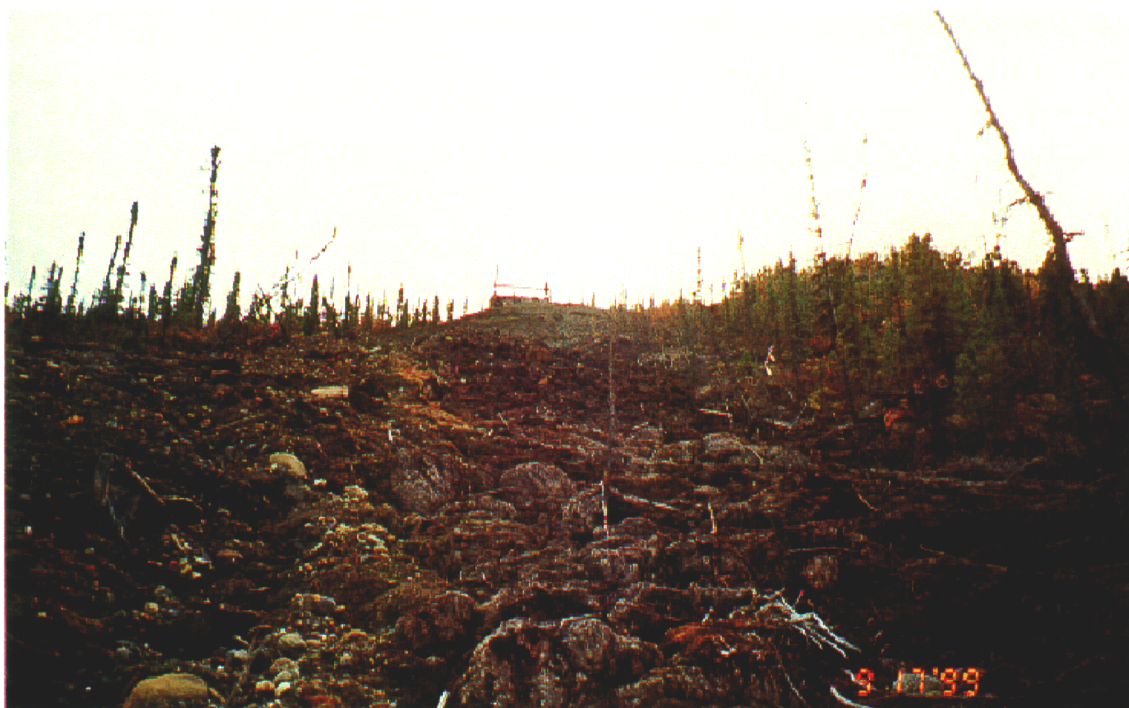
An area of disturbance of approximately 6000 m² was noted at the lower workings site and the waste rock was deposited below the adit.

Photo 57-4: Waste rock below lower workings. Note extensive vegetation kill zone.

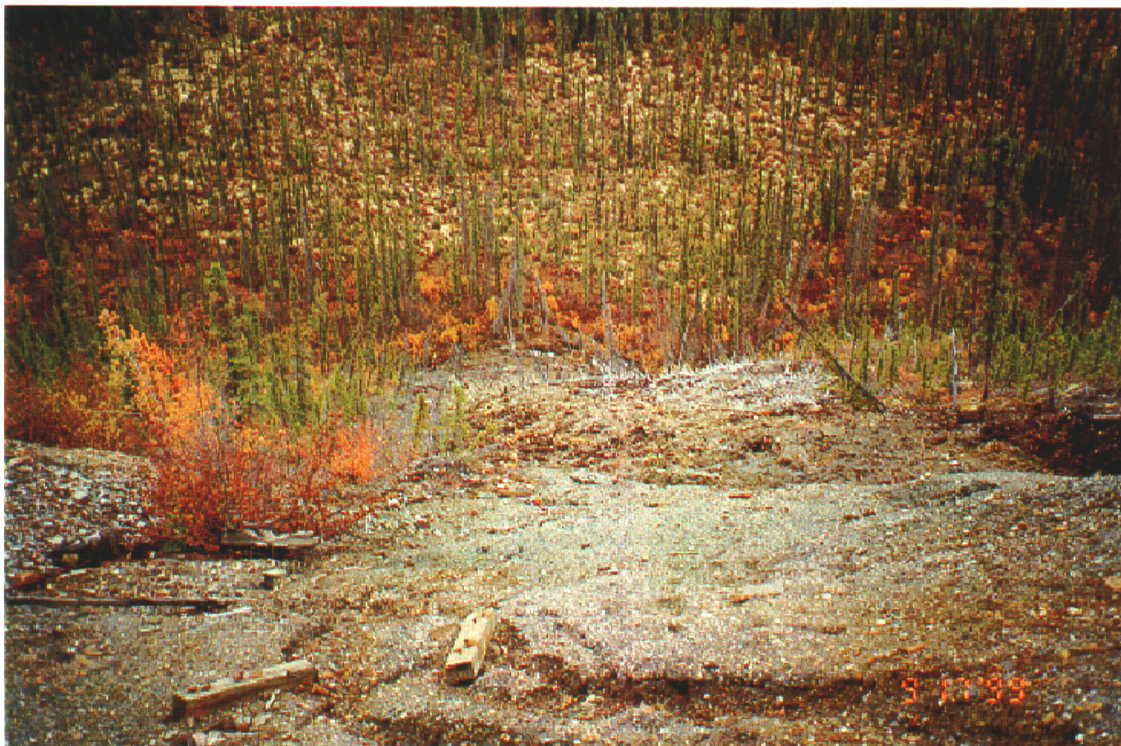
Photo 57-5: Waste rock below lower workings. Note Christal Creek at bottom.

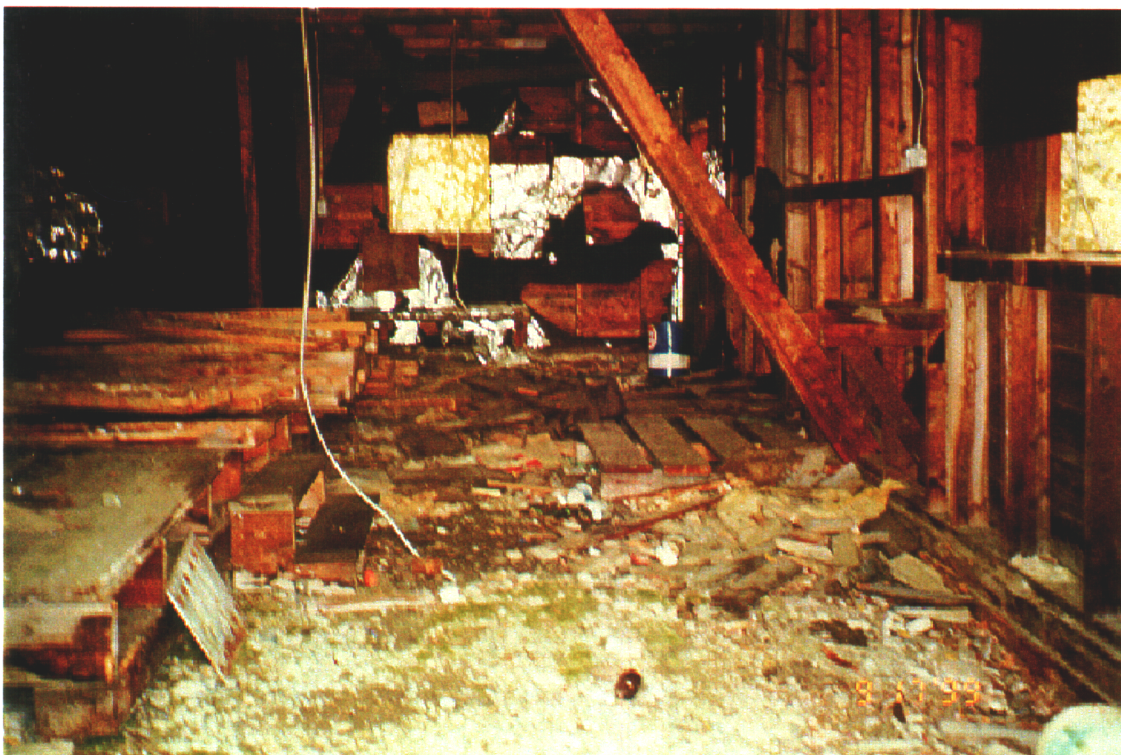
Building 57A – Core Shack (photo 57-6)

Asbestos: Asbestos tar paper cladding.

Photo 57-6: Interior of core shack at upper workings.
