PADDY (# 58)
(MINFILE# 105M 020)

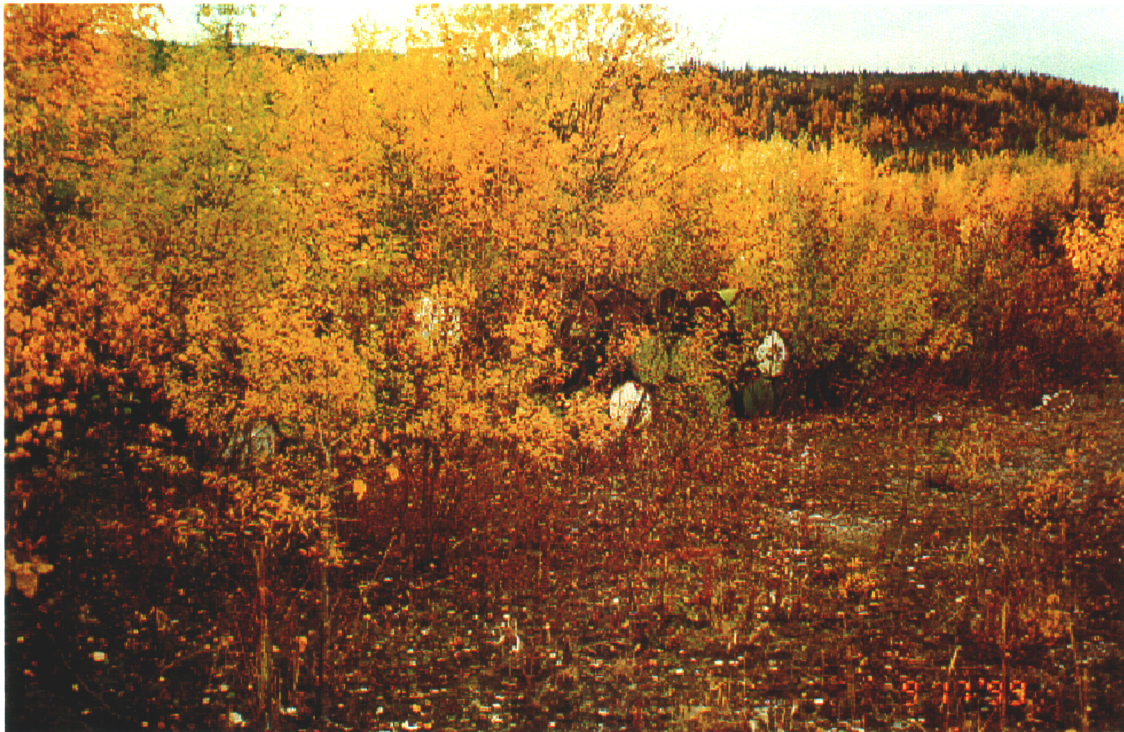
The barrel storage area to the north is located in a relatively flat area of second growth willow forest. While surface drainage from this site is not along established runoff pathways, it is clear that Christal Creek is the local surface water receptor.

There is currently no fuel in storage at the site. Barrels at the barrel storage area were probably formerly used for high grading and are currently empty.

Photo 58-1: Barrel storage area to north of main sites.

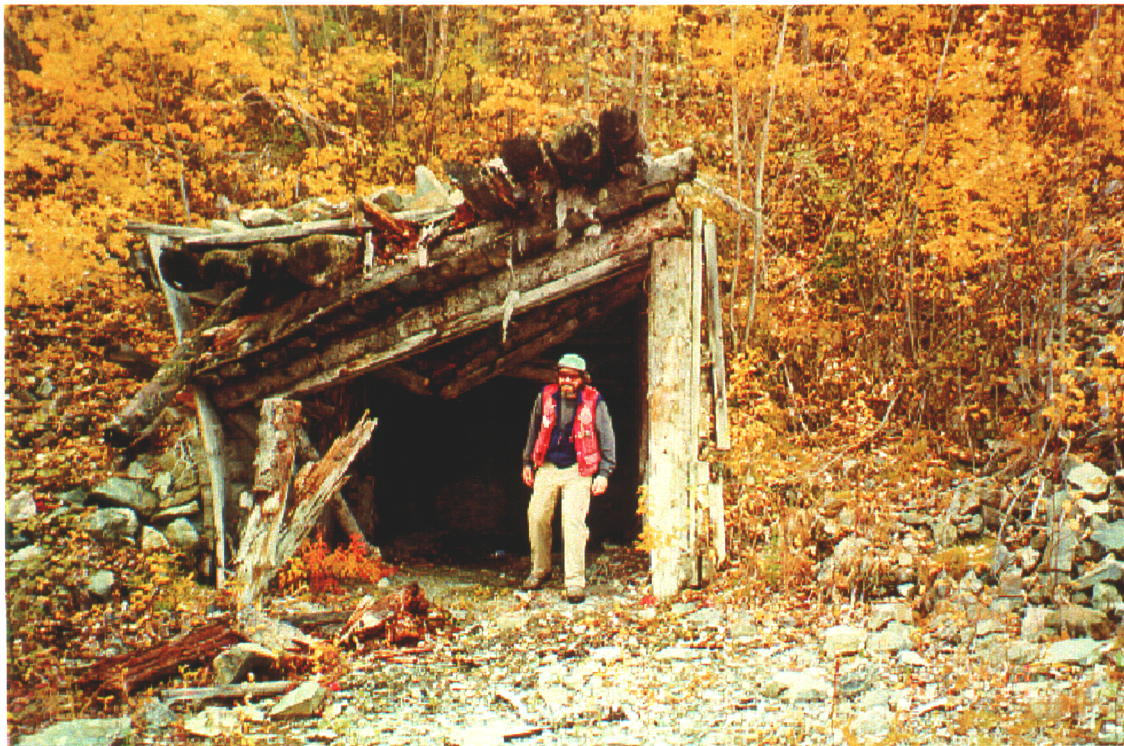
A timbered adit is present just above Christal Creek to the west.

Supports: The timbered portal is partially collapsed.

Condition: Poor condition, could collapse at any time.

Photo 58-2: Open adit.

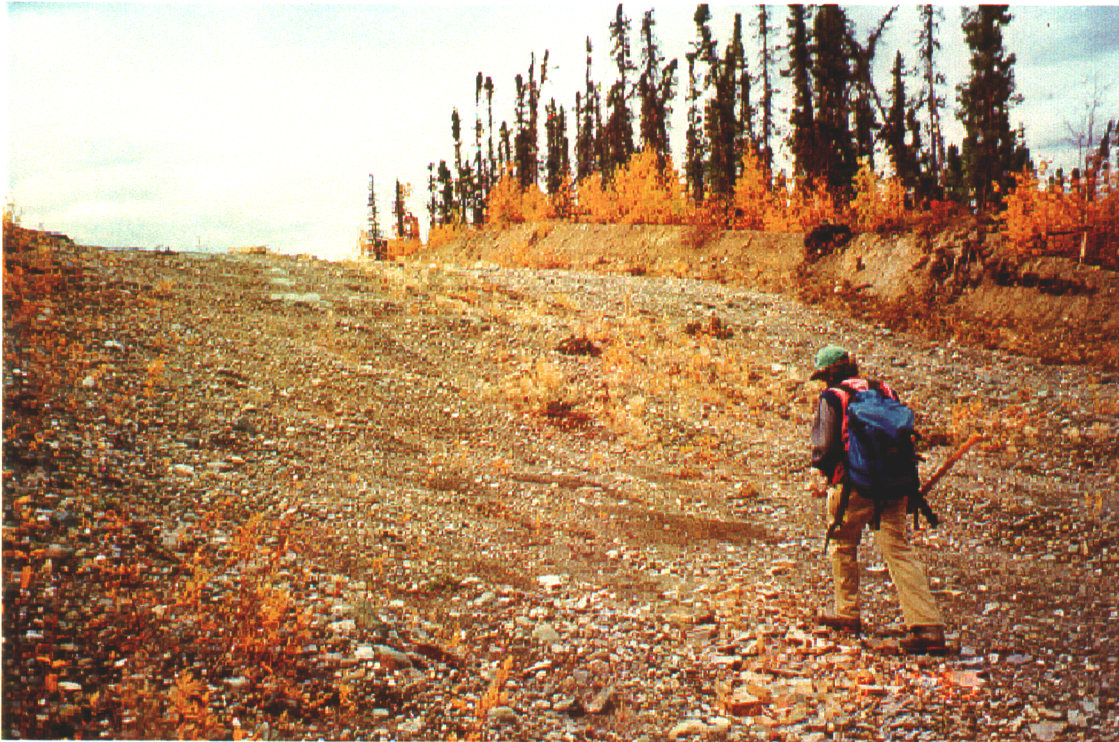
Three trenches basically parallel to each other, not previously discussed, were noted at a separate site to the south of the main (adit) site. Trenches run approximately east-west on top of knoll ending at or near cliff face. Trenches appear to be relatively recent and have had no revegetation over surface. Only a small amount of bedrock is exposed.

Condition: Two largest trenches recent and no revegetation; older trench partially reveged; material sloughing off two newer trenches into adjacent Christal Creek canyon at east end; remainder of trenches are stable.

Photo 58-3: Trenched area to north west of main site.

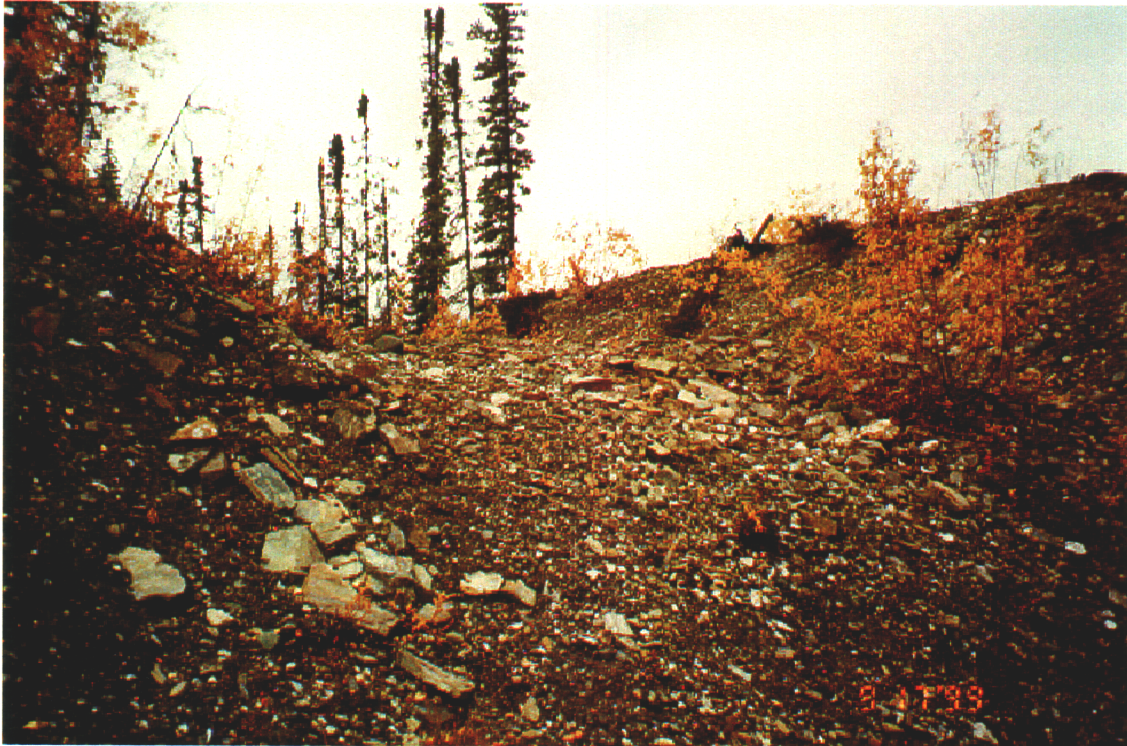
Photo 58-4: Top of knoll at newly trenched area.

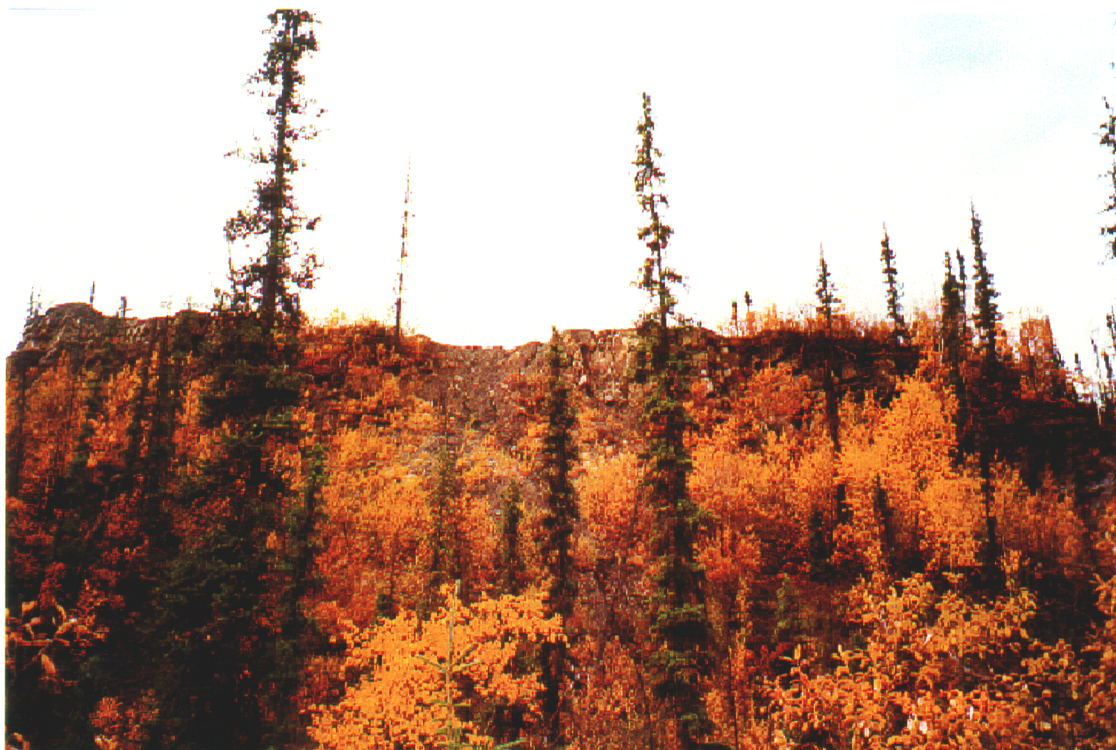
Photo 58-5: Trenched area visible from Christal Creek canyon below.

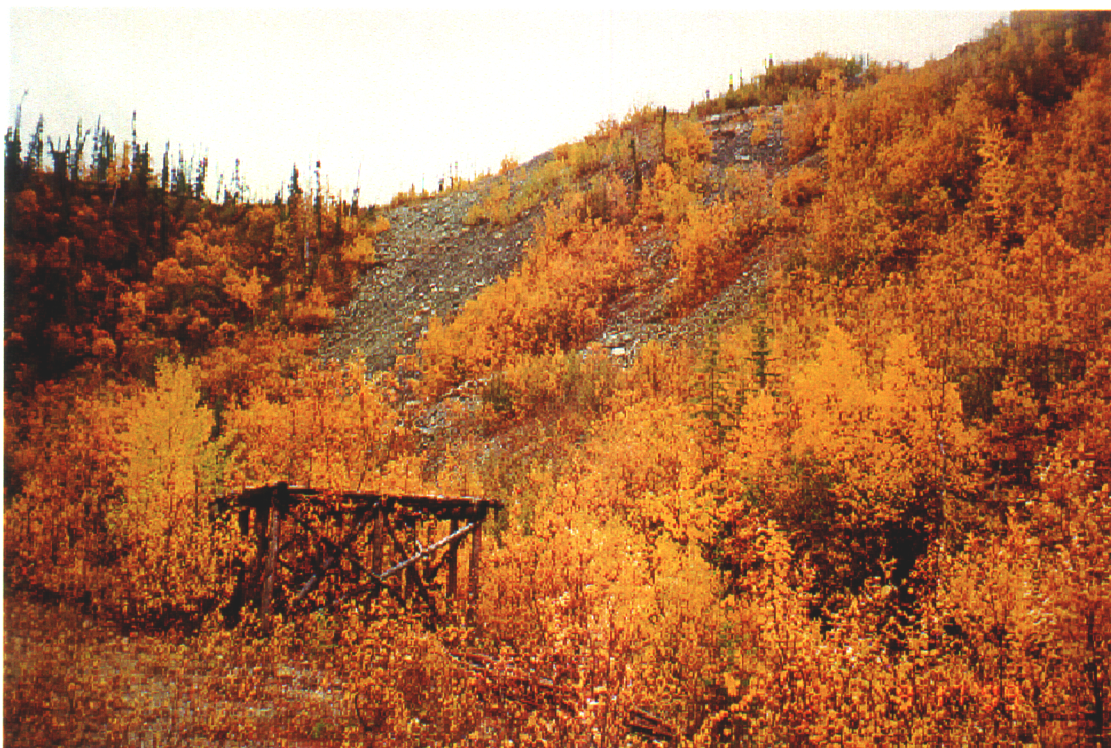
The waste rock from the adit and the excavation located above the adit was dumped down the hillside (photo 58-6). The waste rock dump below the adit extends down to Christal Creek. The rock in the upper waste rock dump has started to slump down the hillside.

Photo 58-6: Waste rock on slope adjacent to adit.

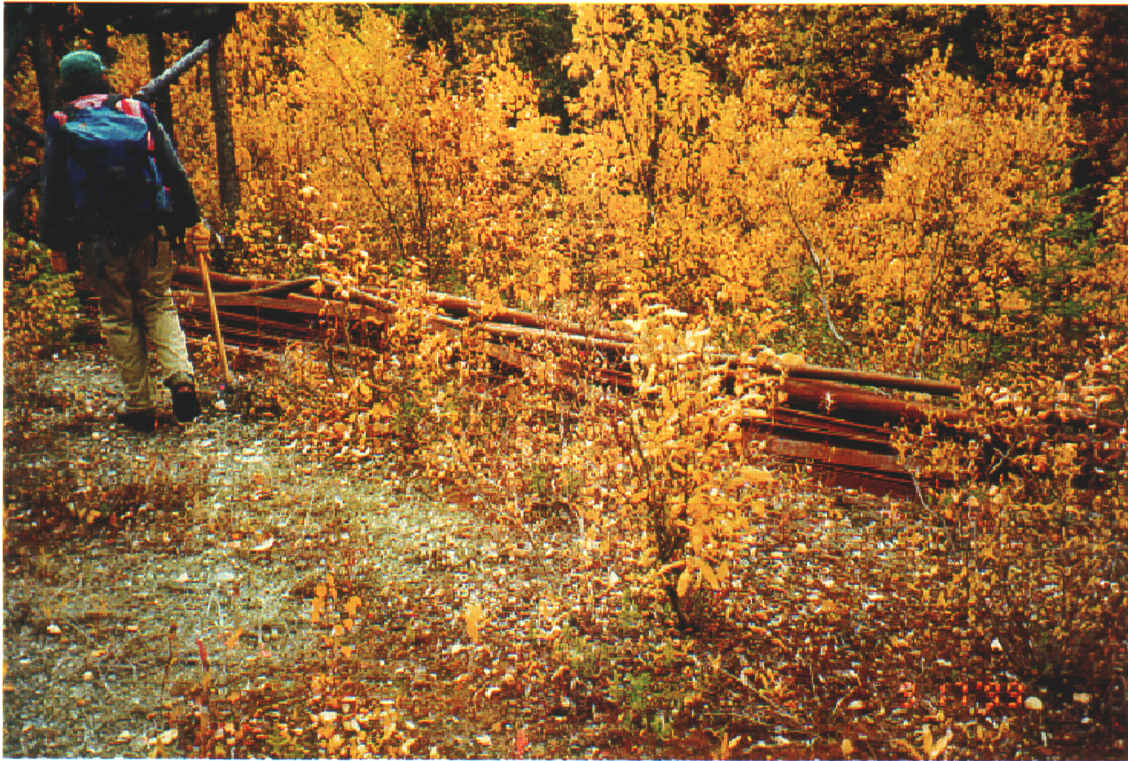
Condition: Rails are in satisfactory condition, however, they have been removed and there is no evidence of their former location.

Photo 58-7: Stockpiled rail below adit.

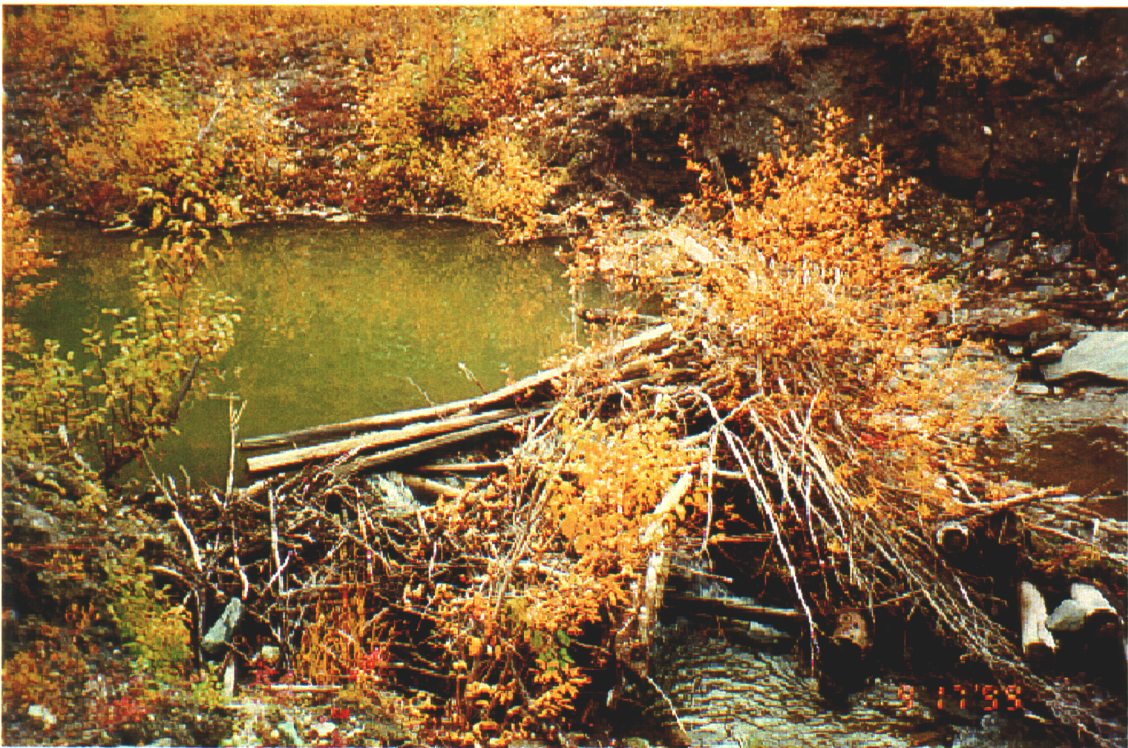
Christal Creek was sampled upstream of the site immediately upstream of a beaver dam (photo 58-8) constructed at the collapsed bridge (58-WQ-StrCD-02). The beaver dam was not identified in previous assessments and is probably of recent construction. Christal Creek was also sampled downstream of the site, immediately upstream of the north collapsed bridge (58-WQ-StrCD-01) at a location similar to previous sampling programs (photo 58-9).

Photo 58-8: Beaver dam immediately downstream of site.

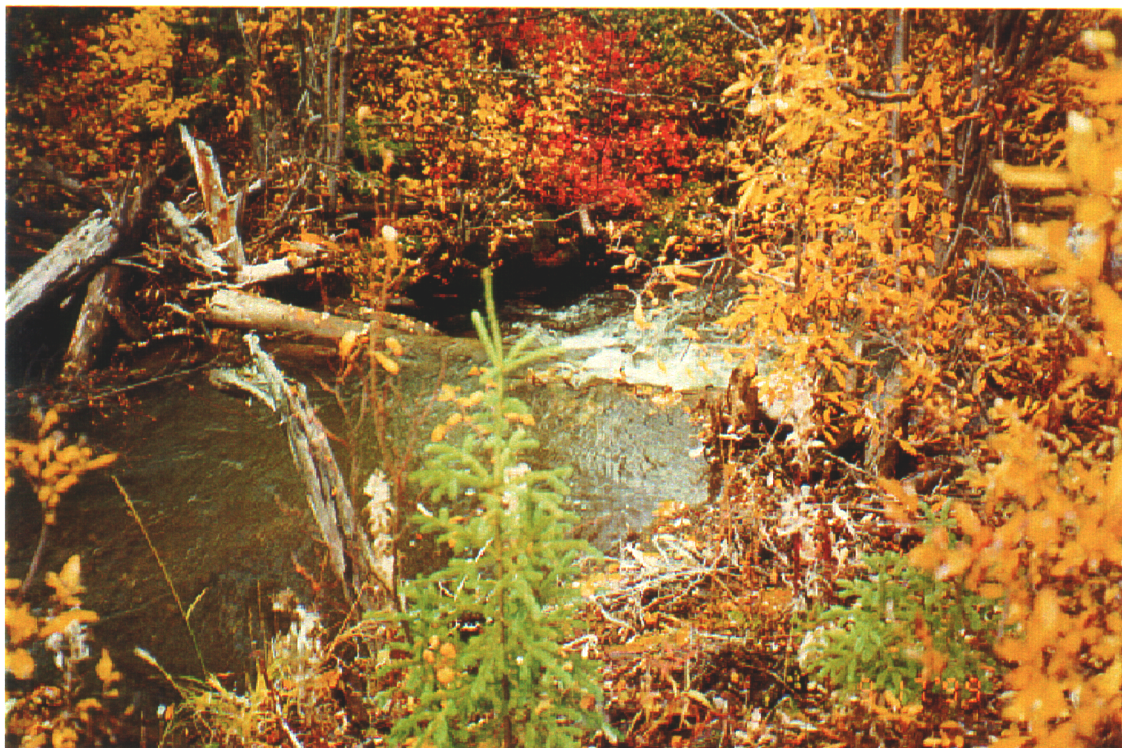
Photo 58-9: Second collapsed bridge downstream of site.
