EAGLE
Site No. 59
MINEFILE: 105M 021

Public Works And Government Services Canada	Travaux publics et Services gouvernementaux Canada	designed by: consou par:	date:
	Architecture & Engineering Services Western Region		drawn by: dessin par:	NOV. /99
			approved by: approuvé par:	
			revisions:	
Drawing title:	Eagle Site #59 Site Assessment Yukon Territory		project no. no. du projet:	125-12.01
			dup. no. dessin no.	1 of 1

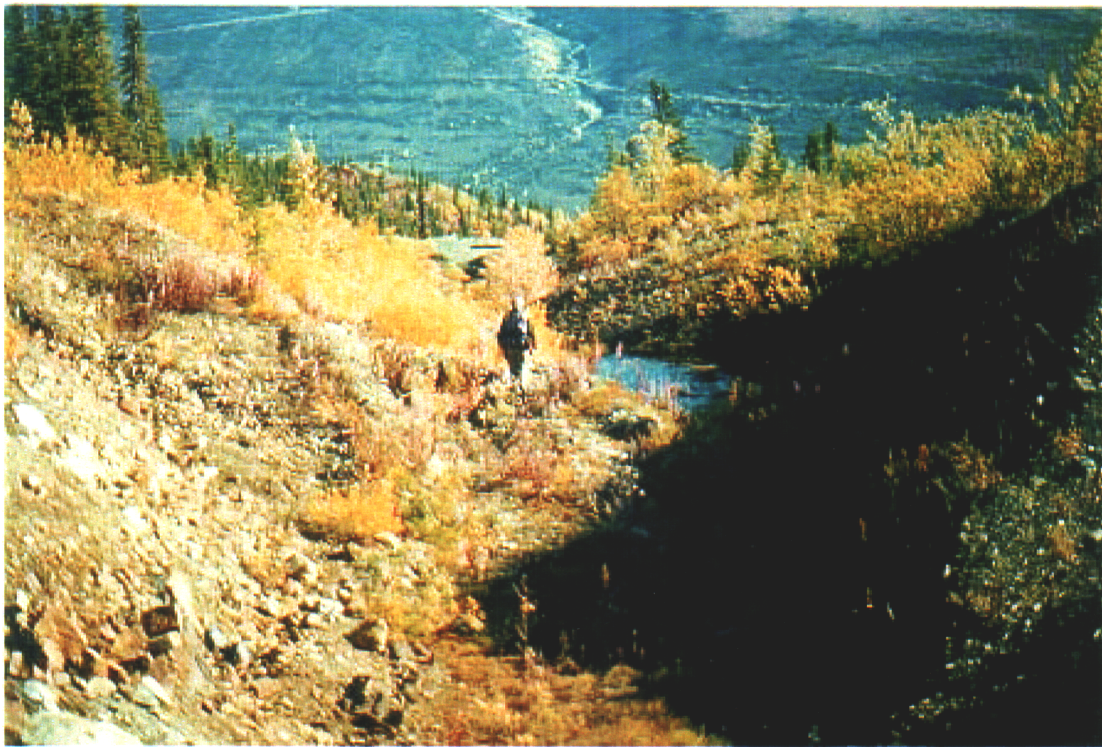
Large Trench (Photo 59-1)

Condition: The trench walls are stable.

Photo 59-1. Trench, looking eastward from below the shaft.

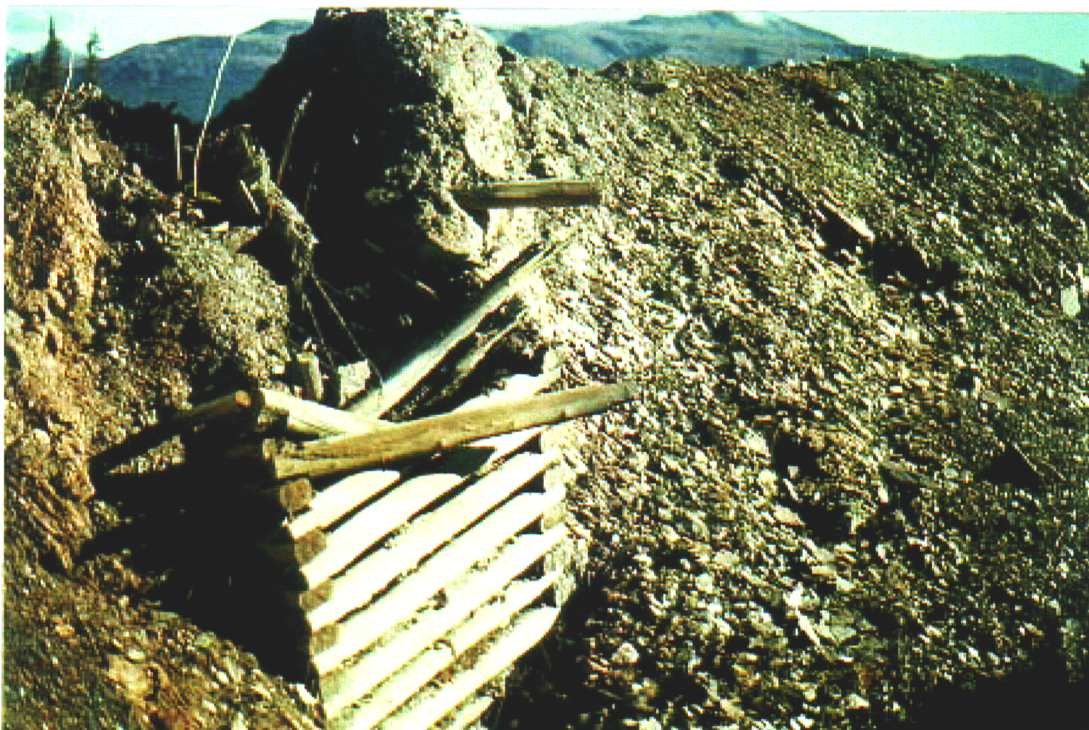
Shaft (Photo 59-2)

Condition: The shaft has completely collapsed. The trench was excavated around the shaft.

Photo 59-2. Collapsed shaft in center of trench.

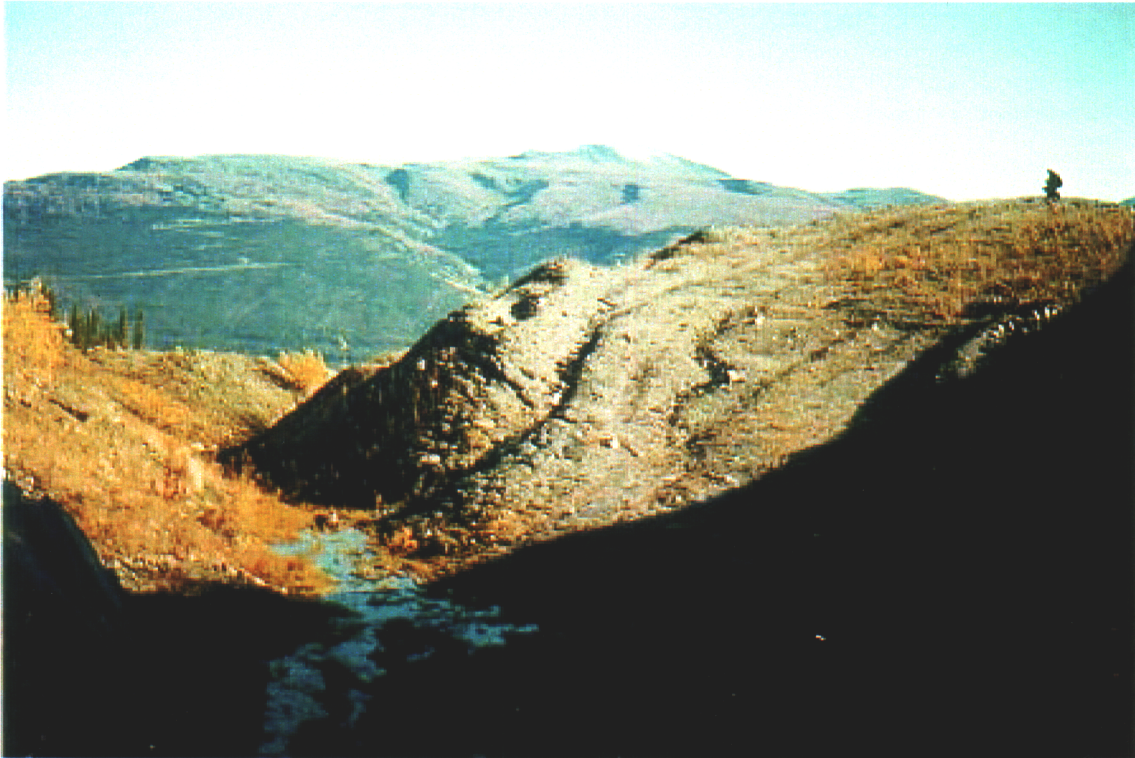
The waste rock dumps at the site were formed by pushing rock up the sides of the trench during excavation. The largest dump, located near the upper (western) end of the trench, comprises approximately 3,000 m³ of rock (Photo 59-3). Quartzite, schist, and quartz vein material make up most of the surface of the dump. All waste rock dumps appear stable.

Few sulfides and little iron staining was seen on the surface of the waste dumps. There was no evidence of seeps from the dump, and no apparent impact on the vegetation growing around it. No waste rock samples were collected from the dump.

Photo 59-3. Main waste rock pile, looking east. Note water from seep and revegetation of waste rock.

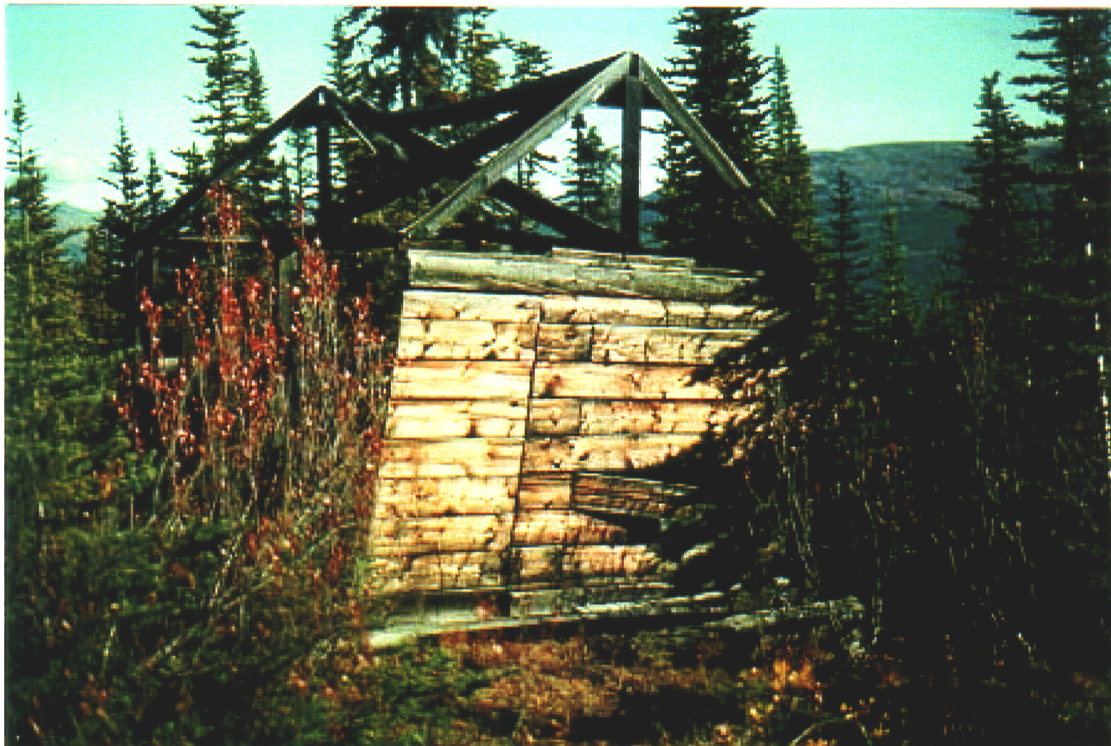
Building 59A - Cabin

Surrounding area: Two empty barrels, one tire and some pieces of metal were seen.

Photo 59-4. Wooden cabin.

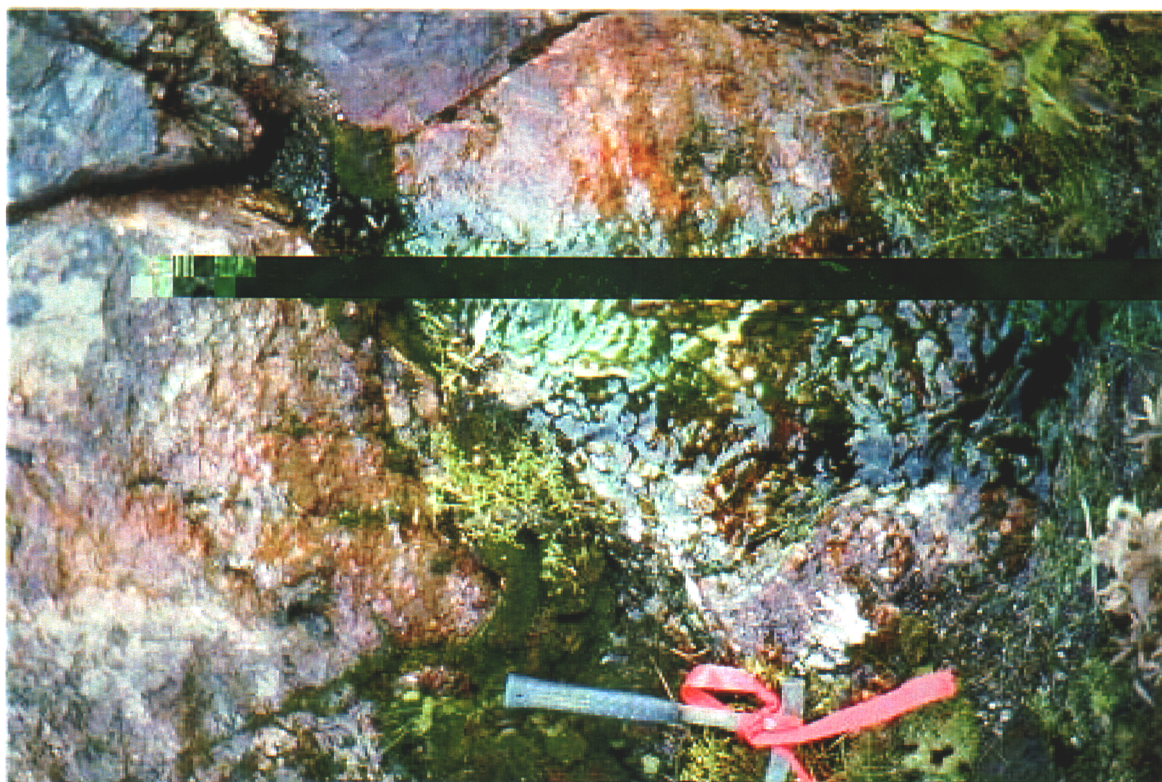
One water sample (59-01-seep) was collected near the upper (western) end of the main trench, from a seep in the footwall of the vein. The flow was < 0.5 L/s. The pH was 7.0 and the conductivity was 80 μ S. Abundant green moss was growing in the seepage. The seep water flows down the trench and then exits it before reaching the shaft. The fall water quality analysis of this sample is provided in Table 1.

Photo 59-5. Seep from the rock around the vein. Note green moss growing in water.
