**FISHER**  
**SITE #60**  
**MINFILE# 105M022**

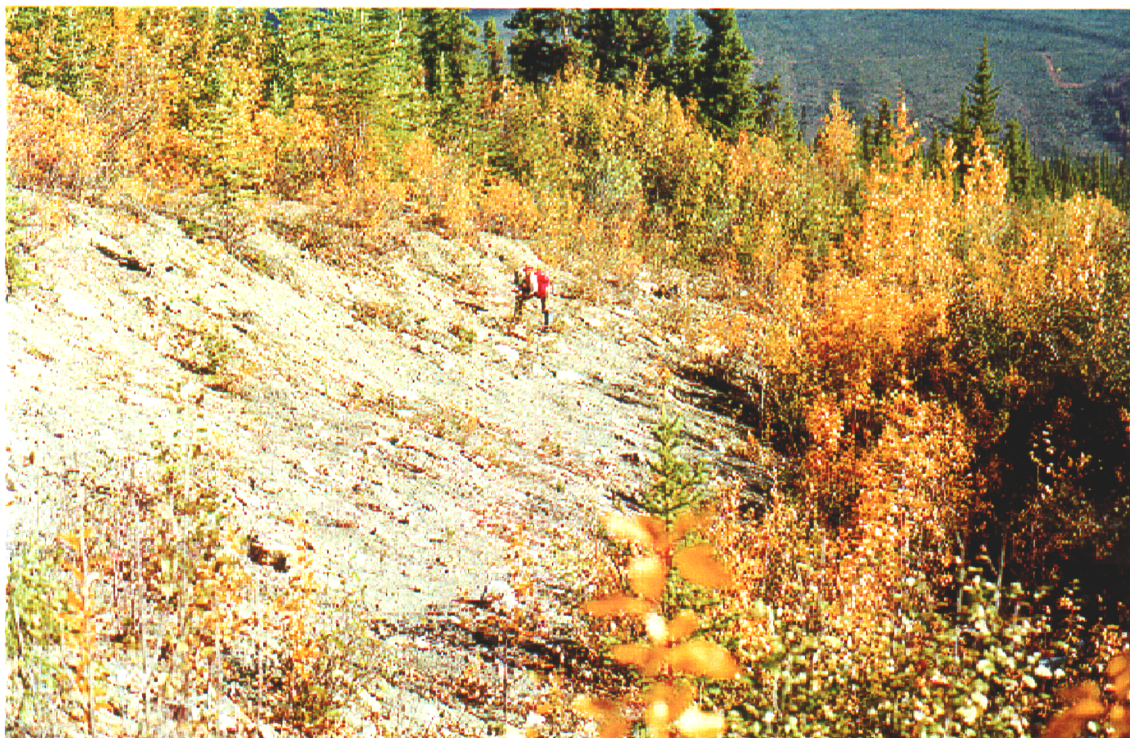
### **Trench (photo 60-1)**

The trench was excavated in overburden creating a shallow cleared area comprised of sand, gravel and boulders. The trench is oriented at 320°. There is no visible outcropping of rock.

Dimensions (L x W x H): 60m x 20m (at rim) x 8m

Condition: There is no danger of stability problems as the trench is so shallow and the sides are gently sloped. The bottom of the trench has sparse vegetation of grasses and small bushes.

The trench is revegetating slowly with bushes and grasses. The vegetation in the area appears healthy.

Photo 60-1: View of trench 1. (Azimuth 140°)
