NORD (#62)
(MINFILE# 105M 025)

1. LOCATION AND ACCESS

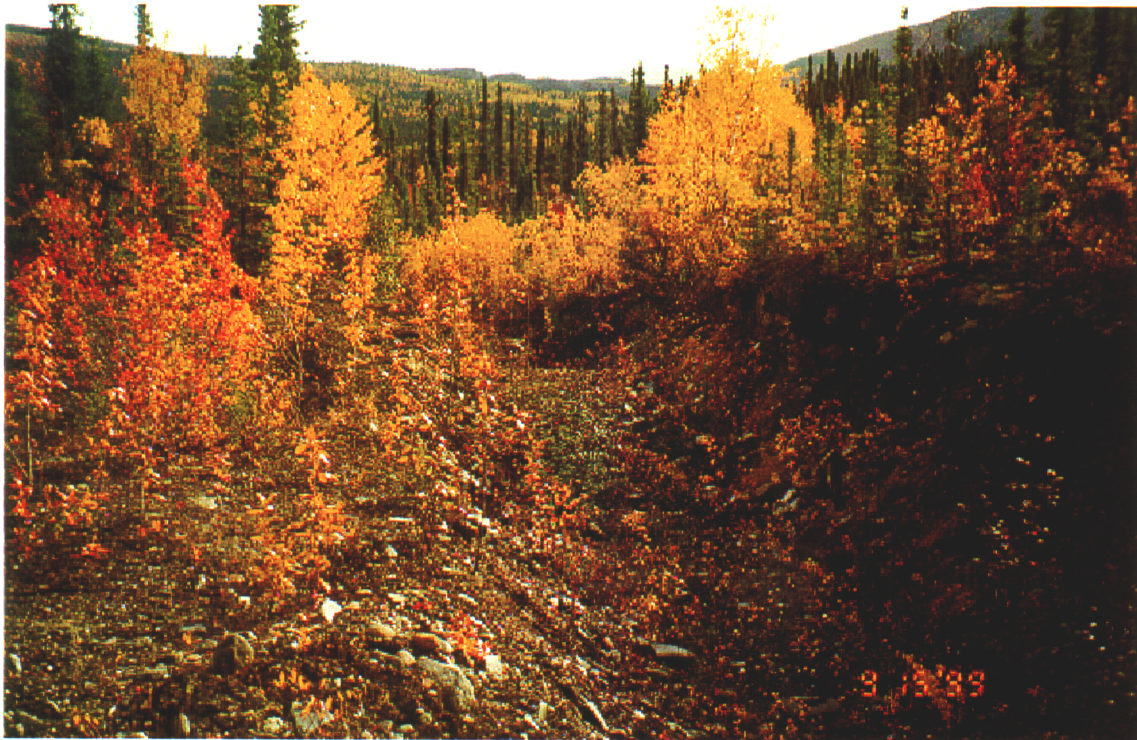
Trenches (photo 62-1)

The main vein is exposed in a bedrock sidehill trench beside the road, with a steep rock wall on the road side and material pushed downslope.

Condition: The trench is stable, with solid rock on its wall. The loose material is at a stable angle of repose, with some natural revegetation. The trench does not appear to be a hazard, except possibly to vehicles driving off the road over the steep bank.

Photo 62-1: Partially overgrown trench adjacent to road.
