GAMBLER
SITE #73
MINFILE #105M 069

1. LOCATION AND ACCESS

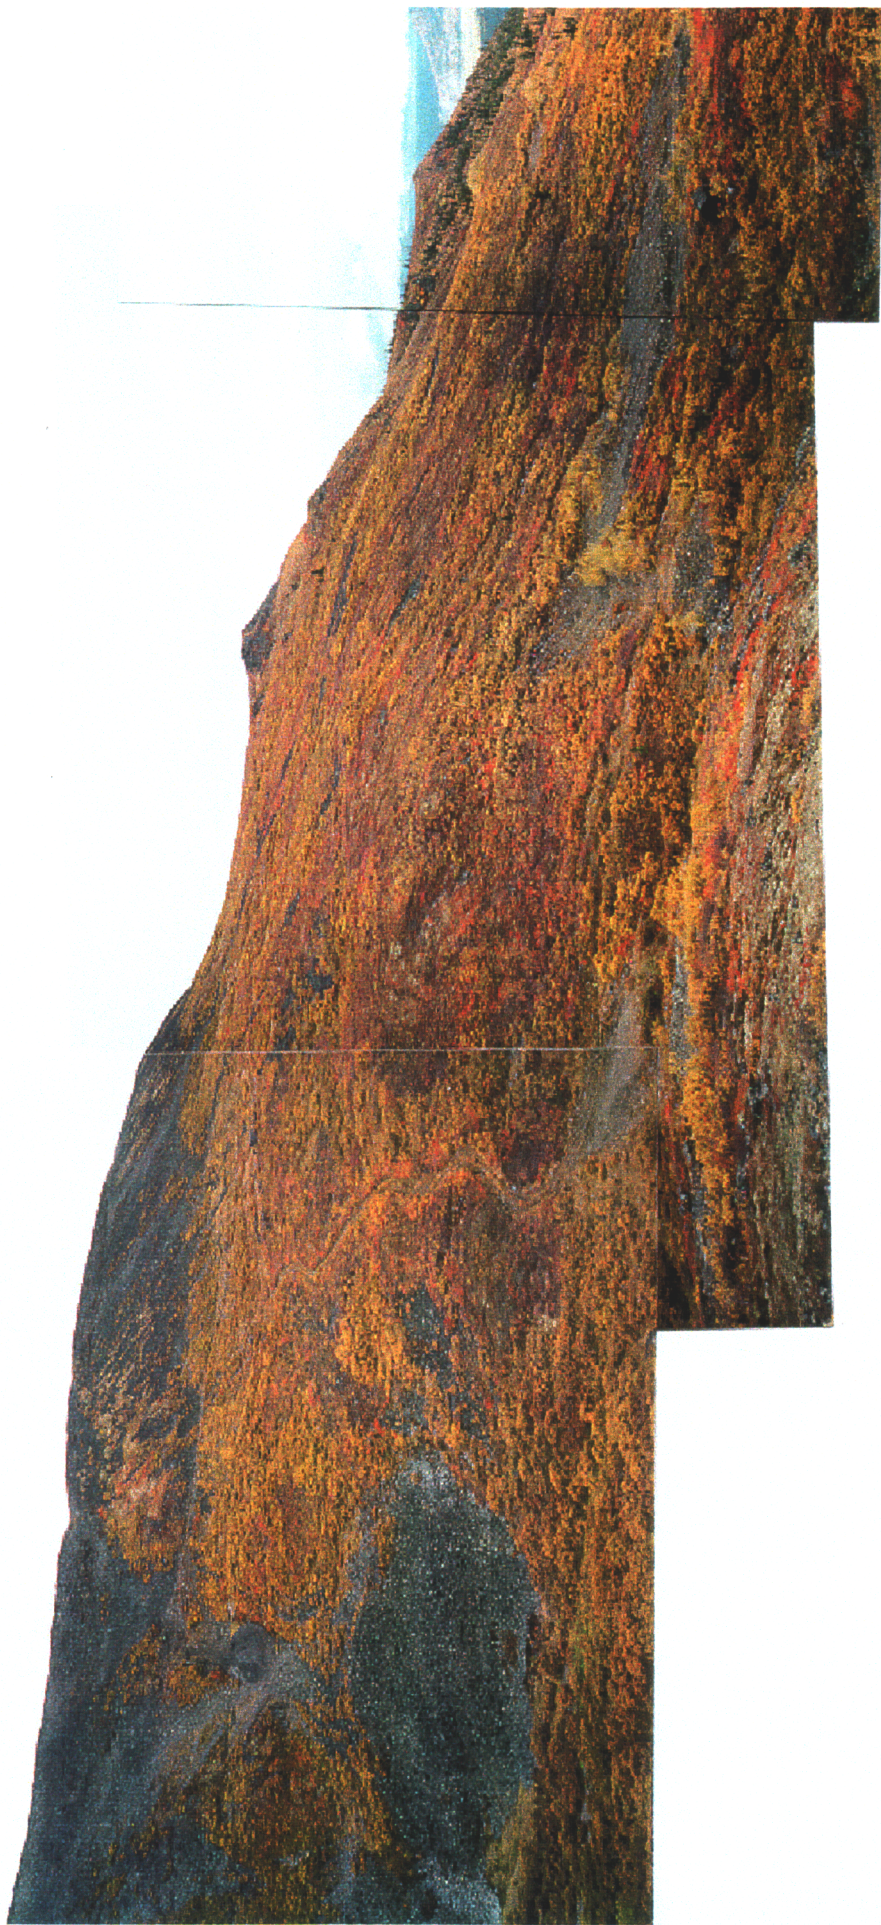
The site is on a moderately steep slope located on the northeast headwall of Faro Gulch near the Keno Summit. The site is underlain by permafrost (GSC Bulletin 111; as cited in PWGSC, 1997). Drainage flows from seeps into Faro Gulch, approximately 60m below and 300m east. The site is above tree line and is characterized by subalpine vegetation; shrubs and bushes, willows, stunted spruce trees and a variety of mosses and lichens.

There are six bulldozer trenches located in a cluster at the base of the slope roughly 250 metres east of the camp buildings. A cat road turns east down the slope from the access trail just past the camp. Three of the trenches are 50m in length and oriented at 045°, 047° and 050°. The other three trenches are 20m in length and oriented at 110°, 110° and 160°. The trenches are easily accessed, shallow and have been partially backfilled.

Photo 73-1: Overview of Gambler site showing mine workings to left, camp buildings left of middle, and more recent surface cat trenches at bottom.

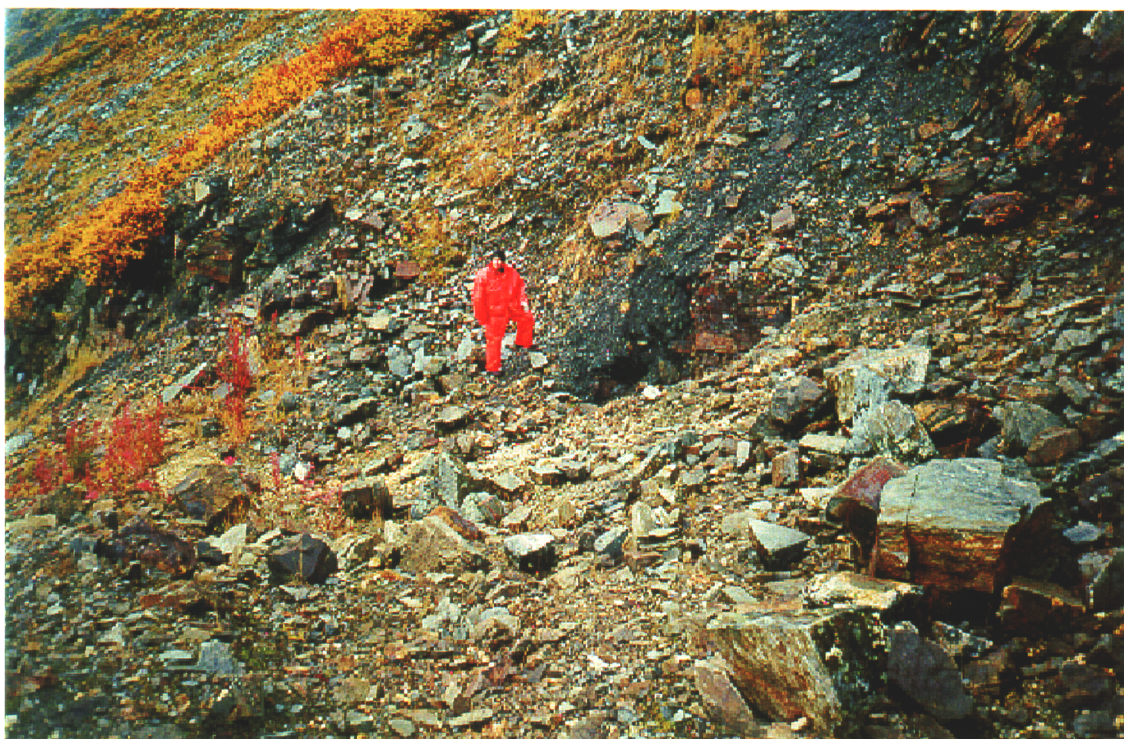
The entrance to the adit is collapsed and is buried with waste rock and overburden.

Condition: The adit appeared stable at the time of the site visit.

Accessibility: Due to the collapse, the adit can not be accessed.

Photo 73-2: Overview of lower adit level from upper adit level. Photo Direction (Azimuth 060°)

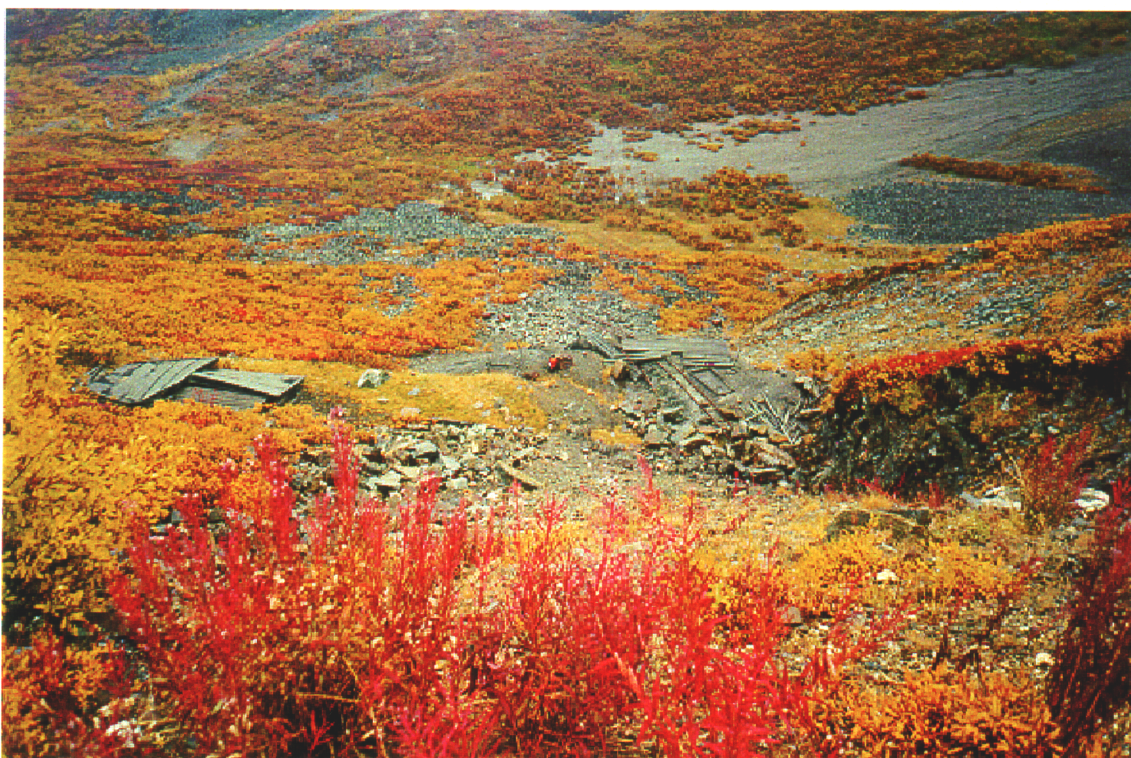
The entrance to the adit has collapsed.

Condition: The adit appeared stable at the time of the site visit, although intermittent rock fall from excavation is expected.

Accessibility: Due to the collapse, the adit can not be accessed.

Photo 73-3: Upper Gambler adit level. (Azimuth 170°)

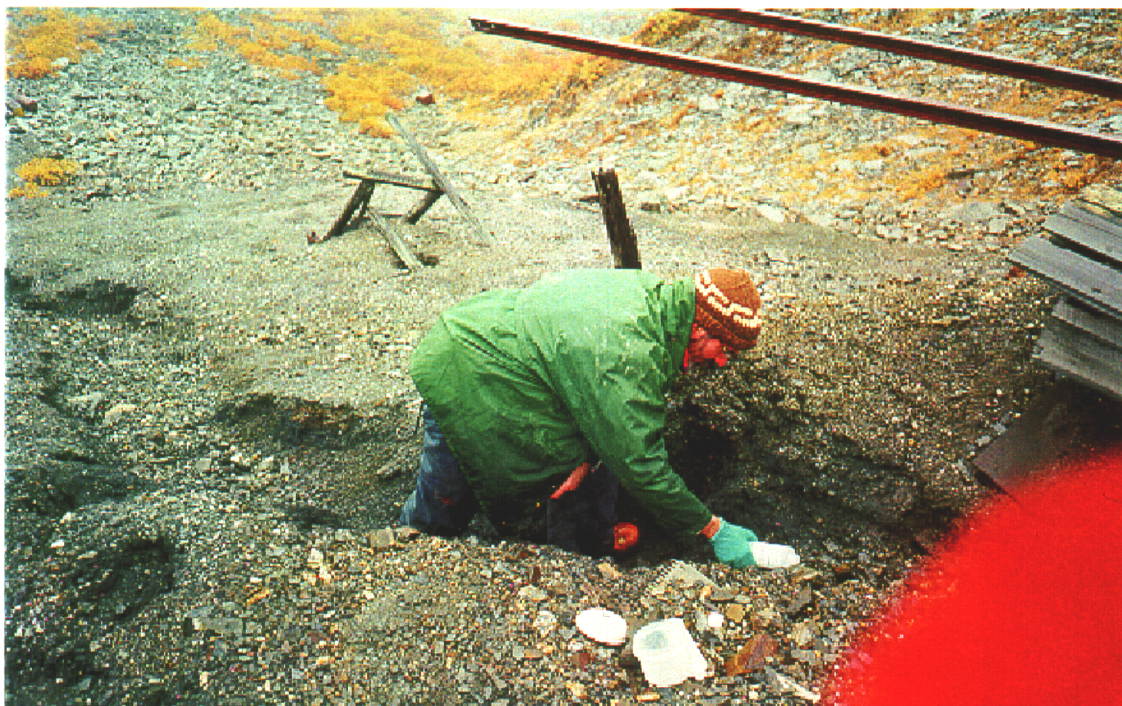
The only surface water encountered at the site was flowing from the lower adit at a rate of less than 1 L/s (visual determination). The water flowed at the surface for less than 10m before disappearing into the ground at the northern edge of the waste pile. No water was observed flowing from the upper adit.

Photo 73-4: Lower Gambler adit drainage sample site (73-WQ-A01-01/-02). (Azimuth 070°)

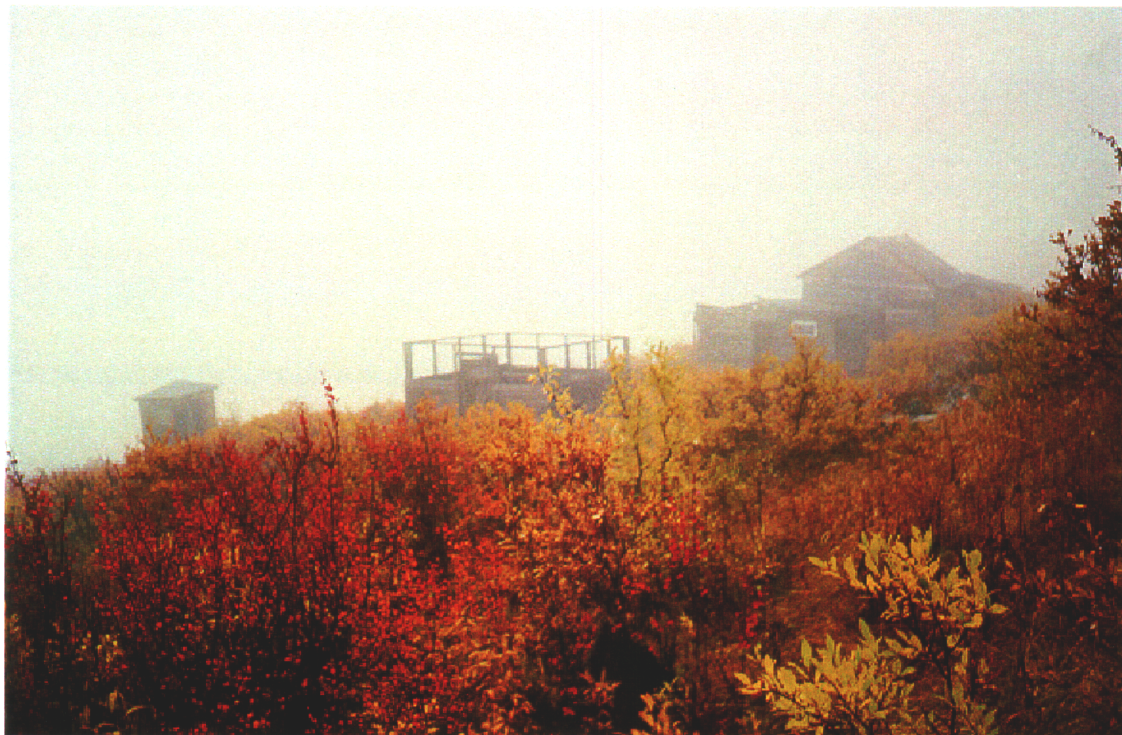
There are 5 buildings at the site. Most of the buildings appeared to be in the same condition as they were in 1996 (PWGSC, 1997). Buildings locations are marked on the site map (Figure 1). A pile wooden platforms or collapsed walls occurs adjacent to the lower adit. There could be part of a collapsed

The shed is fairly unstable: the roof has partially collapsed and the floor is in fair to poor condition.

The floor is in fair to poor condition.

The outhouse leans at angle, but is in stable condition.

Photo 73-5: Overview of Gambler camp buildings. No changes noted since 1996 inspection. (Azimuth 130°)
