**BEMA (#75)**  
**(MINFILE# 105M 073)**

**1. LOCATION AND ACCESS**

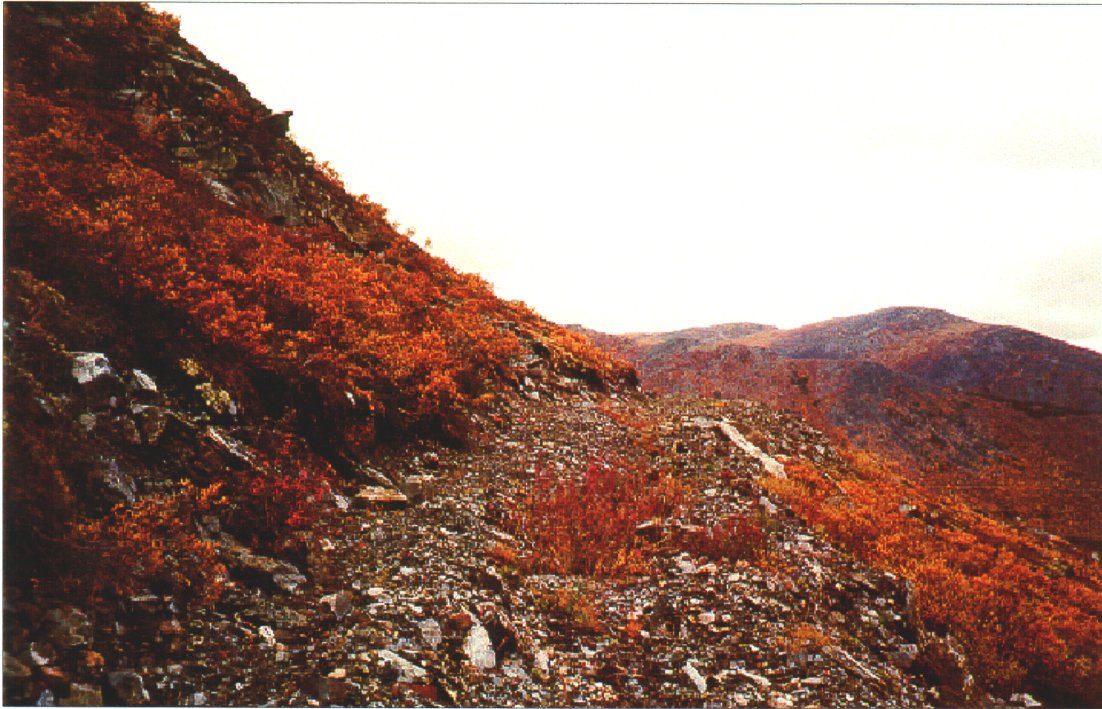
Trench 1 (photo 75-1)

Trench 1 is the only development at the Bema site. It is an exploratory bulldozer trench cut along the contour of the hill. A ripper slot extends about 150 m north down a spur from the trench.

Dimensions: 118 m x 3 m x 1.5 m

Condition: stable

Photo 75-1: View along length of trench cut into side of hill (Trench1) at Bema site.
