TOWNSITE MINE # 76
(MINFILE # omitted from minfile)

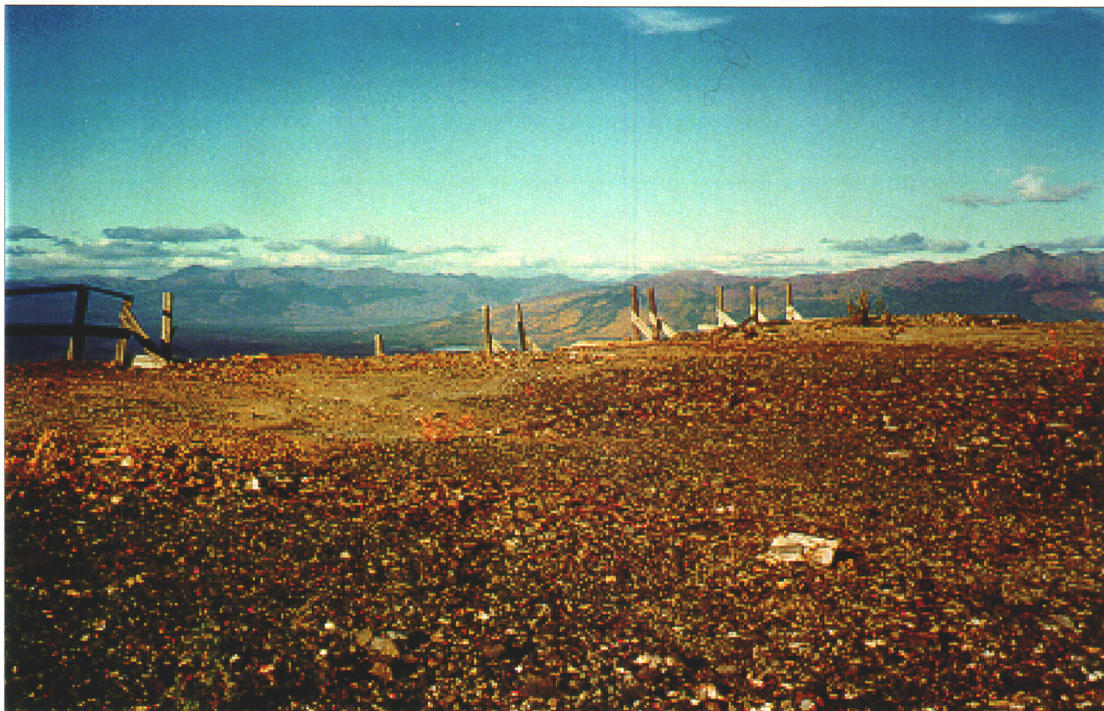
Comprised of development waste rock, vein material and the quartzite excavated to collar the portal. (~ 13,000 tonnes). The dump consists of barren quartzite, schist and quartz veining. It exhibits moderate limonite staining (Oct. 1 F05-P09). There is a small kill zone directly below the dump (~30 m down slope x ~10 m Wide), which does not appear to be regenerating vegetation. There is no sign of any appreciable surface drainage through the dump. Two samples were reported in the literature. These samples consisted of ABA testing conducted in 1995 on two samples, one indicating that it had the potential to produce acid.

Photo 76-1: Facing north from the adit across loading area and dump site.

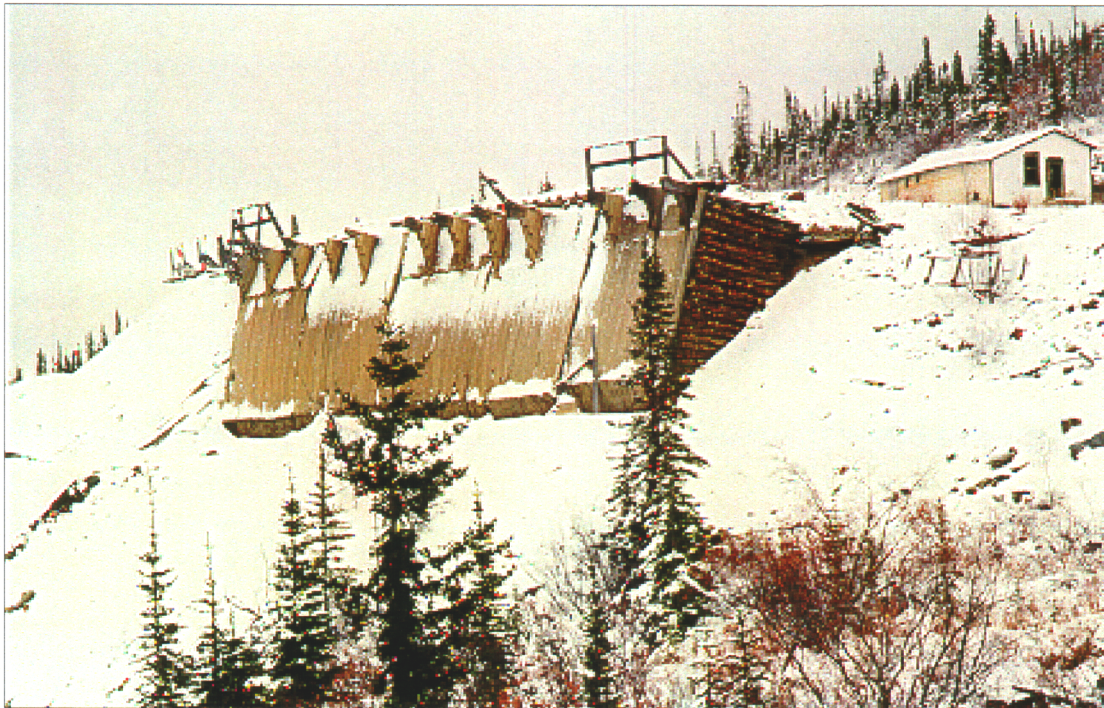
There are two buildings at the site. Building 76A serves as a workshop and office accommodations on two separate levels. Building 76B is the portal entranceway. There was building debris scattered around the site, however, there was no visual sign of staining on the surrounding soils. Wood cribbing and some wood sheathing (photo 76-1) is located to the west of the road to reinforce a waste rock dump that was used as a loading area (photo 76-2).

Photo 76-2: Timber retaining structure for the loading area.

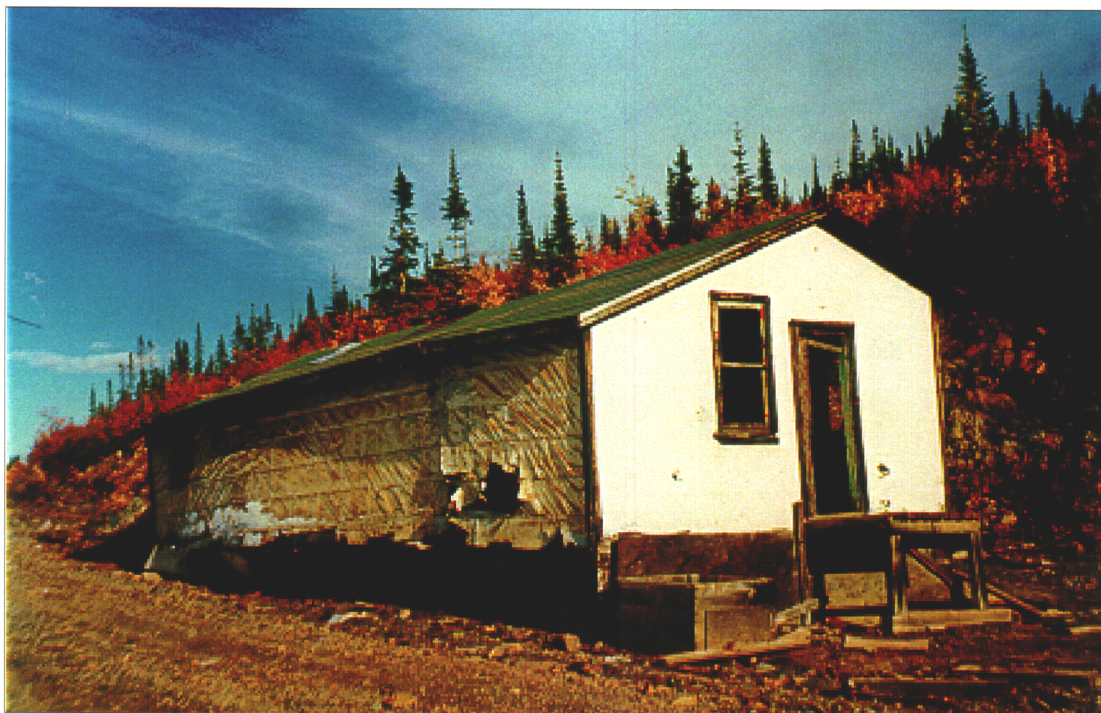
Building 76A – Office/Workshop (photo 76-3)

Office and workshop combined. Flooring is dirt on the lower level that has sustained some staining due to the nature of operations. Fibreglass insulation was used in the office area.

Asbestos: There is the possibility of the office floor tiles having asbestos (see samples below).

Samples: No samples were taken at building 76A. The tile flooring in the building was similar in nature to the tiles found at the Dixie Mine in Building 4A. Analyses completed on the sample indicated that there was some asbestos fiber in the sample, however, it tested between 1-10% indicating that there is very little asbestos in the tiles.

Photo 76-3: Timber frame structure to the northeast of the adit.

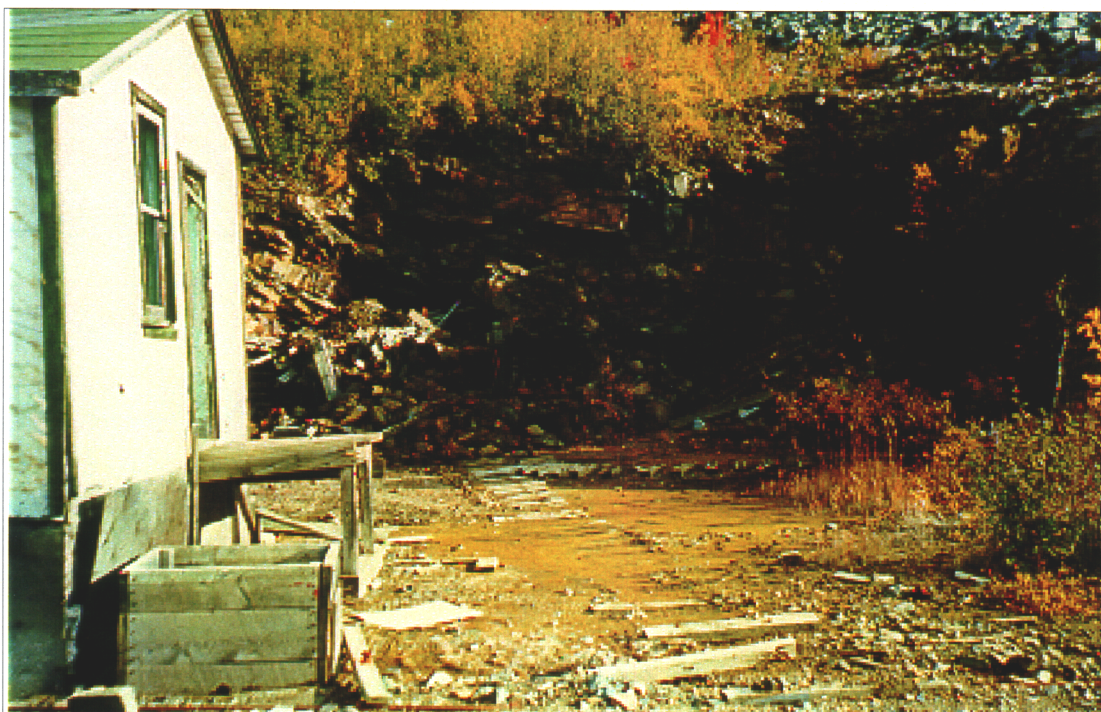
Building 76B - Adit Entrance (photo 76-4)

The portal is caved and totally blocked. There is no sign of any drainage from the adit. All rail and services appear to have been removed prior to the cave in. The estimated dimensions of the drift are 2m wide x 2.5m high. The adit is reported to be 350m in length with over 650m of crosscuts and drifts on the 500 level. The adit is inaccessible and the portal area constitutes a minor hazard of rock fall from the walls of the excavation.

The portal structure was collapsed, there is timber cribbing visible, however, the rock overhang has caved in and the structure is considered a safety hazard. No services were noted at the portal. There was no drainage evident from the structure. No samples were taken at building 76B.

Photo 76-4: Tcollapsed adit in the background.

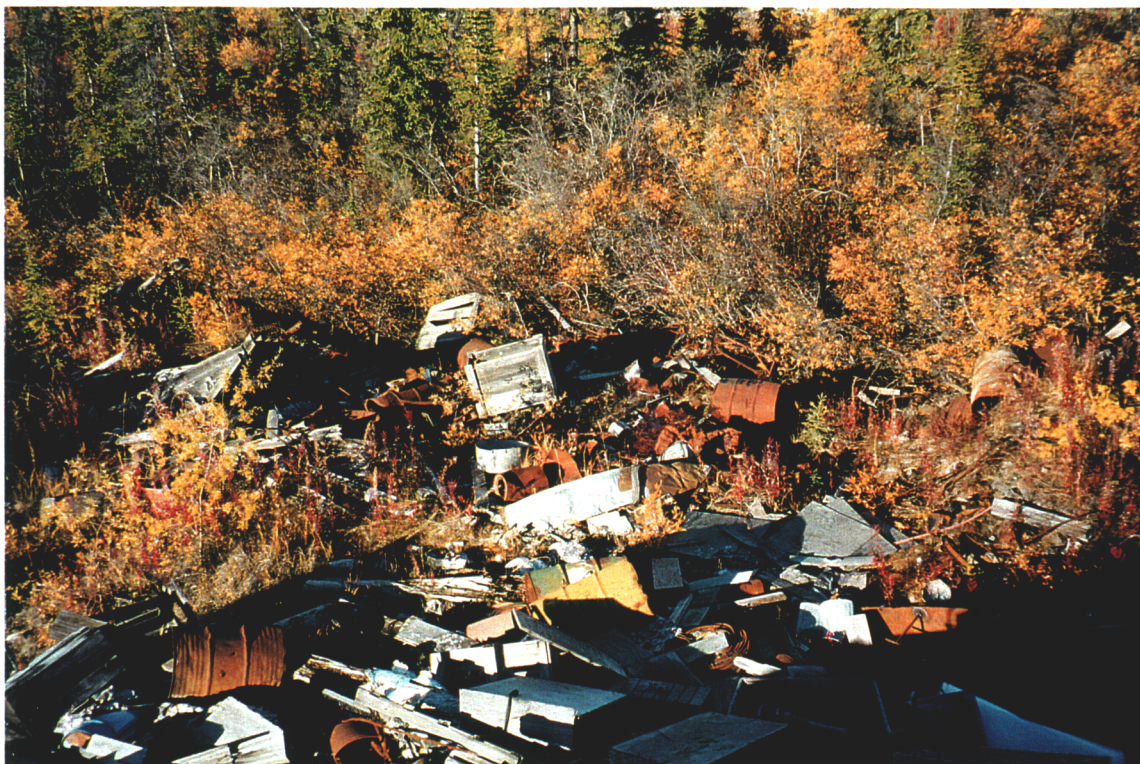
There is a landfill (~60 m x 25 m x 4 m) situated approximately 150 meters west of the Townsite site (photo 76-5). The landfill reportedly contains metal debris (rails, bed frames, pipe & discarded machinery), empty drums and lumber capped with mine waste rock. This site was used by the Calumet town and nearby mines as their garbage dump (Personal Communication - M. Phillips) and may contain other unidentified wastes. There is no sign of any appreciable drainage through the dump. There is no sign of any vegetation stress around the toe of the landfill and the surface of the landfill is revegetating. No sampling was conducted.

Photo 76-5: Photo taken 150m below the Townsite mine waste dump of the solid waste dump.
