SADIE LADUE 600 ADIT (#77) (NO MINFILE)

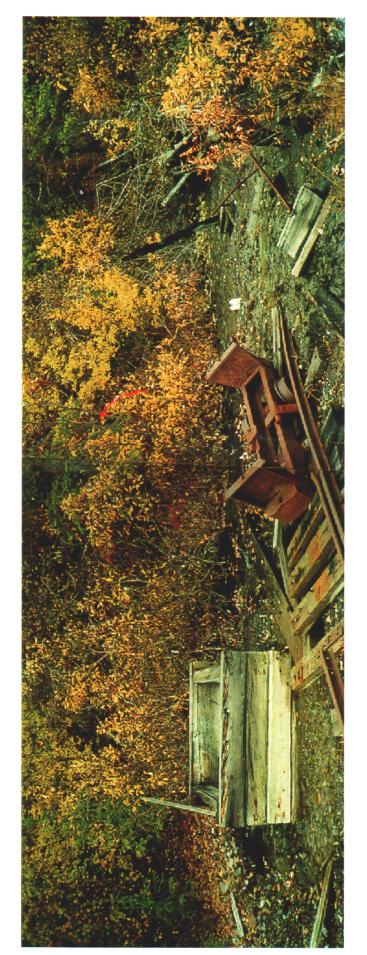
A mine water discharge of about 600-800 liters/minute flows out of the adit into a vertical shaft beside the adit. The mine water is directed via a 40 cm bolted steel culvert beneath the site and the waste rock pile, finally discharging to a gully below the site. The untreated water drains to an unnamed stream flowing into the small unnamed lake west of Gambler Lake. Upslope of the site, a poorly-defined gully channels snowmelt and runoff water onto the site; surface water then flows past the waste rock dump into a gully below the site. Vegetation stress above and below the site was evident.

Photo 77-1: Mine water from portal (right) draining down culvert opening (left).

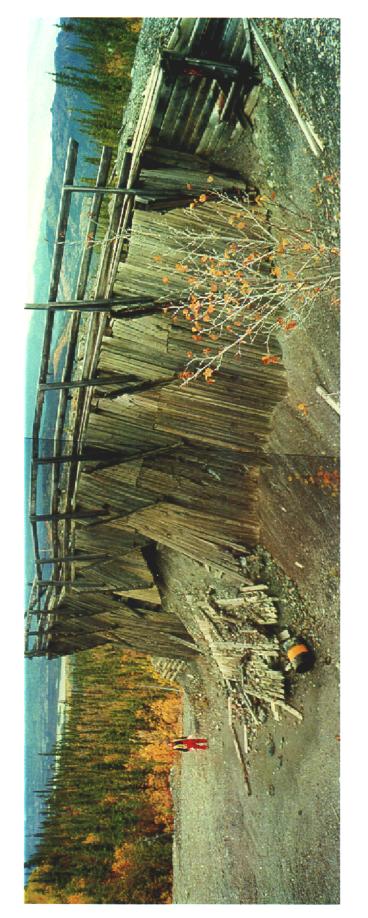
Stability: There is no evidence of the waste rock pile slumping. The waste rock pile appears stable, although the wooden loadout structure is deteriorating and could fail at any time.

Photo 77-2:Load out area.

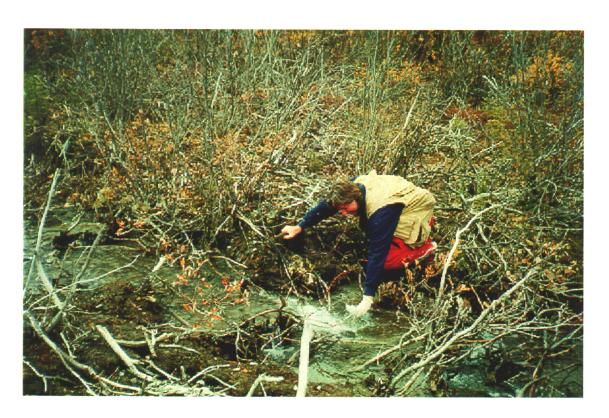
Mine water from this mine and the Ladue mill and mine site at Wemecke flows through the adit and is directed into a 0.5 m corrugated steel culvert. The culvert passes directly beneath the waste rock dump and discharges at the northwest end of the site, 85m downslope of the adit entrance. The estimated flow of the mine seepage at the time of site assessment was 4 - 5 liters/second. Discharged water flows along an unnamed stream channel toward the unnamed lake west of Gambler Lake. No discoloration or precipitated oxides were observed in the mine water or discharge stream channel.

Photo 77-3: Drainage from culvert downslope of waste rock dumps.
