## **MACKENO (#81)**

### **(NO MINFILE)**

Public Works and Government Services Canada Architectural & Engineering Services Western Region	Travaux publics et Services gouvernementaux Canada Architecture et Services d'ingénierie Région de l'ouest	Designed by: conçu par: drawn by: dessiné par: approved by: approuvé par: révisé par:	C.S.I.B. Nov. 1999
Drawing title:	Makino Site # 81 Site Assessment Yukon Territory			Project no. no. du projet:
				125-12.01
				1 of 1

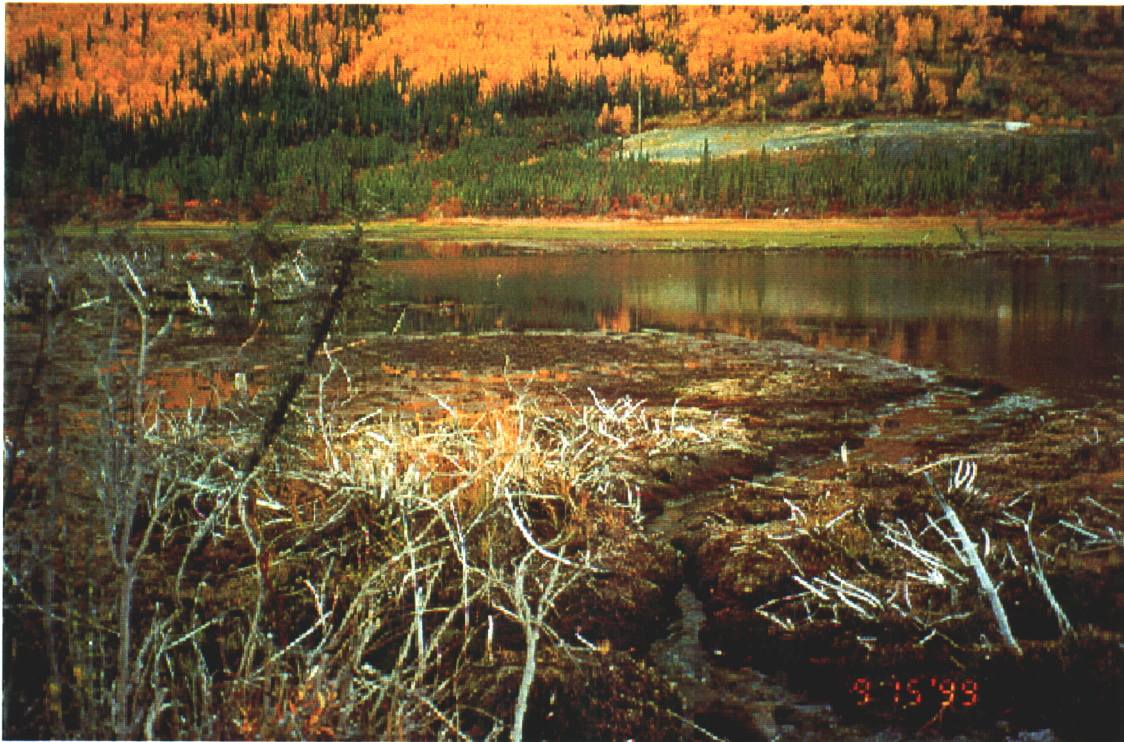
An unnamed creek flows from the east into Christal Lake, approximately 80 m south of the Christal Creek effluent through the forested area between the millsite and tailings (photos 81-1 & 81-6). The creek was sampled (81-WQ-Str-CD-04) upstream of the pumphouse. Christal Lake and Christal Creek (photo 81-3) are immediately downstream of the site and both were sampled adjacent to the tailings area. A water sample (81-WQ-Str-CD-02) was collected from the lake immediately west of the beaver dam enclosing the tailings pond. Another water sample (81-WQ-Str-CD-03) was collected from Christal Creek immediately downstream of the small tailings fan where tailings were reportedly pumped directly into the creek.

Photo 81-1: Mouth of unnamed creek at Christal Lake.

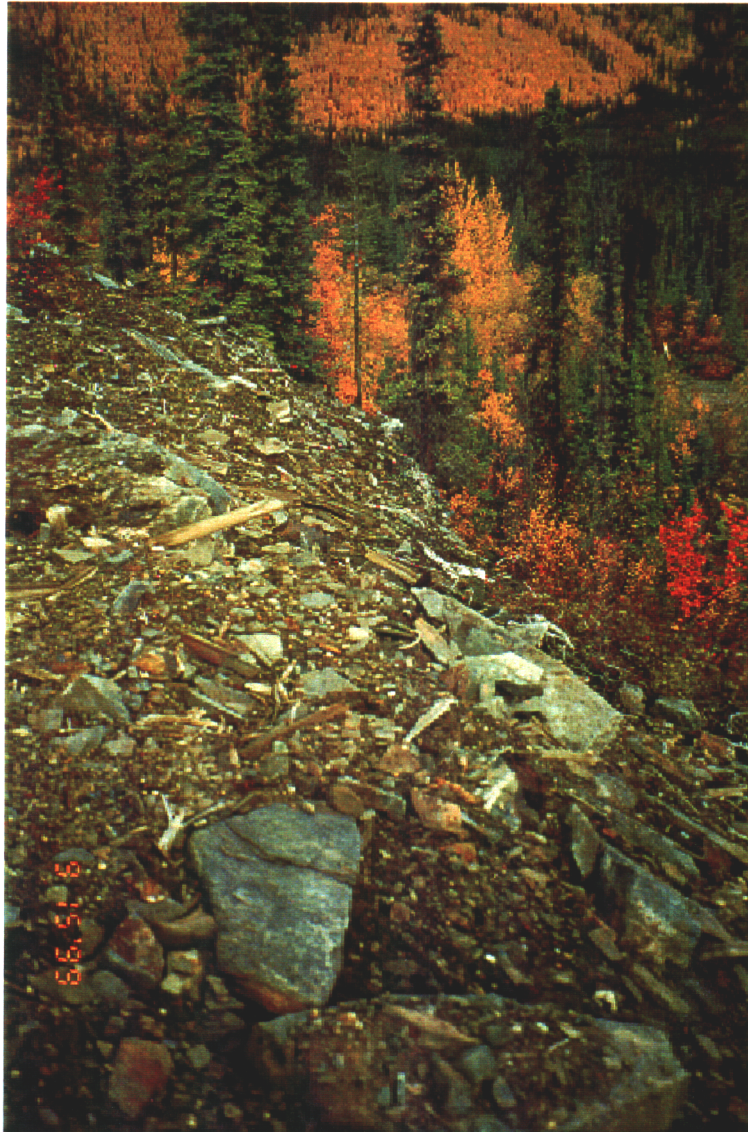
The site is located on the east and north east shore of Christal Lake (photo 81-1). The site slopes gradually to the west and south west down to the lake. The millsite itself consists of two adjacent cleared areas separated by a steep embankment approximately 3 m high running east-west (photo 81-2) and the tailings area, approximately 200 m to the north of the main site through a primary forest. South and south west of the millsite, much of the property is forested with considerable areas of second growth willow saplings. Further south, the forest is dominated by mature spruce forest and the area is relatively flat, sloping down towards Christal Lake to the west.

Photo 81-2: North slope south millsite area. Note wood debris.

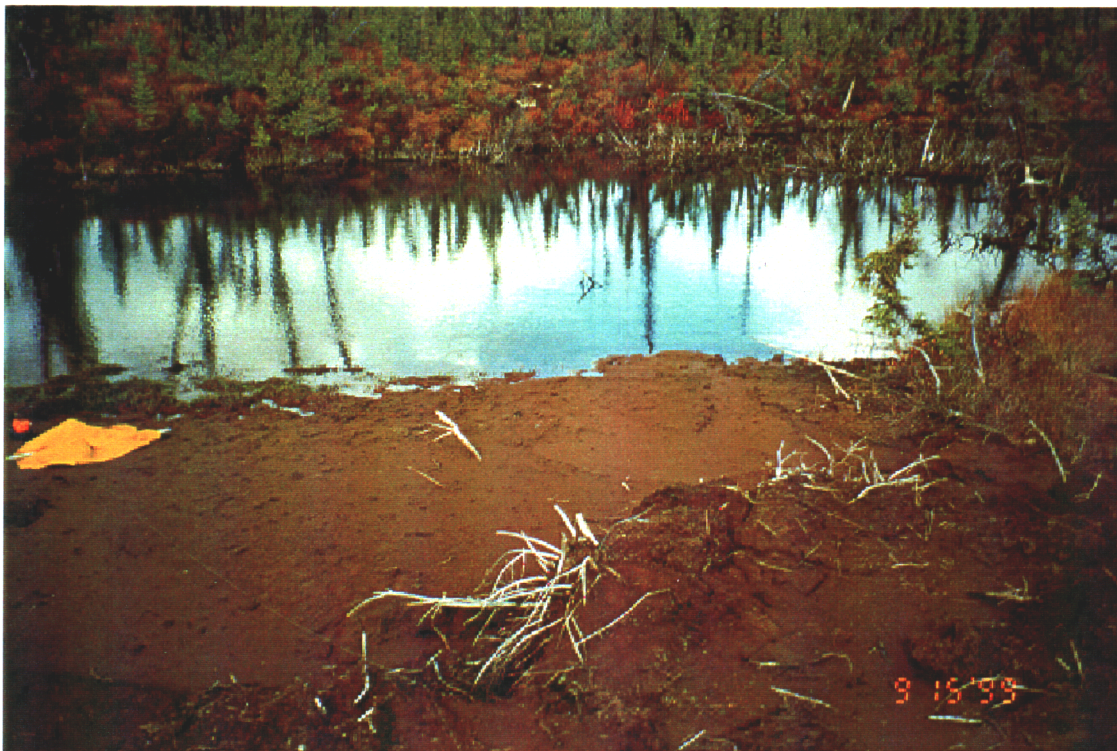
The tailings area abuts directly on the lakeshore, with some tailings noted in the lake (photos 81-3 & 81-4). A portion of the tailings also forms a fan at the mouth of Christal Creek at the north end of the site (photo 81-5). The site slopes gradually down to the lakeshore to the west. East and south of the tailings area is a mature spruce forest. A seasonal creek flows through the forest, entering the lake immediately south of the tailings area (photos 81-1 & 81-6).

Photo 81-3: Small tailings fan directly on Christal Creek.

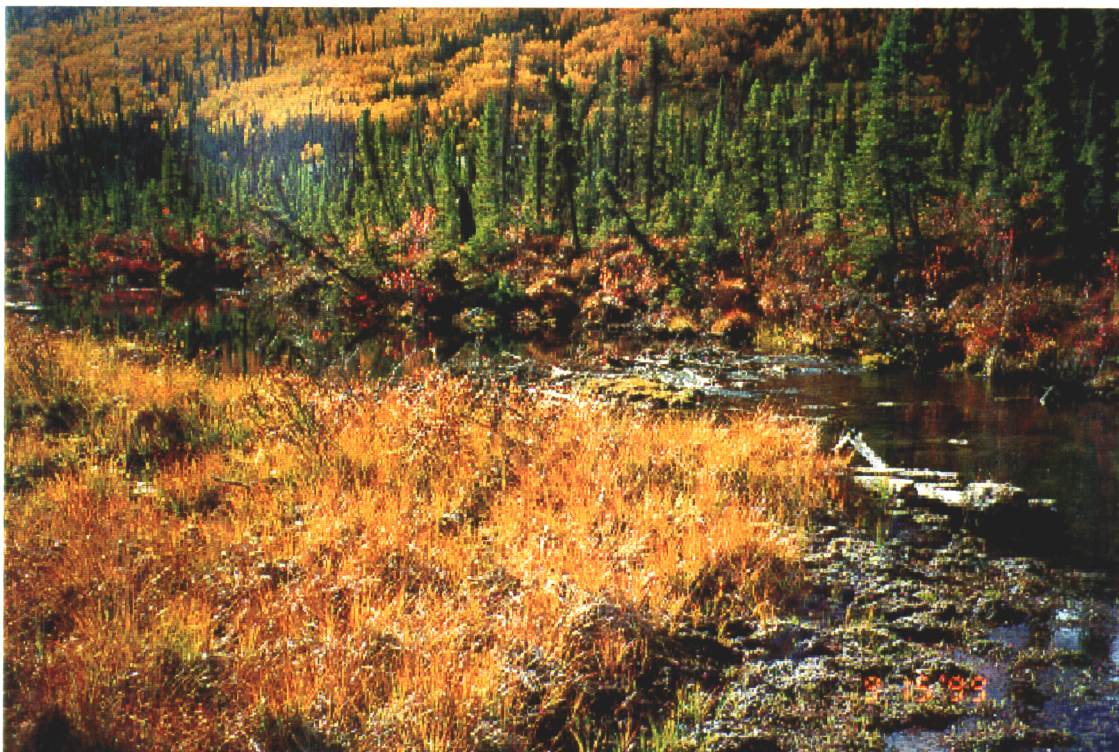
Tailings were deposited in a depression near the lakeshore, and overflowed into the lake. A wetland (sedge) area has formed between the tailings and the lake. A small portion of the impounded area immediately off-shore remains unvegetated.

Oxidation: Discoloration (orange) of tailings (on surface and at depth).

Breakthroughs: No breakthroughs were noted, however, the beaver dam is not an engineered structure and some tailings probably escape the impoundment area. As well, the dam is not a permanent structure but appears to have been present for some time.

A tailings pond has formed immediately west of the main tailings area where the tailings have entered Christal Lake (photo 81-4). The outer edge of the pond has been contained by a (temporary) beaver dam, however, water in the tailings pond is obviously hydraulically connected to the lake. A single water sample (81-WQ-Str-CD-01) was collected from this location.

Photo 81-4: Upstream from small tailings to near mouth of Christal Creek.

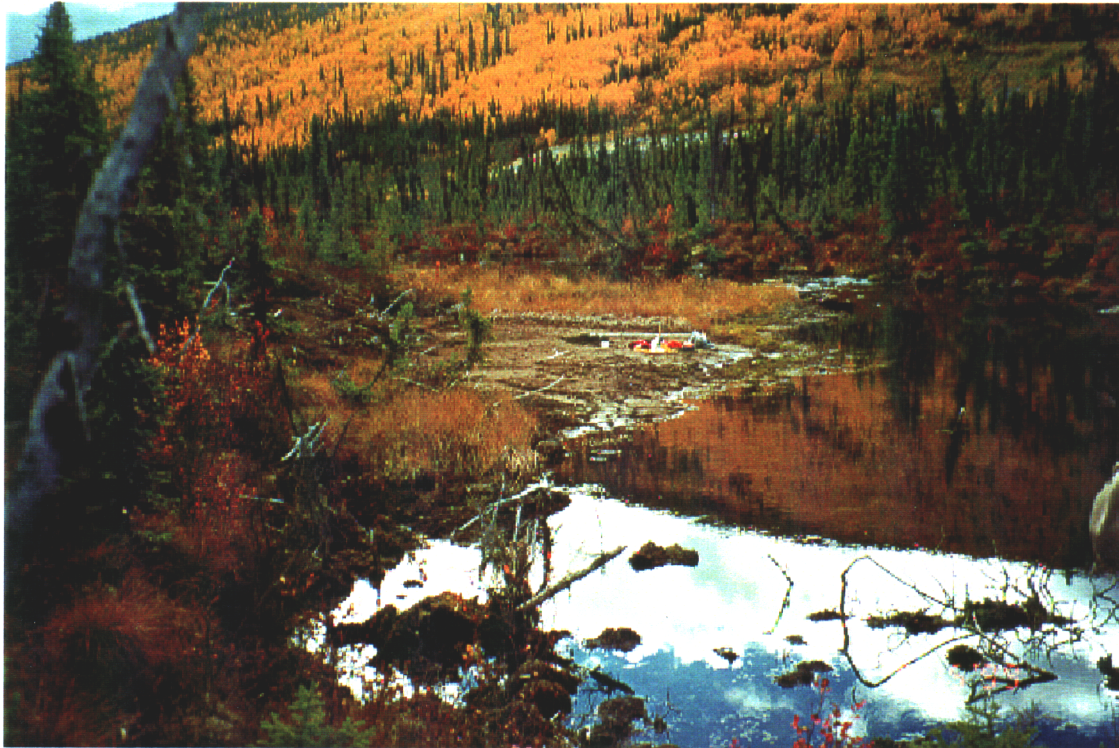
Photo 81-5: Upstream to small tailings fan on Christal Creek.

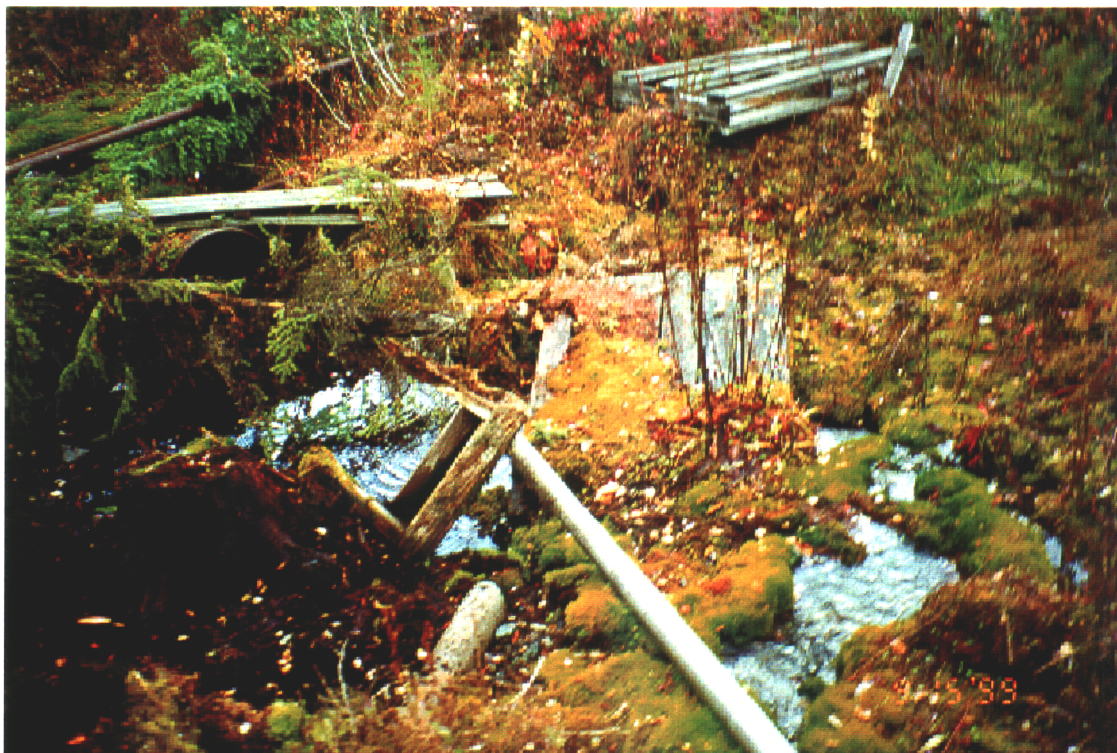
Piping between tailings pumphouse and pond: 4 and 6 inch; approximately 150 m in length; still in place through wooded area running directly along ground and through pumphouse (photo 81-6).

There has been no attempt to reclaim the old tailings site. The pumphouse and associated pipeline are present within the wooded area. The onshore tailings remain uncovered and unvegetated.

Photo 81-6: Tailings pipeline in forested area north of millsite.

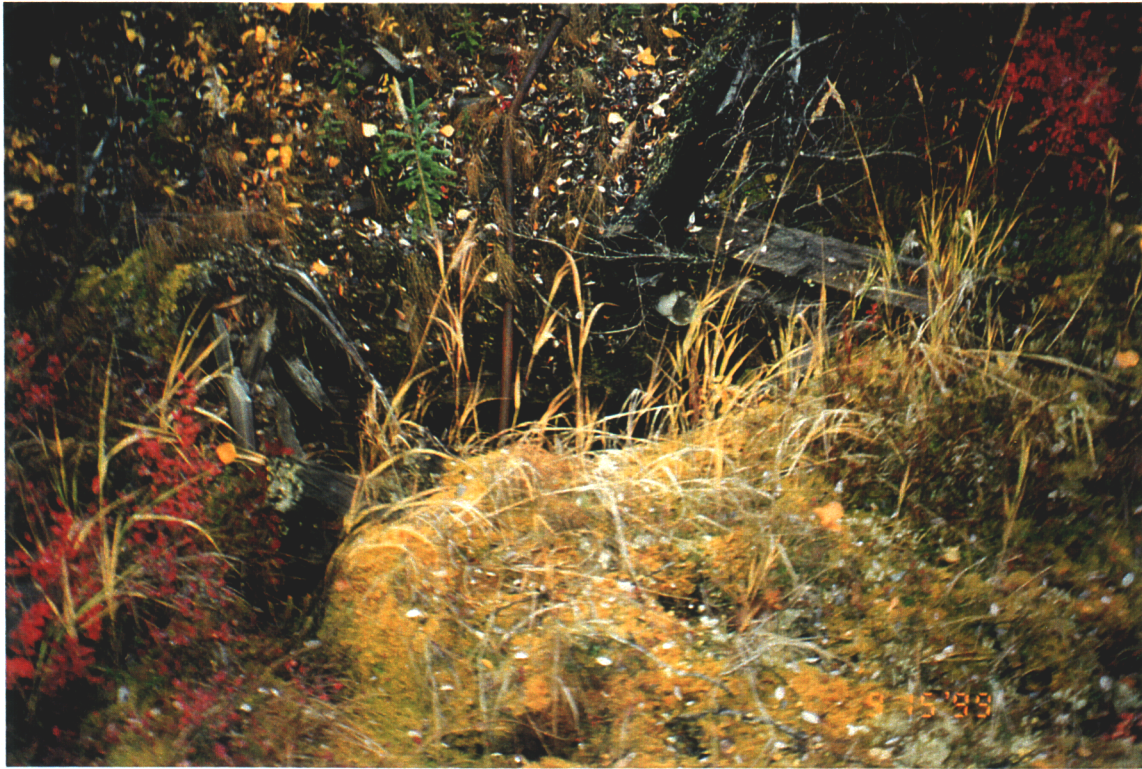
One small test pit was found near the millsite.

Condition: Timbers are rotten, site is revegetated.

Accessibility: Easy access by foot, but low risk to public due to shallow depth.

Photo 81-7: Small timber-lined test pit south west of millsite.

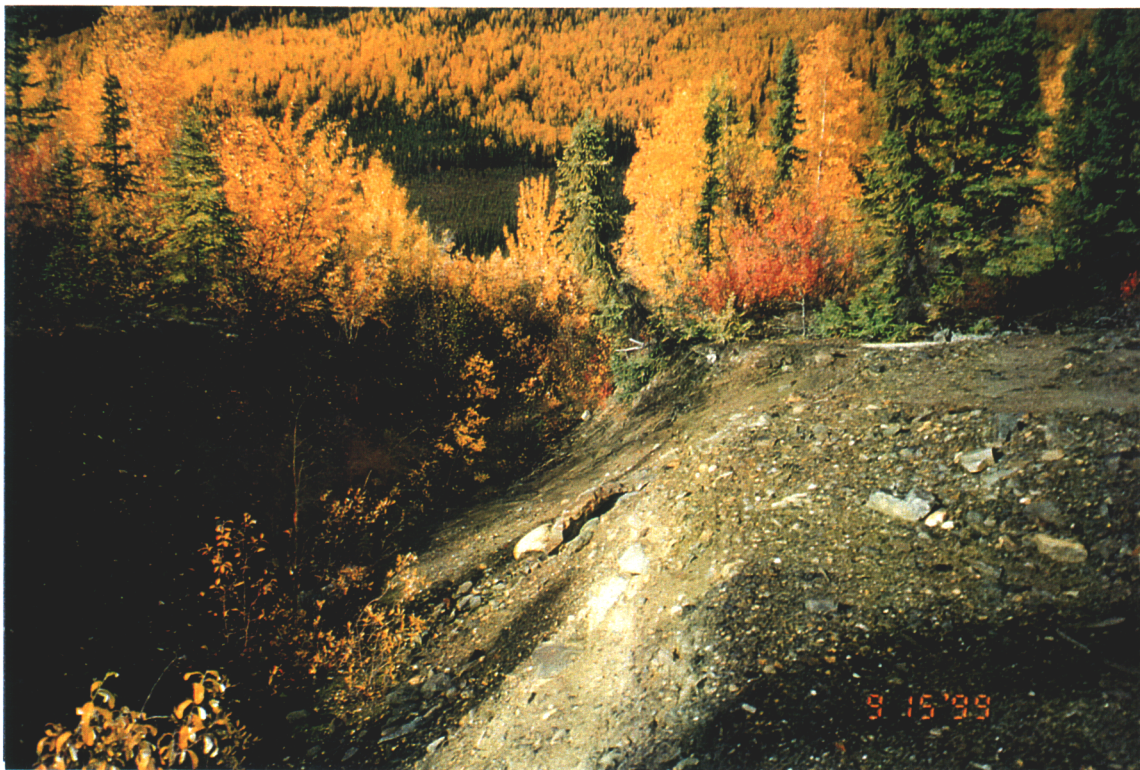
Exploration trenches are present to the south of the millsite. They cut overburden for the most part.

Condition: Fairly stable; partially revegetated.

Photo 81-8: Trench directly south of millsite.

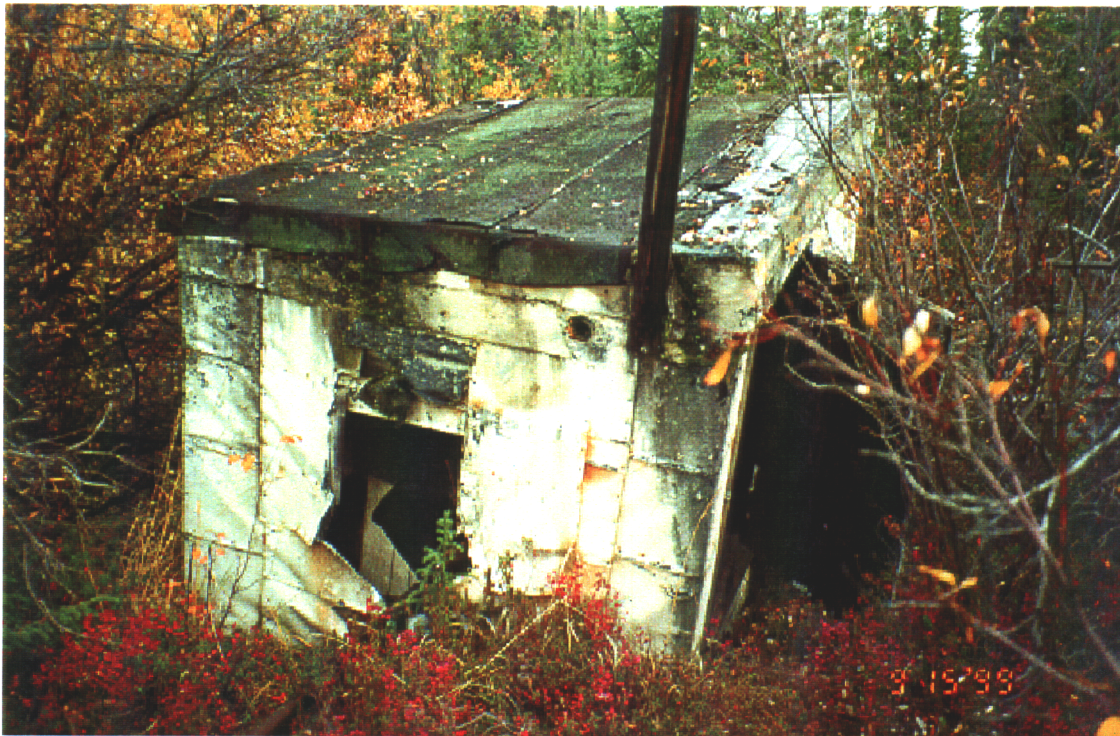
Pumphouse consists of a small deteriorated wood building positioned over a small creek.

Asbestos: Asbestos-impregnated tarpaper was present on the building exterior and was not sampled. Asbestos wallboard is present on the interior walls. Asbestos is considered non-friable in both of these forms.

Photo 81-9: Tailings pumphouse in forested area north of millsite.

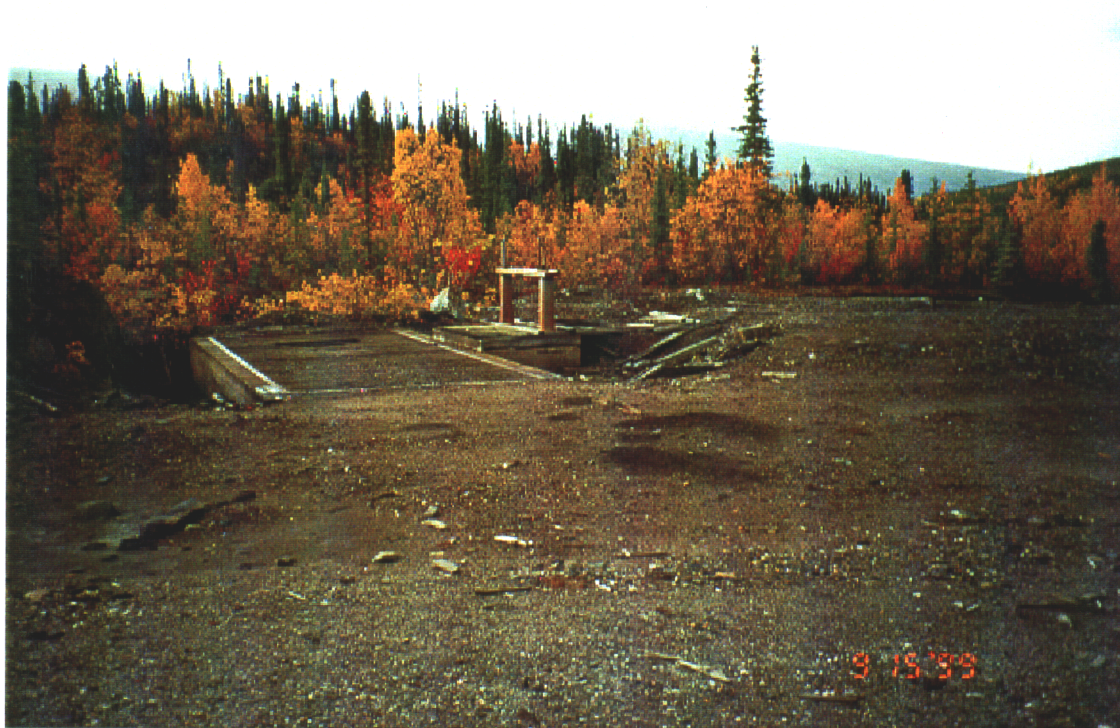
All that remains of the scale is concrete foundation and scale well.

Six very small surface stains with a total area of approximately 1 m<sup>3</sup> were noted immediately north of the weigh scale foundation. Stains may be the result of waste oil leakage and had a faint hydrocarbon odour. Staining was not present below 0.10 m below grade. This portion of the site is a considerable distance from the nearest water body and no samples were collected.

Photo 81-10: Concrete foundation of weigh scale at south end of millsite.

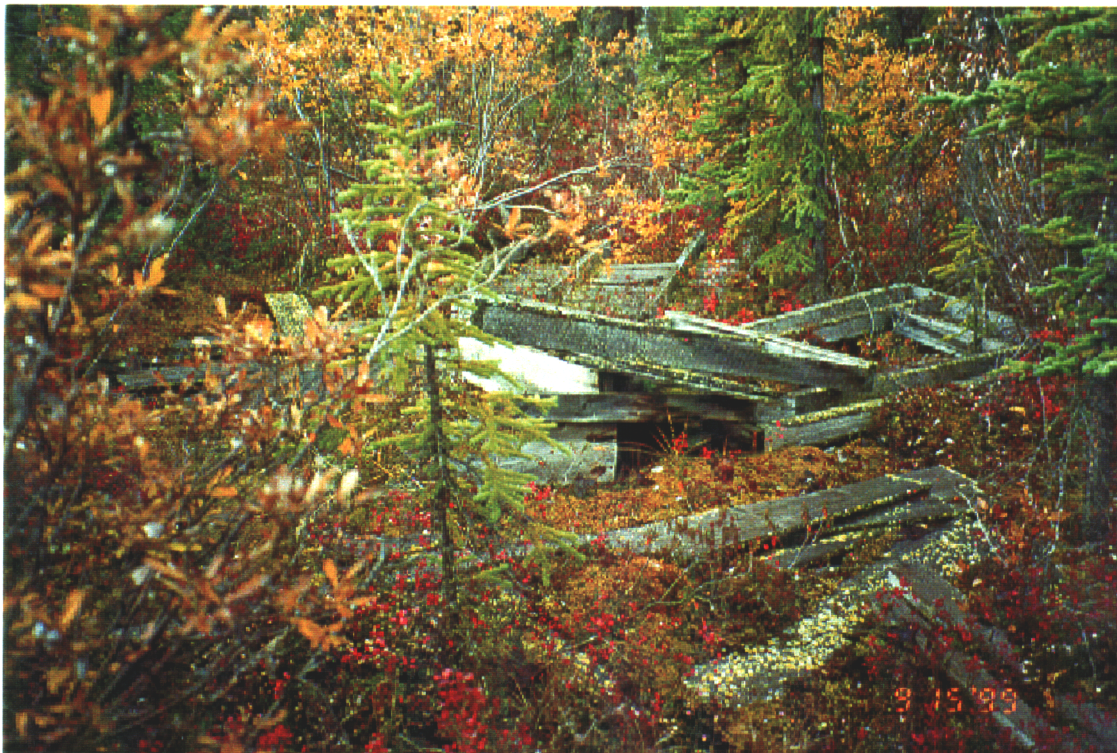
Demolished shack probably used for living quarters.

Photo 81-11: Wood debris remaining from former shack south west of millsite.

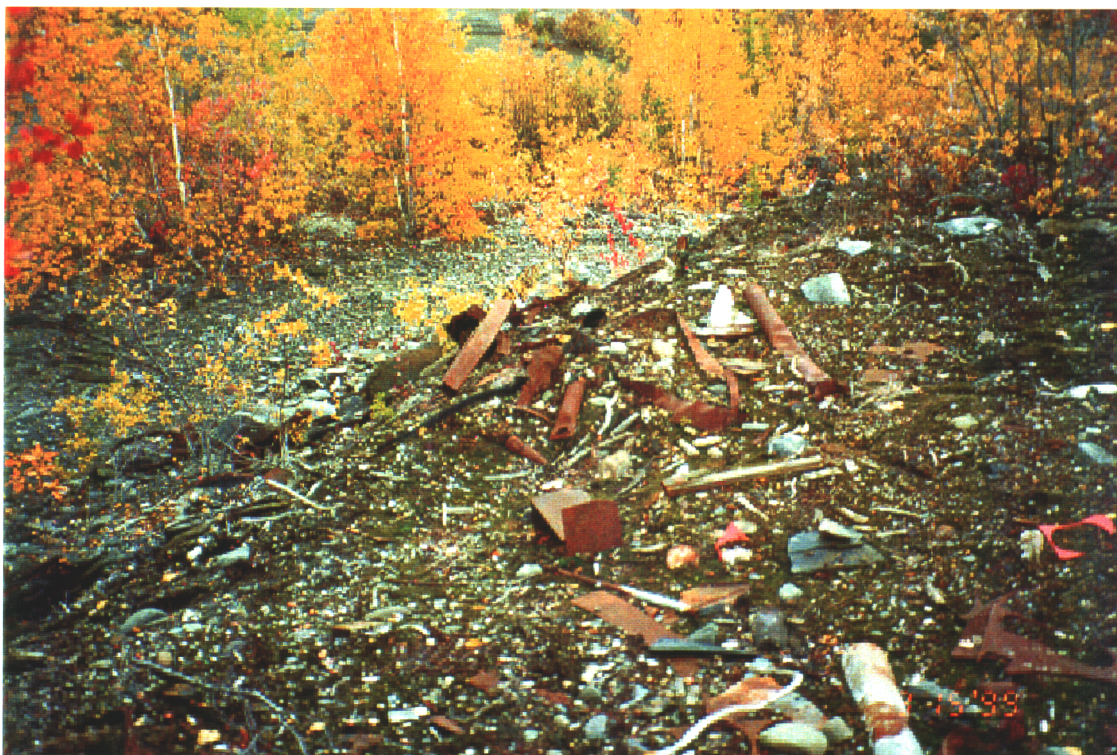
General composition: Non-friable asbestos wallboard; approximately 10 empty barrels; large volume of wood (timber and other) and metal debris; large cogged wheel; loader bucket; lengths of various sizes of pipe (>100 m); and victaulic piping lengths (<20 m).

Photo 81-12: Metal and wood debris at west end of upper millsite area.

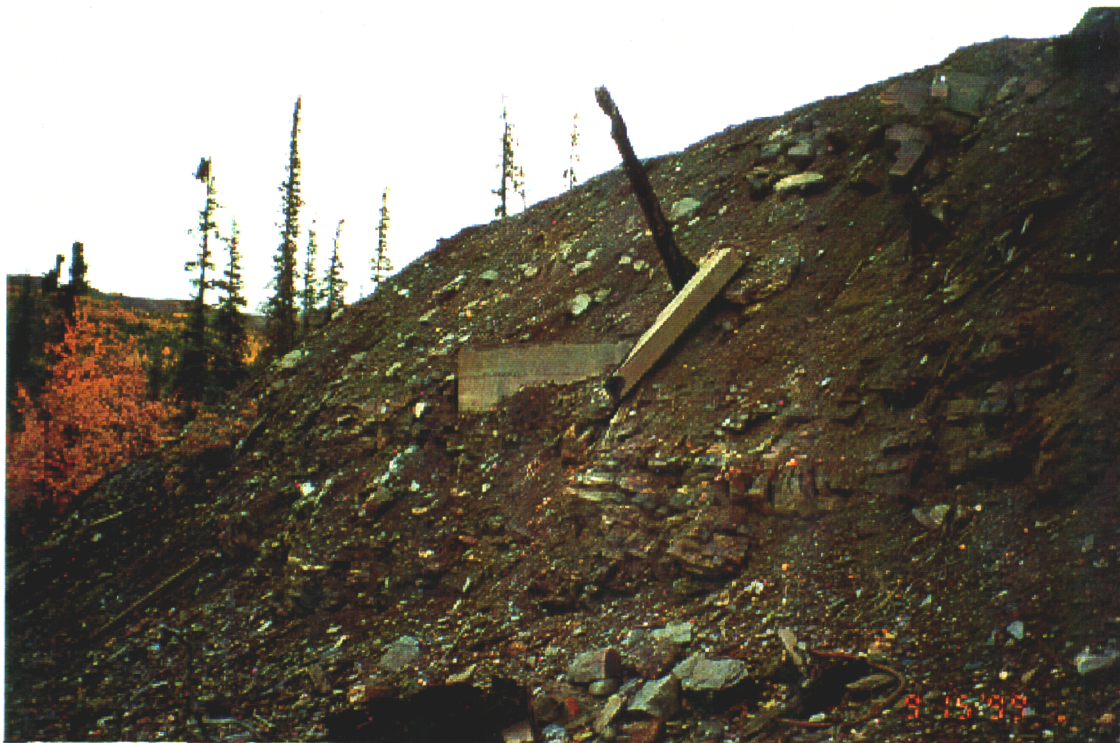
Mill facility: The mill has been removed or buried onsite since it discontinued use in 1954. Evidence of the former mill facility are indicated by the weigh scale at the south end of the site as well as a large volume of assorted debris on the surface and partially buried throughout the site. A concrete foundation was noted protruding from the north end of the upper millsite. A cogged wheel (debris from former heavy equipment) was also noted protruding from the northwest corner of the site.

Photo 81-13: Concrete foundation protruding from north slope of upper millsite area.
