**MEILECKE**  
**SITE #86**  
**(MINFILE #106D 023)**

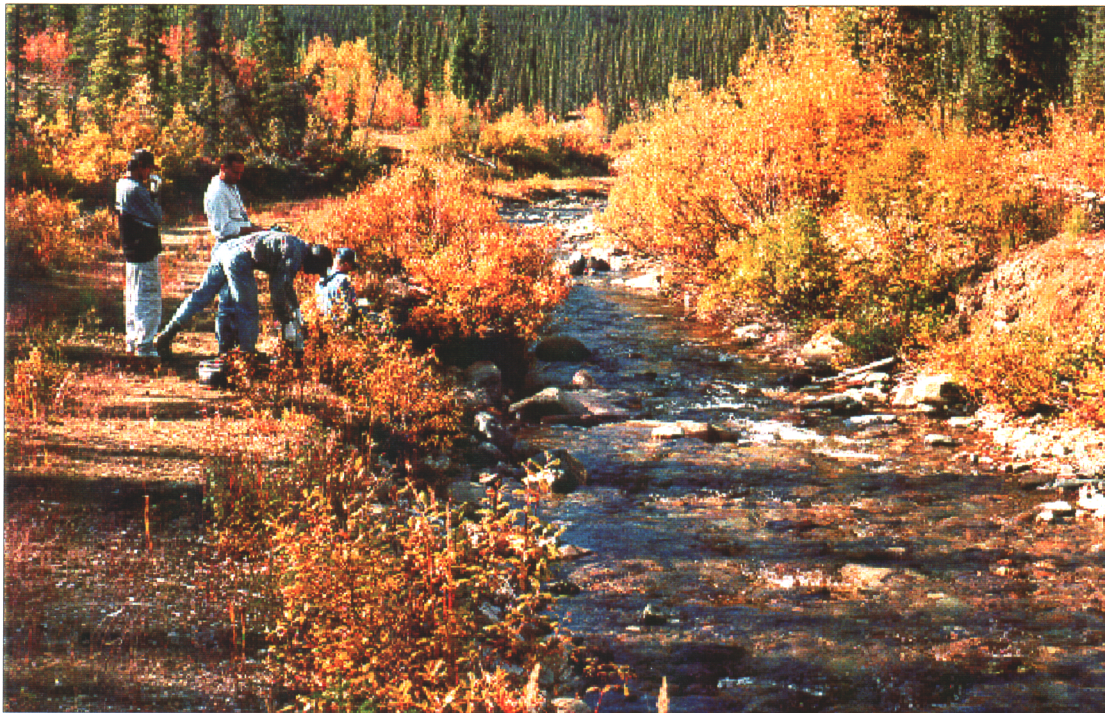
The site faces north-northwest along a series of raised shoreline out-wash terraces on the south site of Haggart Creek, approximately 850 m northeast of its confluence with Iron Rust Creek (Photo 86-1). The presence of permafrost soils could not be ascertained; however, the presence of smaller trees and the high elevation suggests the possibility of discontinuous permafrost.

Photo 86-1 : Upstream of Meilecke Site looking west.

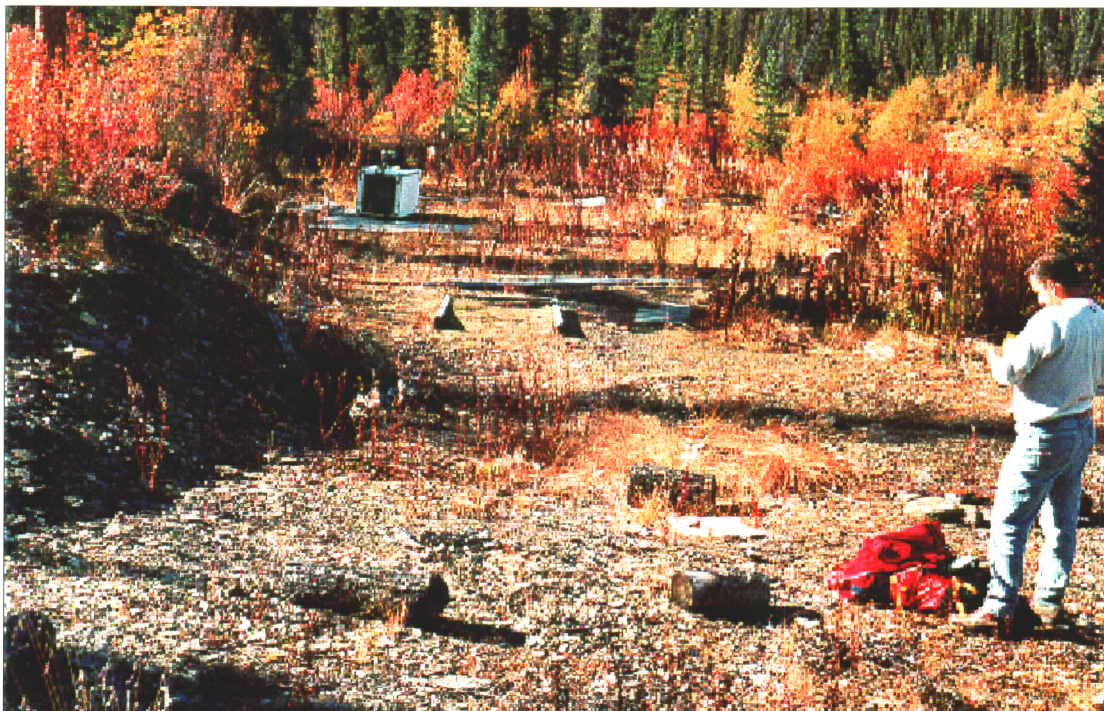
Possible old trench along terrace on south shore terrace by Haggart Creek running east-west; recently used as camp site (Photos 86-2 and 86-3).

Dimensions (L x W x H): ~ 30 m x 15 m x 0.75 m

Condition: hard-packed and overgrown; appears to be stable

Photo 86-2 : Meilecke Site. Camp site located in old trench (looking west).

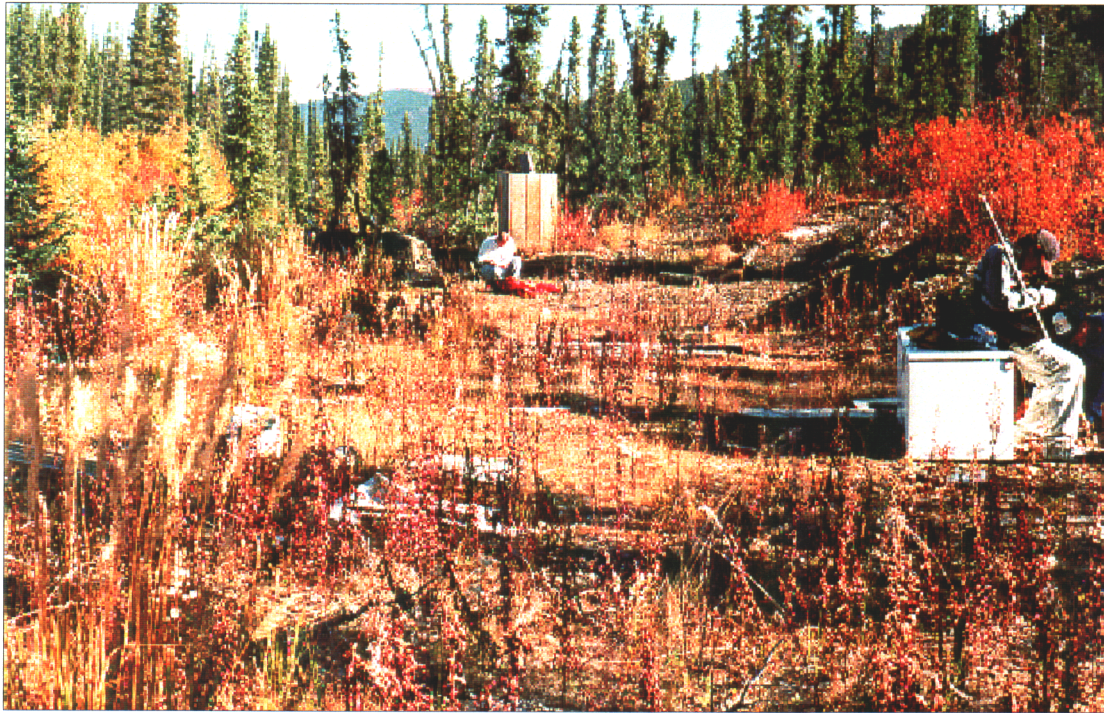
Outhouse (86A) - Wood construction with no roof, dimensions (L x W x D): 0.75 m x 1 m x 2 m (see Photo 86-3).

Natural revegetation is beginning to occur at the site along the suspected trench area, where the camp site is located, including grasses, forbs (e.g., fireweed) and young trees such as spruce and willow (see Photo 86-3). No evidence of any reclamation measures at this site.

Photo 86-3 : Meilecke Site camp looking east.

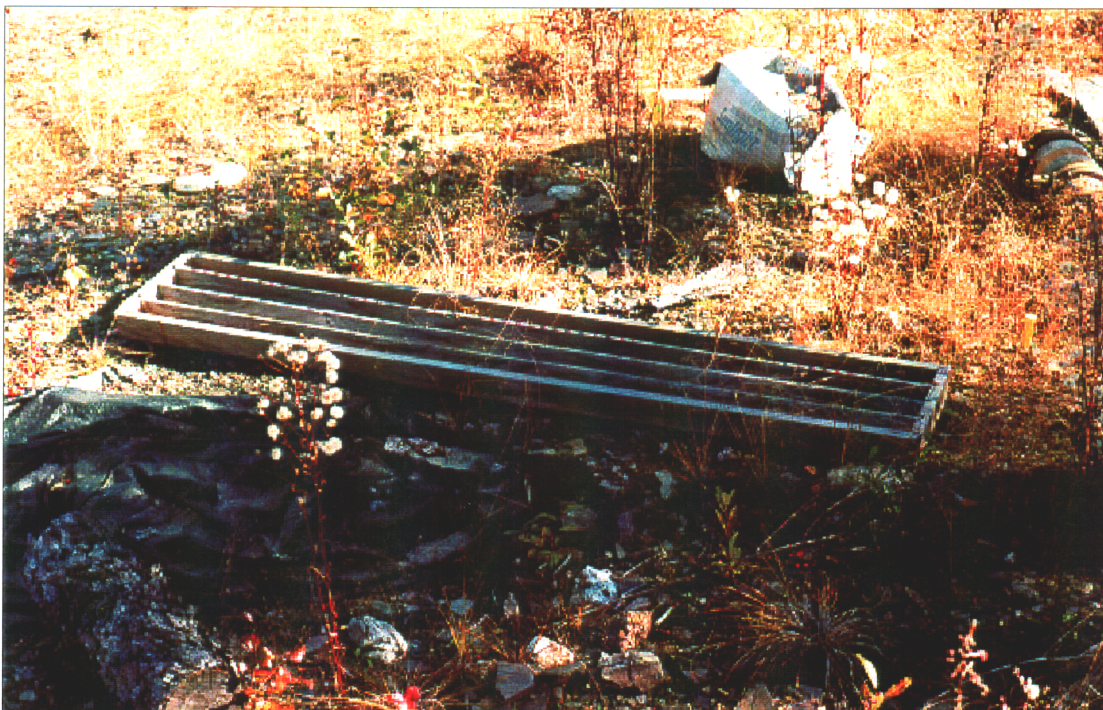
No apparent waste dumps; however, scattered debris over site including core boxes, wood, plastic, appliances (fridge and stove), cans, wooden flowerbox, plastic and metals cans containing ash from camp fire, old mattress and other camp equipment, number of empty 10 gallon cans, old portable generator and car battery (Photo 86-4 and 86-5).

Photo 86-4 : Meilecke Site, core box.

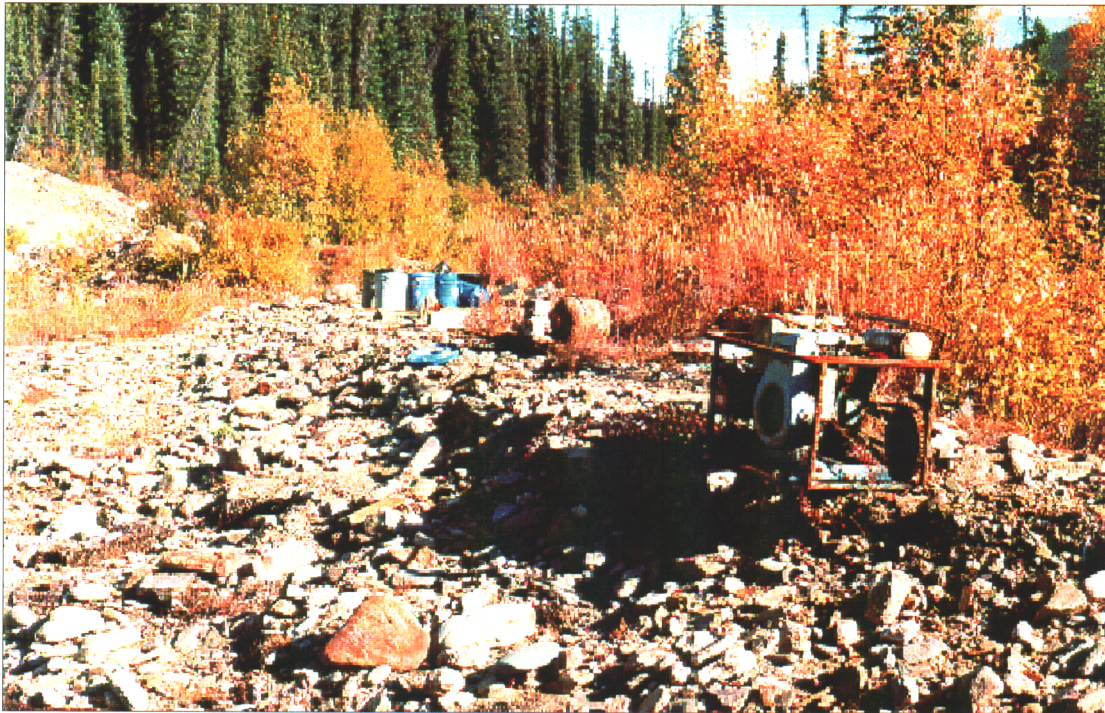
Photo 86-5 : Meilecke Site, generator & debris along creek looking east.

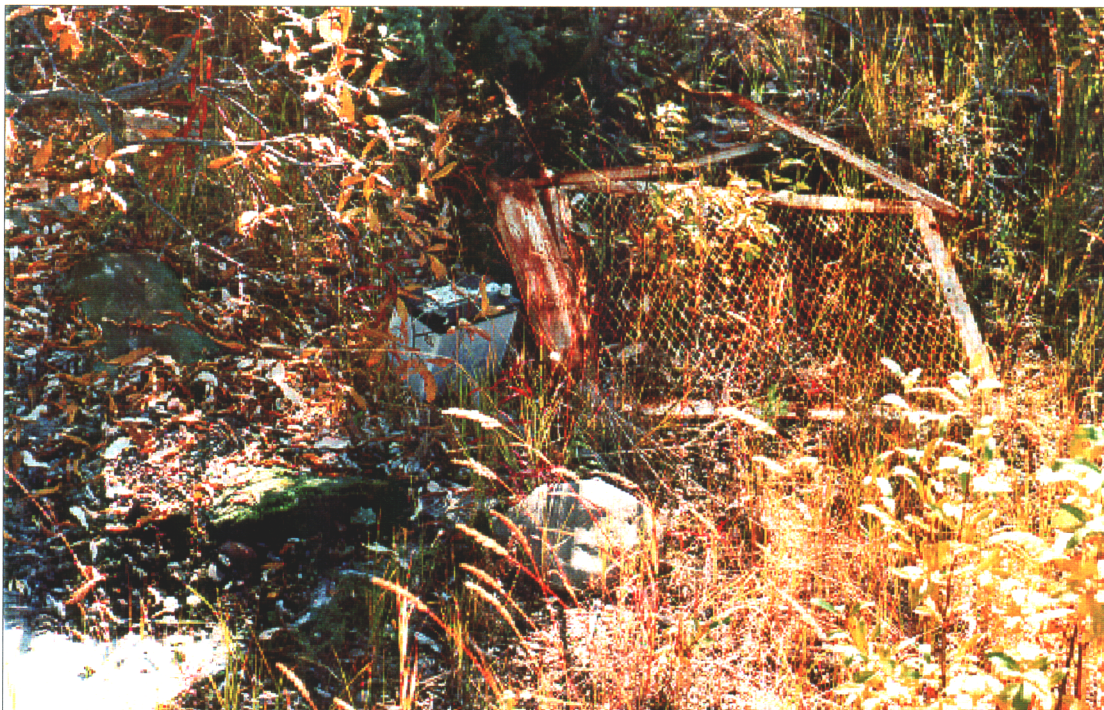
Old car battery located 100 m SW of camp above stream bank. No samples taken, given isolated location of material from stream (Photo 86-6).

Photo 86-6 : Meilecke Site, battery near stream (100m S.W. of camp site).

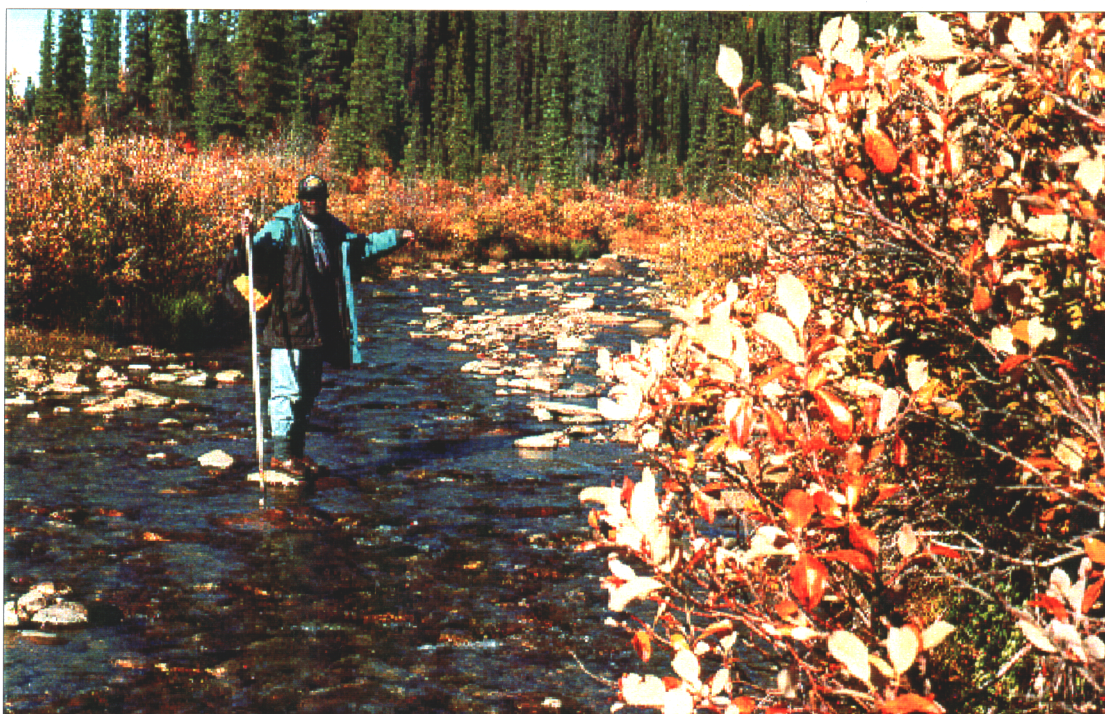
Surface water quality samples were collected 160 m upstream (background) of the site (99-86-WQ-01) and downstream, approximately 50 m east and upstream of the Iron Rust Creek confluence (99-86-WQ-02, Photo 86-7). Results of the geochemistry are listed in Attachment 2.

Photo 86-7 : Meilecke Site. Downstream water sample location 50m E. of confluence of Haggart & Iron Rust Creeks.
