AN ENVIRONMENTAL STUDY OF THE WHITE
PASS & YUKON ROUTE PIPELINE FROM THE
B.C. - ALASKA BORDER TO WHITEHORSE, Y.T.

by: D. MUNRO
K. WEAGLE

ENVIRONMENTAL PROTECTION SERVICE
WHITEHORSE, YUKON - SEPT. 1976

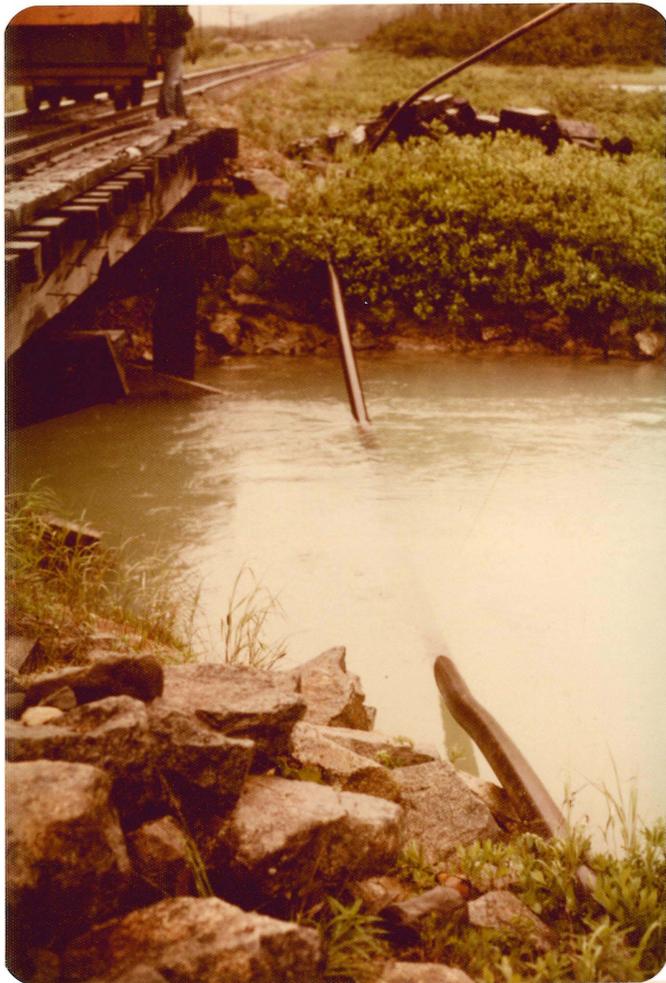
At mile 24.8 the pipe dips into the stream (Plate 1). This is a very unsatisfactory crossing and it is recommended it be rectified by supporting the pipe on the bridge. At this location the draindown is 225 barrels requiring about one and one-half hours to drain. It is felt unless action is taken to improve the crossing there is the possibility of a complete break, during spring breakup, resulting in a large spill directly into the stream.

Plate 1 Stream Crossing
(Mile 24.8).

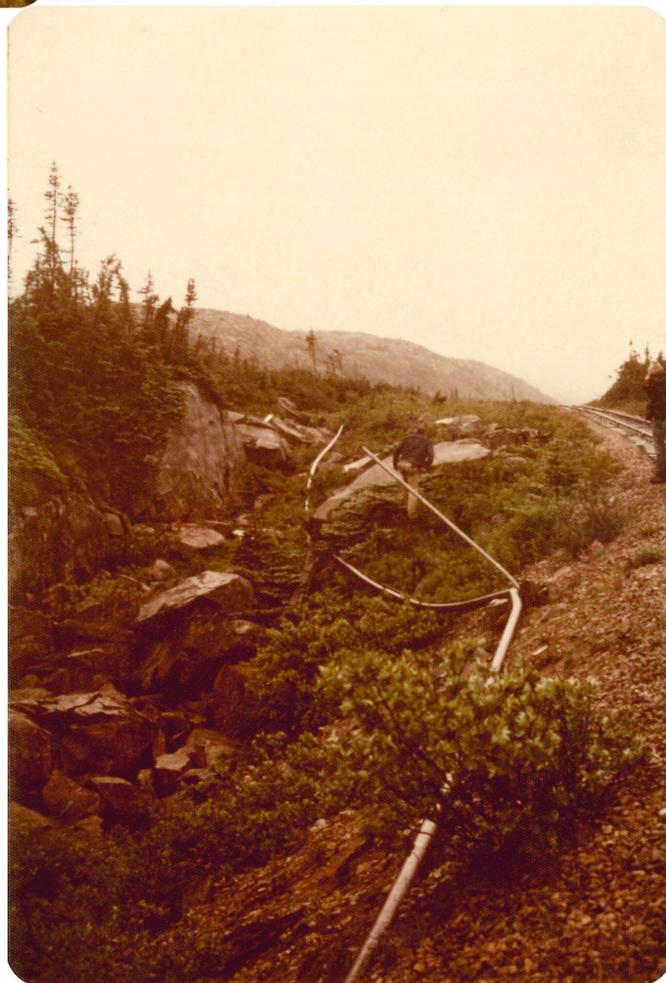
At mile 25.8 the pipe follows above a stream (Plate 2) supported on the large rocks in the stream bed. It is recommended that

Plate 2 Pipeline laying among
the rocks in a stream
bed (mile 25.8).

the pipe be pulled out of the stream bed and placed along the side of the railway to reduce the possibility of damage to the stream.

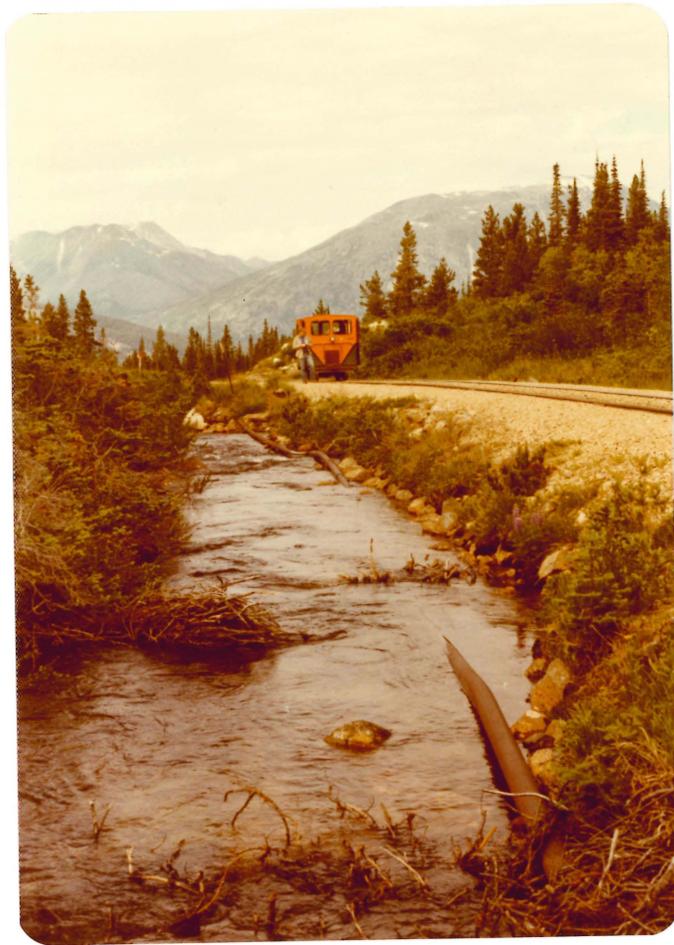
At mile 35.3 the pipeline again follows a stream bed (Plates 3 and 4). At this location the pipeline crosses under the railway track approximately 100 yards beyond the railway motor car shown in Plate 3 and follows along the stream for about one quarter of a mile. For 100 yards of its length at this location the pipe rests in the stream bed in the water. It is recommended that the pipeline be moved to the other side of the railway bed for the one quarter mile that the stream follows the right of way.

Plate 3 Pipeline running
in stream for
approximately
100 yards
(mile 35.3).

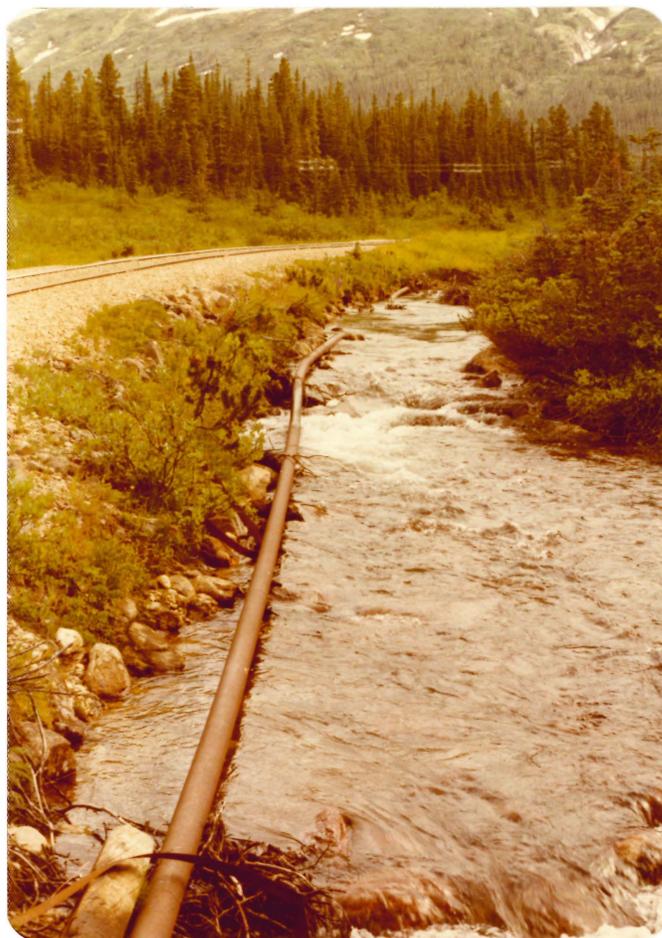
Plate 4 Same as Plate 3
shown from the
opposite
direction.

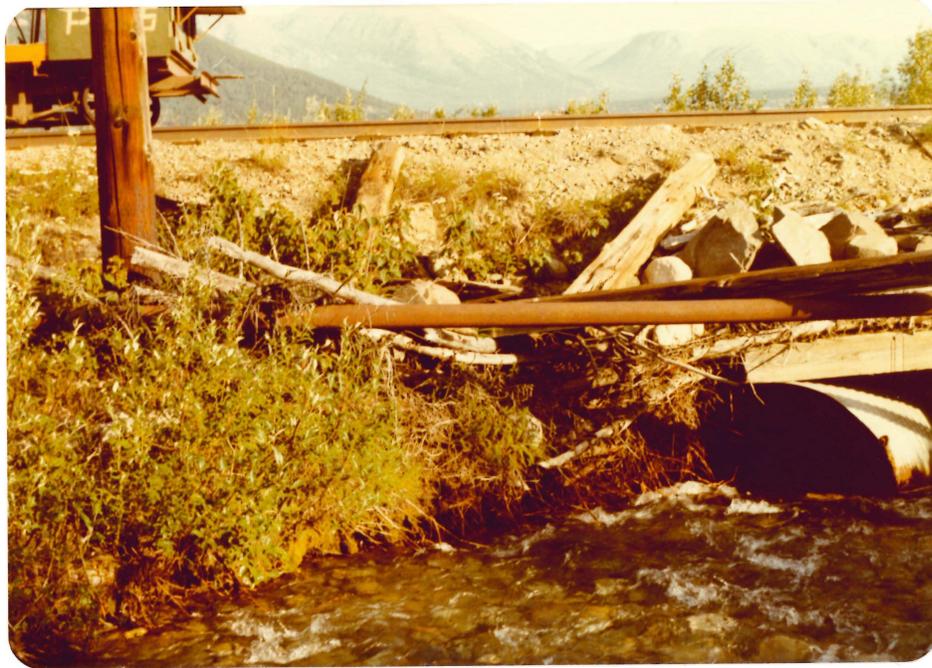
Plate 5 Stream crossing showing old railway tie laying on the pipe (mile 57.2).

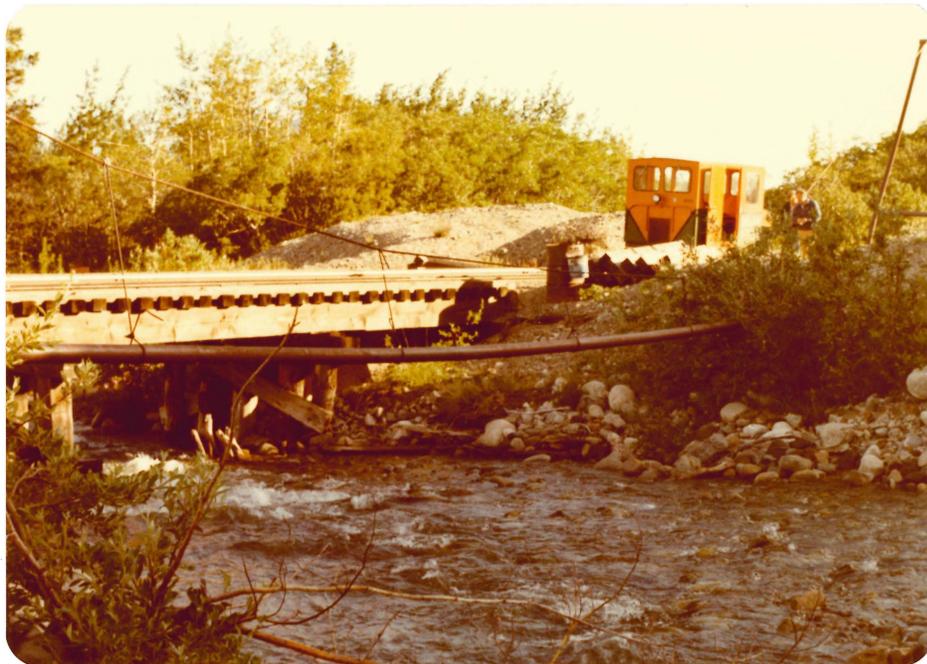
Plate 6 Stream crossing (mile 55.4).

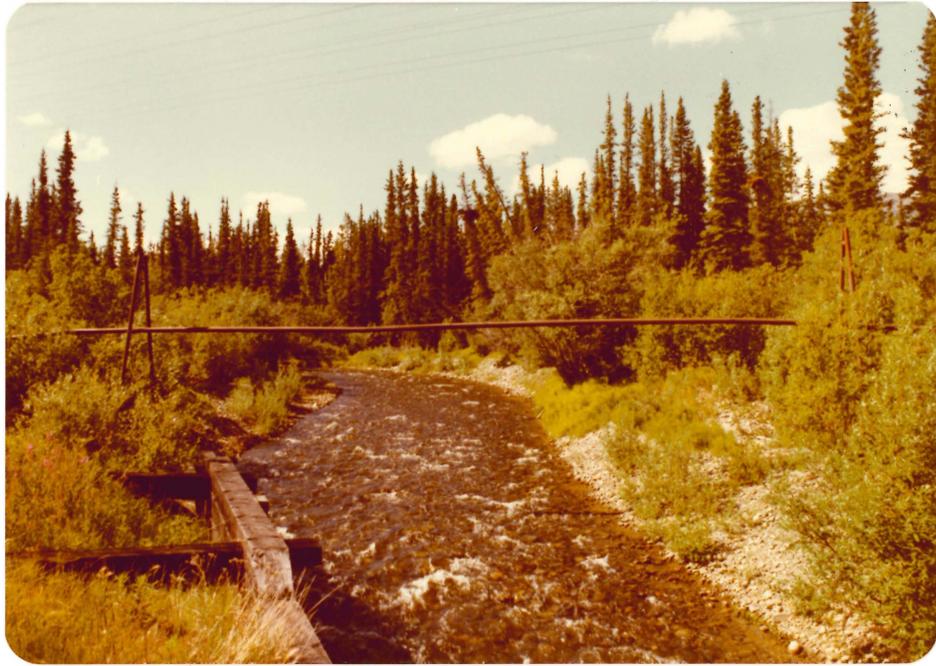
Plate 7 Wolf Creek crossing showing suspended pipe above the creek (mile 101.6).

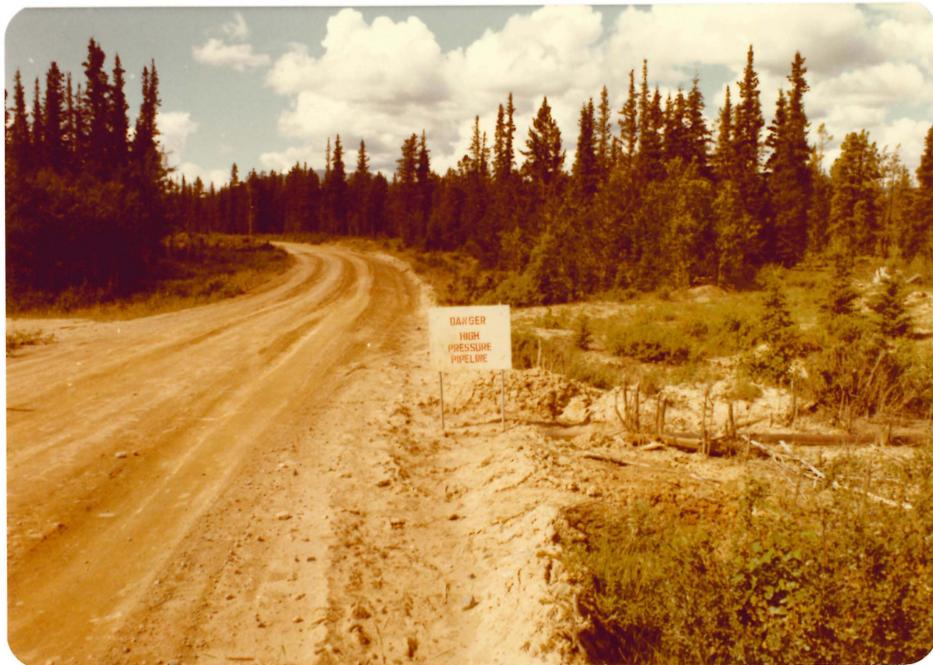
Plate 8 Annie Lake road crossing (mile 89.2).

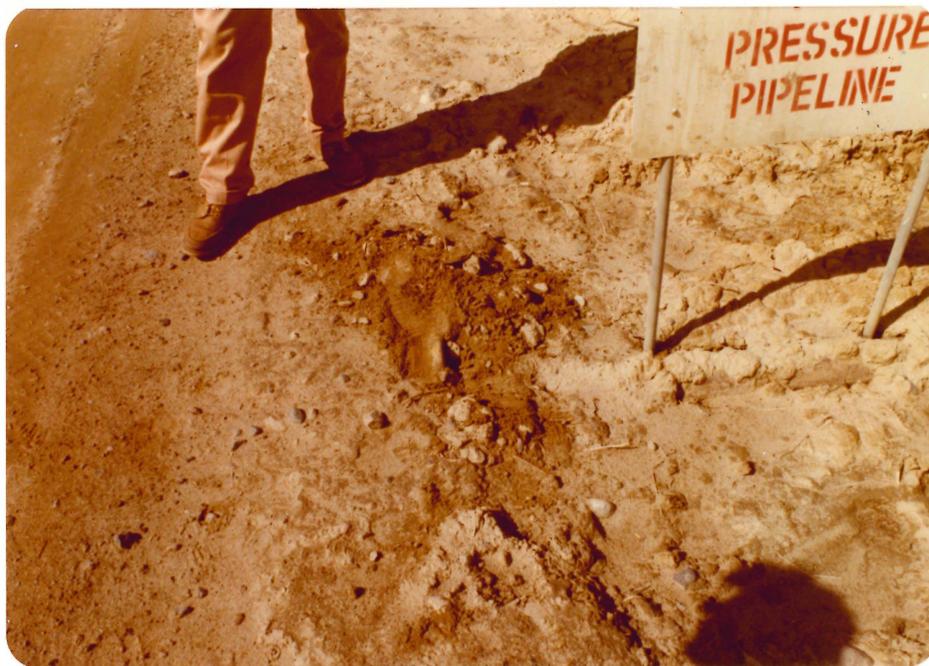
maximum of six inches and unprotected pipe extends out of the road bed on either side of the crossing. The pipe was damaged by a grader plowing the road on November 5, 1973 resulting in the spilling of 25 barrels of furnace oil. However, beyond repairing the pipe no action was taken by WPYR to prevent a similar occurrence. It is recommended that the pipe should be properly buried to meet present standards for road crossings to reduce the possibility of another break.

Plate 9 Annie Lake road crossing showing depth that the sleeve encasing the pipe below is burried and the proximity of the unprotected pipe to the road.

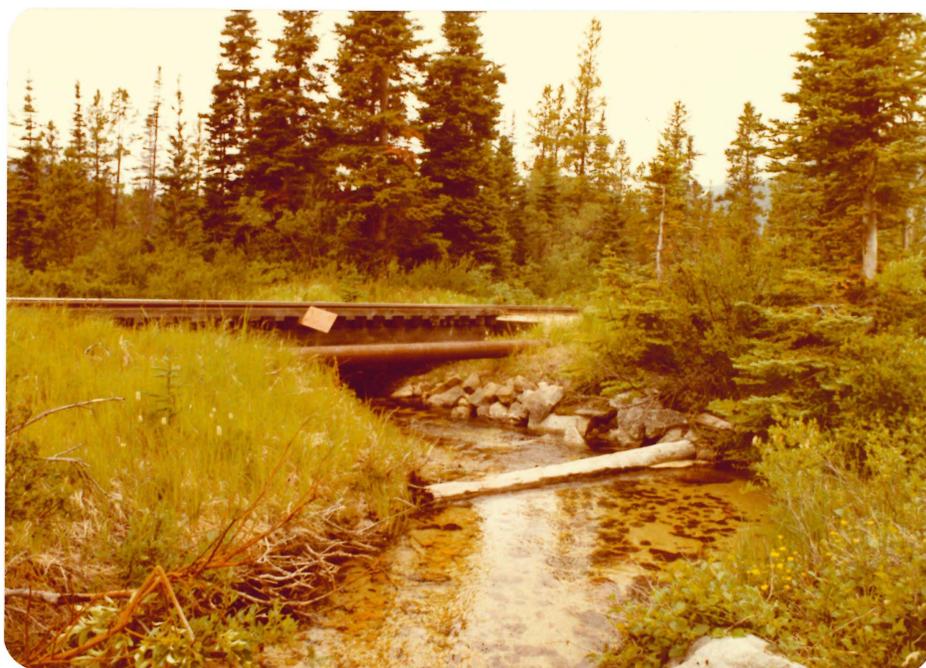
Plate 10 Stream crossing at 38A bridge. At this crossing the pipe is encased in a six inch pipe (mile 38.6).

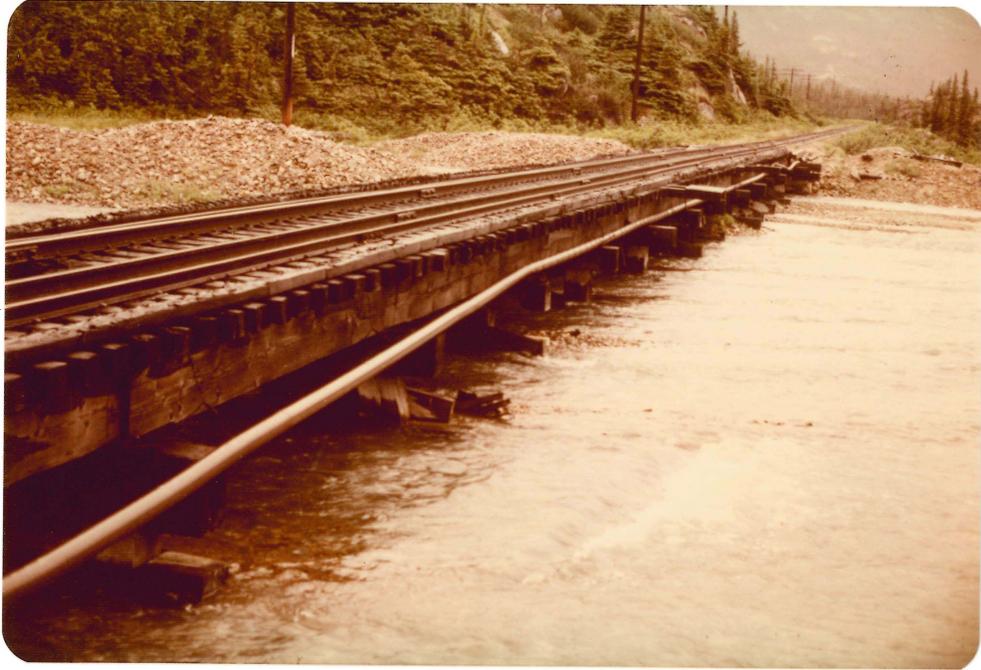
At the Tutshi River crossing mile 26.7 the pipeline is tied to the railway bridge with wire. However, on the south end of the bridge the wire holding the pipe to the bridge has broken, leaving the pipe unsupported for part of the stream crossing (Plate 11). It is recommended that the pipe be securely fastened to the bridge over its entire span.

Plate 11 Tutshi River crossing. The pipe is suspended on the bridge but has broken free at the close end of the bridge (mile 26.7).

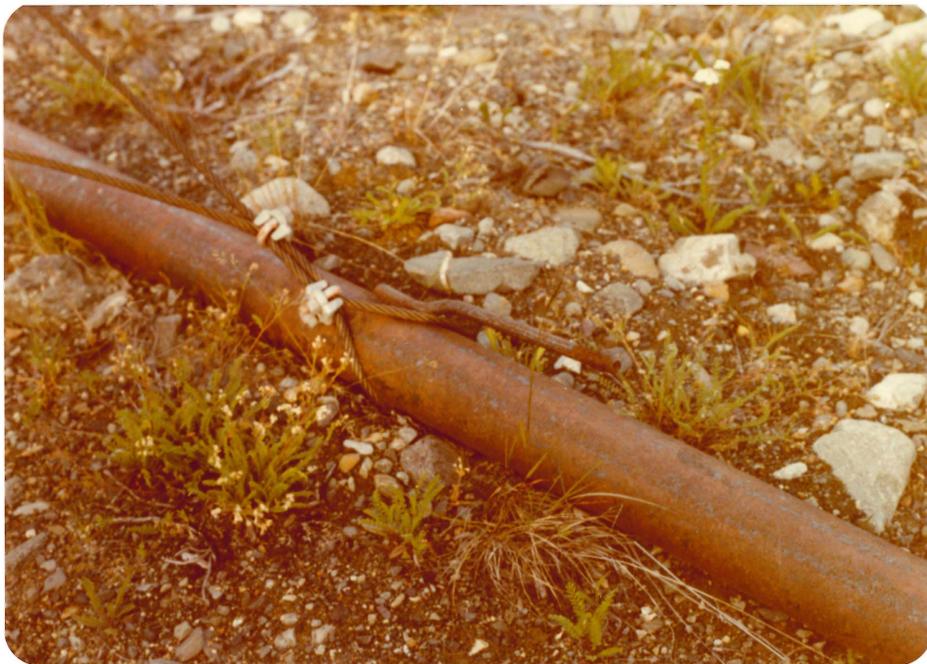
At the stream crossings at miles 55.4 and 57.5 the pipeline is suspended by cables and "A" frames (Plate 5). The cables have been anchored to the pipe, on either side of the creek, by means of a hook welded to the pipe (Plate 12) at mile 57.5 and a clamp at mile 55.4. It is recommended that the cables be anchored by some other means to alleviate stress on the pipe.

Plate 12 Hook welded on pipe in order to fasten the cable which supports the "A" frame and pipe at stream crossing (mile 57.5).

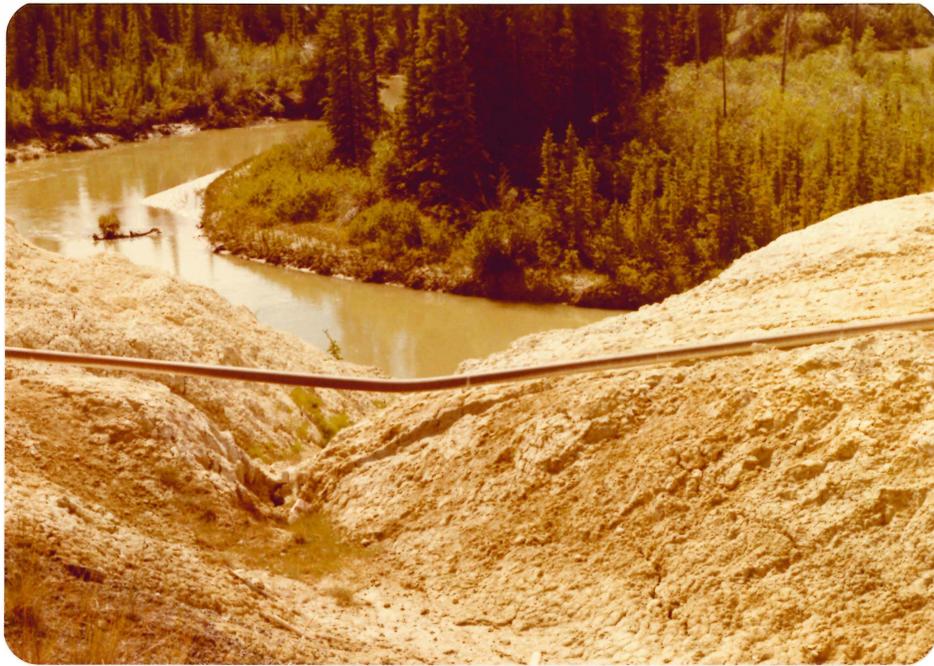
Plate 13 Unsupported pipe in gully leading into the Watson River (mile 77.4).

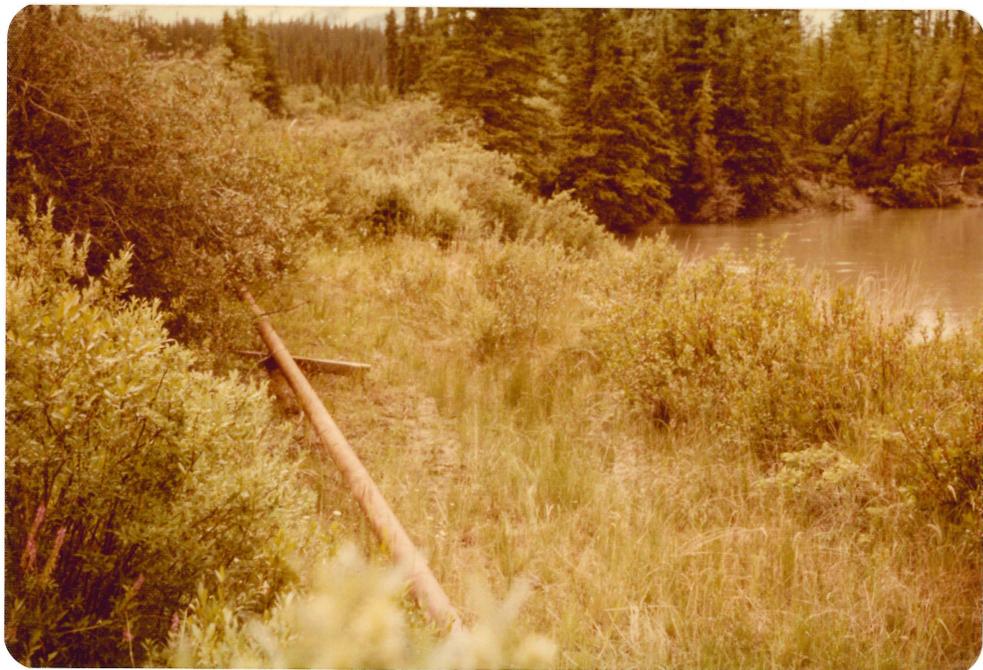
Plate 14 Pipeline with Watson River less than five yards away (mile 85.6).

yards of the river in a low wet area (Plate 14). It is recommended that at both of these locations the pipe be moved to the other side of the rail bed in order to have the rail bed act as a dyke between the pipeline and the river.

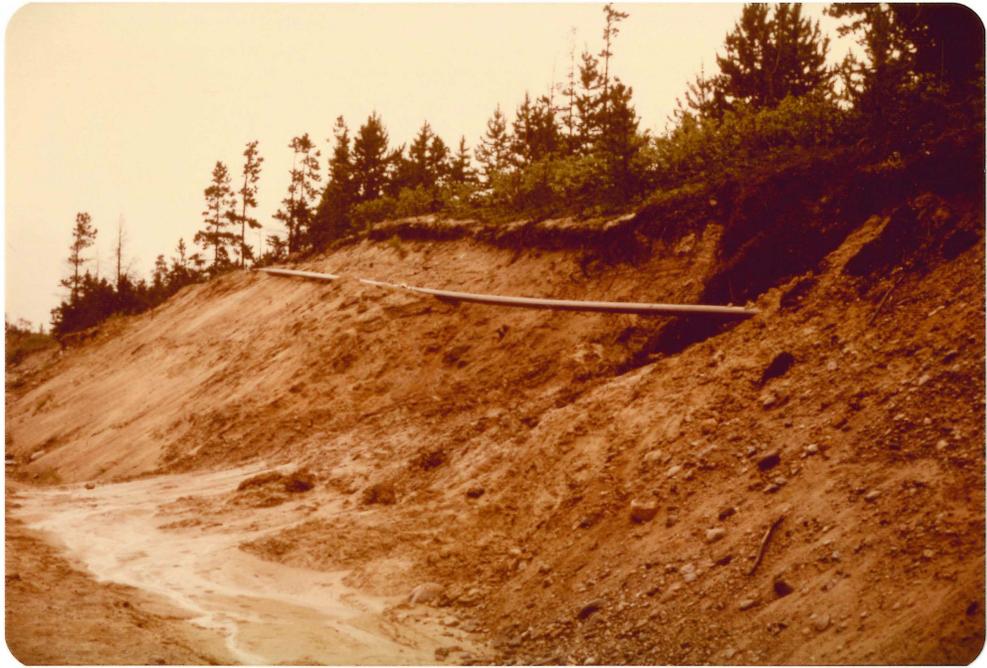
In most wet areas the pipe is above ground and supported on old railway ties at regular intervals (approximately 50 feet). In other areas the pipe is lying on the ground or is buried to various depths. There are two areas, mile 40 (Plates 15 and 16) and mile 74.3 (Plate 17) where the pipe is resting on the ground, on banks above the railway track and the banks are slumping. In these areas it is recommended that the pipeline be moved away from the edge of the bank or moved down onto the railway bed below the banks.

Plate 15 Area of unsupported pipe due to erosion of gravel bank (mile 40.1).

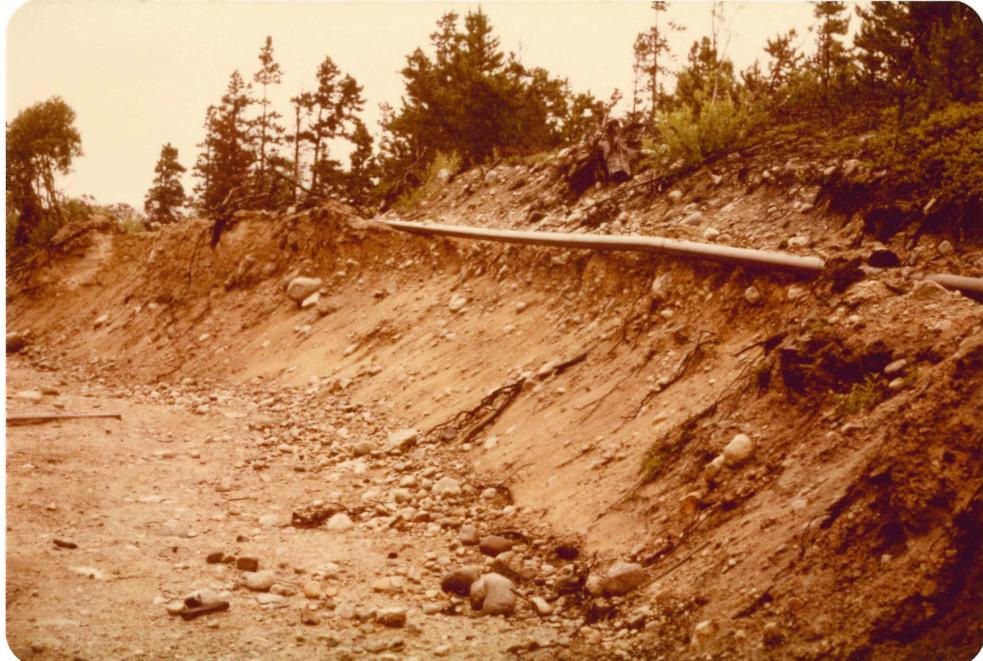
Plate 16 Area of unsupported pipe due to erosion of gravel bank (mile 40.).

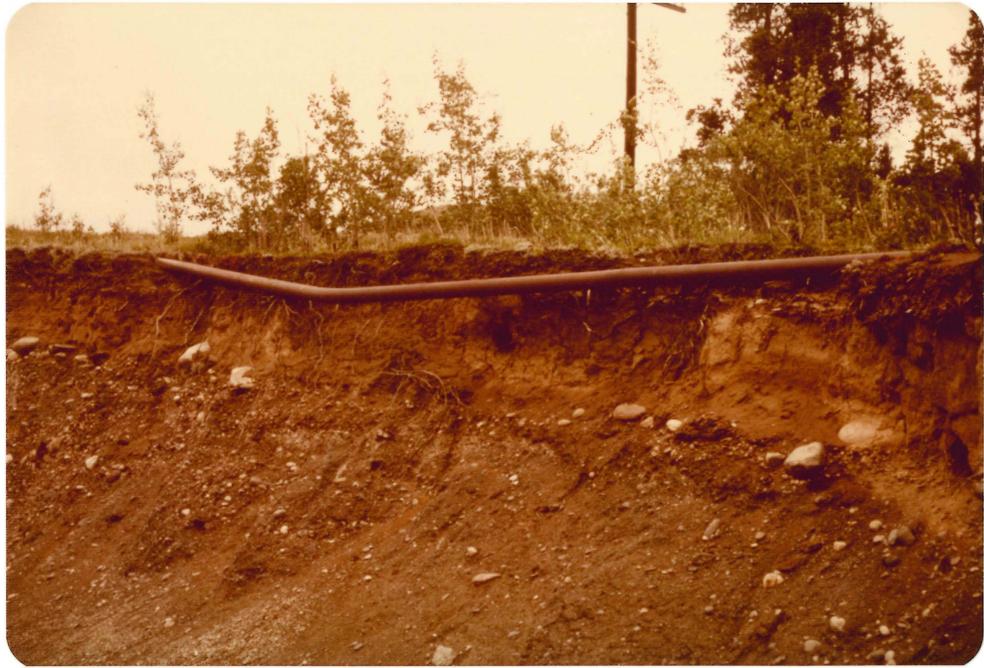
Plate 17 Unsupported pipe due to erosion of bank, above the Watson River (mile 74.4).

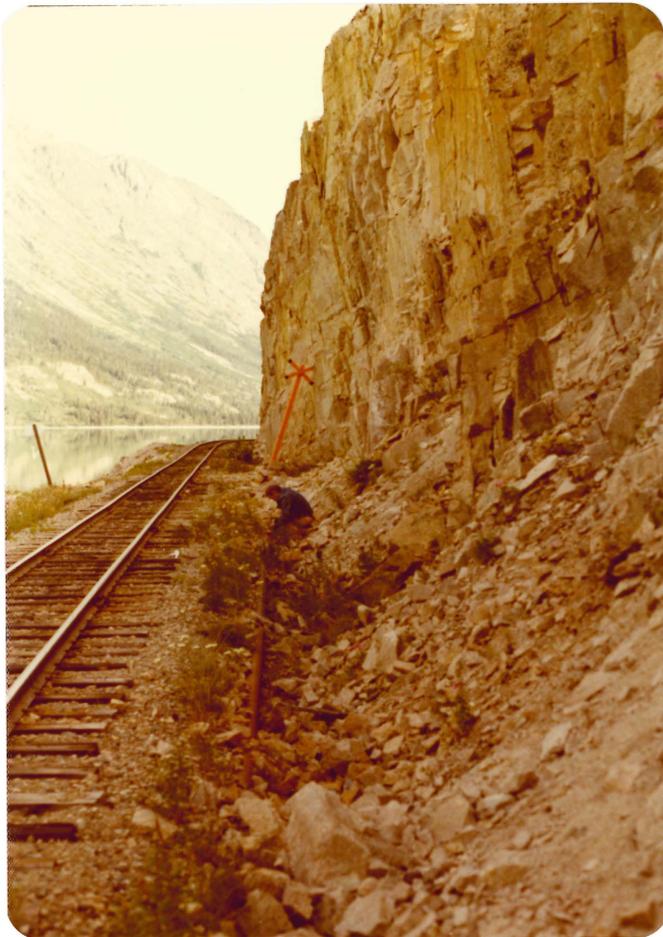
Plate 18 Rock slide area along Bennett Lake (mile 43.6).

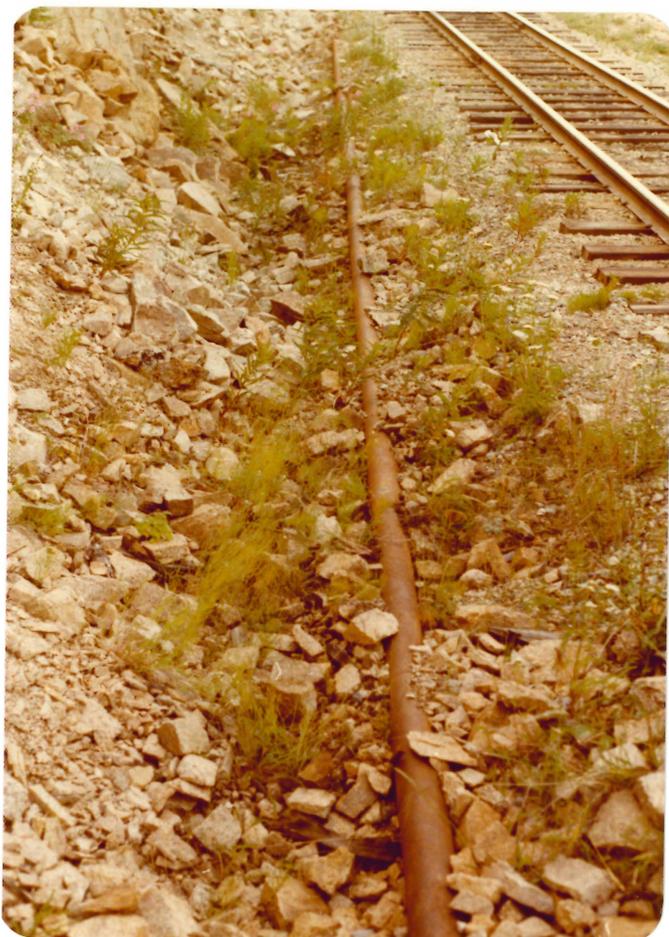
Plate 19 Pipeline in rock slide area (Plate 18) showing fallen rocks on the pipeline.

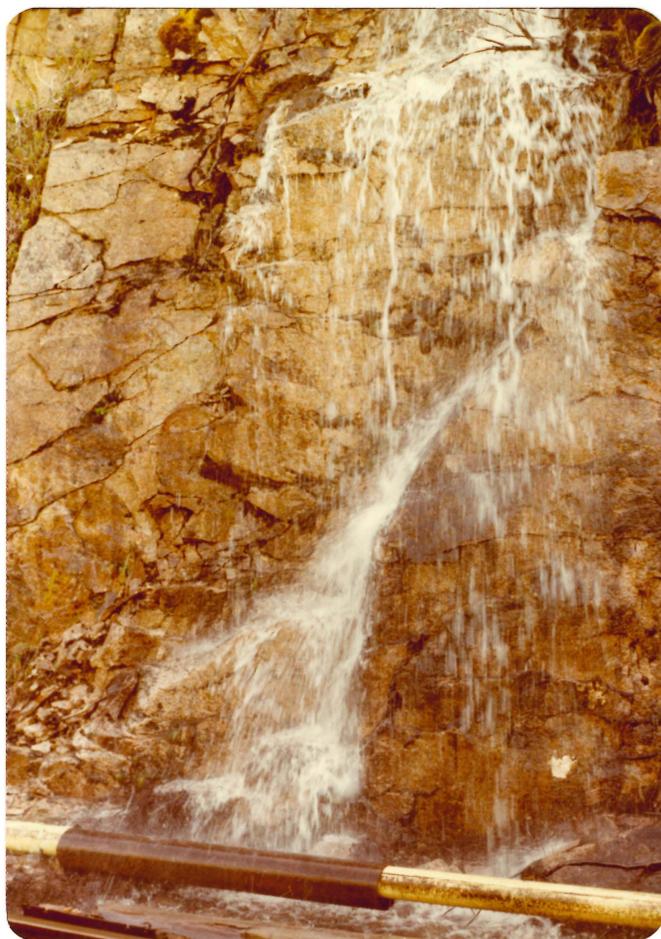
Plate 20 Area of glaciation along Bennett Lake (mile 42.7).

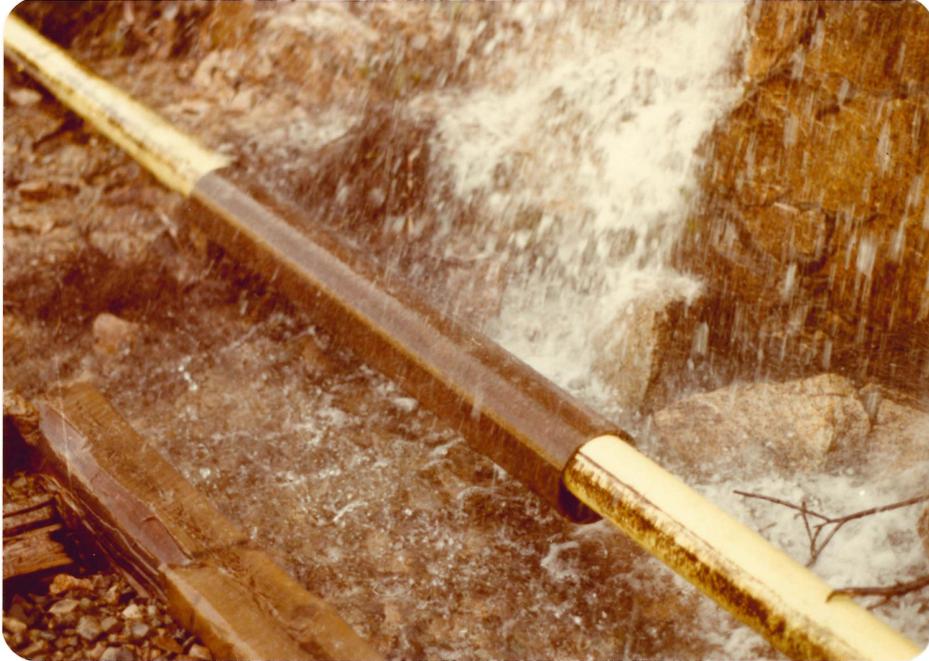
Plate 21 Sleeve on pipe in glaciation area (Plate 20).

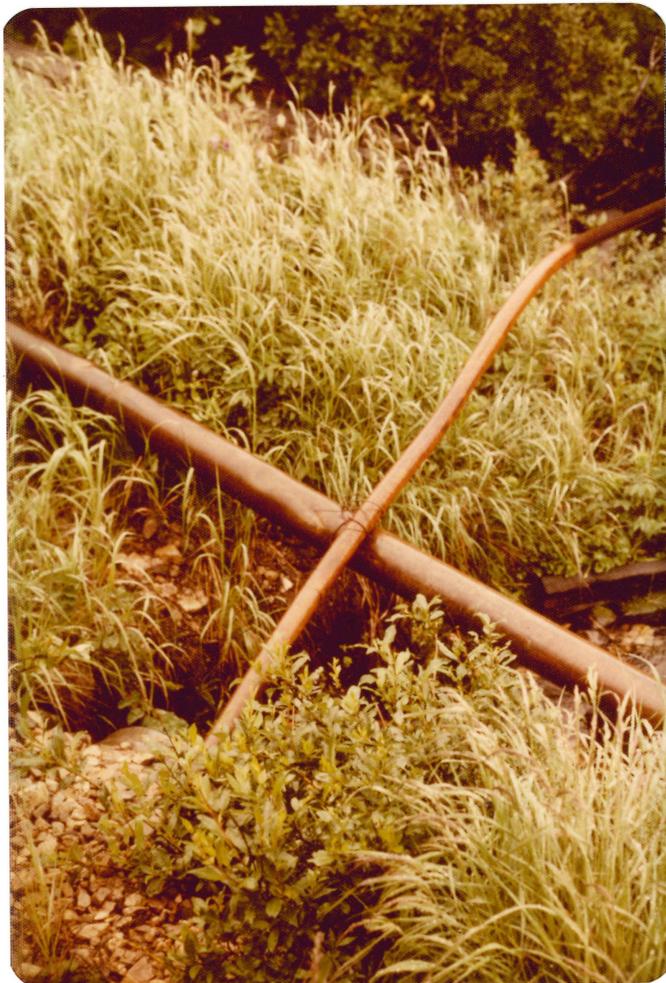
In the area from White Pass to Fraser, miles 20 to 28, the pipe has been dented by snow clearing equipment in many locations. In addition all the pipeline markers have been knocked down during snow clearing operations (Plate 22). Some of the worst areas of damage are at miles 21, 21.5, 25.7 (Plate 23), 28.5 (Plate 22). It is recommended that the section of pipe from miles 20 to 28 should be carefully inspected and all damaged pipe and pipeline markers be replaced.

Plate 22 Dents in pipe and a pipeline marker which has been knocked down by snow clearing equipment (mile 28.5).

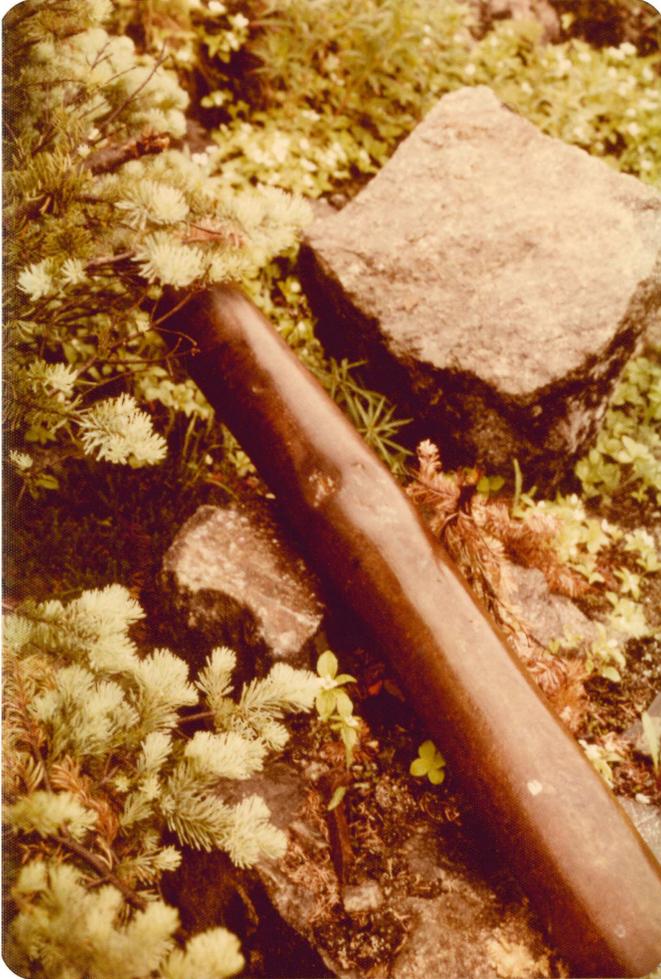
Plate 23 Dents in pipe caused by snow clearing equipment (mile 25.7).

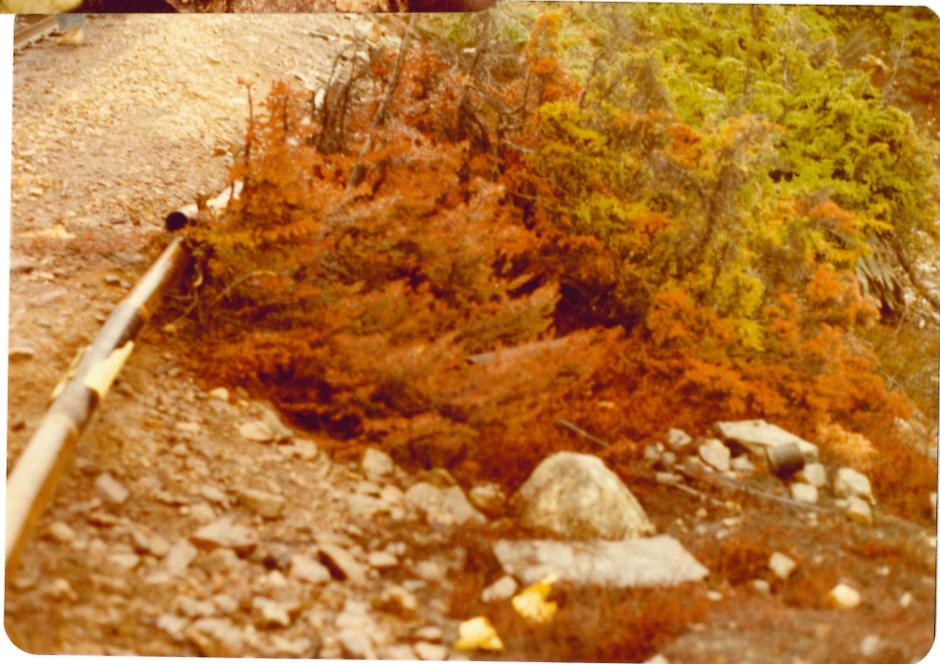
At mile 21 a section of pipe was replaced but put in slightly

Plate 24 Repaired pipe with section of pipe but in off-centre (mile 21.5)

off centre. It is recommended that this section of pipe be properly aligned.

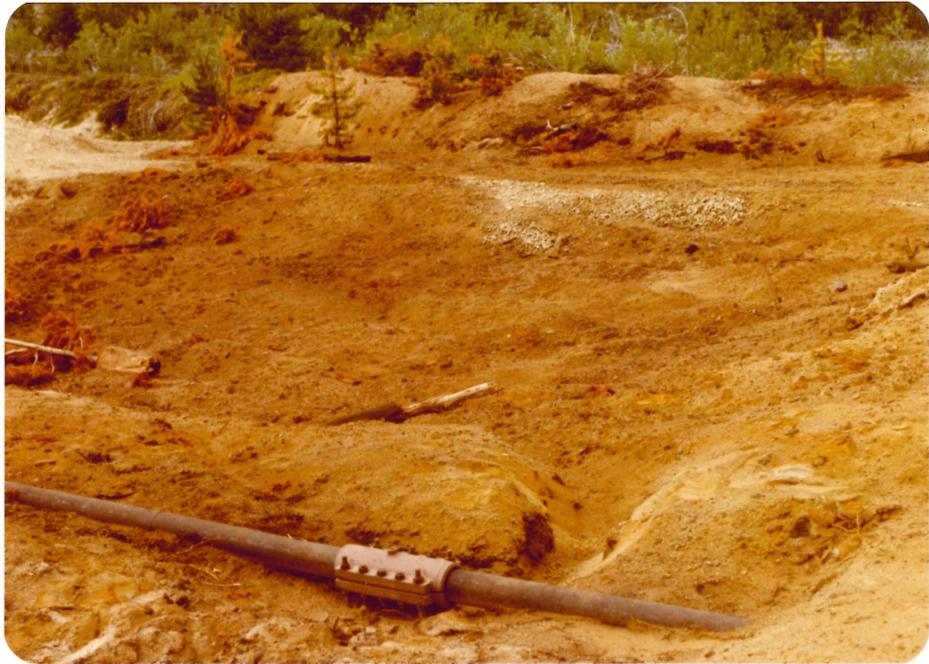
Plate 25 Clamp on old pipeline break (mile 40.1)

A break at mile 40.1 was repaired with a clamp to stop the leakage and get the pipeline back into production as quickly as possible. It is recommended that this clamp be removed and the damaged pipe replaced.

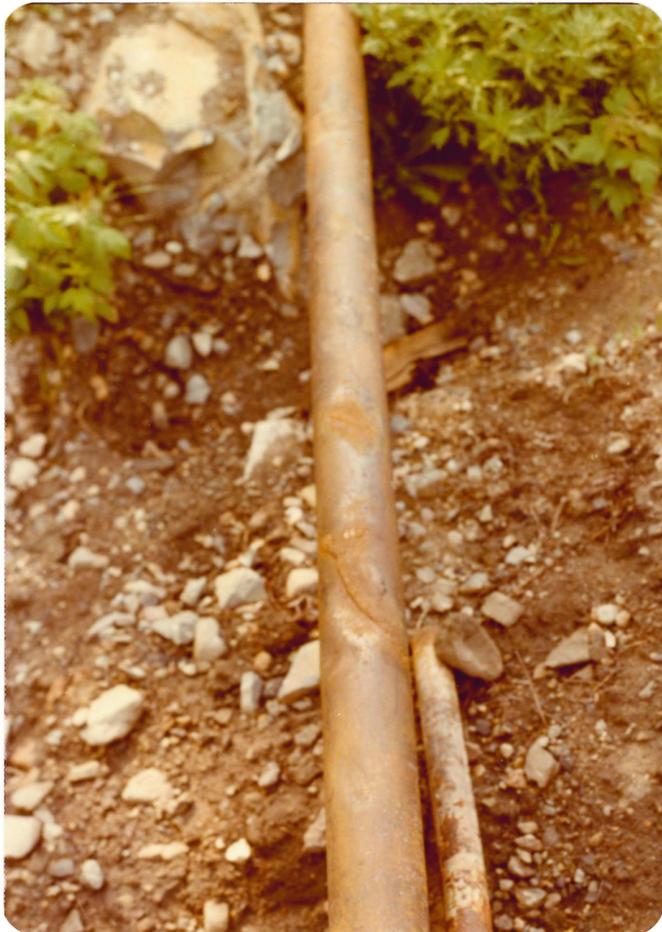
Plate 26 Weld over crack in pipe (mile 49.3).

A break at mile 49.3 was repaired by welding the crease in the pipe. It is recommended that this section of pipe be replaced.

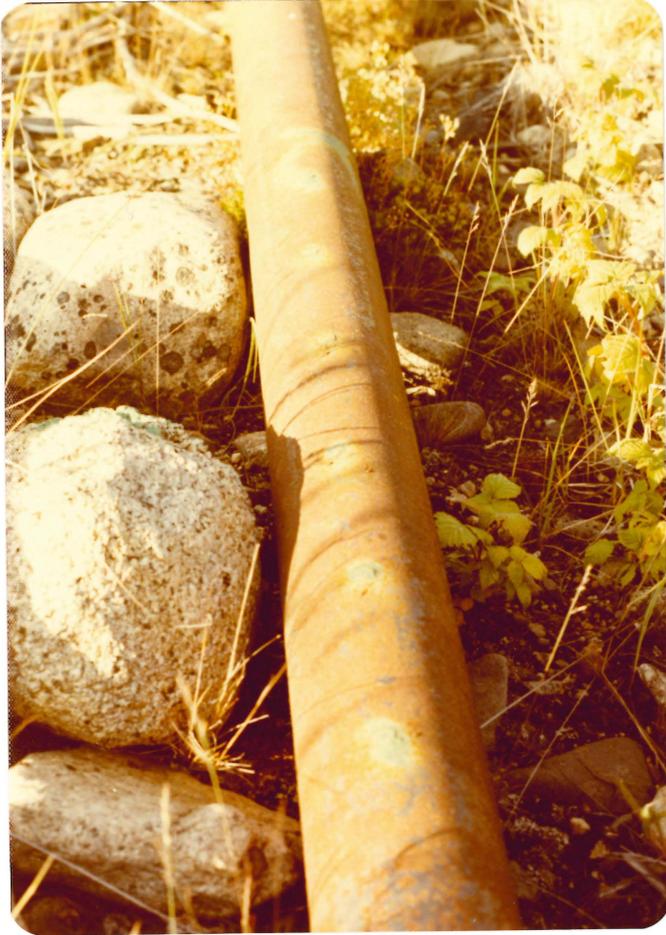
- 8) Other areas suspect of possible weakness or in need of repair. When the U.S. Army shut the pipeline down in 1946 they drilled one-quarter inch holes in various places in order to bleed the pipe. When the pipeline was put back into production, they welded over the holes. Since that time most of these sections of pipe have been removed. However, there are three locations where these sections have not been replaced, at miles 54.4, 55 (Plate 27) and 55.3. It is recommended that these sections of pipe be replaced.

Plate 27 Welded drill holes
in pipe (mile 55).

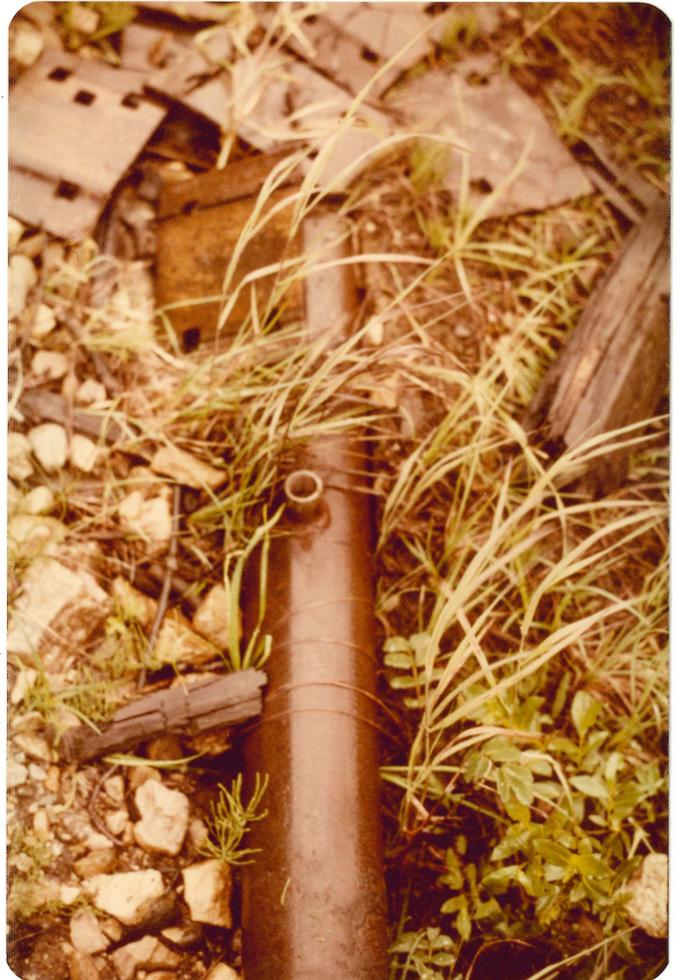
Two other sections of pipe which should be removed are at miles 24.8 and 94. At mile 24.8 there is a one-inch spigot welded to the pipe (Plate 28) which was installed in order to bleed the pipe. At mile 94 there is a three-quarter inch bleeder valve (Plate 29) which is no longer being used. It is recommended that the valve be removed to reduce the possibility of vandalism or uncontrolled bleeding of the pipeline as the valve is in an accessible location.

Plate 28 Spiggot on pipe
(mile 24.8).

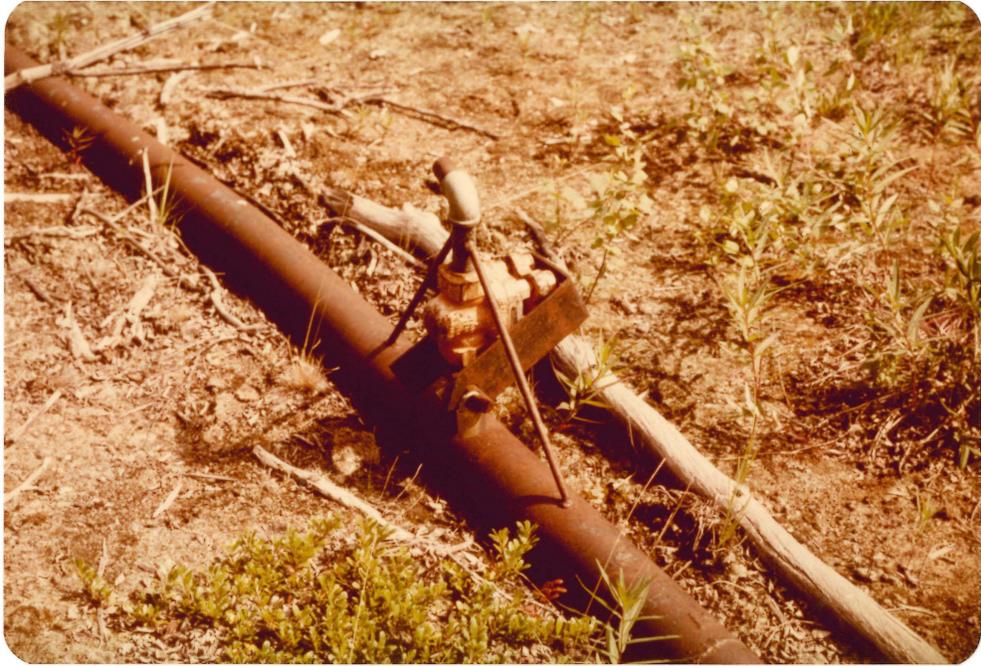
Plate 29 Obsolete valve on pipe near Cowley Lake (mile 94).

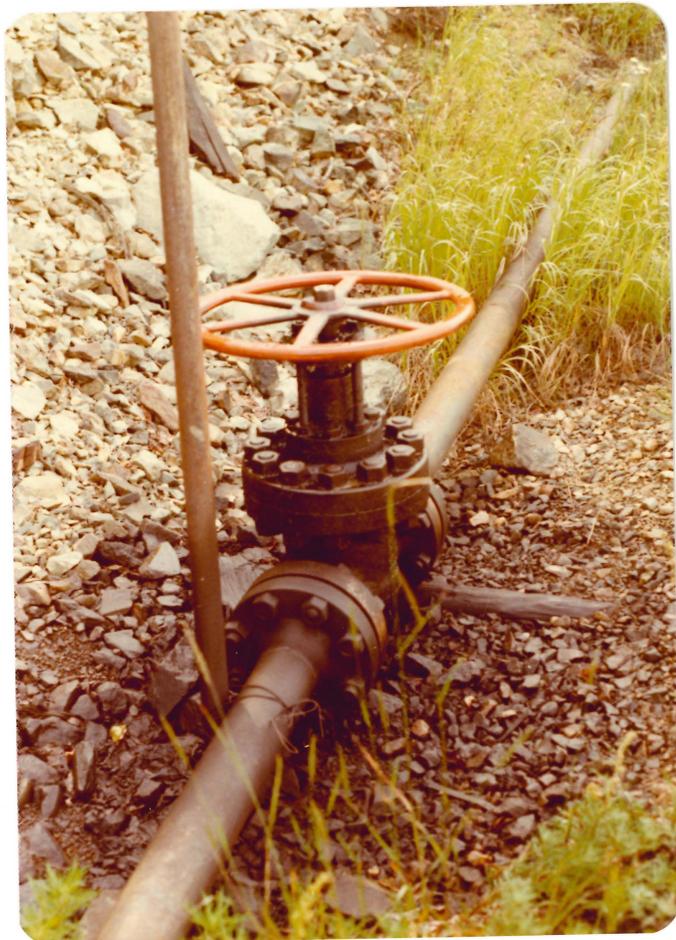
At mile 49.8 the valve needs attention as it is leaking (Plate 30). If the valve cannot be repaired it is recommended that it be replaced.

Plate 30 Leaking valve
(mile 49.8).

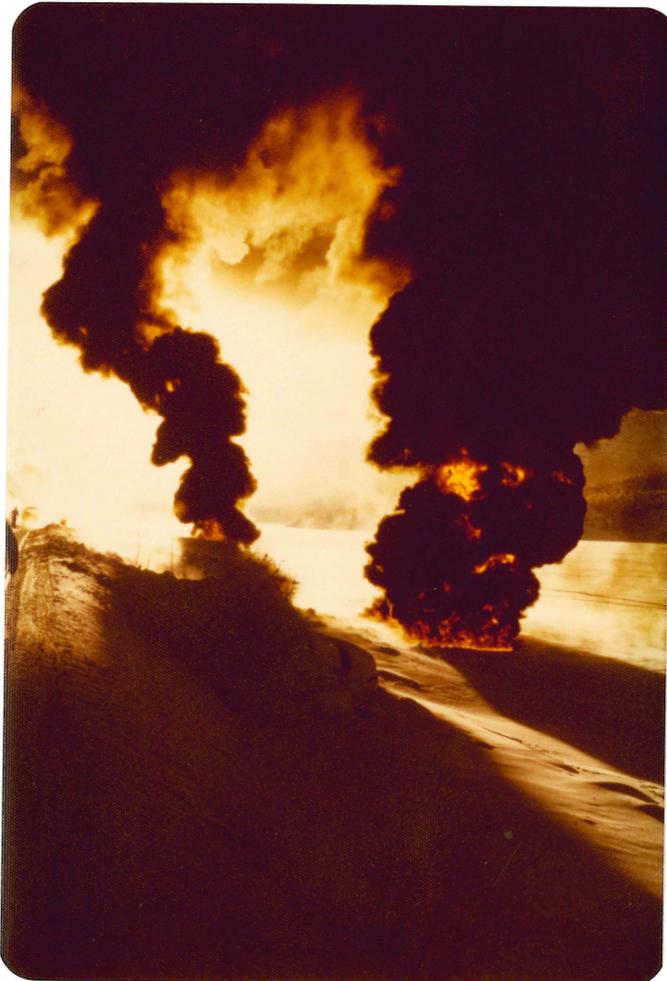
The oil on the lake surface was burnt on December 31, 1973 (Plate 1). Burning continued periodically over the next several months as oil was noticed on the lake. The site was again visited in April 1974 and there was a considerable amount of petroleum residue on the surface of the ice (Plate 2). During another site visit in June 1974 the only trace of the spill was a streak of residue left by the oil at former ice surface (Plate 3). In July 1976 the site was again visited and the residue described above was absent.

Plate 1. Burning off oil that had accumulated on the surface of Bennett Lake after the December 29, 1973 spill.

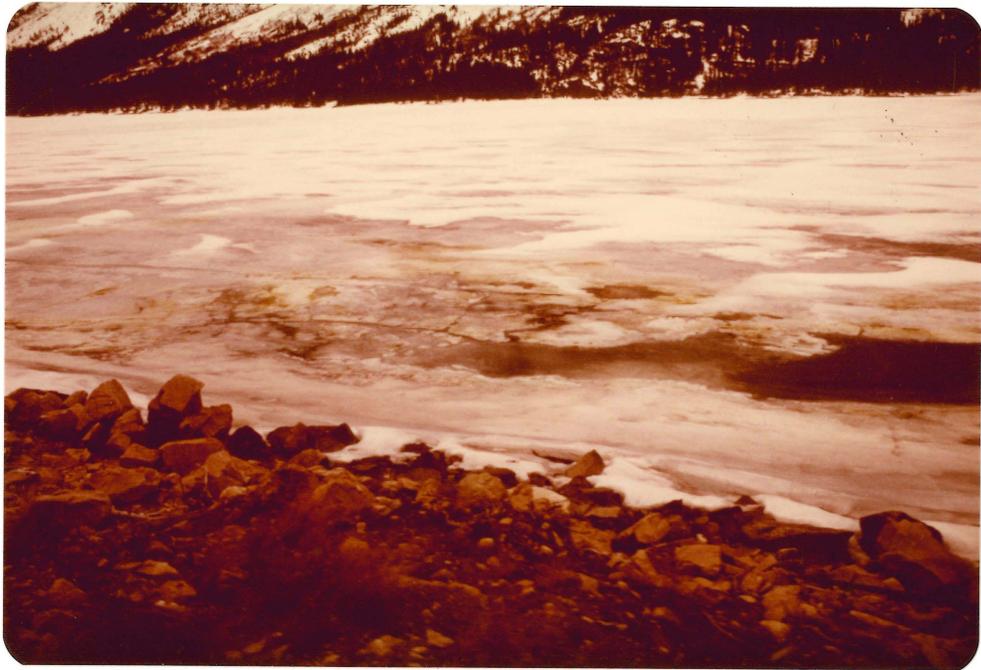
Plate 2. Residue left on the ice of Bennett Lake after the burning of the 1973 spill (Plate 31). Photo taken in April 1973.
