AN ENVIRONMENTAL STUDY OF THE WHITE
PASS & YUKON ROUTE PIPELINE FROM THE
B.C. - ALASKA BORDER TO WHITEHORSE, Y.T.

by: D. MUNRO
K. WEAGLE

ENVIRONMENTAL PROTECTION SERVICE
WHITEHORSE, YUKON - SEPT. 1976

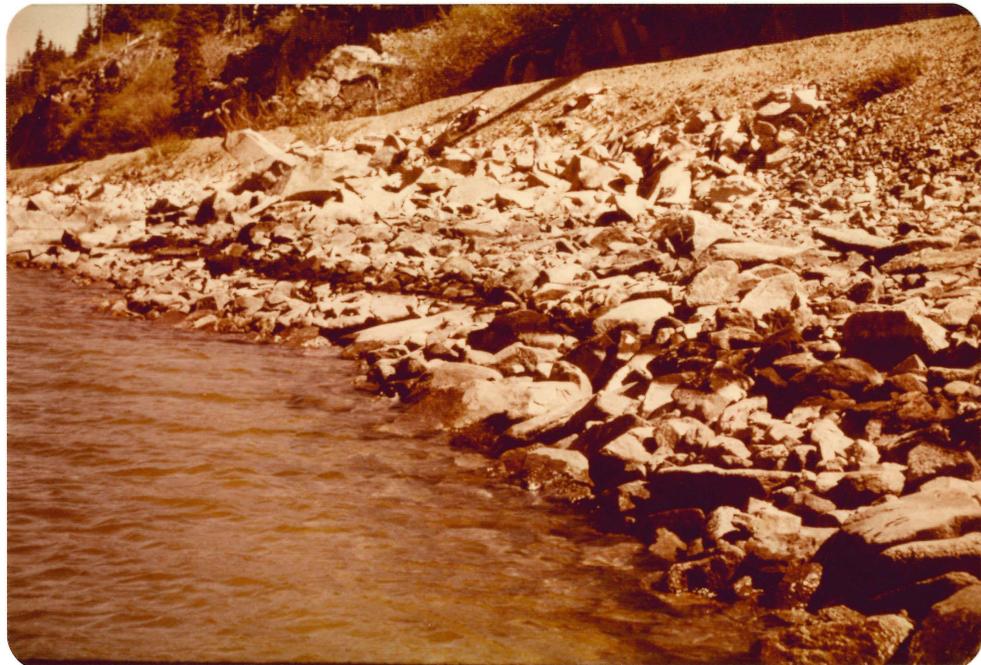
Plate 3. Residue left on the shore of Bennett Lake after ice out in 1974. The residue was left at the level of the top of the ice during the spill. Photo taken in June 1974.

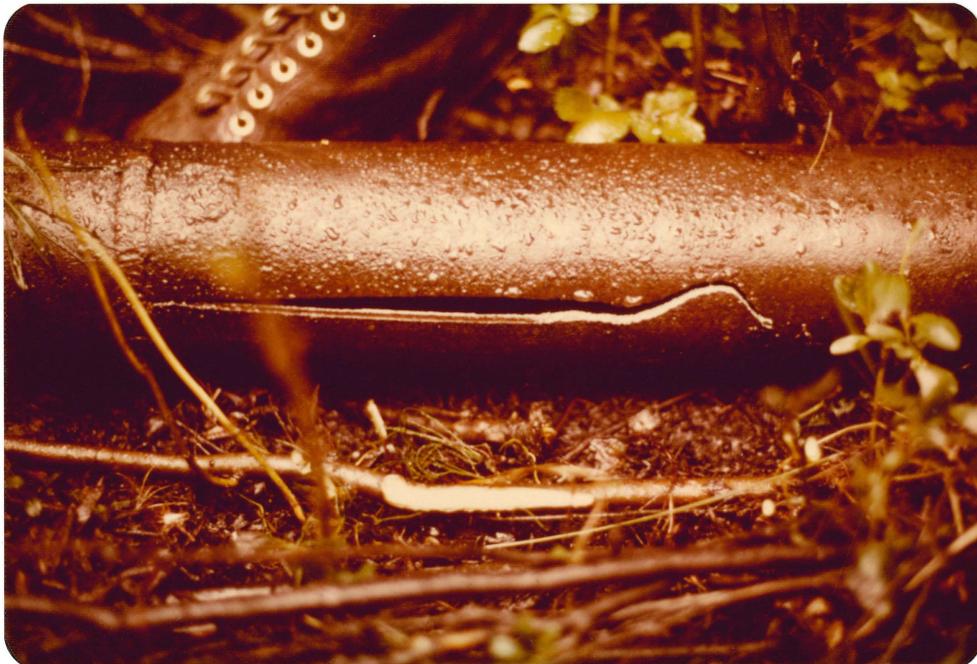
Plate 4. The hole in the pipeline that resulted from the high pressure break on July 4, 1974.

The break was the result of pressure built up in the pipe while product was left in the pipe during downtime. In the area of the break the pipe seam was weakened by rust and the high pressure (3000-psi, estimated by WPYR) cause the break. The break caused a pressure ^{drop} at the Skagway gauging station and the pipe was immediately shut off.

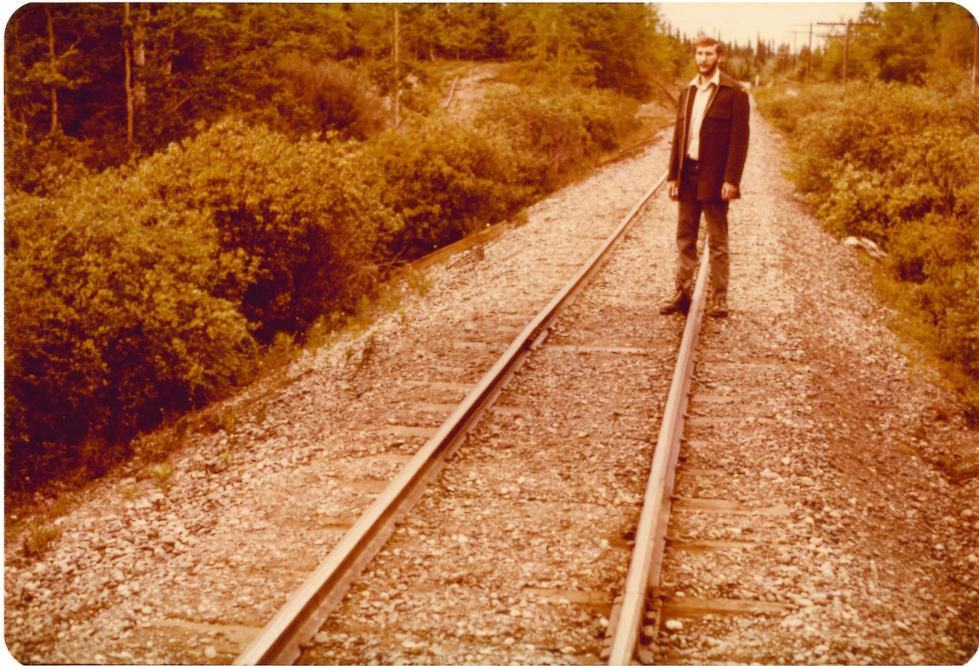
Plate 5. The oil stain over the tracks that resulted from the July 4, 1974 spill. It was finally estimated that 74 barrels of fuel were lost. The pipeline is on the right of the tracks.

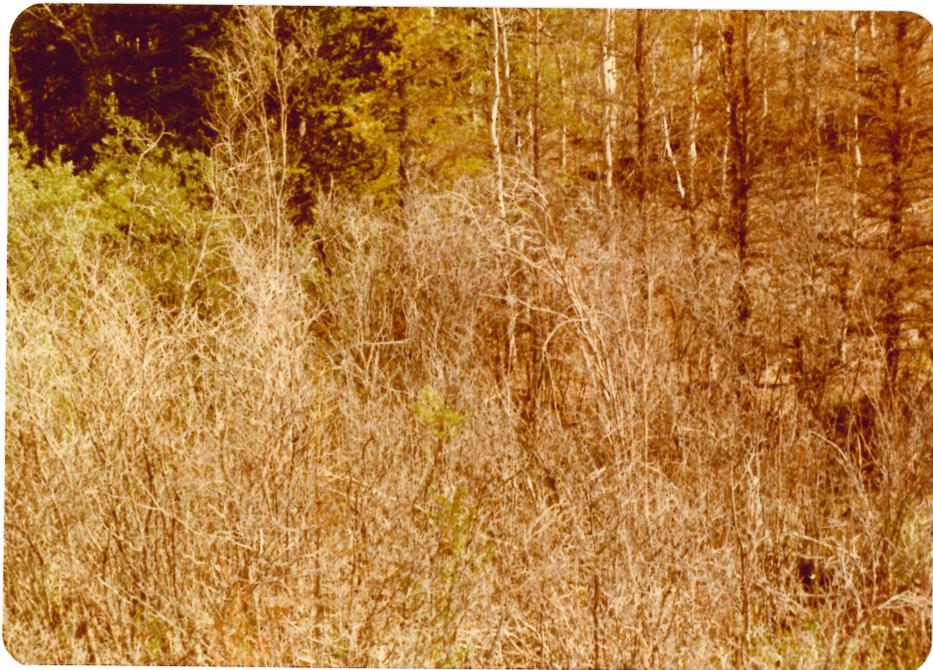
Plate 6. Dead vegetation in the area of the July 4, 1974 spill. This illustrates that even a light skim of oil will cause an extensive vegetation kill (looking toward the track, west).

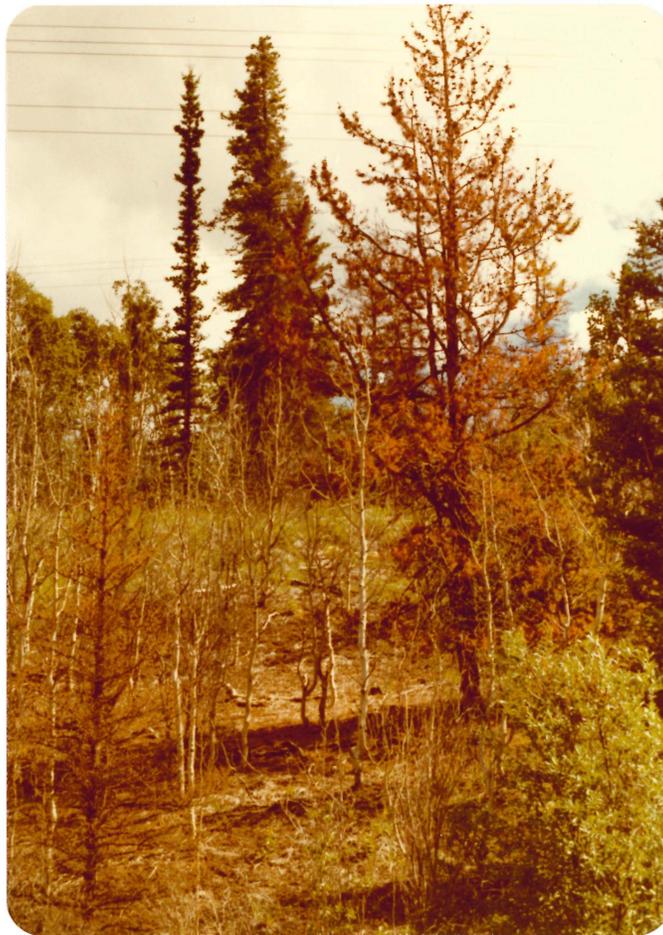
Plate 7. Damage to the vegetation caused by the July 4, 1974 spill (Picture taken looking toward the east on the opposite side of the tracks from the pipeline).

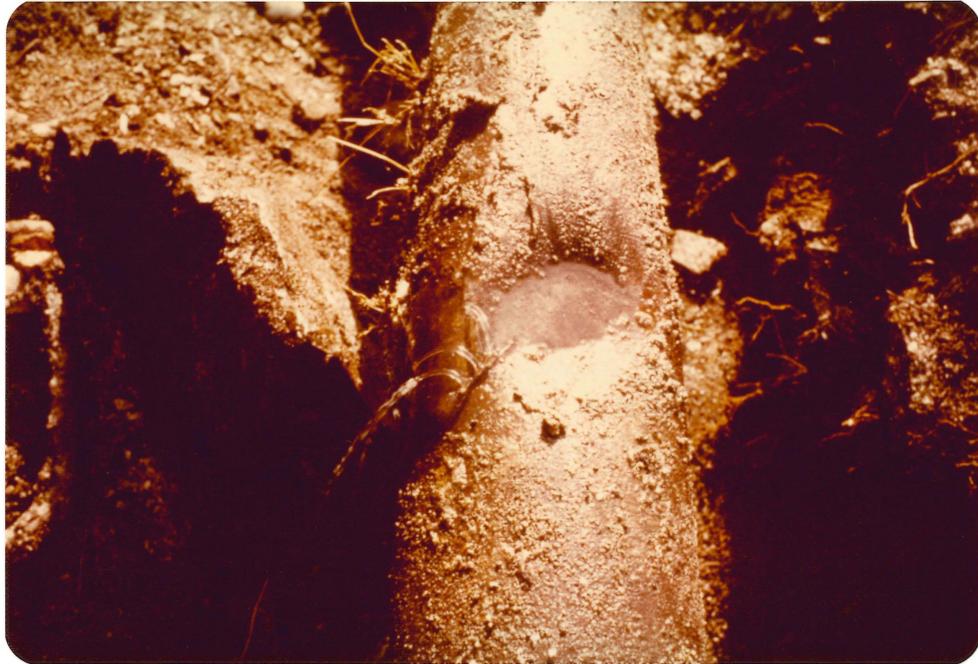
Plate 8. The leaking pipe at mile 46.6 as found on March 26, 1975. The original damage occurred in the fall of 1974 and the pipe ruptured under the stress of winter conditions in 1975.

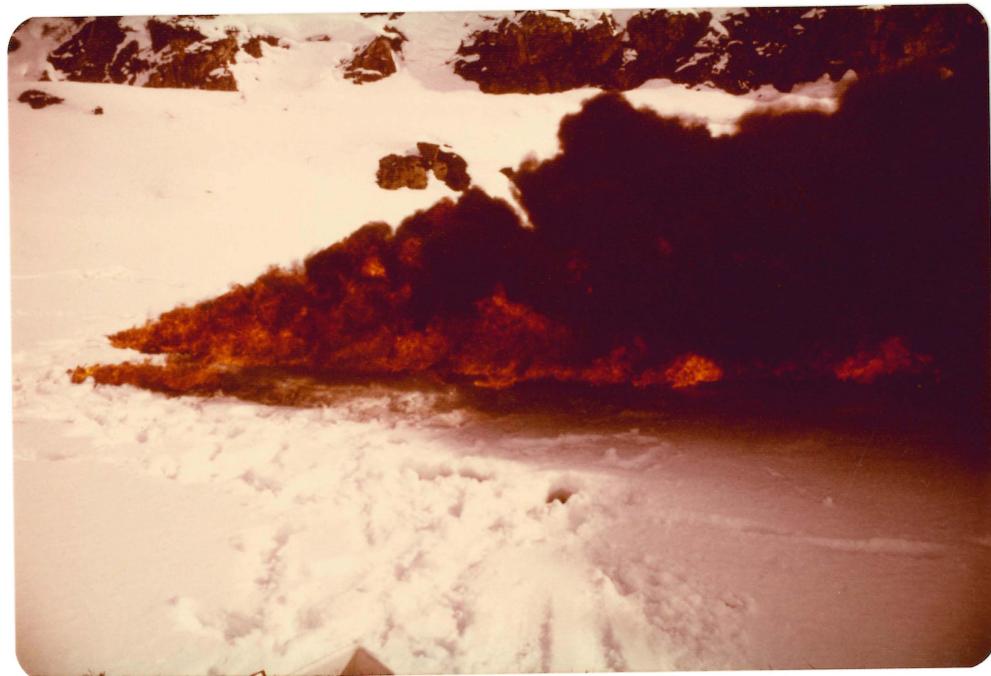
Plate 9. Burning off oil on April 3, 1975 after it had been collected on the ice surface.

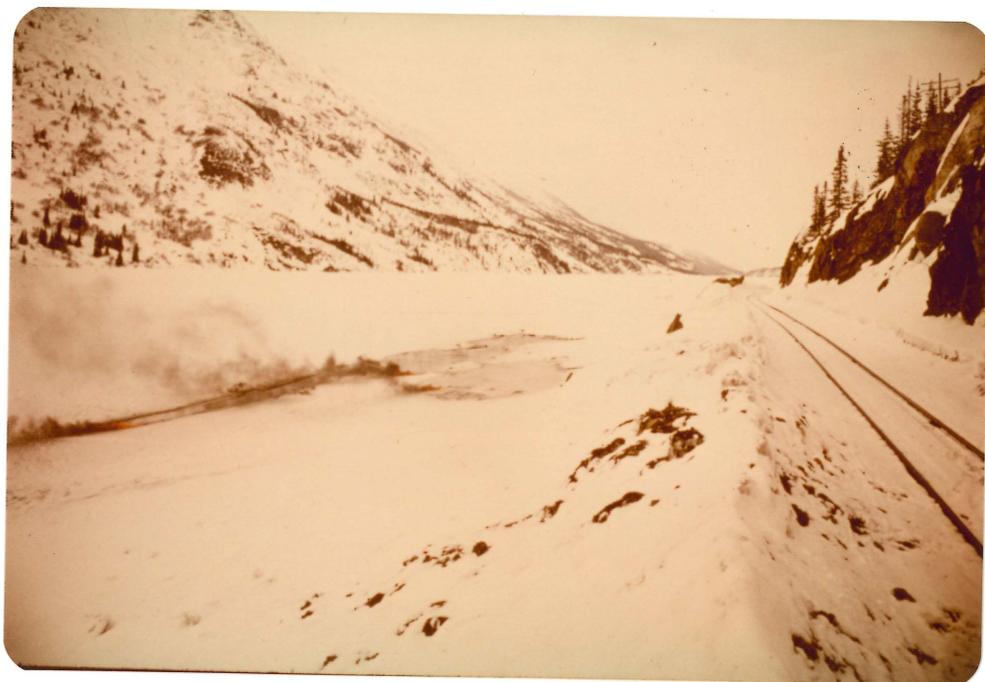
Plate 10. The residue left after burning of the March 25, 1975 spill. It was estimated that 75% of the 3000 gallons spilled were disposed of.

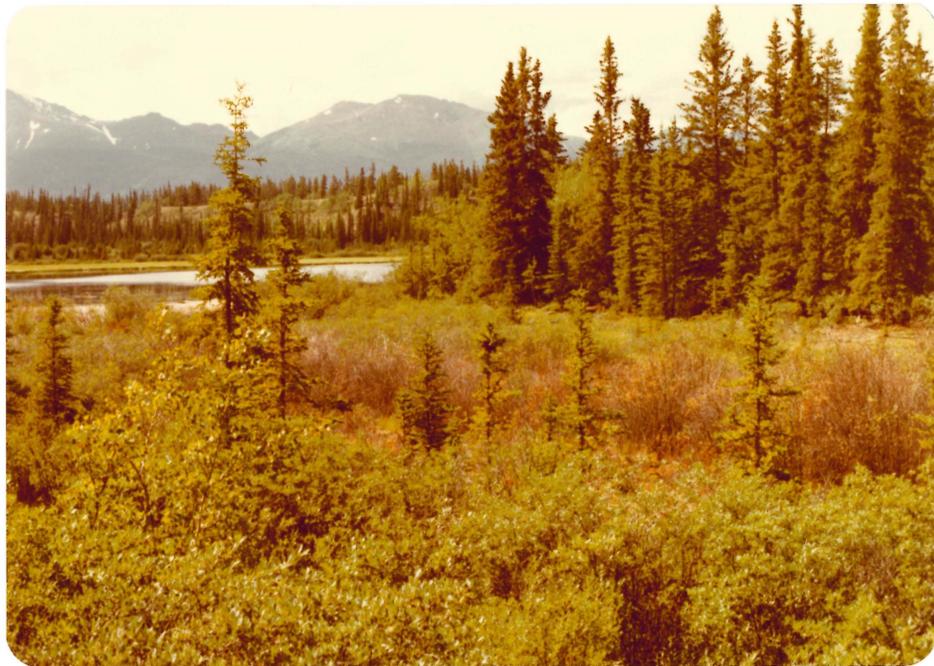
Plate 11. The dead vegetation at the centre of the photo shows the path the oil followed as it flowed toward Rat Lake.

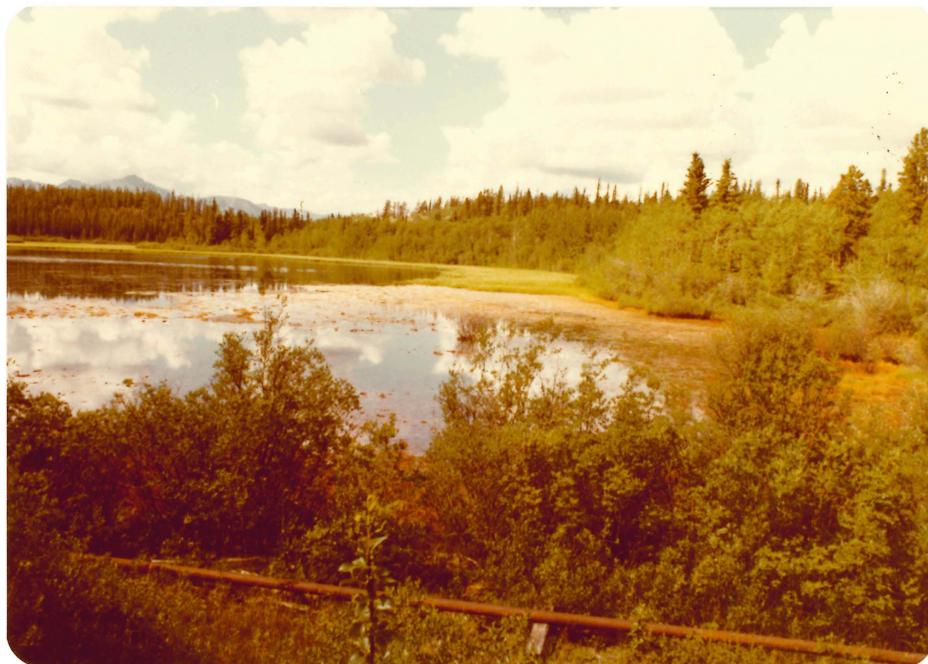
Plate 12. Dead vegetation along the shores of Rat Lake as a result of the October 14, 1975 spill. Photo taken in July 1976.

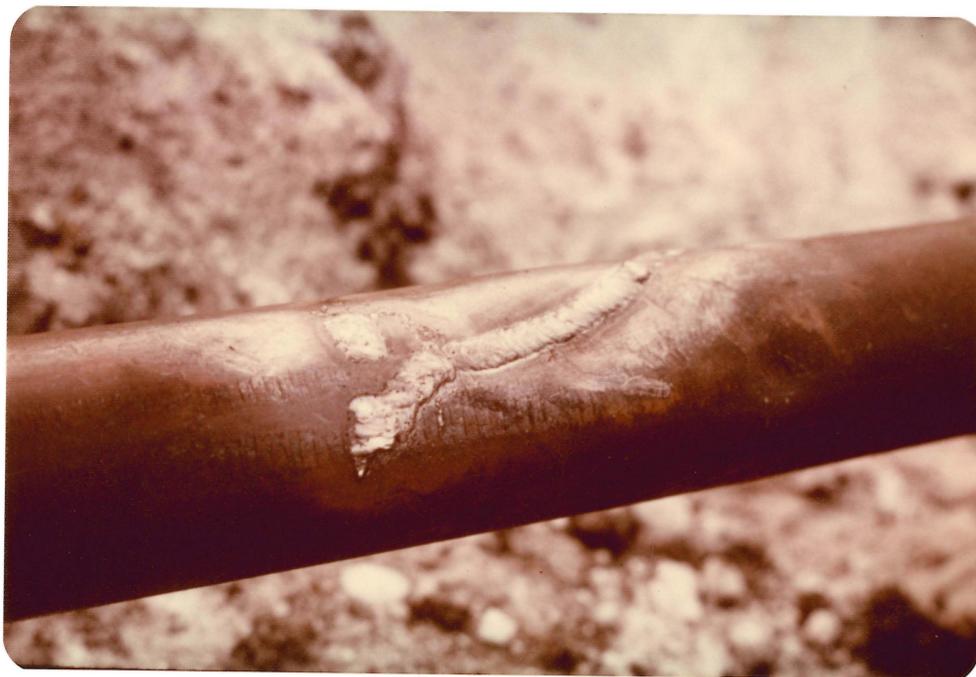
Plate 13. The weld over the hole which caused the January 30, 1976 spill. It is felt that it would be better to remove the damaged section of pipe than to put a weld over the hole.

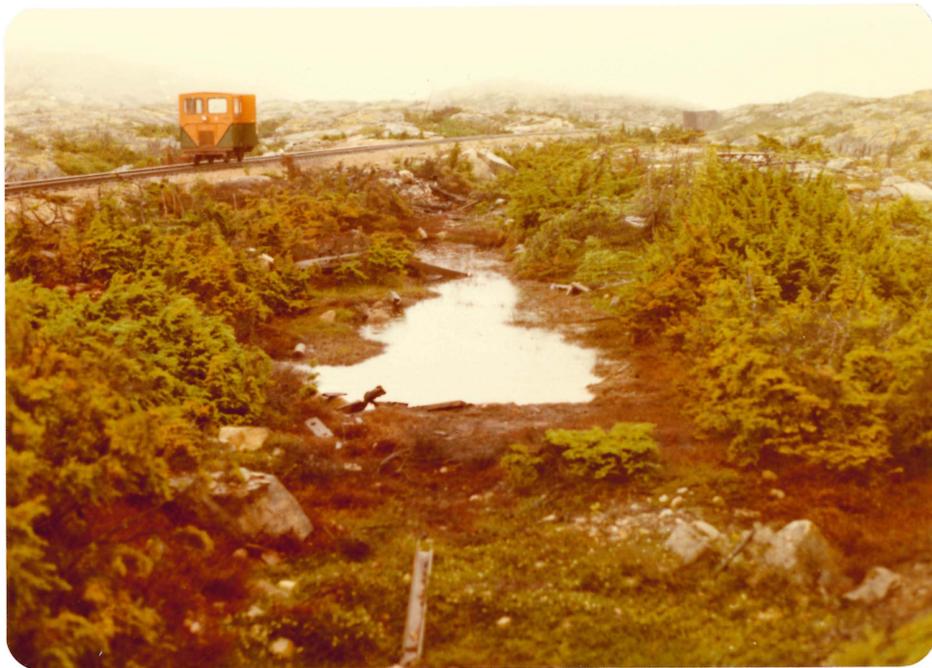
Plate 14. Damage to the vegetation as a result of the April 1, 1976 spill in the White Pass area.

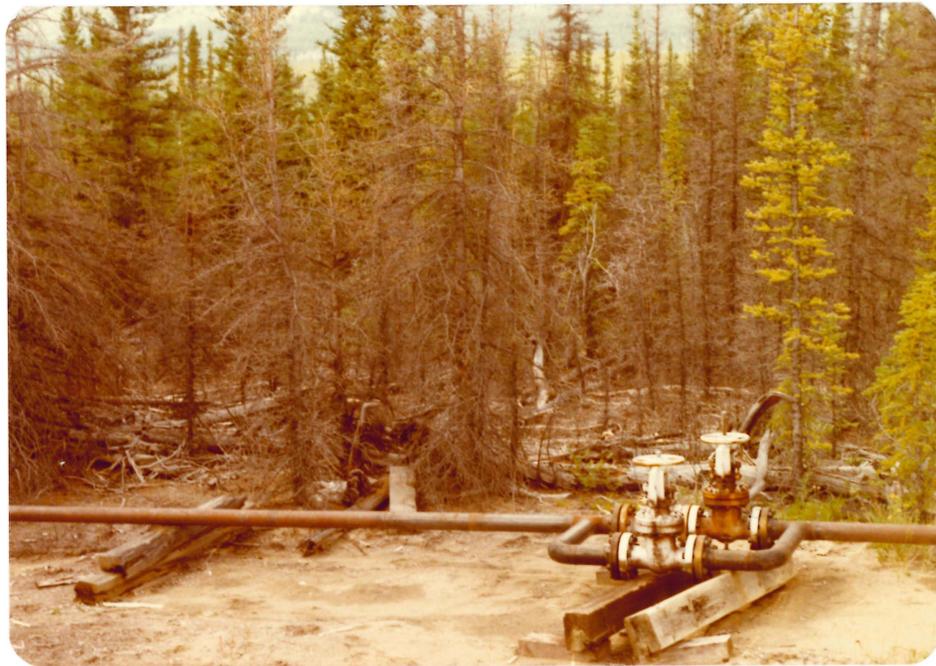
Plate 15. Damage to vegetation caused by a spill of 213 barrels of diesel fuel at Mile 78.4 on May 13, 1969. The photo was taken in July 1976.
