**MERCURY CONTAMINATION
AT YUKON HYDROMETRIC STATIONS**

A Water Contaminants evaluation under the Mercury Project
File 9590-2-9
by

November 1997

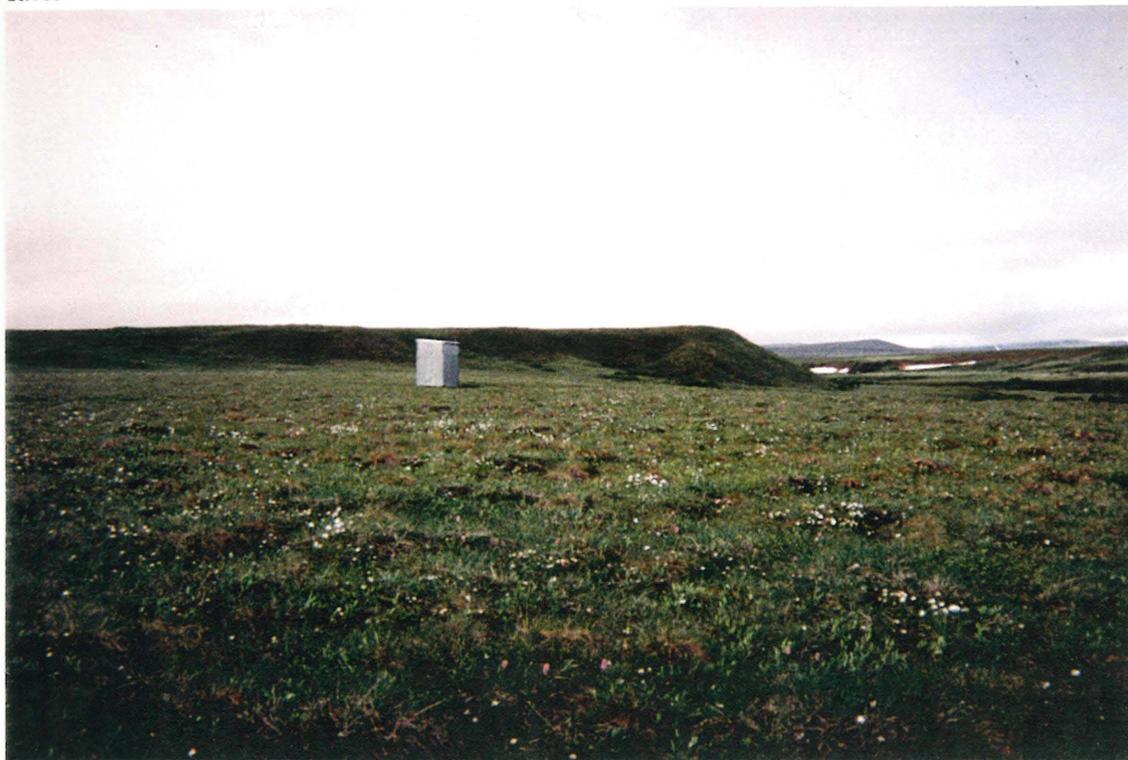
The building is an older style, with a galvanized sheet metal upper structure, and a wood base (photo A). The upper structure is equipped with "ears" to facilitate lifting the unit by helicopter. It is located some 20 metres from the east bank of the Babbage River and approximately 15 metres North of Caribou Creek. The orifice line was missing from the site and the cable to the rain gauge has been removed and is coiled in the building. The rest of the flow monitoring equipment that remains inside the building includes the mercury catchment pan, base for the recorder, and an air bottle. No attempt was made to open the valve and it was treated as a full bottle for the purposes of this evaluation (photo B). The manometer has been removed and there appears to be no mercury present on the floor or in the metal frame lips where the metallic upper structure is bolted to the floor. There is a small quantity of mercury (<5gm) within the pan located on the floor (photo C). Most of the weather station equipment has also been placed within the building, including the installed data logging

Photo A: Babbage Station and Site

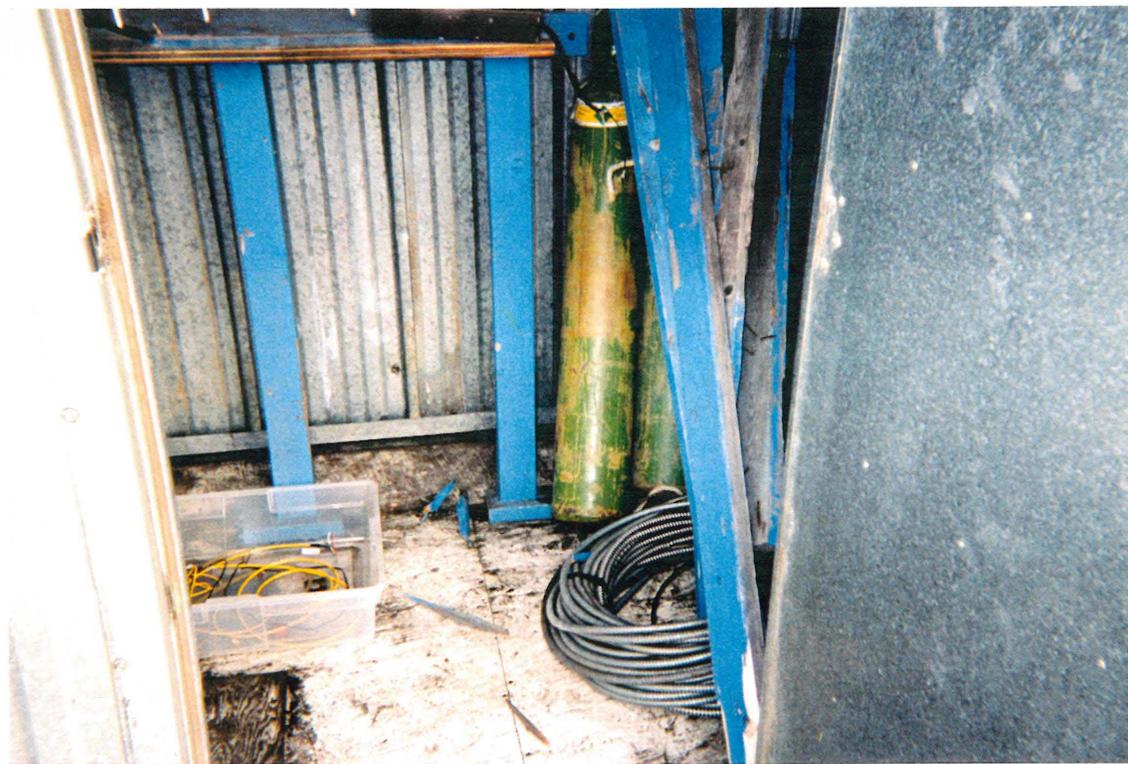
Photo B: View of Station interior

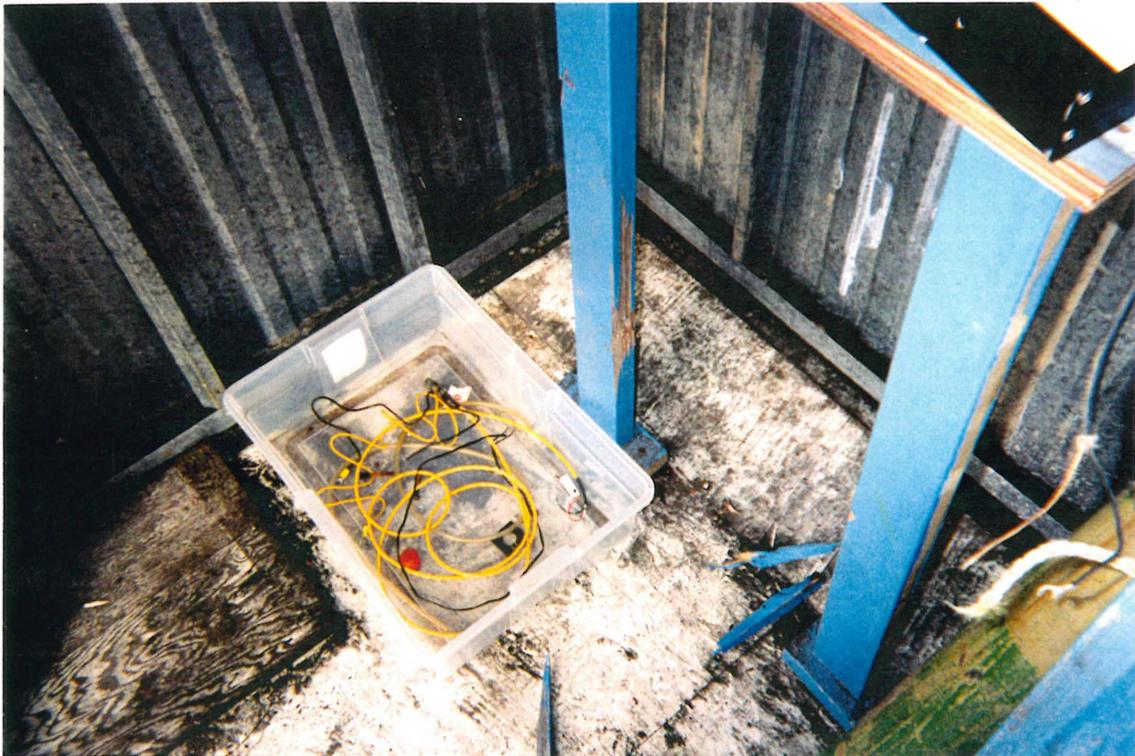
There is a small risk, given the type of floor and degree of observed contamination, that mercury has escaped beyond the confines of the building and reached the tundra. Any quantity that might have escaped would be extremely small. Given the conditions at the site, and within the scope of this investigation, the environmental risk posed by mercury at this site is not measurable. The primary environmental concerns at this site are aesthetic and related to the fuel, which is contained for the moment within the drums.

Photo C: Pan containing small quantity of mercury

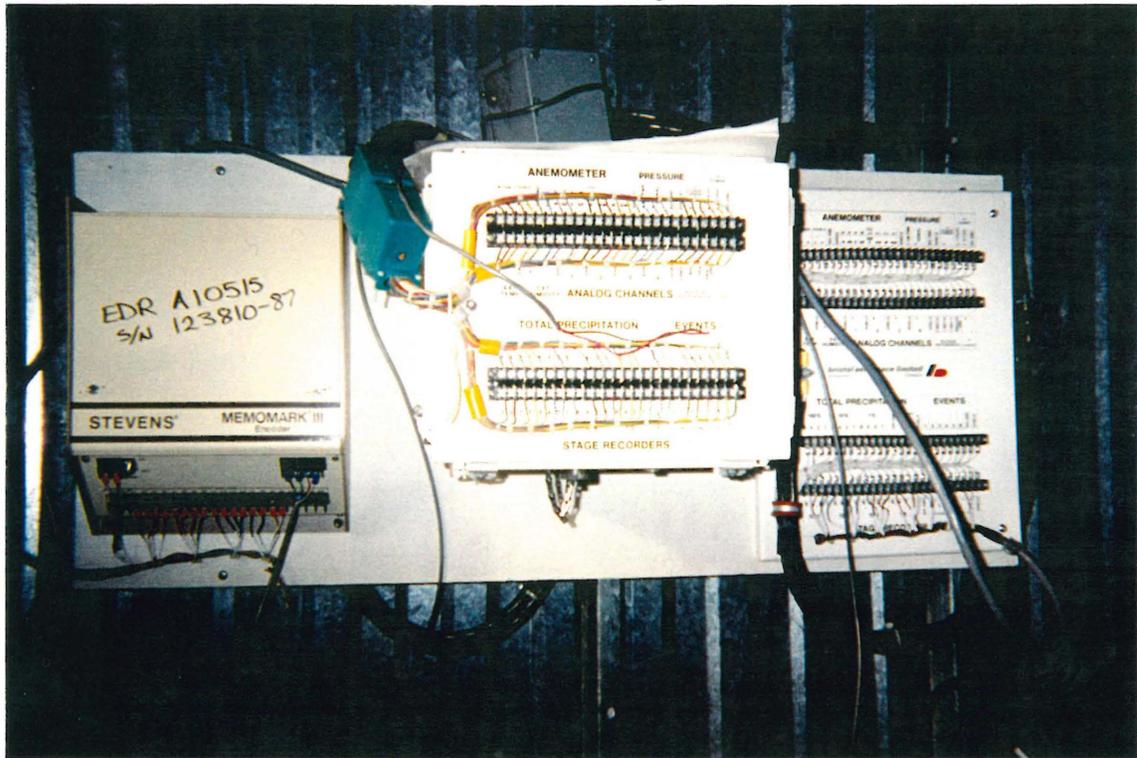
equipment (photo D). The floor of the station is constructed of tight fitted plywood over a frame of undetermined construction but presumed to be entirely of wood. The wood frame base observed outside the building has a single hole through it to allow passage of the orifice line. Construction of the base impeded access to the tundra within the building foot print.

Photo D: Data logging equipment

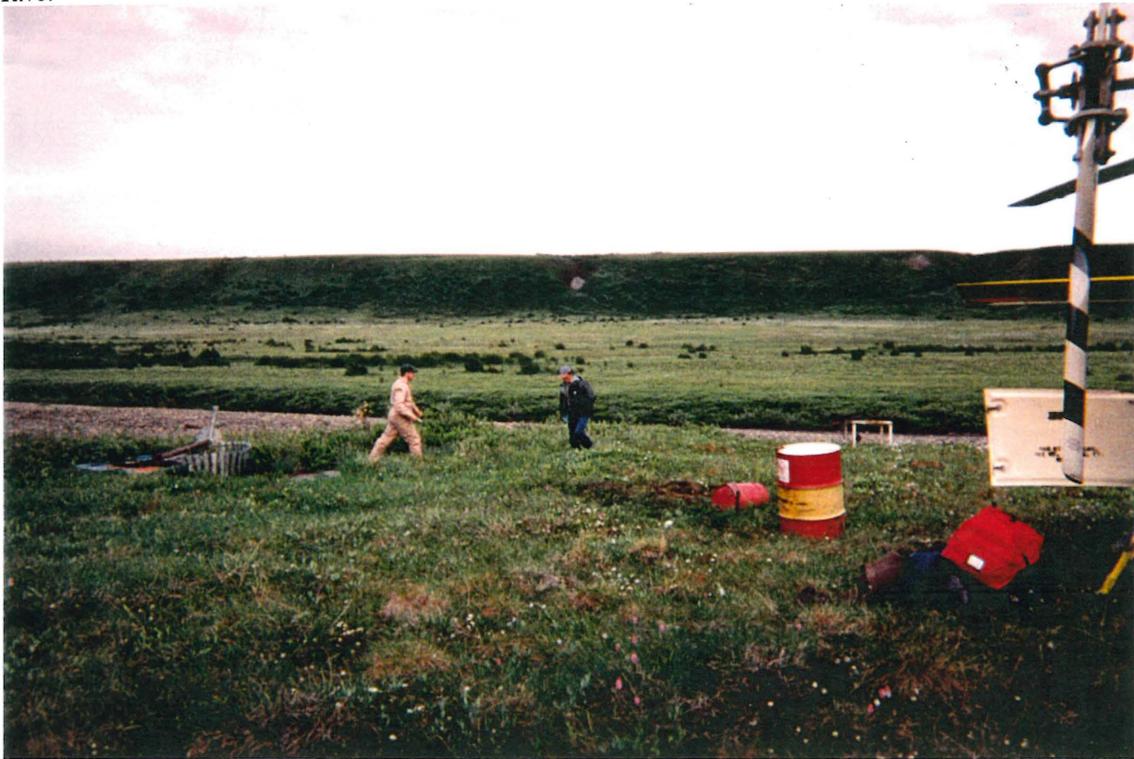
There are two fuel drums, a rain gauge installation, a base for the cable carrier, and a boat remaining within the reserve (photo E). The one unmarked drum is a 22 gallon size and is partially full, while the second is a full 45 gallon container marked as Jet B fuel. The boat appears to be an 18 foot Lund-type craft of aluminum construction and lies on the West side of the Babbage River channel, presumably outside the reserve and within Ivavik National Park. The base for the rain gauge (photo F) is located 5 metres from the Babbage River's east bank, and the base for the cable carrier is located some 10 metres north of the rain gauge.

Photo E: Rain gauge base, fuel drums, and cable system base

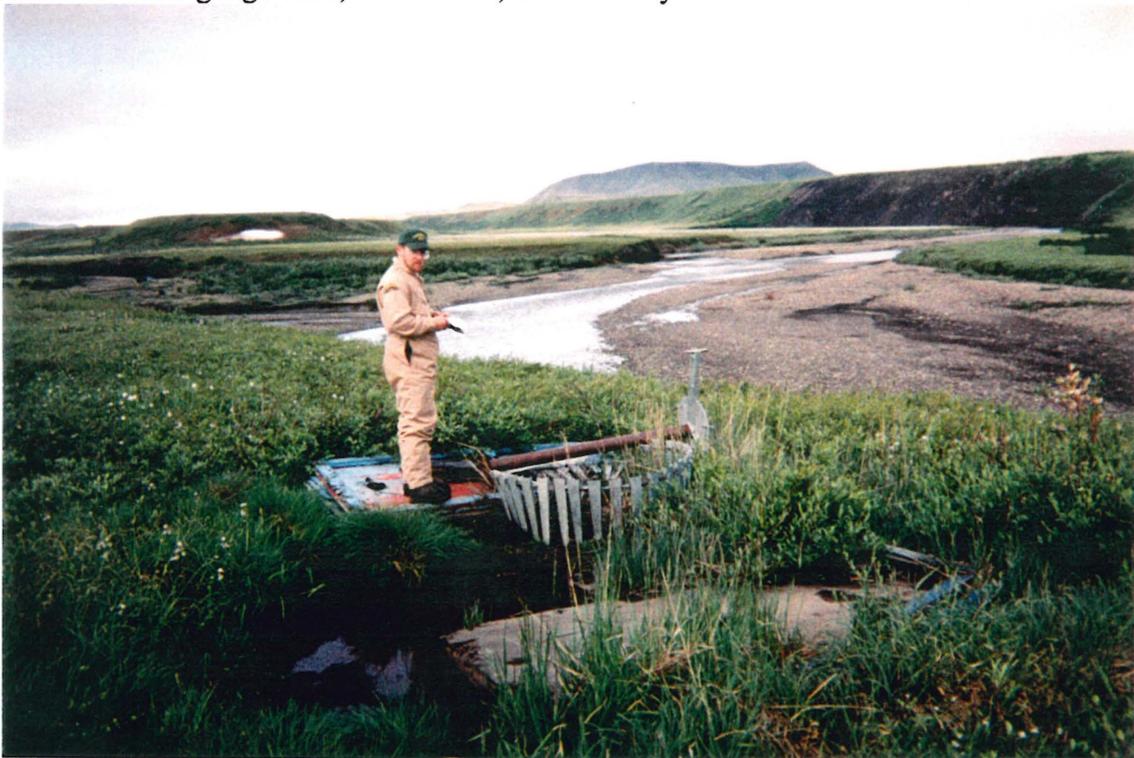
Photo F: Rain gauge base and debris

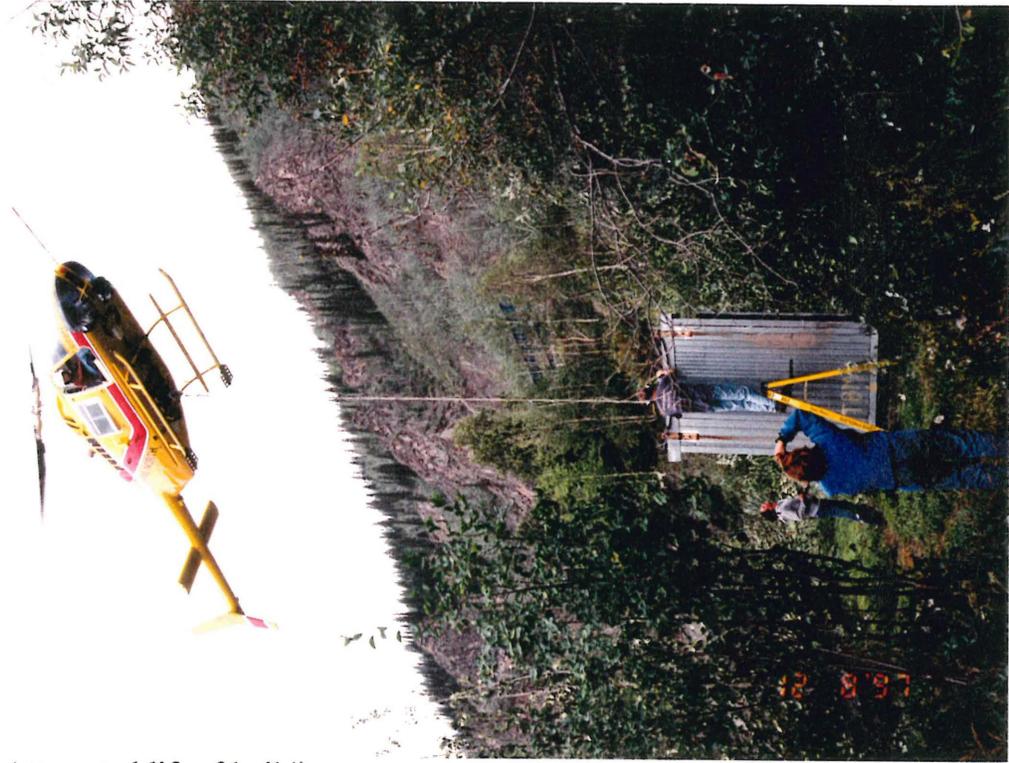
Photo G: Attempted lift of building

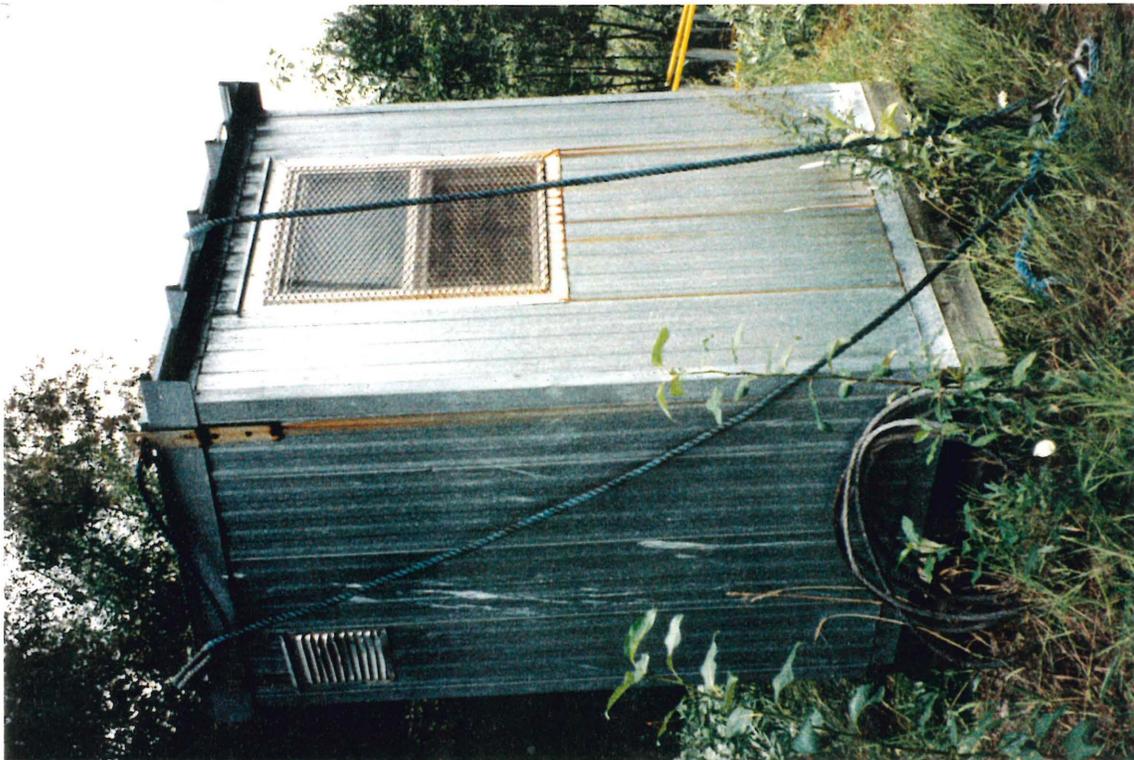
The building is an older style, similar to the Babbage River site, with a galvanized sheet metal upper structure, and a wood base (photo H). The orifice line and cable are still at the site but all other equipment has been removed (photo I). There is mercury present on the floor, in the metal frame lips where the metallic upper structure is bolted to the floor, and on the support under the window. There is a considerable gap in the floor (photo J). A small quantity of mercury is located on the base immediately under the gap in the floor (photo K) and there is

Photo H: View of building

The remedial work of the site can be conducted with the removal of a minimum of contaminated soil. The building, however, is completely contaminated and must be handled as such. Removal can be accomplished easily using an access down the trail and by helicopter. It is recommended that the building be sealed and removed intact by rotary wing aircraft to the

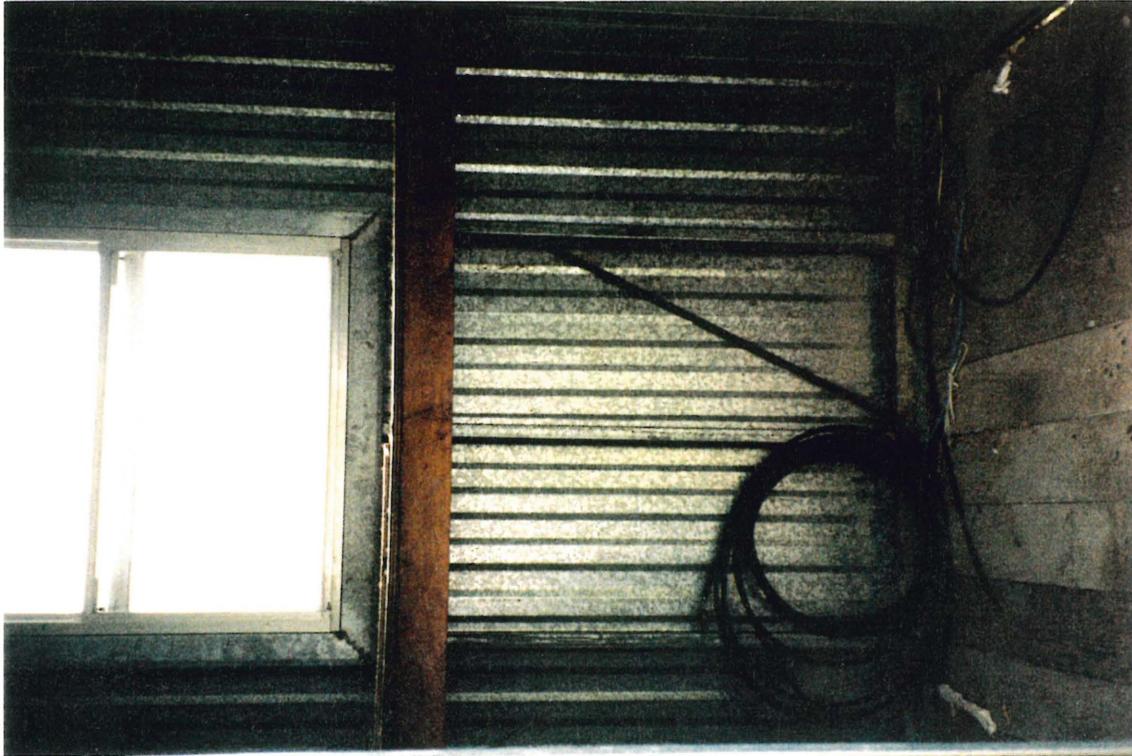
Photo I: Building interior

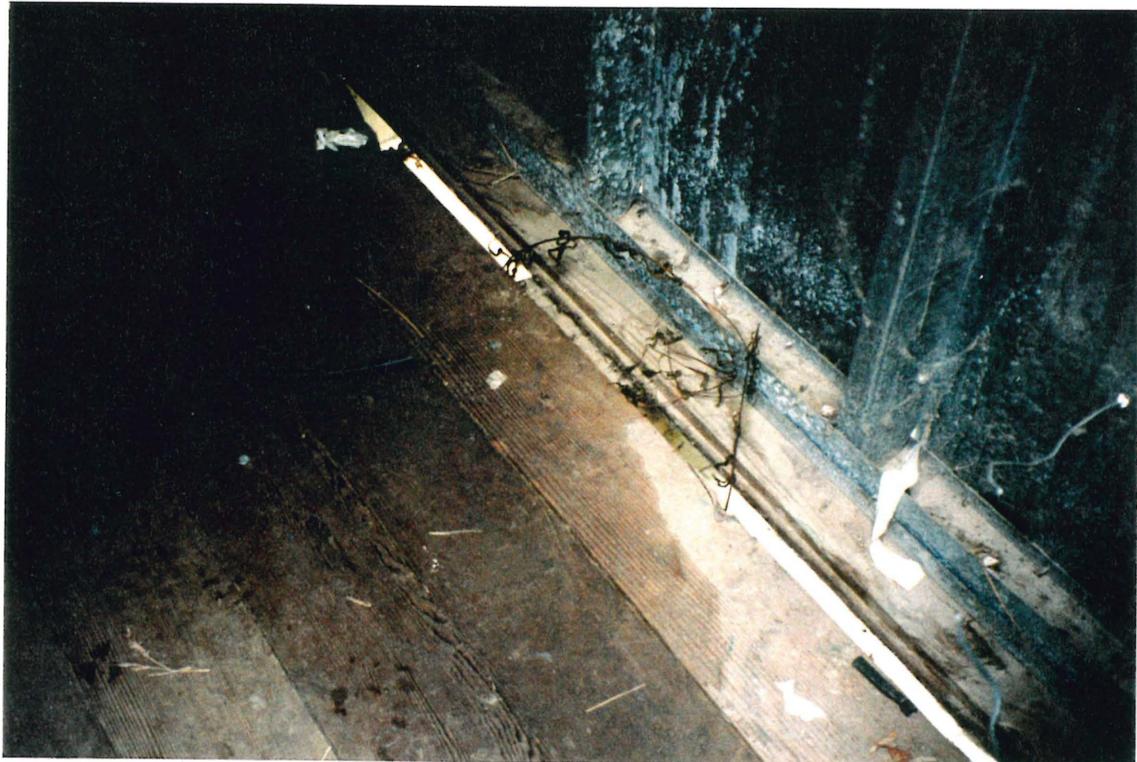
Photo J: Floor of building

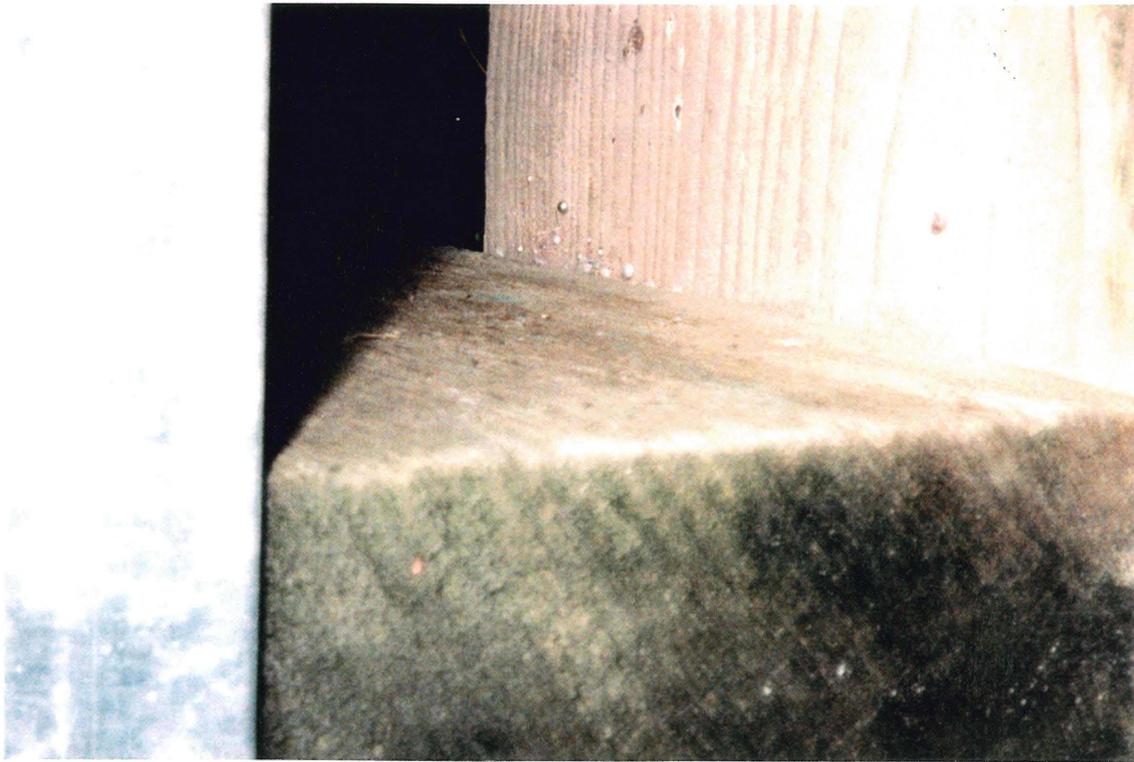
Photo K: Mercury on exterior base

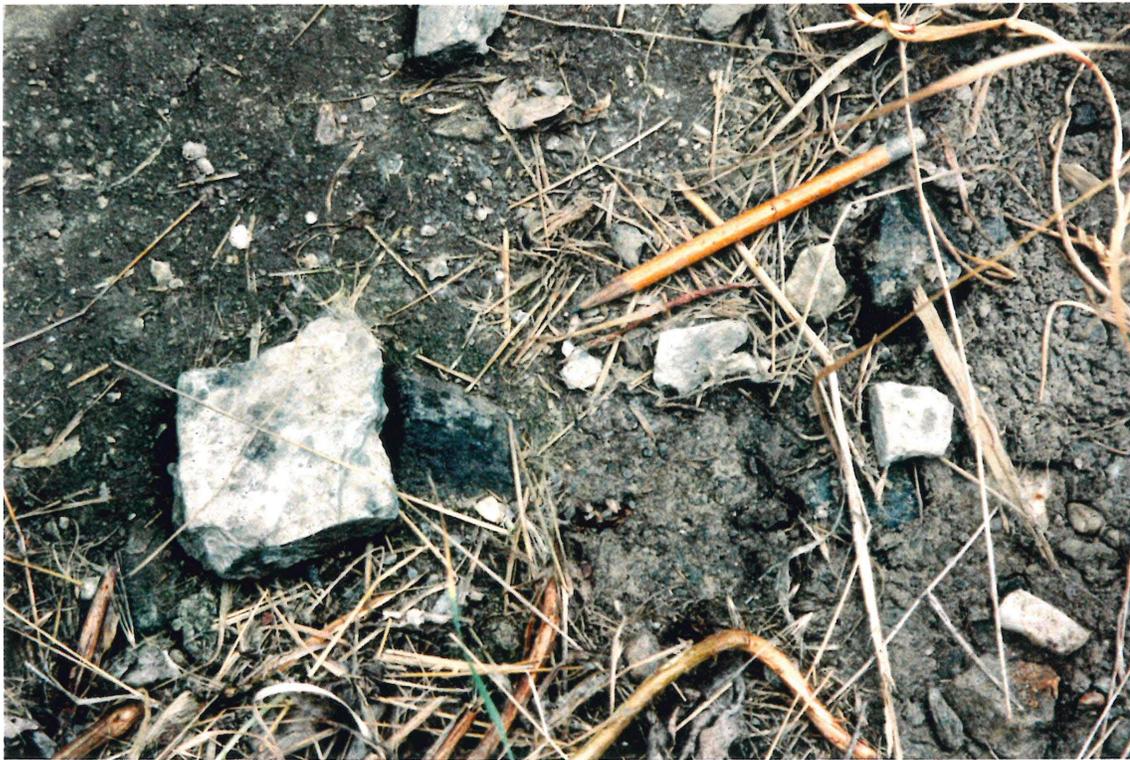
more on the ground beneath were this part of the building had been located (photo L)

Photo L: Mercury on ground

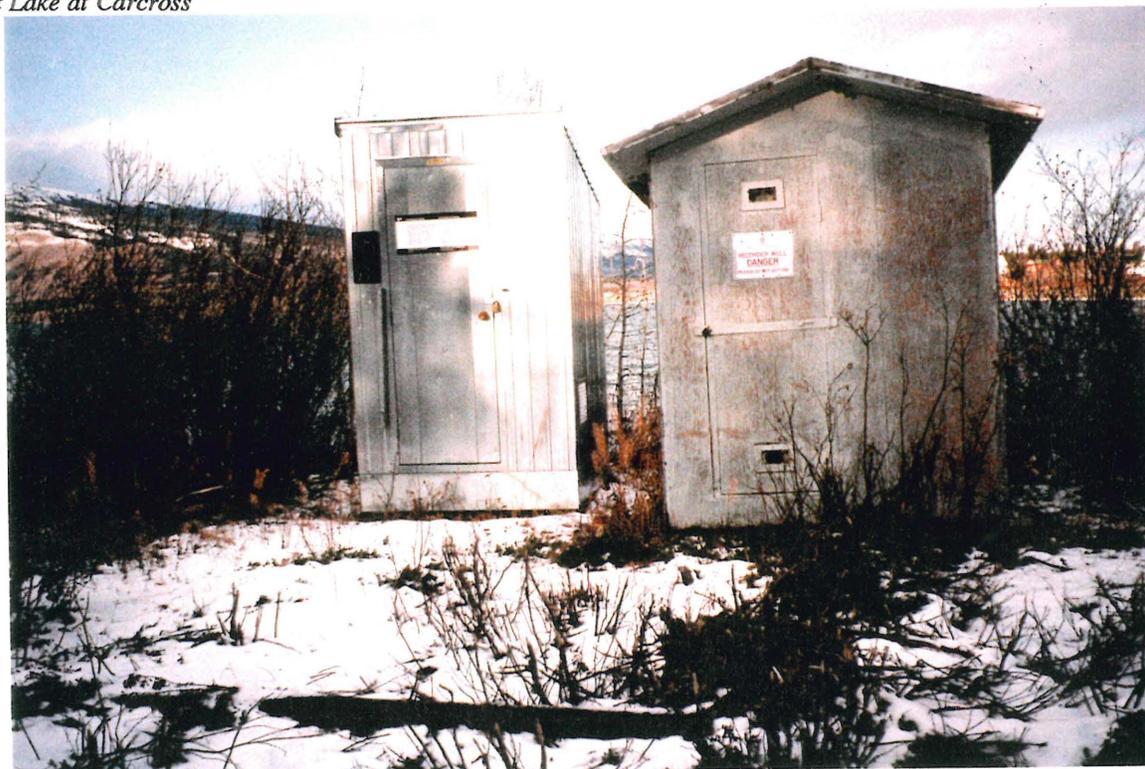
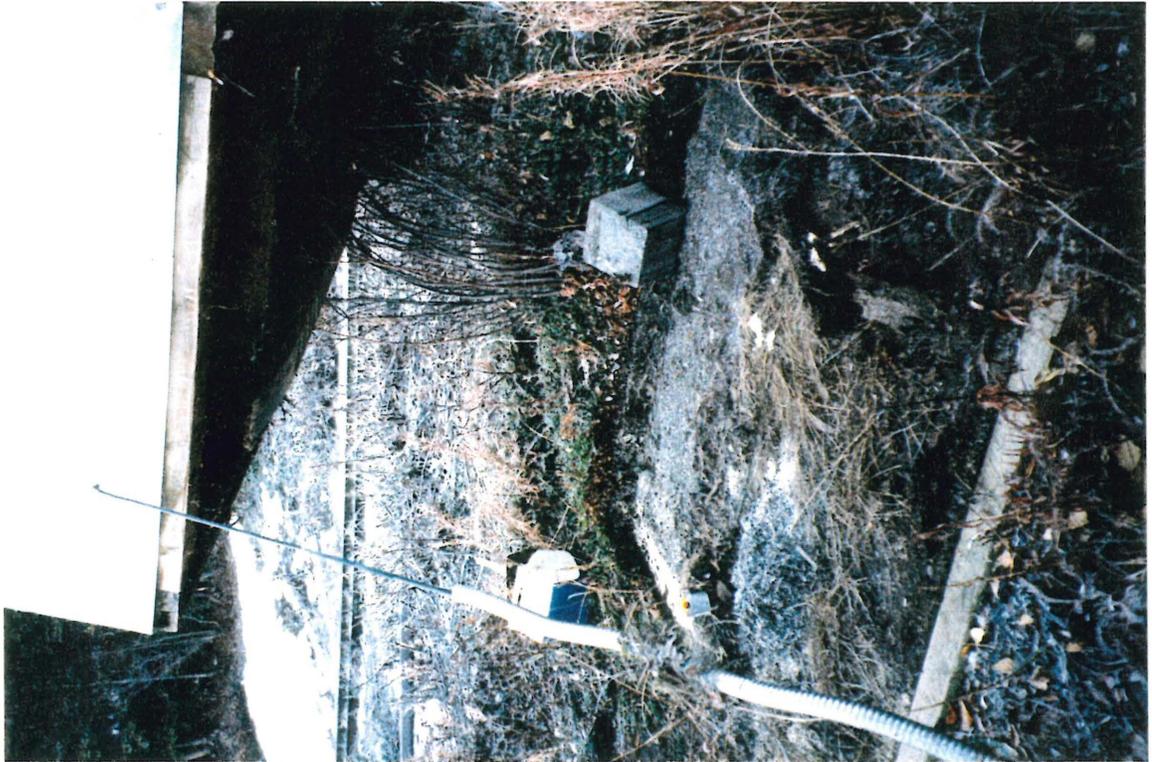
Photo O: Exposed soil under building

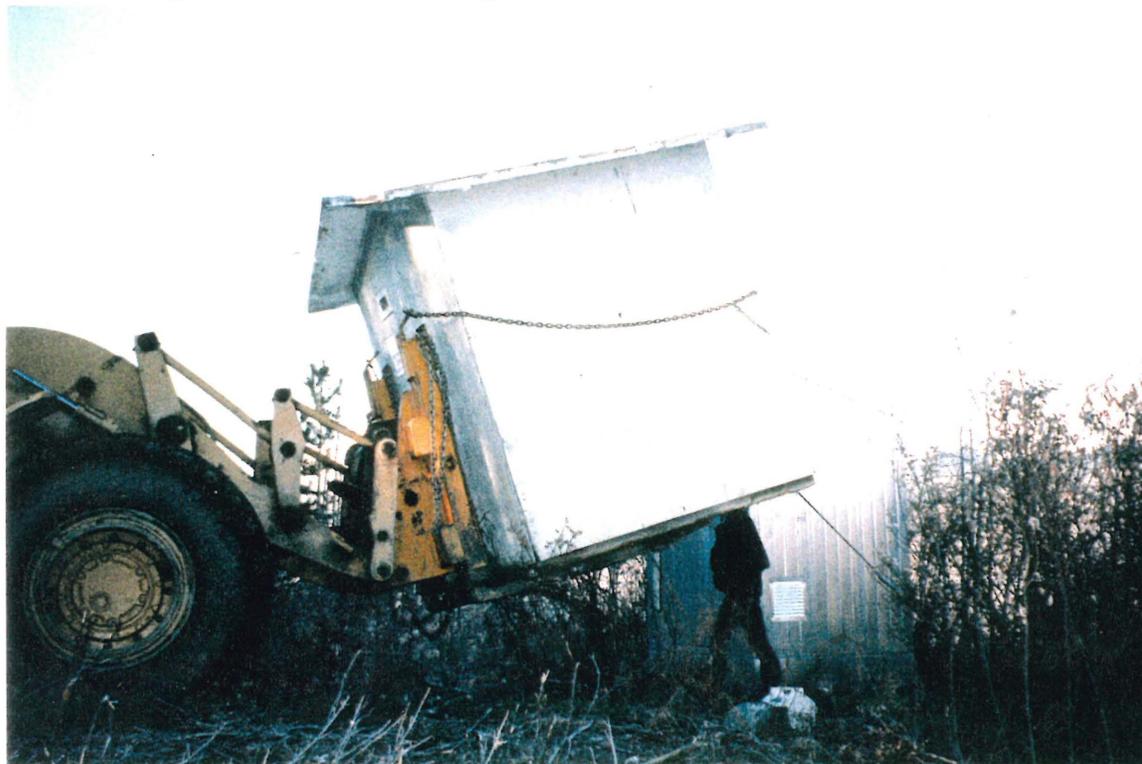
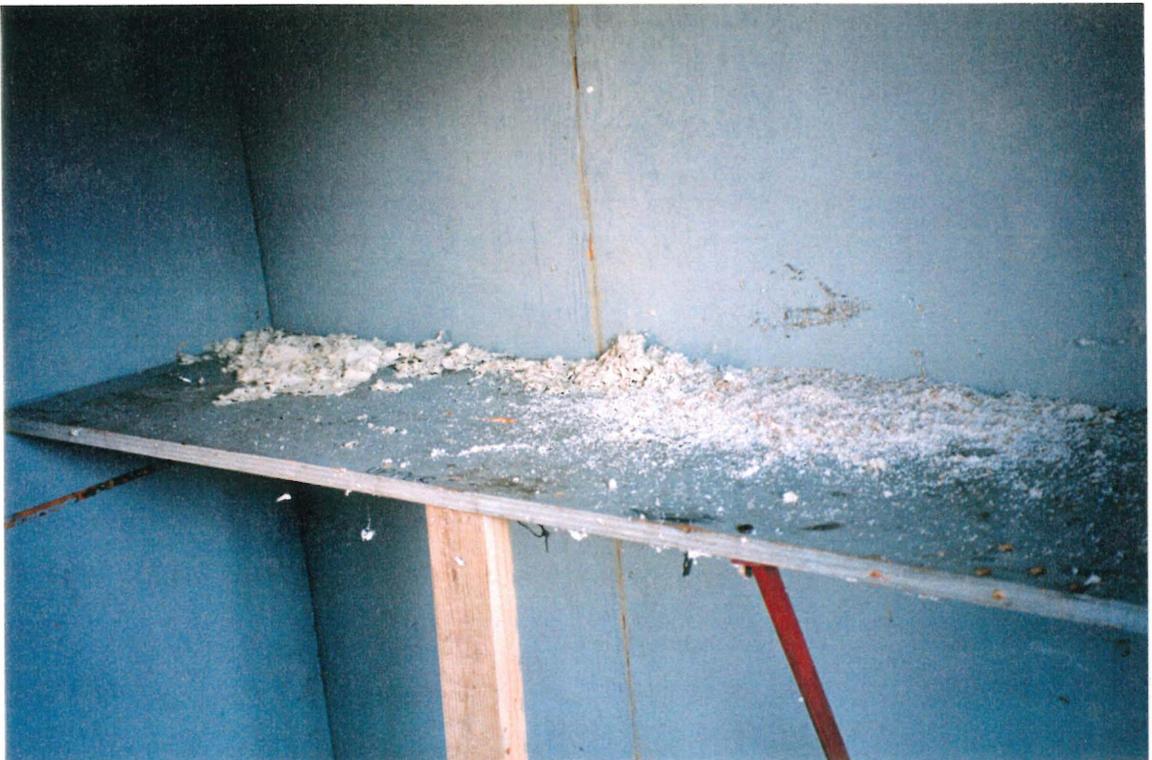
Photo P: Shelf with rodent debris

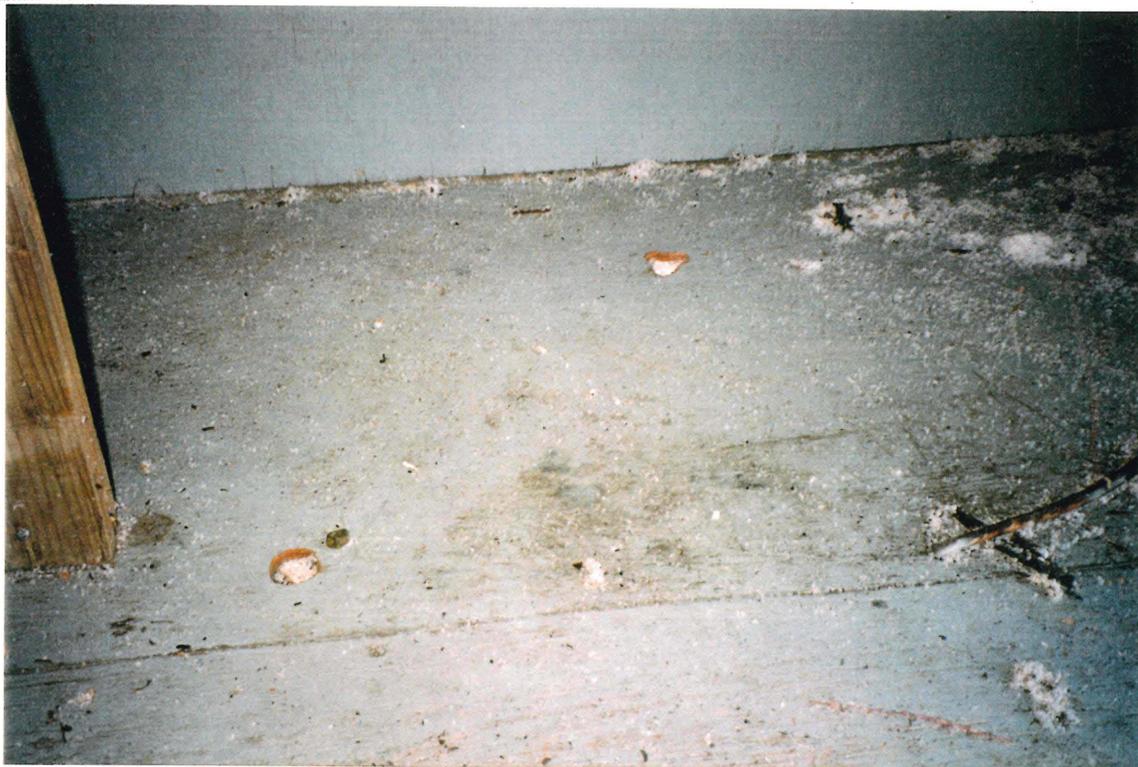
contains shredded material from rodent occupation. The orifice line is still connected to the building and buried (photos N and O) but all other equipment has been removed. There is mercury present on the floor and the recorder support, mixed with the rodent debris. Two drilled holes exist in the floor under the support (photo P). Mercury was observed on the ground beneath the building, below the holes in the floor (photos Q and R).

Photo Q: Holes in floor of building

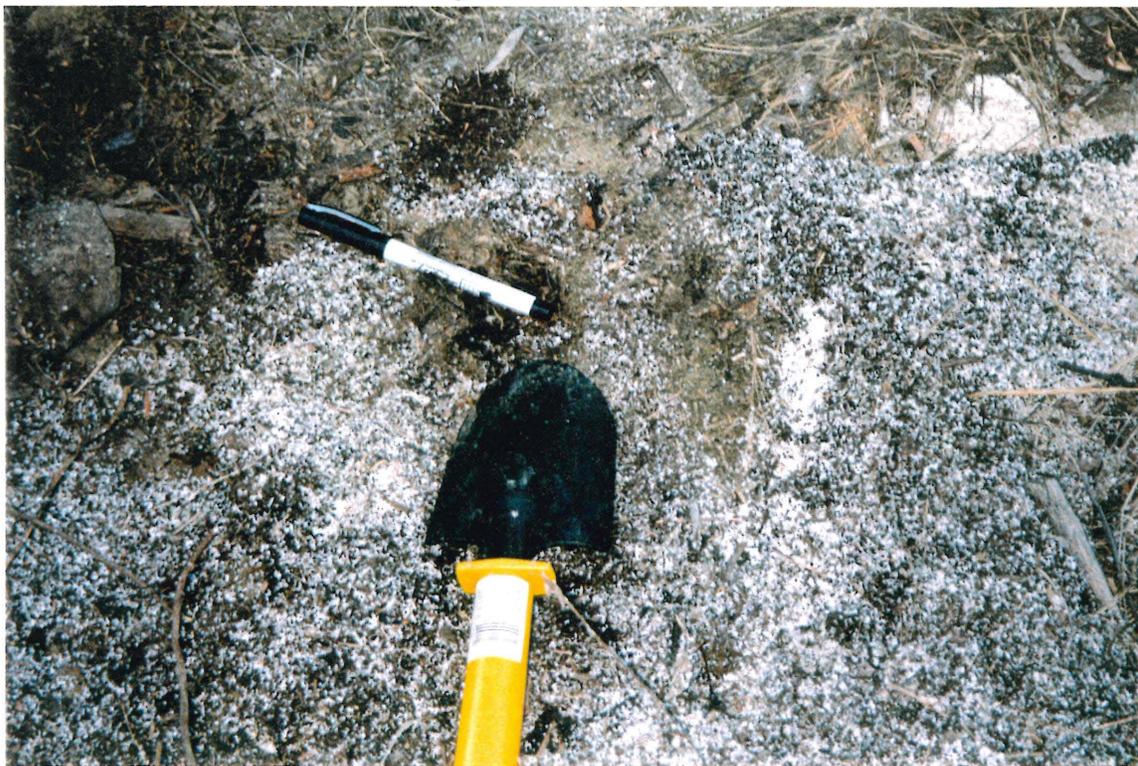
Photo R: Mercury on ground

Removal can be accomplished easily through access down the rail line with light equipment, if permission for such access can be obtained from BYR. It is recommended that the building be sealed and removed intact from the site for disposal outside of the community. The second building may also need to be removed from the site dependent on BYR wishes. At a minimum, the mercury manometer in the operational building should be replaced due to its potential for future contamination and a renewal of the issue.

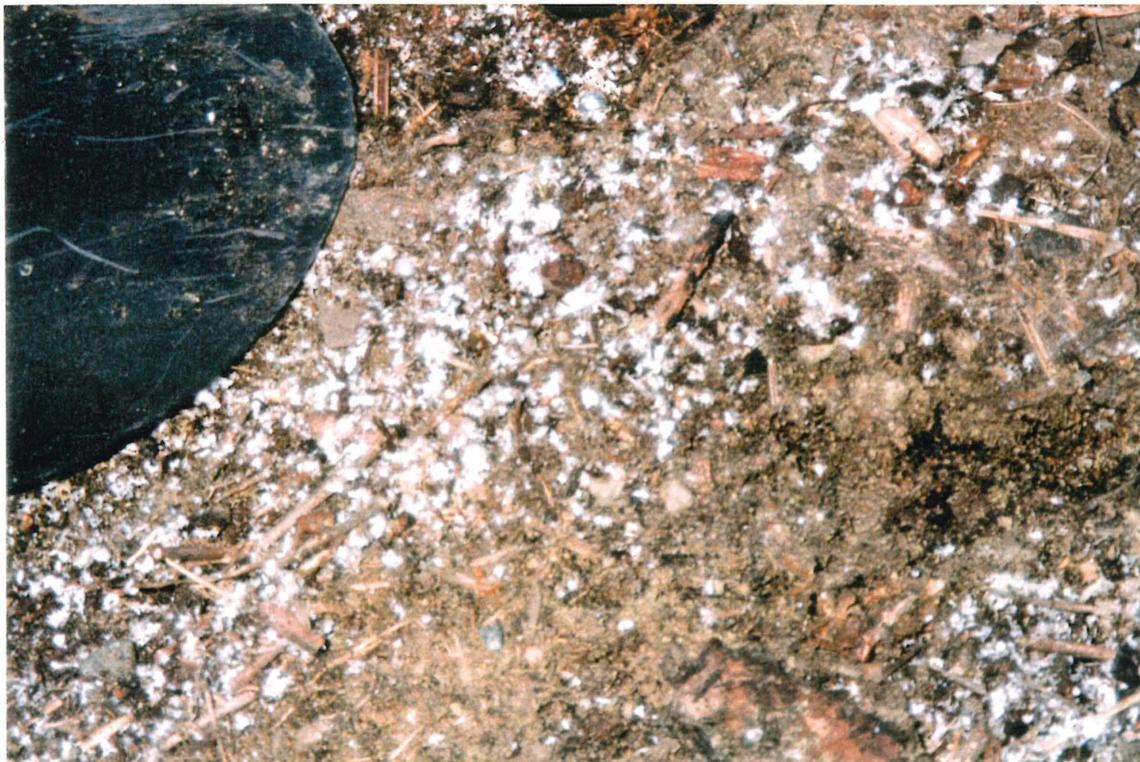
Photo S: Close up of mercury

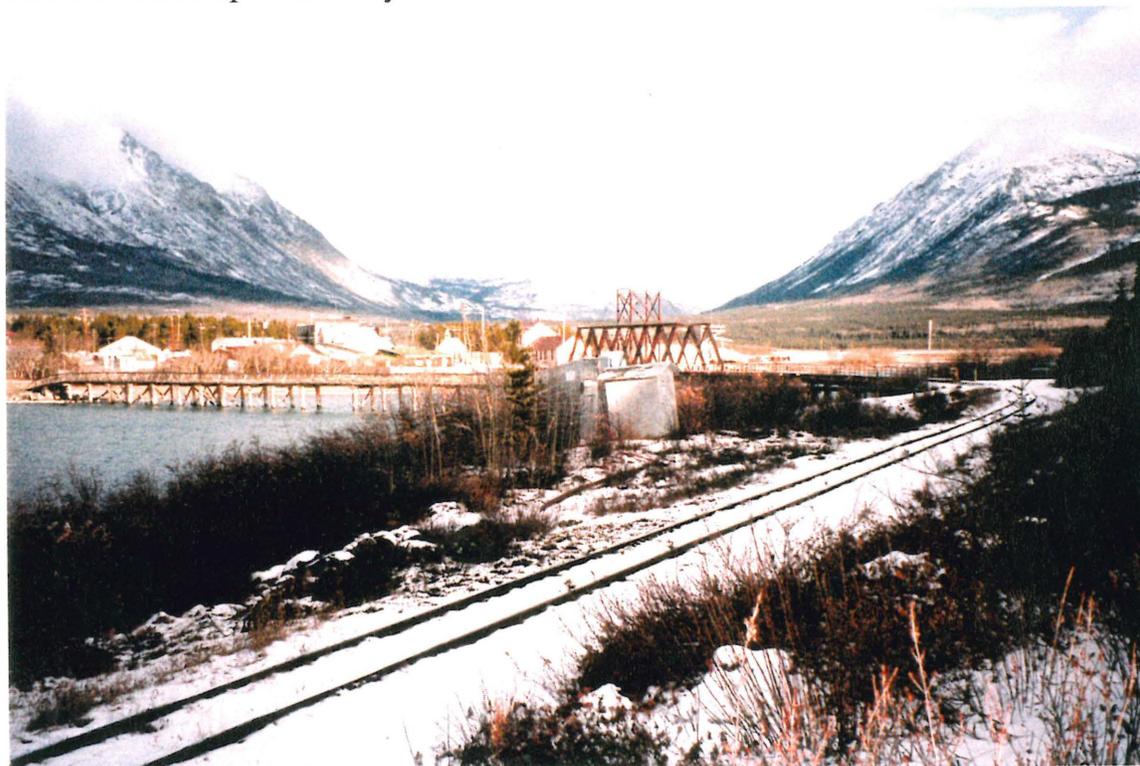
The station is located on a bench some 2 metres from the edge of the bench above Bennett Lake (photo S) at the head of the Nares River. There is a pipeline running 2.5 metres south of the station site and the centerline of the British Yukon Railway line is 7.5 metres south of the building (photo T). As the rail right of way is 60 metres wide at this point the site is on private BYR land. Conversations with Water Survey of Canada staff, who operate the site, indicate no awareness of an agreement on between Water Survey and BYR on the use of this site. To the best of DIAND staff knowledge the site is unauthorized. Soils at the site are cold, but not frozen, as there is no permafrost in this region. The soils here however may be the warmest in the Territory and should offer the highest rate of methylation available in the Yukon.

Photo T: View of buildings on site, rail line, bridge, and Carcross

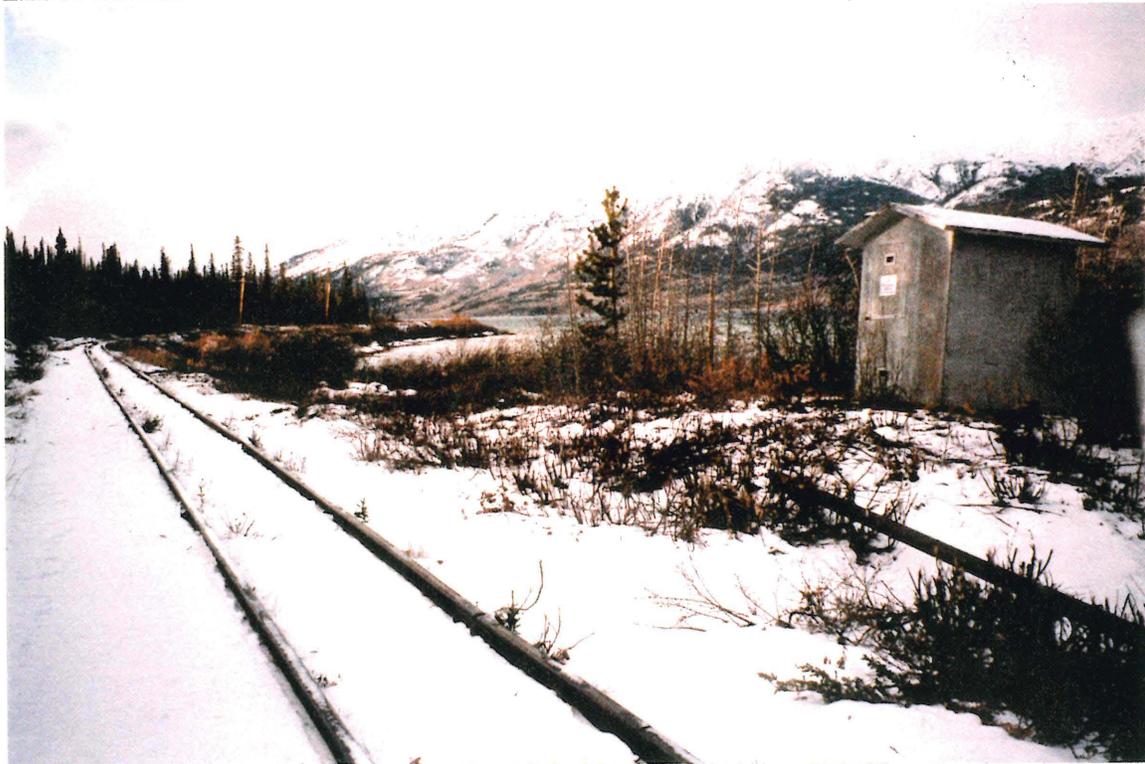
Photo U: View of site with rail line and pipe line
