# Colomac Remediation Project

## Major Civil Works

Lowell Wade, M.Sc., E.I.T. & Cam Scott, M. Eng., P.Eng.

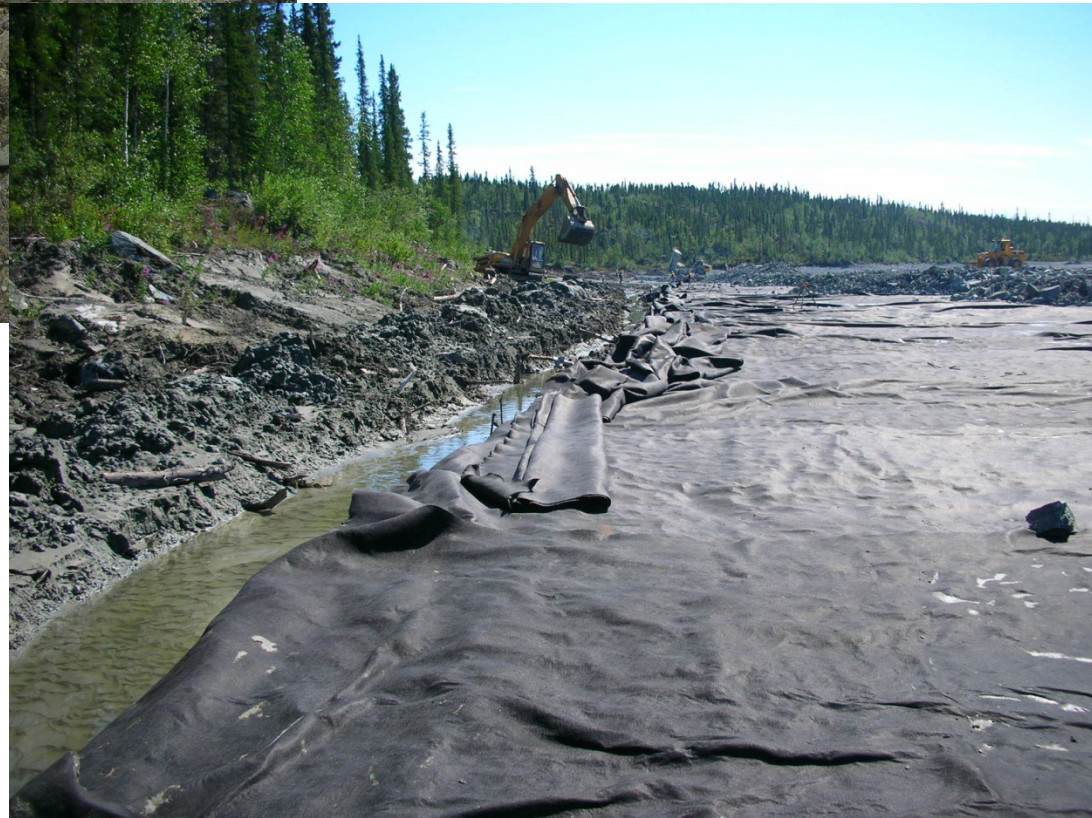
Tailings surface was hummocky in some areas and irregular in others mainly due to the thawing of ice lenses and subsequent water erosion. This made placement of cover and travel by heavy equipment difficult

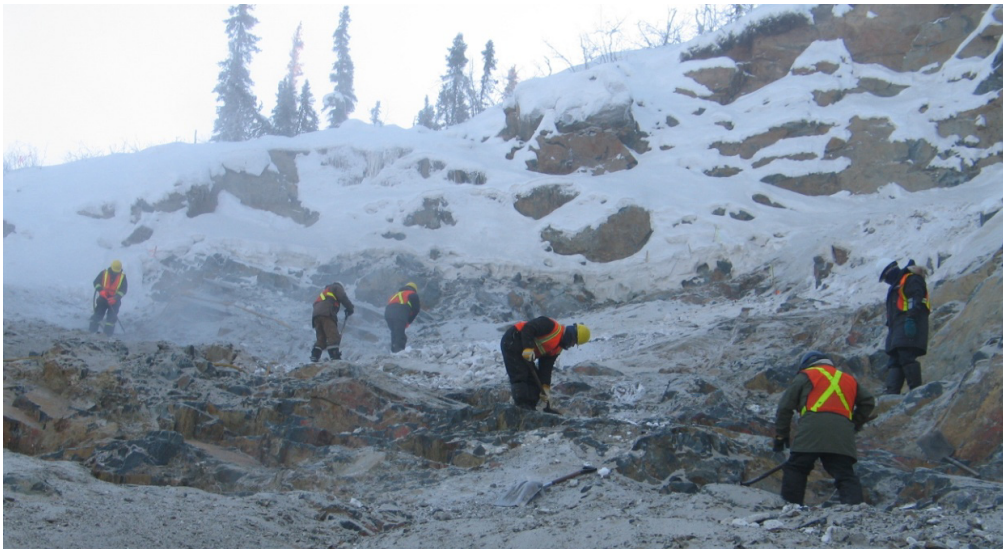
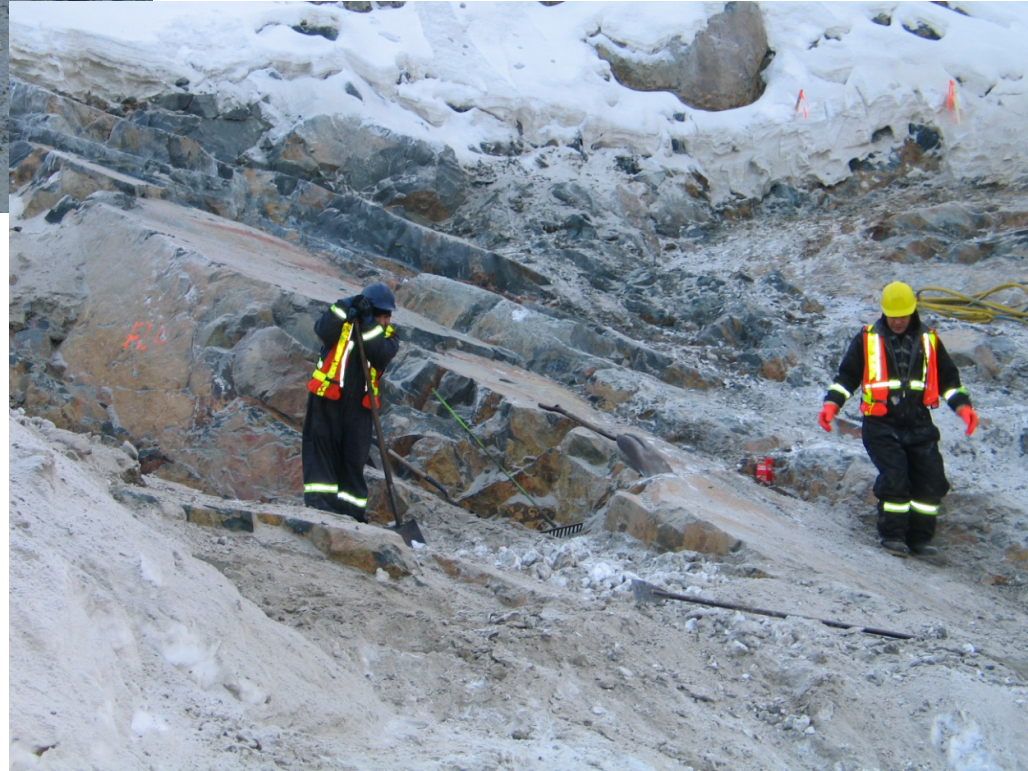
- Relief of the bedrock surface in the abutments was greater than expected.
- The rock surface was cleaned by hand prior to placing a leveling course of granular material

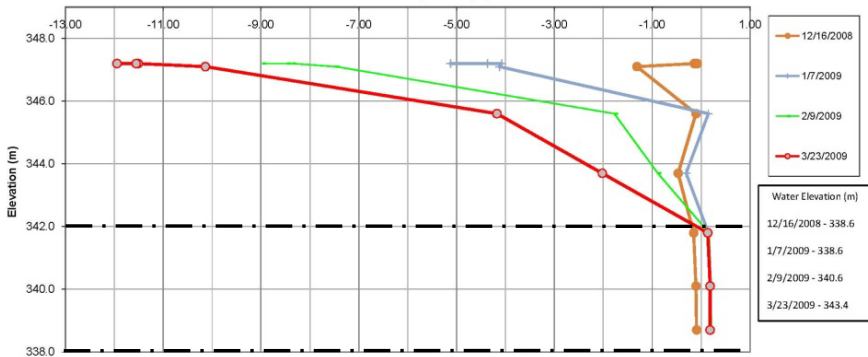
Figure 2A  
Station 0+45 Upstream  
Temperature (°C)

- The data from 16 December is approximately 0.2° C colder than it should be compared to data from the subsequent three data sets (see uniform temperature offset between approximately El. 338 and 342), and reflects the use of a different readout unit on 16 December.
- There is no detectable change in temperatures in the portion of the liner above the chevron (approximate El. 338 m), which is somewhat surprising as one would have expected a modest increase in temperature due water entering the voids in the fill upstream of the liner (see temperatures between approximately El. 338 and 342).

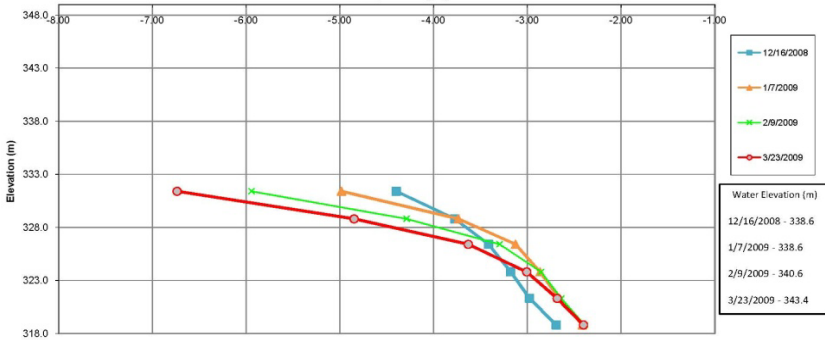
Figure 3B  
Station 0+45 Vertical  
Temperature (°C)

- As expected, the program has had no effect on the trend, observed previously, of falling temperatures within the foundation soils below the cutoff trench during winter.

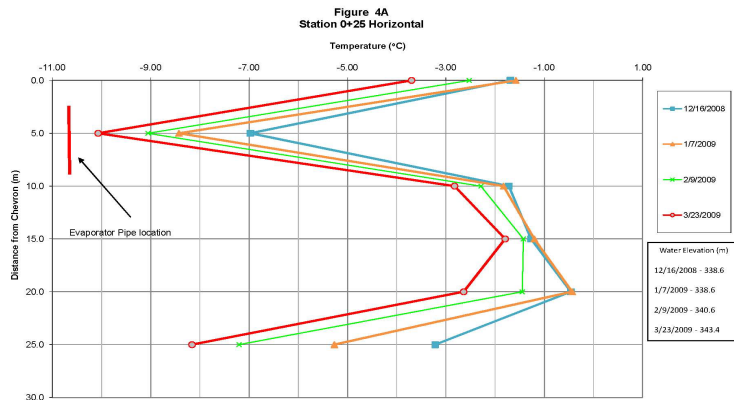
- The thermosyphons are having a significant effect on temperatures within Dam 1B, as evidenced by a temperature differential of about 5 to 6° C in December and 7 to 10° C in March.
