# Performance of Low-permeability Tailings Cover, Arctic Gold and Silver Mine, Yukon

EBA, A Tetra Tech Company

Northern Latitudes Mine Reclamation Workshop, Fairbanks, AK, May 11-12, 2011

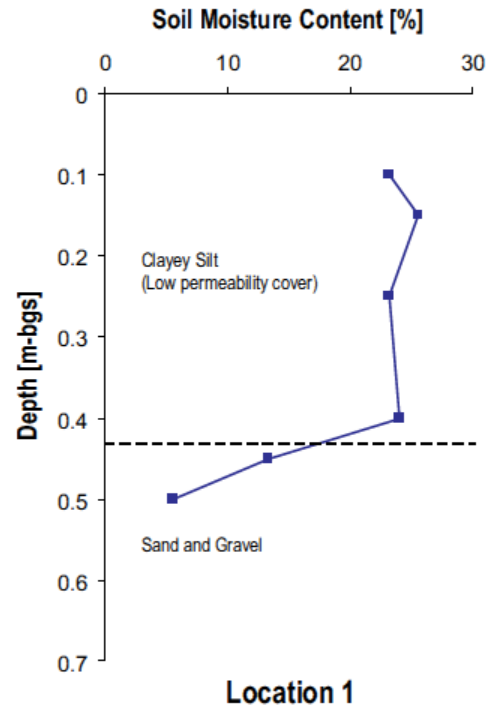
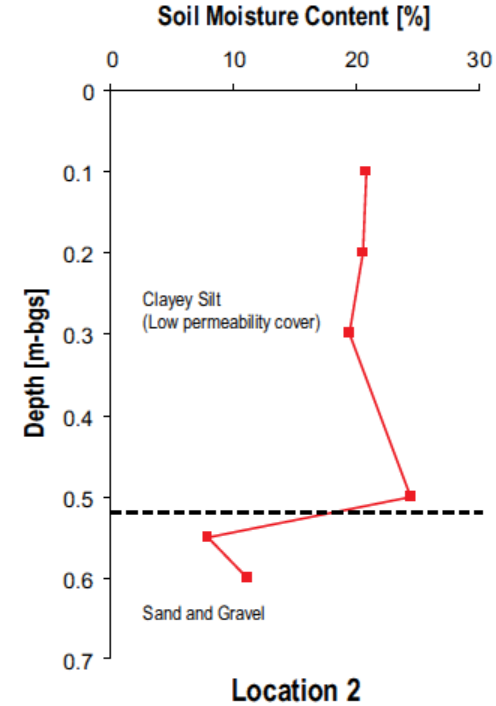
# Soil Moisture Profiles

- Silt was close to fully water saturated.
- Moisture content decreased in sand and gravel.
- Significant decrease in moisture content at the silt/sand and gravel interface indicates that cover is acting as infiltration barrier.

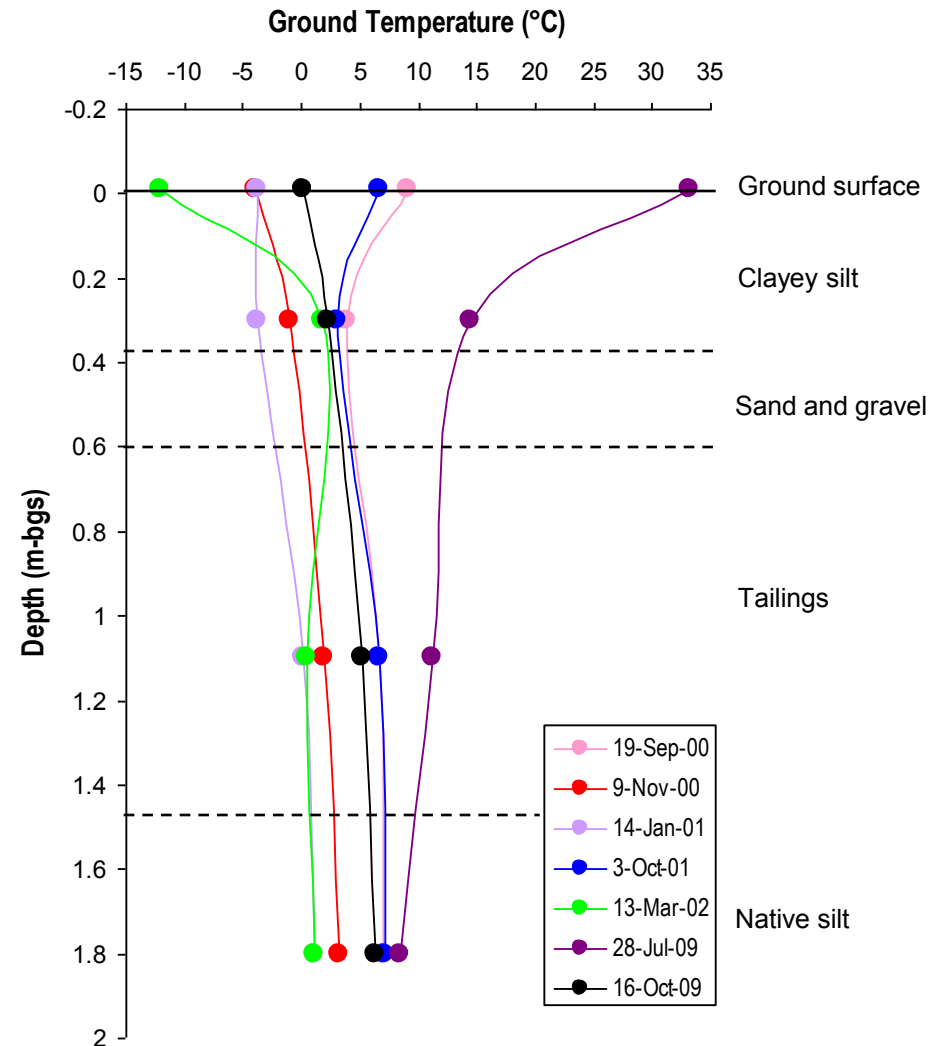
# Ground Temperature Profile

- Ground temperature profiles show typical seasonal variations.
- No general temperature increase was observed within the tailings that could indicate exothermic reactions causing ARD.

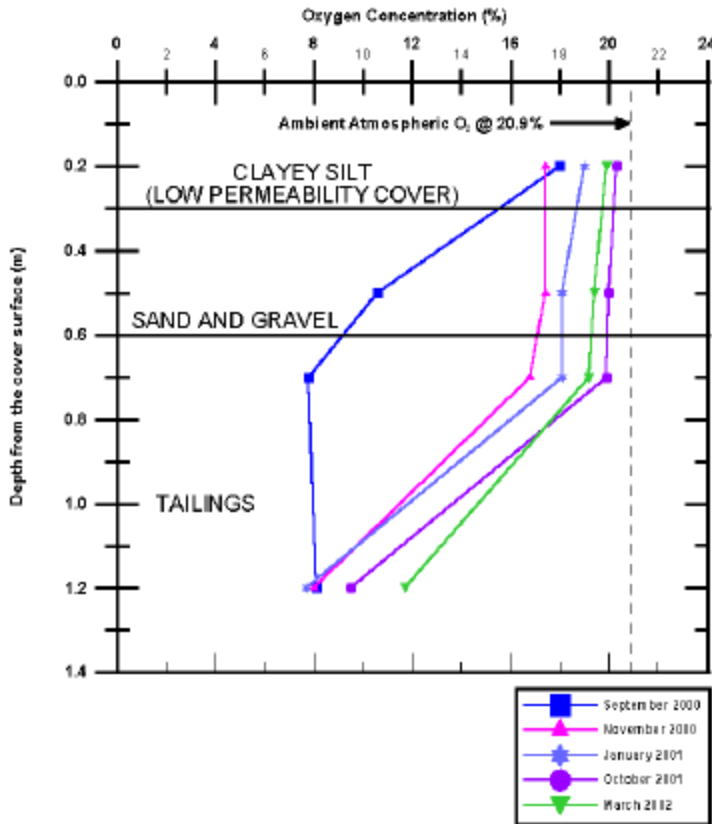
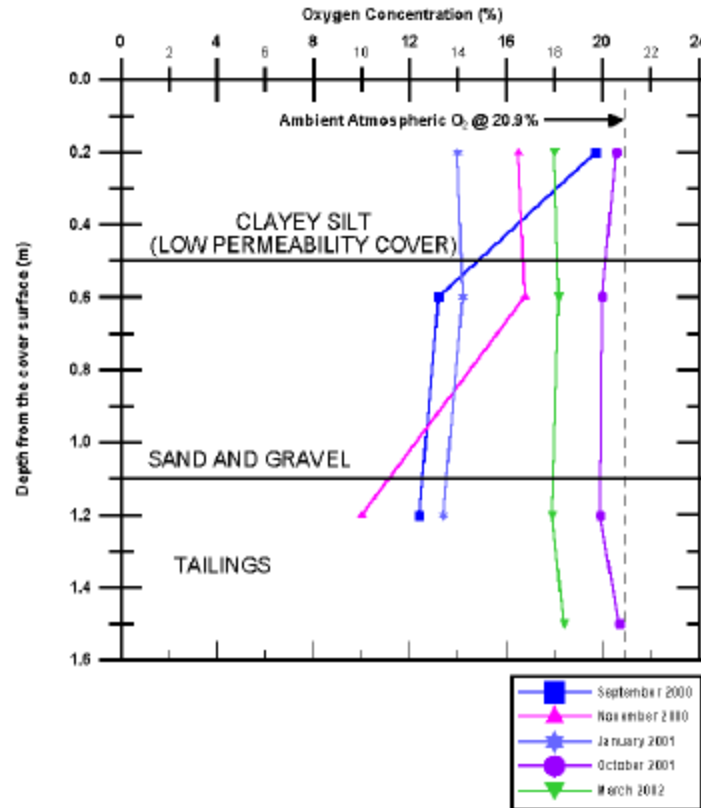
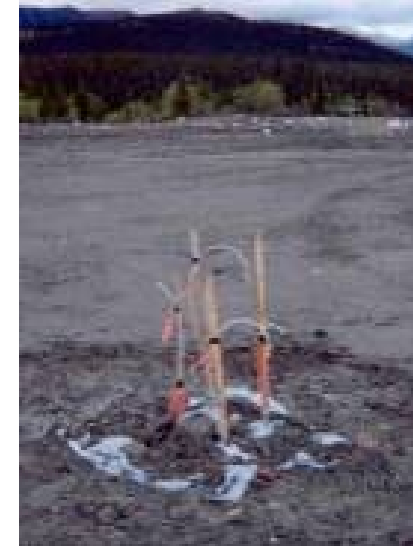
# Oxygen Profiles

- Oxygen concentrations generally increased with no clear decrease within cover.
- Cover does not seem to effectively function as an oxygen barrier.

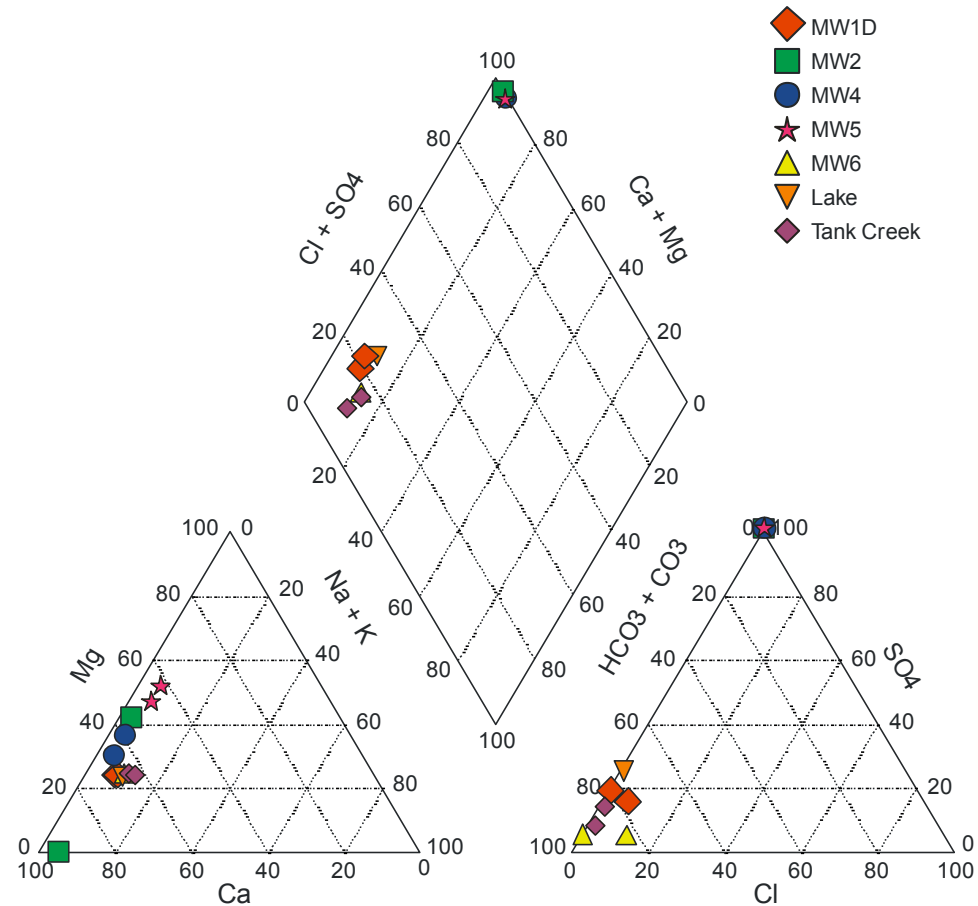
# Groundwater Quality

- Background water quality is considerably different from groundwater quality beneath tailings impoundment.
- Downgradient wells MW2, MW4, and MW5 are most affected.

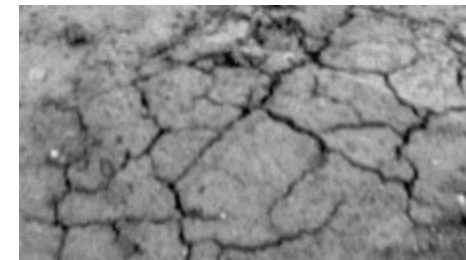
- Measured and interpolated groundwater elevations suggest that some of the tailings might be below the groundwater table – at least seasonally.
- Infiltration through tailings cover along preferential flow path (e.g., surface cracks in silt layer, plant roots).
- Slow groundwater flow velocity (metres to tens of metres per year), i.e., affected groundwater beneath tailings may not have been replaced yet.

Surface cracks in tailings cover

- Collected field data are inconclusive with respect to performance of tailings cover.
- Soil moisture and ground temperature profiles suggest that cover acts as infiltration barrier and limits ARD processes.
- Oxygen profiles and persistent groundwater contamination suggests ongoing ARD processes and impact from tailings on groundwater quality.
- Integrated approach is necessary to assess cover performance (no single parameter is able to provide this information).
- Continued monitoring is recommended to assess long-term performance of tailings cover.
