Forty Mile Cultural Resource Management Plan 2014

VOLUME II

9. UPDATED BUILDING CONDITION SURVEYS

Building 1 – Fish House, FMEB – 1, YHSI ID: 116C/07/003

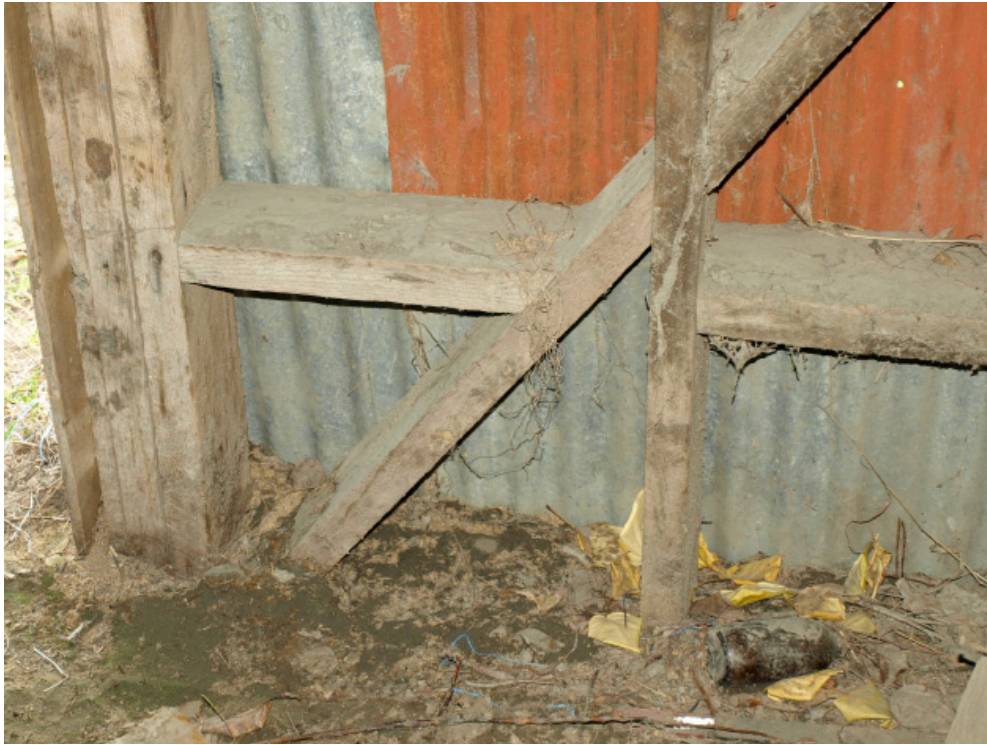
18. Exterior Photo: Water Damage

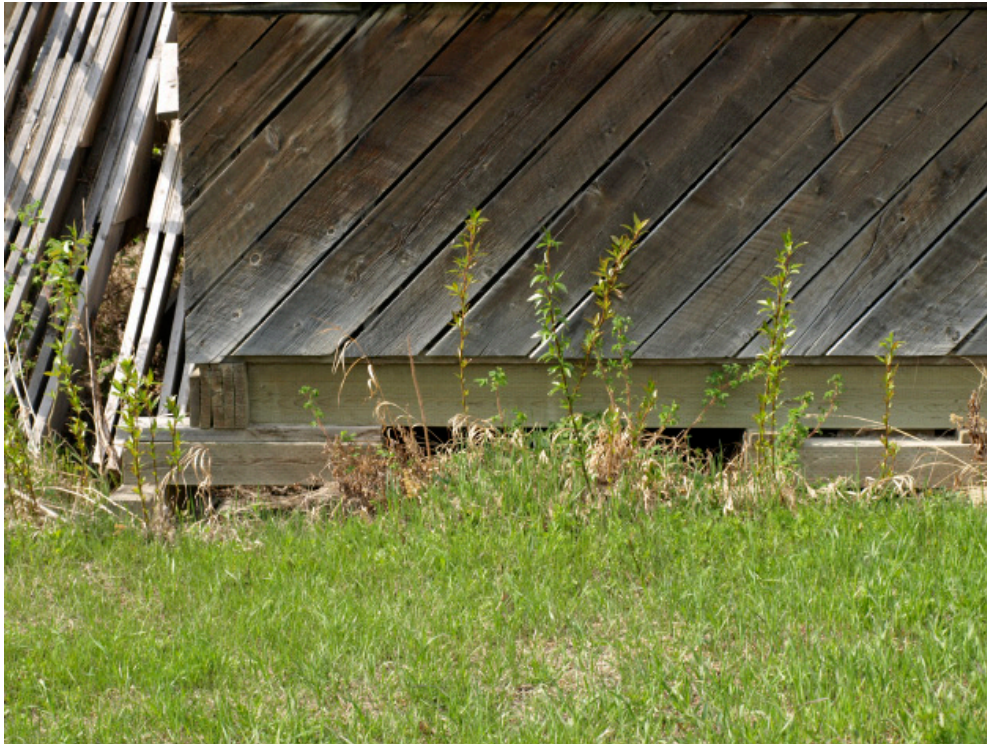
9. Foundation:

Considerable stabilization work has been done, including a new floor and block pile foundation system using a PWF system, with multiple beam lines. Also the longitudinal walls have been sheathed with horizontal rough board sheathing however the building has not been skirted. All this work represents a great improvement to the structure.

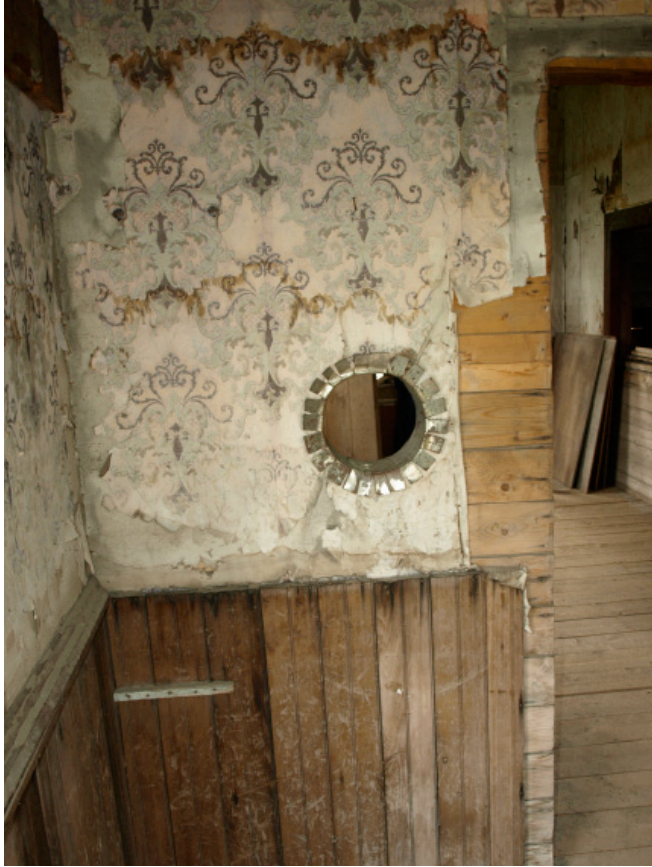
21. Interior Photo: Existing wood burning fire vent hole

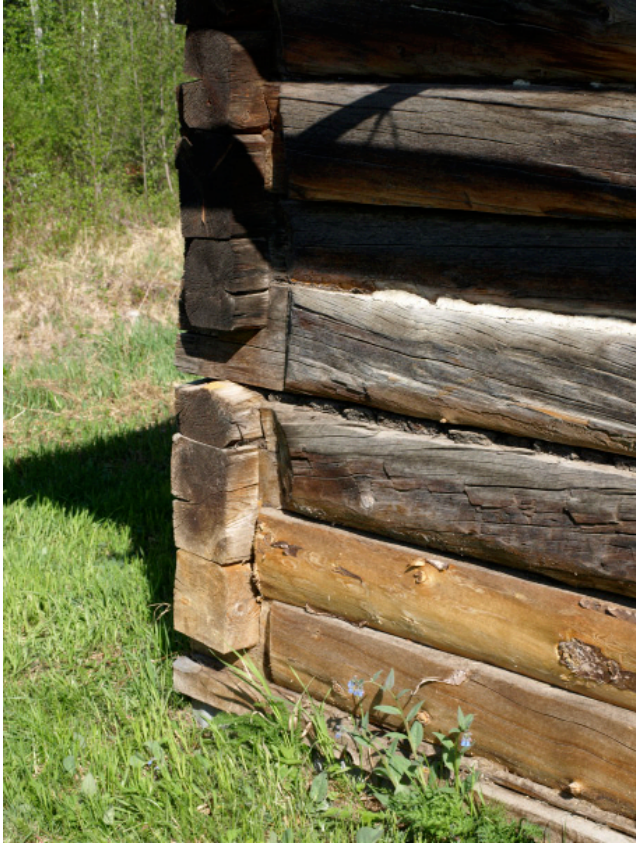
7. Foundation:

This building was reconstructed with the typical PWF and lower log replacement described in Volume I, Section 4.4 and is subject to the same general concerns. In particular there is an animal hole into the foundation void on the west wall that should be investigated and monitored.

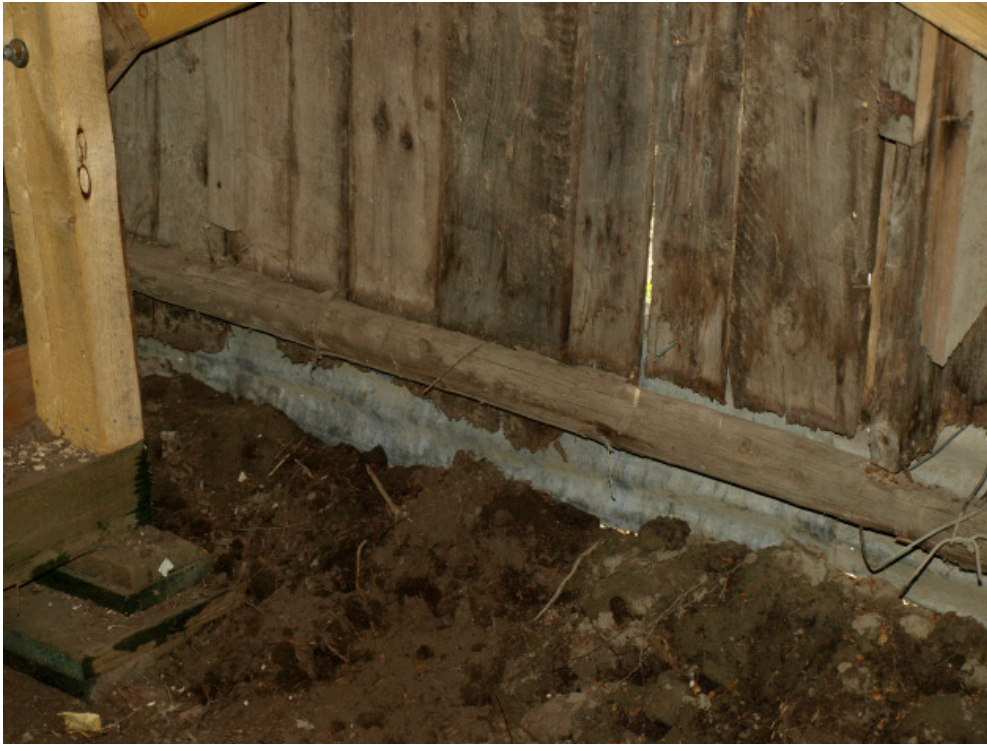
The structure has been reinforced by an internal braced frame of 6x6 timbers, 2x6 cross-braces and plywood gussets. The structure is markedly out of plumb and would not withstand any straightening correction. Therefore we recommend nothing further be done from a structural standpoint. The roof is in fair condition, with the exception of one panel which needs refastening.

5. Interior Photo: Temporary foundation

- i. repair roof panel
- ii. inventory radio equipment
- iii. monitor condition of building, determine whether to reconstruct

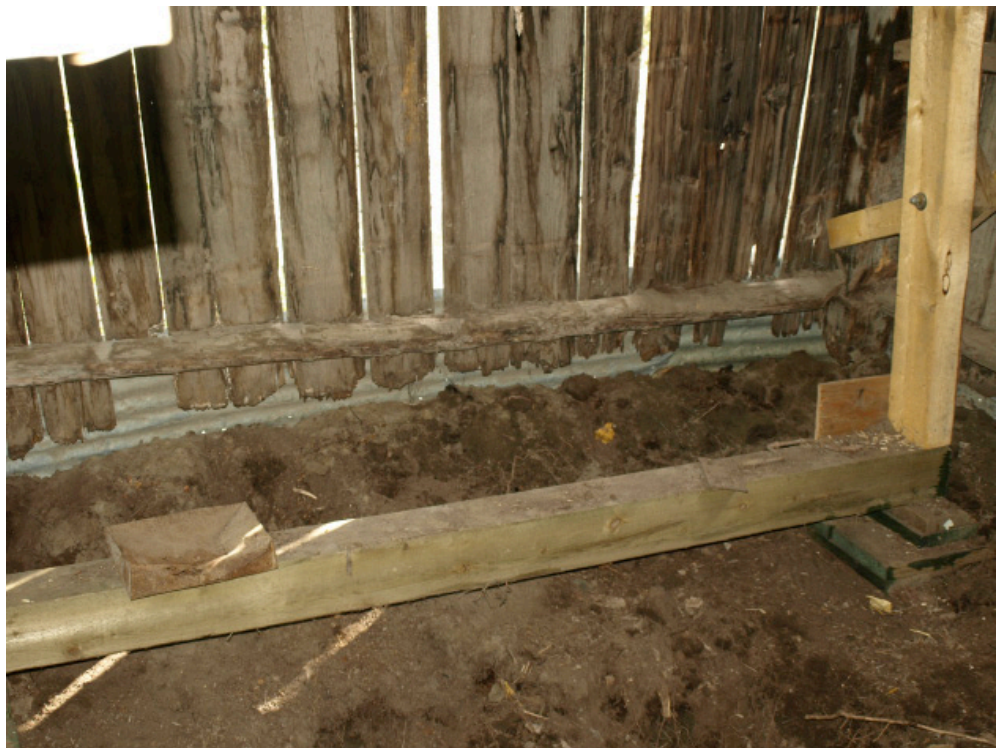
6. Interior Photo: Temporary foundation

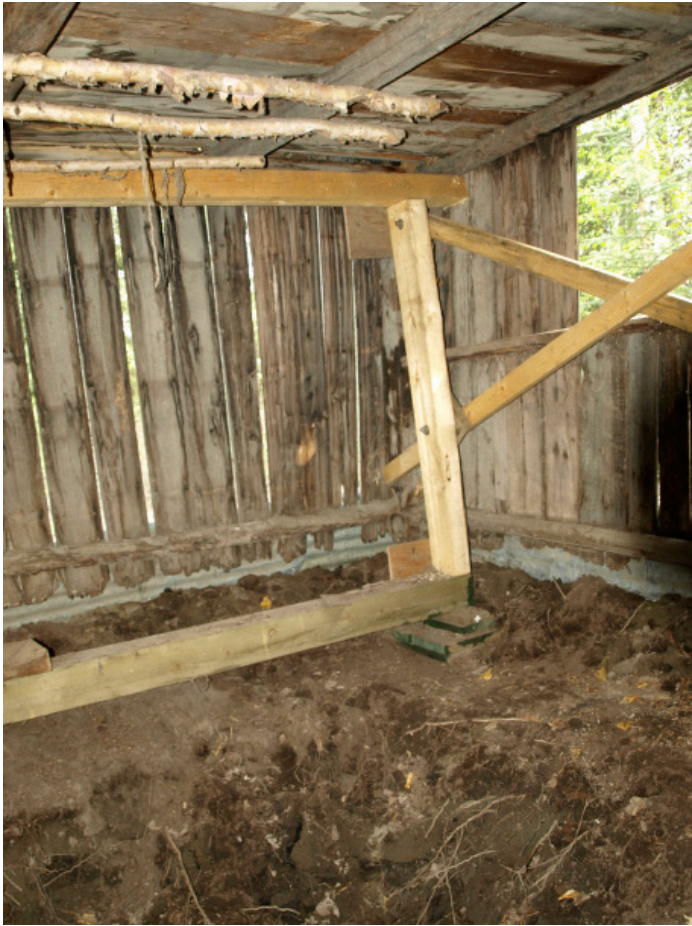
7. Interior Photo: Temporary foundation

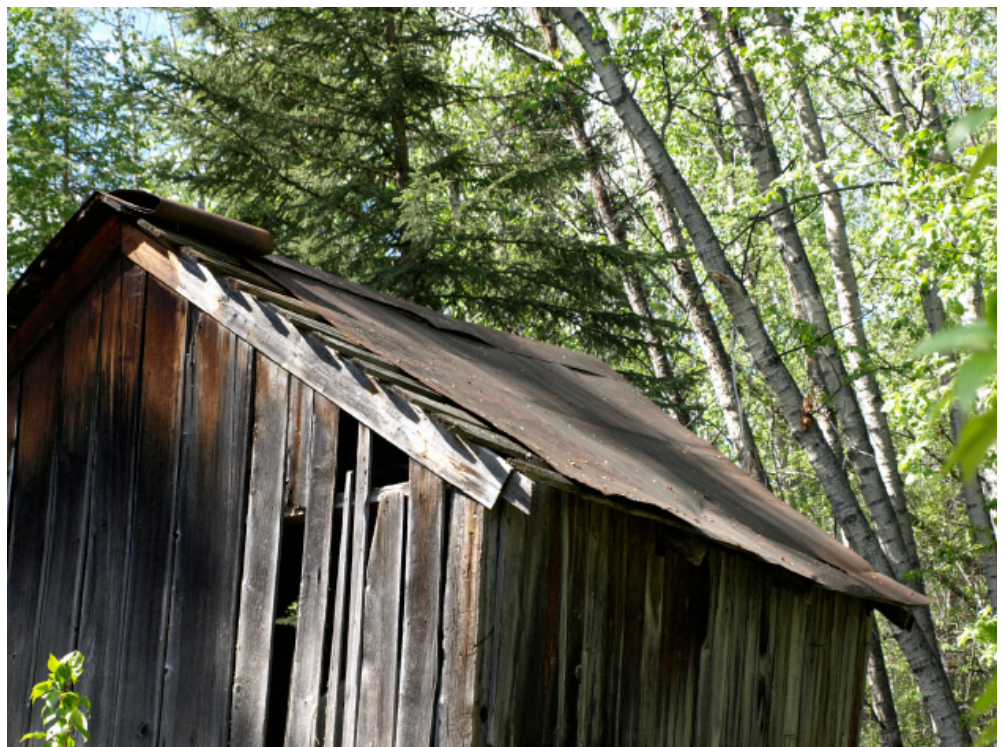
14. Exterior Photo: Roof
