**REPORT ON  
THE CULTURAL RESOURCES AT  
COAL CREEK**

Bob Mitchell  
CAPHC

# REPORT ON THE CULTURAL RESOURCES AT COAL CREEK

AS FOUND IN AUGUST OF 1992

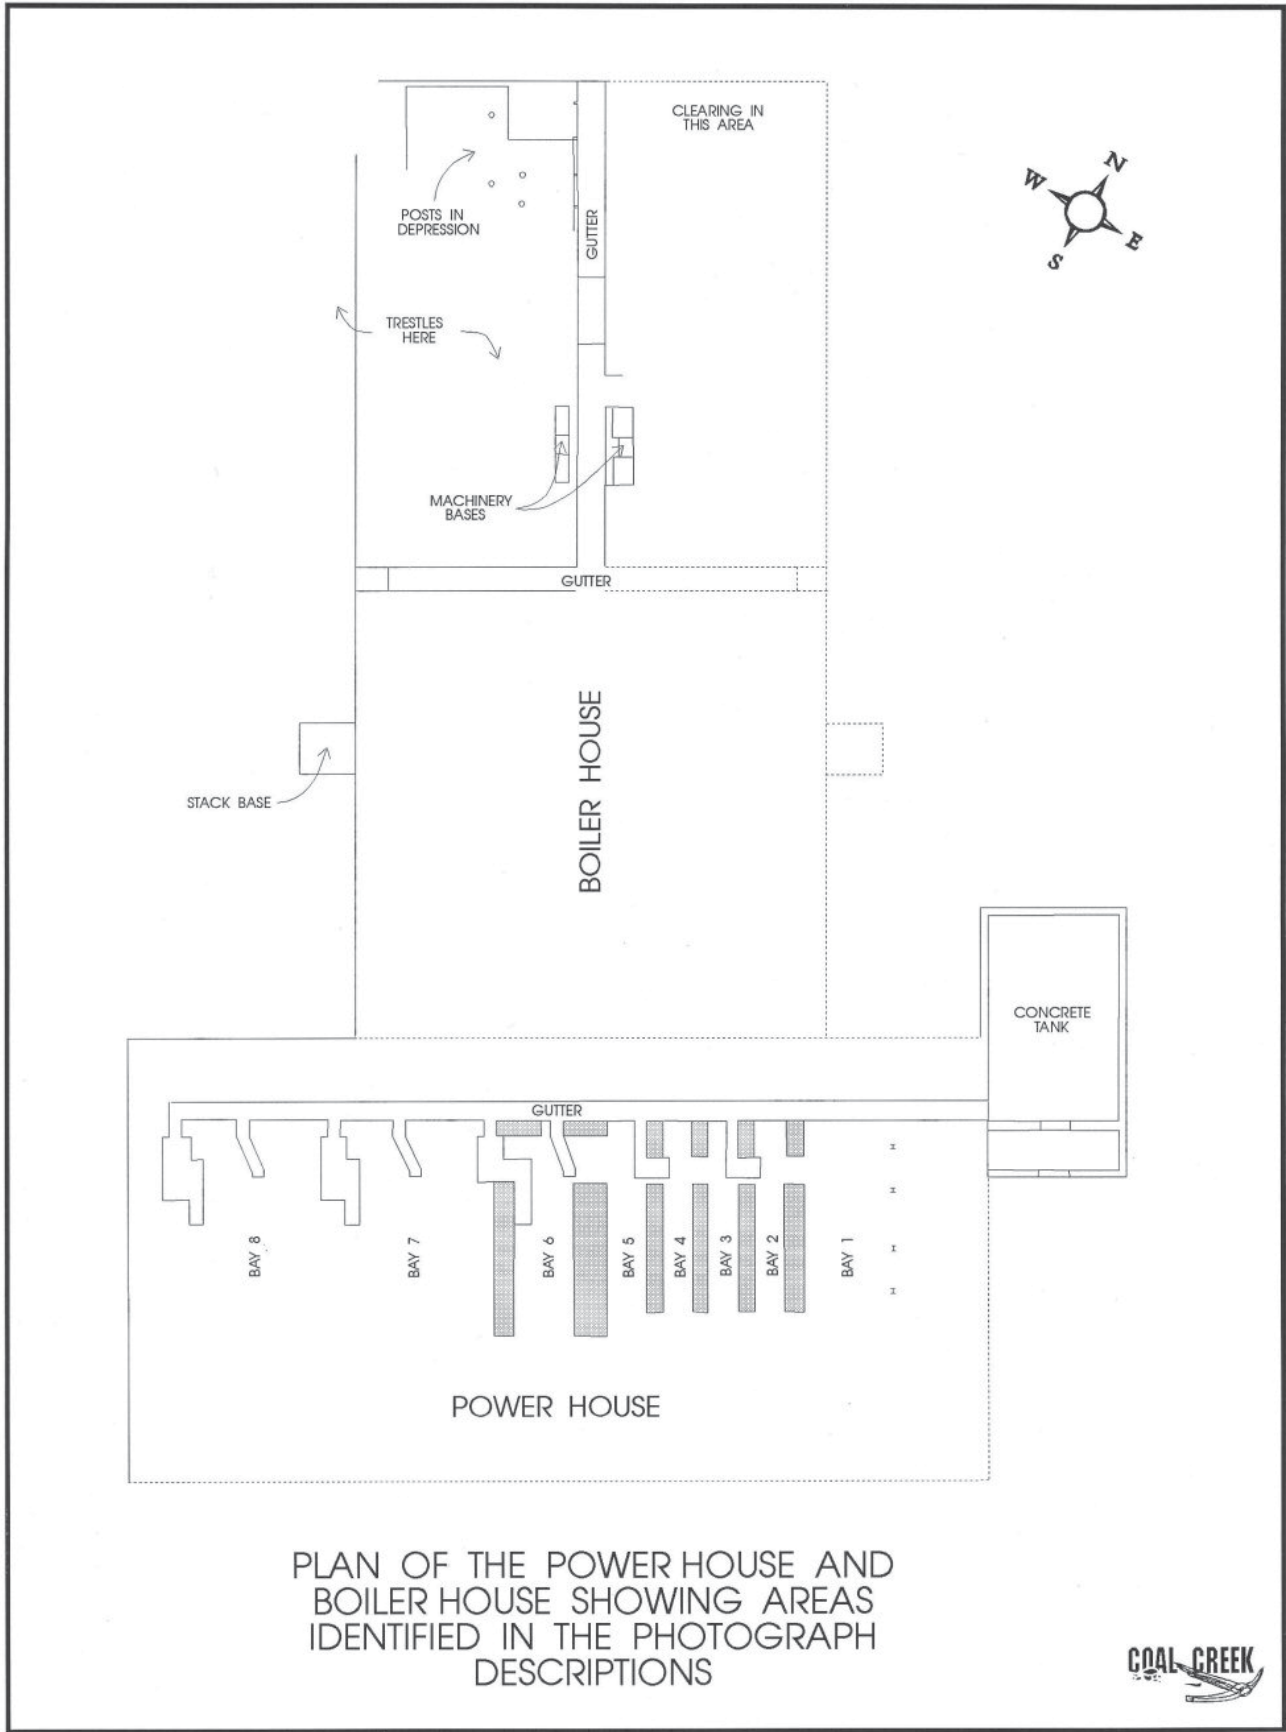
PLAN OF THE POWER HOUSE AND  
 BOILER HOUSE SHOWING AREAS  
 IDENTIFIED IN THE PHOTOGRAPH  
 DESCRIPTIONS

This is the most substantial remain on the site. It originally was a steel and wood frame structure on a concrete foundation, with the exterior of the building sheathed with horizontal boards. The monolithic concrete construction of this foundation is somewhat weathered, though mainly still in place. Iron girders have been used in places as reinforcement in the concrete used for the second floor area (the engine room floor) which once held the generators. All the machinery has been removed, though most of the bolts used to hold them down are still in place. The former wooden shell had probably been entirely taken down to enable the machinery to be removed, along with the structural steel. Some of this wood remains on the foundation, carefully stacked on the south-west corner of the foundation, and in Bay 2.

A majority of the main floor area (called the basement floor on the design drawings of the building), including the boiler house, is covered by a thick layer of soil and moss, making an exact determination of the extent of the foundation impossible without some excavation. In fact, in some areas of the boiler house, bushes are growing right on the foundation, the layer of soil is so thick, these areas being where gutters and pits or sumps are located. The south-east corner of the power house foundation has settled, where the stream bed once was as indicated on the historic map on page 11.

There is a large concrete tank at the north-east corner of the power house foundation, that was used to store cooling water for the various machines used in the installation. It is still partly filled with water, indicating the high level of the ground water. The tank is starting to collapse in on itself.

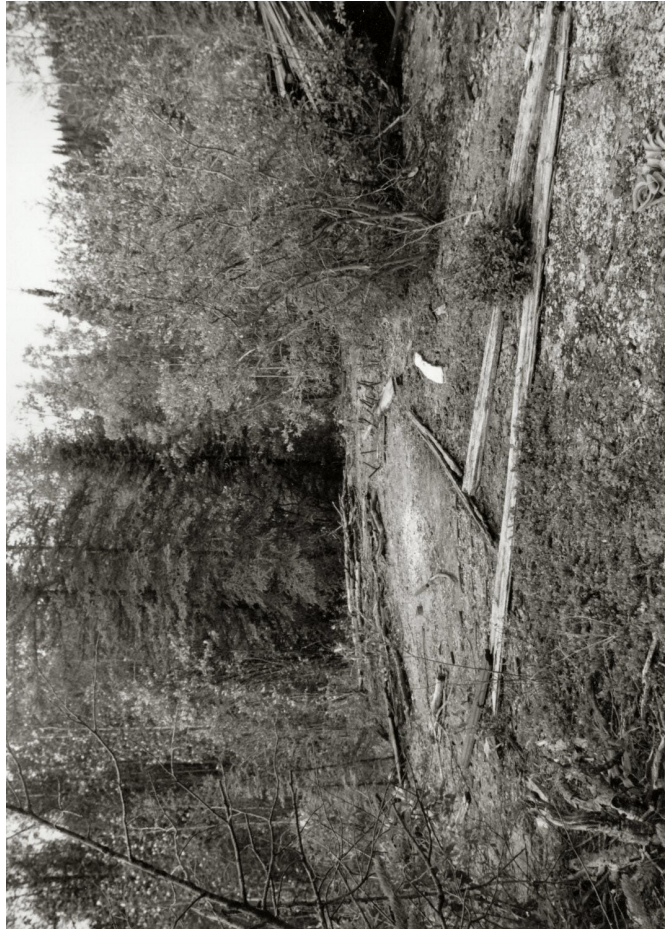
A07

- (A 6) Debris near south-west corner of foundation
- (A 7) Looking west along foundation from south end of Bay 6
- (A 9) Bolts embedded in concrete in Bay 8 for mounting machinery
- (A24) Close-up of debris near south-west corner showing bag shaped casts

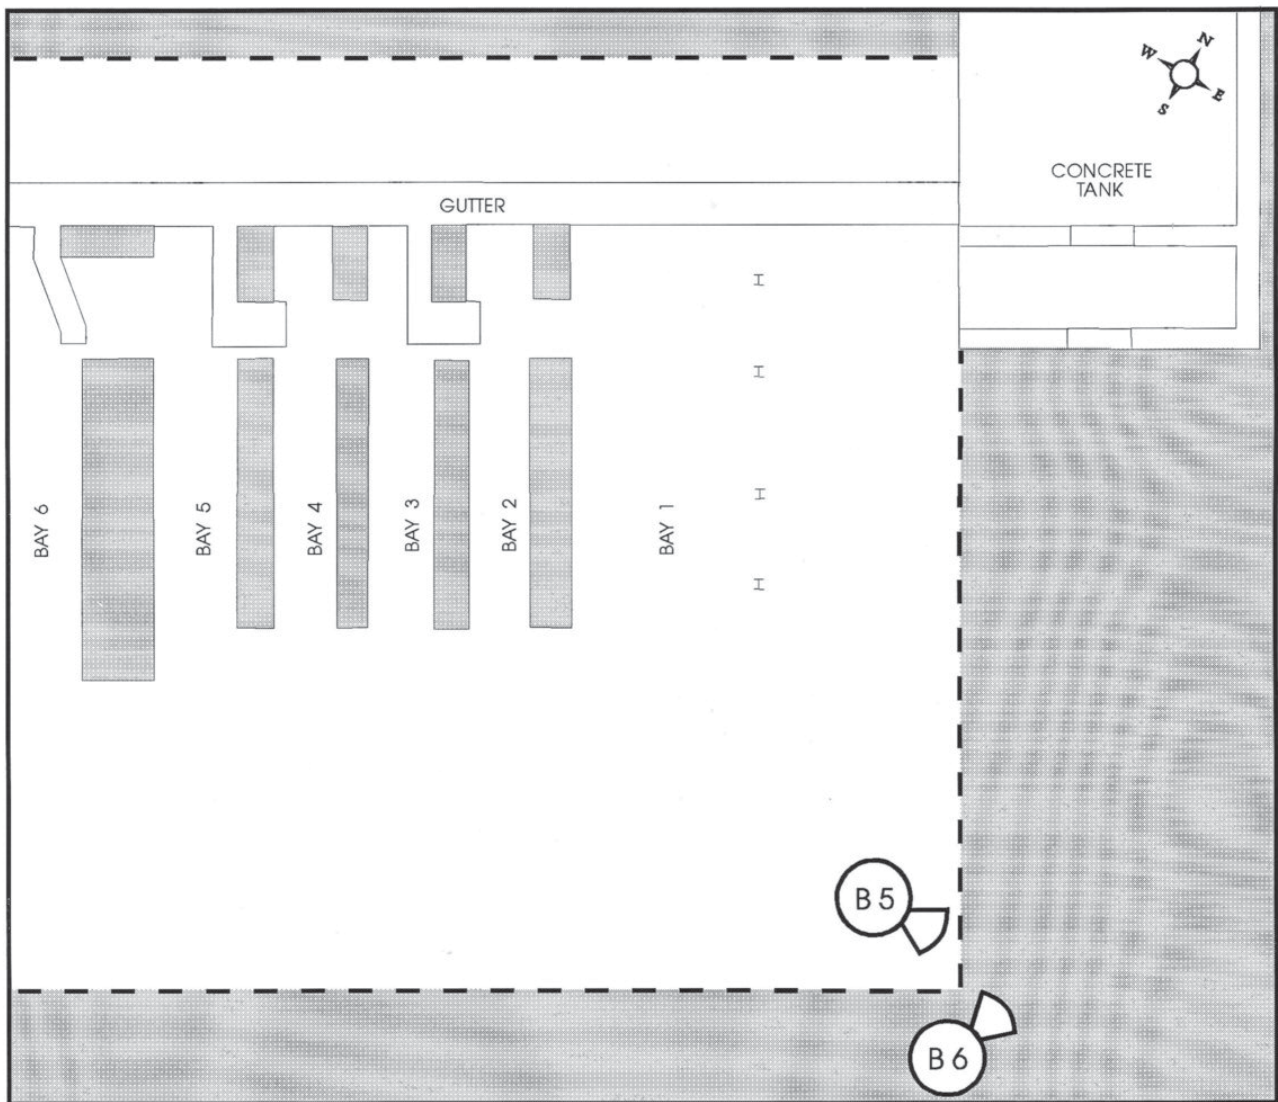
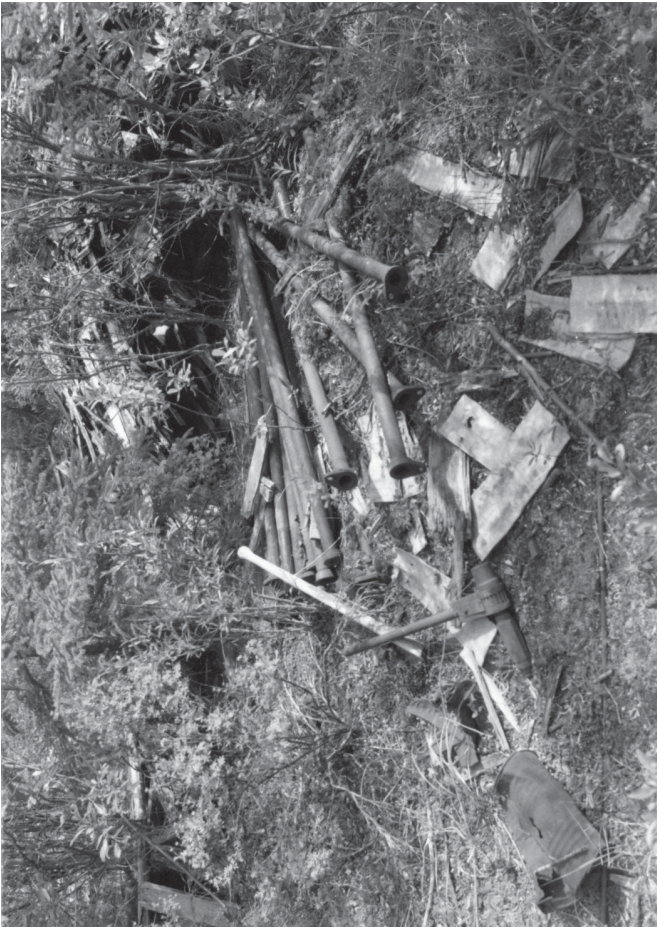
B06

- B 5 Looking east at debris at south-east corner of foundation
- B 6 Close up of debris at south-east corner of foundation

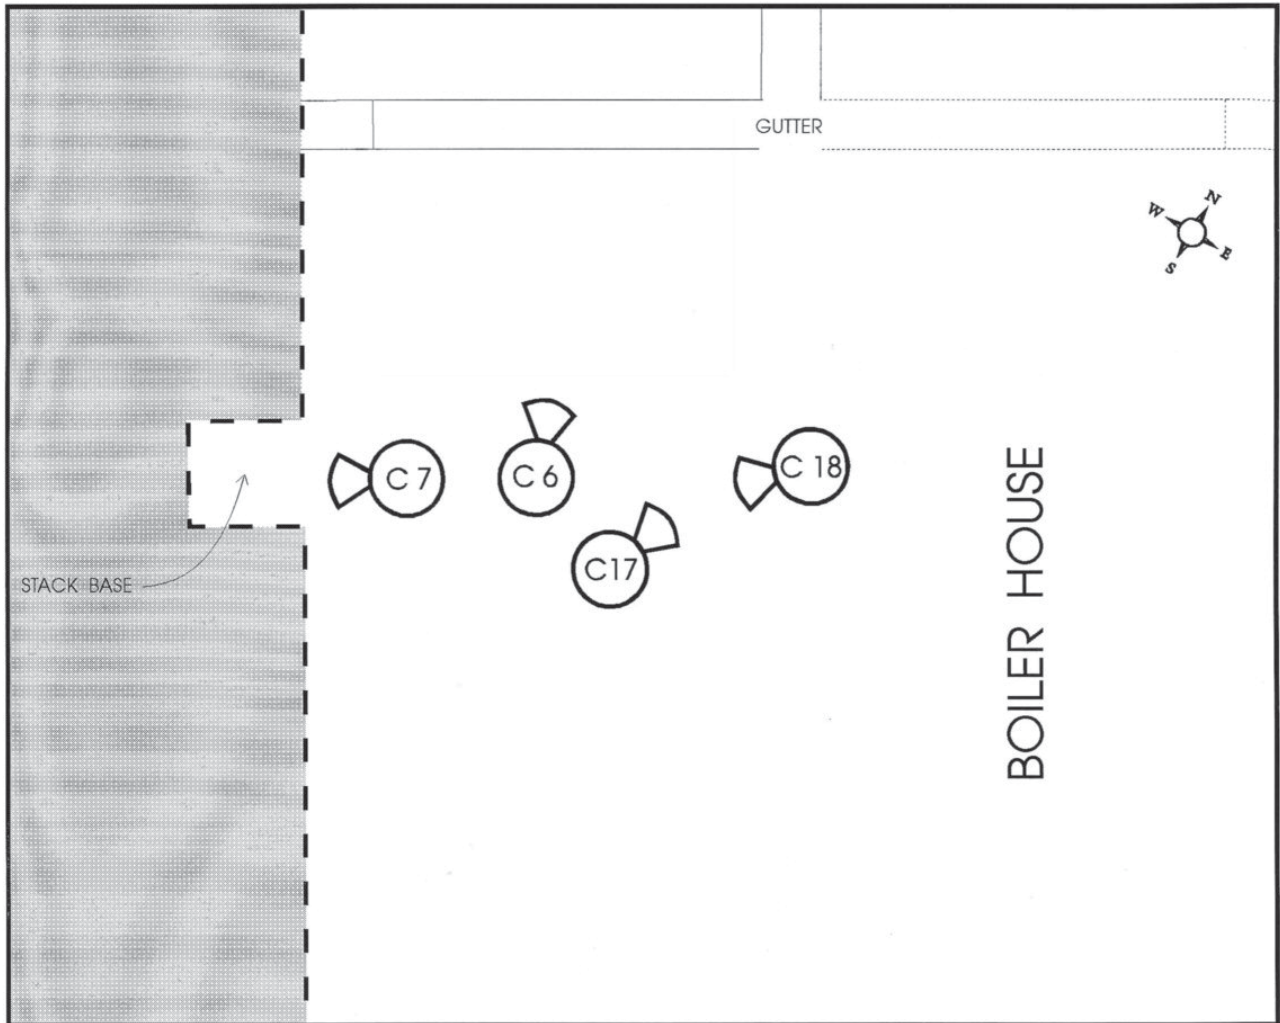
- C 6 Low concrete pad in Boiler House near stack base pad
- C 7 Stack base pad
- C 17 Long stem valve handle in Boiler House near stack base
- C 18 Close up of long stem valve handle

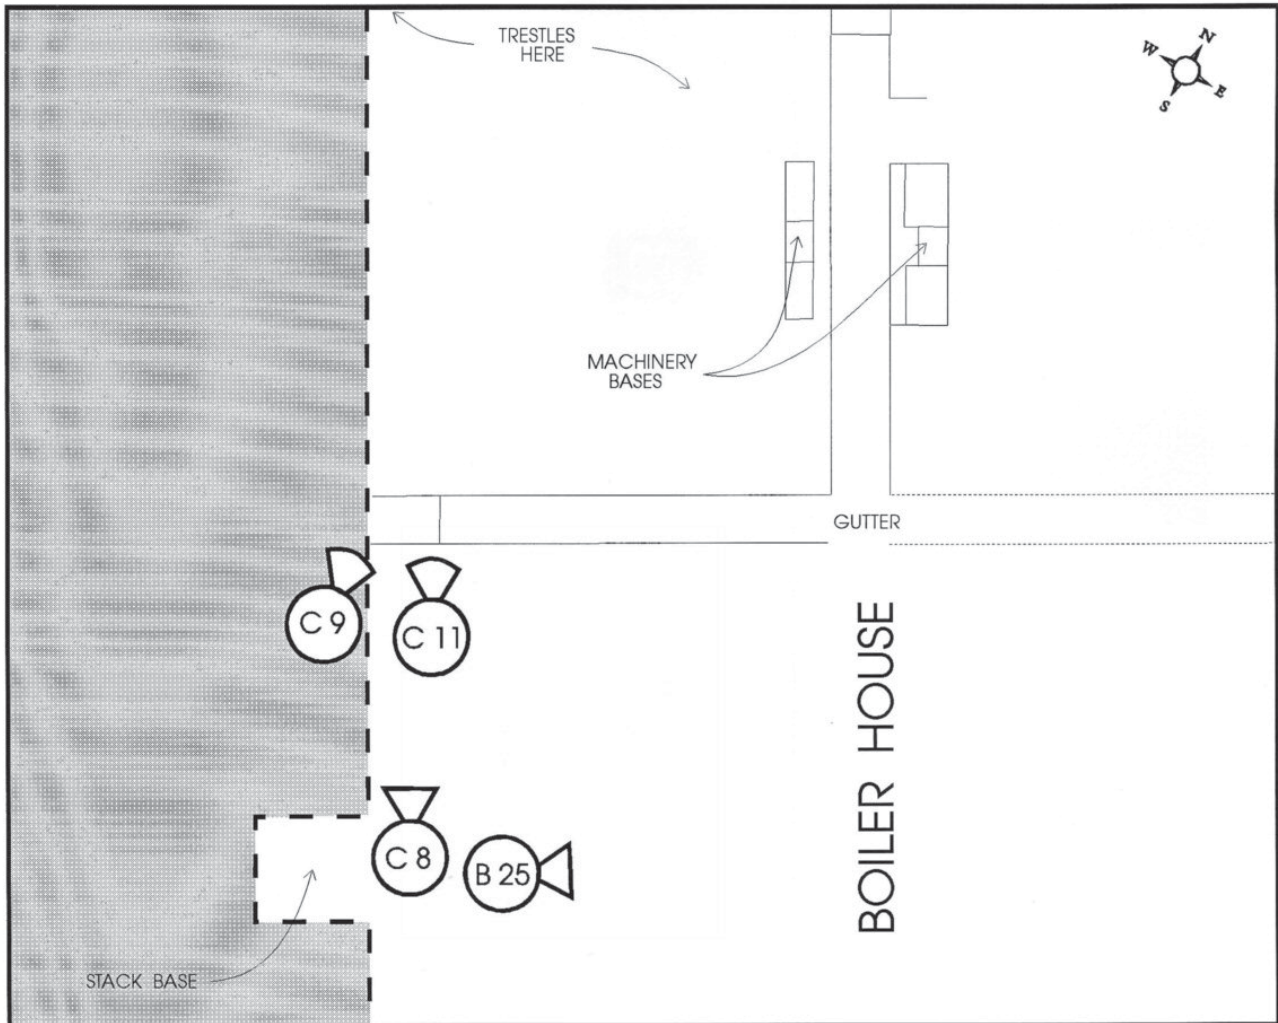
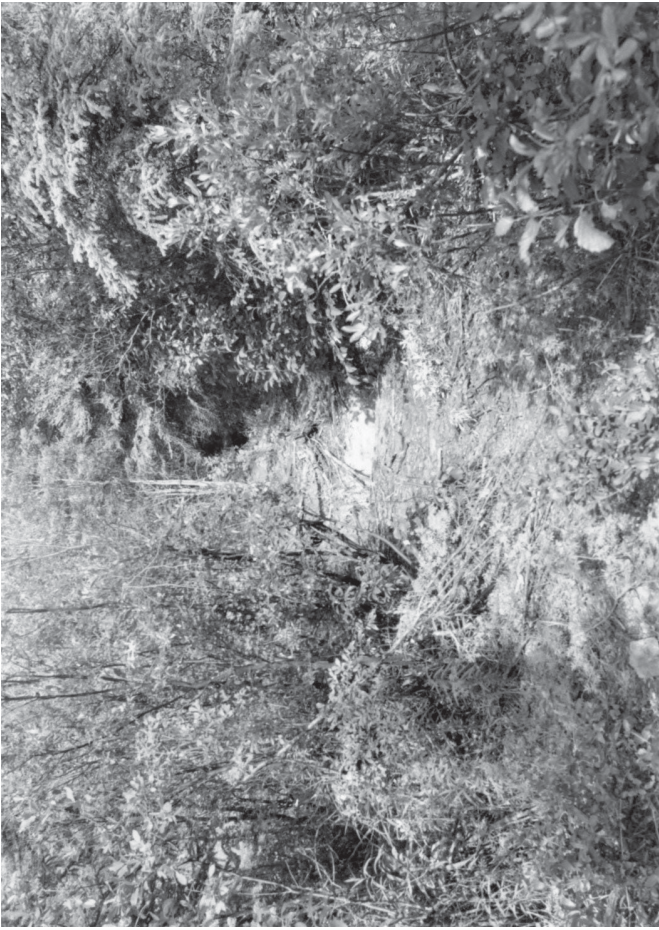
C08

- (B 25) Looking east from base of stack in Boiler House
- (C 8) Looking north from next to stack base towards transverse gutter
- (C 9) Gutter end at west side of Boiler House foundation
- (C 11) Looking into gutter

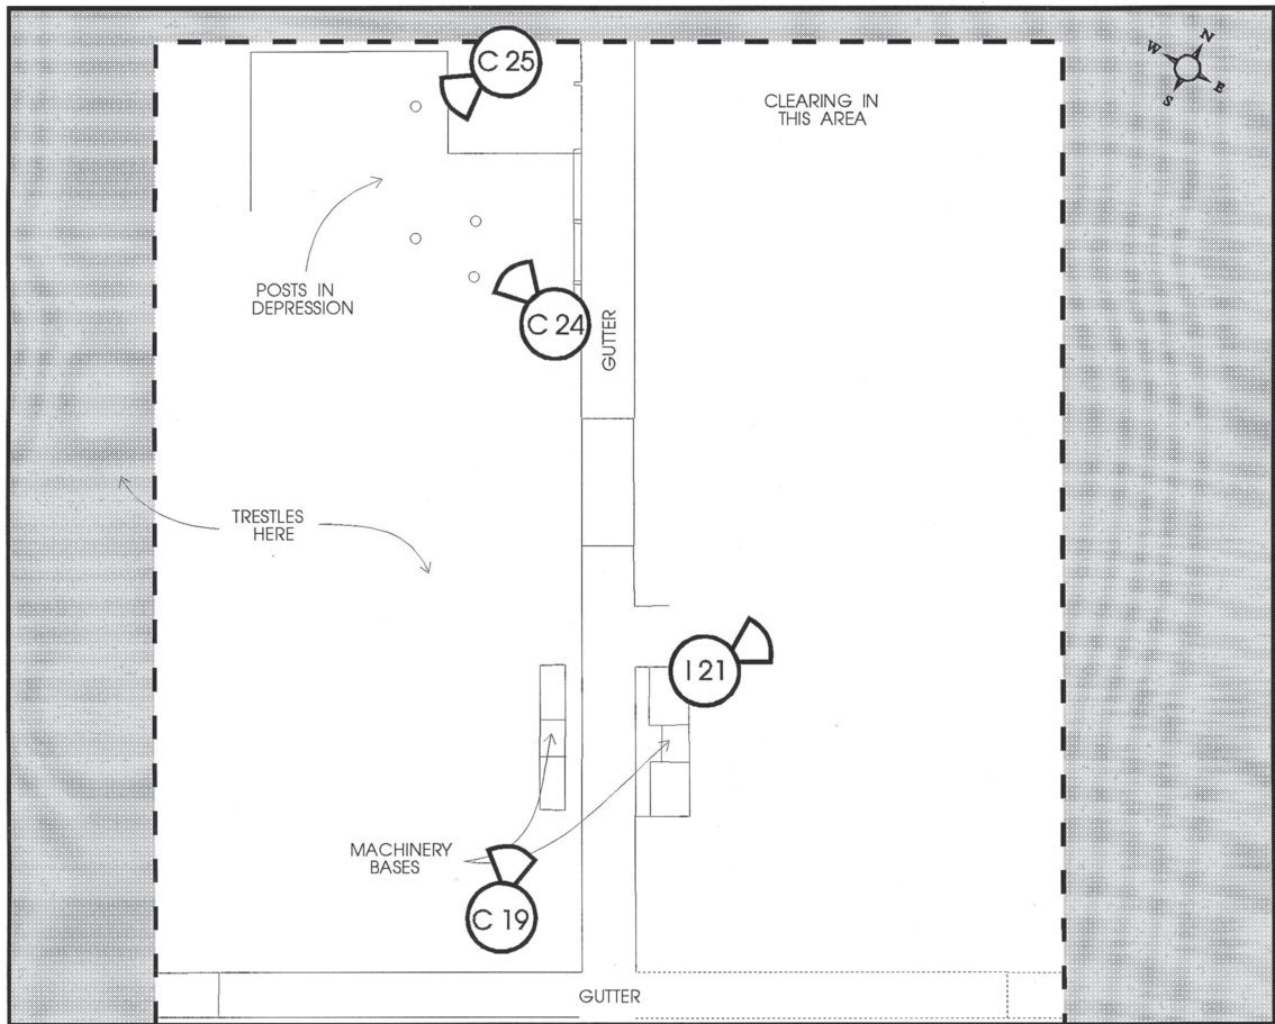
- (C 19) Concrete machinery bases straddling central longitudinal gutter
- (C 24) Posts in depression at north end of Boiler House
- (C 25) Posts in depression at north end of Boiler House
- (I 21) Cart just east of concrete machinery bases

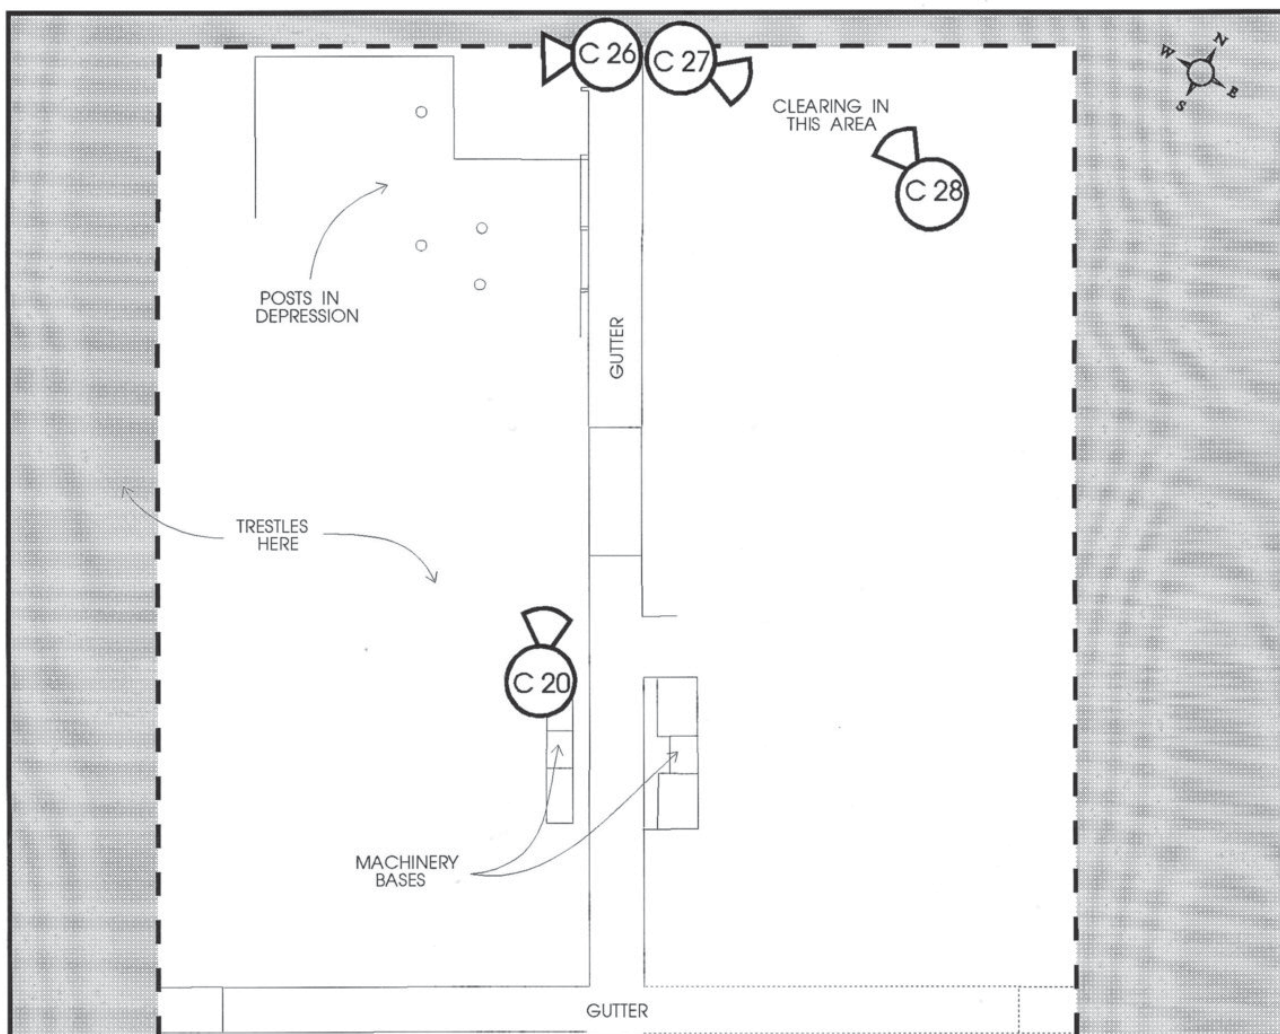
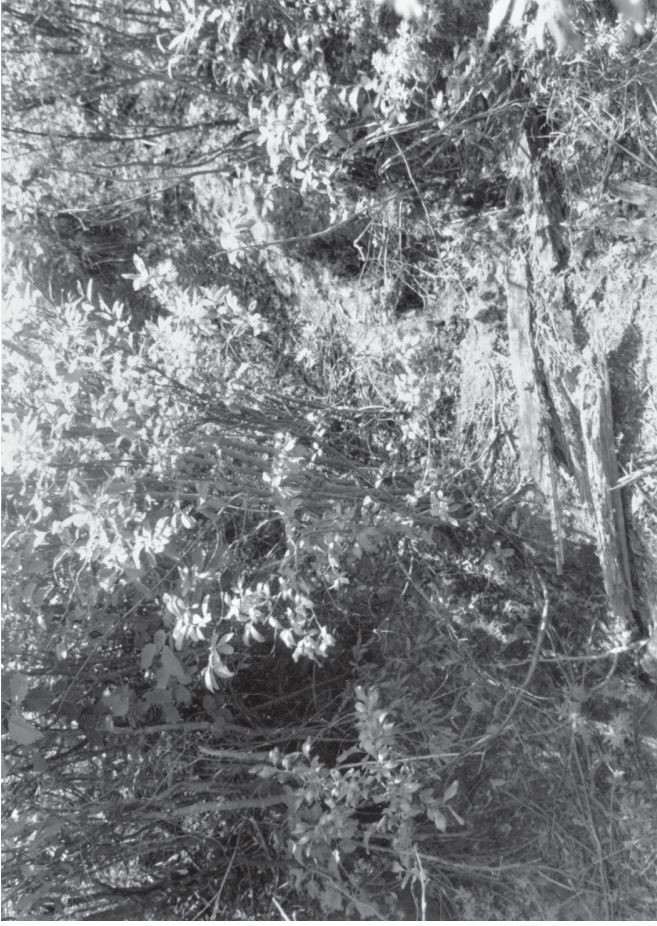
C20

- C 20 Looking north-west from machinery bases
- C 26 Looking west along foundation wall from end of longitudinal gutter
- C 27 Looking east from end of longitudinal gutter towards clearing
- C 28 Corrugated metal in clearing

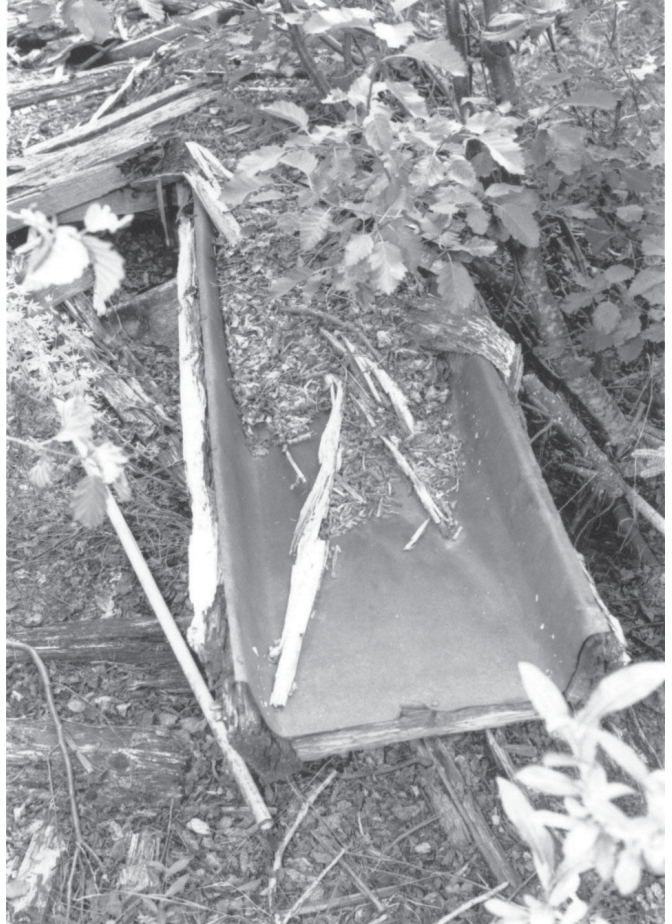
I22

- C 29 Looking south from clearing
- C 30 Looking south from partway along east edge of Boiler House foundation
- I 22 Metal line trough looking south near cart

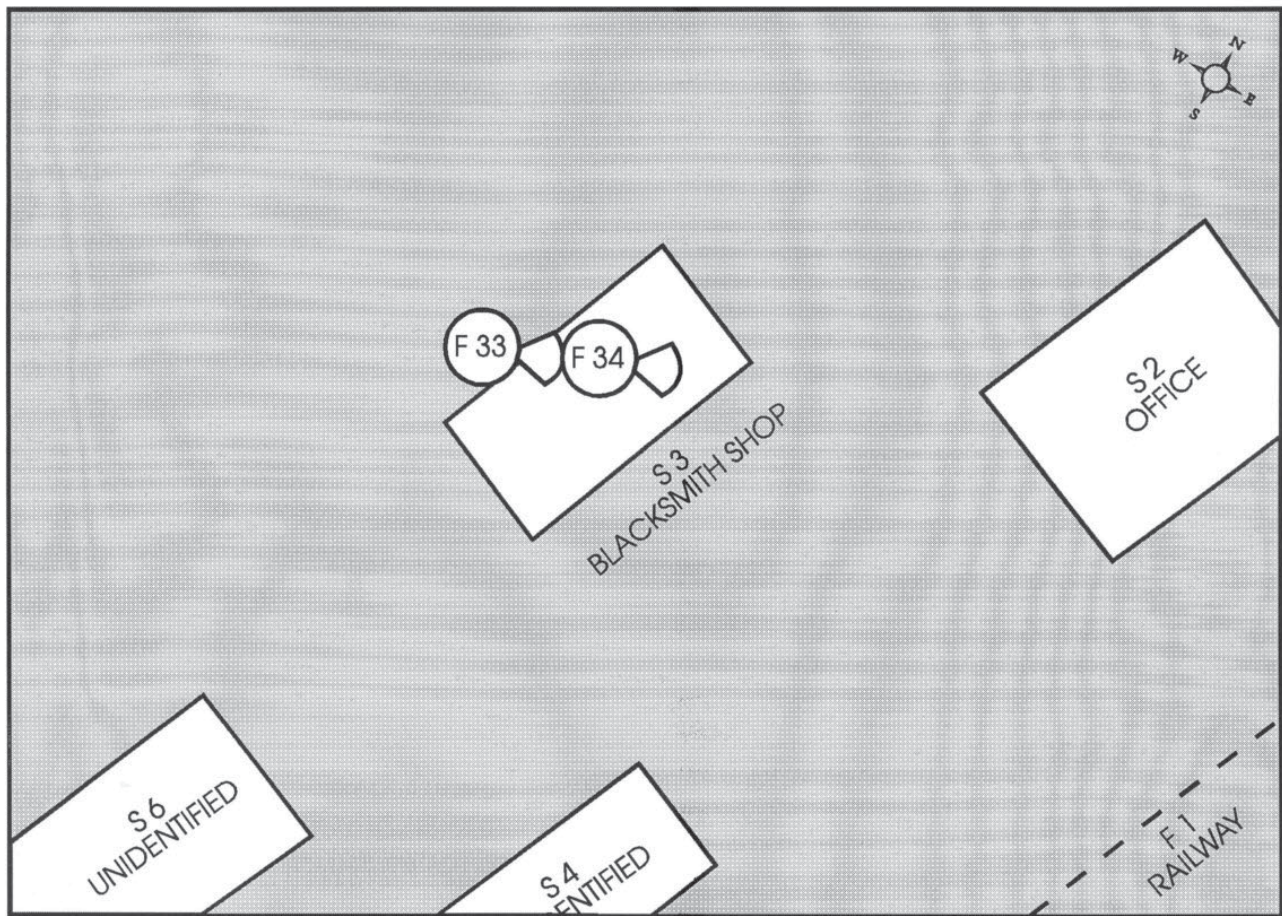
F34

- F 33 Remains of bellows
- F 34 Cable, connector, and other metal scraps

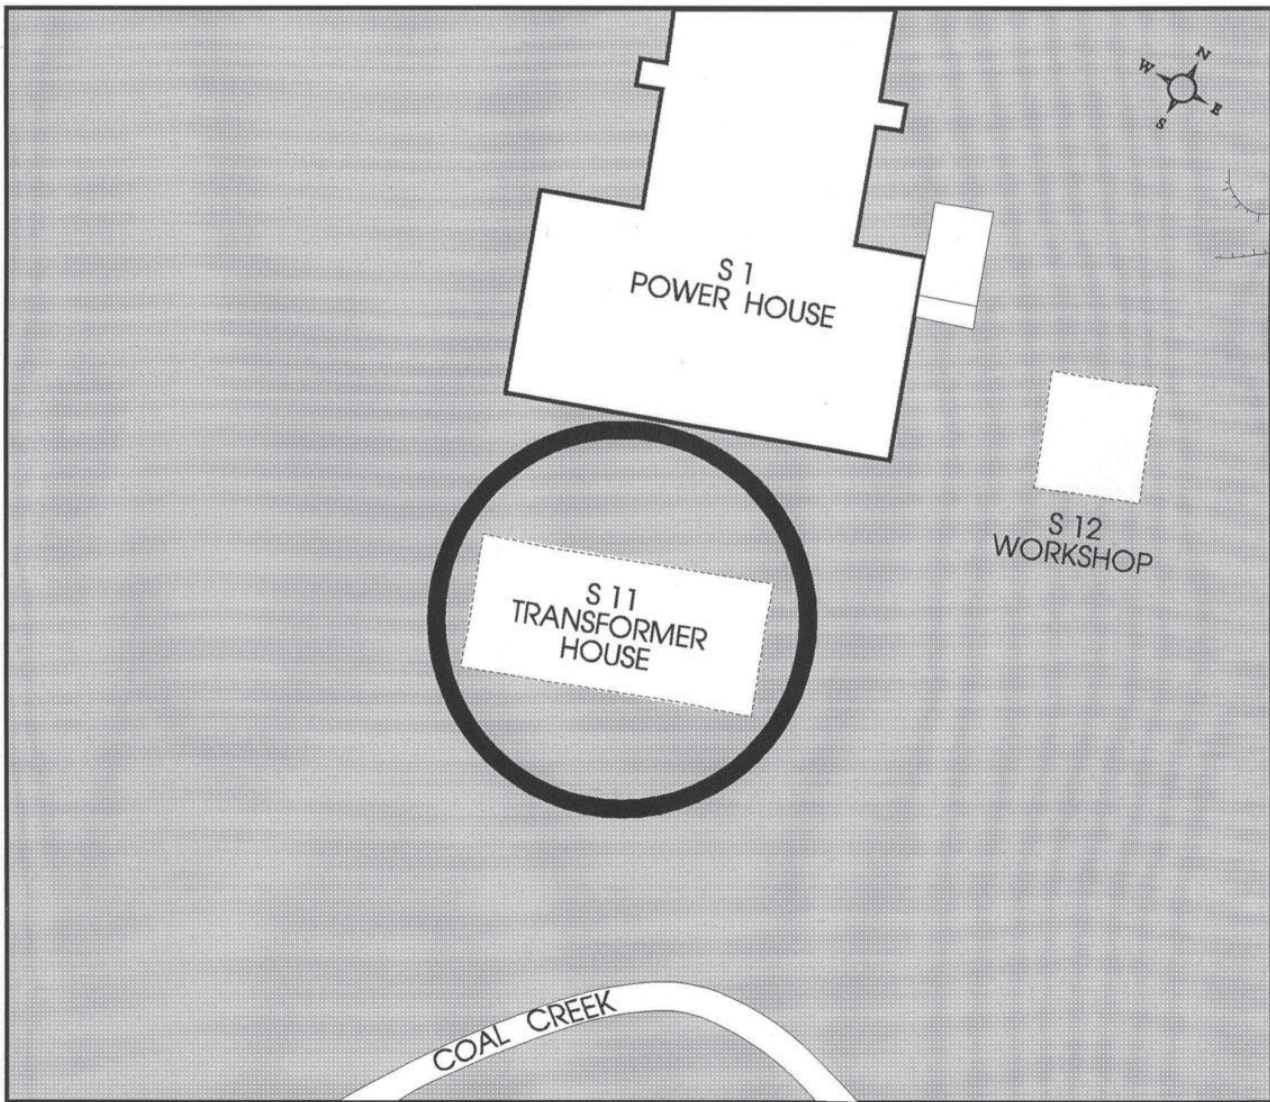
NO REMAINS

The area where this building should have been was investigated, but no remains were found though it appears quite clearly on both the historic photographs, and on the maps. The sawn off stumps of the beginning of the hydro line were found in the same area, along with a single, metre square concrete pad.

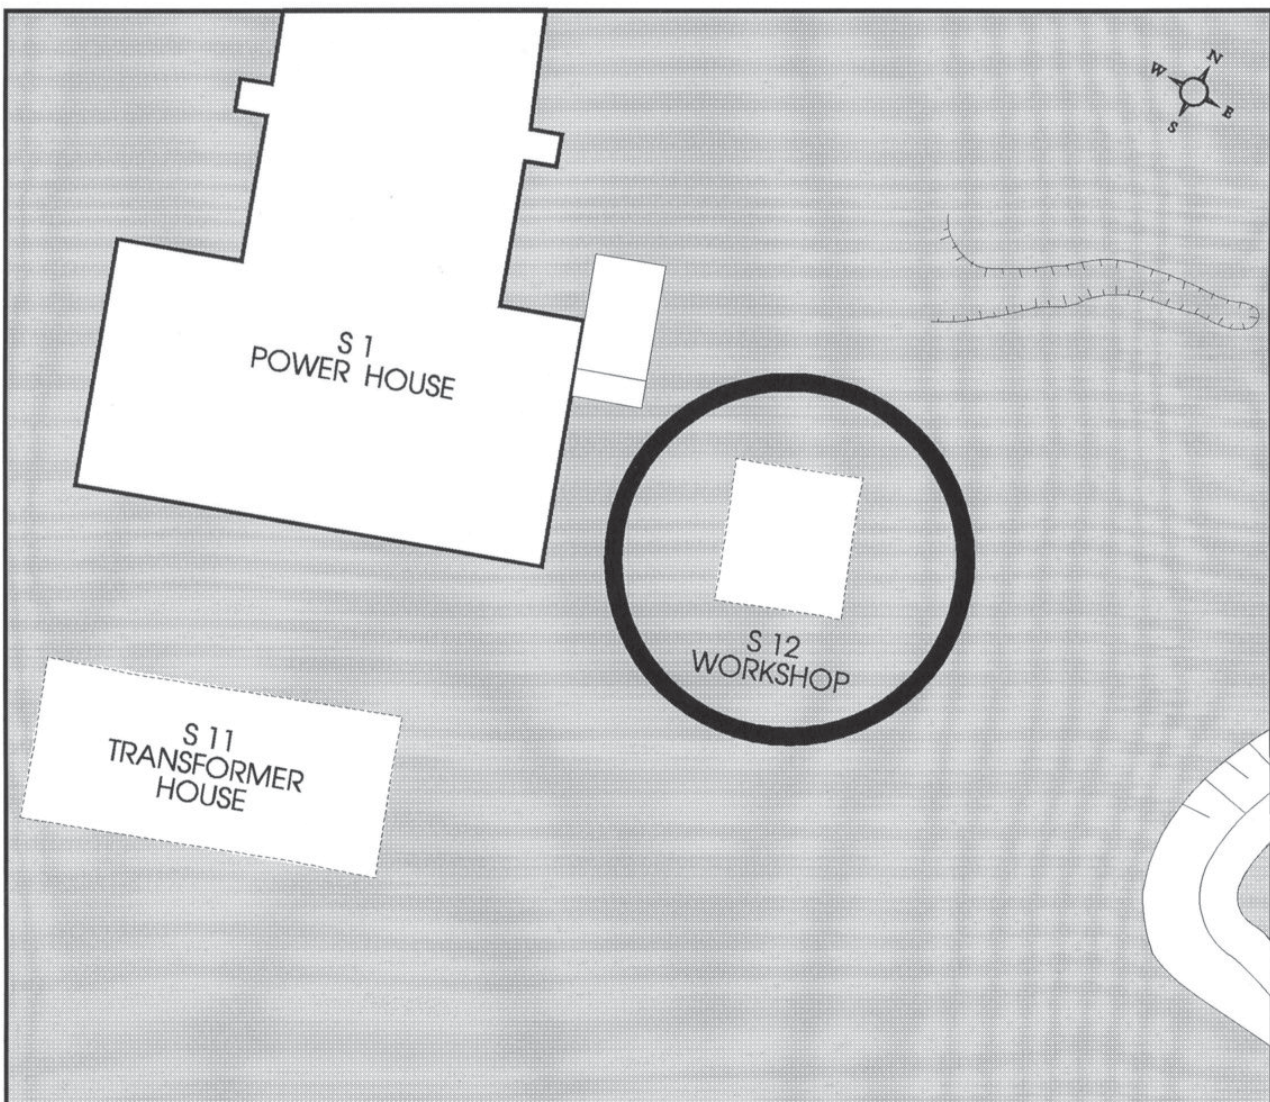
NO REMAINS

No trace of this building was found, and as it only appears on the design drawings and no where else, it probably was not built.

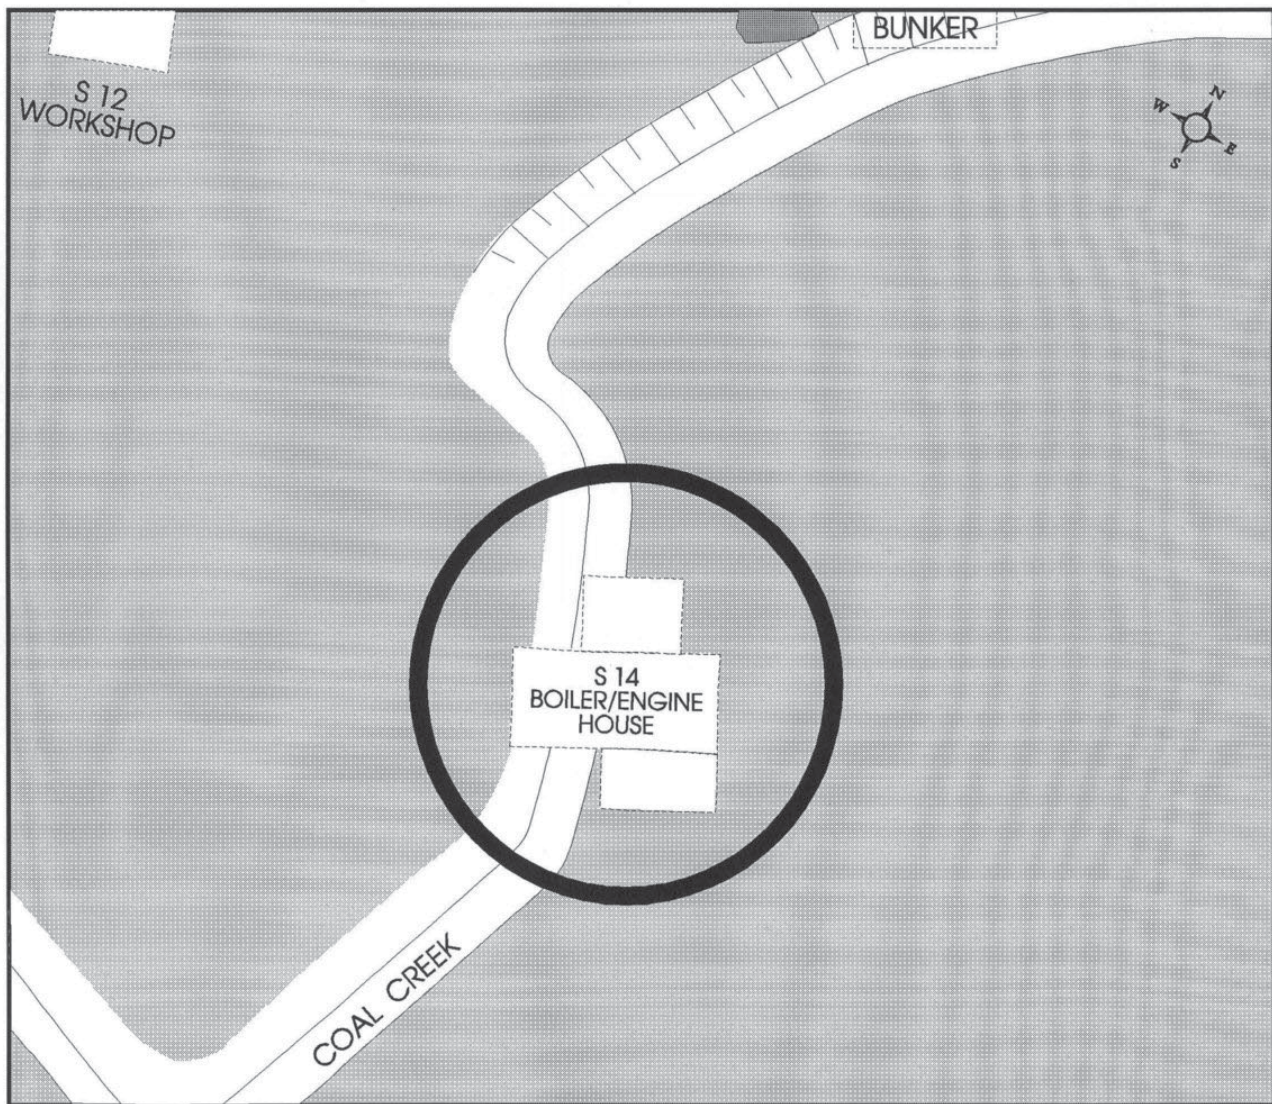
NO REMAINS

No remains were found. This may be because the site of this building appears to be where the stream currently flows. Metal debris was observed washing out of the bank down stream.

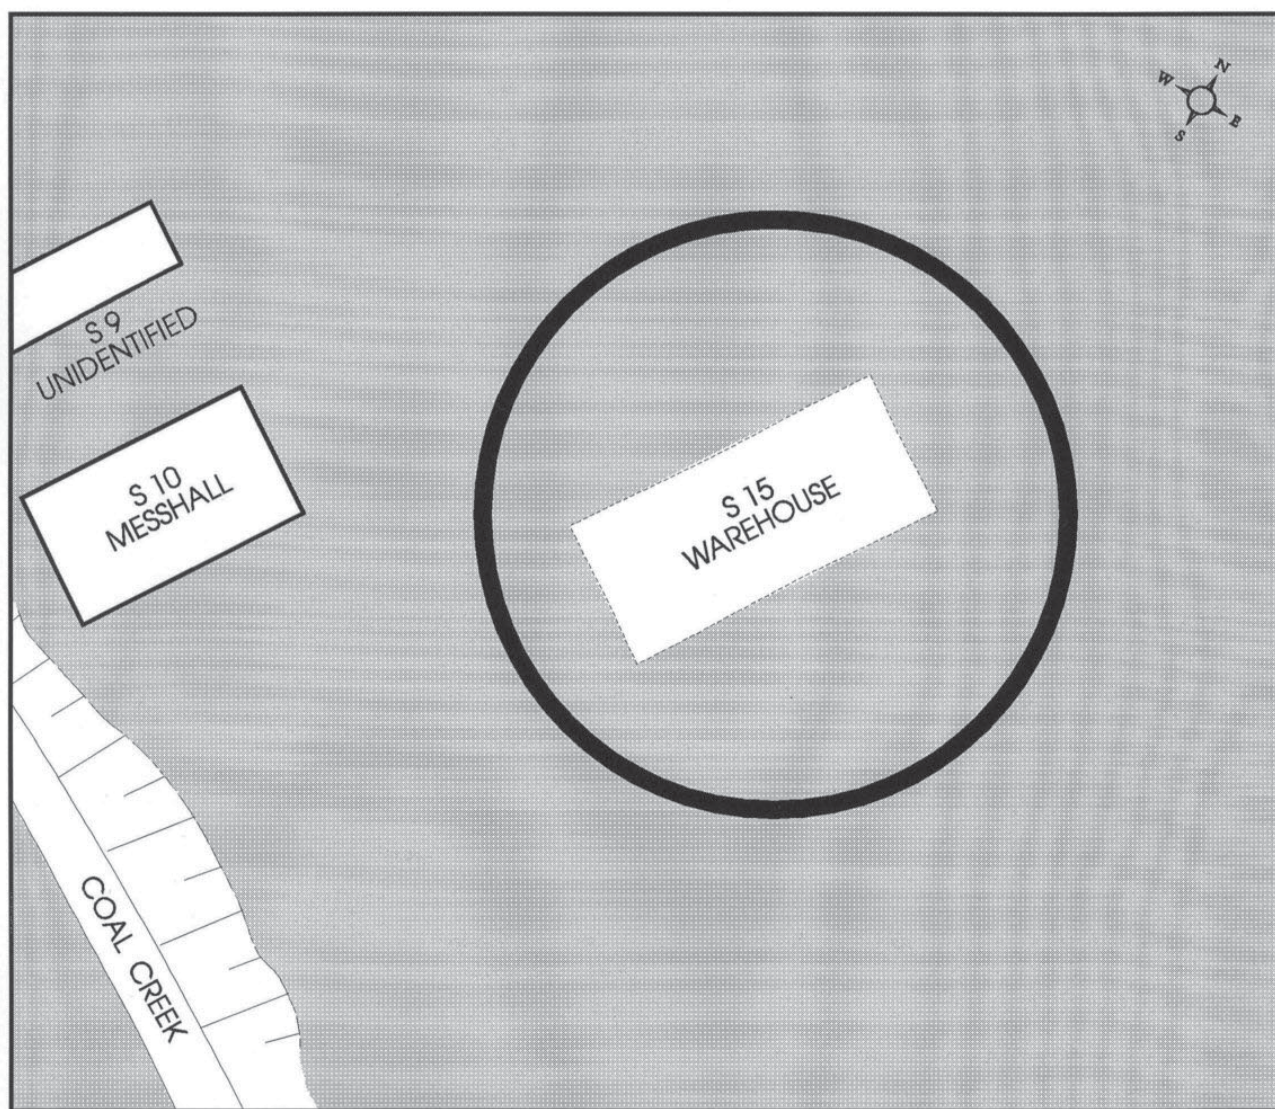
NO REMAINS

No trace of this building was found. Its location was obtained from the historic map appearing on page 11 of this report.

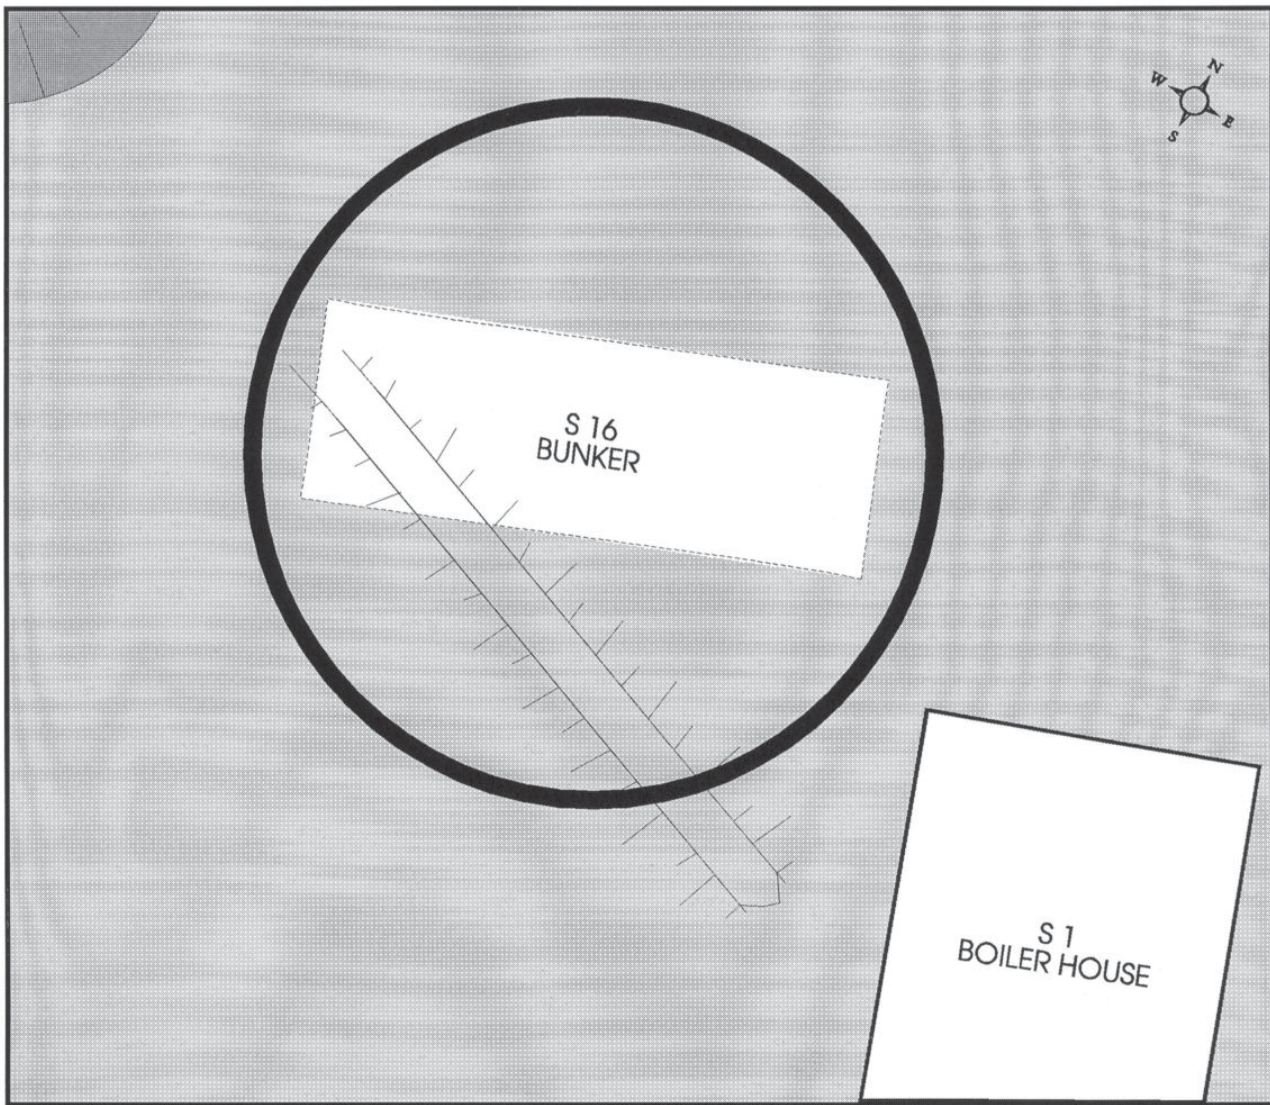
NO REMAINS

No trace of this structure was found. It appears on two historic maps in two different positions. The map on page 12 is a design map, and the other map on page 11 notes this bunker as being proposed. It was probably not built.

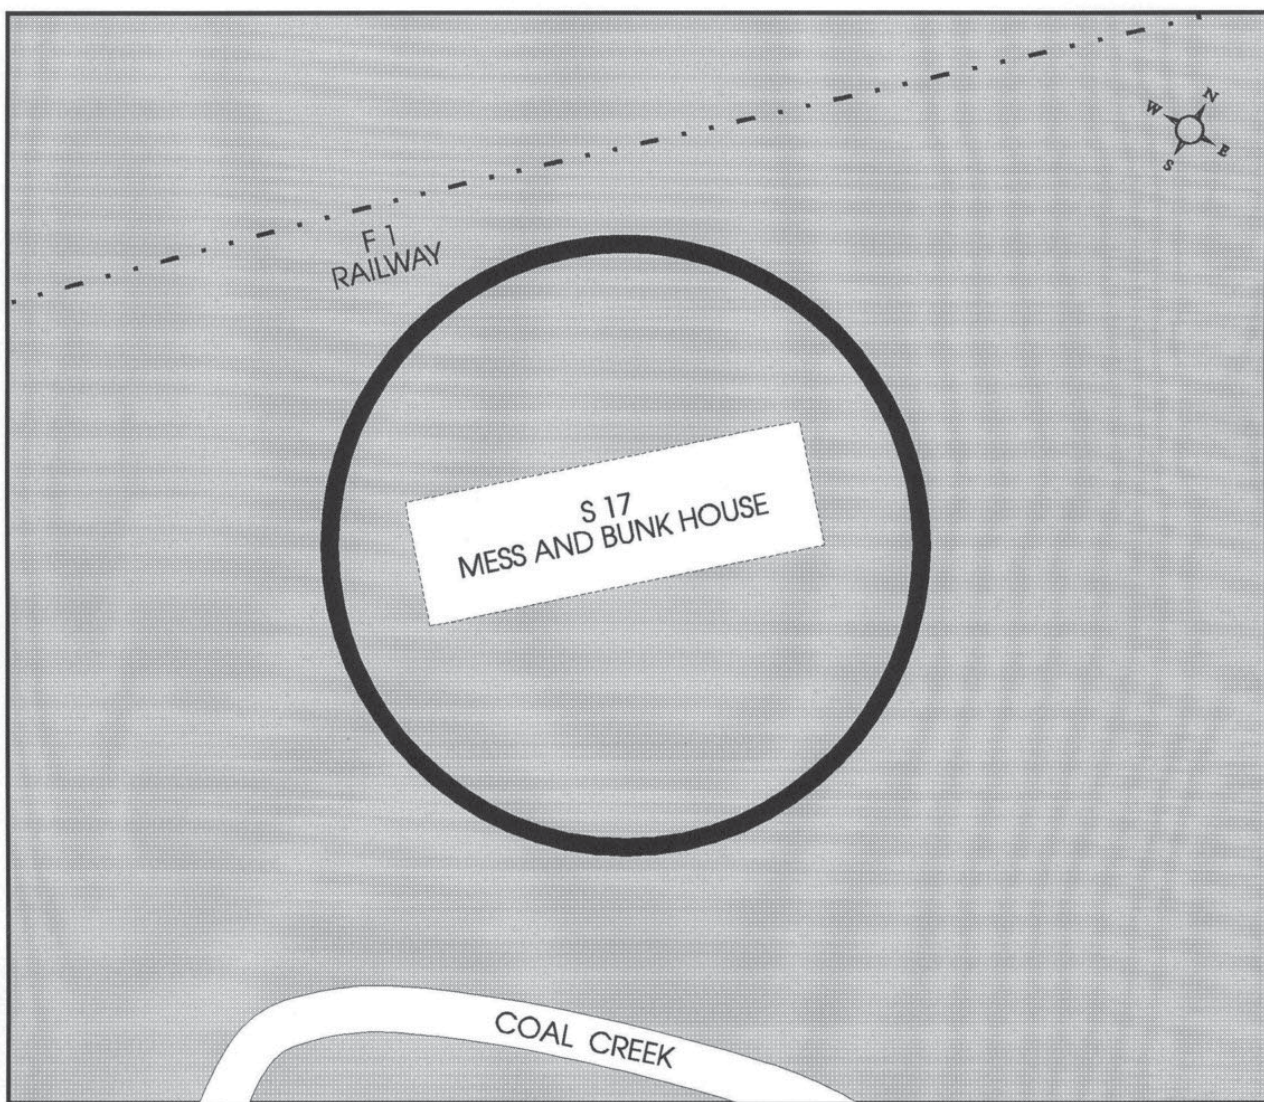
NO REMAINS

No trace of this structure was found. Its location appears on the historic map on page 11, and is probably the structure seen in the background of the historic photograph on page 20. The map describes it as being 24 x 80 feet in size, and being two stories high, which fits the building seen in the historic photograph.
