**REPORT ON  
THE CULTURAL RESOURCES AT  
COAL CREEK**

Bob Mitchell  
CAPHC

# REPORT ON THE CULTURAL RESOURCES AT COAL CREEK

AS FOUND IN AUGUST OF 1992

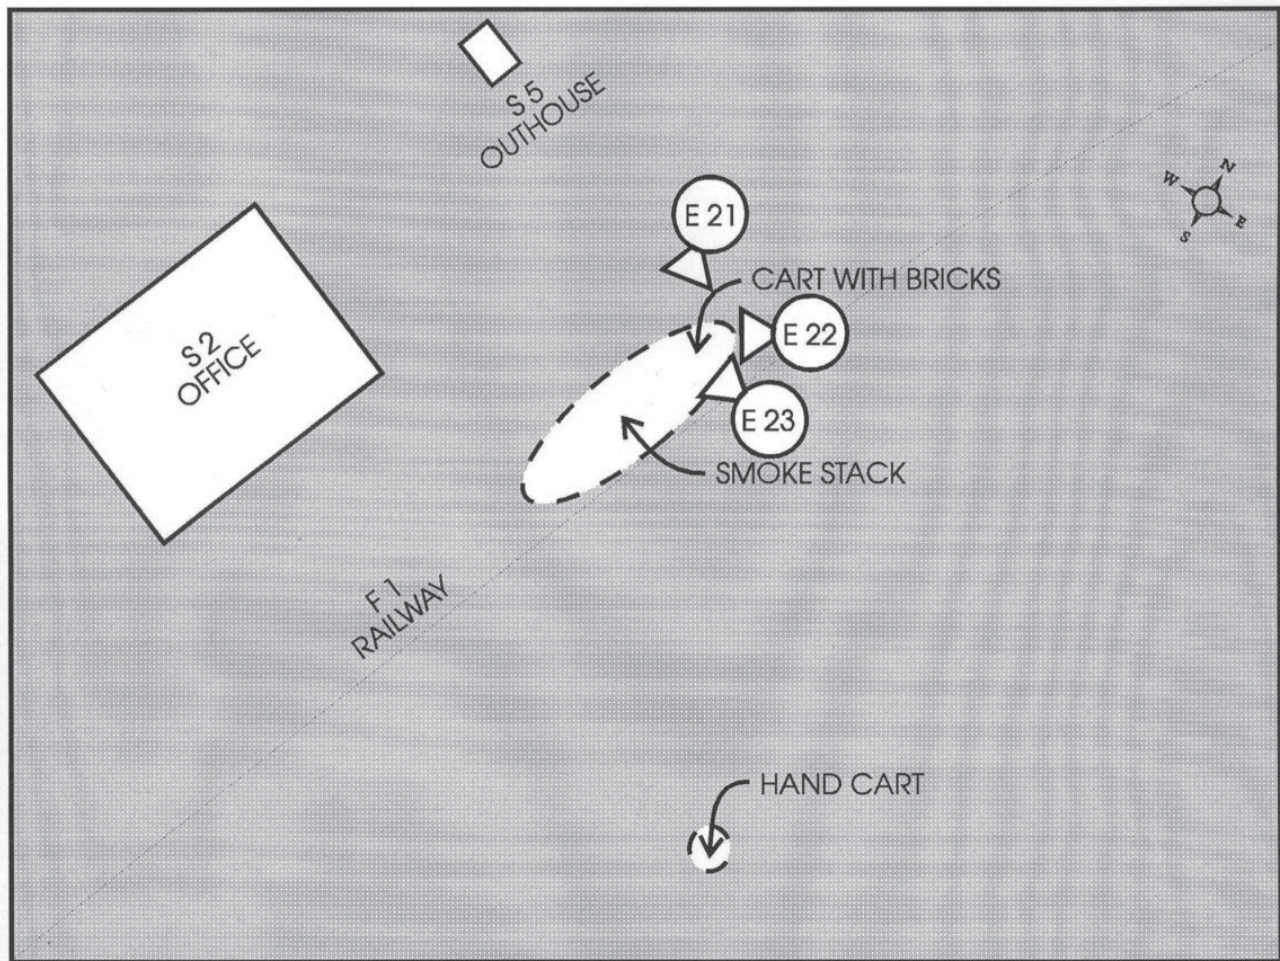
E22

This collection of artifacts is usually the sort of clutter found around railway servicing facilities. The siding to the boiler house started at around this point on the main railway line.

- (E 21) Cart loaded with fire brick, viewed from north
- (E 22) Cart loaded with fire brick, viewed from north-east
- (E 23) Cart loaded with fire brick, viewed from east

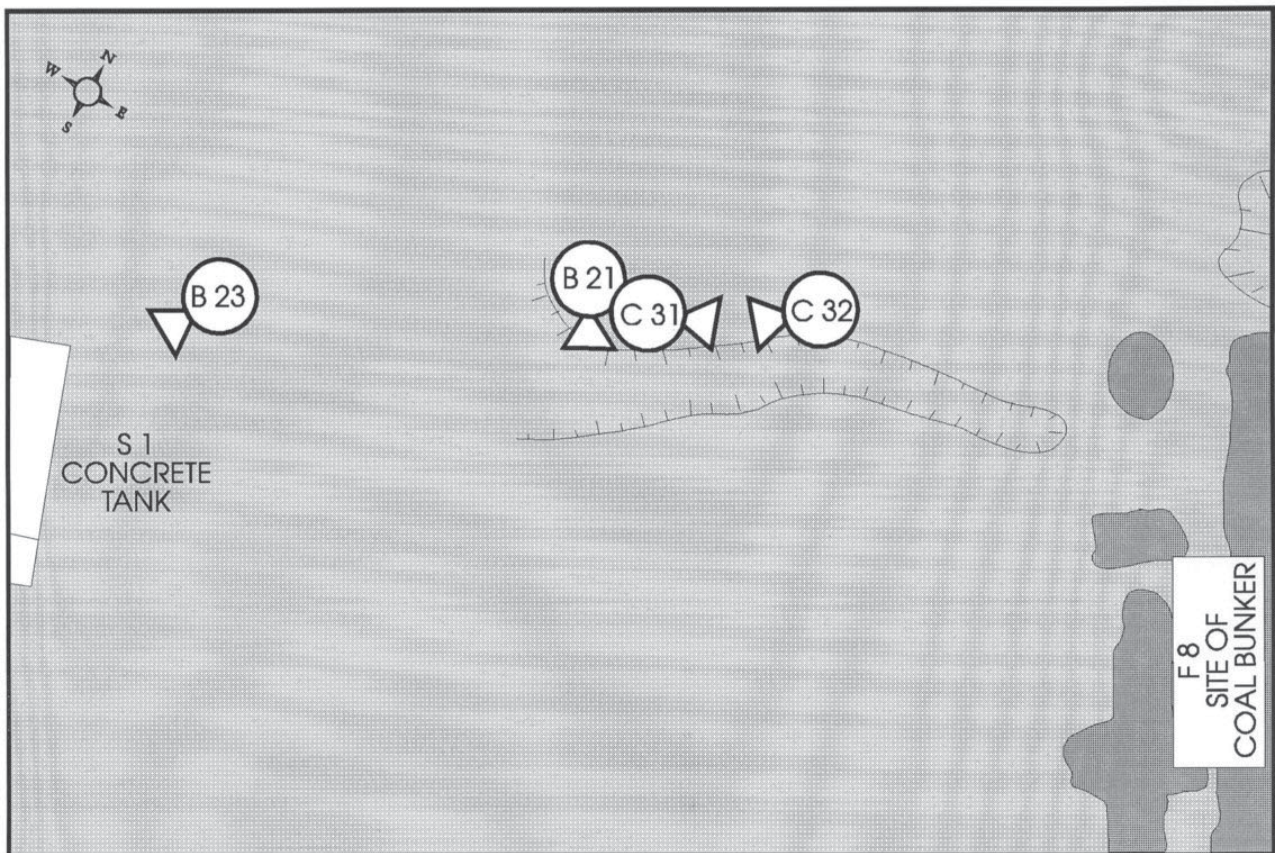
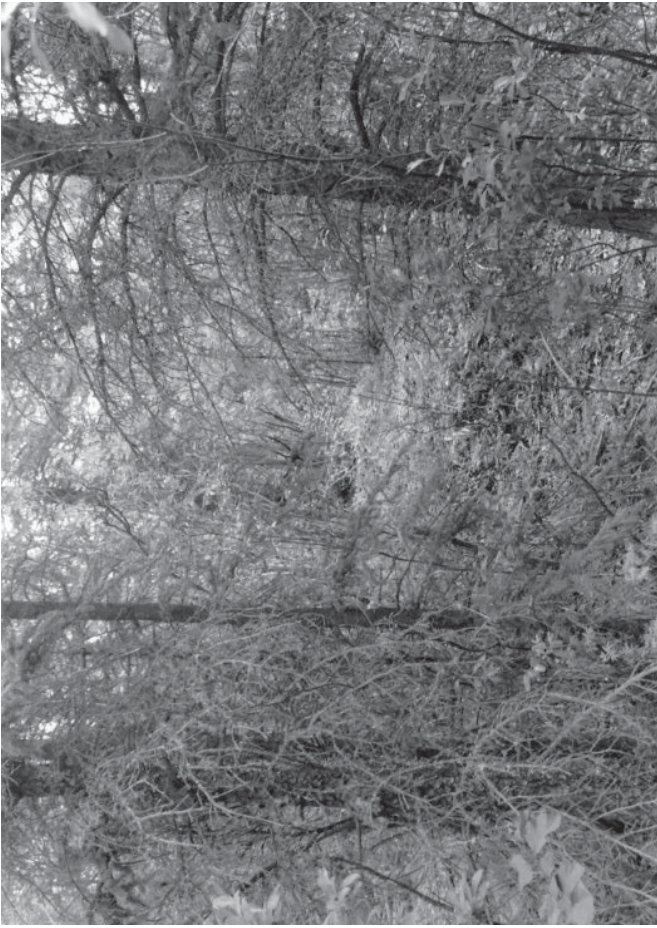
B21

- (B 21) Looking east from east of ring of bag casts
- (B 23) Looking south from south end of probable water channel (F 7)
- (C 31) Wheelbarrow frame at edge of long depression east of foundation
- (C 32) Wheelbarrow frame at edge of long depression east of foundation

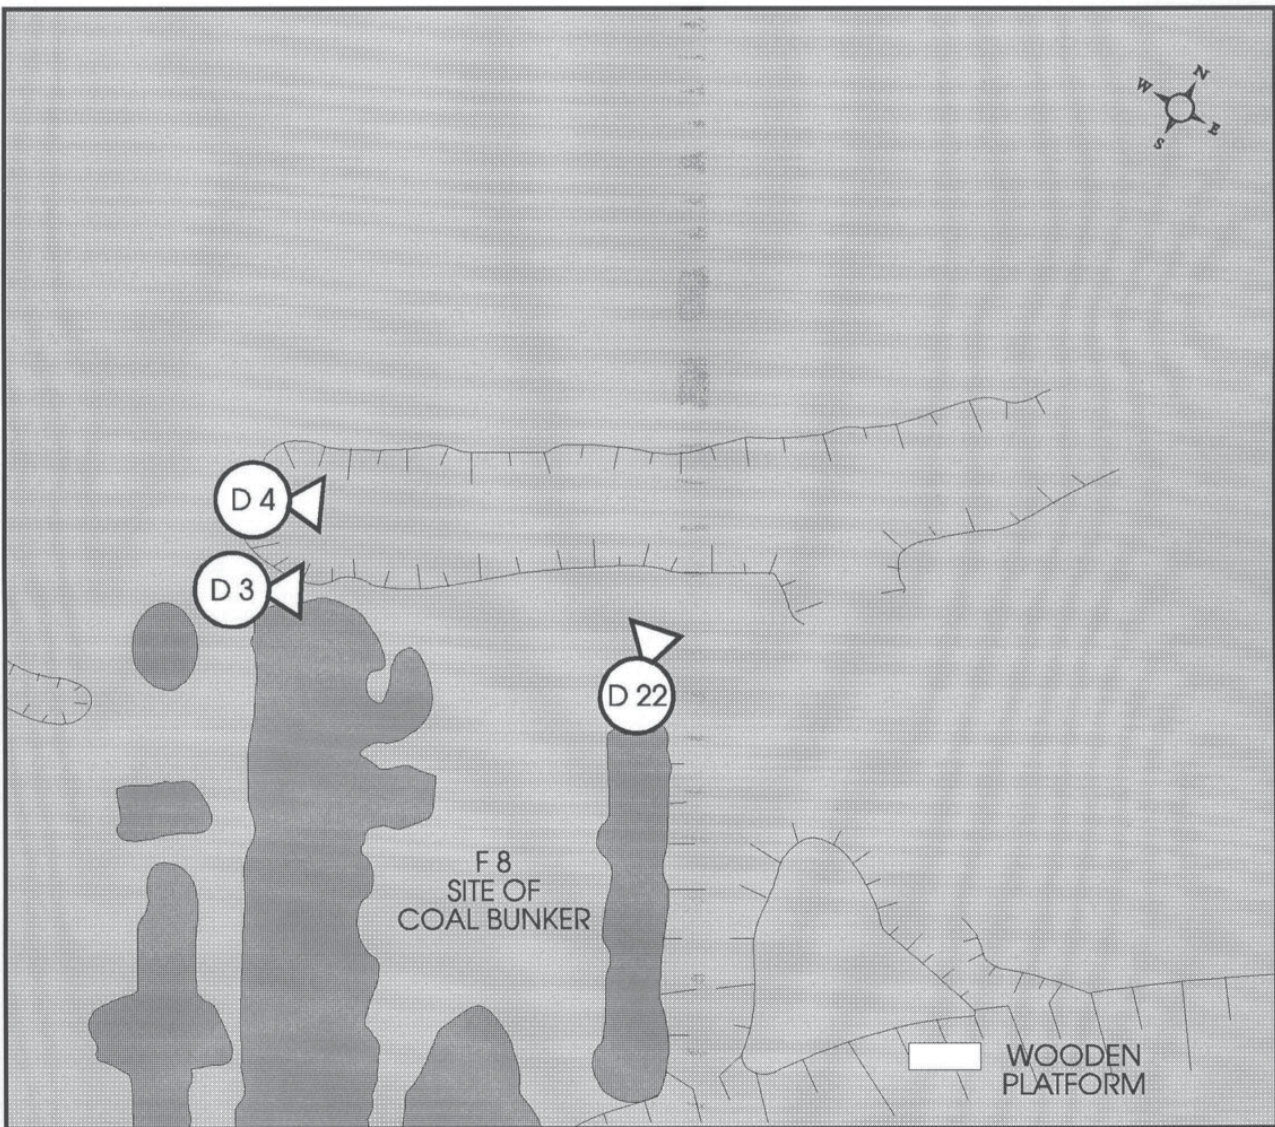
D04

- D 3 Looking north-east along wide ditch
- D 4 Looking north-east along bank of wide ditch
- D 22 Looking north into wide ditch, plough in foreground

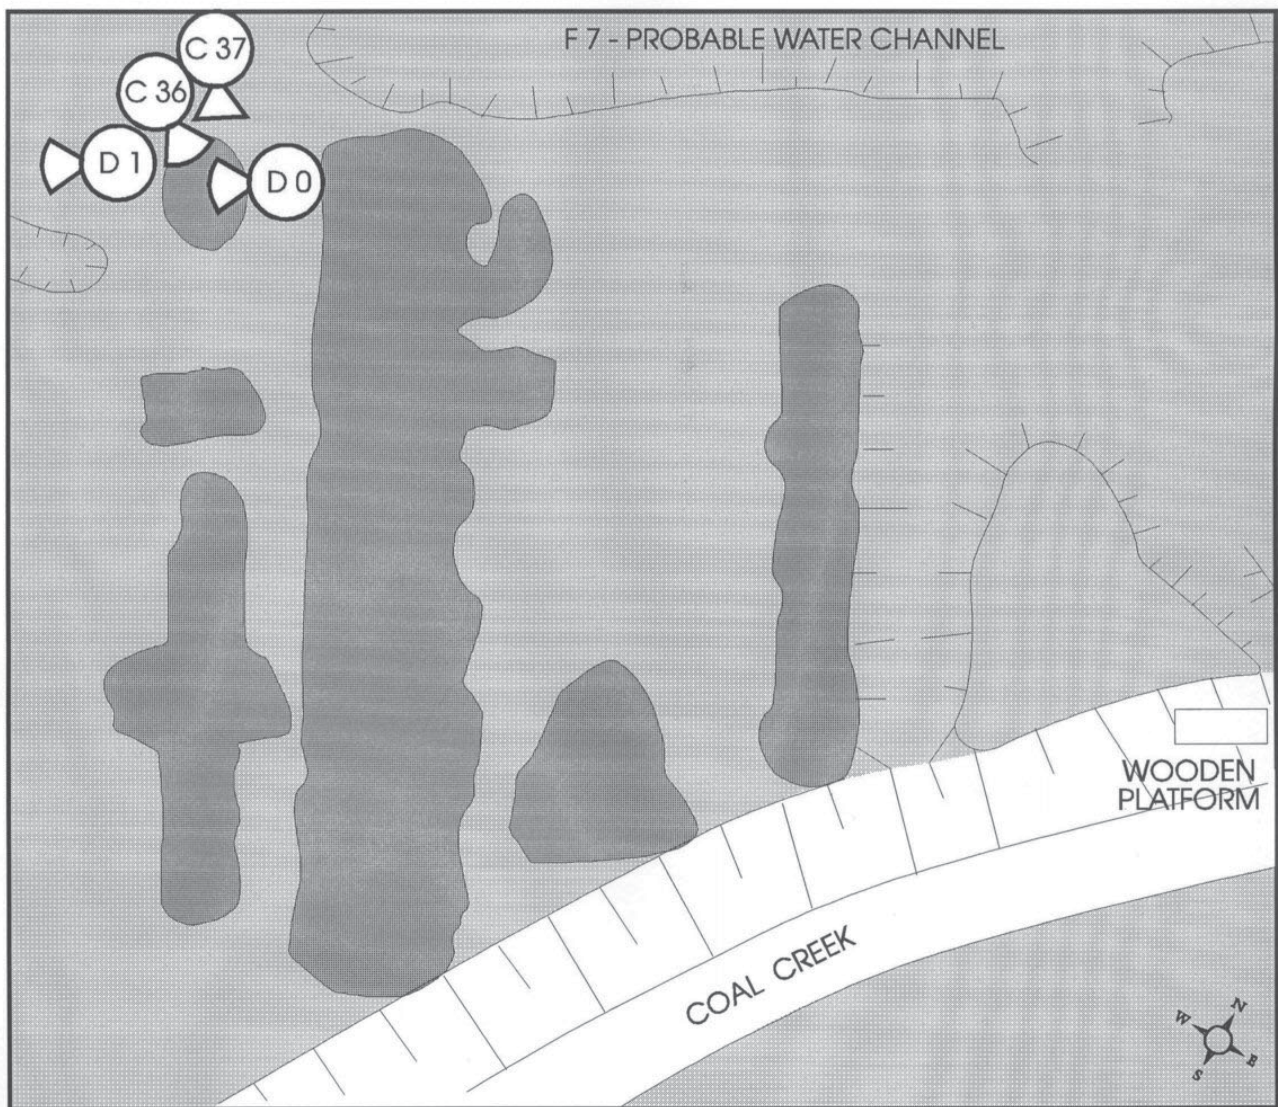
D00

- C 36 Pieces of suction hose north-east of plank wall
- C 37 Looking south-east from suction hose
- D 0 Pieces of suction hose at north-west end of feature
- D 1 Pipe and long handled hoe approximately 2500 mm long

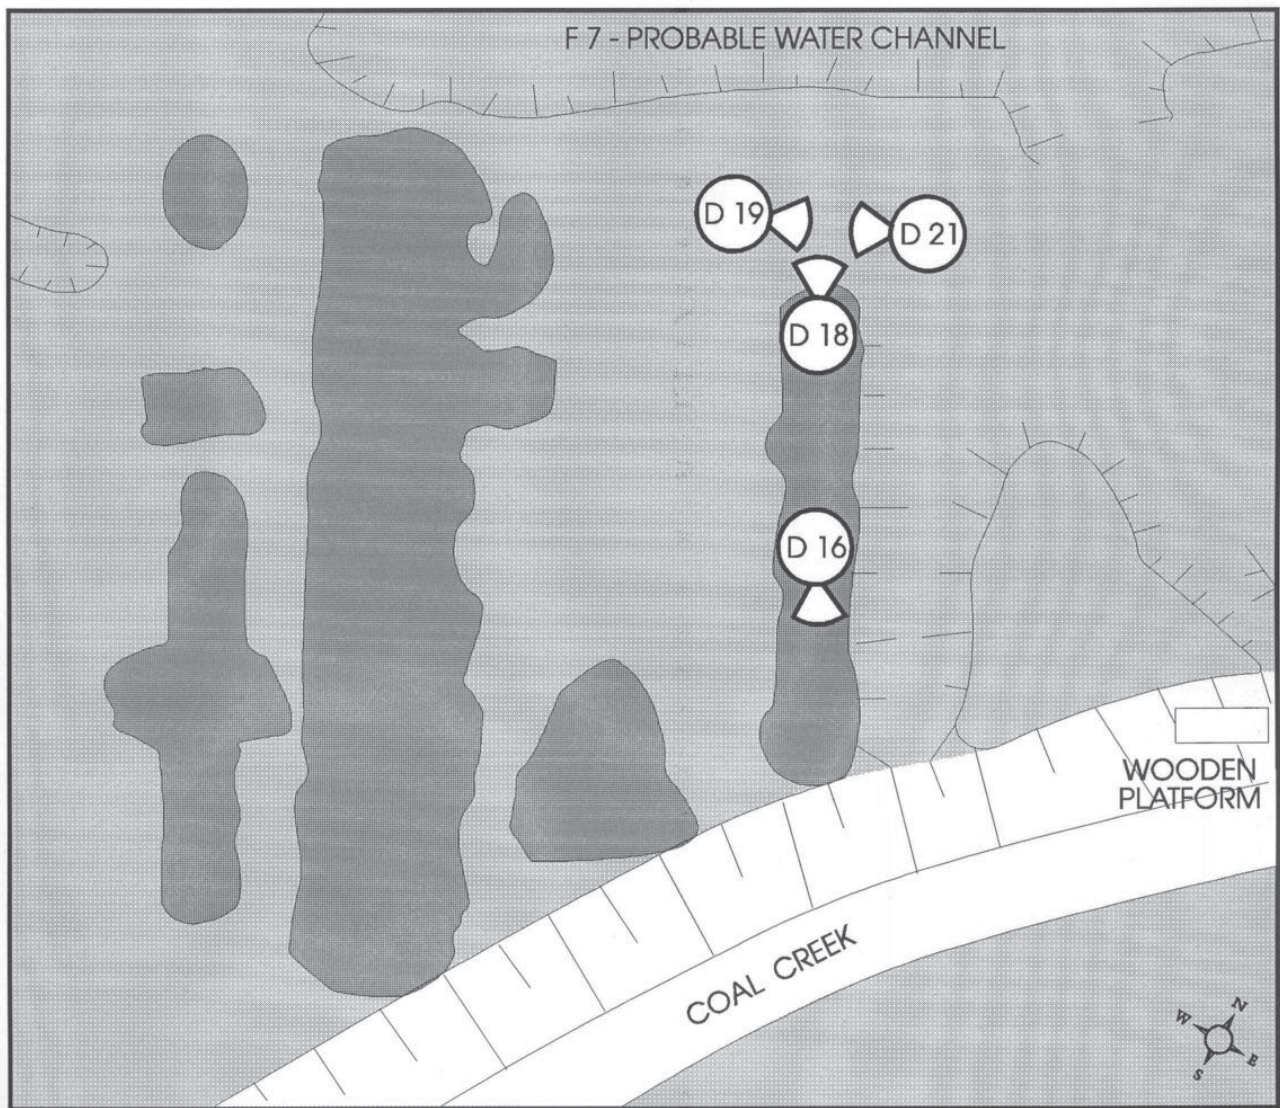
D18

- D 16 Gear cover
- D 18 Plough at north-east end of feature
- D 19 Plough at north-east end of feature
- D 21 Plough at north-east end of feature

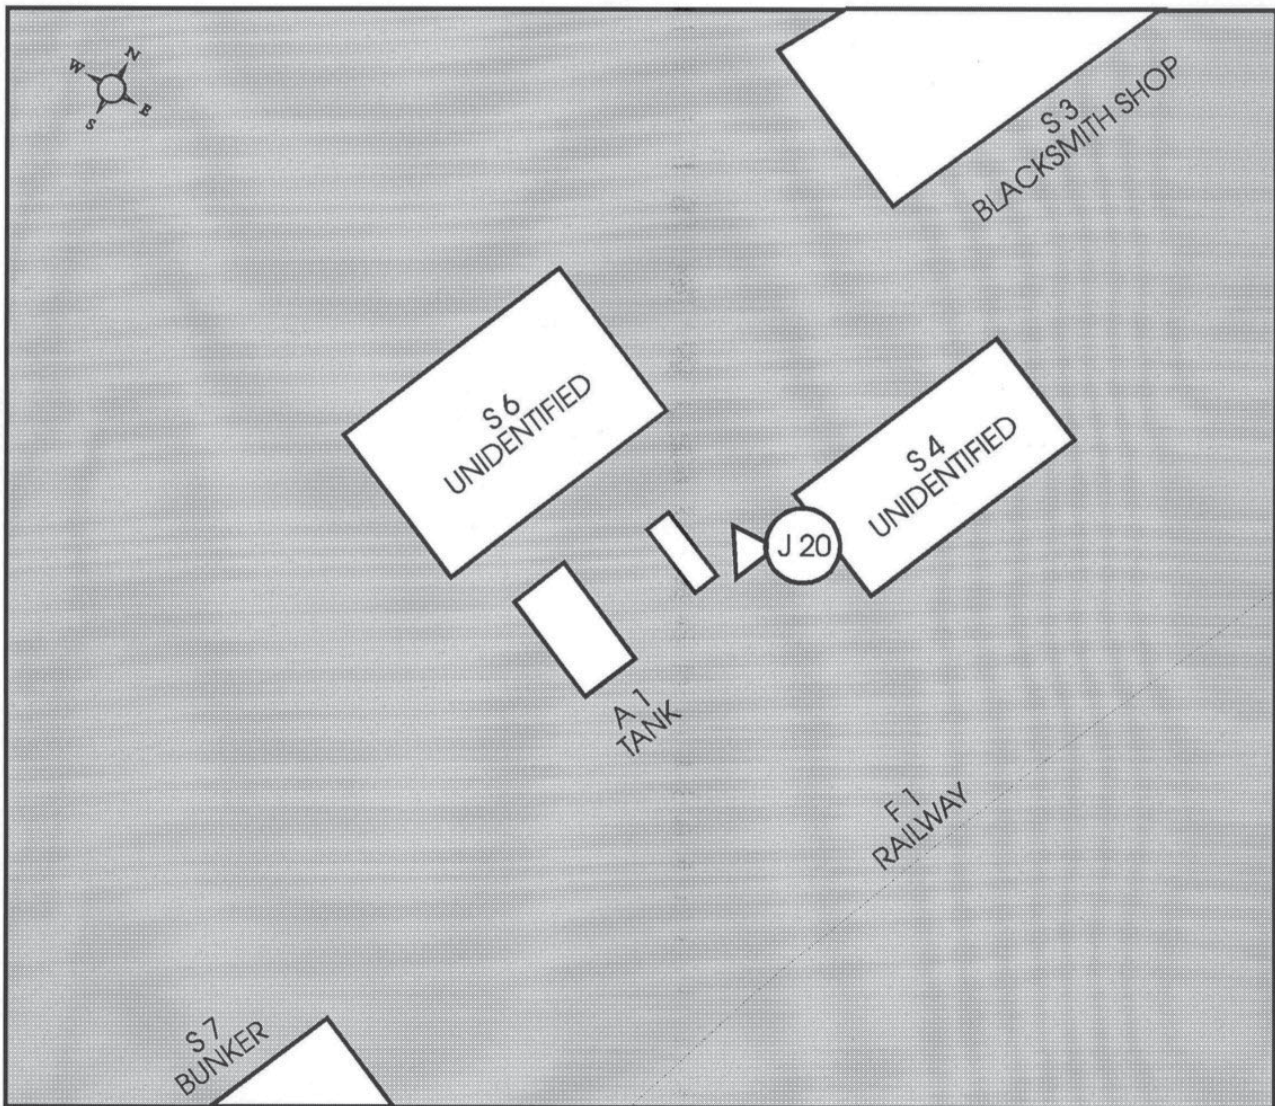
J20

J 20 Boiler near office, looking west

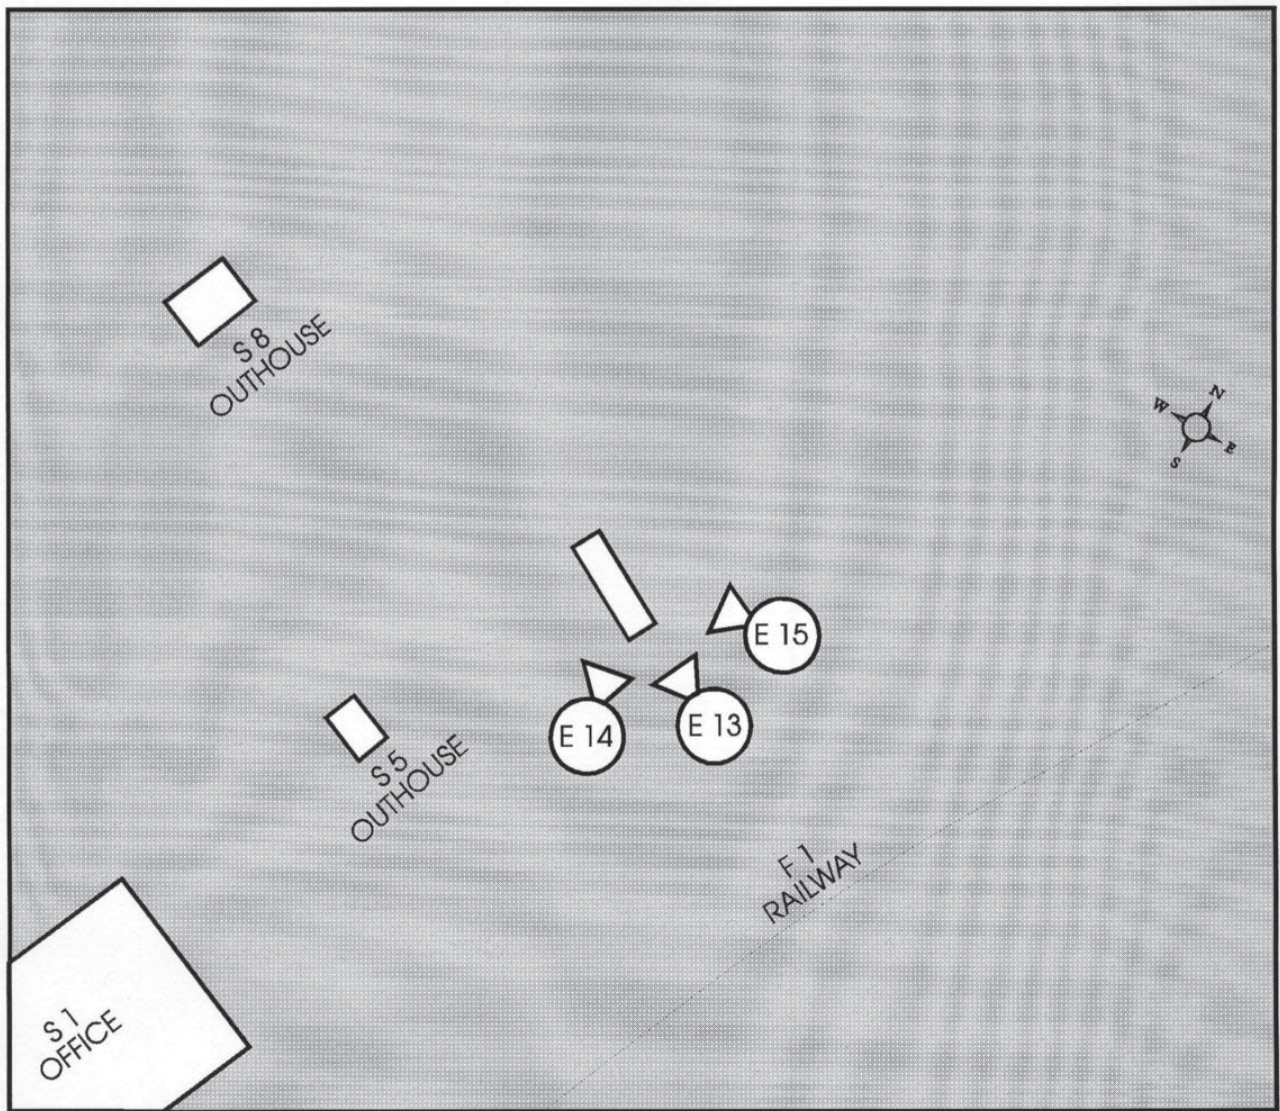
- E 13 Smokebox end of boiler
- E 14 View of underside of smokebox showing brace
- E 15 View of upper side of smokebox showing stack base

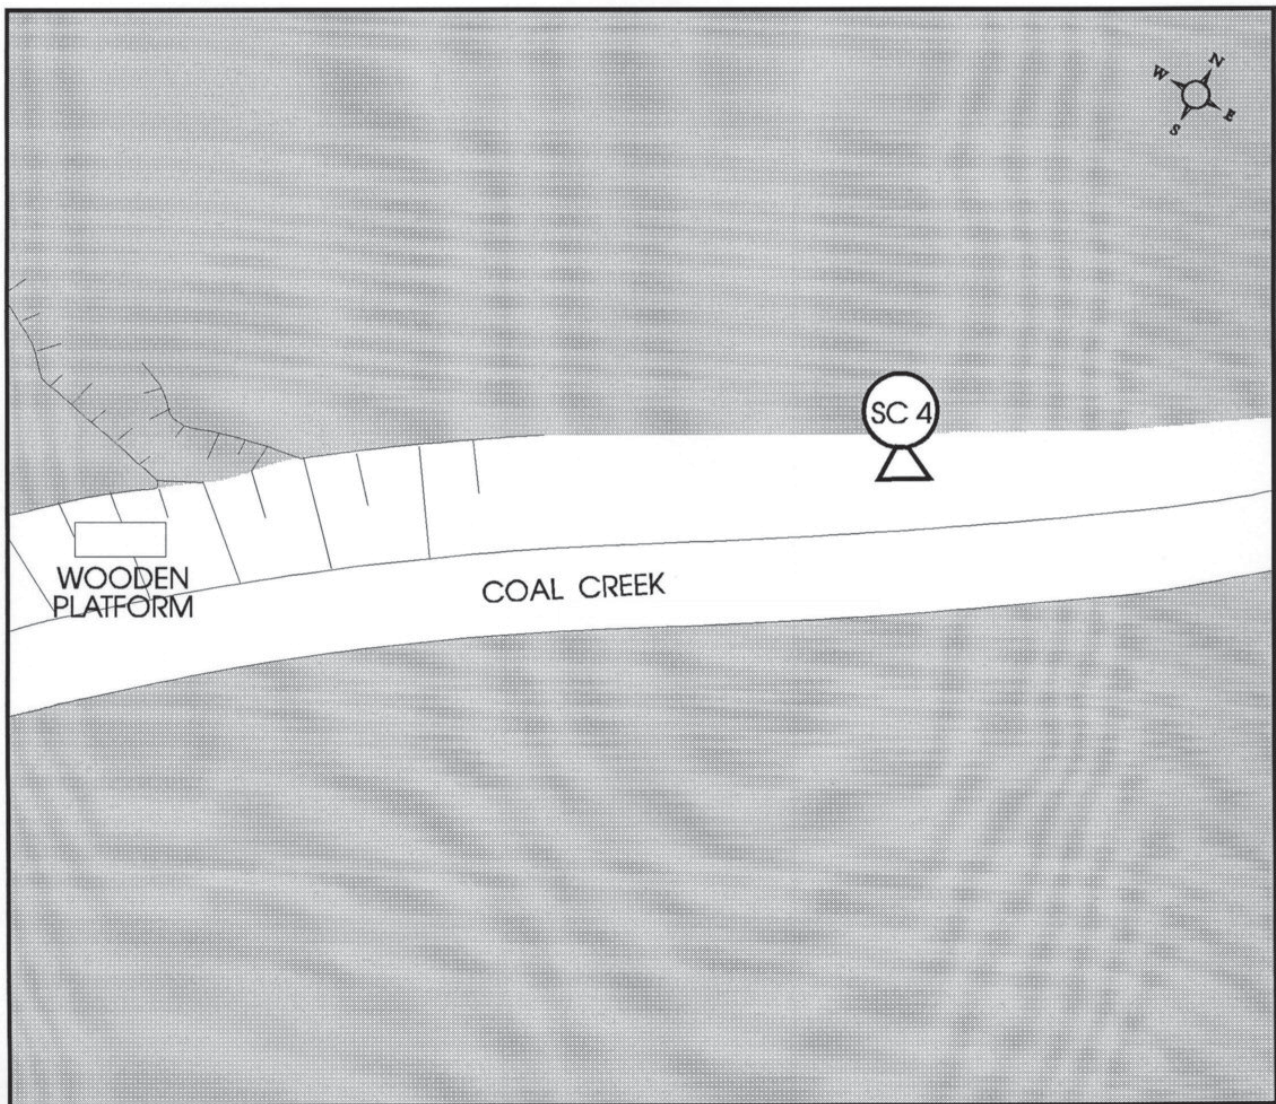
**SC 4** Possible dam abutment in east bank of Coal Creek (see previous page)
