Faro Mine Complex AMP Event #4 Response: 2008 Status Report

*Project Reference Number
SRK 1CD003.110*

**AMP Event #4 Response:
2008 Status Report
FINAL**

2008 GROUNDWATER REVIEW
ANVIL RANGE MINING COMPLEX, YUKON TERRITORY

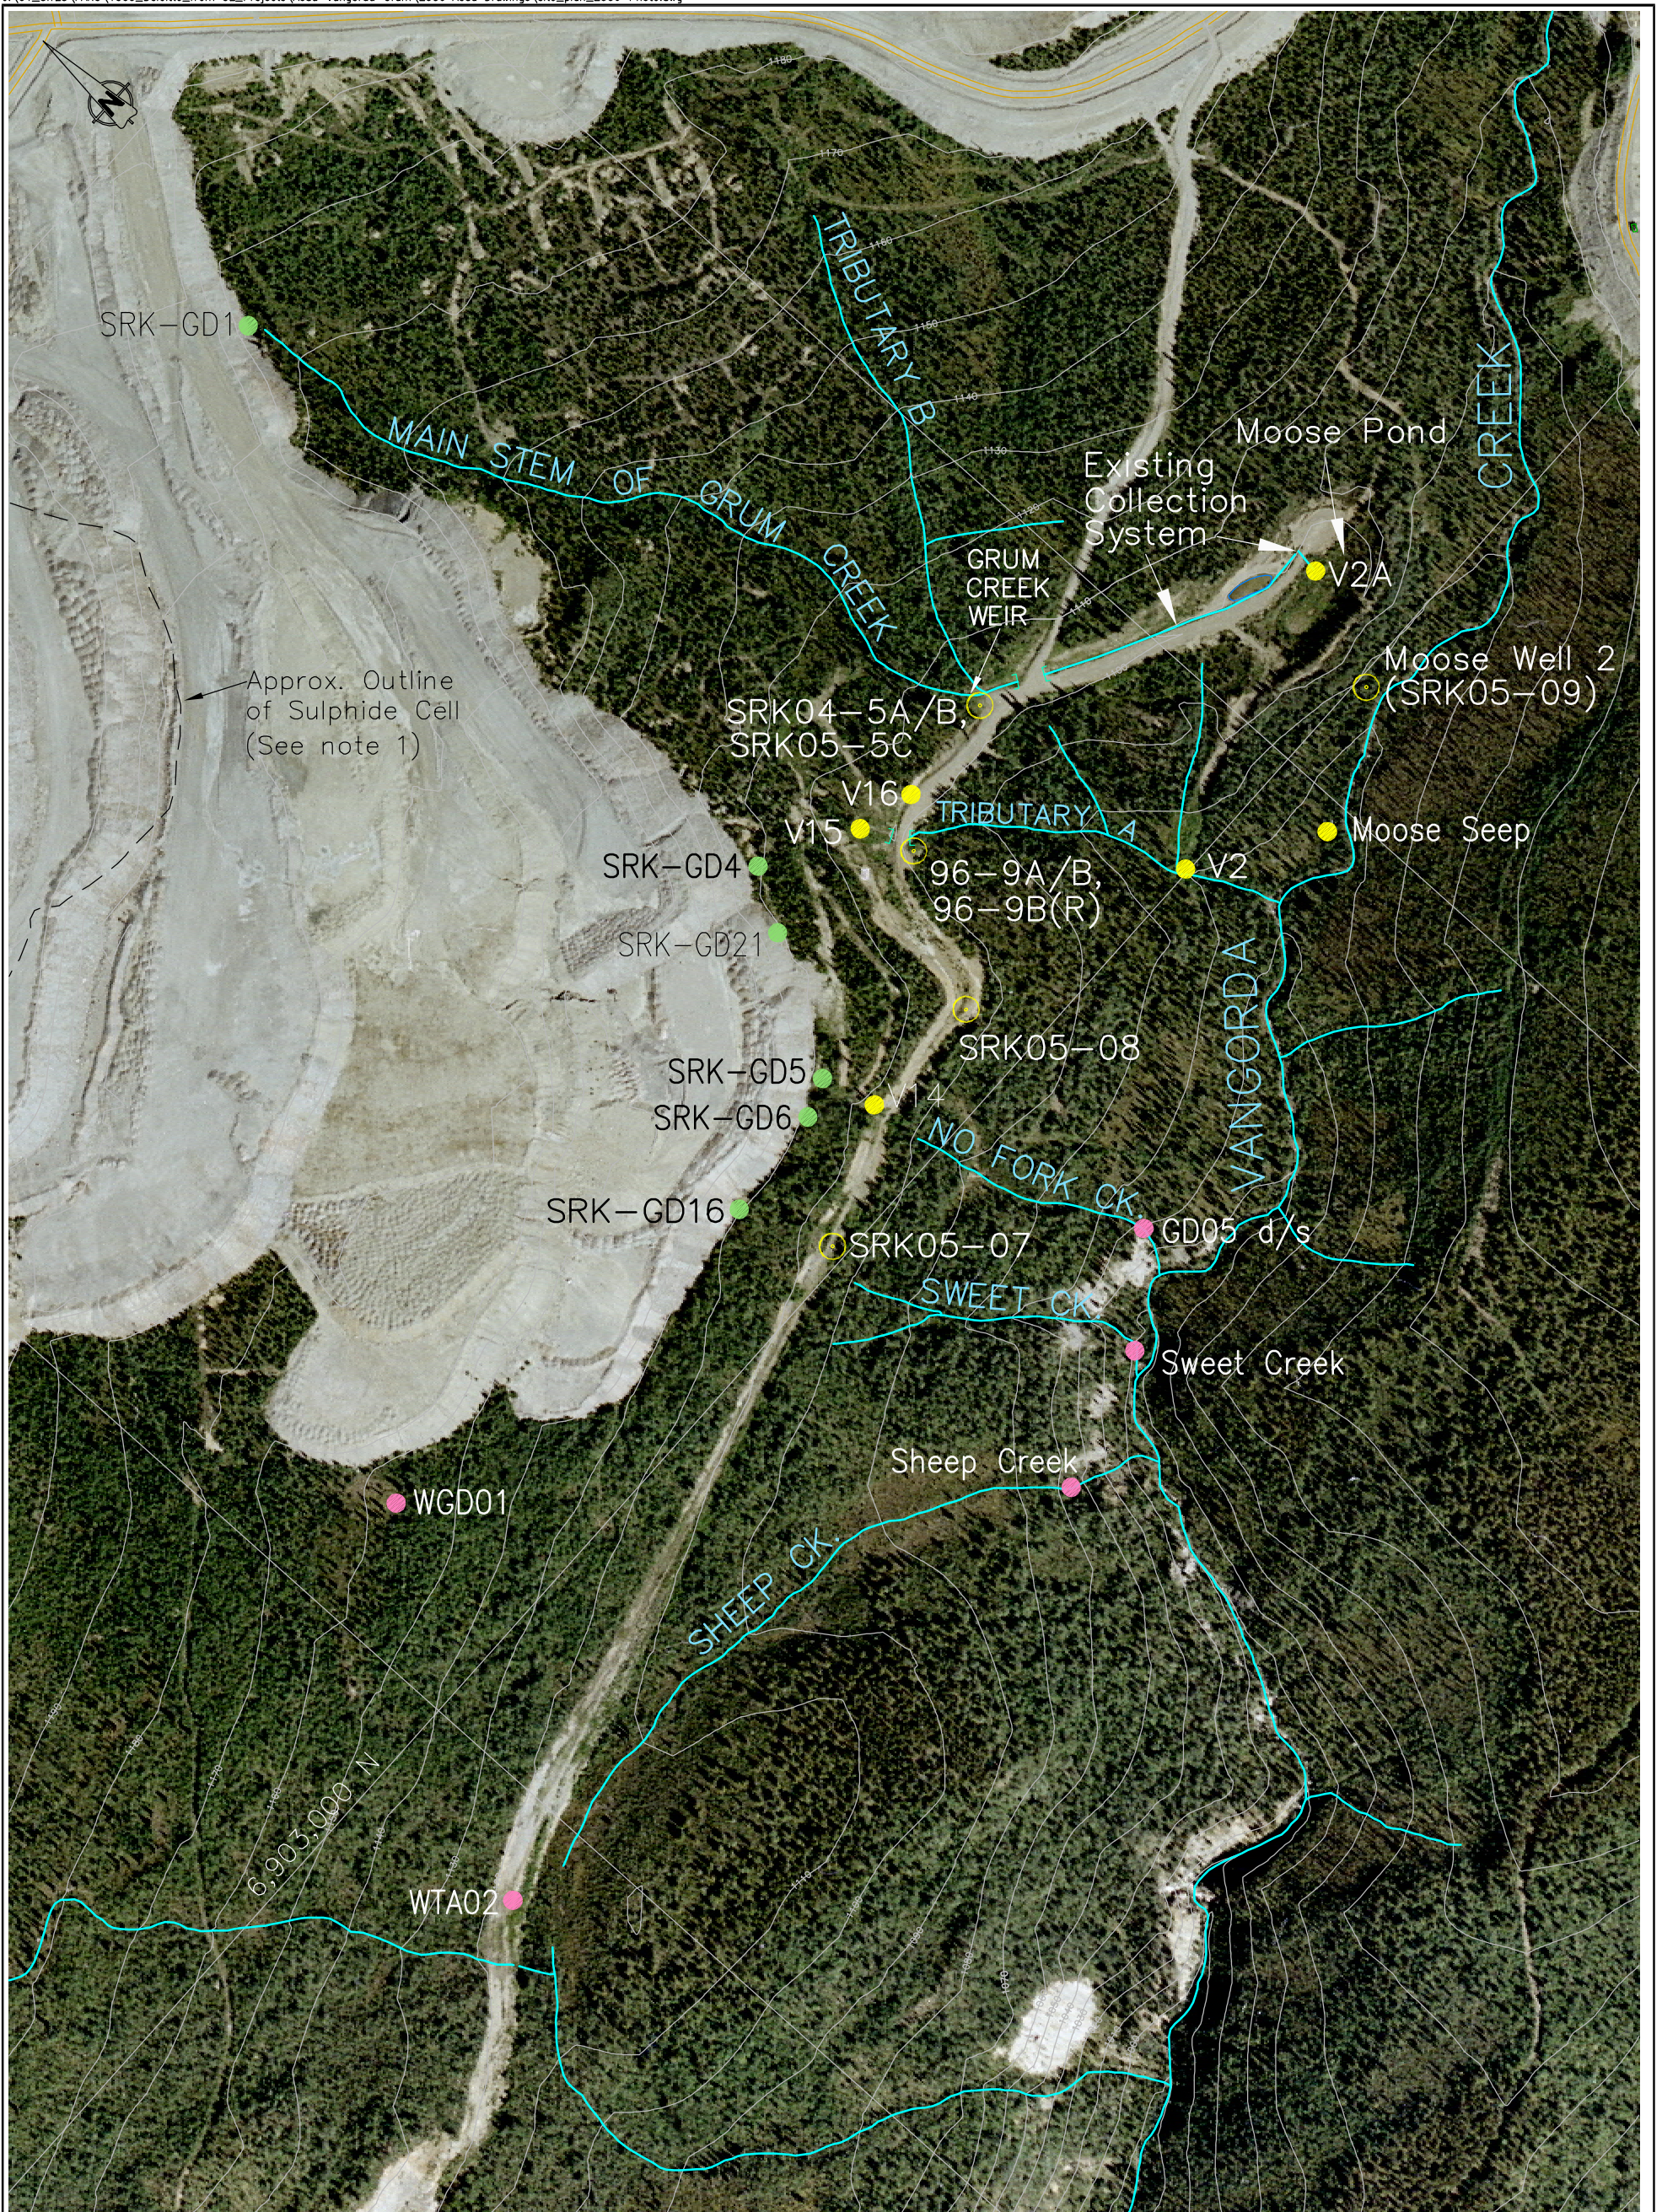
2008 Borehole and Water Sampling Stations

SRK-GD16 is located at the toe of Grum Dump topographically upgradient from the linear depression shown on Figure 1 as Sweet Creek. Flows were observed during only four of fourteen sampling rounds. Results for this station are provided in Appendix A1.

SRK-GD04 and SRK-GD21 are located immediately upgradient of V15 and Tributary A (Figure 1) at a minor topographic low along the dump toe. Surface flows in this area were observed during only seven of fourteen sampling rounds. Field pH values have been circum-neutral at these stations ranging from 6.8 to 8.1. Sulphate concentrations have ranged from 1350 to 2500 mg/L and zinc concentrations have ranged from 1.1 to 6.6 mg/L. The lowest field pH and highest sulphate and zinc concentrations were reported for SRK-GD21B in Fall 2008, however an increasing trend has not been observed. Complete results for this station are provided in Appendix A1.

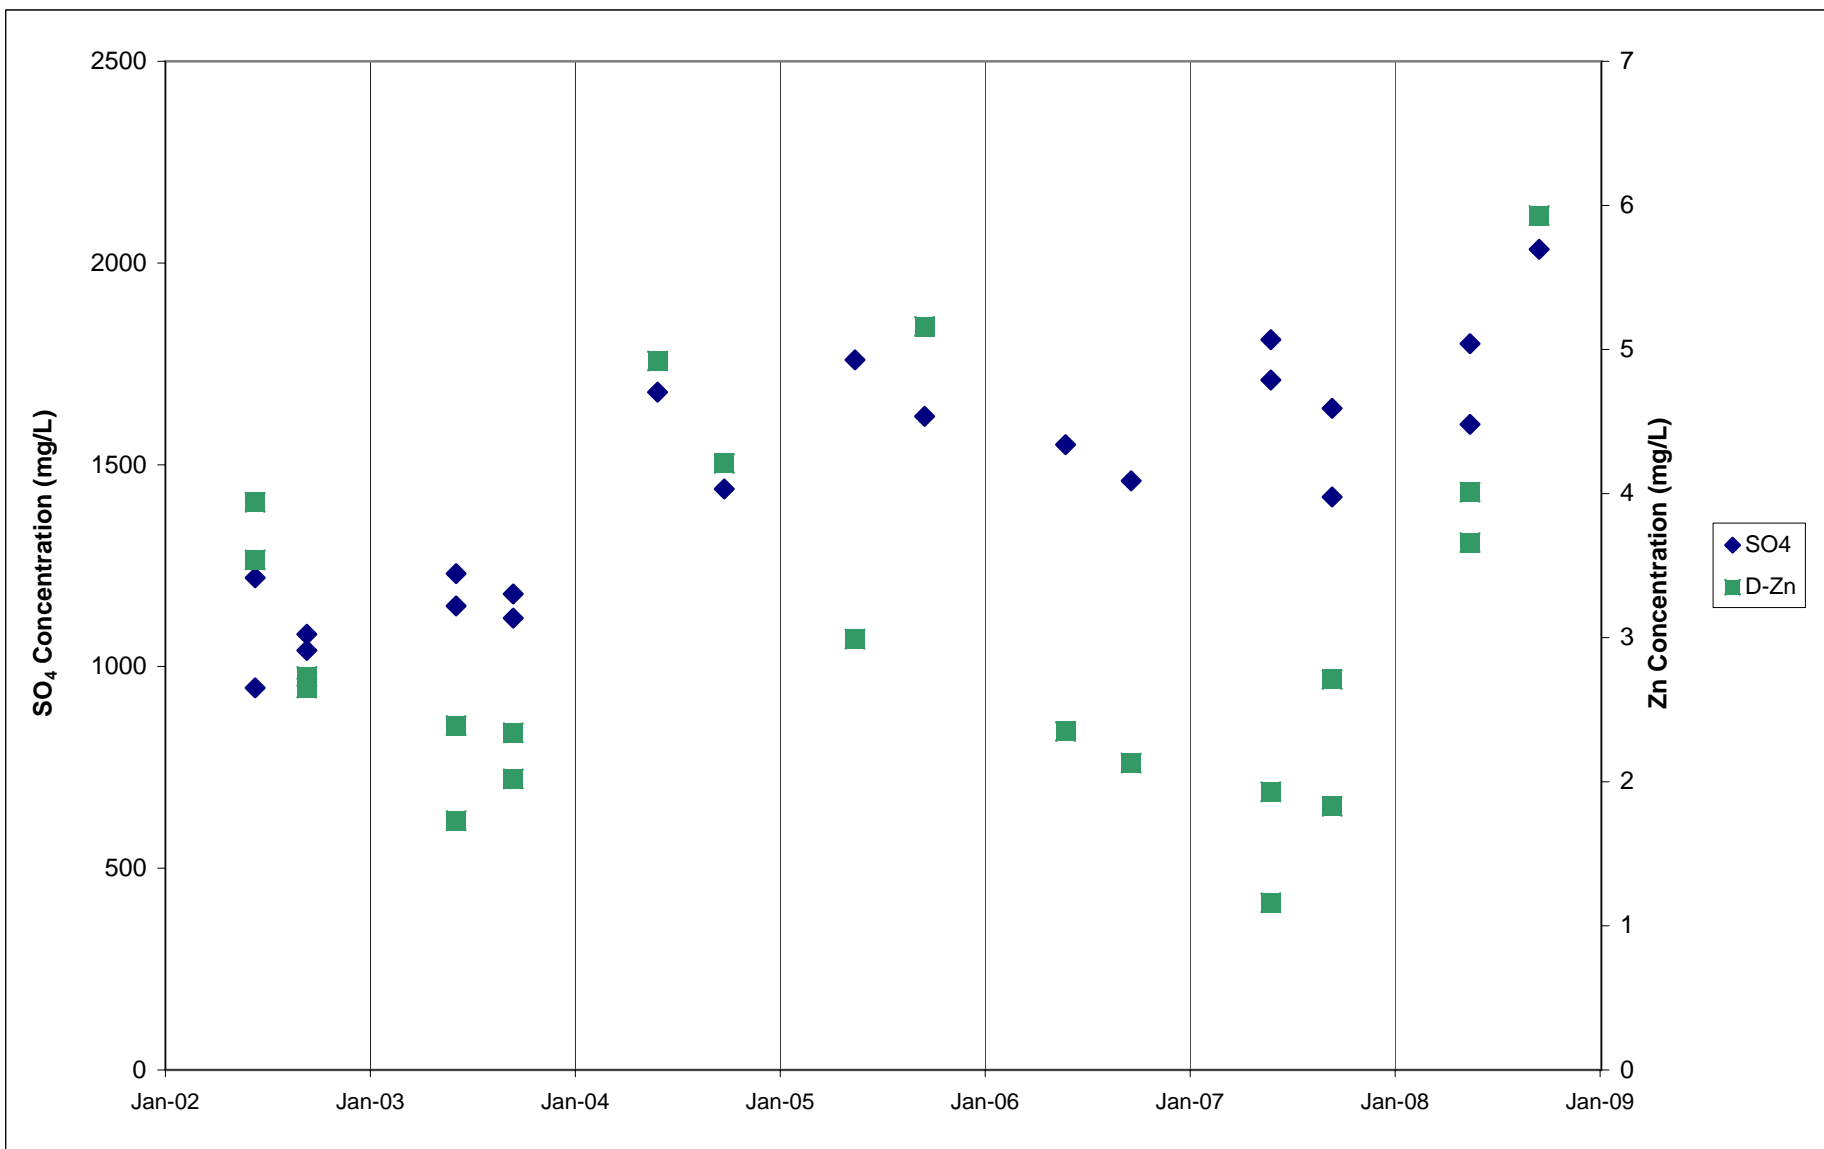
**Zinc and Sulphate Concentrations
at SRK-GD05**

Flows at SRK-GD05 are low compared to flows in Grum Creek, but have been observed consistently during all sampling rounds. The seepage infiltrates into the ground within a few metres of the dump toe. However, emergent seepage is observed topographically downgradient in No Fork Creek at station GD05 d/s, with seepage volumes that exceed those observed at the toe on the basis of visual observation and crude field measurements. It is inferred that subsurface flow is more significant than surface flow at SRK-GD05, and that the No Fork Creek drainage is a preferred groundwater flowpath from Grum Dump to Vangorda Creek. Sampling results from No Fork Creek are discussed under station GD05 d/s.

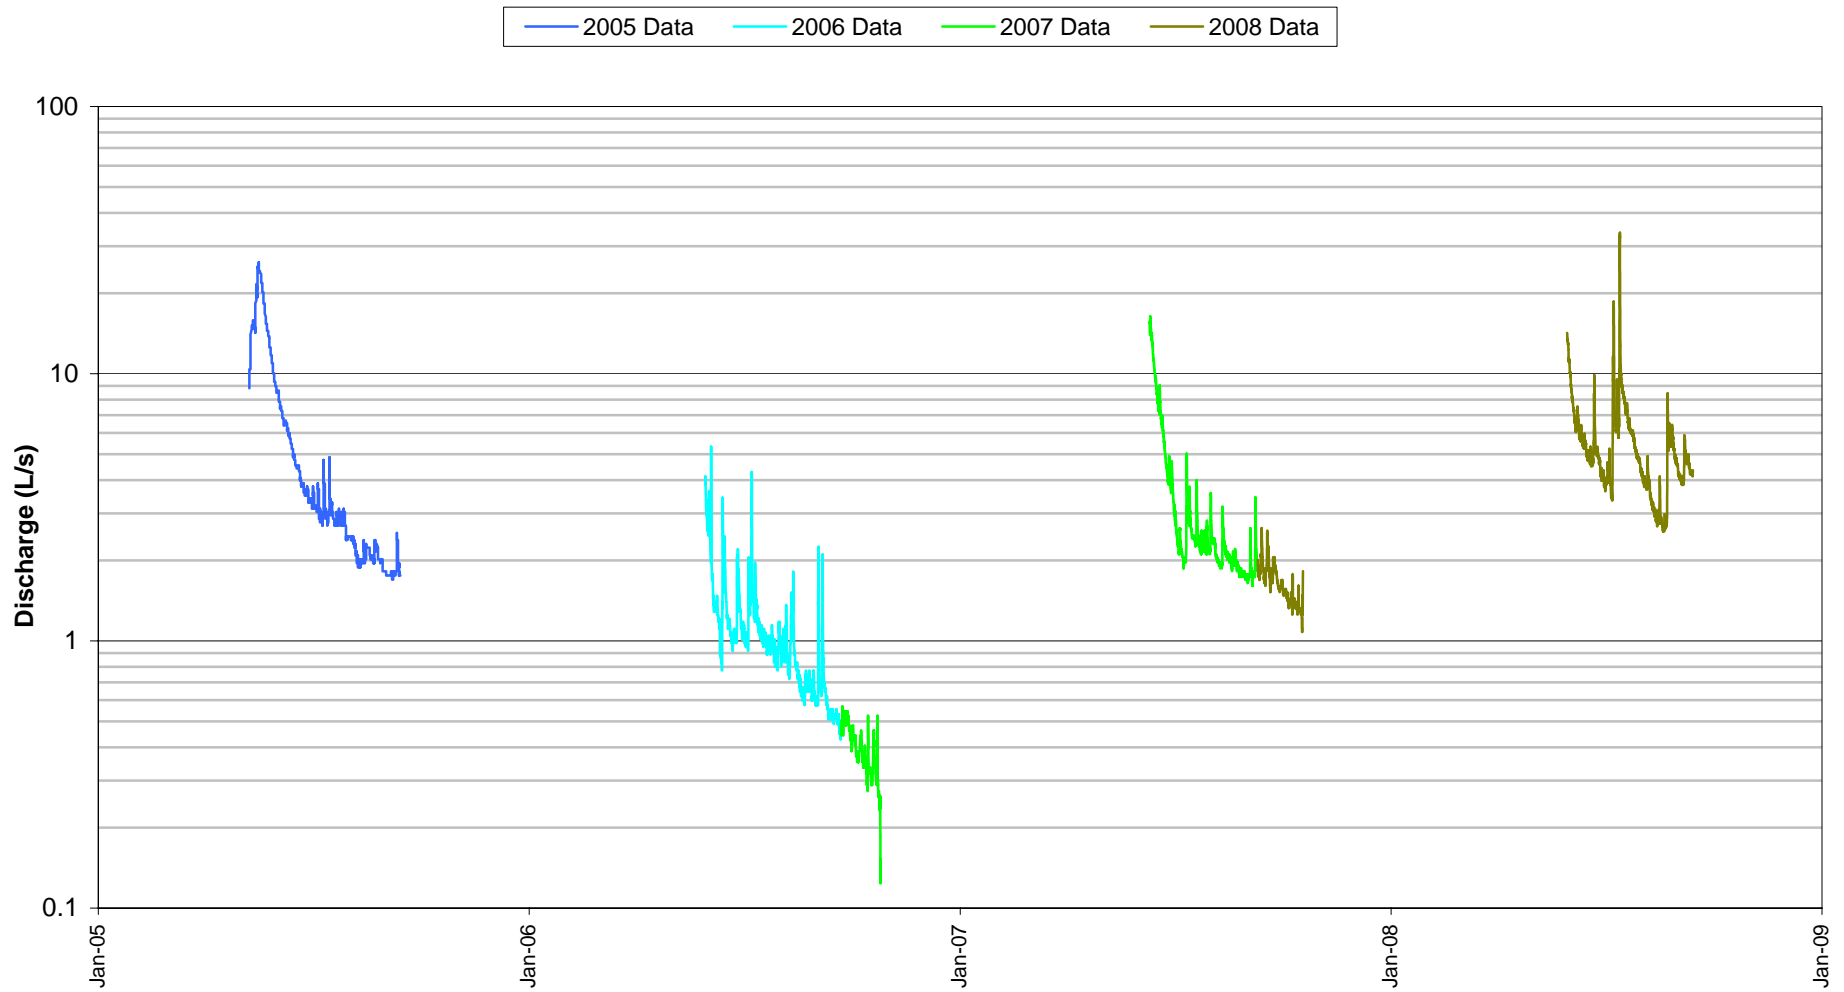
**Grum Creek Weir
2005 - 2008 Flow Monitoring Results**

As mentioned previously, results of the 2008 flow monitoring at the Grum Creek weir were complicated by problems with the instrumentation and staff gauge over the winter months. Data from October 21, 2007 to May 31, 2008 were removed from the database due to erroneous pressure readings resulting from freezing conditions. Data from June 1, 2007 to September 15, 2007 was calibrated to match a spot flow measurement collected in September 2008.

- Data logger was removed for servicing in September 2008 as the instrument was no longer able to be downloaded. The manufacturer retrieved the 2008 water level data, repaired the instrument's communication capabilities and replaced the batteries.
