2001 ANNUAL GEOTECHNICAL EVALUATION AND INSTRUMENT REVIEW

VARIOUS FACILITIES AT FARO MINE, YUKON

PROJECT NO.: 0257-005-04
DATE: FEBRUARY, 2002

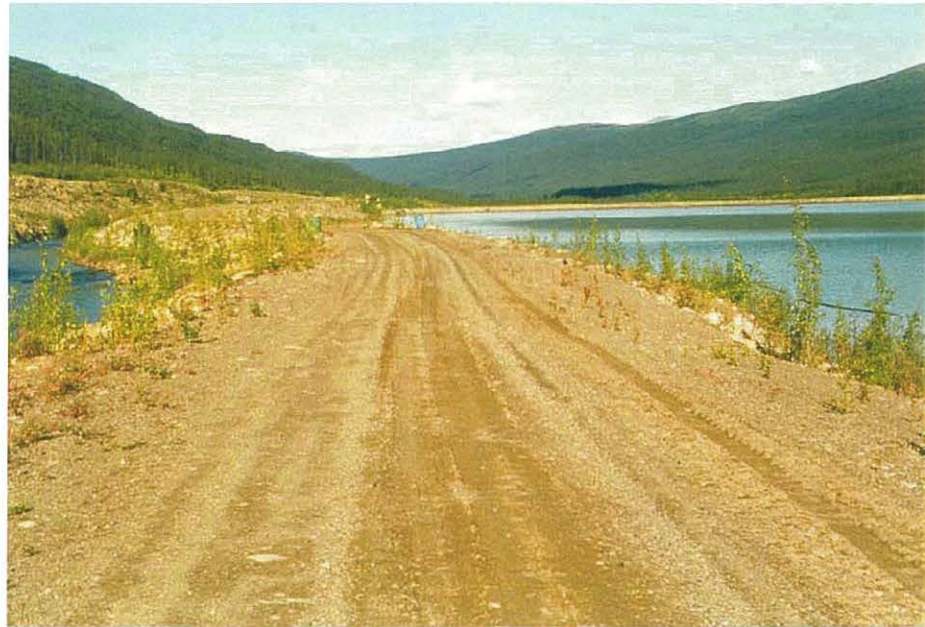
Area of settlement on the crest of the canal dike approximately 50 m west of CD-20. Magnitude of settlement estimated at 0.4m to 0.5 m.

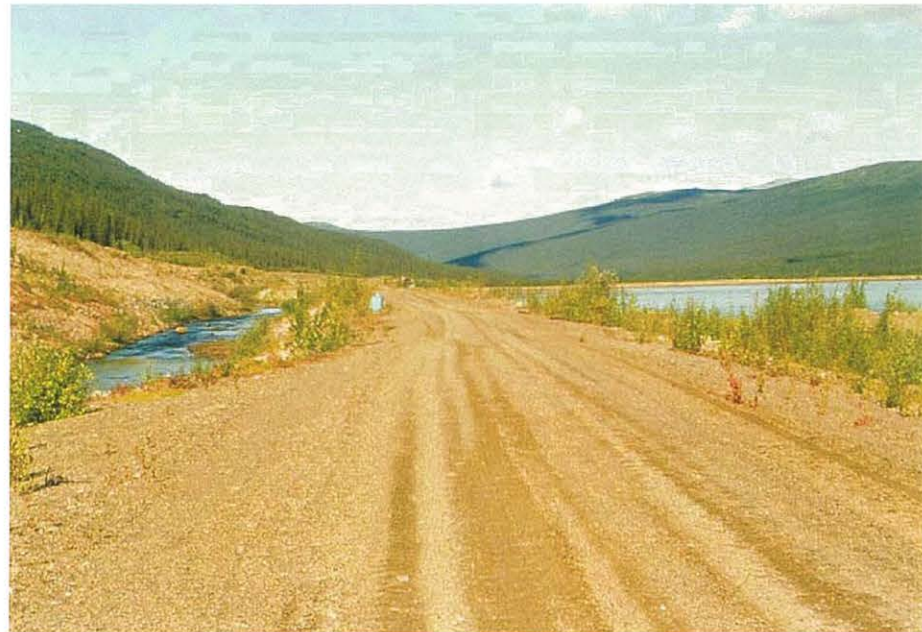
Crest of canal dike looking west as seen from installation CD-18. Note the undulations in the crest.

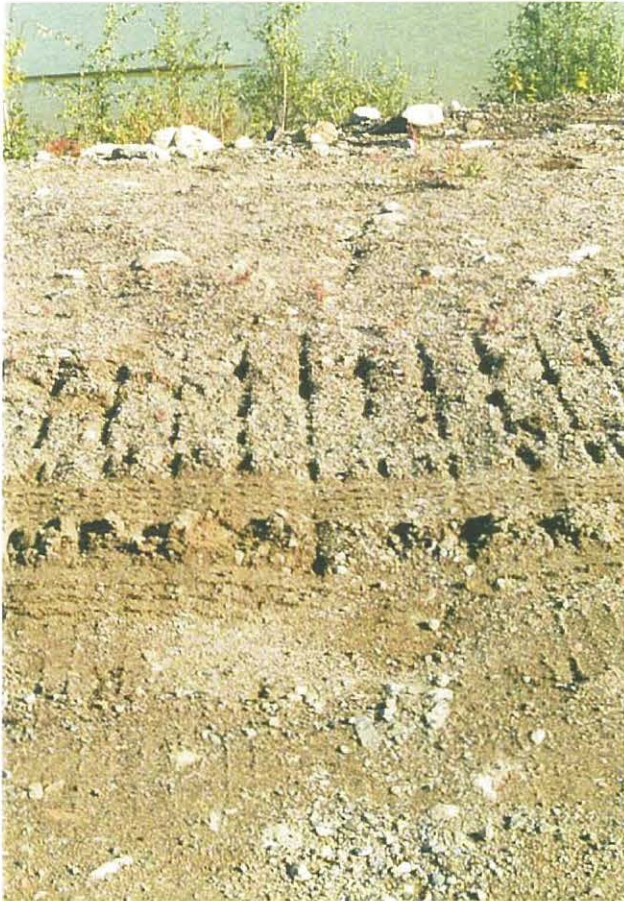
Above:
Transverse crack in crest of canal dike near installation CD-21.

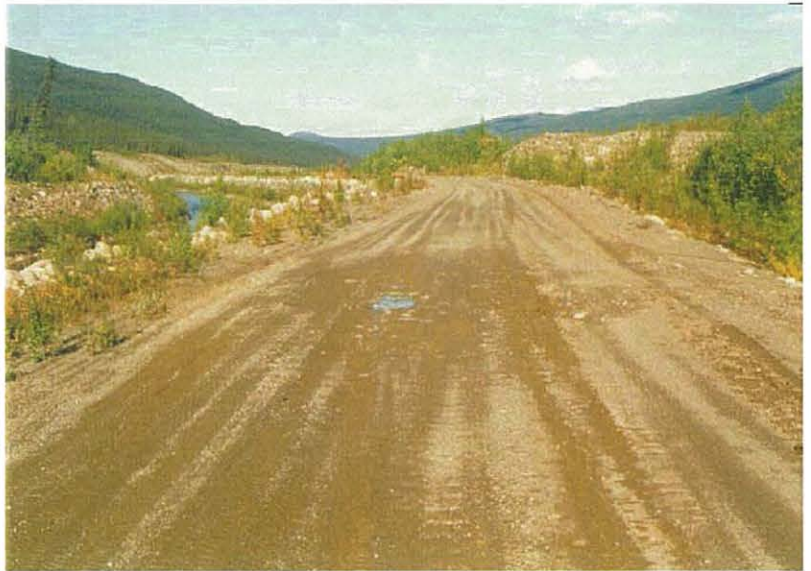
Below:
A slight pot hole depression and some standing water situated approximately 50 m west of CD-13.

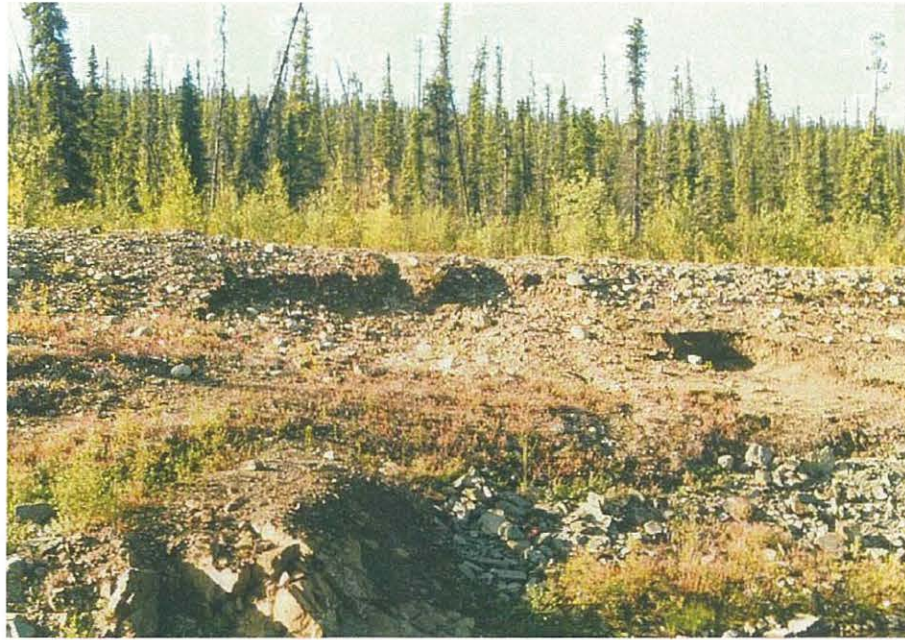
**Frontal view of failure in canal dike back slope.
Located at the entrance to the diversion canal.**

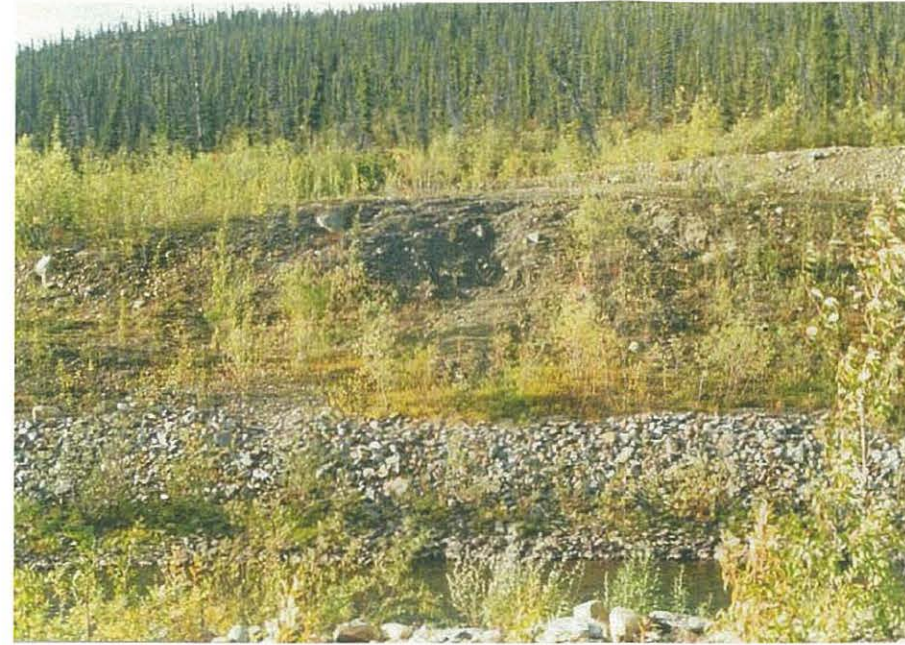
**View of the face of the back slope of the canal dike.
Note the surficial erosion of the face.
Location is proximal to the old slide area at 2+000.**

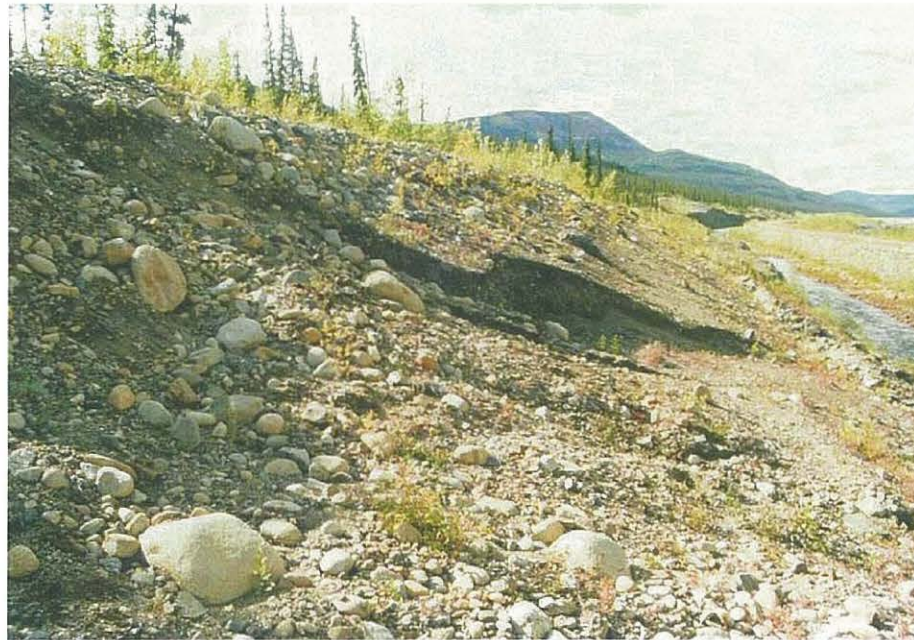
**Cross sectional view of failure in canal dike back slope.
Located at the entrance to the diversion canal.**

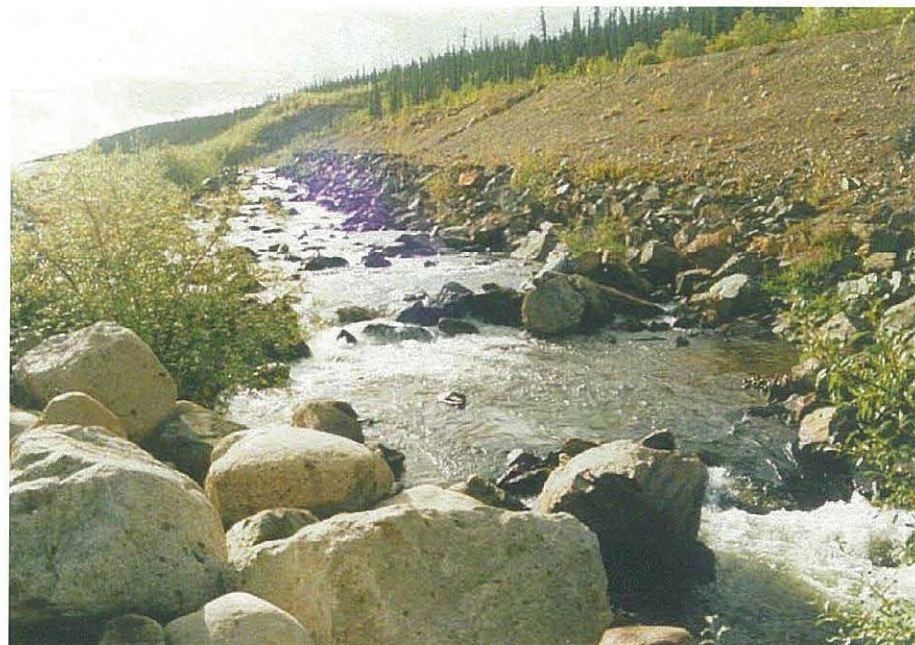
**View of diversion canal and face of the back slope of the canal dike.
Note that the rip rap appears to be in good
condition in the bottom of the canal.**

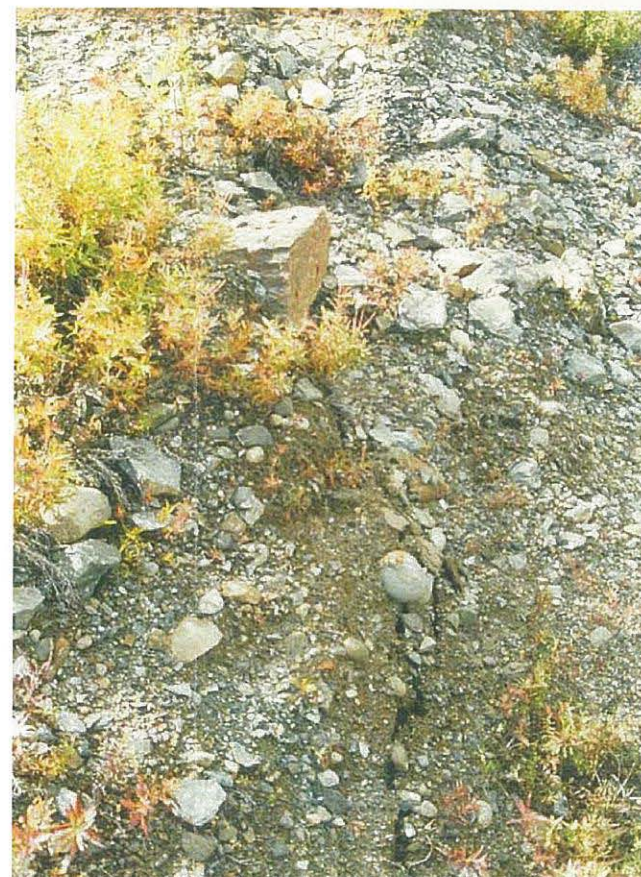
**View of tension crack that has
developed in the back slope of the canal dike.**

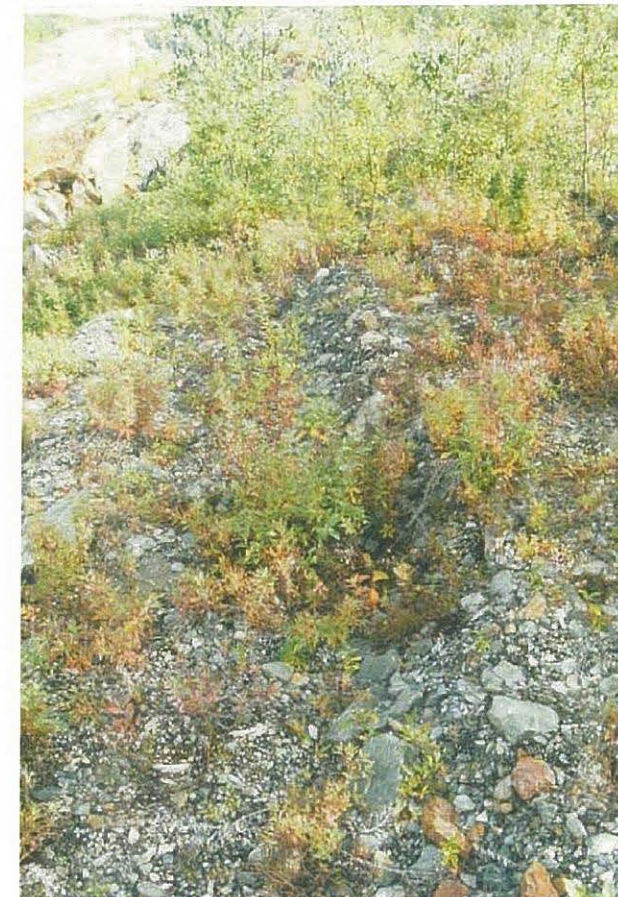
**View of a tension crack in the back slope
of the canal dike.**

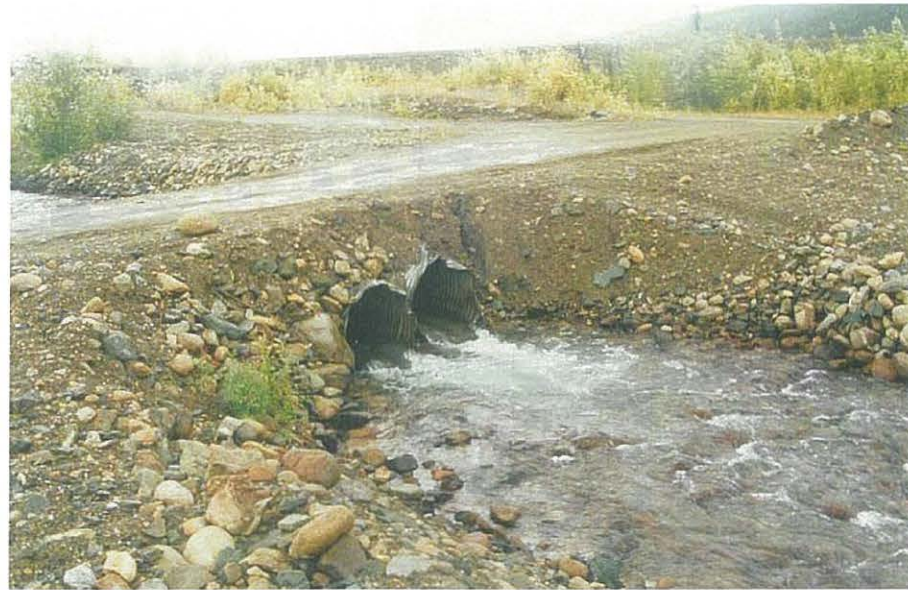
View of outlet side of culverts used to pass water beneath the access road to the Cross Valley Dam which crosses the channel. Note the disturbance to the protective rip rap.

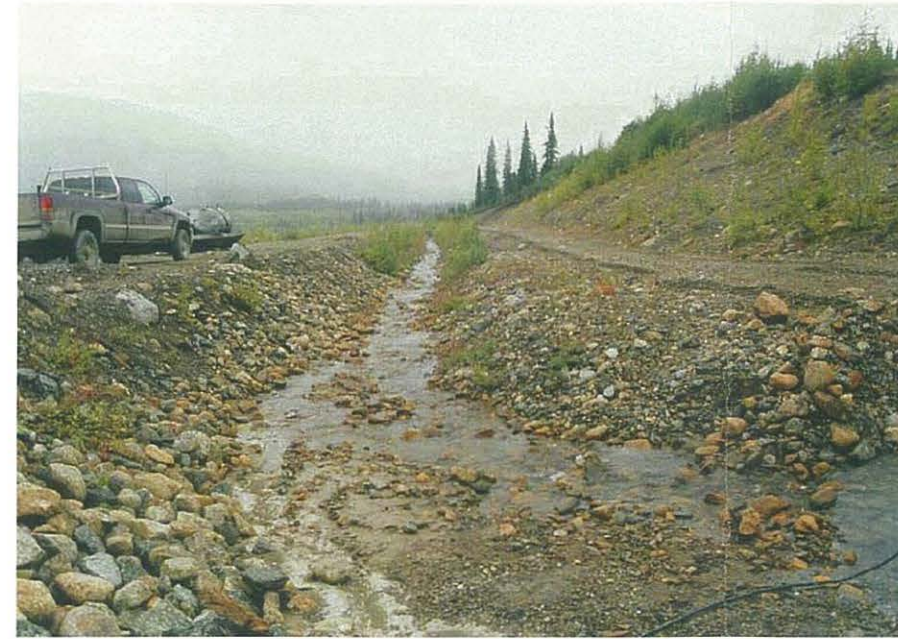
View looking downstream at the channel outflow section adjacent to the Cross Valley Dam. Note the apparent equal elevation of the top of the road on the left and right side of the channel.

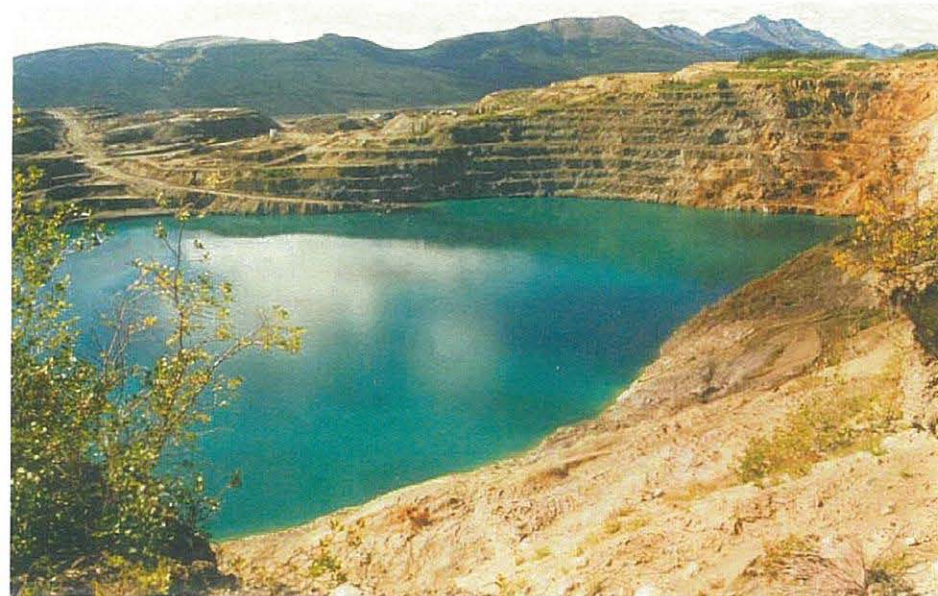
View of Faro Pit. Note failing area in upper right portion of photo.

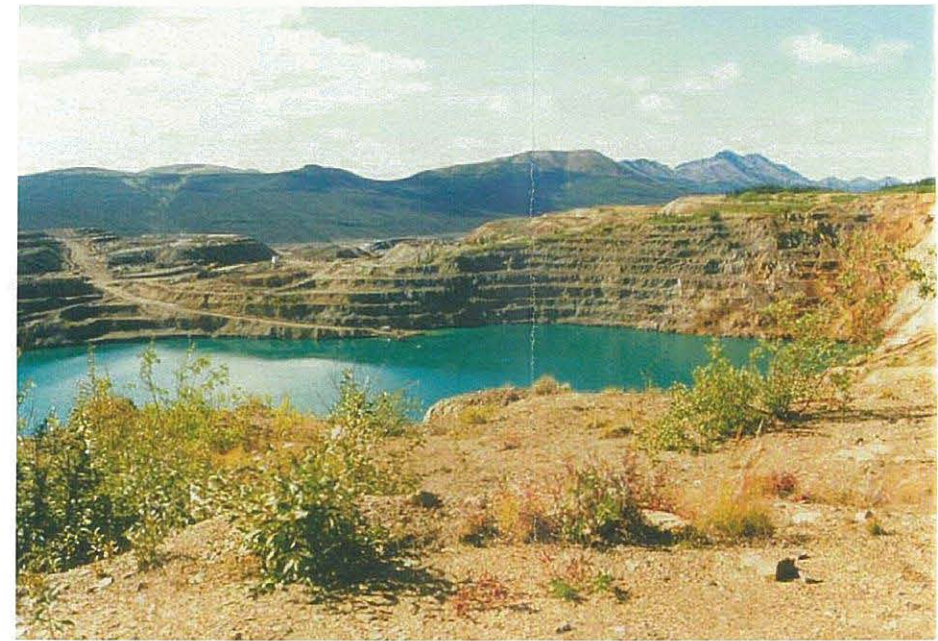
View of Faro Pit. Note failing area in upper right portion of photo.

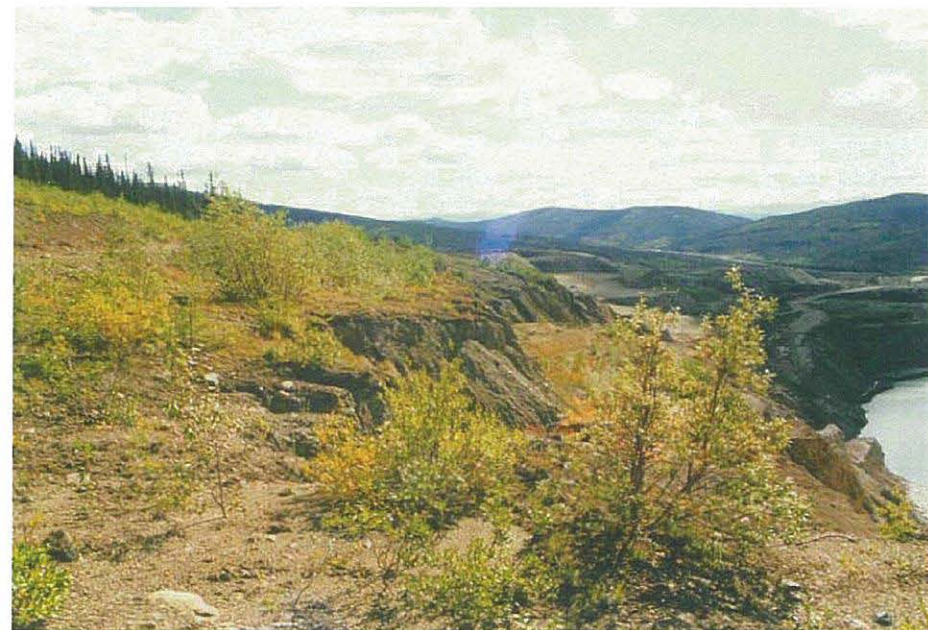
View from top of failing area of pit.

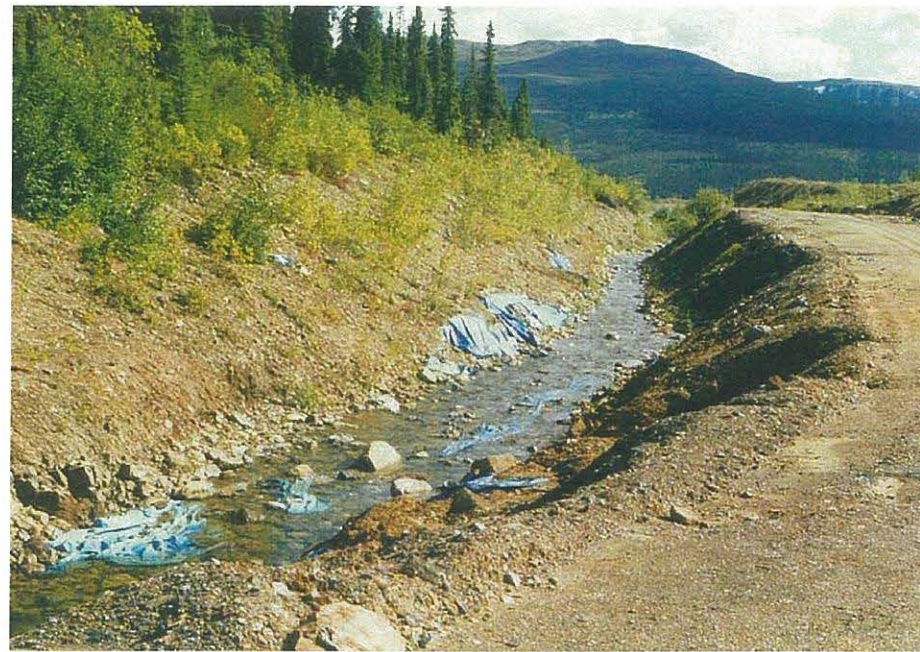
**View of the Faro Creek Diversion Channel above the Faro Pit.
Note the poor state of the blue channel liner.**

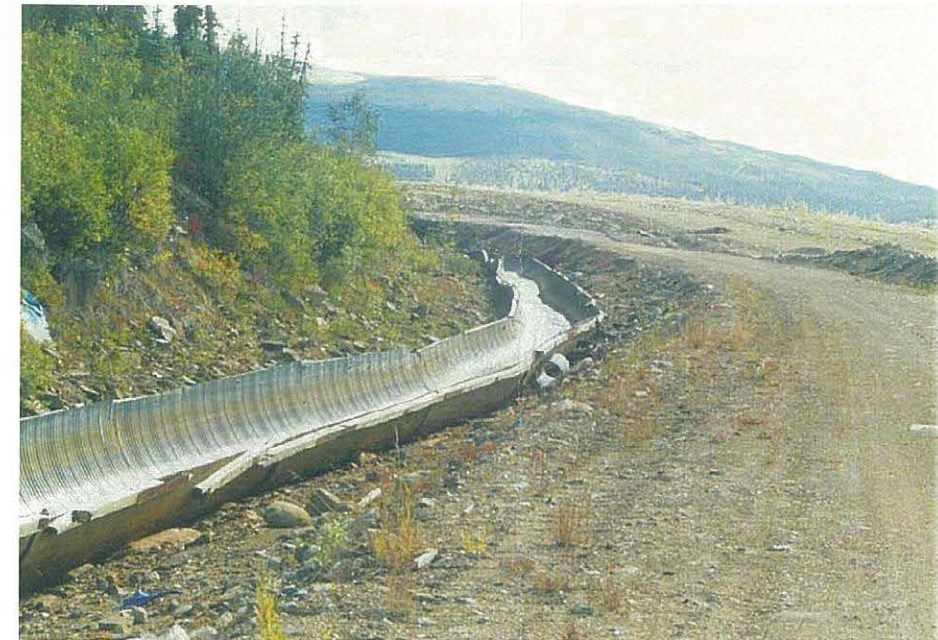
**View of the Faro Creek Diversion Channel.
Note the state of the half culvert channel liner.**

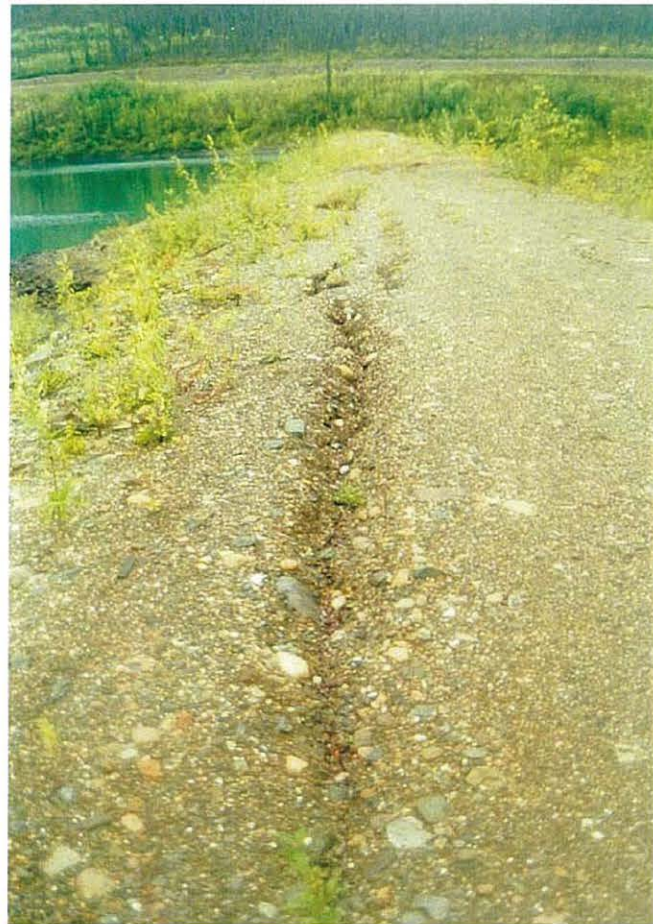
View of settlement trough in crest of Cross Valley Dam.

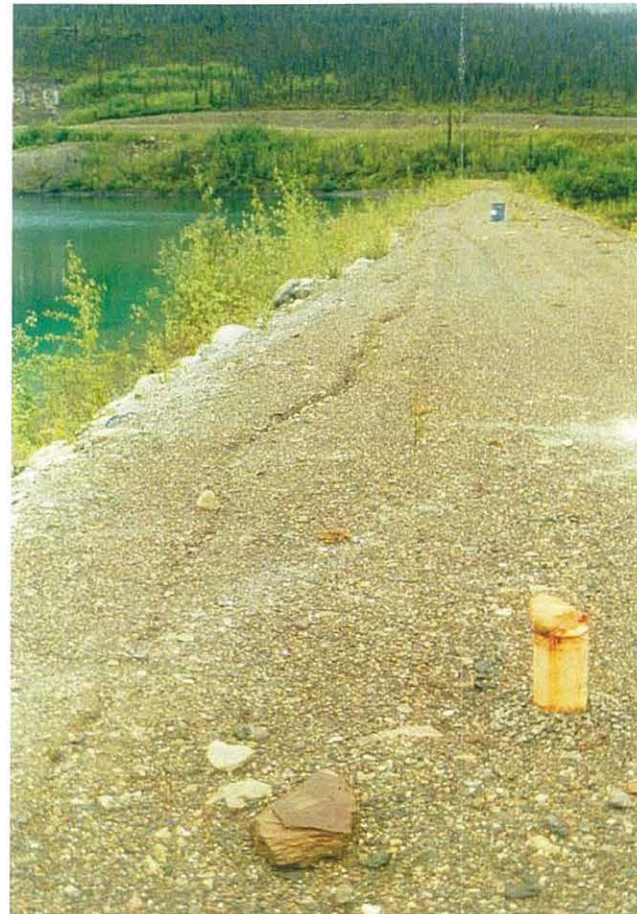
View of settlement trough in crest of Cross Valley Dam near thermistor 88-5.

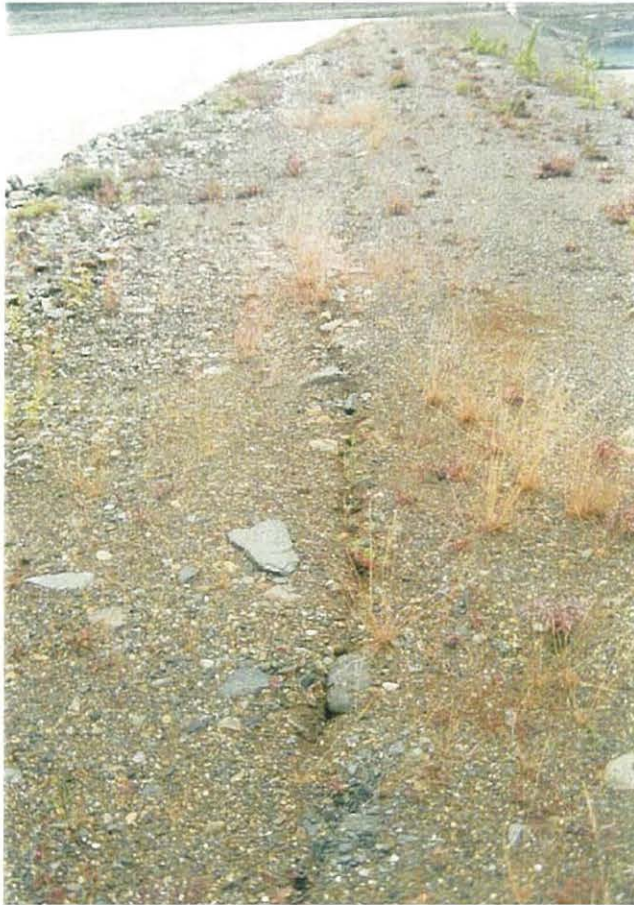
Above:
Tension crack near centreline
of Intermediate Dam.

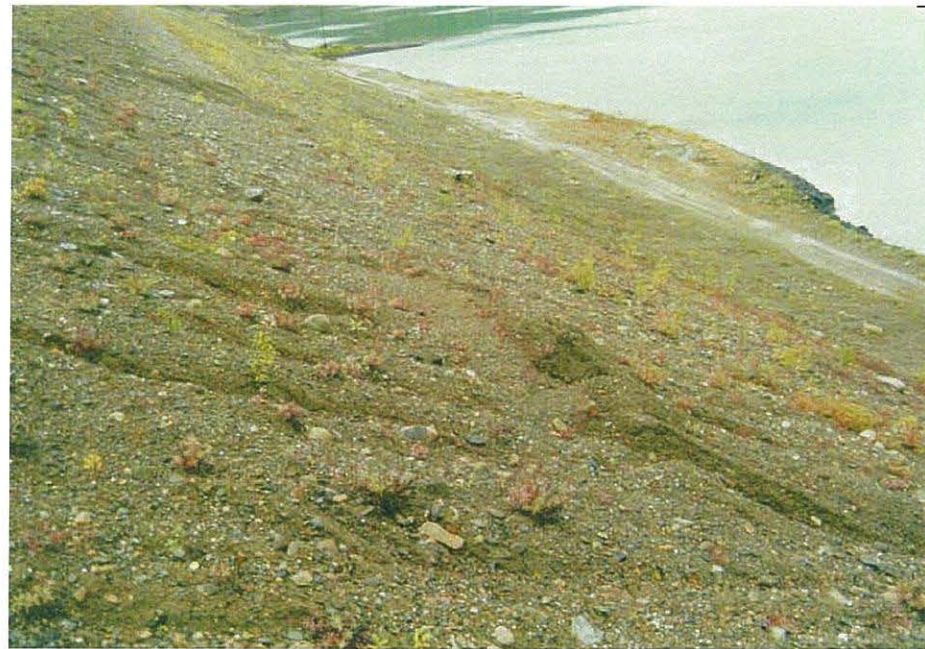
View of a bulge on the face of the Intermediate Dam.

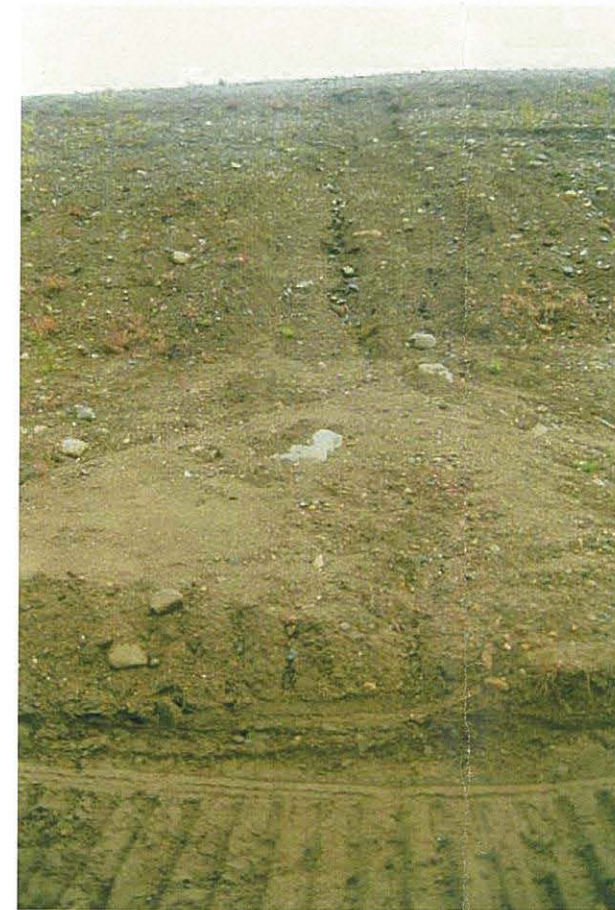
Debris cone at the base of an erosional rill located on the downstream face of the Intermediate Dam.

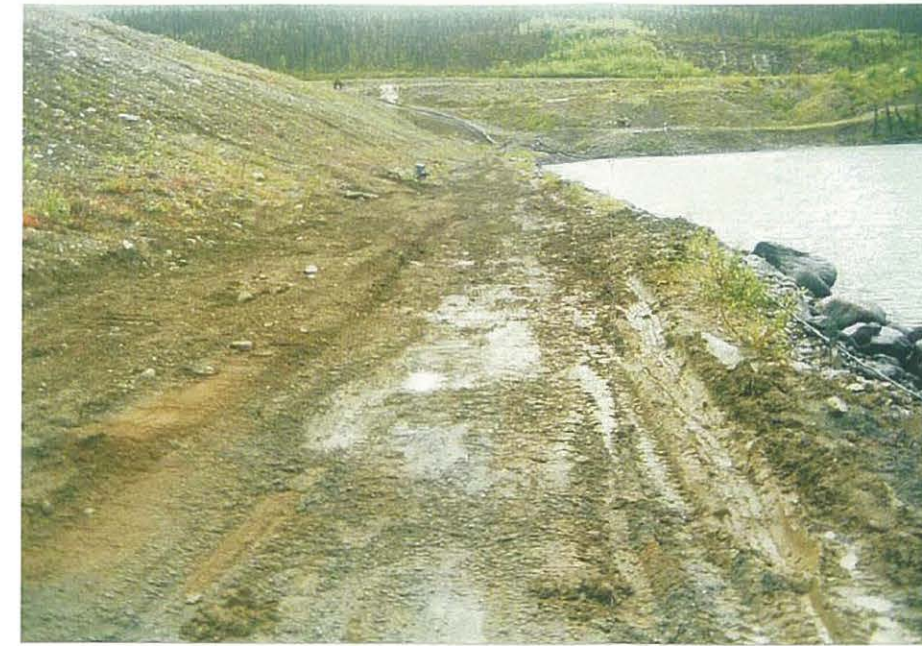
View of standing water and wet softened area at the toe of the Intermediate Dam.

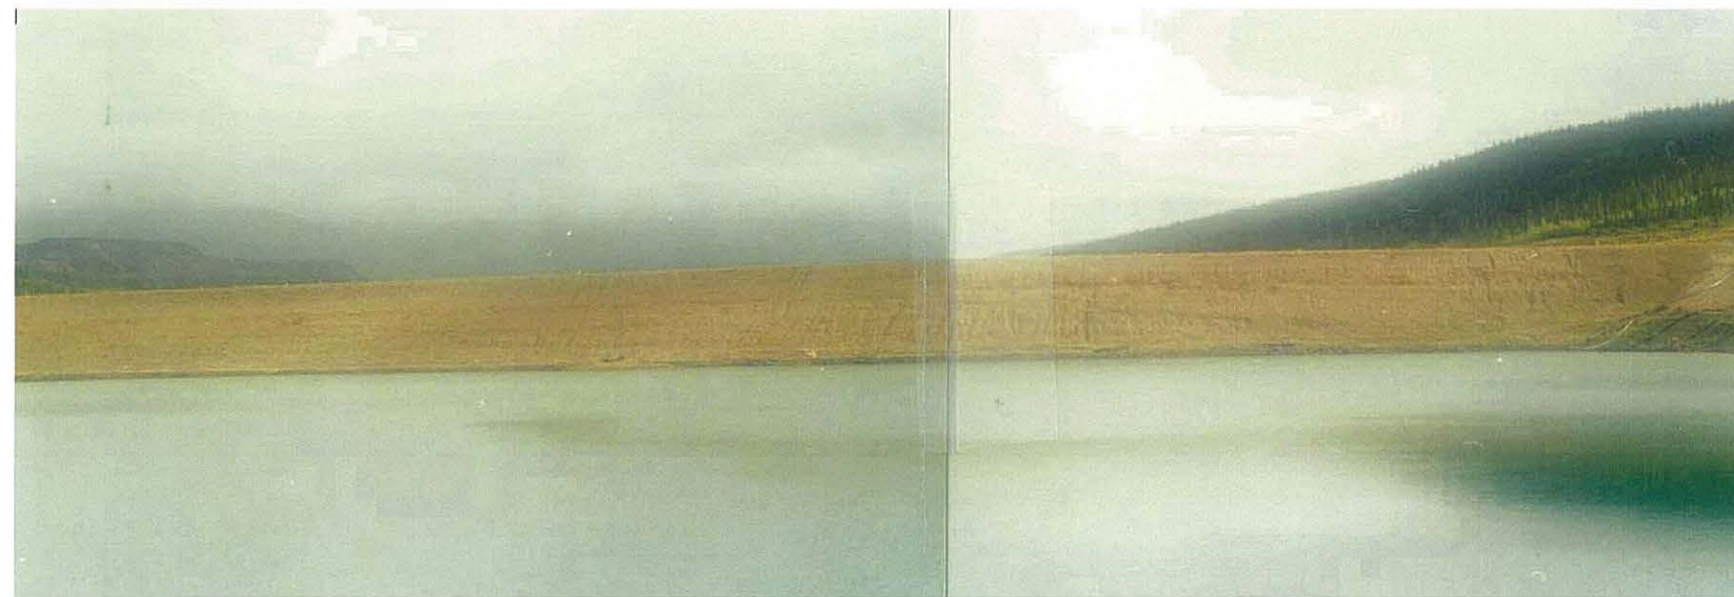
View of the downstream face of the Intermediate Dam. Note the erosional rills on the face of the dam.

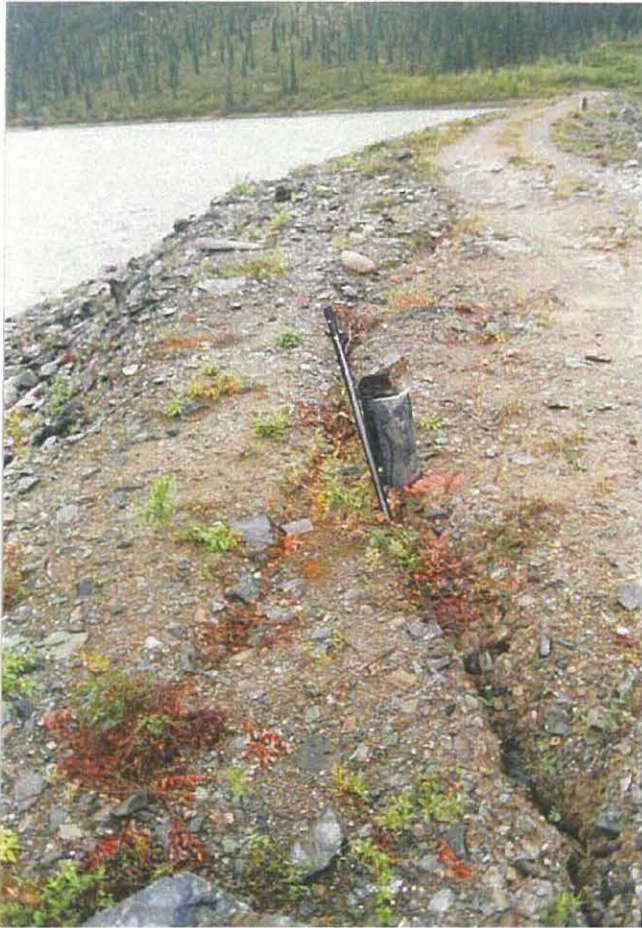
Left:
View of the cracking on the crest of the FWSD.
Approximate location is near installation 85-5.

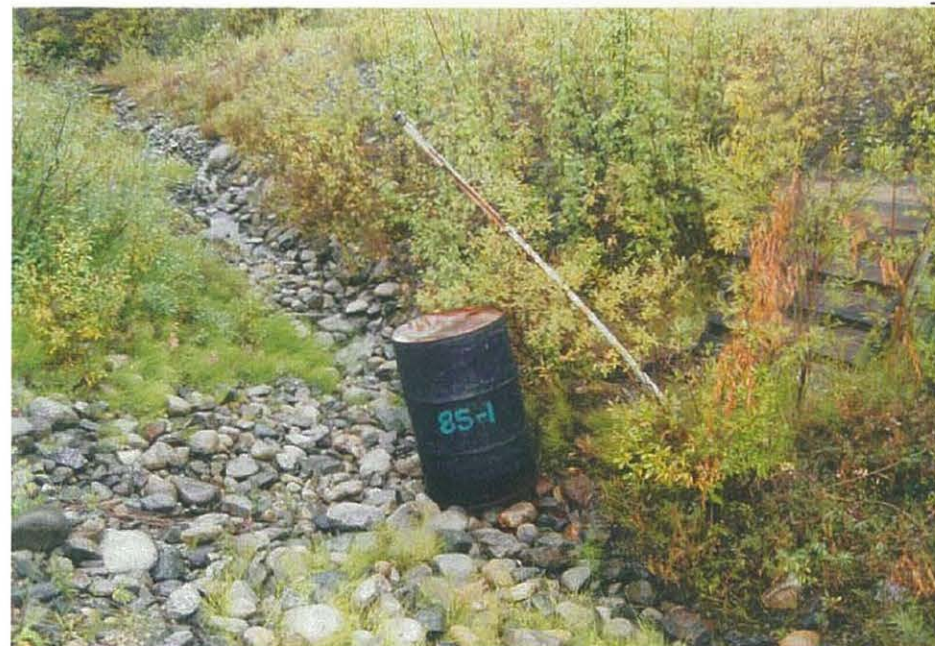
View of seepage collection trench at installation 85-1. Note seepage in trench.

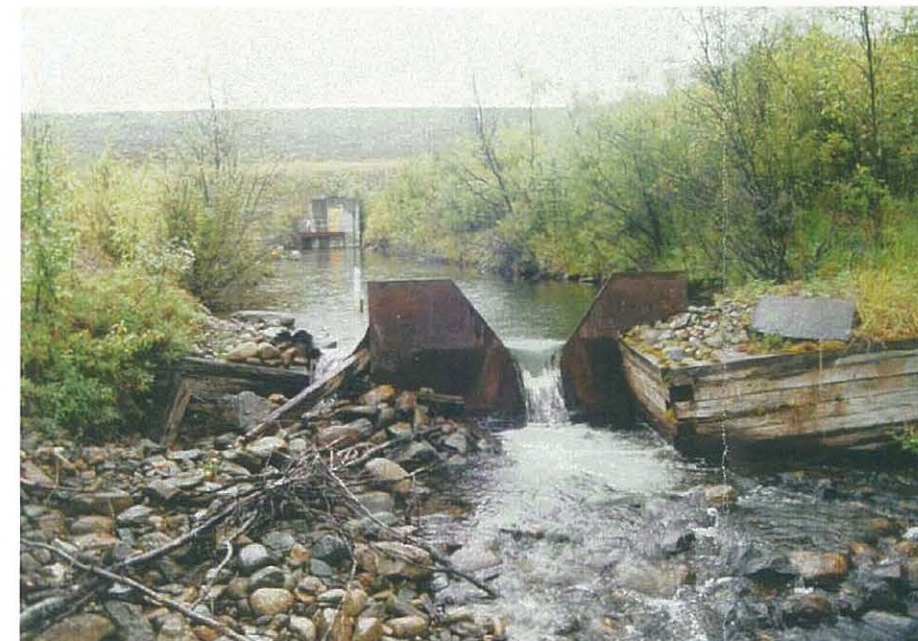
View of seepage weir in channel downstream of valve house. Note seepage flowing around side of weir.
