## **DELOITTE & TOUCHE INC.**

### **2005 ANNUAL GEOTECHNICAL EVALUATION AND INSTRUMENT REVIEW**

### **VARIOUS FACILITIES AT FARO MINE, YUKON**

PROJECT NO.: 0257-032-05  
DATE: FEBRUARY 22, 2006

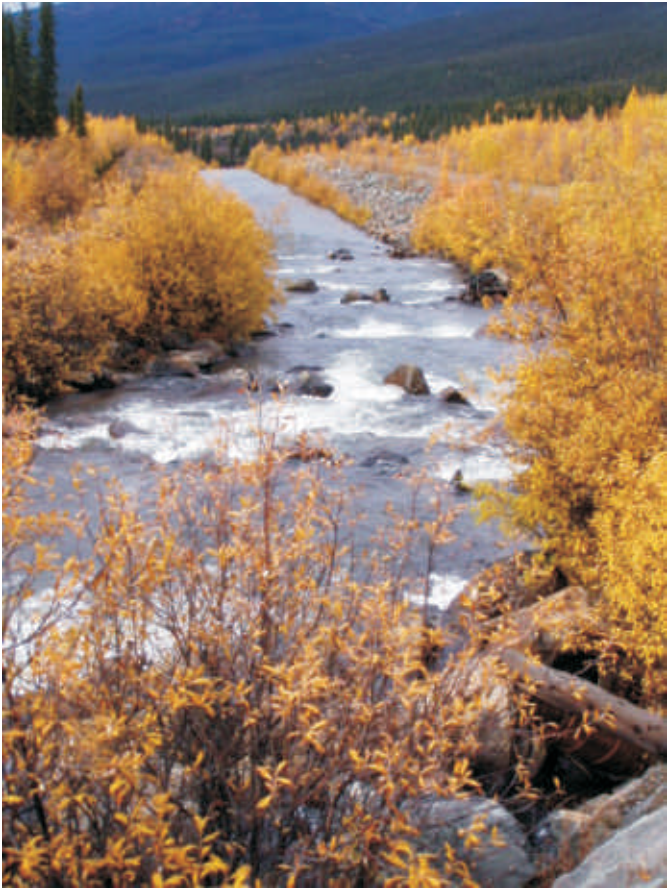
Photo shows the lower most portion of the upper weir section. No concerns were noted with the first upper weir section.

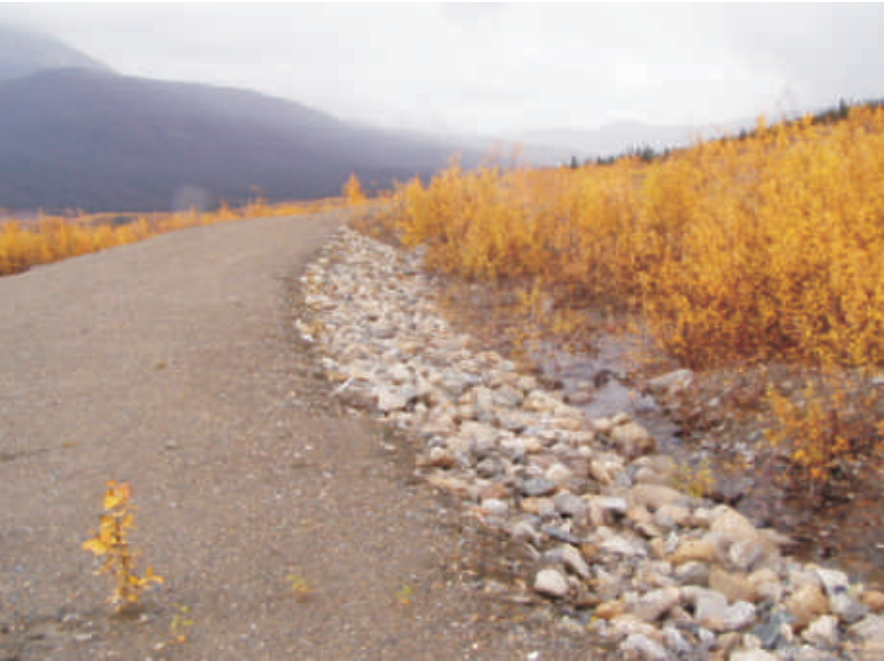
September: Photo shows the continuation of the berm and the ditch which runs along the hillside uphill from the Intermediate Dam. The ditch appears to be working satisfactorily with no noted blockages or problems from this perspective.

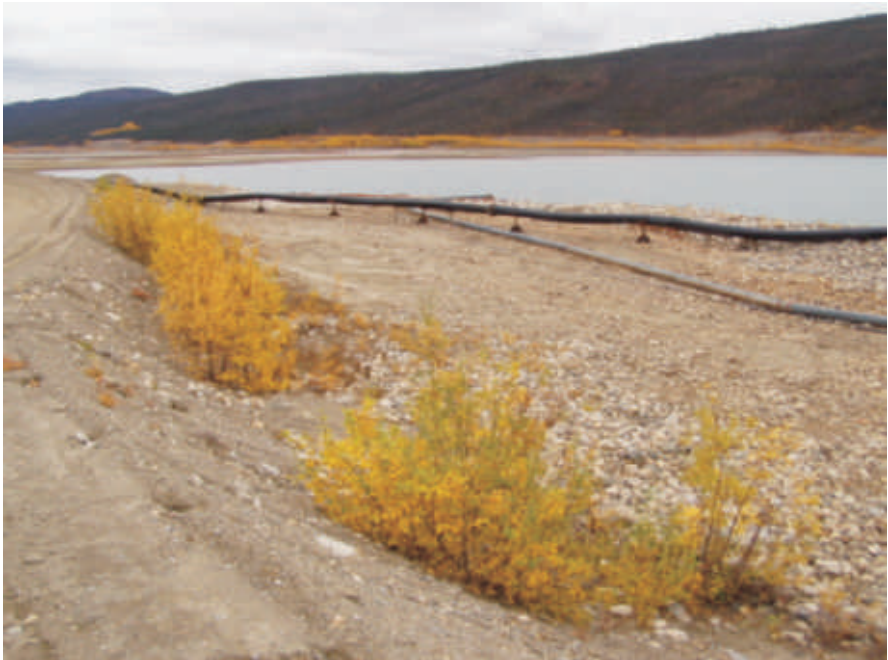
September: Photo shows the current condition of the inlet to the spillway. No water is currently flowing in the spillway.

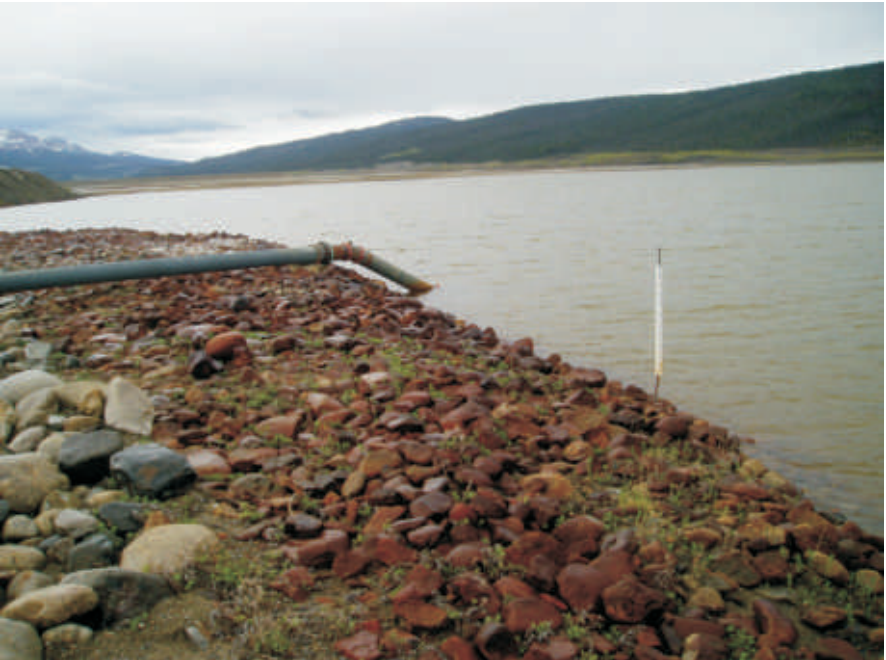
May: Photo shows the pond level at the inlet area to the spillway. and the water level is currently below the staff gauge.

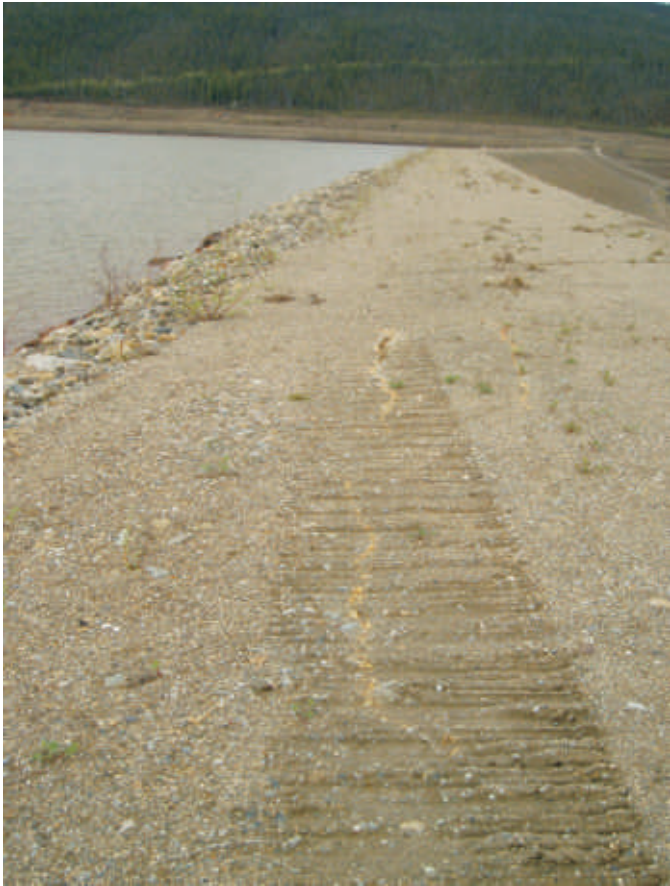
May: Photo shows some longitudinal cracks on the crest. These cracks progress further into the background of the photo as well along the crest. This is in the area where historically cracking has always been seen.

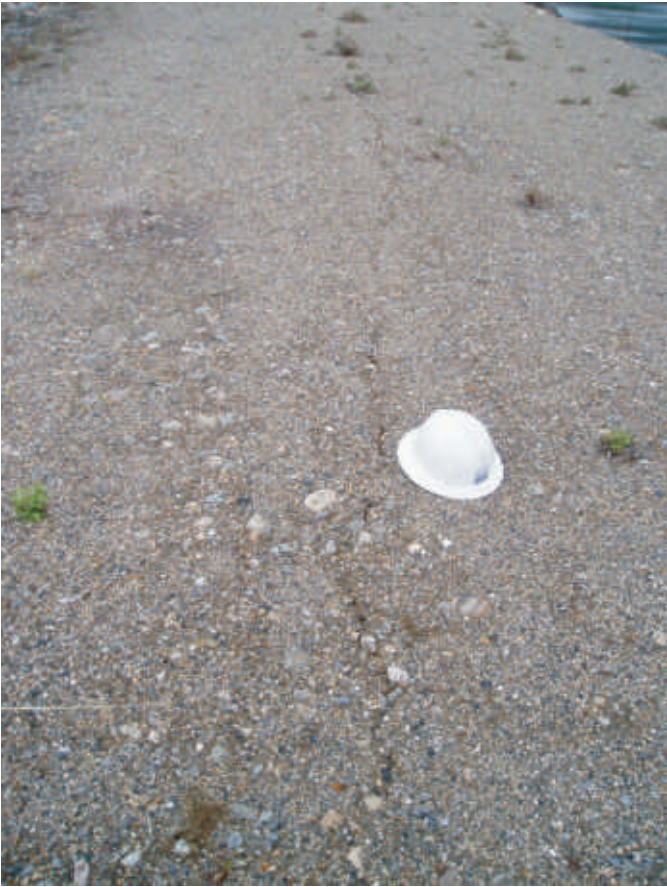
May: Photo shows some thin cracking located in the centre of the crest just immediately to the left of the hard hat.

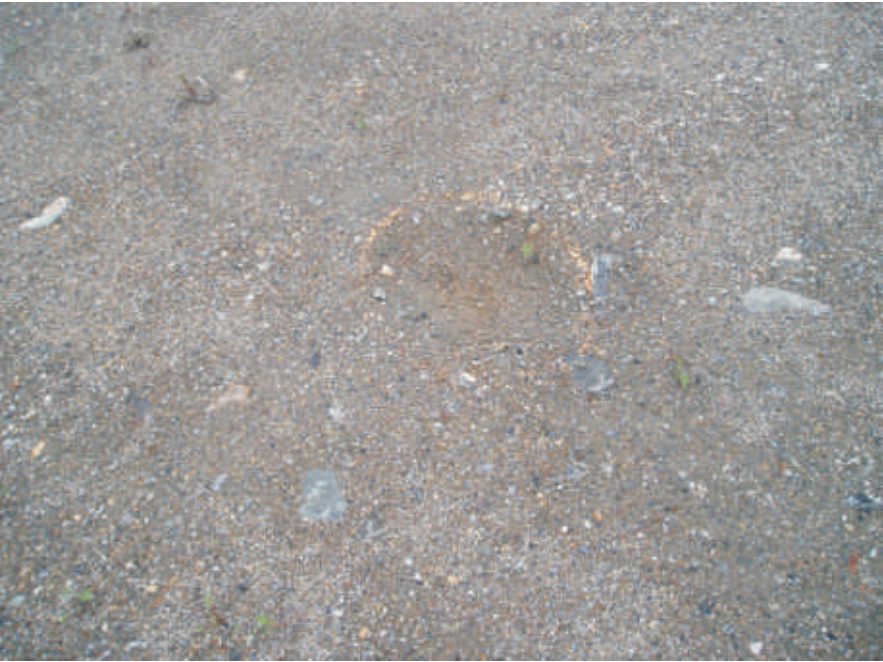
May: Photo shows one small sinkhole approximately 40 cm in diameter located on the crest. This sinkhole was marked last year. It does not appear to be getting much larger.

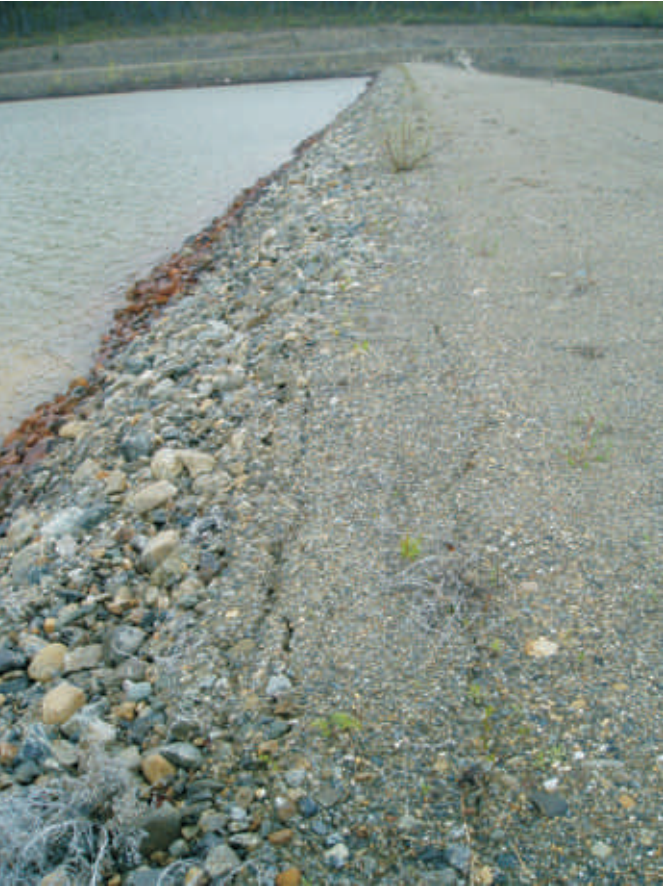
May: Photo shows some minor crest edge cracking on the upstream side, proximal to the riprap.

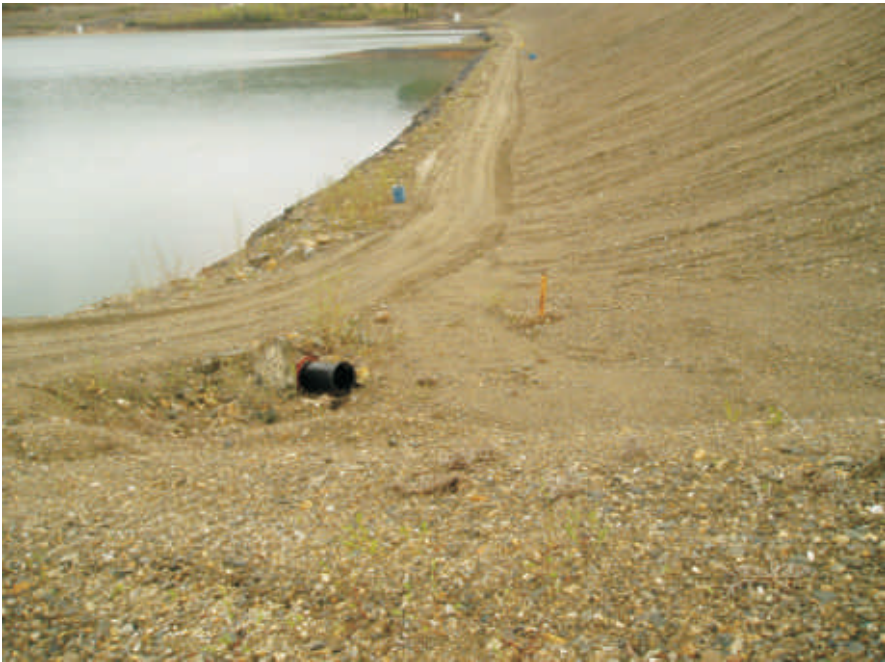
May: Photo shows the toe at the south abutment. As can be seen, there are no signs of seepage discharging in this area, where seepage has been noted in previous years.

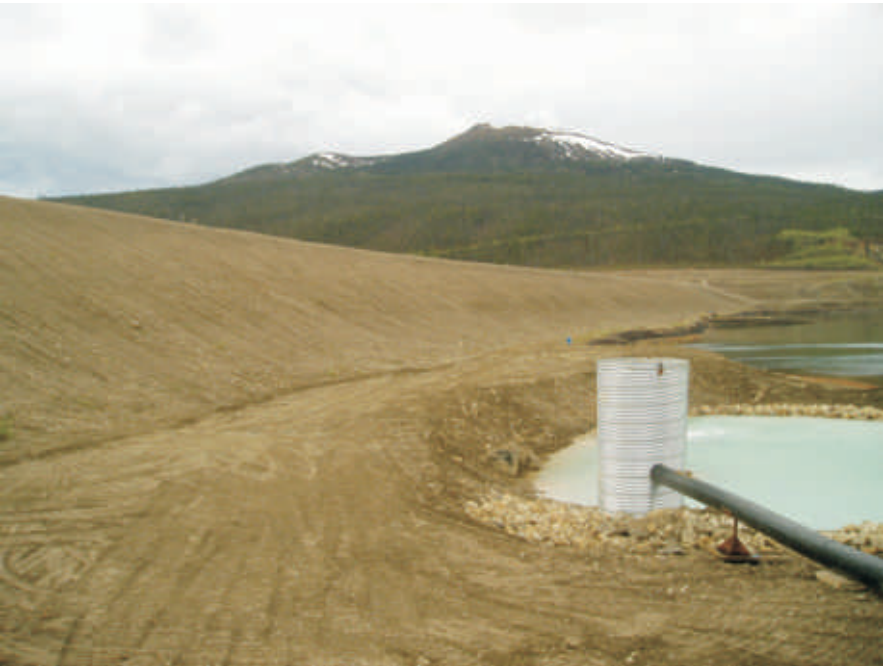
May: Photo shows another view of the downstream side of this dam. No signs of seepage, discharge or standing water were noted on the toe.

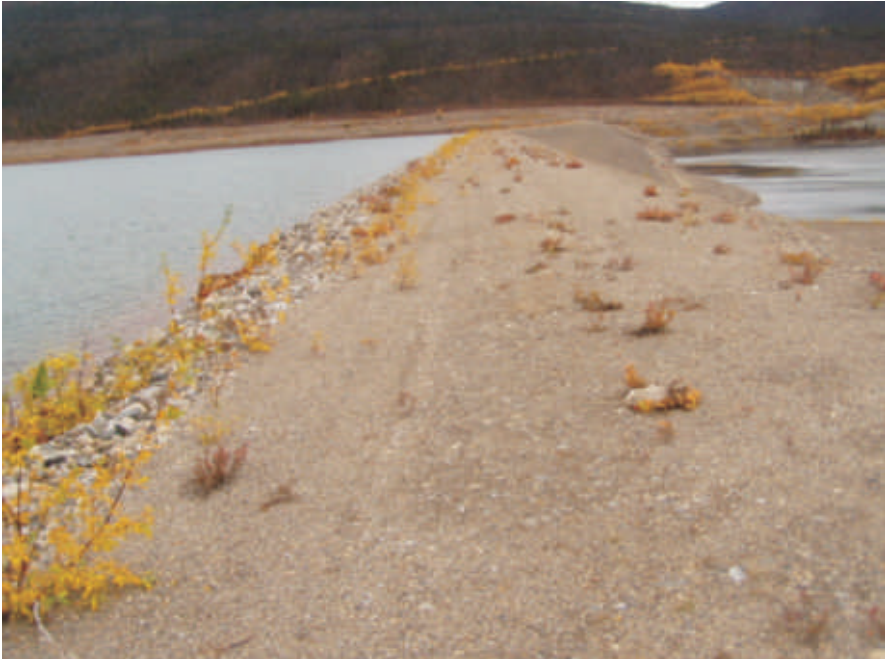
September: Photo shows a view of the crest looking towards the south. The crest appears to be properly graded with no signs of settlement or standing water.

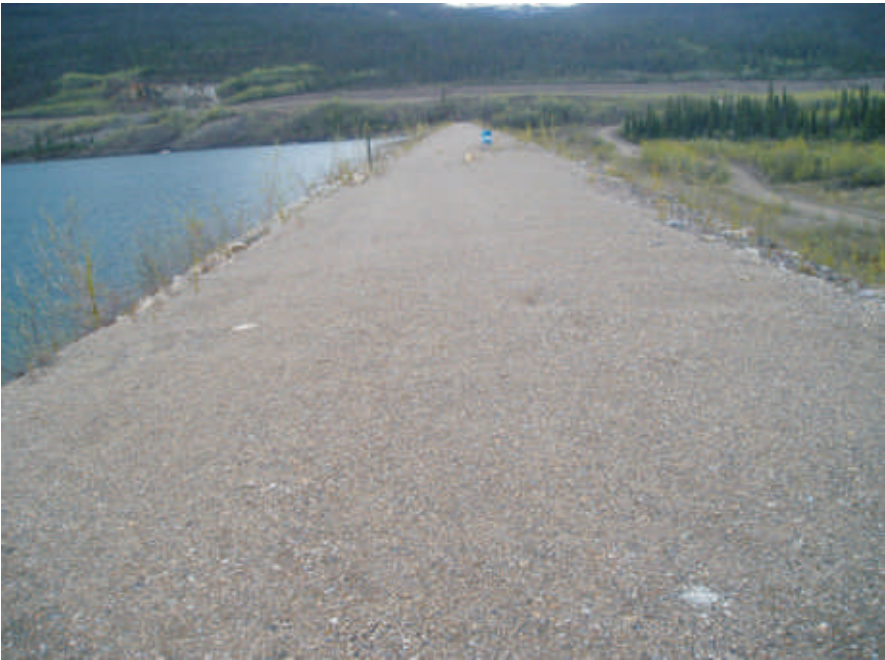
May: Photo shows the crest looking towards the south abutment. Within this area there is some minor cracking near the upstream side.

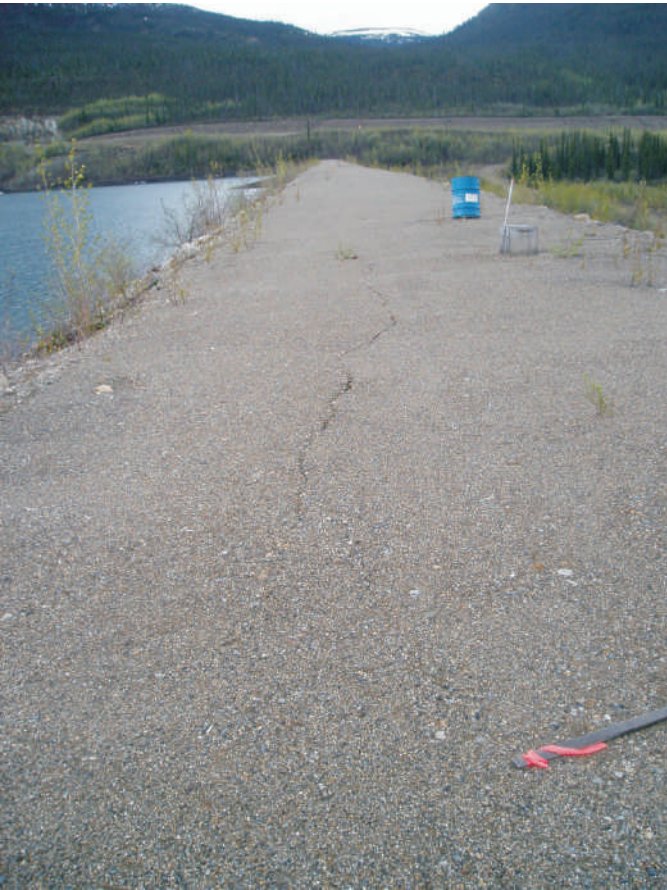
May: Photo shows a crack located on the upstream side.

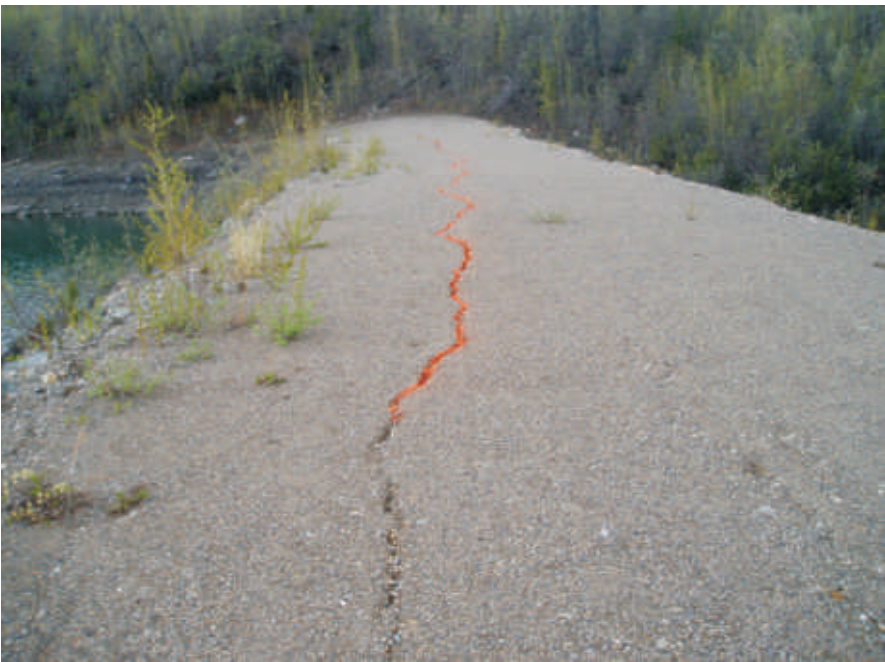
May: Photo shows an orange painted crack which progresses all the way to the south abutment of this dam. Water infiltration is leading to subsidence directly proximal to the crack.

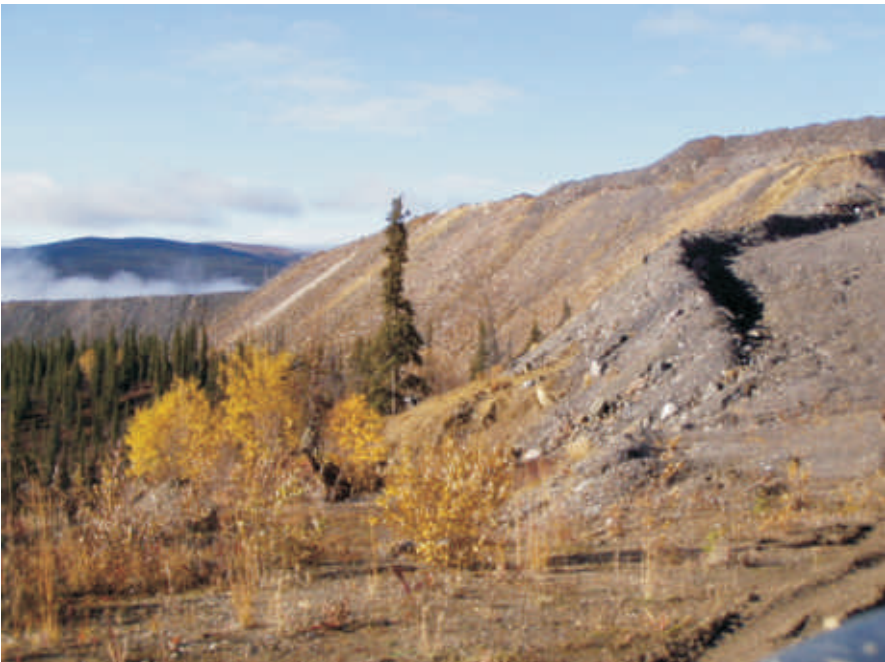
September: view of the face of the waste dumps. No signs of bulging or cracking were noted.

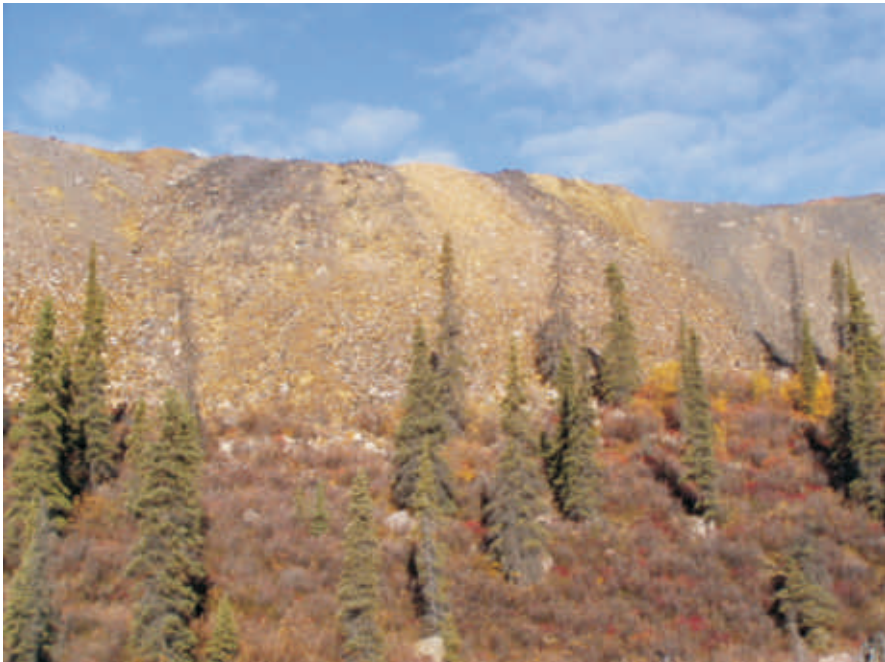
September: view of the face of the waste dumps. No signs of bulging or cracking were noted.

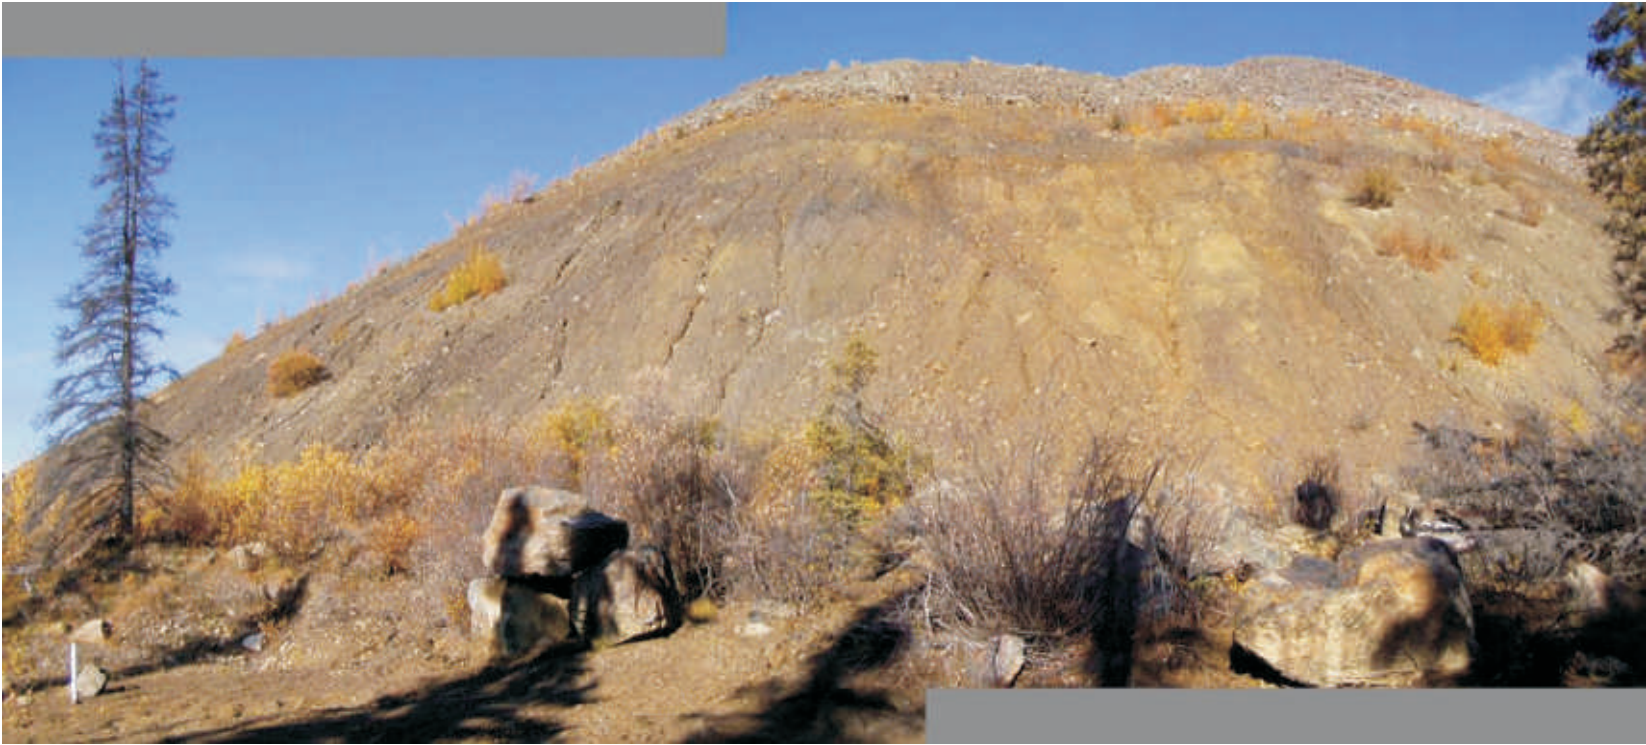
September: View of location, where till soils are exposed and eroding along the side of the waste dump.

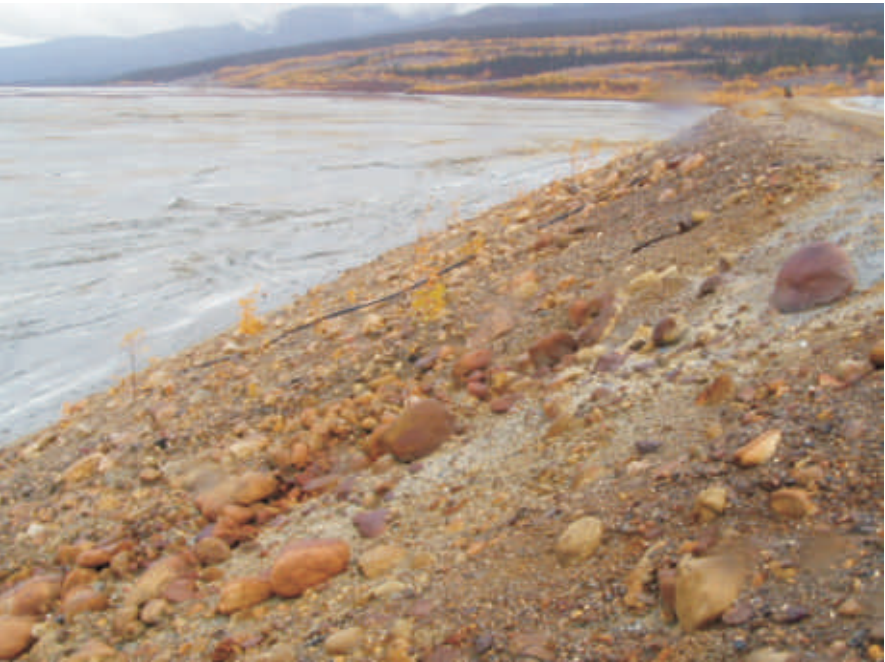
September: Photo shows another view of the downstream side of the face. The face is well armoured with granular gravel, cobbles and boulders. Some vegetation is catching on but in a very sporadic matter. No direct indications of seepage which discharges directly from the face were observed.

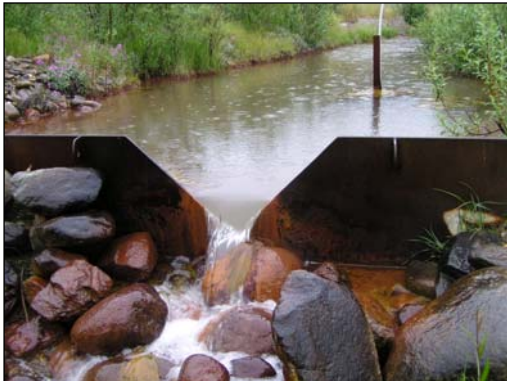
**X\_11 or CVS\_5 - 90° V-notch weir at seepage channel**

For July 13 2005, the H value was incorrectly reported for as 0.224 m. This was an error. The actual H over the notch was not .224, rather 0.154 measured at the crest. (The value 0.224 had been derived from the staff gauge height). Applying the weir formula  $Q \text{ L/sec} = 1362.9 \cdot H^{2.5}$ , the discharge was  $1362.9 \cdot 0.154^{2.5} = 12.7 \text{ L/sec}$ , *not 32.4 L/sec as reported*. On September 2, 2005 rocks were removed to allow a volumetric measurement at X\_11. The discharge was 7.6 L/sec. Applying the formula, the discharge was  $1362.9 \cdot 0.126^{2.5} = 7.7 \text{ L/sec}$ . The staff gauge reading was initially 0.260 m. A new staff gauge was installed and set to read H, or 0.126 m.
