### **2006 ANNUAL GEOTECHNICAL EVALUATION AND INSTRUMENT REVIEW**

### **VARIOUS FACILITIES AT FARO MINE, YUKON**

PROJECT NO.: 0257-039-05  
DATE: FEBRUARY 14, 2007

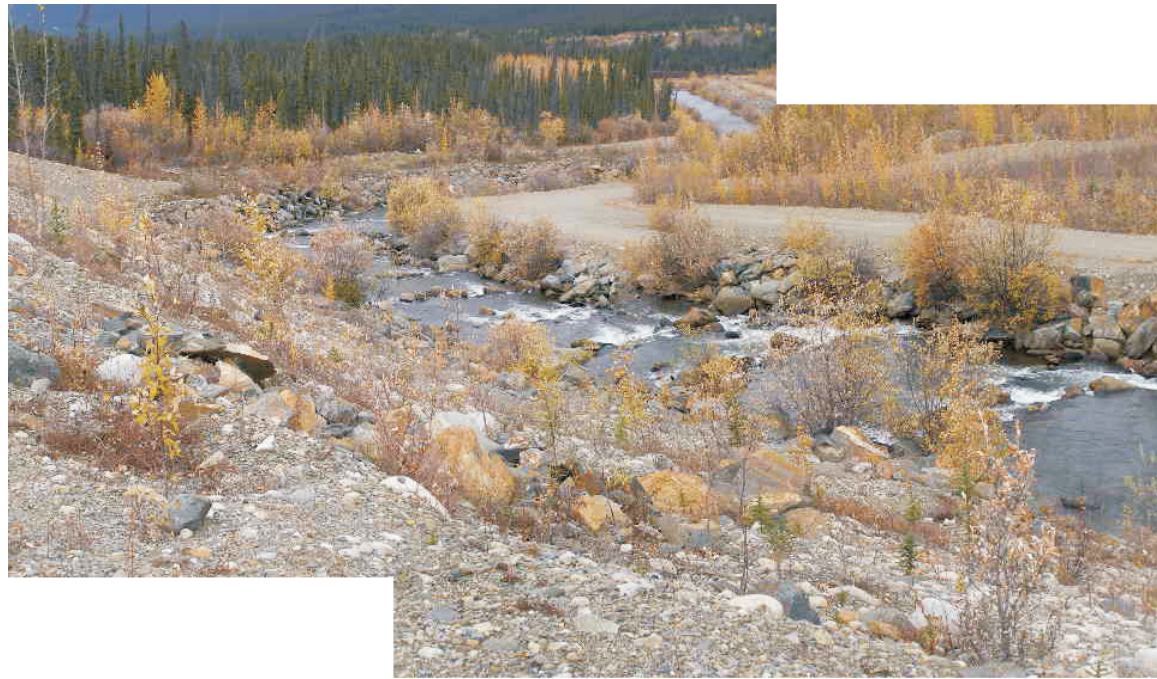
September: panoramic view showing the condition of the weirs located within the upper weir section. A number of the central boulders have been displaced due to concentrated water flow.

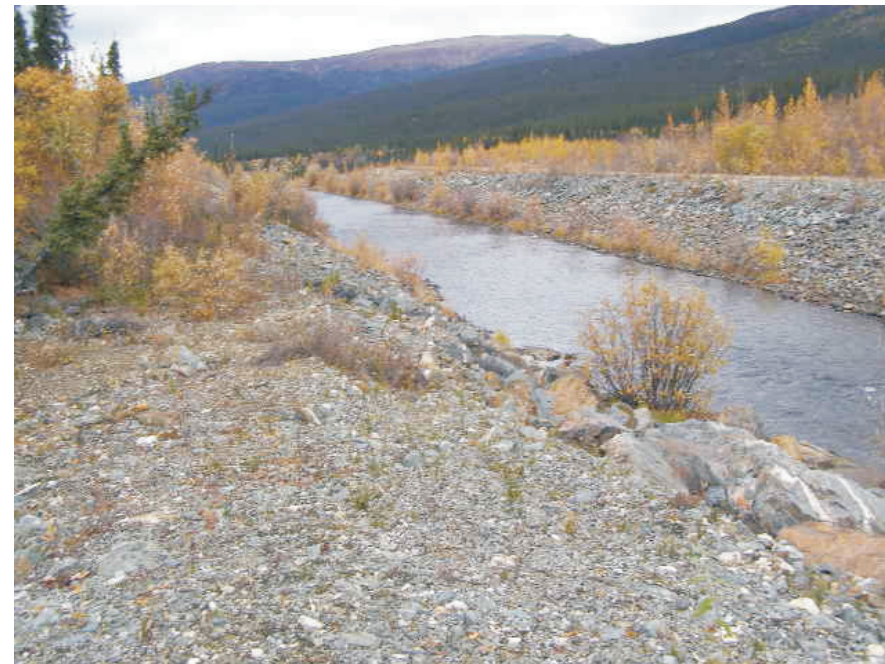
September: shows a view looking downstream on the canal. As can be seen, this is a low gradient part of the diversion between the upper and lower weir sections.

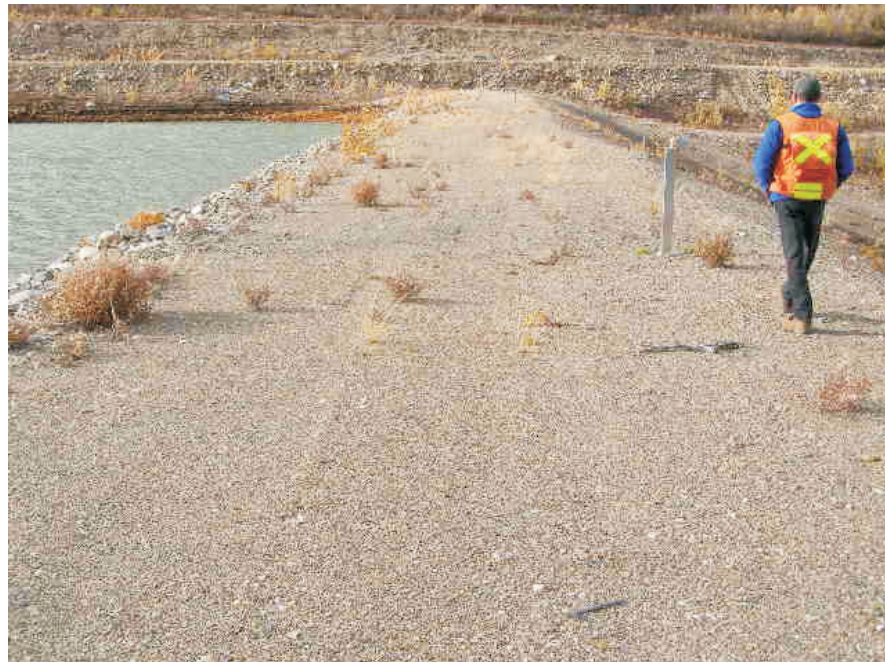
September: view of the crest looking towards the south abutment. No signs of settlement, cracking or deformation have been seen on the crest.

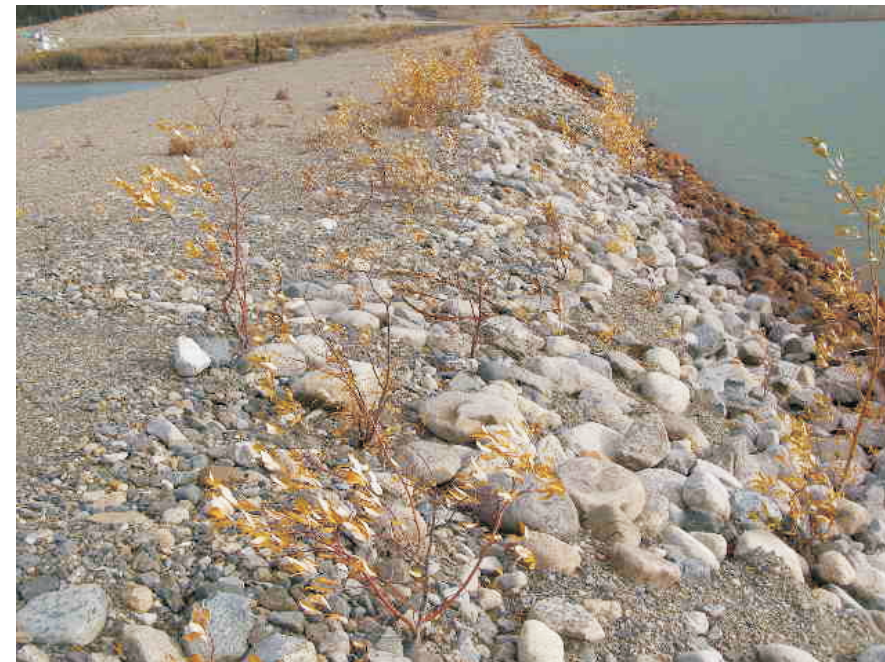
September: view of the upstream side of the crest. Vegetation which is catching on and should be removed.

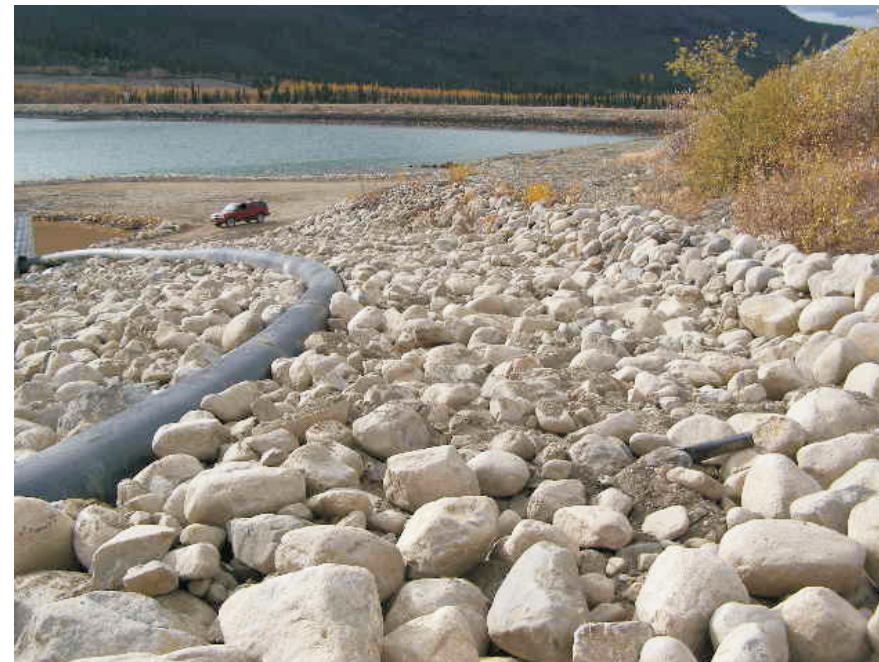
September: another view of the recently repaired riprap.

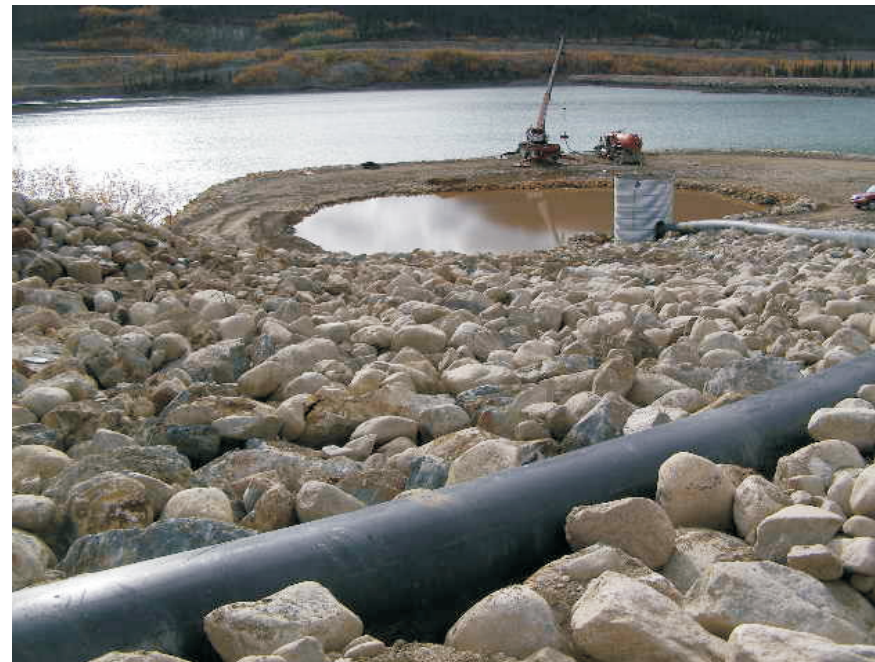
September: overlooking the sludge collection area. Looking at the riprap apron that was repaired by removing the riffle/pool arrangement between August and September 2007.

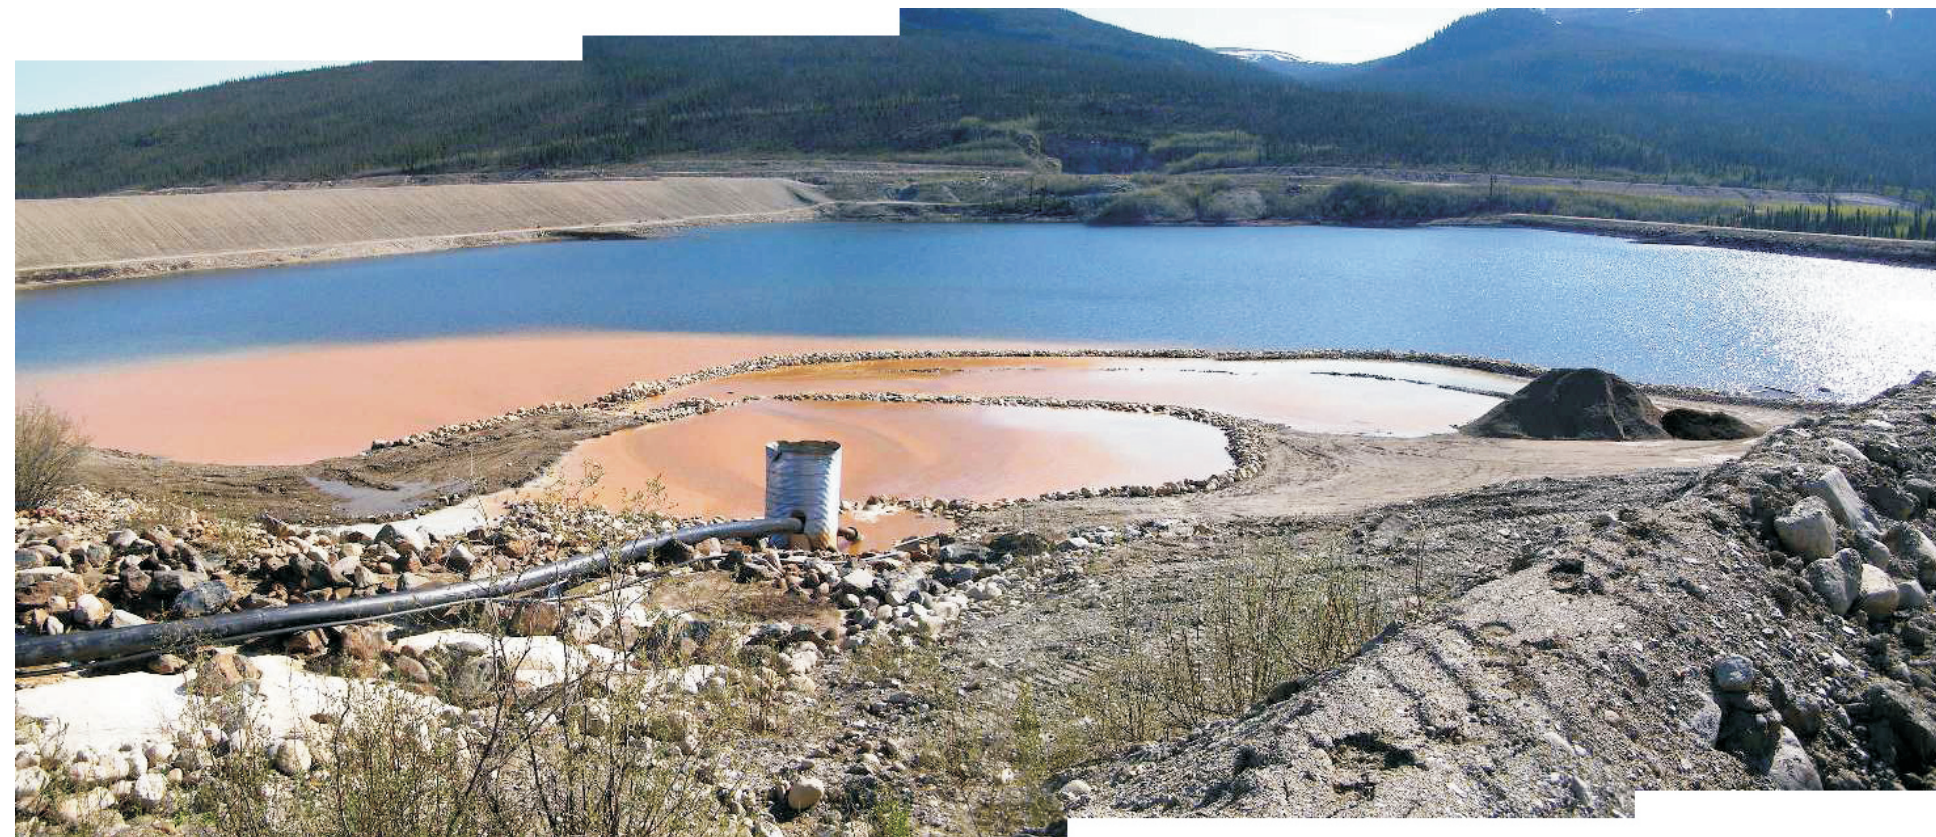
June: Three shot panorama showing the sludge collection area built at outlet of the Intermediate Dam Spillway.

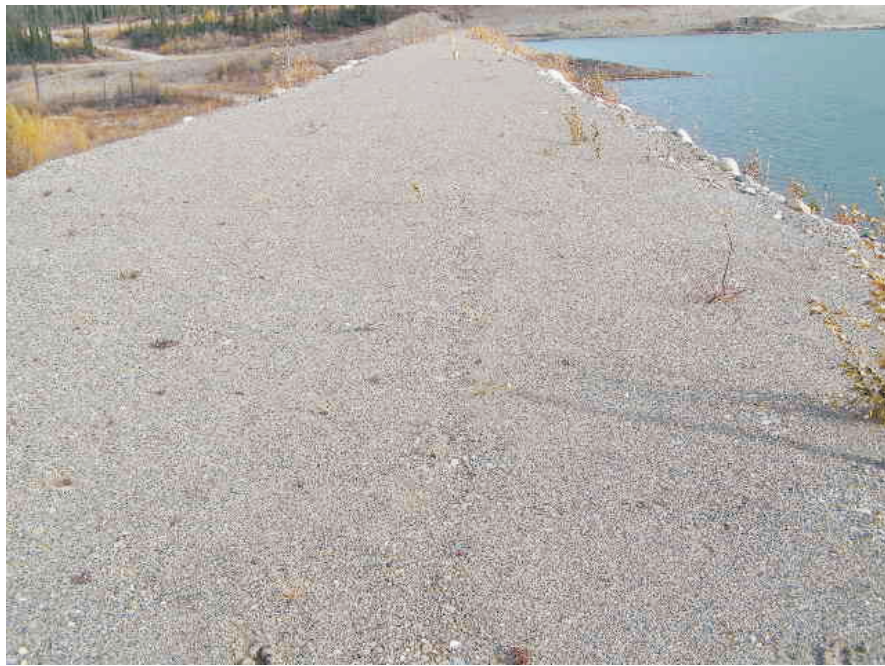
September: shows a very subtle manifestation of some previously existing cracks in the crest. The outline of a small trace of a settlement trough can be seen in this photo.

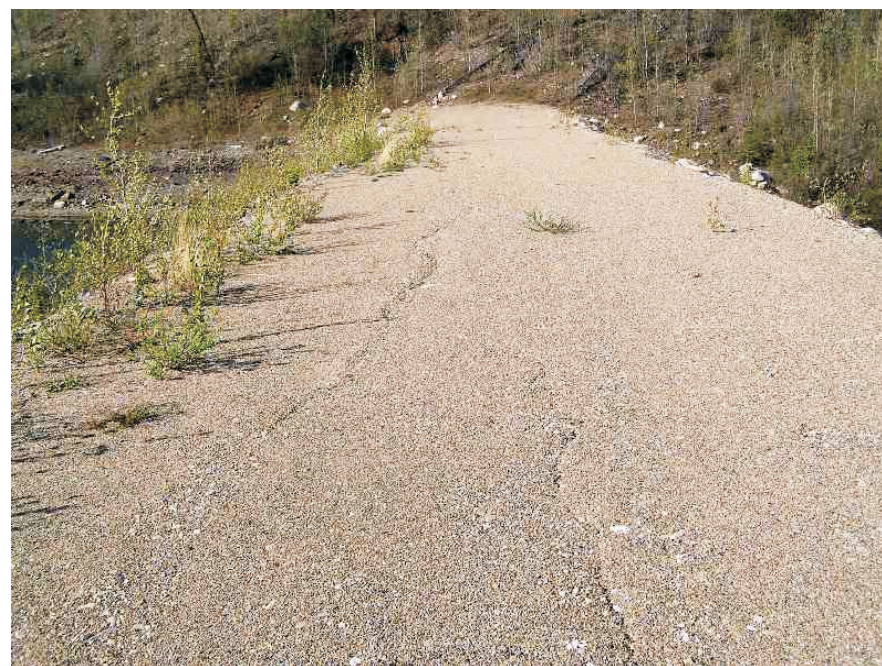
June: Nearing the south abutment, with a faint crack on the crest of the dam.

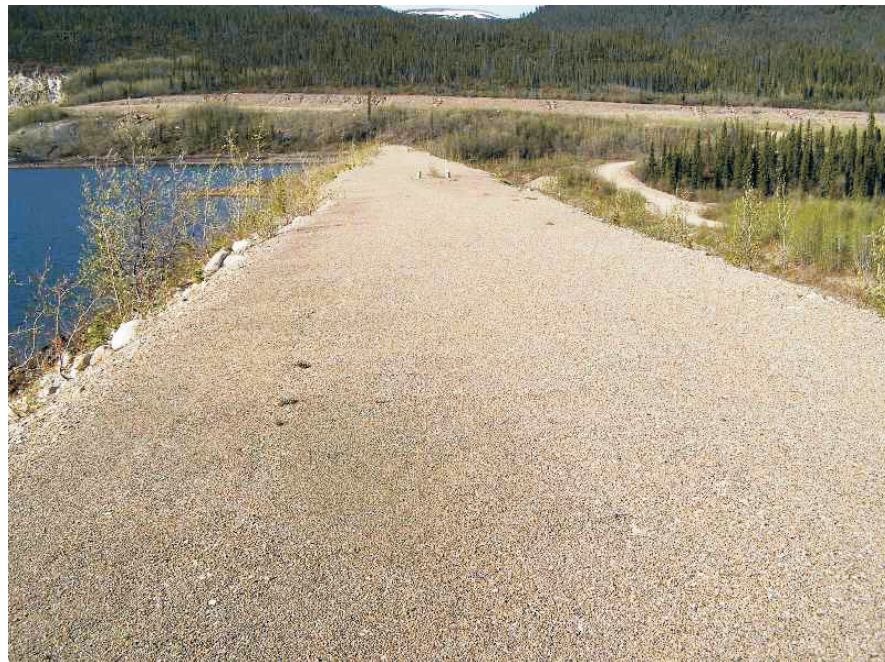
June: Note the faint evidence of past cracking on crest, near the northern quarter point.

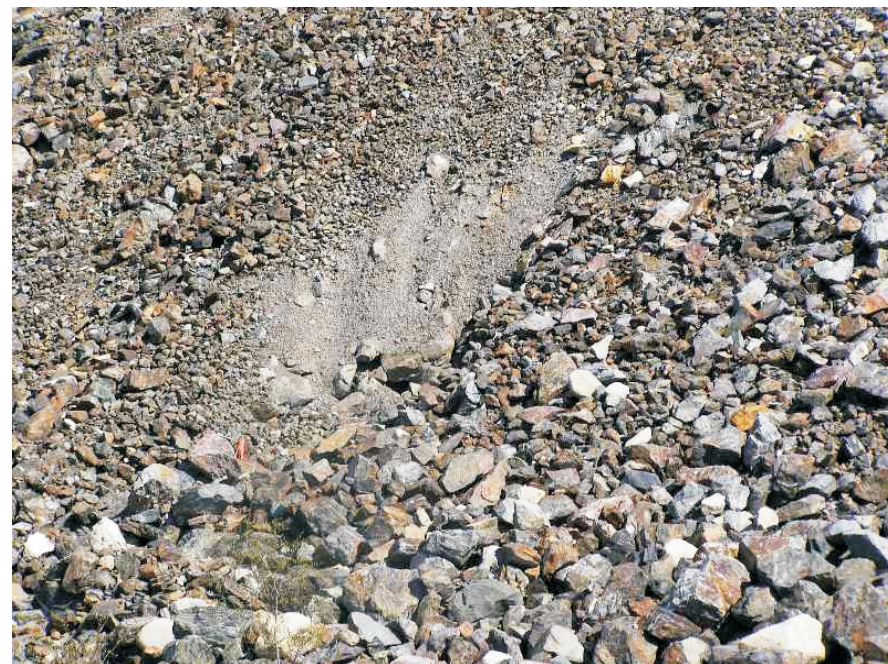
June: shows a close up view of the area noted last year as being eroded out. It is almost in the centre of the Rock Drain.

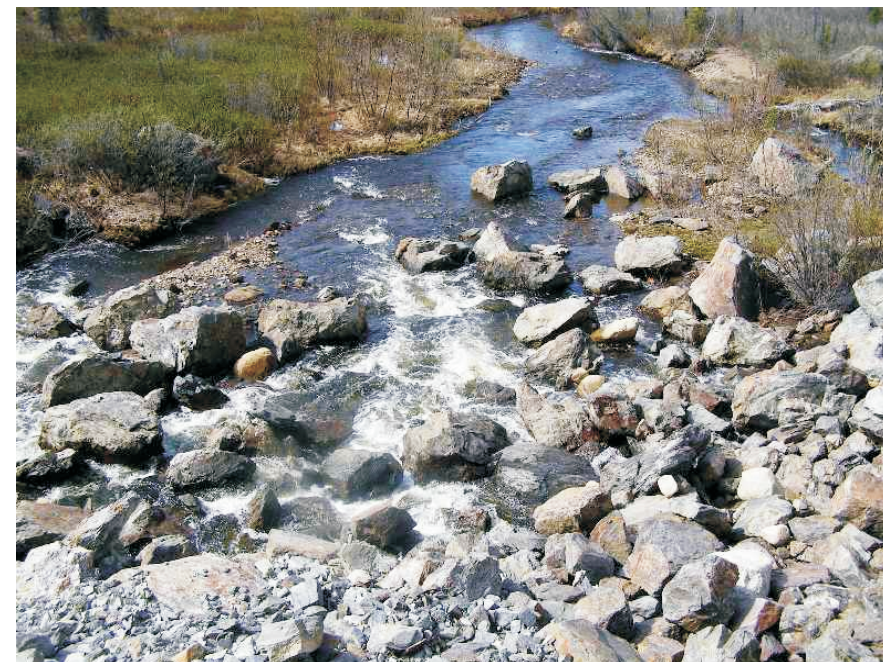
June: shows a view looking at the creek as it flowing out of the base of the Rock Drain free and clear with no obstructions.

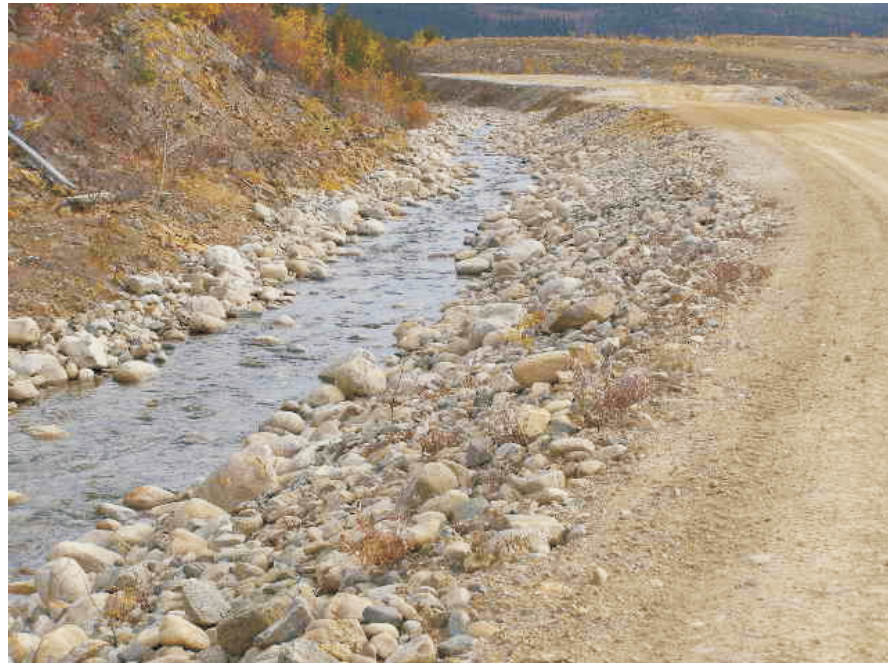
September: shows the continuation of the previously constructed Pilot Channel with the Faro Creek Diversion. The channel appears to be in good condition, no signs of significant erosion or deformation.

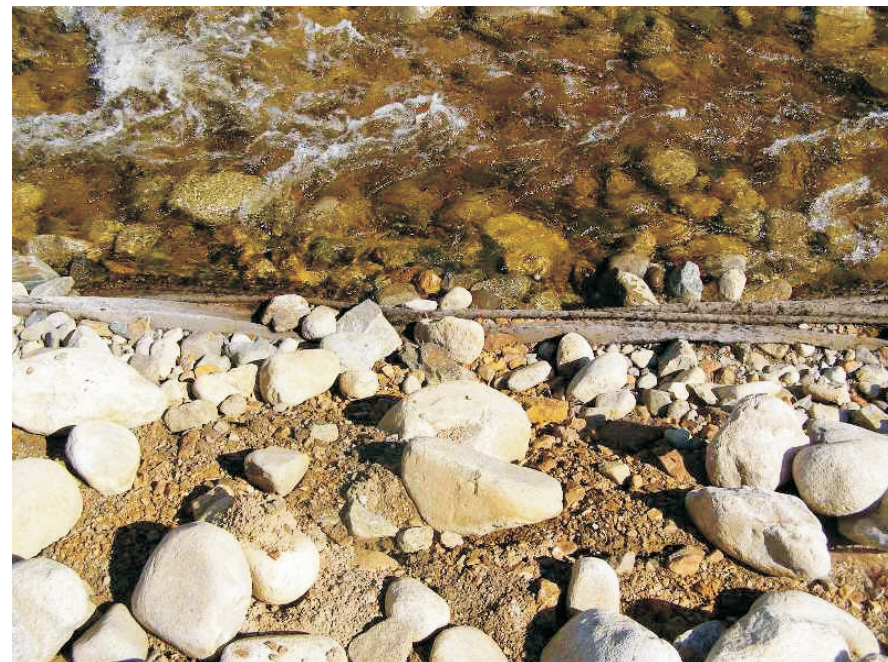
June: Note the exposed geotextile in the channel bottom. This was repaired prior to the August inspection.

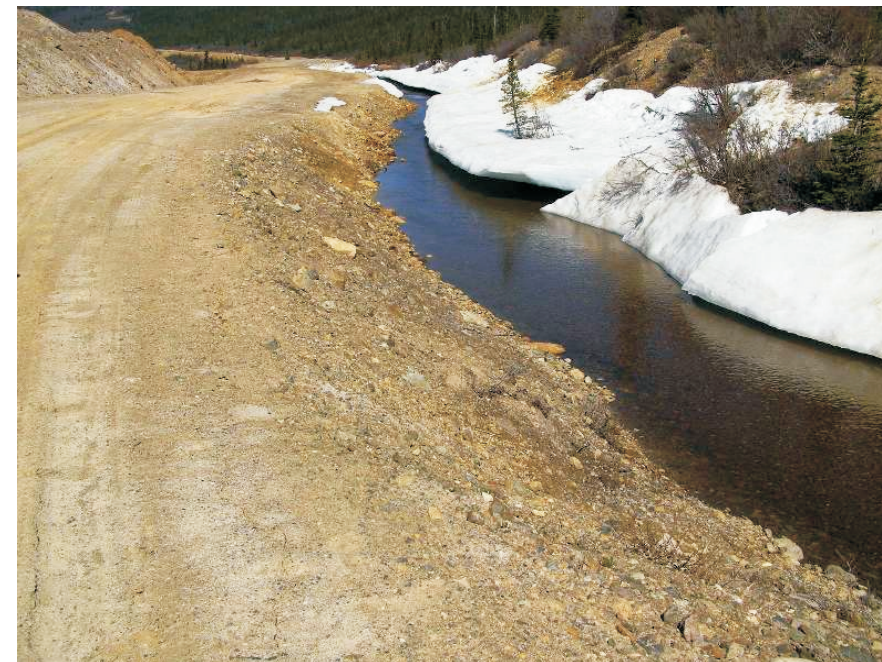
June: Northern leg of the diversion. Note the overhanging banks of snow and ice.

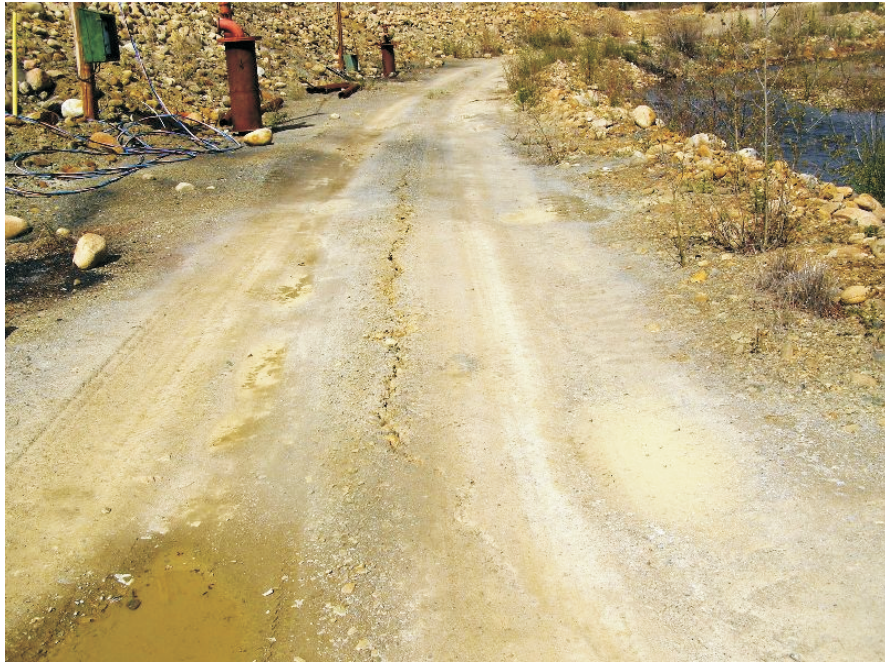
June: shows of the continuing view of the crack on the lower road of the Secondary Tailings Dam, just near the area of the pumping wells.

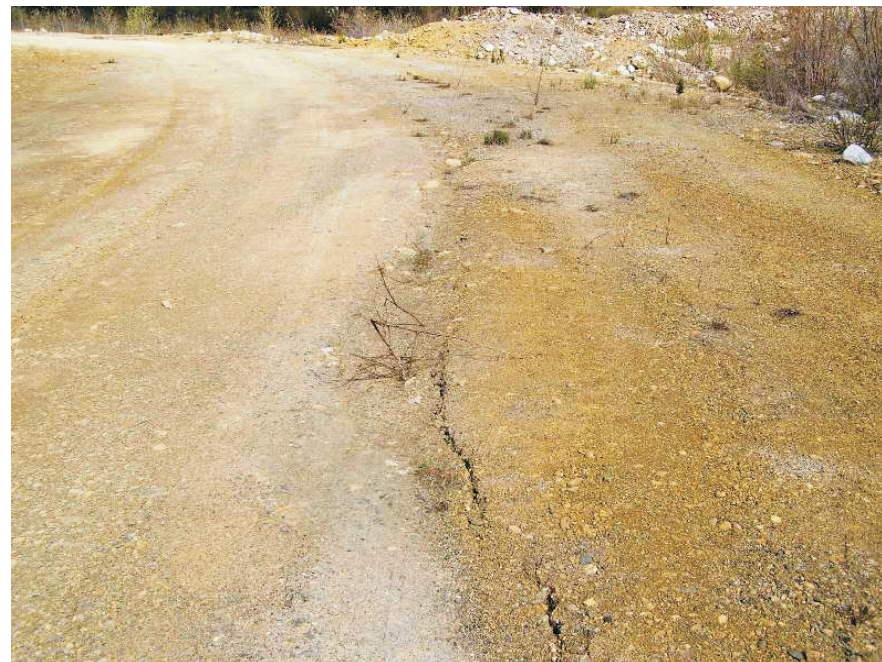
June: shows a view of a settlement trough crack along the edge of the lower road. This is near the entrance to the Diversion Canal.

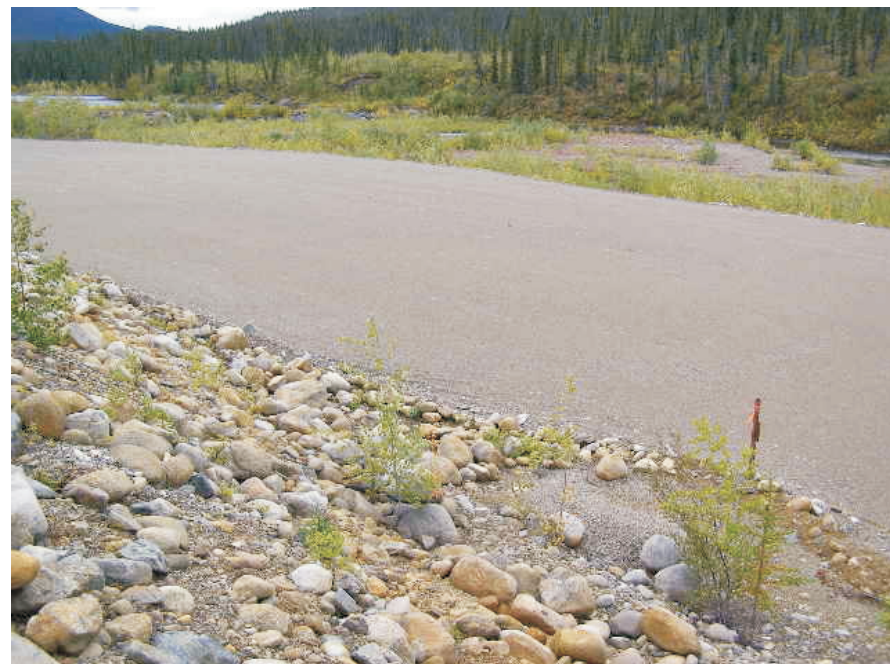
August: lower road surface near pumphouse pond, showing the re-graded surface.

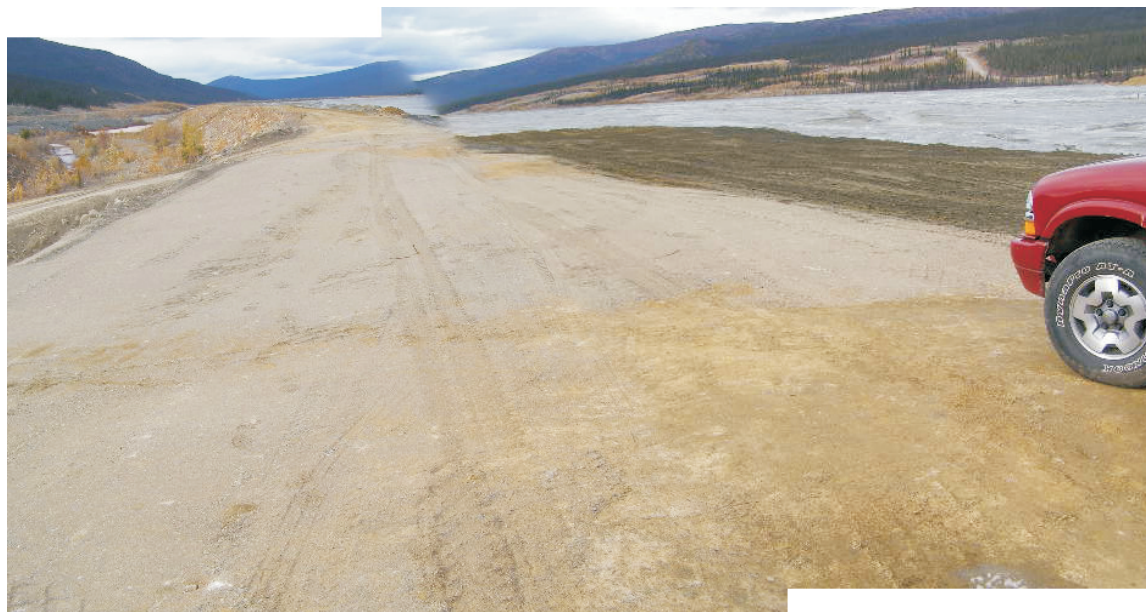
September: a two shot panoramic showing the repair which has been done to the small trench in the crest of the Secondary Impoundment Dike, (see first photo).

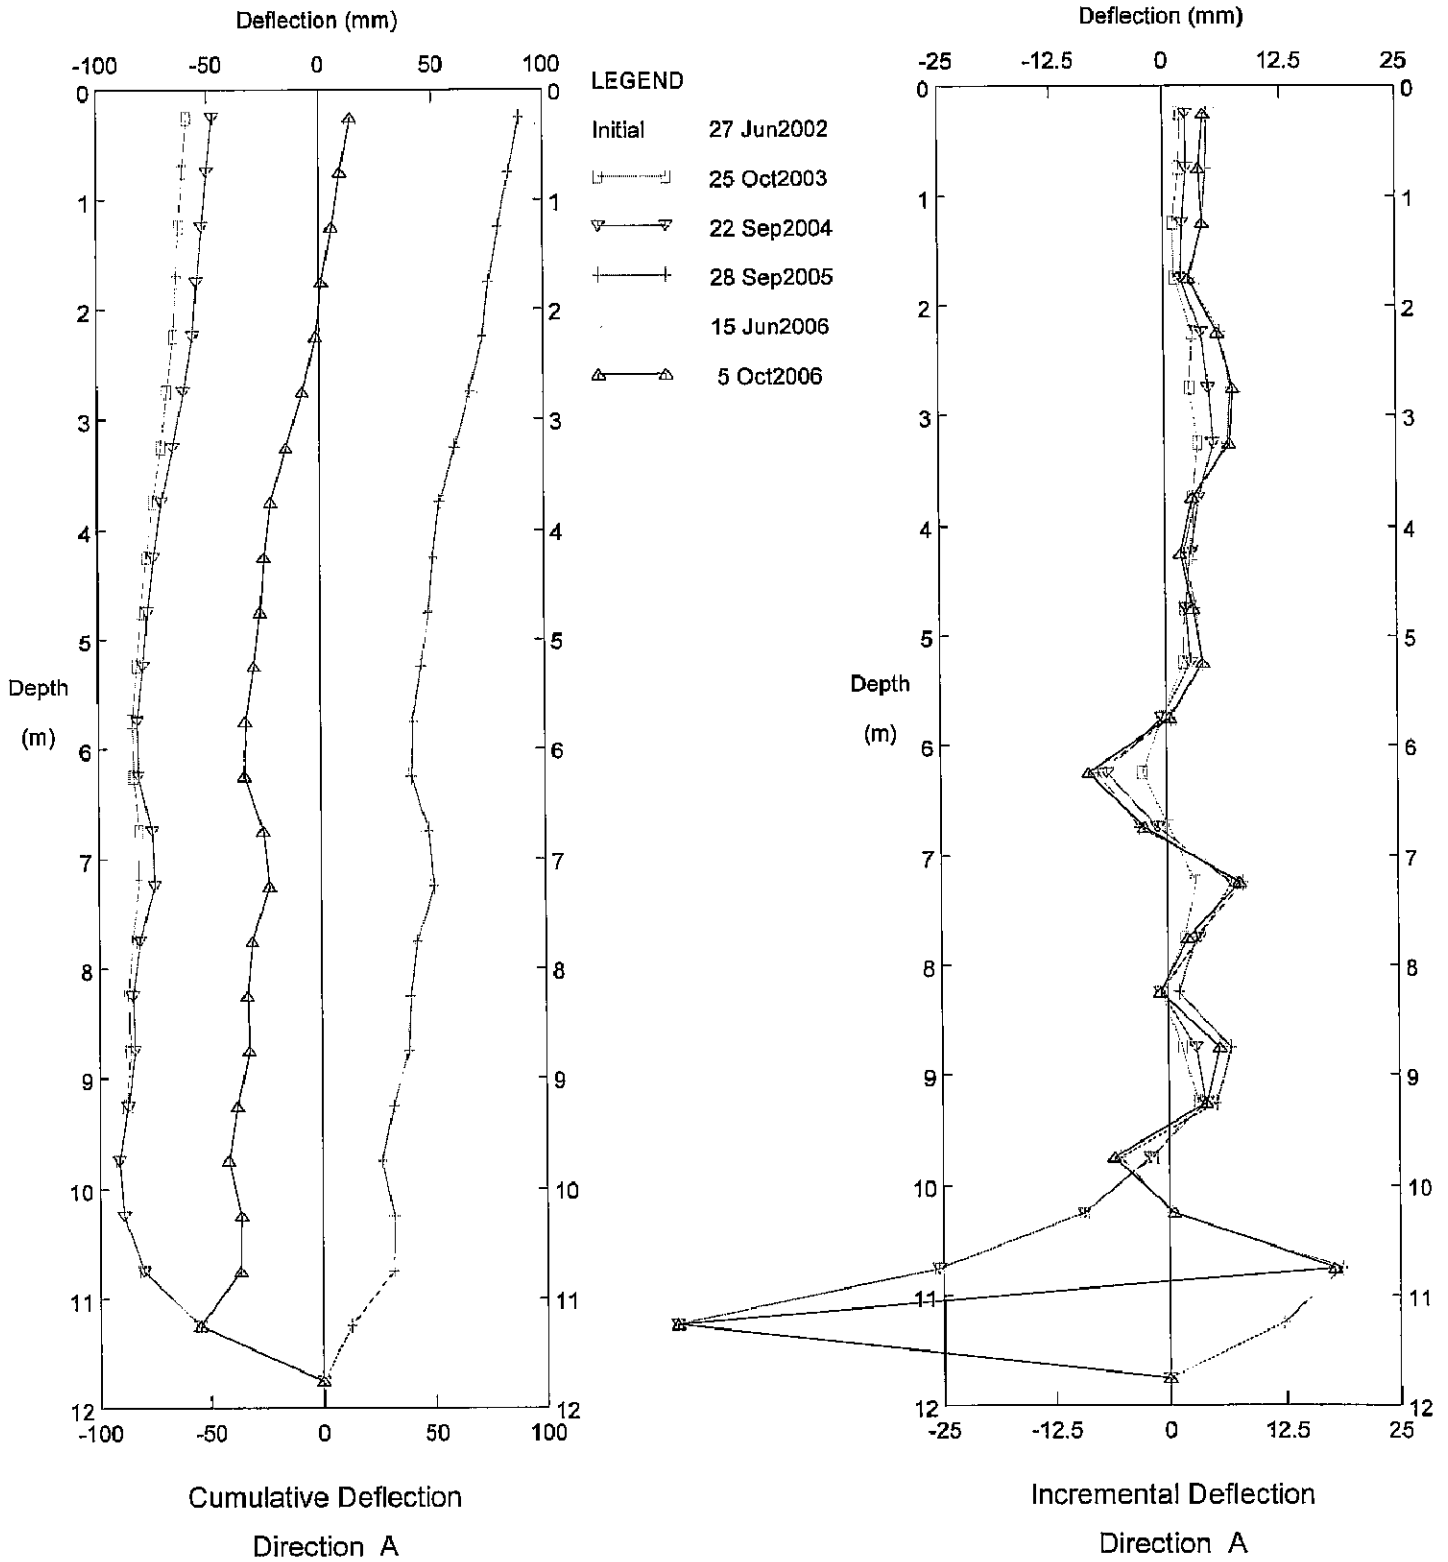
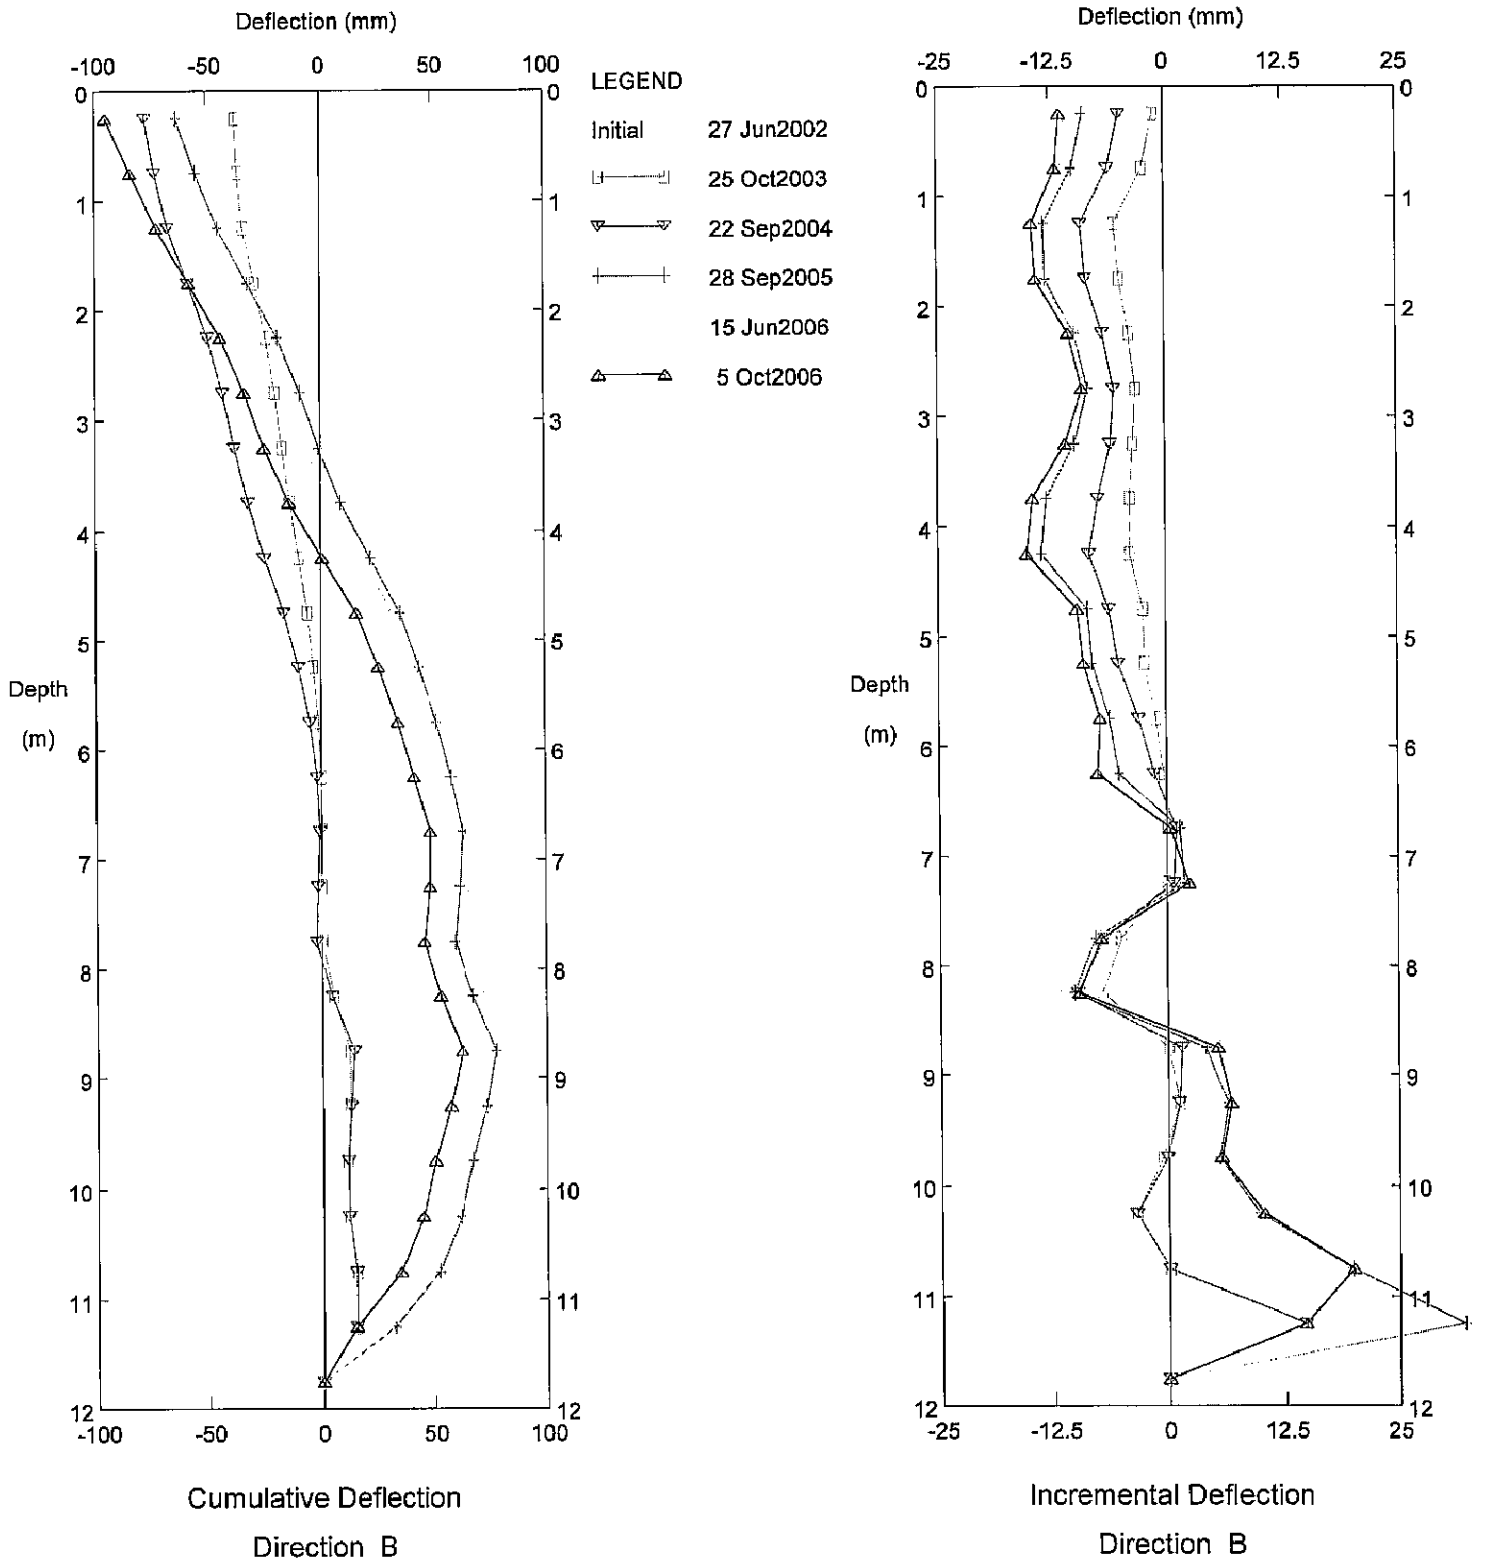
BGC01-01, Inclinometer BGC01-01

In addition to these general comments the plots for slope inclinometer at BGC01-01 shows significant variation to other installations. When installed, this casing was 14 m deep (below the ground) but can be only measured in its upper 10 m in 2006. This is likely due to freezing at depth and gradual build up of ice in the casing. This has made on going comparison difficult. This SI should no longer be read as it is not providing useful information, with the 2005 installations near this location, the SI does not need to be replaced.
