2008 ANNUAL GEOTECHNICAL EVALUATION AND INSTRUMENT REVIEW

VARIOUS FACILITIES AT FARO MINE, YUKON

PROJECT NO.: 0257-051-05
DATE: FEBRUARY 13, 2009

**RE: 2008 ANNUAL GEOTECHNICAL EVALUATION AND INSTRUMENT REVIEW
VARIOUS MINE WASTE FACILITIES AT FARO MINE, YUKON**

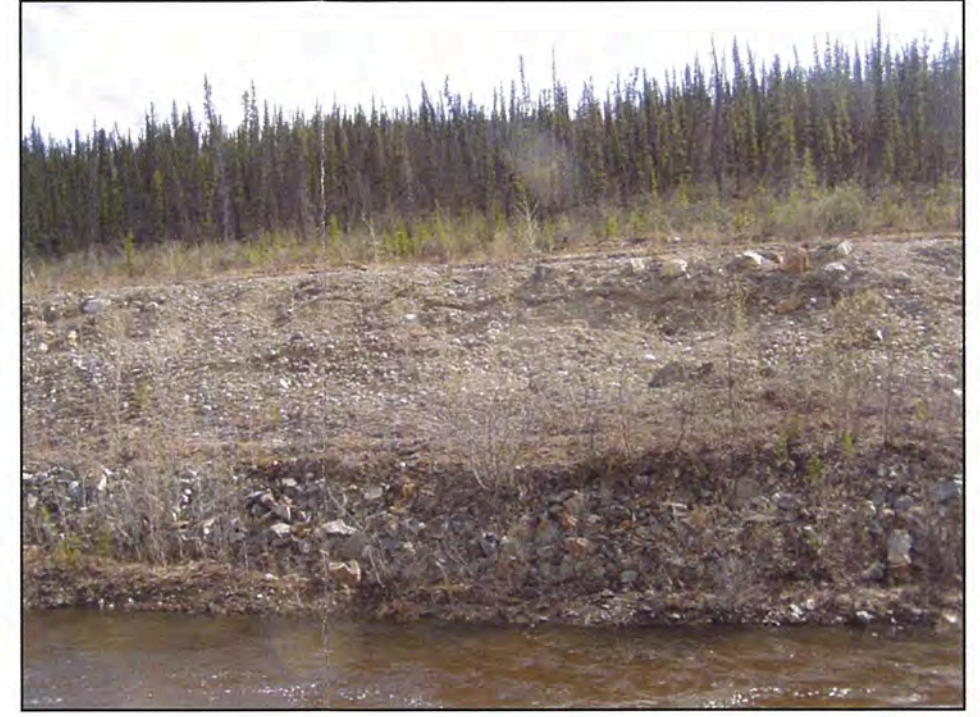
May: shows a view of the slump in the backslope of the Diversion Channel.

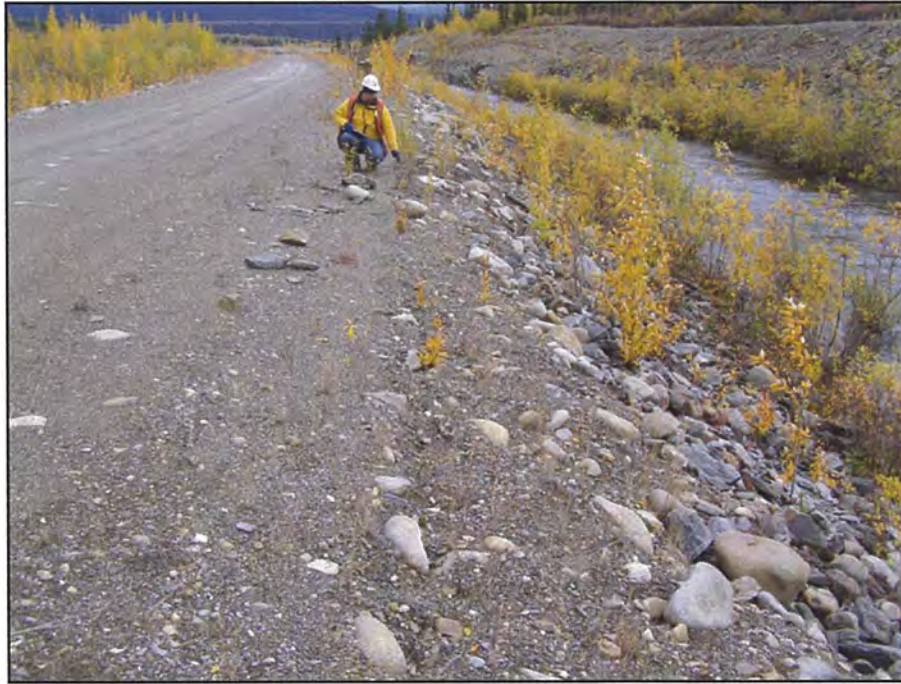
September: shows a tension crack that has formed on the upstream crest. The crack extends approximately 20 m and should be observed for further propagation and repair. Trees on the upstream slope should be removed next year.

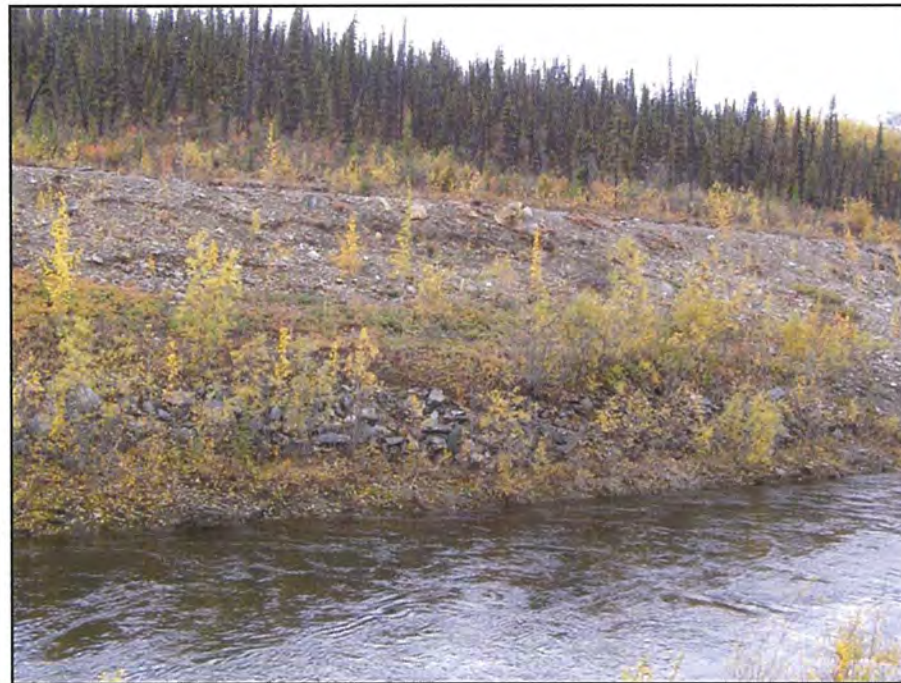
September: shows a slump area that has had some advancement over the past year. Repair is not yet needed.

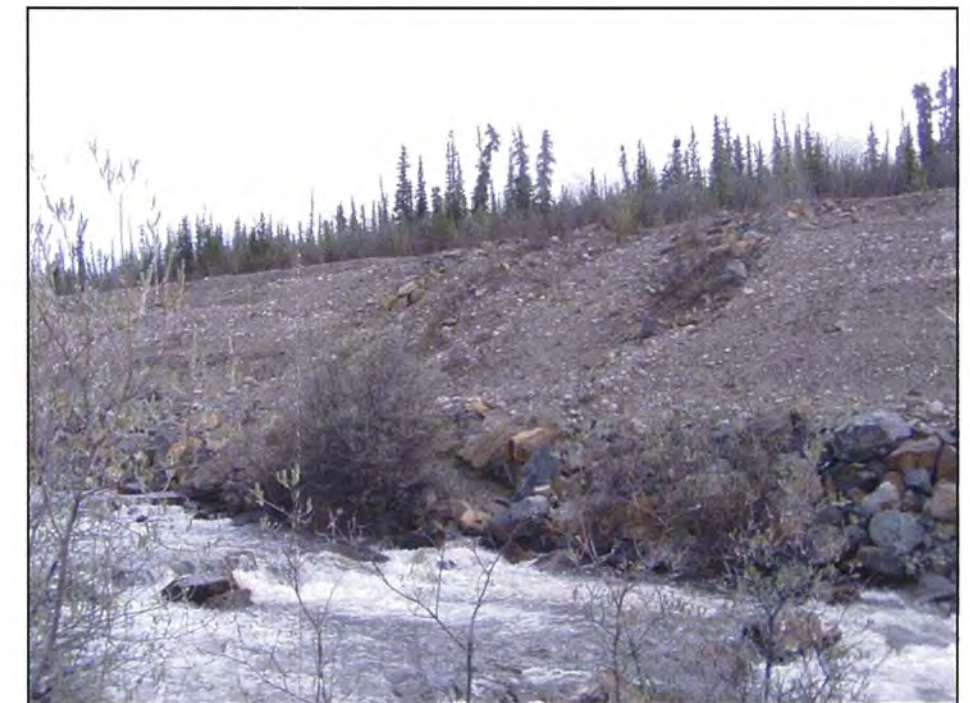
May: shows a view of some erosion gullies in the backslope of the canal.

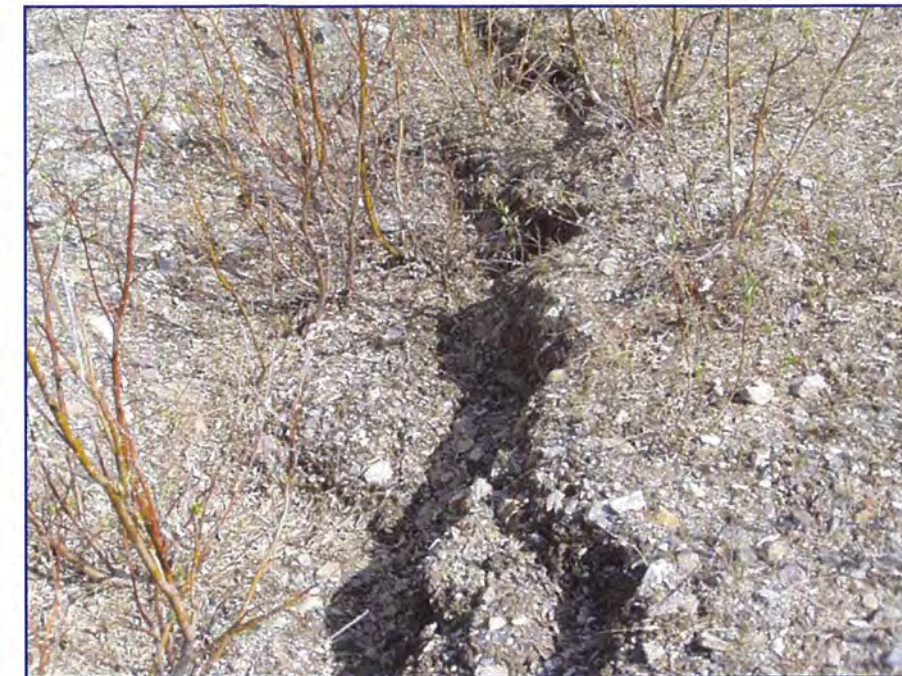
May: view of the headscrap formed by the slumping area, was noted in last year's inspection.

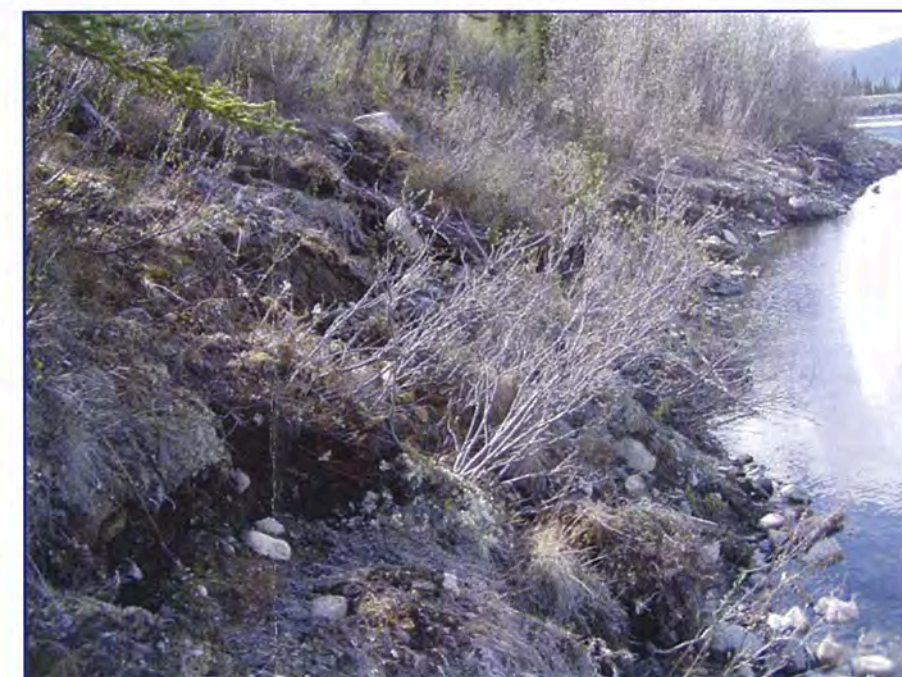
May: shows retrogression of bank in seepage discharge area.

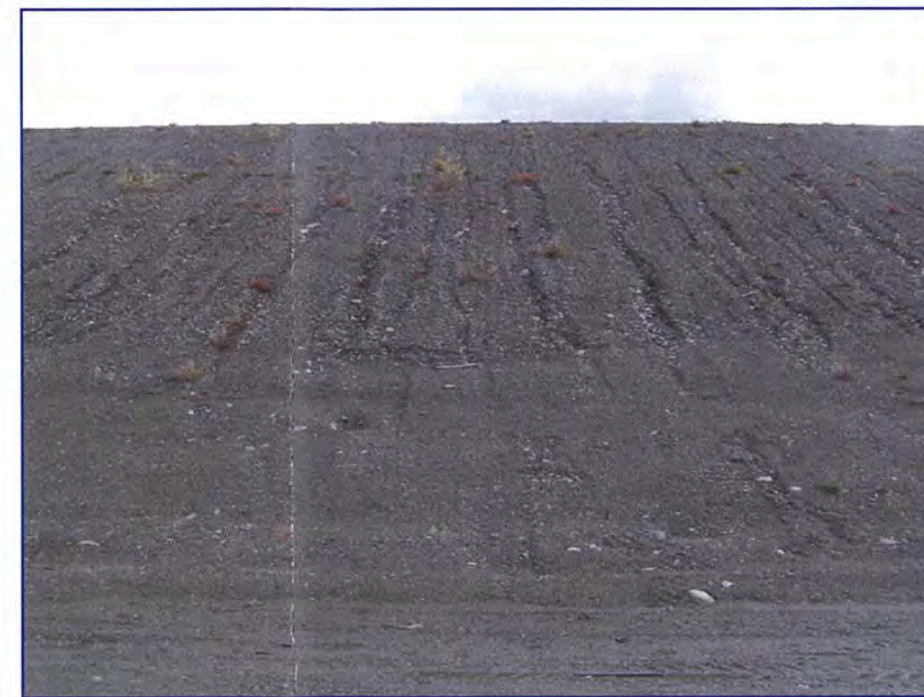
September: a view from the crest of the Intermediate Dam looking at the downstream face. Note the appearance of the erosion rills on the face.

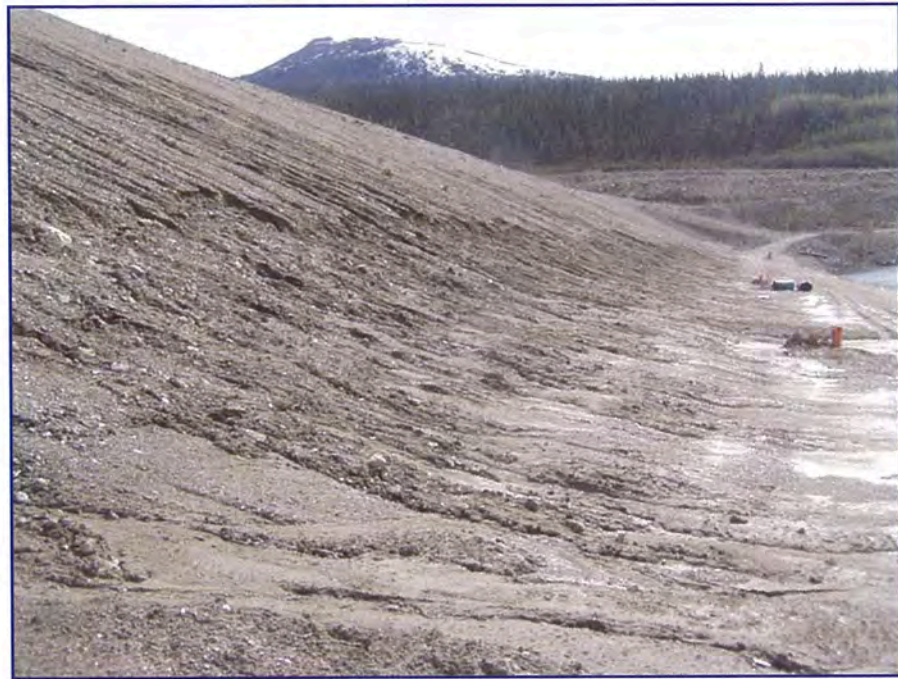
May: shows a view of erosion on the downstream face of the dam. This area should be repaired by removing the fines from the road surface.

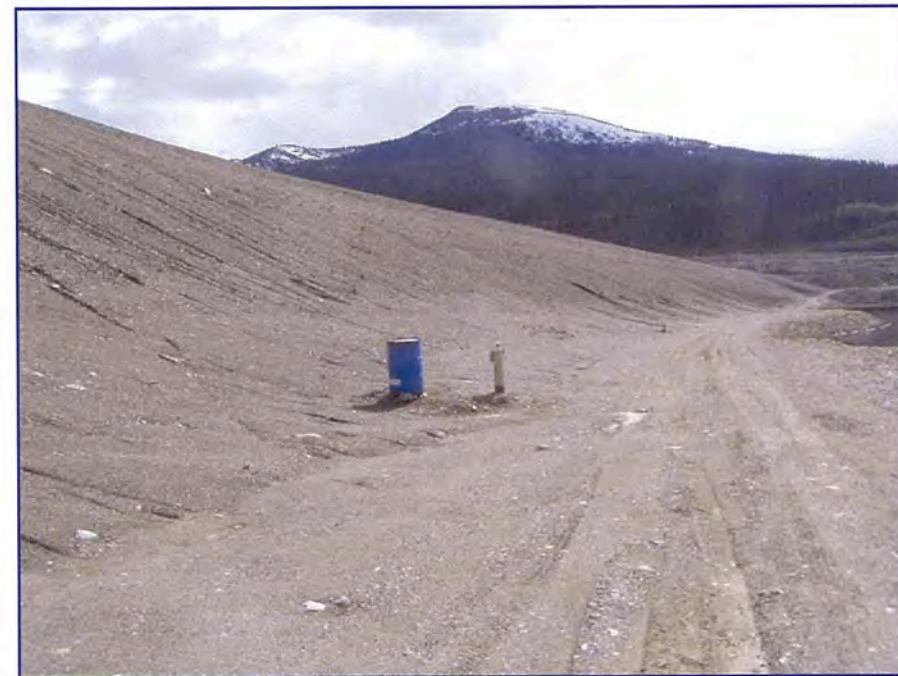
May: shows a view of the toe of the dam at the lower road. Note slough material at the toe.

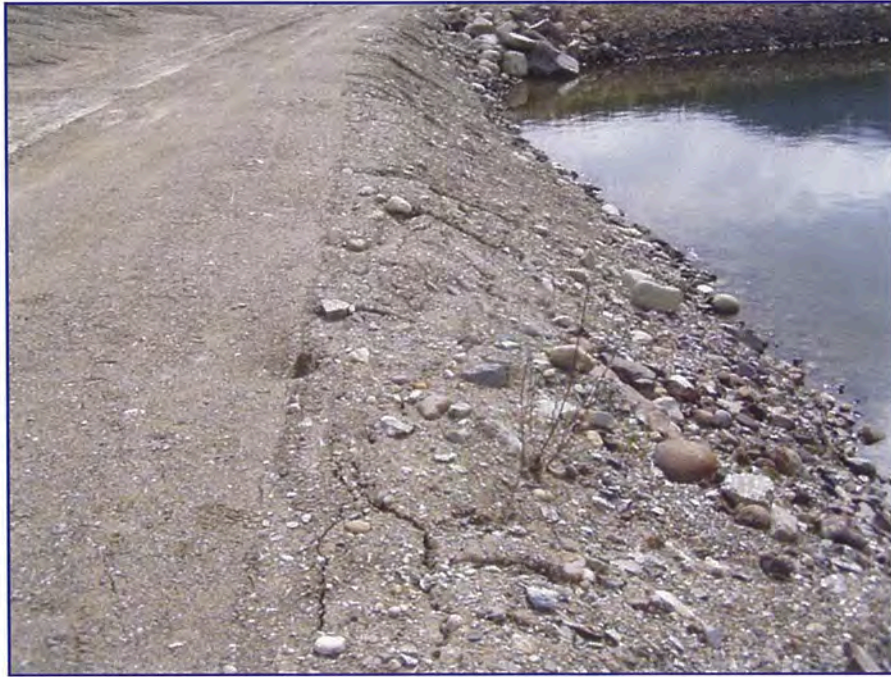
May: a view of minor cracking occurring at the edge of the polishing pond. Note that cracking has historically been seen in this area.

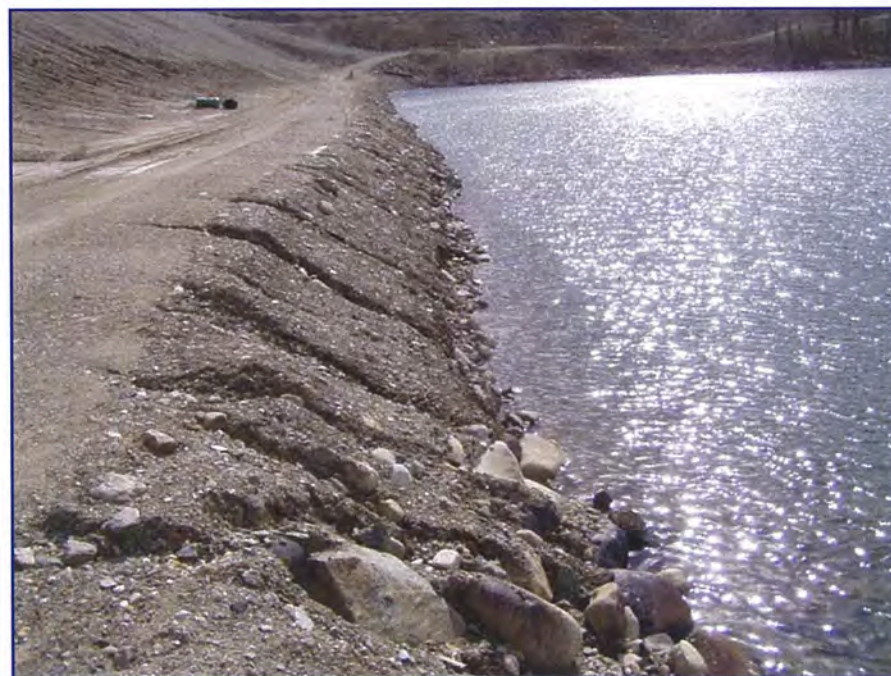
May: shows a view of the edge of the polishing pond. Note that some rilling and wave erosion is evident.

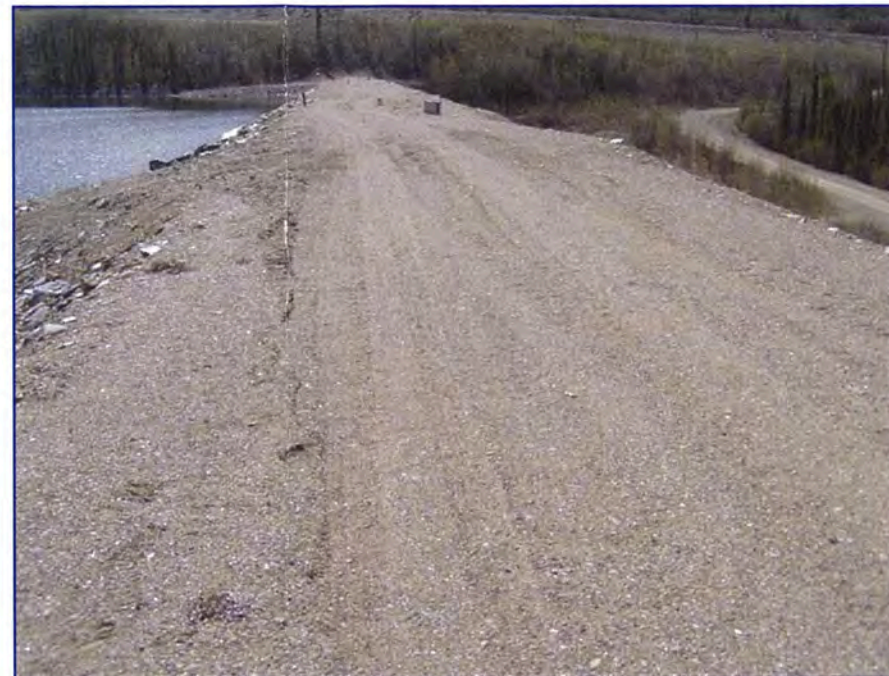
May: shows a view of the crest of the dam, with a faint crack in the road.

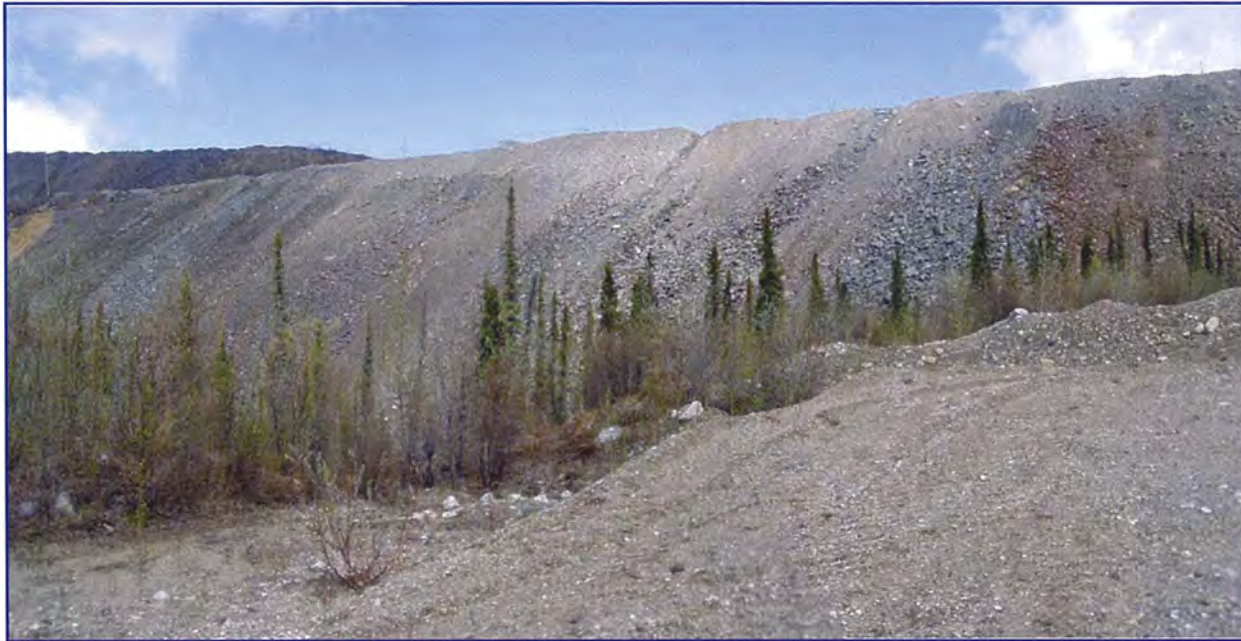
May: shows an overview of the downstream side of the North Fork Rock Drain. Note the erosion gully on the face.

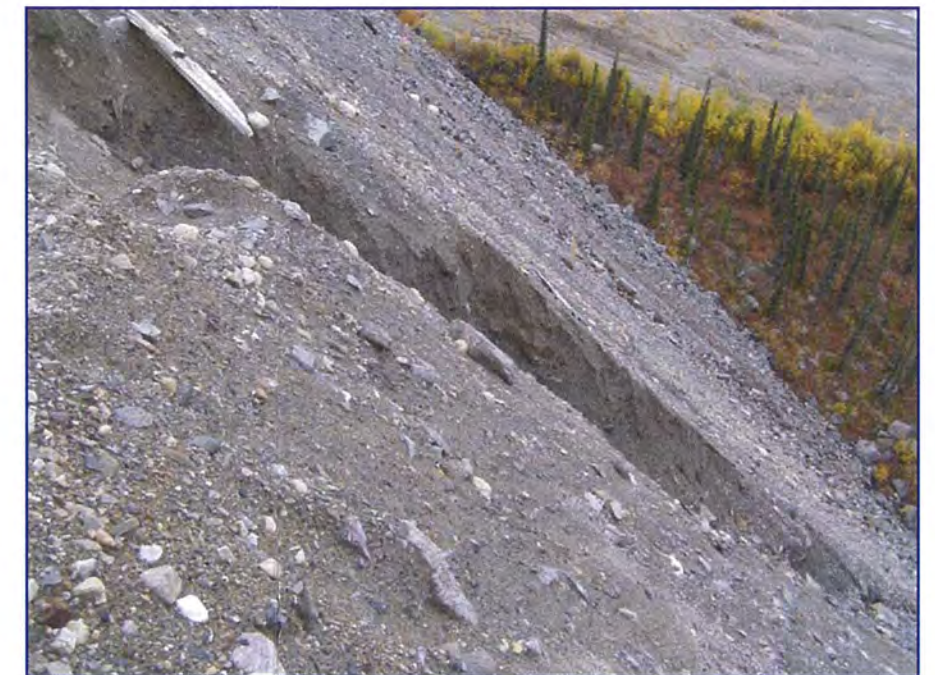
September: a view of the side slope of the drain and the erosion channel cutting through it. This erosion gap in the protection berm should be repaired to prevent further erosion on the face.

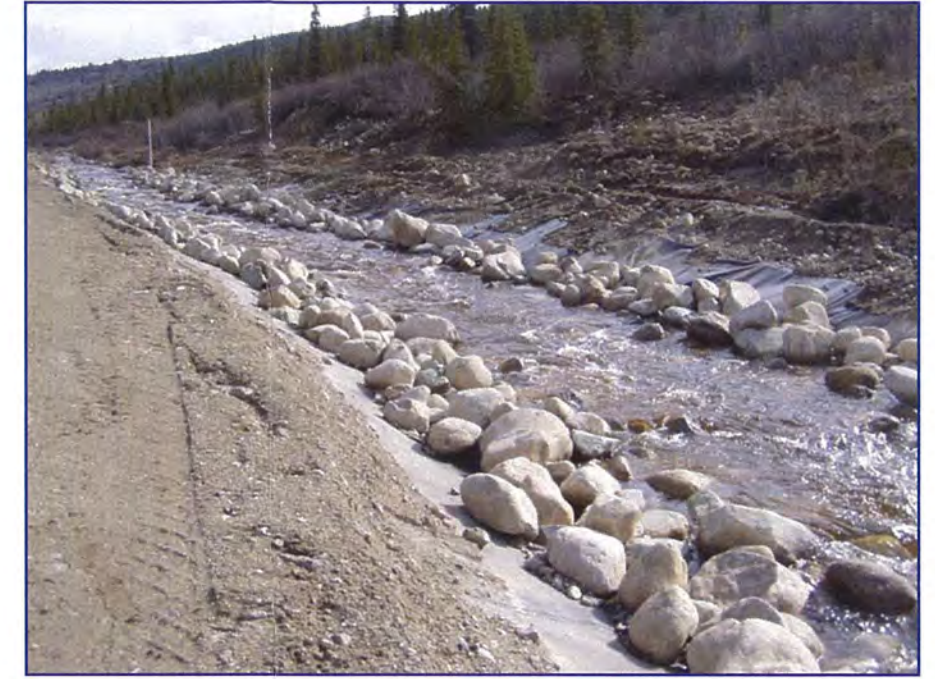
May: shows an upstream view of an area with geotextile exposure.

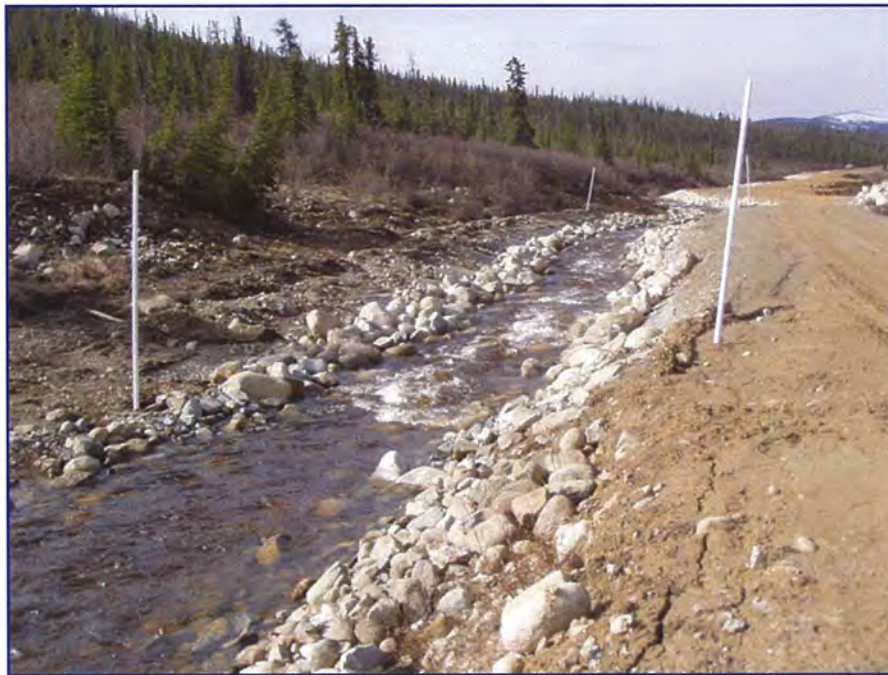
May: shows an downstream view of the area that was repaired in 2007. Note that some of the fill is soft and cracking.

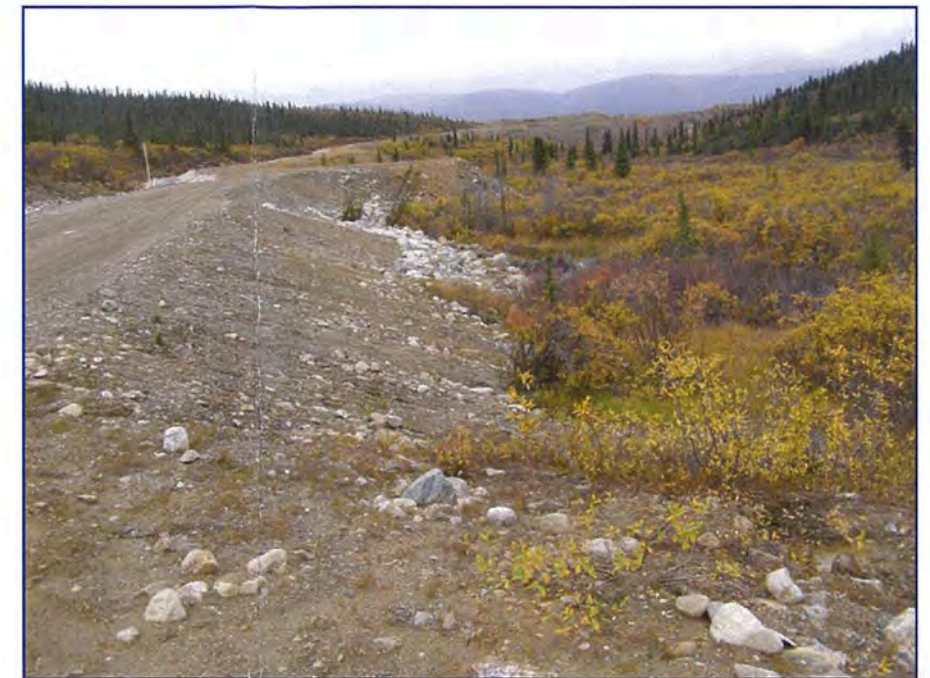
September: shows the toe of the road in the repair area. Note the ponded water in the toe area.

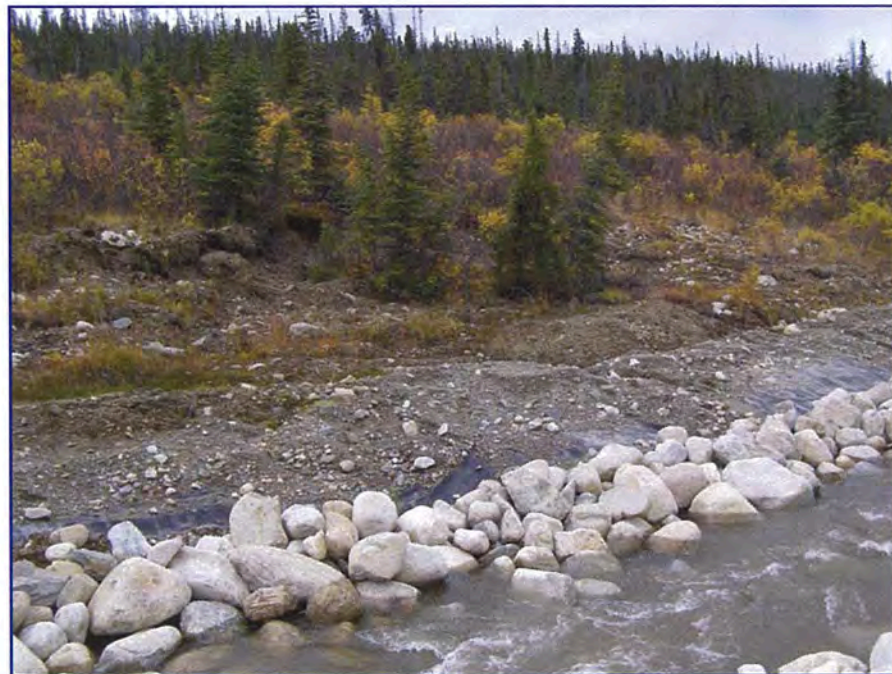
September: shows the backslope above the repair area. Note the slumping of the disturbed ground.

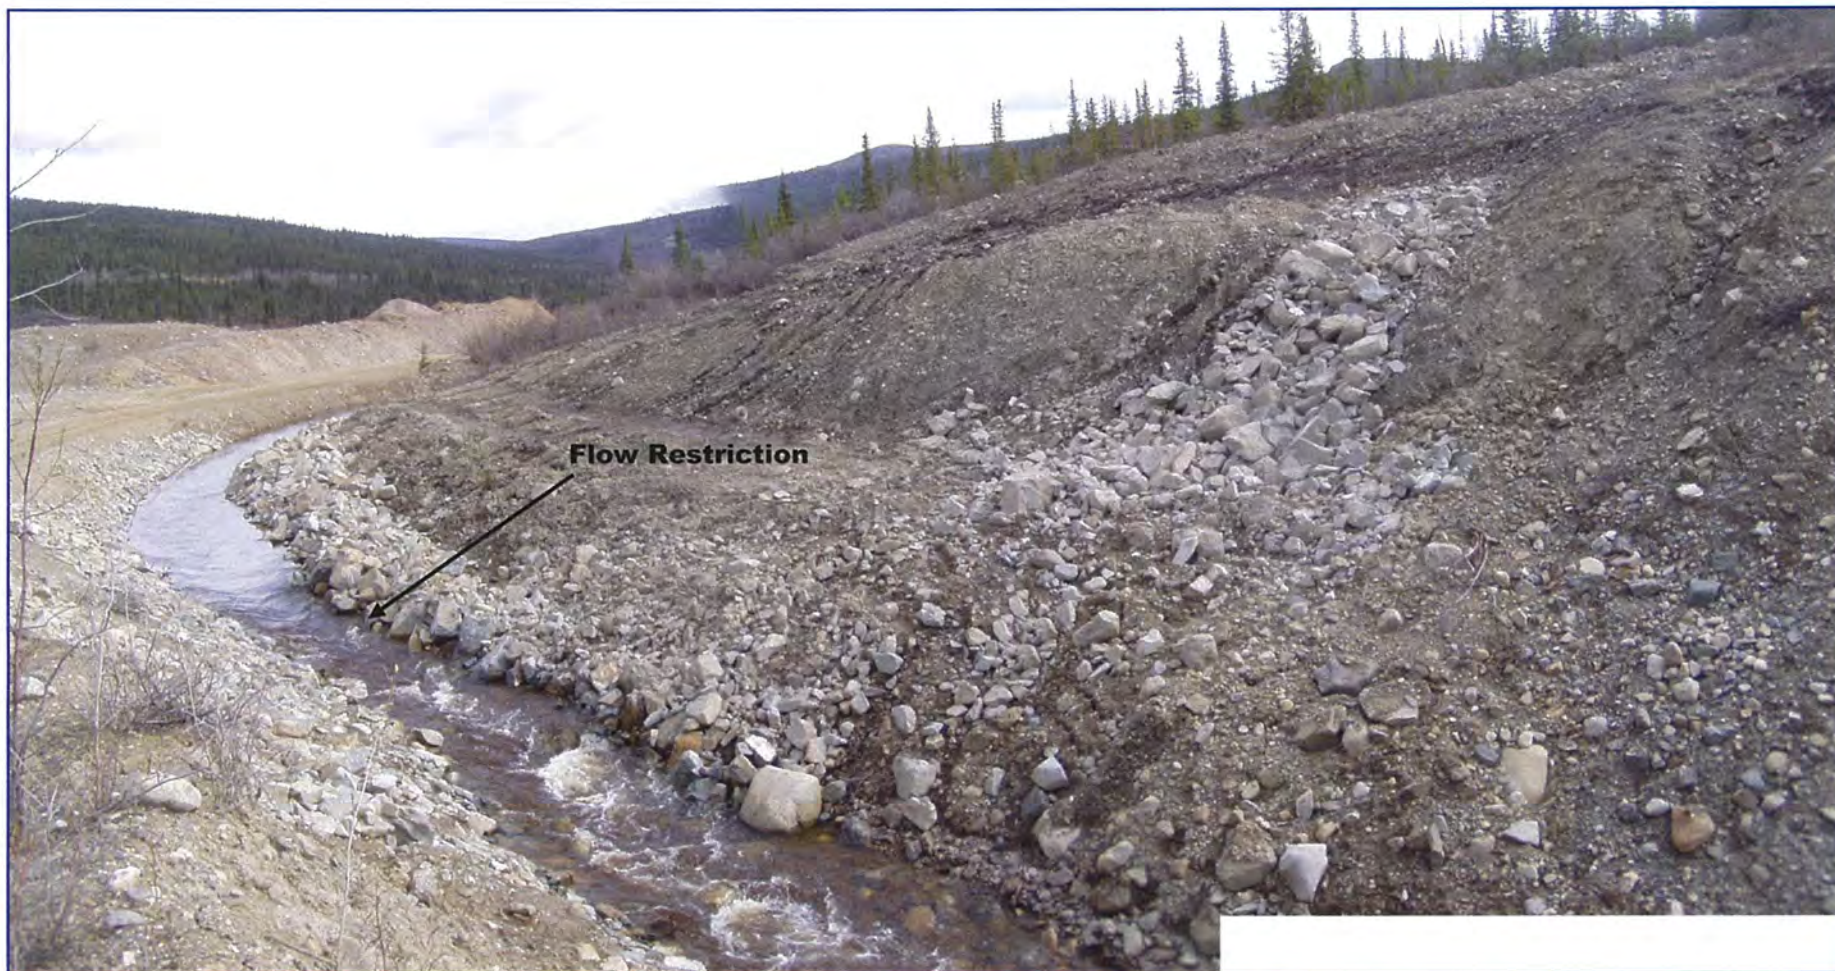
May: a panoramic view of the repaired slough area which was caused partially by over steepened banks. The area is still restricting the flow through the channel.

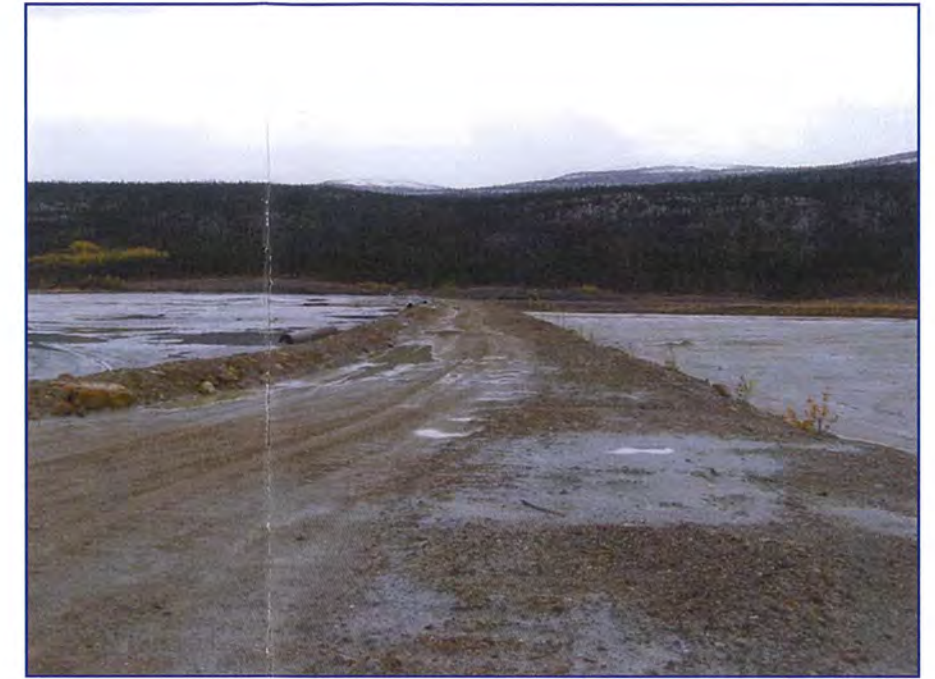
September: a view of the crest of the dam. Note that some settlement holes are forming and erosion is evident.
