2009 ANNUAL GEOTECHNICAL EVALUATION AND INSTRUMENT REVIEW

VARIOUS FACILITIES AT FARO MINE, YUKON

PROJECT NO.: 0762-002-05
DATE: FEBRUARY 26, 2010

**RE: 2009 ANNUAL GEOTECHNICAL EVALUATION AND INSTRUMENT REVIEW
VARIOUS MINE WASTE FACILITIES AT FARO MINE, YUKON**

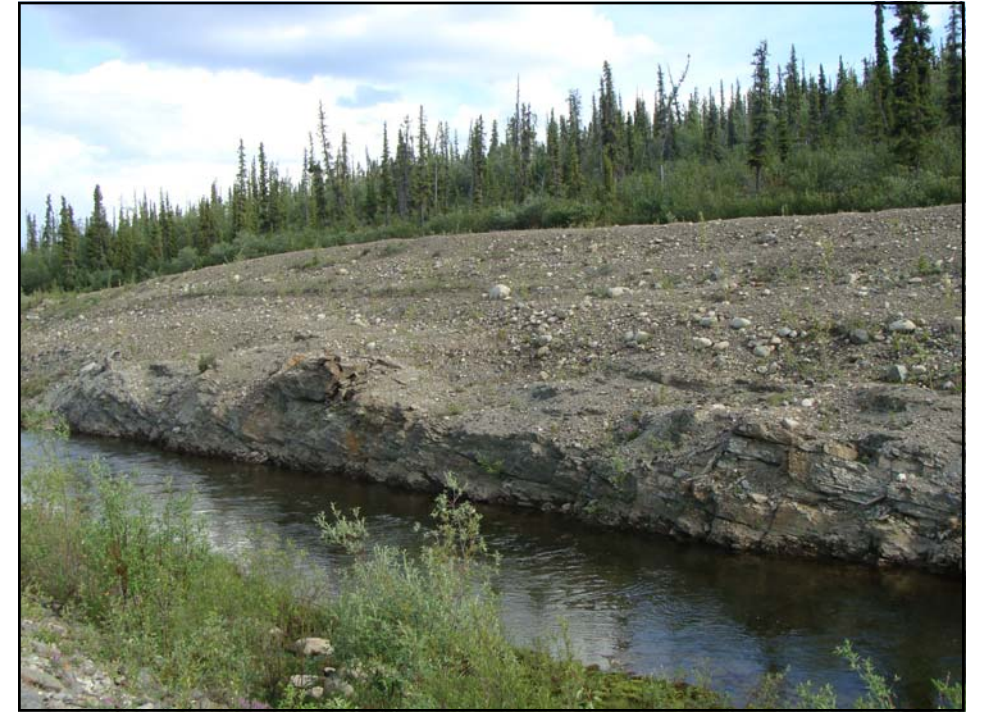
July: shows a view of the slump in the backslope of the Diversion Channel.

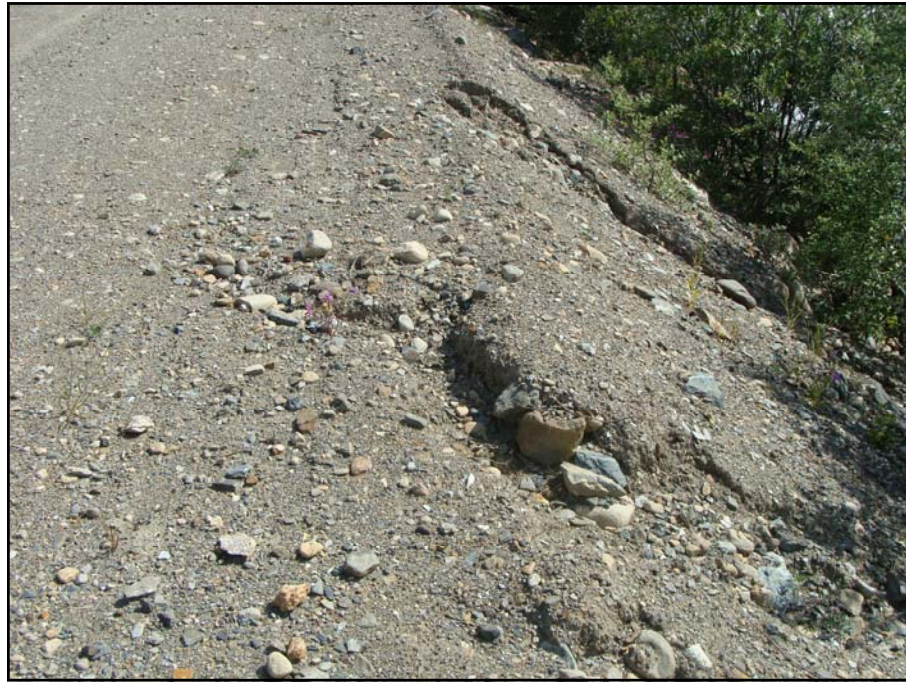
July: shows minor erosion occurring on road edge. Repairs not needed, but should be monitored.

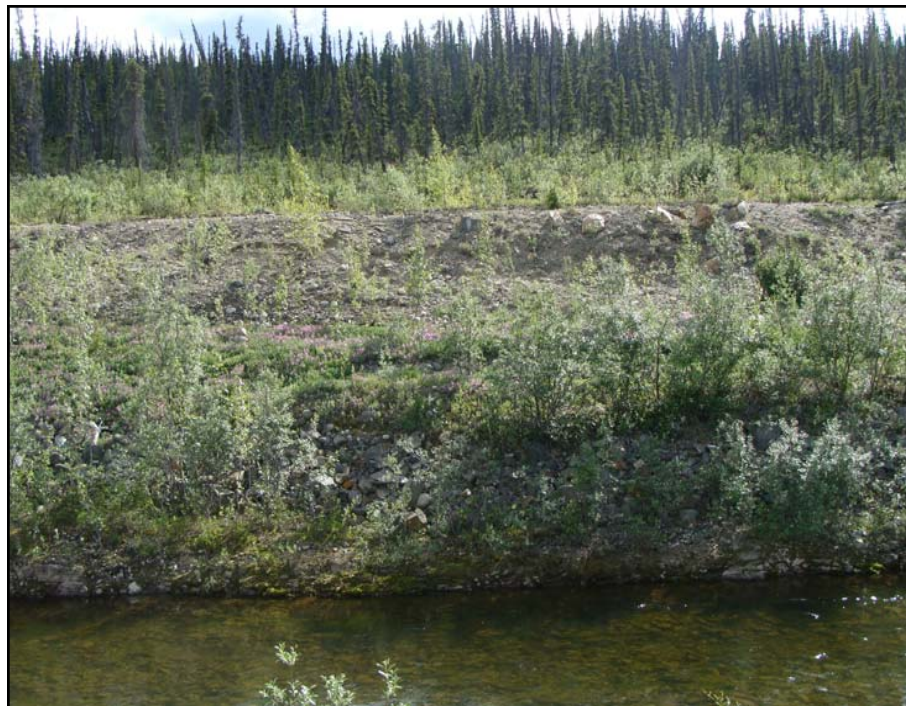
July: shows a slump area that has had some advancement over the past year. Repair is not yet needed.

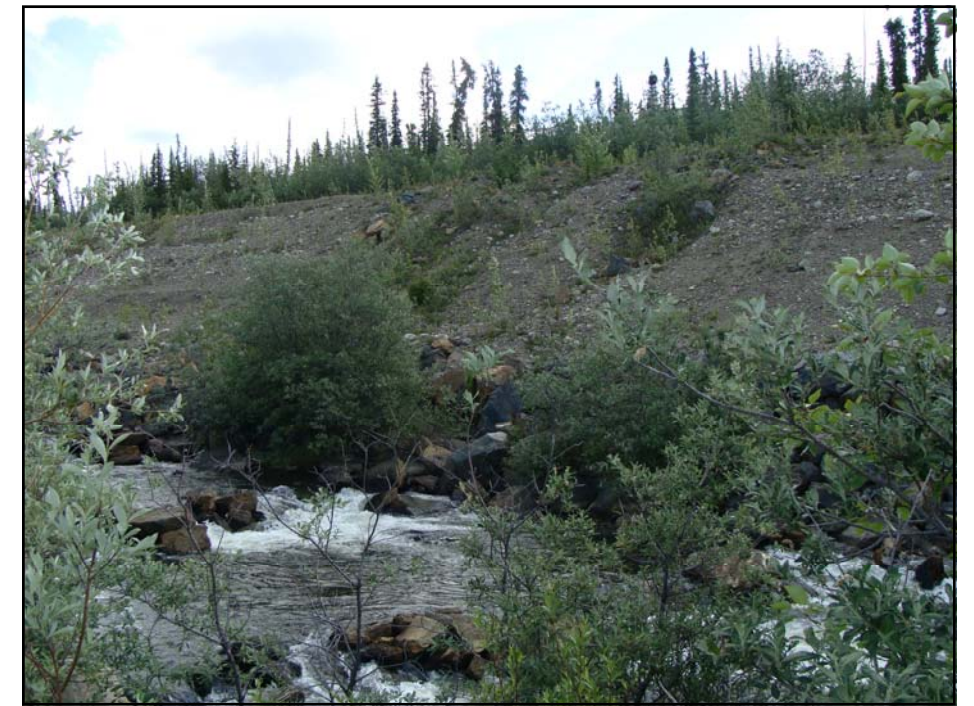
July: shows a view of some erosion gullies in the backslope of the canal.

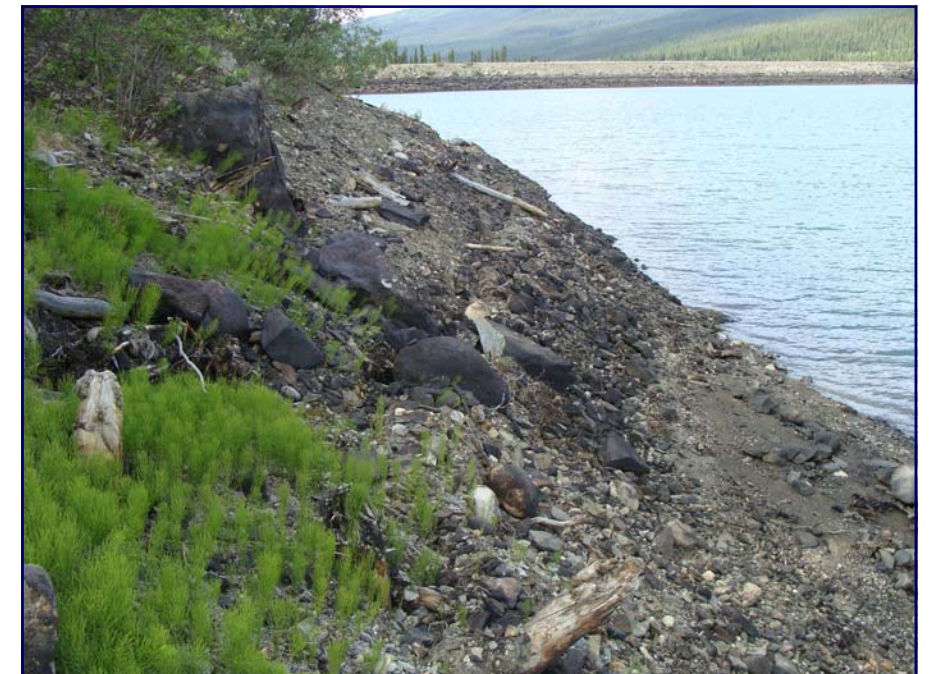
July: shows ice plucking damage to shoreline.

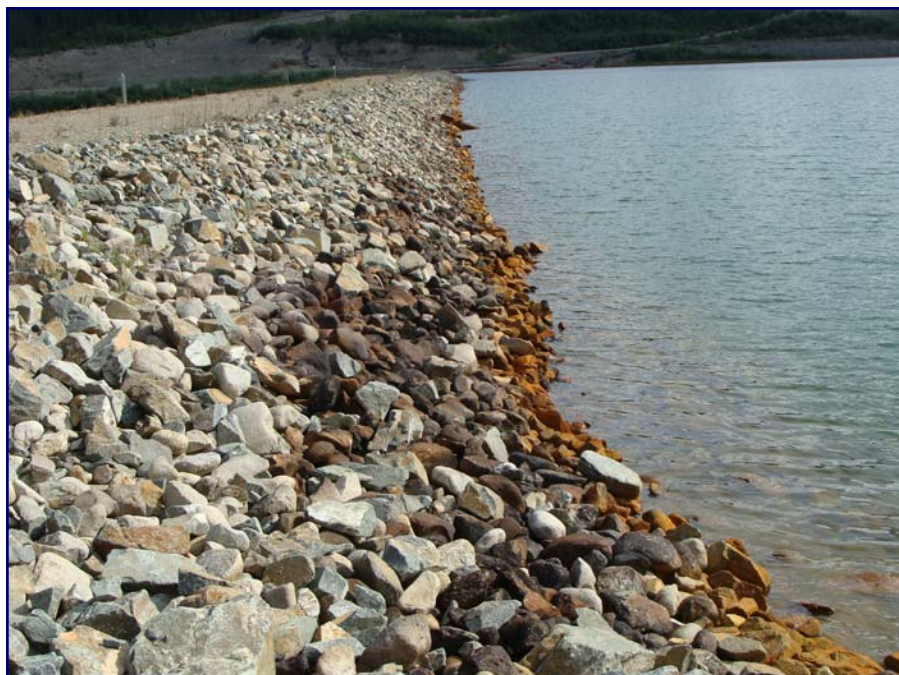
July: shows a view of the upstream face which was repaired in July 2007. Appears to be in good condition with no wave erosion occurring.

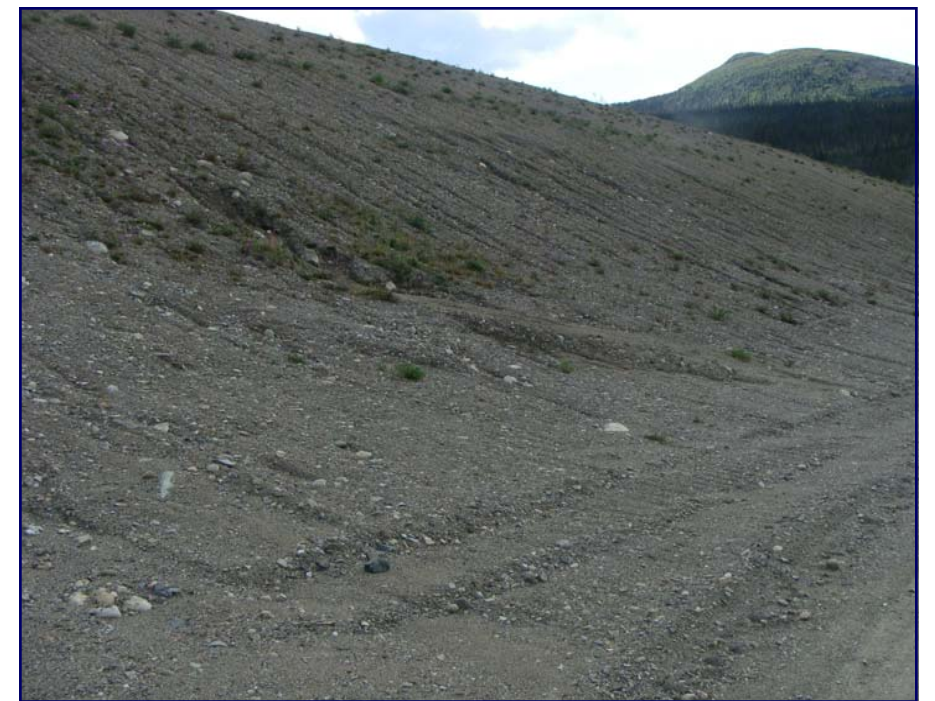
July: a view of the downstream face of the Intermediate Dam Note the appearance of the erosion rills on the face.

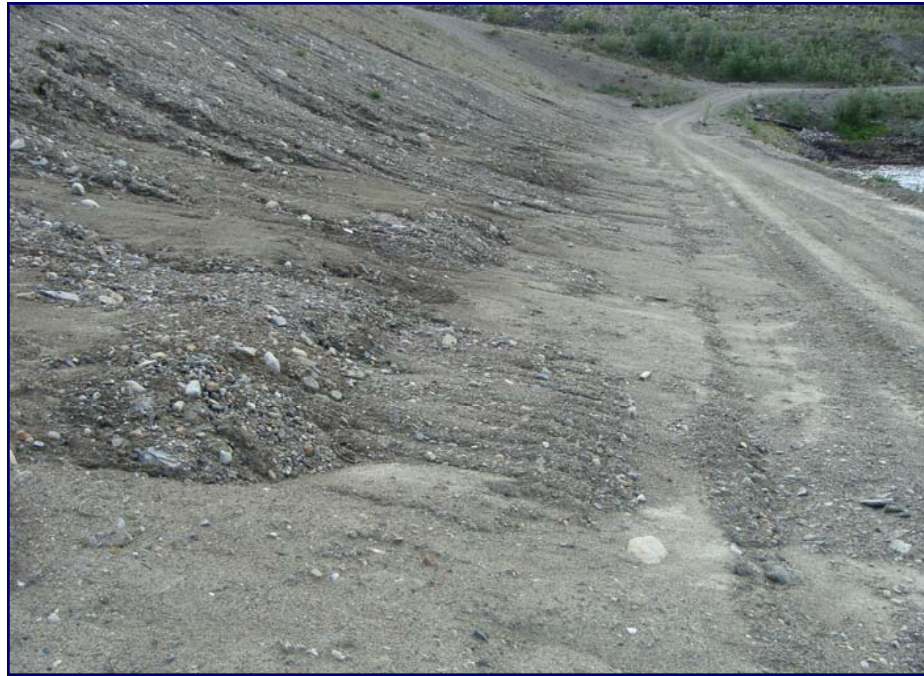
July: shows a view of erosion on the downstream face. This area should be repaired by removing the eroded sand and silt from the gravel drain outlet.

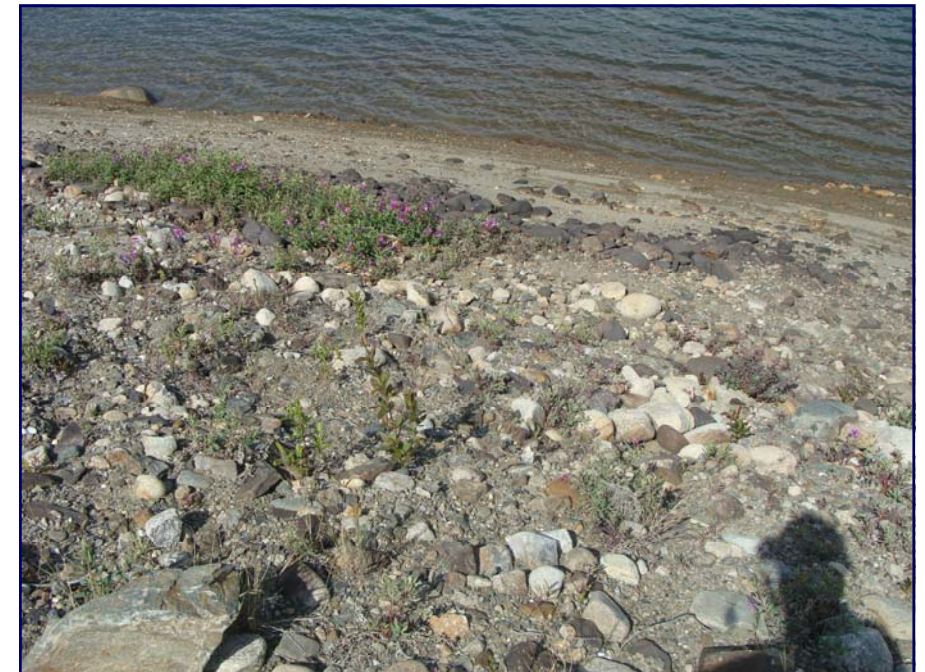
July: a view of the edge of the polishing pond, note some ice plucking damage to the riprap.

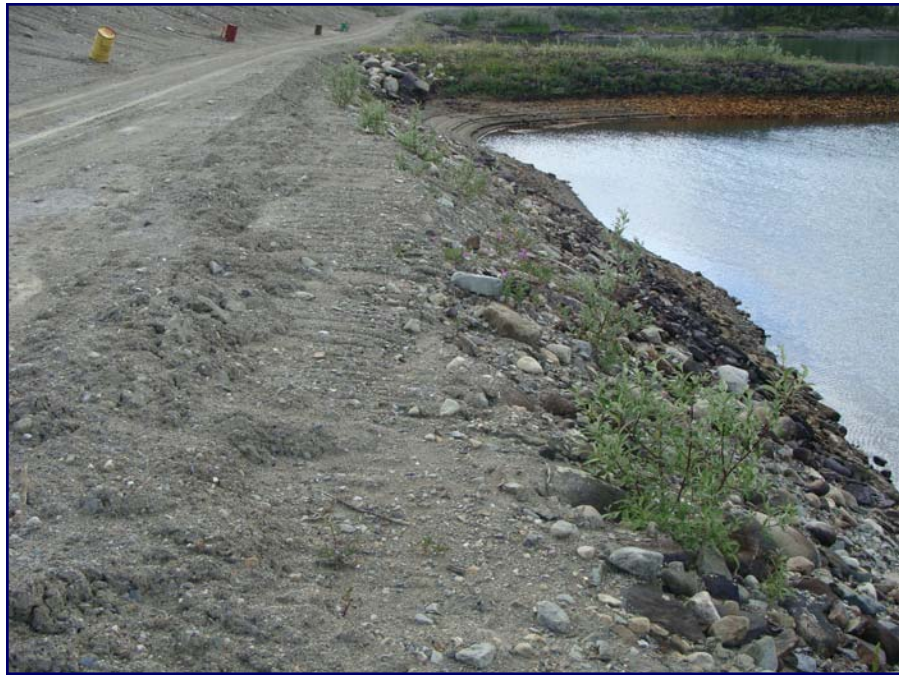
July: a view of minor cracking occurring at the edge of the polishing pond. Note that cracking has historically been seen in this area.

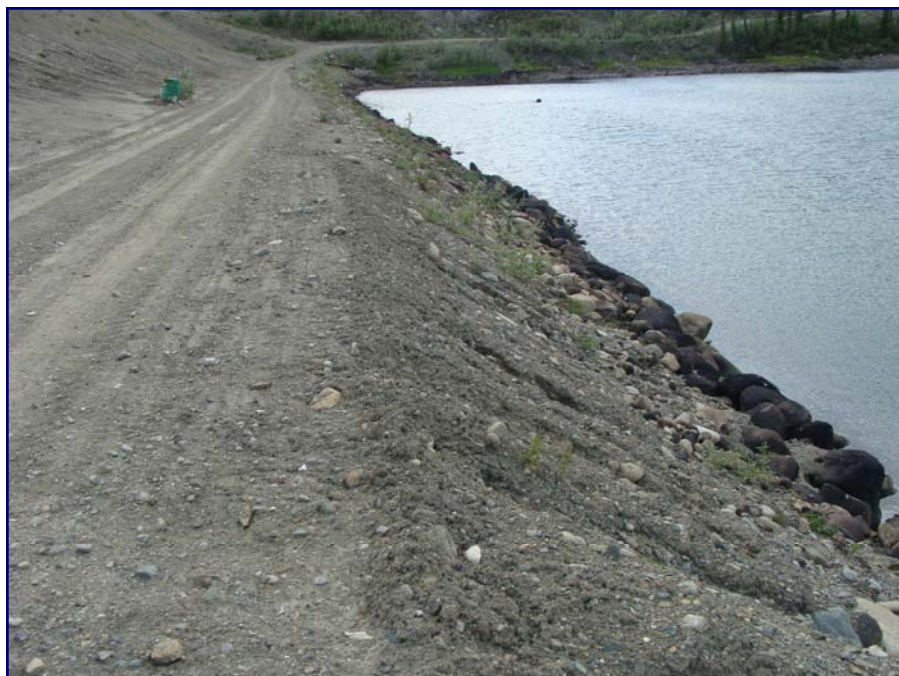
July: shows a view of the edge of the polishing pond. Note that some rilling and wave erosion is evident.

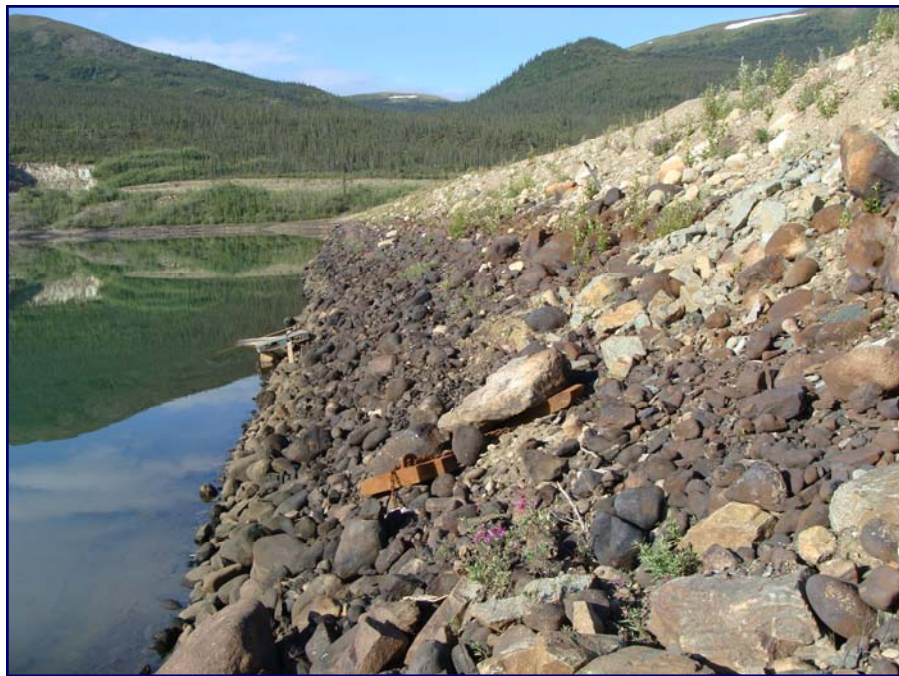
July: looking along the upstream face of the dam at the riprap. Note the water level is lower than the historic high water marks. Some ice plucking damage was noted in 2009, and should be monitored regularly in 2010.

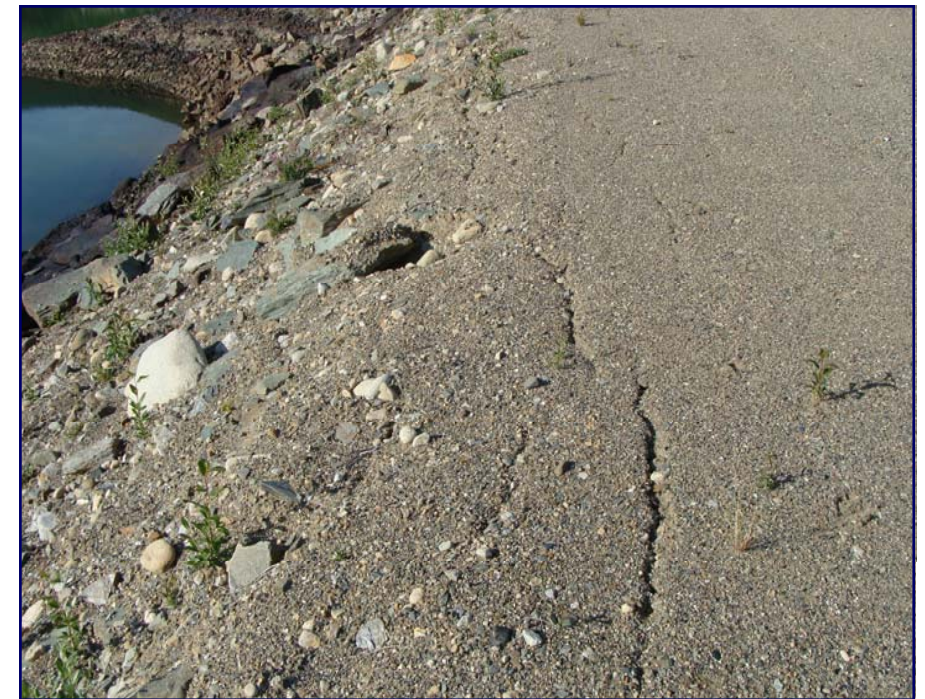
July: view of cracking in the upstream edge of the dam crest. This is likely due to frost action and should be graded and compacted.

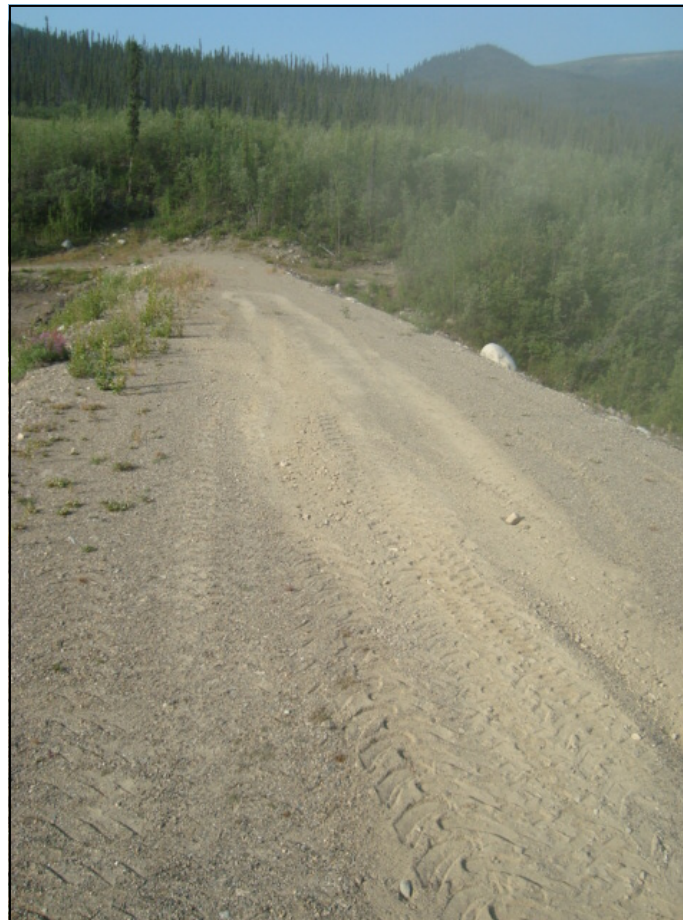
Site Staff Photo, July: shows the crest of the dam after the crack has been repaired.

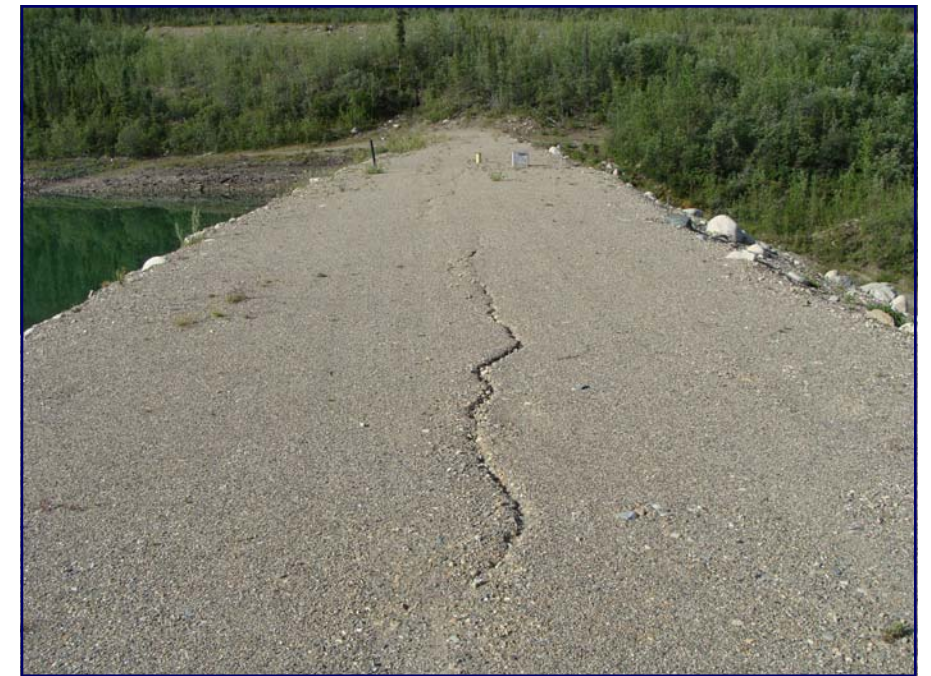
July: shows a crack in the crest of the dam. This is due to frost action and the area should be graded and compacted.

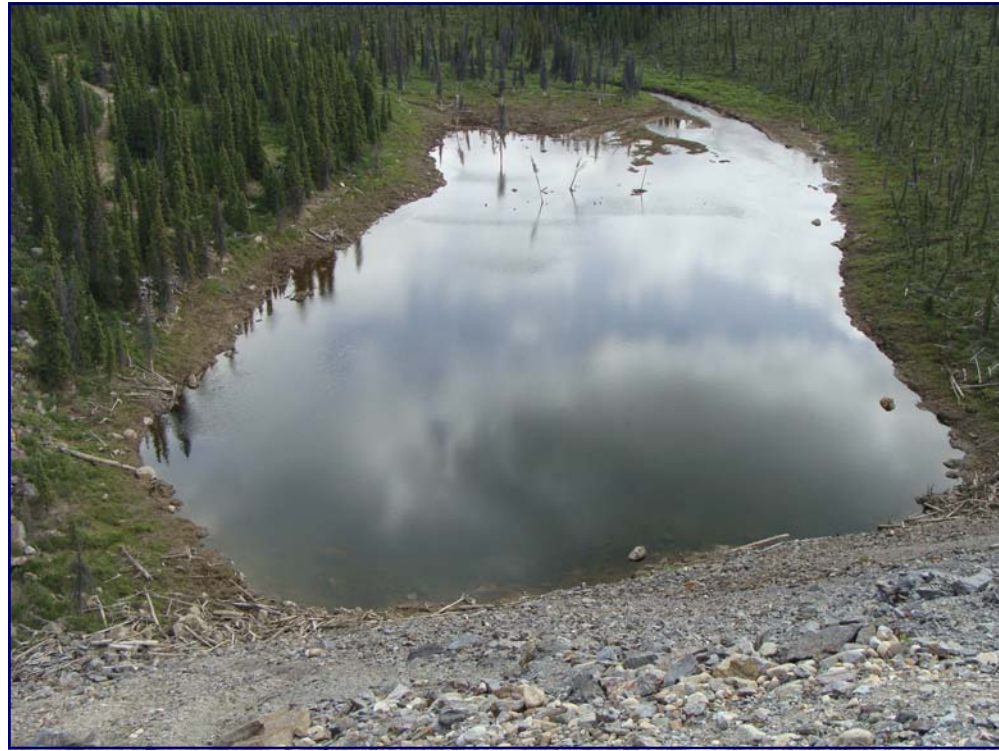
June: shows a view of the upstream head pond of the North Fork Rock Drain. Note that the pond level is higher than for the same flow 4 years ago. This appears to be due to beaver activity on the upstream face of the rock drain.

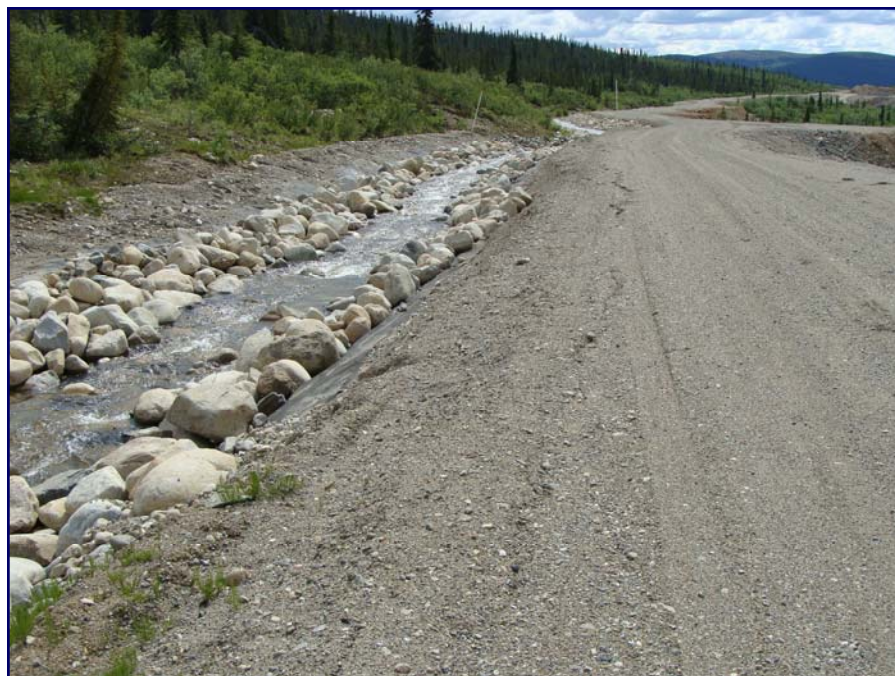
June: shows an downstream view of the area that was repaired in 2007. Note that some of the fill is soft and cracking.

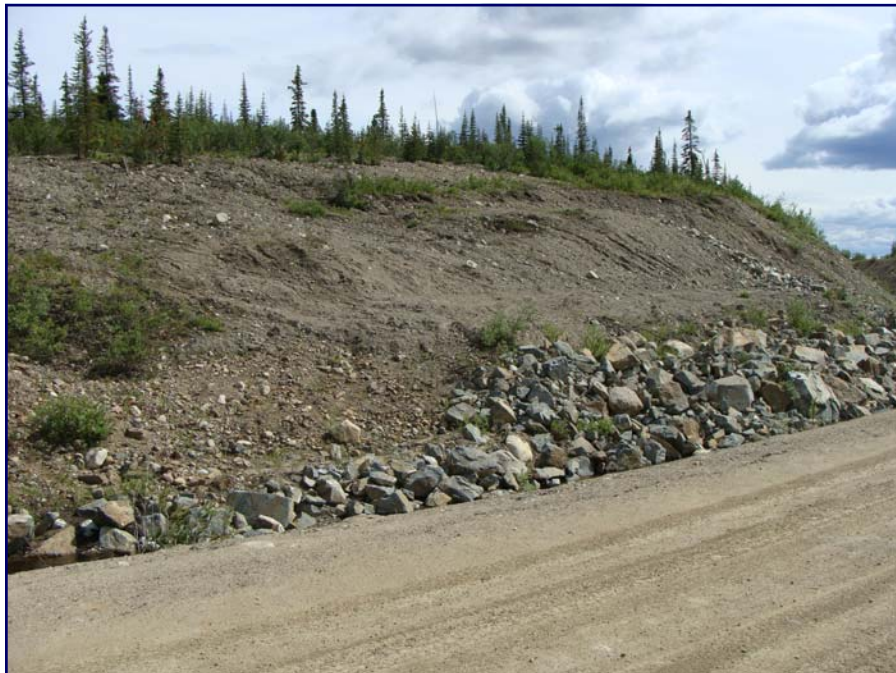
June: shows the slope stability repair zone in the backslope. Note the slumping of the disturbed ground.

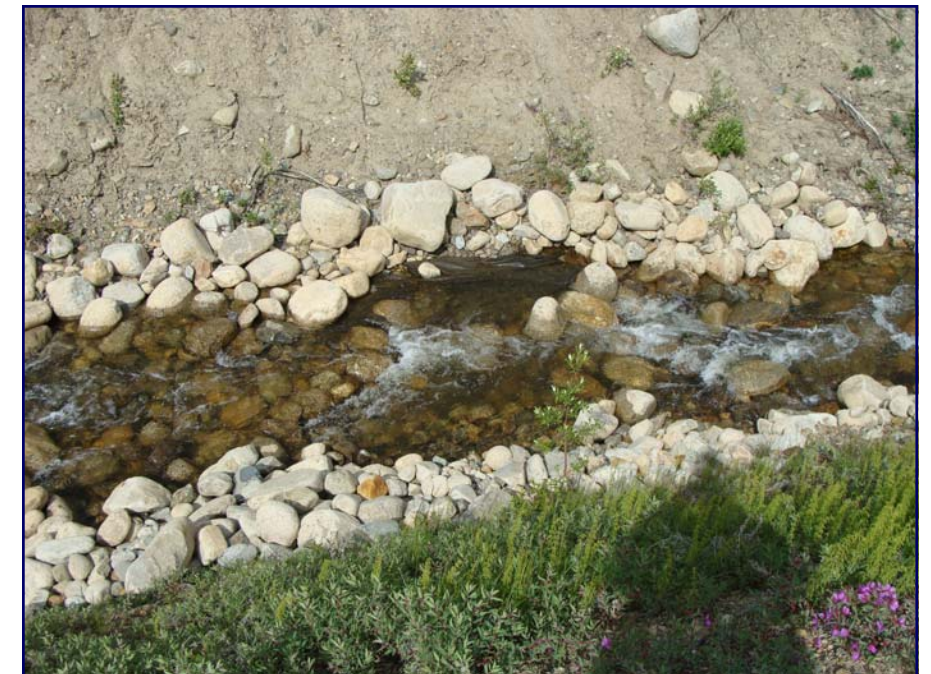
June: shows a view of the lower end of riprap placement in the Faro Creek Diversion. Riprap has been moved downstream and geotextile is exposed. No repairs needed.

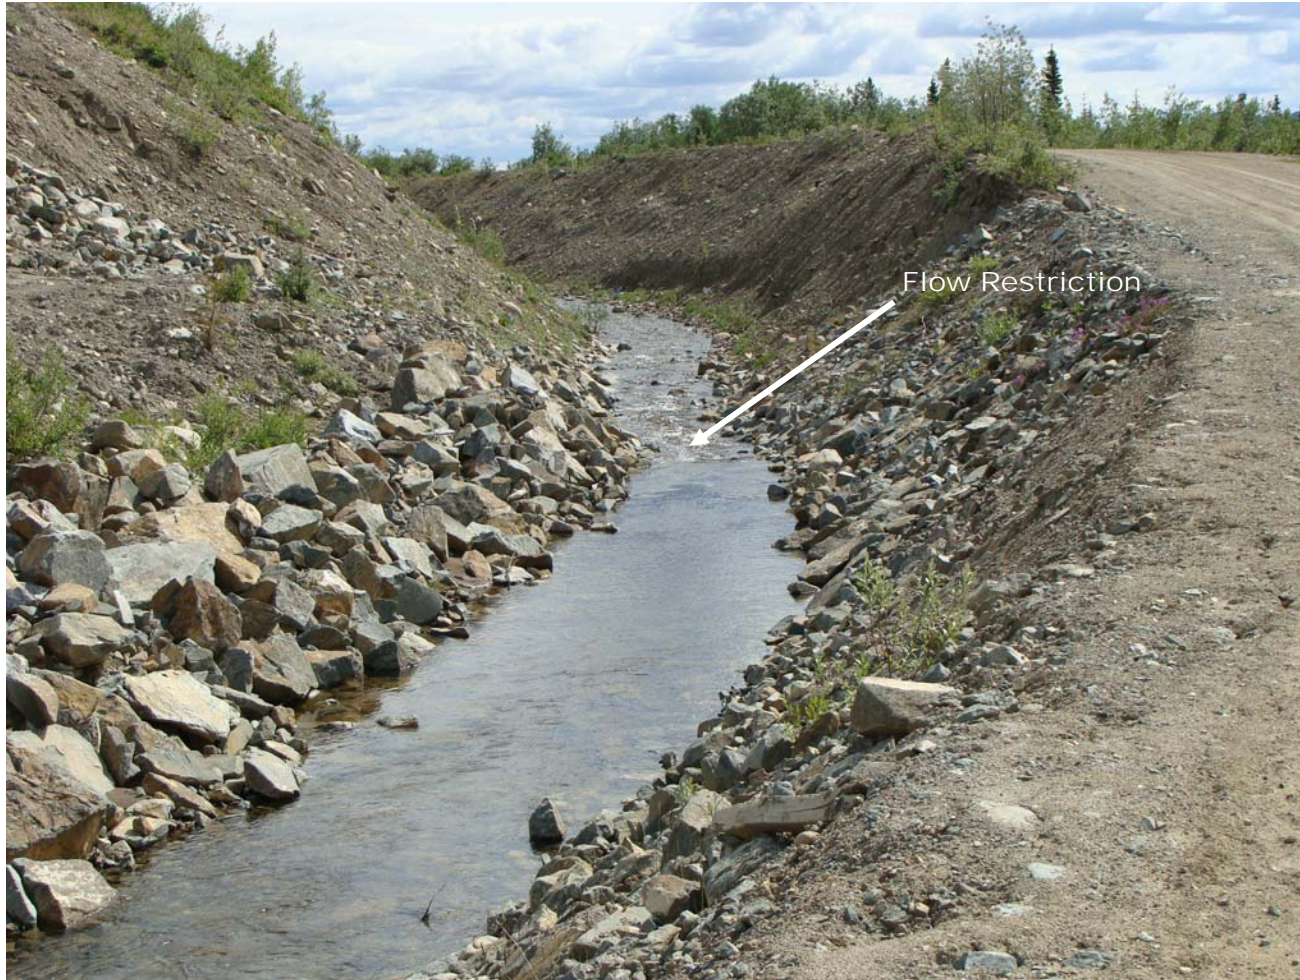
June: a view of the repaired slough area which was caused partially by over steepened banks. The area is still restricting the flow through the channel. Repaired in July 2009 by site staff.

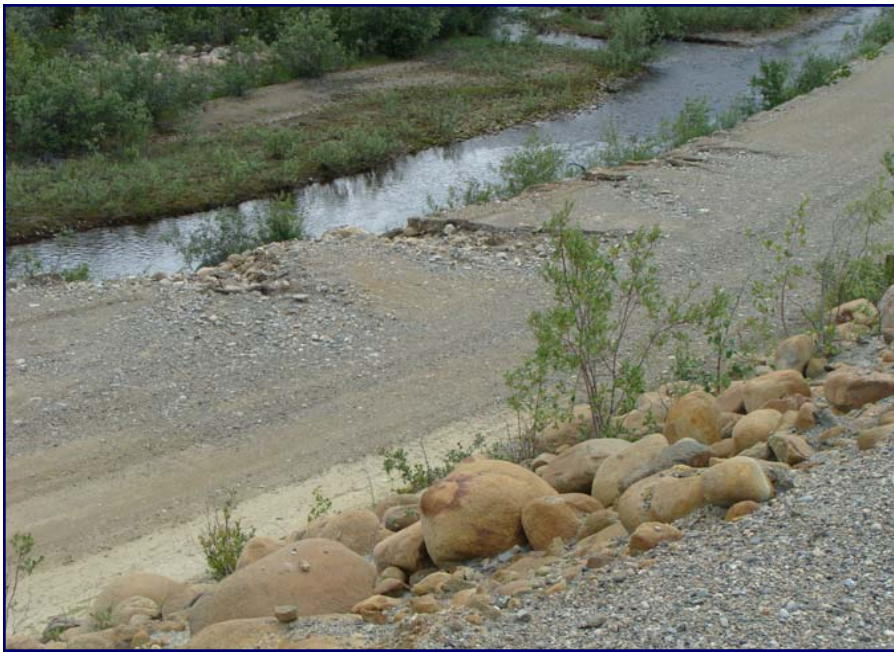
July: shows a view of erosion that is occurring on the lower road at the toe of the dam. This should be repaired by creating a channel to divert run-off.

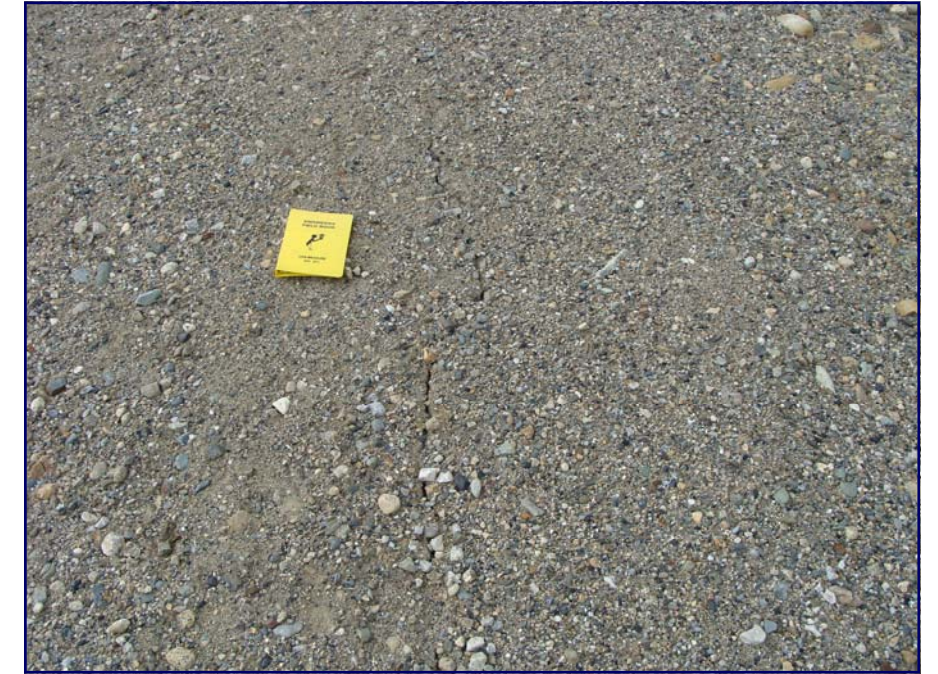
July: A faint crack in the crest of the dam on the tailings side. Monitor the area in 2010 for deterioration.

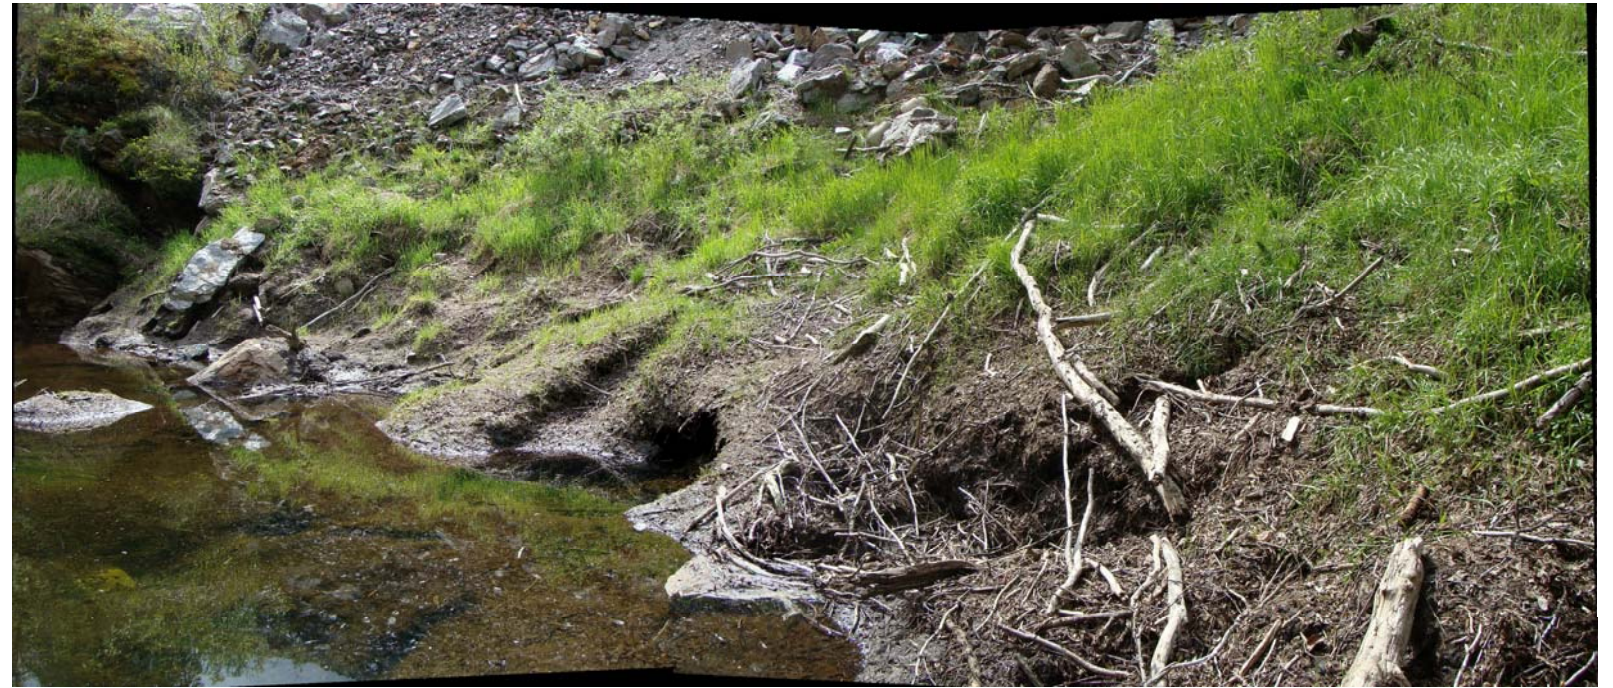
June: a view of the sediment and grass that is present on the upstream face of the rock drain.
