Klohn Crippen Berger

Faro Mine Complex

2012 Annual Geotechnical Review

March 28, 2013

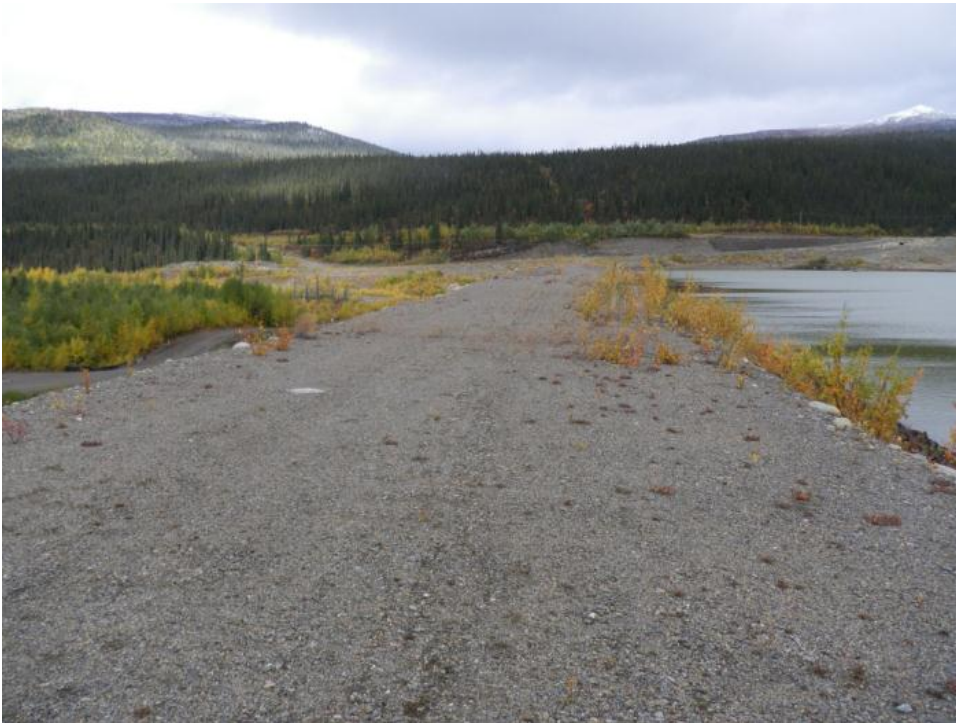
Photo 42 Dam crest along southwest segment – looking northeast, note no visible longitudinal cracks on crest surface (September 11, 2012)

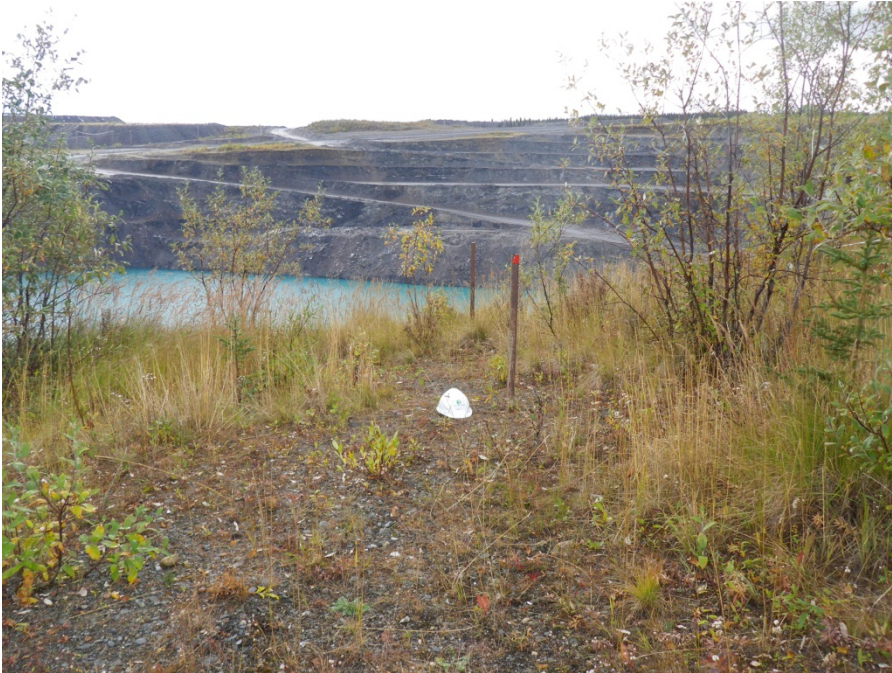
Photo 52 Reference Rods NP-1 and NP-2 along north array – crack noted at hard-hat location near NP-2 (September 12, 2012)

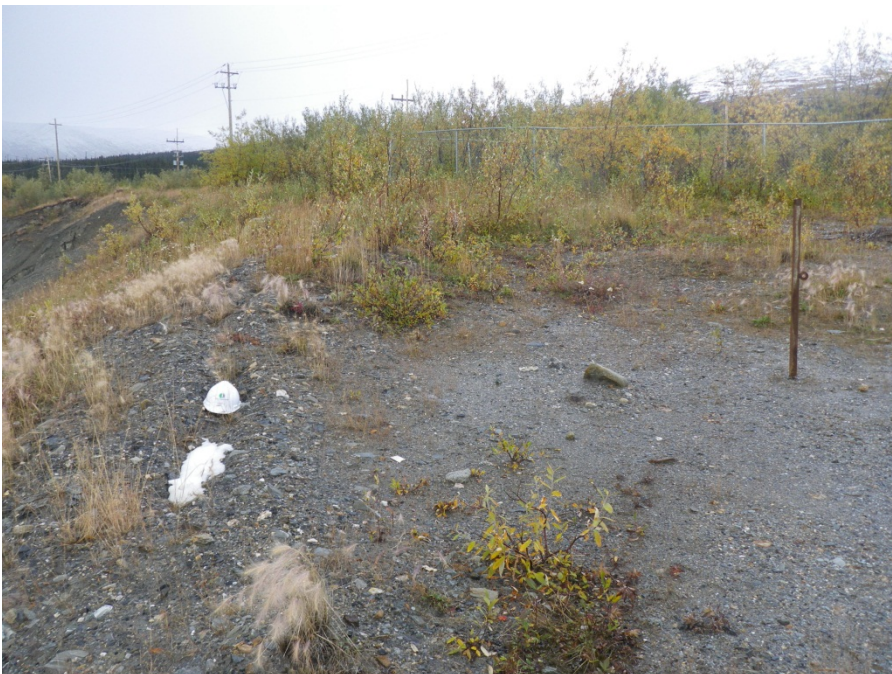
Photo 53 Reference Rod SP-1 along south array – ground deformation noted at hard-hat location (September 12, 2012)

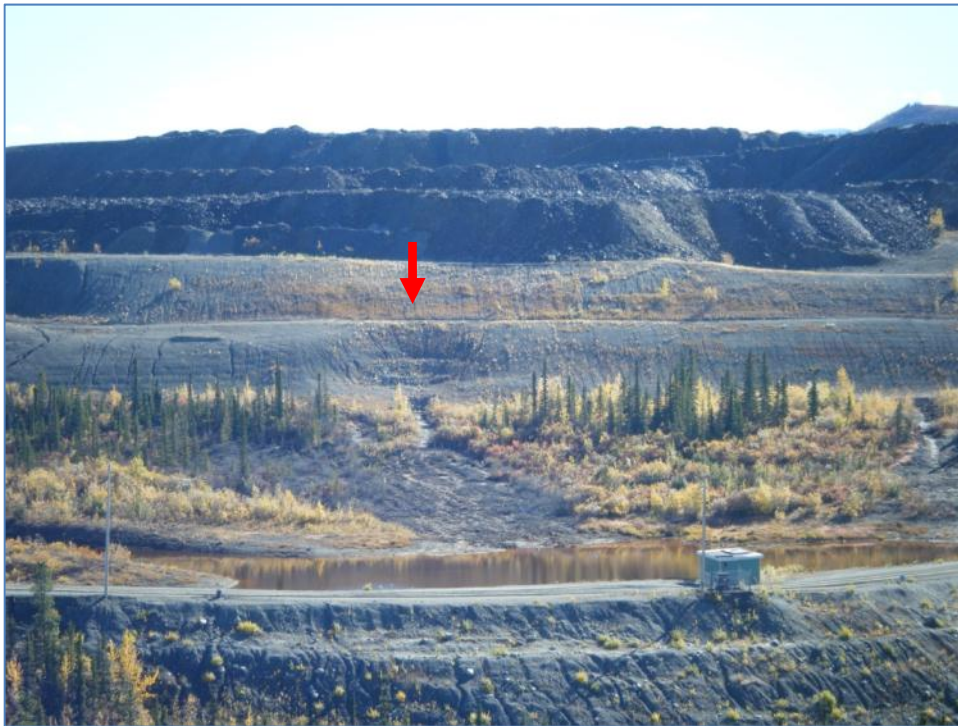
Photo 62 Waste Dump previously noted subsidence at the arrow (September 20, 2012)

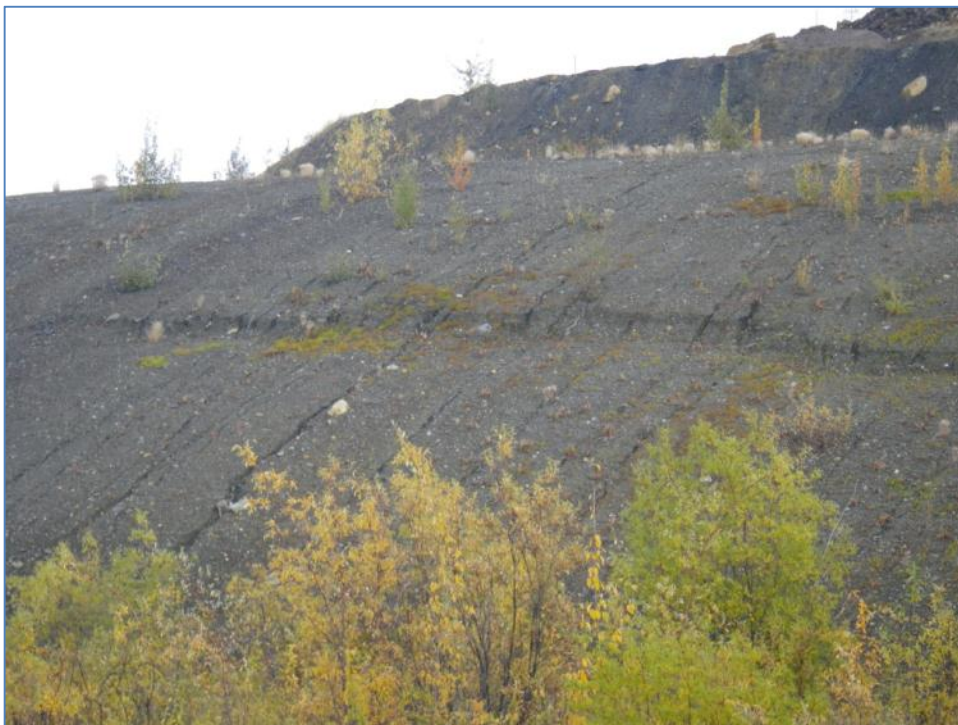
Photo 63 Waste Dump slope with old scarp and rill erosion (September 13, 2012)

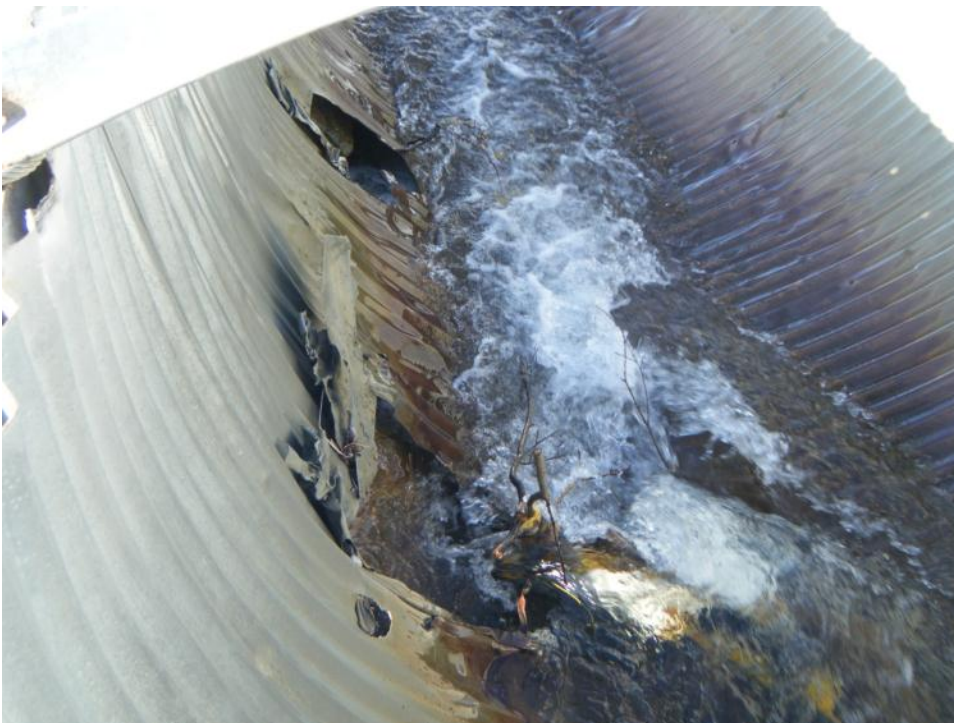
A flash flood occurred at the Vangorda Creek flume diversion in June 2012. The flume overflowed and the overflow was barely contained by the channel bank slopes outside the flume without spilling into the Vangorda Pit. The flash flood also eroded the riprap and earthfill around the upstream end of the main culvert feeding the flume. It also damaged the half-pipe flume at numerous locations requiring emergency repair. Damage to the flume included dents and holes in half-pipe and bent bracings. There was accumulation of sediments in the flume along the flatter section upstream of the plunge pool. This event was similar to that which occurred in 2004 (SRK 2004). The discharge capacity of the channel outside the flume needs to be checked, and capacity along the reach that barely contained the flow in June, 2012 needs to be enlarged to minimize the potential of spilling flood water into the Vangorda Pit. Moreover, the function of the Vangorda flume needs to be reviewed. We understand that a similar flume was removed from the Faro Creek Diversion Channel in the past with no significant detrimental impact.

Photo 91 Damaged Flume (September 20, 2012)

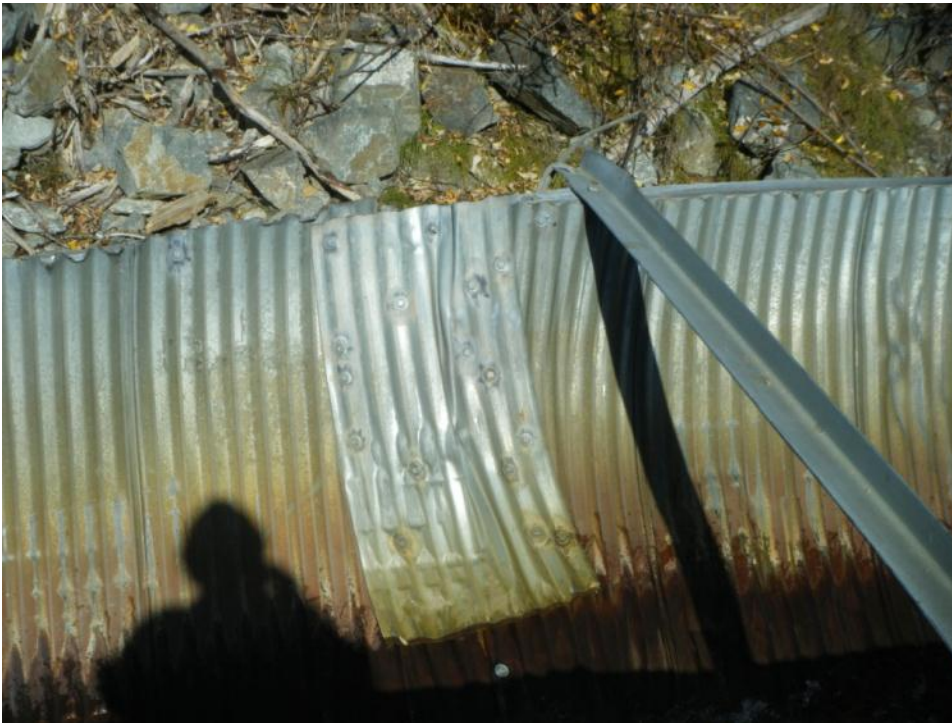
Photo 92 **Repaired flume segment (September 20, 2012)**

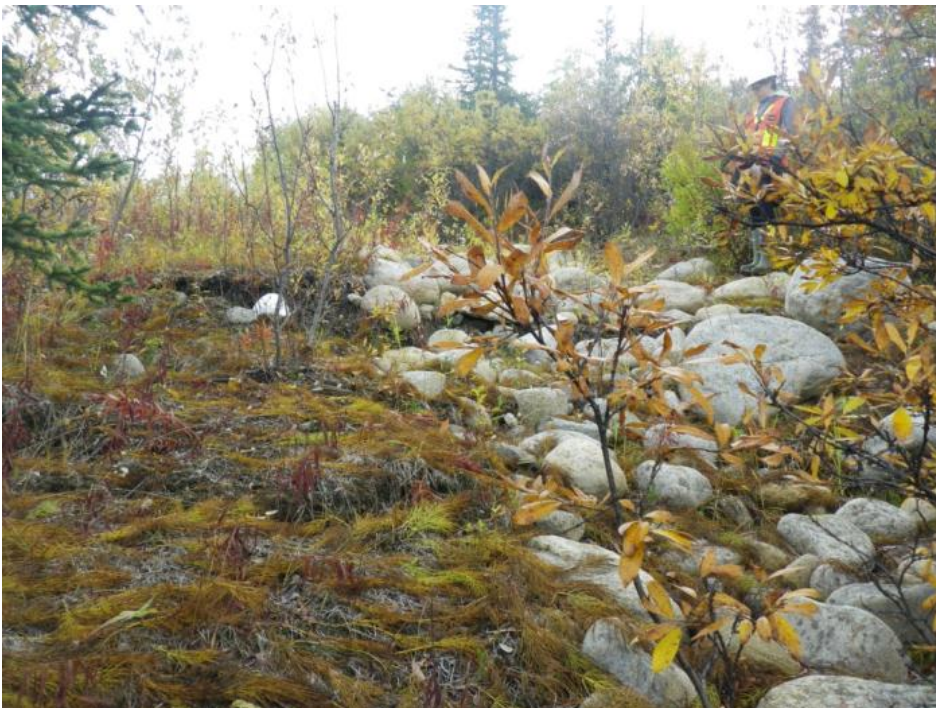
Photo 105 Spillway channel downstream end – note deep crack perpendicular to channel
(September 13, 2012)

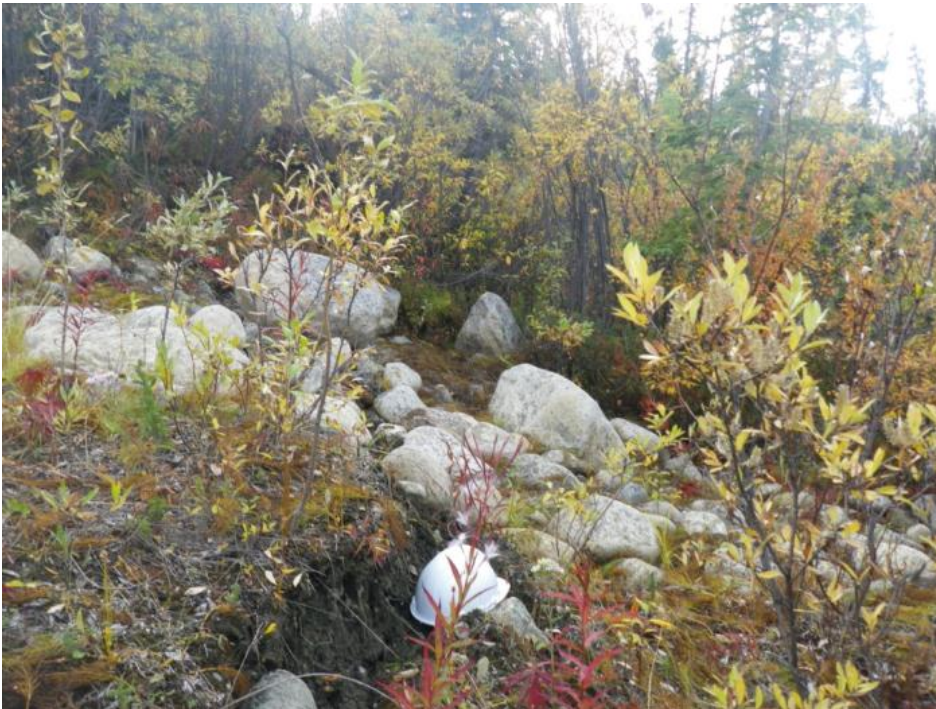
Photo 106 Close up of crack across spillway channel shown on Photo ____ (September 13, 2012)

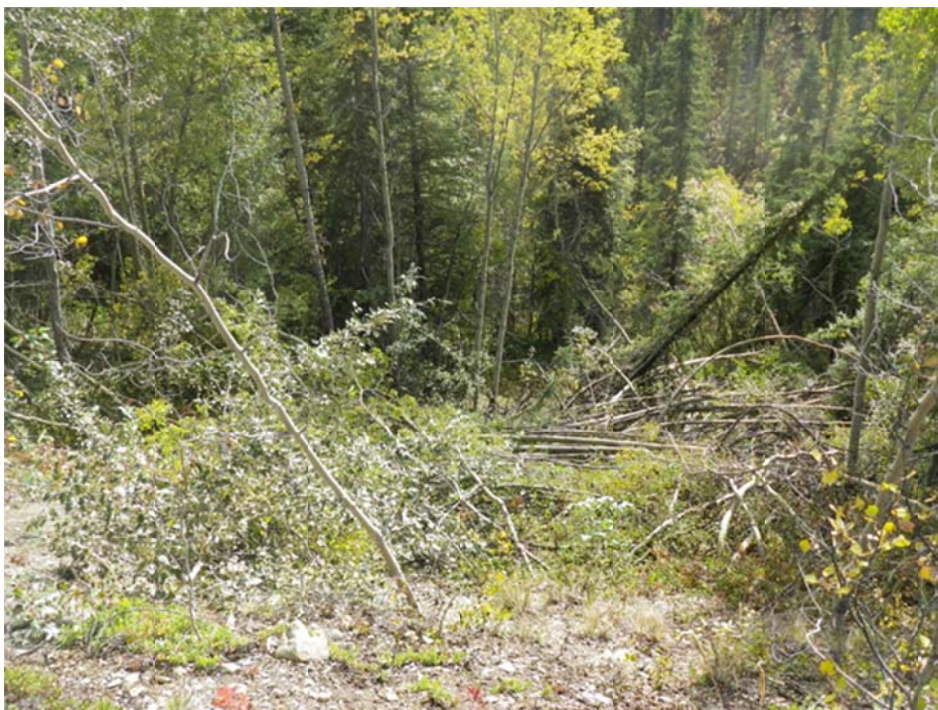
Photo 121 Fallen trees caused by excess seepage issuing from esker slope During 2011 spring runoff event (September 13, 2012)
