Klohn Crippen Berger

Faro Mine Complex

2016 Annual Geotechnical Review

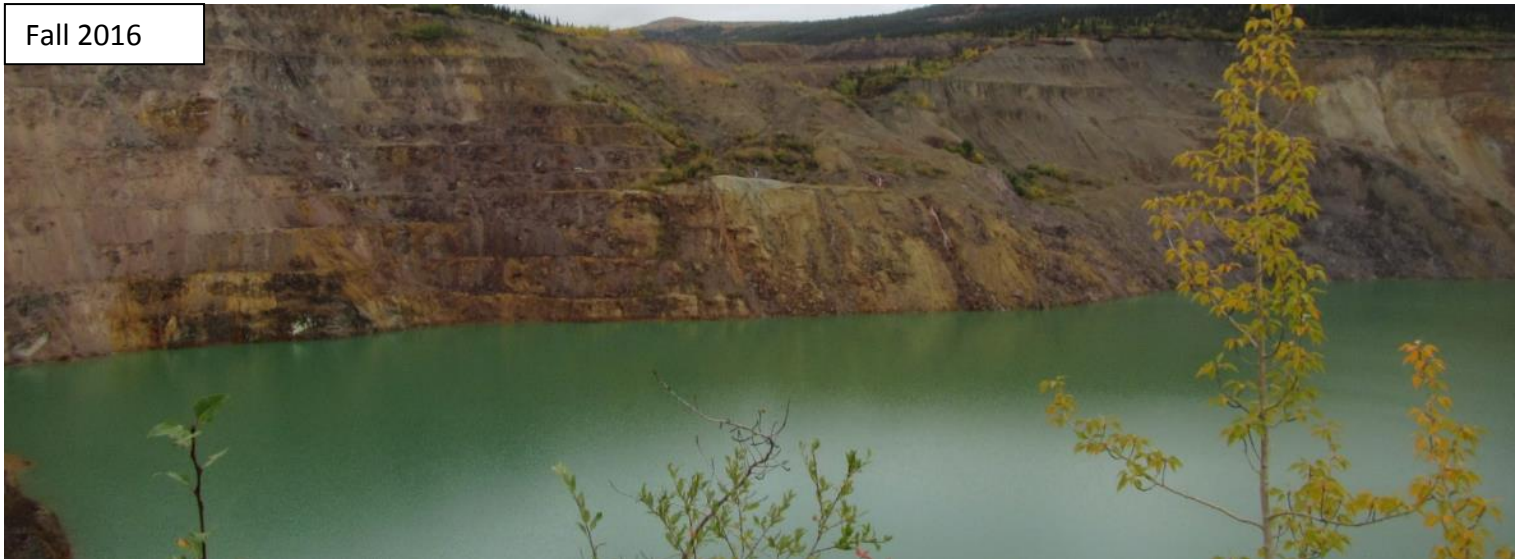
Photograph 1 Faro Pit from “eye-in-the-sky” (Looking at the North and East Walls). Similar conditions in spring and fall.

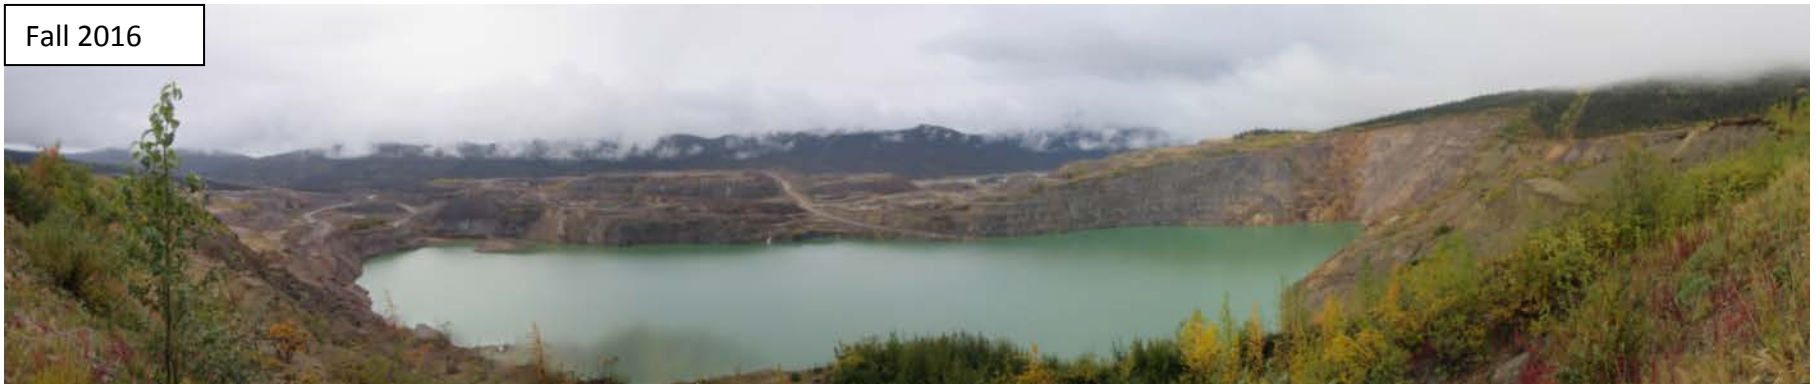
Photograph 2 Faro Pit Northwest Wall and West Wall (from the Faro Creek Diversion Channel). Similar conditions in spring and fall.

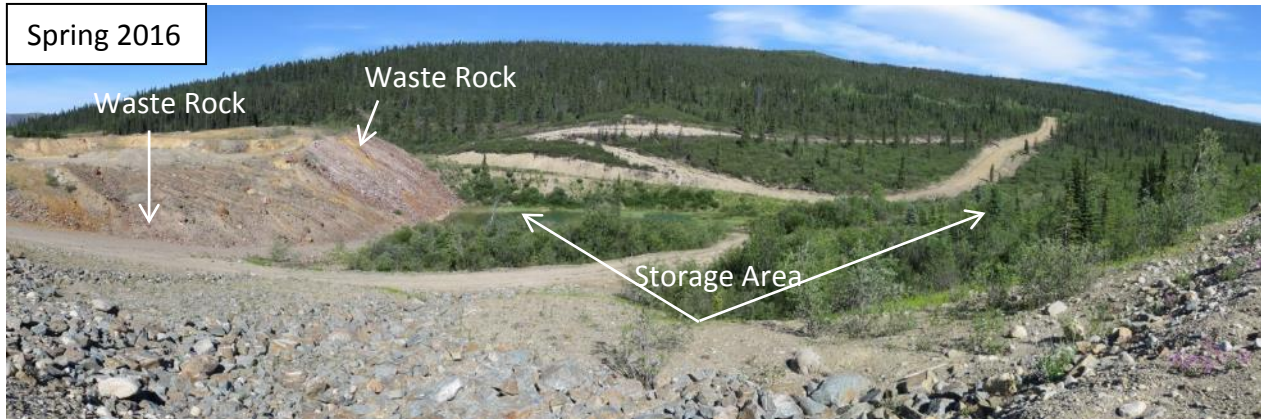
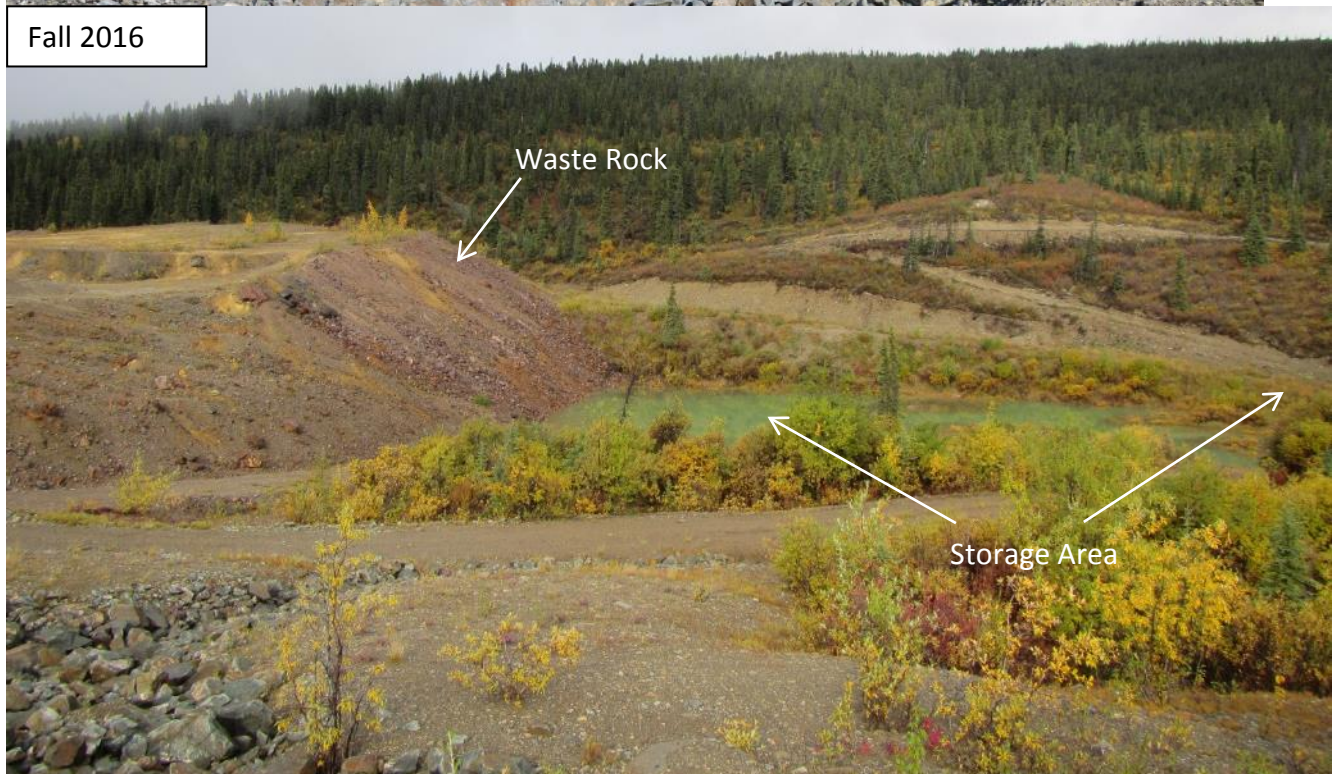
Photograph 3 Faro Creek Diversion Overflow (FCO) Sump (looking west)

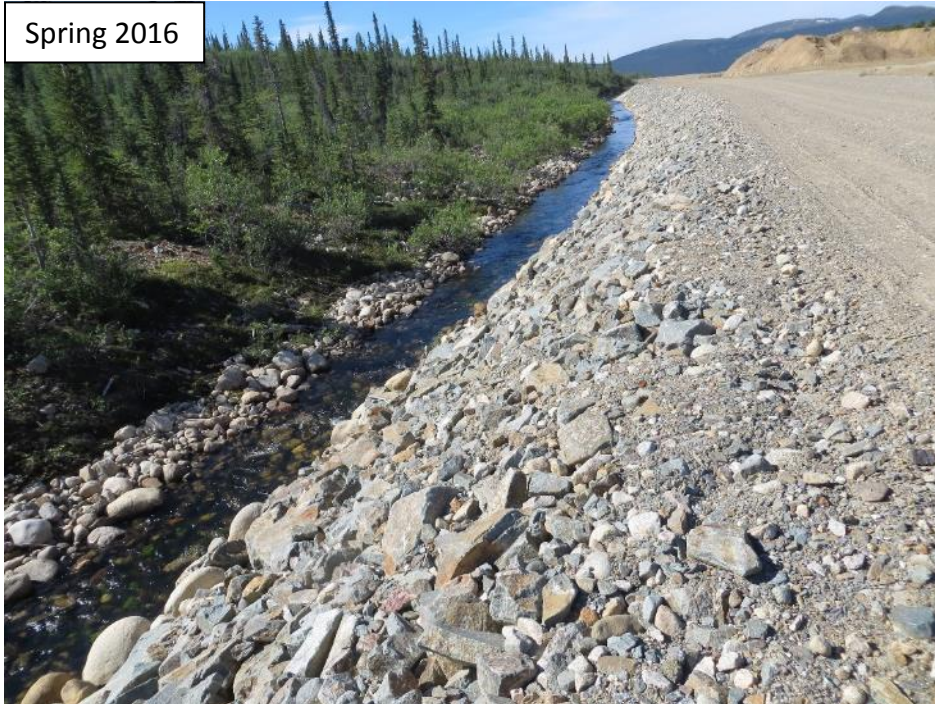
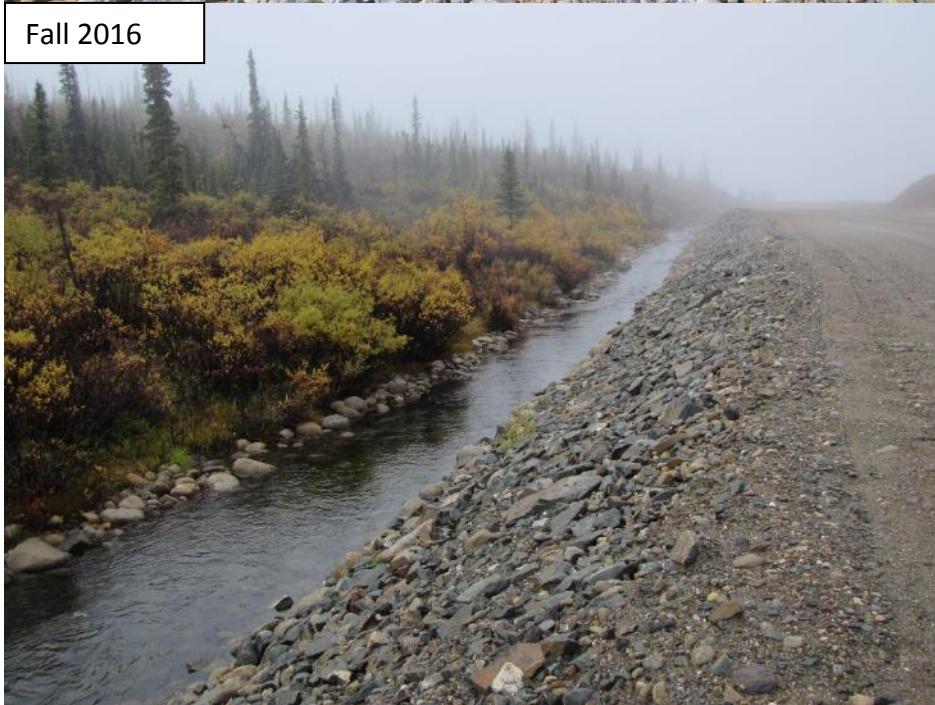
Photograph 4 Upper Faro Creek Diversion. Satisfactory conditions.

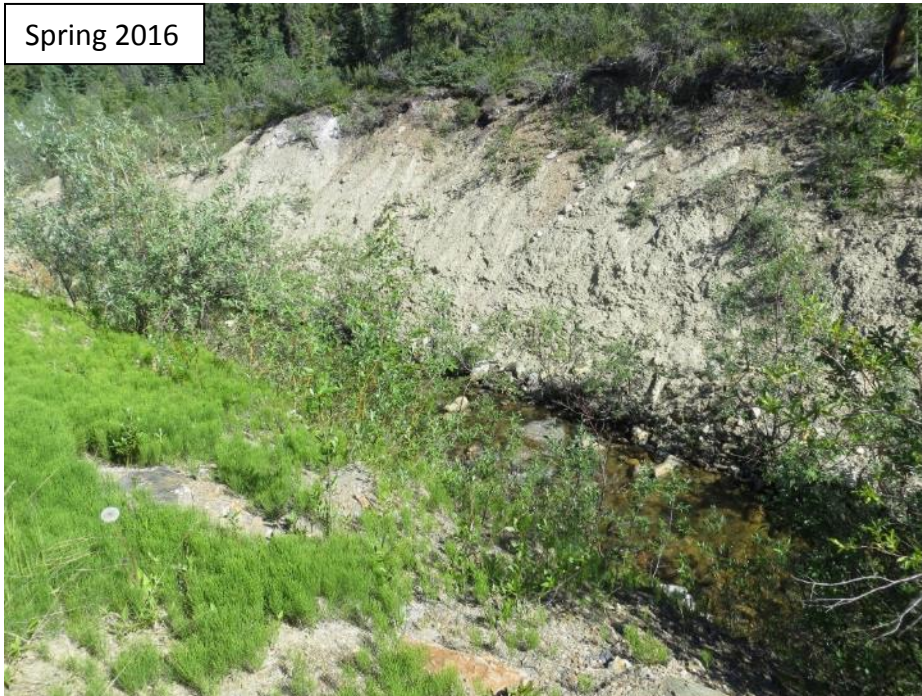
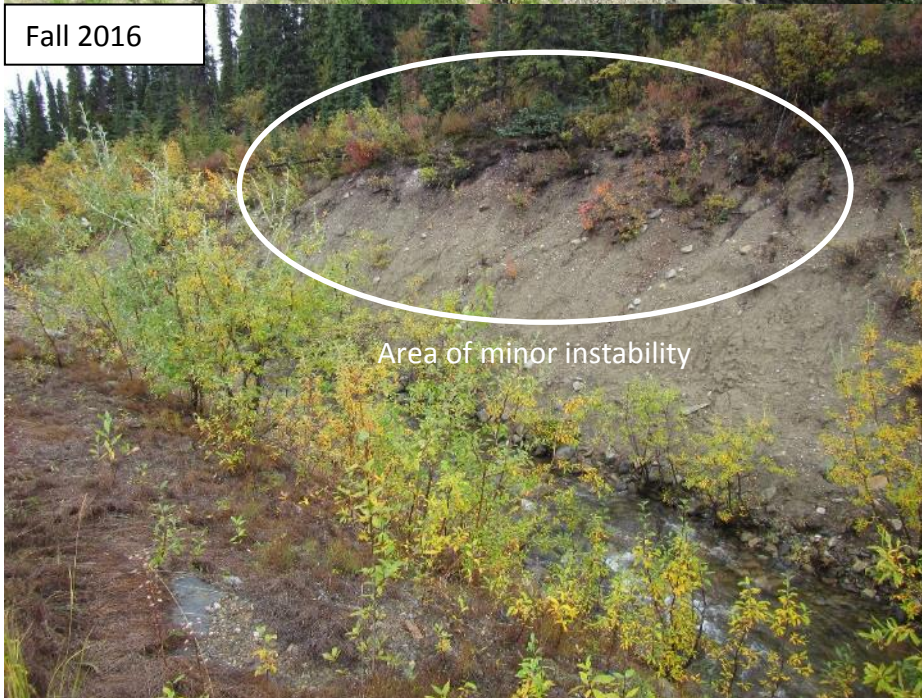
Photograph 5 **Vegetation and Slumping on the Faro Creek Diversion Ditch (Upstream of the FCD-4 Stream Gauge Station)**

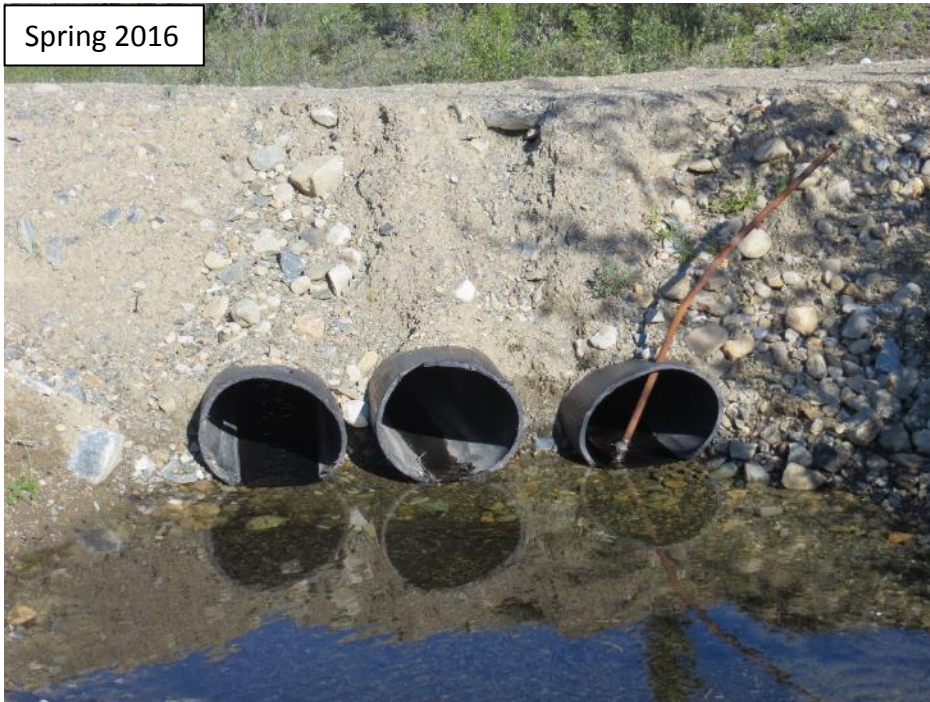
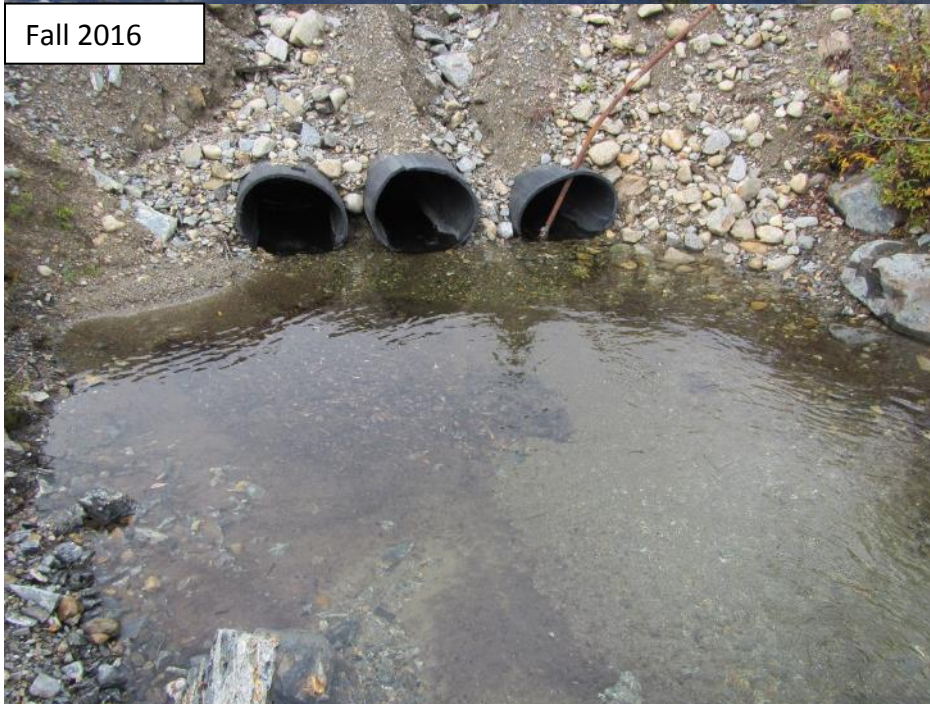
Photograph 8 Interceptor Ditch (Faro Creek) upstream side of the well access road. Satisfactory conditions. Approximately 255 m from the diversion inlet.

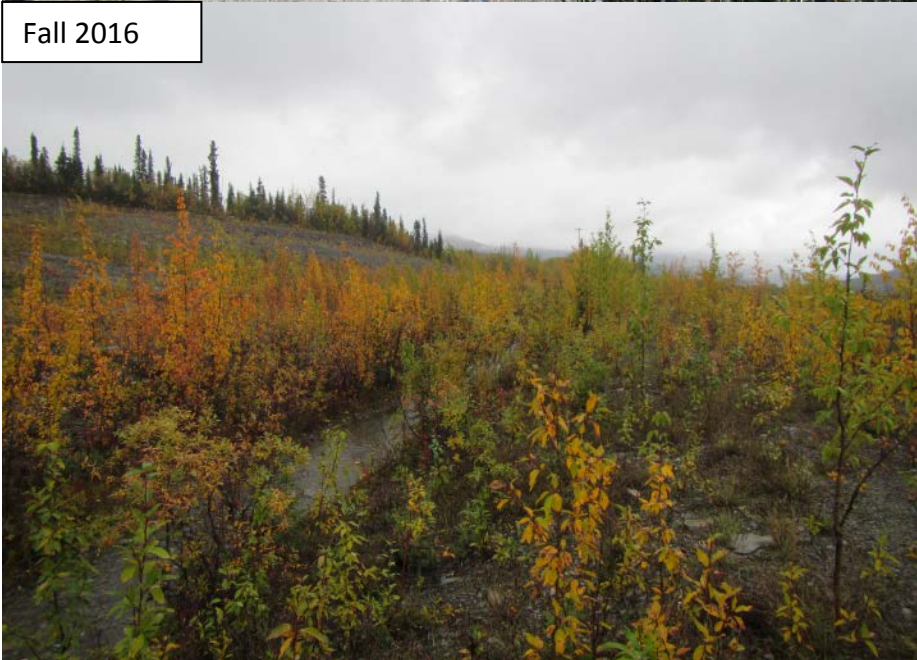
Photograph 9 Middle reach of ditch – vegetation along ditch and dyke, vegetation to be cleared for capacity and visibility. Fall photo looking east. Similar conditions in spring and fall. Approximately 2000 m from the diversion inlet.

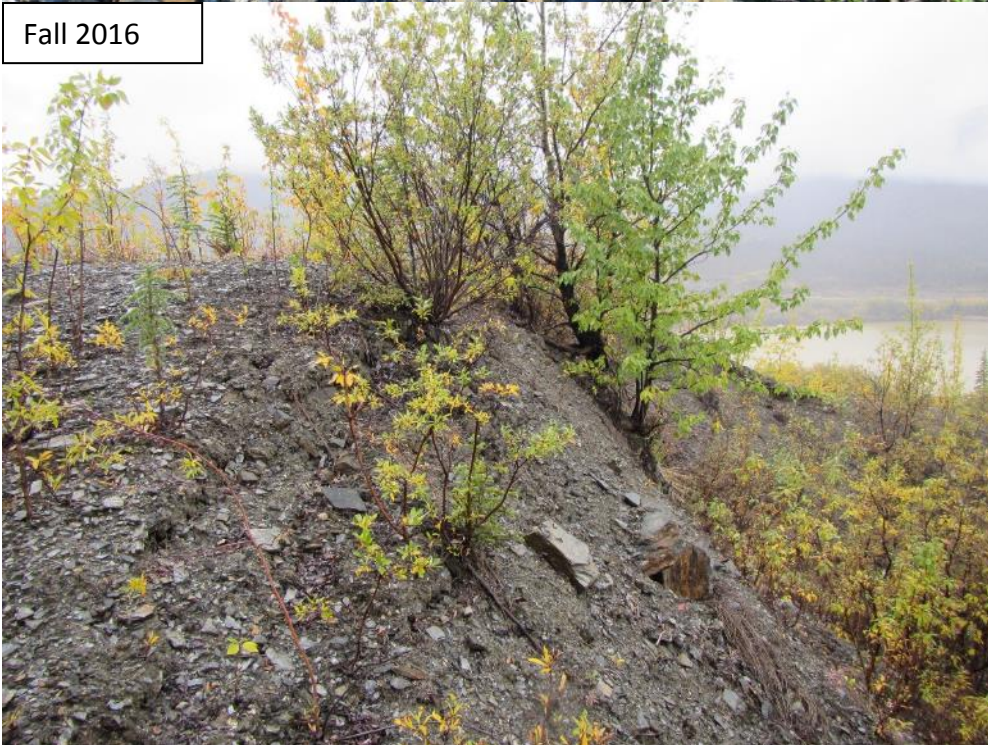
Photograph 10 Slumping at the End of the Middle Reach. Similar conditions in spring and fall. Approximately 2150 m from the diversion inlet.

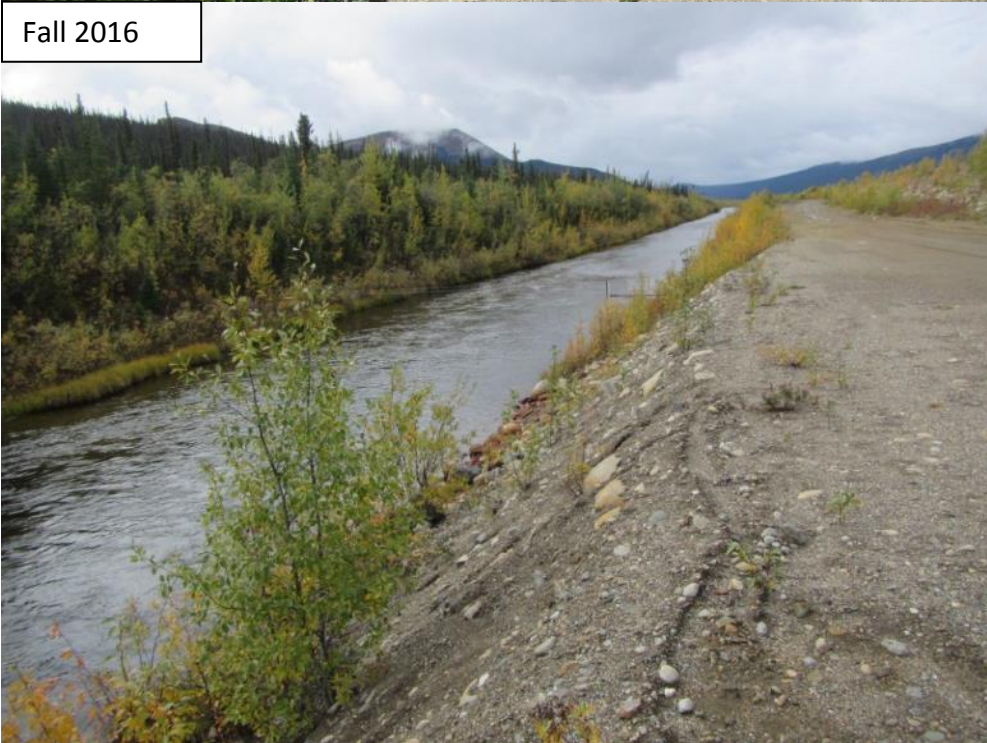
Photograph 12 Rose Creek Diversion Channel near Secondary Tailings Dam, looking downstream. Similar conditions in spring and fall.

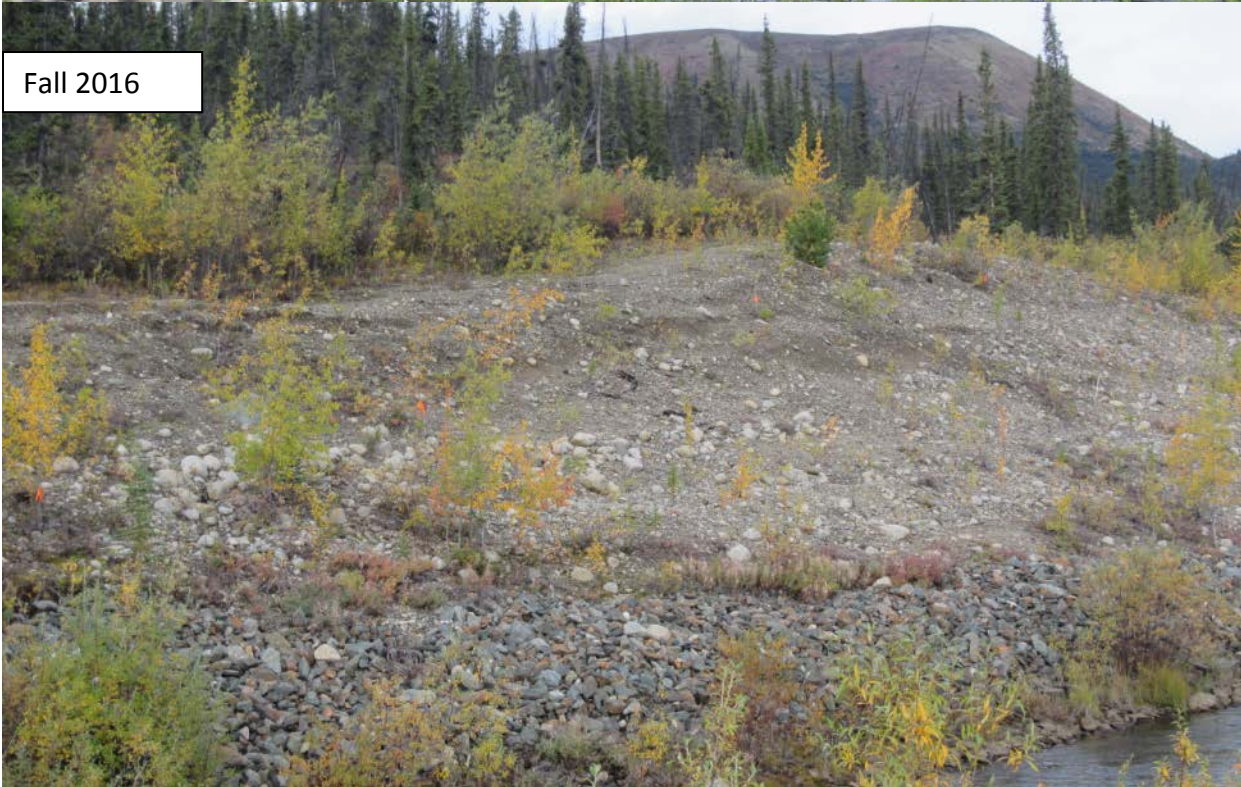
- ♦ BS-12: 9 of 10 beads functioning.
- In 2015 we reviewed the Back Slope instrumentation and could not determine conclusively the cause of the slumping; however, we believe the slumping is due to the melting of the underlying permafrost as shown in the general warming trend of BS-5 and BS-10 which correspond to the areas of slumping. Other possible causes include infiltration of surface water from upslope, and/or freeze-thaw action on the loose sand and gravel cover. We believe that this can be managed through a program of monitoring and maintenance.

Photograph 13 Rose Creek Diversion Channel back-slope slumping. Similar conditions in spring and fall.

- Explore permit requirements regarding investigation and repair of the above slope slumps. RCDC is the main diversion channel at the Faro site; prevention of a major slump and blockage is a high priority.

- Develop an emergency response plan for failure of the Back Slope and blockage of the Rose Creek Diversion.
- Clear vegetation from the diversion and access path along the Back Slope as per guidelines in KCB brushing letter dated August 5, 2016. YG reports that Minnow Environmental Inc. are developing environmental considerations and measures for this work.

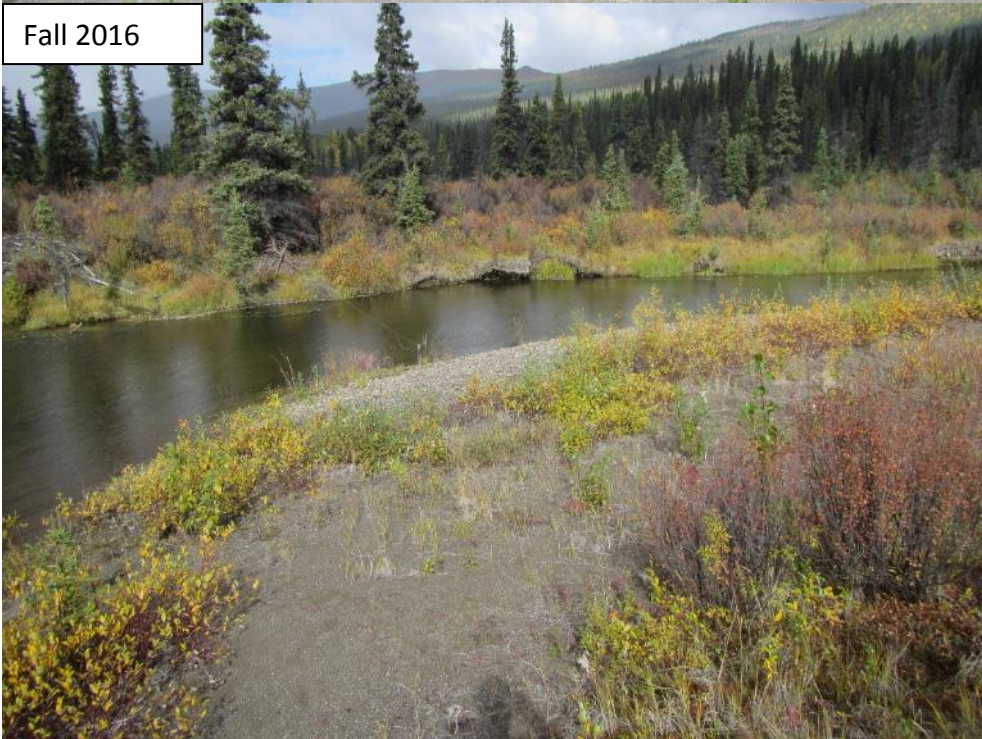
Photograph 14 Rose Creek Diversion Channel flow gauge station downstream of Tailings Facility. Satisfactory conditions.

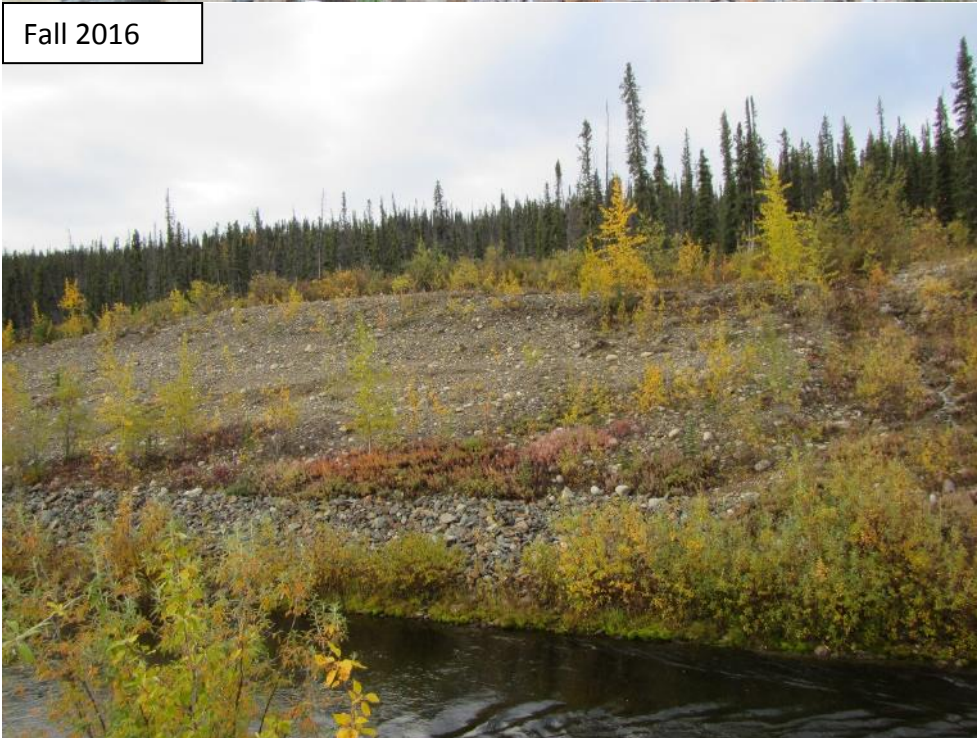
Photograph 16 Rose Creek Diversion Channel Back Slope Observation Location B. Conditions similar in spring and fall.

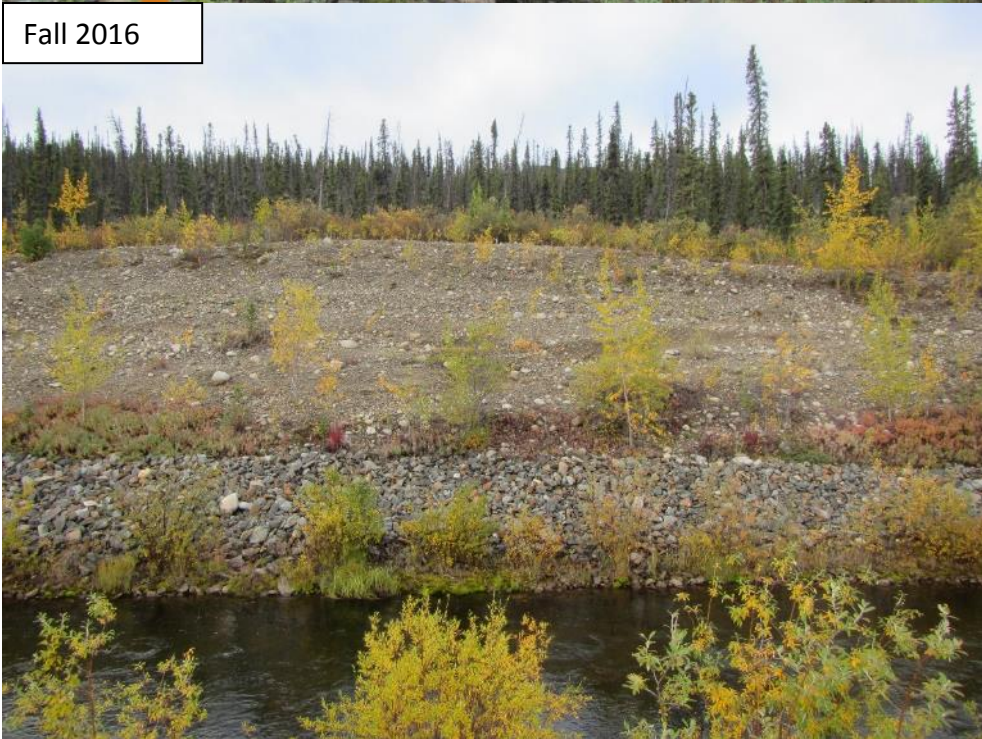
Photograph 17 Rose Creek Diversion Channel Proposed Back Slope Observation Location C. Conditions similar in spring and fall.

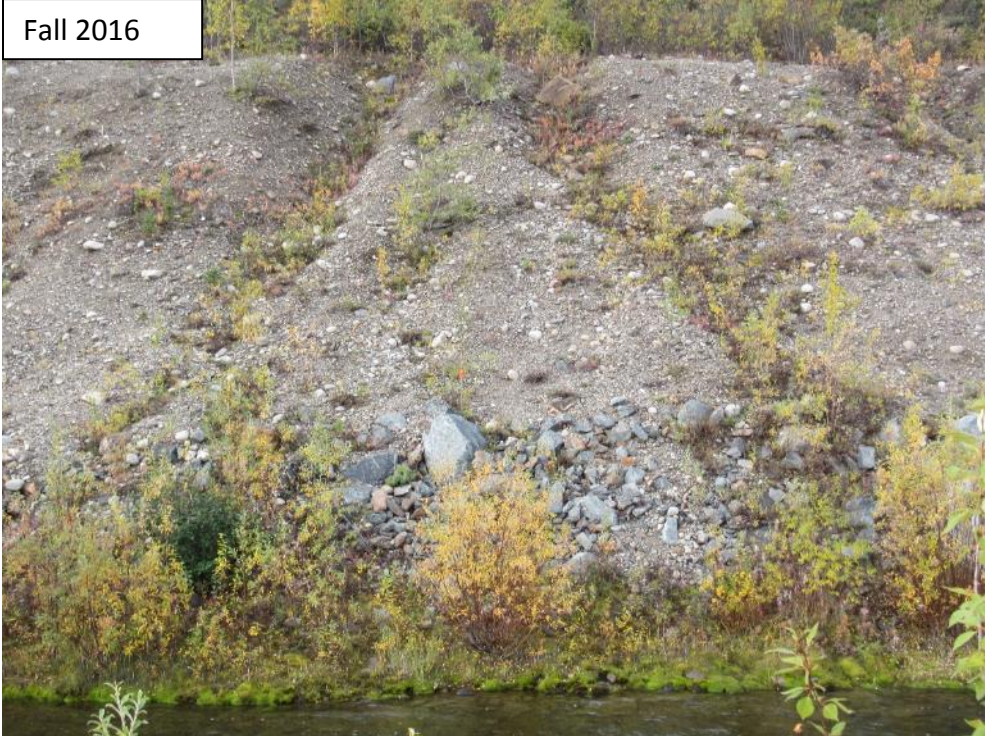
Photograph 18 Rose Creek Diversion Channel Proposed Back Slope Observation Location D. Conditions similar in spring and fall.

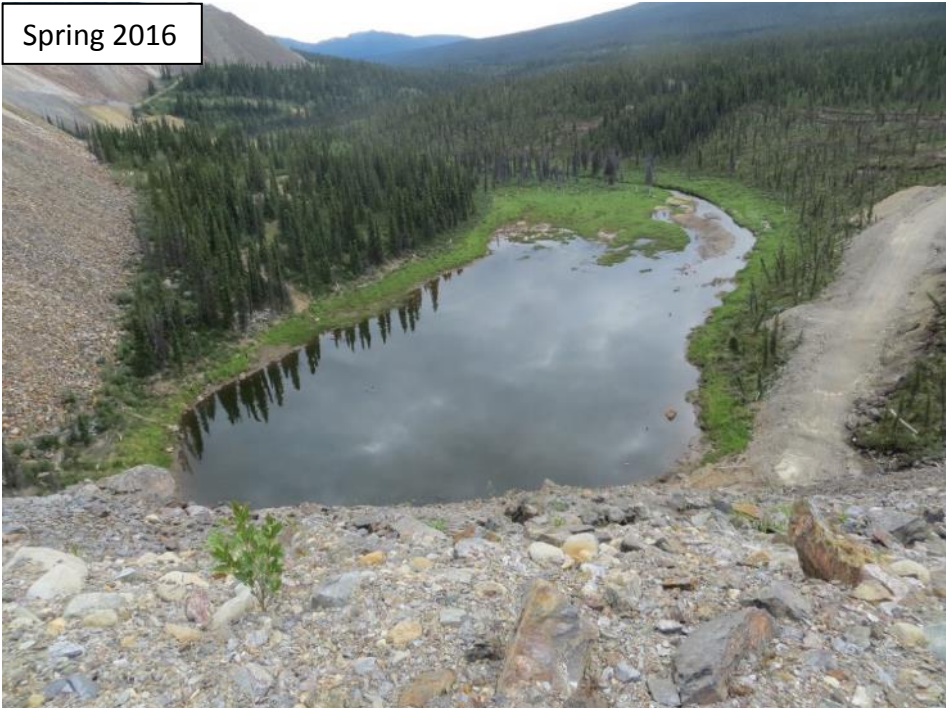
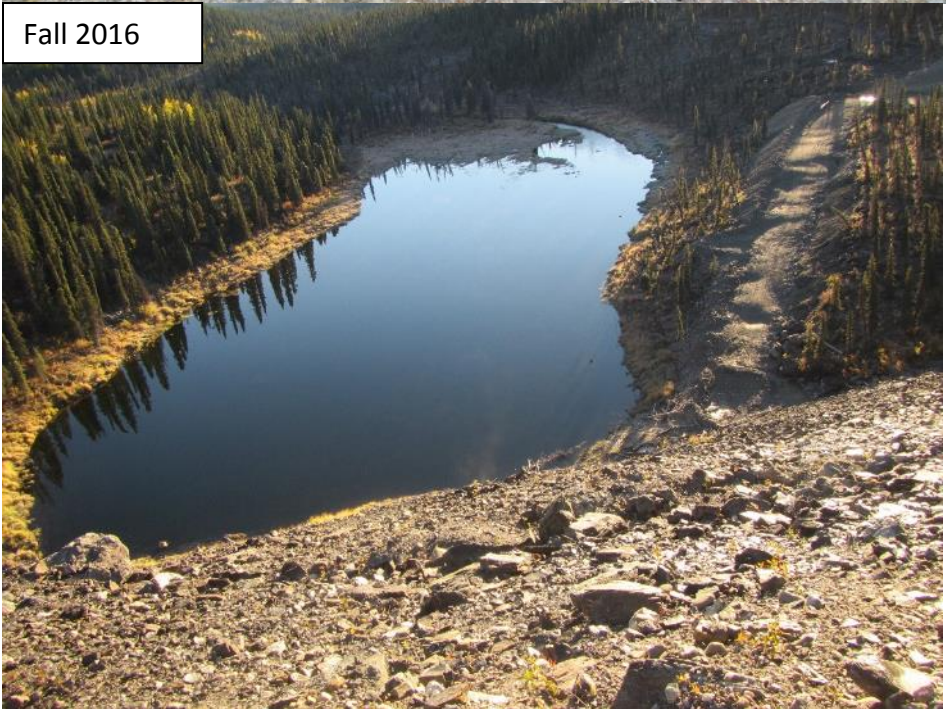
Photograph 19 North Fork Rock Drain upstream pool at access road. Satisfactory condition.

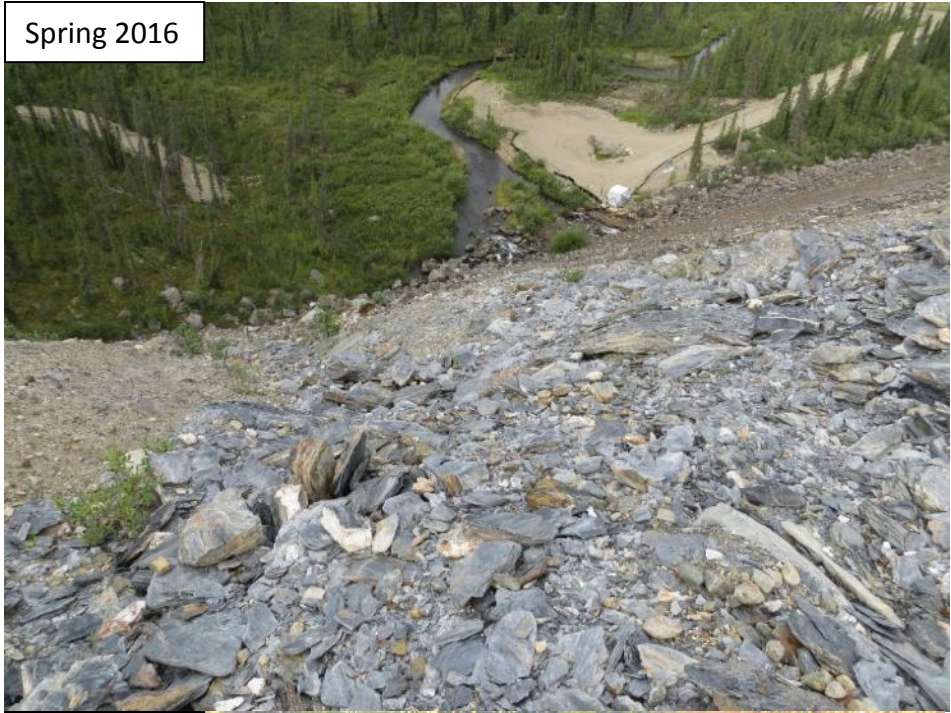
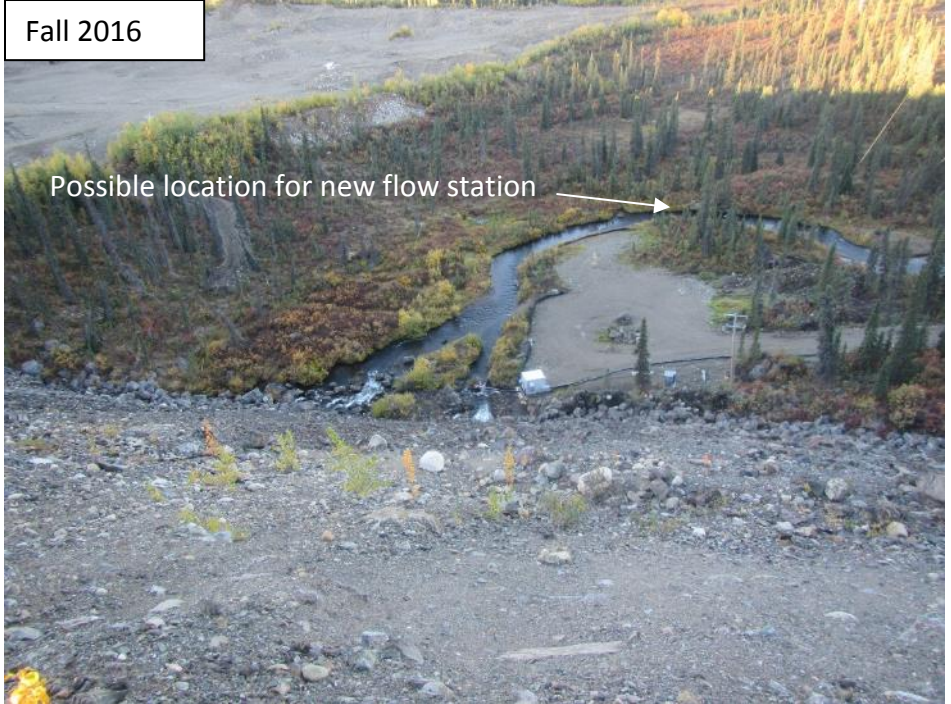
Photograph 20 North Fork Rock Drain outlet, looking downstream. Satisfactory conditions. Possible location of new flow station shown.

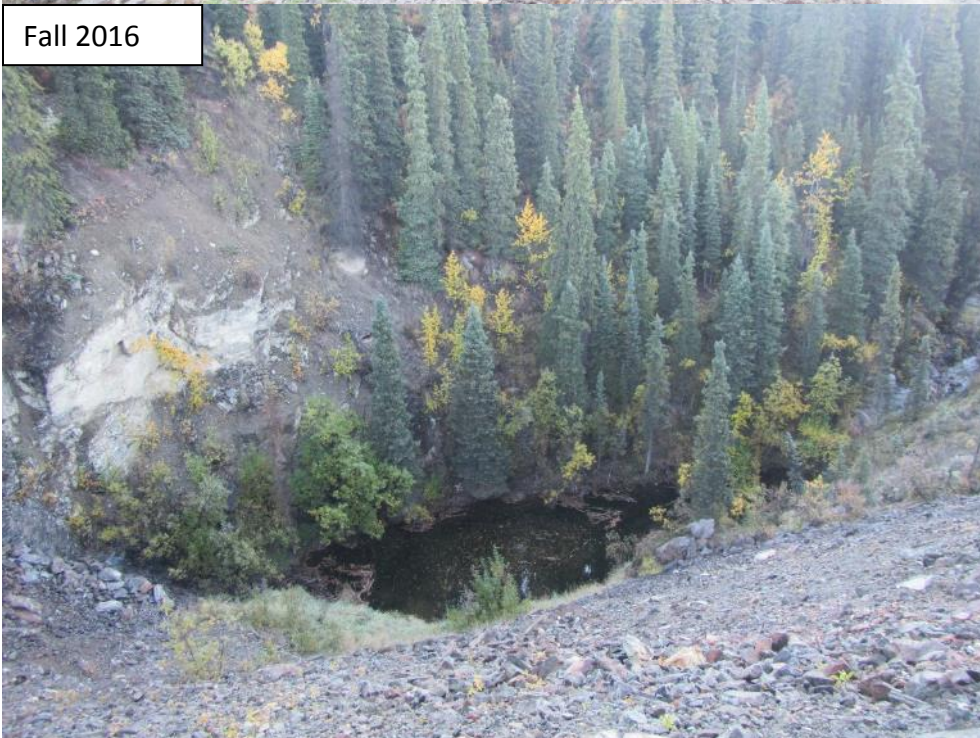
Photograph 21 K8 Rock Drain upstream pool. Satisfactory conditions.

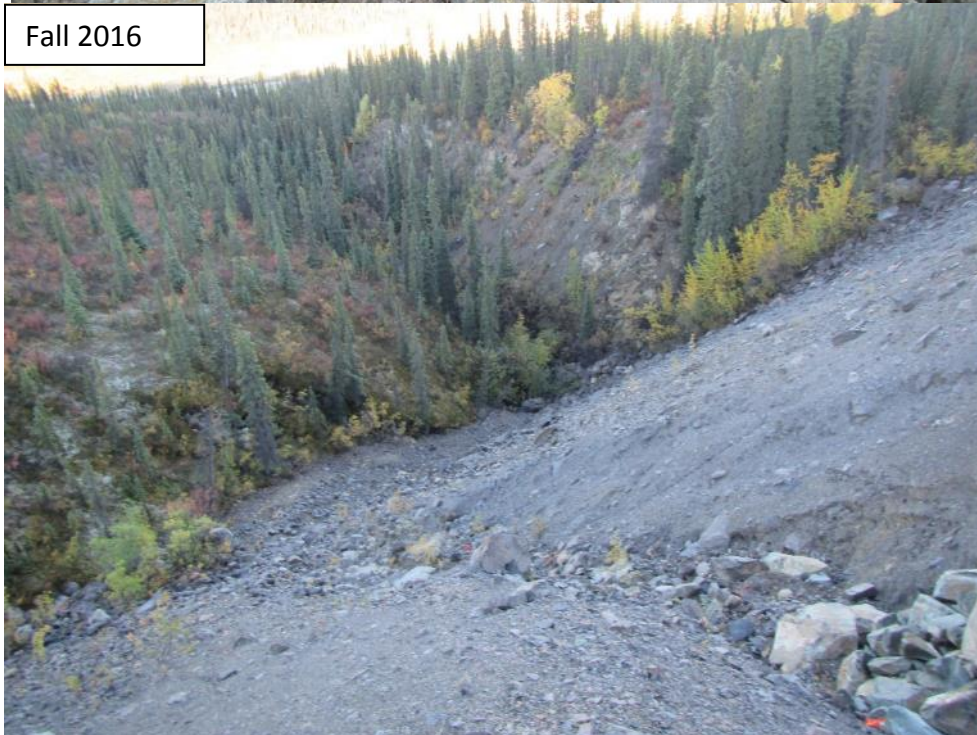
Photograph 22 K8 Rock Drain downstream outlet, looking down. Satisfactory conditions.

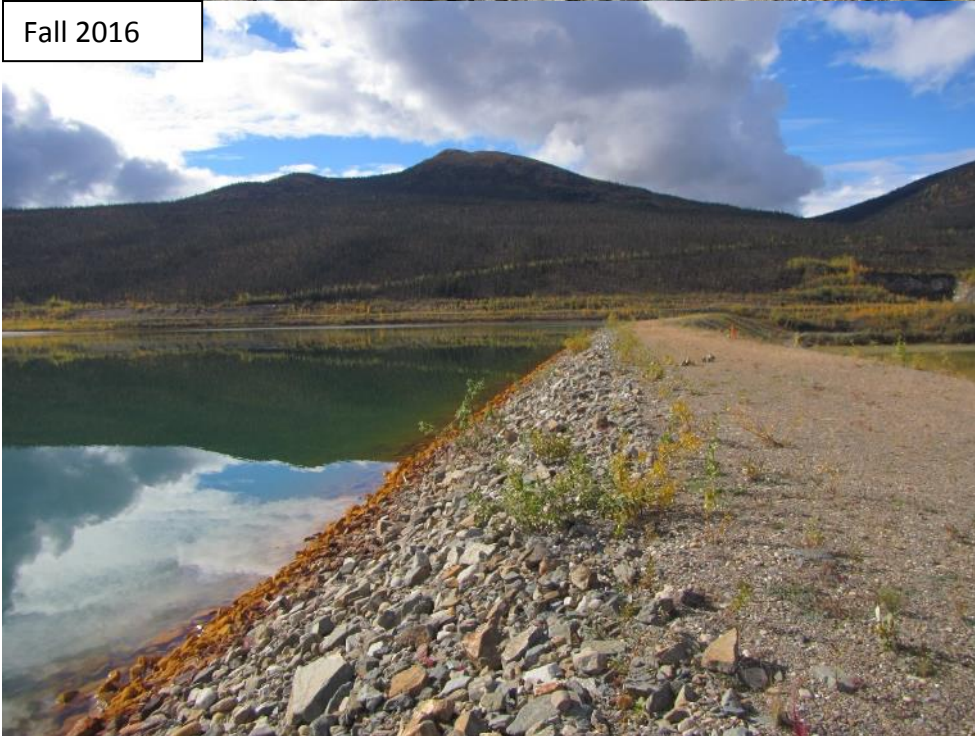
Photograph 25 Intermediate Dam from access road, looking south. Satisfactory conditions.

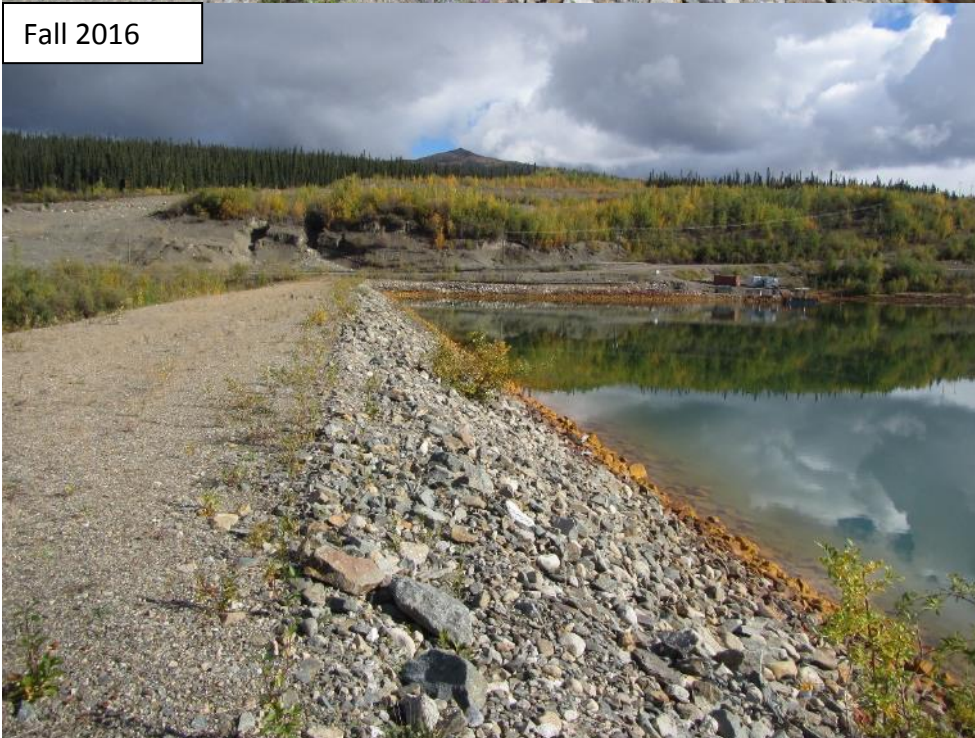
Photograph 26 Intermediate Dam crest and upstream slope, looking north. Satisfactory Conditions.

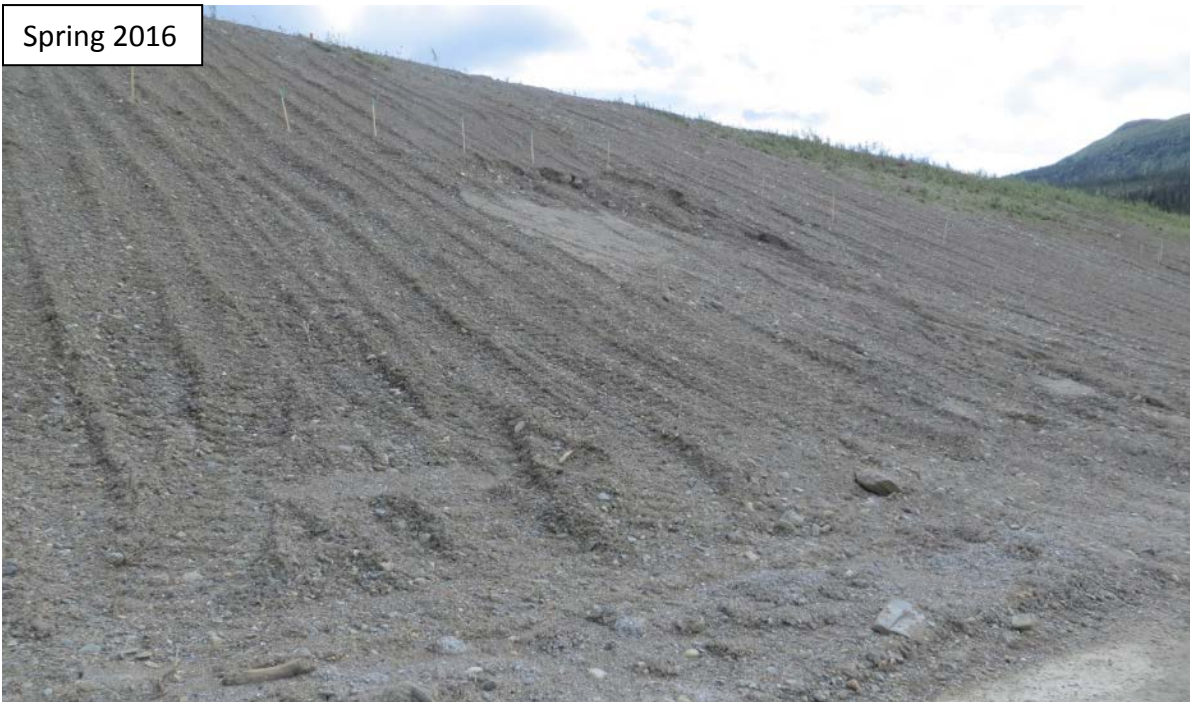
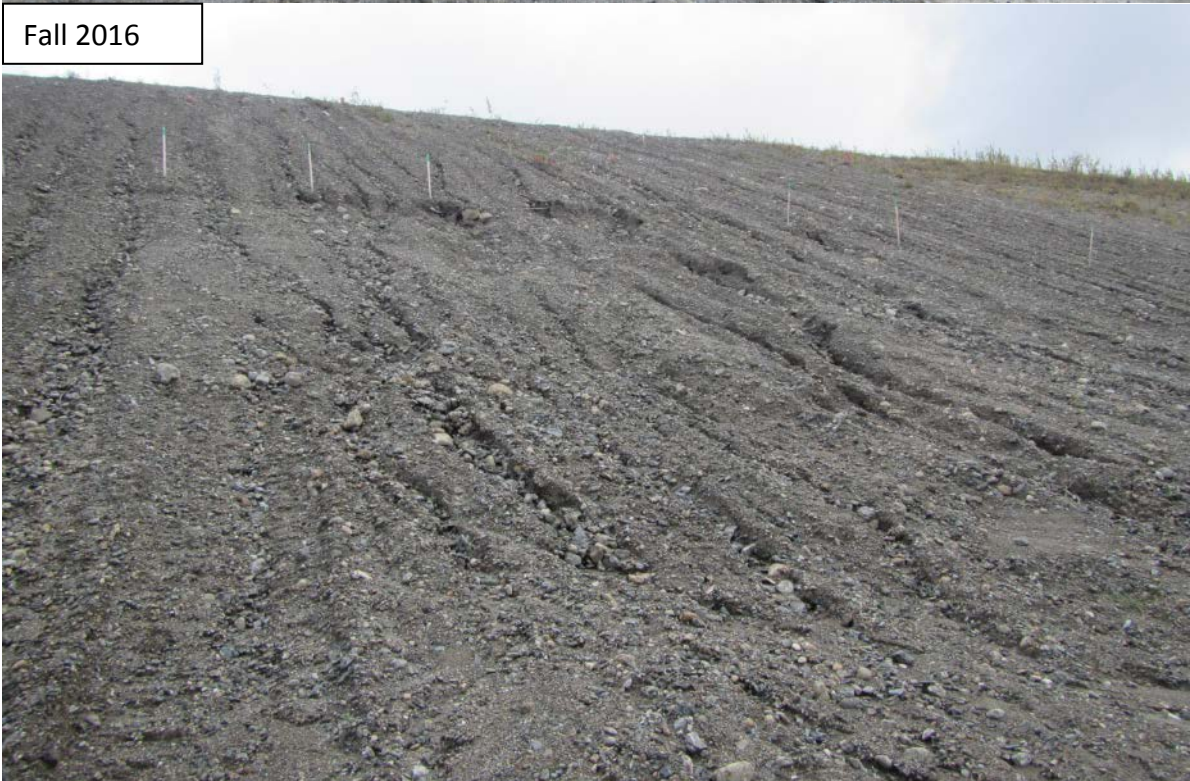
The Intermediate Dam experienced some sloughing and erosion on the downstream slope in 2016. The response for this is documented in KCB 2016b and KCB 2016d. This was determined to have resulted from a combination of continuing rill erosion and placing wet, poorly compacted material during the last repair. Preliminary repairs were completed.

Photograph 27 Repairs along downstream slope. Some surface erosion since spring.

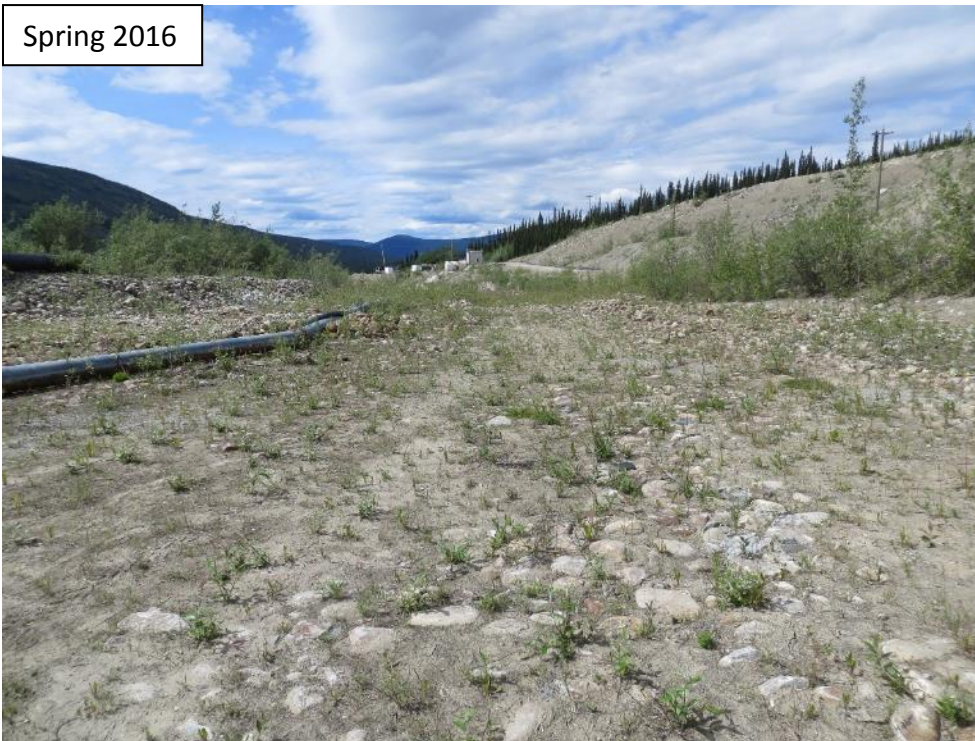
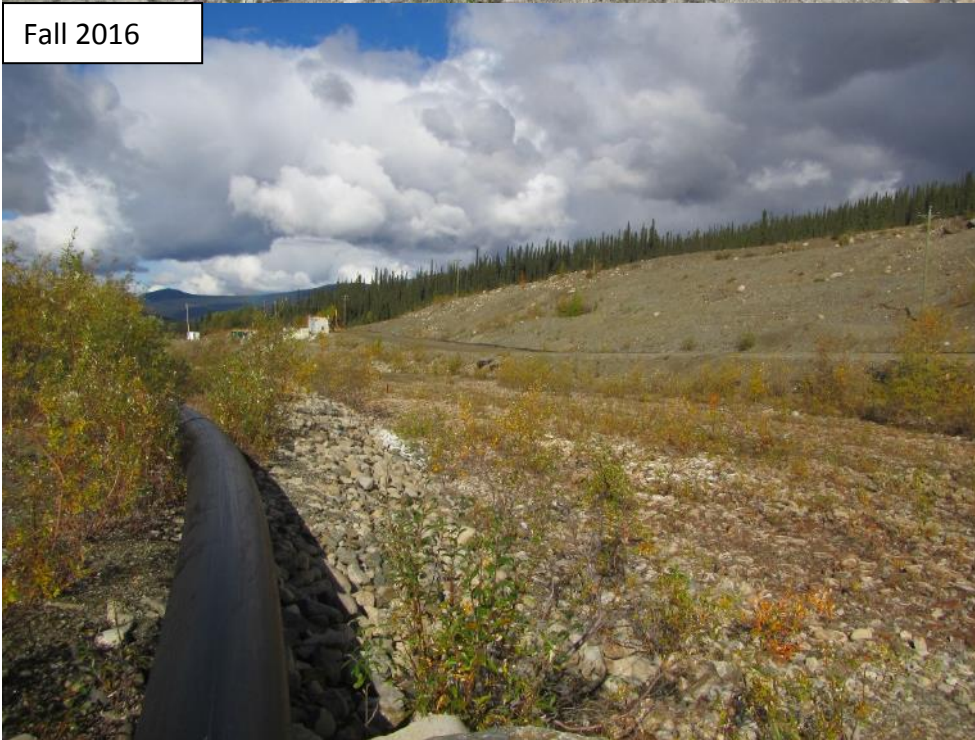
Photograph 28 Spillway, looking downstream. Pipeline in the spillway was removed in Fall 2016.
