Klohn Crippen Berger

Faro Mine Complex

2016 Annual Geotechnical Review

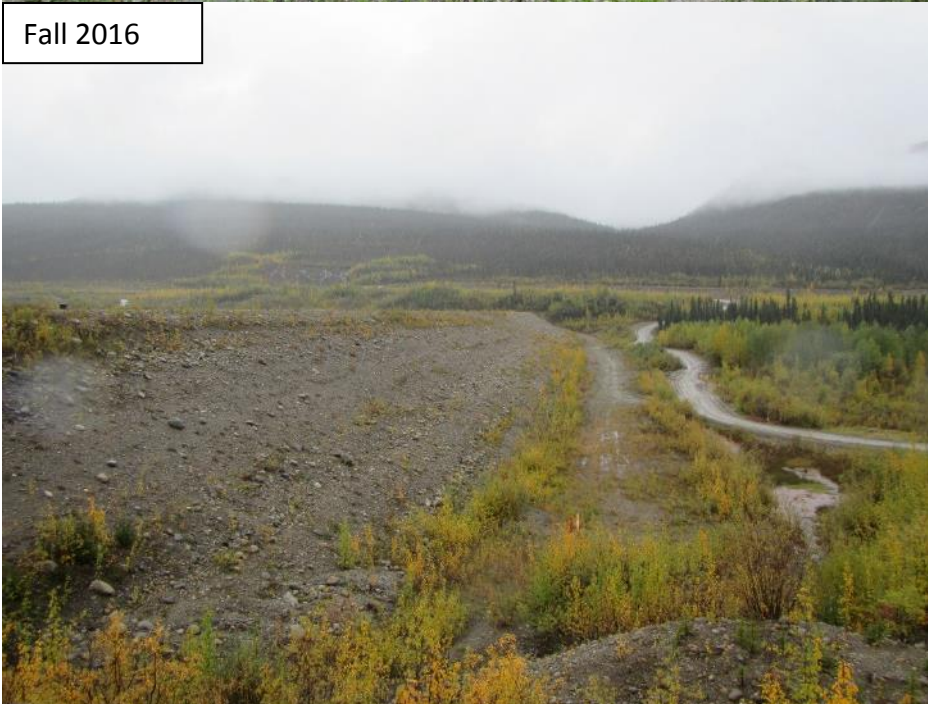
Photograph 29 Downstream slope of Cross Valley Dam looking south. Some minor rill erosion and vegetation on slope. Conditions are similar across the whole slope.

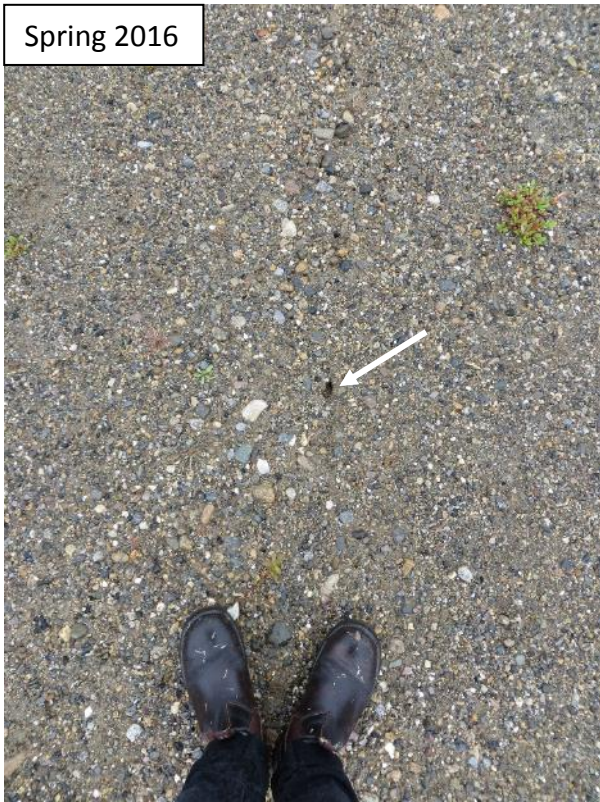
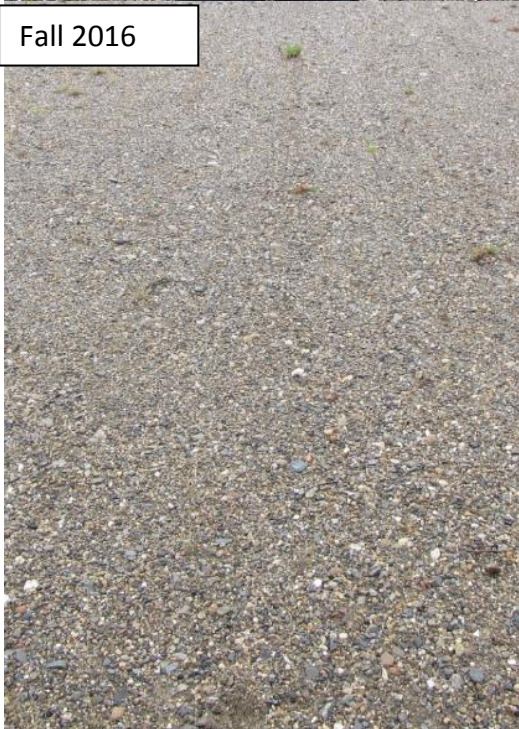
Photograph 30 Freeze-thaw longitudinal cracks closed along dam crest, looking south. Crack is closed (not visible in photo) in fall.

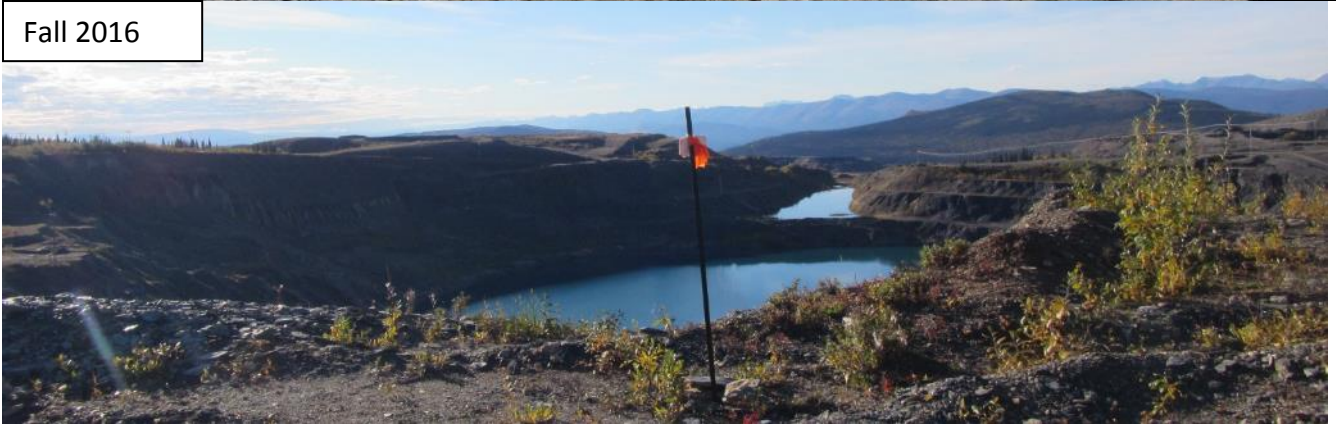
Photograph 33 Grum Pit (looking south, southeast). Similar conditions in spring and fall.

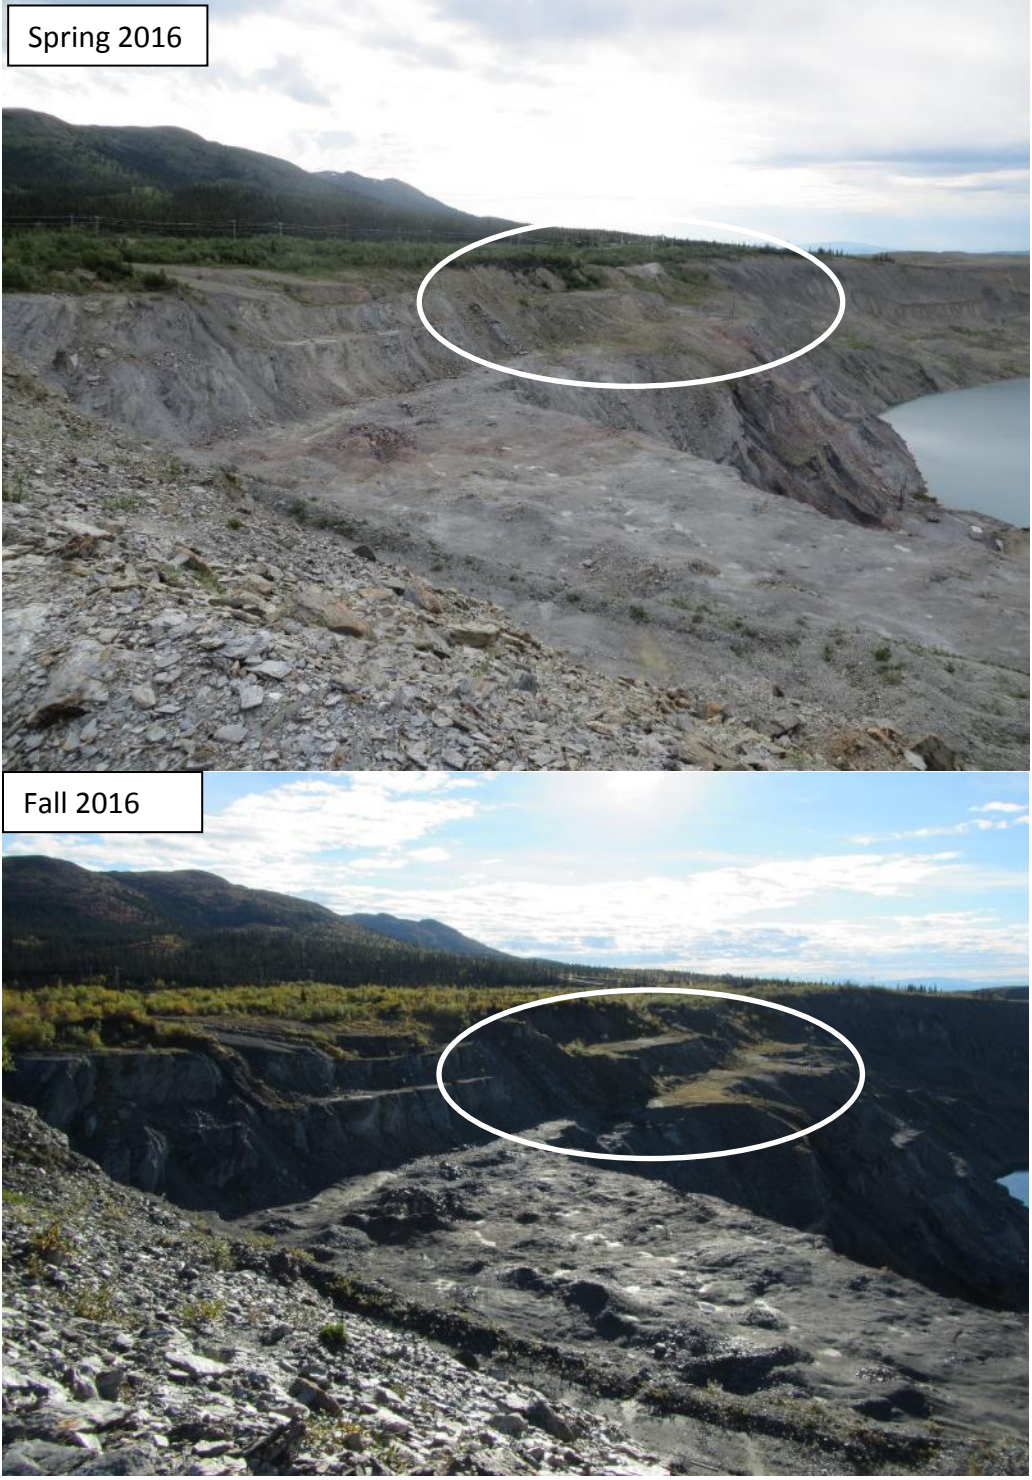
Photograph 34 East pit wall along instability zone. Similar conditions in spring and fall.

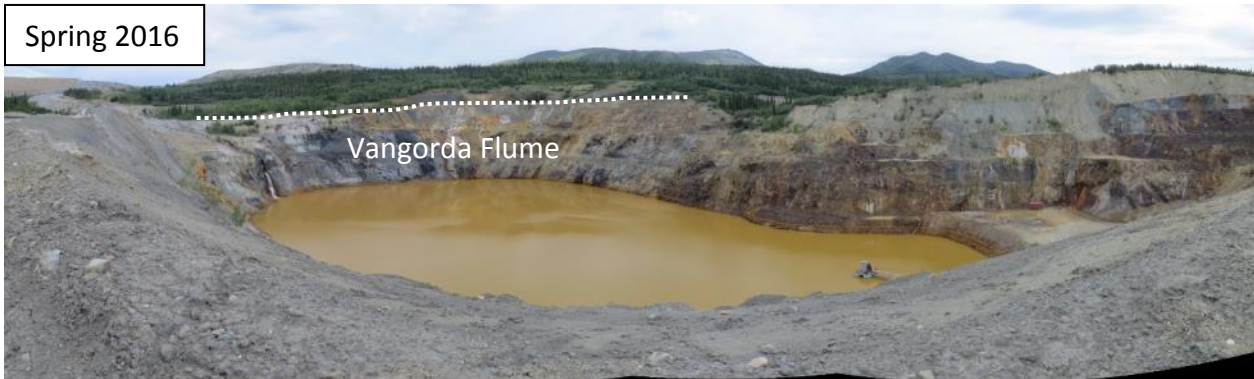
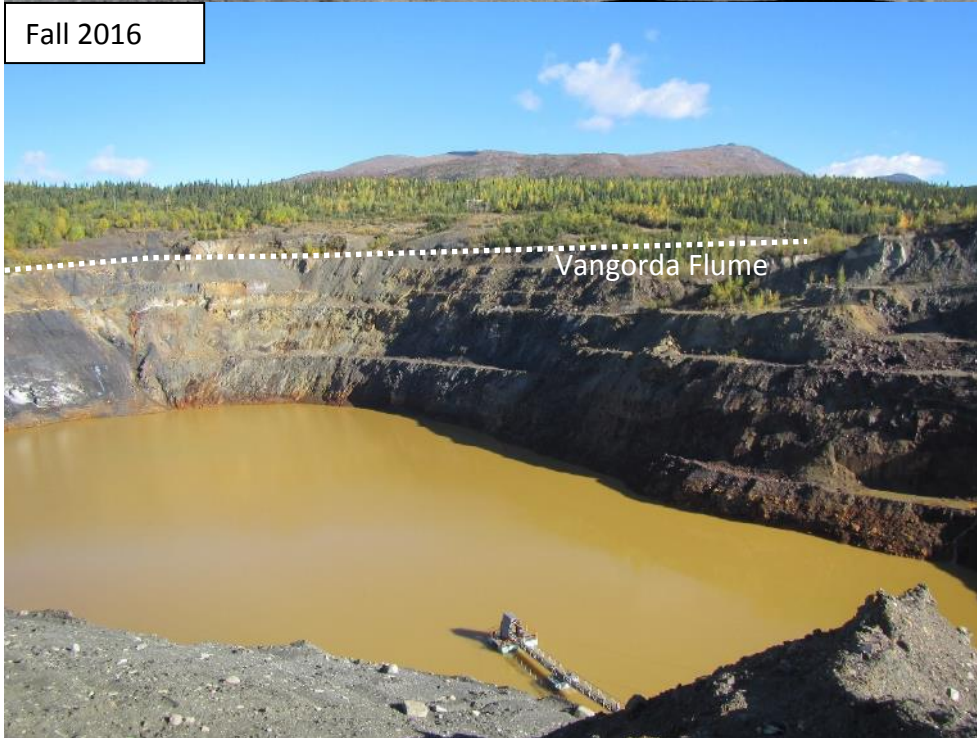
Photograph 35 Northwest pit wall adjacent to Vangorda Diversion Flume

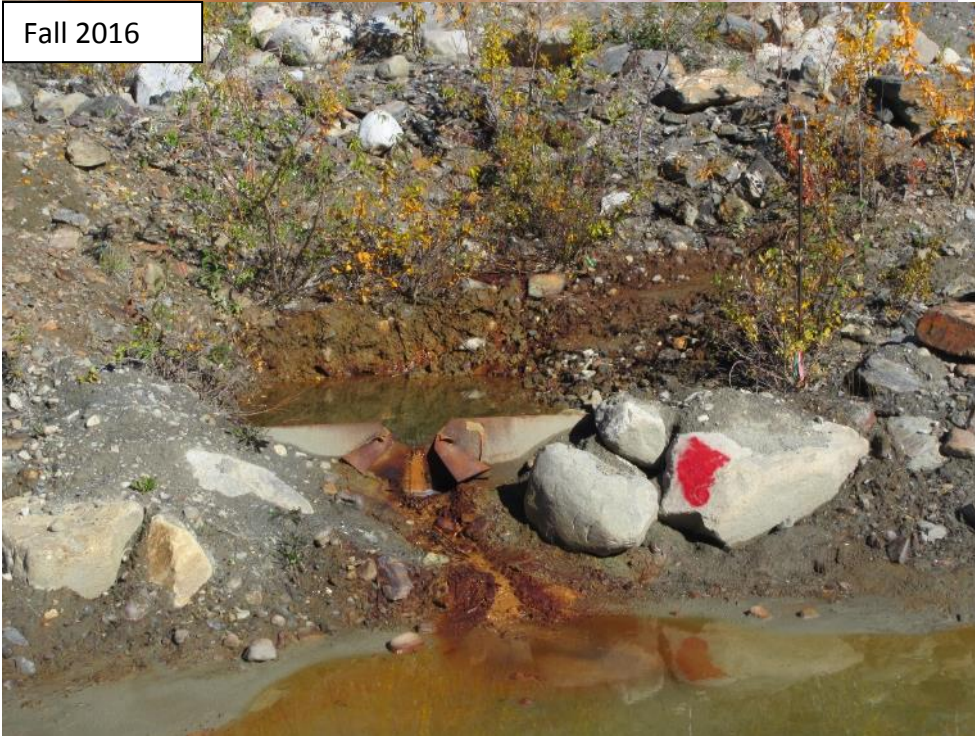
Photograph 37 Drain No. 3 (V30). Satisfactory conditions.

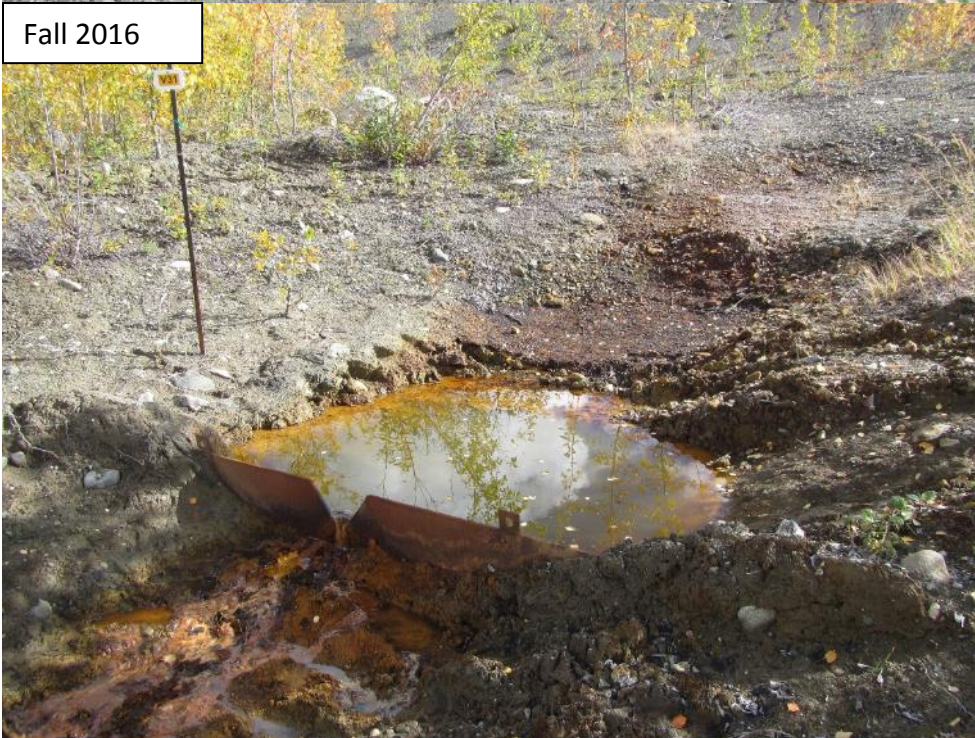
Photograph 38 Drain No. 4 (V31). Satisfactory conditions.

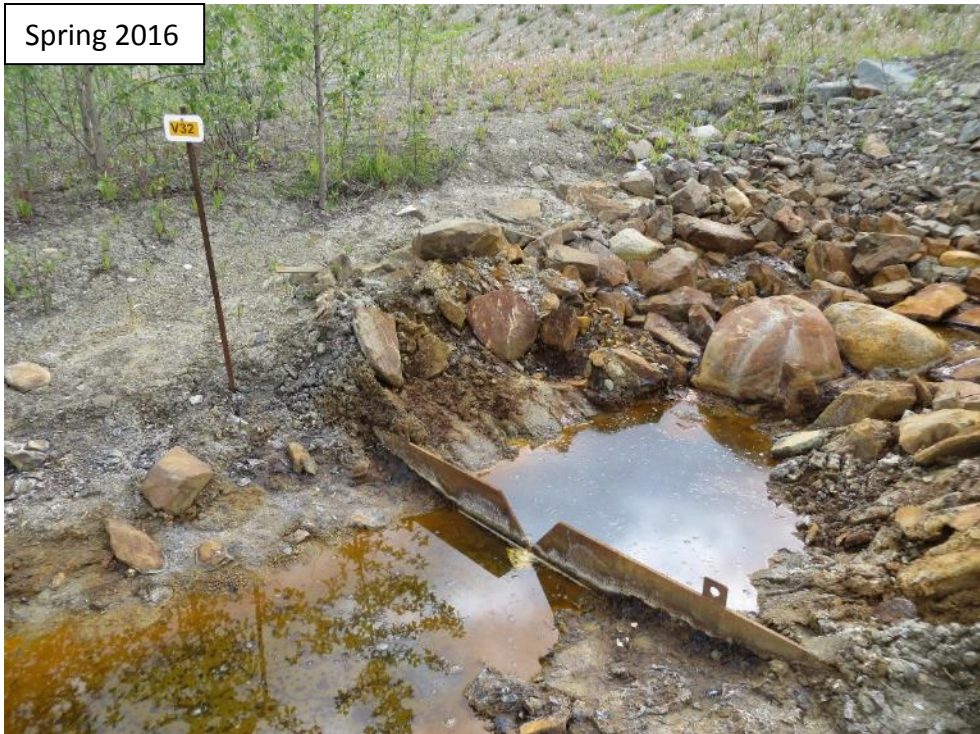
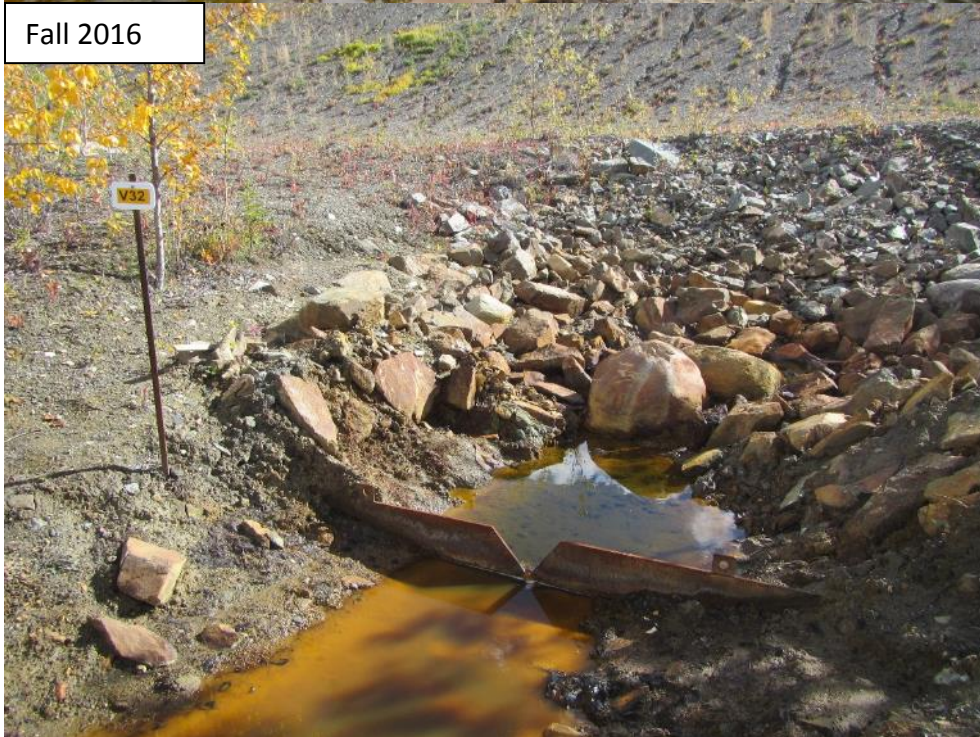
Photograph 39 Drain No. 5 (V32). Pooling downstream of weir. Pond should be cleaned out so it doesn't backwater the weir.

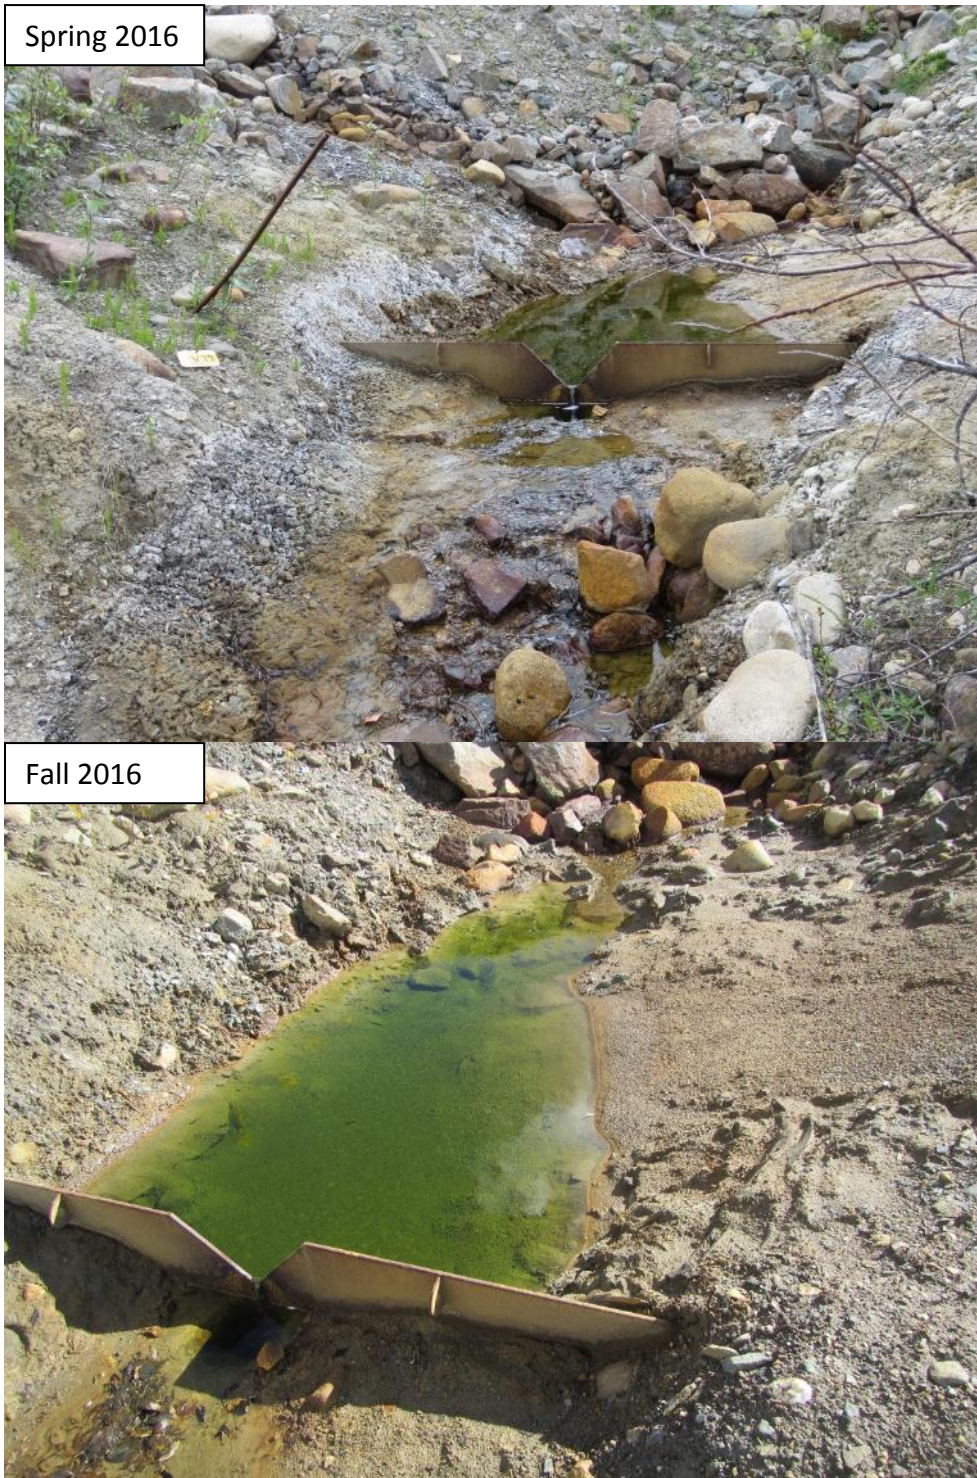
Photograph 40 Drain No. 6 (V33). Satisfactory conditions.

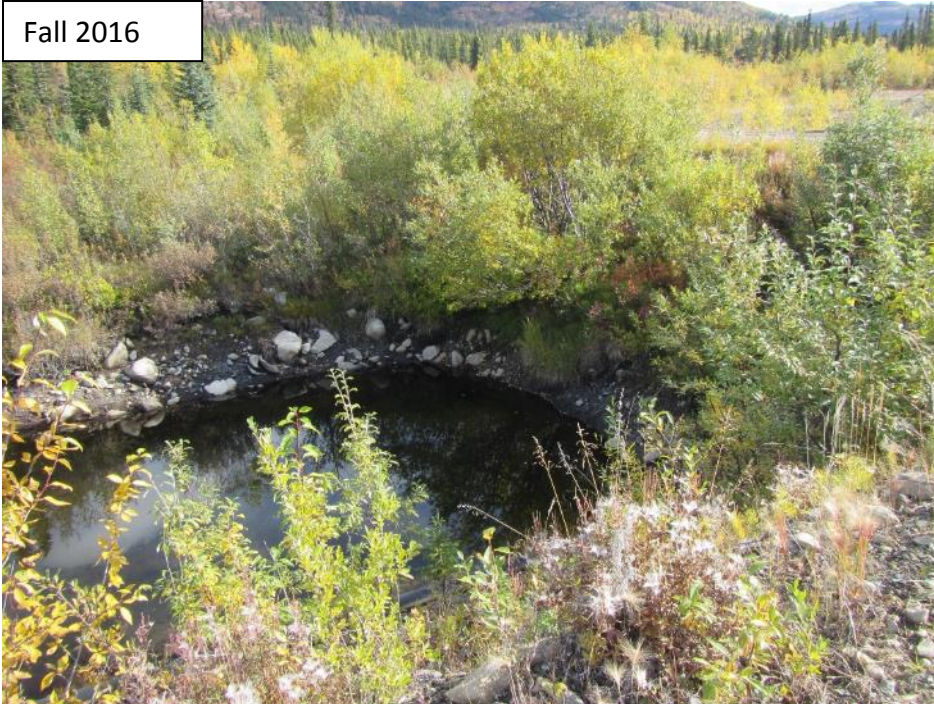
Photograph 41 Wes' Pond. Satisfactory conditions.

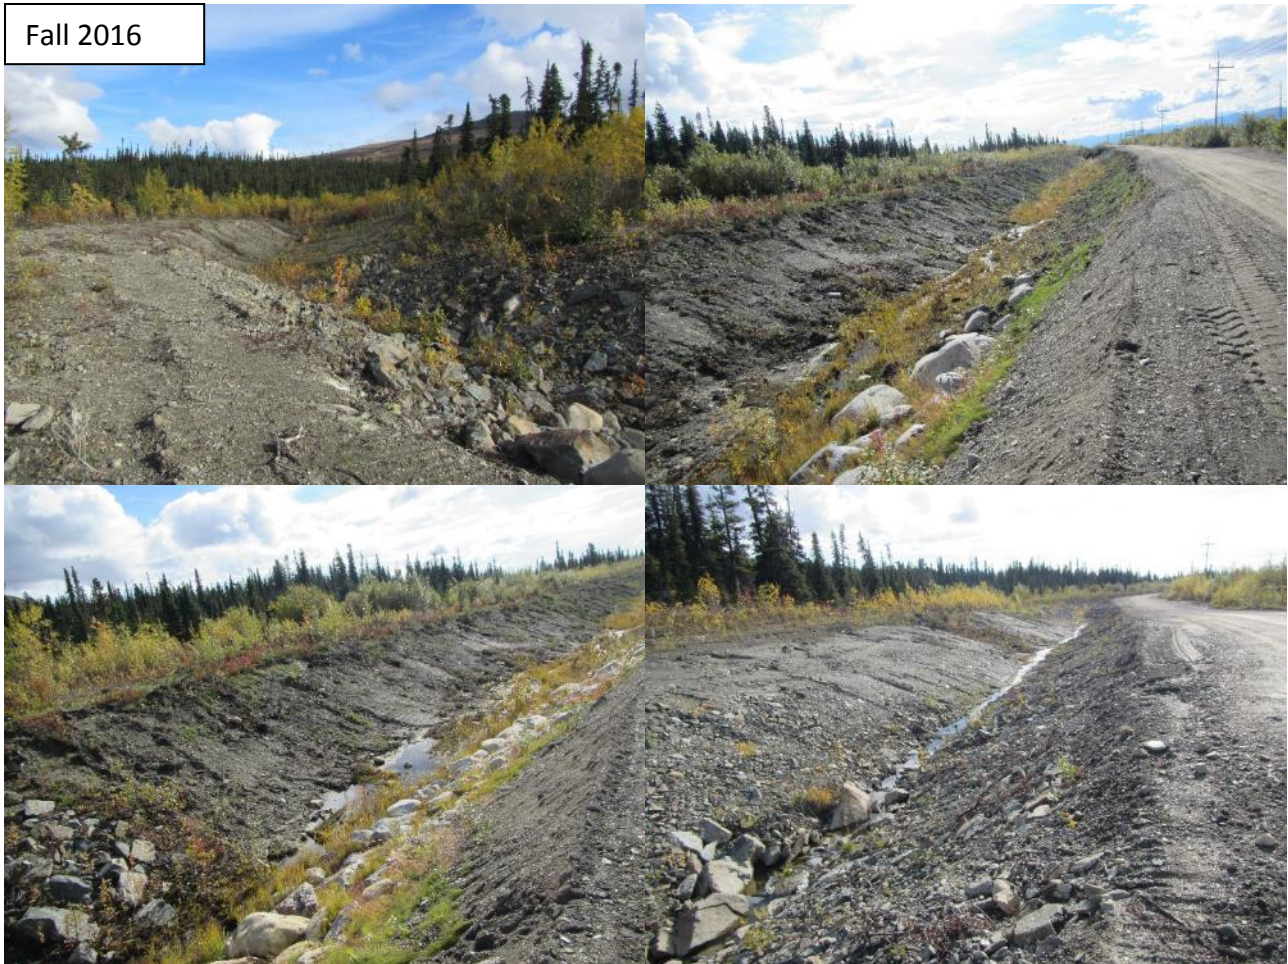
Photograph 42 Vegetation clearing in the upper reach of Interceptor Ditch (Fall 2016). Slopes are susceptible to erosion.

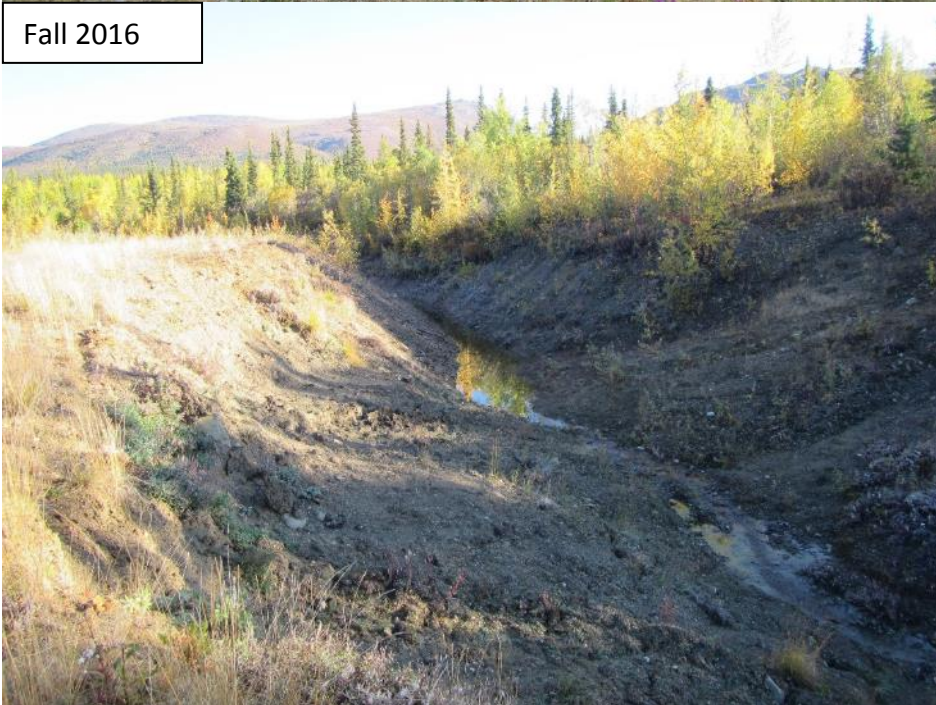
Photograph 45 Slumping of side slopes. Similar conditions in spring and fall.

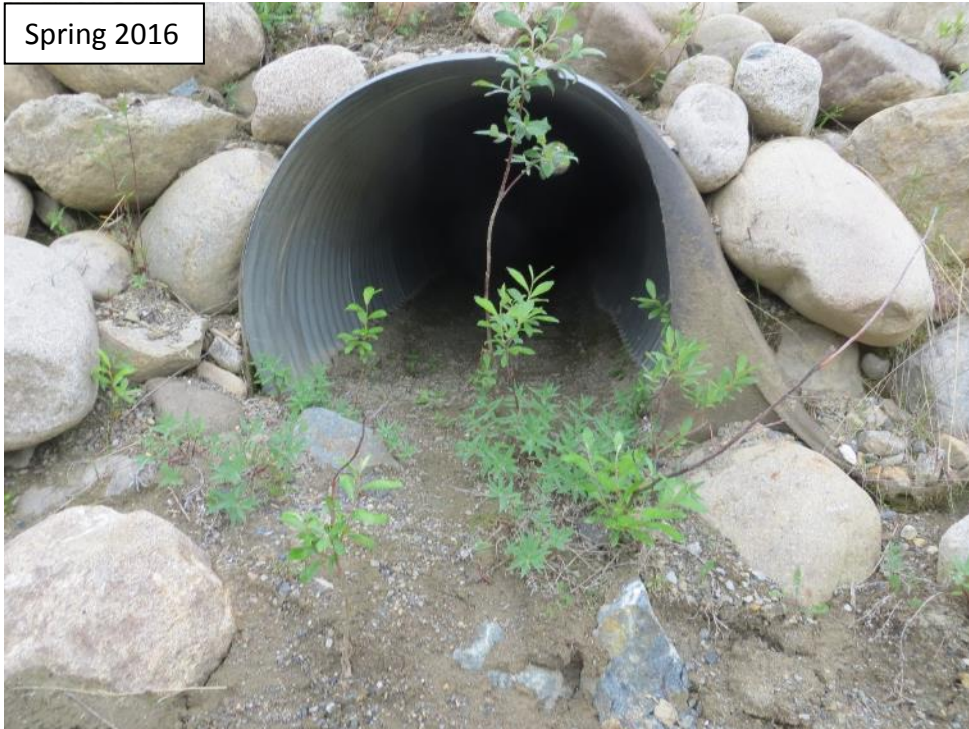
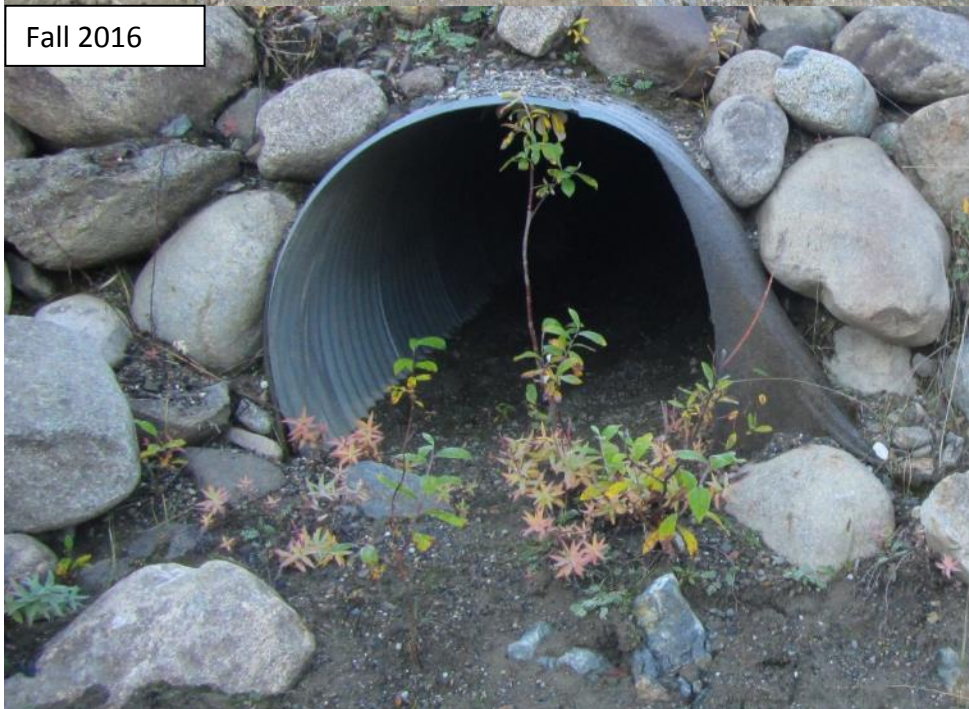
Photograph 46 Flume emergency spillway culvert entrance area (only one culvert shown).
Sediment in culvert.

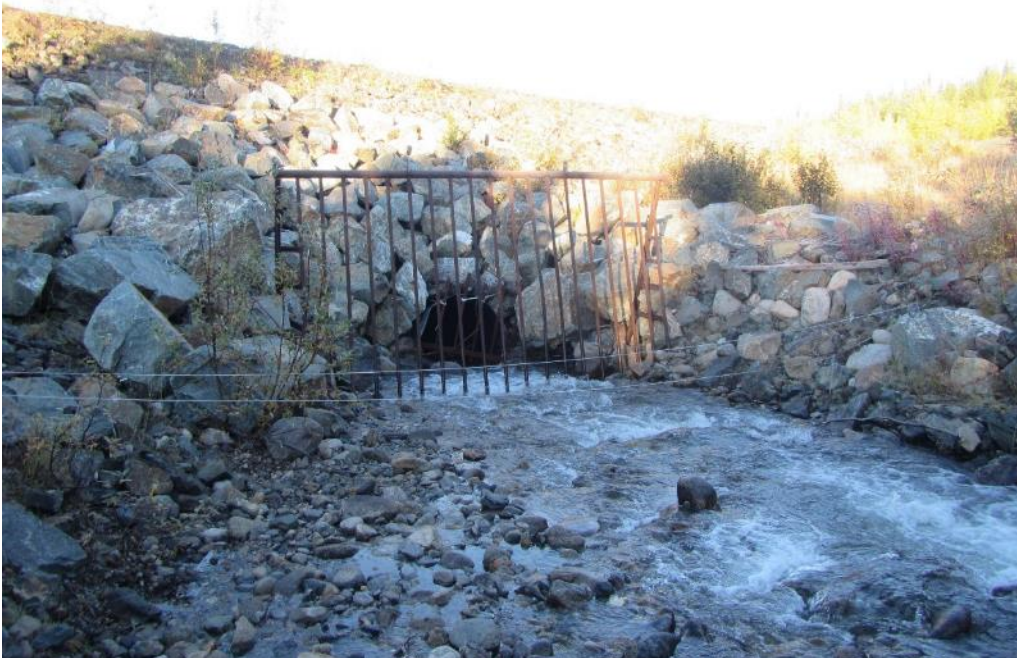
Photograph 47 Vangorda Flume intake culvert upstream trashrack. Satisfactory conditions.

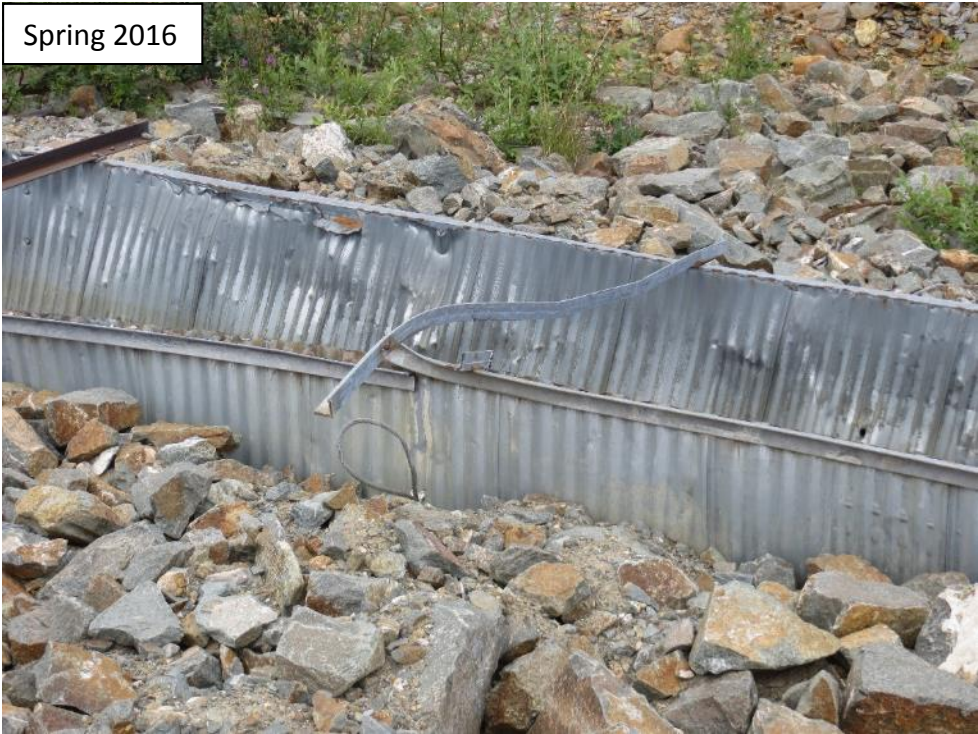
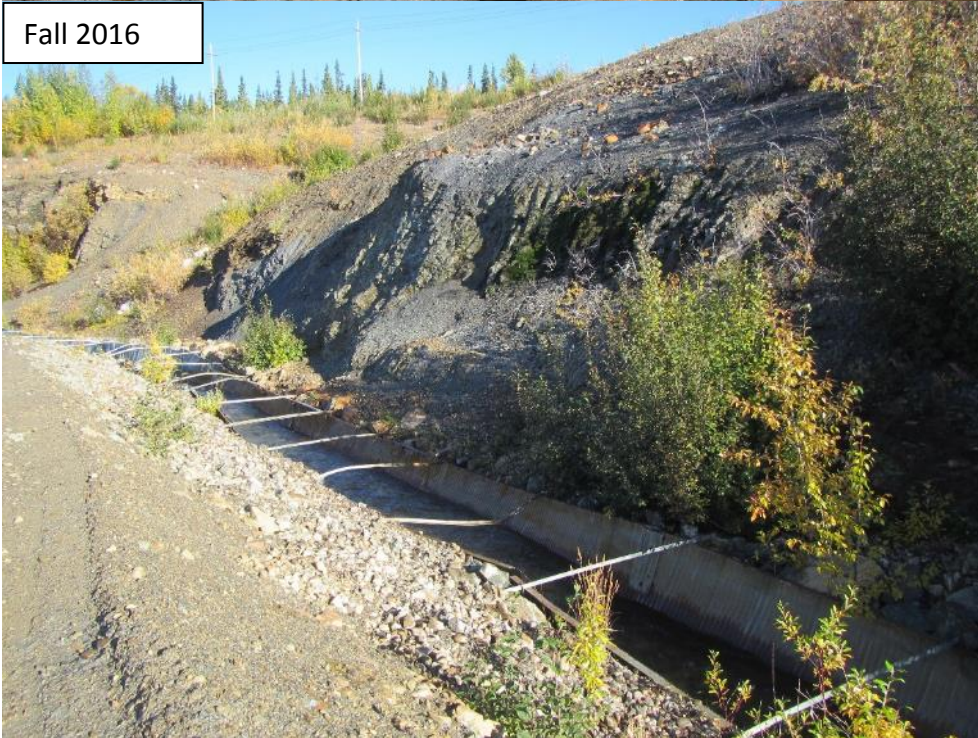
Photograph 48 Damaged flume and bent bracing rods

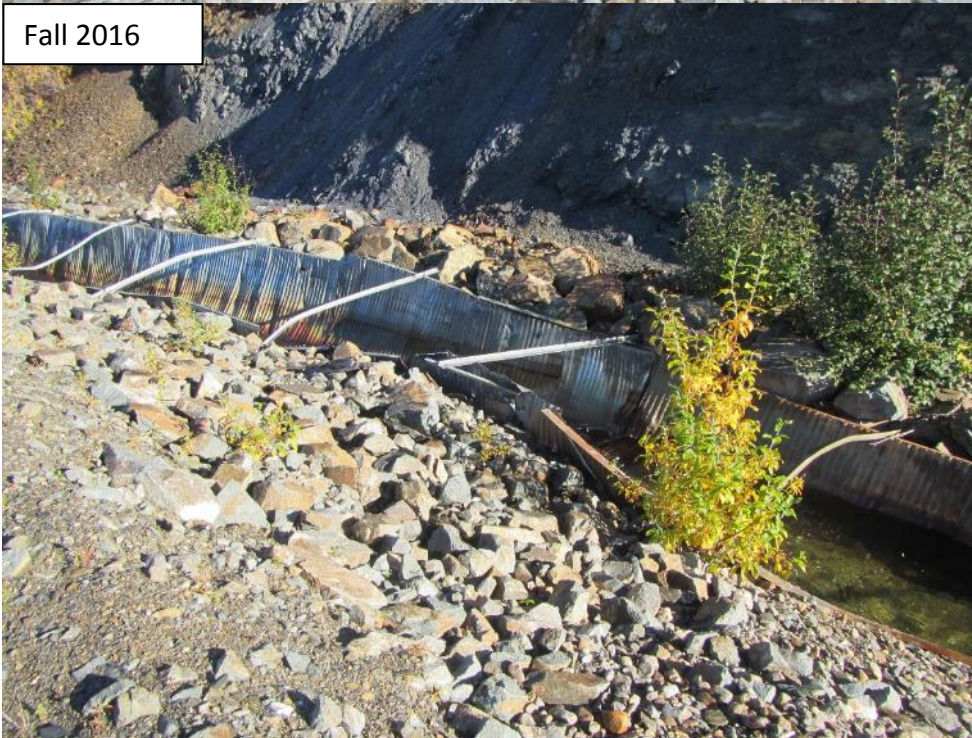
Photograph 50 Damaged flume, flat slope, and constricted channel

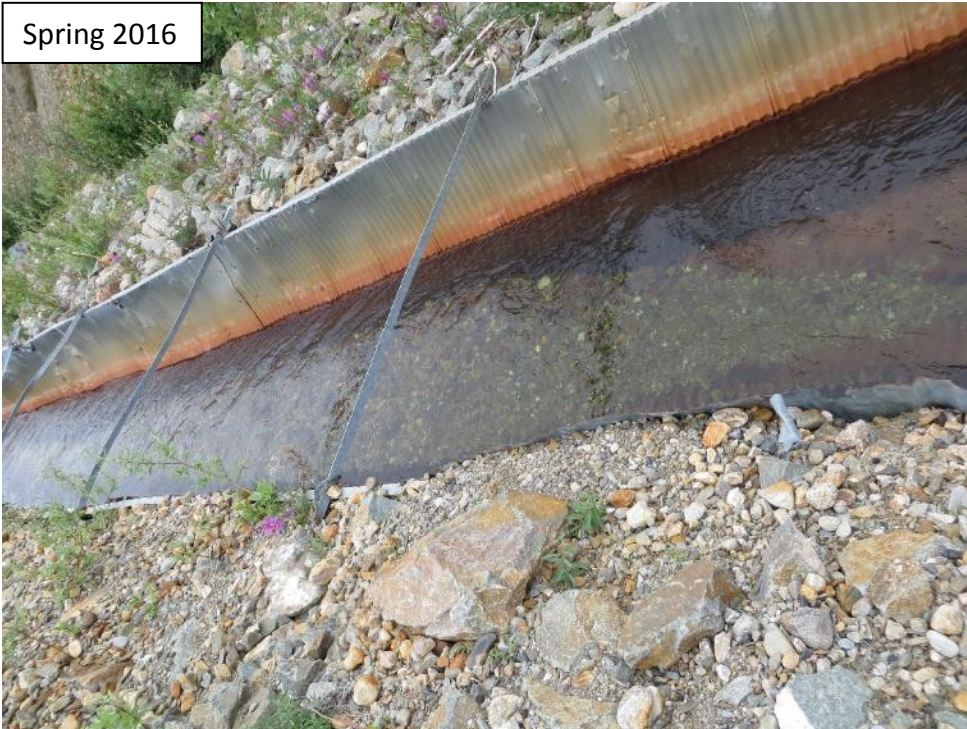
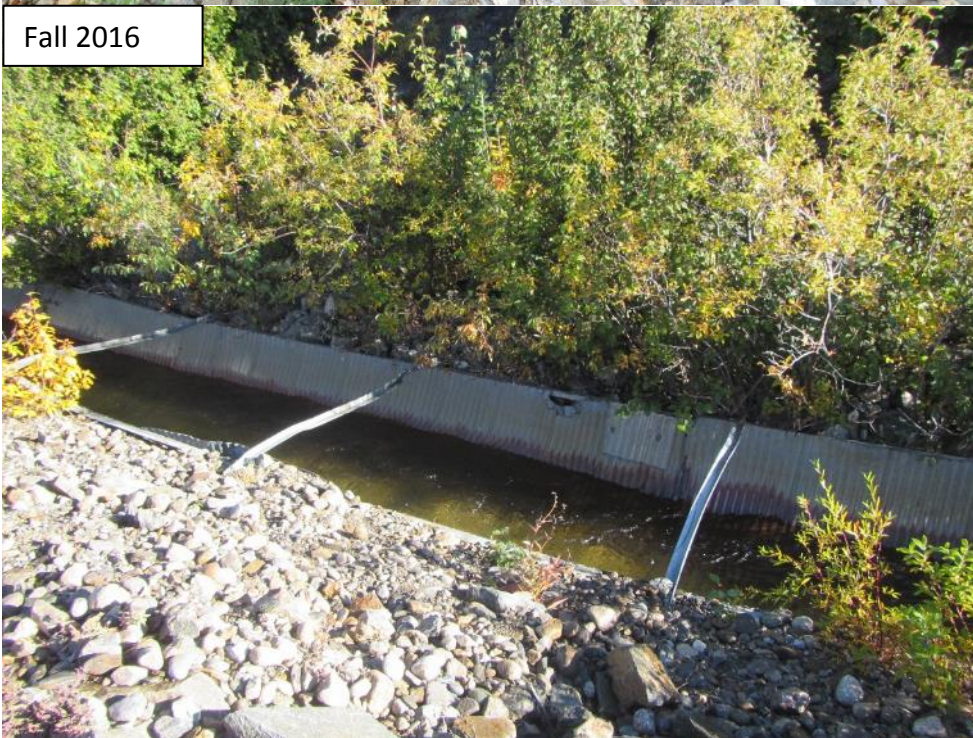
Photograph 51 Flat slope section, overtops during high flow

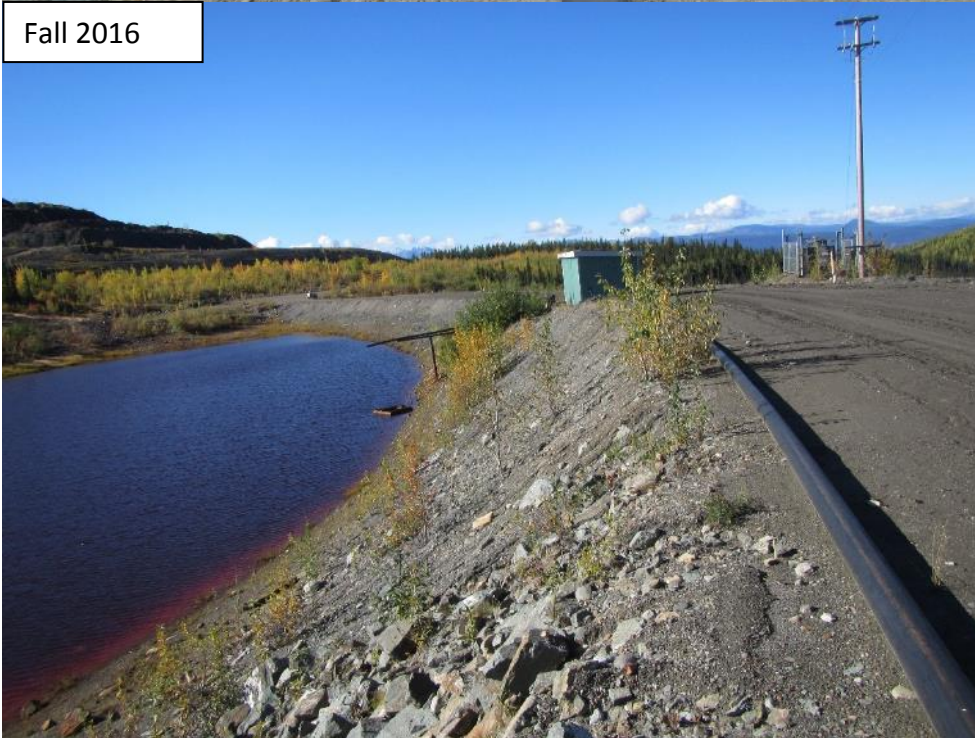
Photograph 53 Little Creek Dam from the access road (looking west). Satisfactory conditions.

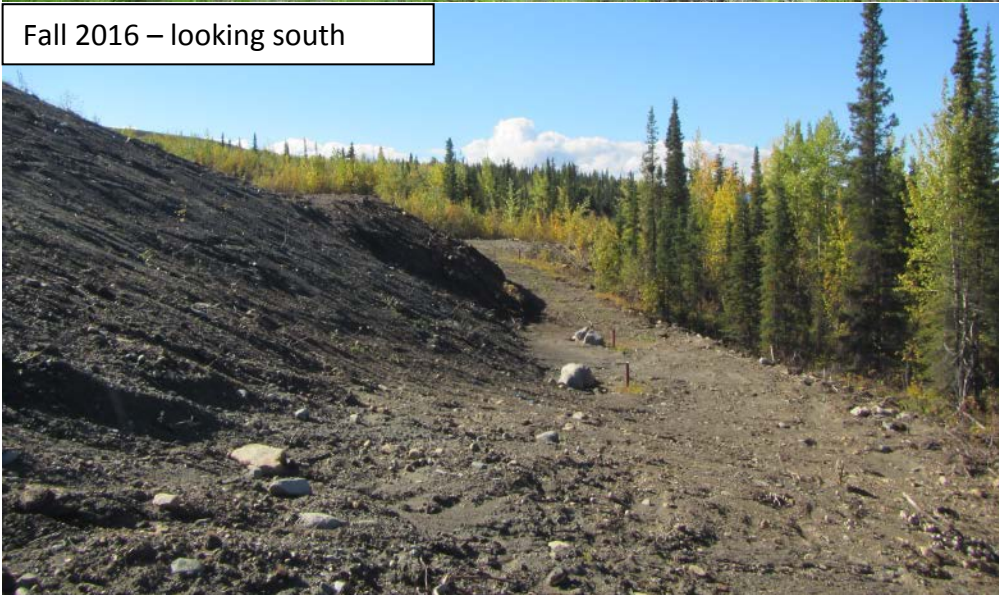
The erosion on the downstream slope of Little Creek Dam was repaired and the trees removed but erosion quickly started again. A second round of repairs was done which involve improving drainage at the crest and on the small benches on the downstream dam face. Plans are underway to vegetate the slope to control erosion. This is expected to take significant effort given the difficult growing conditions.

Photograph 55 Little Creek Dam downstream toe. Vegetation has been removed since spring. Slope is subject to erosion and should be repaired and stabilized.

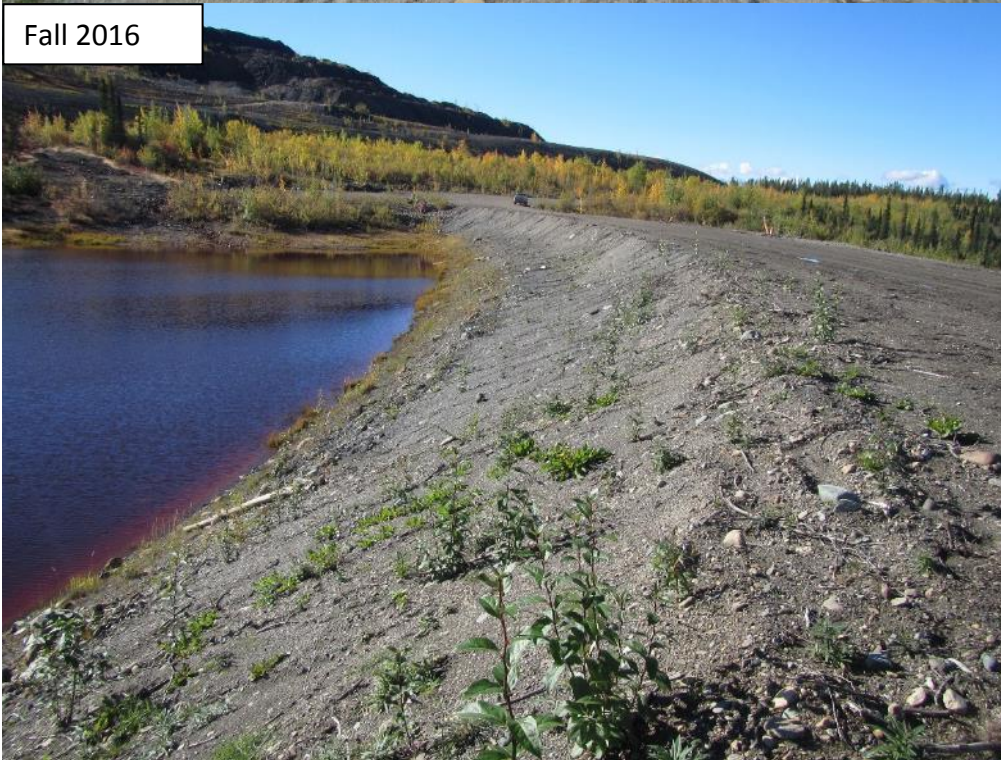
Photograph 56 Little Creek Dam upstream slope, repaired rill erosion. Minor vegetation.

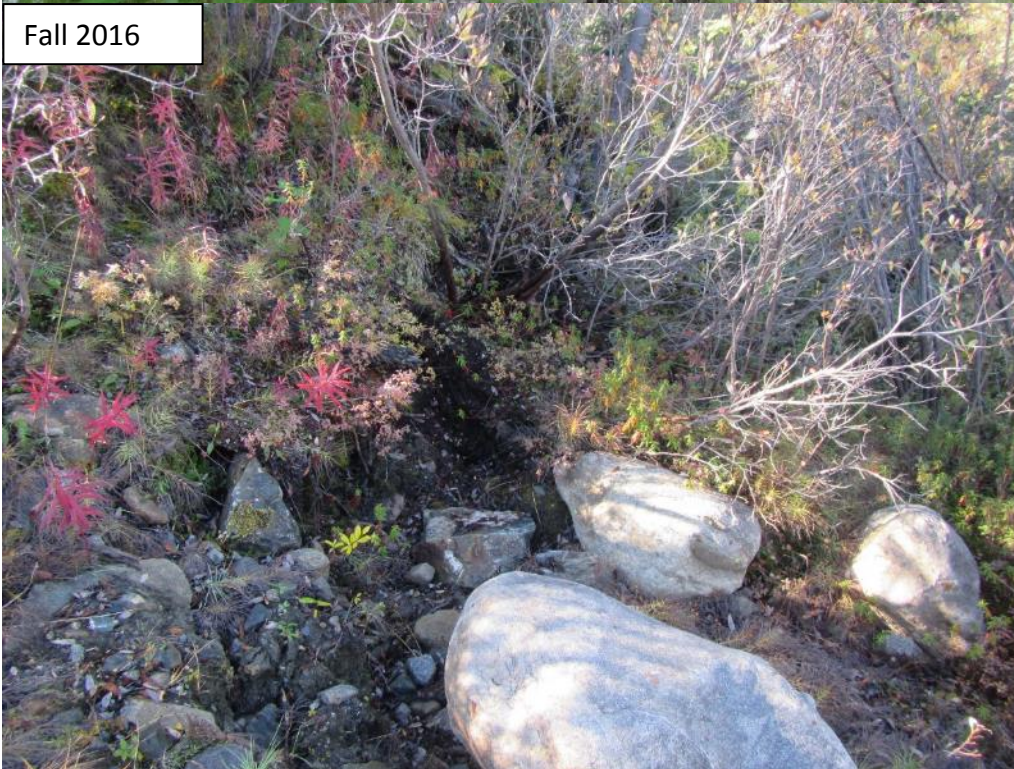
Photograph 58 Ground slope crack across downstream spillway channel near discharge end. Similar conditions in spring and fall.

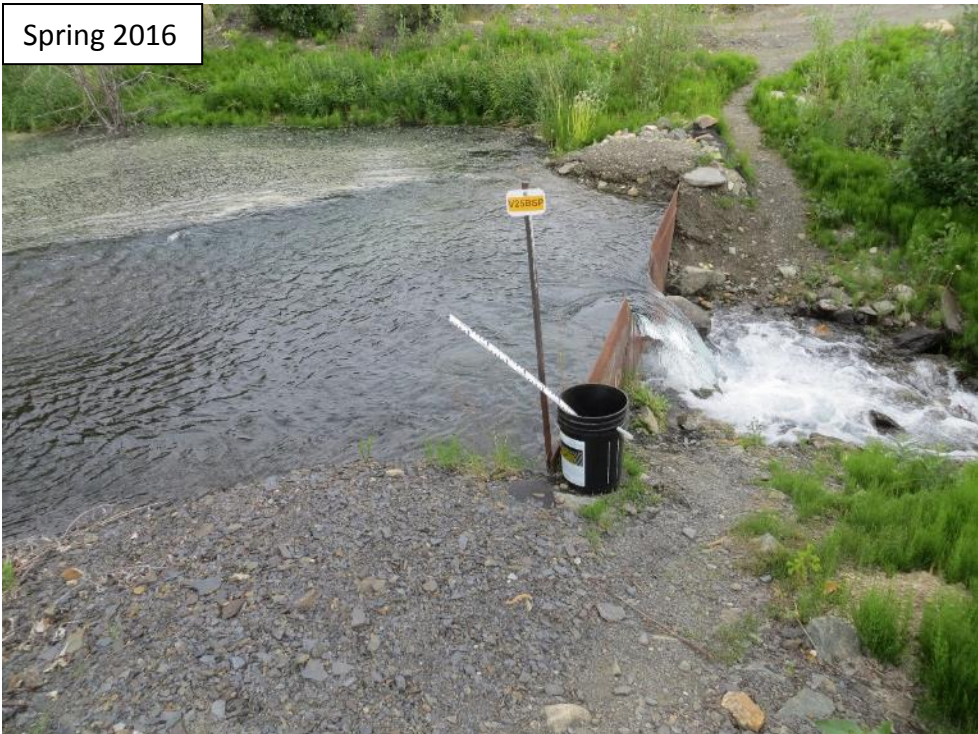
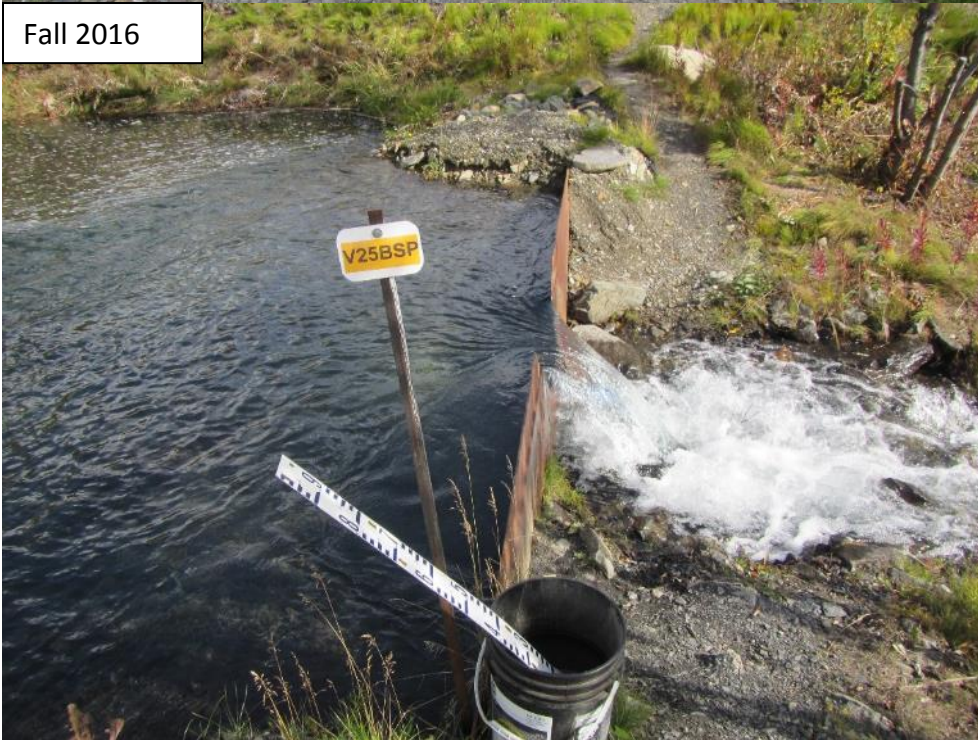
Photograph 60 Outflow of Sediment Pond upstream of Plunge Pool. Satisfactory conditions.
