Klohn Crippen Berger

Faro Mine Complex

2016 Annual Geotechnical Review

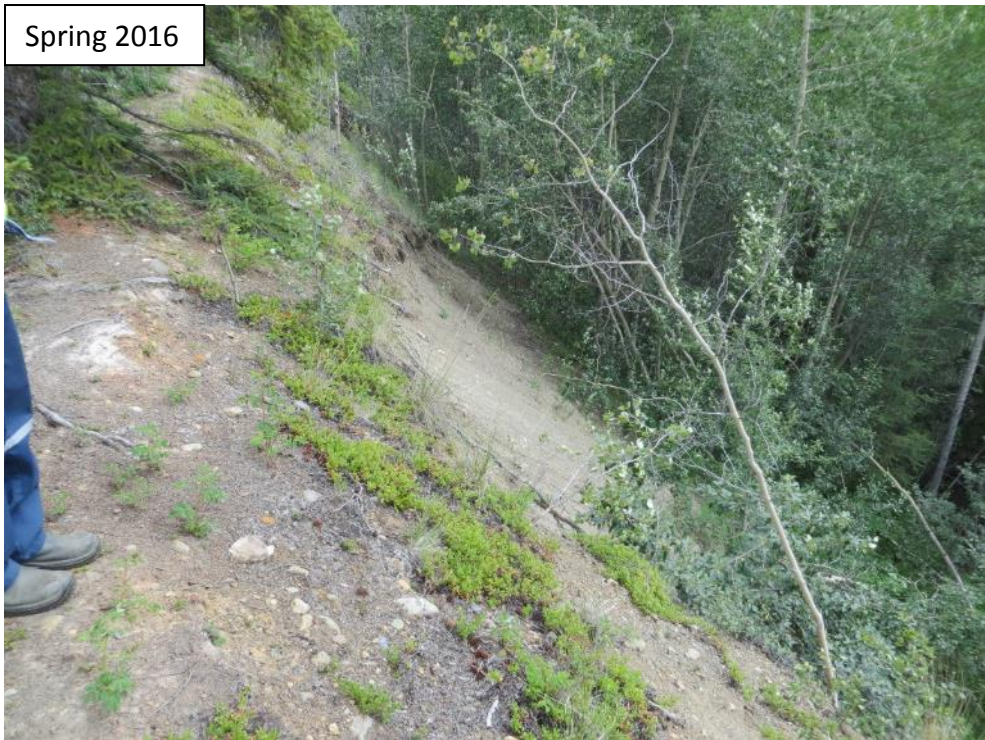
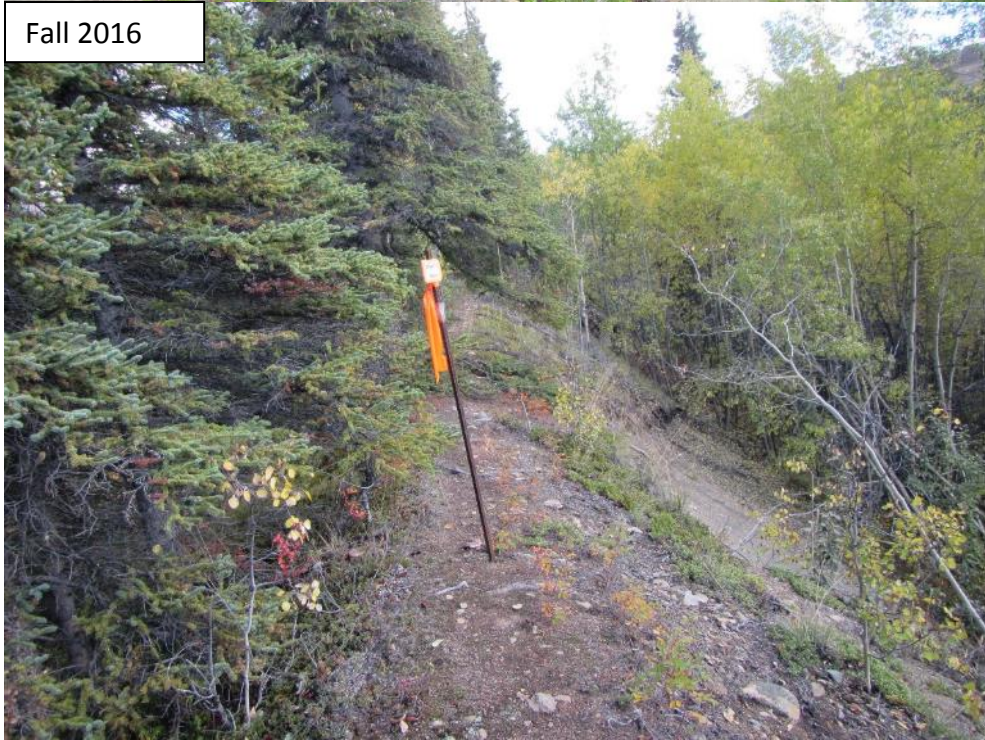
Photograph 64 Moose Pond Esker downstream slope. Similar conditions in spring and fall.

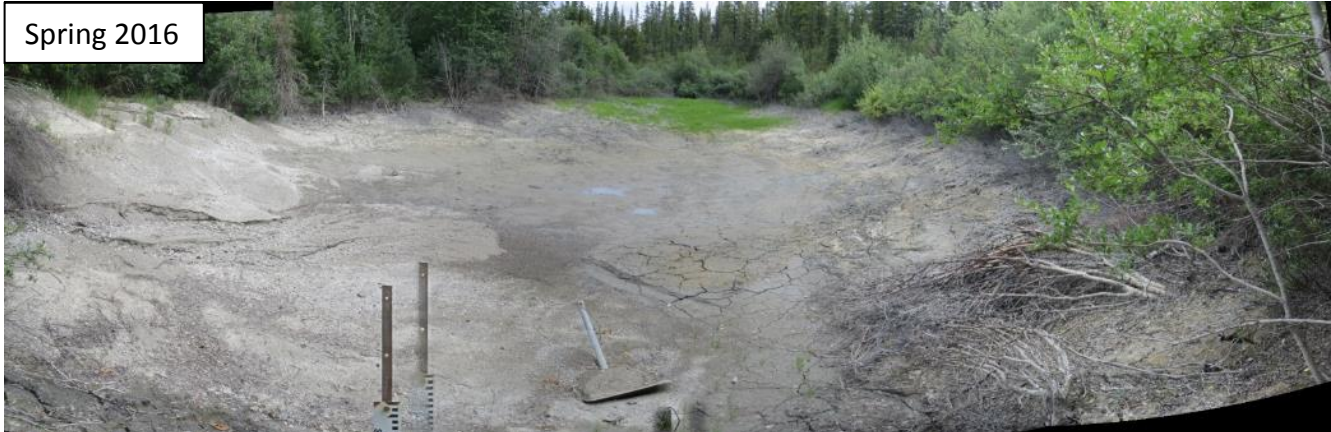
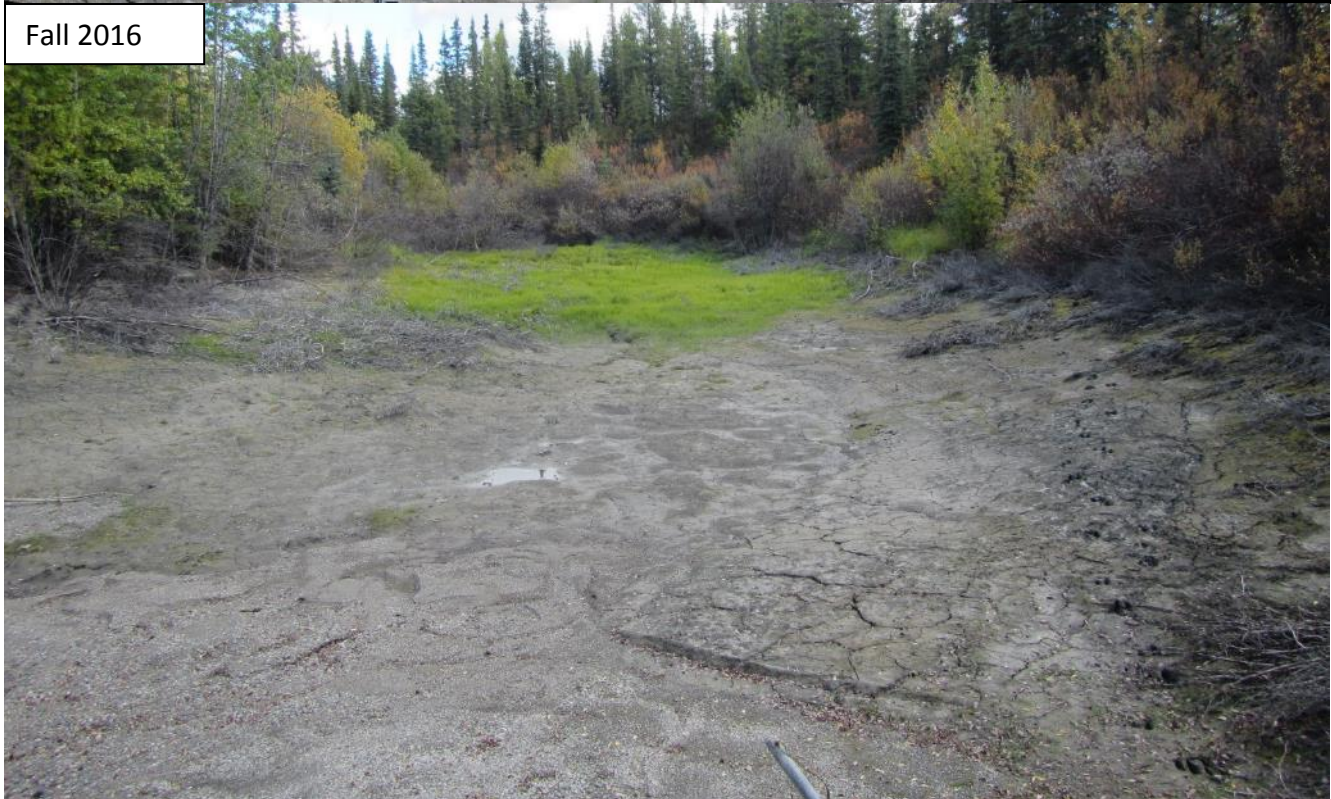
Photograph 65 Moose Pond. Satisfactory conditions.

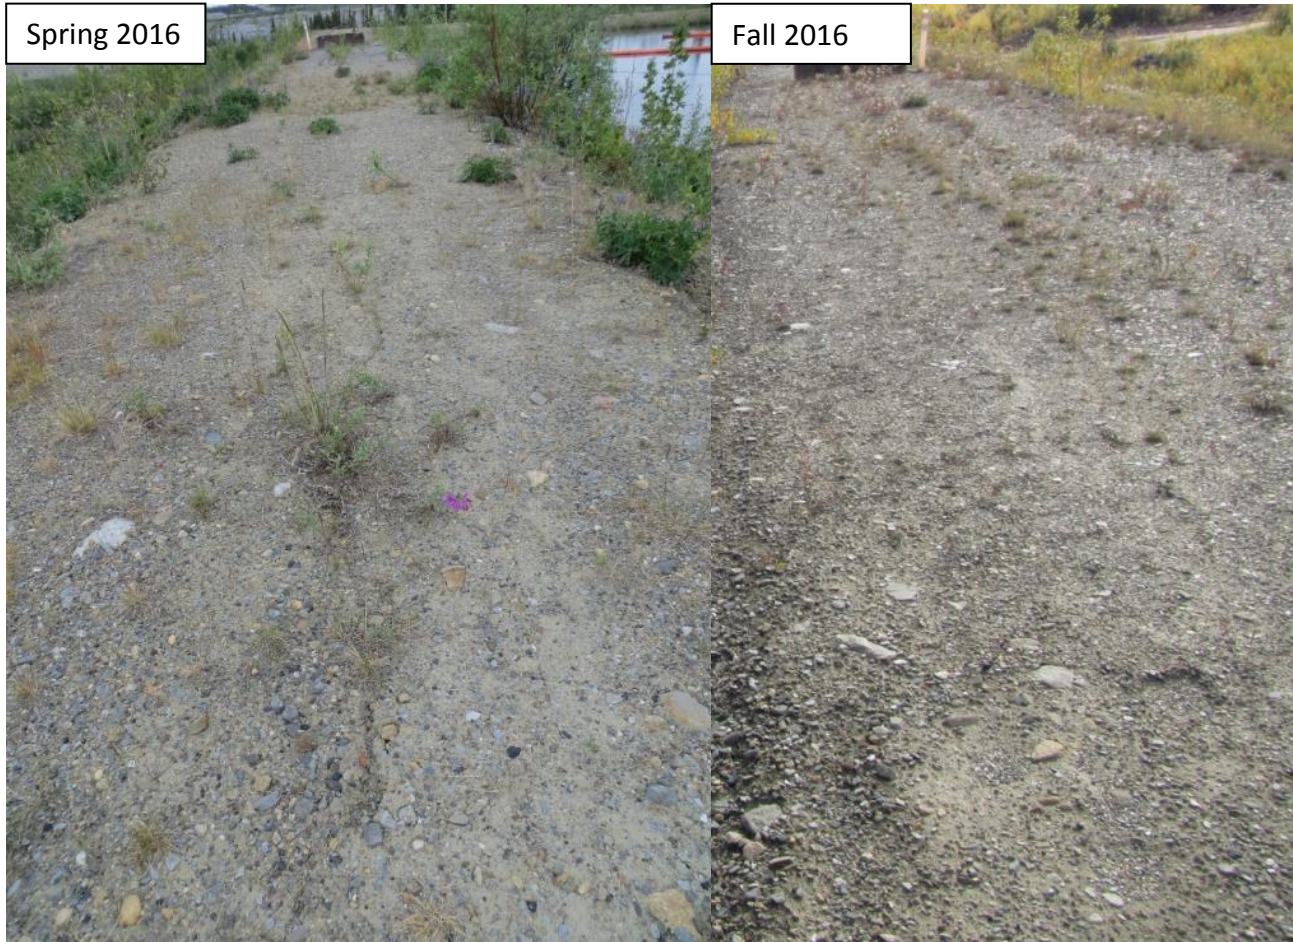
Photograph 68 Clarification pond, longitudinal freeze-thaw cracks. Not as evident in the fall.
