**1999 Annual Inspection  
Waste and Water Management  
Facilities Vangorda Mine  
Yukon Territory**

**Report No. 1CD003.02**

**December, 1999**

**STEFFEN ROBERTSON AND KIRSTEN (CANADA) INC.**

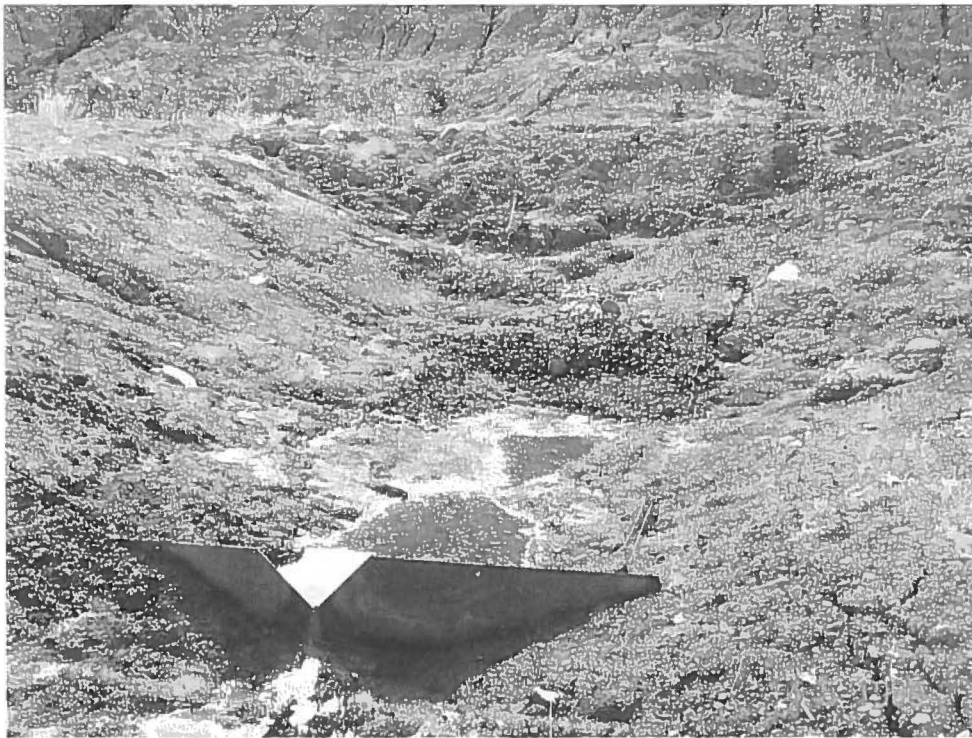
During the inspection, small amounts of seepage were observed in Drains 3 (Photo 6), 5 (Photo 3) and 6 (Photo 5) only. Weir 6 remains silted up and the erosion gully in the till starter dyke behind the drain continues to provide further opportunity for silt build up behind the weir and instability of the dyke. Ice was observed in behind the drain at the toe of the dyke (Photo 4).

Photo 3: Weir at Drain 5

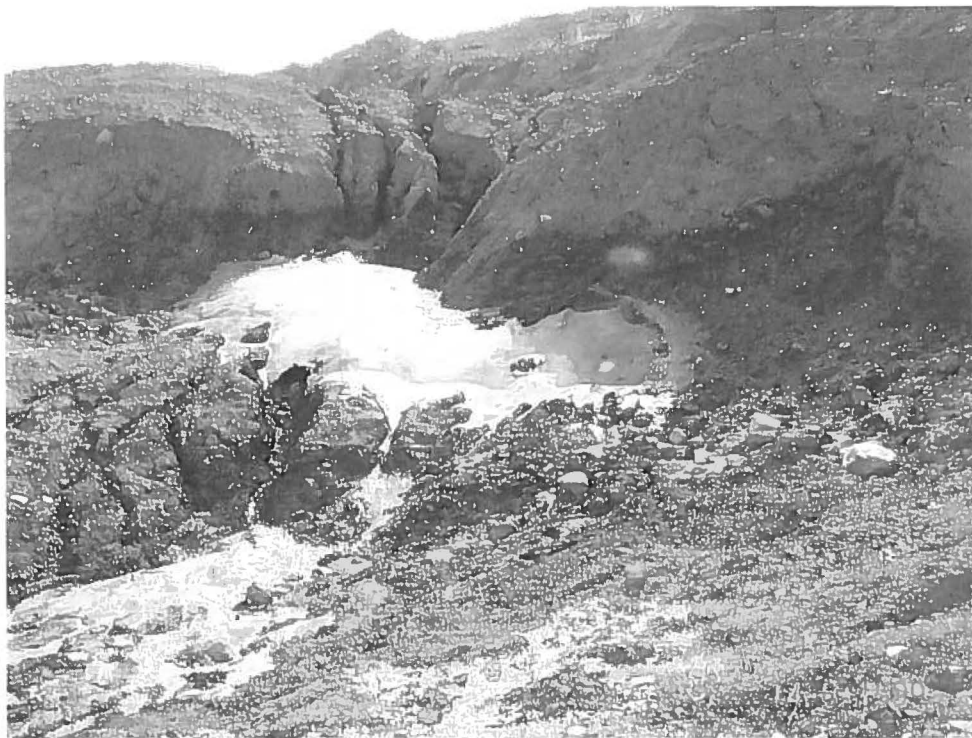
Photo 4: Erosion above Weir 6

To minimise the erosion and silt build-up in Weir 6, DTI should divert the runoff from the road above, away from the weir. DTI should also remove the silt in the area behind the weir and remove the loose material from the face of the drain to expose the granular filter material in the underdrain. SRK understands that some of this work was carried out in the fall of 1999.

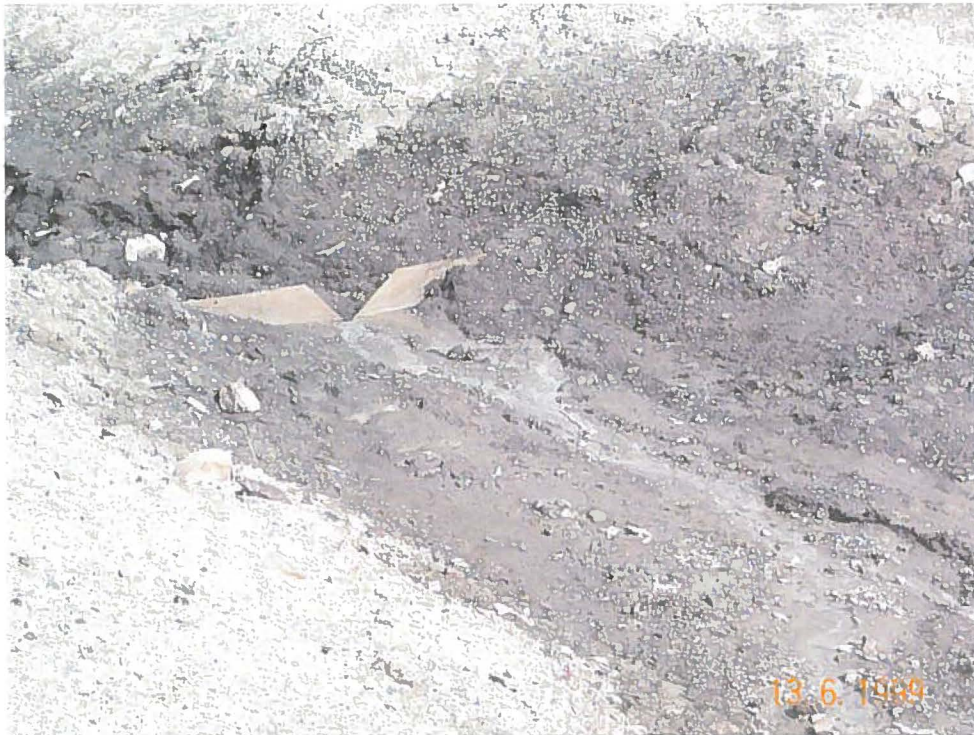
Photo 5: Weir 6

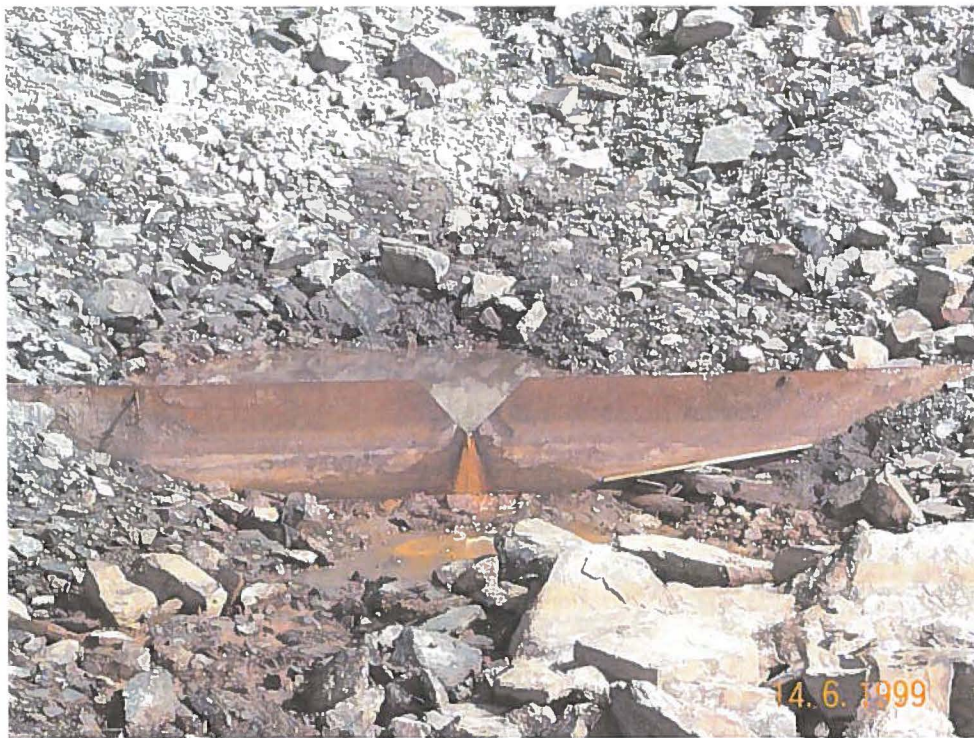
Adjacent to Weir 3, till was removed from the toe of the starter dyke in 1992 by the mine to construct an adjacent sump. This remains a potential risk to the stability of the dyke with the possible loss of the piezometers above (P94-01A and 01B). Erosion gullies that have formed below P94-3A and 3B pose a threat to these piezometers also.

Photo 6: Weir 3

DTI should also place backfill up against the toe of the starter dyke adjacent to Weir 3, where material has been removed.

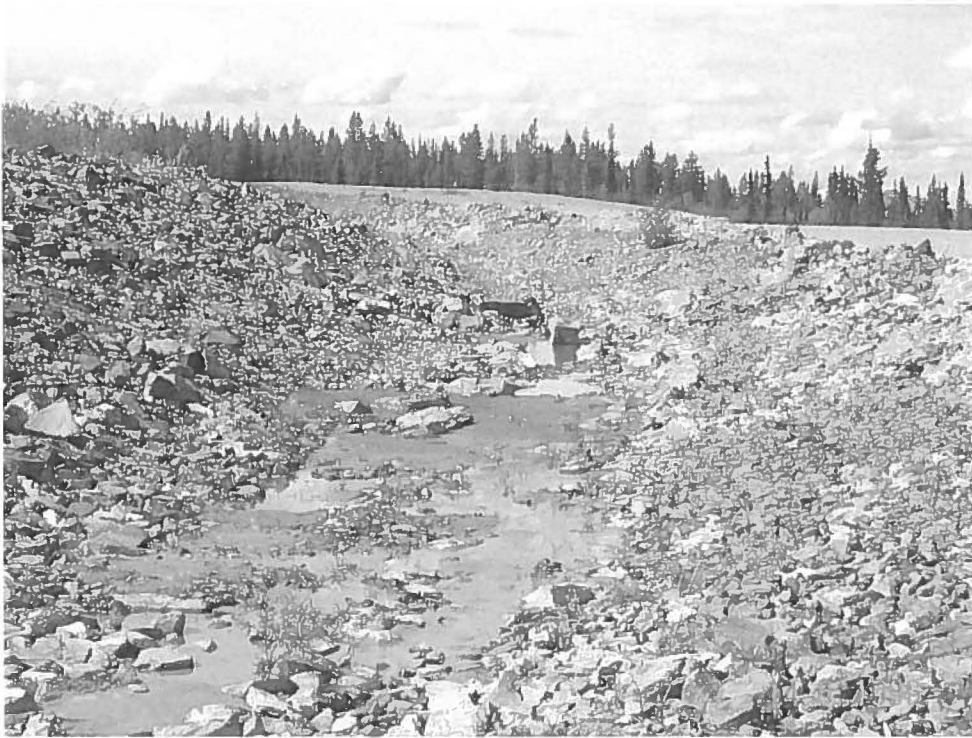
No instability of the sideslopes of the seepage channel was observed. Seepage from the transverse drains at Weir 3 is entering the channel and a measurable amount of flow was observed in the lower reaches of the channel as shown on Photo 7.

Photo 7: Seepage Collection Ditch on Northside of Waste Dump

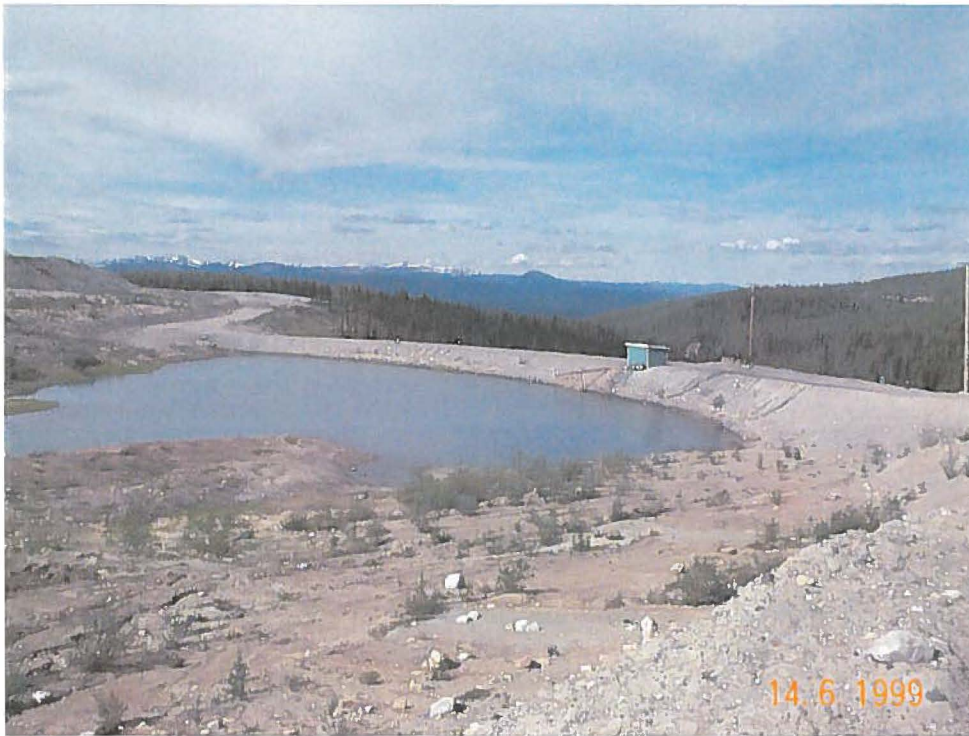
Water level in the pond during our inspection was recorded at about 1110.5m (Photo 10). The mine periodically pumps water from the pond to Vangorda Pit. However, at the time of our inspection no water was being pumped from the pond. Small erosion gullies were observed along the upstream face (Photo 12) of the dam resulting from runoff from the crest. No cracks or major settlement of the dam were observed and there was no noticeable seepage along the toe.

Photo 10: Ponded Water Behind Little Creek Dam

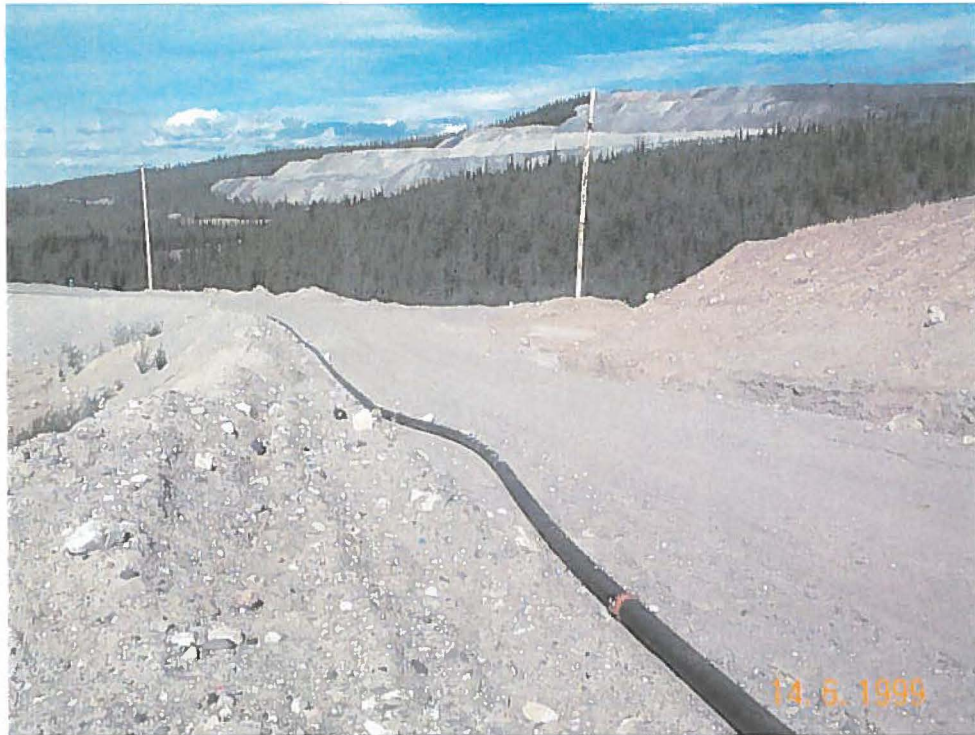
A view of the dam and the new emergency spillway are shown on Photos (8 and 9). Runoff from the eastern approach road (Photo 11) continues to cause erosion of the road embankment sideslopes. Two erosion gullies (photo 13), which are in places 1m deep, are located on the upstream face of the approach road. Runoff from the road flows through the two gullies and over the sideslopes. These gullies pose no immediate threat to the stability of the dam itself but if allowed to go unchecked could result in loss of a section of the road.

Photo 11: Approach Road to Little Creek Dam after Pipeline Return to Treatment Plant on side of Road

It is recommended that the runoff from the approach road be directed into a CMP culvert constructed in the road, which would feed into a half-round culvert section installed down the upstream fare of the approach road. Furthermore, the road surface should be regraded to encourage drainage off the crest and a 150mm layer of 20mm minus sand and gravel should be placed and compacted on the crest.

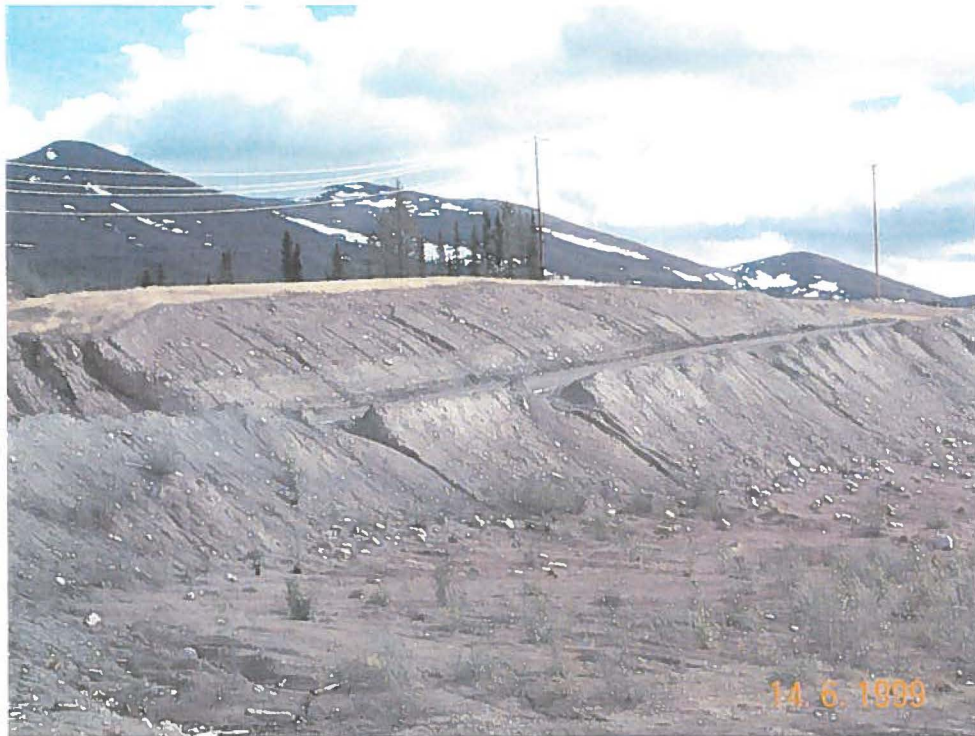
Photo 13: Erosion Gullies in Approach Road to Little Creek Dam

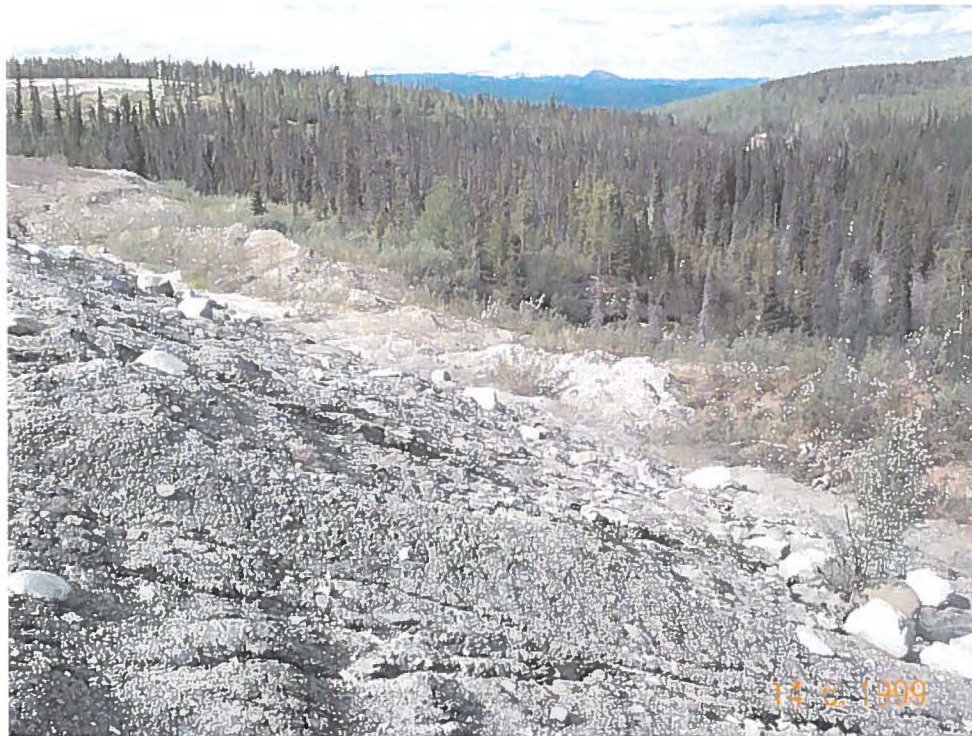
The downstream face of the dam (Photo 14) shows little evidence of surficial movement, bulging or instability. The loose, uncompacted material at the toe of the dam, which was deposited during it's construction in 1991, has not moved but does shows signs of erosion.

Photo 14: Downstream Face of Little Creek Dam

The mine should continue to regularly monitor the crest of the dam for any cracks, settlement or surficial movement of the slope.

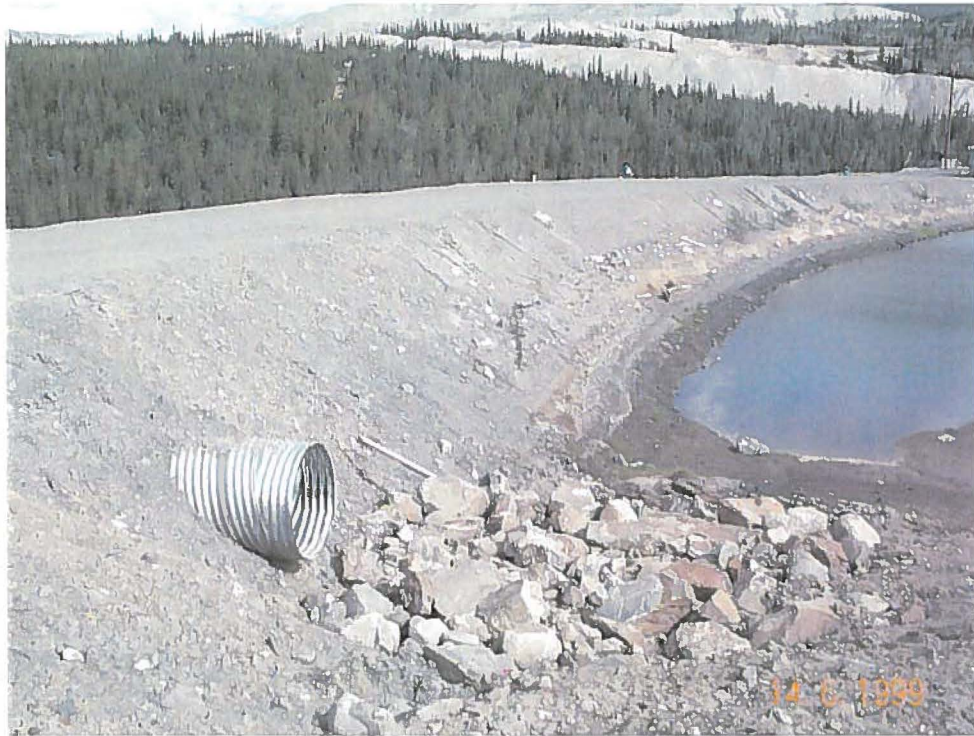
The new spillway culvert in Little Creek dam (photos 15 and 16) was also inspected during the site visit. It was noted that the upstream entrance to the culvert (photo 15) required more riprap around the pipe. Following the site visit, DTI added more riprap around the inlet of the pipe as shown in photo 16.

Photo 15: Inlet of Culvert Spillway at South end of Little Creek Dam

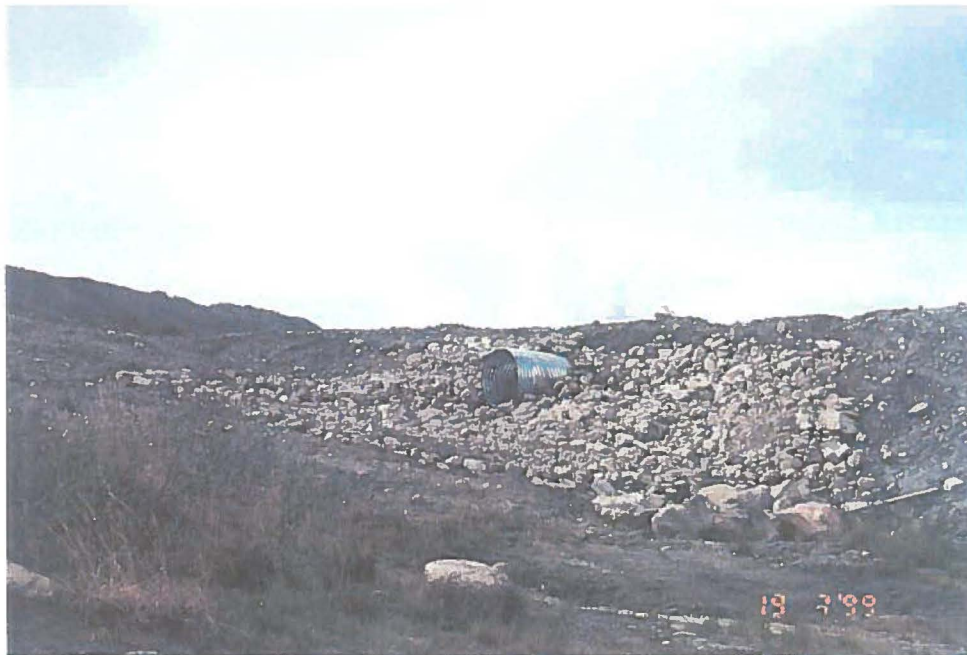
Photo 16: View of the inlet to the culvert after more rip rap was placed

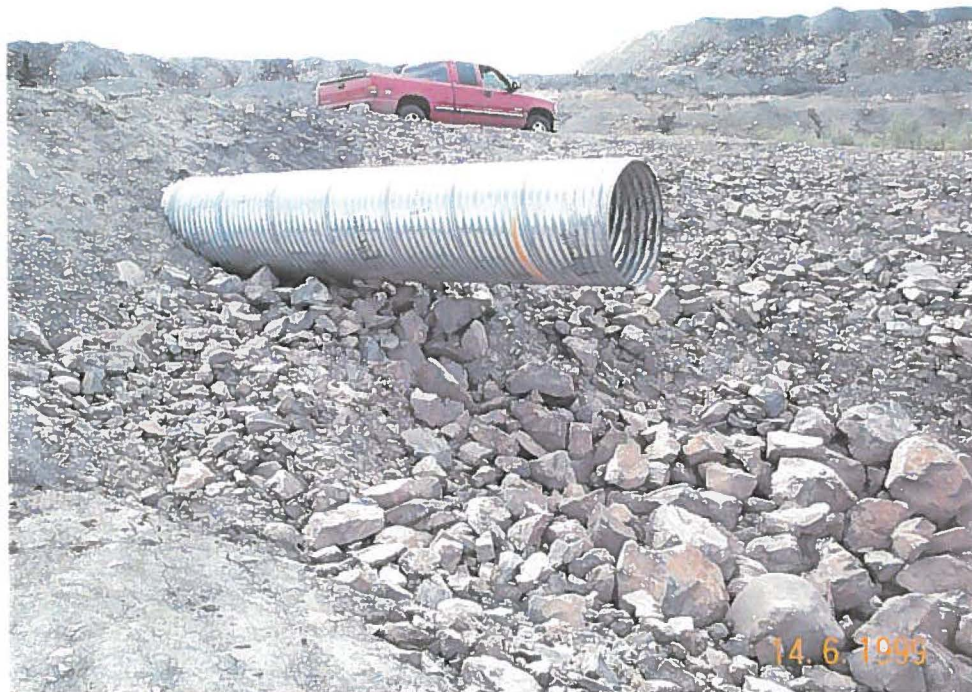
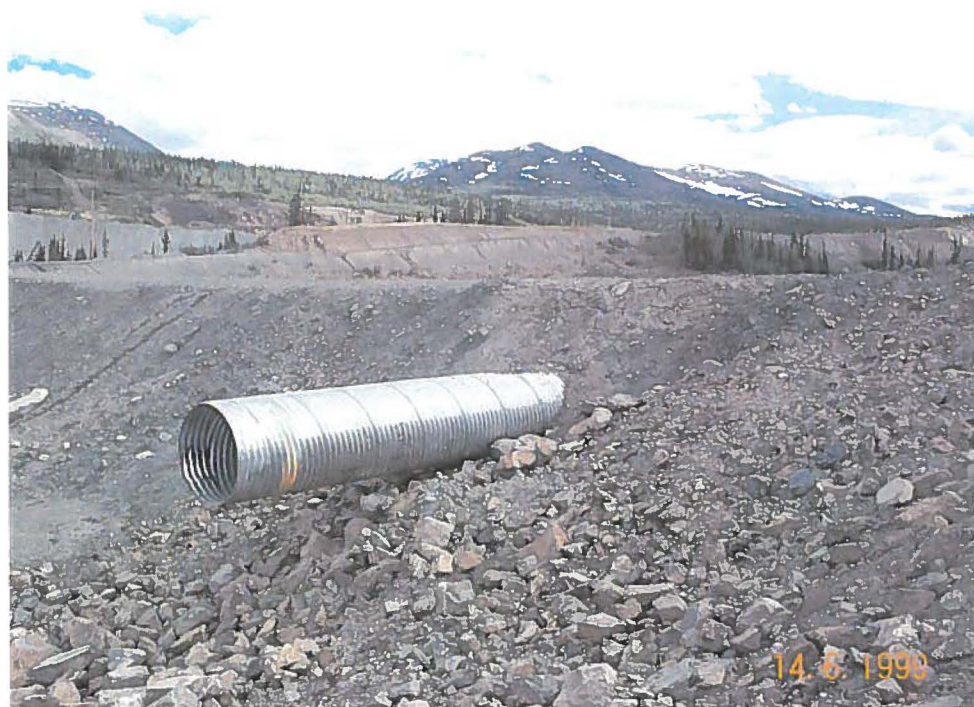
The outlet end of the culvert (Photo 17 and 18) was constructed in such a way that in the event of a discharge, the projected path of the flow would impact the riprapped side of the plunge pool rather than the pool itself. Although the riprap is considerably

Photo 17: View South of Outlet end of Spillway in June 1999

Photo 18: View North of Outlet end of Culvert Spillway at Little Creek Dam

larger where the discharge would impact than the riprap on the remaining sides of the pool, SRK has recommended that a flume be added to the end of the pipe to convey any flow directly to the pool area. This work was carried out in September 1999 as shown on Photos 19 and 20.

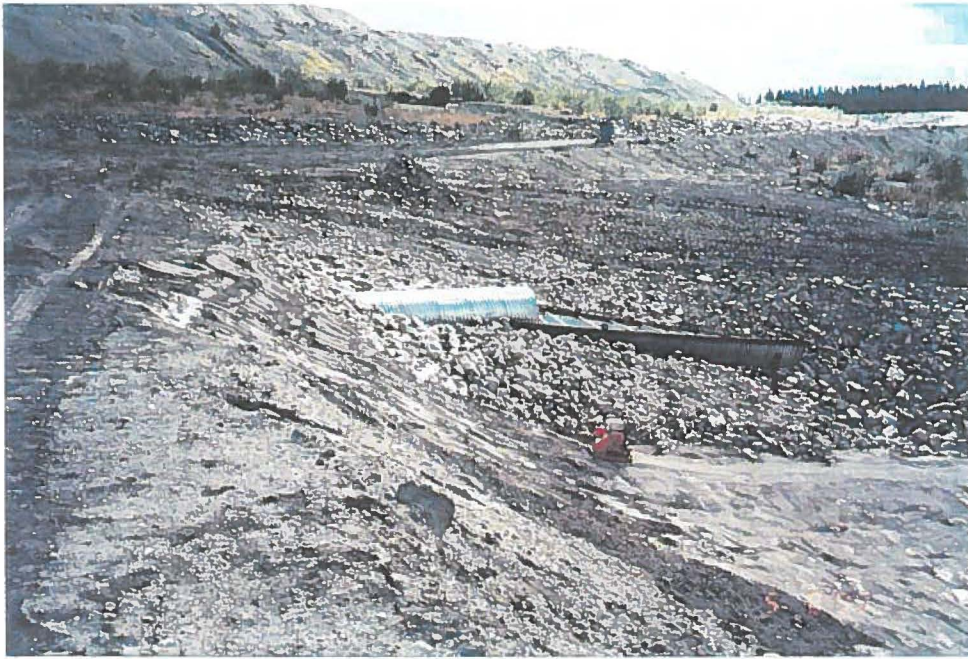
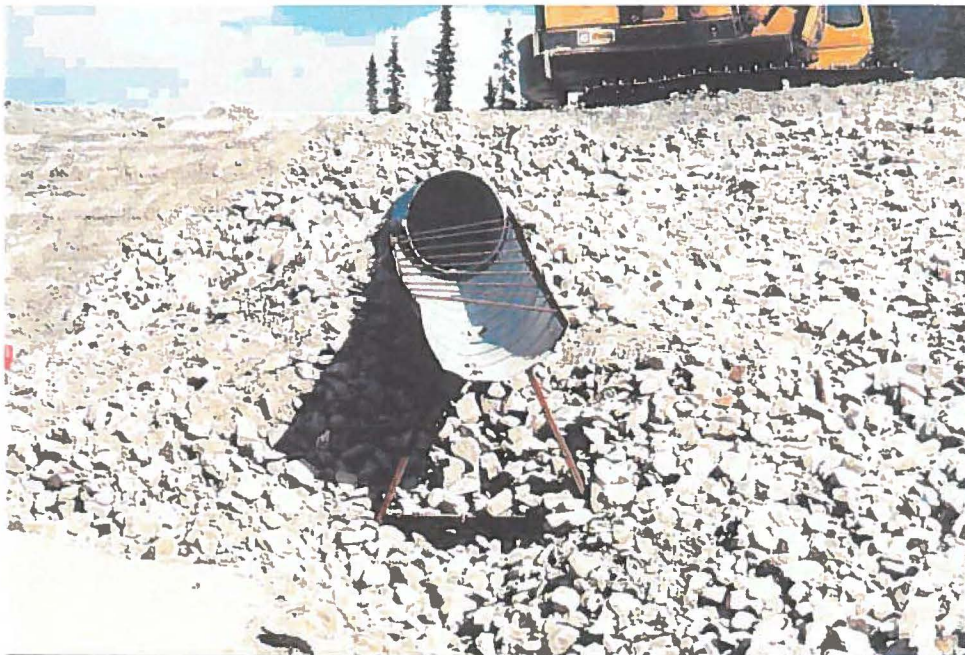
Photo 19: View of the Culvert outlet with additional riprap and the attached half-round flume, September 1999

Photo 20: outlet of LCD culvert with Flume attached, September 1999

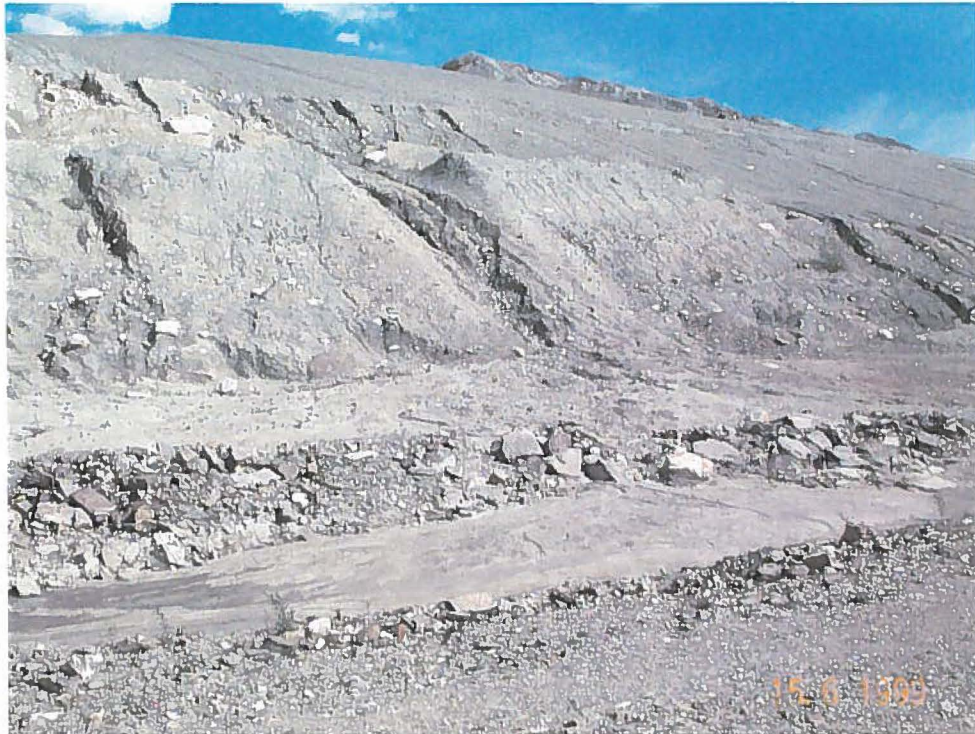
The sideslopes of the till starter dyke remain susceptible to erosion. There is one area that is particularly eroded (Photo 21). This area lies just below the 1994 resloping and till cover placement. Runoff concentrates in-between the till cover and the resloped rock causing erosion gullies and silt spill into the seepage channel at the toe of the dyke.

Photo 21: Erosion Gullies in till Berm below resloped areas of Vangorda Waste Dump

In the upper reaches of the seepage collection channel below the till cover, DTI should remove any silt that has accumulated in the channel. When the next phase of till cover is placed, this area would be recontoured and the sediment problem would be reduced. In the meantime, DTI should continue to monitor the silt build-up and periodically remove the material.

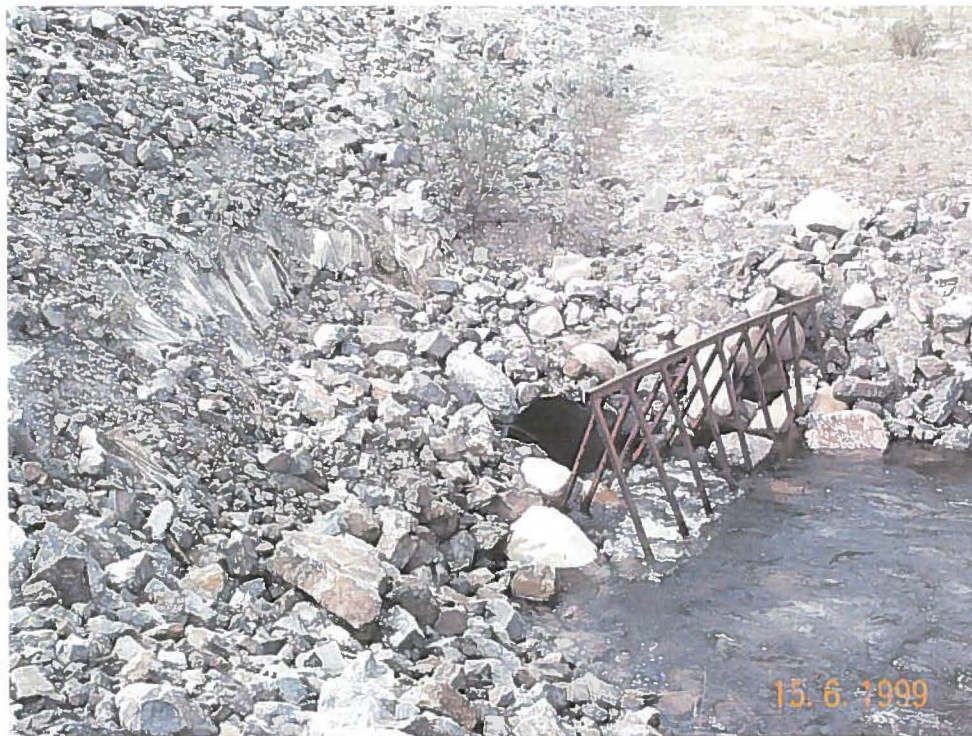
Riprap around the entrance to the culvert at the headwork's of the Vangorda diversion has dropped away exposing the underlying geotextile (Photo 22). This situation is not new and has been noted on previous inspections. Furthermore, riprap has begun to collect in the channel and around the trash rack at the inlet to the CMP narrowing the entrance. The pipe itself appears to be sound.

Photo 22: Headworks of the Vangorda Creek Diversion

DTI should place additional riprap over exposed geotextile at the headworks and continue to monitor the sideslopes above the flume for sloughing. SRK also recommends that a more complete evaluation of the stability of the rock face above the flume be carried out.

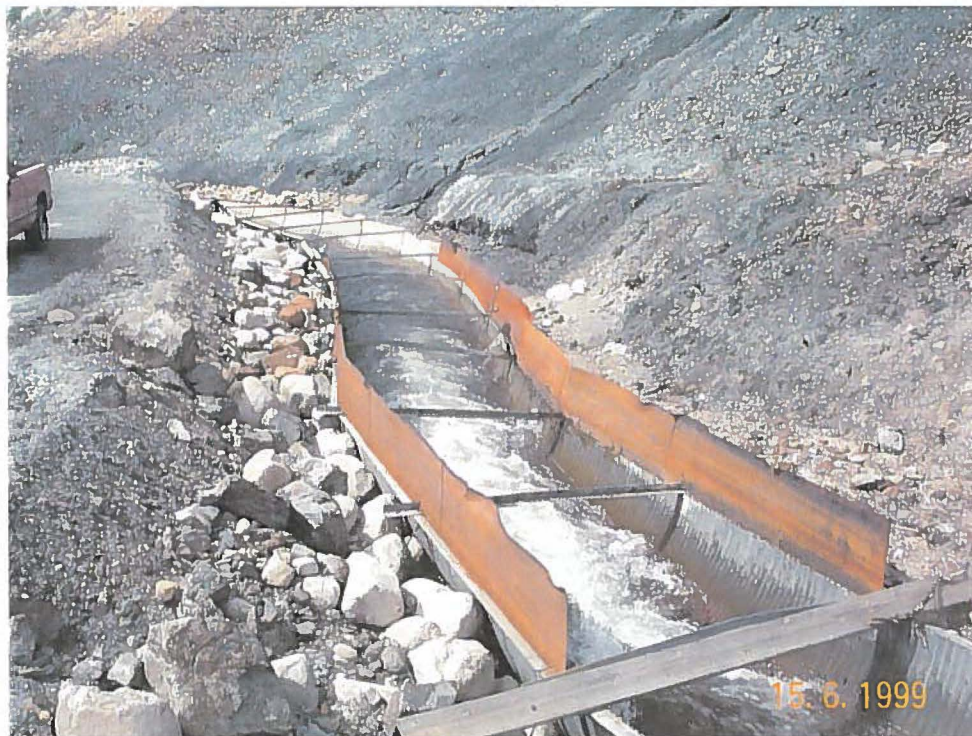
The half-round culvert in the upper reaches has performed well but the flume does not weather well along the lower reaches. The crossbars are badly bent and the flume is buckled in places. In several areas along the flume, riprap has settled to below the lip of the culvert (Photo 23).

Photo 23: Vangorda Creek Diversion

The riprap along flume where the material has settled below the rim of the culvert sections should be topped up and additional riprap should be placed in the excavated pool at the southeast corner of the plunge pool. Additional riprap should also be placed on the sideslopes around the perimeter of the pool. Where fresh soil is exposed non-woven geotextile filter fabric should be placed prior to laying down the rock.

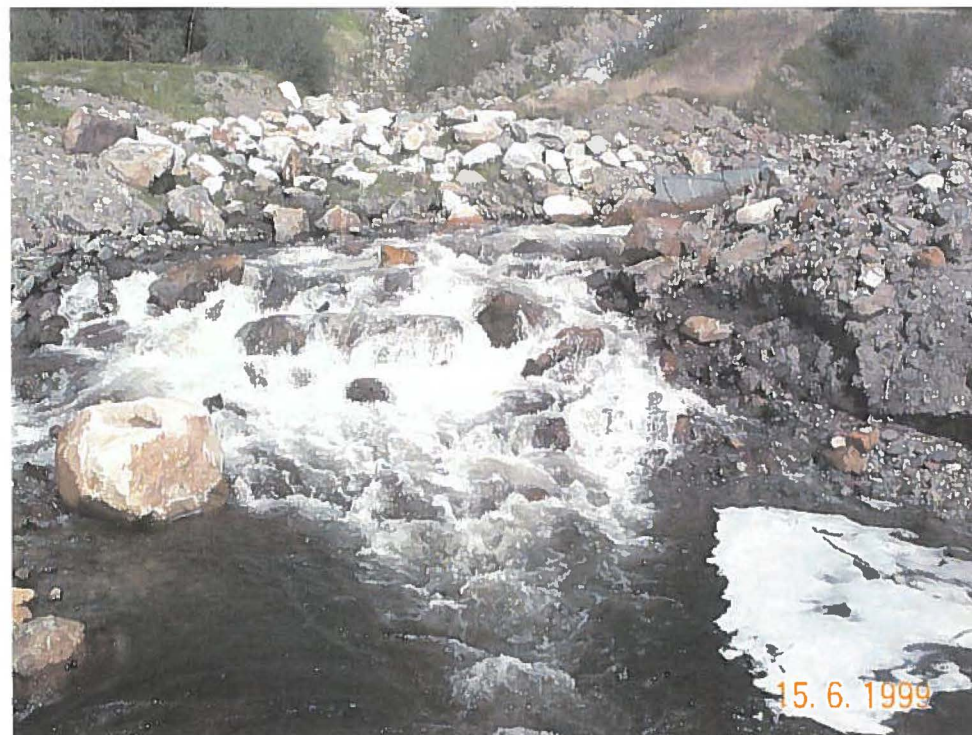
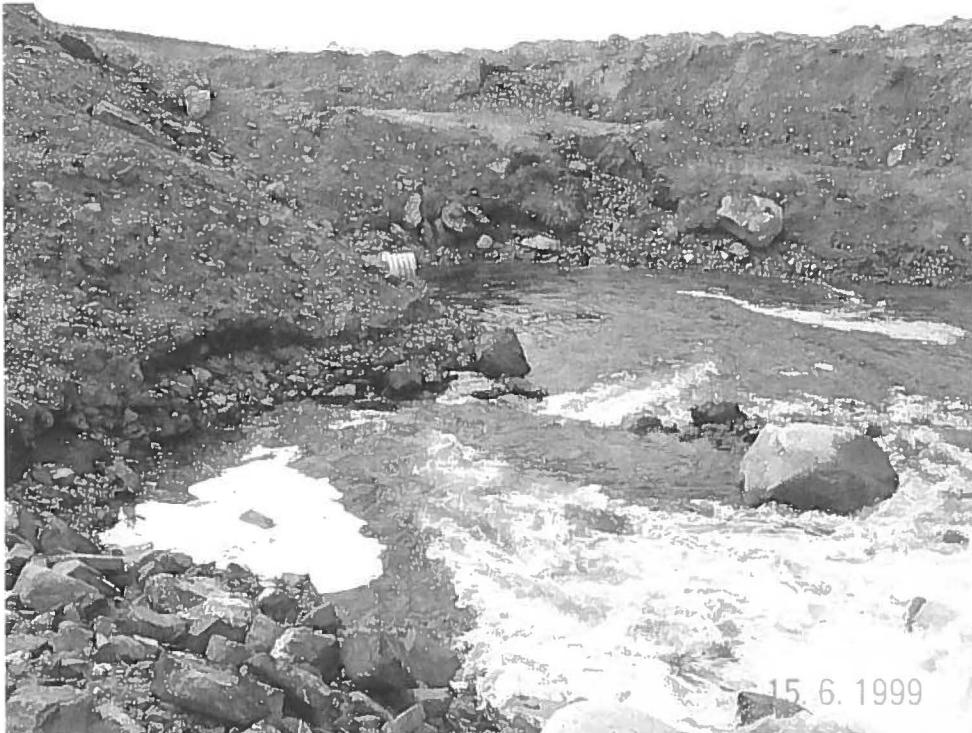
The plunge pool (photo 24 and 25) at the outlet of the flume has lost some of the original riprap that had been placed on the sideslopes of the basin. Furthermore, where an area of the pool was excavated to allow water trucks to be filled, the water is slowly undermining the bank. The issue of the capacity of the system to accommodate peak flows with the addition of flow from Sheep Pad Settling pond, remains a concern.

Photo 24: Outlet of the Vangvorda Creek Diversion

Photo 25: Erosion of the Sideslopes at the Stilling Basin below the Vangorda Creek Diversion

We also recommend that a hydrological evaluation be carried out of the Plunge pool.

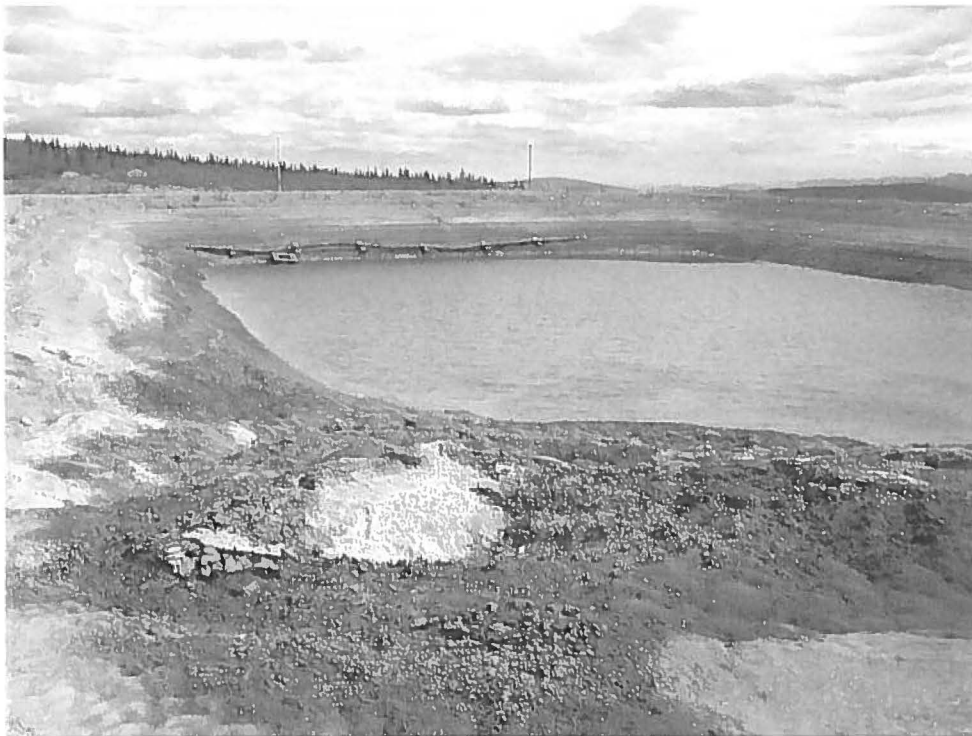
At the time of our inspection, the water level in the sludge pond was about 6 m below the crest of the dyke and the outlet pipe at the south end of the pond was exposed (Photo 26). At the north end of the pond, dry sludge has covered over the inlet pipe to the pond. The tension cracks along the inside face of the pond and along the crest of the dyke have narrowed since the last inspection. Although there is still evidence of previous settlement and minor sloughing of the downstream slope in the southwest corner of the pond, there are no signs of recent movement. Vegetation on the downstream slope is providing some stability to the face.

Photo 26: Sludge Pond at the Treatment Plant

- Ensure that the pond level does not exceed 2m. below crest;
- Continue to monitor on a monthly basis, the crest and sideslopes for cracking or any signs of sloughing. With the pond level at an all time low, the risk of any instability is quite small.
- Fill in or blade over tension cracks both in the crest and along the upstream face to prevent entry from runoff and precipitation.
- Weekly inspection of the upstream face and the crest for further development of the cracks is recommended.

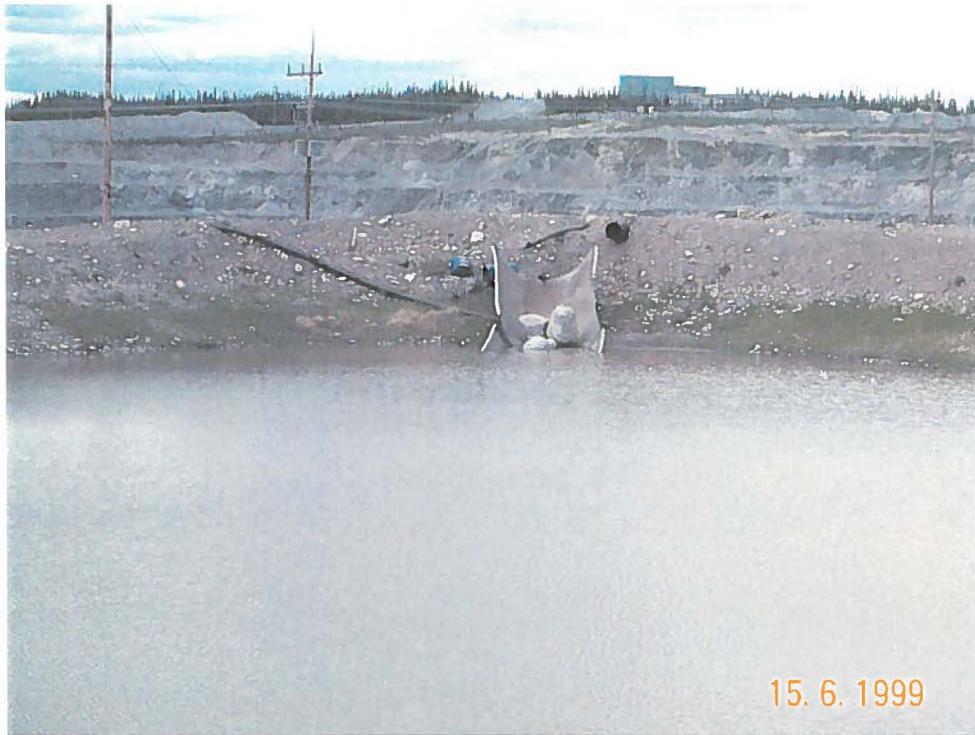
At the time of our inspection the water level in the pond was about 3m below the crest of the dyke (Photo 27) and the downstream sideslopes showed no signs of any recent movement. No significant cracks were observed in the crest.

Photo 27: Croucho Pond (Grum Settling Pond)

The crest of the embankment should be monitored monthly for cracks and the pond level should not exceed 1.0 m below crest. Seepage into and out of the pond should also be monitored.

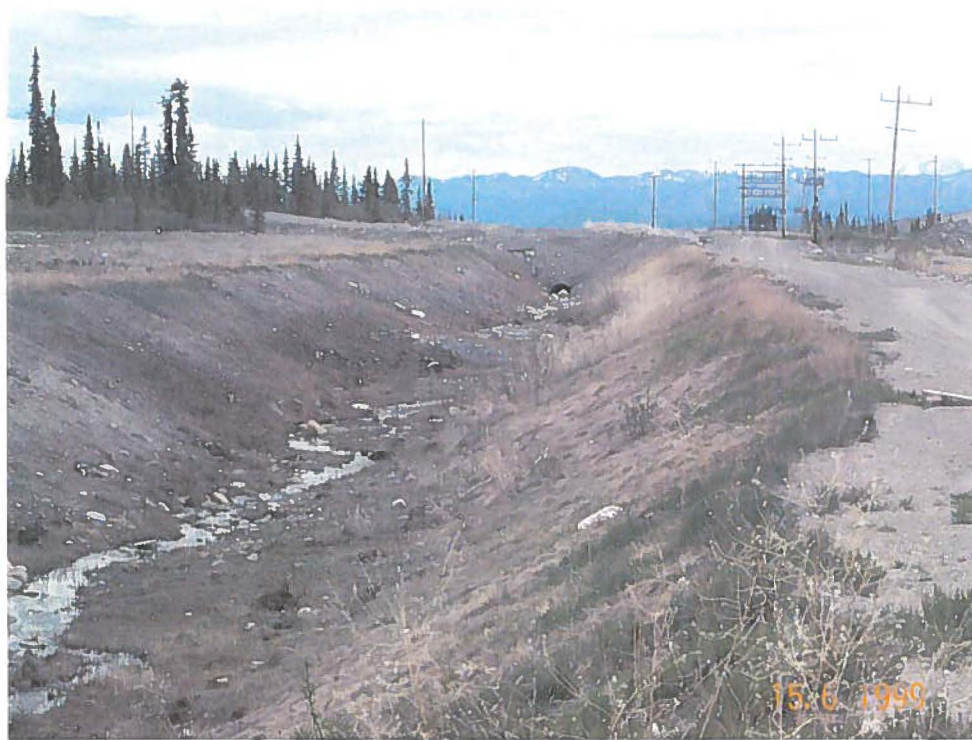
In the upper reaches of the GID, the slopes have performed well and the vegetation is providing effective erosion control of the sideslopes (Photo 28). Inlets and outlets of some of the culverts are silted up and require cleaning. Below the treatment plant, however, there are sections of the ditch where the grade steepens and the sideslopes have subsided narrowing the channel (photo 29 and 30). This subsidence results in an increase in the sediment load reporting to the Sheep Pad ponds. No riprap has been placed on the sideslopes in this area. During the inspection it was noted that the culvert that conveys flow from the GID into the sediment ponds has been damaged and the road fill above the culvert is badly eroded. However, in September 1999 DTI removed the road and the culvert (Photo 30).

Photo 28: Grum Interceptor Ditch above Treatment Plant

- Place riprap (shotrock) around inlets and outlets of all culverts where applicable to prevent erosion and sediment build-up. Geotextile should be placed against the exposed soil prior to placing the riprap;
- Monitor for tension cracks in the settling pond dykes, on the crest and on the upstream and downstream slopes;
- Monitor for seeps that develop along the toe of the dykes;
- Clean out the fine material in the two small sediment ponds at the base of the channel.

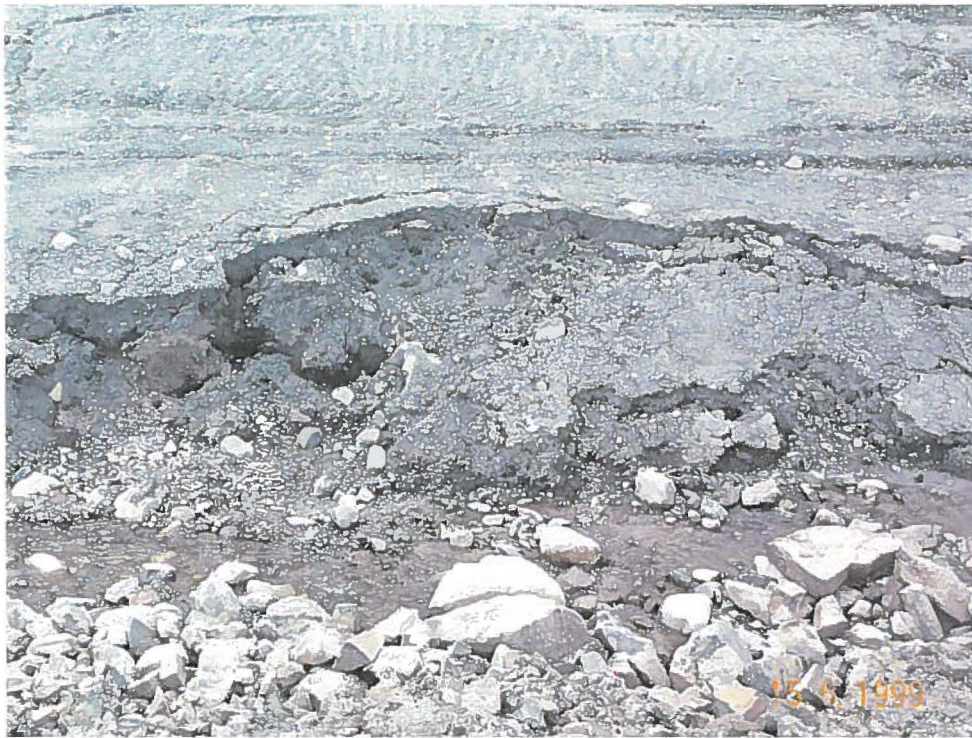
Photo 29: Erosion in GID Sideslopes below Treatment Plant

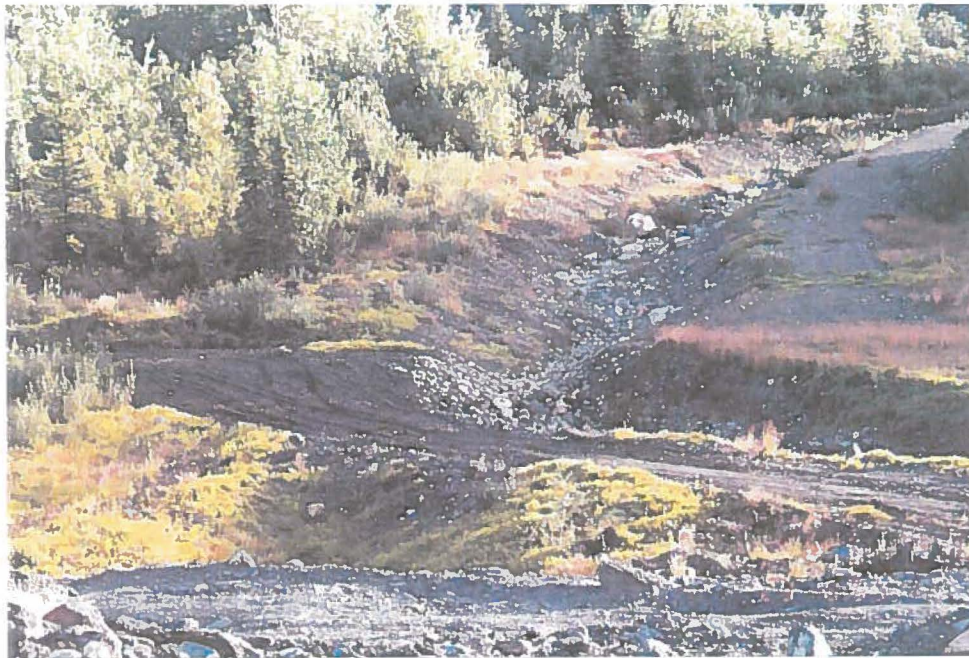
Photo 30: View of removed culvert at the end of the GID
