2000 Annual Inspection Waste and Water Management Facilities Vangorda Mine Yukon Territory

February, 2001

**2000 ANNUAL INSPECTION
WASTE AND WATER MANAGEMENT FACILITIES
VANGORDA MINE
YUKON TERRITORIES**

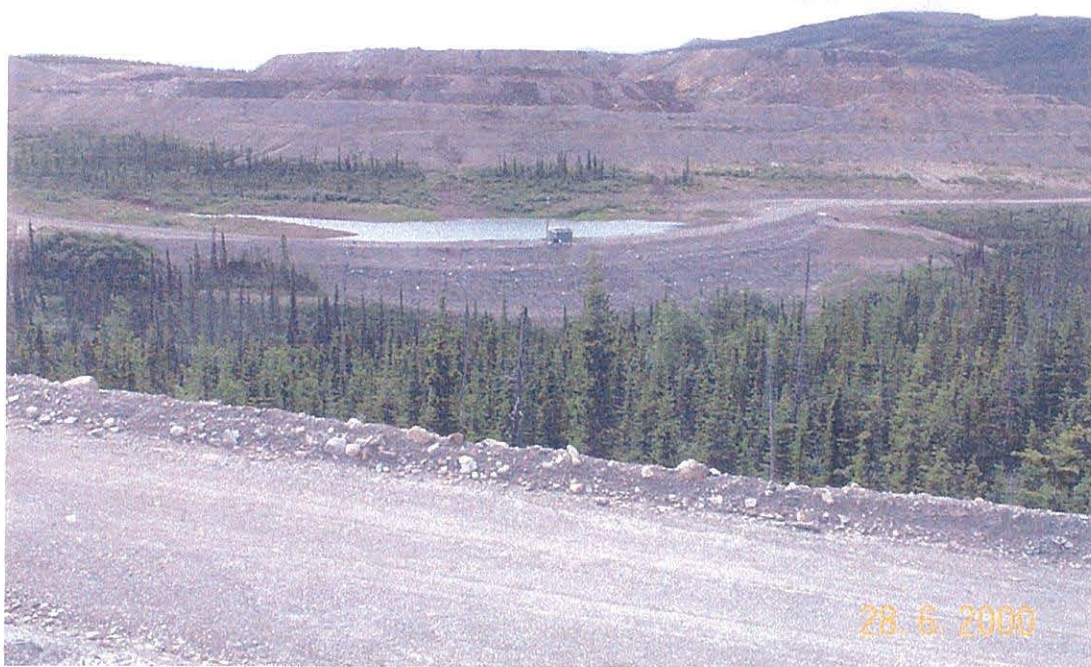
A view of the Little Creek dam and the new emergency spillway are shown on Photo 1. Photo 10 shows a view of Little Creek Pond. Runoff from the eastern approach road continues to cause erosion and subsidence of the road embankment sideslopes as shown in Photo 11. DT constructed a drainage ditch along the inside edge of the approach road (Photo 12), which has directed much of the runoff over to the opposite bank. However, this flow passes over a loosely end dumped pile of till material before it eventually finds its way into Vangorda Creek. Consequently, the stockpile is badly eroded.

Photo 1 A view overlooking the Vangorda Waste Dump with Little Creek Pond in the foreground

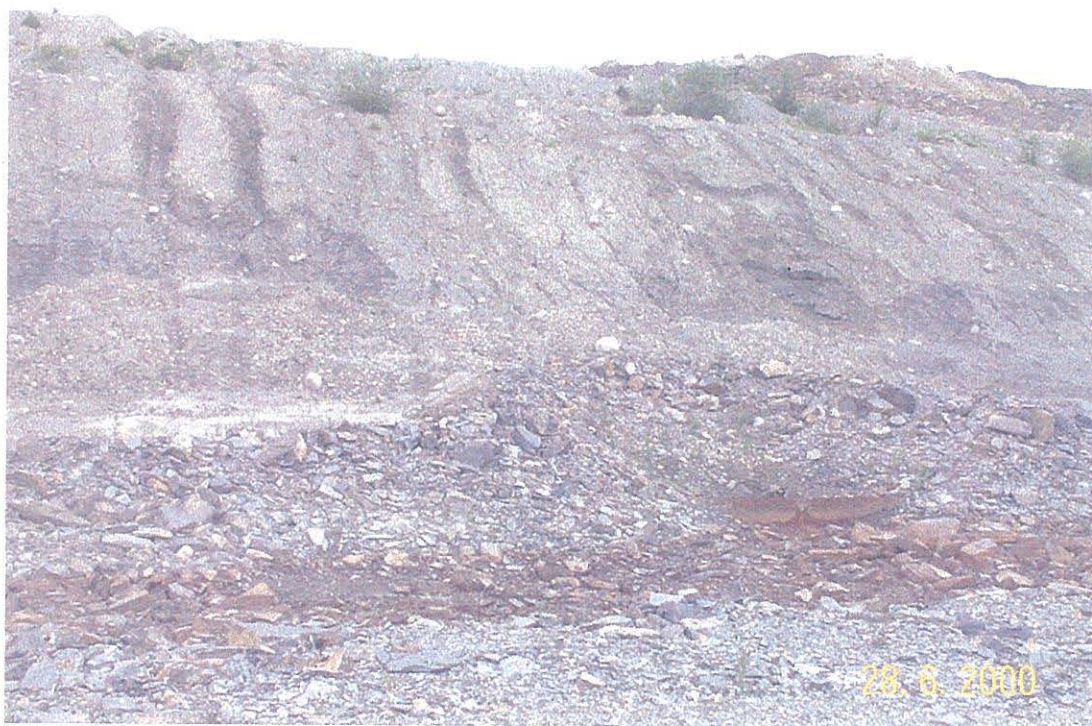
During the inspection, minor seepage was observed at Drains 2, 3 (Photo 2), 5 (Photo 3) and 6 (Photo 4) only. The silt that was observed in behind the weir at drain 6 had been removed but during construction of a diversion ditch along the crest of the till Starter dyke, material had been pushed over the bank causing unstable conditions as shown in Photo 4.

Photo 2 Weir at Drain 3

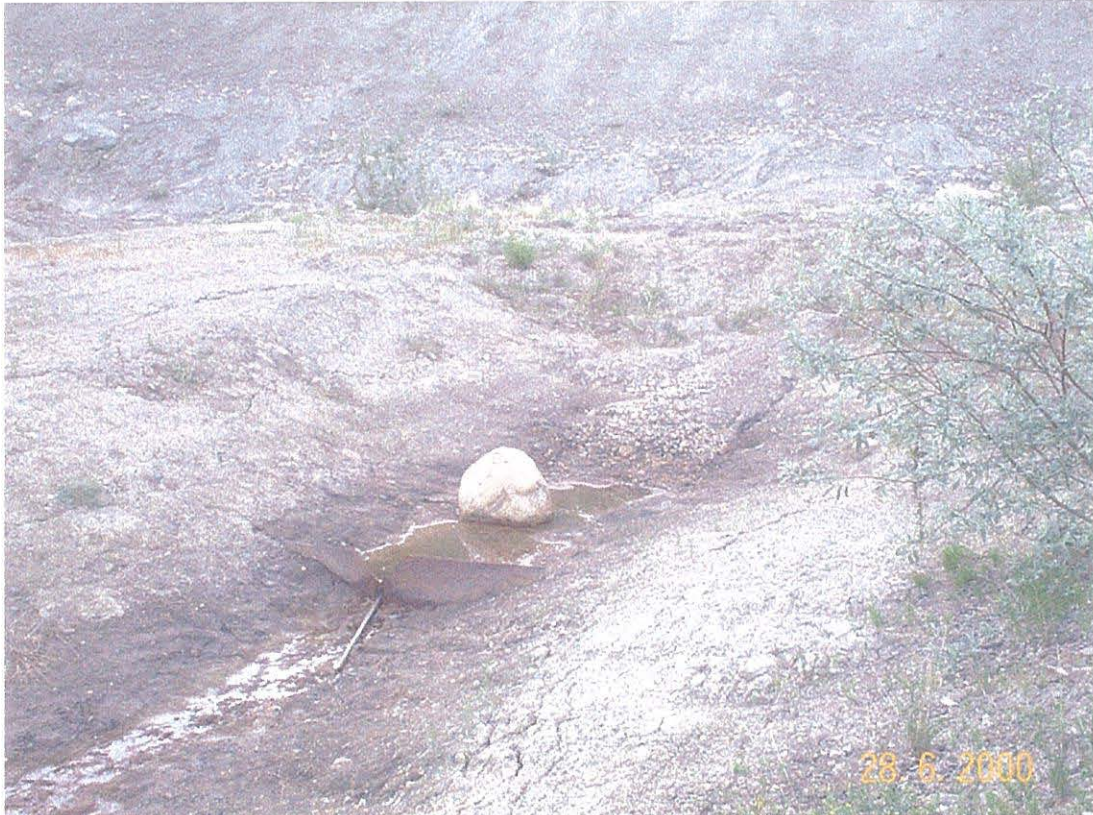
The weir at Drain 5 is functioning adequately, however there is a large boulder located in behind the weir, which should be removed.

Photo 3 Weir at Drain 5

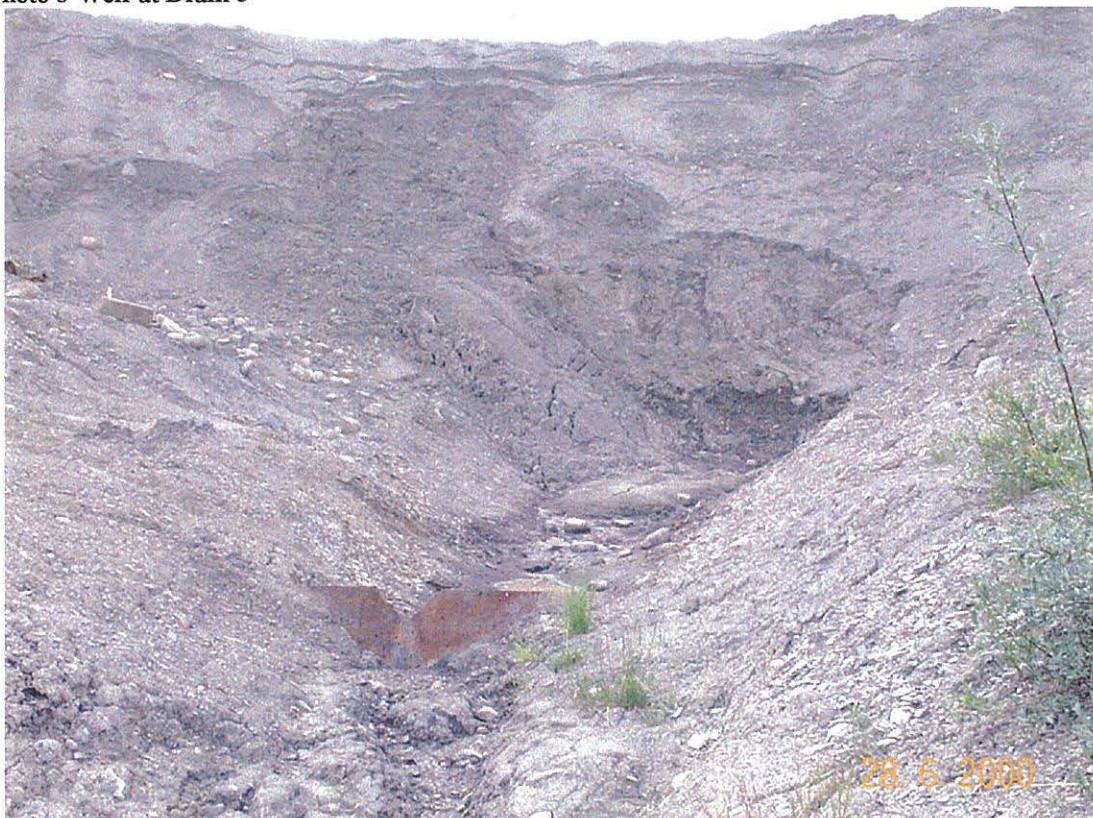
Photo 4 Weir at Drain 6

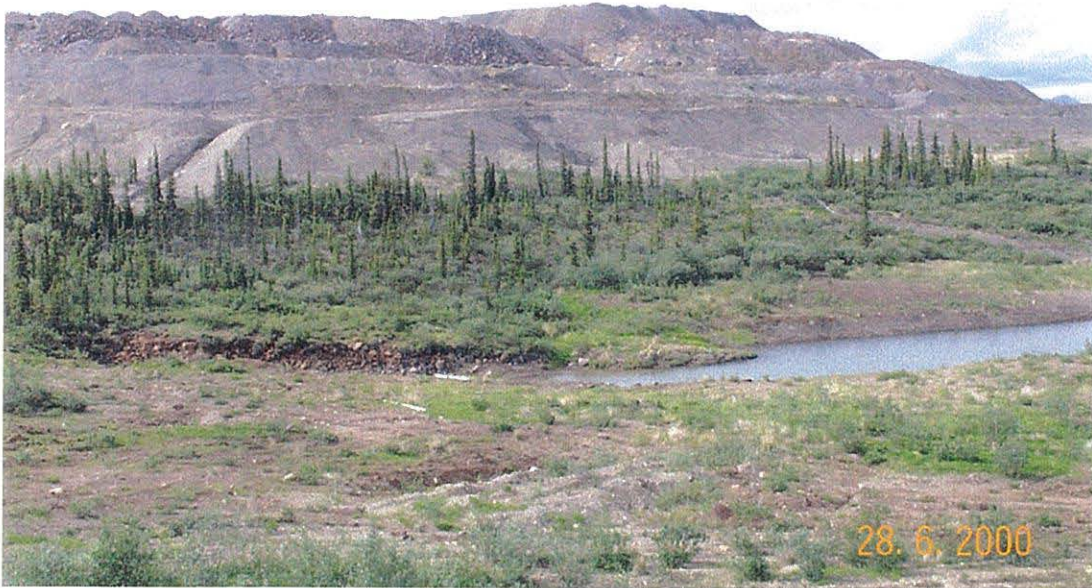
In an attempt of control runoff and instability of the area above the weir at Drain 6, a ditch was excavated within the crest of the till starter dyke along the north side of the Vangorda Waste dump in September 1999. The depth of the excavation varied from about 1 to 4 m. The sideslopes of the ditch were vertical in most places and had sloughed in at several locations causing water to pool in the ditch. The excavated material had been placed on the downstream slope of the starter dyke resulting in an oversteepening of the upper section of the slope (See photos 5 to 9). Figure 3 shows a

The excavated ditch along the crest of the starter dyke that was completed in 1999 has done little to minimise the instability of the bank above the Weir 6 and the siltation potential. Furthermore the bank above the weir is now steeper than before the ditch was excavated and is less stable.

Photo 5 View of the Starter Dyke Diversion Ditch

SRK was asked to inspect the ditch during the site visit. SRK prepared an action plan for the ditch, which was presented to DT in a memo dated July 4, 2000. The recommendations included the following:

1. Runoff should not be allowed to pond in the ditch behind the sloughed material and any accumulation should be monitored;
2. Survey a profile along the bottom of the ditch including a number of cross sections;
3. Prepare a longitudinal profile and cross sections from the survey data;
4. Determine an optimum grade for the centreline of the ditch and develop a final profile and sections
5. Backfill the existing ditch to the revised grade, providing a ditch with sideslopes of at least 1.75 to 1 (H:V). Backfill should be taken from the over-steepened section of the starter dyke and compacted in lifts no less than 300mm.
6. Compaction should consist of 3 to 4 passes of a vibratory smooth drum roller.

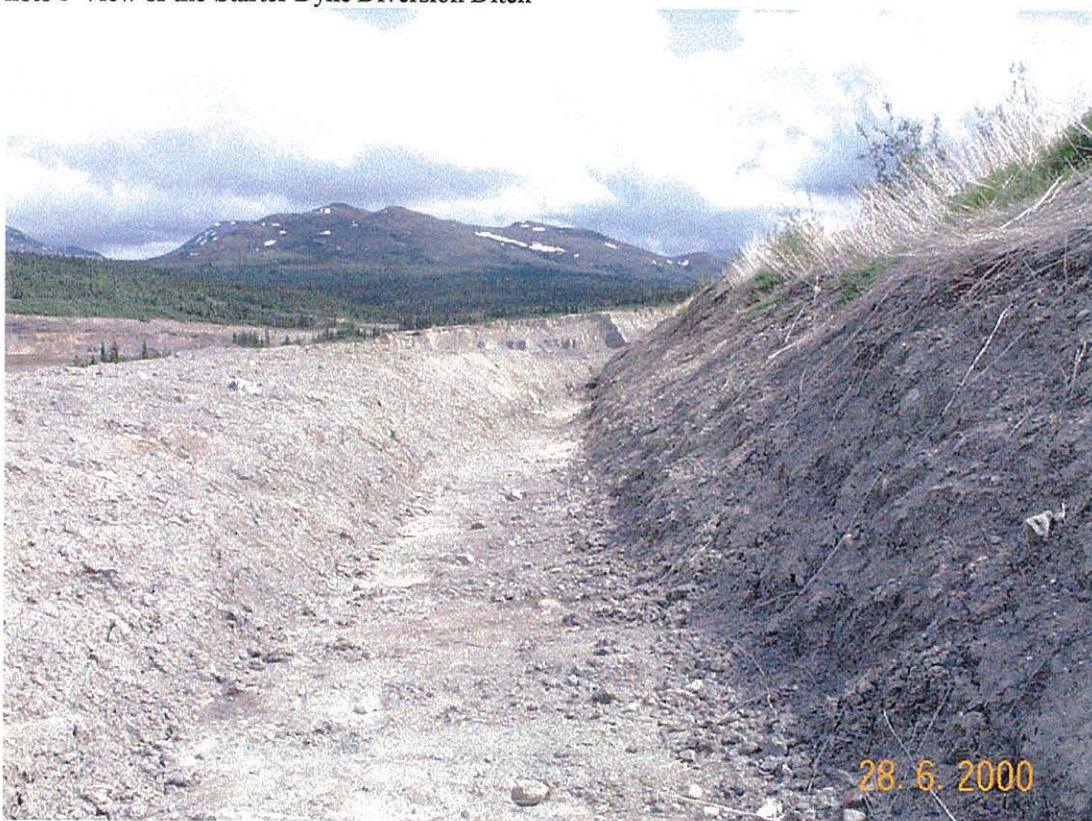
Photo 6 View looking downgradient of the upper reaches of the ditch

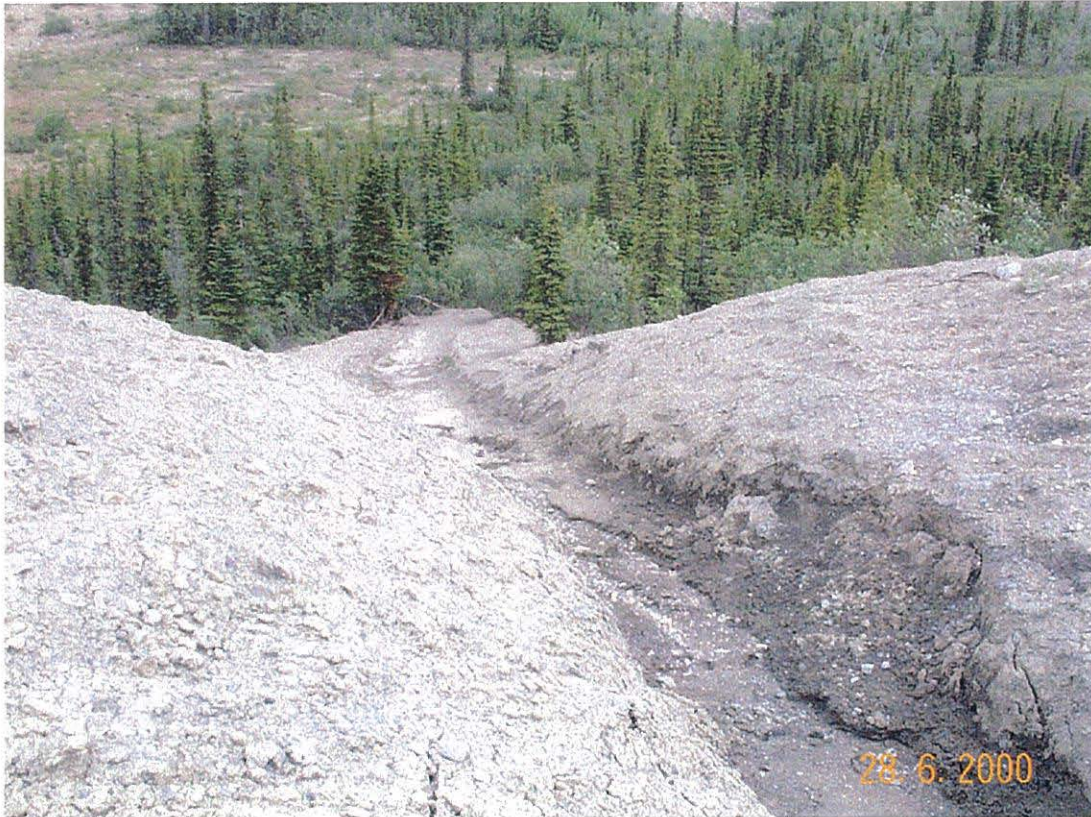
Photo 7 Exit reach of the diversion ditch

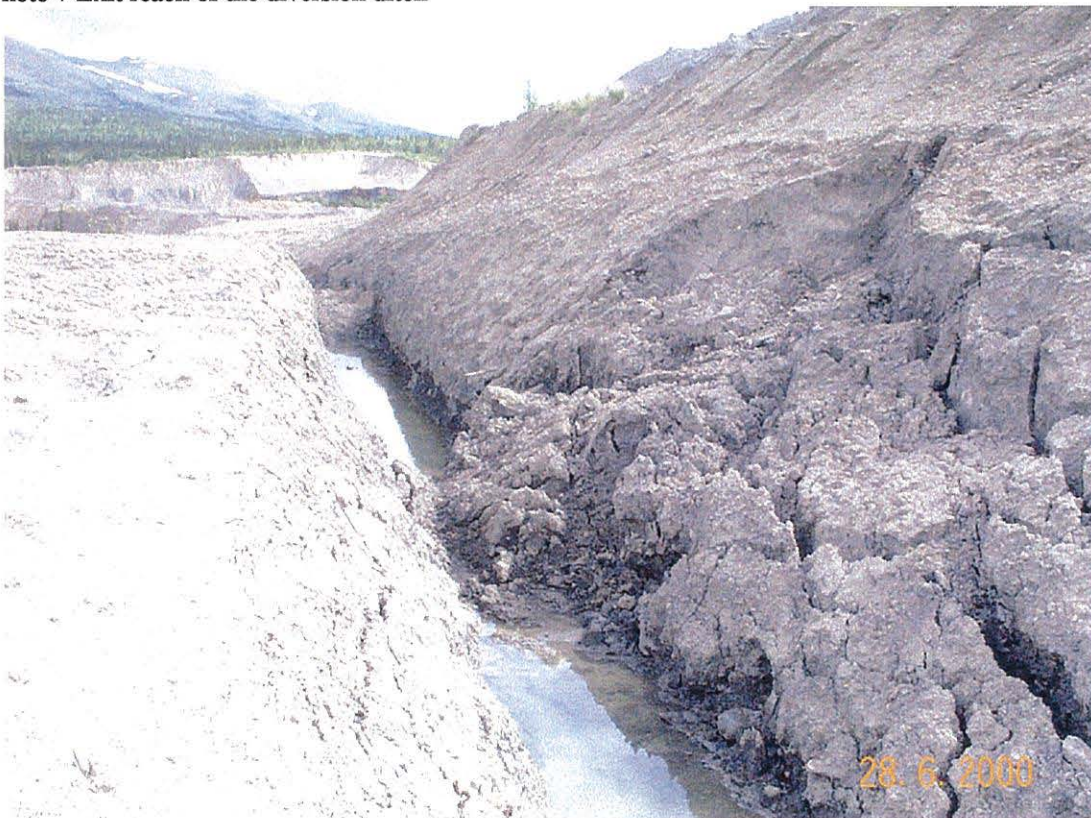
Photo 8 Subsidence in the Diversion ditch

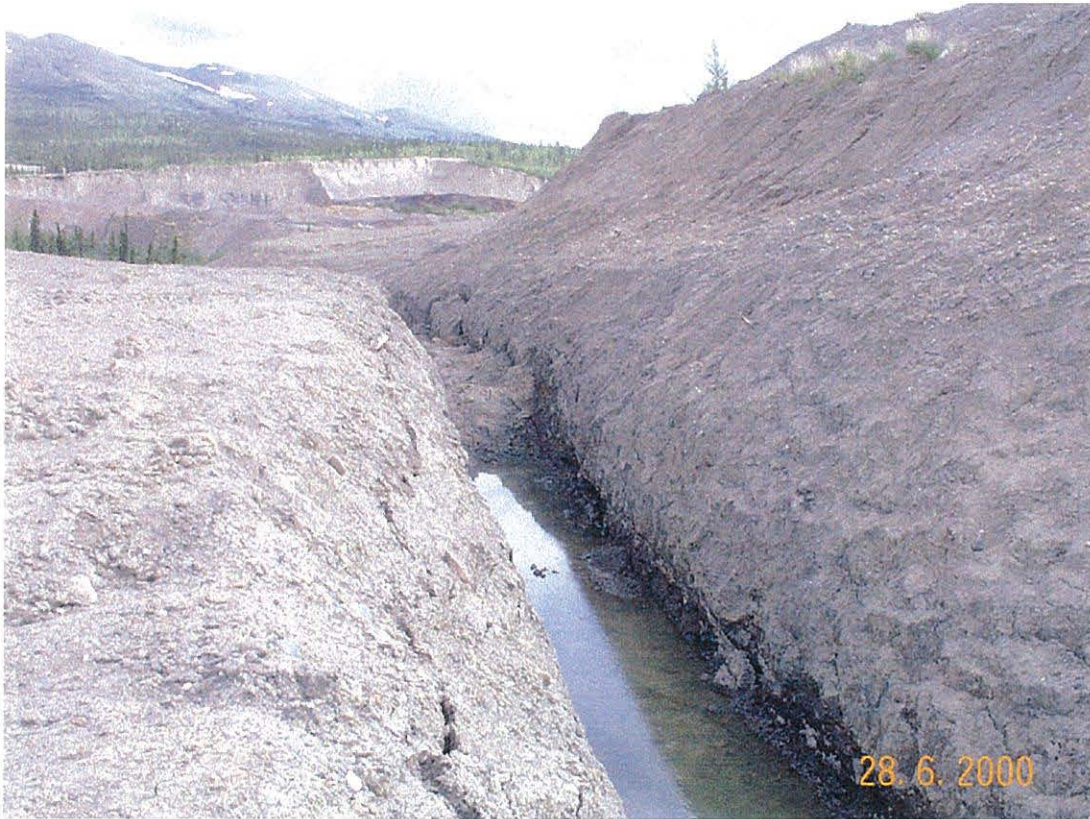
Photo 9 Poned Water in the diversion ditch

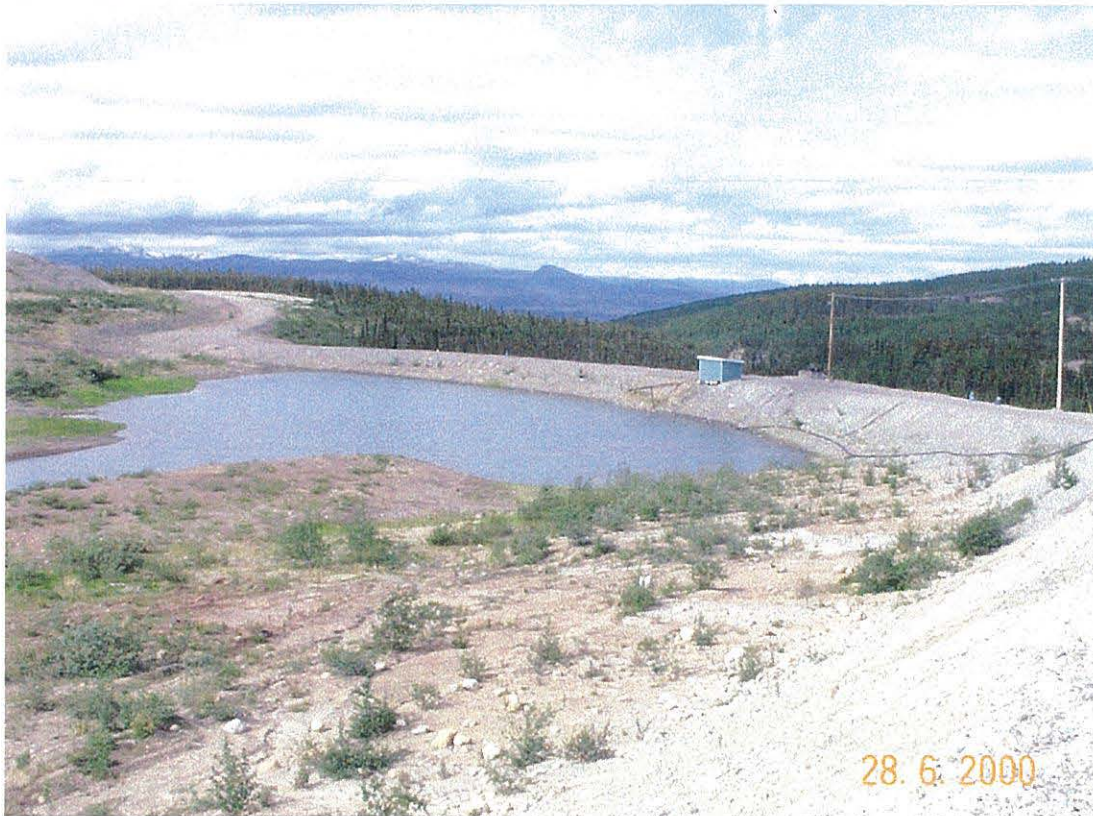
Photo 10 Little Creek Pond

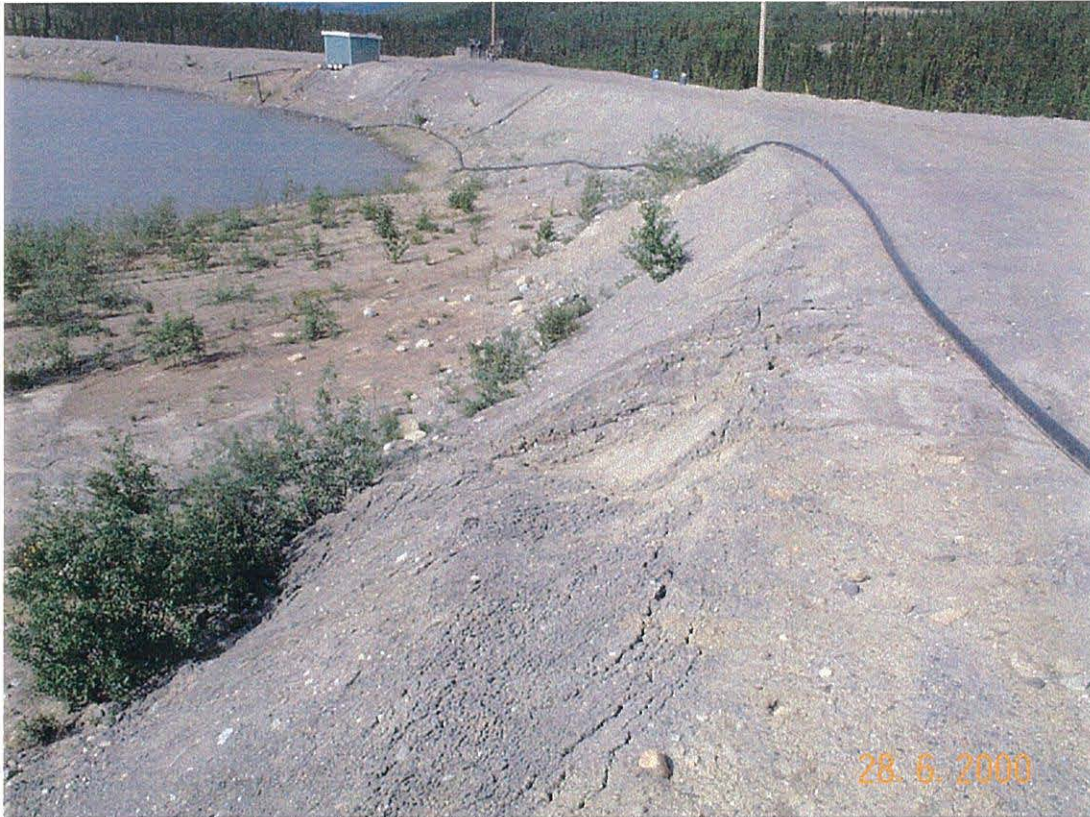
Photo11 Bank Erosion on east approach road

It is recommended that DT construct either a riprapped or CMP lined channel down the face of the end dumped material to minimize the erosion and the potential for sediment entering Vangorda Creek. Furthermore, the road surface should be regraded to encourage drainage off the crest and a 150mm layer of 20mm minus sand and gravel should be placed and compacted on the crest.

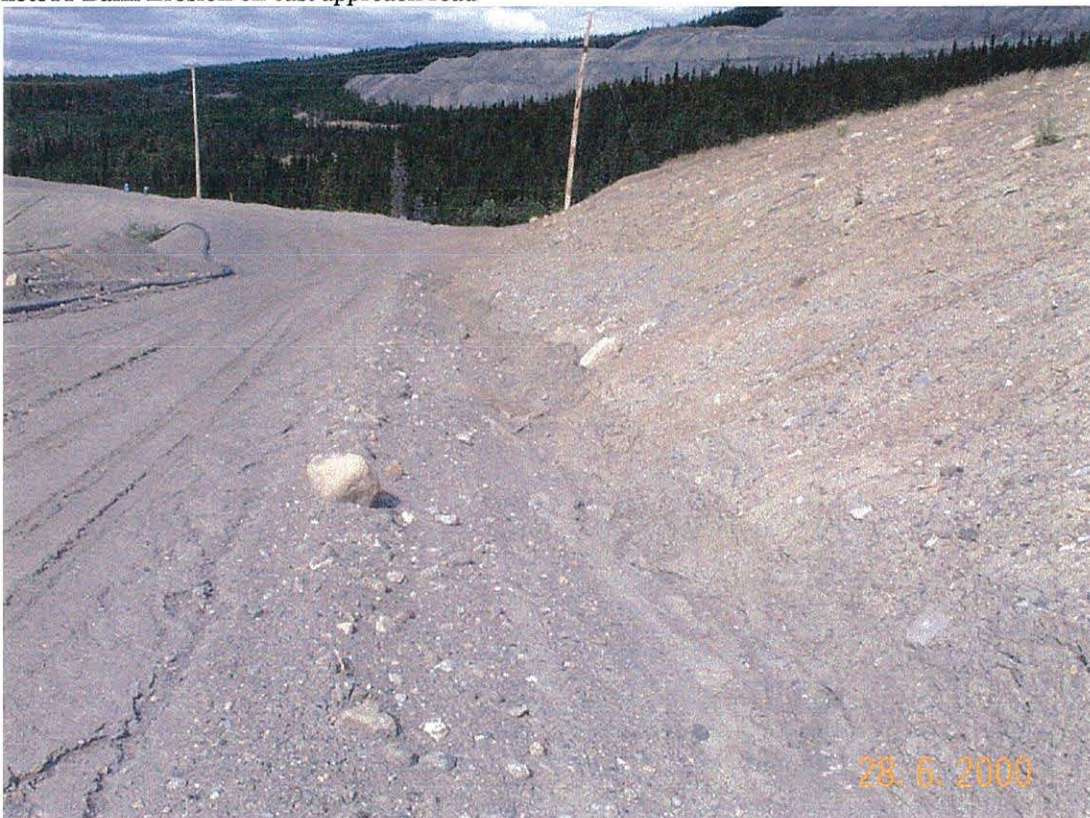
Photo 12 Drainage ditch on the Approach road to Little Creek Dam

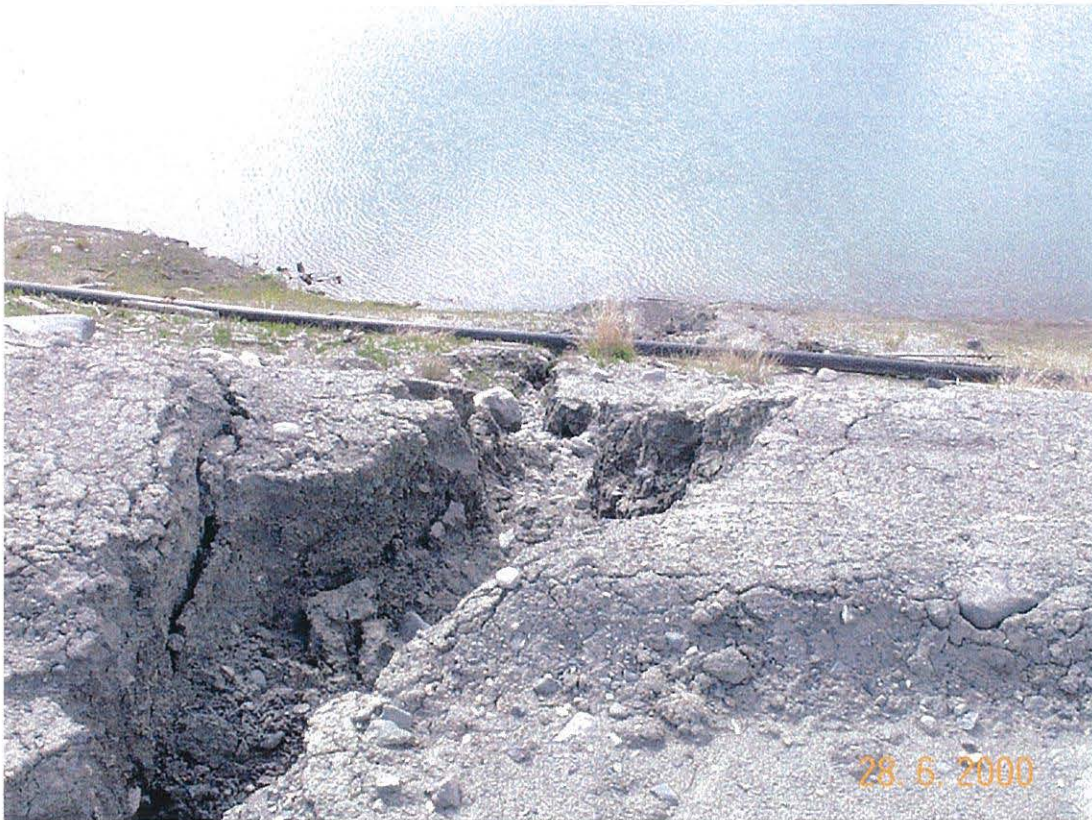
There is a significant erosion gully (Photo 13) on the upstream face of the dam, which has developed as a result of the runoff. The gully is located about 30m east of the pumphouse.

Photo13 Erosion Gully on the upstream face of Little Creek Dam

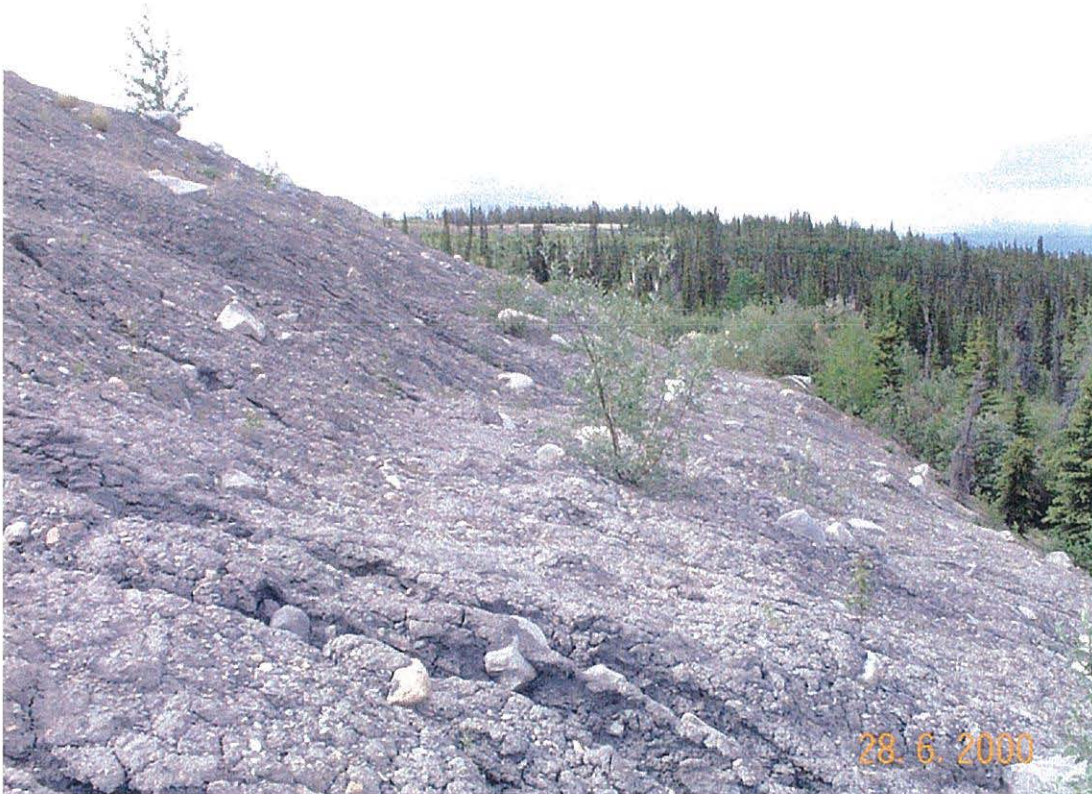
The downstream face of the dam (Photo 14) shows little evidence of surficial movement, bulging or instability. The loose, uncompacted material at the toe of the dam, which was deposited during it's construction in 1991, has not moved but does shows signs of erosion.

Photo 14 Downstream face of Little Creek Dam

DT should continue to regularly monitor the crest of the dam for any cracks, settlement or surficial movement of the slope.

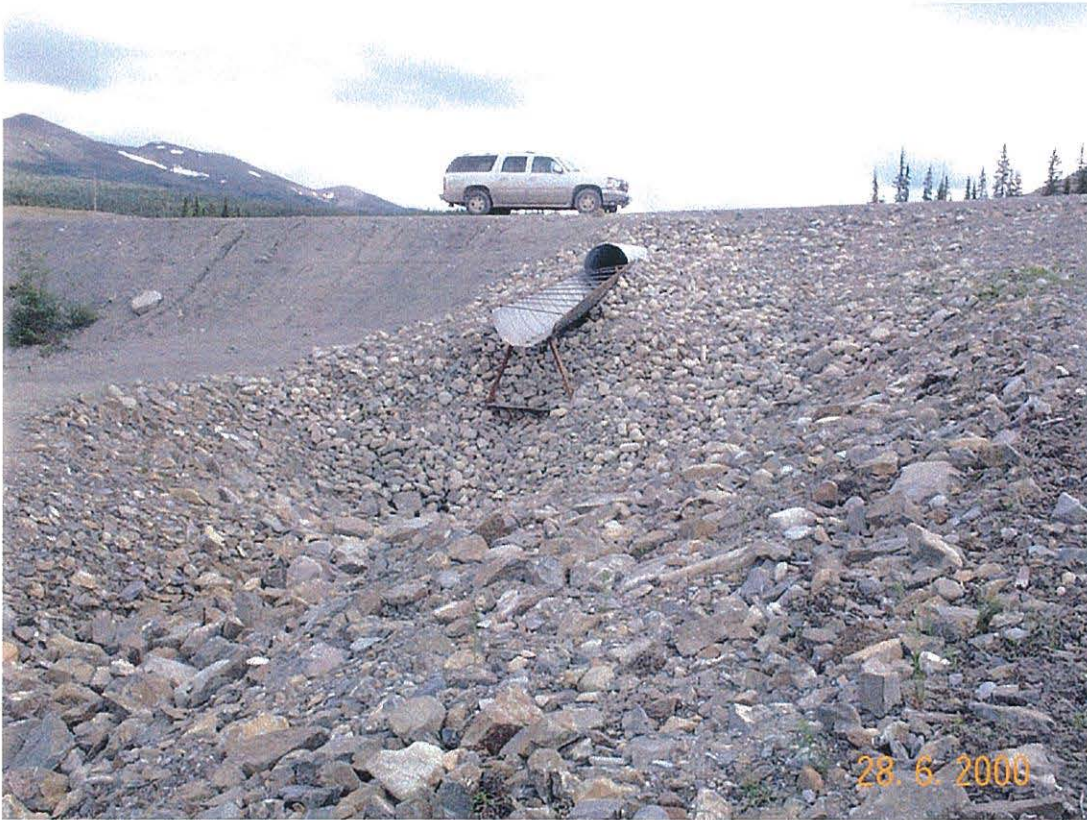
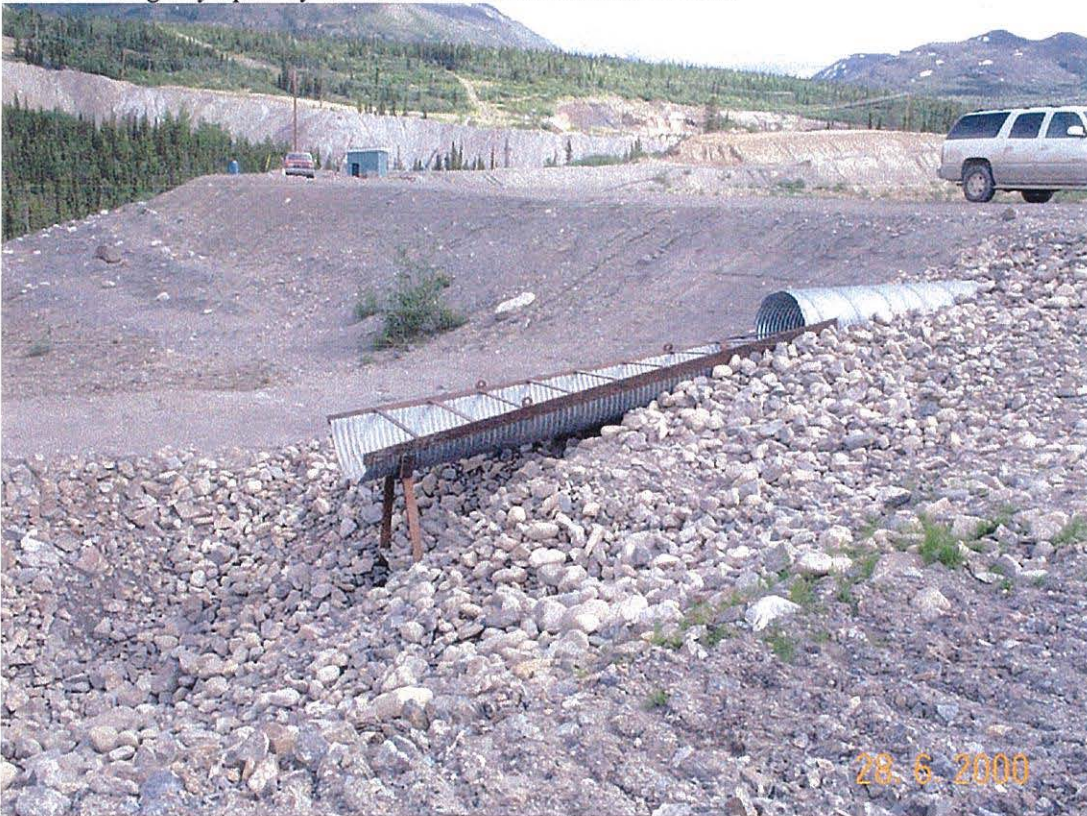
The new spillway culvert in Little Creek dam (photos 15 and 16 and Figure 8) was also inspected during the site visit. The additional riprap that was added in September of 1999 provided the needed erosion control at the entrance to the pipe.

Photo 15 Emergency Spillway Culvert and chute at Little Creek Dam

Photo 16 Emergency Spillway at Little Creek dam

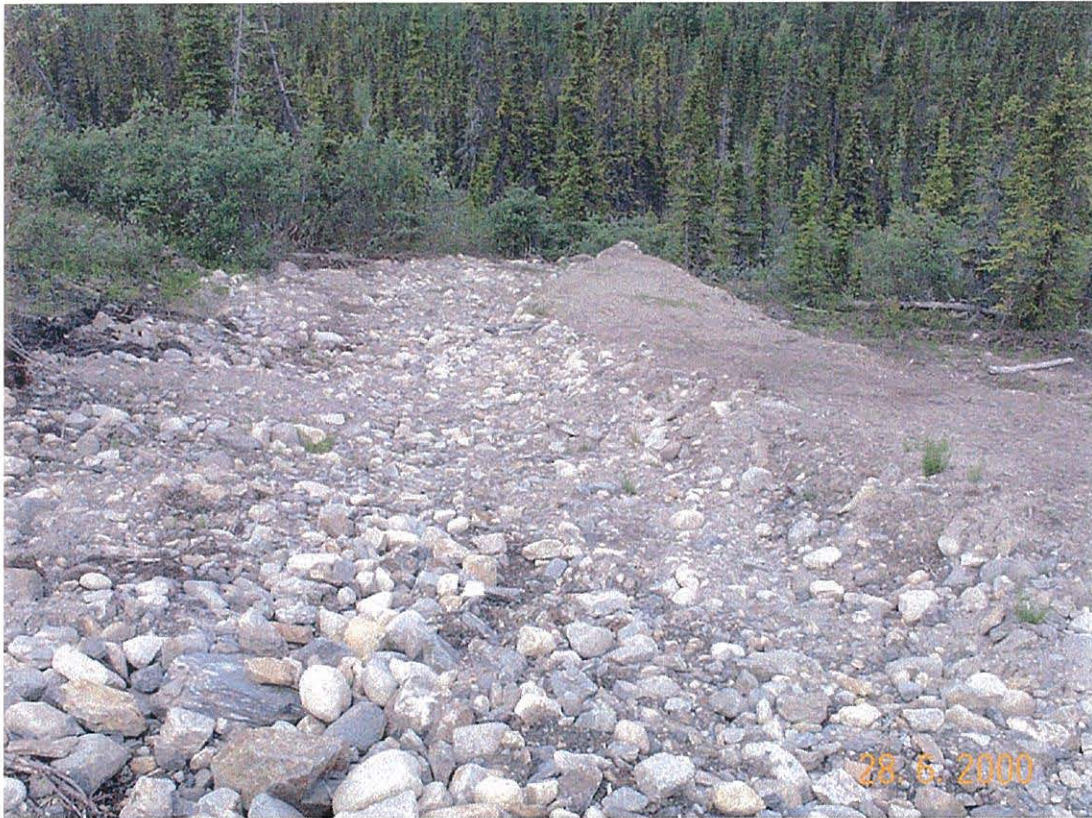
The riprap in the plunge pool and the upper reaches of the exit chute meets design criteria. However, more riprap is required in the lower reaches of the exit chute to provide adequate erosion protection for the 200-year flood event (Photo 17).

Photo 17 Exit Channel below Plunge pool at Little Creek Dam Spillway

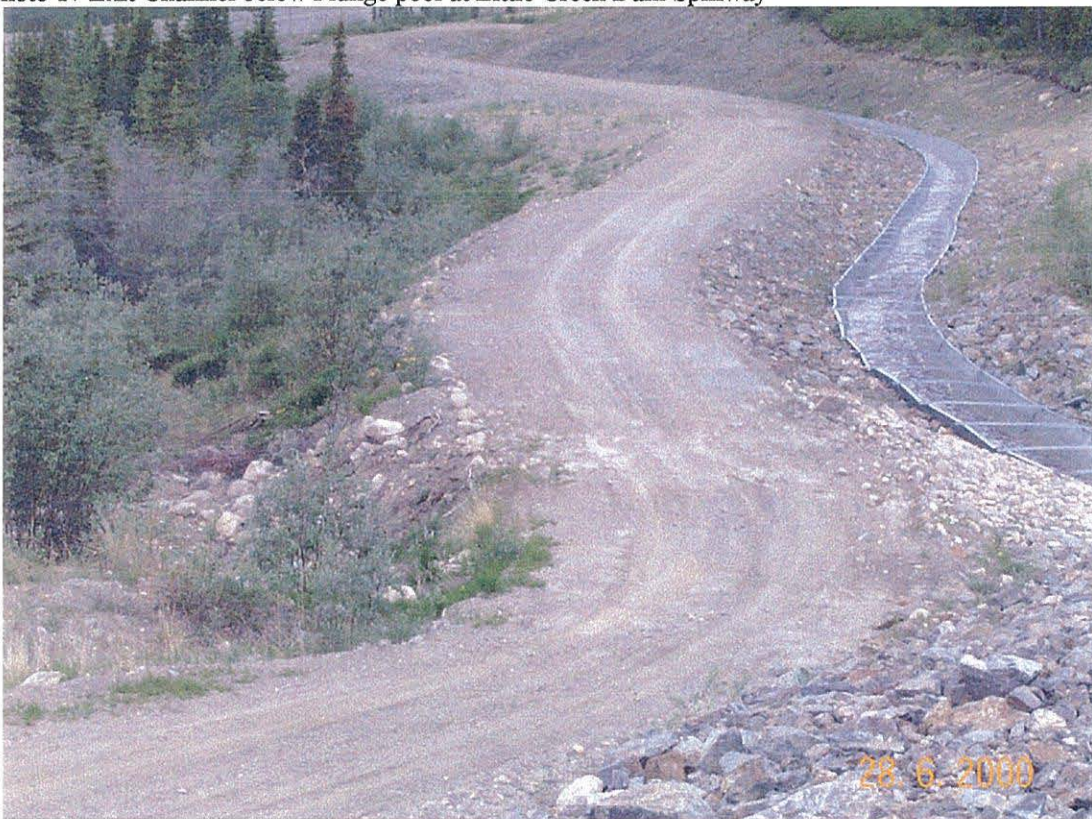
The half-round culvert in the upper reaches (Photo 18) has performed well but the flume does not weather well along the lower reaches. The potential still remains for slide debris to enter the flume at certain locations along the channel. The crossbars are badly bent and the flume is buckled in places (Photo 19). In several areas along the flume, riprap has settled to below the lip of the culvert.

Photo 18 Upper Reaches of Vangorda Creek Diversion

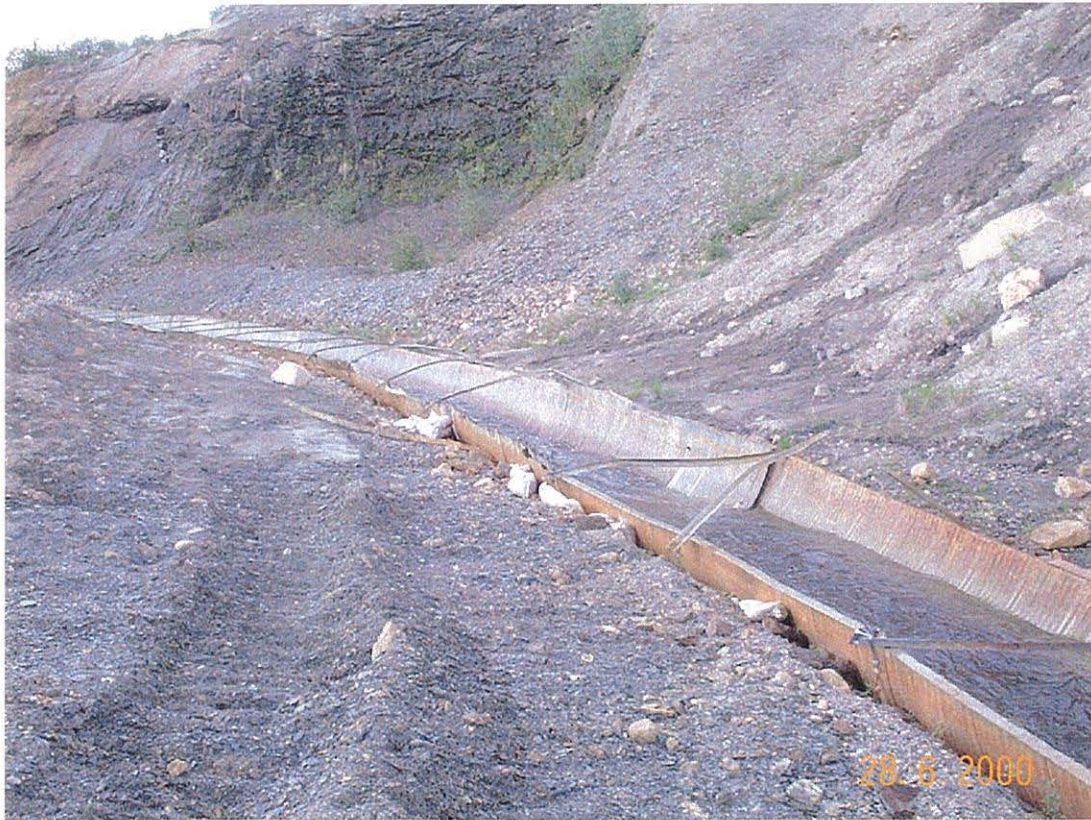
Photo 19 Lower Reaches of Vangorda Creek Diversion

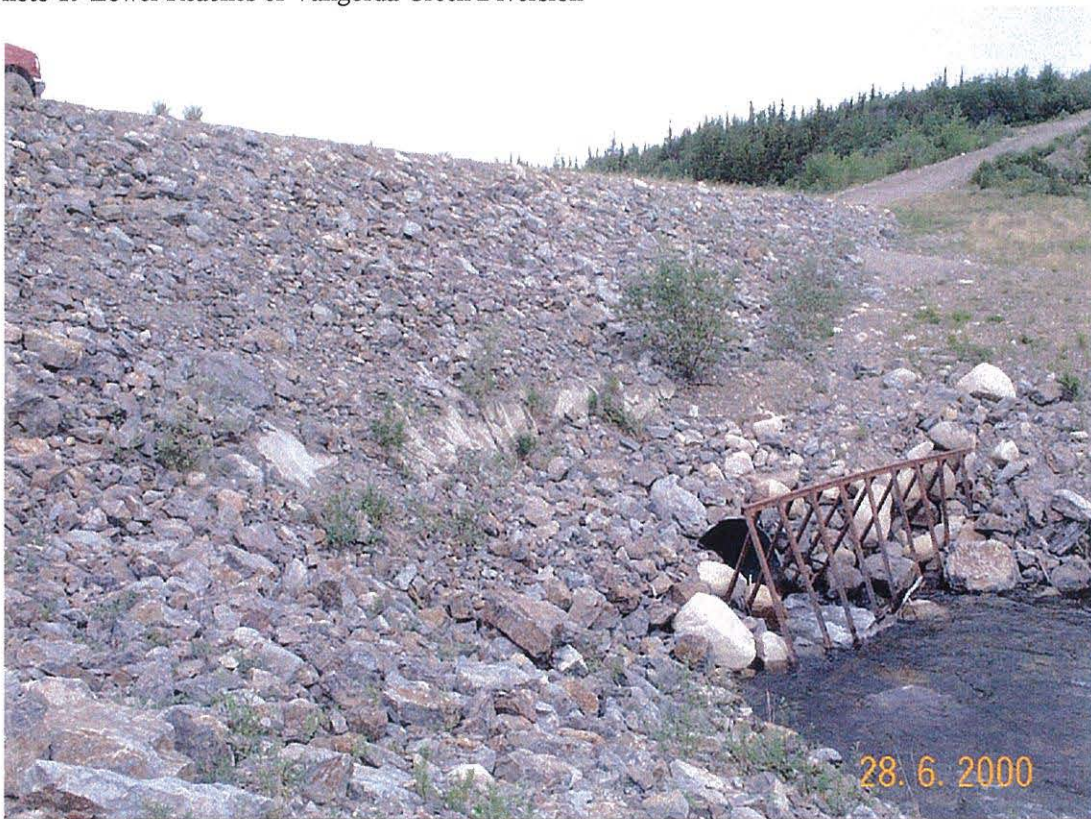
Riprap around the entrance to the culvert at the headwork's of the Vangorda diversion has dropped away exposing the underlying geotextile (Photo 20). This situation is not new and has been noted on previous inspections. Furthermore, riprap has begun to collect in the channel and around the trash rack at the inlet to the CMP narrowing the entrance. The pipe itself appears to be sound.

Photo 20 Headworks of the Vangorda Creek Diversion

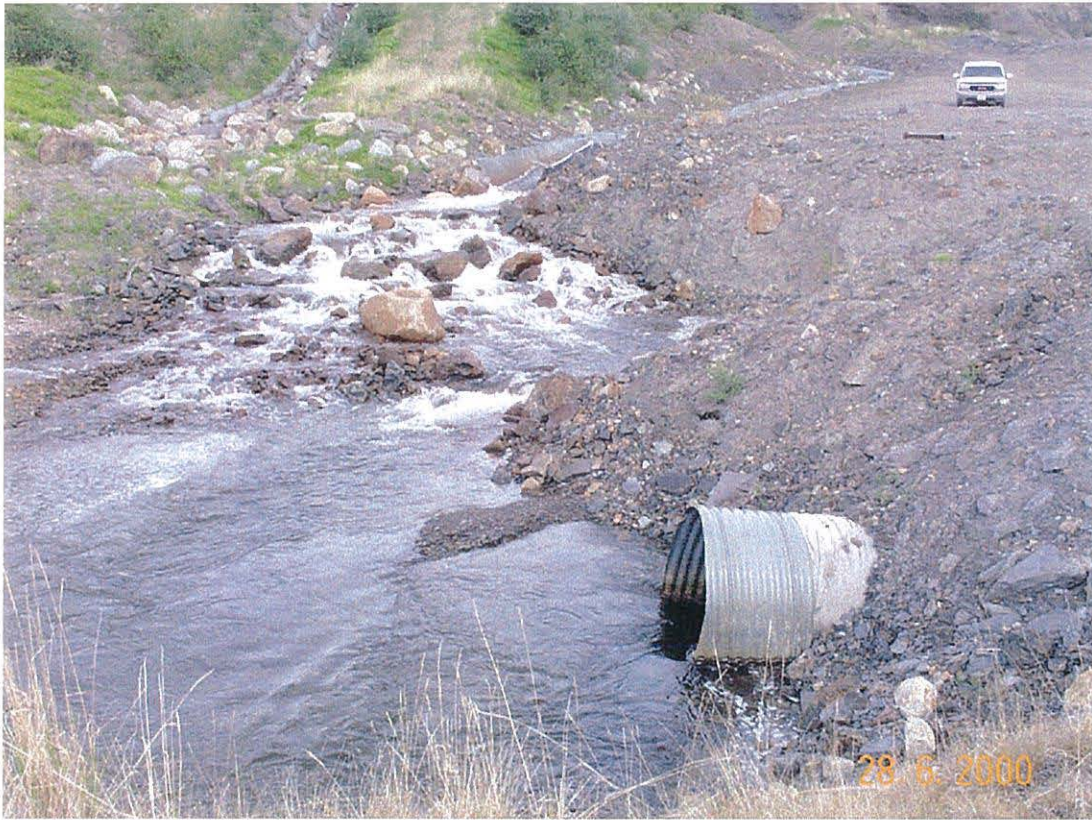
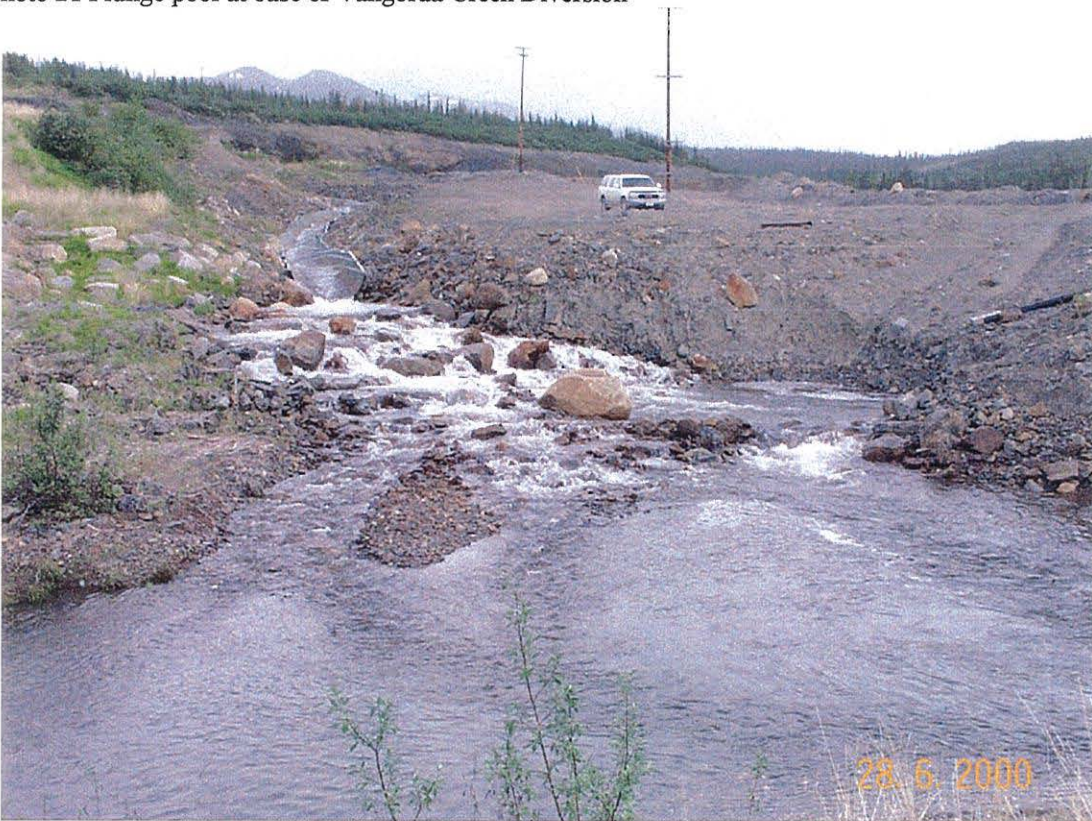
Photo 21 Plunge pool at base of Vangorda Creek Diversion

Photo 22 Plunge pool at base of Vangorda Creek Diversion

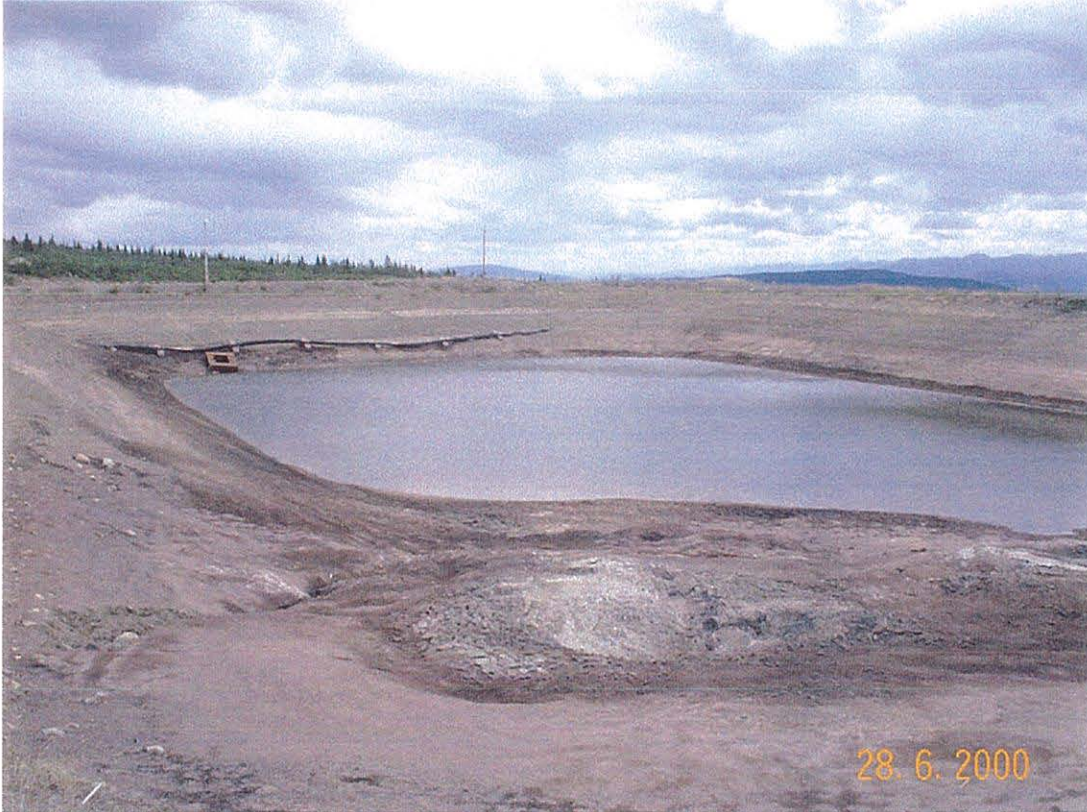
At the time of our inspection, the water level in the sludge pond was about 1m below the intake pipe at the south end of the pond (Photo 23). The tension cracks along the inside face of the pond and along the crest of the dyke have not changed since the last inspection (Photos 24). Although there is still evidence of previous settlement and minor sloughing of the downstream slope in the southwest corner of the pond, there are no signs of recent movement. Vegetation on the downstream slope is providing some stability to the face (Photo 25).

Photo 23 Sludge Pond at the Treatment Plant

- Ensure that the pond level does not exceed 2m. below crest;
- Continue to monitor on a monthly basis, the crest and sideslopes for cracking or any signs of sloughing. With the pond level at an all time low, the risk of any instability is quite small.
- Fill in or blade over tension cracks both in the crest and along the upstream face to prevent entry from runoff and precipitation.
- Weekly inspection of the upstream face and the crest for further development of the cracks is recommended.
