2000 Annual Inspection Waste and Water Management Facilities Vangorda Mine Yukon Territory

February, 2001

**2000 ANNUAL INSPECTION
WASTE AND WATER MANAGEMENT FACILITIES
VANGORDA MINE
YUKON TERRITORIES**

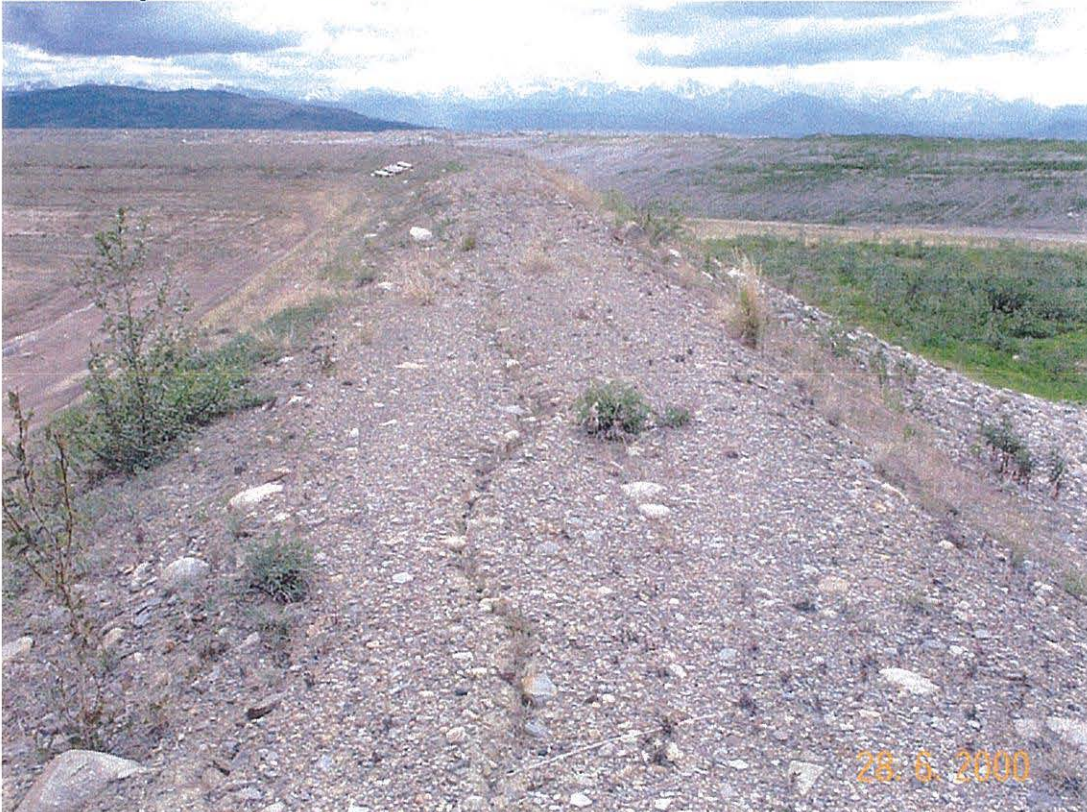
At the time of our inspection, the water level in the sludge pond was about 1m below the intake pipe at the south end of the pond (Photo 23). The tension cracks along the inside face of the pond and along the crest of the dyke have not changed since the last inspection (Photos 24). Although there is still evidence of previous settlement and minor sloughing of the downstream slope in the southwest corner of the pond, there are no signs of recent movement. Vegetation on the downstream slope is providing some stability to the face (Photo 25).

Photo 24 Tension Crack in crest of the Sludge Pond Dyke

- Ensure that the pond level does not exceed 2m. below crest;
- Continue to monitor on a monthly basis, the crest and sideslopes for cracking or any signs of sloughing. With the pond level at an all time low, the risk of any instability is quite small.
- Fill in or blade over tension cracks both in the crest and along the upstream face to prevent entry from runoff and precipitation.
- Weekly inspection of the upstream face and the crest for further development of the cracks is recommended.

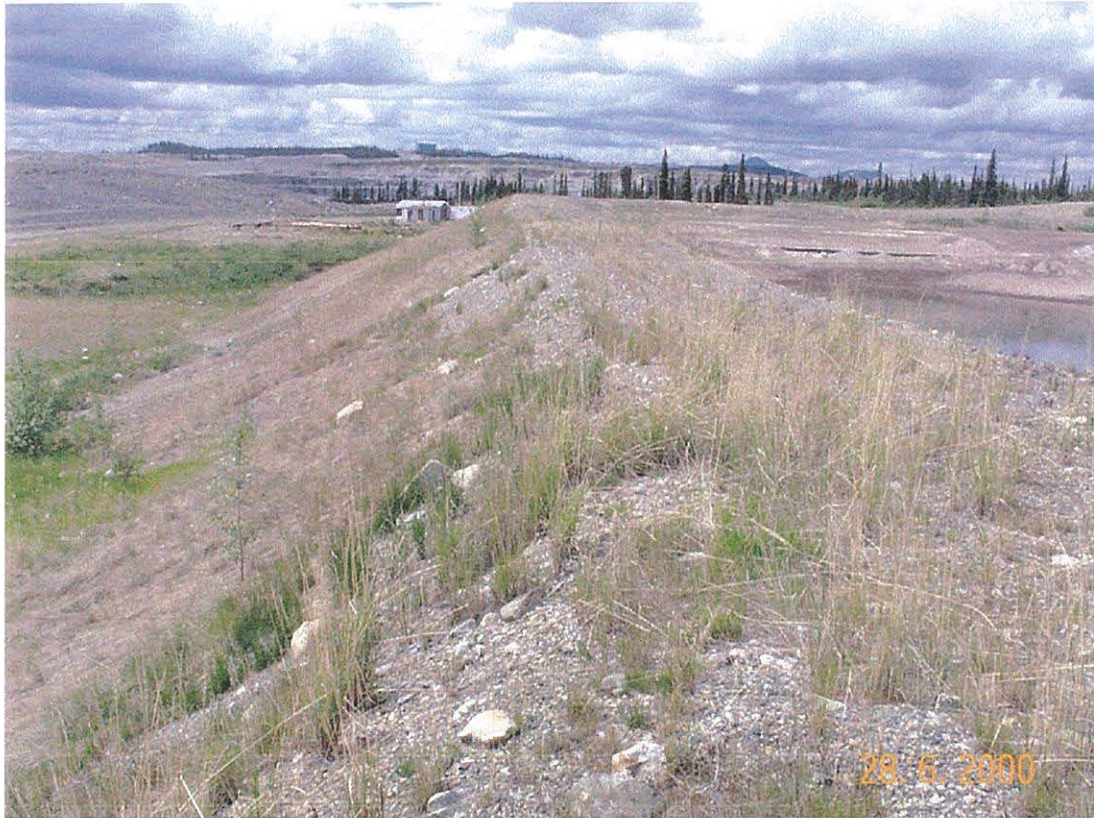
Photo 25 Vegetation on downstream face of Sludge Pond Dyke.

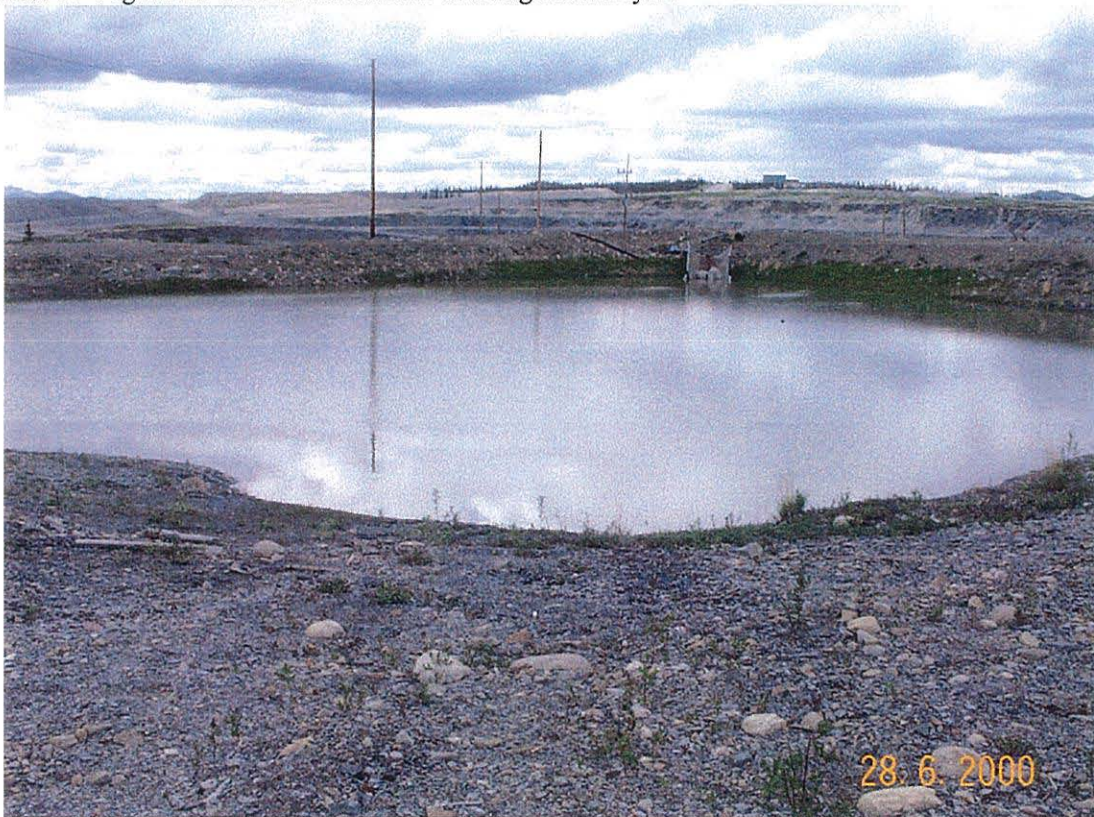
At the time of our inspection the water level in the pond was about 3m below the crest of the dyke (Photo 26) and the downstream sideslopes showed no signs of any recent movement. No significant cracks were observed in the crest.

Photo 26 Grouco Pond

The crest of the embankment should be monitored monthly for cracks and the pond level should not exceed 1.0 m below crest. Seepage into and out of the pond should also be monitored.

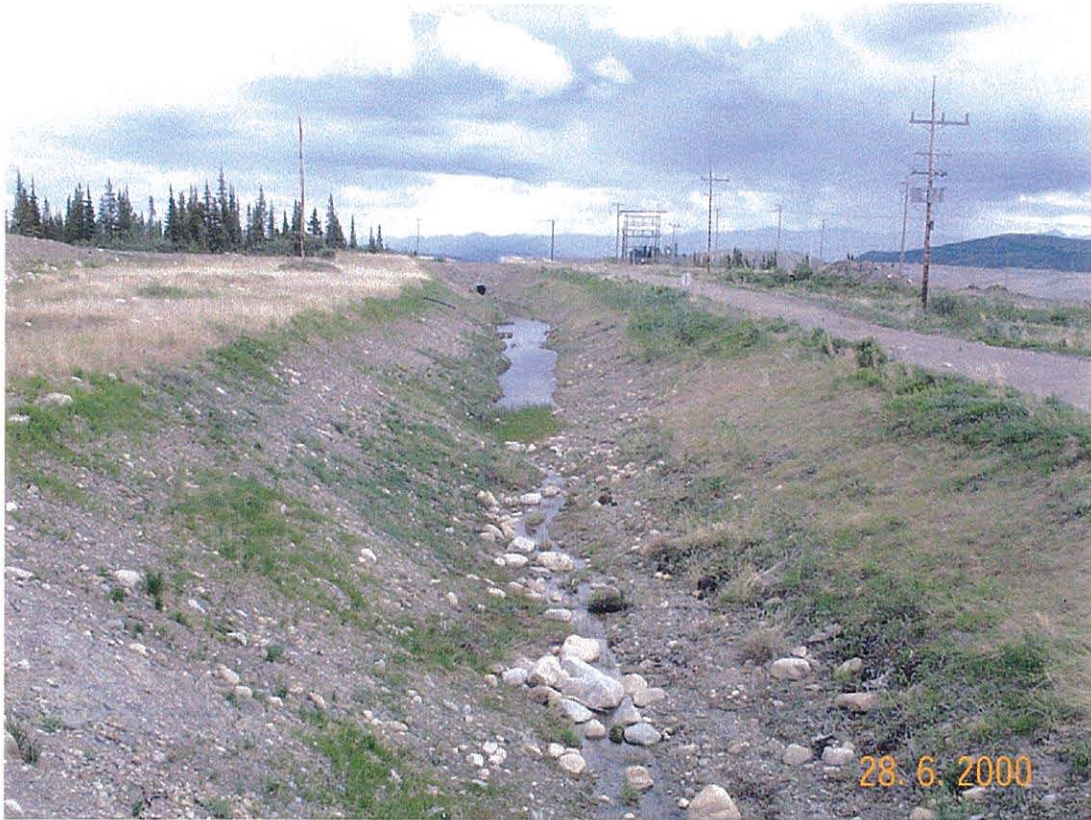
In the upper reaches of the GID, the slopes have performed well and the vegetation is providing effective erosion control of the sideslopes (Photo 27). Inlets and outlets of some of the culverts are silted up and require cleaning. Below the treatment plant, however, there are sections of the ditch where the grade steepens and the sideslopes have subsided narrowing the channel (photo 28). This subsidence results in an increase in the sediment load reporting to the Sheep Pad ponds (Photo 29). It was noted that water collecting in the ponds was being siphoned into the Vangorda Pit because of the high level of suspended solids.

Photo 27 Grum Interceptor Ditch

- Place additional riprap (shotrock) around inlets and outlets of all culverts where applicable to prevent erosion and sediment build-up. Geotextile should be placed against the exposed soil prior to placing the riprap;
- Monitor monthly tension cracks in the settling pond dykes, on the crest and on the upstream and downstream slopes;
- Monitor monthly the toe of the dykes for any seeps;
- Continue to provide riprap protection on the lower reaches of the GID to minimize erosion and sedimentations.

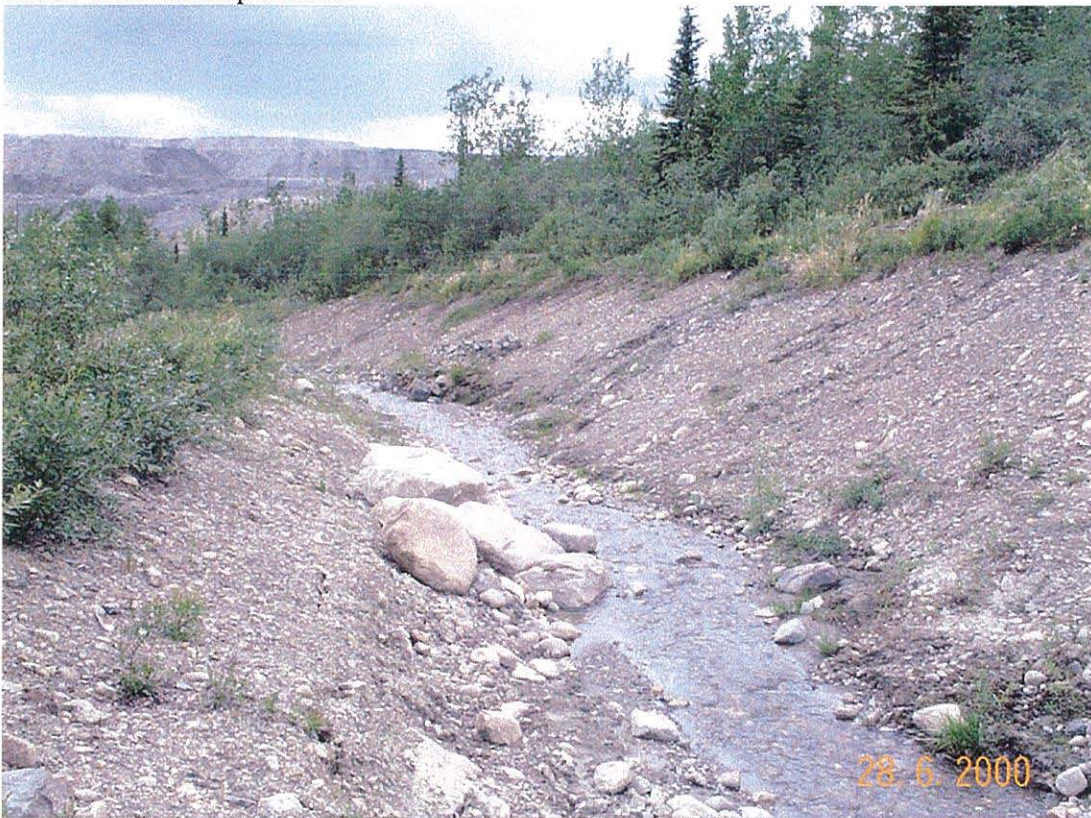
Photo 28 Subsidence in the lower reaches of the GID
