2001 Annual Inspection Waste and Water Management Facilities Vangorda Mine Yukon Territory

February, 2002

**2001 ANNUAL INSPECTION
WASTE AND WATER MANAGEMENT FACILITIES
VANGORDA MINE
YUKON TERRITORIES**

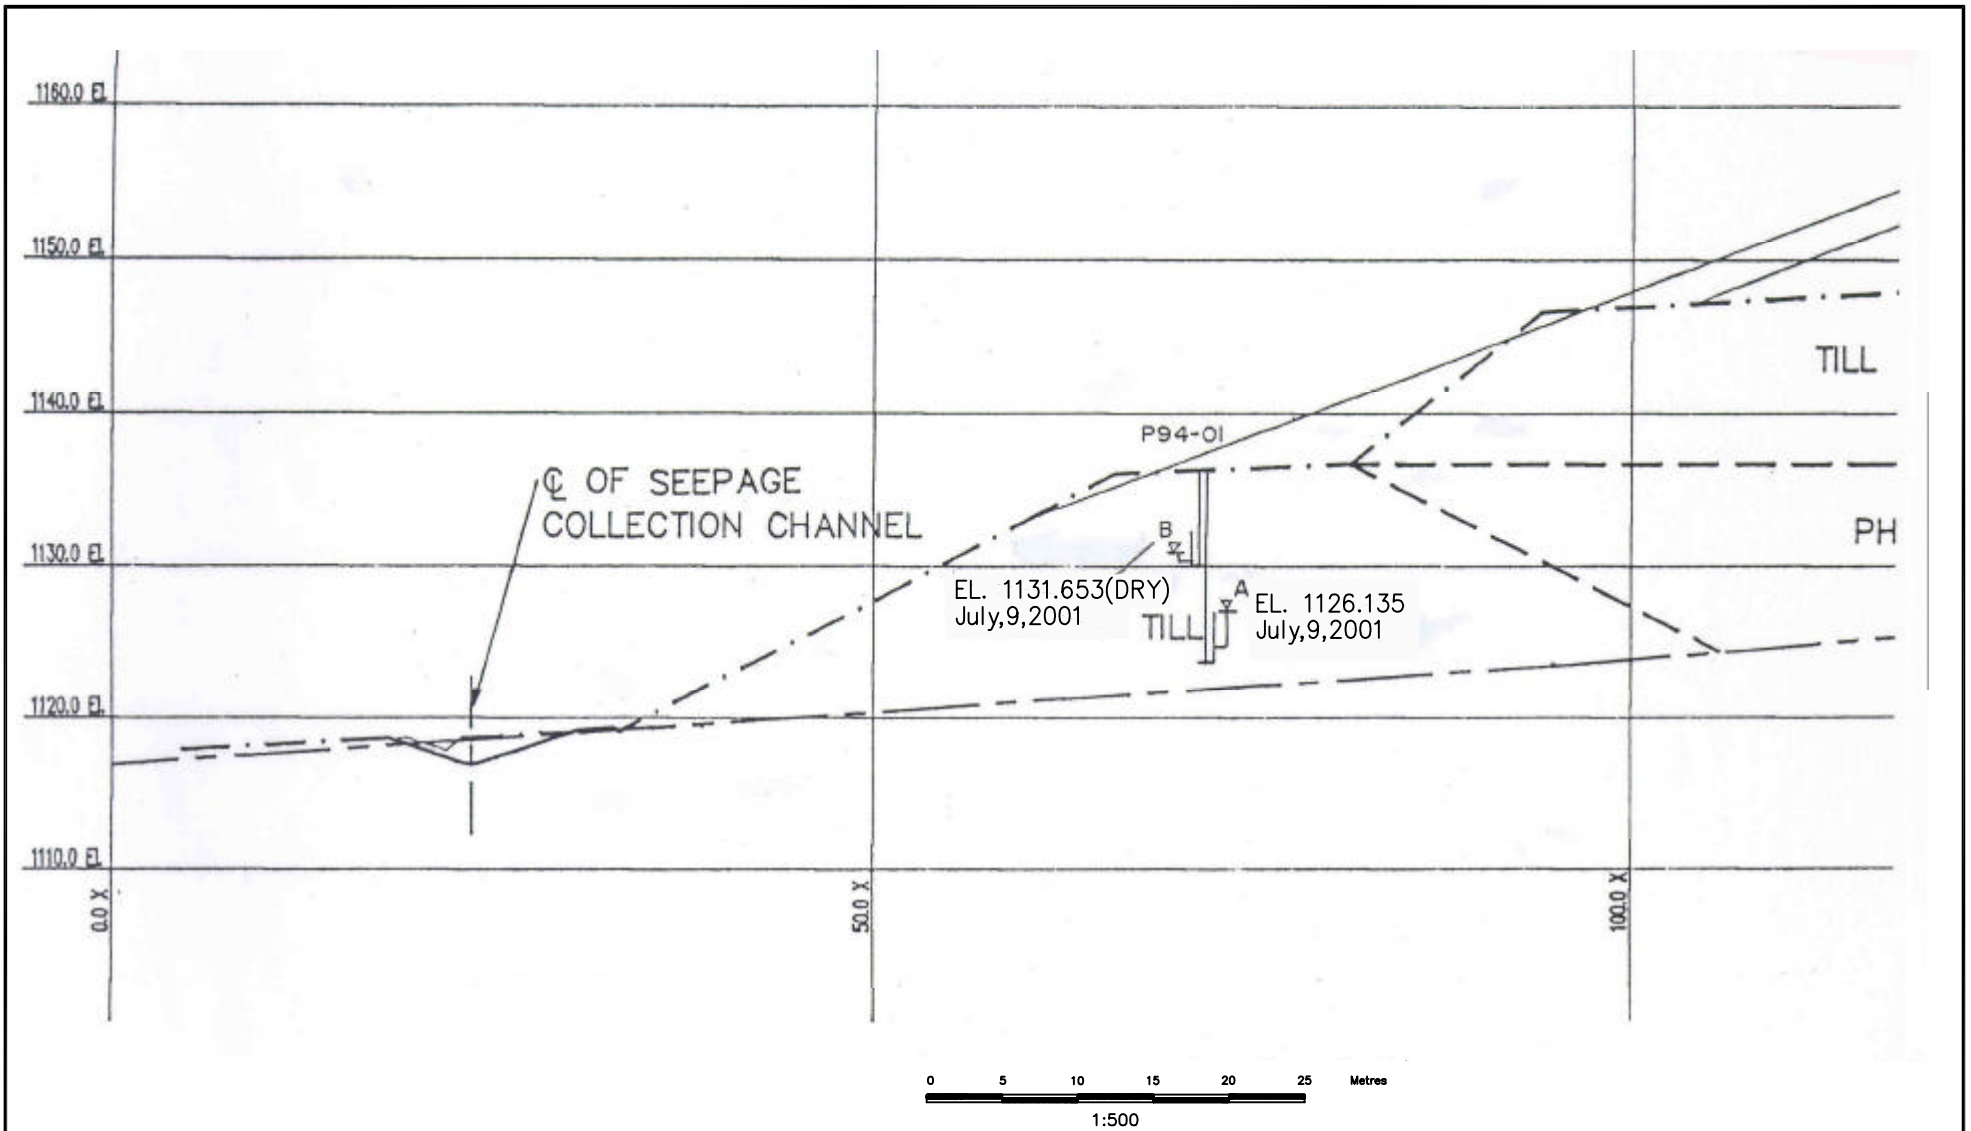
SECTION D-3
CHANNEL STA. 4+80

The seepage channel around the Vangorda Waste dump is functioning normally and no instability of the sideslopes of the seepage channel was observed. Staining along the base of the ditch indicated that there had been significant flow in the channel during in 2001. During the inspection, however there was no measurable flow observed in the ditch.

In the upper reaches of the seepage collection channel below the till cover, DT should remove any silt that has accumulated in the channel. Assuming the dump will eventually be covered with till, this area would likely be recontoured and the sediment problem would be reduced. In the meantime, DT should continue to monitor the silt build-up and periodically remove the material.

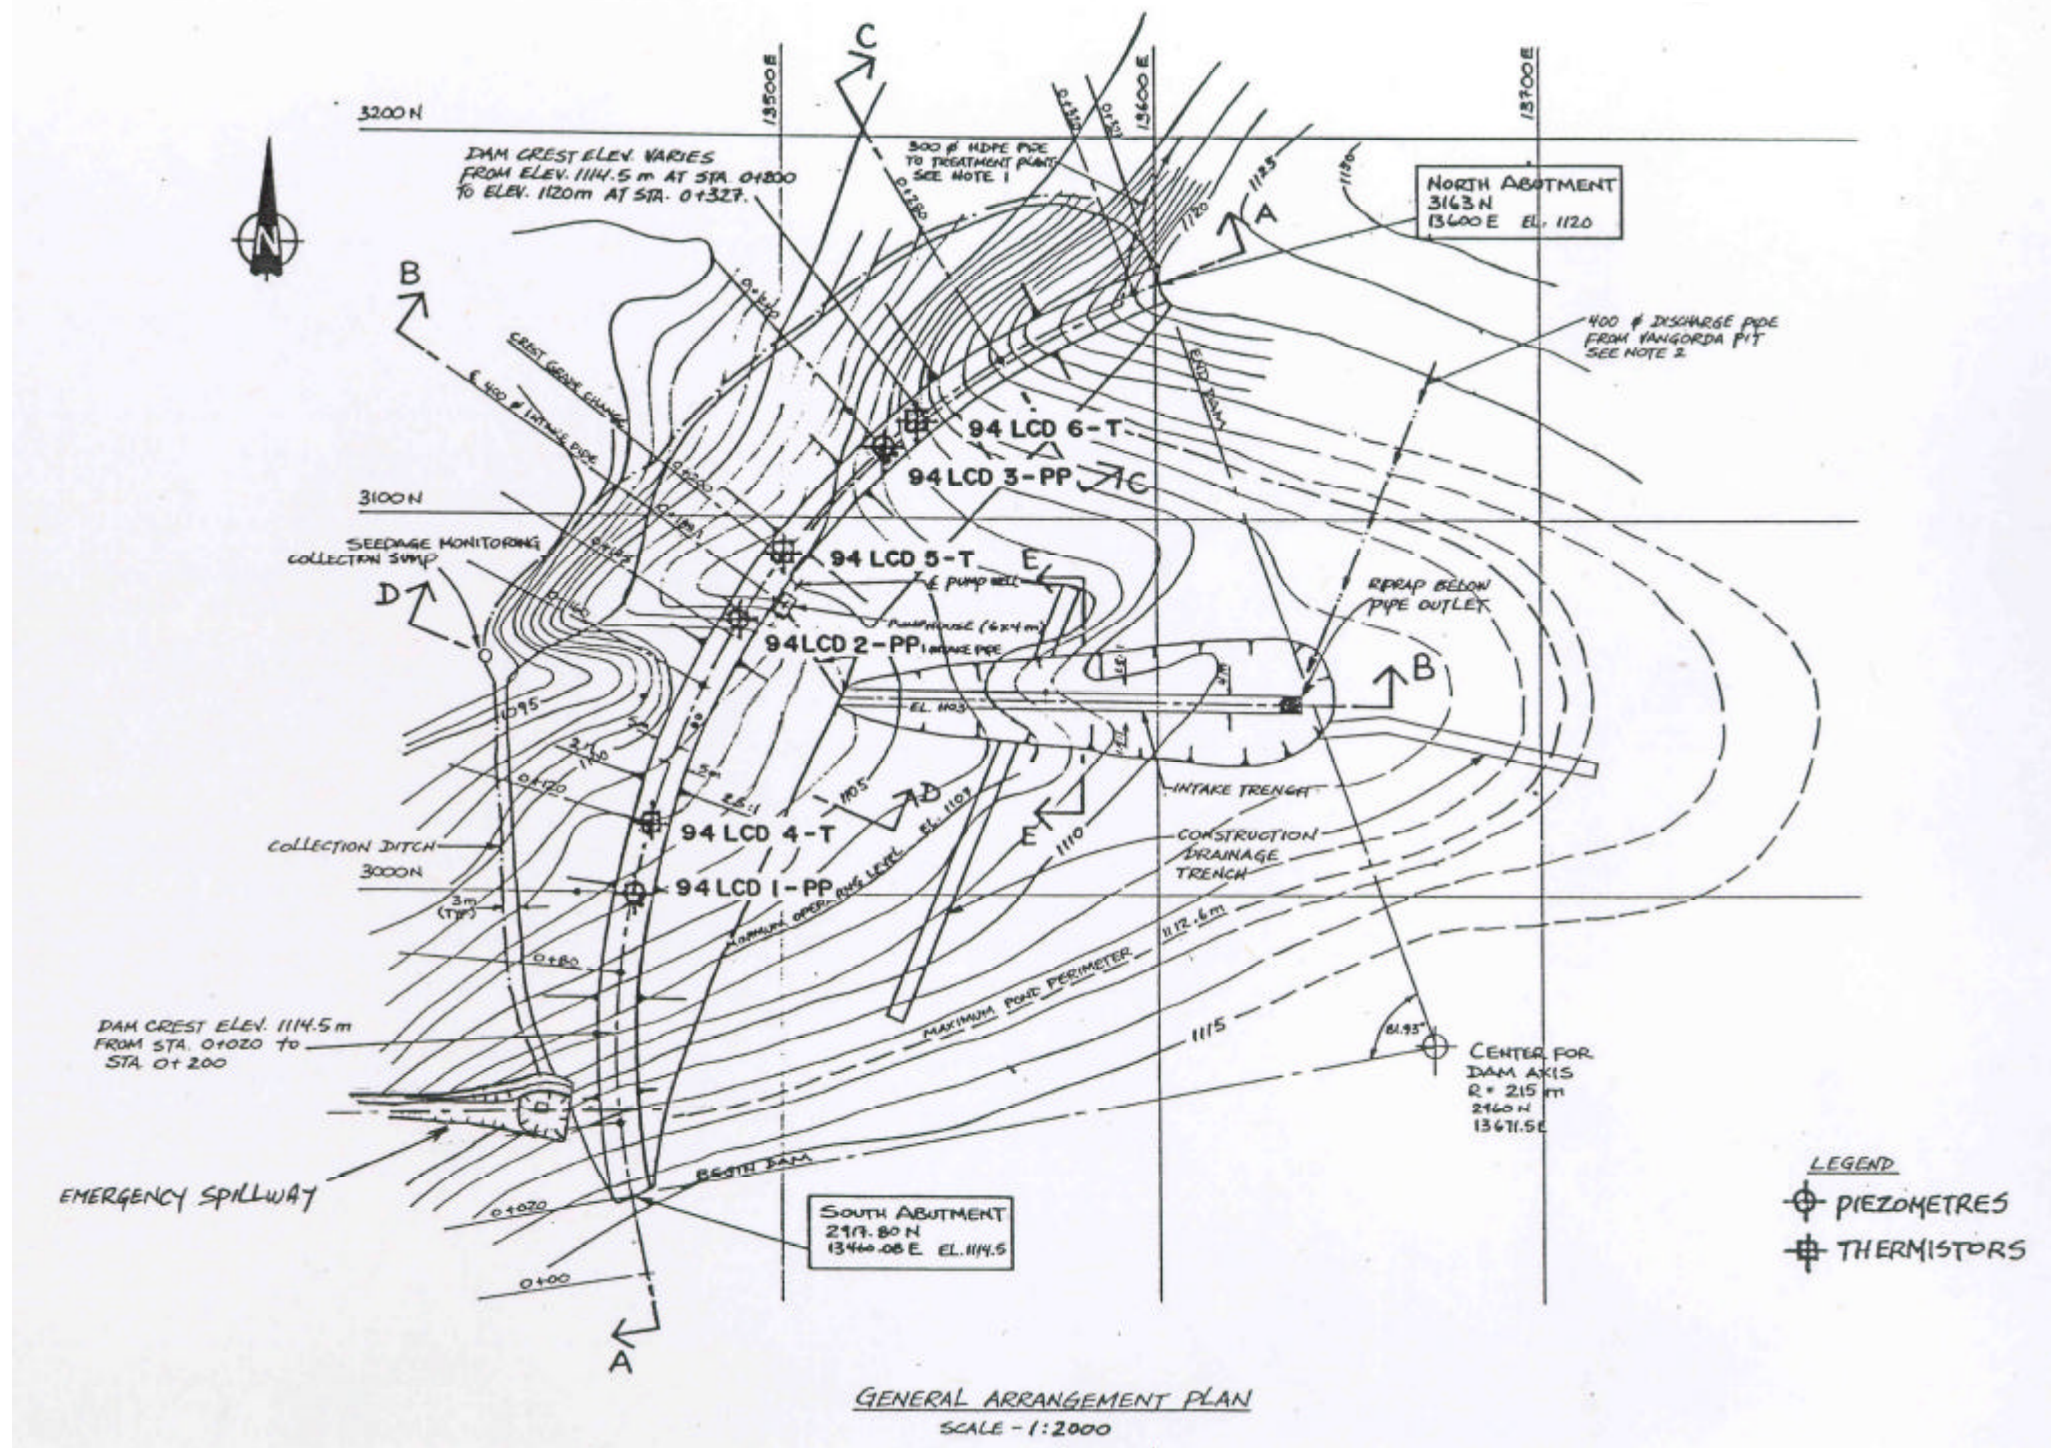
SRK Consulting Engineers and Scientists	VANGORDA PLATEAU MINE			
	LITTLE CREEK DAM GENERAL ARRANGEMENT PLAN			
DELOITTE & TOUCHE	PROJECT NO. 1CD003.05	DATE Feb 2002	APPROVED	FIGURE 5

A view of the Little Creek dam and the new emergency spillway are shown in Photos 9 and 10. Runoff from the eastern approach road continues to cause erosion and subsidence of the road embankment sideslopes as shown in Photos 11 and 12 .

Water level in the pond during our inspection was recorded at about 1109m. DT periodically pumps water from the pond to Vangorda Pit. However, at the time of our inspection no water was being pumped from the pond. No cracks or major settlement of the dam were observed and there was no noticeable seepage along the toe.

The downstream face of the dam shows little evidence of surficial movement, bulging or instability. The loose, uncompacted material at the toe of the dam, which was deposited during its construction in 1991, has not moved but does show signs of erosion.

It is recommended that DT construct either a riprapped or CMP lined channel down the face of the end dumped material to minimize the erosion and the potential for sediment entering Vangorda Creek. Furthermore, the road surface should be regraded to encourage drainage off the crest and a 150mm layer of 20mm minus sand and gravel should be placed and compacted on the crest.

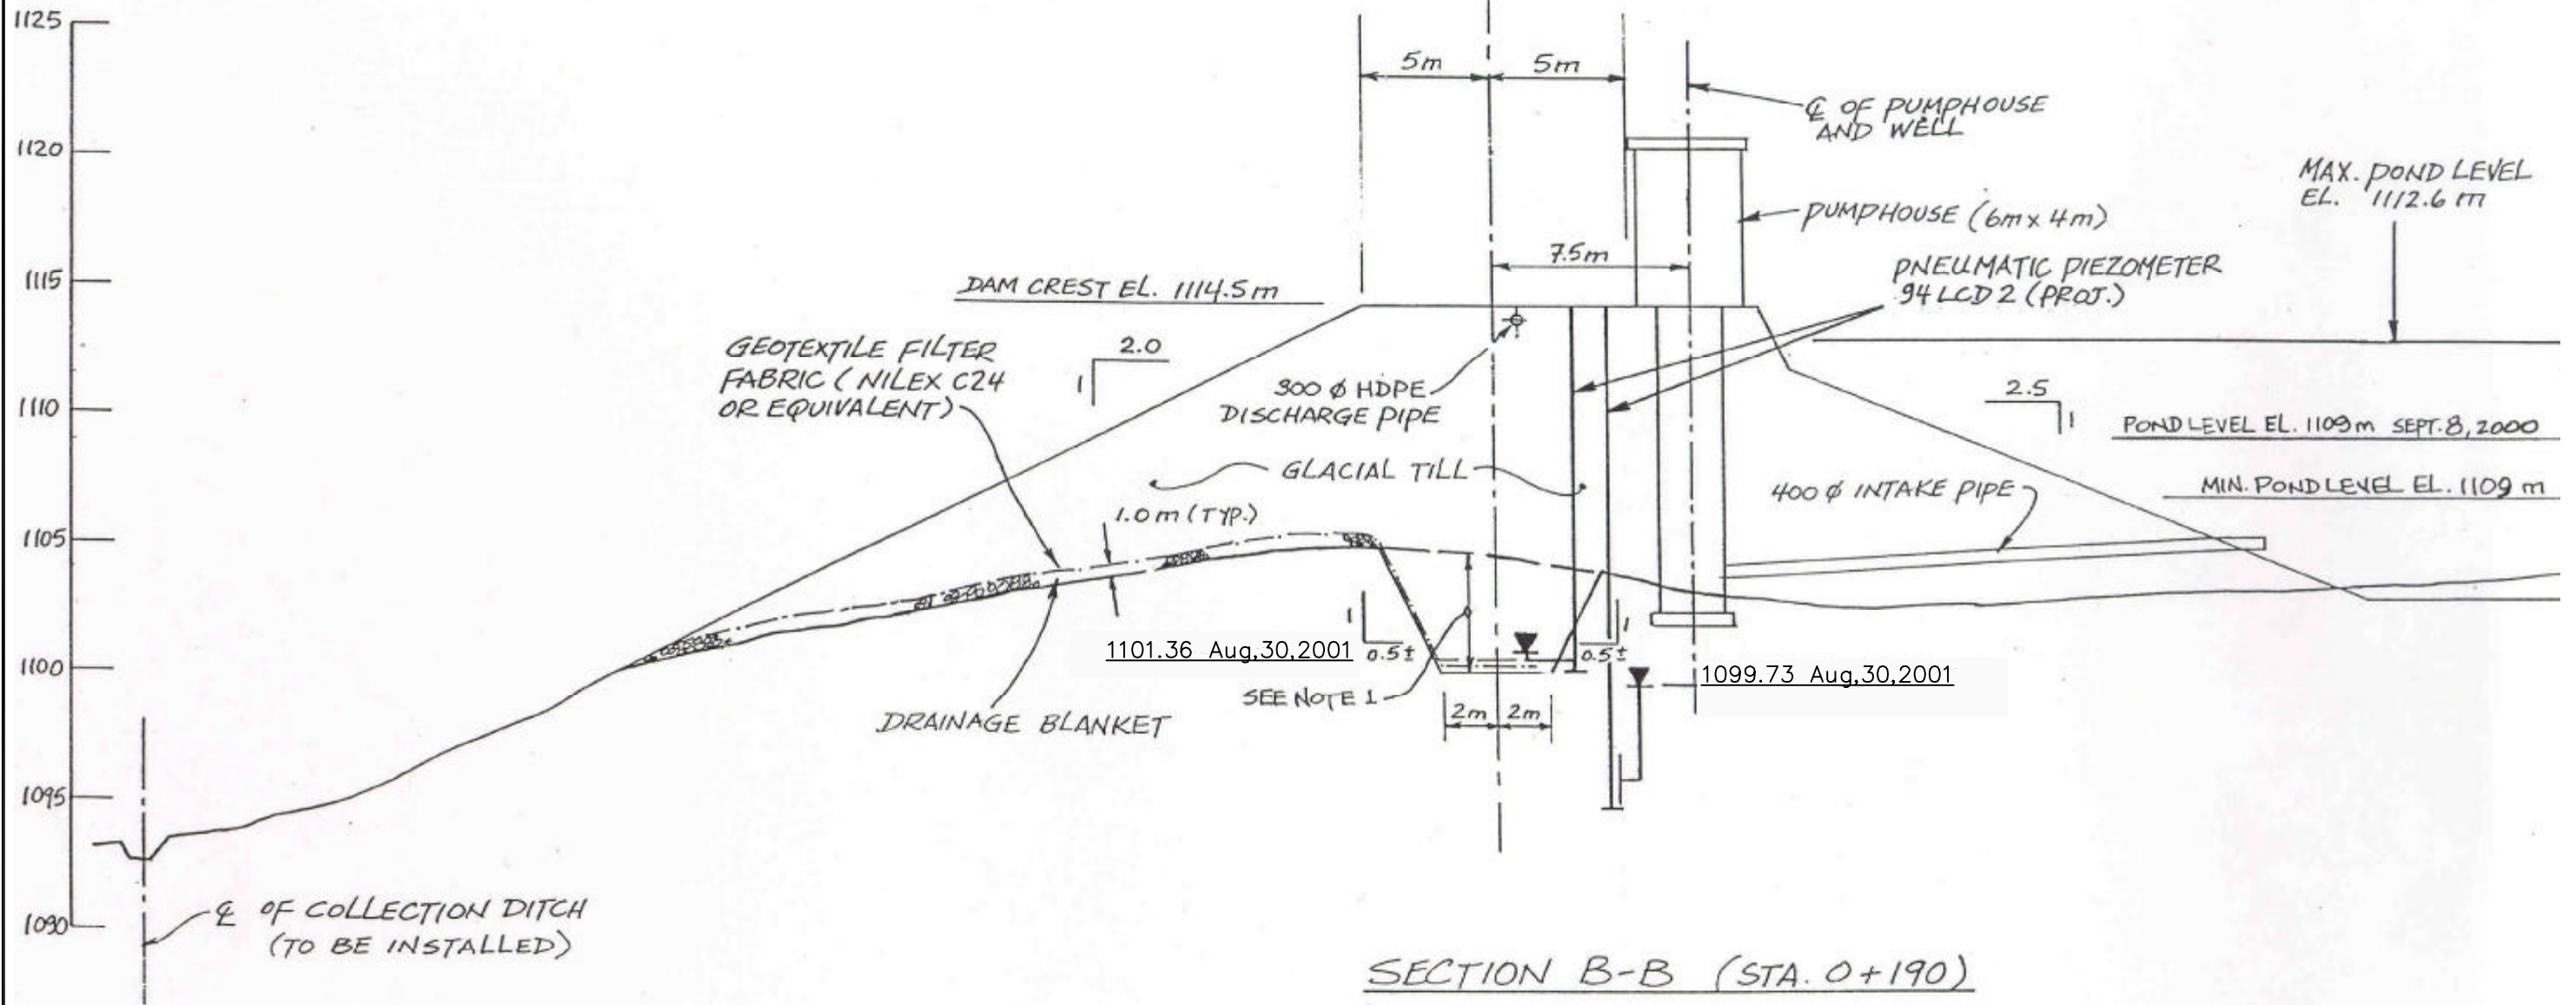
LITTLE CREEK DAM
SECTION B-B

In 1994, six pneumatic piezometers and three thermistors were installed along the crest of the Little Creek dam. The six piezometers are located at three separate locations; two piezometers, one deep and one shallow, at each location. The location of the piezometers and thermistors are shown on Figure 5 and the most recent 2001 piezometric levels are shown in section on Figures 6, 7 & 8. Actual readings are presented in Appendix B.

The piezometric levels are consistent with the water levels recorded in the impoundment and are in accordance with the design safety factors associated with the stability of the dam.

SRK recommends that the pneumatic piezometers and thermistors are monitored on a semi-annual basis and the results compiled and forwarded to SRK.
