## 2007 Annual Inspection Waste and Water Management Facilities Vangorda Mine, Yukon Territory

**SRK Consulting**  
*Engineers and Scientists*

*Project Reference Number  
SRK 1CD003.098*

*January 2008*

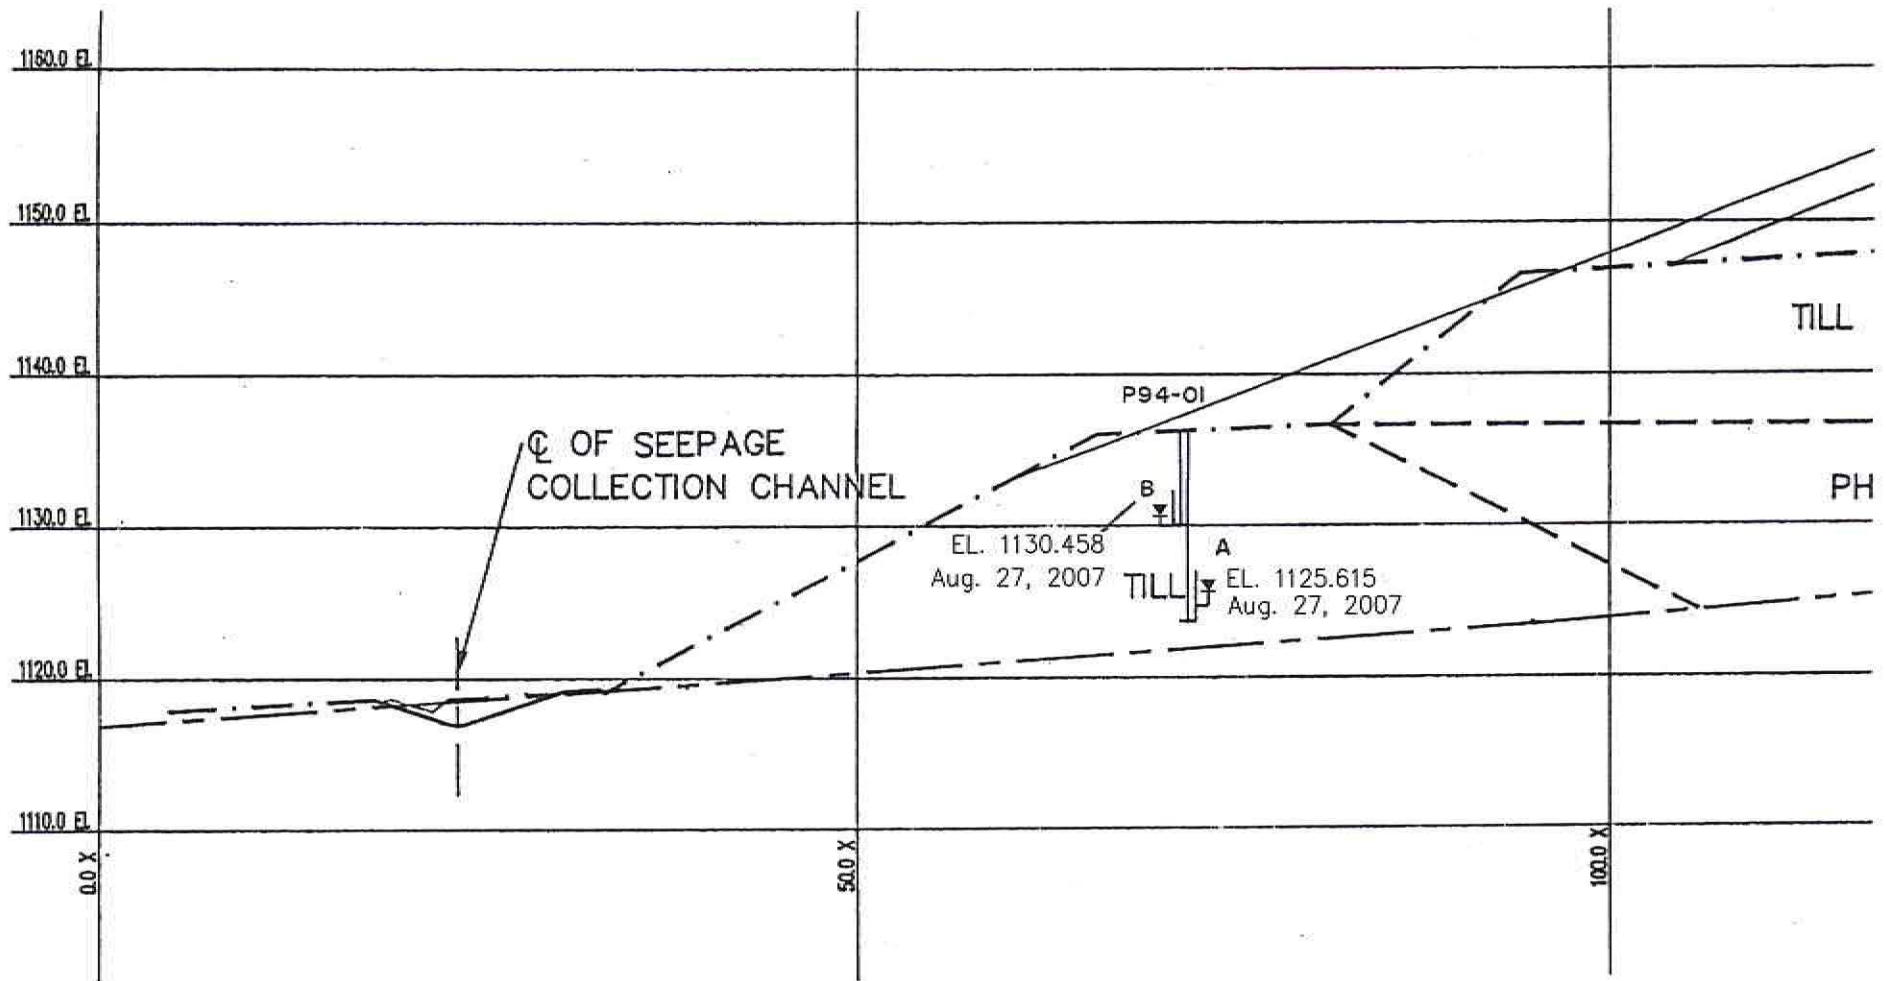
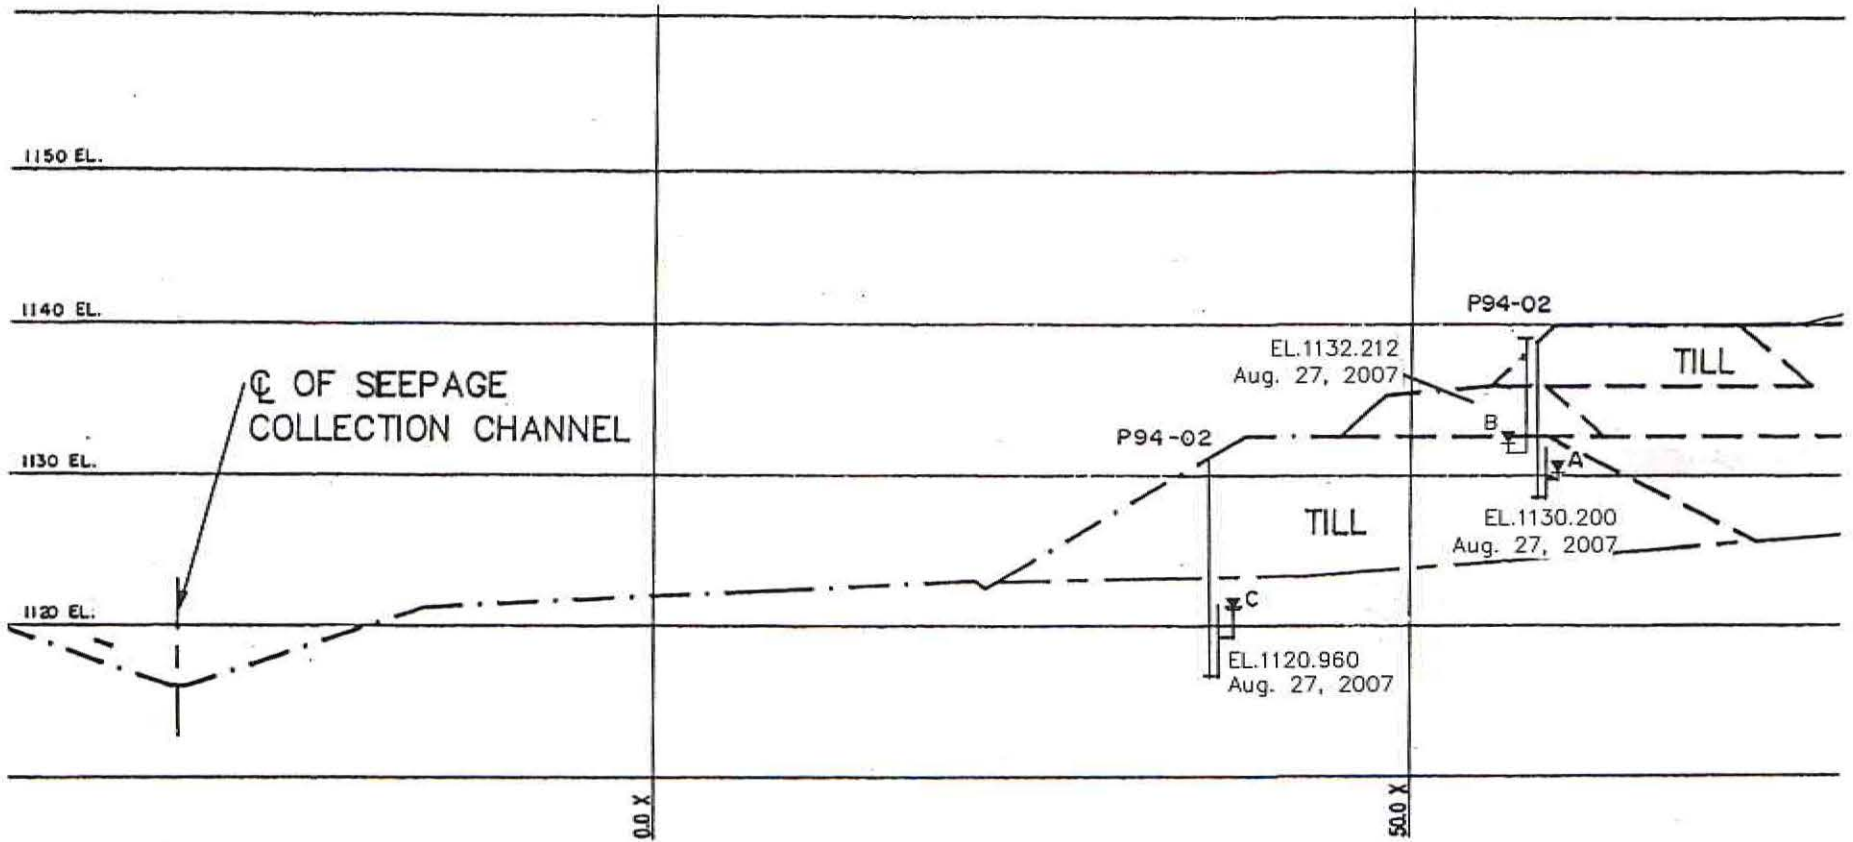
In accordance with SRK's recommendations, DTI has been taking water level readings twice a year from the piezometers that were installed in the till starter Dyke in 1994. A summary of the water level readings taken to date in the piezometers are presented in Table 1. Water levels, as recorded on August 27, 2007 in Piezometers P94-01A, 01B, 02A and 02B, are shown in Figures 4 and 5.

The levels in these piezometers are consistent with levels recorded since 1994 and do not indicate any potential instability. One of the piezometers (P94-04A) is broken and no readings have been reported from this piezometer since July, 2001.

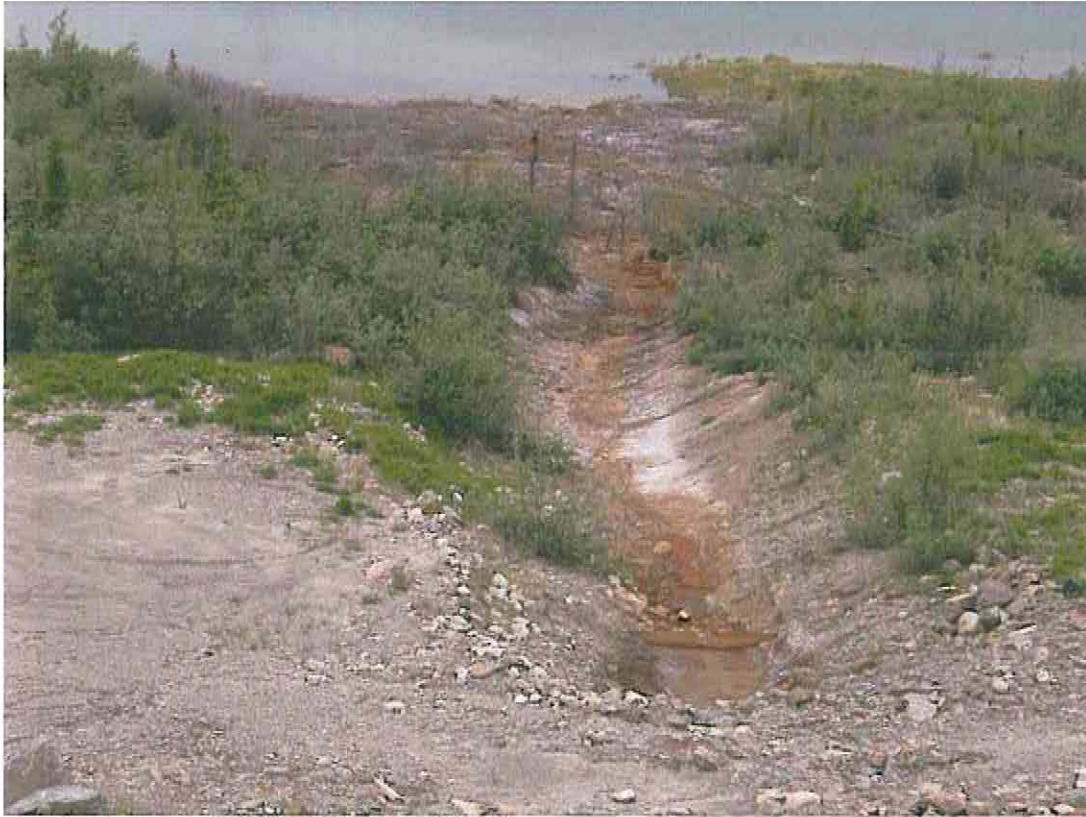
During this year's inspection, seepage flow was observed at Drain #6 (Photo 1), Drain #5 (Photo 2), and Drain #3 (Photo 3). The flow in each of these drains varied from a trace to less than 0.5L/min. Drain #2 (Photos 7 and 8) and Drain #4 (Photo 6) were dry.

Photo 1: Vangorda Waste Dump, Weir #6

The drains should be inspected monthly for any signs of instability around the outlet and deterioration of the steel v-notch weirs. The inspection should include recording of any flow or seepage.

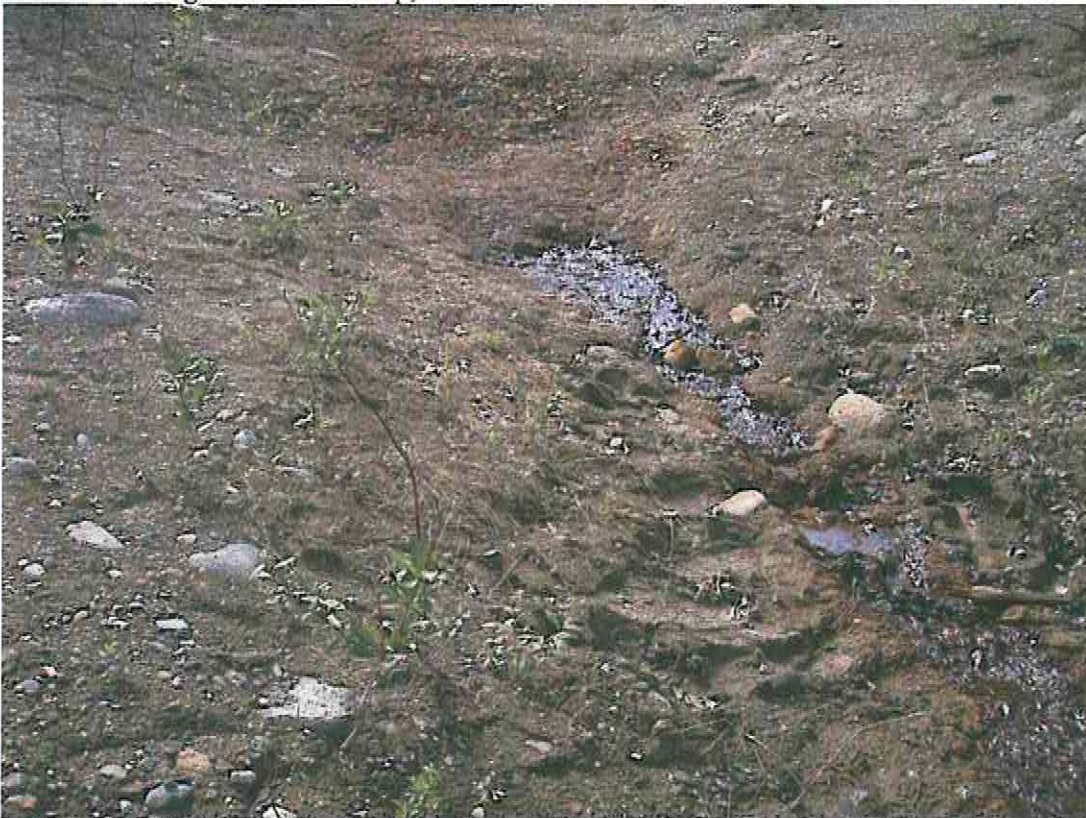
Photo 2: Weir #5

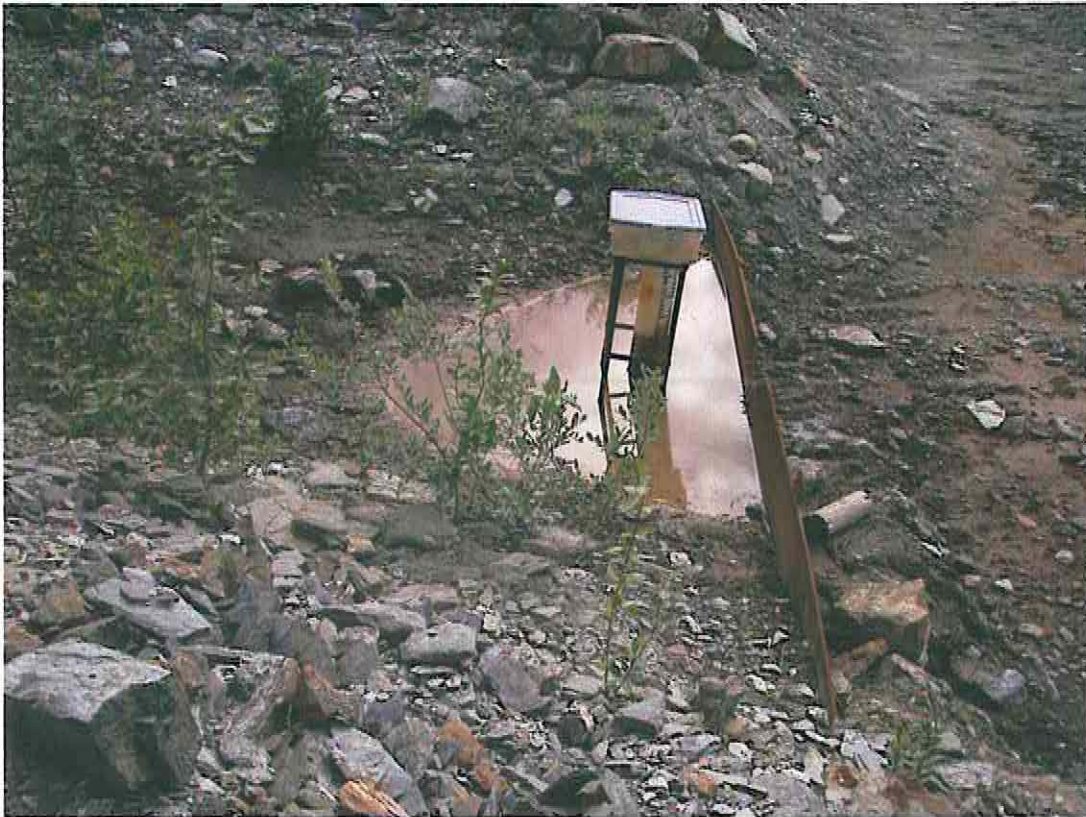
Photo 3: Weir 3

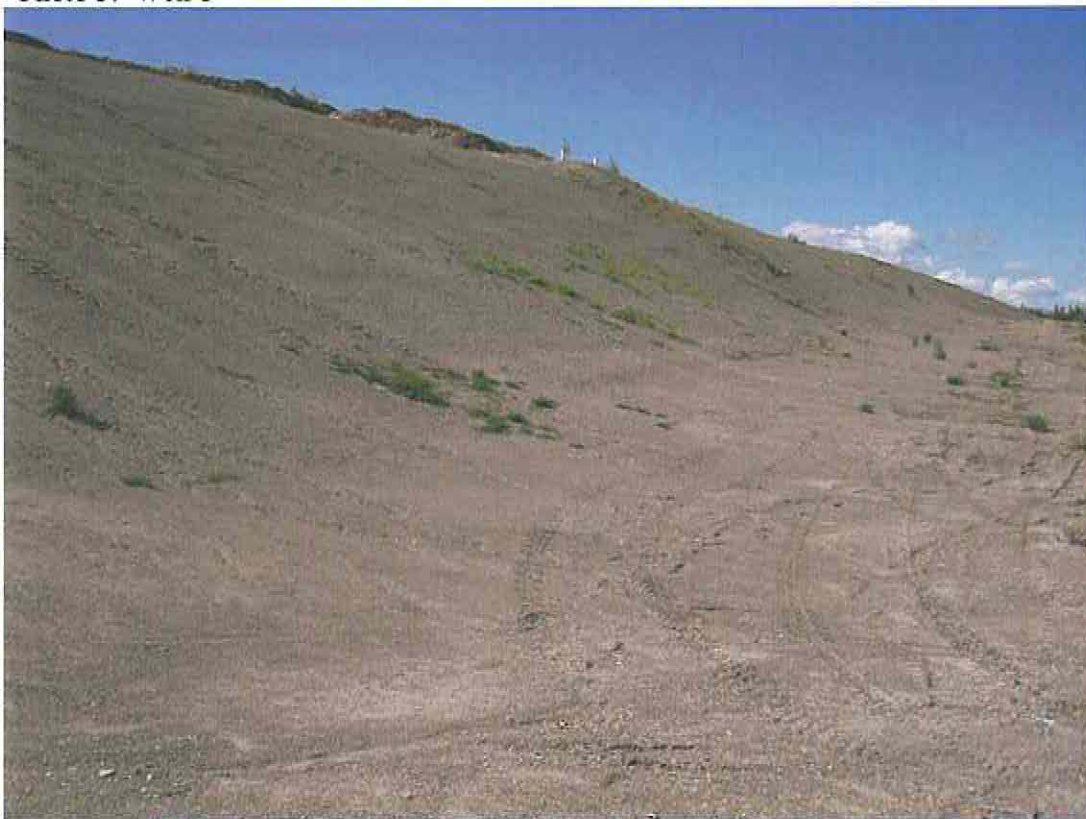
The resloping work that was carried out on the till starter dyke above Drains 5 and 6 shows no signs of excessive erosion or instability (Photo 4).

Photo 4: Till Slope above Weirs #5 and #6

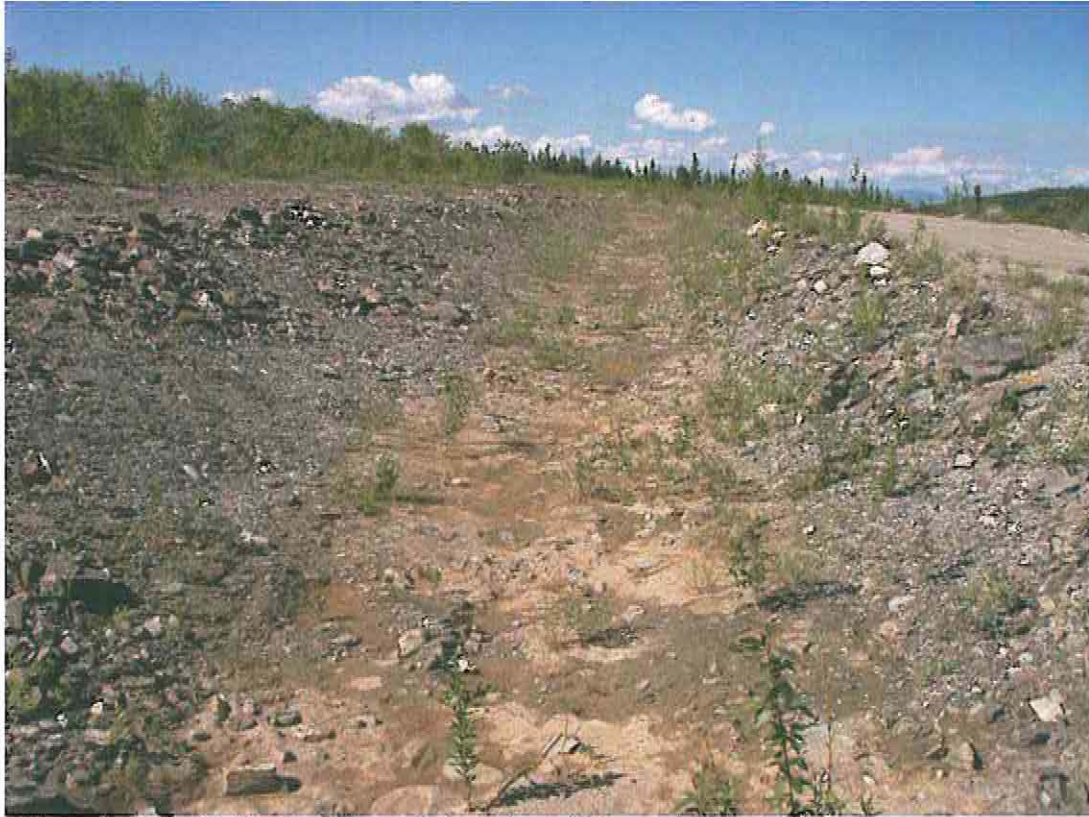
The seepage collection channel along the toe of the Vangorda Waste dump (Photo 5) shows no sign of instability. In the lower reaches of the channel, no measurable flow was observed in the ditch during the inspection.

Photo 5: Seep Collection Channel along toe of Vangorda Waste Dump

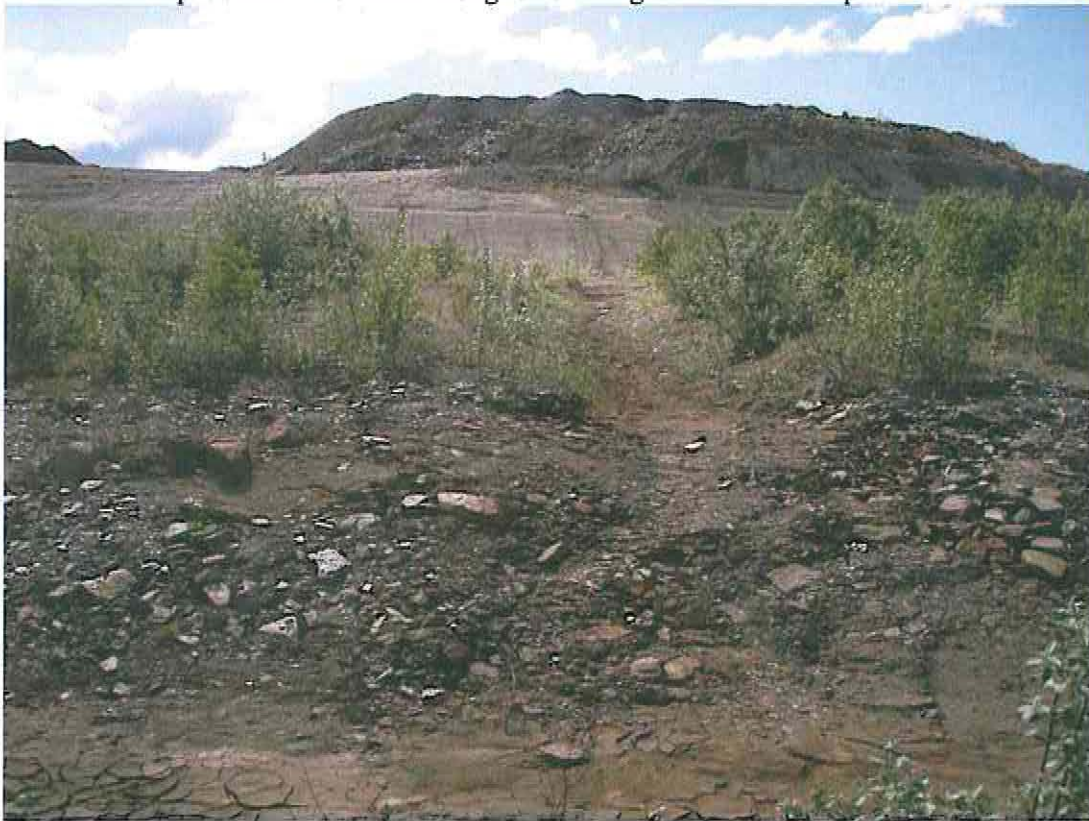
Photo 6: Drain 4 at toe of Vangorda Waste Dump

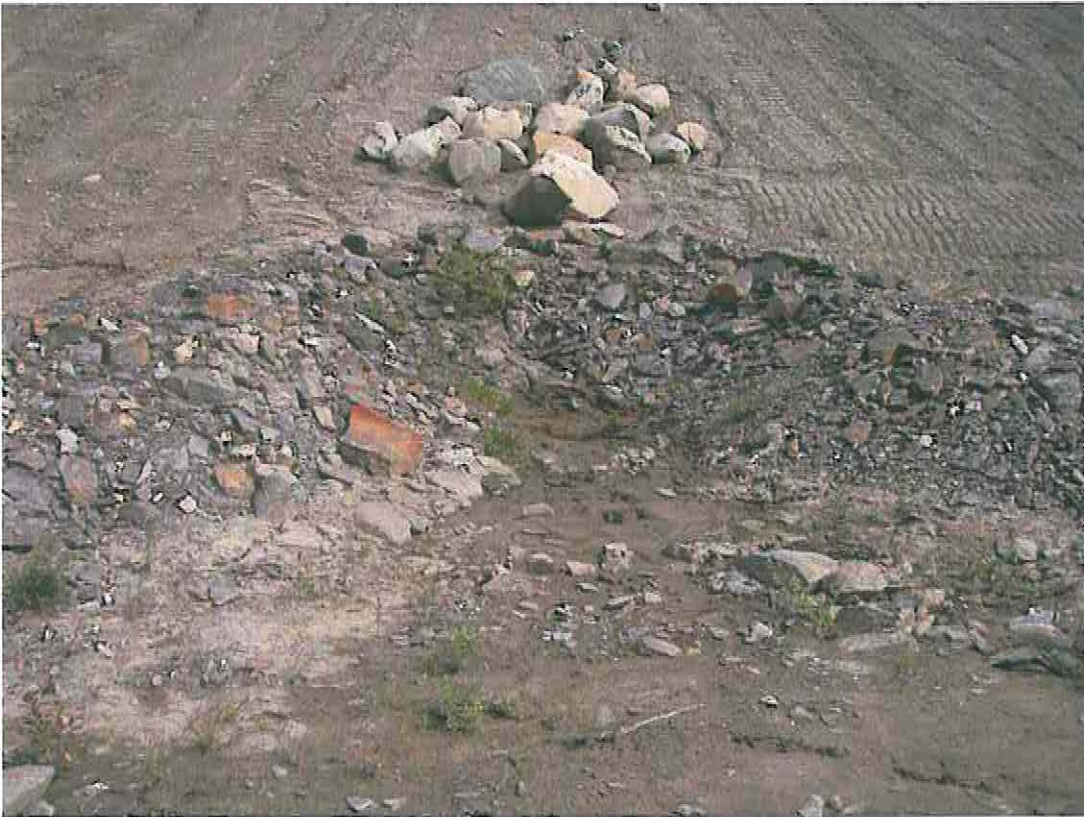
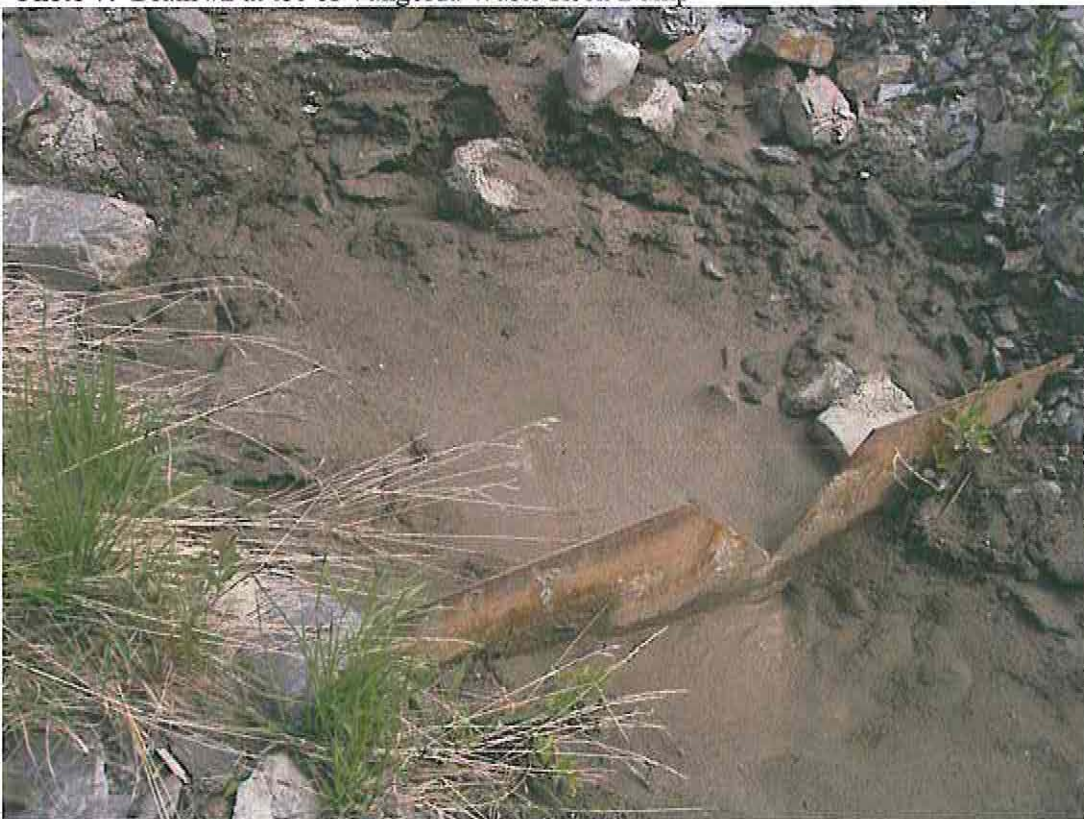
Photo 7: Drain #2 at toe of Vangorda Waste Rock Dump

Photo 8: Close-up of Drain #2

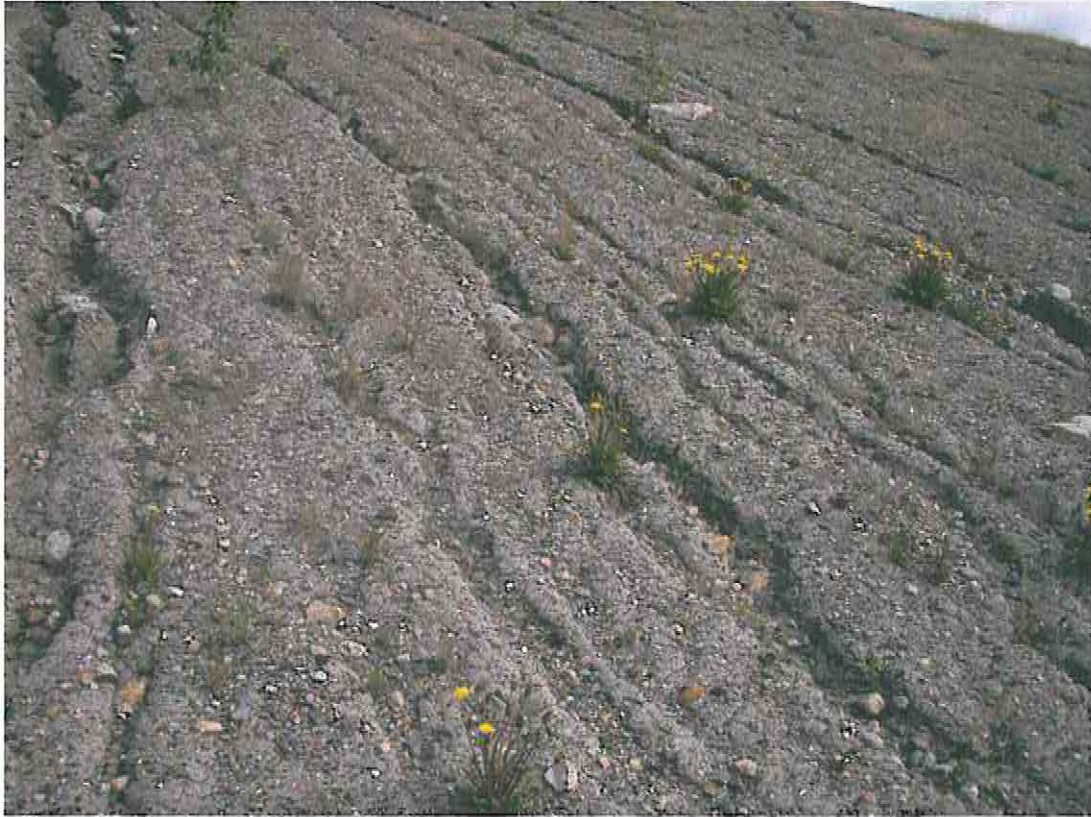
Photo 9: Erosion Gullies in the till cover on Vangorda Dump

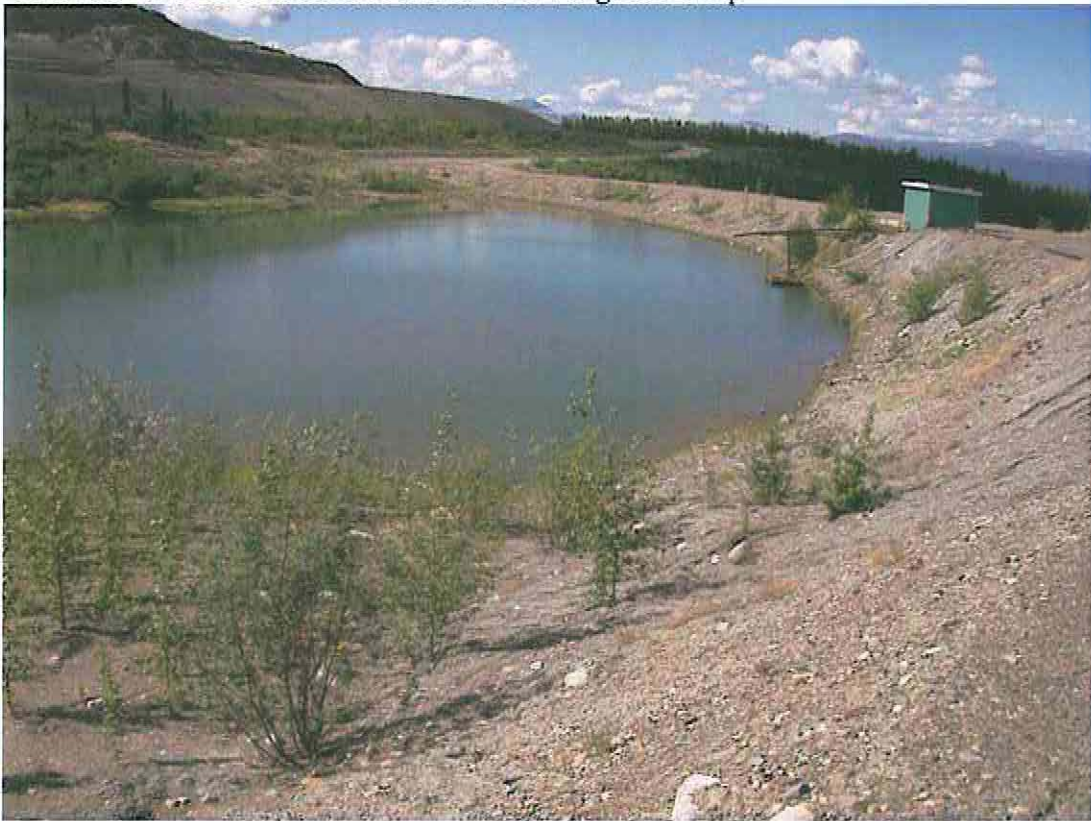
Water level in the pond (Photo 10) during our inspection on June 18, 2007 was recorded at about 1110m. No cracks or major settlement of the dam were observed and no seepage was observed along the downstream toe. Erosion rills are evident on both the upstream and downstream slopes of the dam. An erosion gully caused by runoff was observed on the upstream face of the approach road to Little Creek Dam (Photo 11).

Photo 10: Little Creek Pond

DTI should continue to regularly monitor the crest of the dam for any cracks, settlement or surficial movement of the slope.

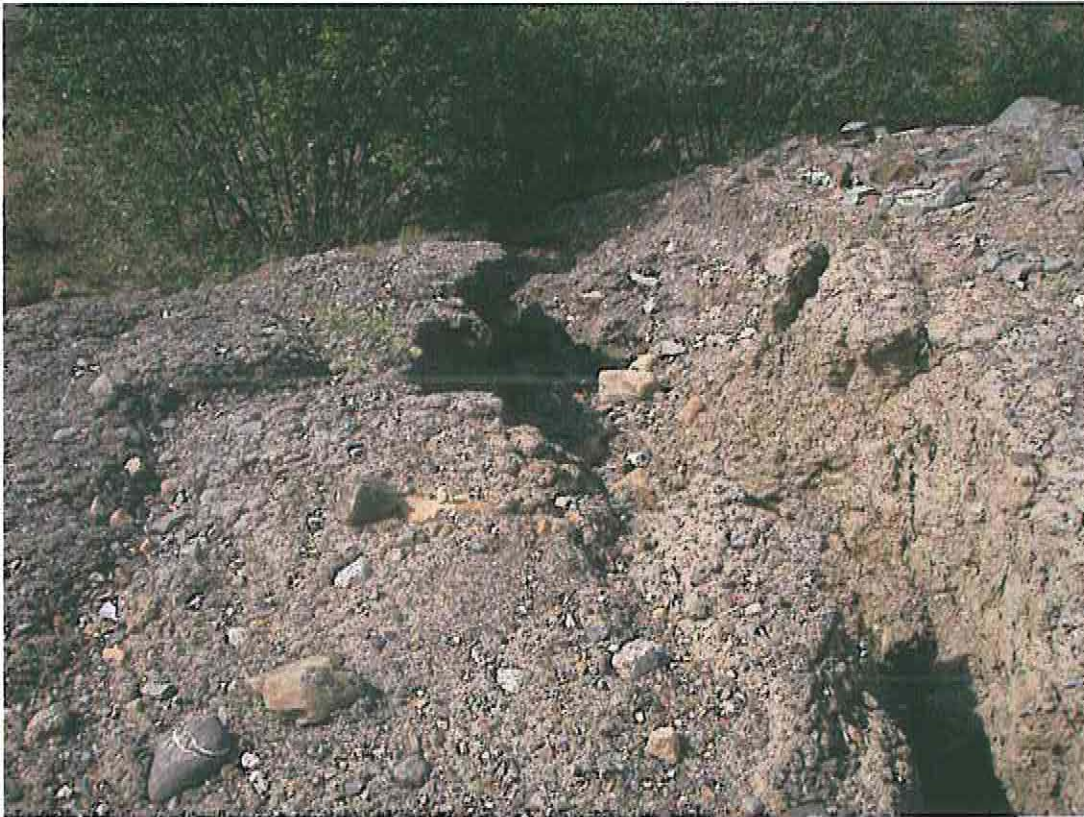
Photo 11: Erosion gully in approach road to Little Creek Dam

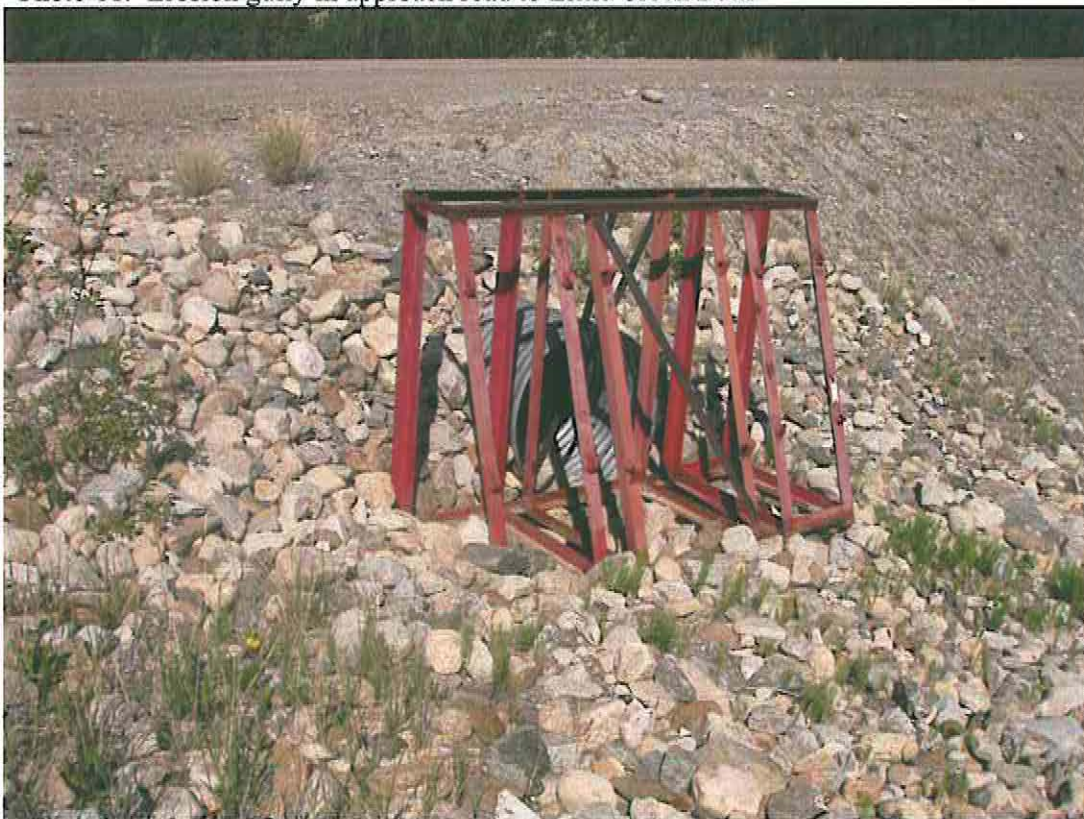
The 900mm CMP emergency spillway (Photo 12) was inspected and is in good condition.

Photo 12: Emergency culvert (inlet) at Little Creek Pond

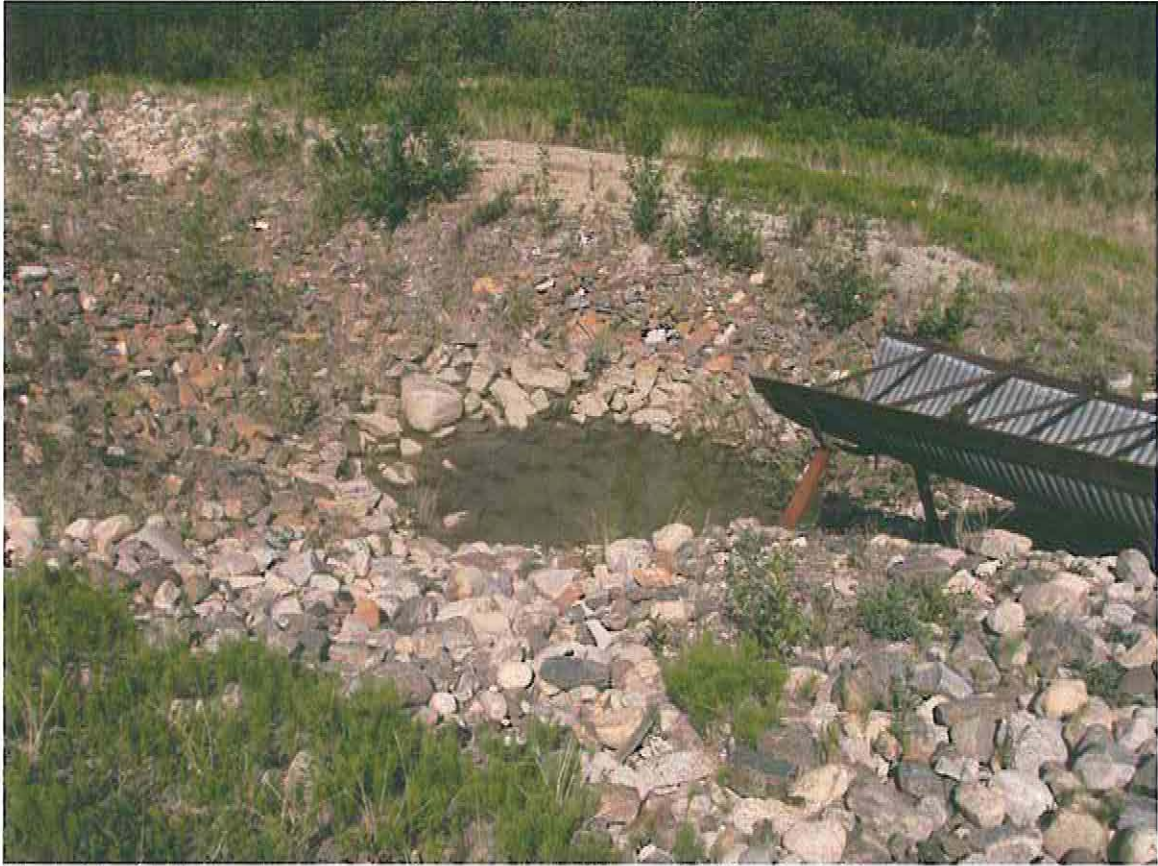
Photo 13: Outlet to plunge pool of emergency spillway at Little Creek Dam

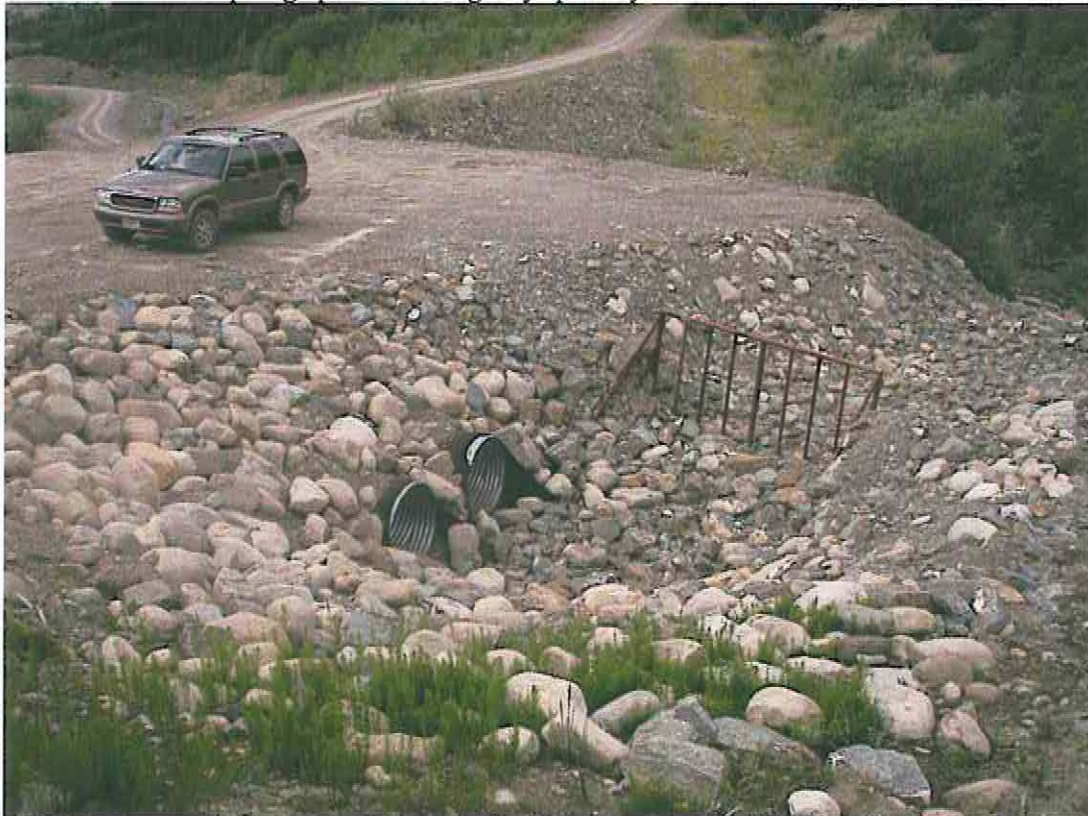
In accordance with a recommendation from SRK, an emergency overflow spillway (2x1m diameter CSP's) was installed at the headworks of the diversion in August 2005 (Photo 14). DTI continues to maintain the 2.4m diameter flume to ensure safe passage of flow in Vangorda Creek. Boulders that fall into the flume (Photo 15) are periodically removed. There are no signs of instability or settlement of the embankment at the headworks of the diversion.

Photo 14: Emergency Spillway at the headworks of Vangorda Creek Diversion

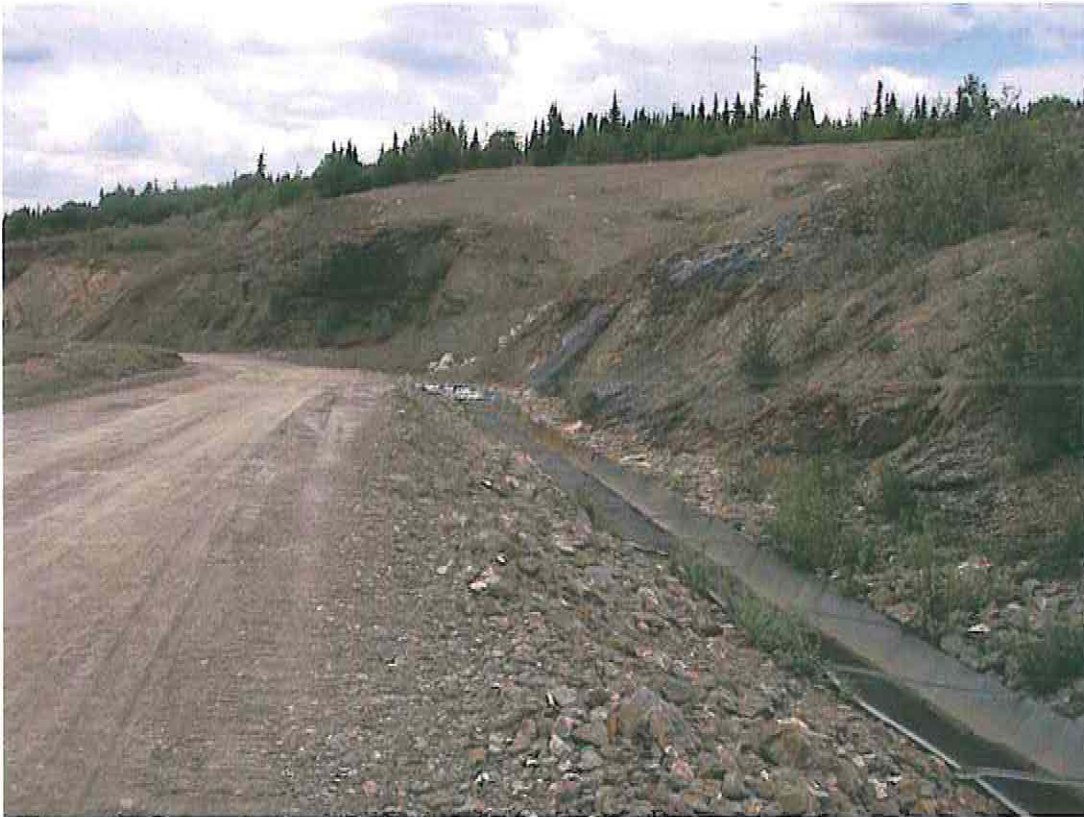
Photo 15: Vangorda Creek Diversion (lower reaches)

DTI should continue to monitor the sideslopes above the flume for sloughing and areas of instability and should top-up riprap along the flume where the material has settled below the rim of the culvert sections. Any debris or rocks that accumulate in the flume, at the entrance to the 2m CMP or at the headwork's trashrack should be removed. SRK should be notified of any excessive seepage from the flume and increase of discharge into the pit. If any damage to the cross braces and if the structural integrity of any of the flume sections is compromised by ice formation or slides, DTI should replace the impacted sections.

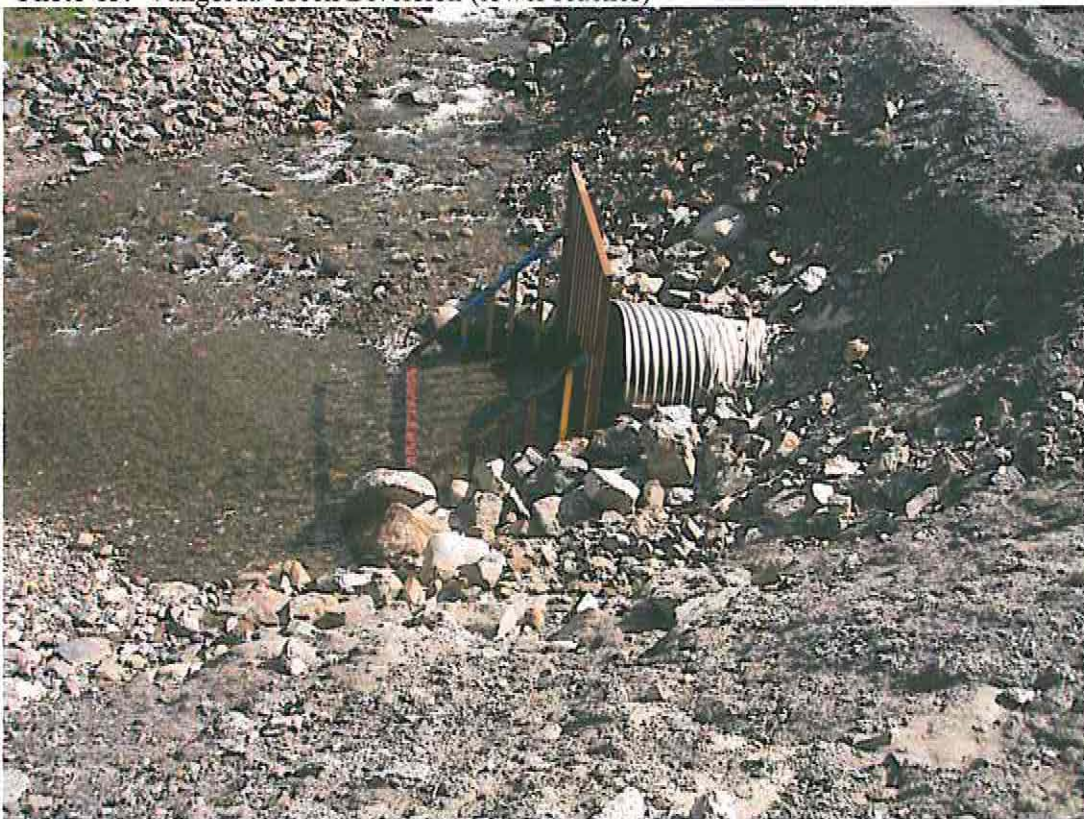
The 2m diameter CMP culvert in the plunge pool shows signs of wear and tear around the entrance to the pipe (Photo 16). A trash rack has been installed at the entrance.

Photo 16: Inlet to the 2m dia CMP at the Vangorda diversion plunge pool

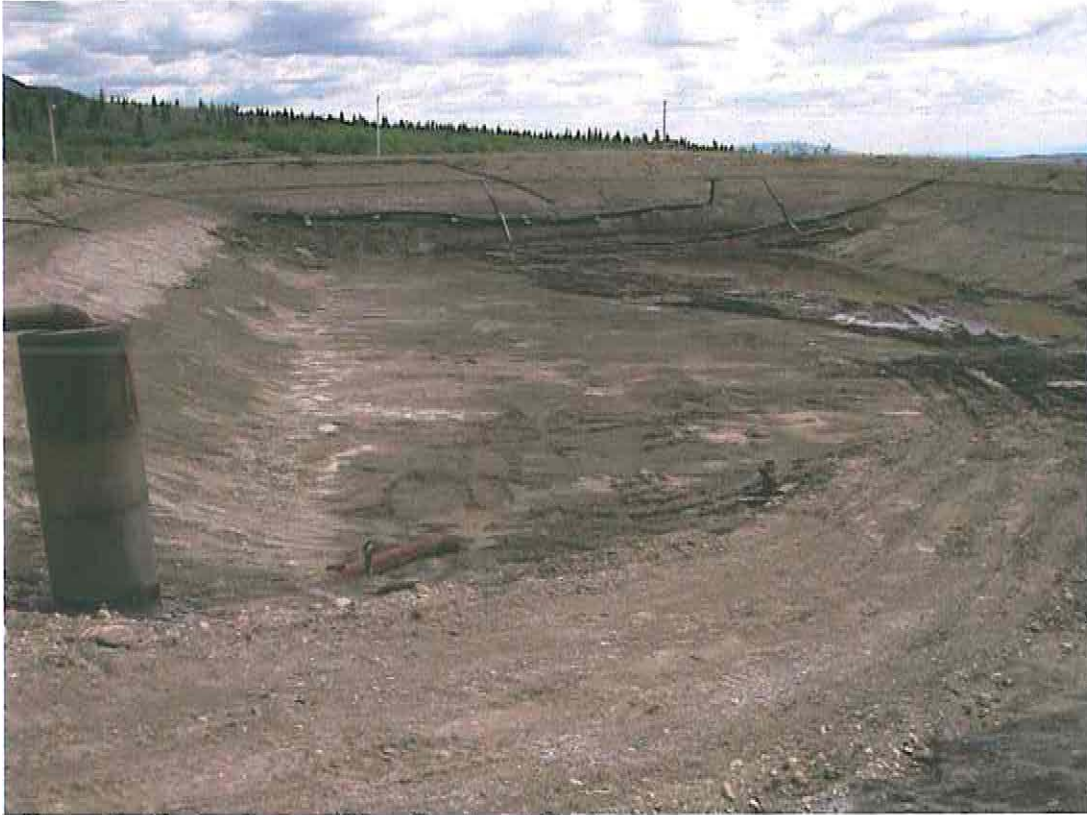
At the time of our inspection, the sludge pond was dry (Photo 17). SRK inspected the downstream slopes and crests of the four embankments that make up the sludge pond. Neither subsidence of the slopes, nor settlement of the crest and no tension cracks were observed (Photo 18). However as shown in Photo 19, there was an area of subsidence on the inside slope of the northern end of the pond.

Photo 17: Sludge Pond at Water Treatment Plant

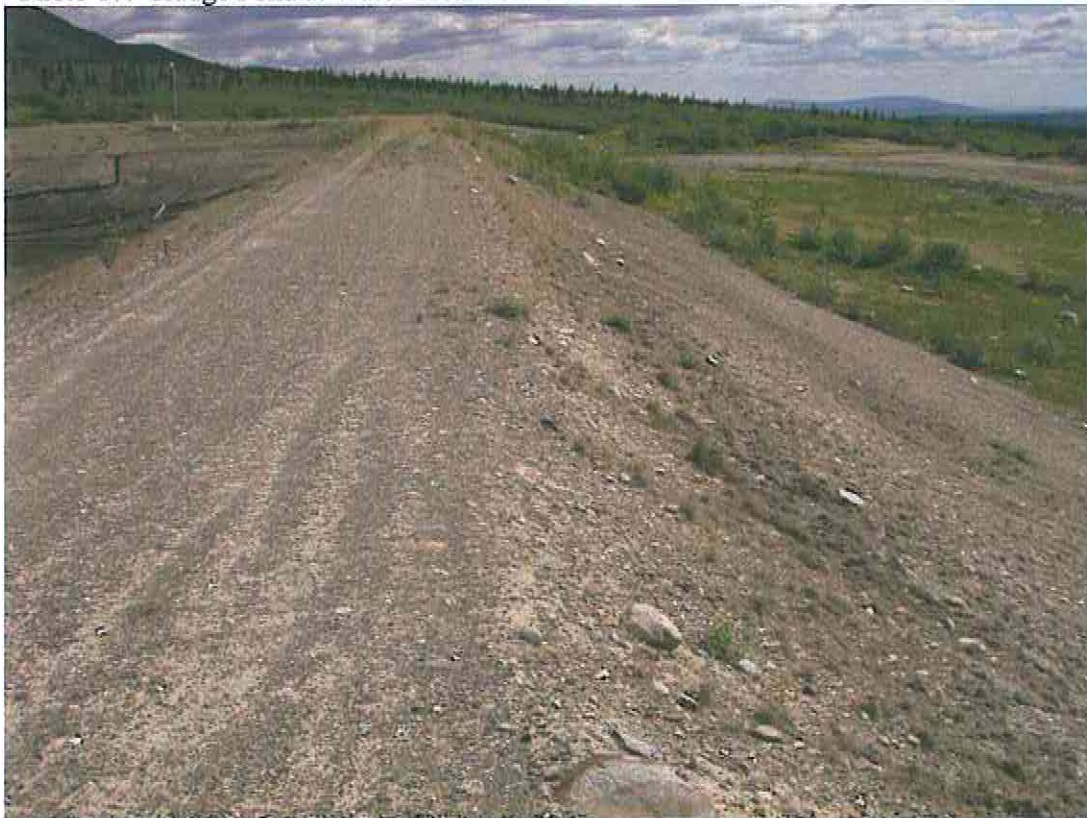
Photo 18: Till Embankment around the Sludge Pond

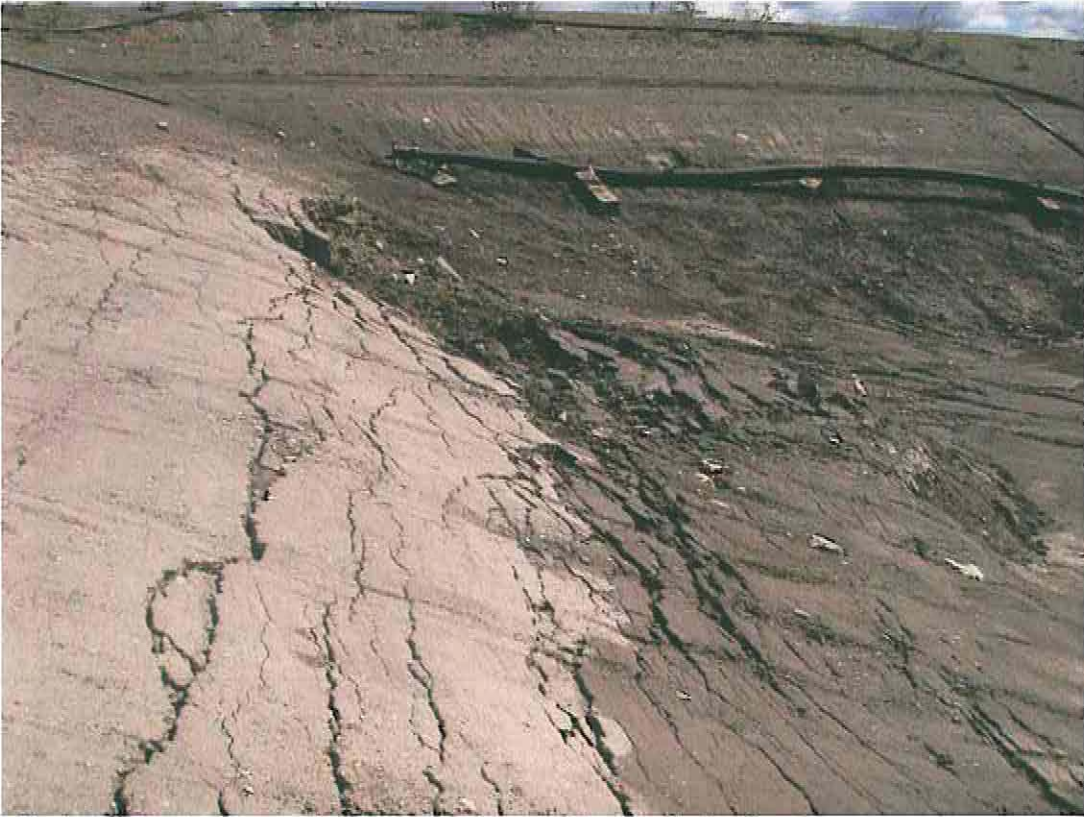
Photo 19: Instability on the upstream slope inside the Sludge Pond

- Ensure that the pond level does not exceed 2m. below crest;
- Continue to monitor on a monthly basis, the crest and sideslopes for cracking or any signs of sloughing;
- Repair the subsidence by excavating out the loose material, placing geotextile filter fabric over the exposed material and placing compacted granular fill over the filter fabric. SRK understands that DTI completed this work in September 2007 (See Photos 28, 29 and 30).

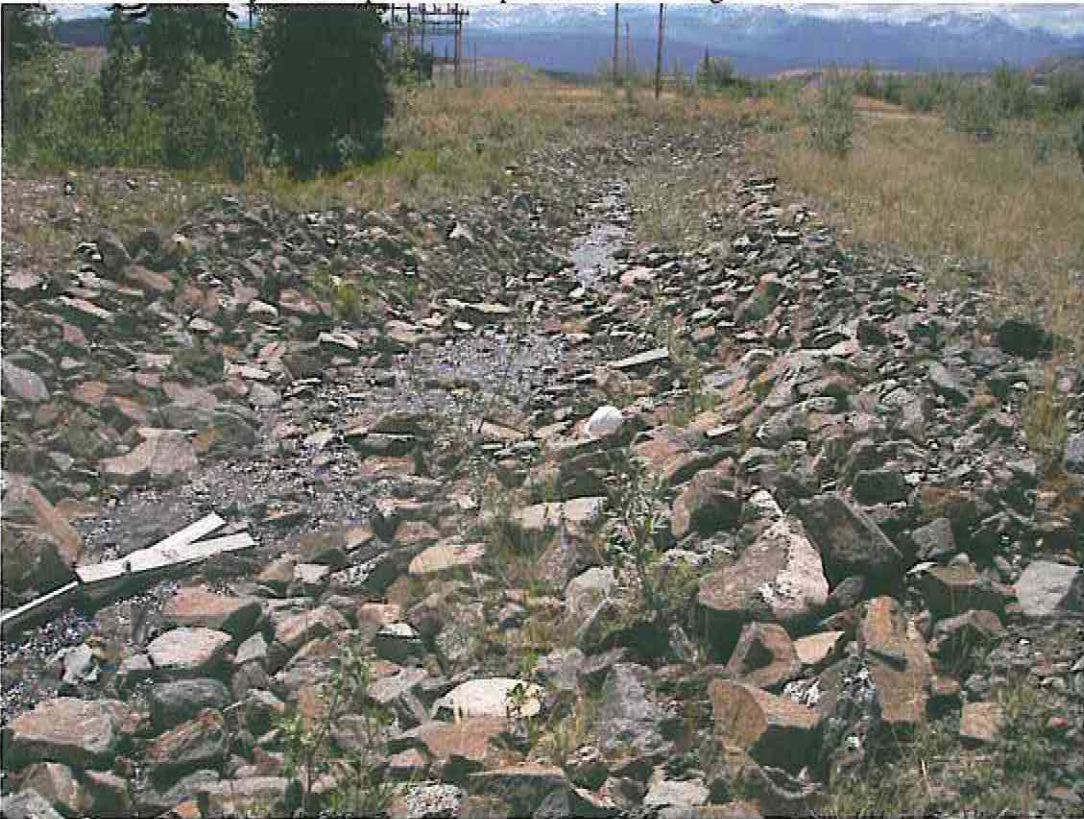
Photo 20: Grum Interceptor Ditch

- Monitor monthly the crest of the settling pond dykes for any cracks
- Monitor monthly the toe of the dykes for any seeps
- Clear any debris that accumulates at either end of the GID culverts and the settling pond spillway.
