## 2007 Annual Inspection Waste and Water Management Facilities Vangorda Mine, Yukon Territory

**SRK Consulting**  
*Engineers and Scientists*

*Project Reference Number  
SRK 1CD003.098*

*January 2008*

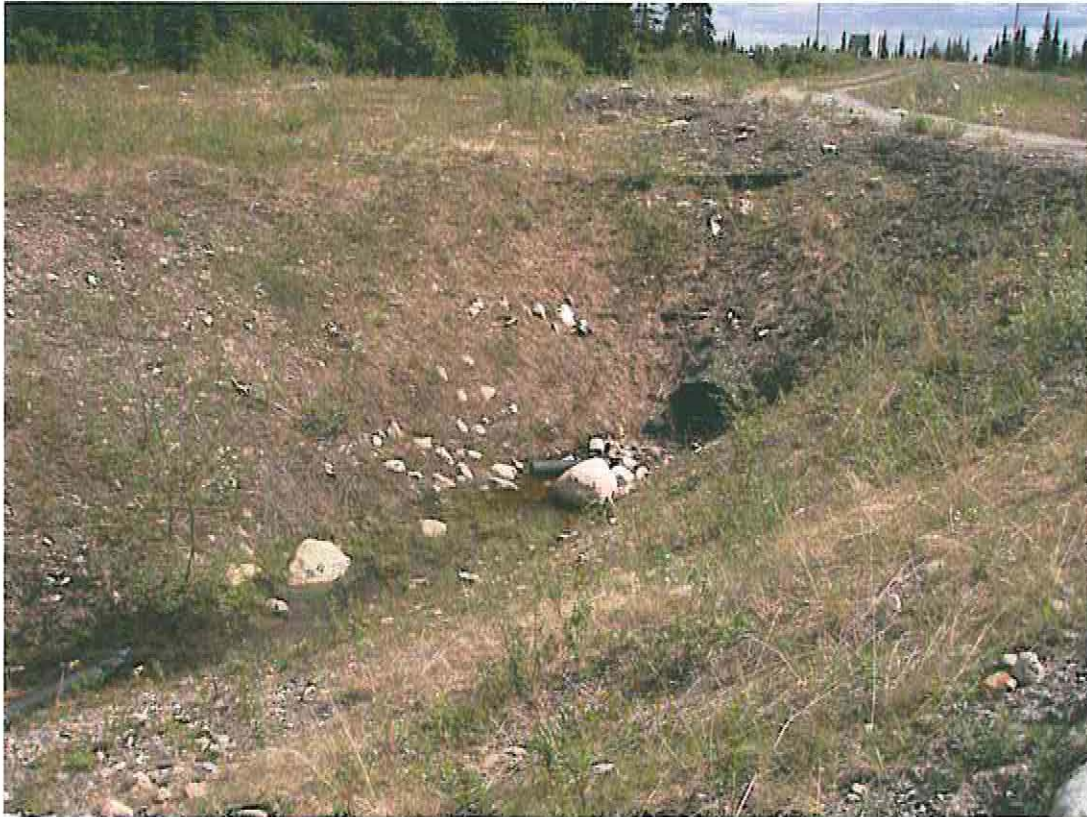
Photo 21: Debris accumulation at culvert entrances along Grum Interceptor Ditch

- Monitor monthly the crest of the settling pond dykes for any cracks
- Monitor monthly the toe of the dykes for any seeps
- Clear any debris that accumulates at either end of the GID culverts and the settling pond spillway.

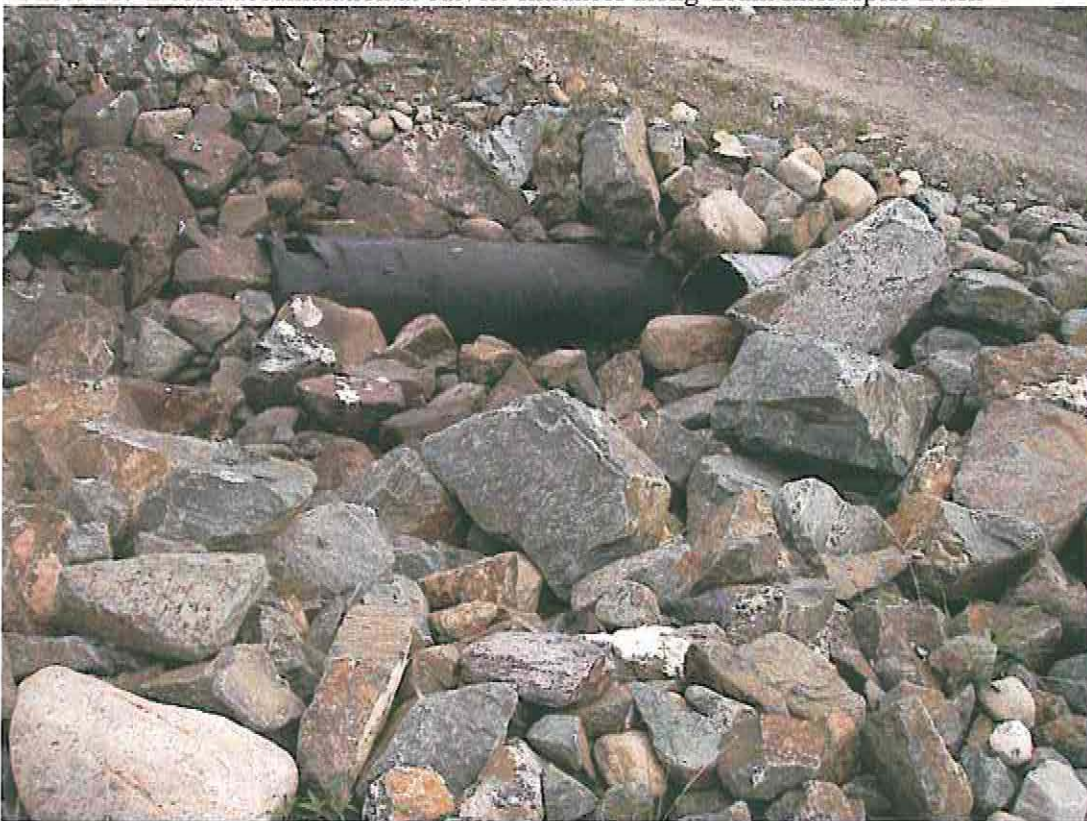
Photo 22: Culvert entrance just above Sheep Pad Pond

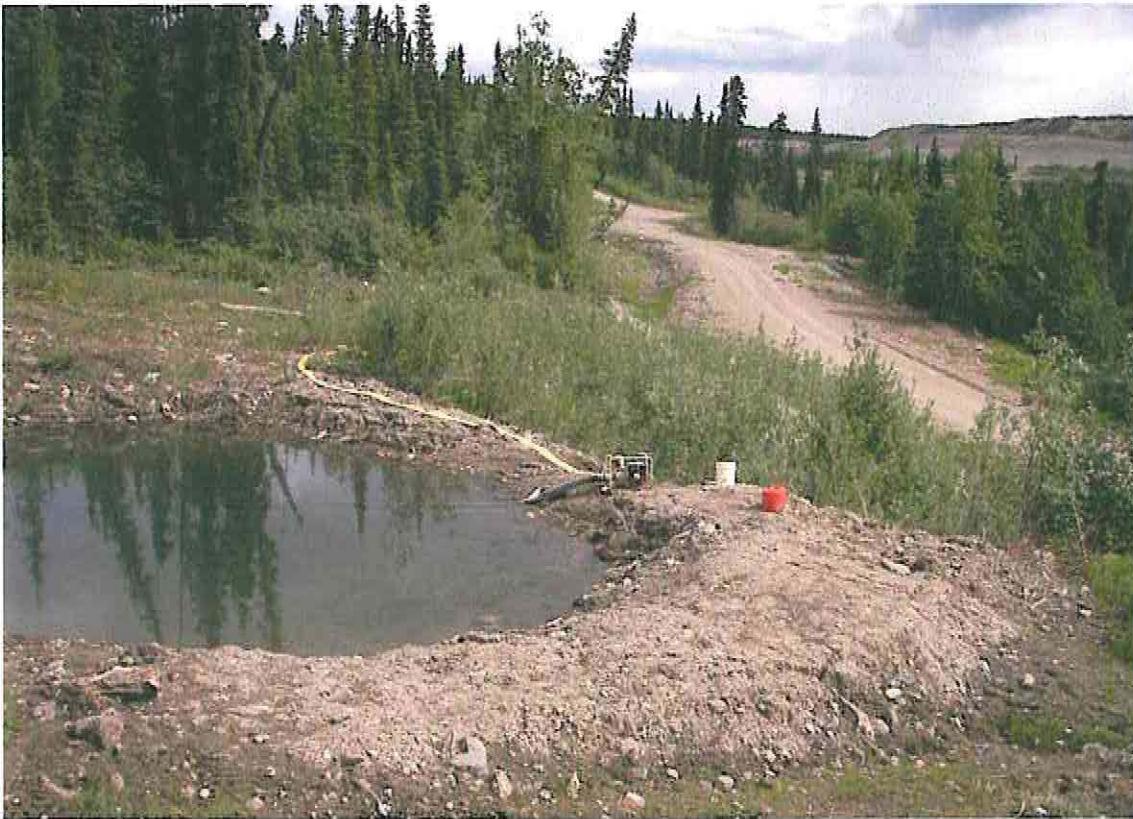
Photo 23: V-15 Sedimentation Pond prior to construction of diversion ditch

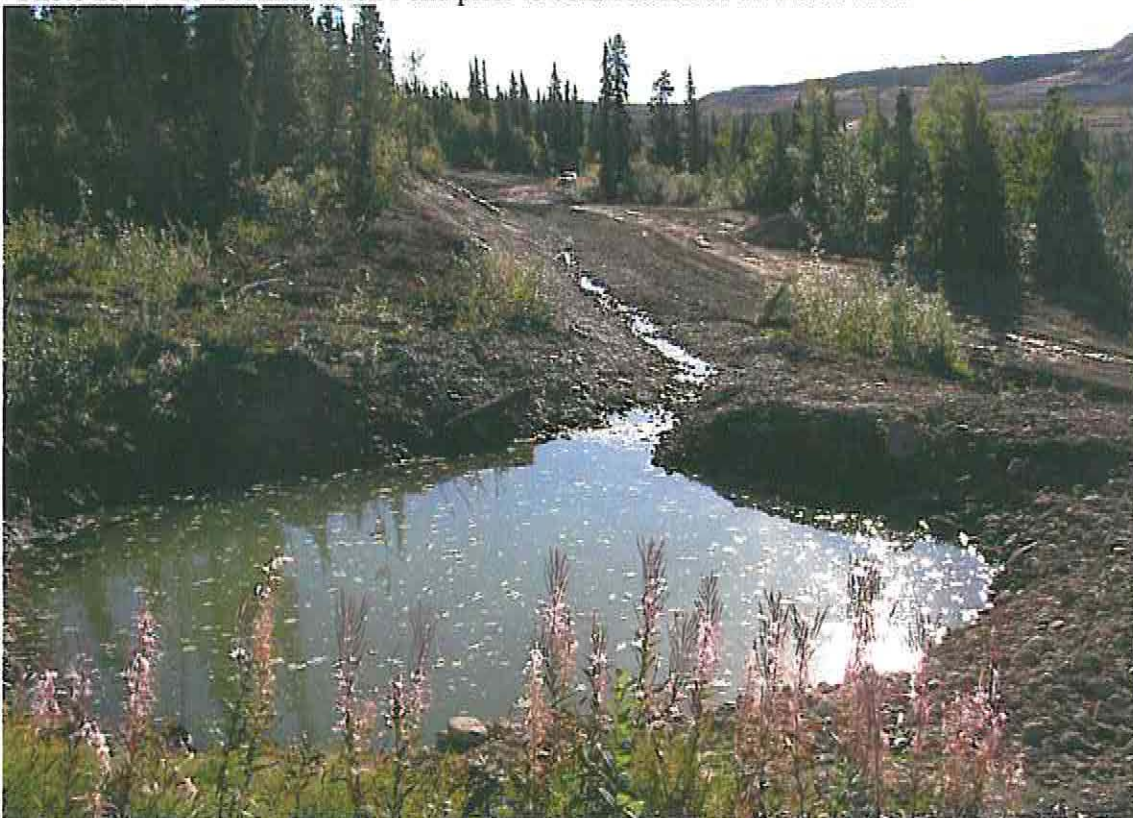
Photo 24: V-15 Sedimentation Pond after construction

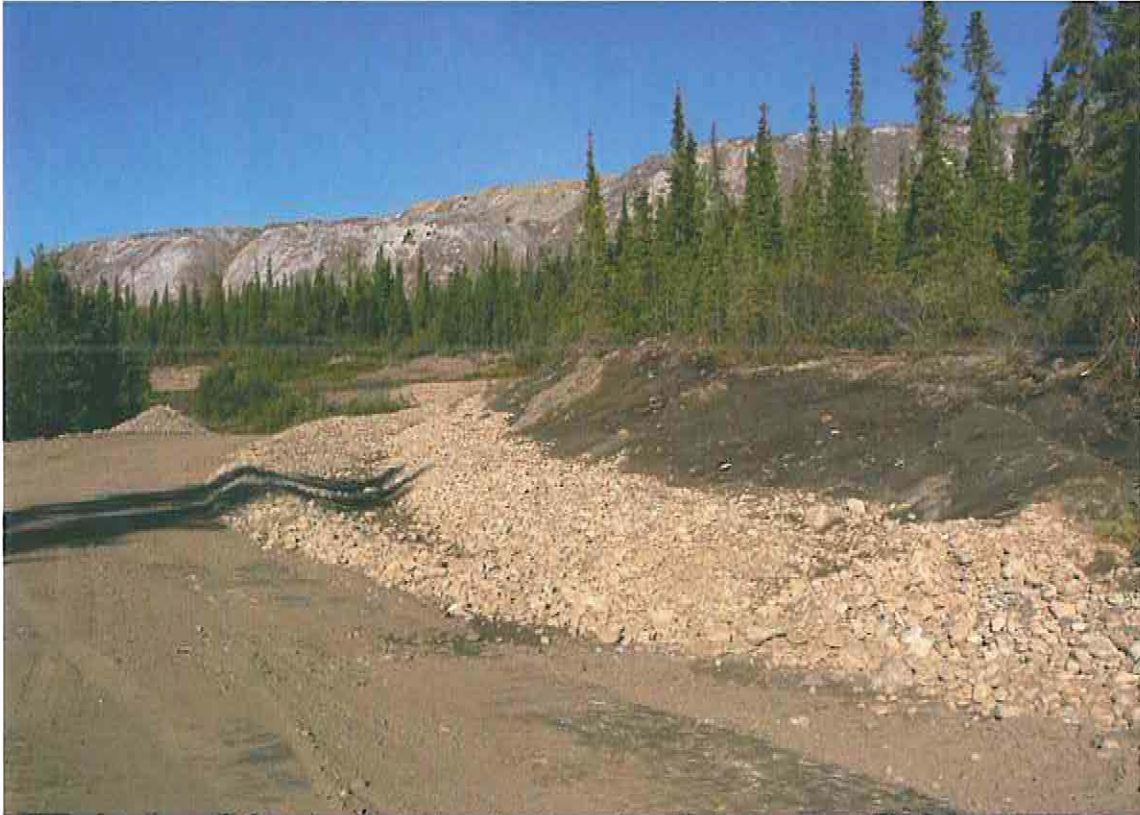
Photo 25: Runoff diversion ditch along haul road from V-15 constructed in August 2007

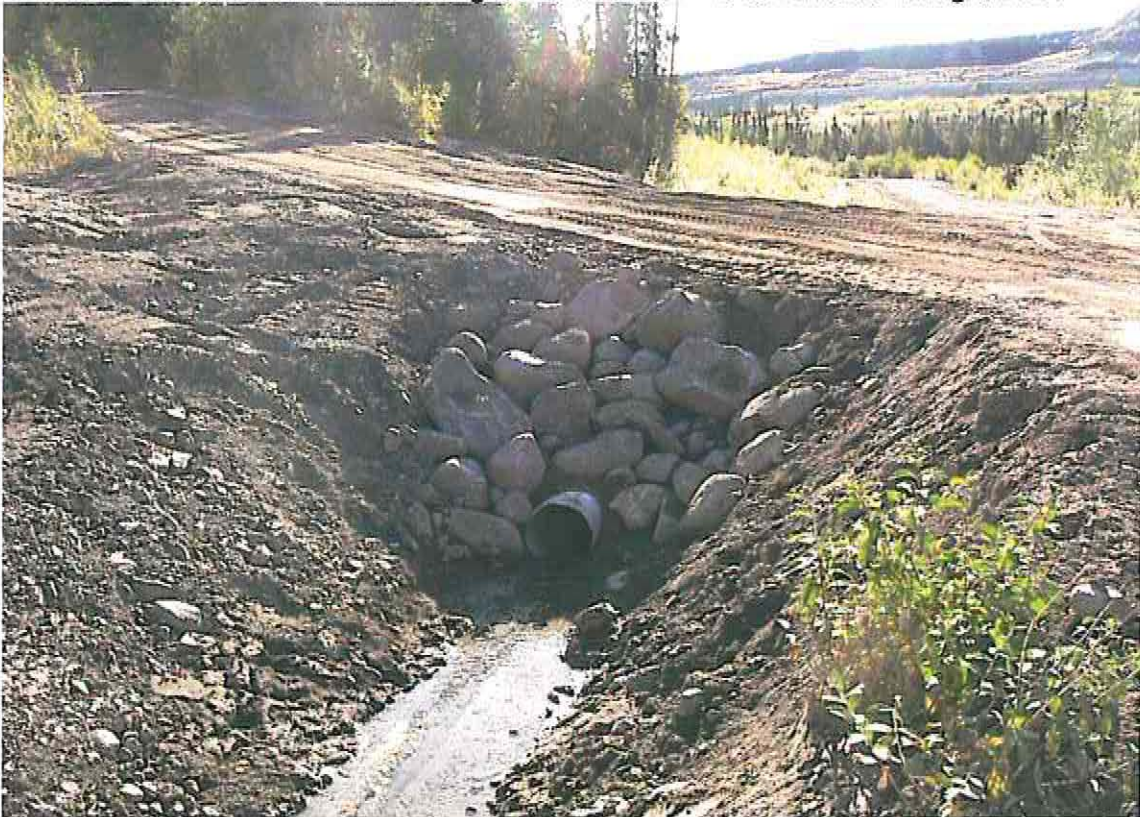
Photo 26: New culvert (2007) below V-notch Weir on Grum Creek and new diversion

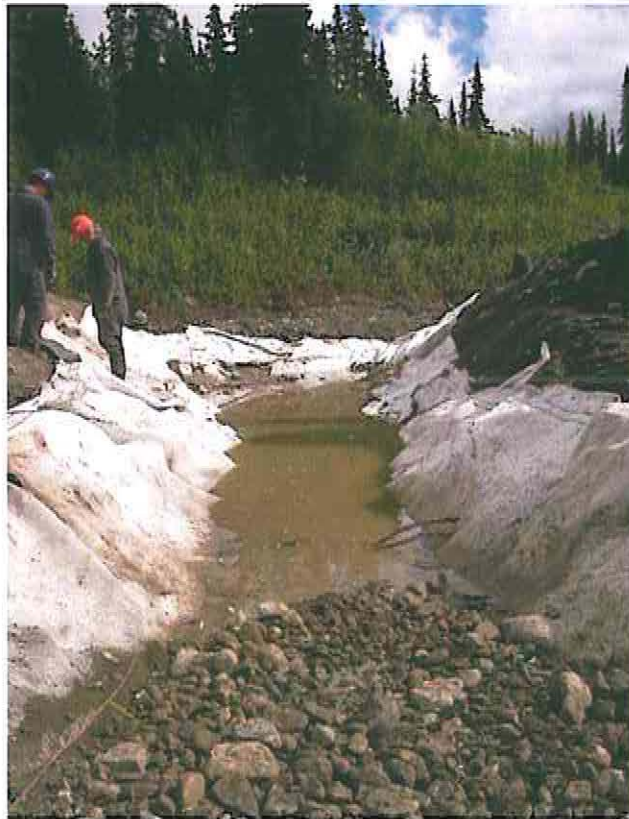
Photo 27: Runoff diversion ditch along haul road during construction showing the Bentamat Liner and course granular cover

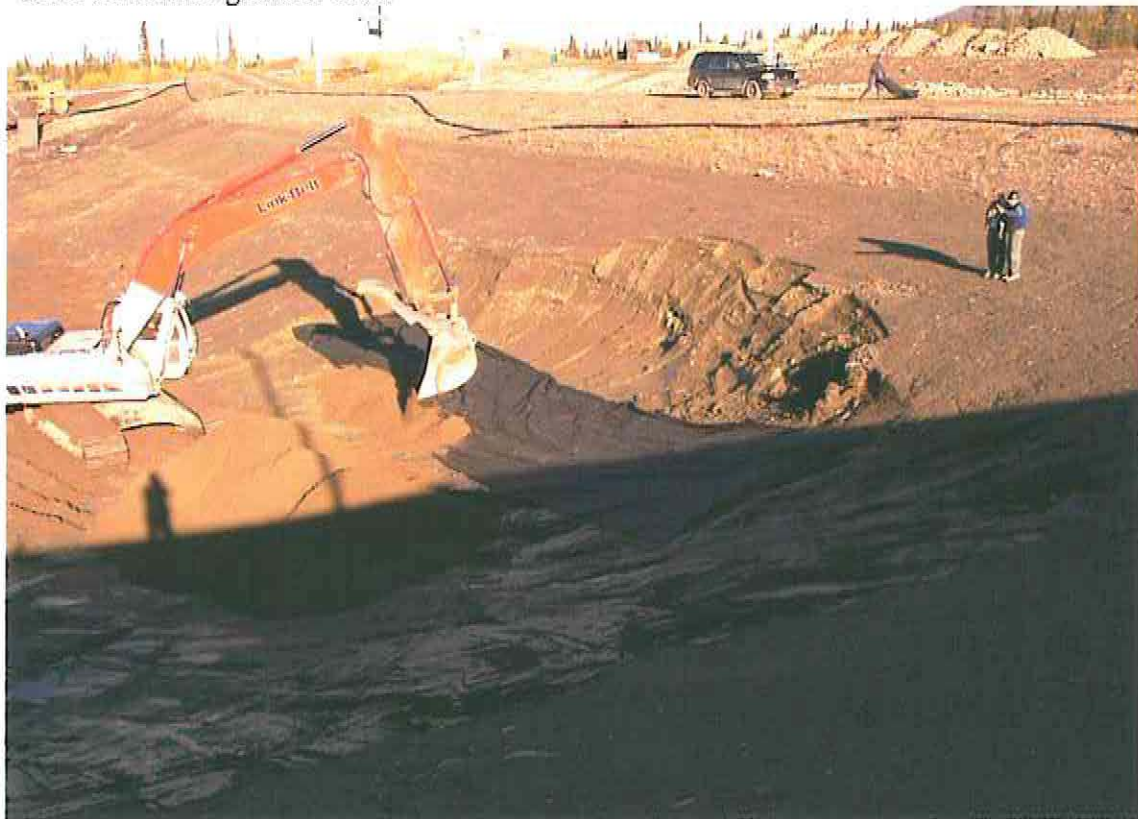
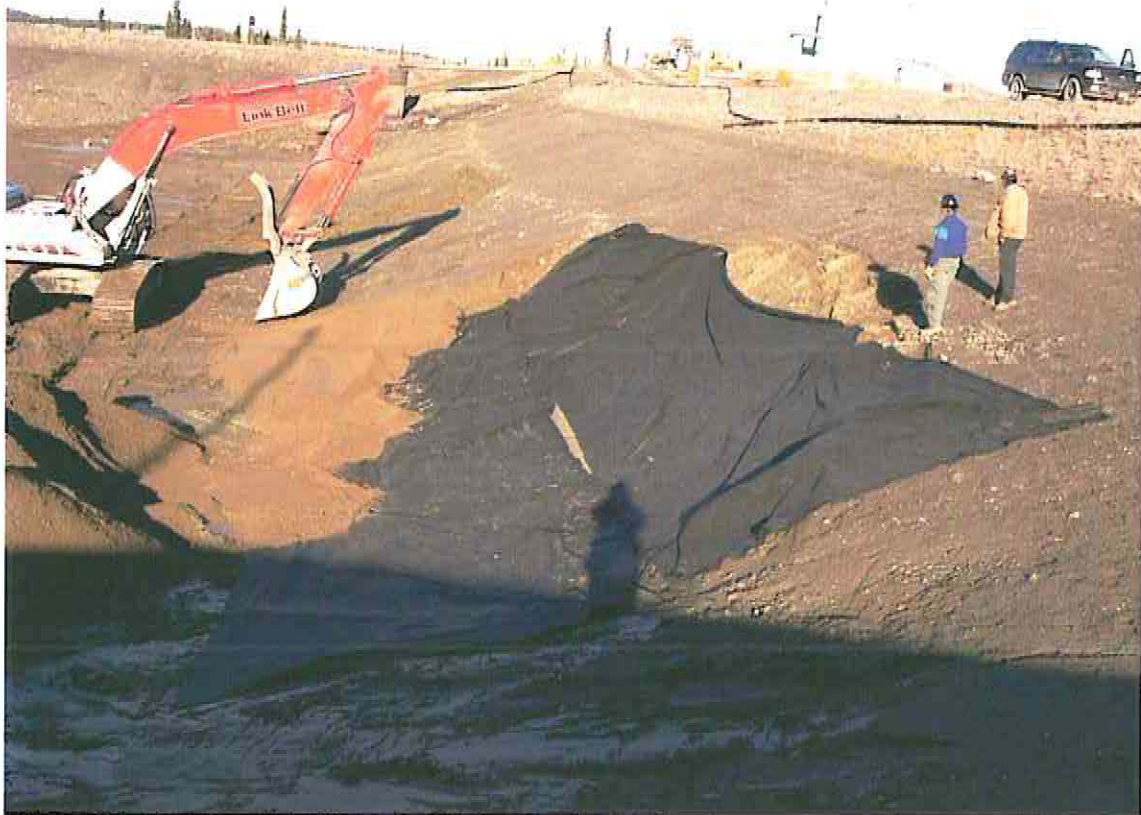
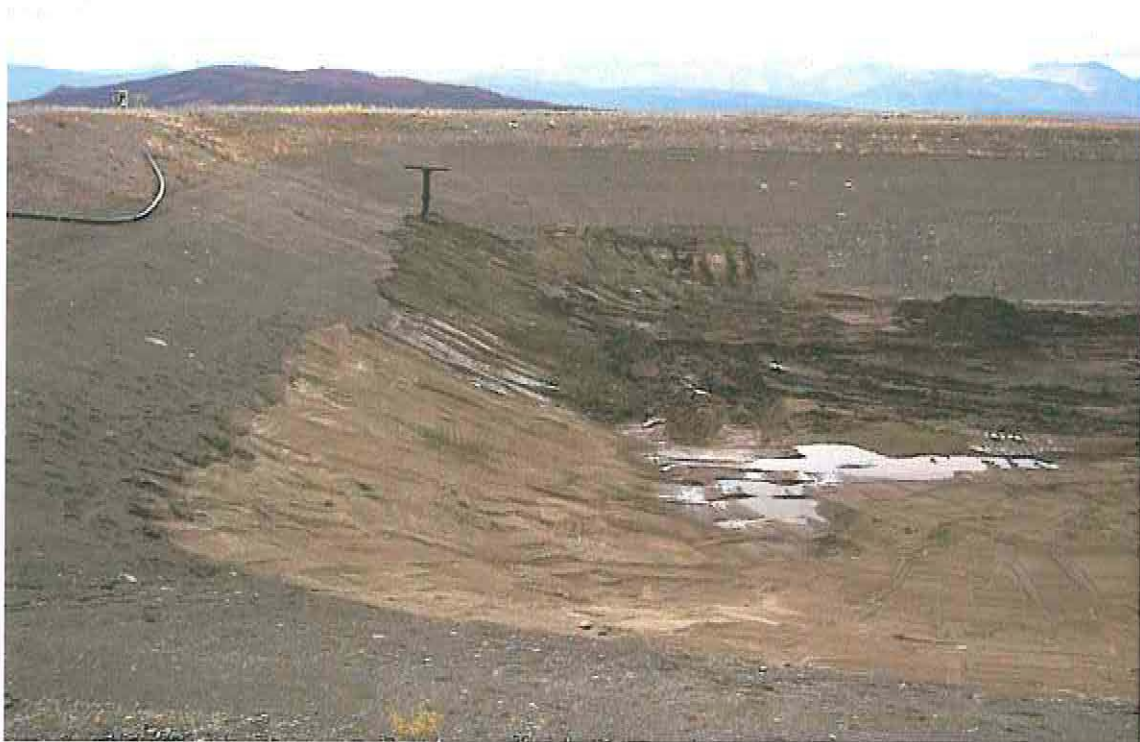
Photo 28: Repair to subsidence in Sludge Pond at Vangorda

Photo 29: Repair to subsidence in Sludge Pond at Vangorda

Photo 30: Completed remediation to subsidence in Sludge Pond at Vangorda

- Ensure that the pond level does not exceed 2m. below crest;
- Continue to monitor on a monthly basis, the crest and sideslopes for cracking or any signs of sloughing;
- Repair the subsidence by excavating out the loose material, placing geotextile filter fabric over the exposed material and placing compacted granular fill over the filter fabric. SRK understands that DTI completed this work in September 2007 (See Photos 28, 29 and 30).

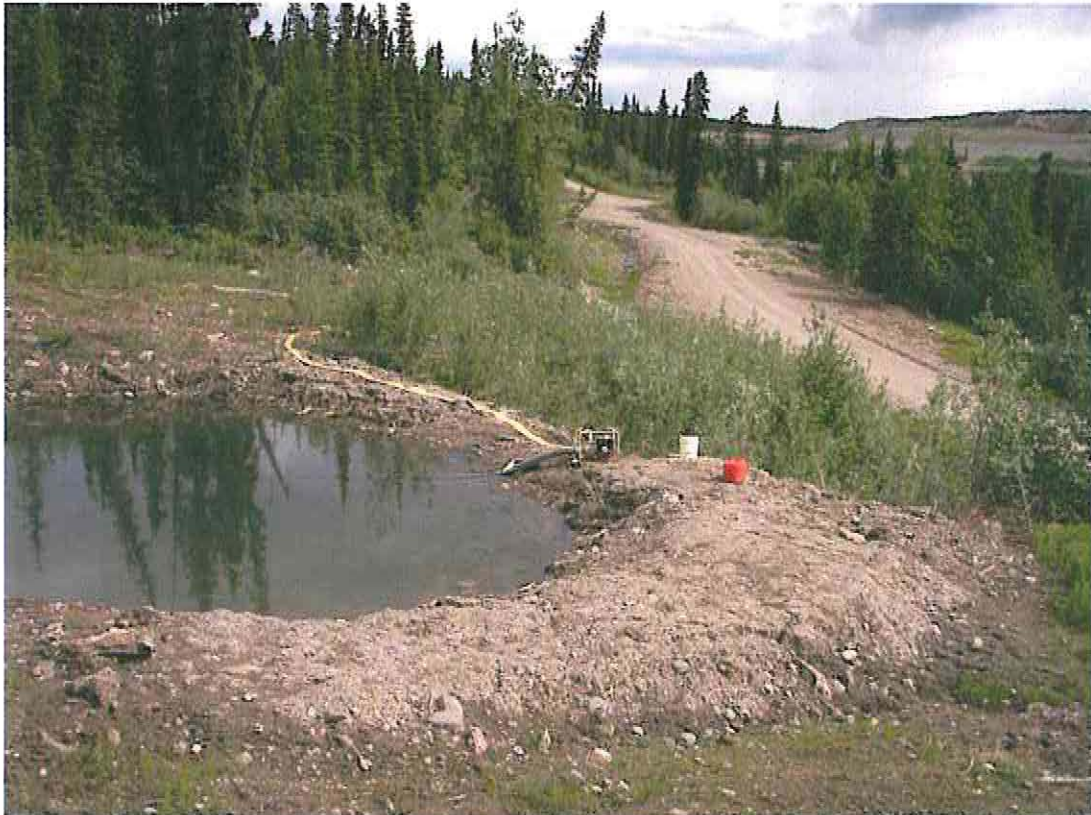
As shown on Photo 1, DT has built a soil berm around the southern perimeter of the pond to restrict outflow to V2. A small gas powered pump has been installed in the pond to periodically divert the seepage to V2A via the existing ditch below the V-Notch weir on Grum Creek (Photo 2). It was also noted that a small ditch located below the groundwater wells (SRK 04-5A/B and 05-5C) collects seepage from the catchment above the wells and directs the flow over to the existing Grum Creek ditch below the weir (Photo 3). A survey completed by DT on Wednesday June 20, 2007 confirmed that there is sufficient grade for the proposed ditch.

Photo 1: V-15 Sedimentation Pond looking east towards location of V-notch weir on Grum Creek.
