## 2008 Annual Inspection Waste and Water Management Facilities Vangorda Mine, Yukon Territory

*Project Reference Number  
SRK 1CD003.111*

*January 2009*

**Prepared by  
Peter Healey, P.Eng.**

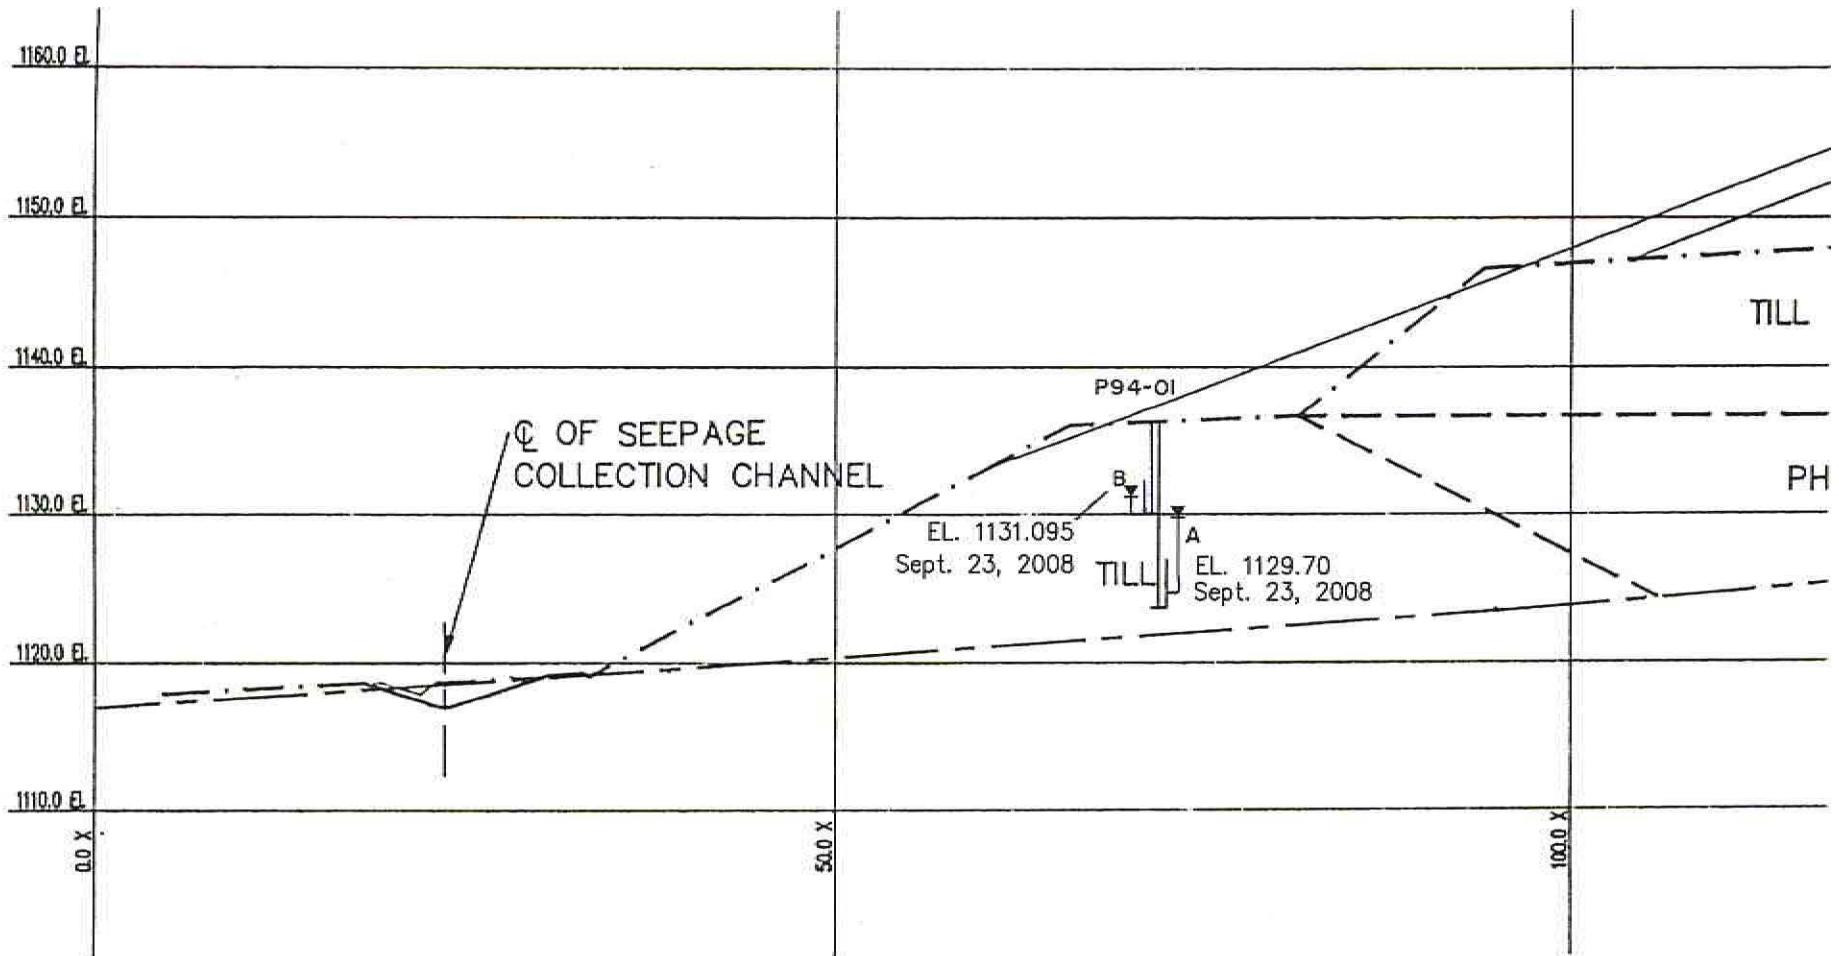
SECTION D-3  
CHANNEL STA. 4+80

In accordance with SRK's recommendations, DTI has been taking water level readings twice a year from the piezometers that were installed in the till starter Dyke in 1994. A summary of the water level readings taken to date in the piezometers are presented in Table 1. Water levels, as recorded on September 23, 2008 in Piezometers P94-01A, 01B, 02A and 02B, are shown in Figures 4 and 5.

The levels in these piezometers show increases varying from 1 to 4m. This rise in the water table is consistent with the wet spots observed on the till dyke slopes.

More frequent monitoring of the 1994 Piezometers along the crest of the till dyke are recommended to establish whether there is a trend or pattern in the rising water table behind the dyke. Results should be forwarded to SRK.

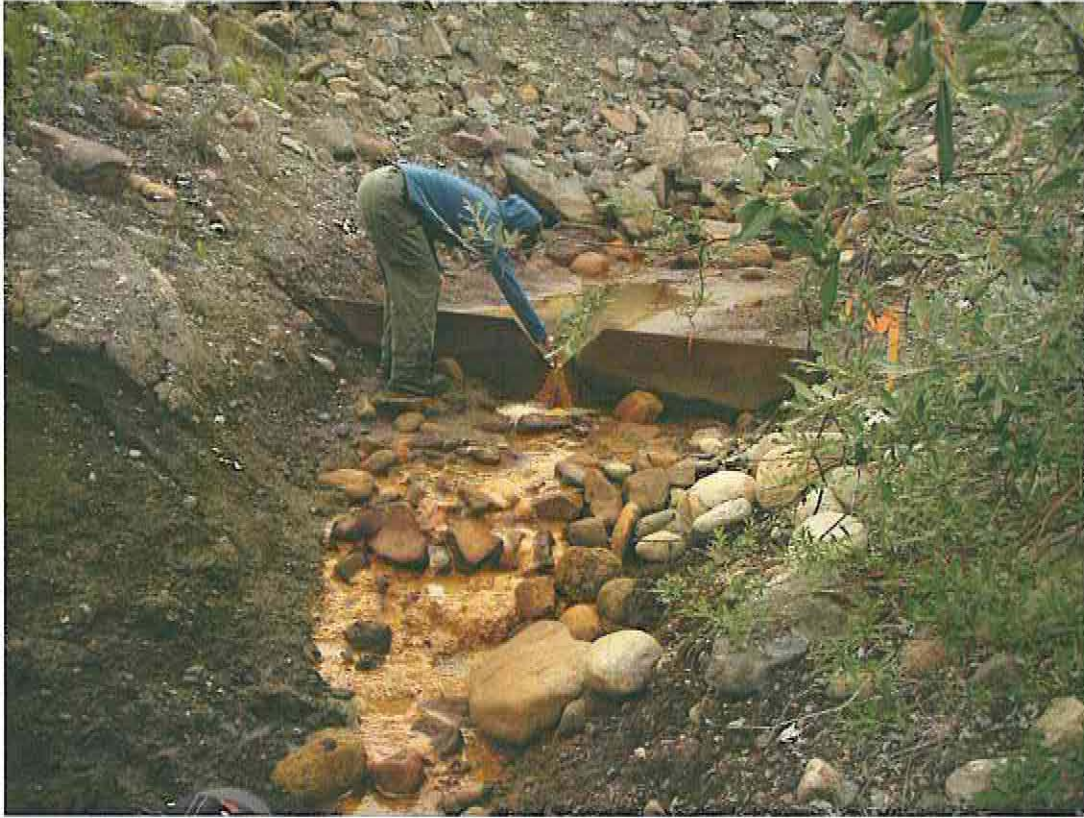
Photo 1: Vangorda Waste Dump, Weir #6

During this year's inspection, seepage flow was observed at Weir #6 (Photo 1), Weir #5 (Photo 2), Weir #3 (Photo 3), Drain #4 (Photo 4) and Weir #2 (Photo 7). The flow in each of these drains varied from a trace to about 0.5L/min.

The drains should be inspected monthly for any signs of instability around the outlets and deterioration of the steel v-notch weirs. The inspection should include recording of any flow or seepage.

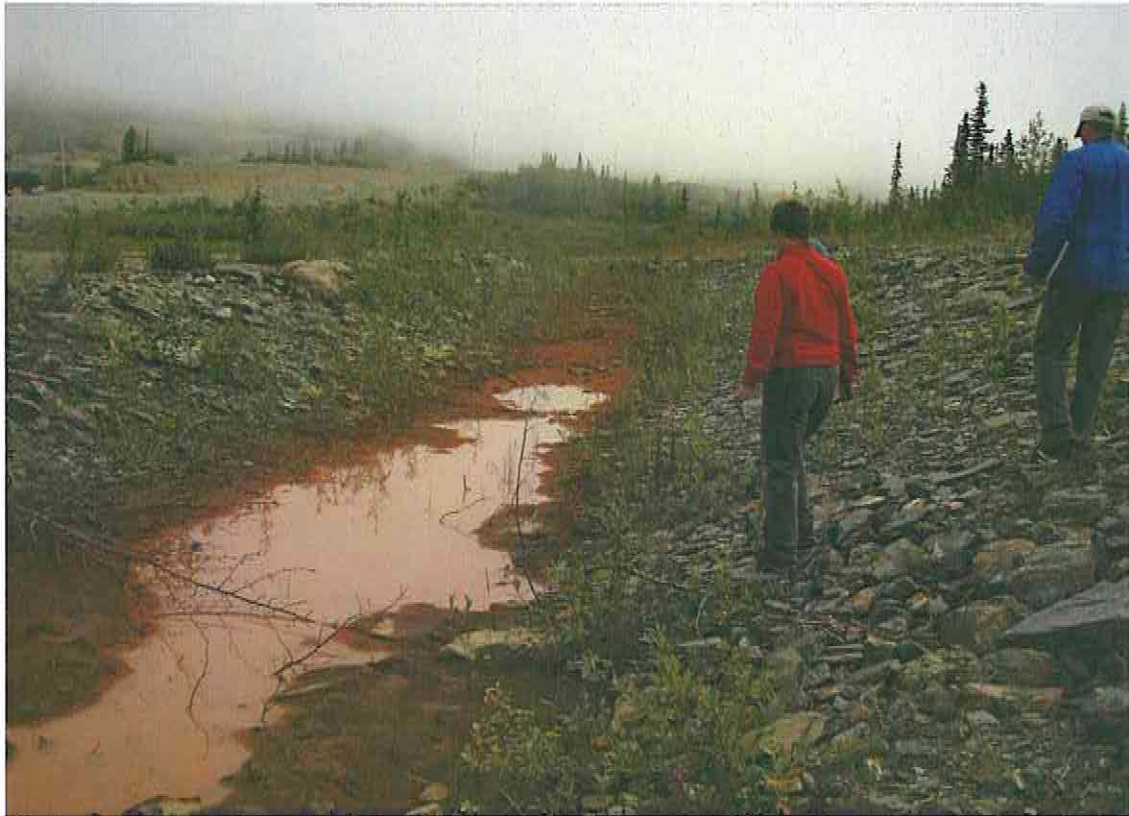
As seen in the photo 5, seepage in the Vangorda seepage collection channel around the Waste dump tends to pond in places along the channel. While it is recognized that the gradient of the channel is very flat because of grade constraints, it appears that the HDPE culvert that was installed several years ago to permit vehicles to cross the channel (see the background in photo 5) is blocking the flow to Little Creek Pond.

Photo 5: Seepage Collection Channel along toe of Vangorda Waste Dump

SRK understands that DTI removed the HDPE culvert along the toe of the dump in the fall of 2008 after the inspection and regraded the bottom of the channel to permit any ponded water to escape to the Little Creek Pond.

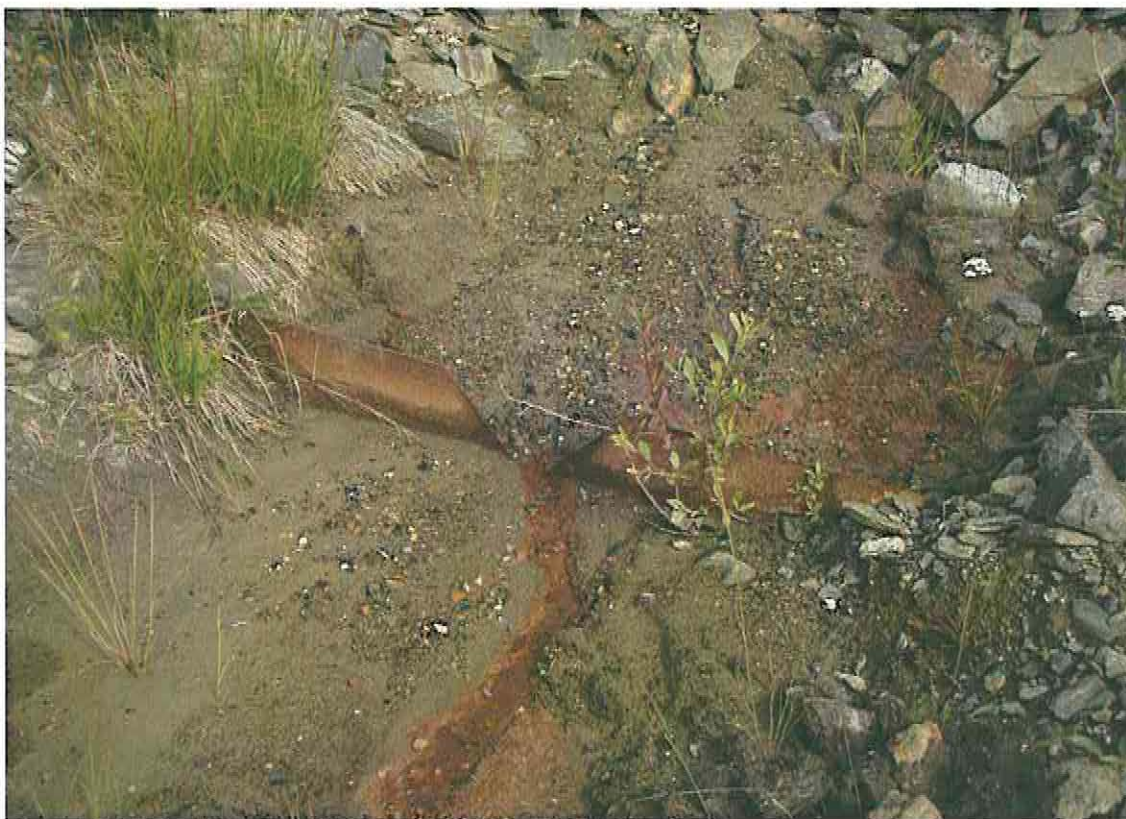
Photo 7: Drain #2 at toe of Vangorda Waste Rock Dump

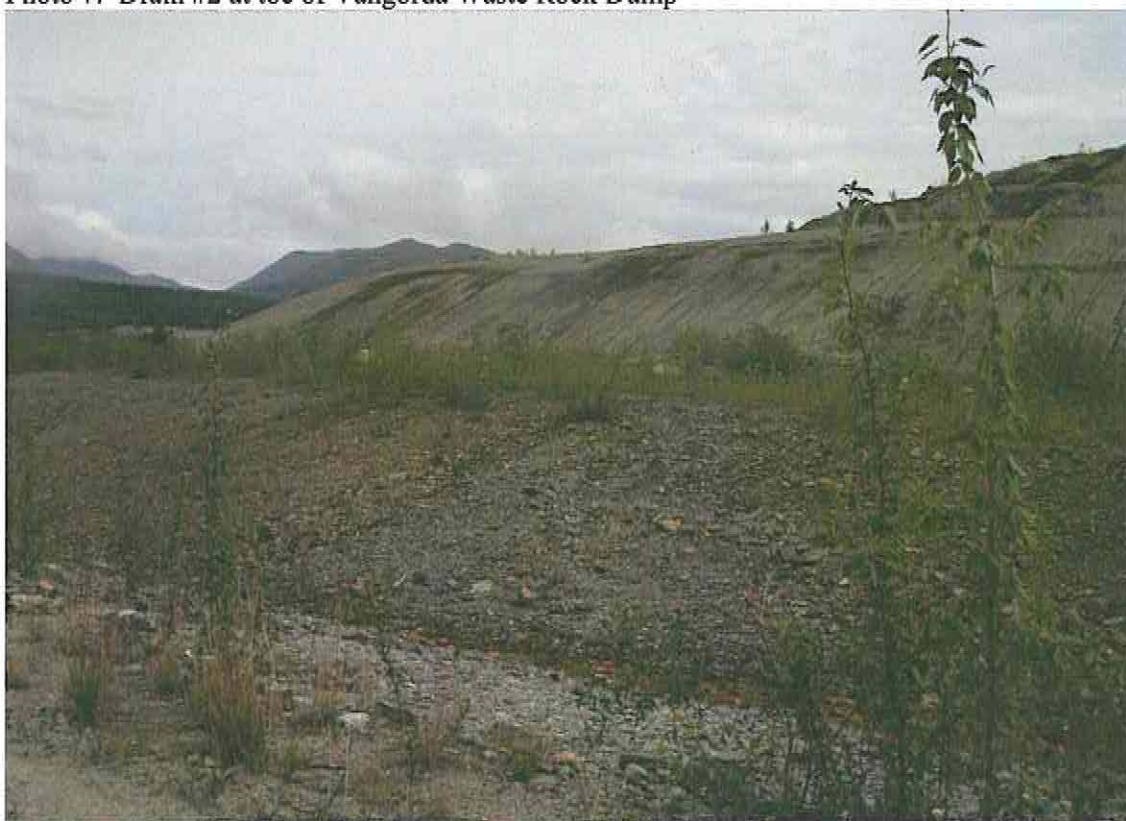
In 2006, DTI resloped sections of the till dyke at the western end of the waste rock dump. A small shallow subsidence was observed on the sideslope of these resloped areas as shown on Photo 8. Furthermore, wet spots were also noted in a number of areas at the crest of the dyke. It is believed the wet spots and the shallow subsidence are the result of an elevated water table within the waste rock behind the dyke.

Photo 8: Wetspots and a shallow subsidence on the resloped surface of the Till Starter Dyke at the Vangorda Waste Dump

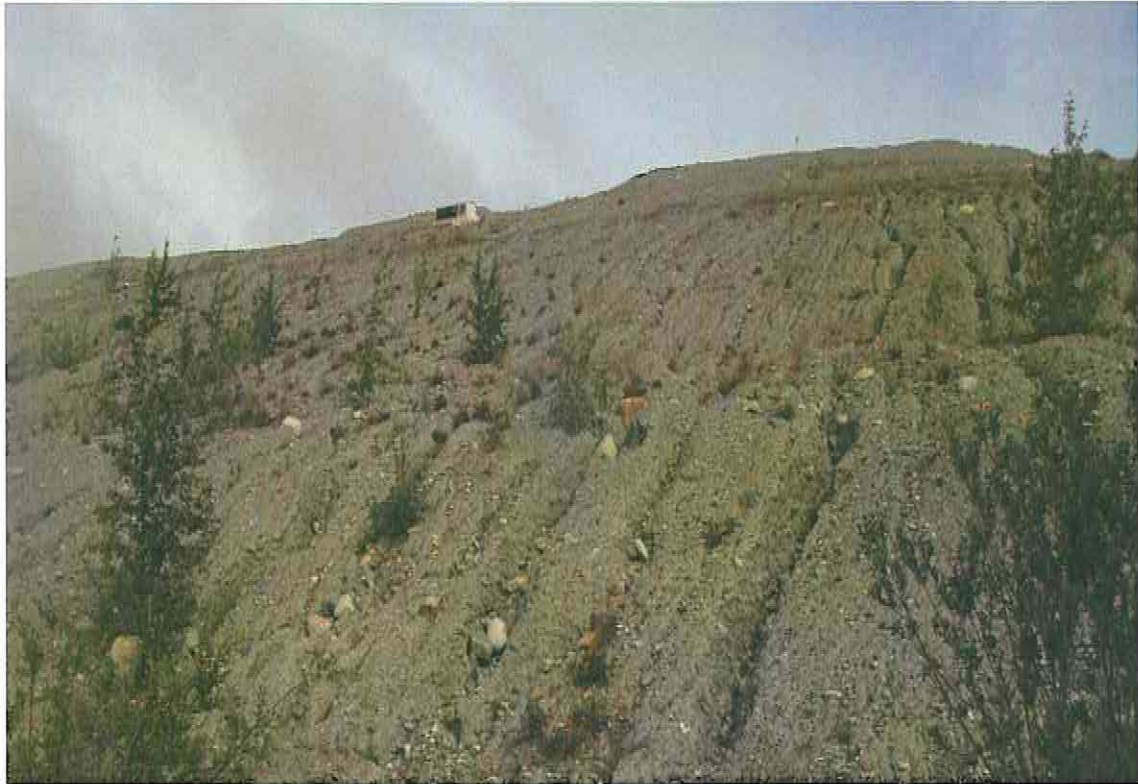
The remaining unresloped sideslopes of the till dykes around the perimeter of the dump continue to experience some erosion (Photo 9). However, there are no signs of major instability. DTI continues to maintain the integrity of the upper reaches of the ditch by regular removal of sediment both above and within the channel.

Photo 9: Erosion Gullies in the till cover on Vangorda Dump

In the upper reaches of the seepage collection channel at the location of the till cover, DTI should continue to monitor any sediment build-up and periodically remove the sediment that accumulates in the channel.

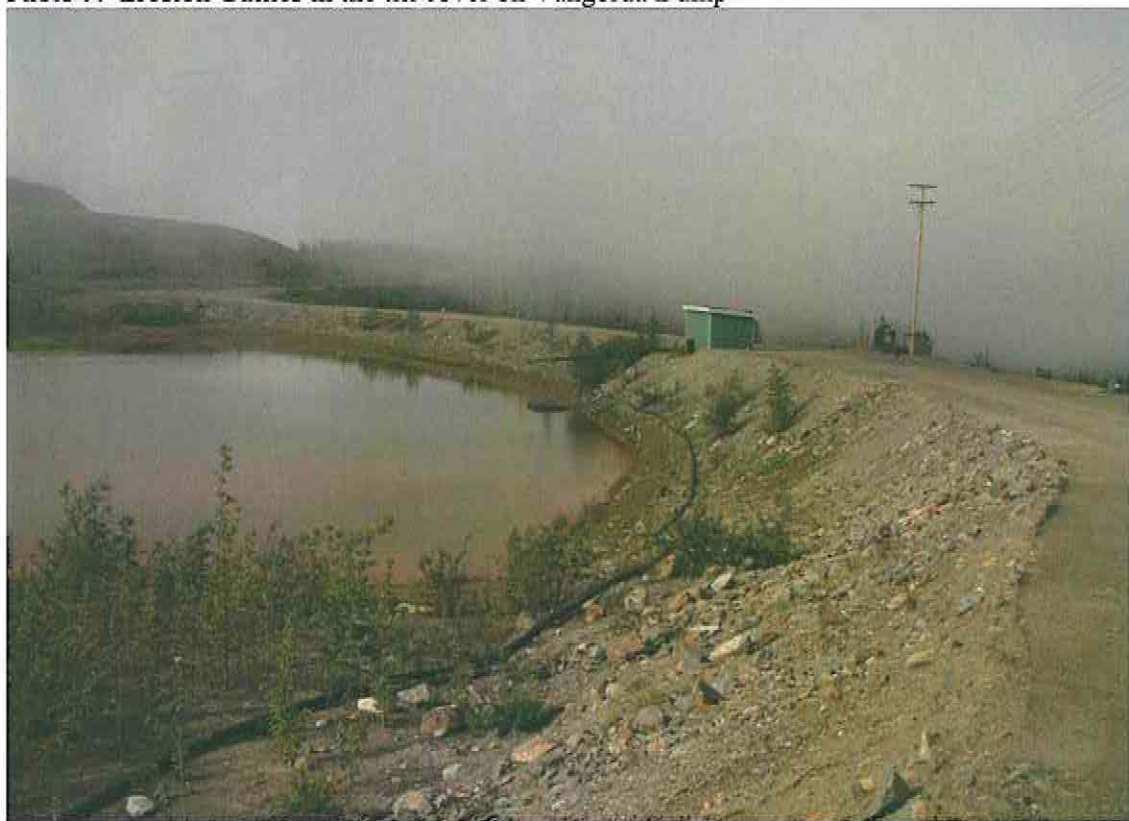
Photo 10: Little Creek Pond Dam

Water level in the pond (Photo 10) during our inspection on August 6, 2008 was recorded at about 1110m. No cracks or major settlement of the dam were observed and no seepage was observed along the downstream toe. Erosion rills are evident on both the upstream and downstream slopes of the dam (Photo 11).

DTI should continue to regularly monitor the crest of the dam for any cracks, settlement or surficial movement of the slope.

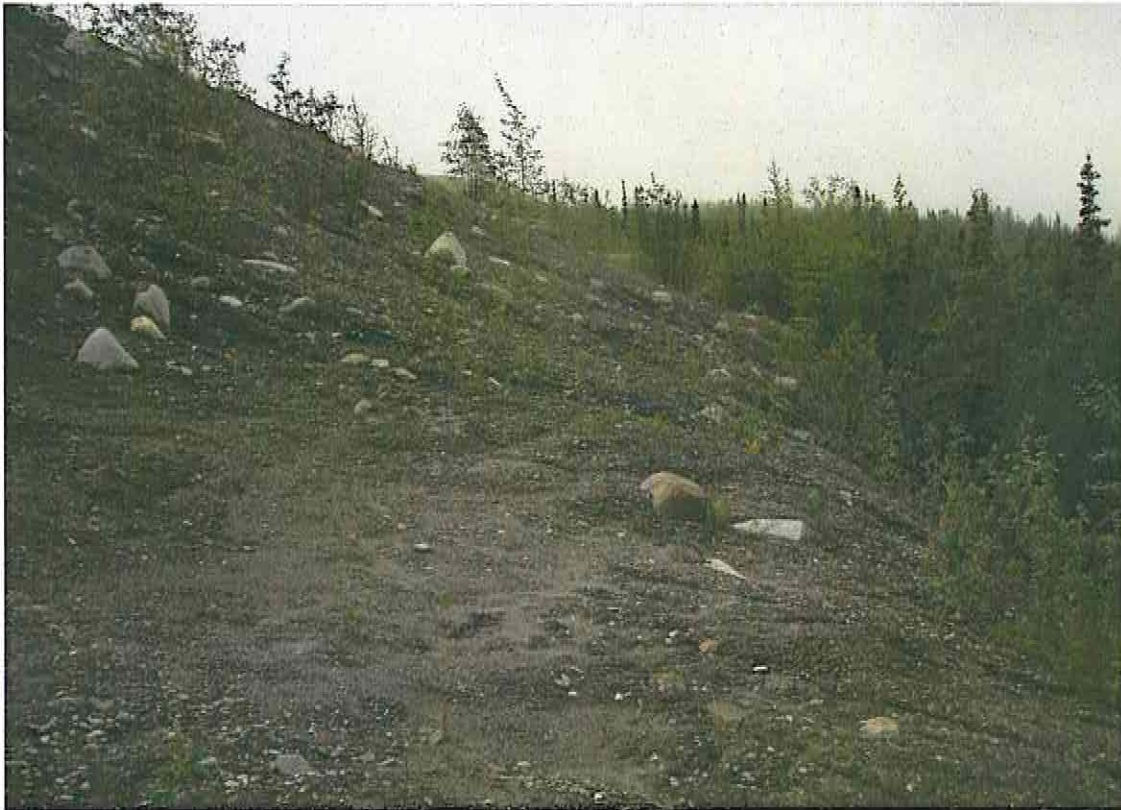
Photo 11: Erosion gullies on downstream slope of LCD

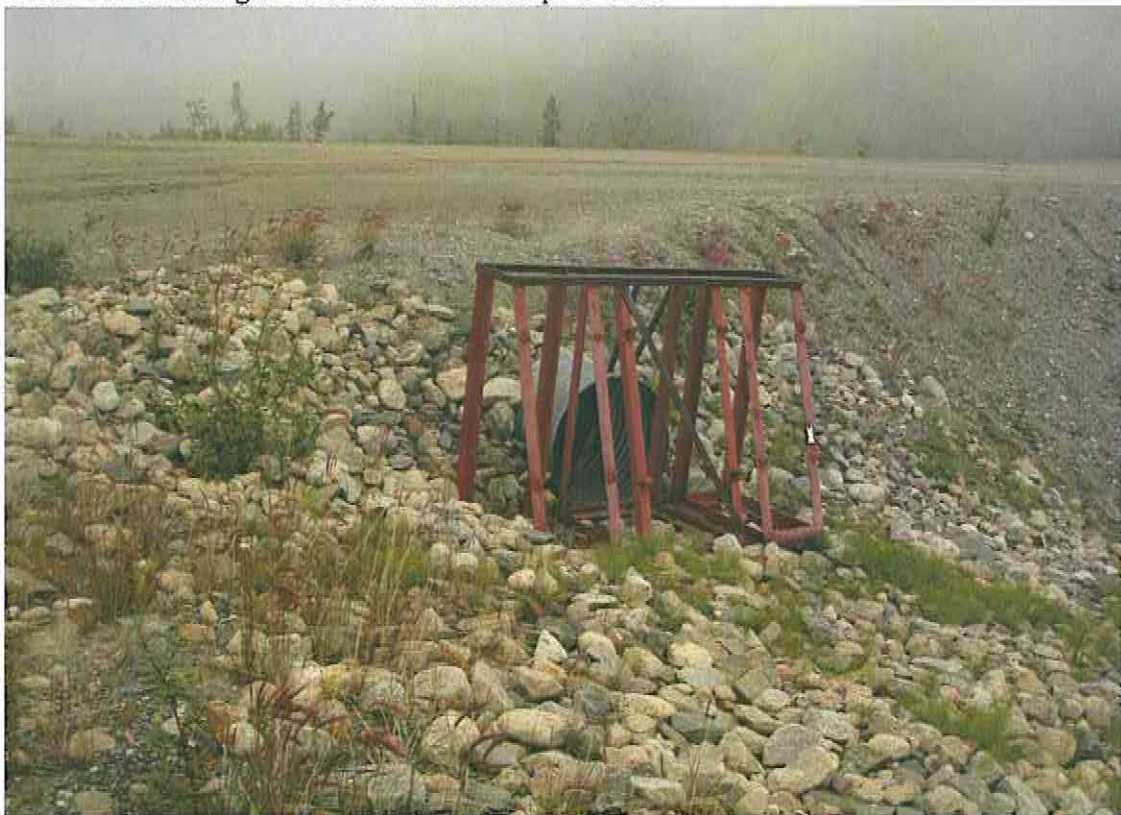
Photo 12: Emergency culvert (inlet) at Little Creek Pond

The 900mm CMP emergency spillway (Photo 12) was inspected and is in good condition.

DTI should also continue to remove any build-up of debris at the inlet end of the culvert spillway.

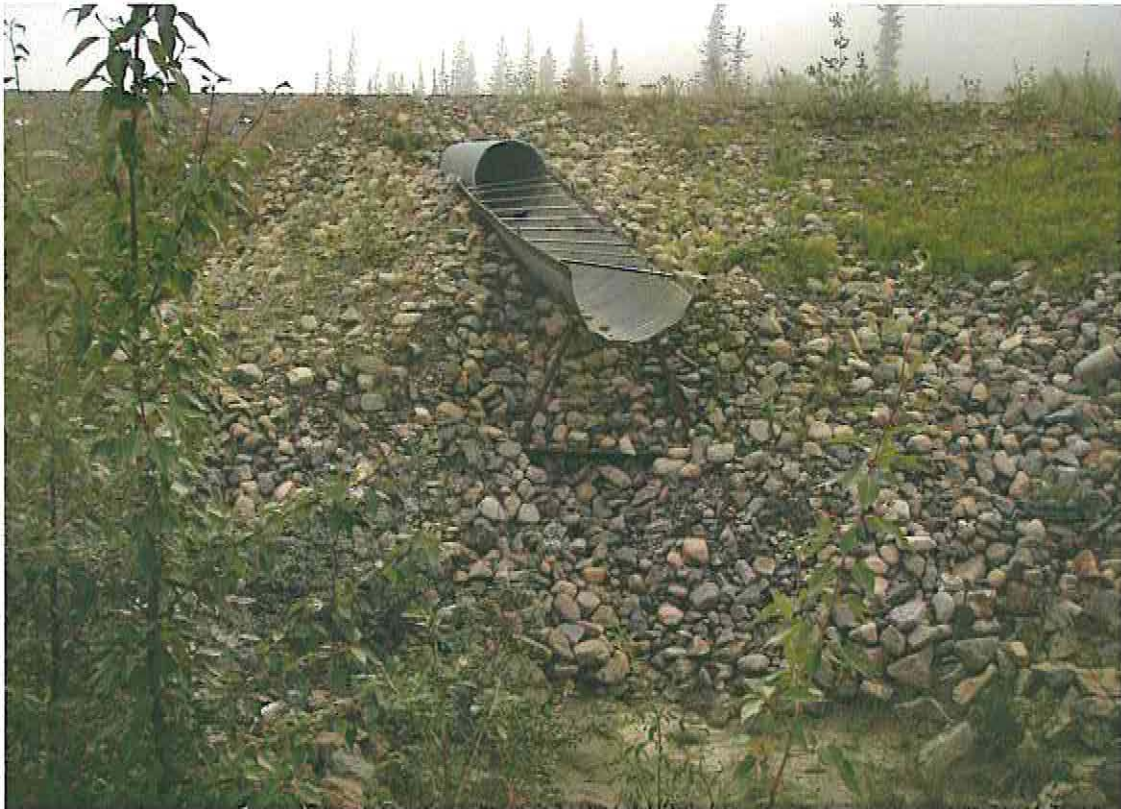
Photo 13: Outlet to plunge pool of emergency spillway at Little Creek Pond

The culvert plunge pool and outlet are shown on Photo 13.

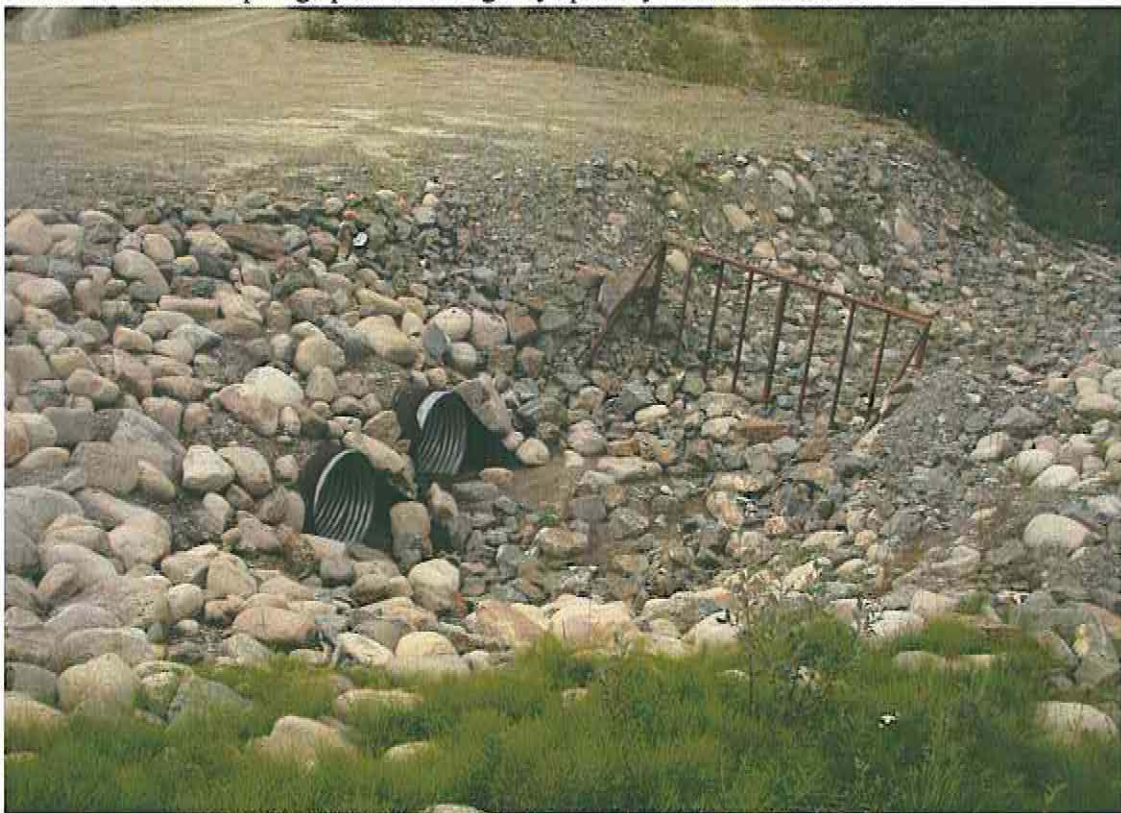
Photo 14: Emergency Spillway at the headworks of Vangorda Creek Diversion

In accordance with a recommendation from SRK, an emergency overflow spillway (2x1m diameter CSP's) was installed at the headworks of the diversion in August 2005 (Photo 14). DTI continues to maintain the 2.4m diameter flume to ensure safe passage of flow in Vangorda Creek. Boulders that fall into the flume (Photo 15) are periodically removed. There are no signs of instability or settlement of the embankment at the headworks of the diversion. However, the cross braces that support the flume continue to deteriorate and water continues to escape through cracks in the flume.

DTI should continue to monitor the sideslopes above the flume for sloughing and areas of instability and should top-up riprap along the flume where the material has settled below the rim of the culvert sections. Any debris or rocks that accumulate in the flume, at the entrance to the 2m CMP or at the headwork's trashrack should be removed. SRK should be notified of any excessive seepage from the flume and increase of discharge into the pit. If any damage to the cross braces and if the structural integrity of any of the flume sections is compromised by ice formation or slides, DTI should replace the impacted sections.

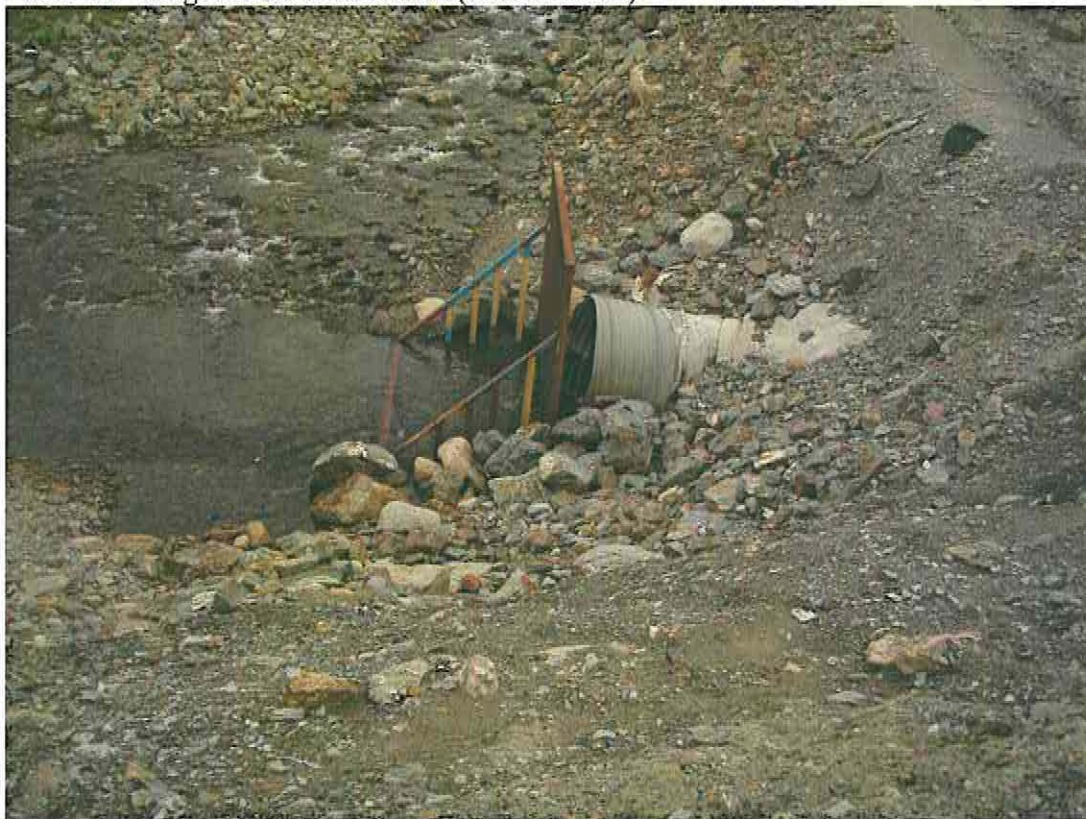
Photo 16: Inlet to the 2m dia CMP at the Vangorda Creek diversion plunge pool

The 2m diameter CMP culvert in the plunge pool shows signs of wear and tear around the entrance to the pipe (Photo 16). A trash rack has been installed at the entrance.

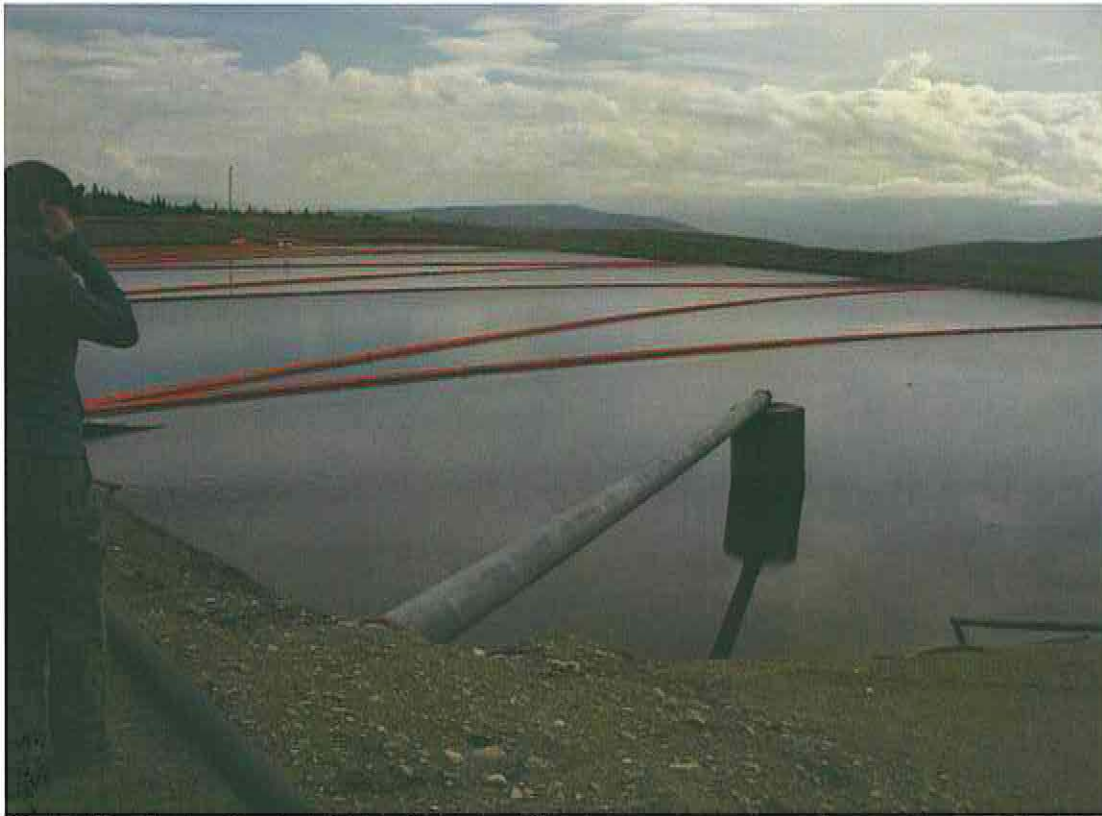
Photo 17: Sludge Pond at Water Treatment Plant

At the time of our inspection, the sludge pond was full (Photo 17). SRK inspected the downstream slopes and crests of the four embankments that make up the sludge pond. Neither subsidence of the slopes, nor settlement of the crest and no tension cracks were observed (Photo 18 and 19).

- Ensure that the pond level does not exceed 2m. below crest; and
- Continue to monitor on a monthly basis, the crest and sideslopes for cracking or any signs of sloughing

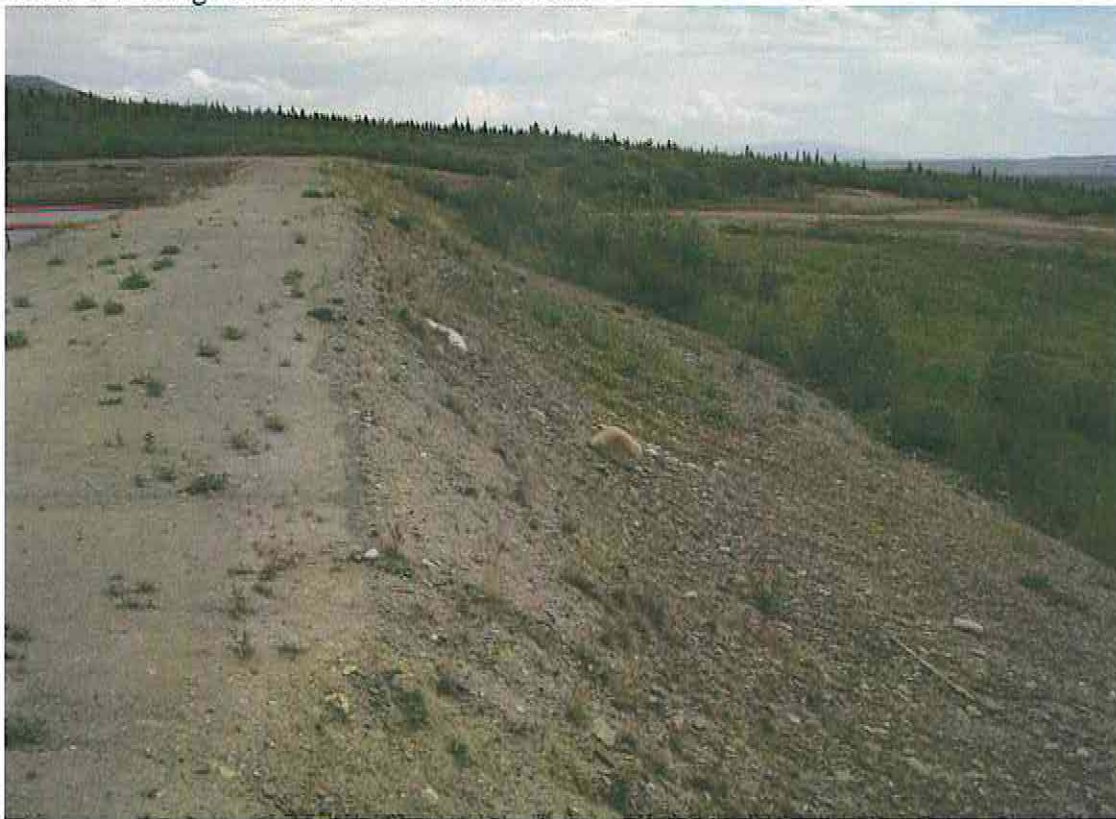
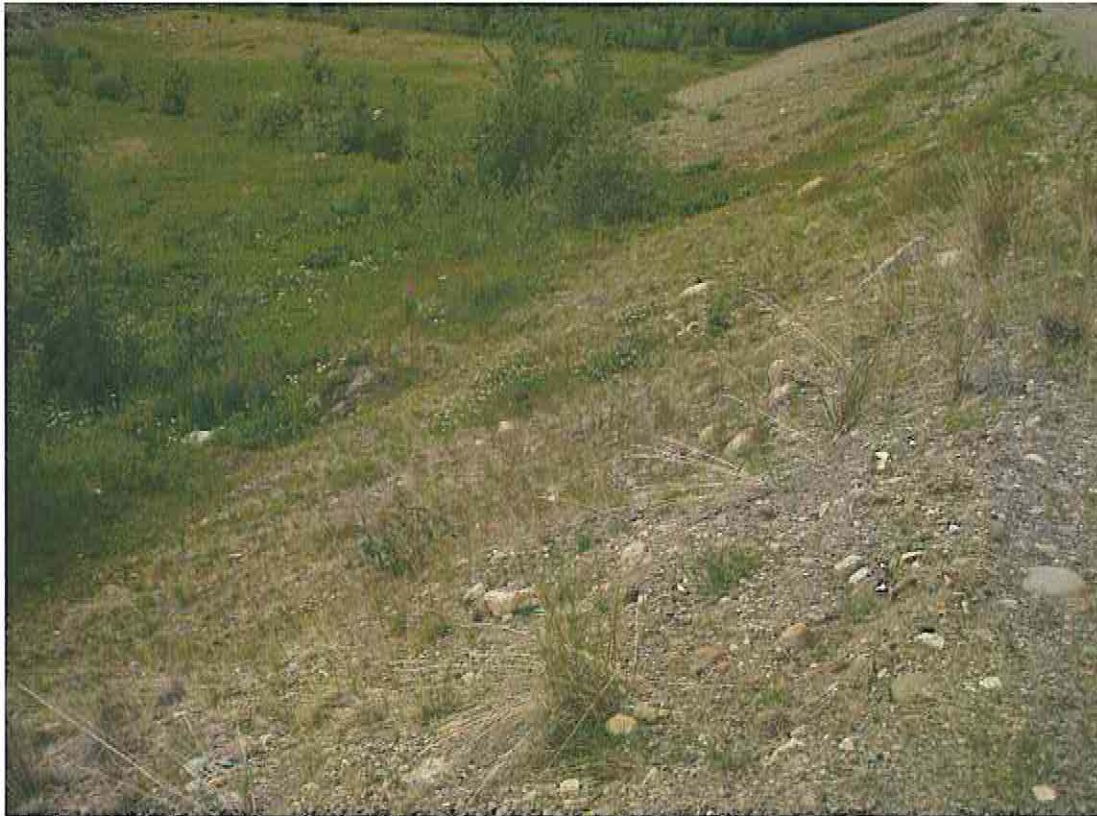
Photo 18: Till Embankment around the Sludge Pond

Photo 19: Downstream slope of the dyke around the Sludge Pond

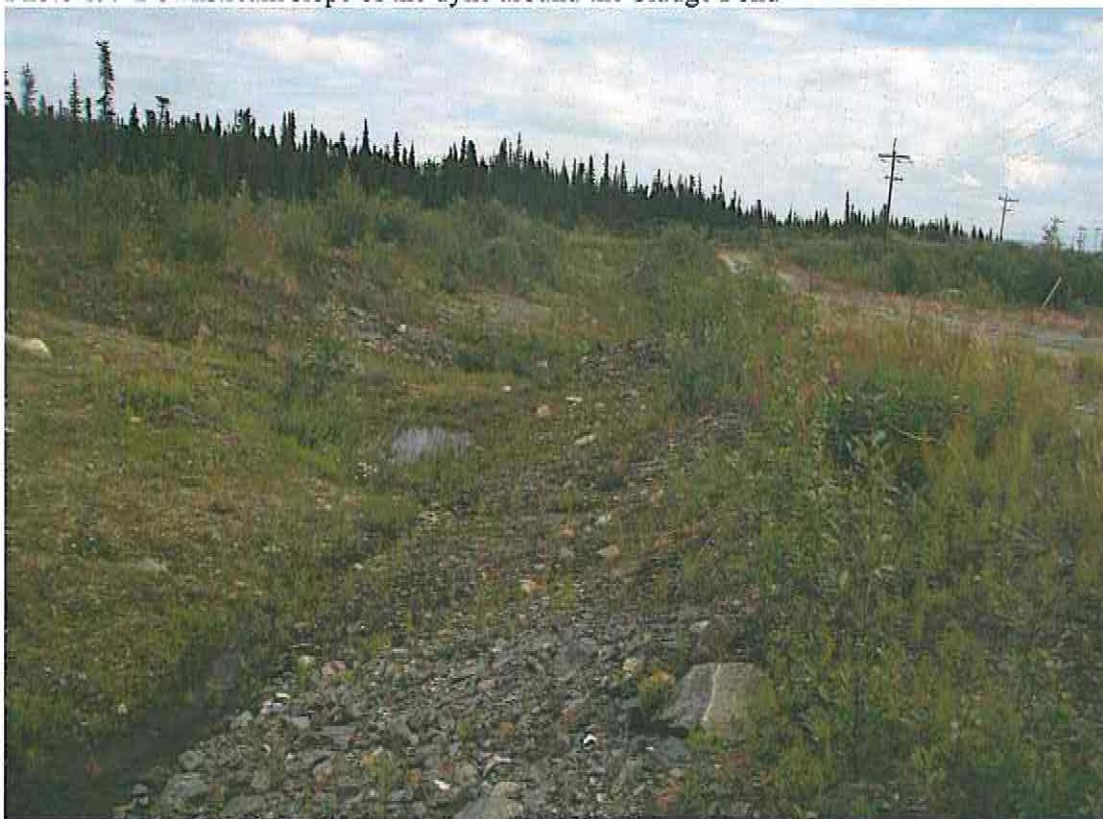
Photo 20: Grum Interceptor Ditch

In the upper reaches of the GID, the ditch slopes remain stable and the vegetation continues to provide effective erosion control of the ditch sideslopes (Photo 20). However, debris and the odd boulder are beginning to partly block culvert outlets and entrances along the route (Photo 21).

- Monitor monthly the crest of the settling pond dykes for any cracks;
- Monitor monthly the toe of the dykes for any seeps; and
- Clear any debris that accumulates at either end of the GID culverts and the settling pond spillway. SRK understands that this was completed this year.

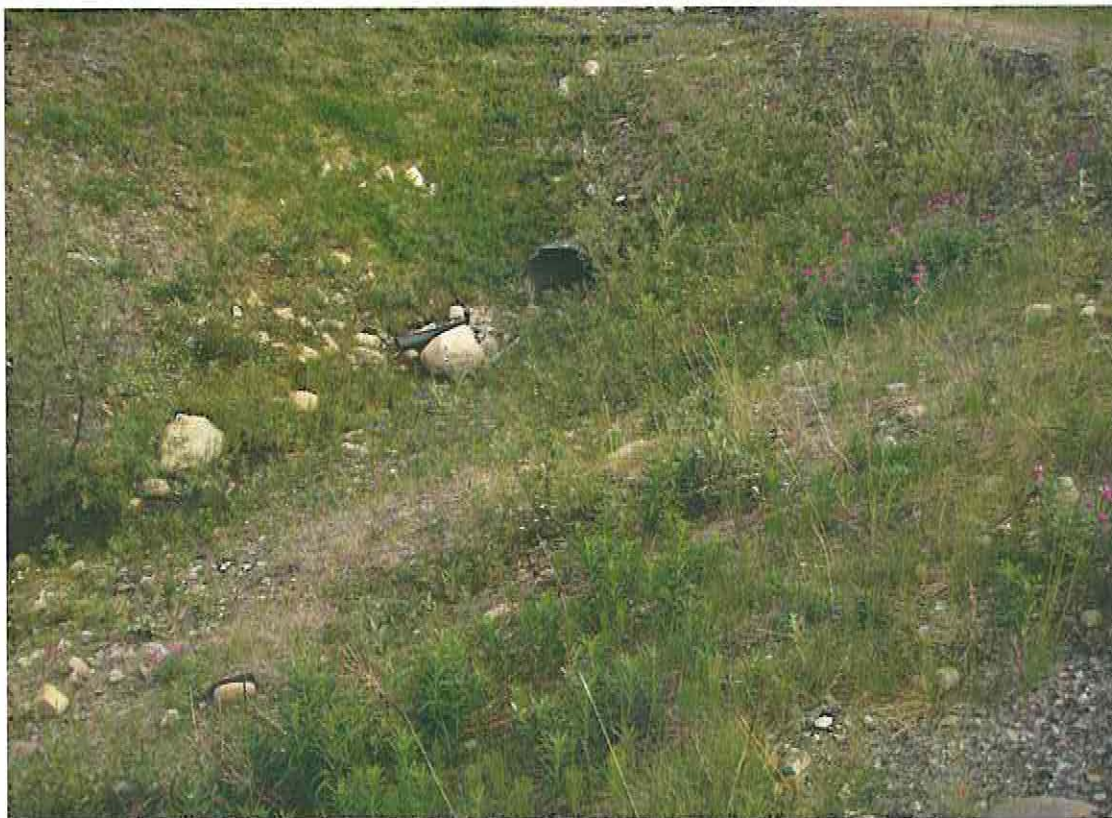
Photo 21: Debris accumulation at culvert entrances along Grum Interceptor Ditch

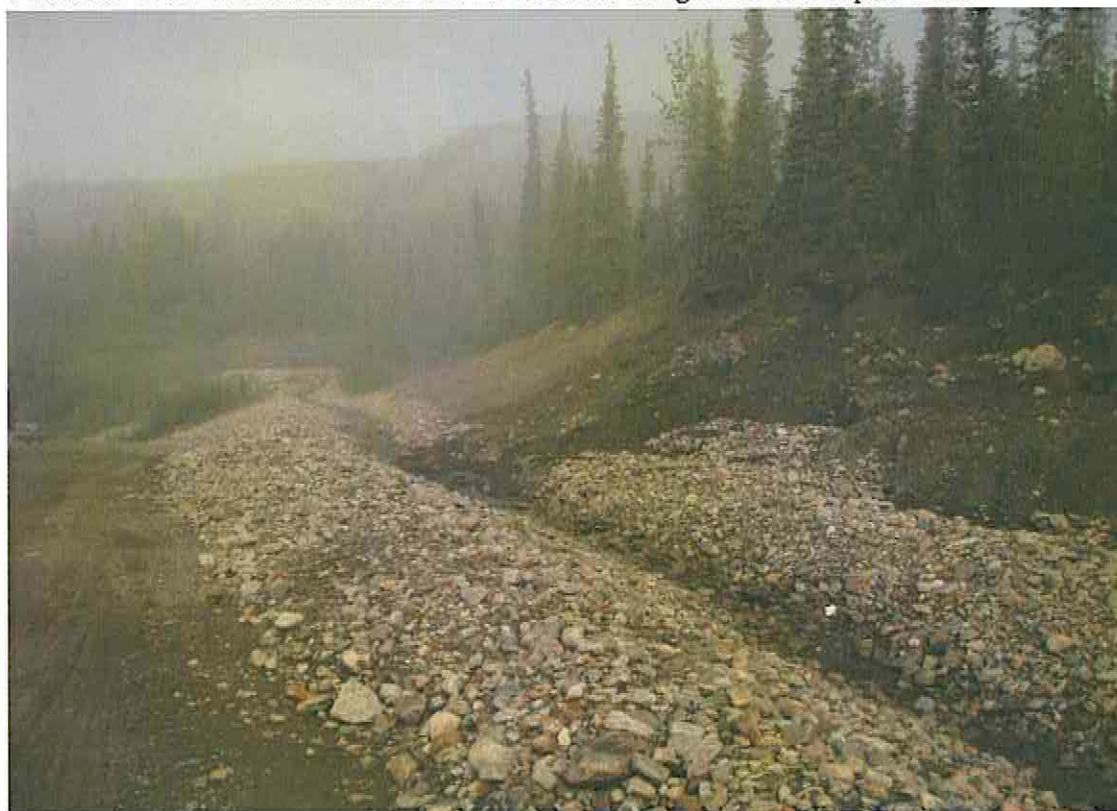
During the inspection of the ditch, a subsidence was observed on the upstream side of the channel (Photo 22). Material from the subsidence had sloughed over the erosion protected sideslope and entered the channel. The cause of the subsidence appears to be seepage from the hillside above. There was no indication of ice or permafrost.

Photo 22: Subsidence on the V-15 Seepage Interceptor ditch

As further soil movement is likely which may block the flow in the channel, SRK recommends that the sloughed material be removed from the channel and the subsidence area be stabilized. SRK recommends that the stabilization involve removal of all loose saturated material from the slope followed by the placement of a gravel/rock buttress. Geotextile filter fabric should be placed over the slope prior to placing the buttress material.

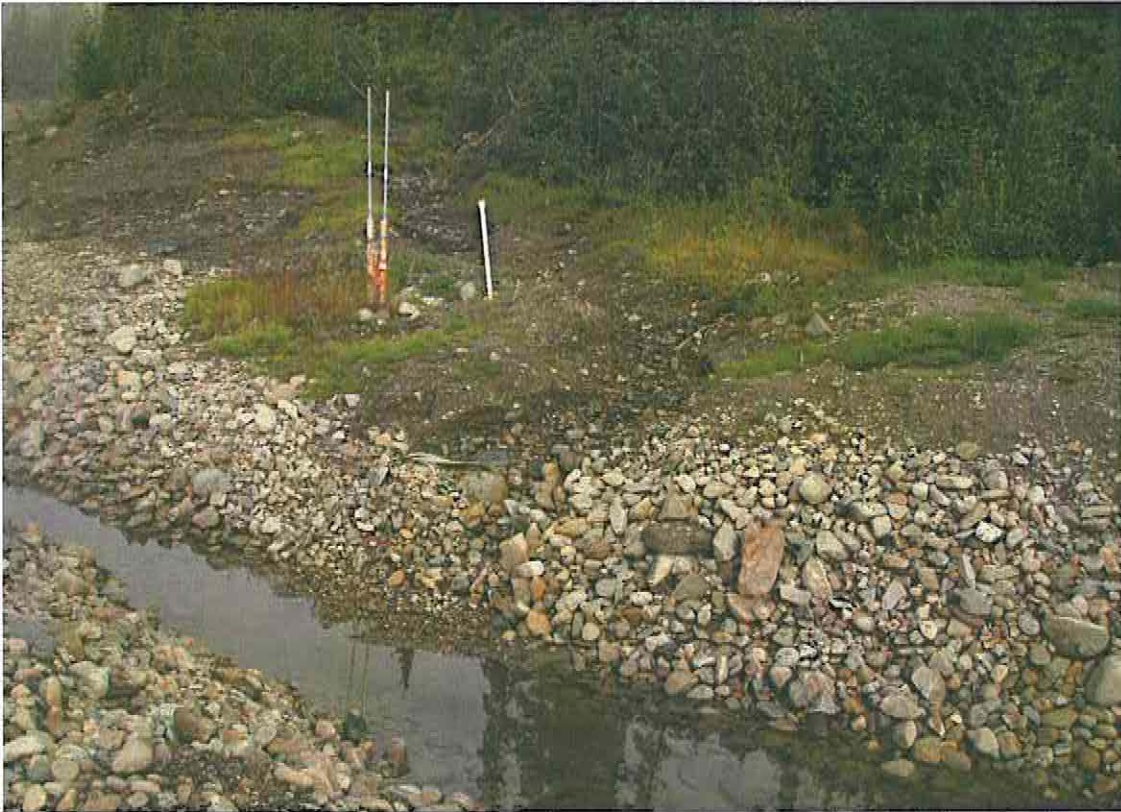
Further down the diversion channel there is a tributary ditch, which captures hillside seepage and discharges the flow into the V-15 diversion as shown in Photo 23. During the inspection it was noted that flow in the ditch has undermined the sideslope at the confluence point causing exposure of the Bentomat clay liner.

Photo 23: Seepage discharge into V-15 diversion

SRK also recommends that where the flow has been undermining the Bentomat liner, the later be extended back up the tributary channel and protected with gravel or rock.
