Denison
Environmental
Services

2009 Annual Inspection Waste and Water Management Facilities Vangorda/Grum

Faro Mine Complex, Yukon

February 2010

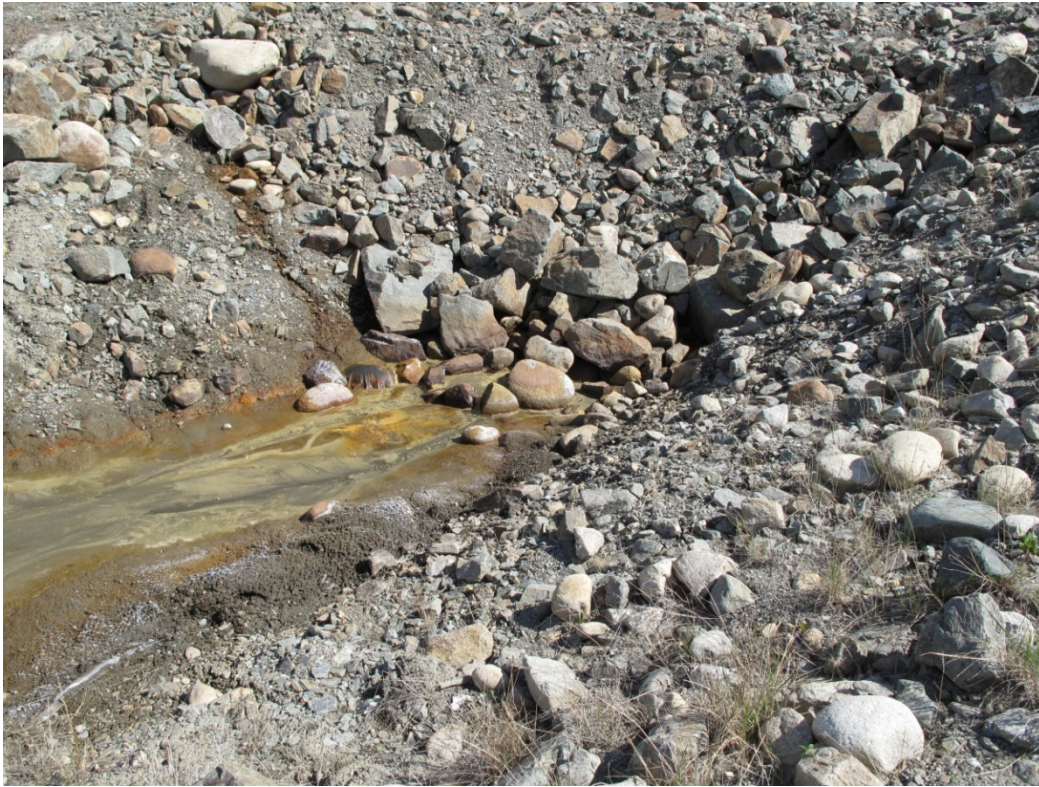
During this year's inspection, seepage flow was observed at Weir #6 (Photo 1), Weir #5 (Photo 2), Weir #3 (Photo 4), Drain #4 (Photo 3) and Weir #2 (Photo 5). The flow in each of these drains varied from a trace to about 0.5L/min.

Photo 1: Vangorda Waste Dump, Weir #6

The outlet of these drains should be inspected monthly for any signs of damage or deterioration of the steel v-notch weirs. The inspection should include recording of any flow or seepage rates.

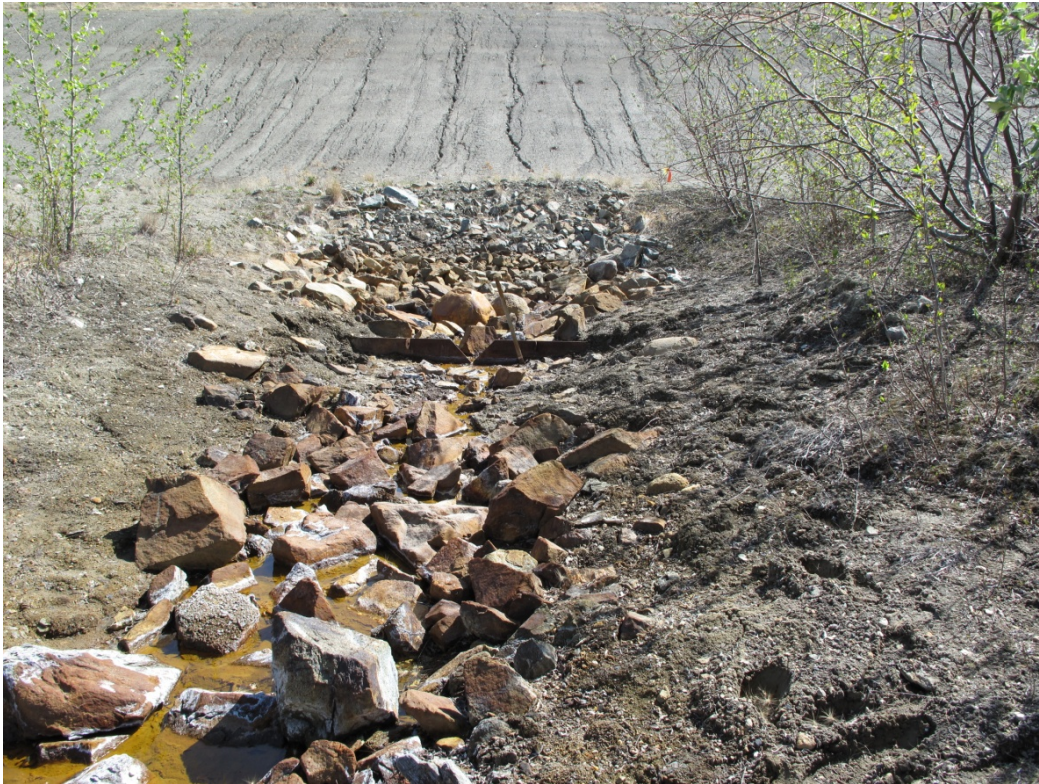
Photo 2: Vangorda Waste Dump, Weir #5

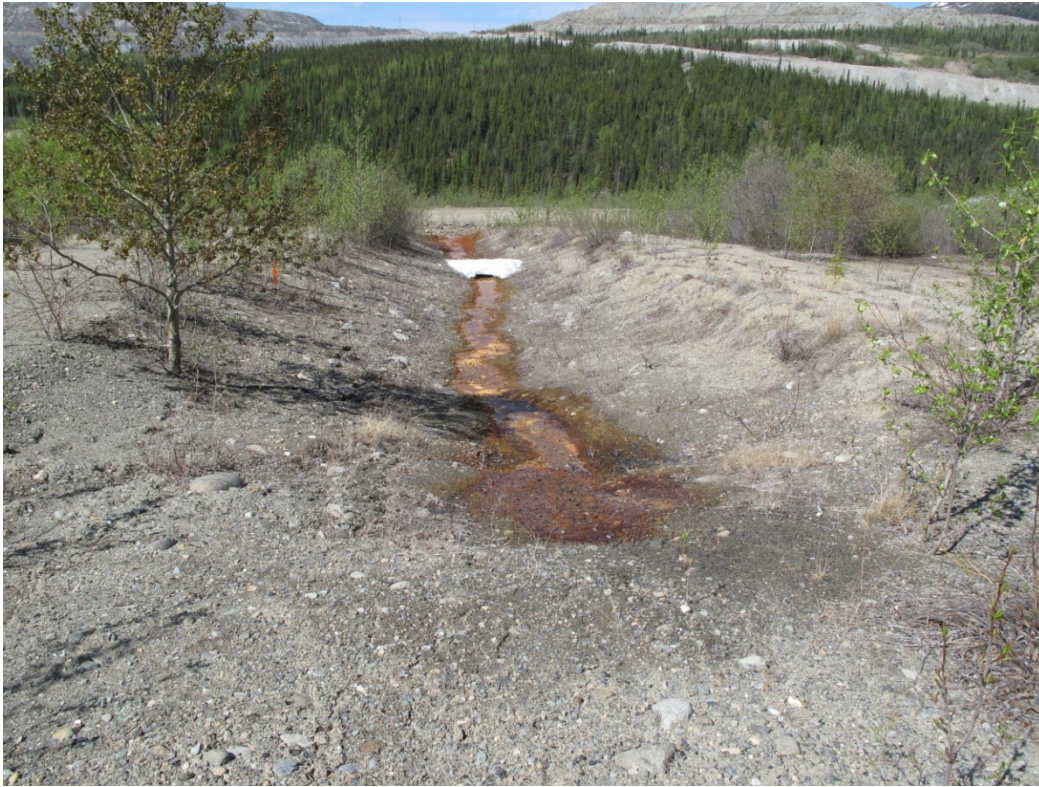
Photo 3: Vangorda Waste Dump, Weir #4

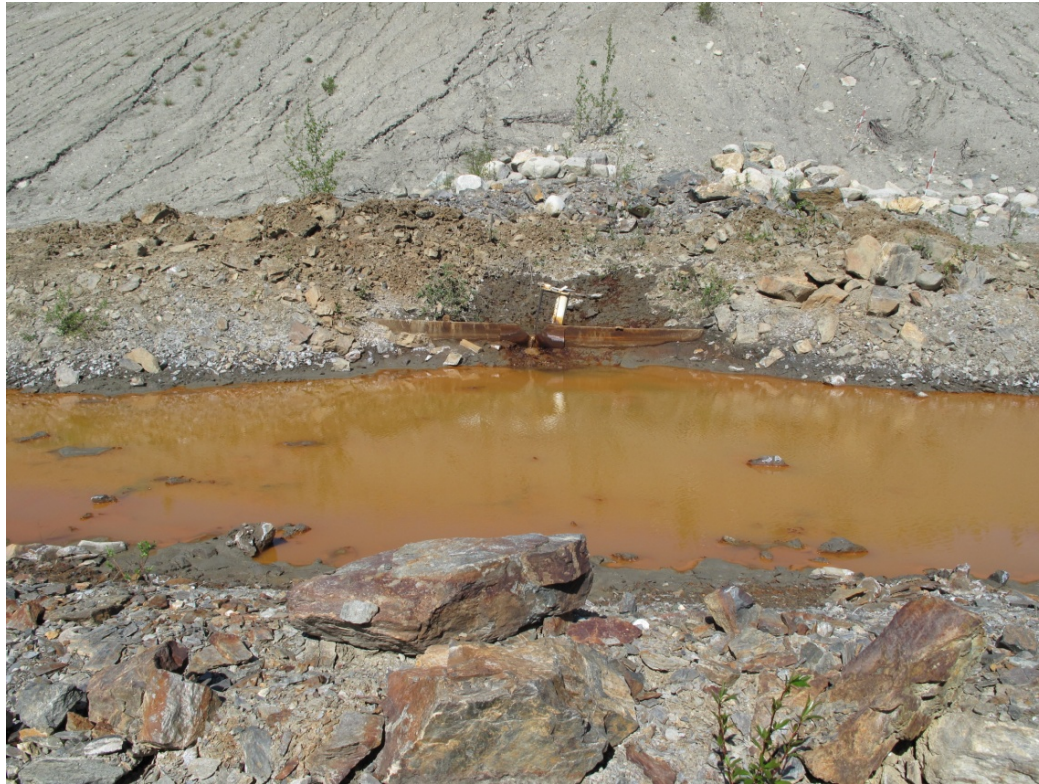
Photo 4: Vangorda Waste Dump, Weir #3

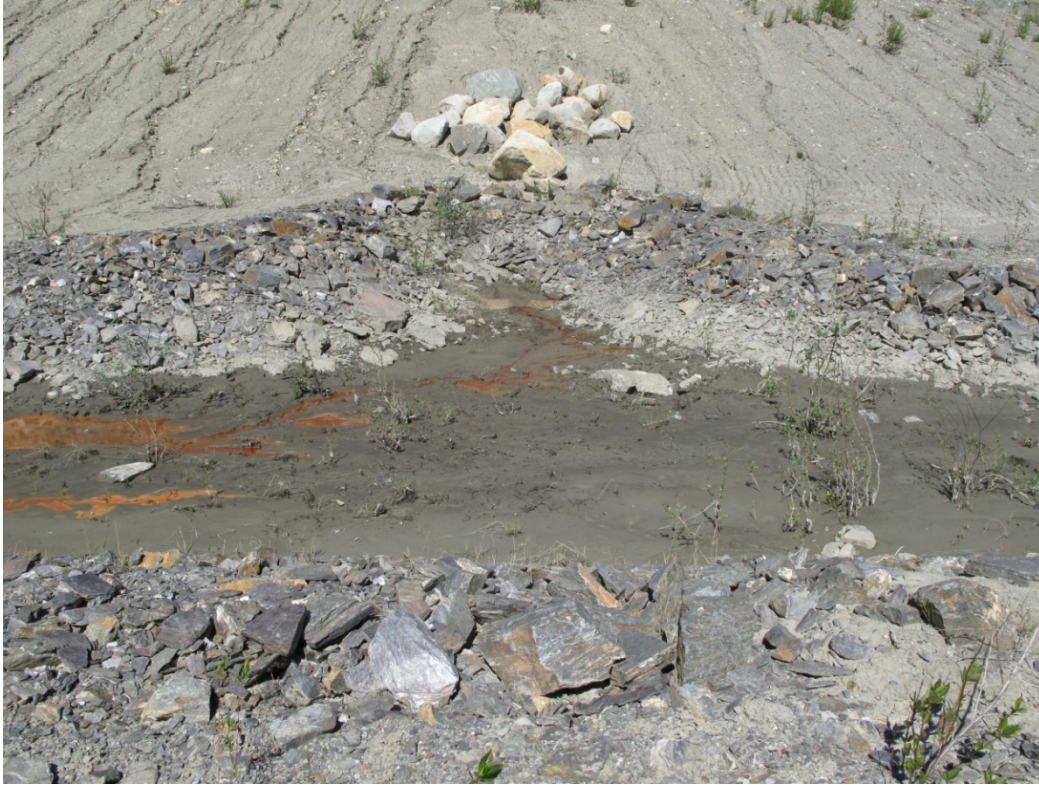
Photo 5: Vangorda Waste Dump, Weir #2

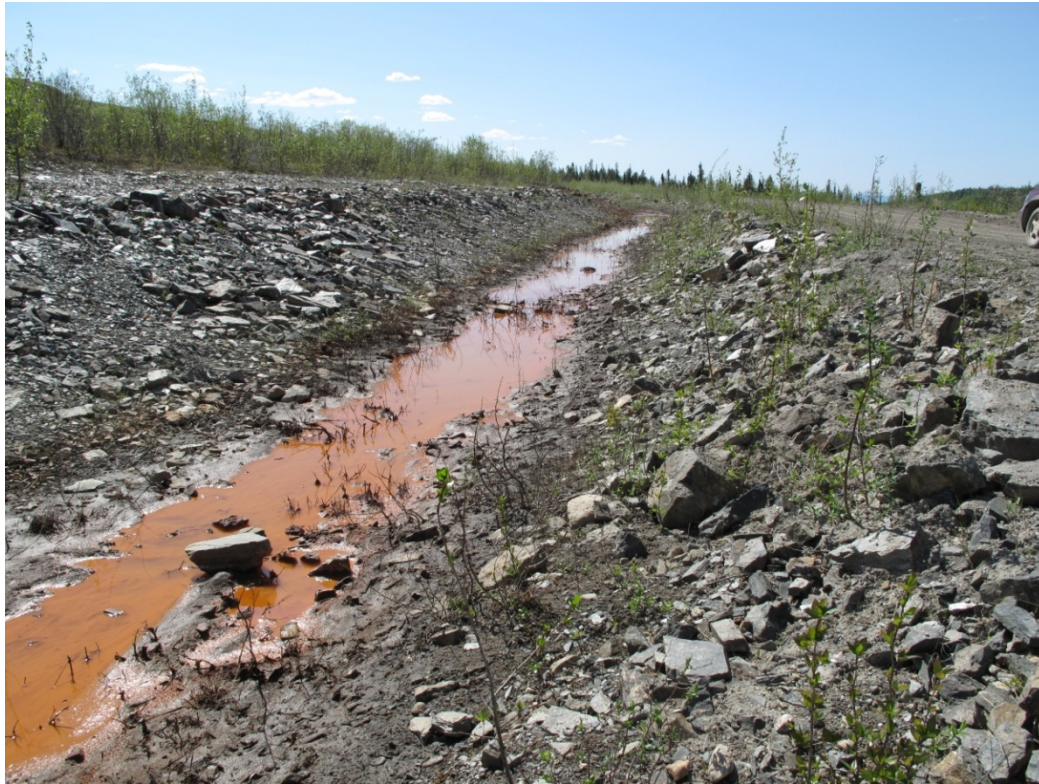
As seen in the Photos 6, 7 and 8, seepage is collected in the Vangorda seepage collection channel around the Waste dump and discharges into Little Creek Pond. During the 2008 inspection, SRK had observed that an HDPE culvert that was installed several years ago to permit vehicles to cross the channel was restricting the flow to Little Creek Pond. The care and maintenance contractor has since removed this culvert and seepage is now allowed to flow freely into the pond.

SRK inspected this ditch at a number of locations and did not find any areas of instability.

Photo 6: Seepage Collection Channel along toe of Vangorda Waste Dump

In the upper reaches of the seepage collection channel at the location of the till cover, DES should continue to monitor any sediment build-up and periodically remove the sediment that accumulates in the channel.

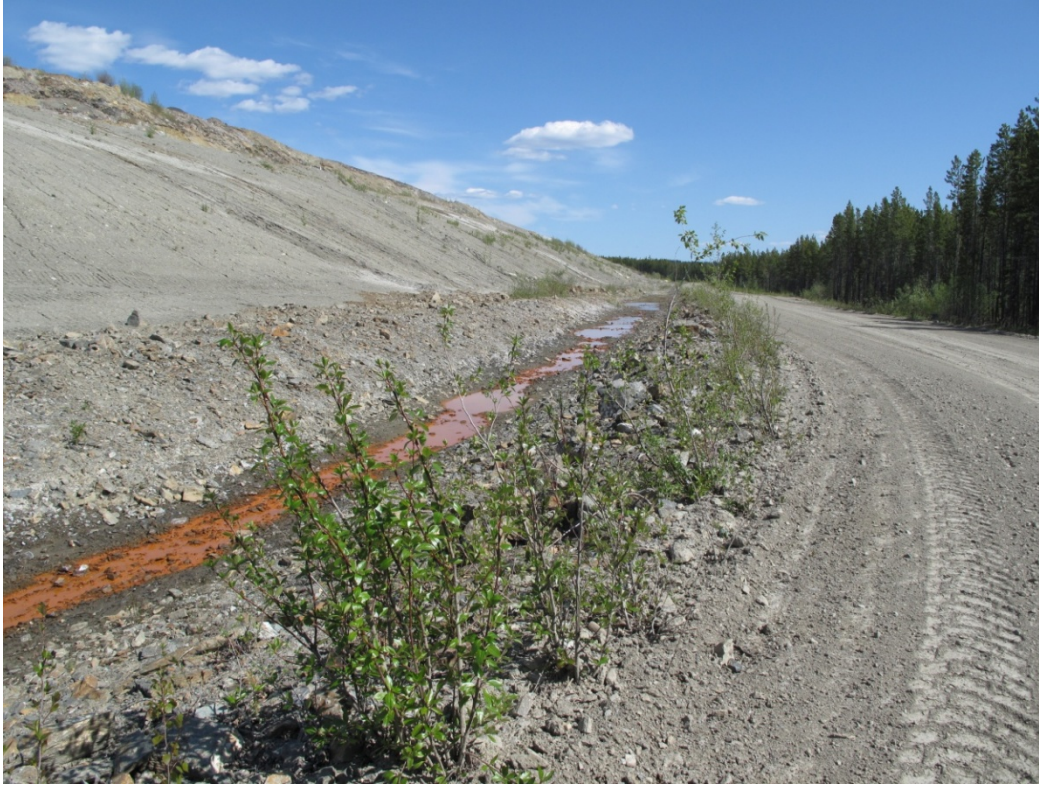
Photo 7: Seepage Collection Ditch along south toe of Vangorda Waste Rock Dump

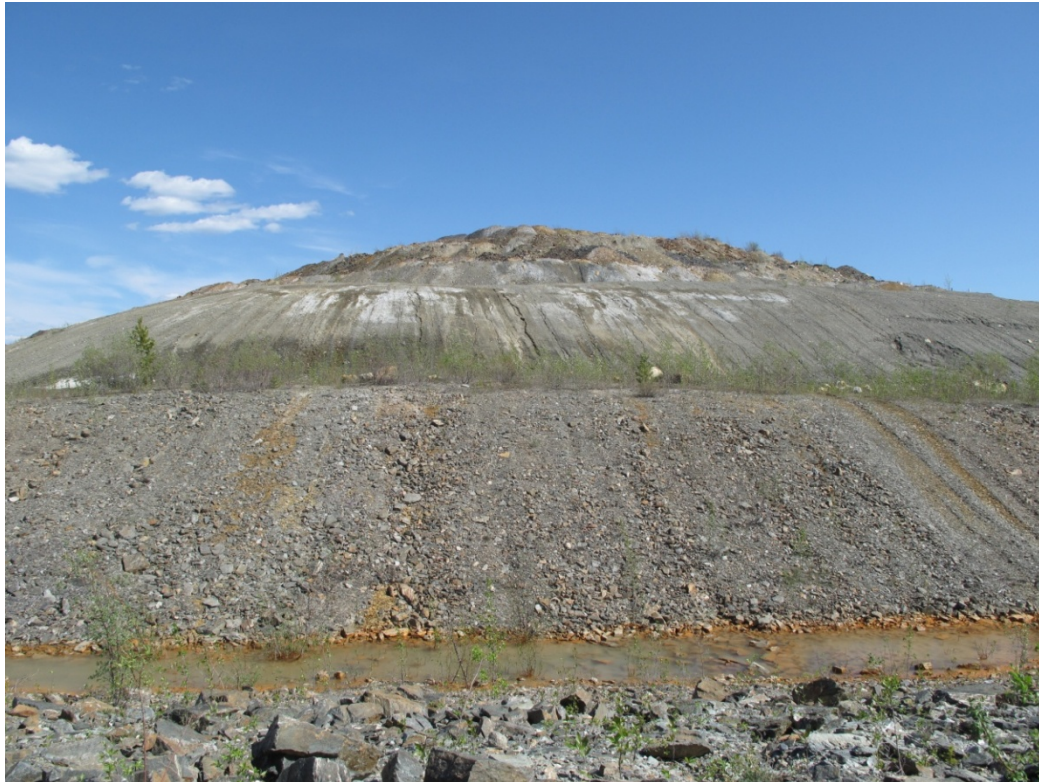
In 2006, a previous care and maintenance contractor resloped sections of the till dyke at the western end of the waste rock dump. During the 2008 inspection, a small shallow subsidence was observed on the sideslope of these resloped areas as shown to right of Photo 8. In addition to this subsidence, a number of wet spots and salt depositions were also noted near the crest of the dyke. SRK is of the opinion that a possible cause of the wet areas and the shallow subsidence is an elevated water table within the waste rock behind the dyke. The latter may also be a source of the salt depositions. However, another source of the deposits is runoff from the uncovered sulphide waste above the till dyke.

Photo 8: Wet spots and shallow subsidence on resloped surface of till starter dyke at Vangorda Waste Rock Dump

DES should inspect the resloped areas of the Till Starter dyke for any signs of instability or the development of significant erosion gullies. DES should also identify any wet or soft areas on the slopes. These inspections should be carried out on a monthly basis and any unusual observation should be forwarded to SRK.

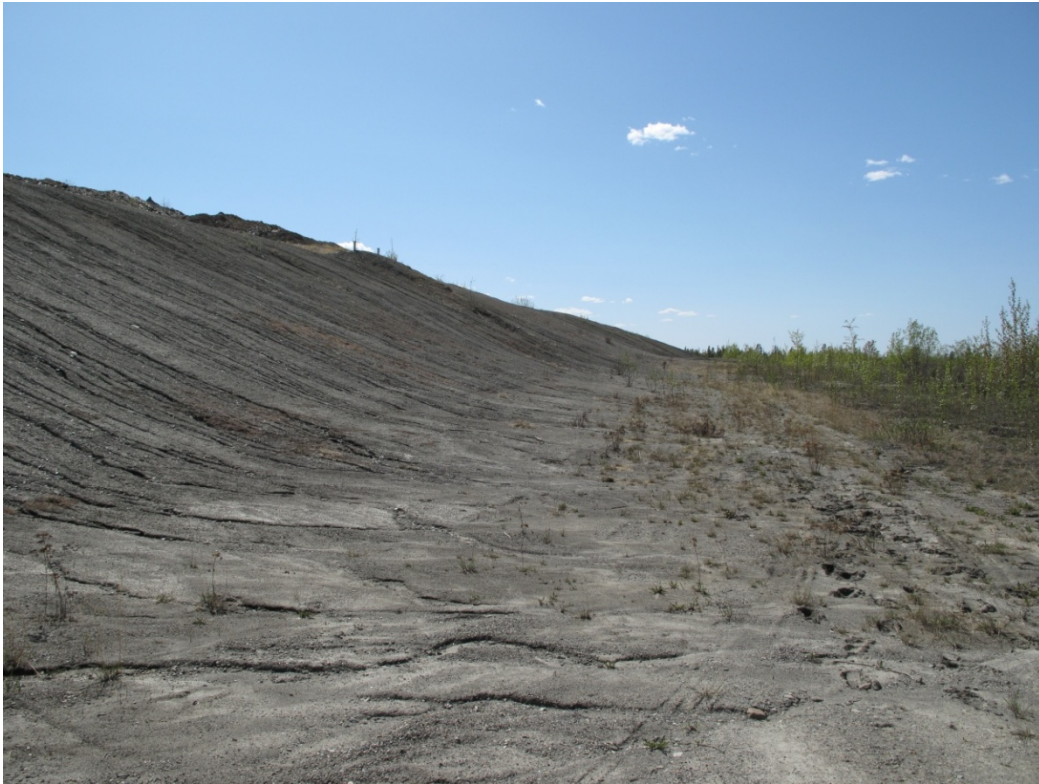
Photo 9 shows the area of the resloped till dyke above drains #5 and #6. These slopes show some signs of erosion but not significant enough to warrant any immediate remedial action. The remaining unresloped sections of the Starter Dyke along the southern side of the dump and the 1994 Trial Till cover continue to experience some erosion (Photo 10). However, there are no signs of major instability. DES continues to monitor the upper reaches of the ditch for infill by sediment caused by erosion of the cover.

Photo 9: Till Slope above Weirs #5 and #6

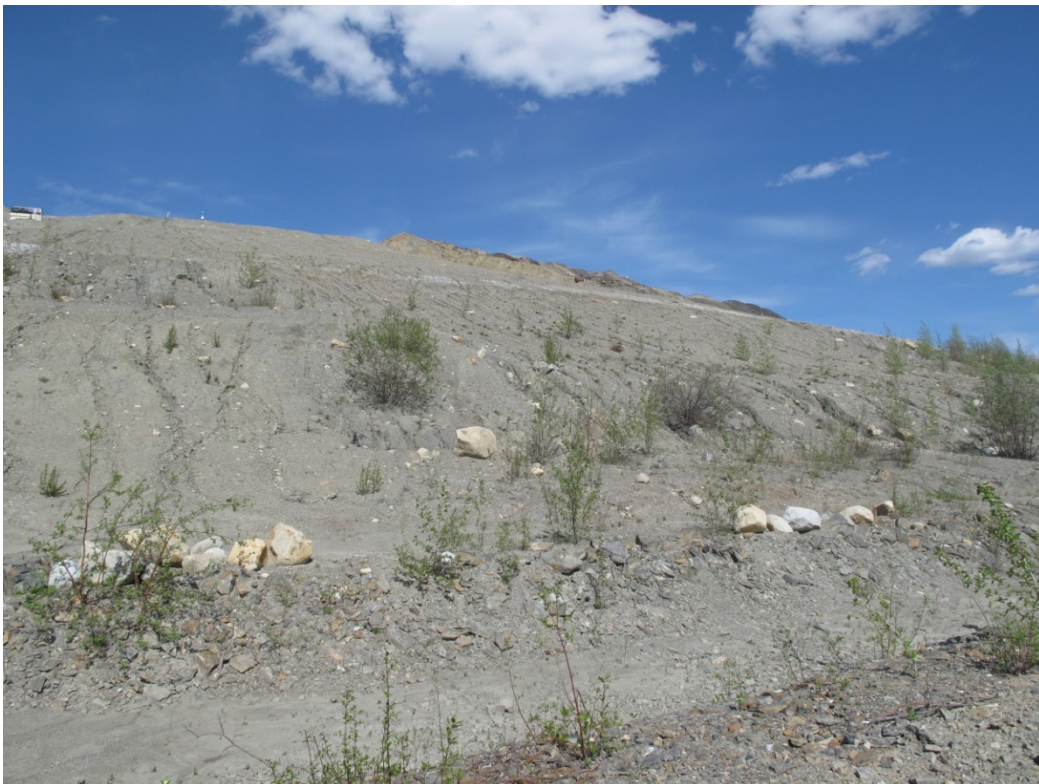
Photo 10: Erosion Gullies in the till cover on Vangorda Dump

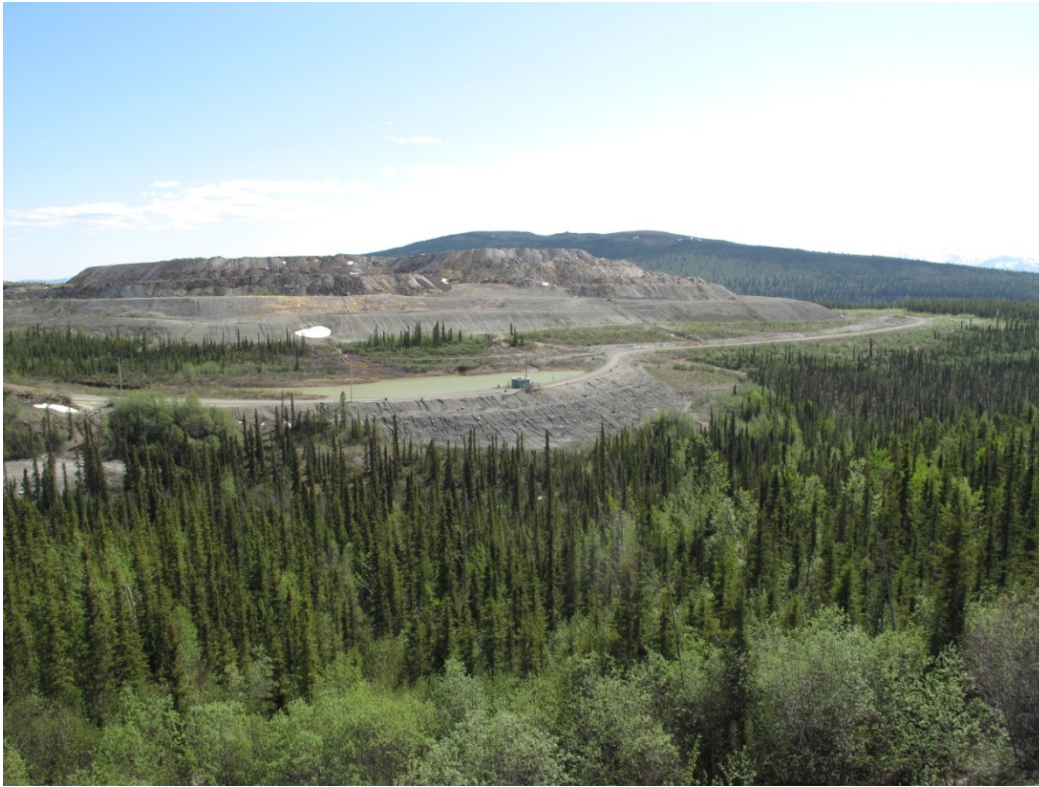
Water level in the pond (Photo 11) during our inspection on June 2, 2009 was recorded at about 1109.110m. No cracks or major settlement of the dam were observed and no seepage was observed along the downstream toe. Erosion rills are evident on both the upstream and downstream slopes of the dam (Photos 12 and 14).

Photo 11: Little Creek Pond

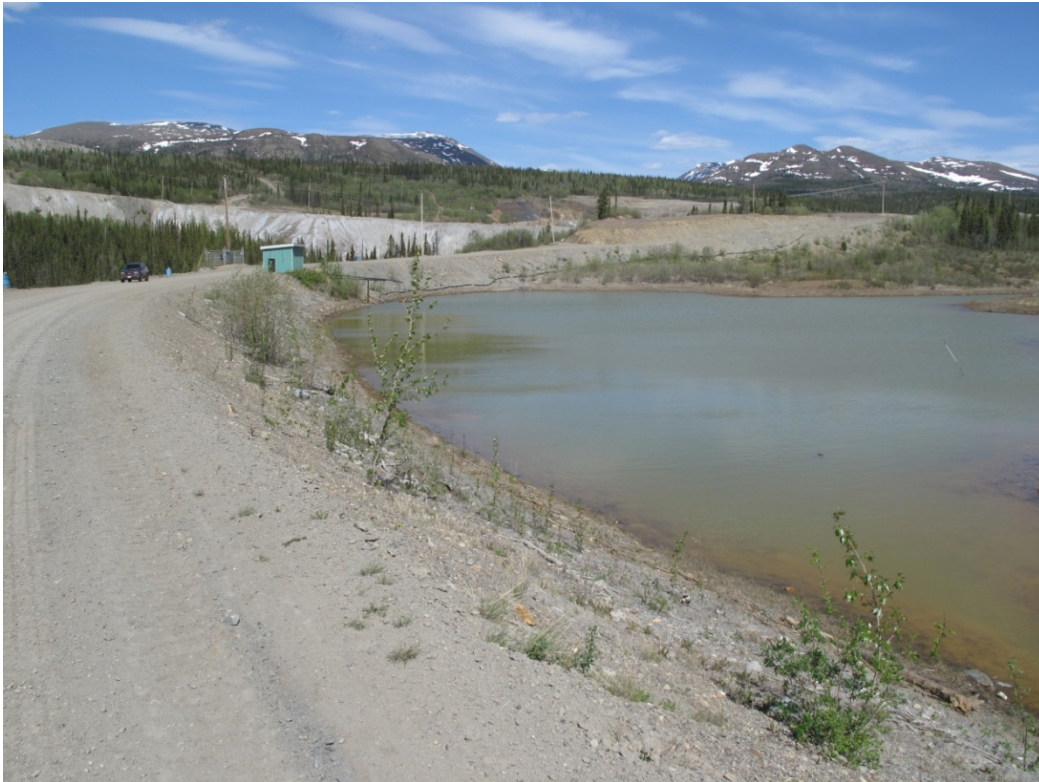
Photo 12: Upstream slope of Little Creek Dam

DES should continue to regularly monitor the crest of the dam for any cracks, settlement or surficial movement of the slope.

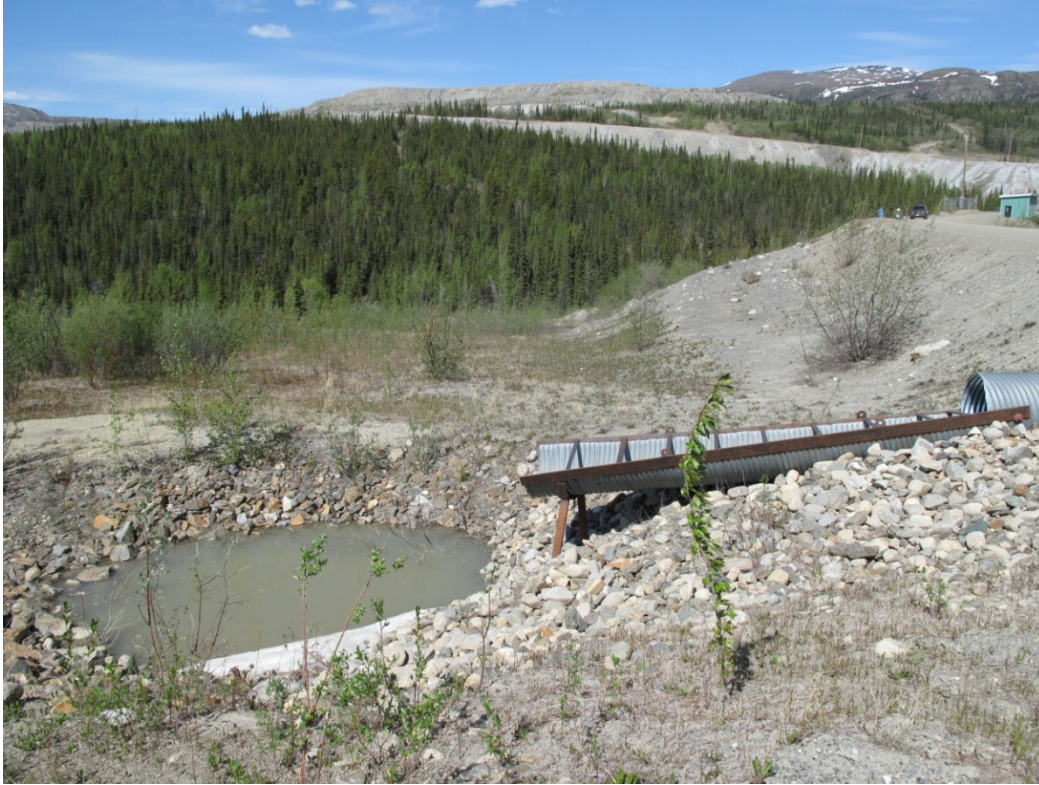
The 900mm CMP emergency spillway (Photo 13) was inspected and is in good condition.

Photo 13: Emergency Spillway (outlet) from Little Creek Pond

DES should also continue to remove any build-up of debris at the inlet end of the culvert spillway.

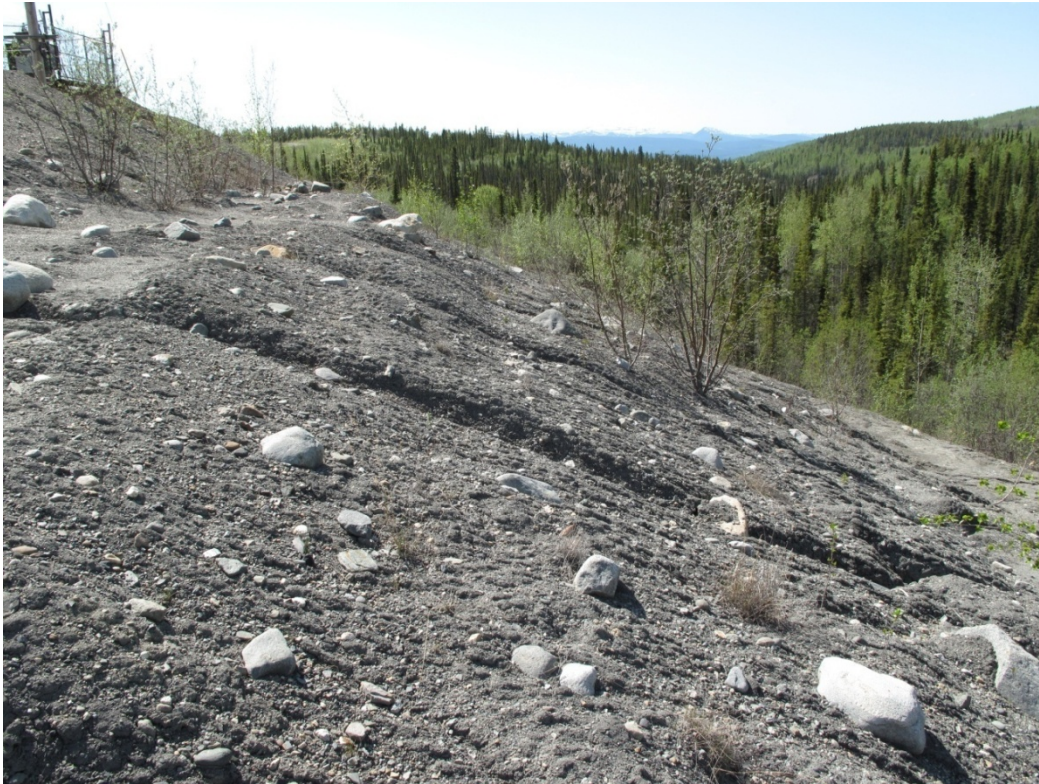
Photo 14: Erosion Gullies on downstream face of Little Creek Dam

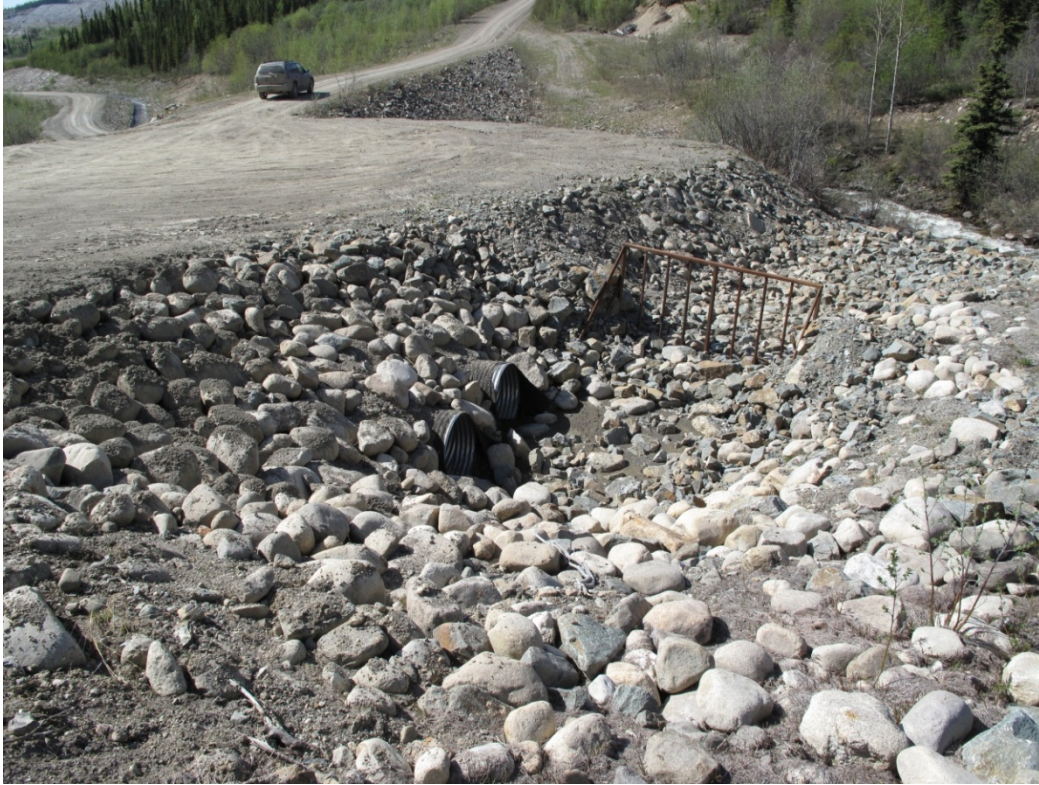
In accordance with a recommendation from SRK, an emergency overflow spillway (2x1m diameter CSP's) was installed at the headworks of the diversion in August 2005 (Photo 15). DES continues to maintain the trash rack at the headworks (Photo 16) and the 2.4m diameter flume (Photos 17) to ensure safe passage of flow in Vangorda Creek. Boulders that fall into the flume are periodically removed. There are no signs of instability or settlement of the embankment at the headworks (Photos 16 and 17) of the diversion. However, the cross braces that support the flume continue to deteriorate and water continues to escape through openings in the flume joints (Photos 18, 19 and 20).

Photo 15: Entrance to emergency spillway on Vangorda Creek Diversion

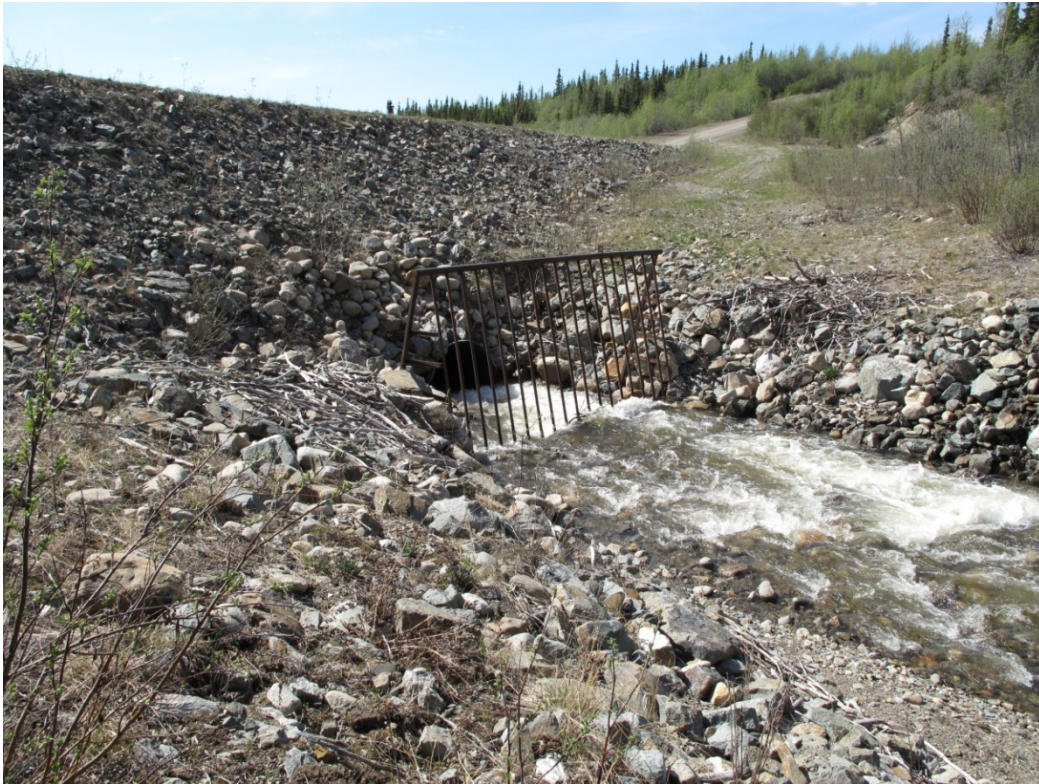
Photo 16: Trash rack at inlet to Vangorda Creek Diversion

DES should continue to monitor the sideslopes above the flume for sloughing and areas of instability and should top-up riprap along the flume where the material has settled below the rim of the culvert sections. Any debris or rock that accumulates in the flume, at the entrance to the 2m CMP or at the headwork's trashrack should be removed. SRK should be notified of any excessive seepage from the flume and increase of discharge into the pit. If any damage to the cross braces and if the structural integrity of any of the flume sections is compromised by ice formation or slides, DES should replace the impacted sections.

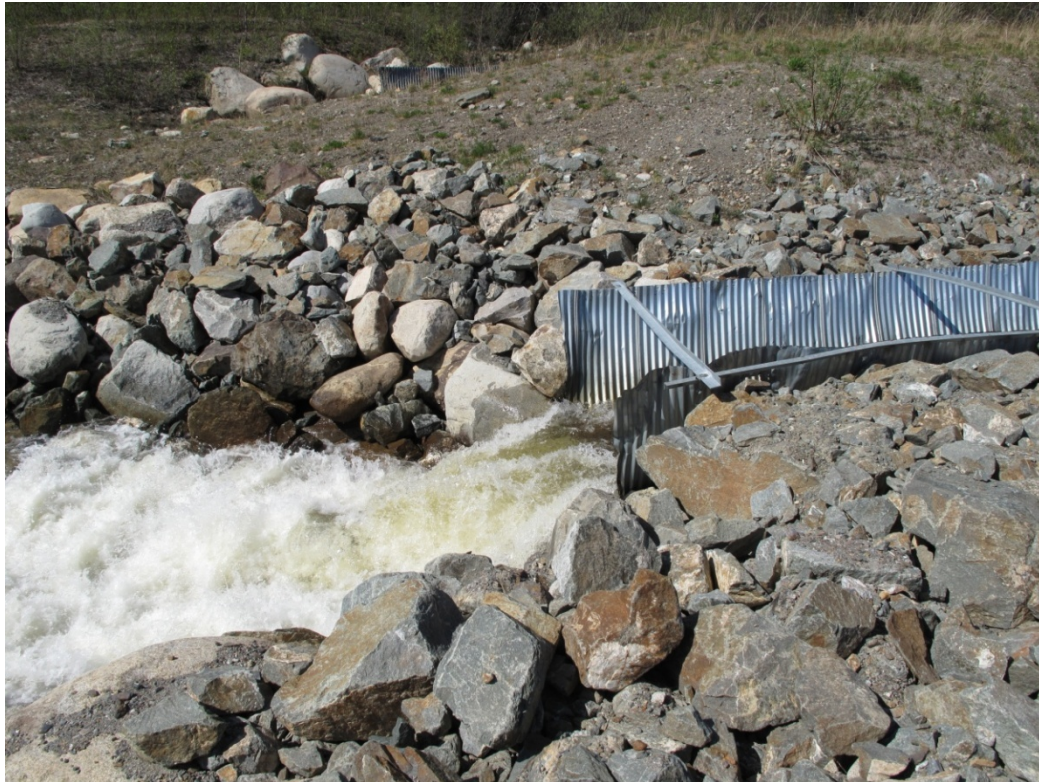
Photo 18: Outlets of the Vangorda Creek Diversion into Plunge Pool

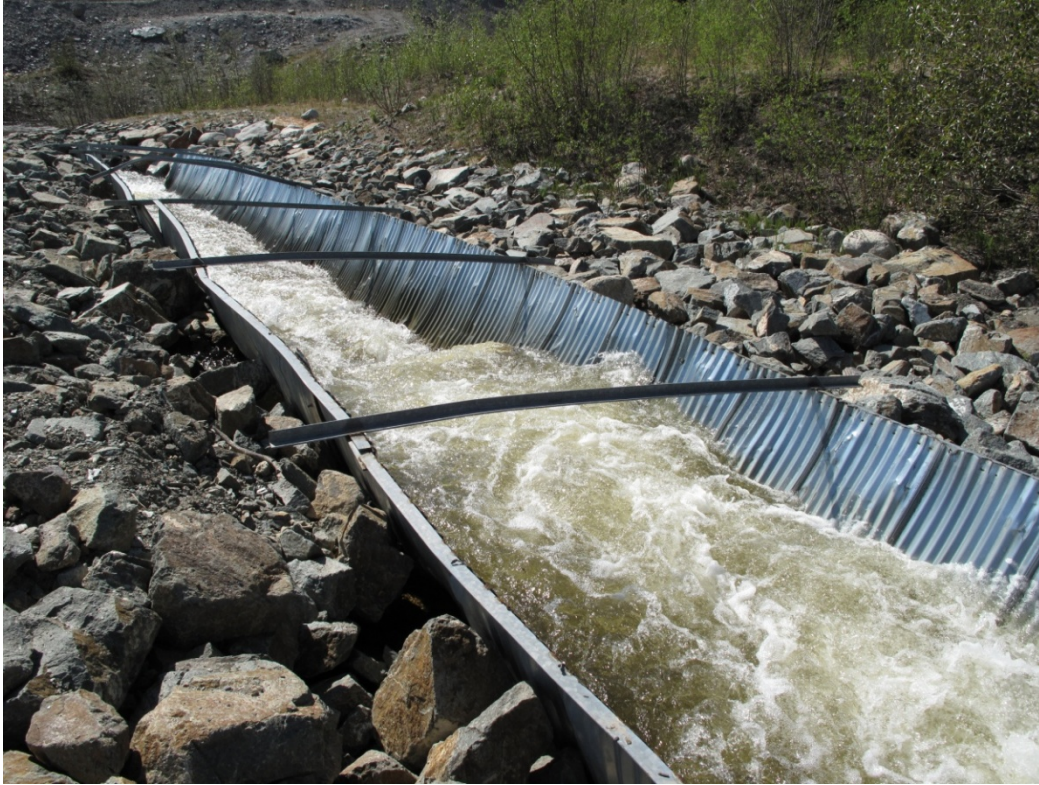
Photo 19: Half round culvert flume in Vangorda Creek Diversion

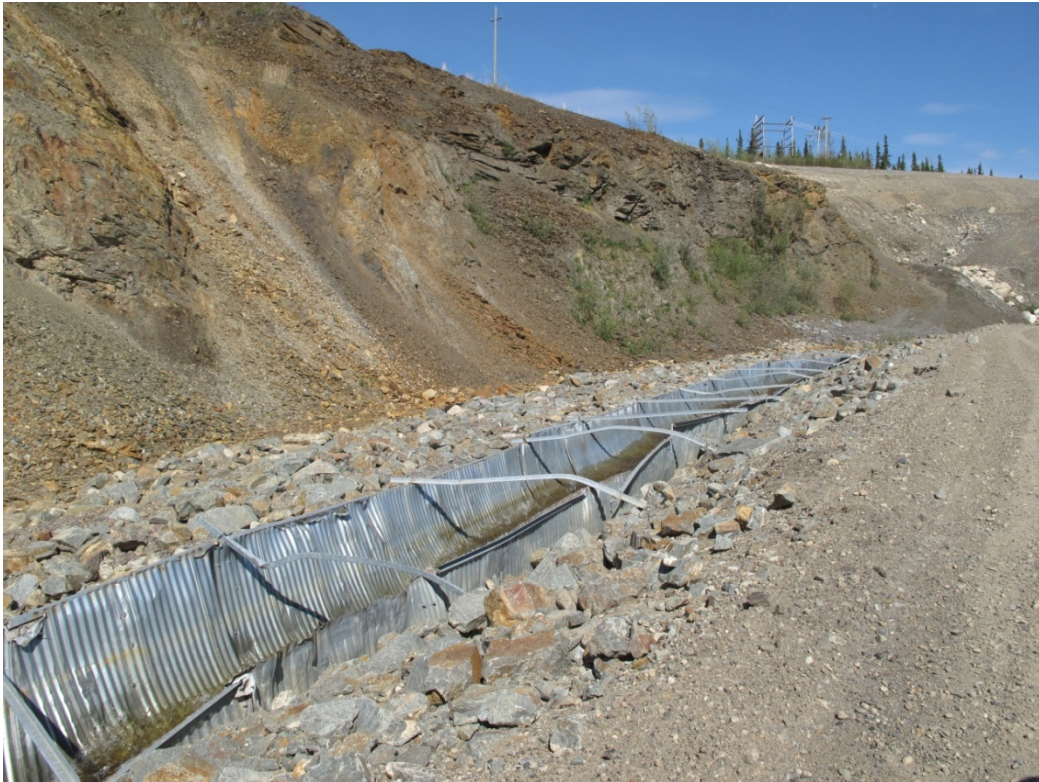
Photo 20: Flume in the Vangorda Creek Diversion

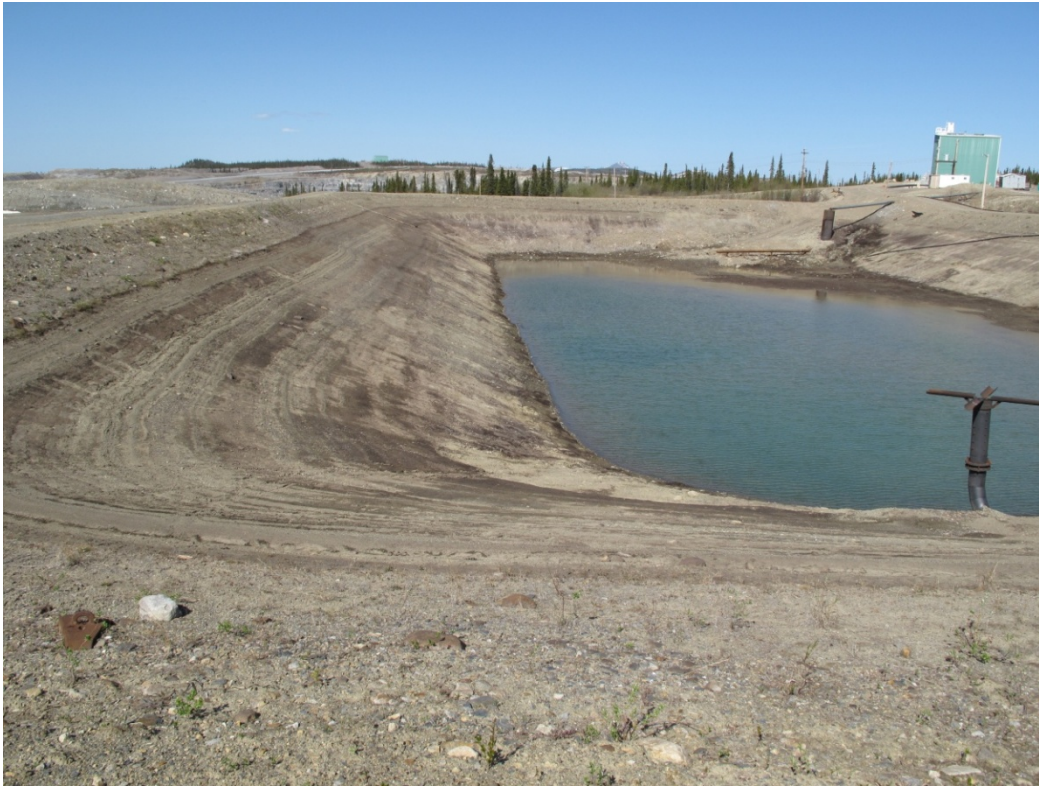
At the time of our inspection, the sludge pond was almost empty (Photo 21). SRK inspected the downstream slopes and crests of the four embankments that make up the sludge pond. Neither subsidence of the slopes, nor settlement of the crest and no tension cracks were observed (Photo 22 and 23).

Photo 21: Upstream view of the dyke around the Sludge Pond at Water Treatment Plant

- Ensure that the pond level does not exceed 2m. below crest; and
- Continue to monitor on a monthly basis, the crest and sideslopes for cracking or any signs of sloughing.

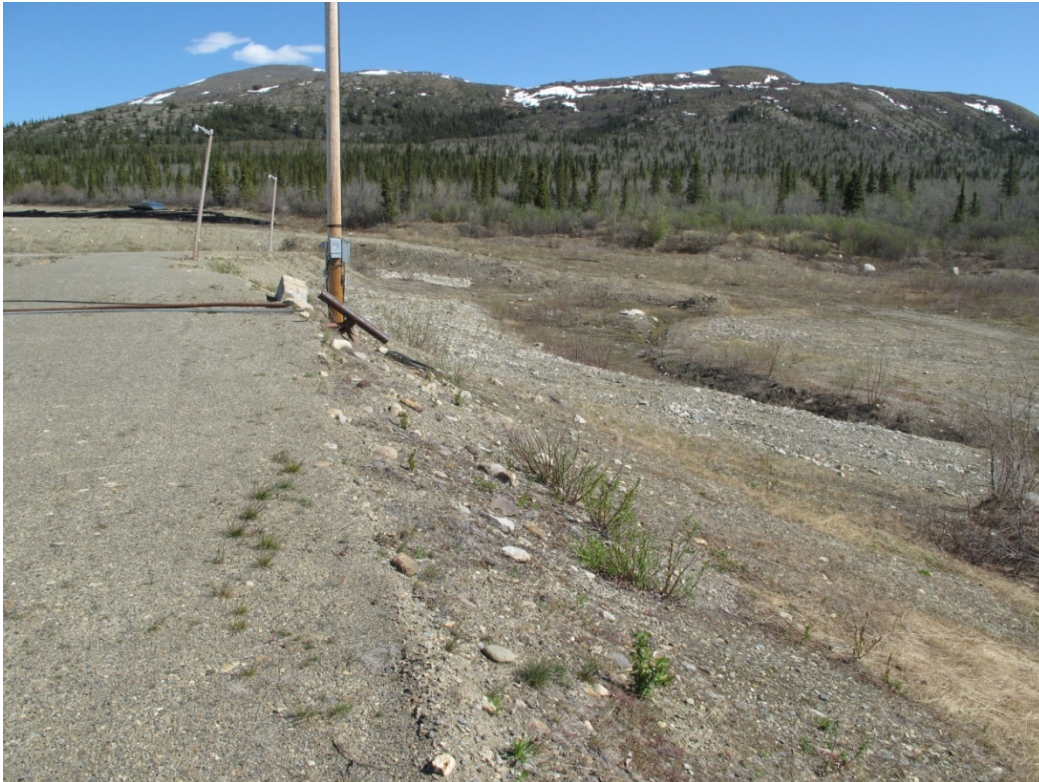
Photo 22: Downstream slopes of Dyke around Sludge Pond at Vangorda (south end)

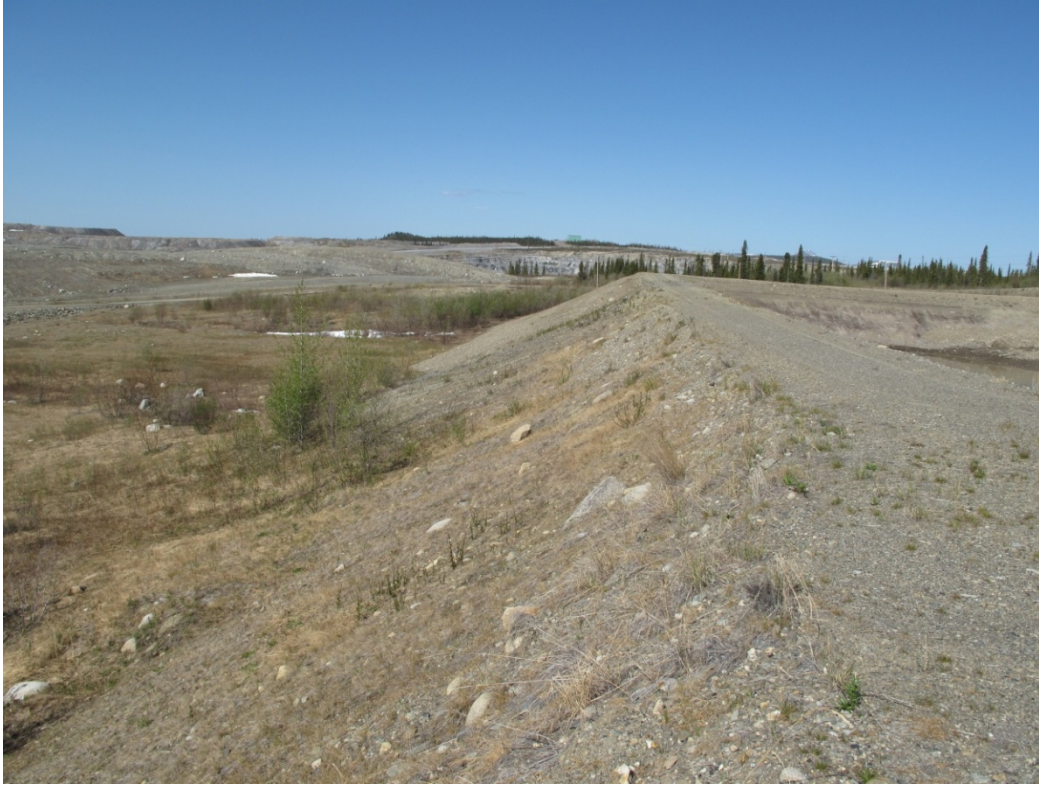
Photo 23: Downstream slopes of Dyke around Sludge Pond at Vangorda Water Treatment Plant

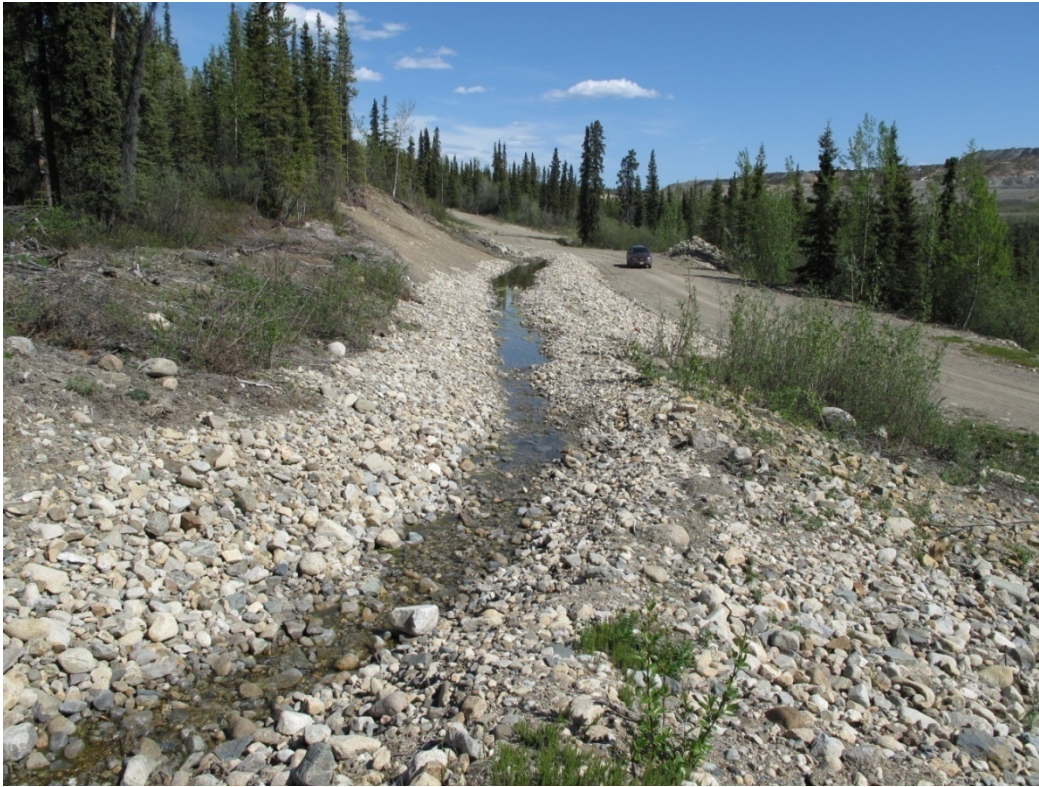
In 2006, increasing concentrations of zinc were observed at the outlet of the V15 sedimentation pond upstream of Tributary A. In response to this finding, a Bentomat lined diversion ditch was constructed in August, 2007 (Photo 27) to divert outflow from this pond to a naturally formed Kettle called Moose Pond. A siphon pipeline from the pond to the V2 sampling station, which was installed during the operation of the mine in the mid 90's to drain any water that may accumulate in the pond, is still fully functional. However, SRK understands that the pipe has never been used because there has not been any significant accumulation of water in the pond.

Photo 27: Bentamat lined Diversion ditch from V-15 to main stem of Grum Creek

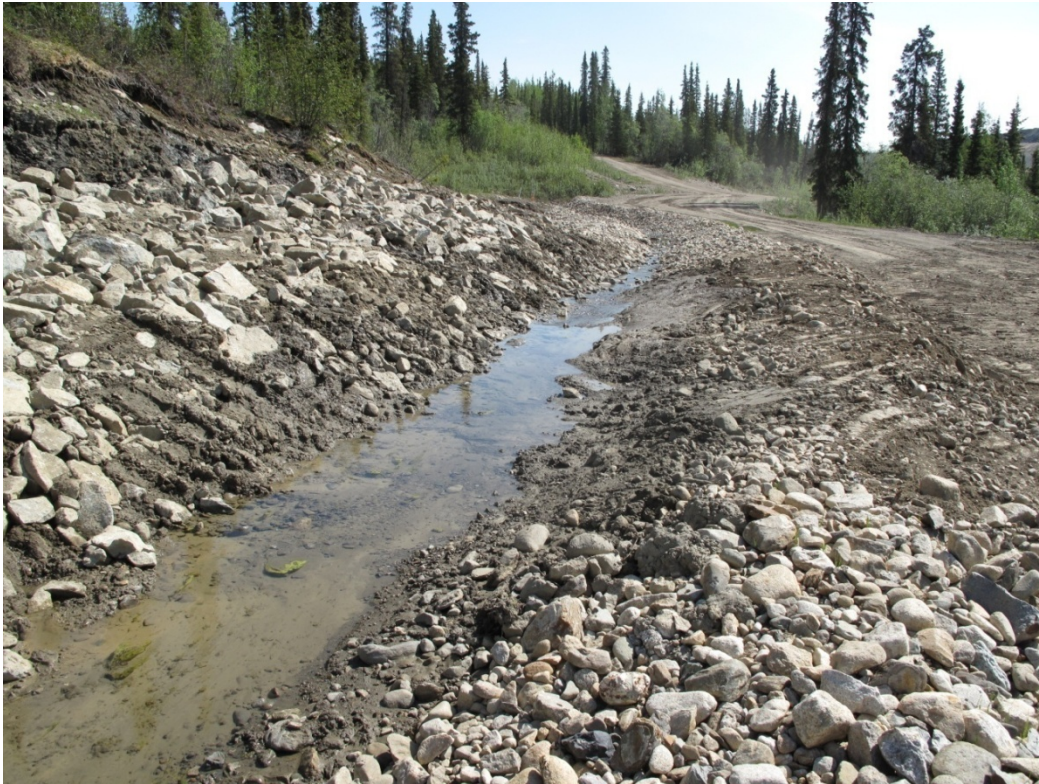
During SRK's inspection in 2008, we observed that a small subsidence had occurred above the lined ditch which was restricting flow in the ditch. SRK noted this in our 2008 inspection report. DES was able to remove the debris and restore the sideslope during SRK's 2009 inspection (Photo 28).

Photo 28: Area of subsidence noted during the 2008 inspection. The slide debris has been removed and the side slope was repaired

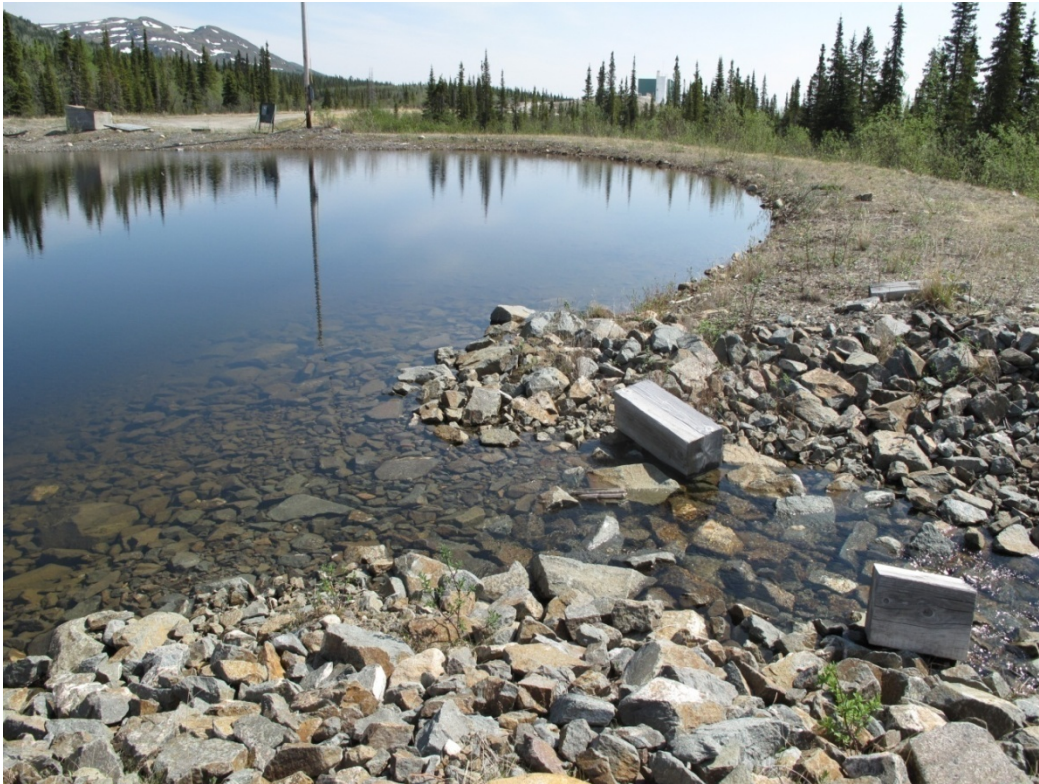
SRK inspected the riprapped open channel spillway (Photo 30), which conveys flow from the Grum settling pond to the Grum Interceptor Ditch (GID). The spillway is functioning normally. There was no sign or any instability or cracking in the surrounding dyke. No seepage was observed along the toe of the dyke.

Photo 30: Grum Settling Pond (Groucho Pond) – Spillway Entrance

The crest of the embankment around the pond should be monitored monthly for cracks and any seepage into and out of the pond.
