2010 Annual Inspection Waste and Water Management Facilities Vangorda/Grum

Faro Mine Complex, Yukon

Project Reference Number
SRK 1CD009.003

February 2011

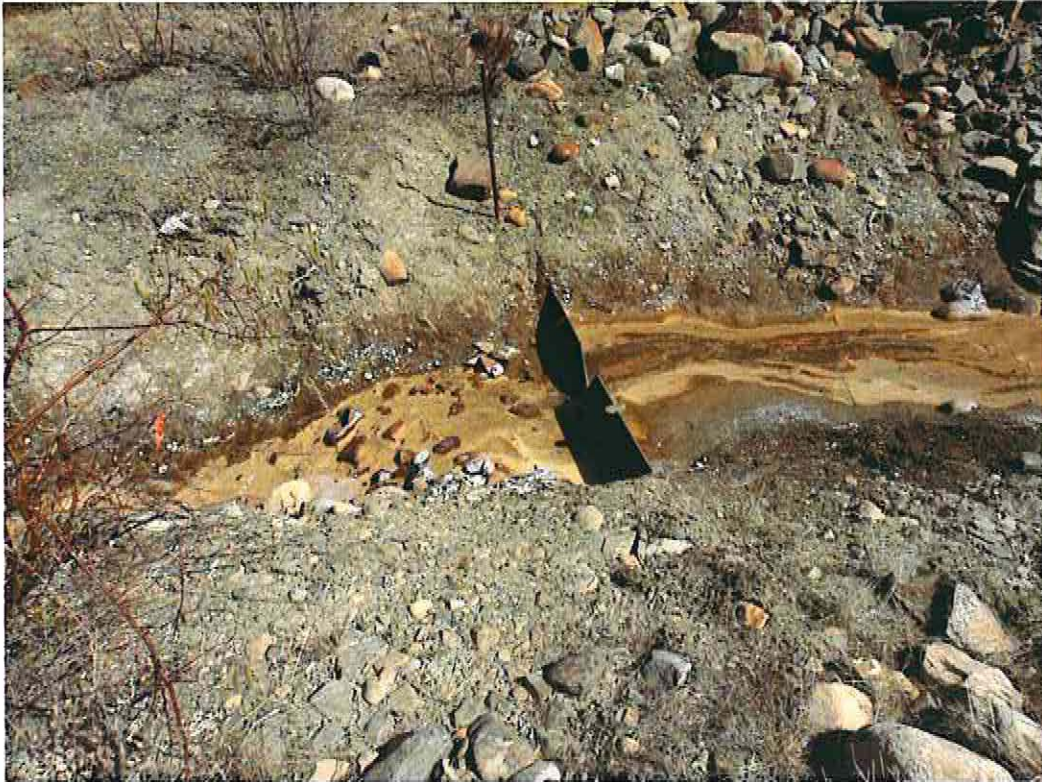
During this year's inspection, seepage flow was observed at Weir #6 (Photo 1), Weir #5 (Photo 2), Weir #3 (Photo 4), Drain #4 (Photo 3) and Weir #2 (Photo 5). The flow in each of these drains varied from a trace to about 0.5L/min.

Sediment has built up behind the steel plates (V-notch) at some of the weirs as shown in the photo 1. SRK understands that DES Environmental crew cleared out the sediment buildup behind the weirs on June 15, 2010.

Photo 1: Drain #6

The outlet of these drains should be inspected monthly for any signs of damage or deterioration of the steel v-notch weirs. The inspection should include recording of any flow or seepage rates.

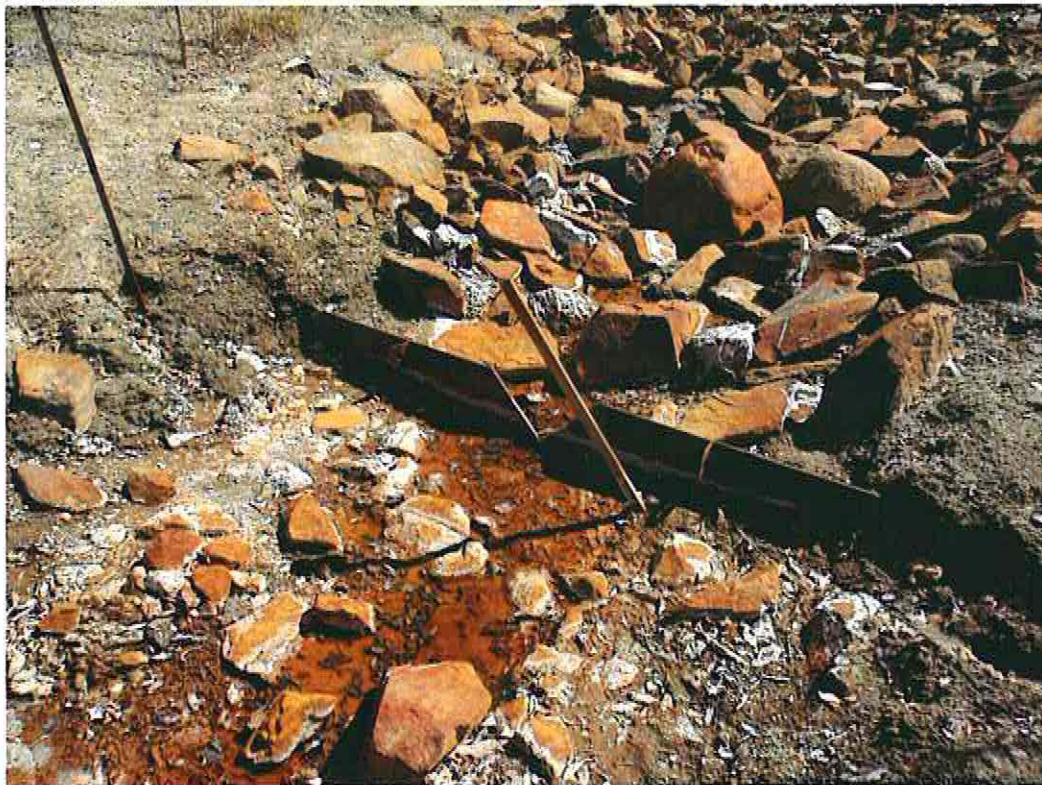
Photo 2: Drain #5

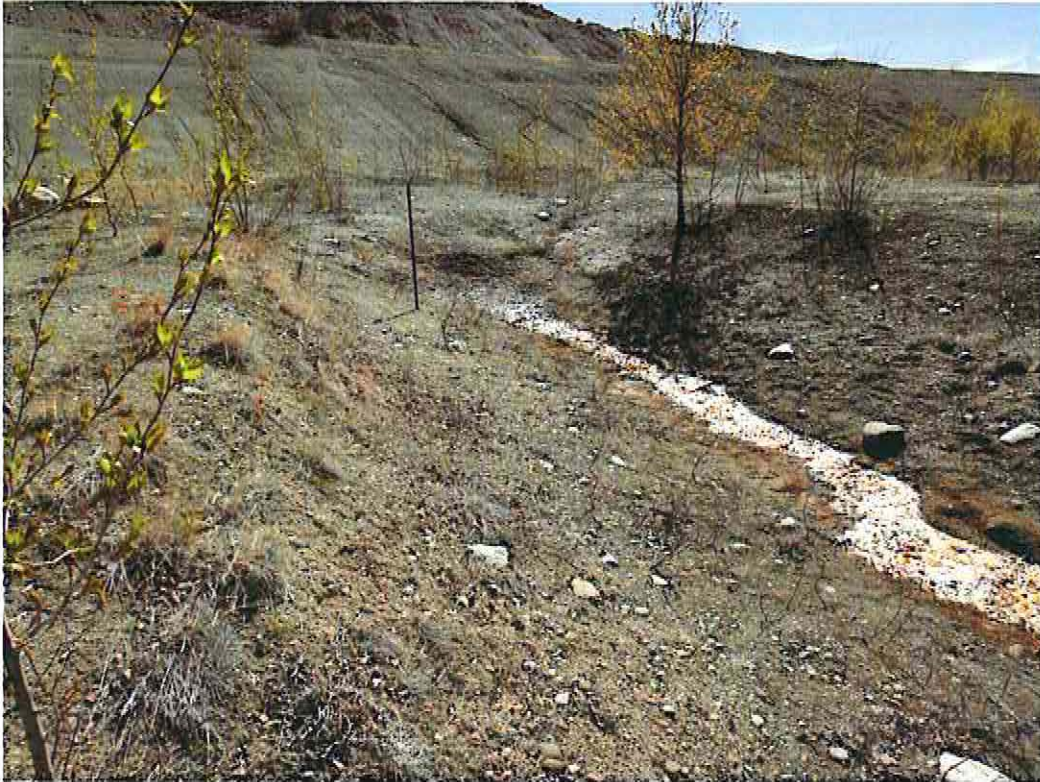
Photo 3: Drain # 4

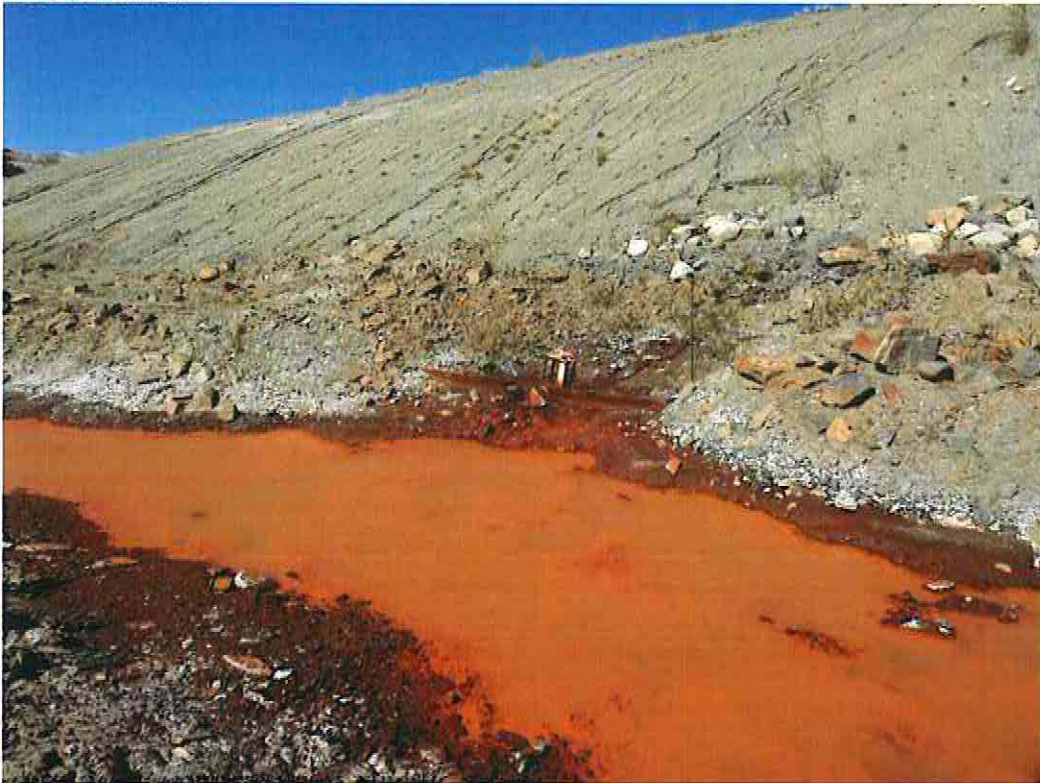
Photo 4: Drain #3

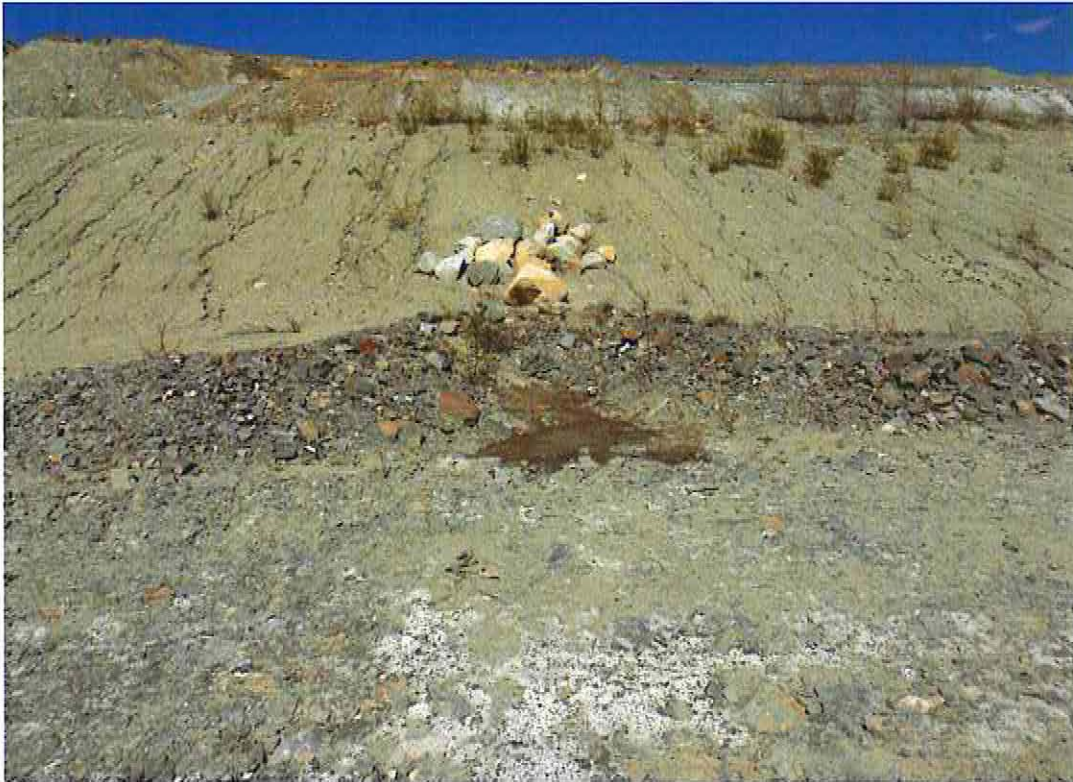
Photo 5: Drain #2

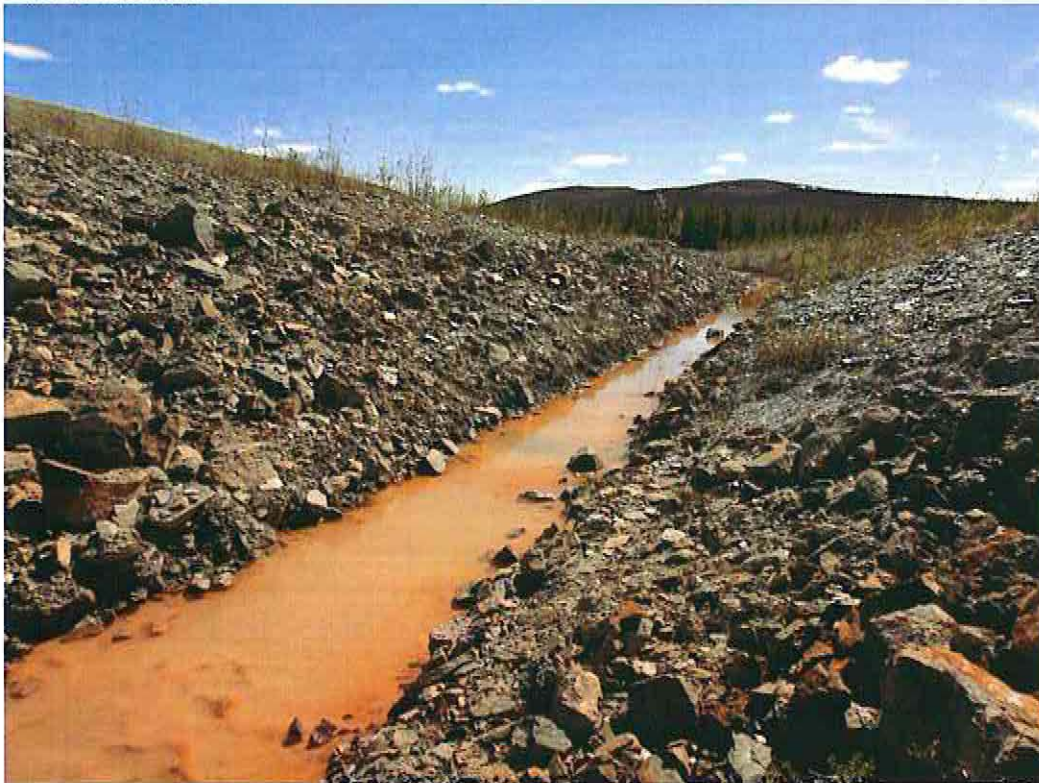
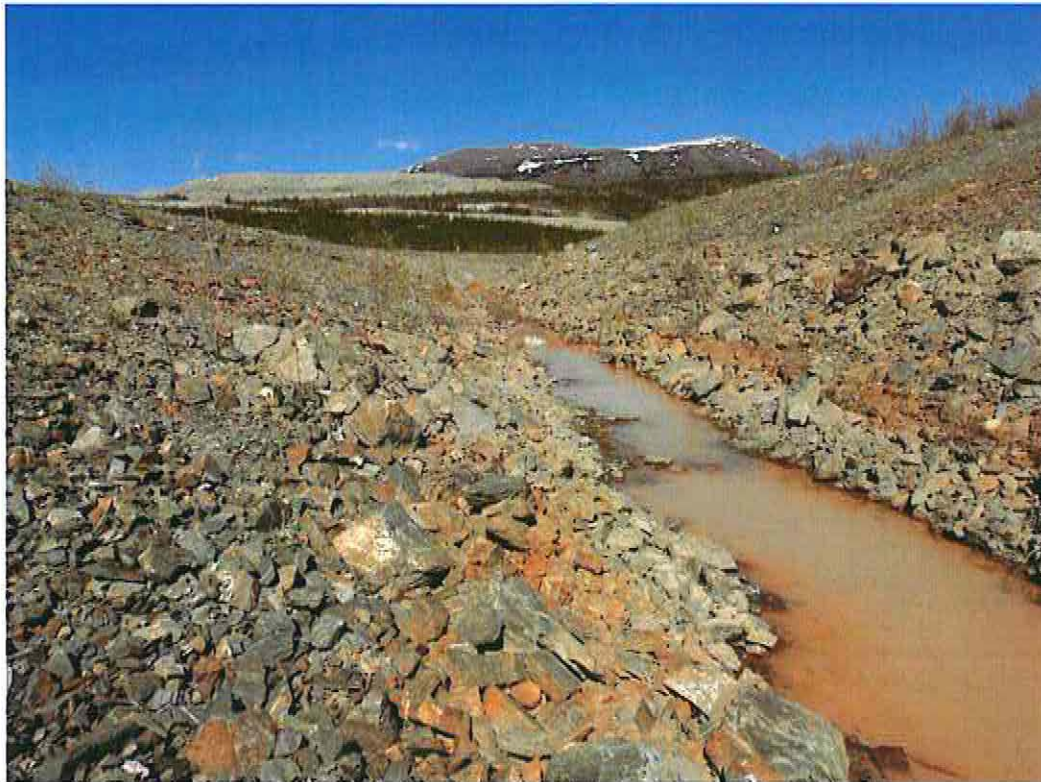
As seen in the Photos 6, 7 and 8, seepage is collected in the Vangorda seepage collection channel around the Waste dump and discharges into Little Creek Pond.

Photo 6: Seepage Collection looking back towards Drain #3

Photo 7: Seepage Collection Ditch looking downstream towards Drain #4

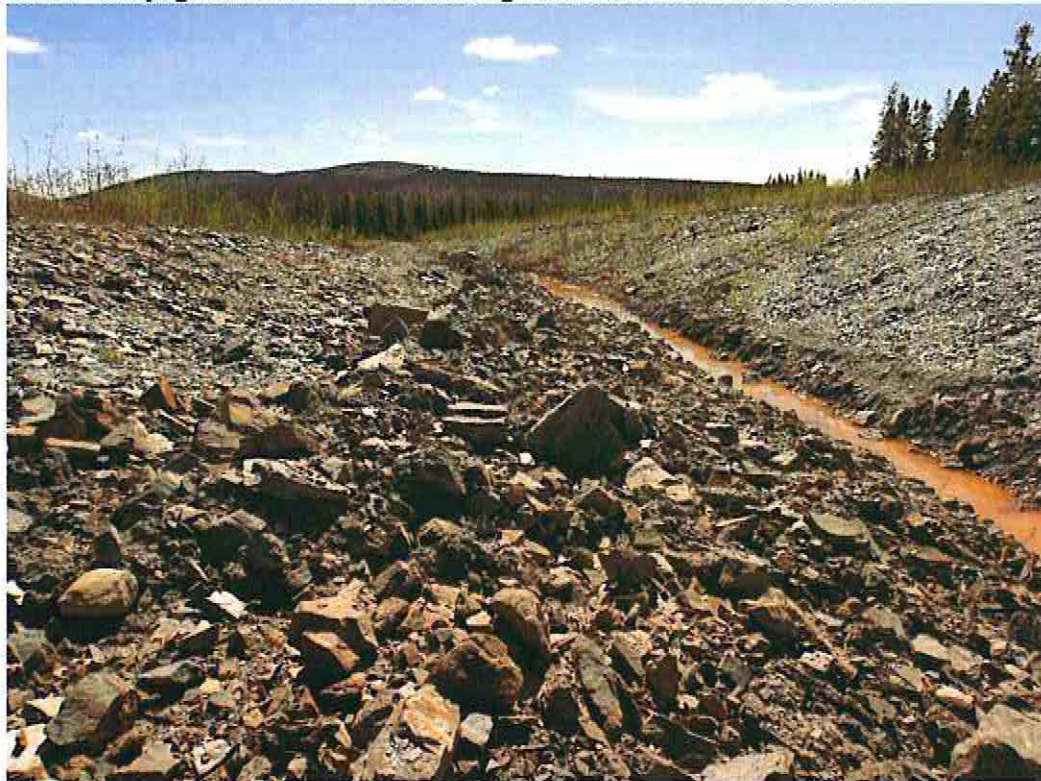
Last fall (2010) DES excavated riprap from the bottom of the Vangorda Waste rock dump seepage collection ditch downgradient from Weir #3 over a distance of about 200m (see Photo 8). The objective was to improve drainage along the ditch and reduce the ponding that occurs around Weir #3. This ditch has a very flat grade overall (about 0.5%) and drainage is difficult at best. While SRK has no problem with the attempt to improve drainage, the material removed from the bottom of the channel was placed at too steep a slope for long-term stability.

Photo 8: Fall 2009 Excavation of the riprap from the base of the seepage Collection Ditch

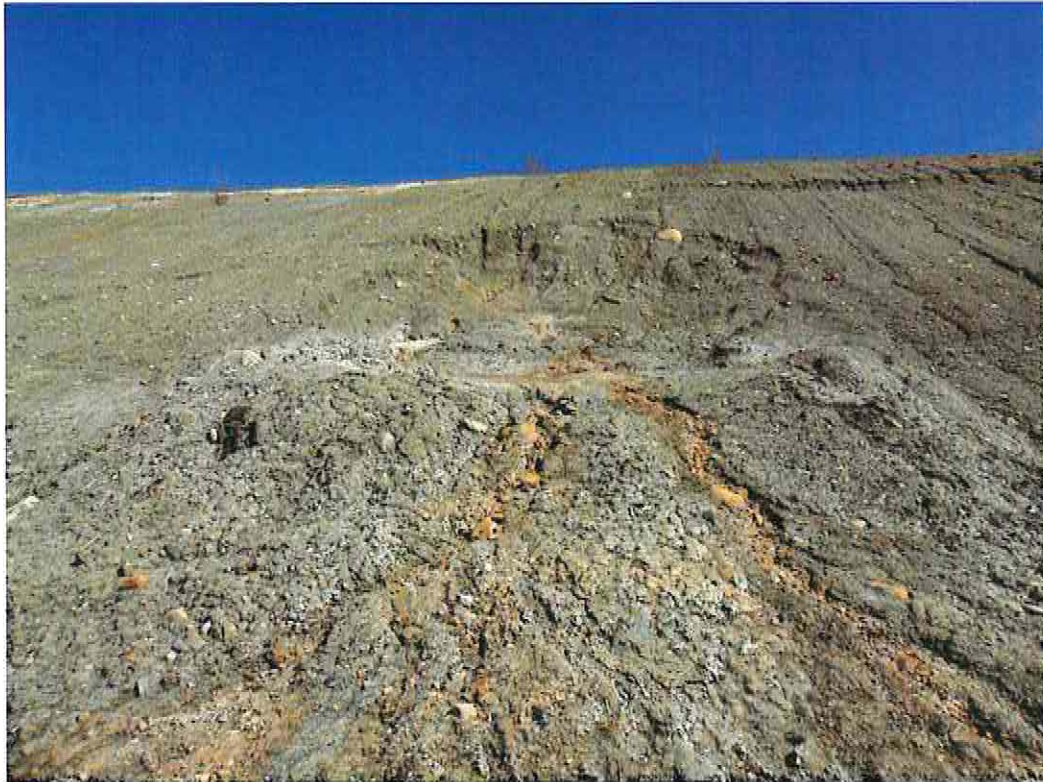
In 2006, a previous care and maintenance contractor resloped sections of the till dyke at the western end of the waste rock dump. During the 2008 inspection, a small shallow subsidence was observed on the sideslope of these resloped areas as shown on Photo 8. In addition to this subsidence, a number of wet spots and salt depositions were also noted near the crest of the dyke. In last year's report, SRK commented that a possible cause of the wet areas and the shallow subsidence is an elevated water table within the waste rock behind the dyke. The latter may also be a source of the salt deposits. However, another source of the deposits is runoff from the uncovered sulphide waste above the till dyke. During the 2010 inspection of the shallow subsidence on the till dyke at the western end of the dump (Photo 9), although there was evidence of previous seepage, we observed that the area was dry and no further subsidence had occurred since our inspection in 2009.

Photo 9: Shallow subsidence on till Dyke above seepage collection ditch

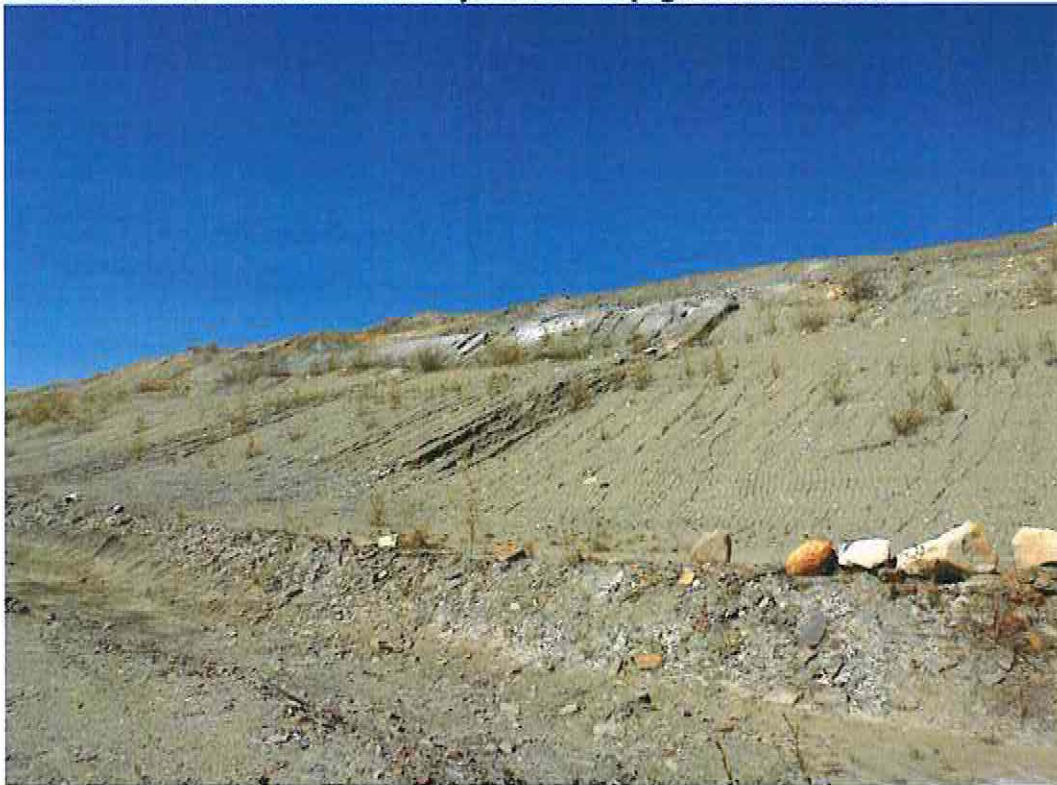
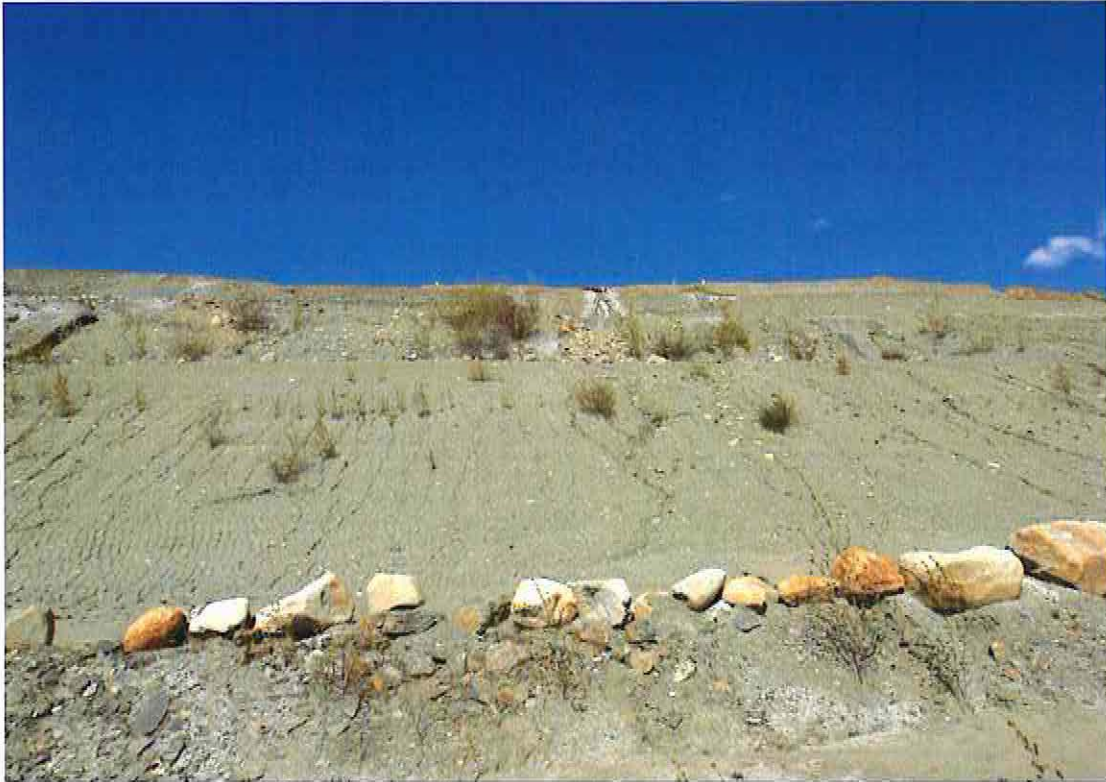
Photos 10 and 11 show the area of the resloped till dyke below the till cover trials. These slopes show some signs of erosion but not significant enough to warrant any immediate remedial action. There were no signs of major instability. DES continues to monitor the upper reaches of the ditch for infill by sediment caused by erosion of the cover.

Photo 10: Erosion on the till dyke below cover trials

Photo 11: Erosion on the till dyke blow cover trials

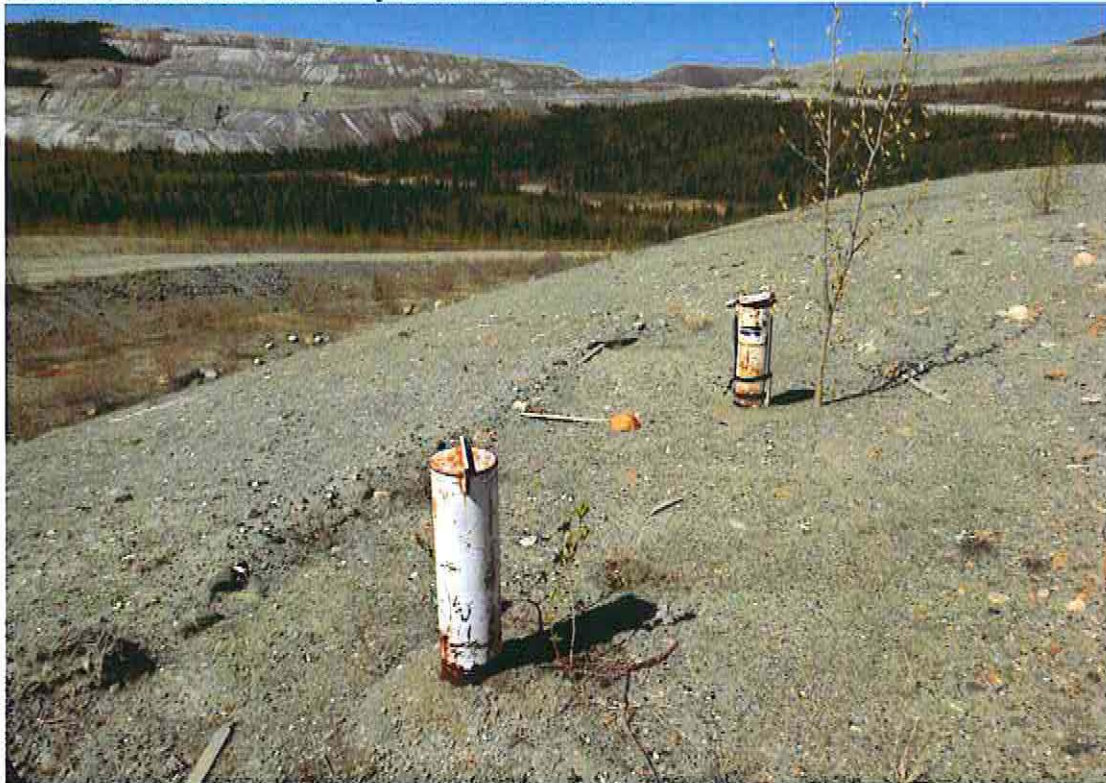
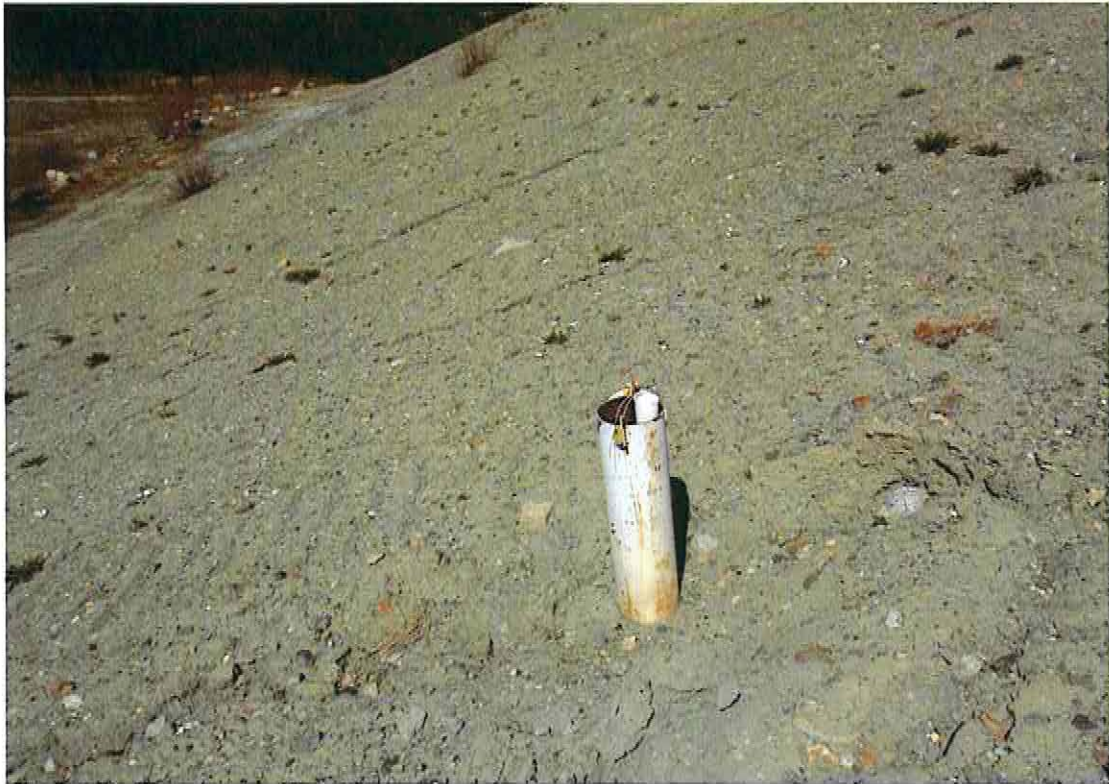
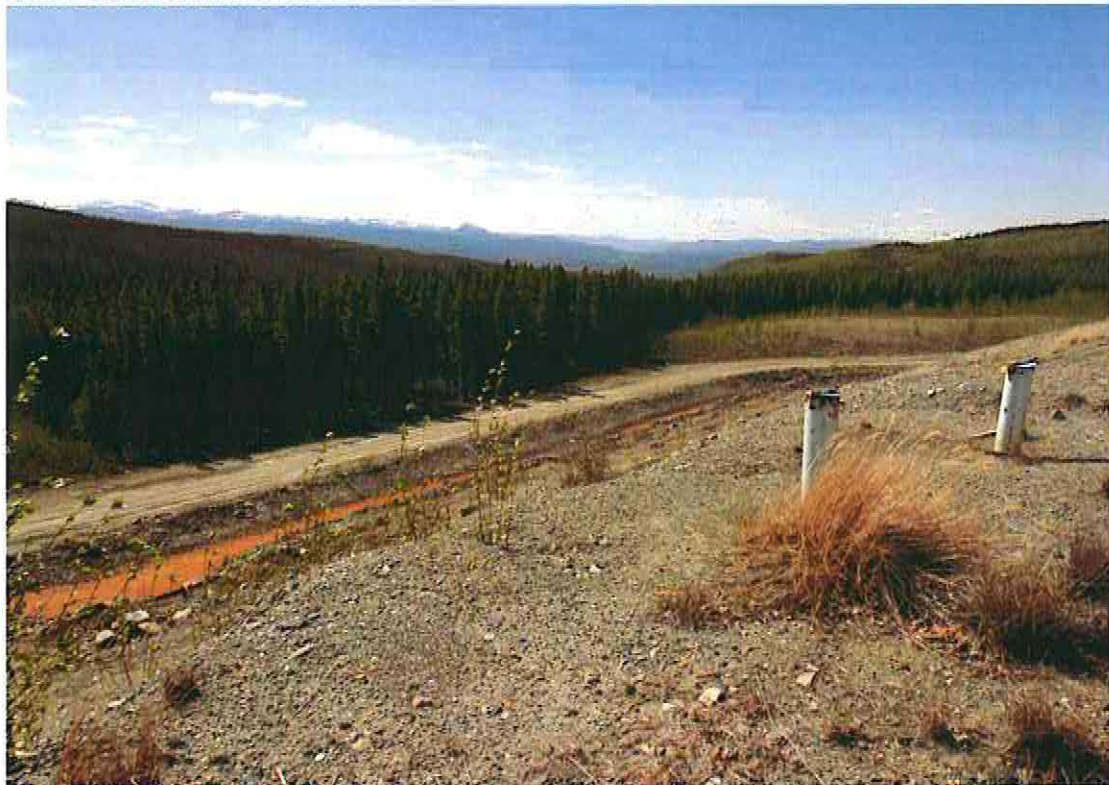
Water levels in the standpipe piezometers (P94 series see photos 12 to 14) located in the till dyke around the Vangorda Waste Rock Dump have normally been recorded twice a year since they were installed in 1994. A summary of the water level readings taken to date (Feb 2011) in the 94 series piezometers and wells and the recently installed wells (DH, or "PW-10-x" series) are presented in

Photo 12: Piezometers 94-2A and 2B

Photo 13: Piezometer P94-2C

Photo 14: Piezometers P94-1A and 1B

SRK is recommending that DES consider the installation of levelloggers in each of the eight 94 series piezometers and the remaining four 94 series groundwater wells. SRK has already installed levelloggers in three of the new 2010 series wells in the dump and recommends that levelloggers are installed in the remaining two wells. SRK is of the opinion that to properly understand the behaviour of the water table in the waste rock dump, it will be necessary to monitor the seasonal variation of the water table more accurately. The continuous record provided by the levelloggers would provide this data.

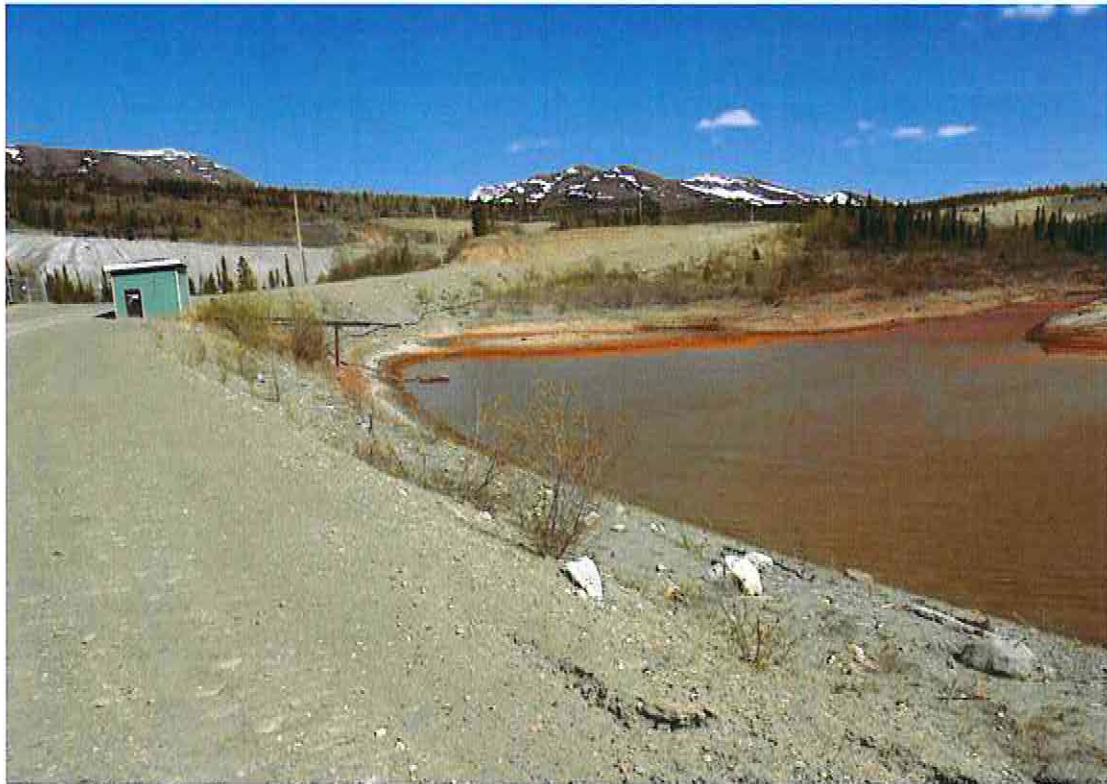
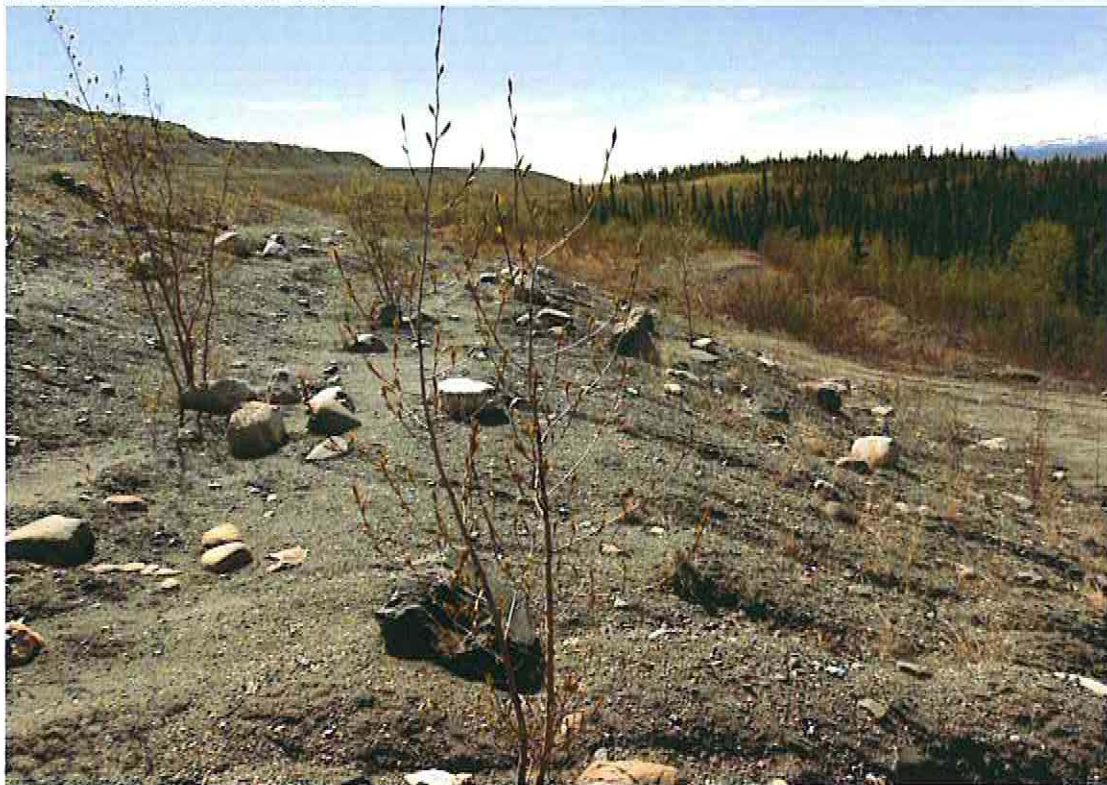
Water level in the pond (Photo 15) during our inspection on May 26, 2010 was recorded at about 1109m. No cracks or major settlement of the dam were observed and no seepage was observed along the downstream toe. Erosion rills are evident on both the upstream and downstream slopes of the dam (Photos 15 and 16).

Photo 15: Little Creek Pond

Photo 16: Downstream face of Little Creek Pond

DES should continue to regularly monitor the crest of the dam for any cracks, settlement or surficial movement of the slope.

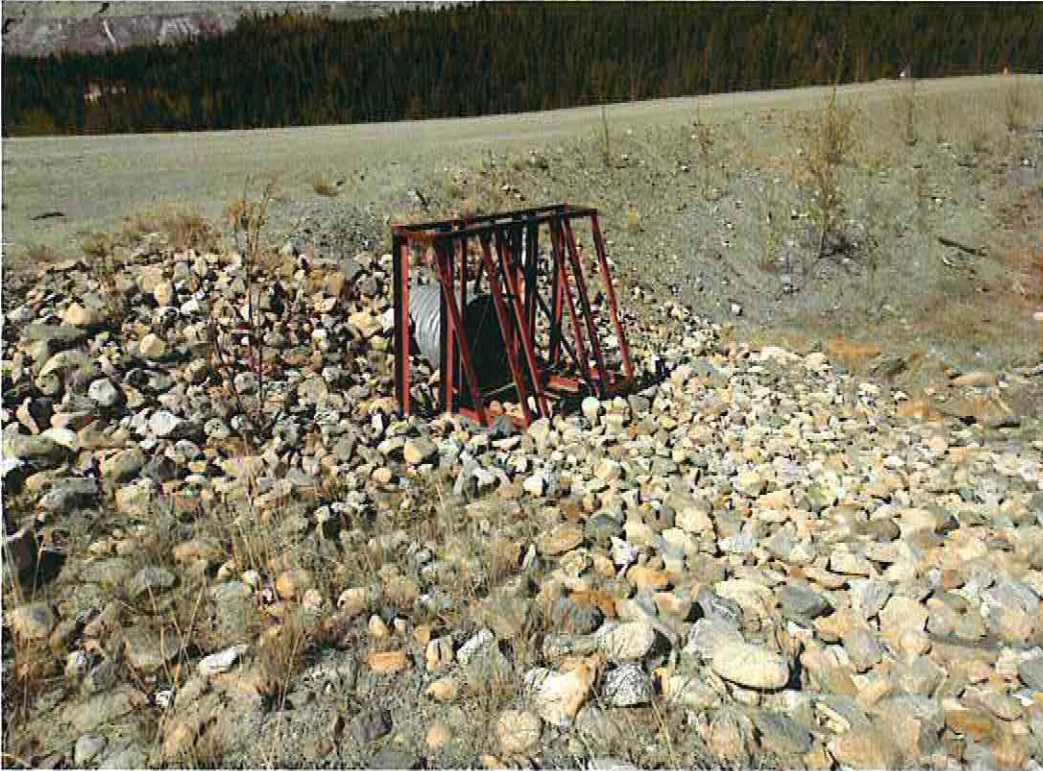
The 900mm CMP emergency spillway (Photo 17) was inspected and is in good condition.

Photo 17: Inlet to the Emergency spillway at The Little Creek Pond

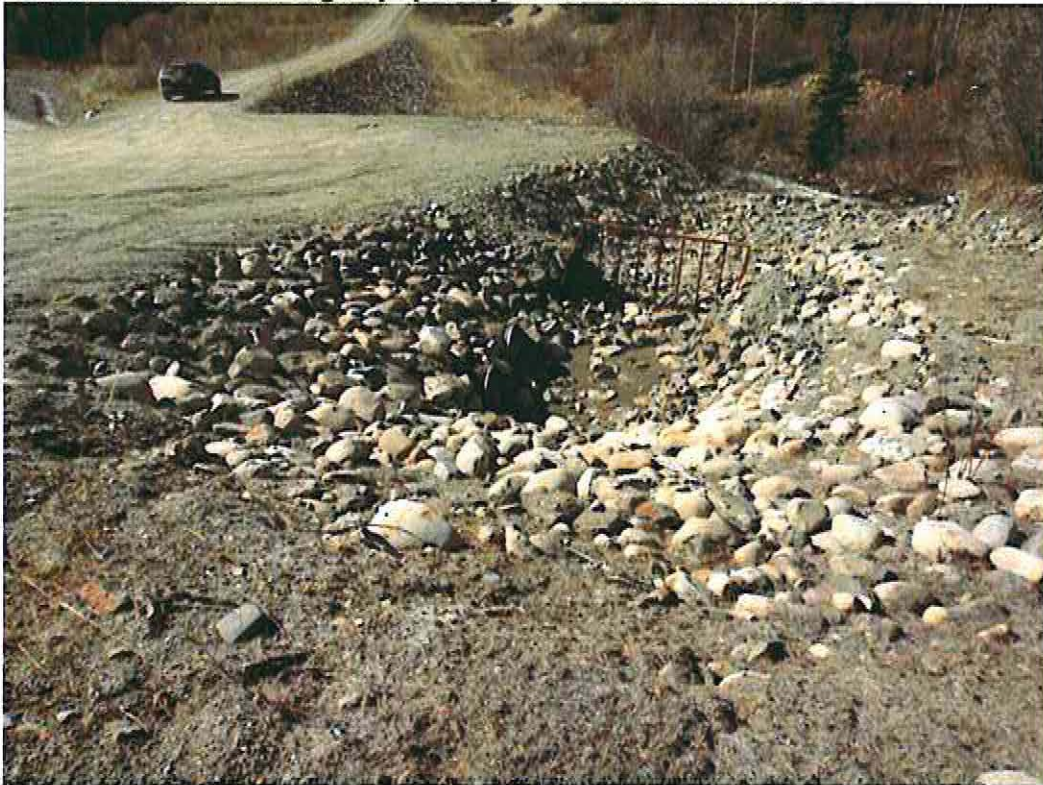
In accordance with a recommendation from SRK, an emergency overflow spillway (2x1m diameter CSP's) was installed at the headworks of the diversion in August 2005 (Photo 18). DES continues to maintain the trash rack at the headworks and the 2.4m diameter flume (Photos 19) to facilitate safe passage of flow in Vangorda Creek. Boulders that fall into the flume are periodically removed. There are no signs of instability or settlement of the embankment at the headworks of the diversion. However, the cross braces that support the flume continue to deteriorate and water continues to escape through openings in the flume joints.

Photo 18: Inlet to emergency spillway at the Headworks of the Vangorda Ck Diversion

SRK recommends that weekly inspections be made of the trash-racks to record any offending debris.

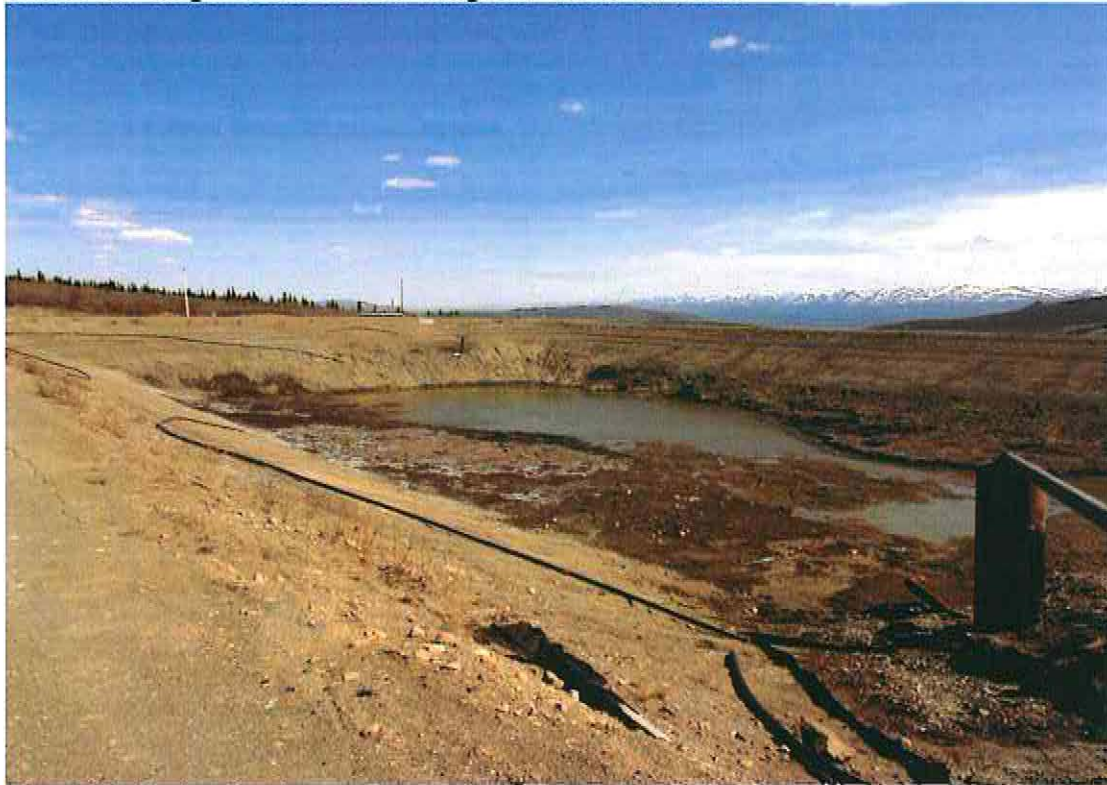
At the time of our inspection, the sludge pond was almost empty (Photo 22). SRK inspected the downstream slopes and crests of the four embankments that make up the sludge pond. Neither subsidence of the slopes, nor settlement of the crest and no tension cracks were observed.

Photo 22: Sludge Pond

- Ensure that the pond level does not exceed 2m. below crest; and
- Continue to monitor on a monthly basis, the crest and sideslopes for cracking or any signs of sloughing.

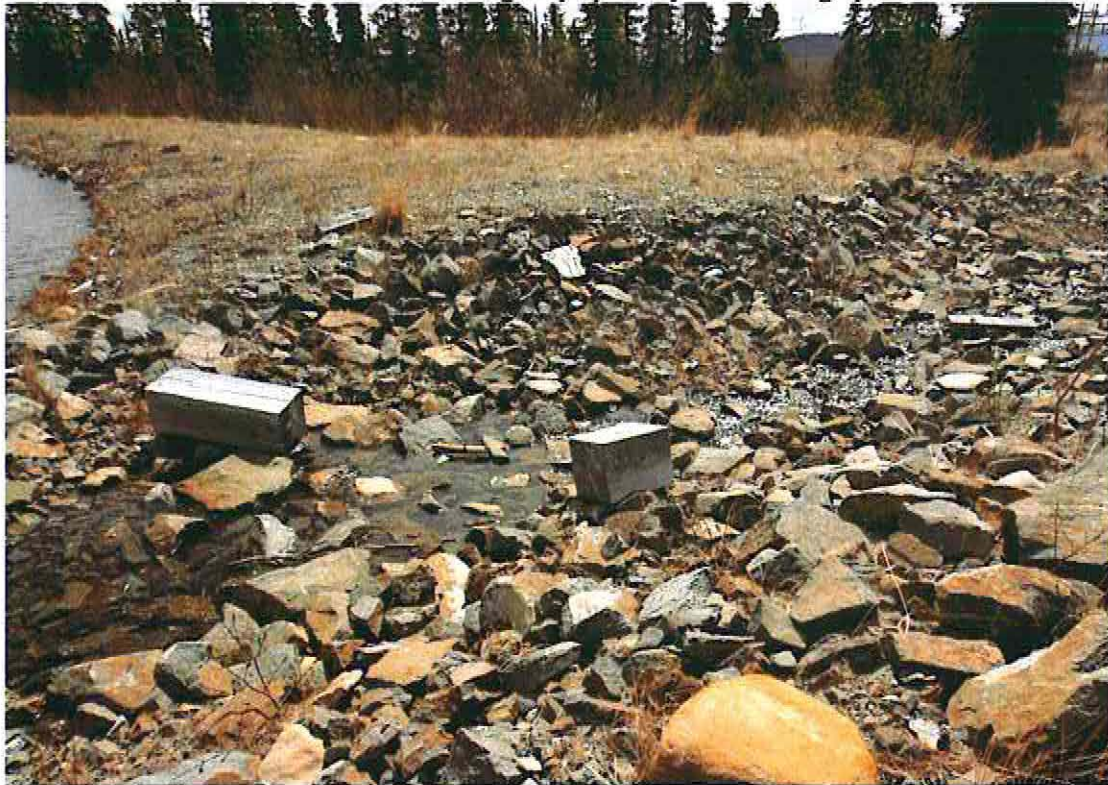
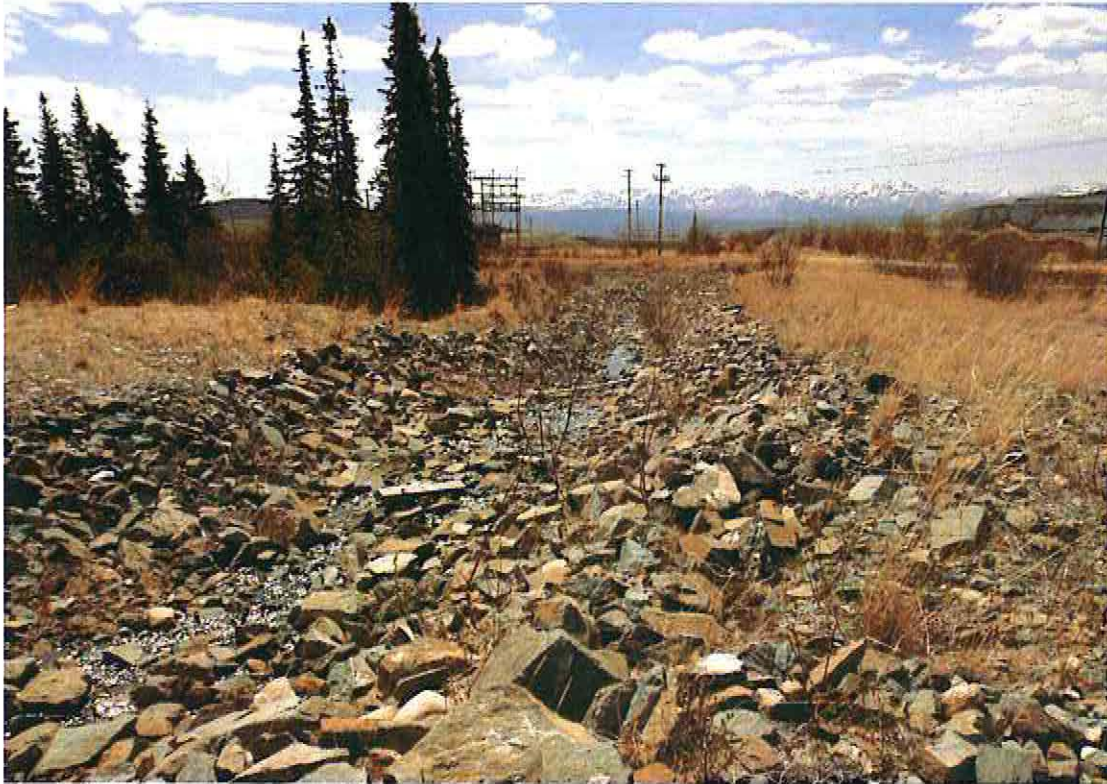
SRK inspected the riprapped open channel spillway (Photo 24 and 25), which conveys flow from the Grum settling pond to the Grum Interceptor Ditch (GID). The spillway is functioning normally. There was no sign or any instability or cracking in the surrounding dyke. No seepage was observed along the toe of the dyke.

Photo 24: Spillway from Grum Settling Pond to GID

Photo 25 Grum Interceptor Ditch

The crest of the embankment around the pond should be monitored monthly for cracks and any seepage into and out of the pond.

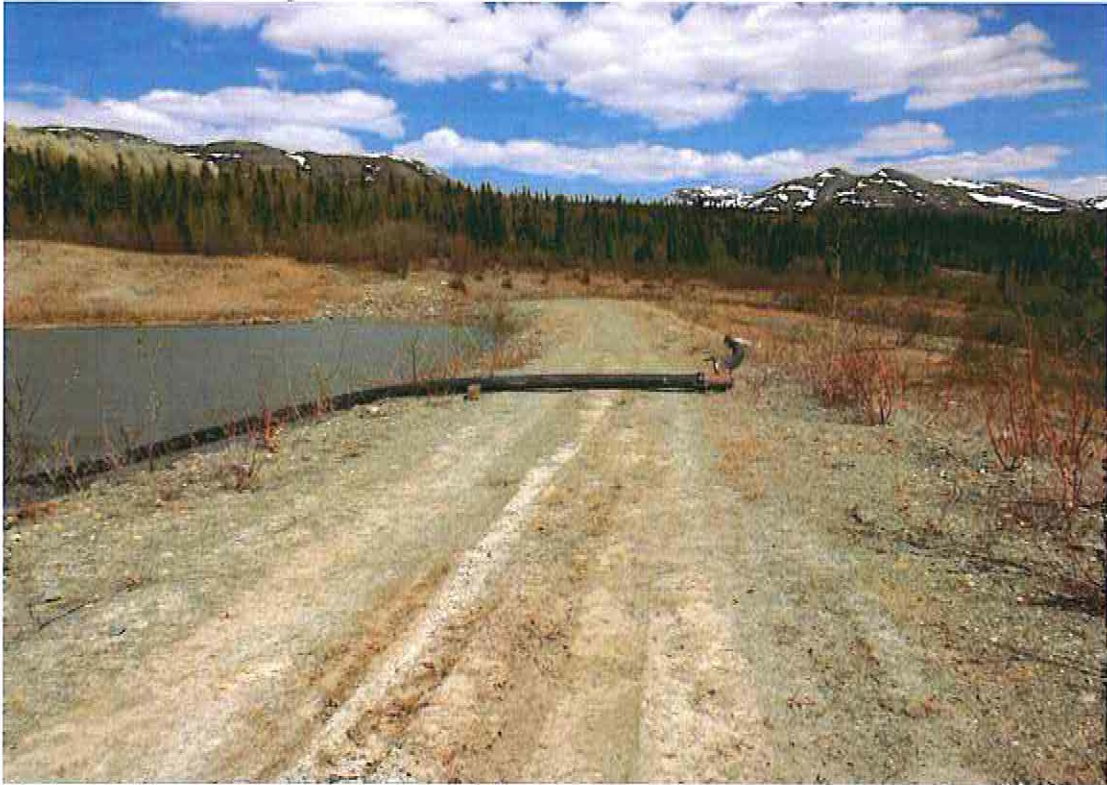
SRK inspected the Sheep Pad Pond dyke (Photo 26) and found no sign of slope instability, settlement or cracking.

Photo 26: Sheep Pad Pond perimeter dyke

- Monitor monthly the crest of the settling pond dykes for any cracks;
- Monitor monthly the toe of the dykes for any seeps; and
- Clear any debris that accumulates at either end of the GID culverts and the settling pond spillway.

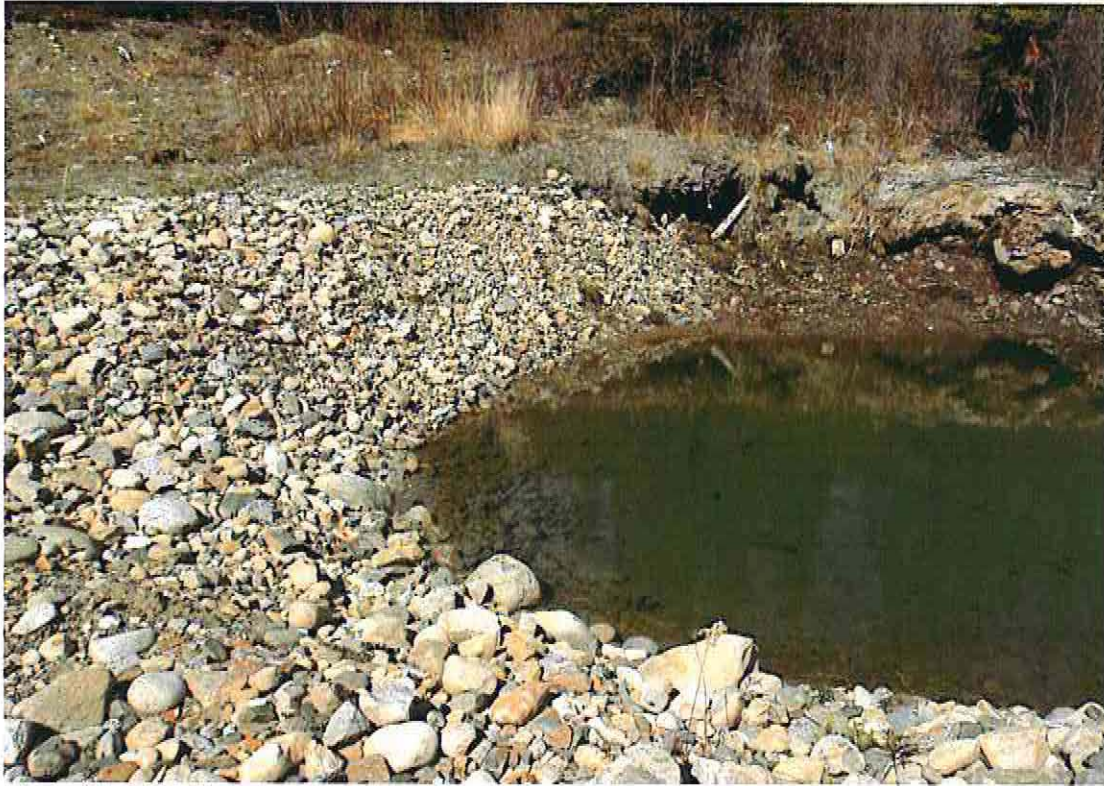
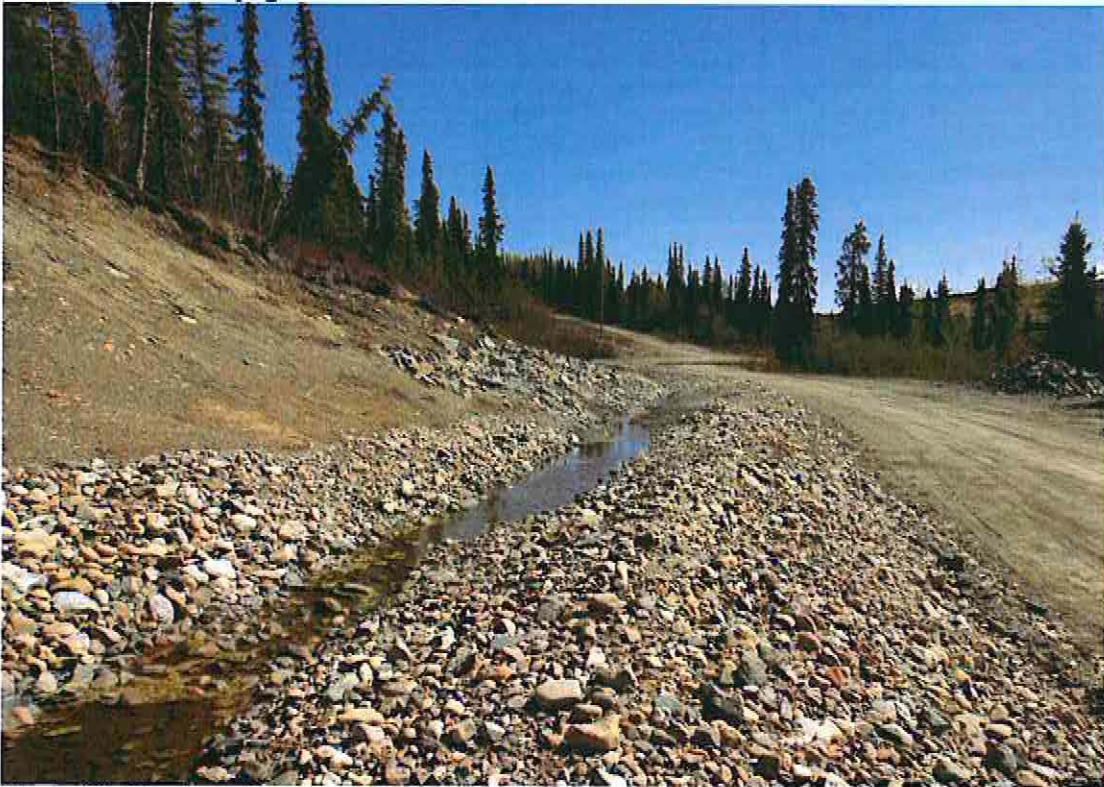
In 2006, increasing concentrations of zinc were observed at the outlet of the V15 sedimentation pond (Photo 27) upstream of Tributary A. In response to this finding, a Bentomat lined diversion ditch (Photo 28) was constructed in August, 2007 to divert outflow from this pond to a naturally formed Kettle called Moose Pond. In previous years a subsidence on an upstream section of the ditch had occurred and blocked off the ditch. Last fall, DES removed the debris and reconstructed that section of the bank by placing additional riprap over the area in question. SRK inspected the ditch during the 2010 site visit and no further subsidence was noted. However the area was showing signs of ongoing seepage and it is likely that further subsidence could occur in the future. SRK also understands that during the winter, this ditch glaciates both upstream and downstream of the culvert crossing just below the V notch weir.

Photo 27: V15 Seepage collection Pond

Photo 28: Bentomat Lined Ditch from V-15
