2010 Annual Inspection Waste and Water Management Facilities Vangorda/Grum

Faro Mine Complex, Yukon

Project Reference Number
SRK 1CD009.003

February 2011

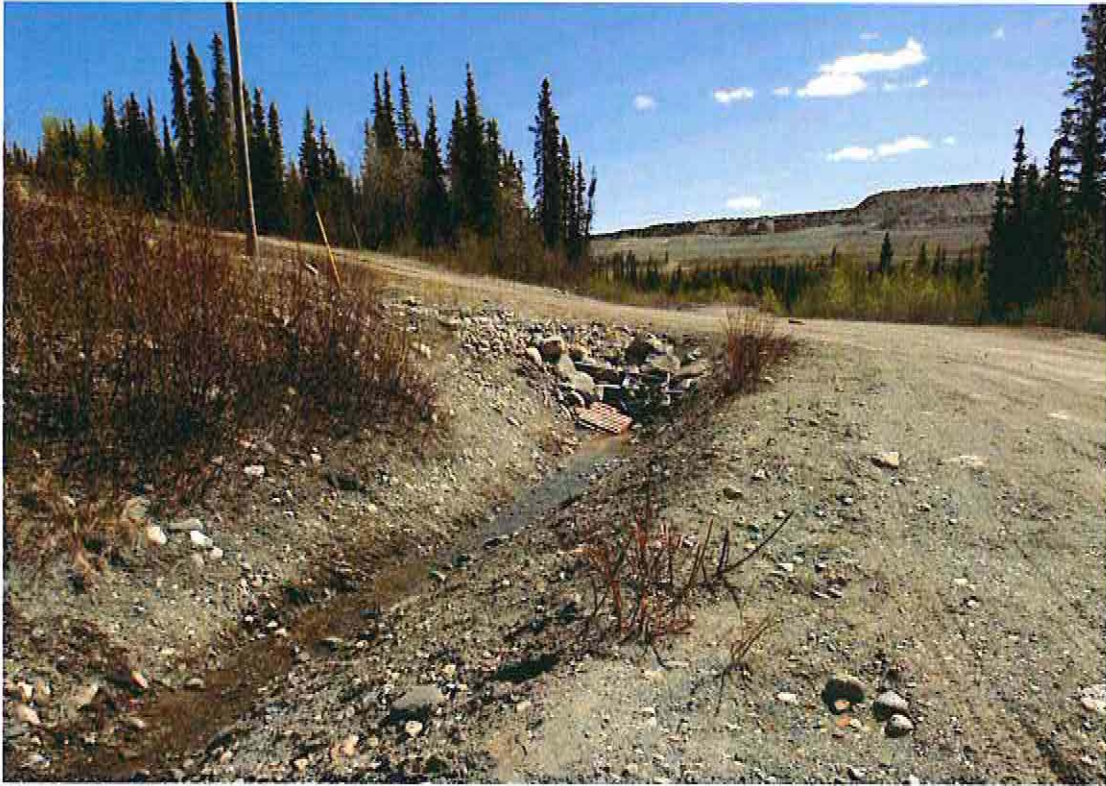
SRK also noted that debris had built up in front of the culvert just below the V notch weir in the Main Stem of Grum Creek (Photo 29). This blockage likely exacerbates the glaciation. SRK understands that DES has removed the debris.

Photo 29: Culvert below V-notch weir on Grum creek

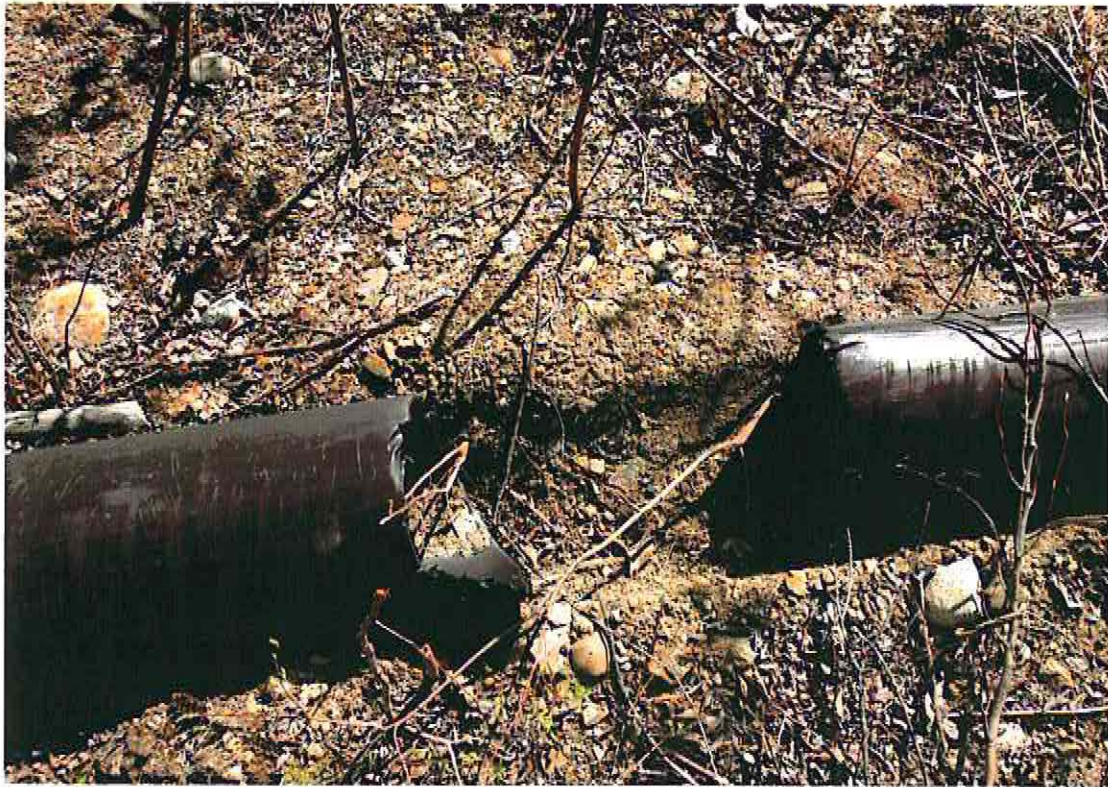
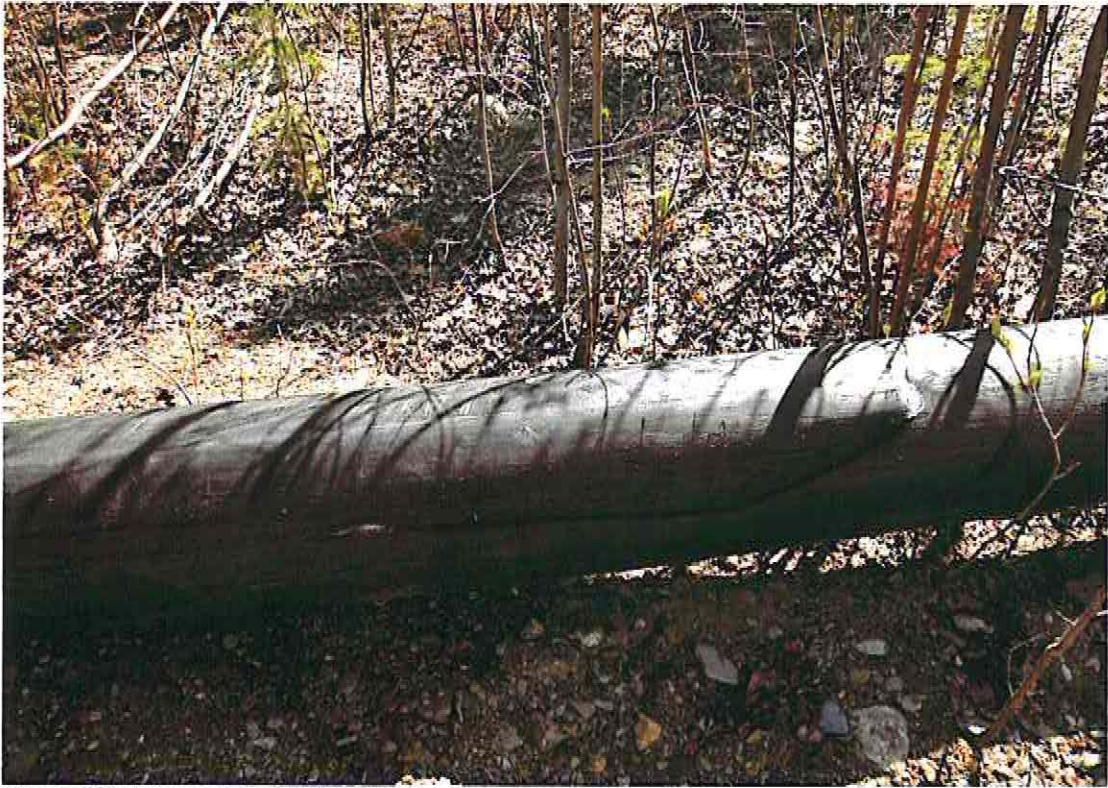
The siphon pipeline that was installed to convey excess water from Moose Pond to Tributary A has been damaged in a number of places (Photo 31 and 32). However SRK understands that a pipeline and electrical infrastructure has been installed at the V-15 sump to facilitate pumping from the pond to the Vangorda Pit. The response to activate the system is a few days and this system could be used to reduce the risk of overflow from Moose Pond. This would reduce the immediate requirement to repair the damaged siphon pipeline.

Photo 31: Break in siphon line from Moose Pond

Photo 32: Damage to Siphon Line

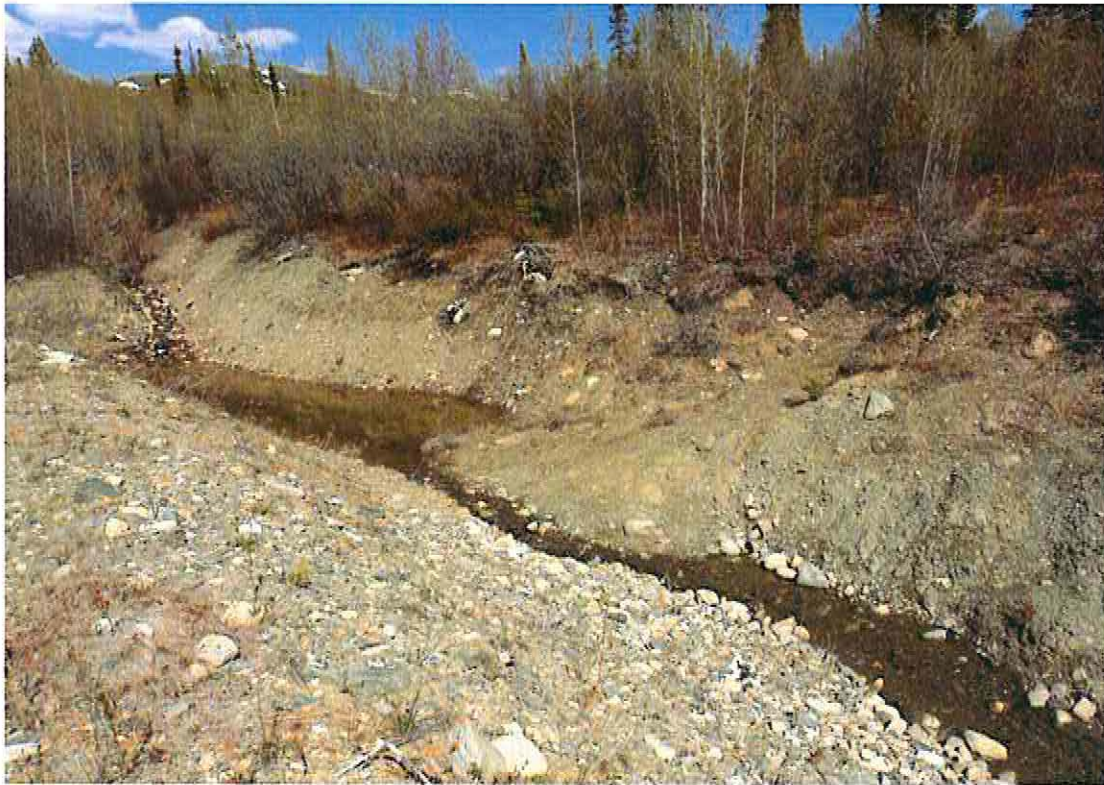
Photo 33: Subsidence in the Surface water runoff diversion ditch above the Vangorda Pit

SRK recommends that DES inspect this ditch on a monthly basis during the summer months looking for signs of subsidence similar to the one in photo 33. These occurrences should be noted and if found to restricting flow, should be excavated out.
