2011 Geotechnical Inspection Waste and Water Management Facilities Vangorda/Grum Faro Mine Complex, Yukon

Denison Environmental Services

SRK Consulting (Canada) Inc.
1CD009.005
August 2011

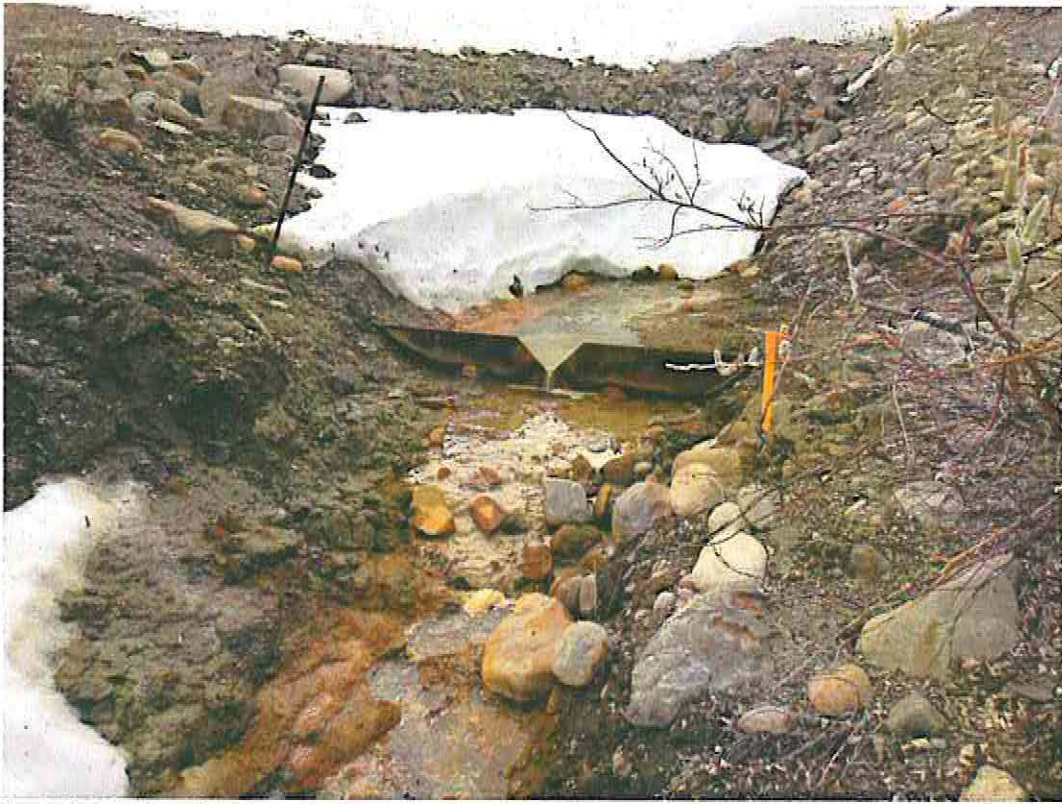
During this year's inspection, seepage flow was observed at Weir #6 (Photo 1) and Weir #5 (Photo 2). The ditch from Weir #4 (Photo 3) was snow covered with a trace of seepage. Measurable seepage was observed at Weir #3 (Photo 4).

Photo 1: Drain #6

The outlet of these drains should be inspected monthly for any signs of damage or deterioration of the steel v-notch weirs. The inspection should include recording of any flow or seepage rates.

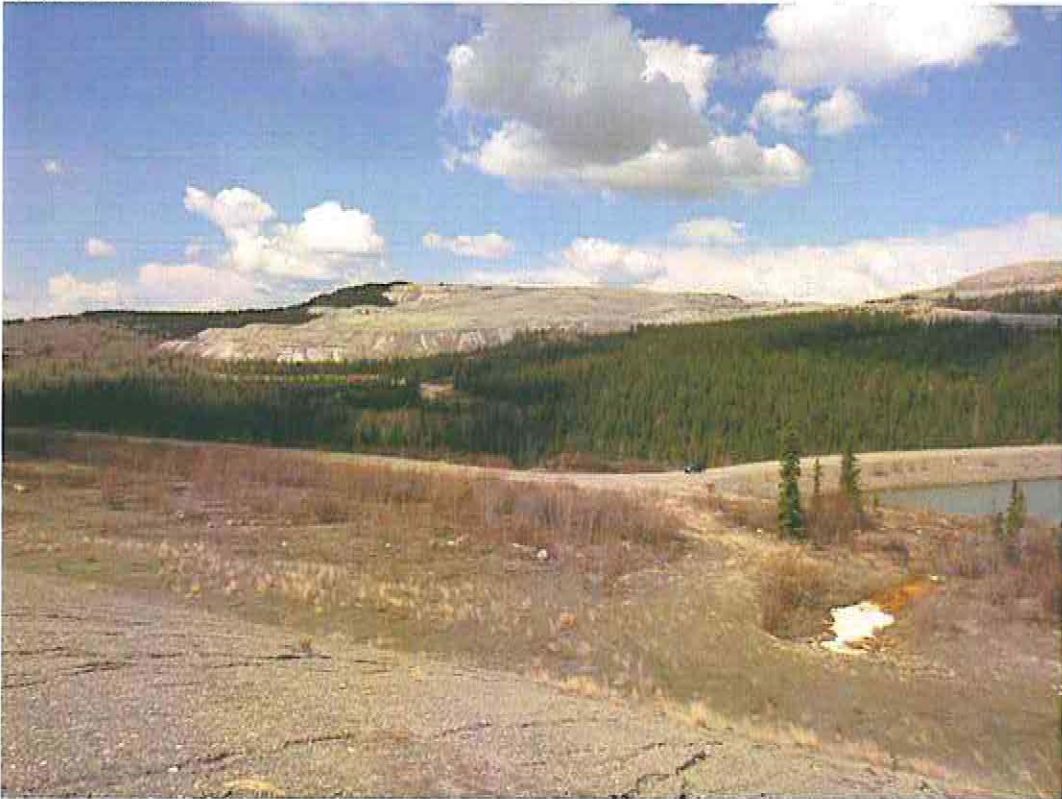
Photo 2: Drain #5 with Grum Dump in Background

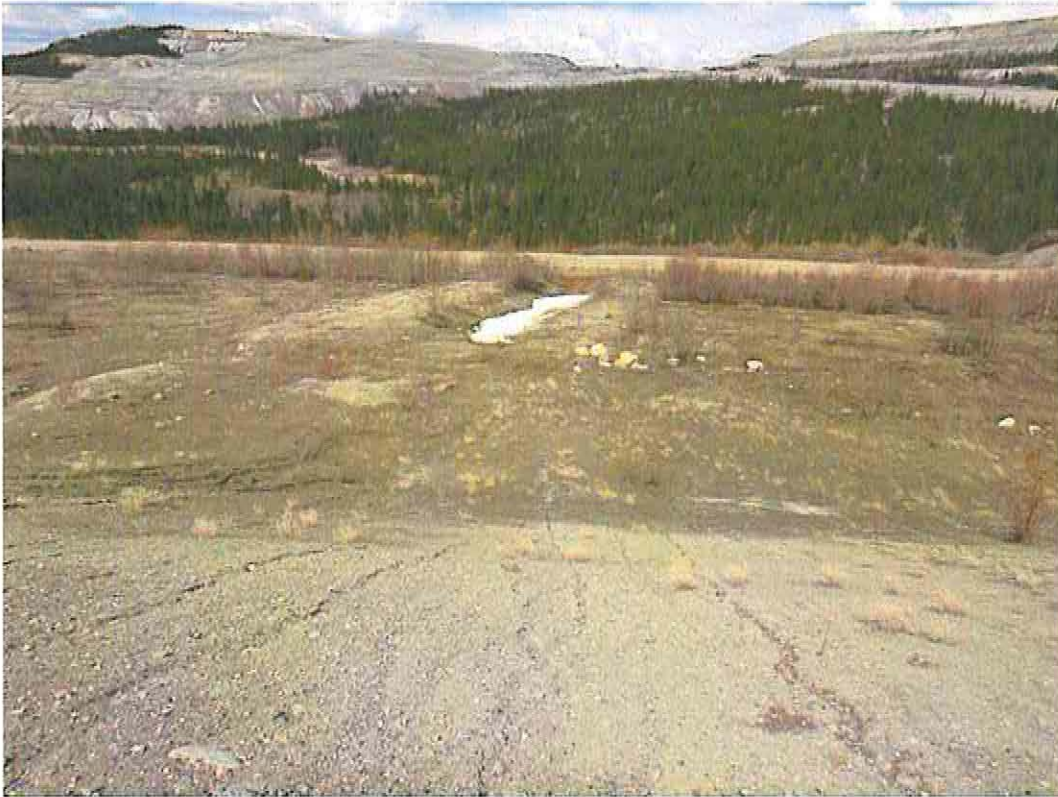
Photo 3: Drain # 4

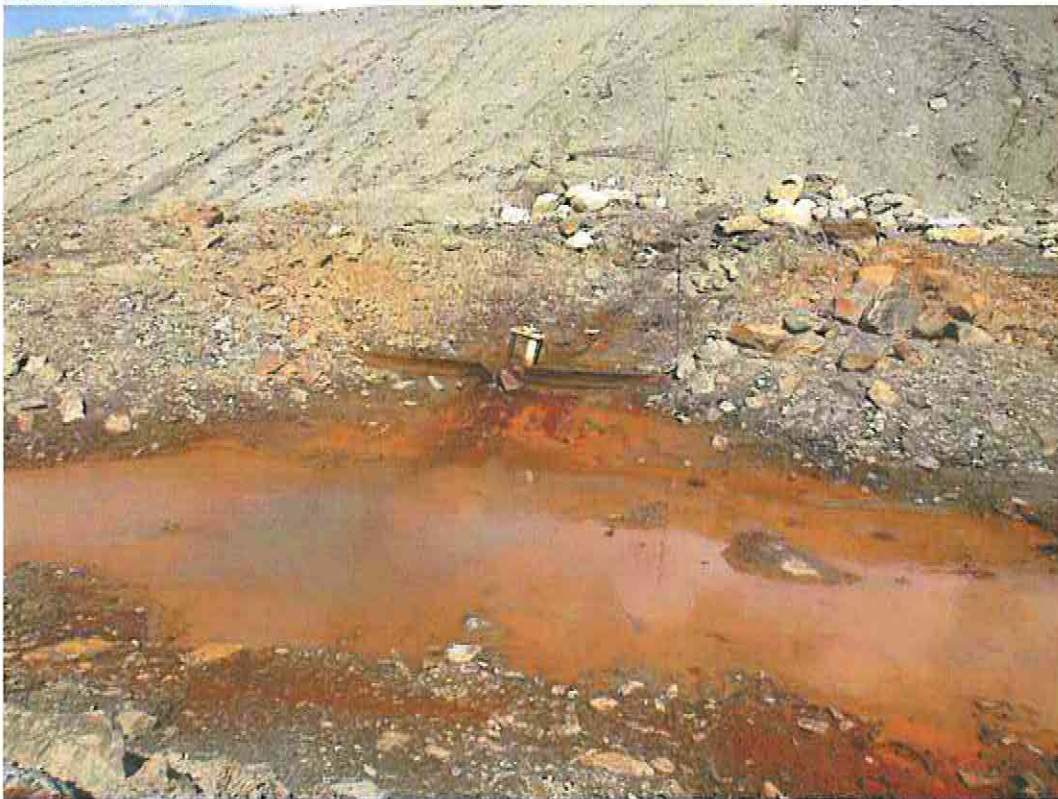
Photo 4: Drain #3

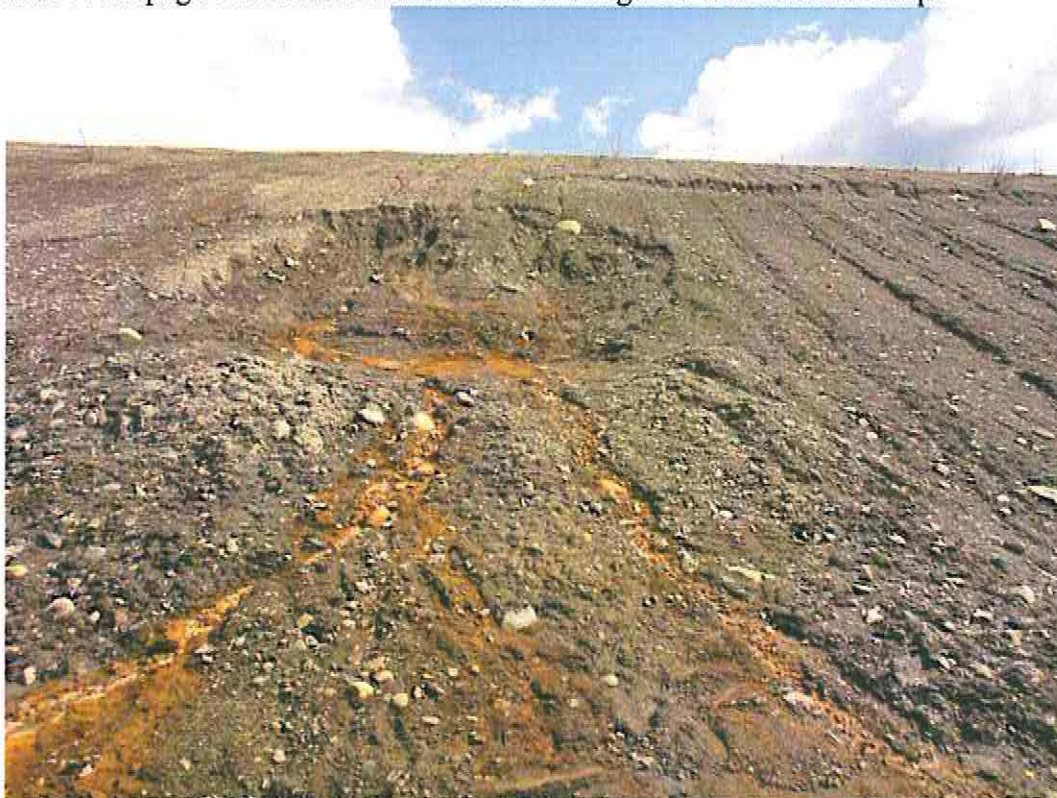
In 2006, Deloitte and Touche resloped sections of the till starter dyke. During the 2008 inspection, a small shallow subsidence was observed on the sideslope of these resloped areas. In addition to this subsidence, a number of wet spots and salt depositions were also noted near the crest of the dyke.

In the 2009 report, SRK commented that a possible cause of the wet areas and the shallow subsidence may be due to an elevated water table within the waste rock behind the dyke. However water levels recorded in the dumps wells installed by SRK in 2010, demonstrated that the water table within the waste rock was too low to cause the observed seepage associated with the subsidence. During the 2011 inspection of the shallow subsidence on the till dyke at the western end of the dump (Photo 8), although there was evidence of seepage, we observed that the area was dry and no further subsidence had occurred since our inspection in 2010.

Photo 8: Shallow Subsidence on Till Dyke Above Seepage Collection Ditch

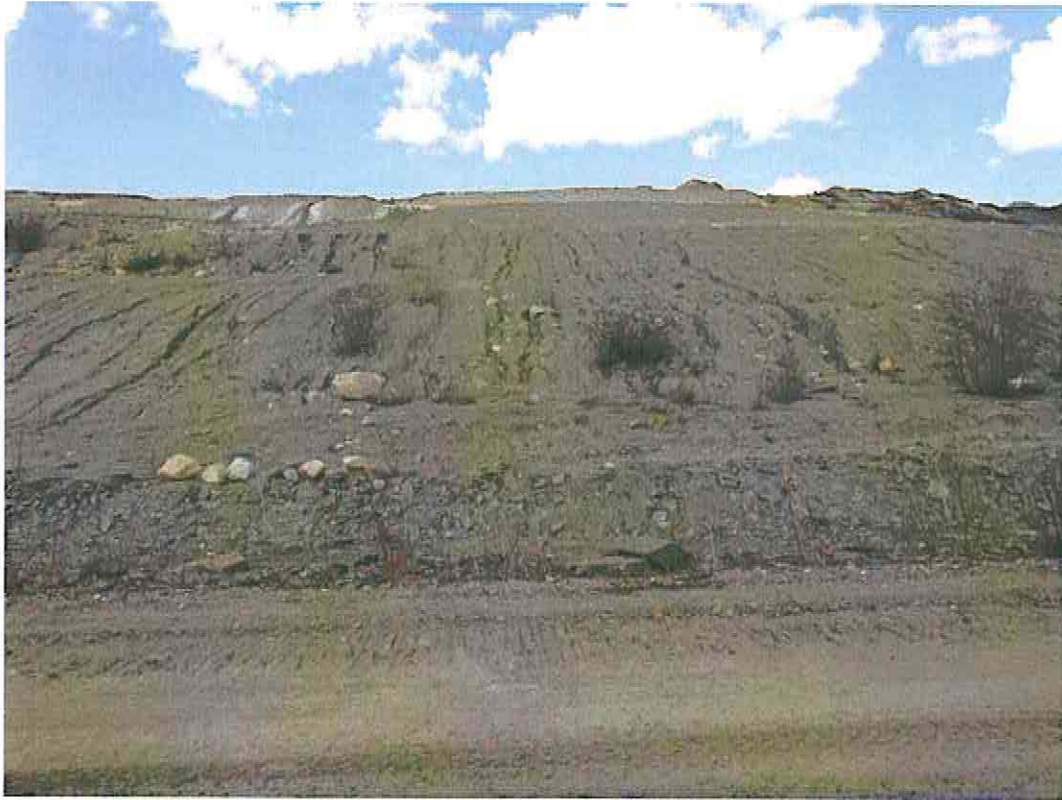
Photo 9 shows the area of the resloped till dyke below the till cover trials. These slopes show some signs of erosion but not significant enough to warrant any immediate remedial action. There were no signs of major instability. DES continues to monitor the upper reaches of the ditch for infill by sediment caused by erosion of the cover.

Photo 9: Erosion on the Till Dyke Blow Cover Trials

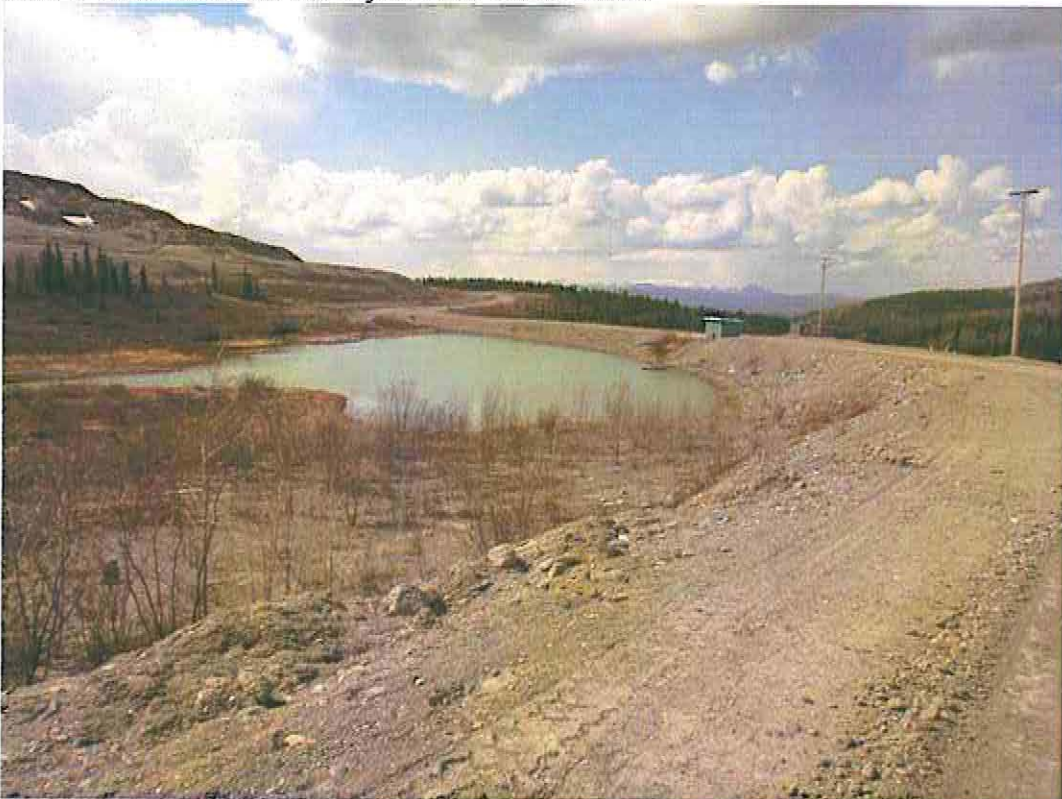
Water level in the pond (Photo 10) during our inspection on May 24, 2011 was recorded at about 1109m. No cracks or major settlement of the dam were observed and no seepage was observed along the downstream toe. Erosion rills are evident on both the upstream and downstream slopes of the dam (Photo 11).

Photo 10: Little Creek Pond

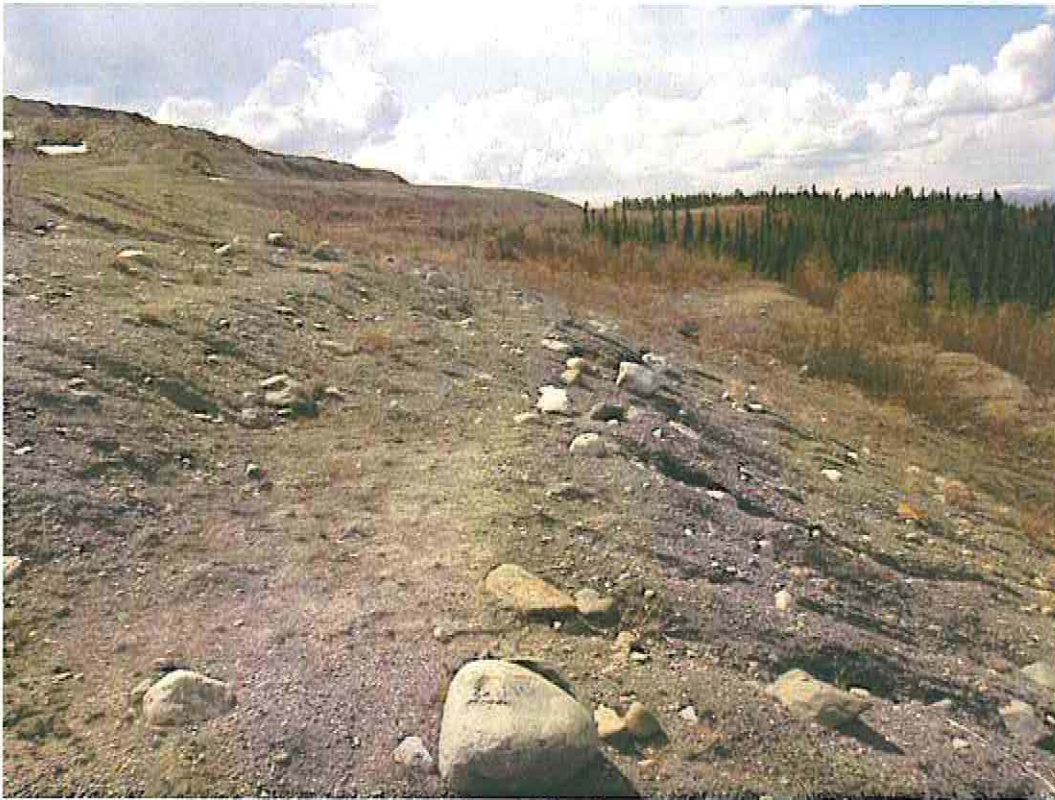
Photo 11: Downstream Face of Little Creek Pond

DES should continue to regularly monitor the crest of the dam for any cracks, settlement or surficial movement of the slope.

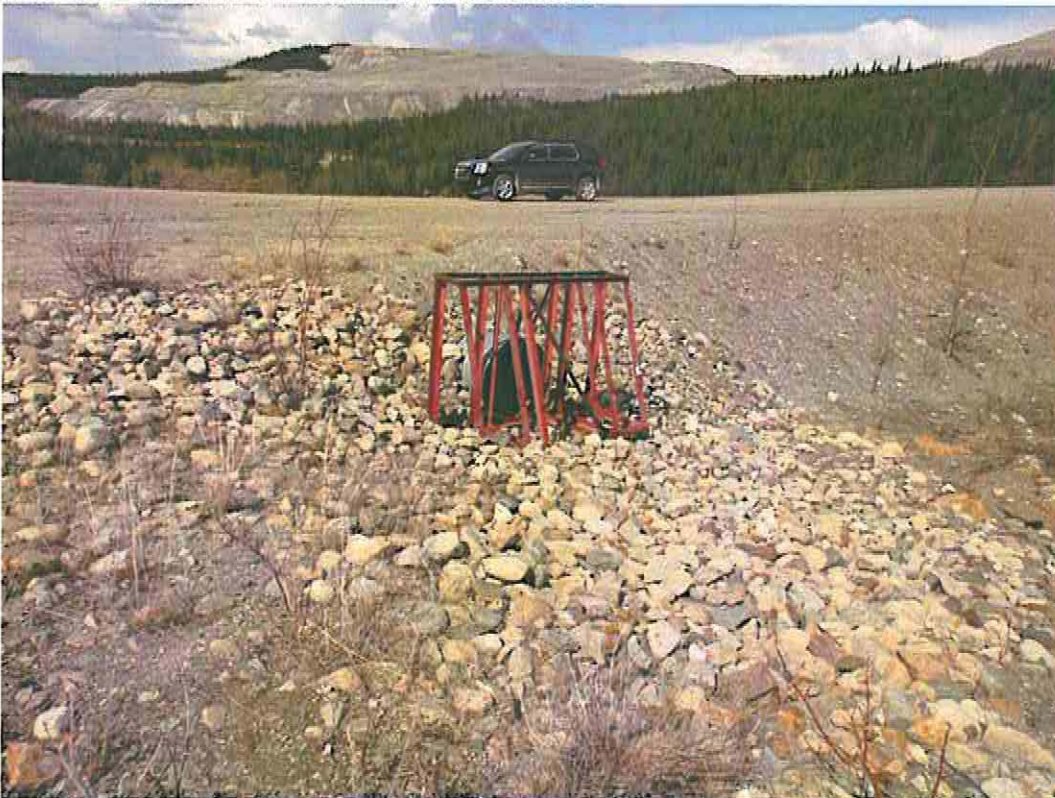
The 900mm CMP emergency spillway (Photo 12) and the associated plunge pool (Photo 13) were inspected and are in good condition. The water ponded in the pool was derived from snow melt and runoff.

Photo 12: Inlet to the Emergency Spillway at Little Creek Pond

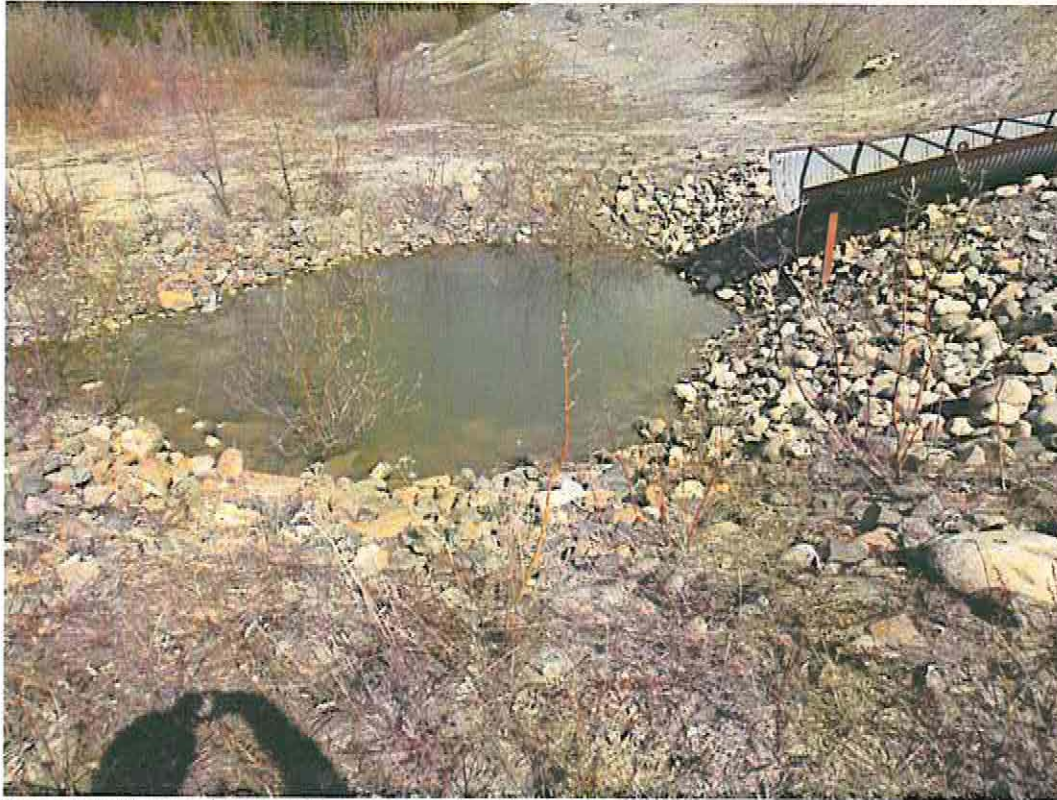
Photo 13: Plunge Pool at Emergency Spillway at LCD

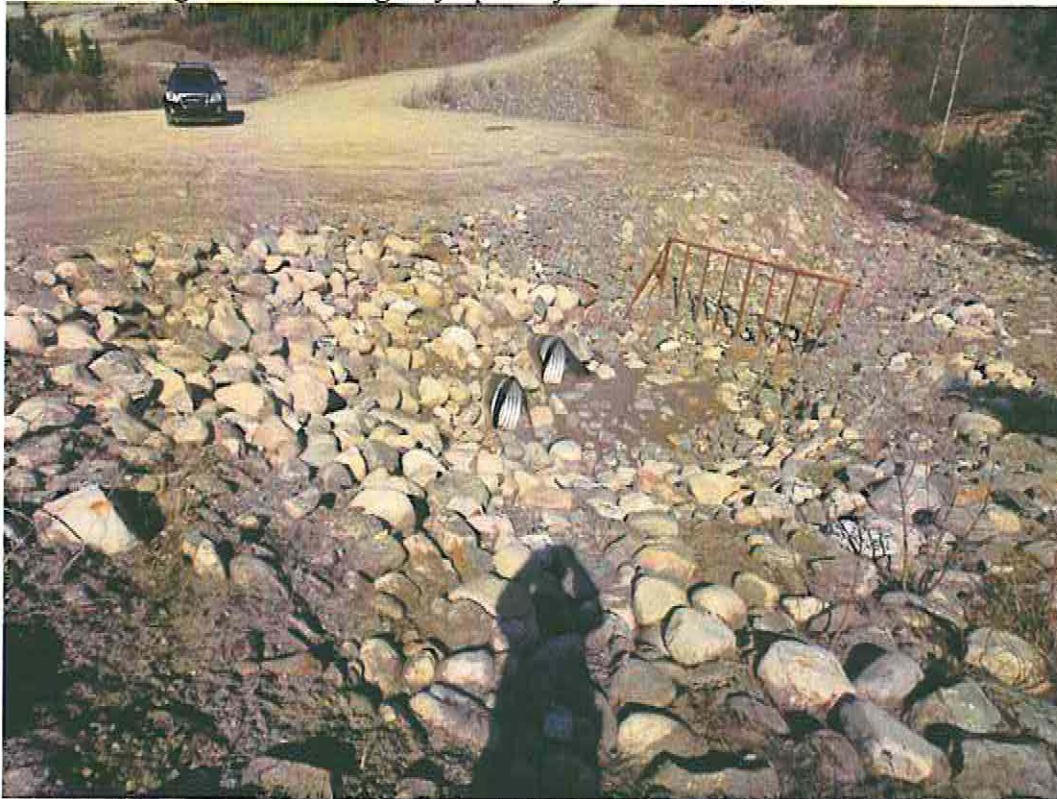
In accordance with a recommendation from SRK, an emergency overflow spillway (2x1m diameter CSP's) was installed at the headworks of the diversion in August 2005 (Photo 14). DES continues to inspect the trash rack at the headworks (Photo 15) and the 2.4m diameter flume (Photos 16, 17 and 18) to facilitate safe passage of flow in Vangorda Creek. Boulders that fall into the flume are periodically removed. There are no signs of instability or settlement of the embankment at the headworks of the diversion. However, the cross braces that support the flume continue to deteriorate and water continues to escape through openings in the flume joints.

Photo 14: Inlet to Emergency Spillway at the Headworks of the Vangorda Ck Diversion

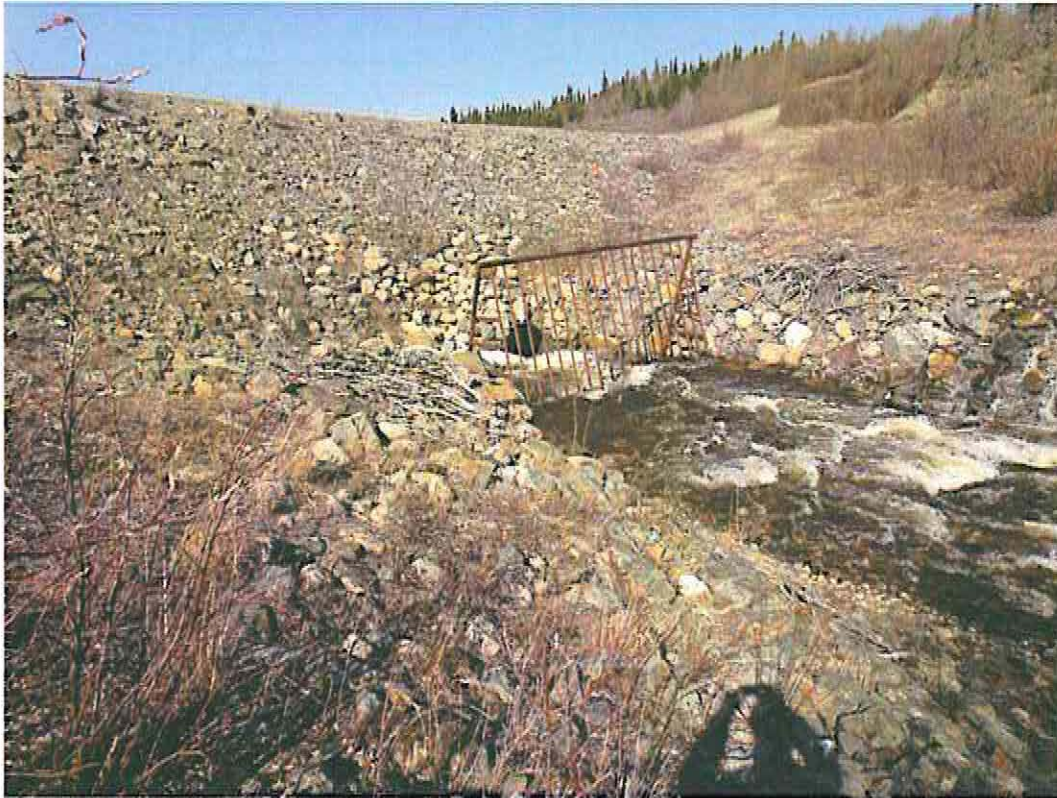
Photo 15: Trashrack at Headworks of Vangorda Creek Diversion

SRK recommends that weekly inspections be made of the trash-racks to record any offending debris.

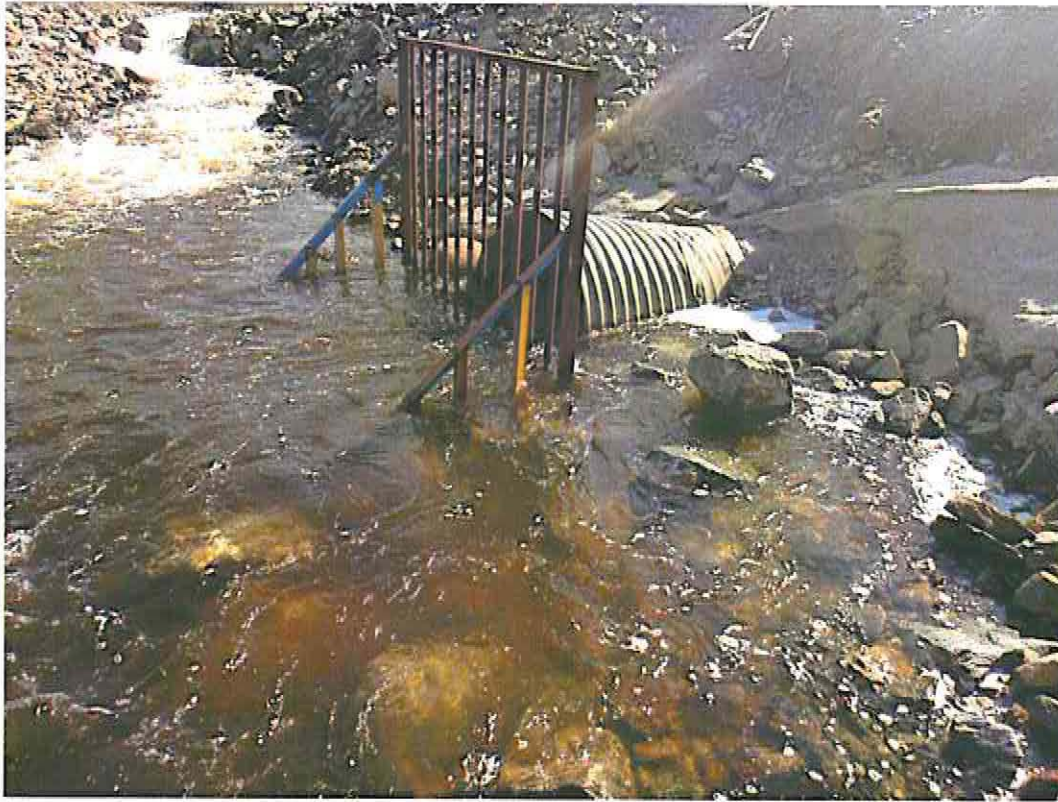
The 2m diameter CMP culvert in the plunge pool shows signs of wear and tear around the entrance to the pipe (Photos 19 and 20). A trash rack has been installed at the entrance. During the inspection no debris on the trash rack was noted.

Photo 19: Plunge Pool at Base of Vangorda Creek Diversion

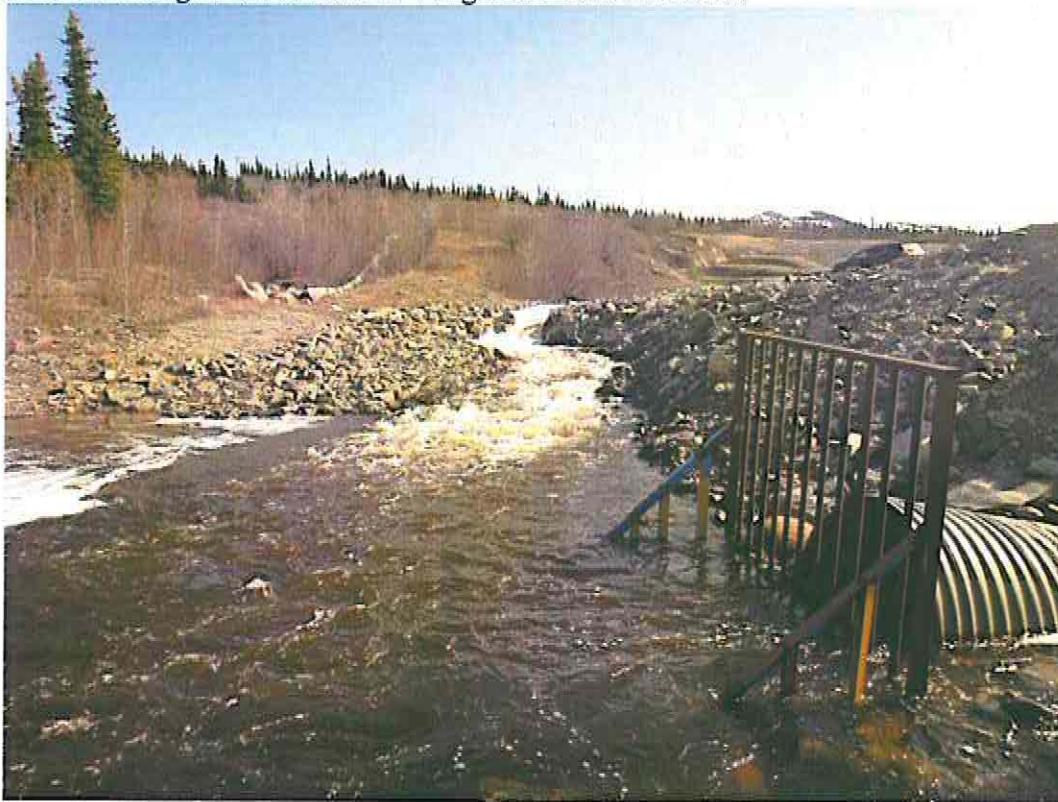
Photo 20: Vangorda Diversion Entering Plunge Pool

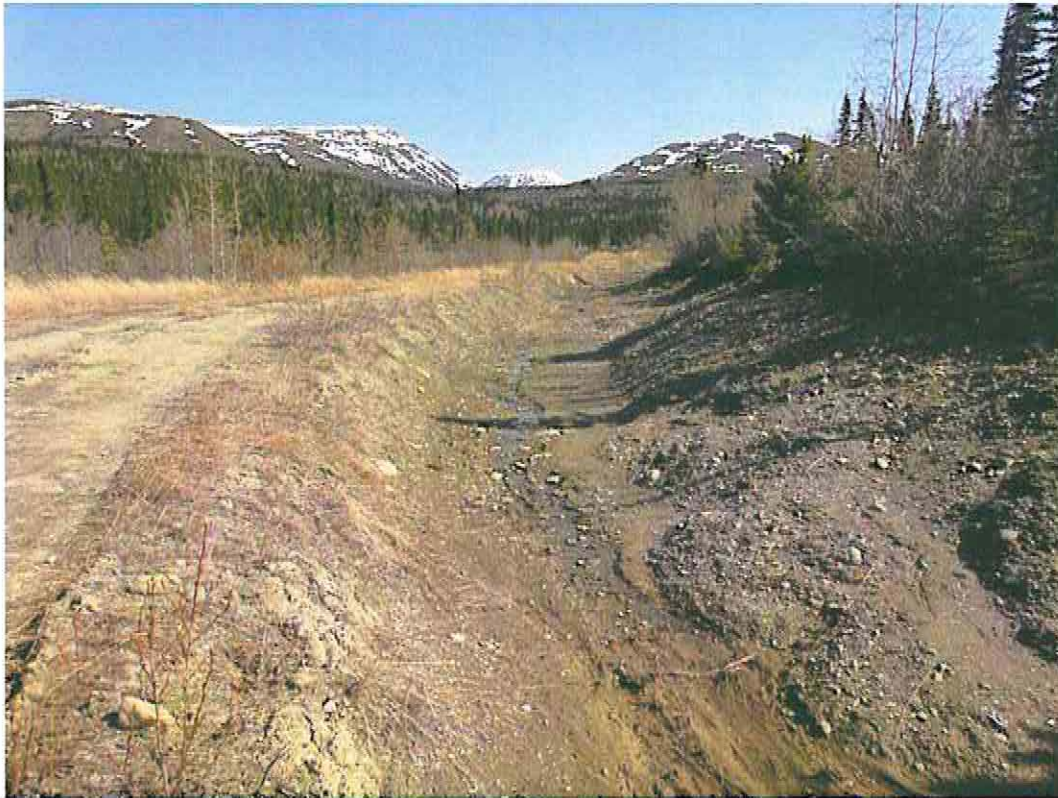
Photo 21: Vangorda Pit North Interceptor Ditch (upper reach)

SRK recommends that DES inspect this ditch on a monthly basis during the summer months looking for signs of subsidence similar to the one in Photo 21. These occurrences should be noted and if found to restricting flow, should be excavated out.

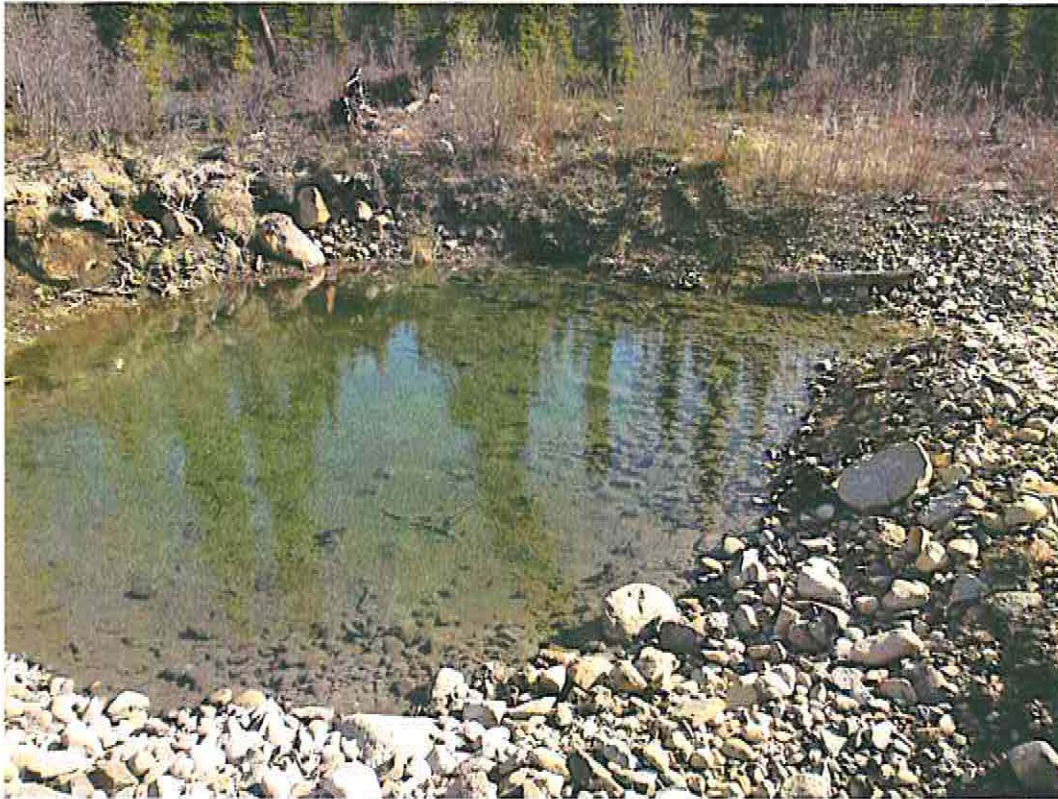
In 2006, increasing concentrations of zinc were observed at the outlet of the V15 sedimentation pond (Photo 23) upstream of Tributary A. In response to this finding, a Bentomat lined diversion ditch (Photo 24) was constructed in August, 2007 to divert outflow from this pond to a naturally formed Kettle called Moose Pond. Flow from this diversion ditch and the Main Stem of Grum Creek are directed to Moose Pond via a drainage ditch (see Photo 29). Below the V-15 pond is a culvert across the access road which discharges seepage and runoff to the Tributary A. At the time of our inspection, it was noted that the culvert was blocked and water was ponding at the inlet of the culvert (Photo 25). There was evidence in the shoulder of the road above the outlet of the culvert indicating that water had overtopped the road and caused some erosion (Photo 26).

Photo 23: Seepage Collection Pond

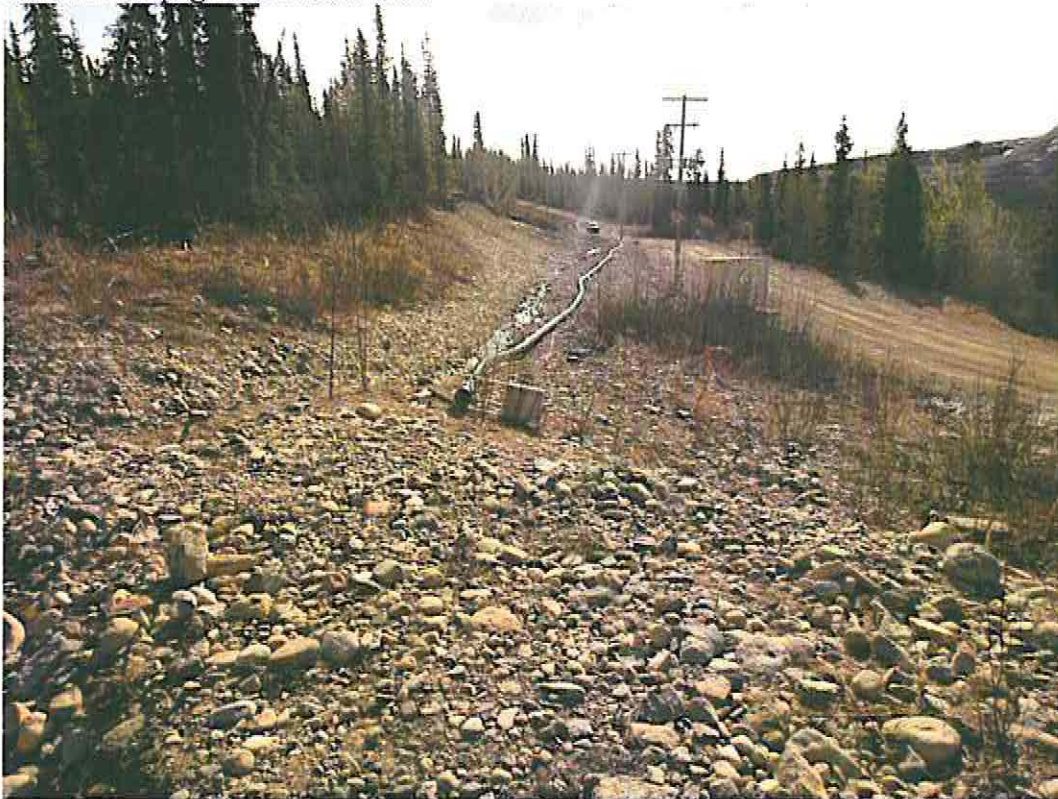
Photo 24: Bentomat Lined Ditch from V-15

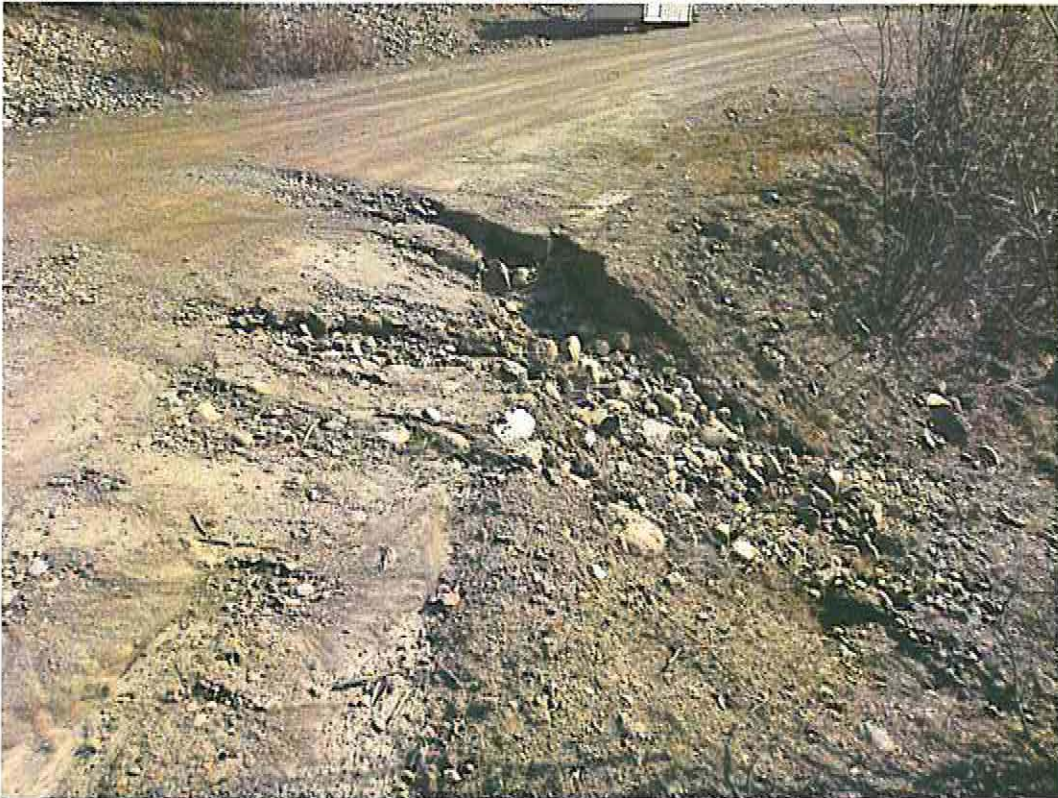
Photo 26: Outlet End of Blocked Culvert V-15 Pond

The culvert upstream of Tributary A has been cleaned out but the shoulder above the culvert outlet still needs to be repaired.

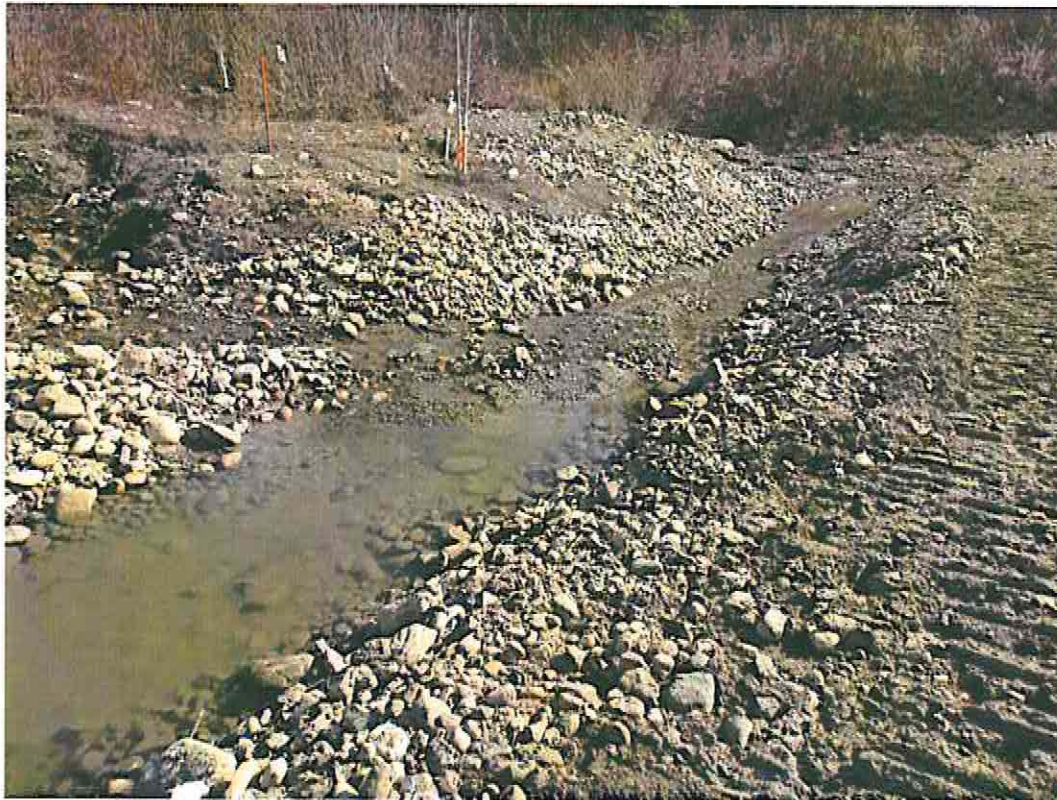
At the lower reach of the V-15 seepage collection ditch (Photo 27), just above the confluence with the Main Stem of Grum Creek and the V-notch weir (Photo 28), it was noted that sediment had built up in the channel. There was also evidence that a significant volume of silt had passed through the V-notch weir and made it way down to Moose Pond (Photo 30). SRK understand that in earlier May 2011, a unexpected rapid snow melt had resulted in the release of high silt laden runoff from the recently completed till cover on the Grum Sulphide cell (GSC) which ended up in Moose Pond. SRK also understands that at one point the volume of runoff from the GSC resulted in a rapid rise of the water level in Moose Pond (Photo 31) which was stressing the downstream slope of the natural embankment of Moose Pond causing high seepage flow through gravel seams in the embankment.

Photo 27: Seepage Collection Ditch Upstream of V-notch Weir in Main Stem of Grum Creek

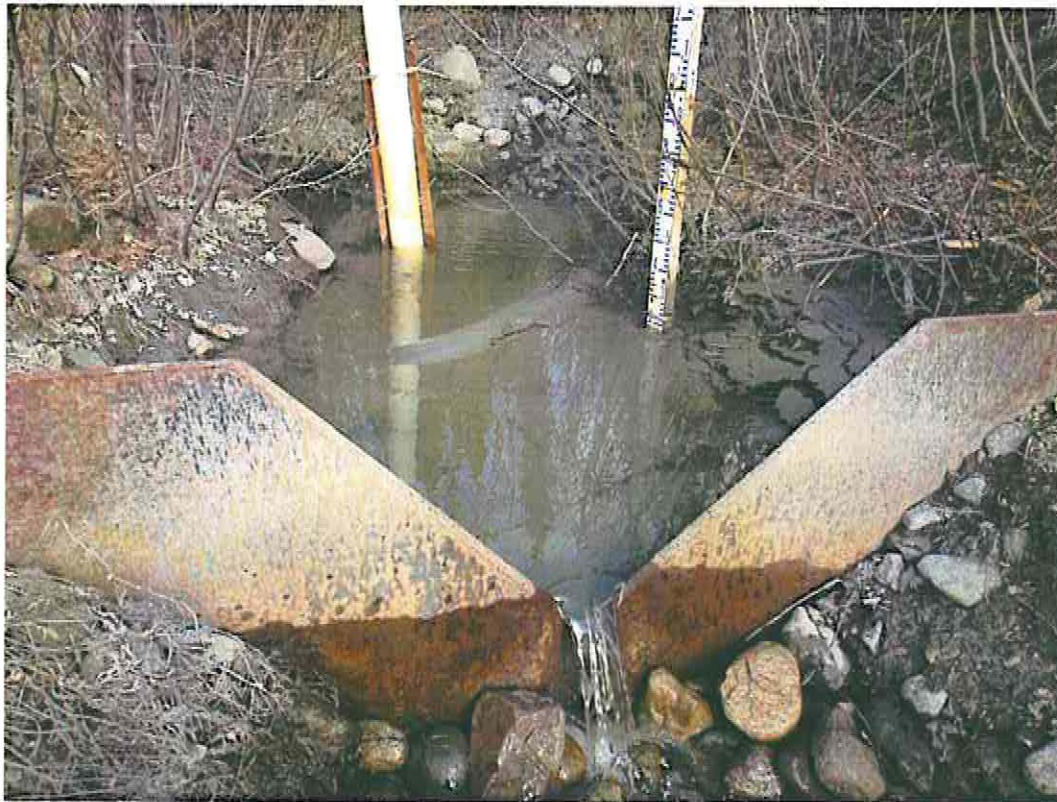
Photo 28: V-notch Weir on Main Stem of Grum Creek

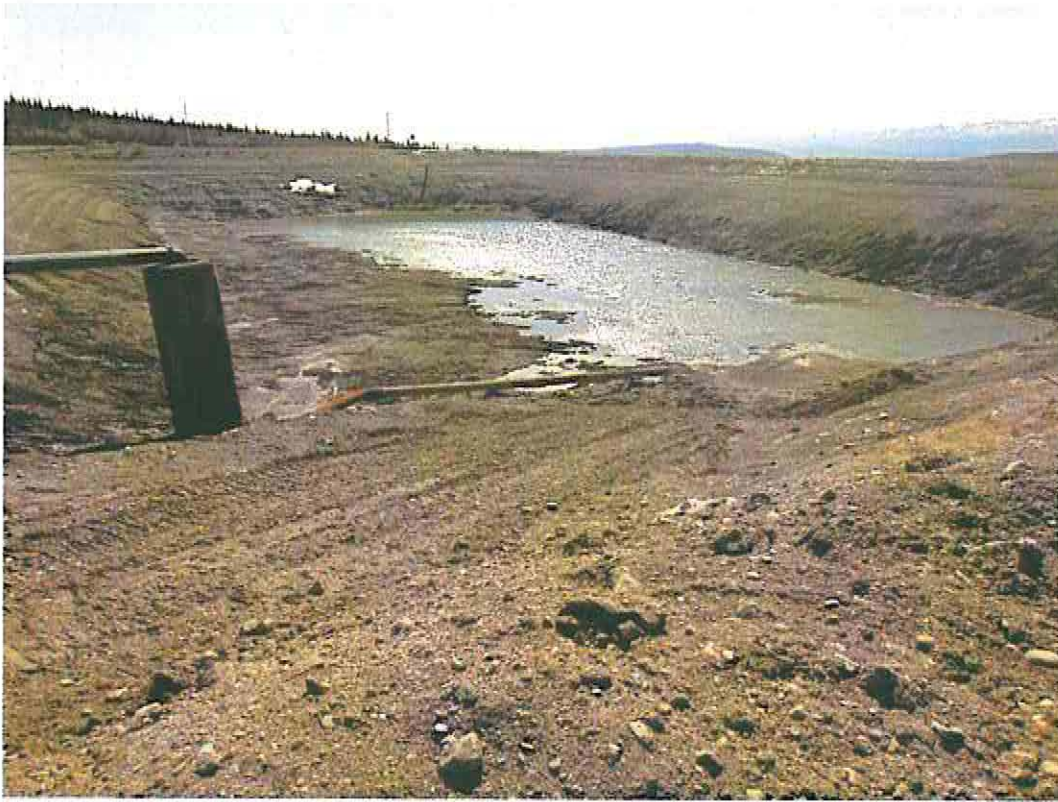
At the time of our inspection, the sludge pond was almost empty (Photo 33). SRK inspected the downstream slopes and crests of the four embankments (Photos 34 and 35) that make up the sludge pond. No subsidence of the slopes, or settlement of the crest and no tension cracks were observed.

Photo 33: Sludge Pond

- Ensure that the pond level does not exceed 2m. below crest; and
- Continue to monitor on a monthly basis, the crest and sideslopes for cracking or any signs of sloughing.

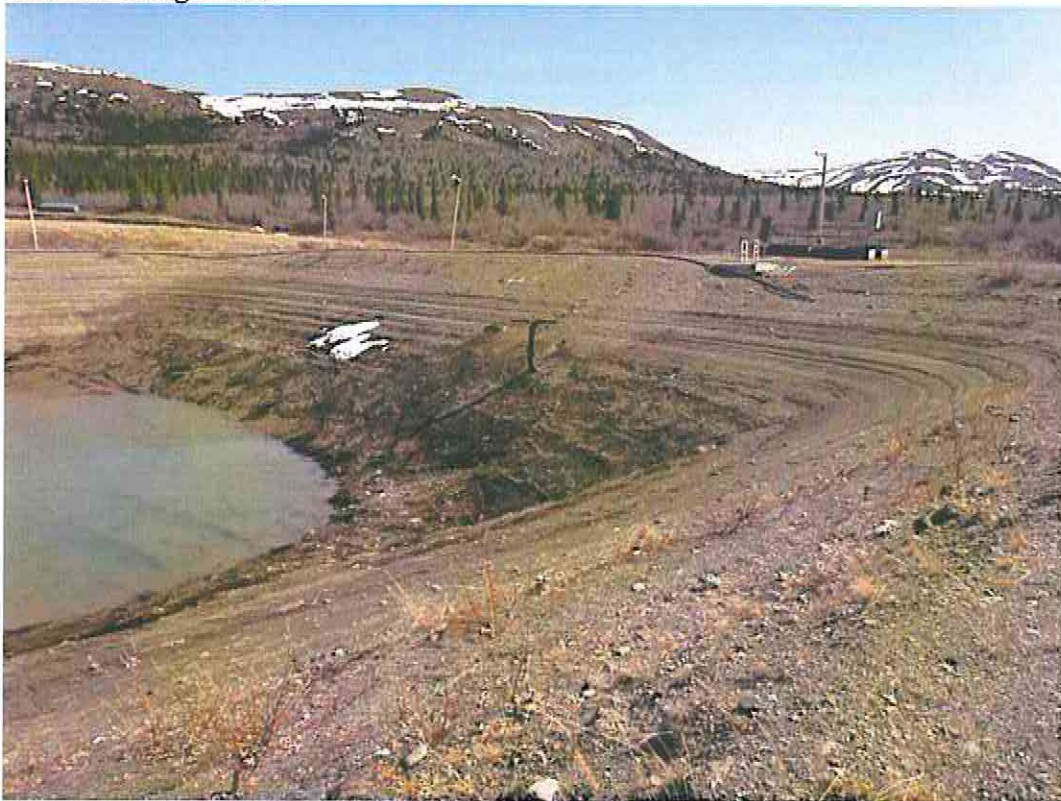
Photo 34: Sludge Pond

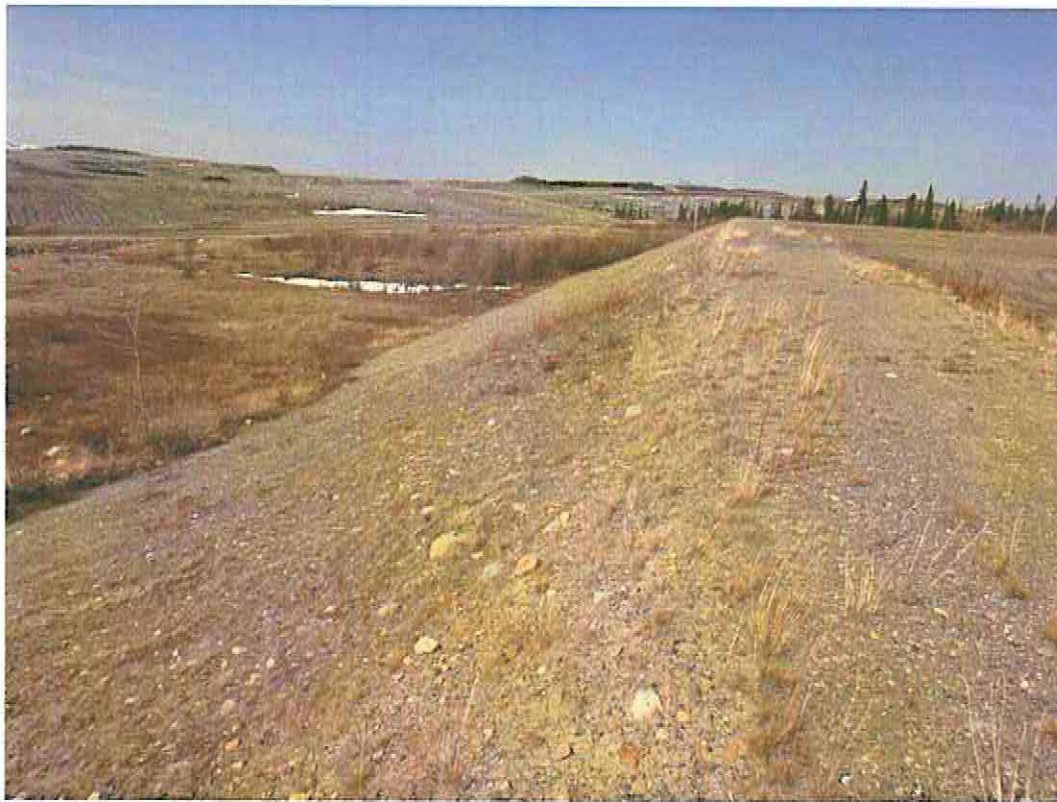
Photo 35: Downstream Slope of Sludge Pond Embankment

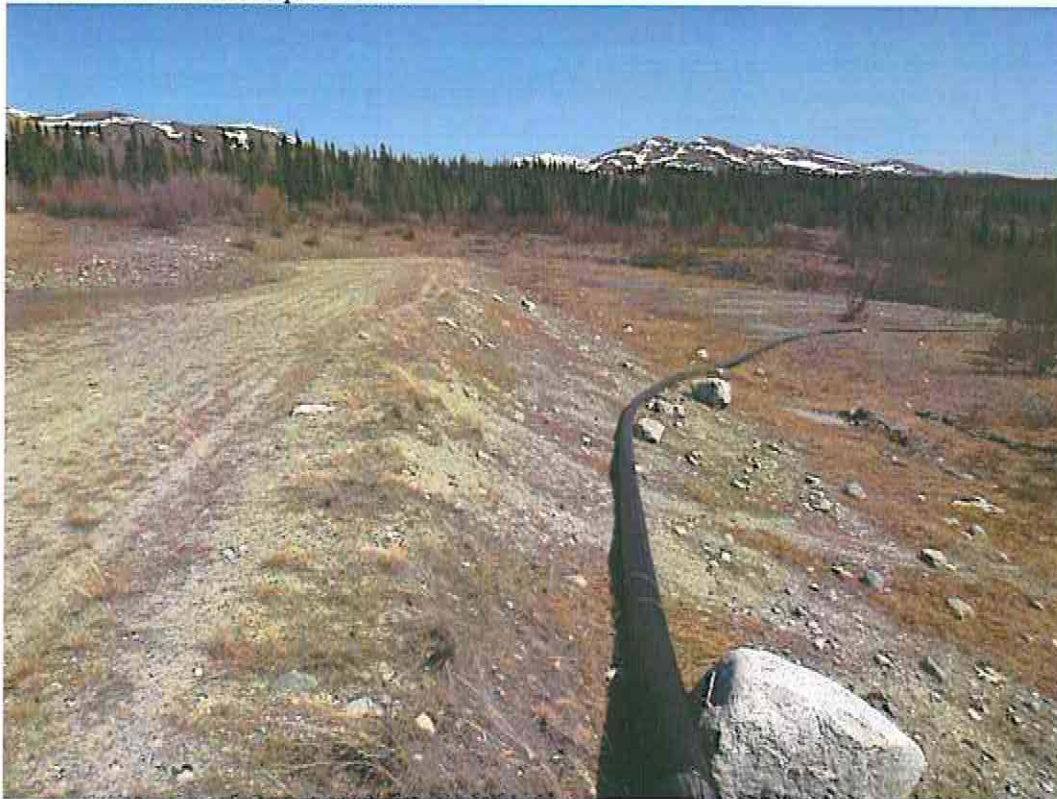
SRK inspected the Sheep Pad Pond dyke (Photo 38) and the Spillway to Vangorda Creek. No signs of slope instability, settlement or cracking were noted.

Photo 38: Sheep Pad Pond Embankment

- Monitor monthly the crest of the settling pond dykes for any cracks;
- Monitor monthly the toe of the dykes for any seeps; and
- Clear any debris that accumulates at either end of the GID culverts and the settling pond spillway.
