February 7, 2013

REPORT ON

Faro Mine Complex Annual Pit Slope Stability Inspection

Project Number: 1214260031-001-R-Rev0-6000

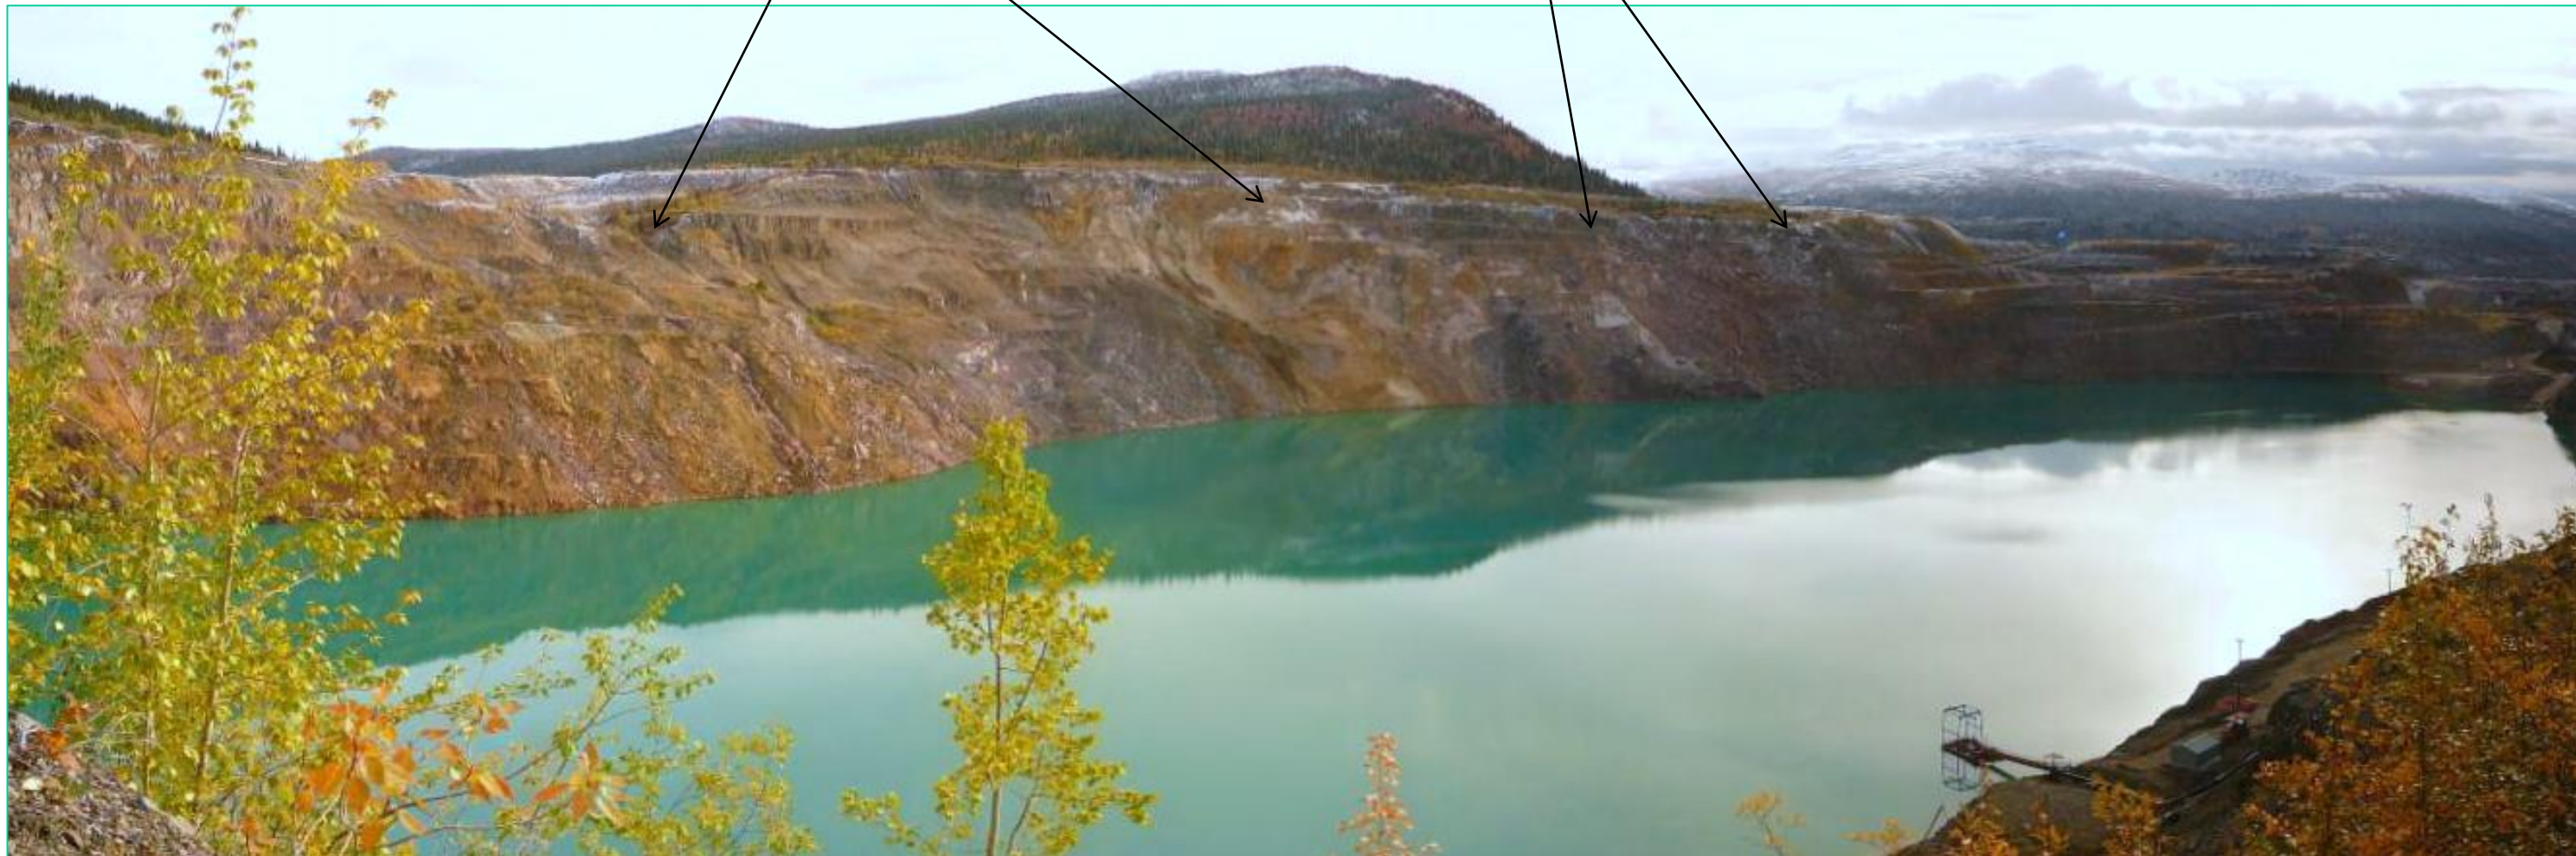
Photograph A-1
Faro Pit east wall. View looking east-southeast.

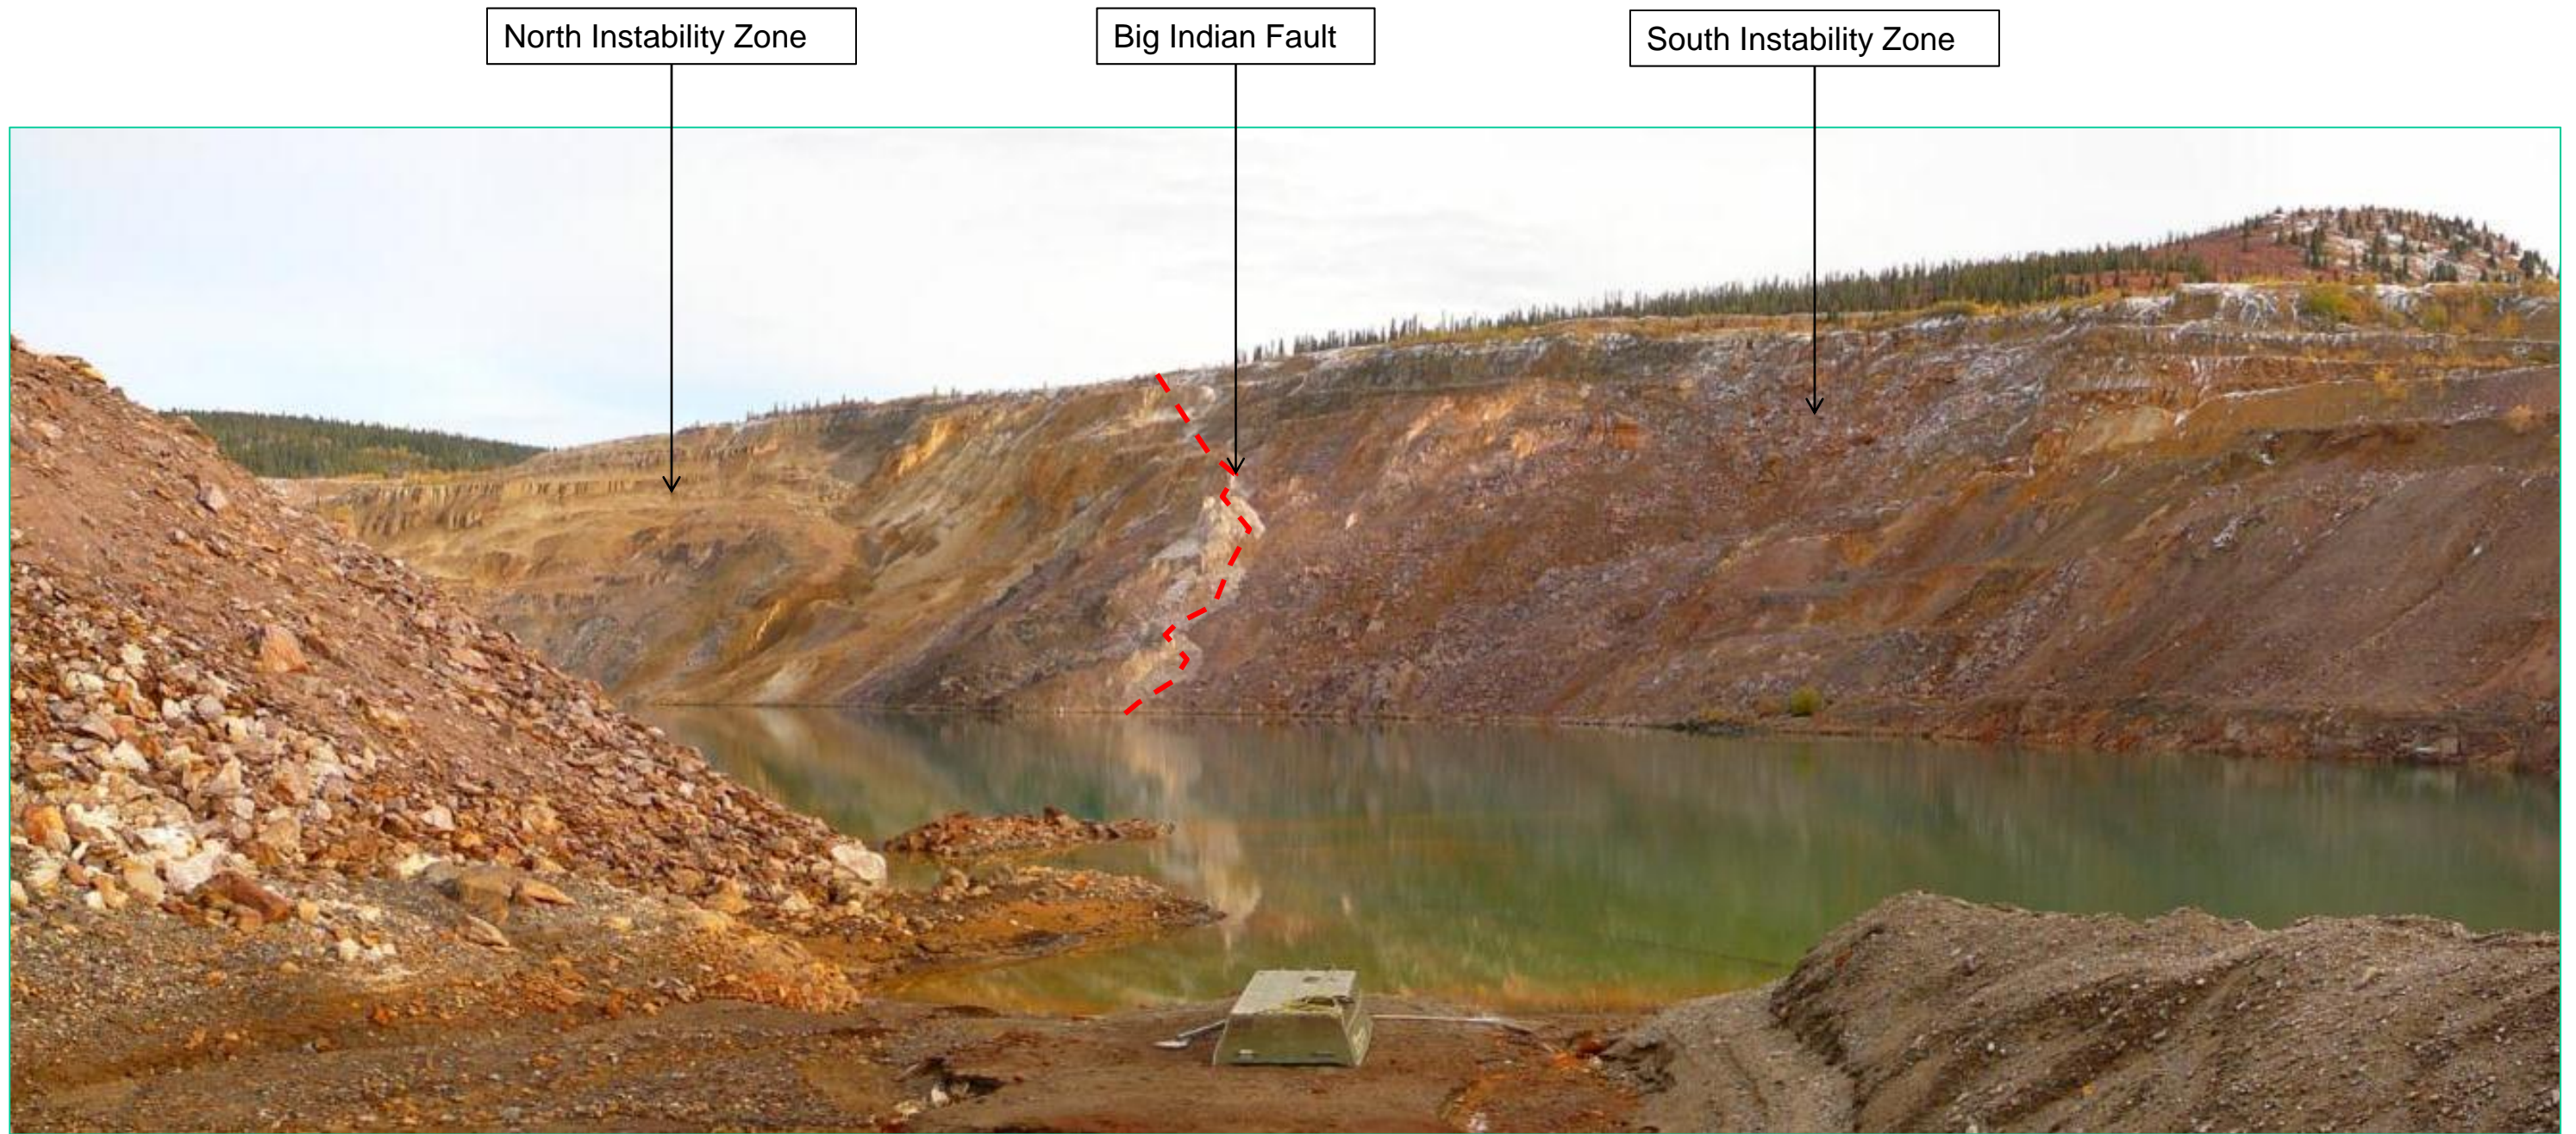
The Big Indian Fault is the most dominant structural feature observed in the east wall (Photograph A-2). This fault strikes roughly north–south and dips toward the west at an inclination of approximately 60 degrees. The west boundary of the north–south trending band of calc-silicate rock in the east wall is defined by the Big Indian Fault.

Photograph A-2
Faro Pit east wall. View looking north-northeast.

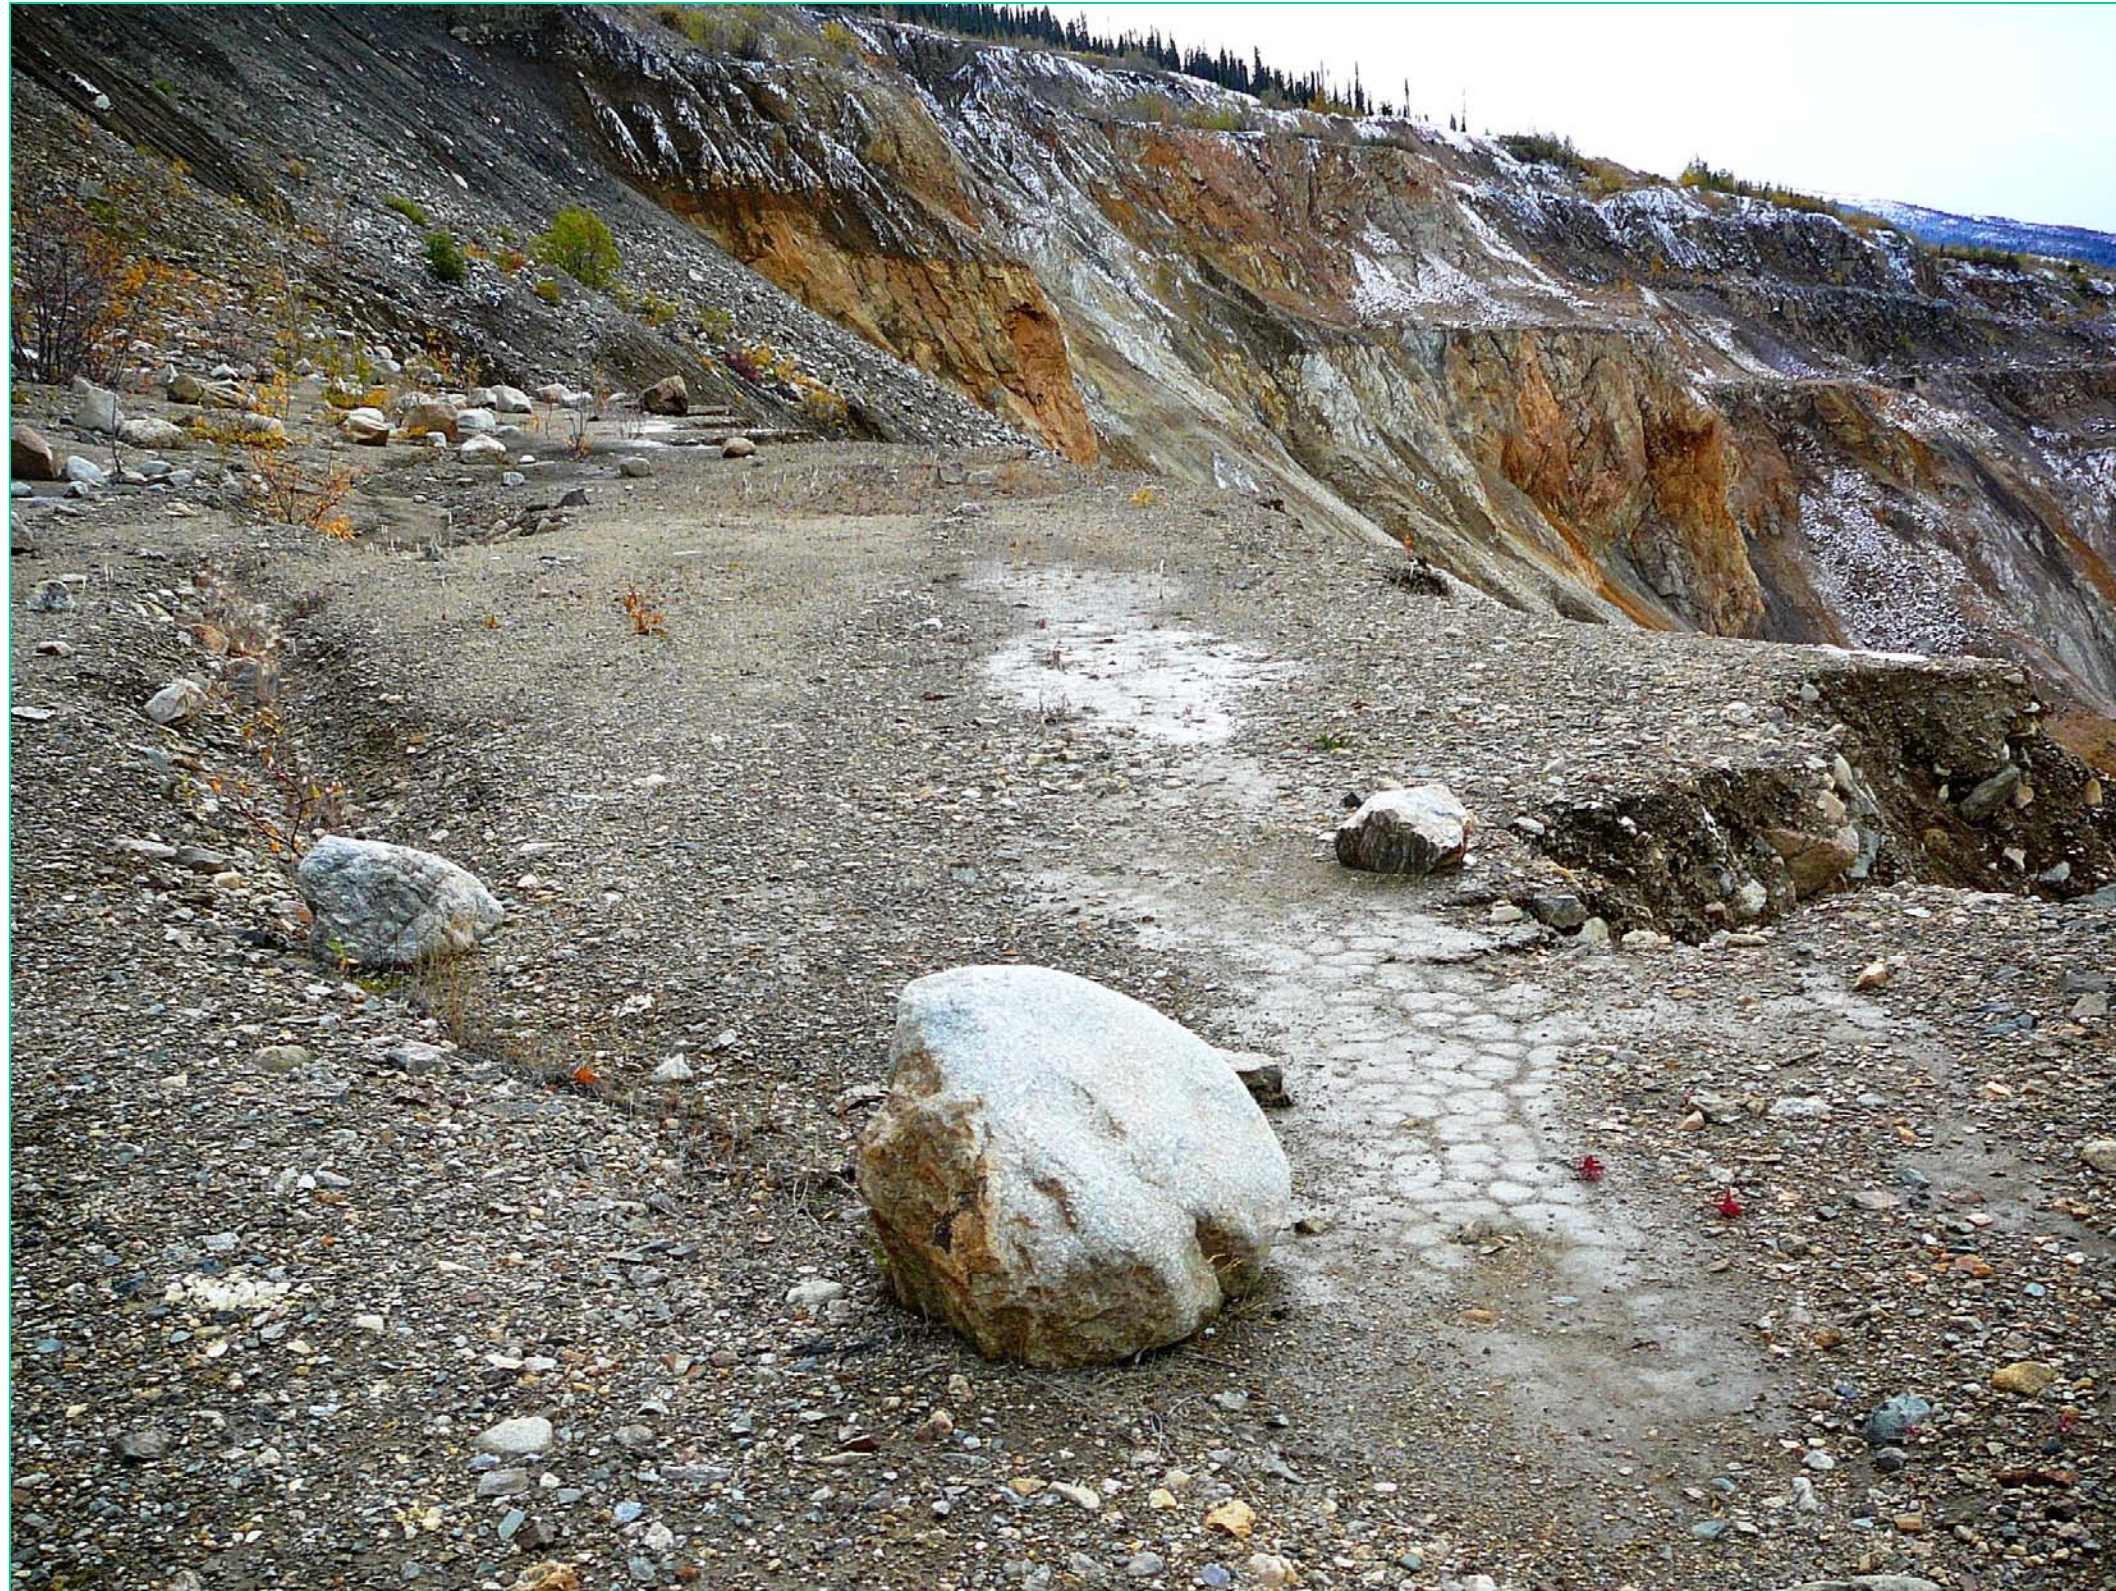
- No recent cracks were observed either behind the crest of the east wall or behind the backscarps of the instability zones. Some old cracks were observed that did not indicate any recent activity (Photograph A-3).

Photograph A-3
Faro Pit – North Instability Zone. Old crack to the north of the instability zone.

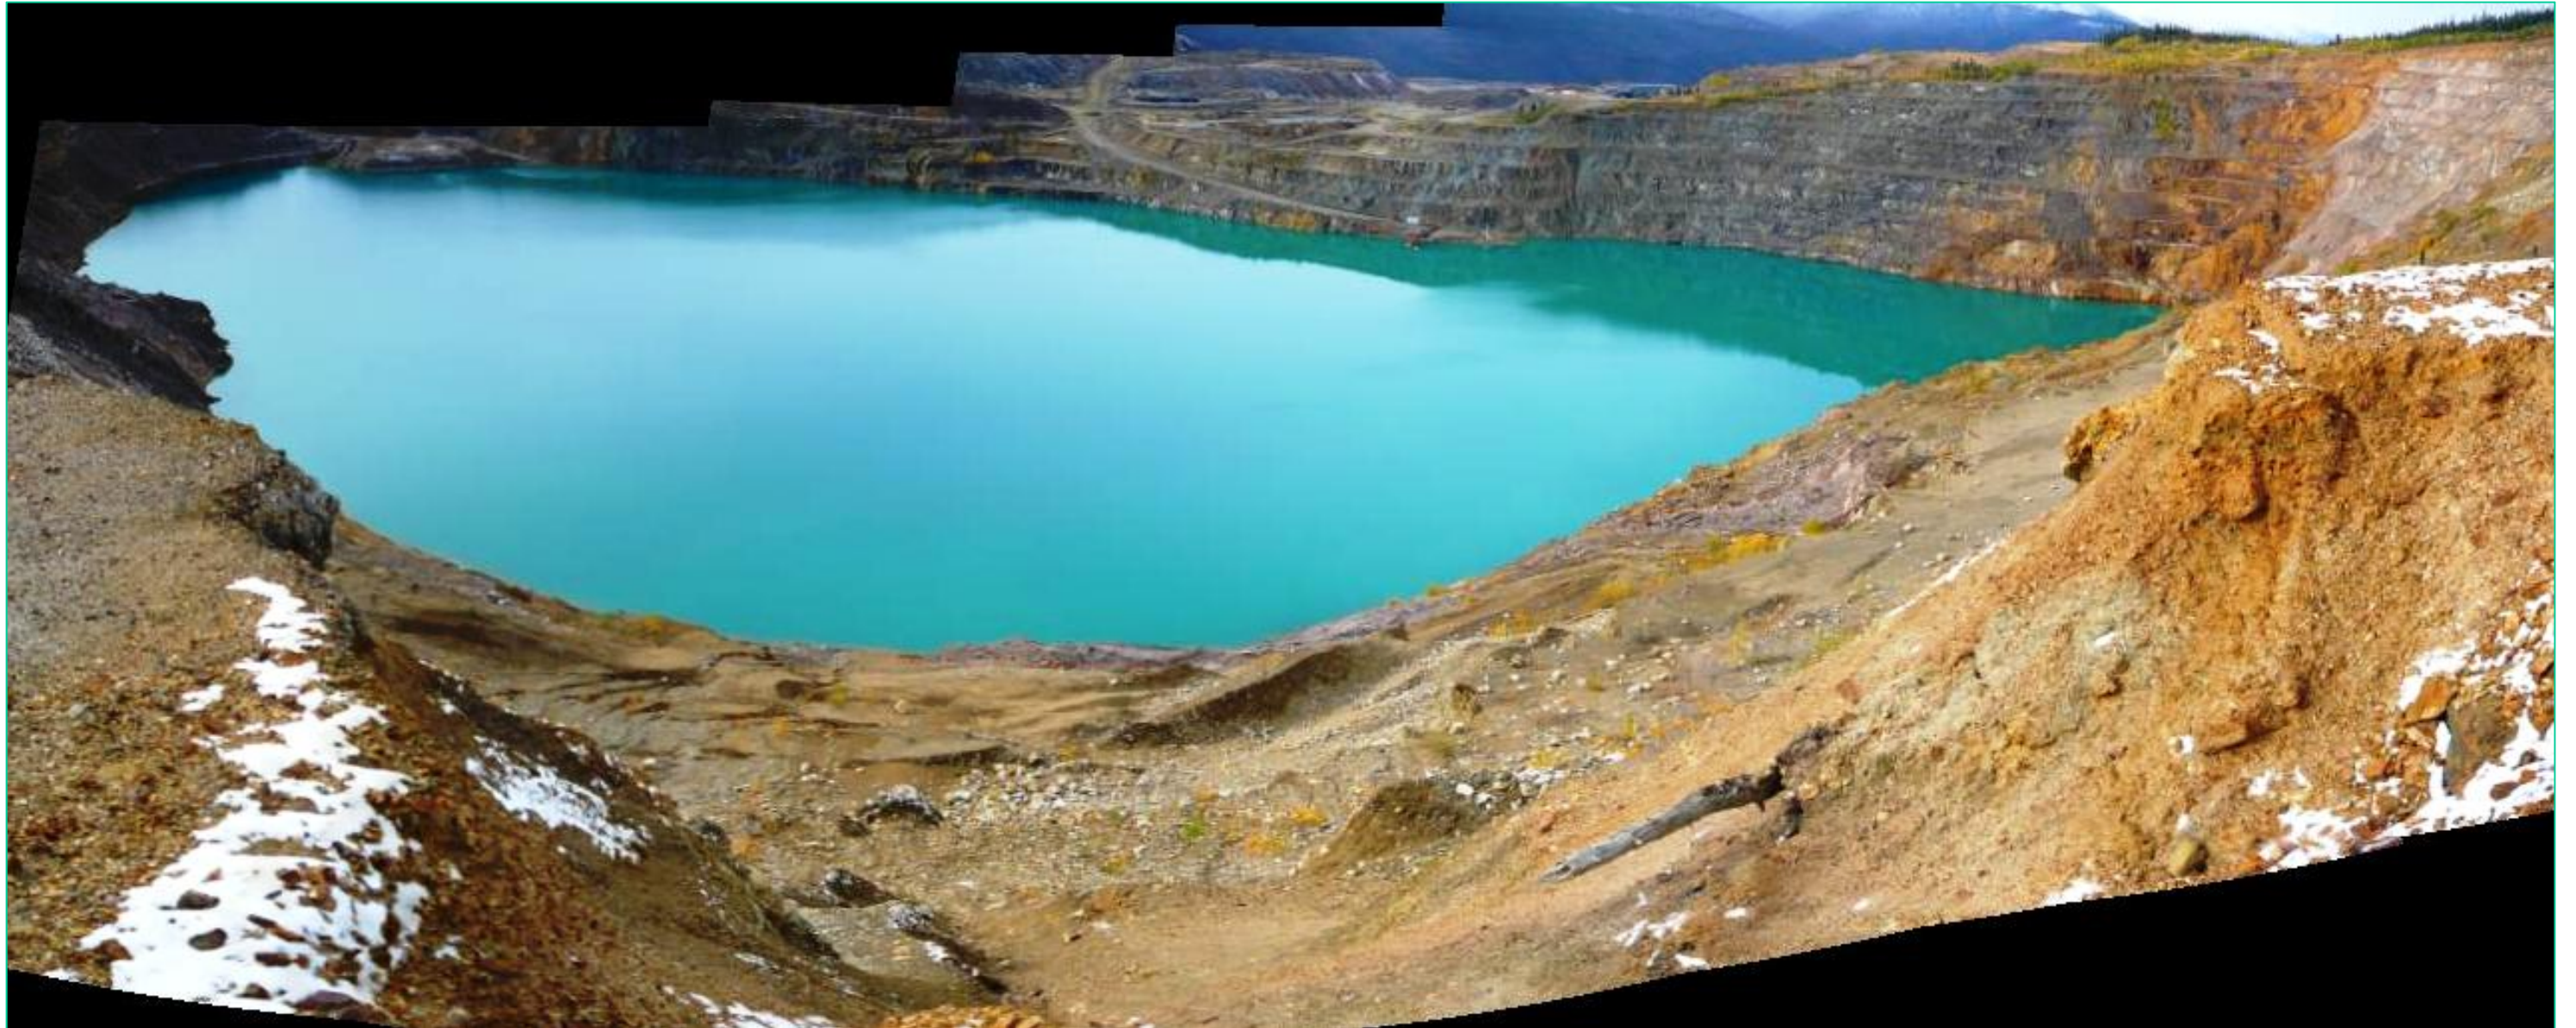
- No cracks were observed along the road behind the crest of the east wall.
- No recent cracks were observed in the North Instability Zone (Photograph A-4).

Photograph A-4
Faro Pit – North Instability Zone. View looking southwest behind backscarp.

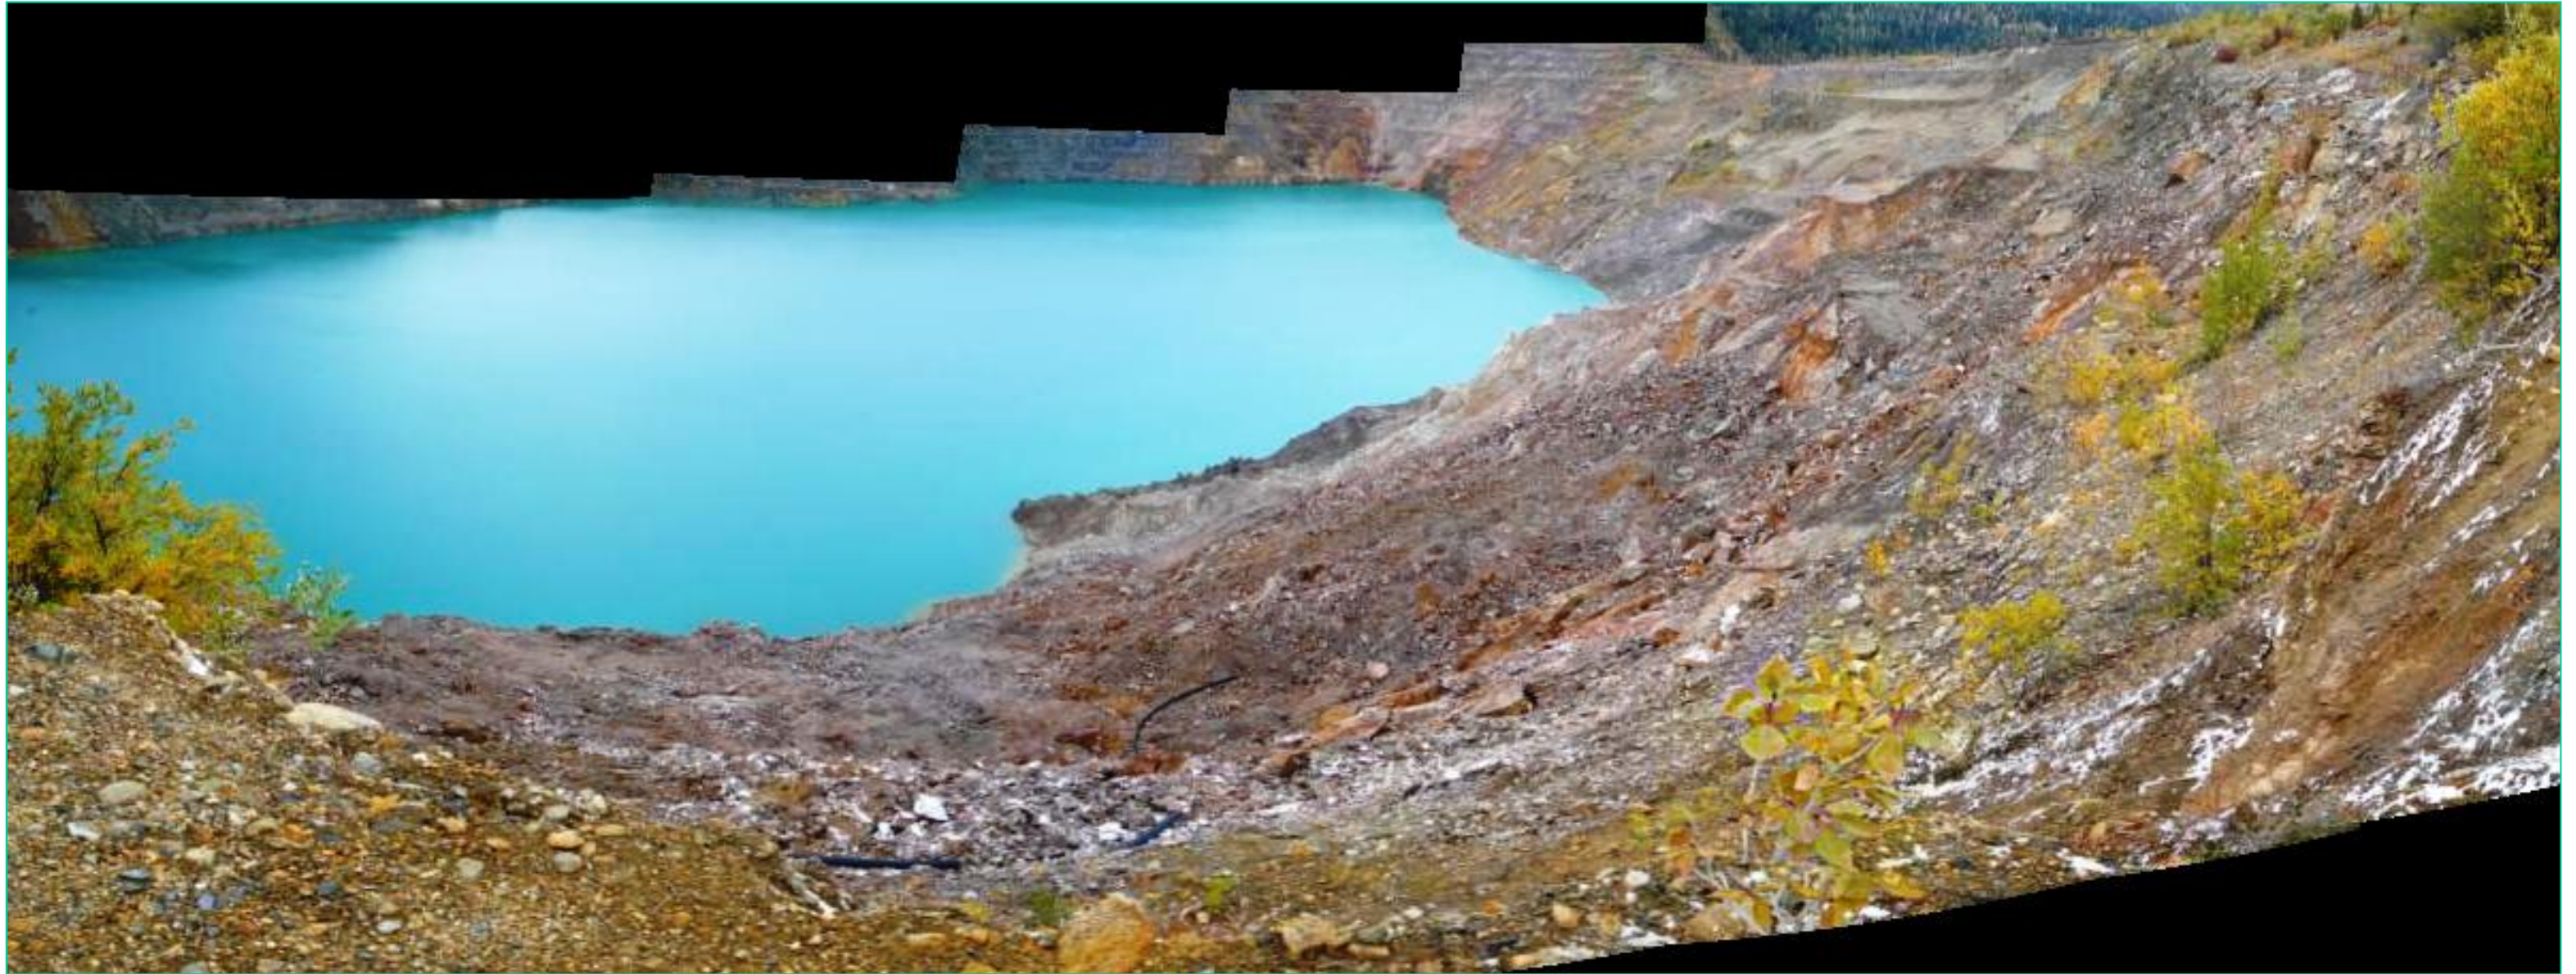
- No recent cracks were observed in the South Instability Zone (Photograph A-5).
- Some small areas of ponded water were observed behind the crest of the east wall (Photograph A-6). However, the majority of the water appears to be draining either along the FCDC or along a creek to the north of the North Instability Zone that drains into the pit.

Photograph A-5
Faro Pit – South Instability Zone. View looking northwest behind backscarp.

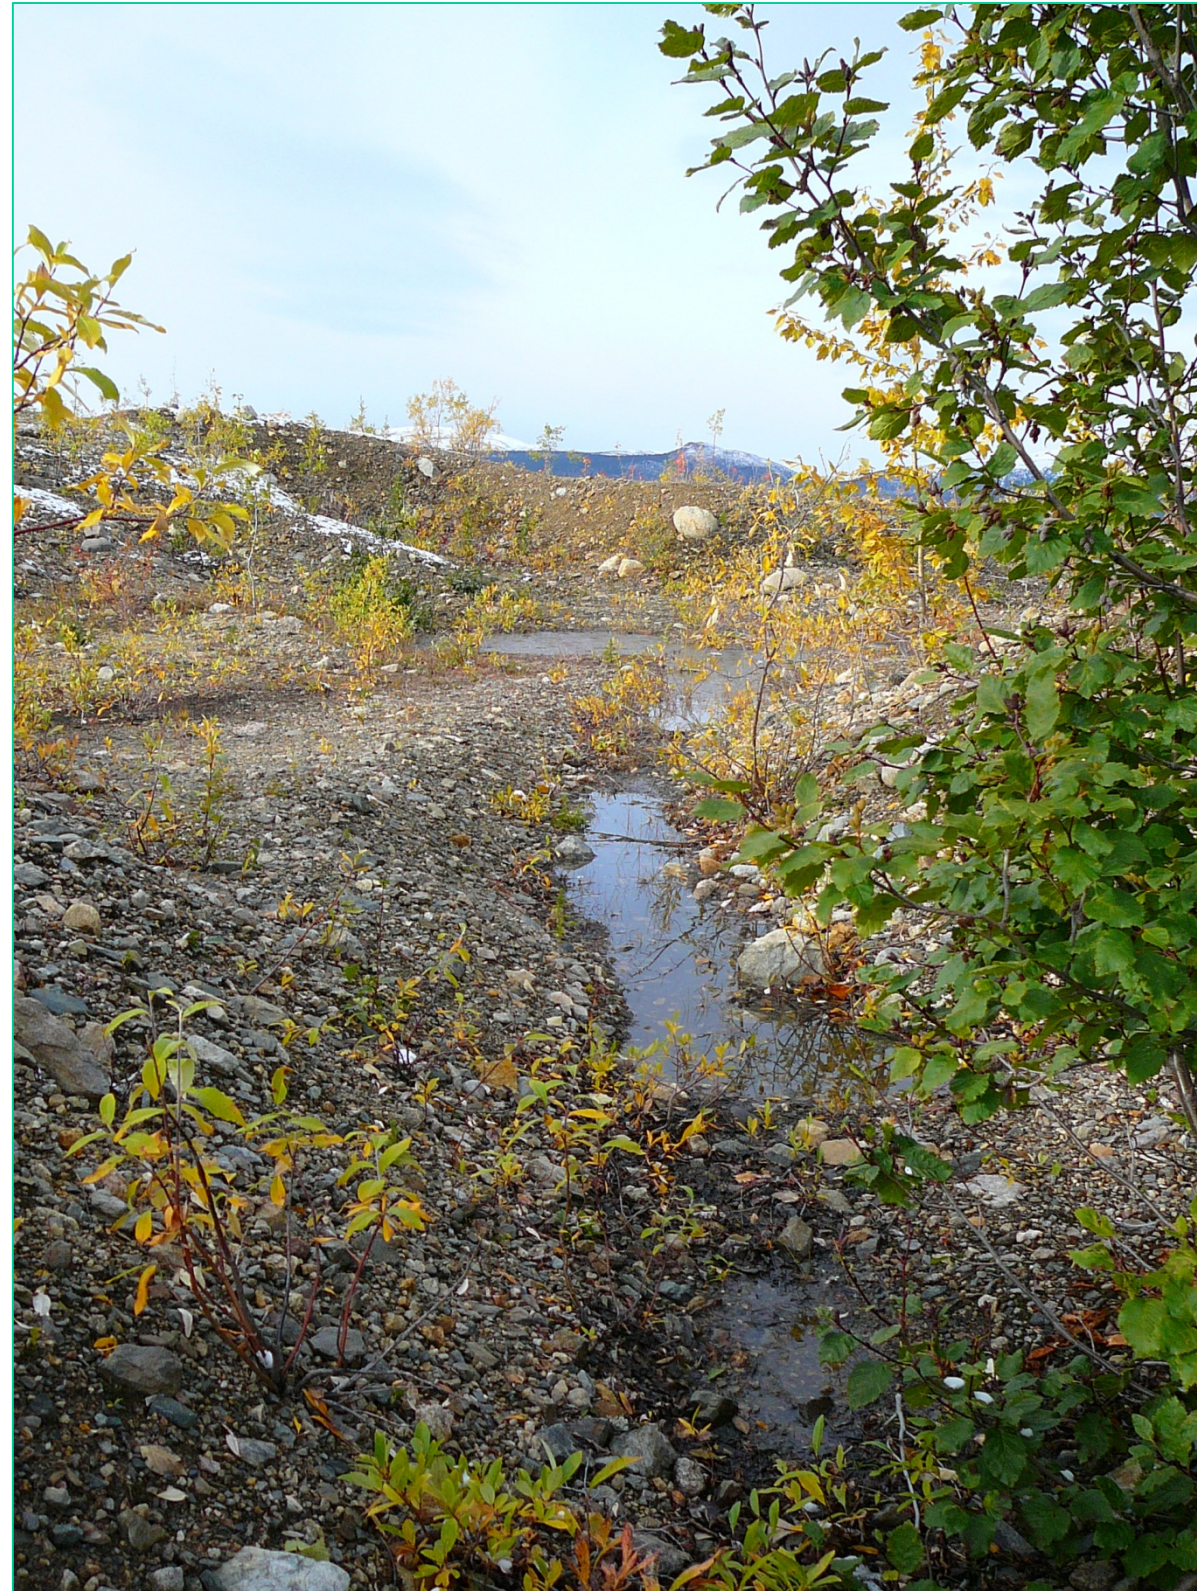
Photograph A-6
Faro Pit – North Instability Zone.
Area of ponded water behind crest of east wall.

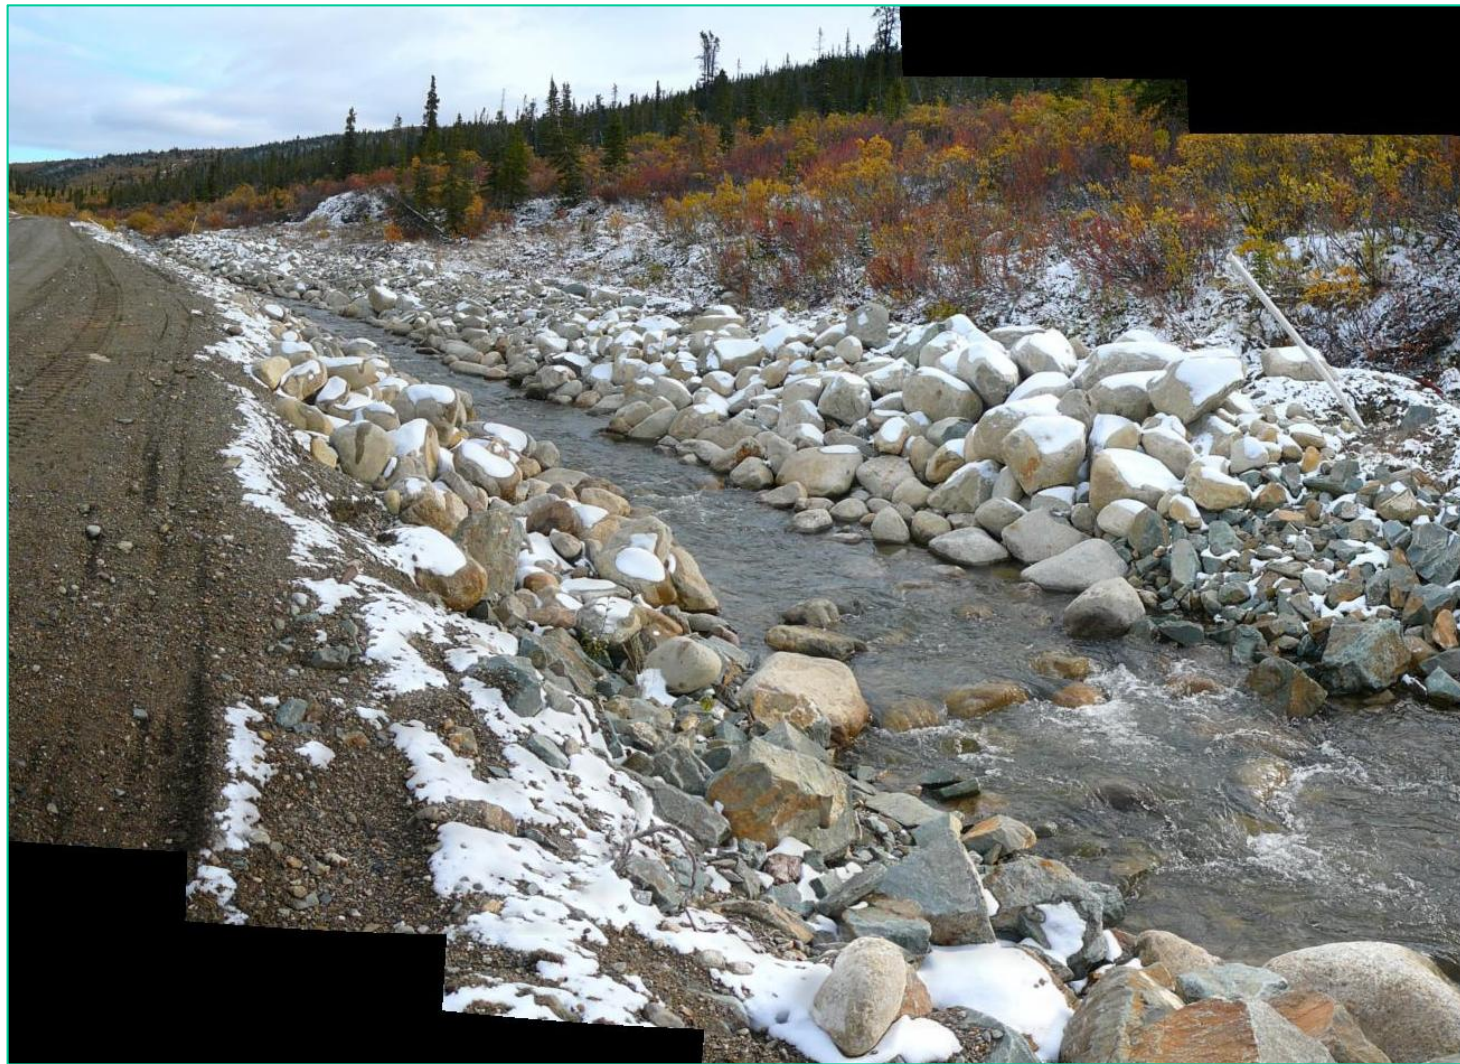
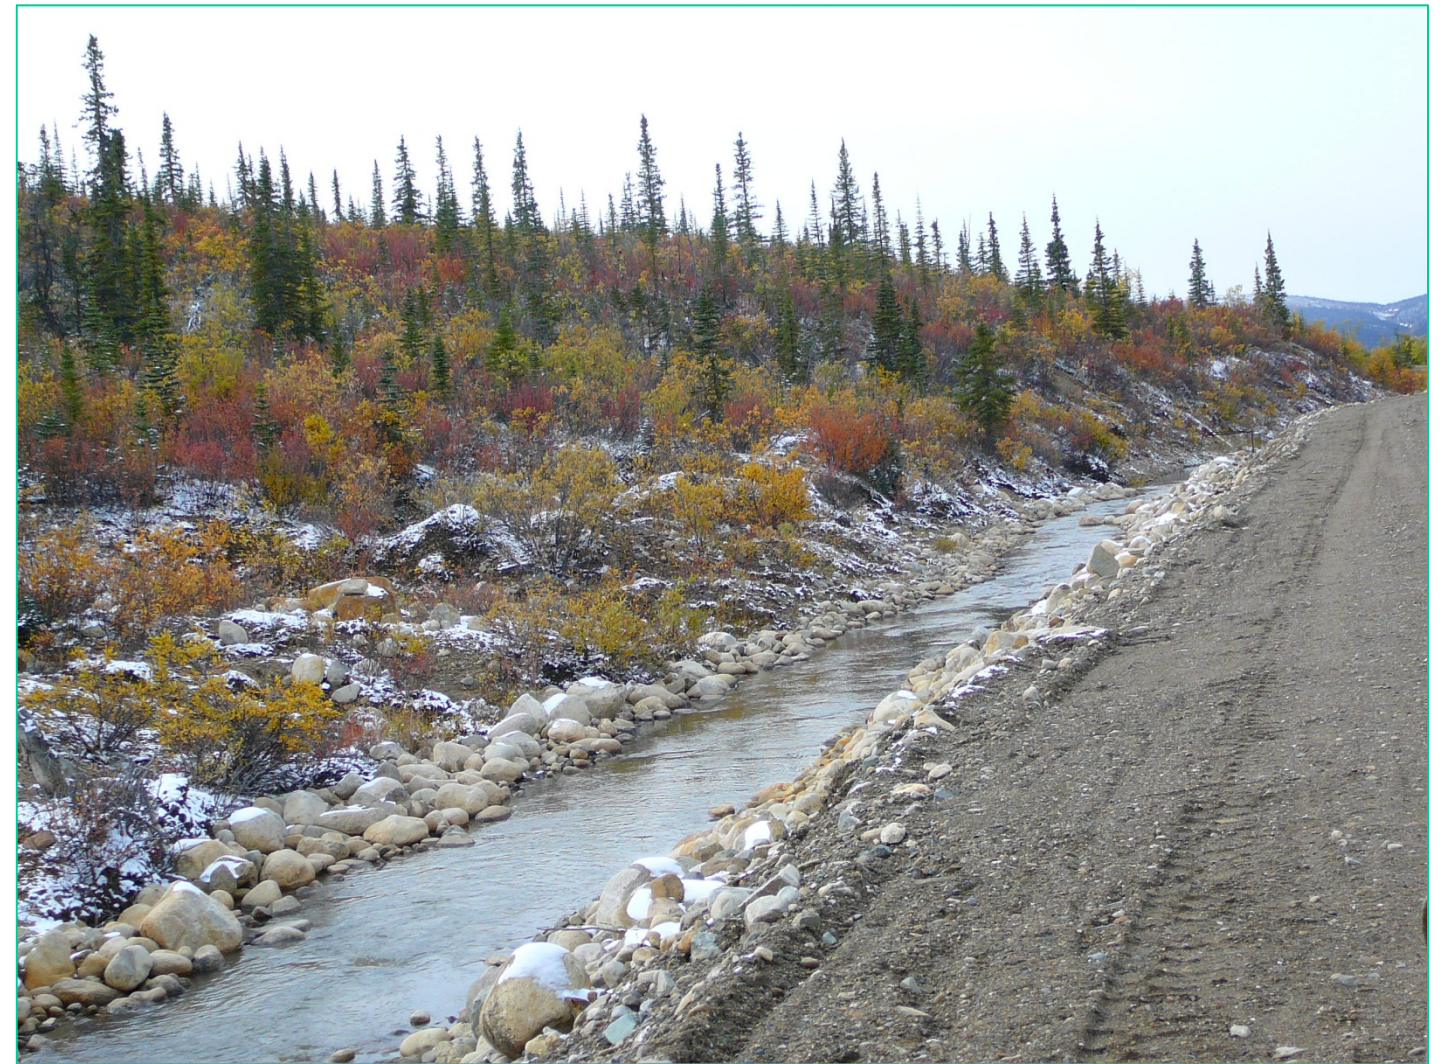
- The FCDC was conveying water at the time of the site visit. The side slopes appeared to be in good condition and no cracks or offsets in the geometry were observed. The FCDC appears to be diverting the majority of the water away from the crest of the east wall (Photographs A-8 and A-9).

Photograph A-8
Faro Creek Diversion Channel. View looking northwest.

Photograph A-9
Faro Creek Diversion Channel. View looking southeast.

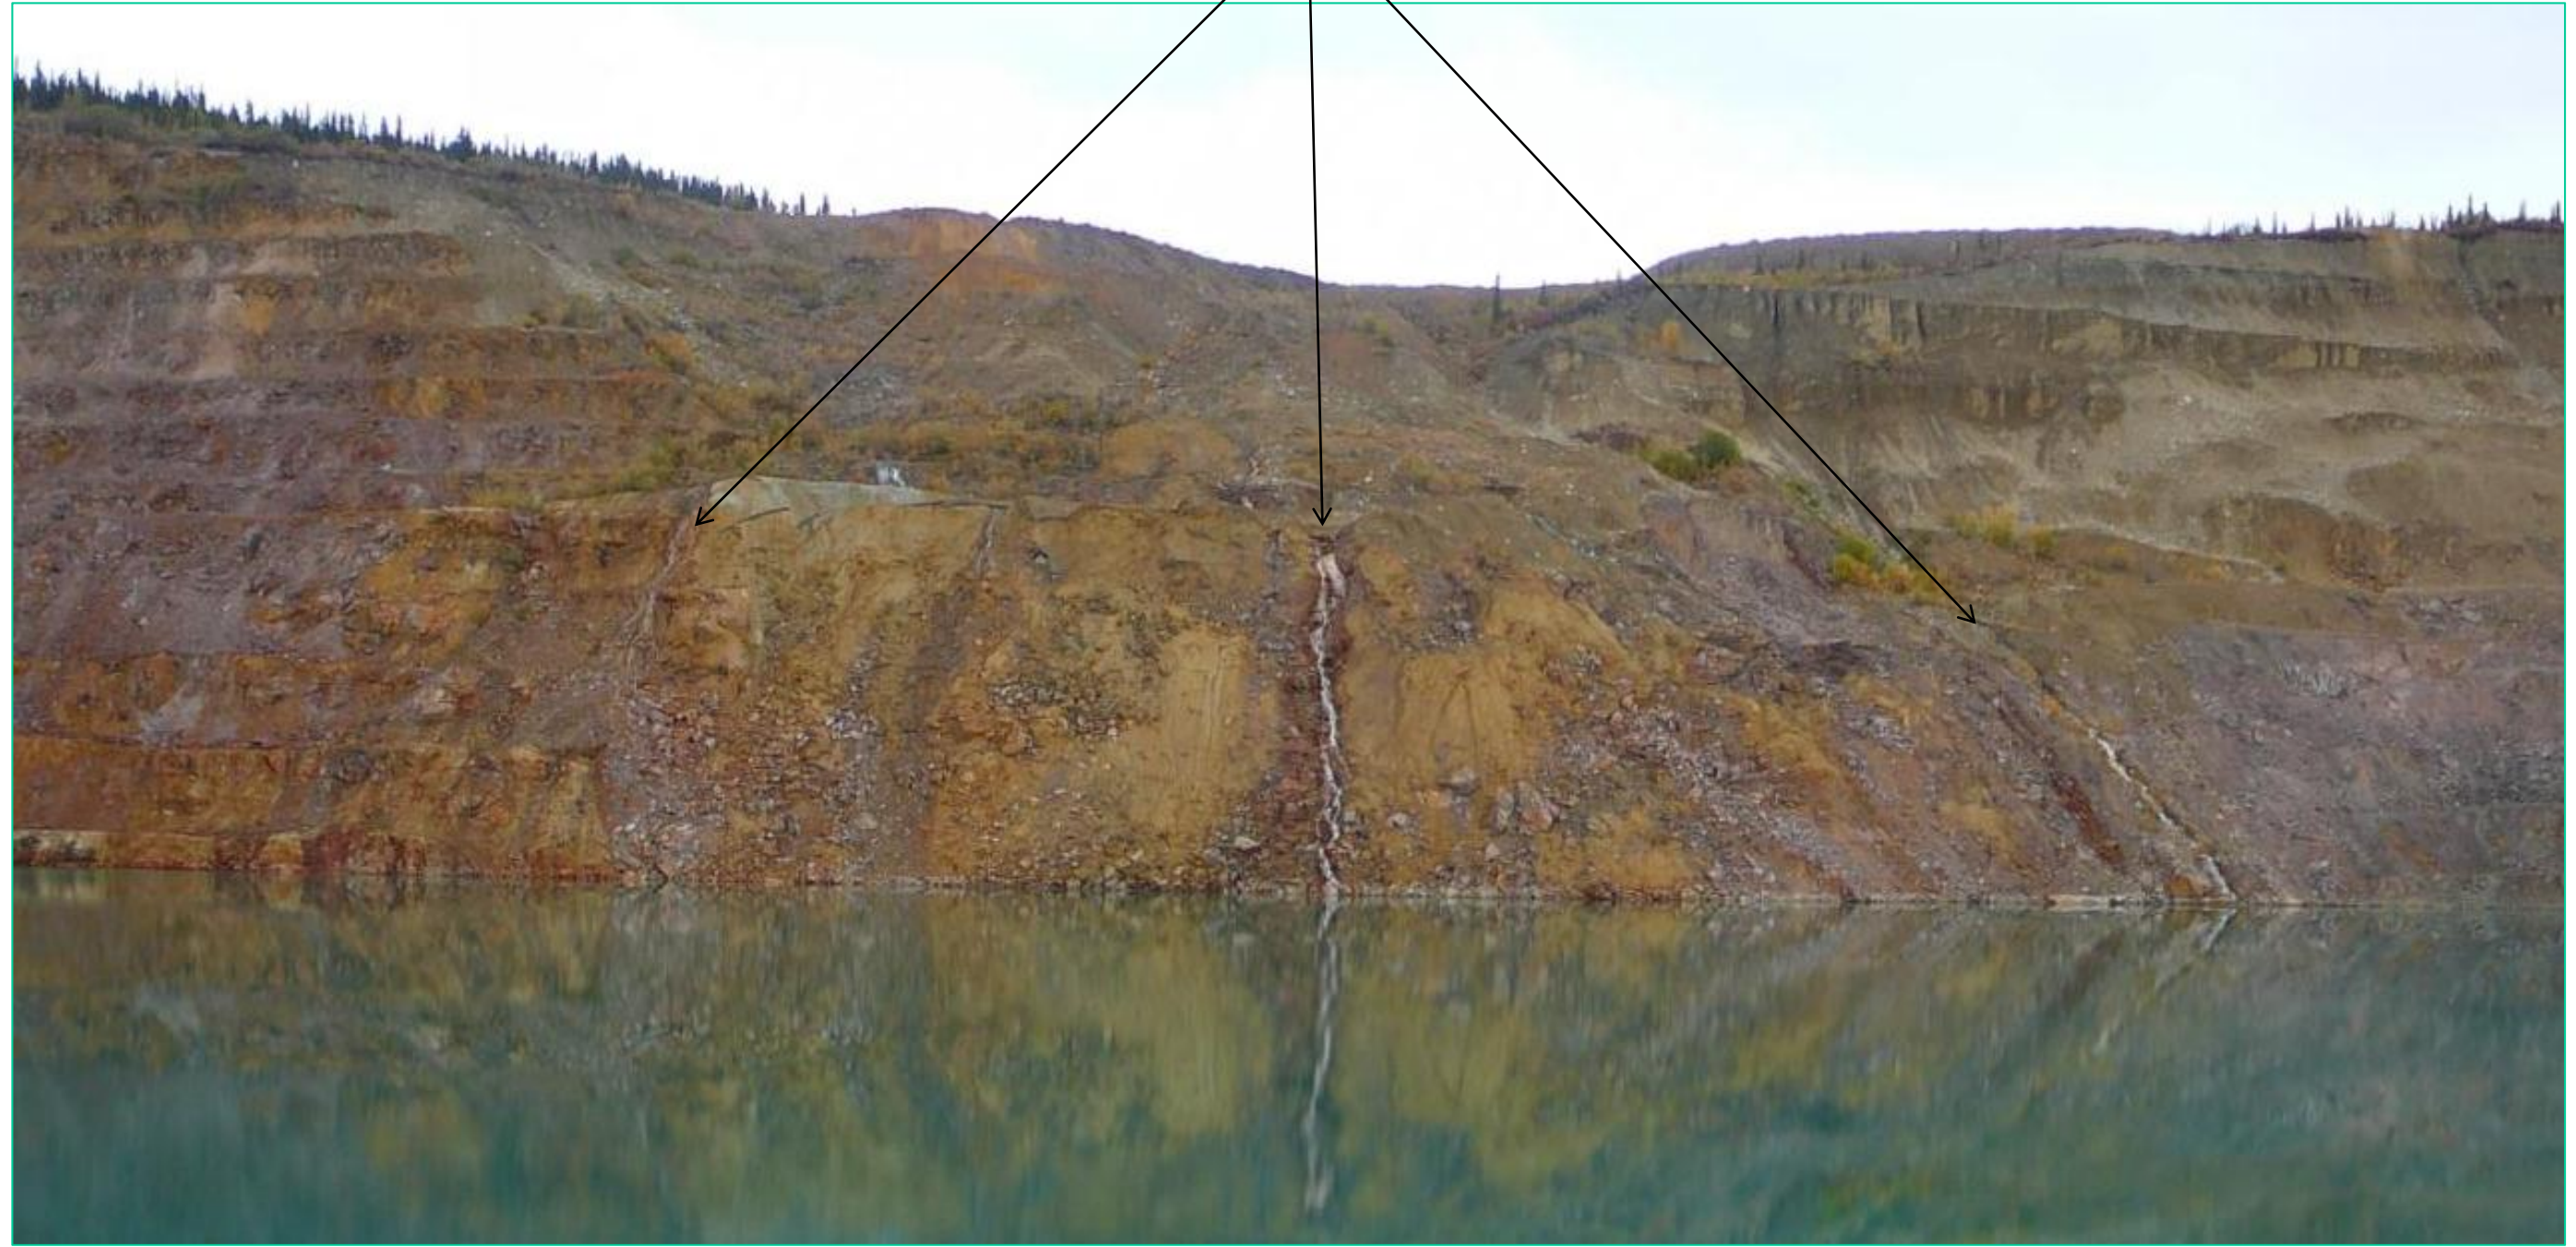
Seepage and erosion

Photograph A-10
Faro Pit east wall, north of North Instability Zone. View looking east.
