February 7, 2013

REPORT ON

Faro Mine Complex Annual Pit Slope Stability Inspection

Project Number: 1214260031-001-R-Rev0-6000

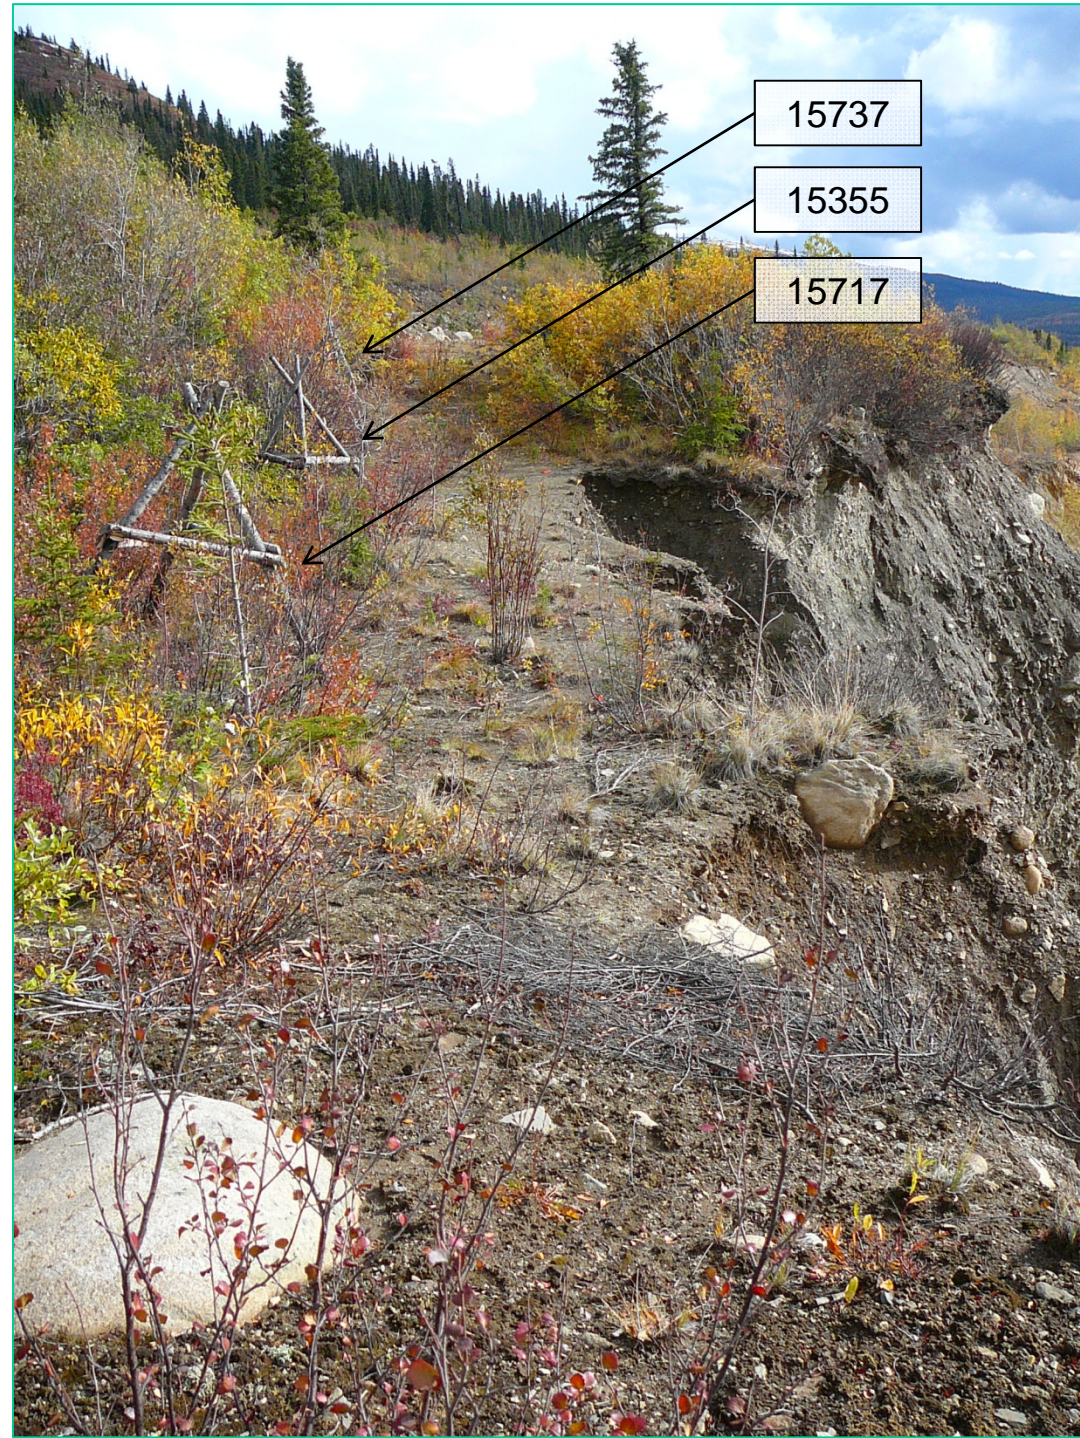
Photograph A-12
Faro Pit Reference Bars 15737, 15717, and 15355

- The crest at reference bar 15355 exhibited a loss of crest of approximately 0.5 metres during the interval of 2006 to 2010. These observations appear to indicate that large-scale failure of the slope was not imminent, and there was no immediate threat to the FCDC.

- Last, two additional reference bars were recommended to be installed adjacent to reference bar 15355 to monitor the lateral extent of the crest regression that was occurring at this location. These reference bars were installed in 2011.

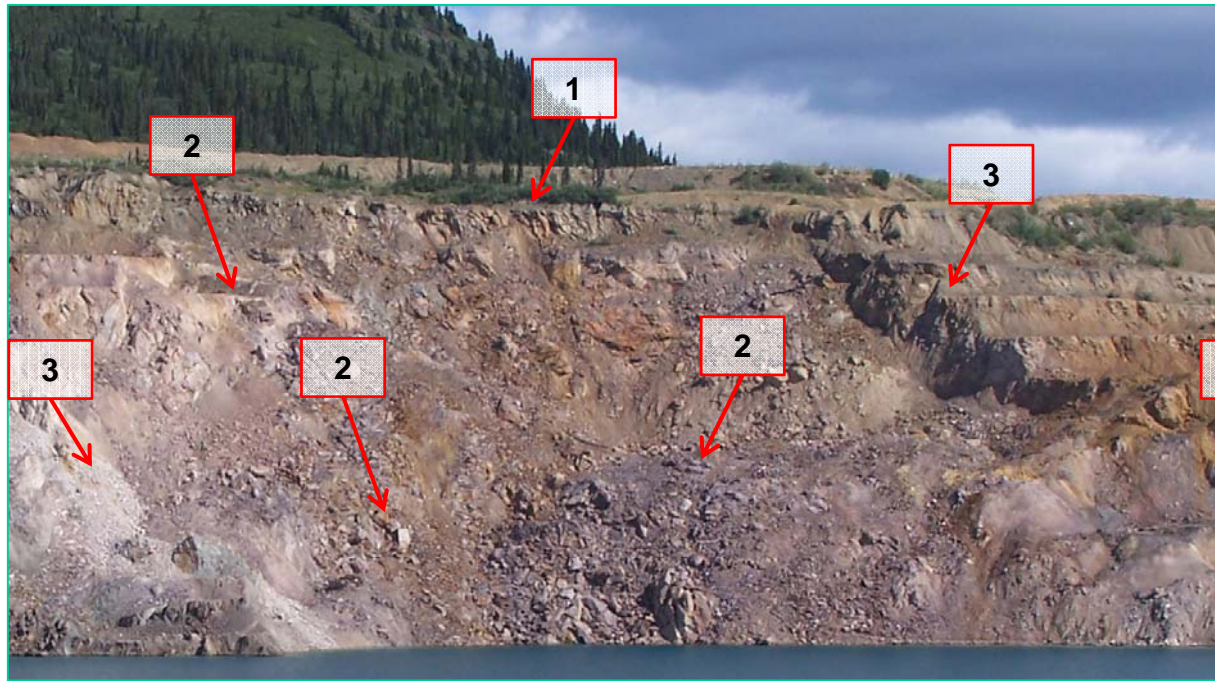
Figure B-1: Faro Pit East Wall – North Instability Photo Comparison

1. The crest and backscarp do not exhibit signs of significant erosion or regression.
2. Erosion gully does not appear to have changed significantly. Appears to have widened slightly overall between 2010 and 2012.
3. Failure debris does not appear to exhibit significant displacements from year to year.

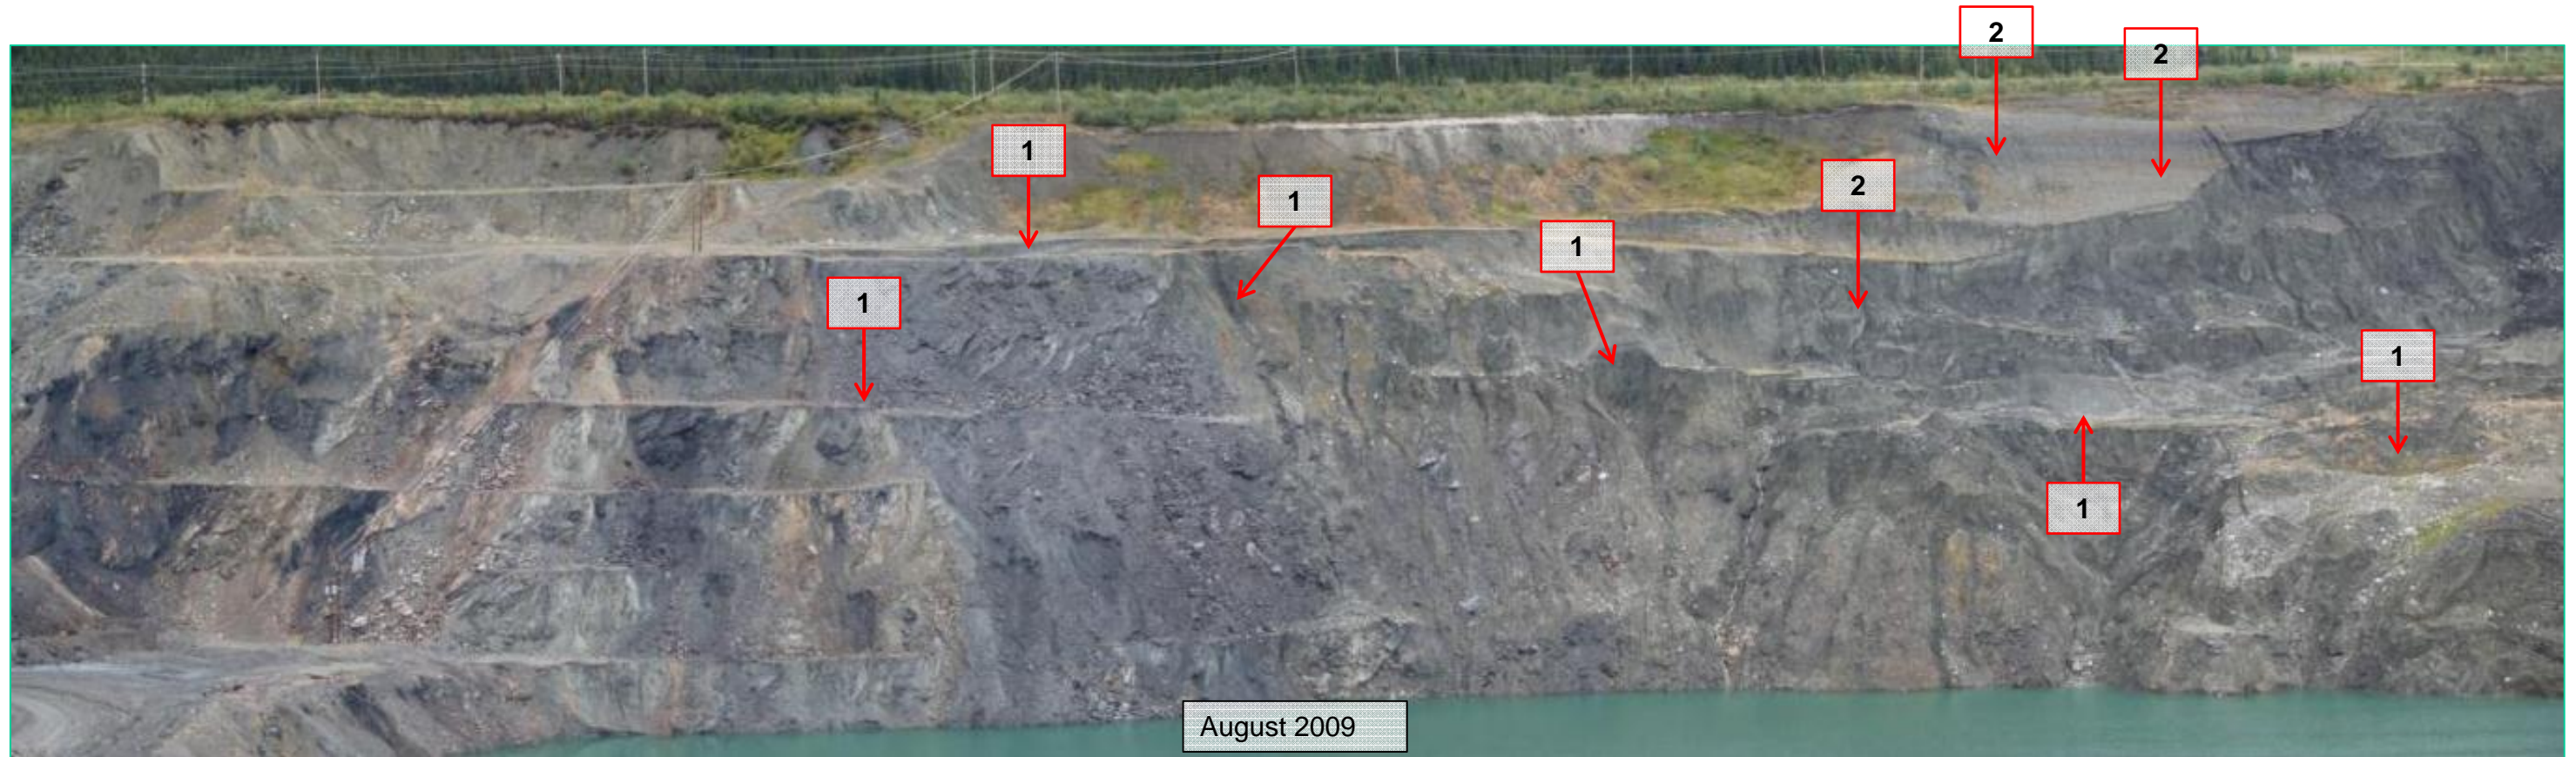
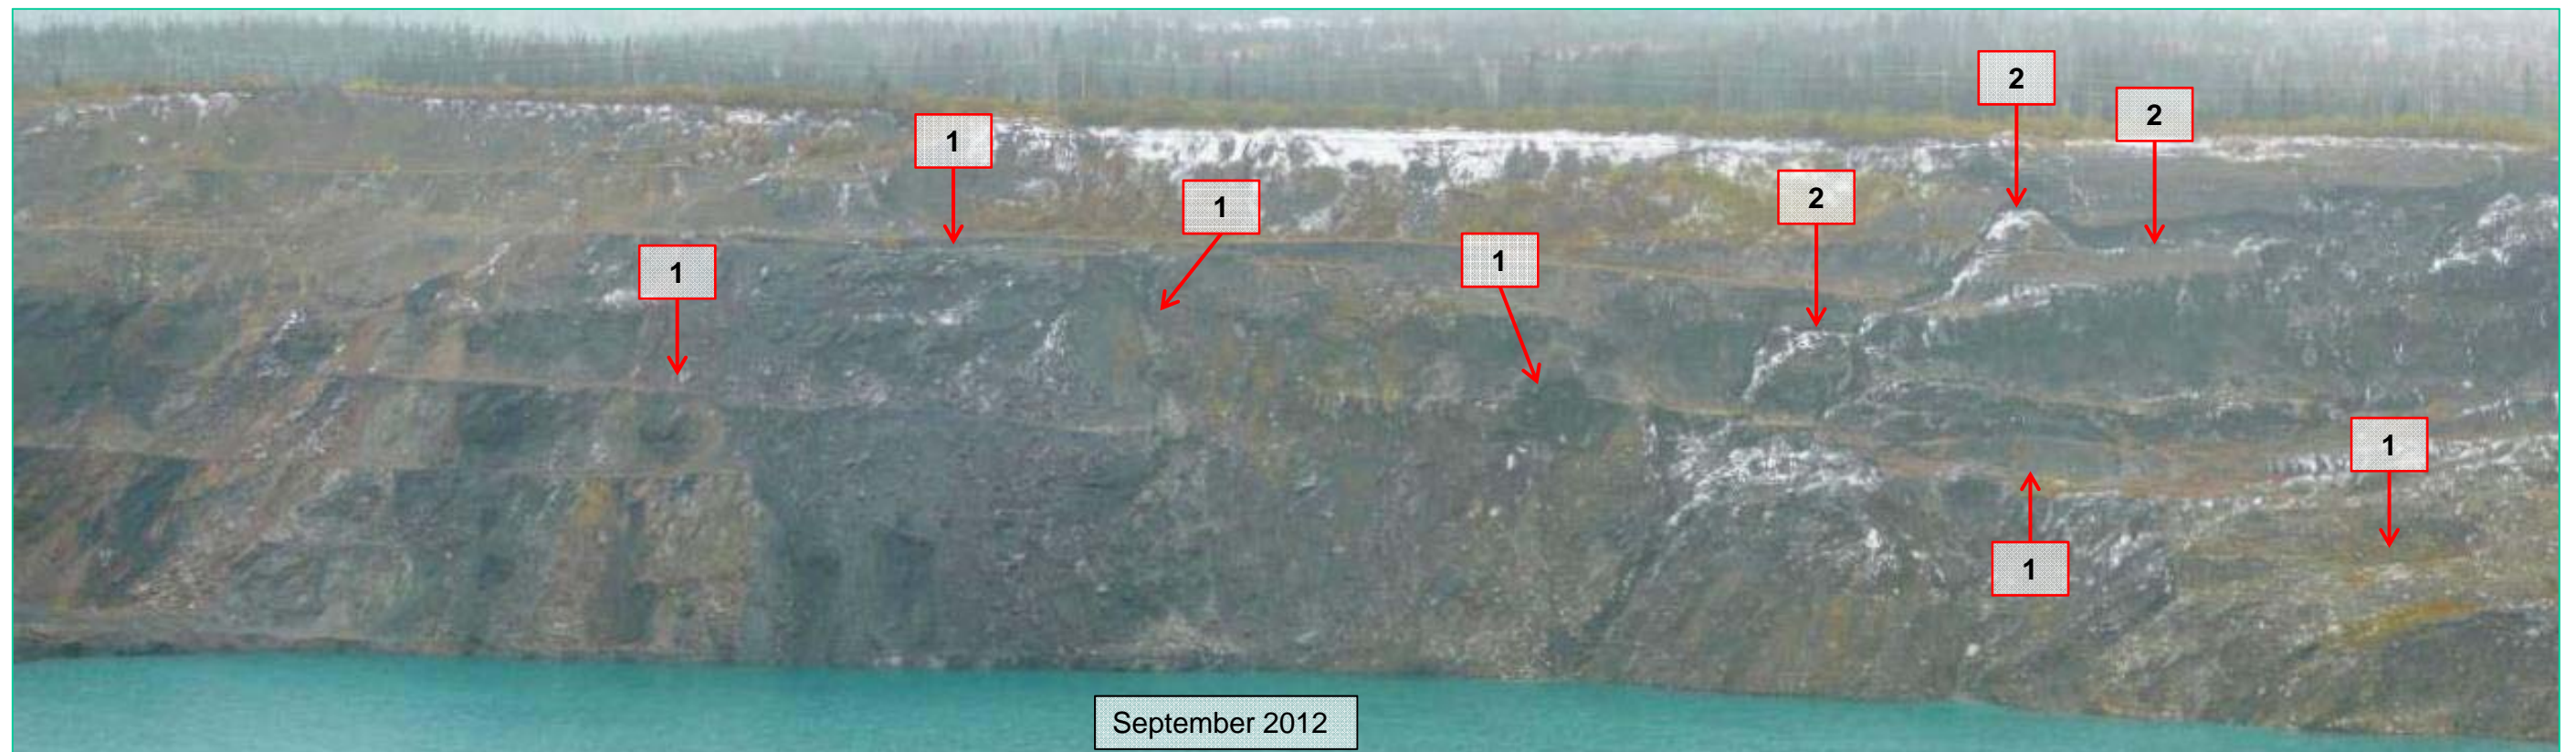
Figure B-3: Grum Pit East Wall –Photo Comparison

- 1. Areas where no significant change is apparent.
- 2. Recent movement on north side backscarp.

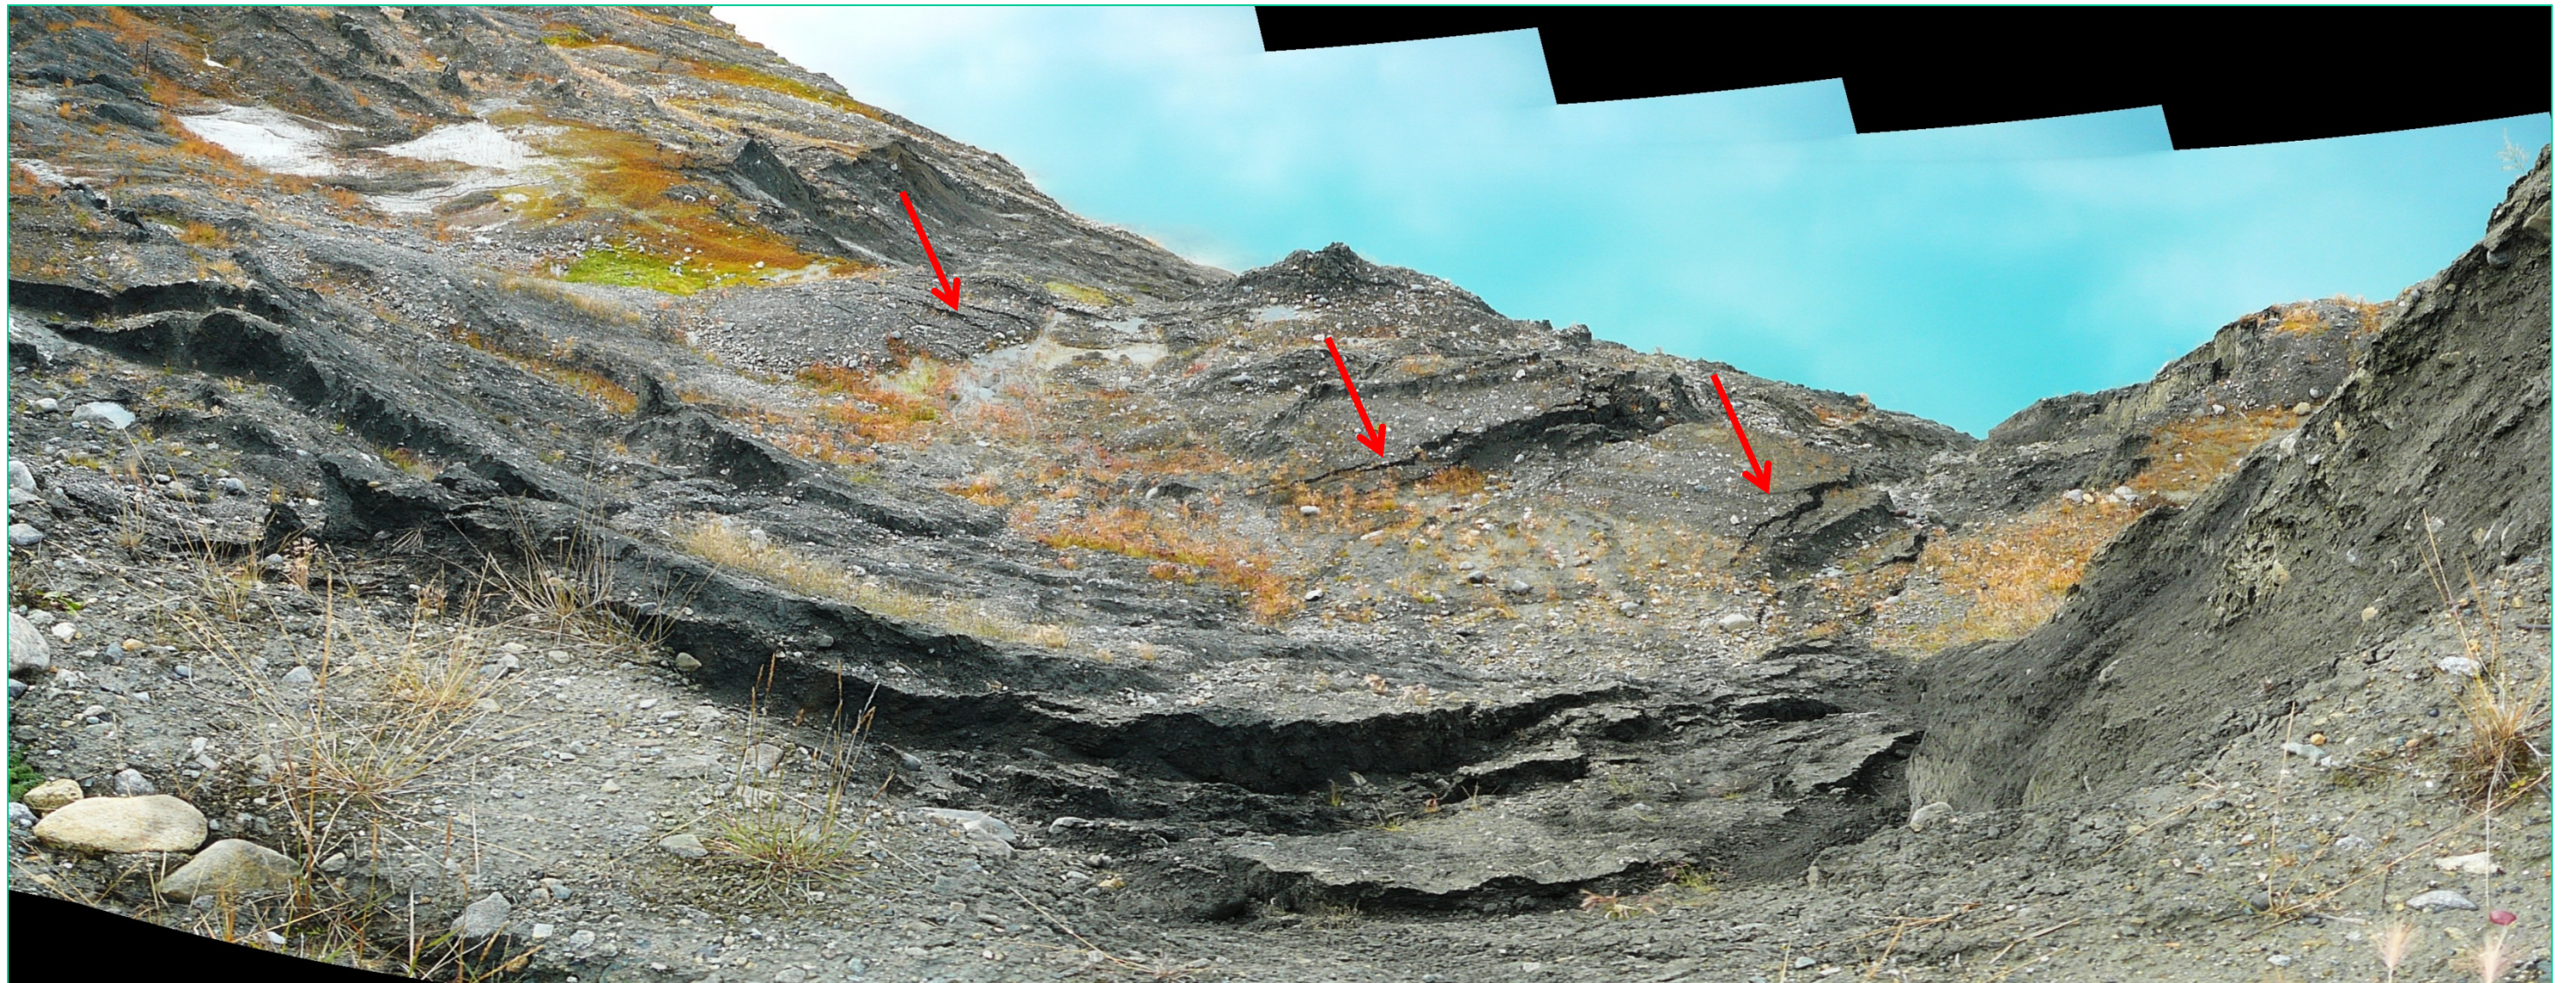
Figure B-4: Grum Pit East Wall – Instability Zone
Photograph looking down slope toward pit lake.
Fresh cracks in failure debris below backscarp indicated by red arrows.

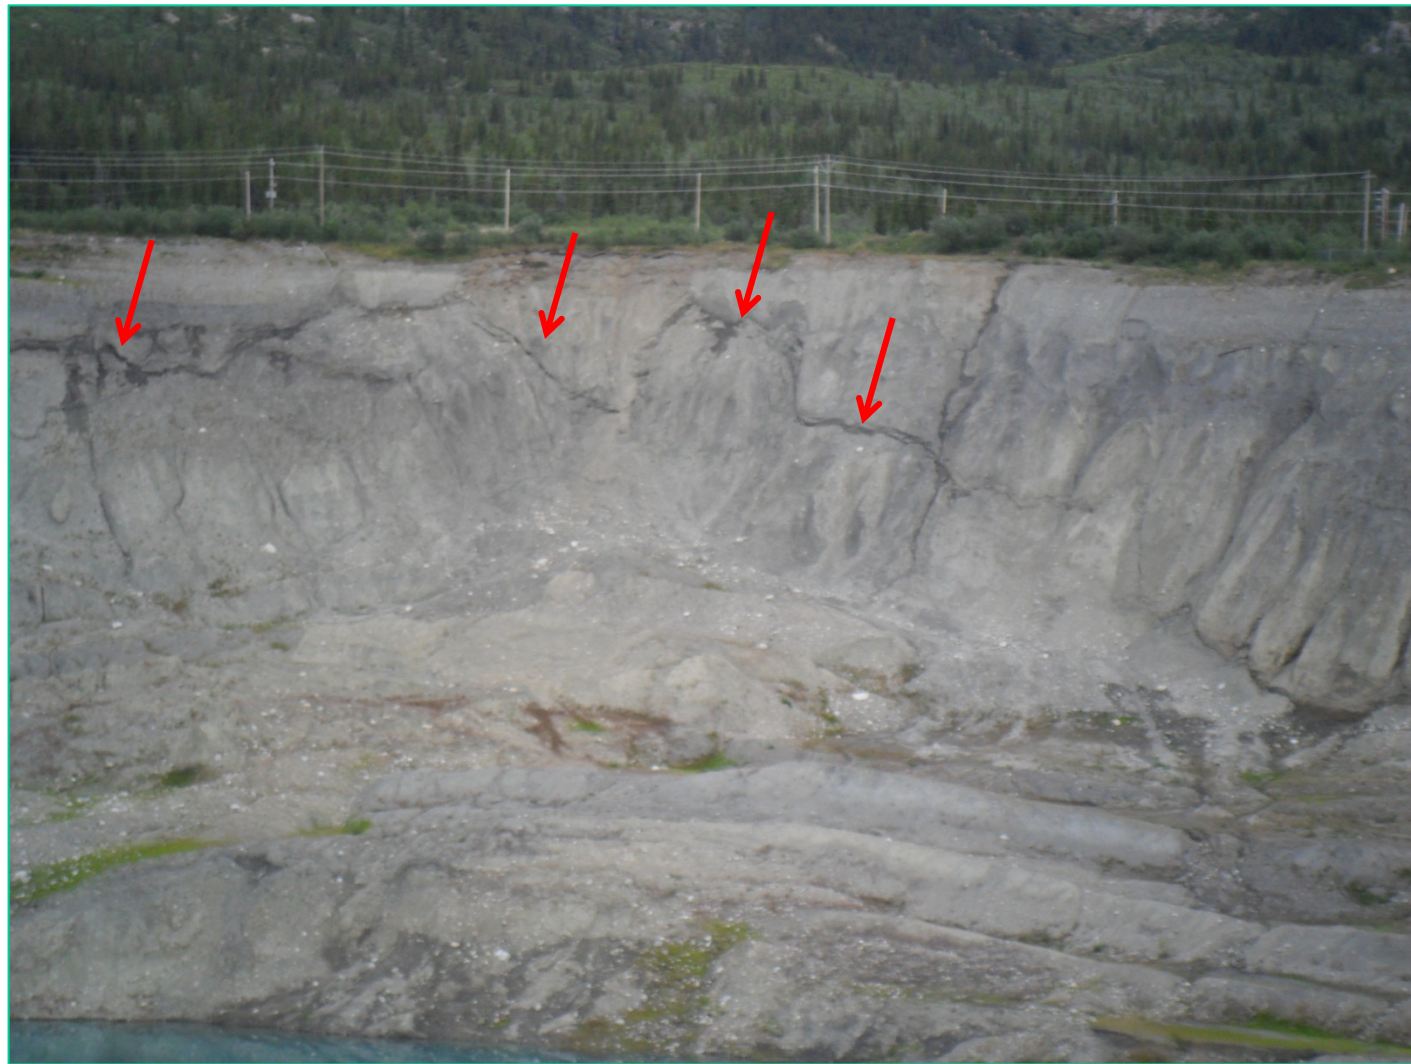
Photograph D-2
Grum Pit Instability Zone – new cracks reported in August 2012 indicated by red arrows. View looking east.

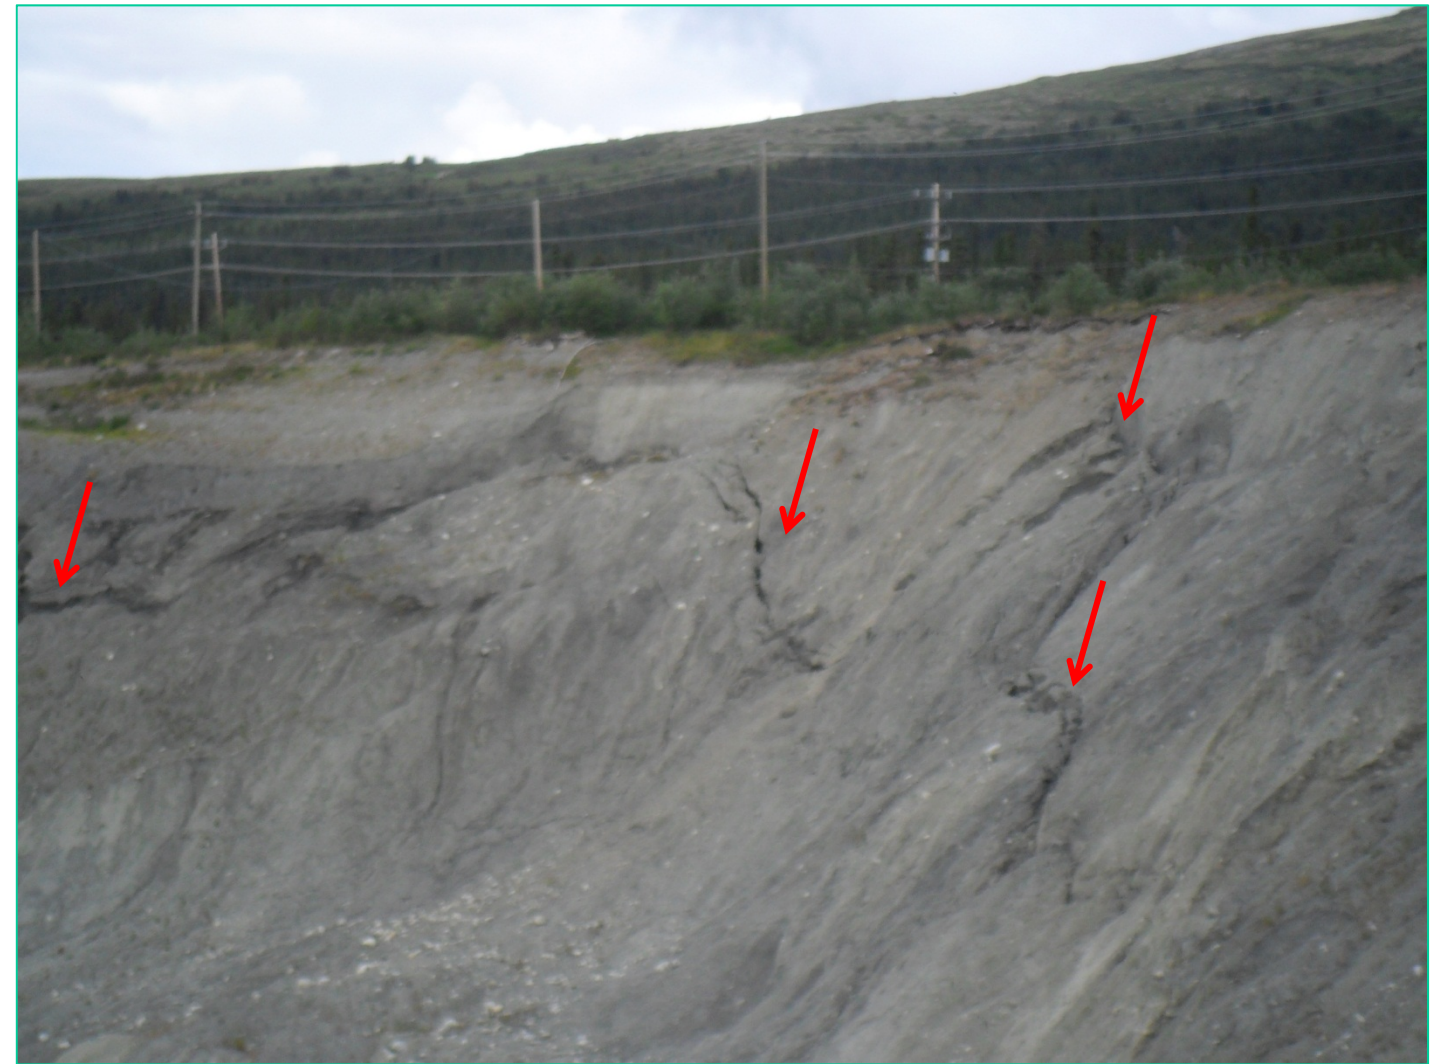
Photograph D-3
Grum Pit Instability Zone – new cracks reported in August 2012. View looking north.

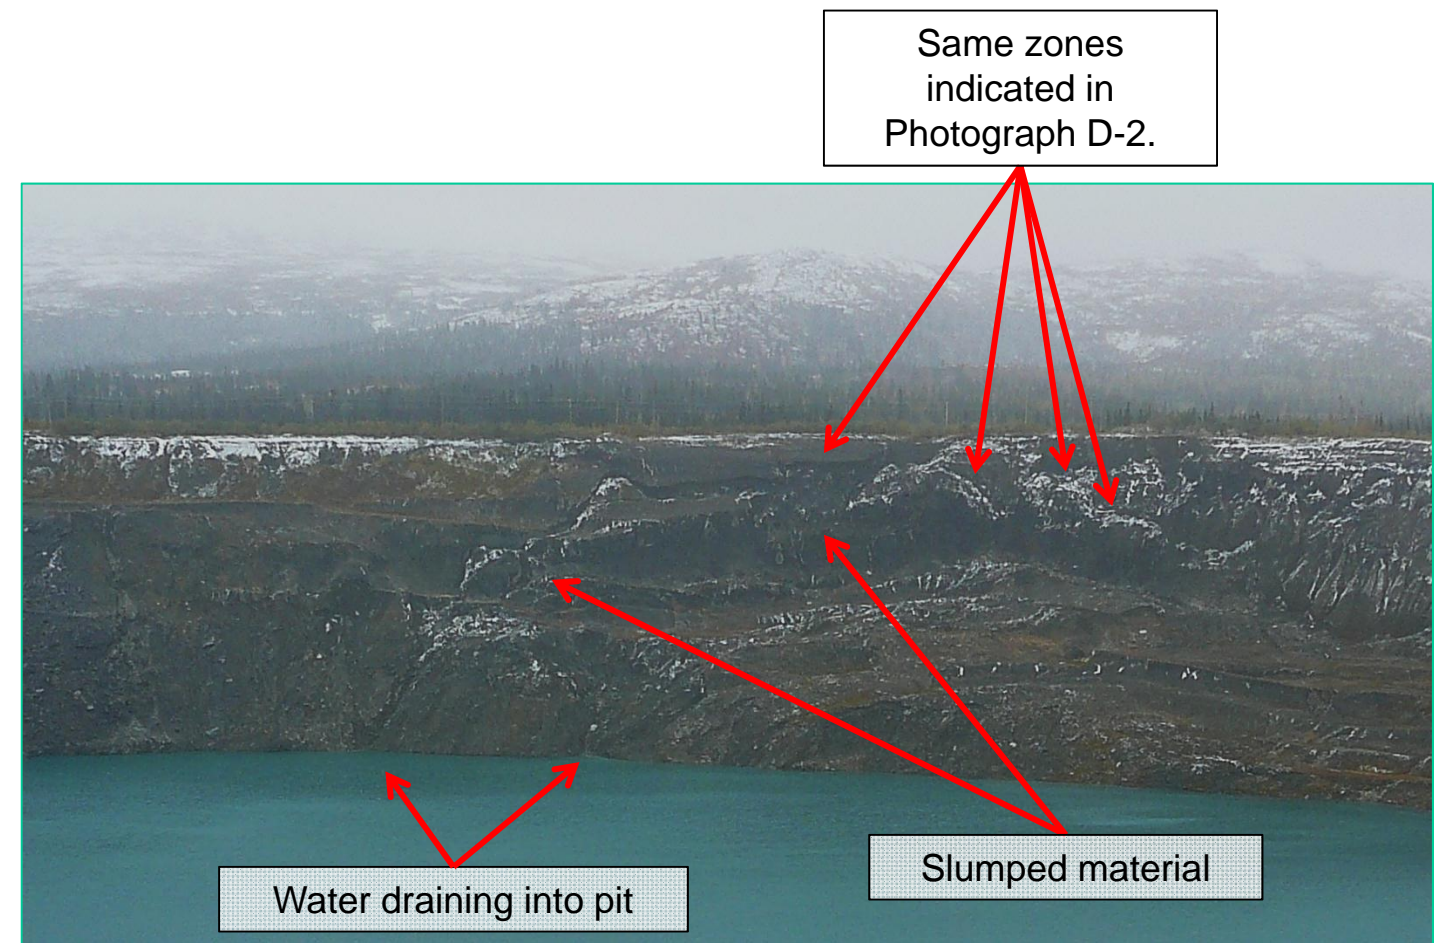
Photograph D-4
 Grum Pit Instability Zone. Cracks had extended to the north by the September 2012 site visit and a portion of the backscarp had slumped. View looking east.

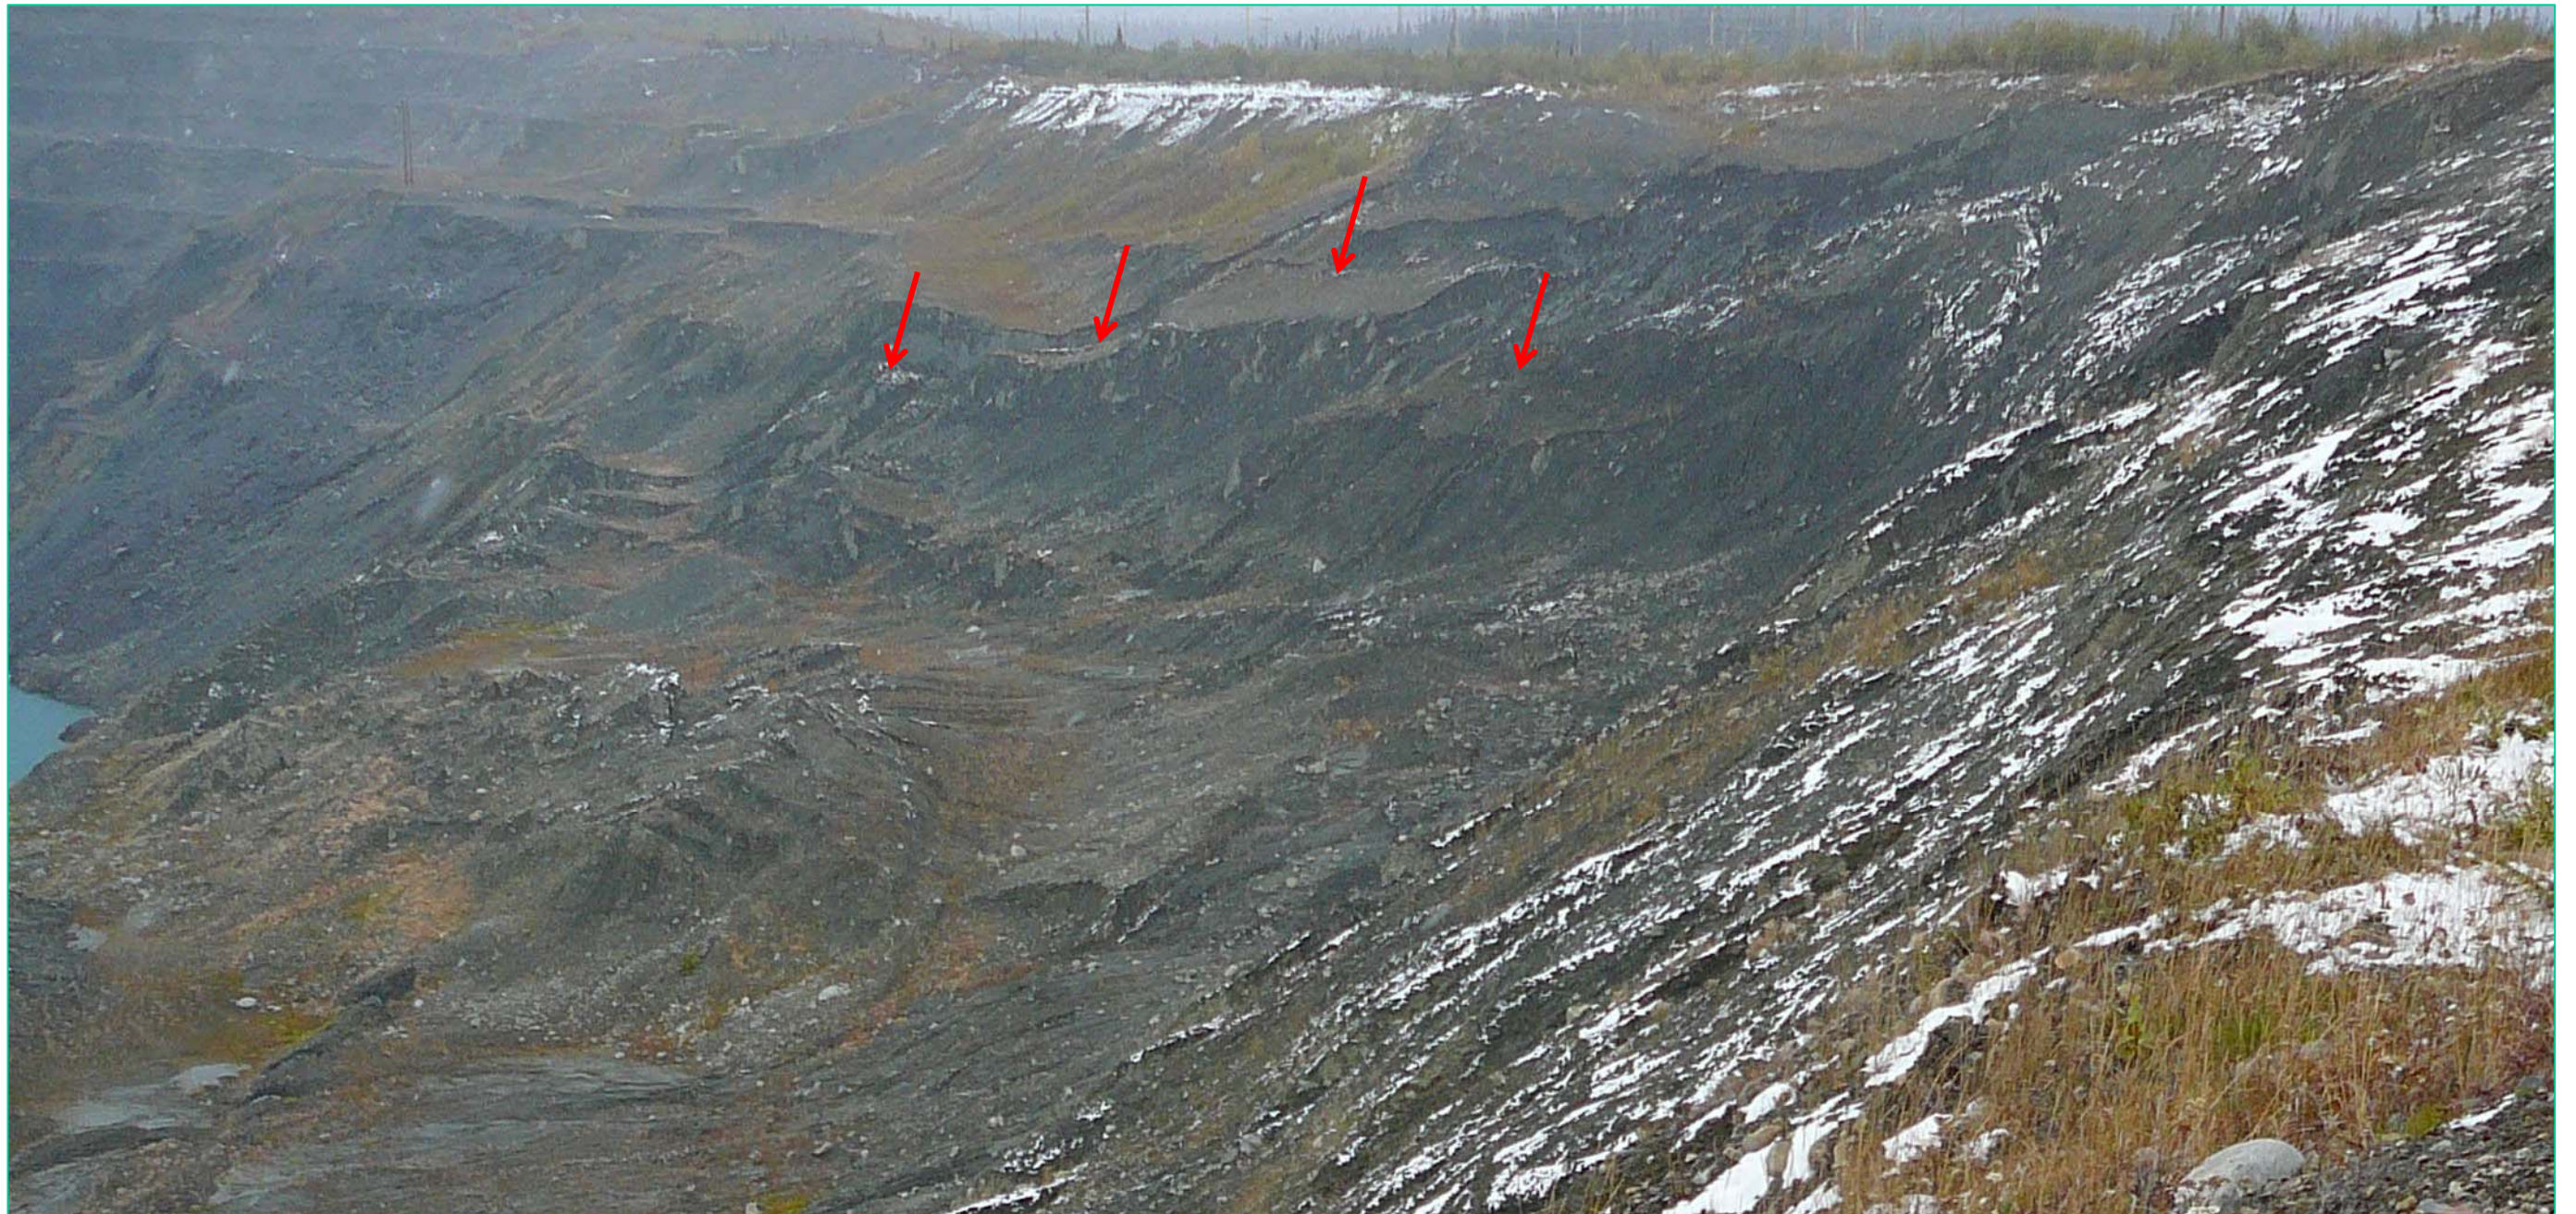
Photograph D-5
Grum Pit east wall and instability zone. Side view of recent instability. View looking north.

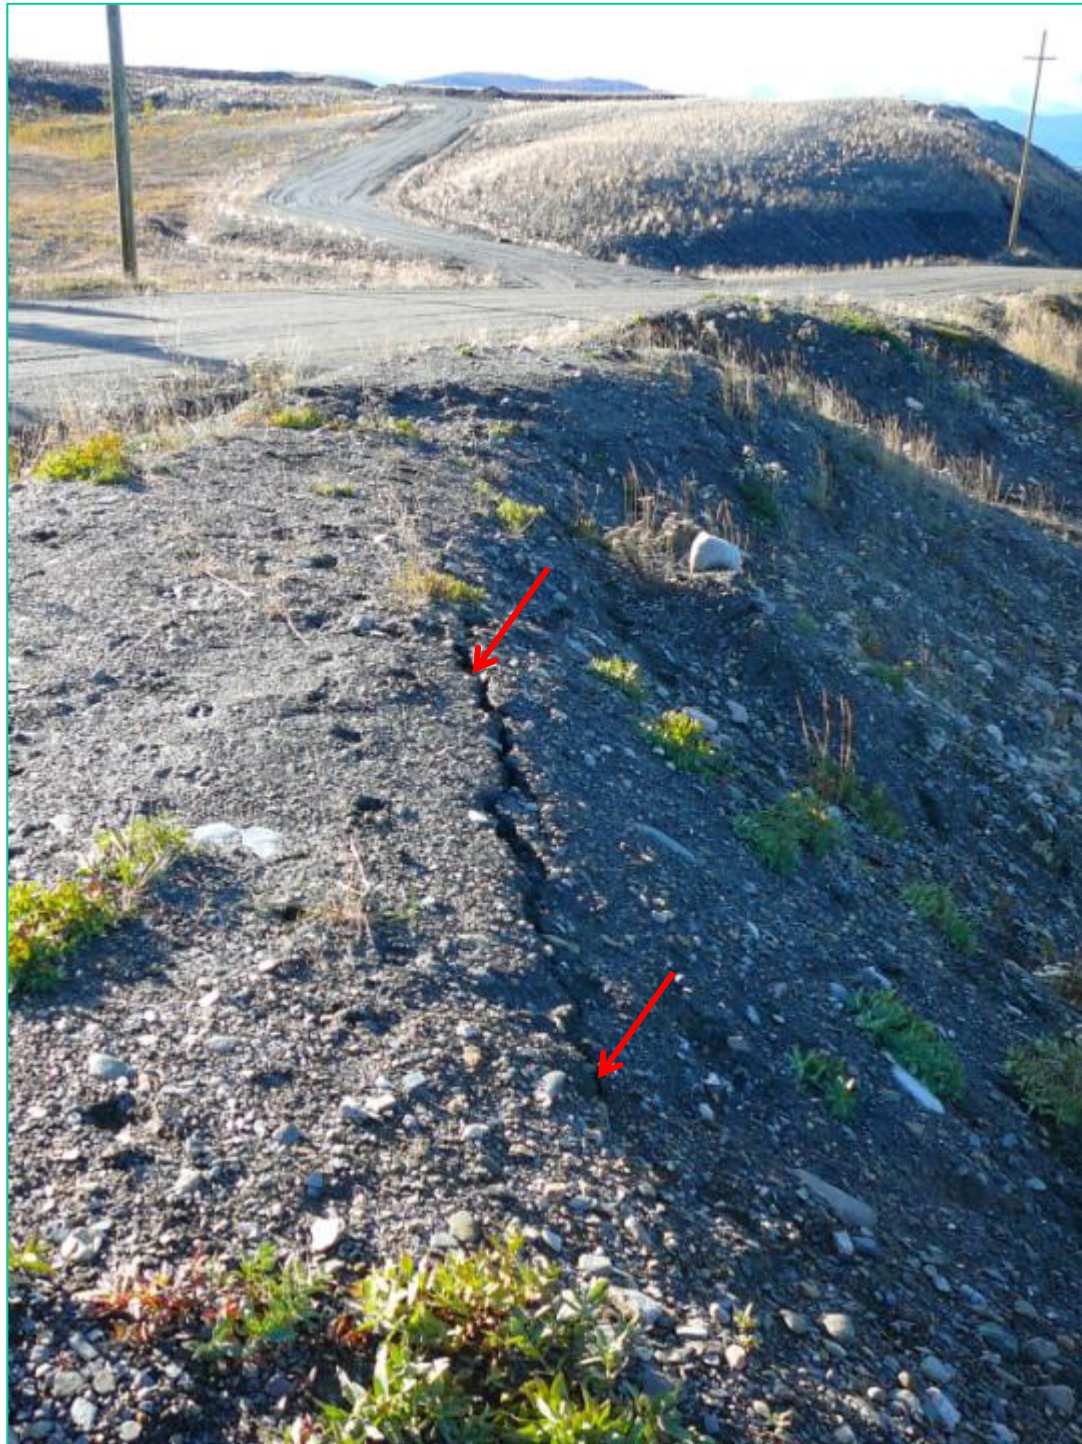
Photograph D-6
Grum Pit recent crack, located to the south of the South Array, near road. View looking southwest.

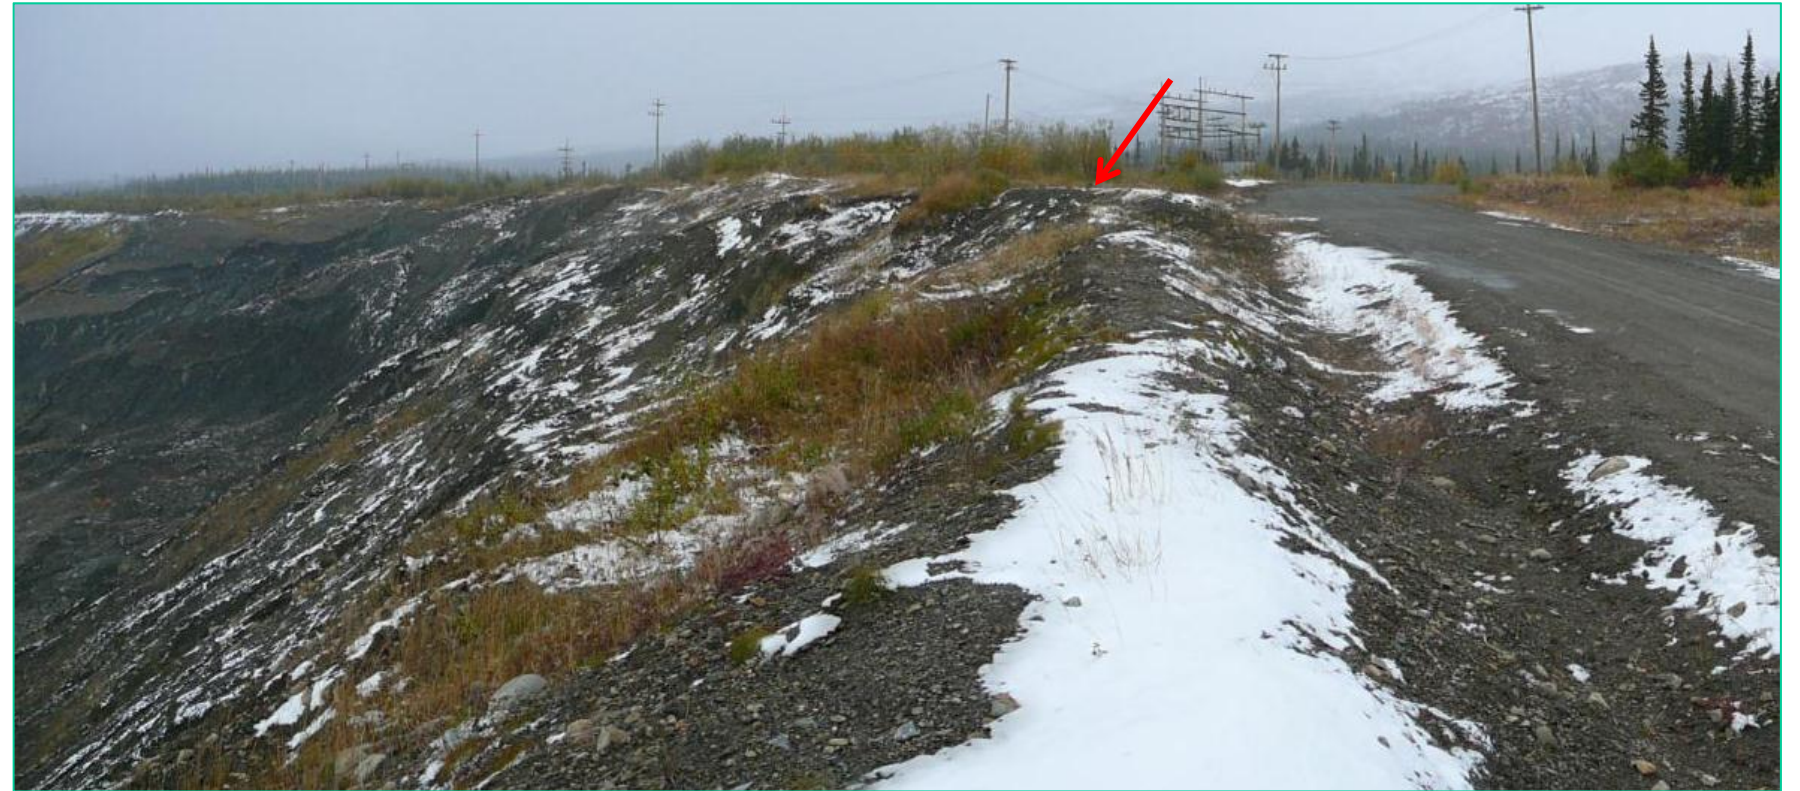
Photograph D-7
Grum Pit recent crack, located to the south of the South Array, near road. Approximate location indicated by red arrow. View looking northeast.

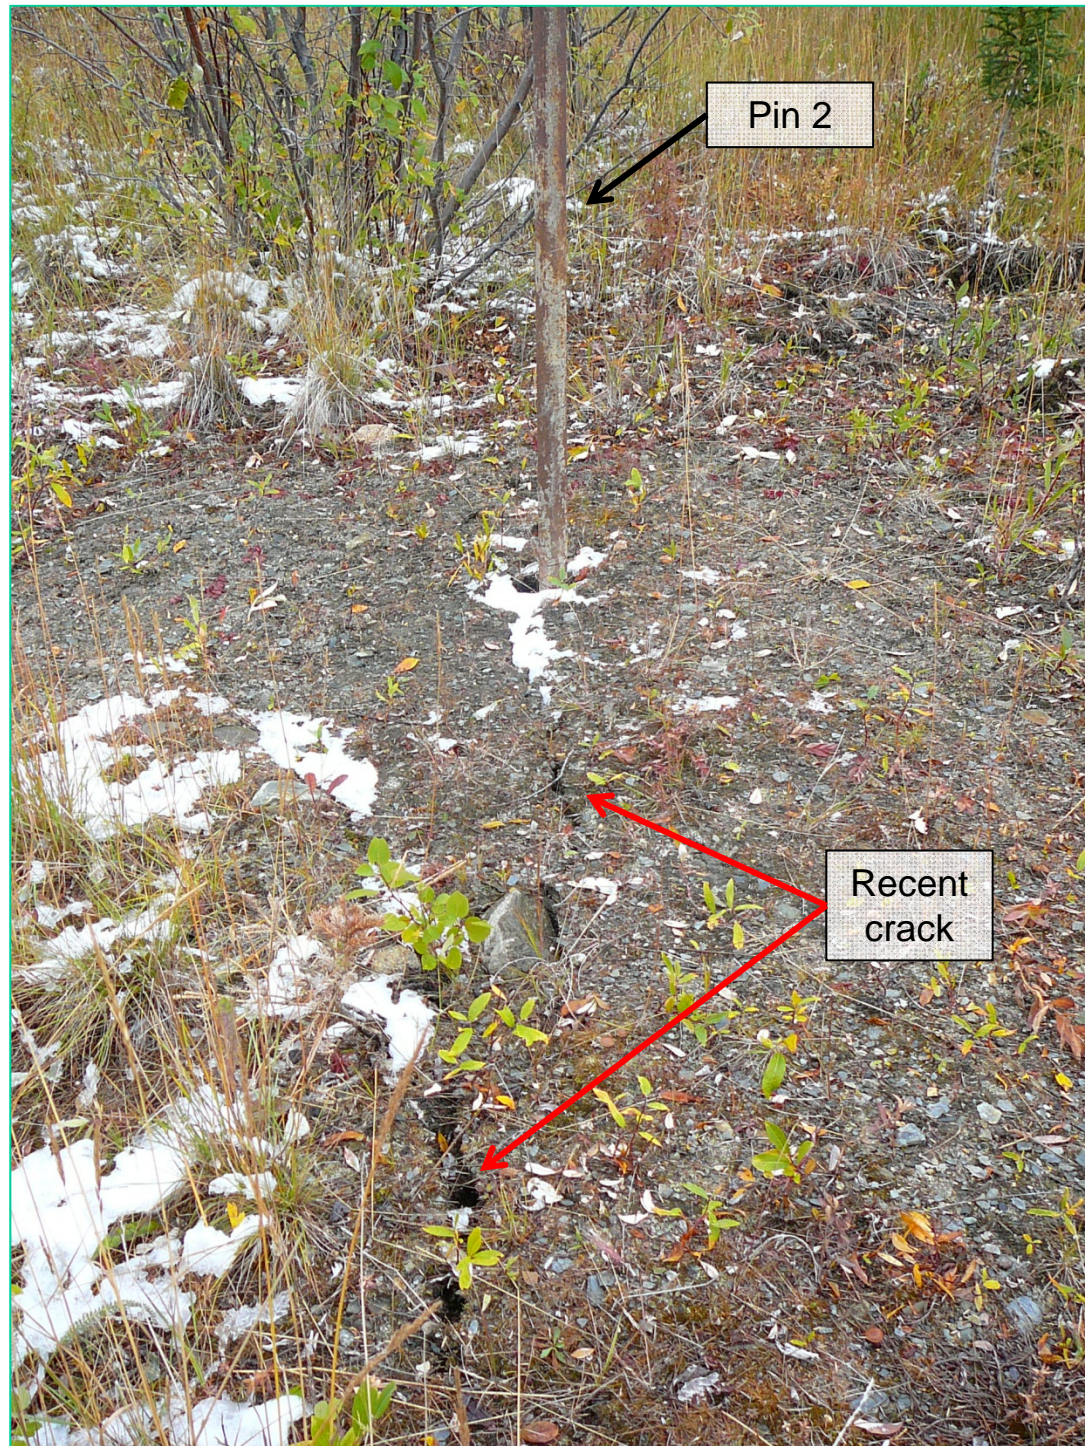
Photograph D-8
 Grum Pit recent crack, located across the second pin from the crest in the North Array. View looking northwest.
