February 7, 2013

REPORT ON

Faro Mine Complex Annual Pit Slope Stability Inspection

Project Number: 1214260031-001-R-Rev0-6000

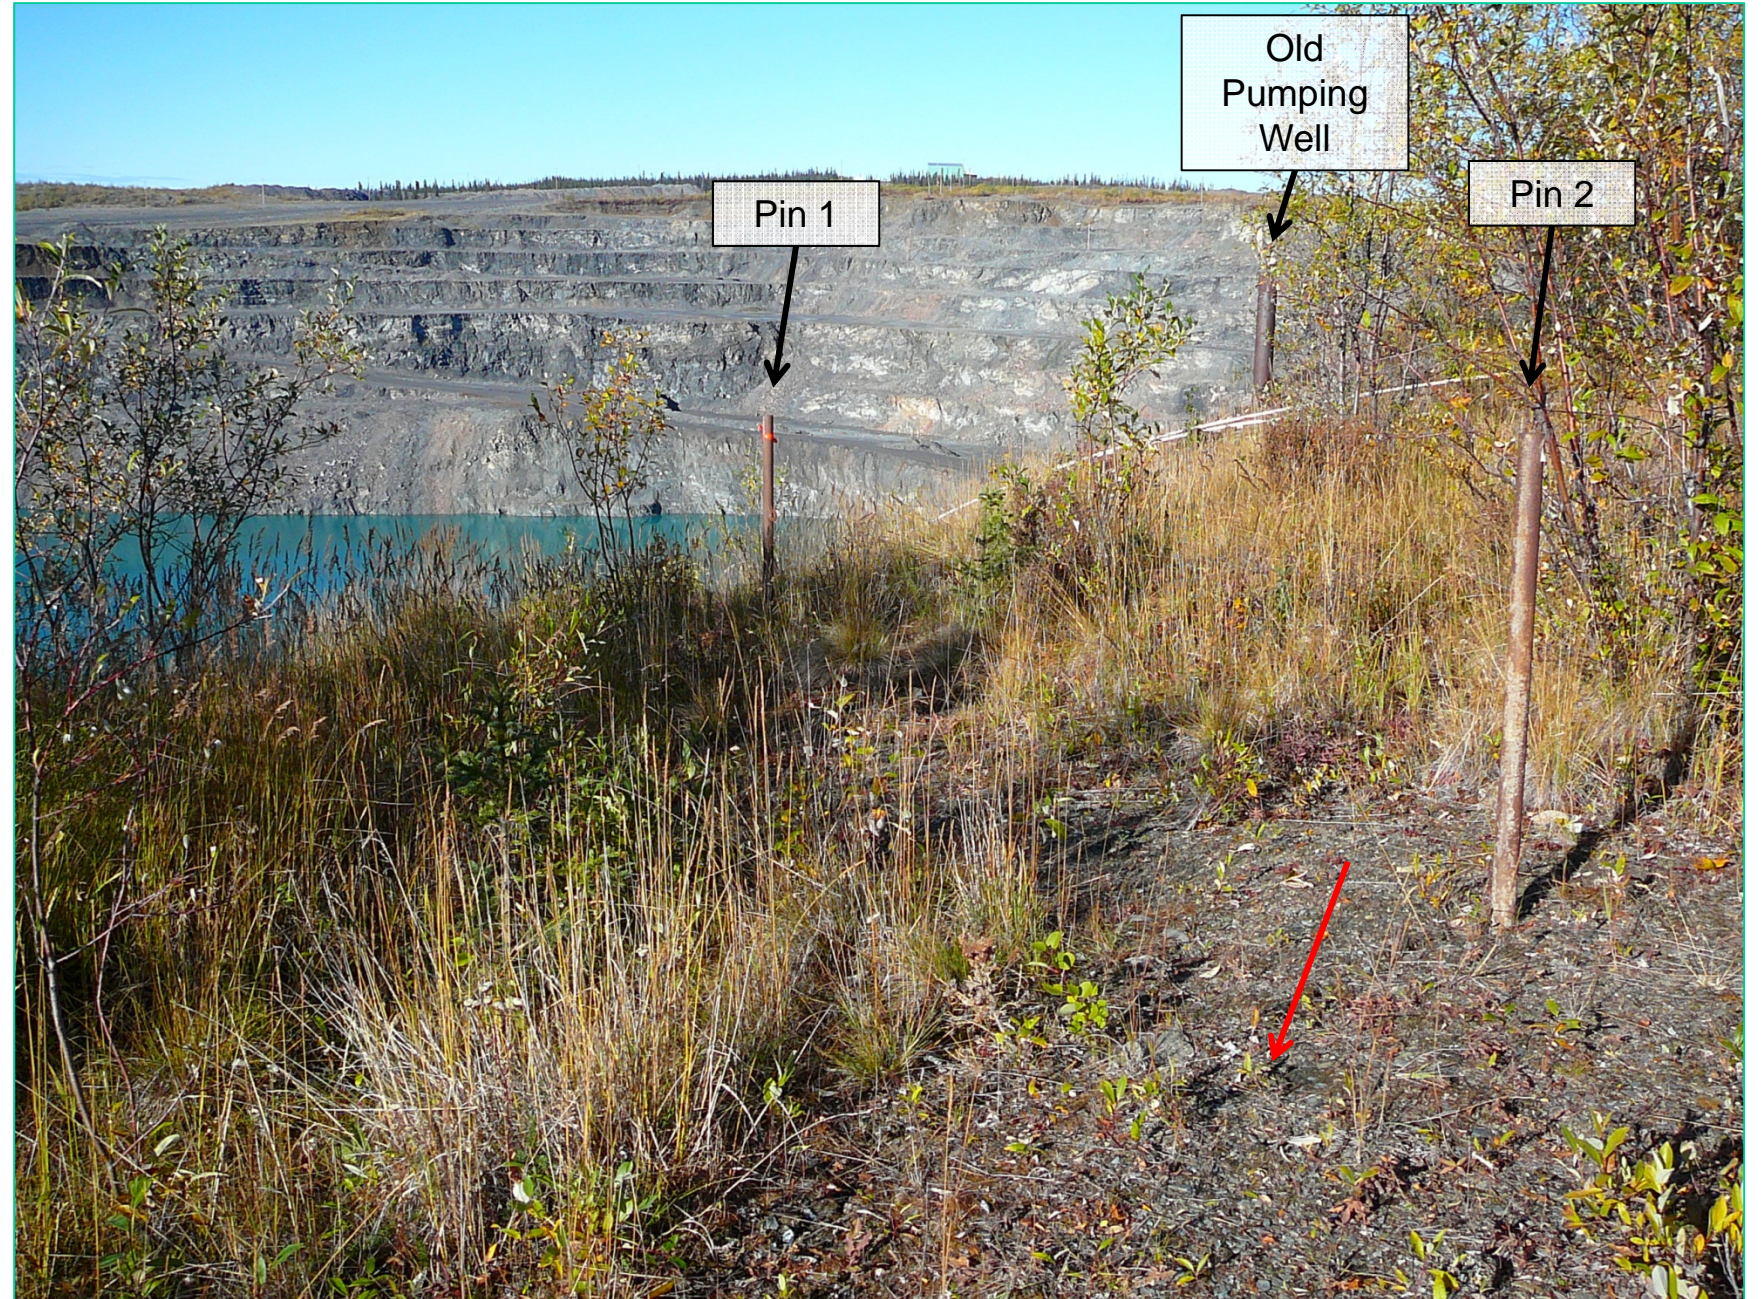
Photograph D-9
 Grum Pit recent crack, located across the second pin from the crest in the North Array. Approximate location indicated by red arrow. View looking west.

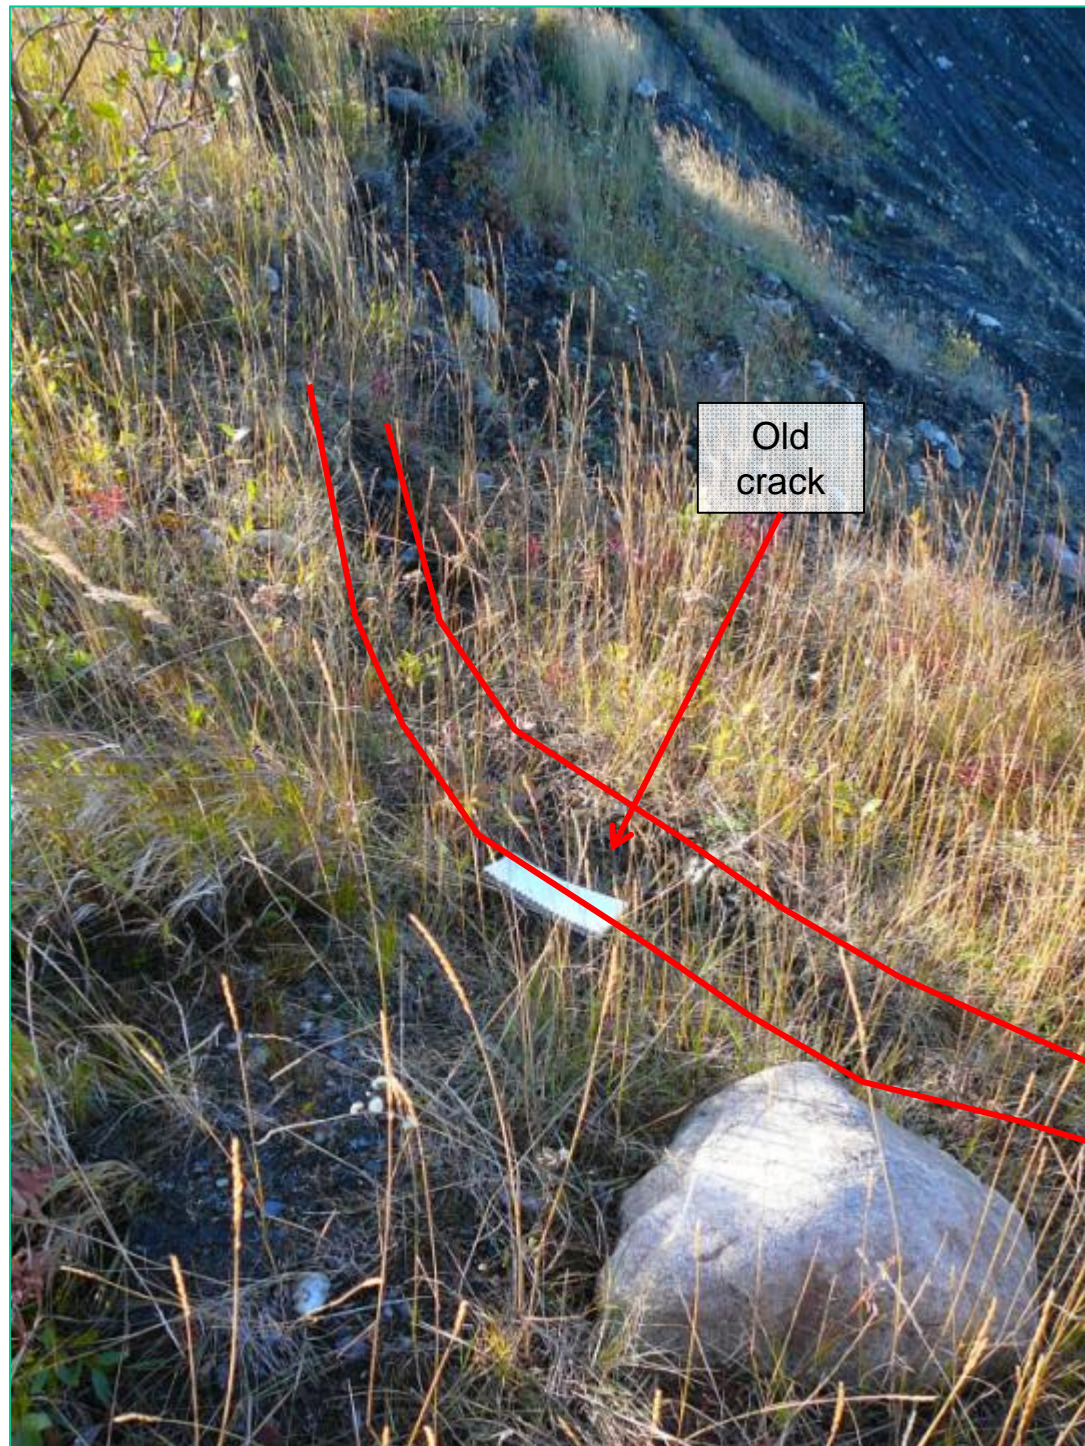
Photograph D-10
Grum Pit old crack, located at crest of east wall, south of
the South Array. View looking south.

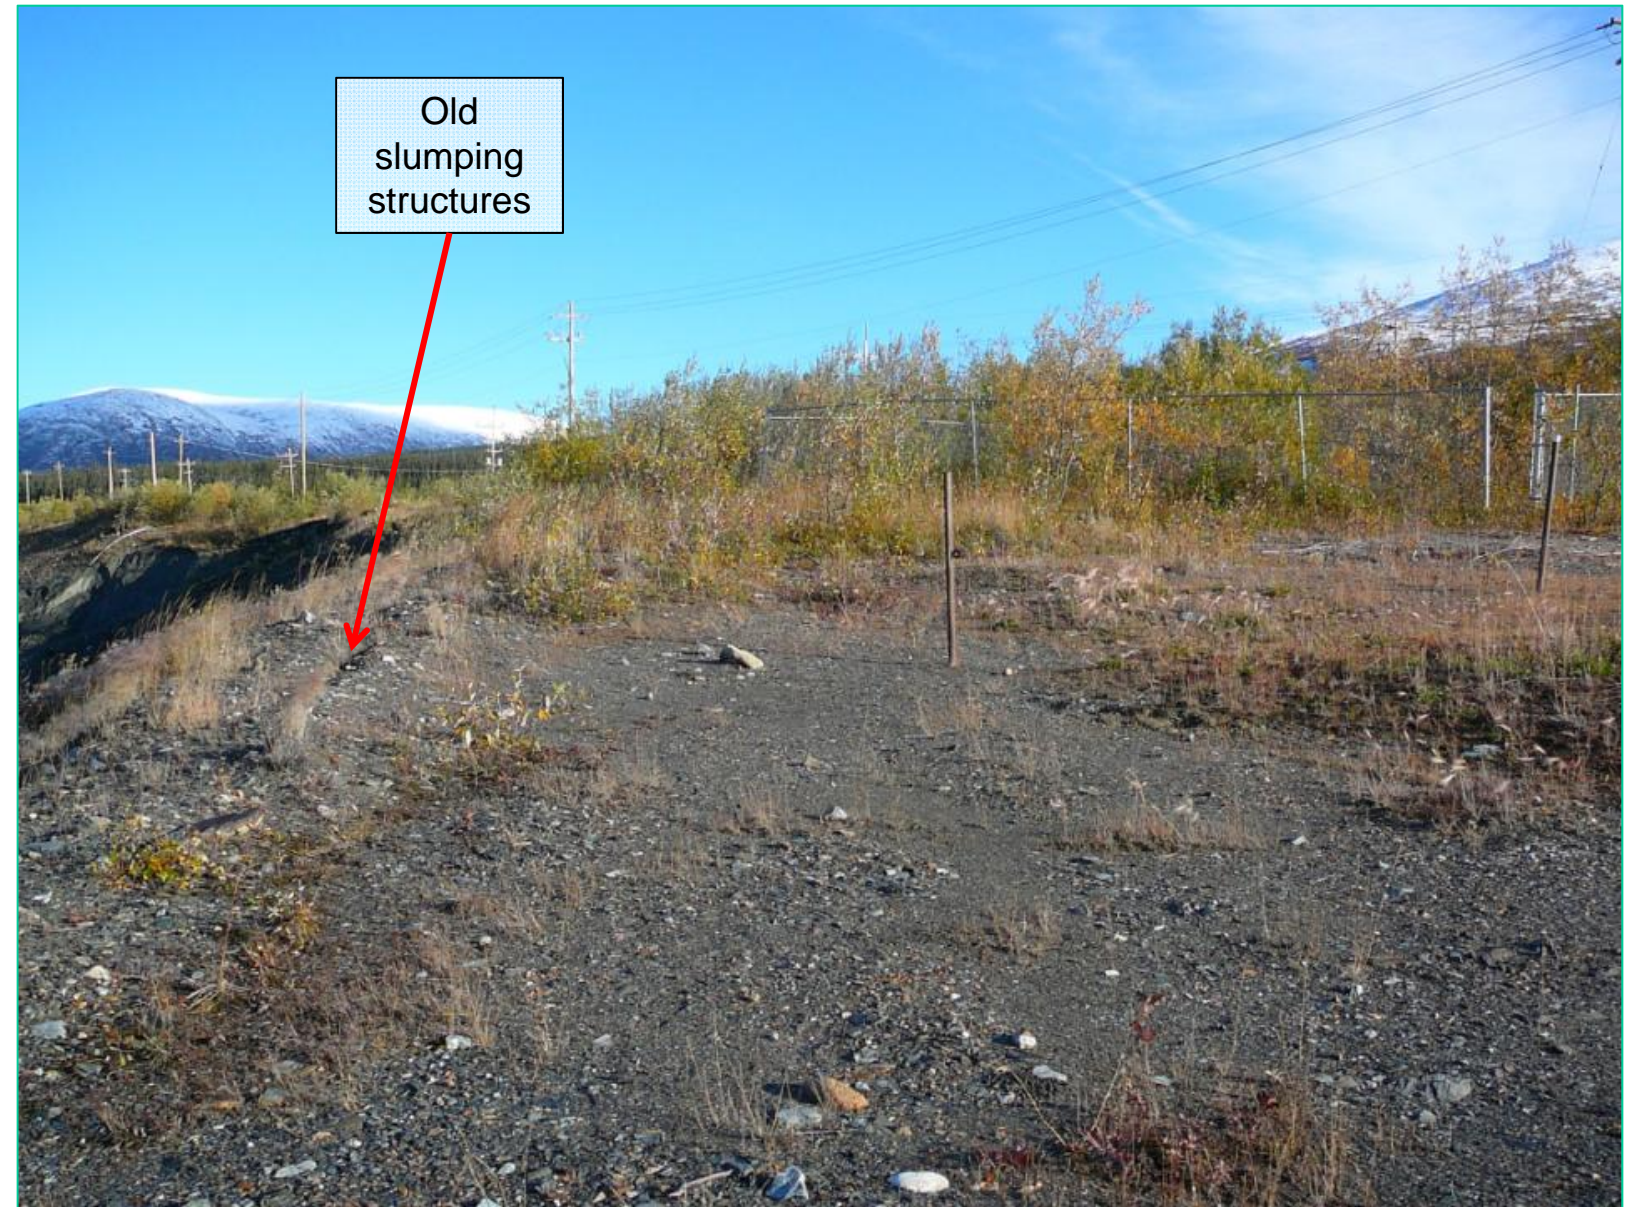
Photograph D-11
Grum Pit old slumping structures near South Array. View looking north.

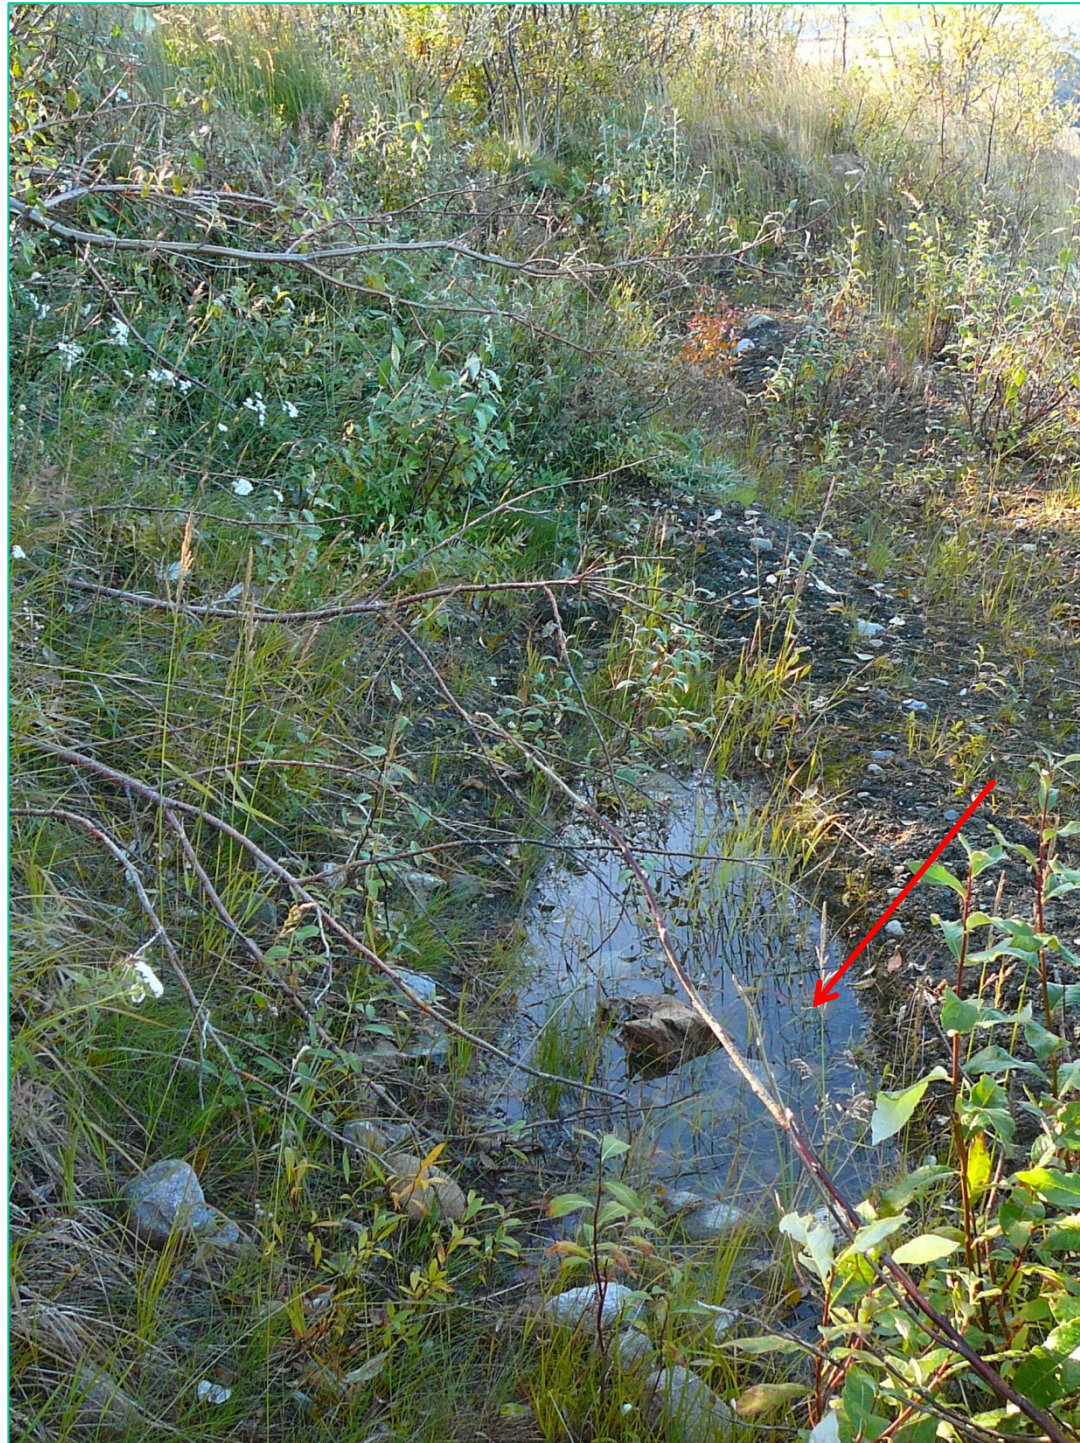
Photograph D-12
Grum Pit - small pond of water near crest, between
North and South Arrays. View looking south.

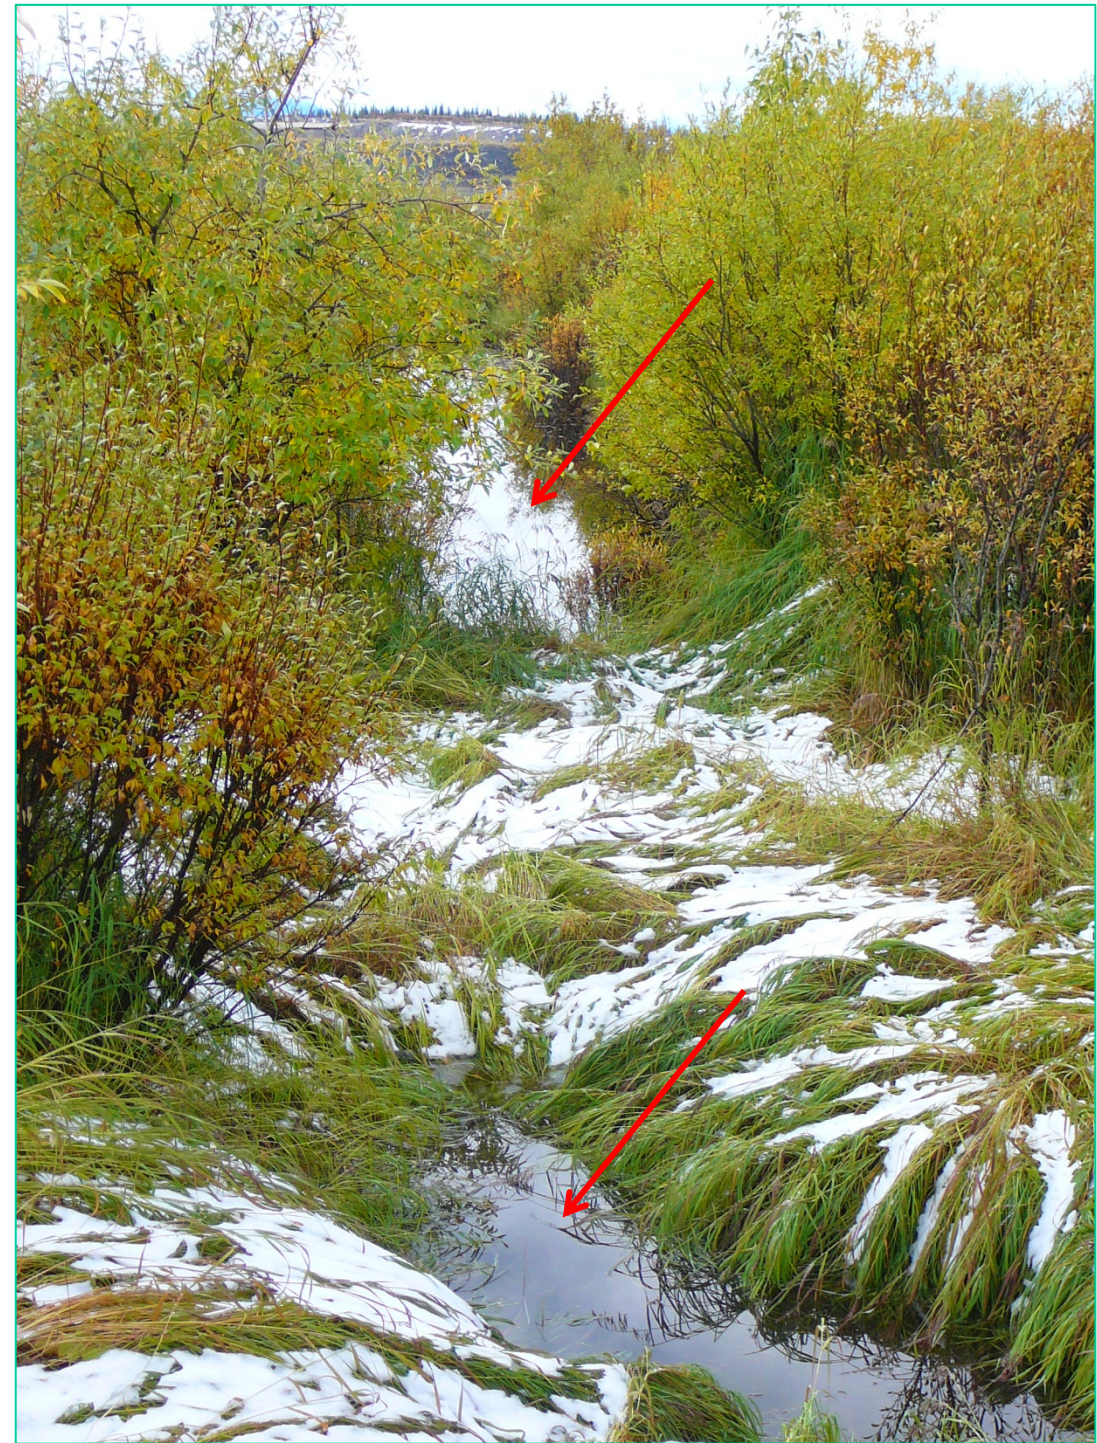
Photograph D-13
Grum Pit – areas of ponded water behind crest, in
vegetated area. View looking west.

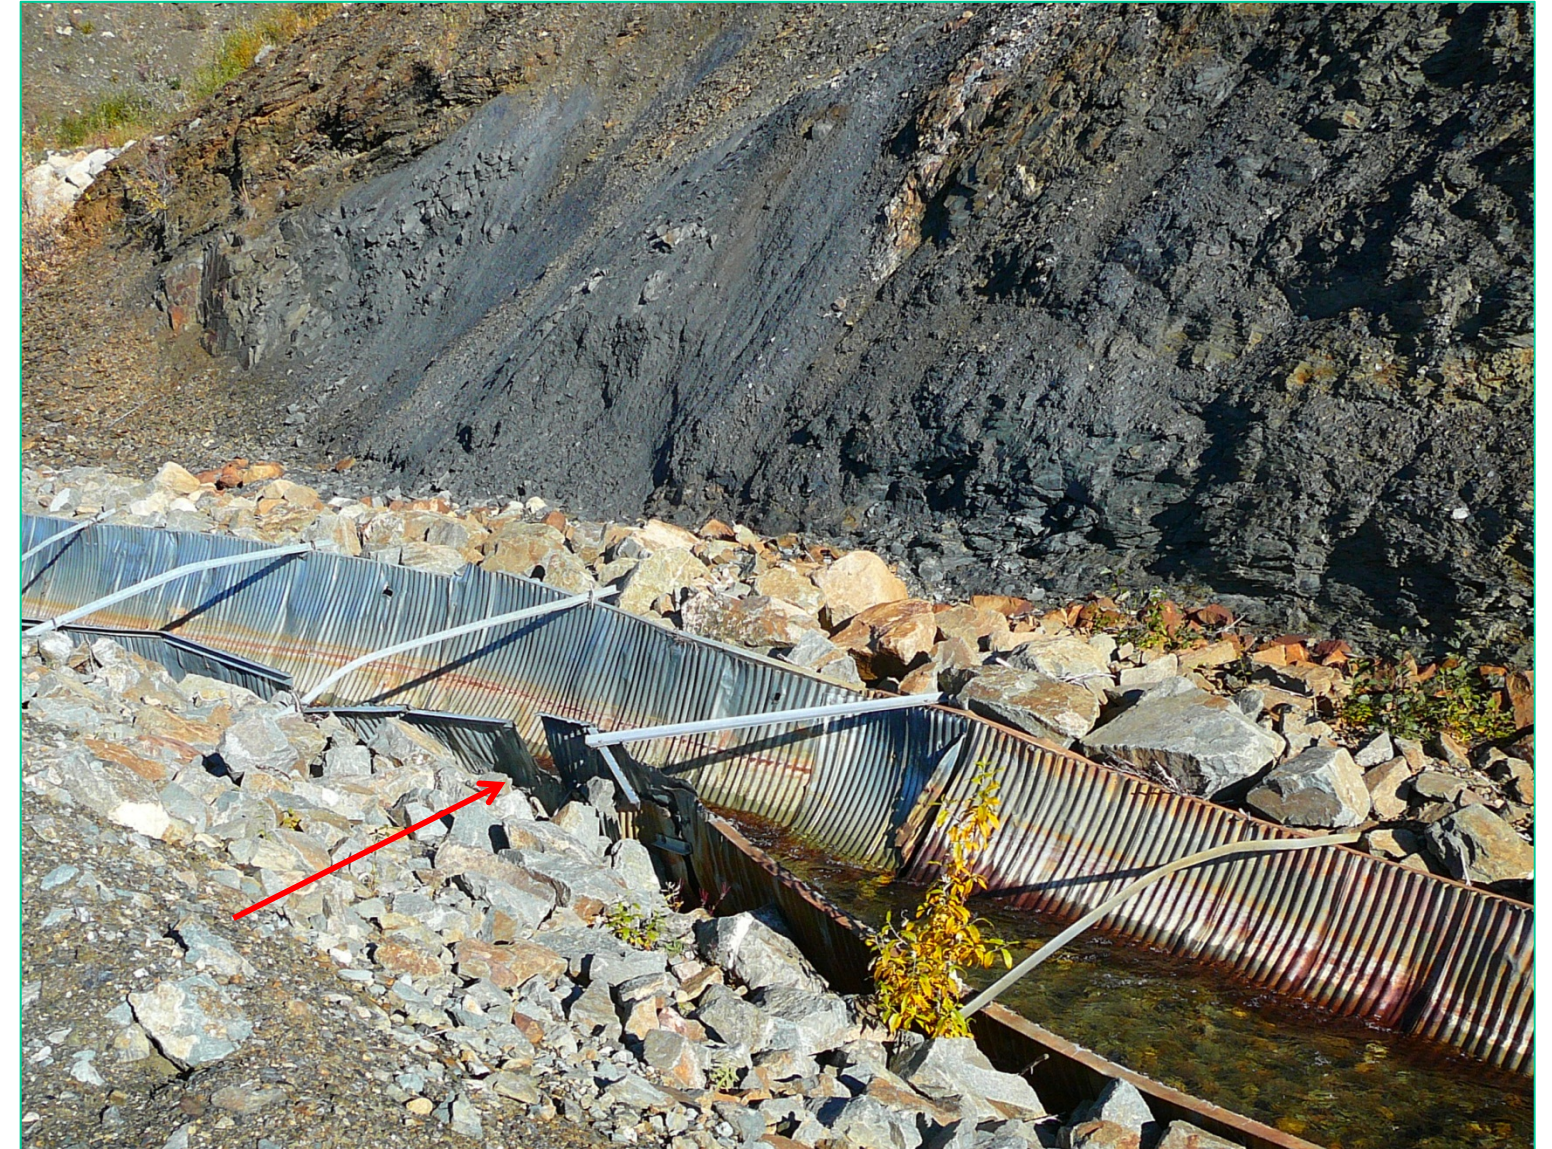
Photograph E-8
Vangorda Pit – Vangorda Creek Diversion Channel.
Sections are in disrepair, allowing leaks. View looking north.

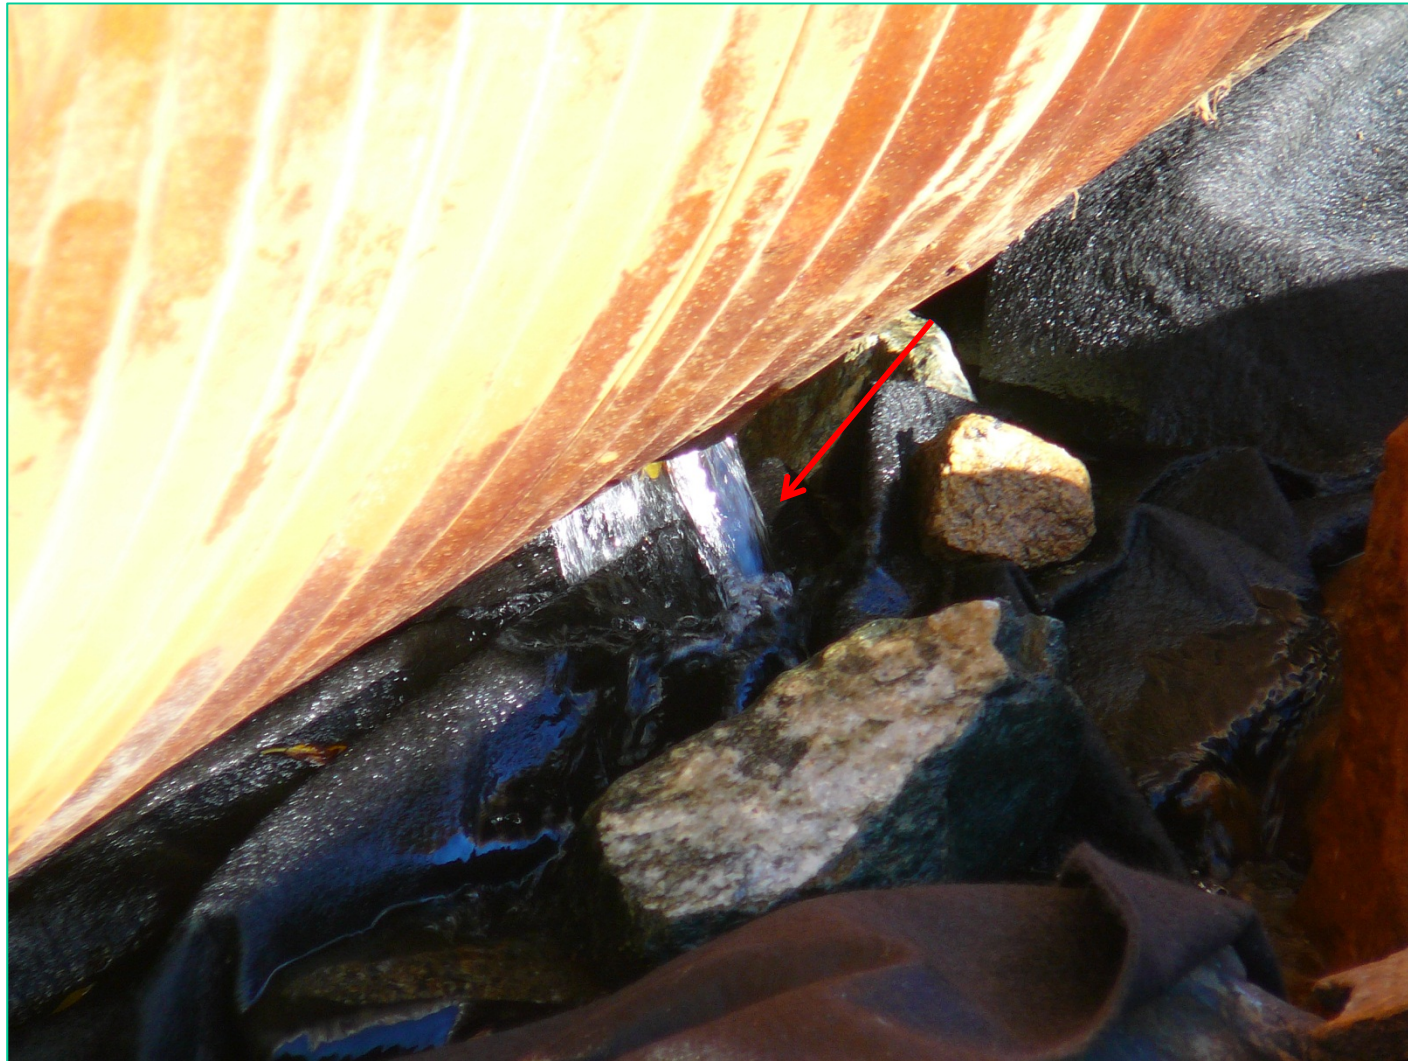
Photograph E-9
Vangorda Pit – Water leaking beneath flume.

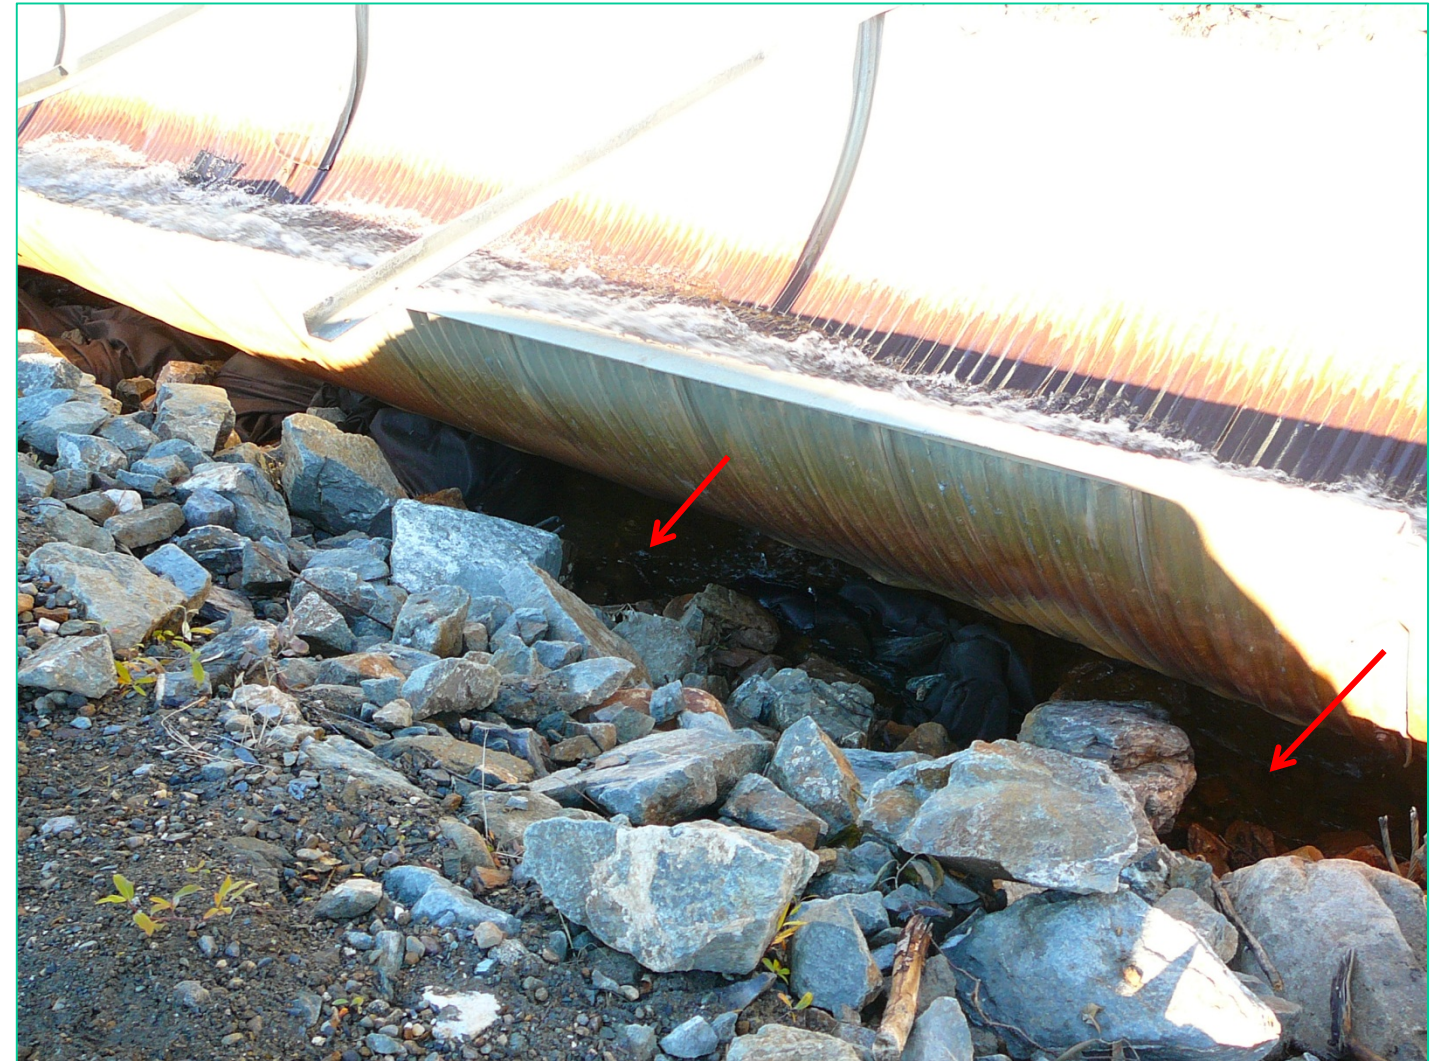
Photograph E-10
Vangorda Pit – Water flowing in channel beneath flume indicated by red arrows.

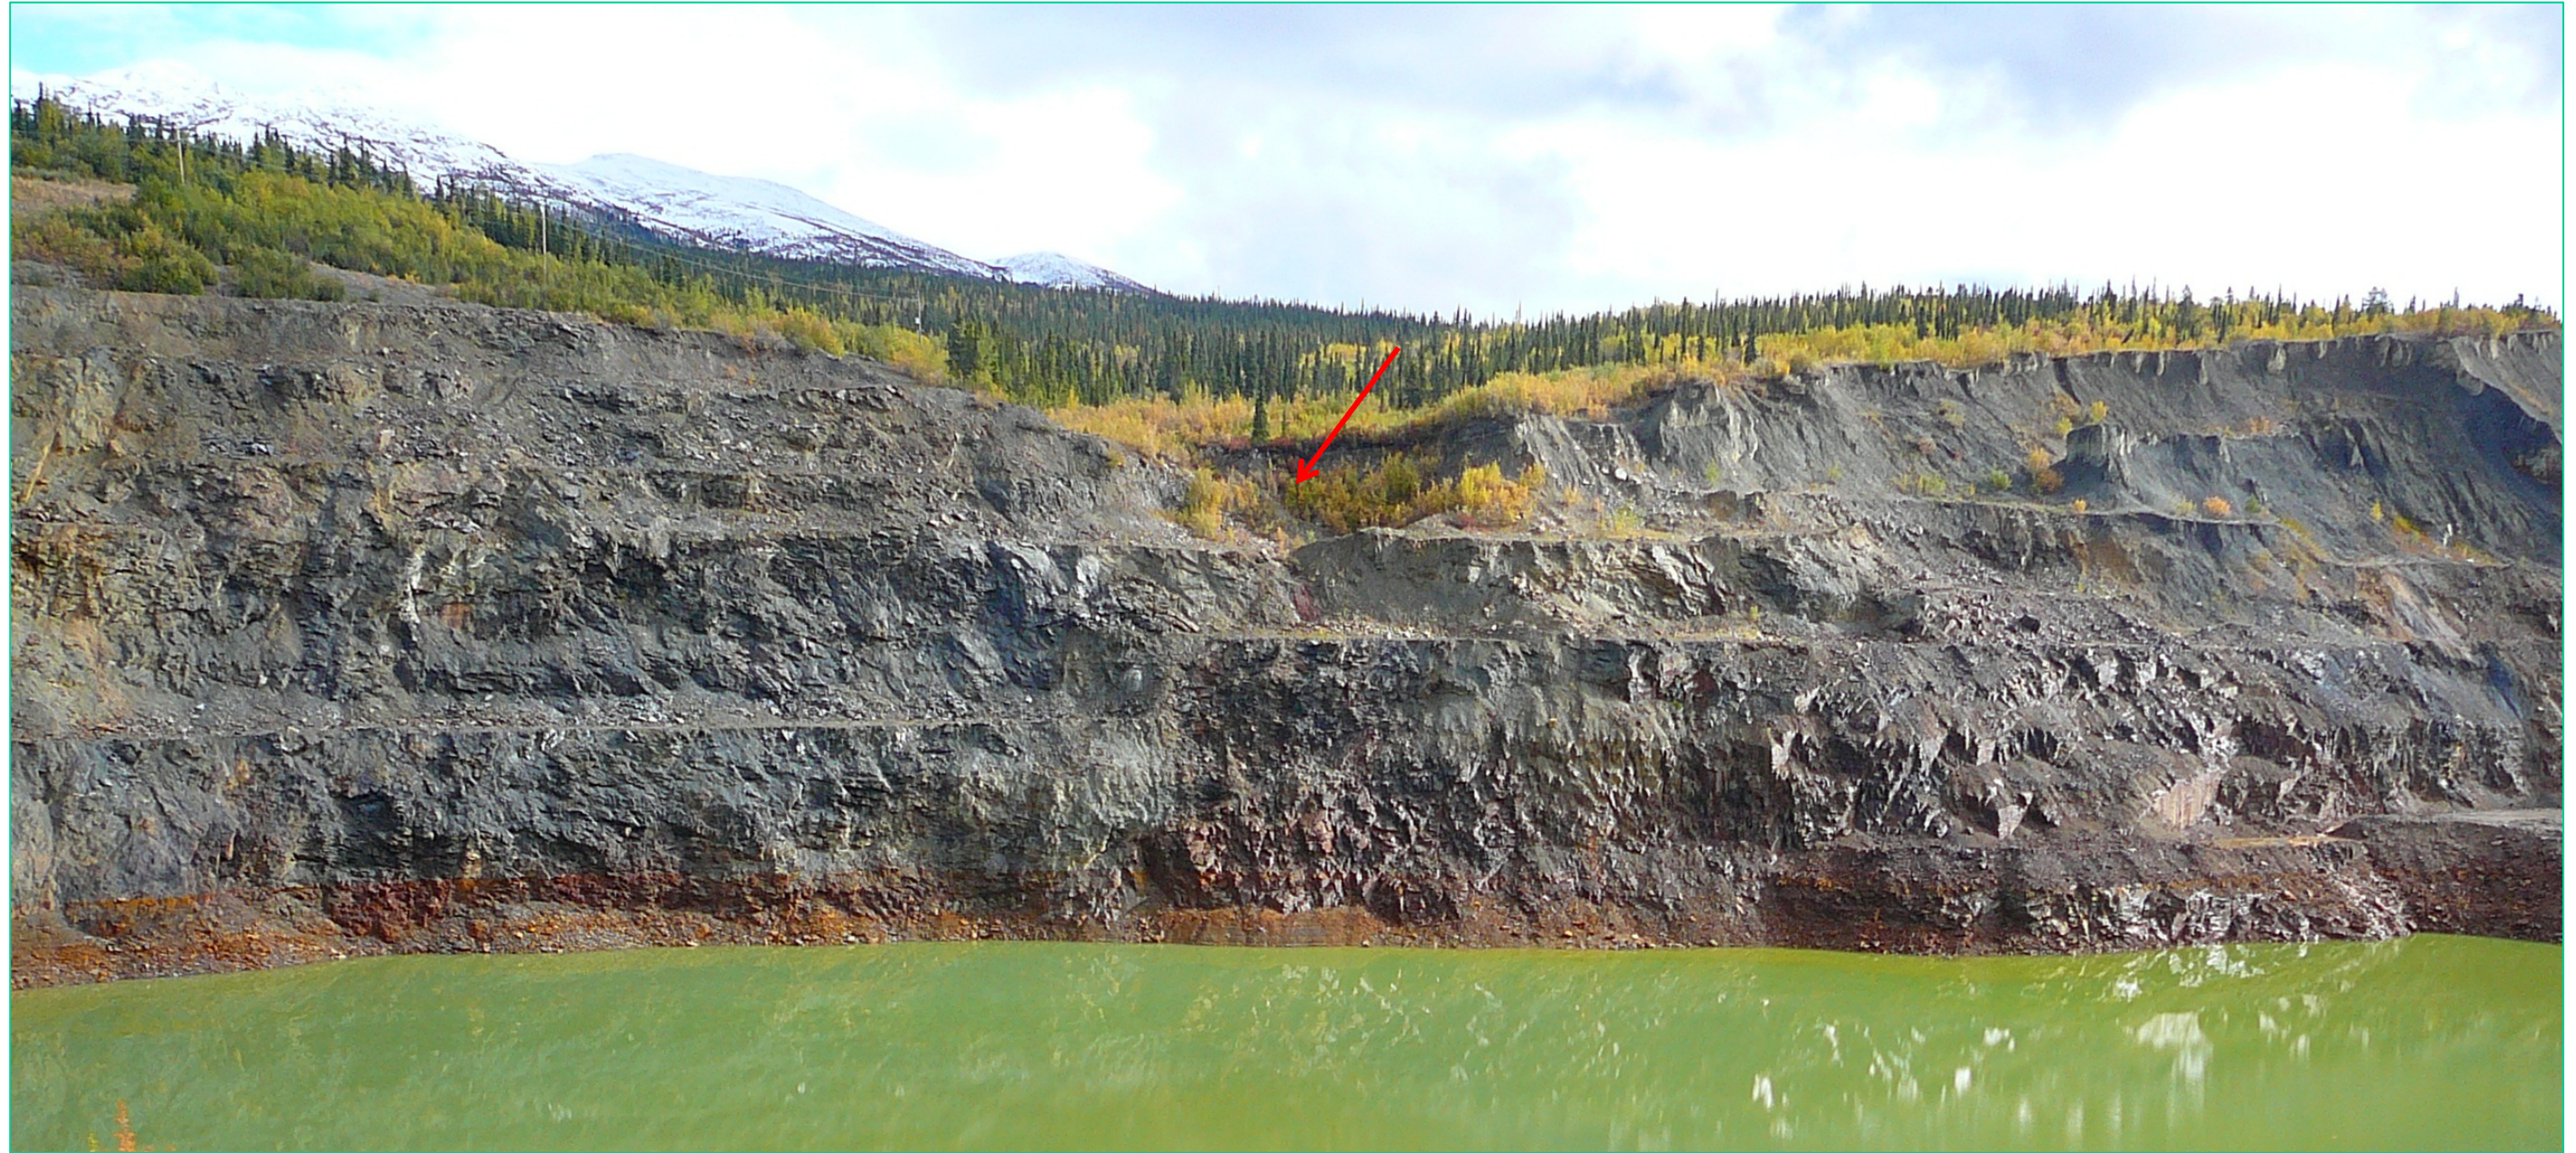
Photograph E-11
Vangorda Pit – Location of original Vangorda Creek channel. Some water enters the pit from this location.
View looking northeast.

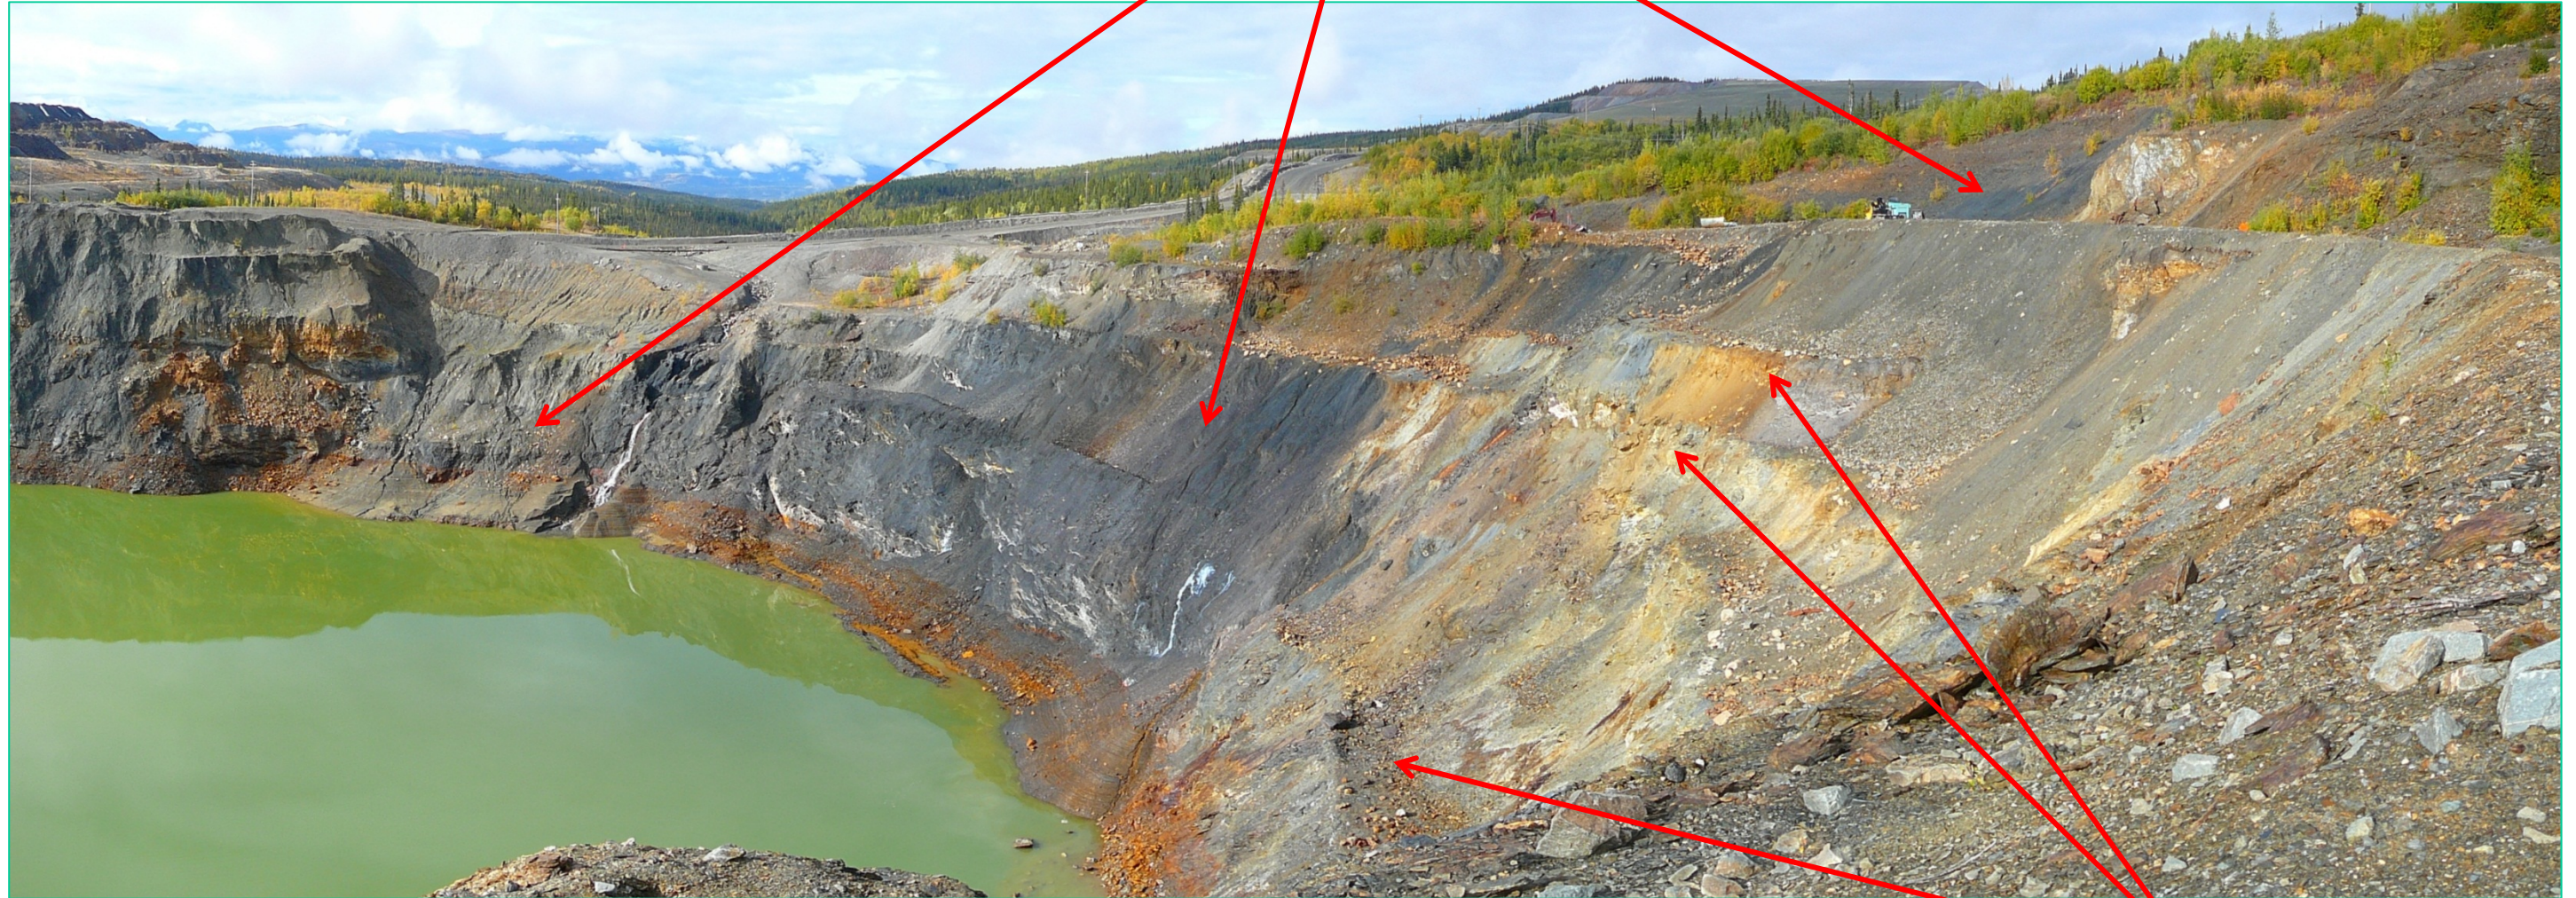
Weak rock raveling and eroding into talus slopes.

Some intact bench crests in slightly more competent rock, but little catchment remaining.

Photograph E-16
Vangorda Pit northwest wall. View looking west.

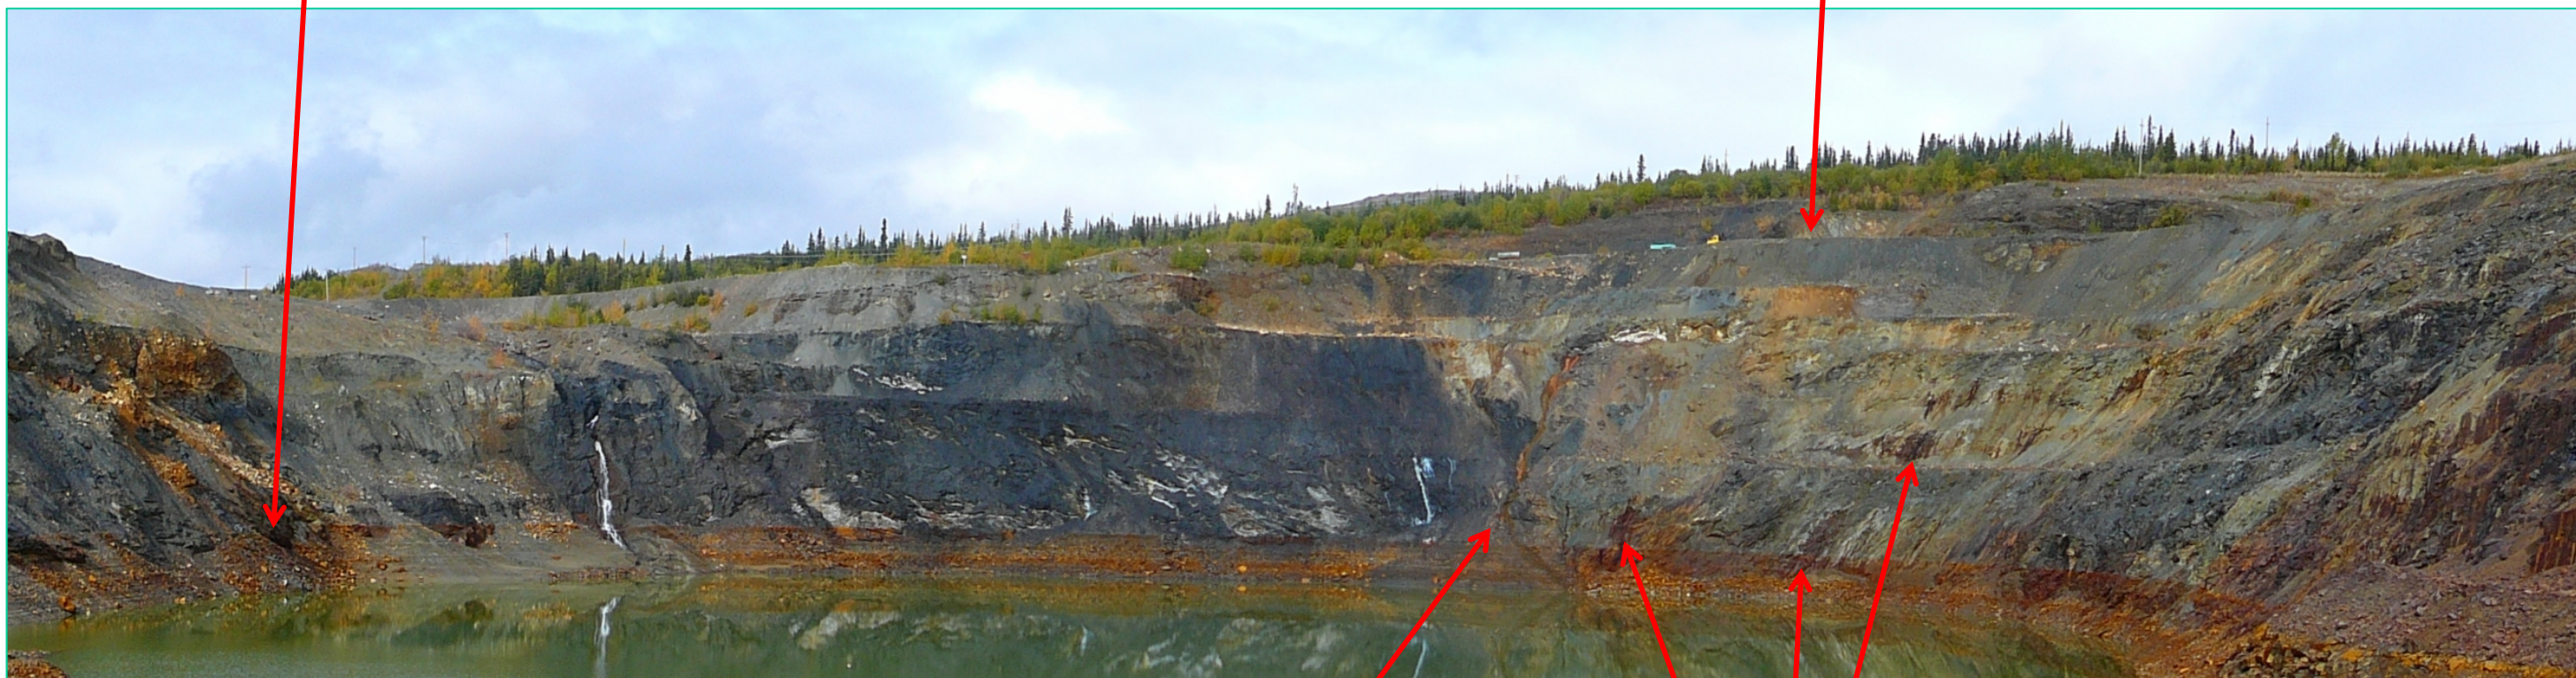
Erosion and seepage along
Creek Fault

Seepage observed in wall.

Photograph E-17
Vangorda Pit northwest wall. View looking northwest.
