February 7, 2013

REPORT ON

Faro Mine Complex Annual Pit Slope Stability Inspection

Project Number: 1214260031-001-R-Rev0-6000

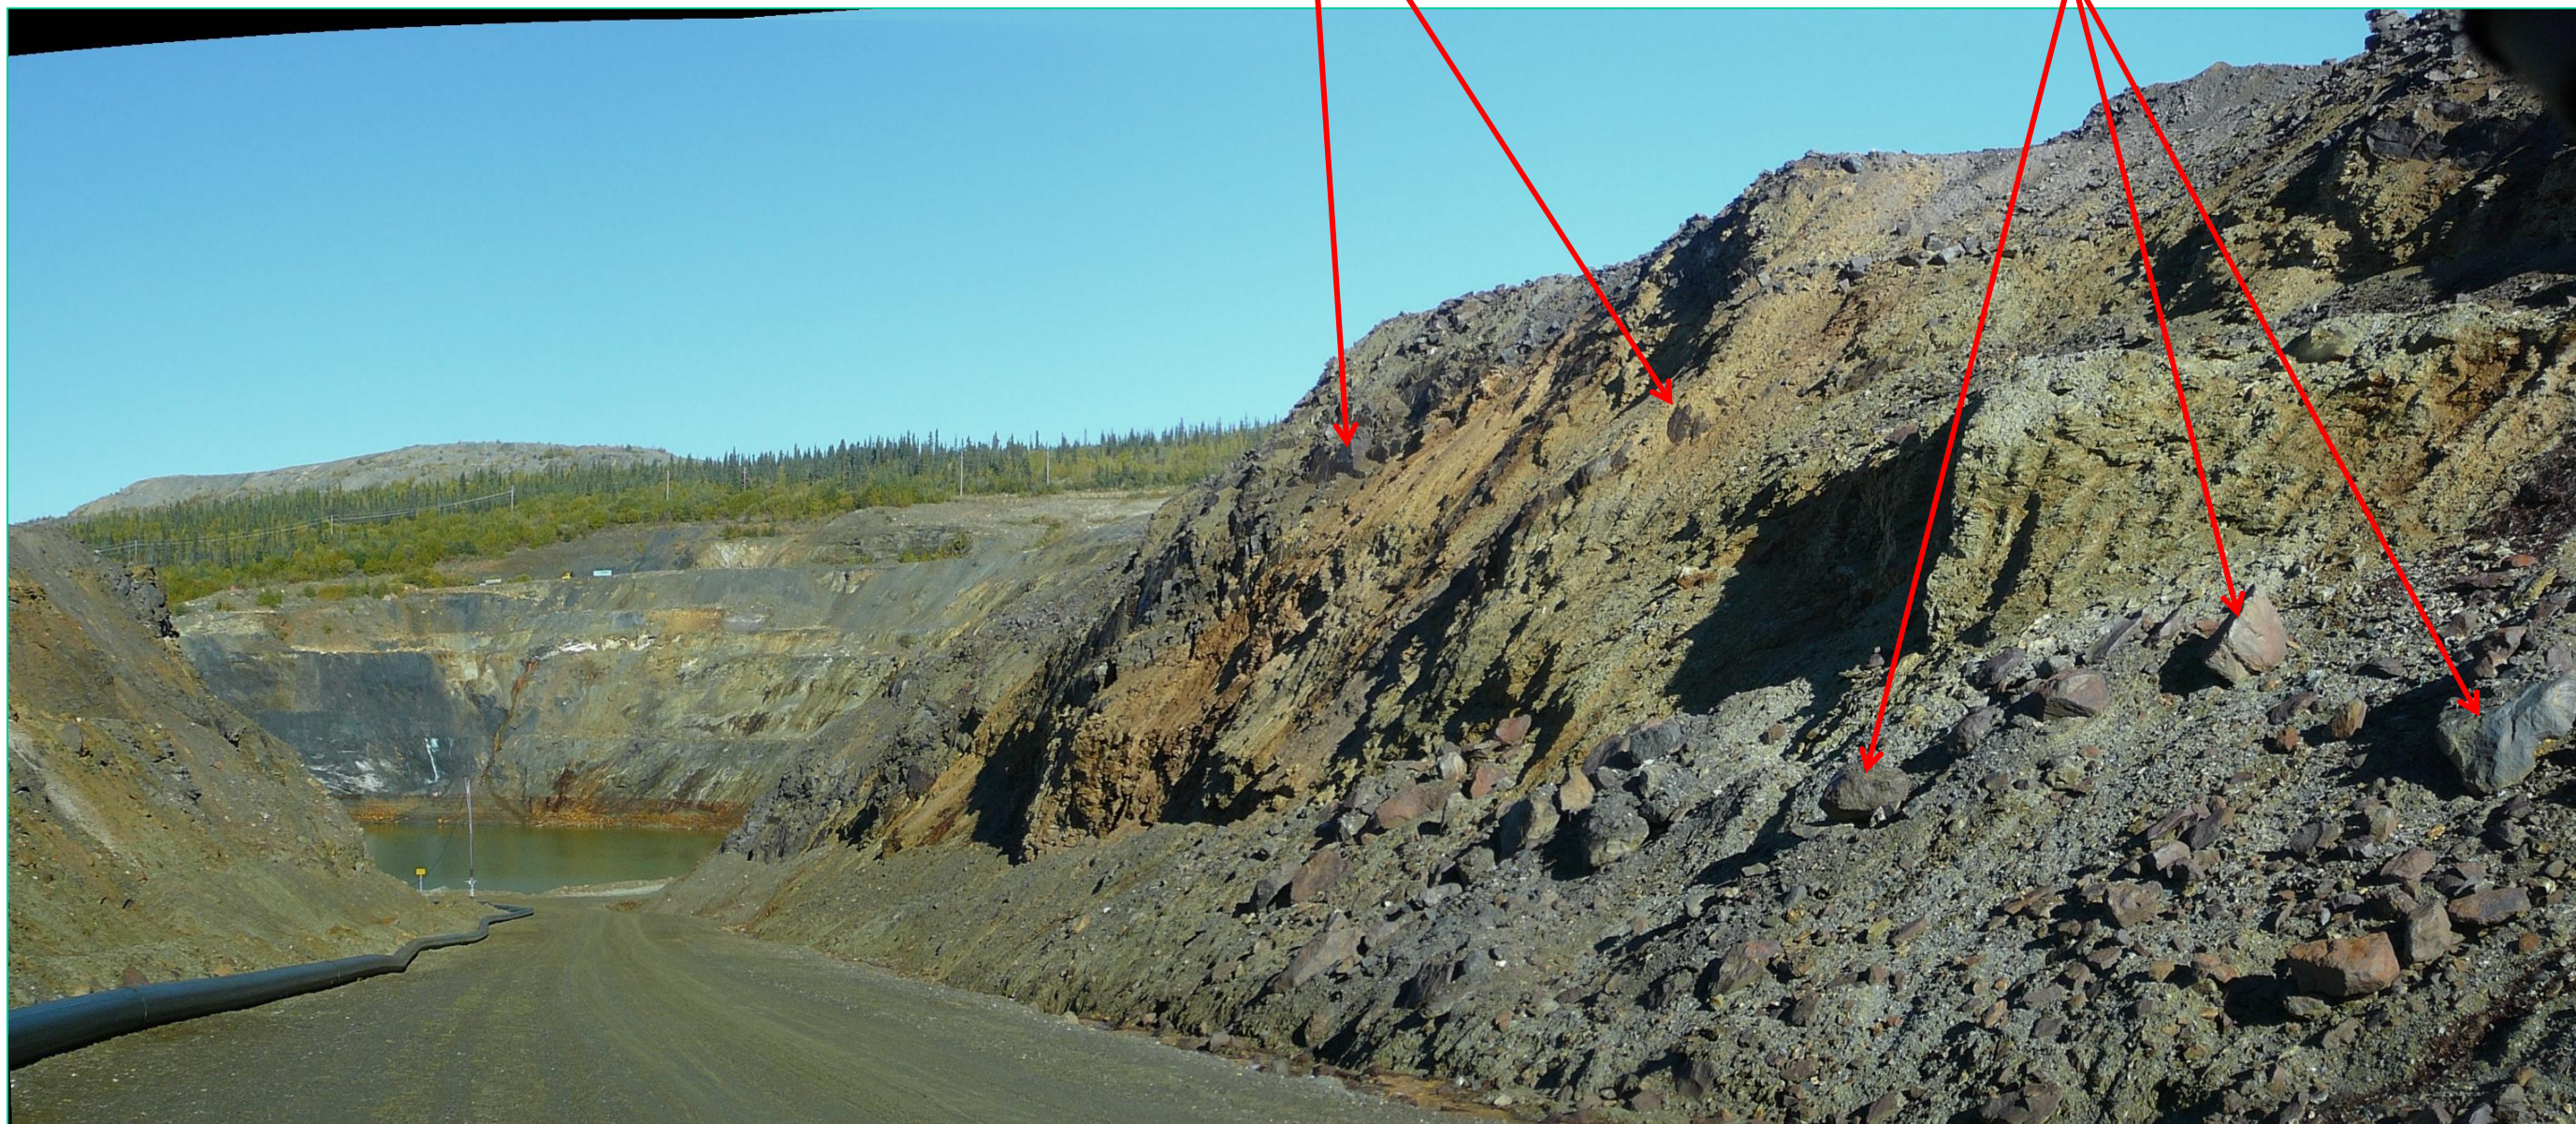
Competent rock blocks in the wall

Competent blocks lying on weak, fine-grained material

Photograph E-21
Vangorda Pit access road, east slope. View looking northwest.

Zone of raveling in weaker rock. Maintain a minimum distance of 10 m.

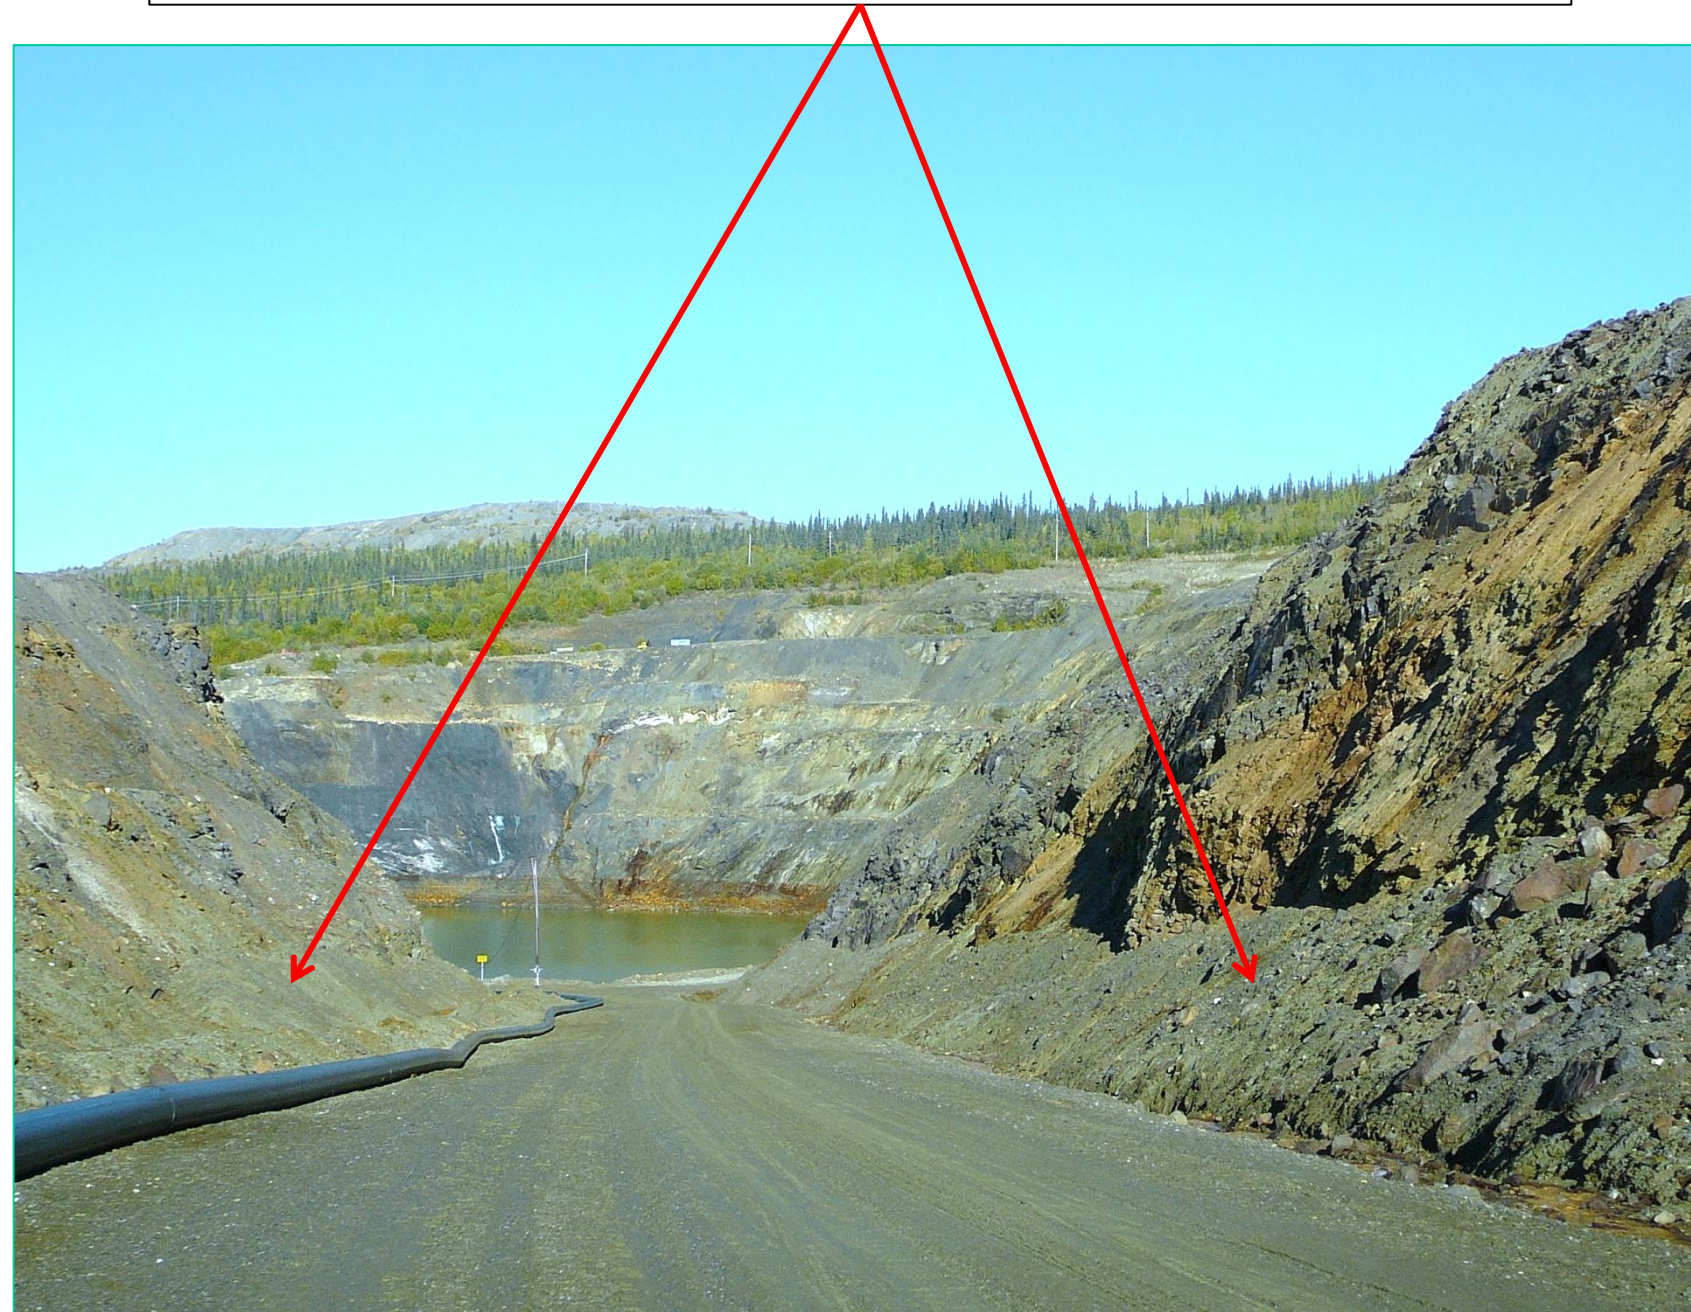
Photograph E-24
Vangorda Pit access road. View looking northwest.

Doze this material into a berm, with a catch ditch between the berm and the slope.
Do not undercut the toe of the slope.

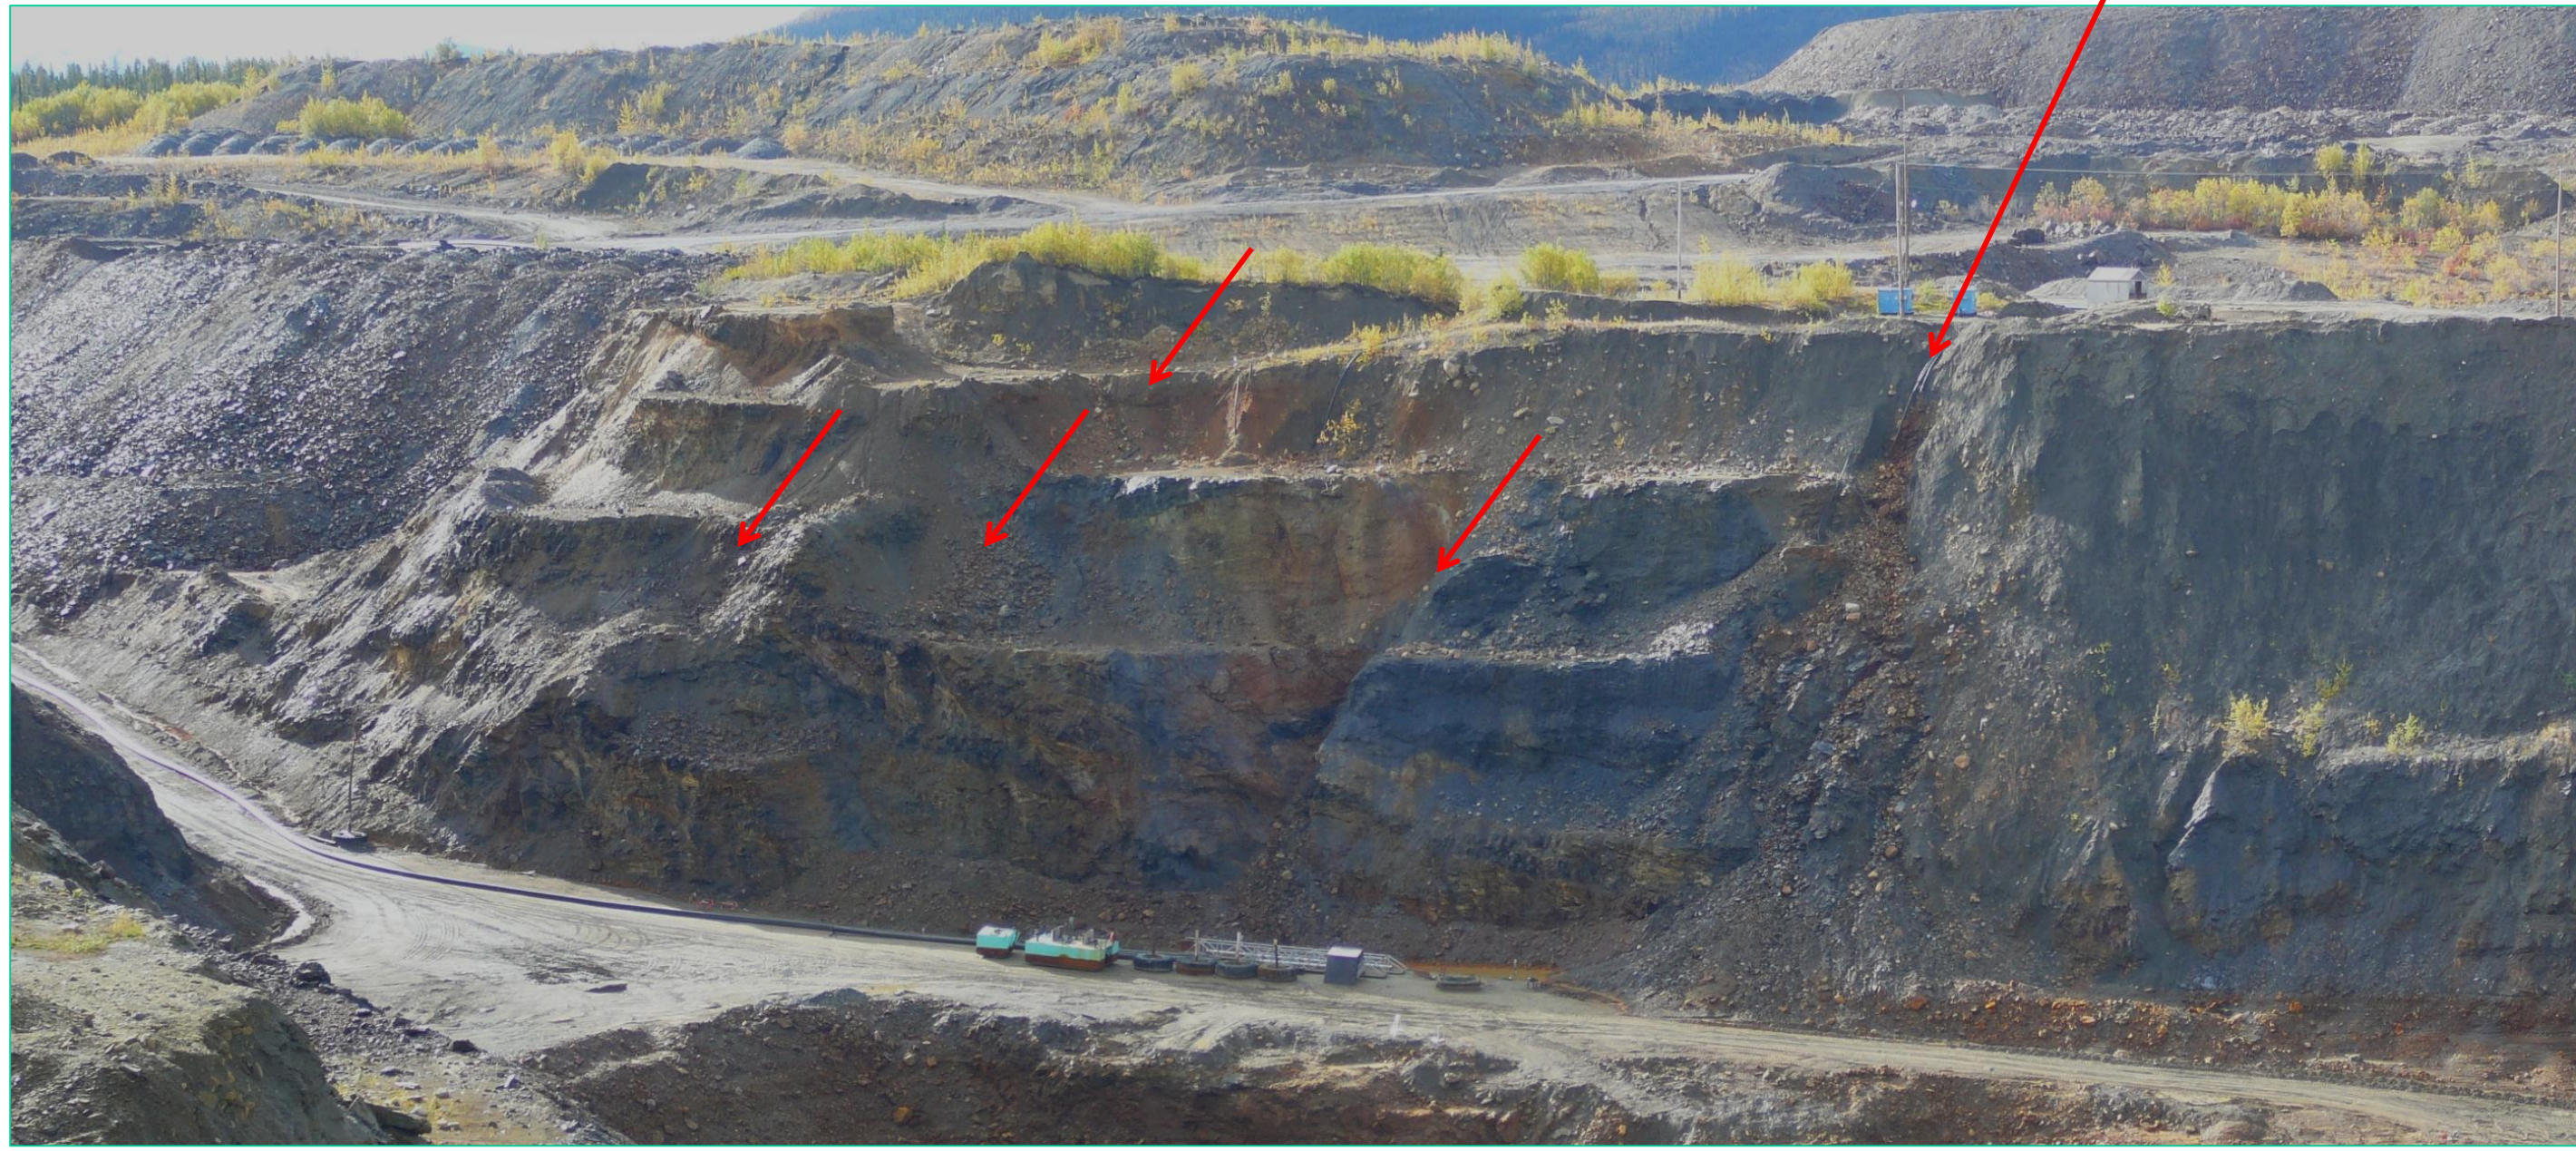
Photograph E-28
Vangorda Pit – South side of southwest wall. Raveling in oxidized rock indicated by red arrows.
View looking south.
