FARO MINE COMPLEX

2014 Annual Pit Slope Stability Inspection

Reference Number: 1410944-002-R-Rev0-6000

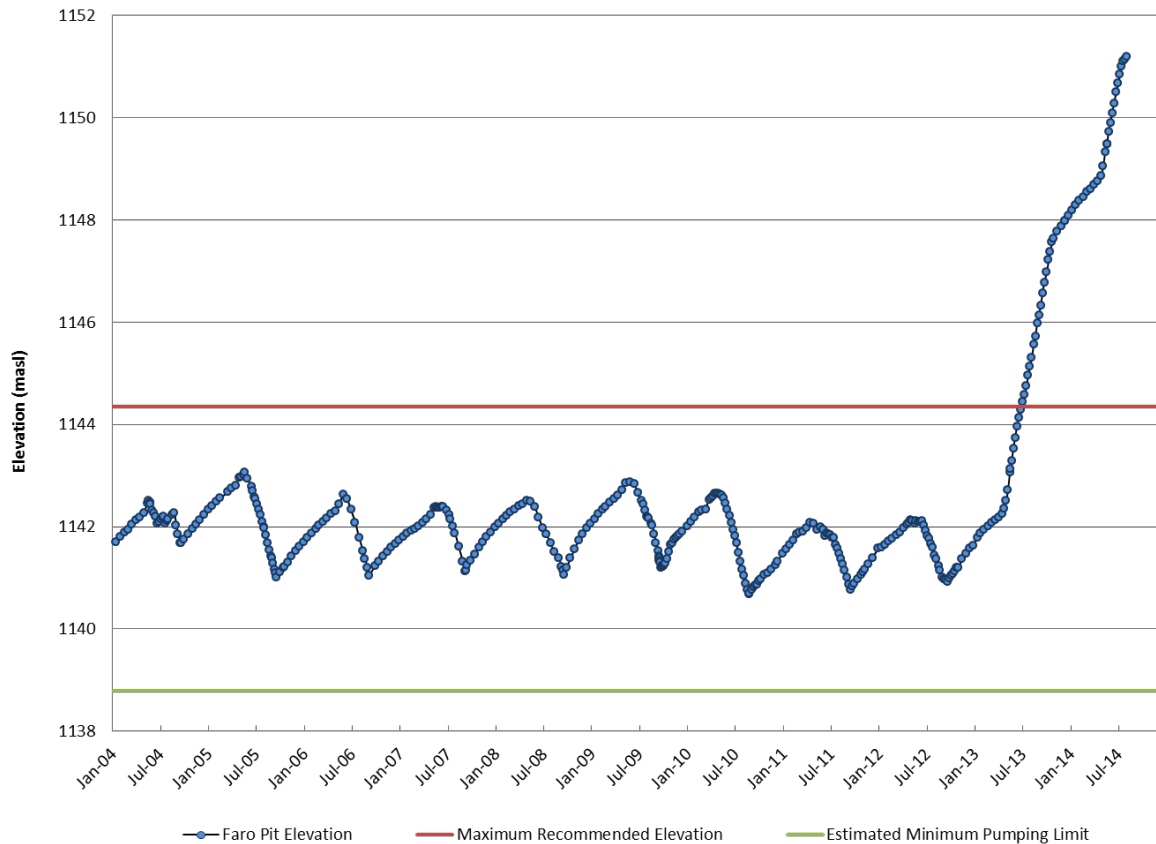
Plate 4: Faro Pit Lake Levels to August 11, 2014

Plate 4 shows the change in the Faro Pit lake level from January 2004 to August 2014. The pit lake levels have historically fluctuated between 1,141 and 1,143 masl. However, in April 2013 pit lake levels rose beyond the historical maximum due to suspension of water treatment because of safety issues with the plant. As of August 11, 2014, the pit lake level is at approximately 1,151 masl, which is 7 metres above the maximum recommended elevation of 1,144 masl, and 1 metre above the estimated elevation of the lowest contact between overburden and bedrock at approximately 1,150 masl (Klohn Crippen Berger 2014). There is a concern that pit water could seep into the overburden and contaminate groundwater. As well, rising water levels have the potential to destabilize the pit slopes. However, the current recommended maximum water level is based overburden seepage issues and not on pit slope stability concerns. YG has indicated that it is in the process of resolving the water treatment suspension and intends to pump the pit lake back down to appropriate levels as soon as practicable.

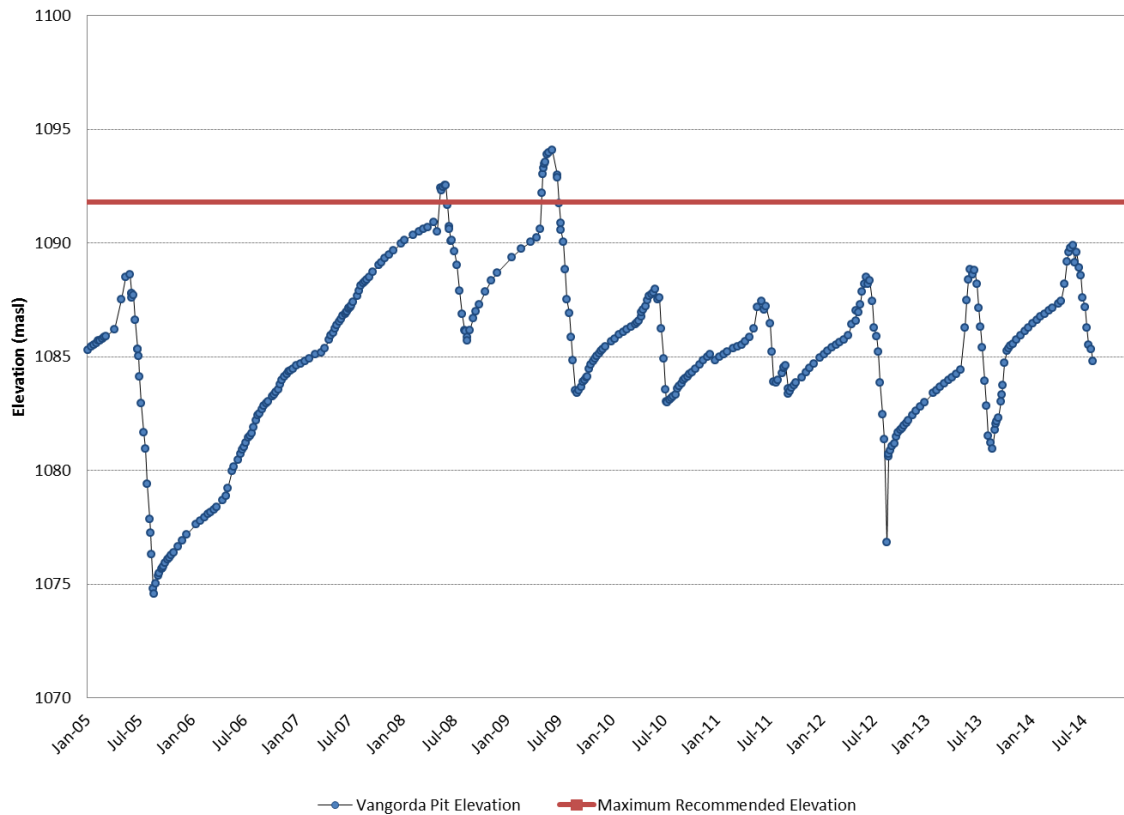
Plate 9: Vangorda Pit Lake Levels to August 11, 2014

Plate 9 shows the change in the Vangorda Pit lake level from January 2005 to August 2014. The plot shows that lake levels have remained well below the maximum recommended elevation except on two occasions in June of 2008 and June of 2009. The Vangorda Pit lake level was measured at 1,085 masl on August 11, 2014. This is 7 metres below the maximum elevation of 1091.8 masl.

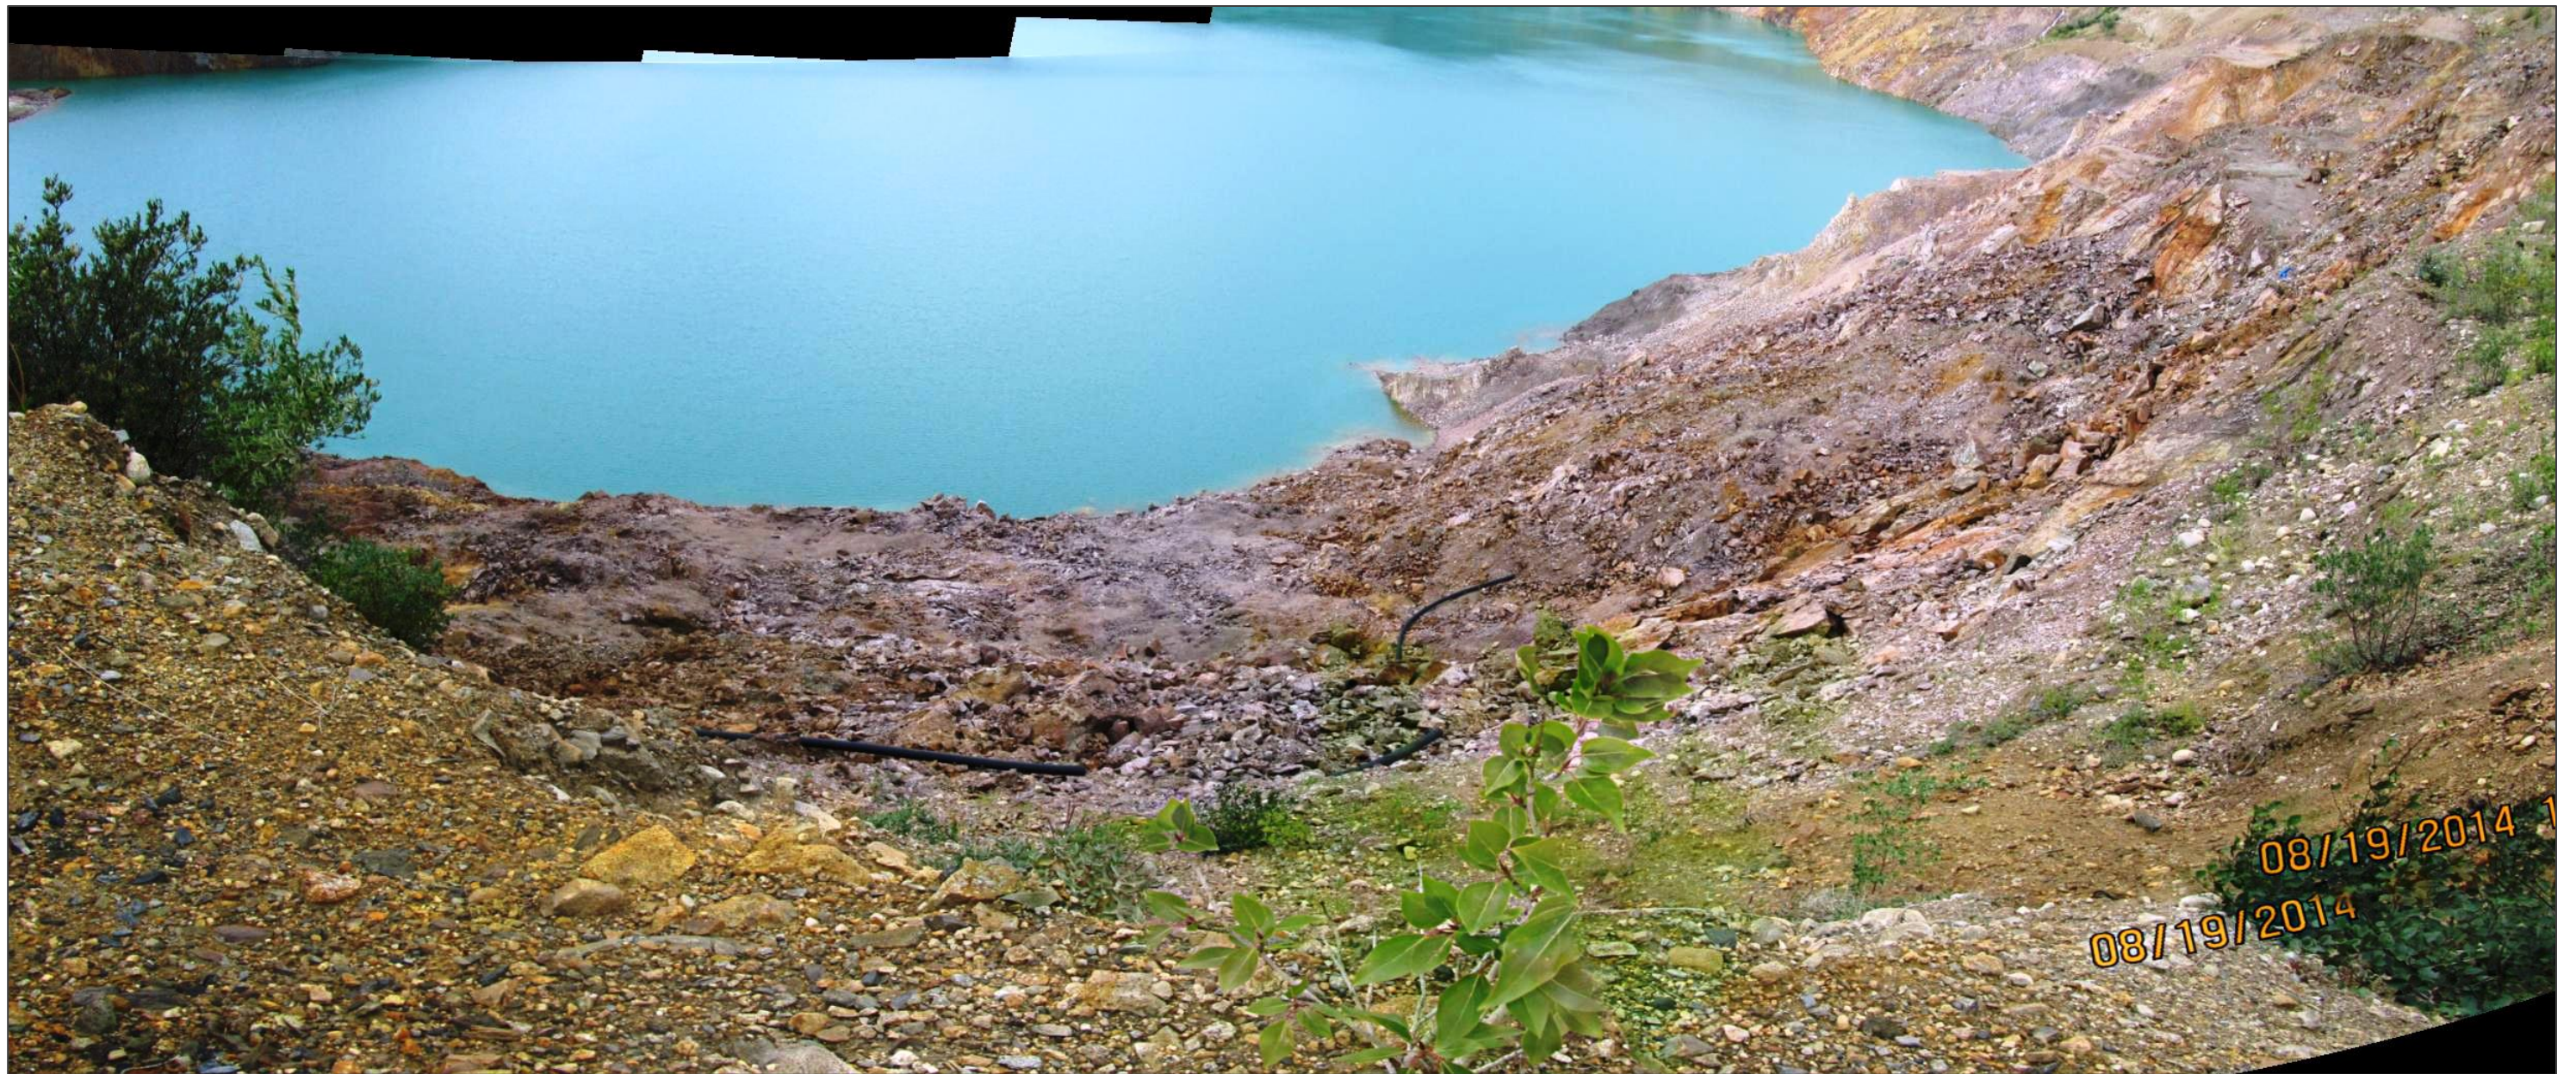
Golder Associates			SOUTH INSTABILITY ZONE VIEW FROM BEHIND BACKSCARP			
						FIGURE No.
						A-3

- No recent cracks were observed behind the North Instability Zone.
- No recent cracks were observed in the South Instability Zone (Figure A-3).
- Cracks were observed in the till at the sound end of the South Instability Zone (Figure A-4). Some of these cracks had been observed in 2012, but it is possible that new cracks have also developed in this area.

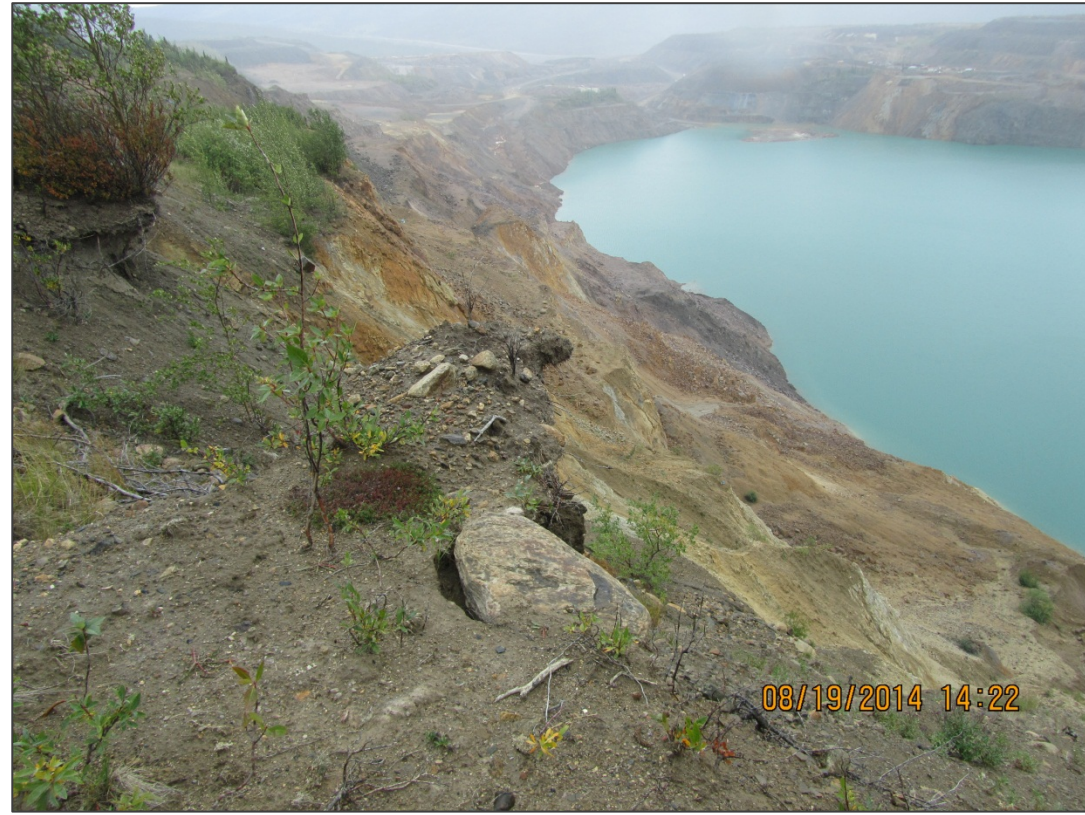
FIGURE No.
A-5

- The till and rock on the northwest side of the pit are slowly raveling and toppling (Figure A-5).
- There is ponded water behind the small dam (Figure A-6) as was observed and reported in 2012.

TILL SLOWLY ERODING AND RAVELING

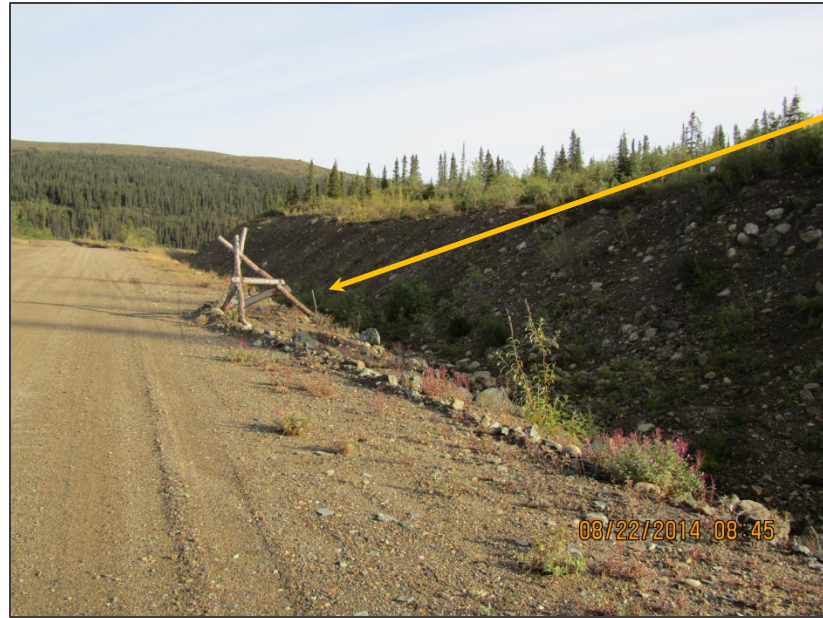
- The monitoring pins and regression pins that were observed appear to be in poor to good condition (Figure A-8). These are discussed further in Section 3.4.2 of this report.

PRESUMABLY 13908
(REPLACED 15353?)

- Repair any damaged wooden marker structures over the crest regression pins and replace missing tags on the pins. Ensure that all the reference pins are tagged correctly so that the various contractors are able to refer to the correct pins when taking measurements and reporting data. In addition, it is recommended that YG ensure that there is documentation of the coordinates of all the monitoring points and pins so they may be plotted correctly in reference maps by contractors. If any coordinates are missing, YES should survey them as soon as practicable.

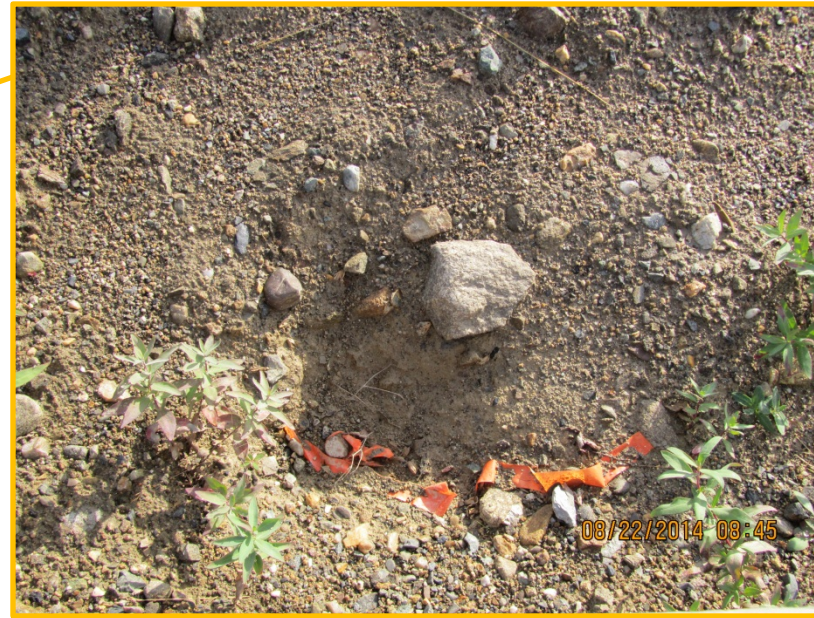
13908?
PIN IS VISIBLE, BUT TAG IS MISSING

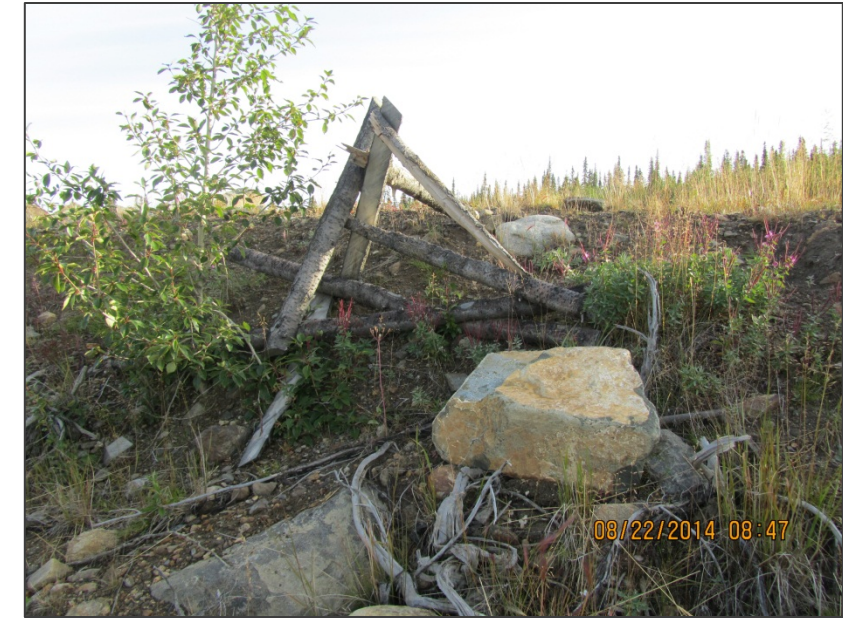
15742? COULD NOT FIND TAG OR PIN, AND
STRUCTURE IS COLLAPSED

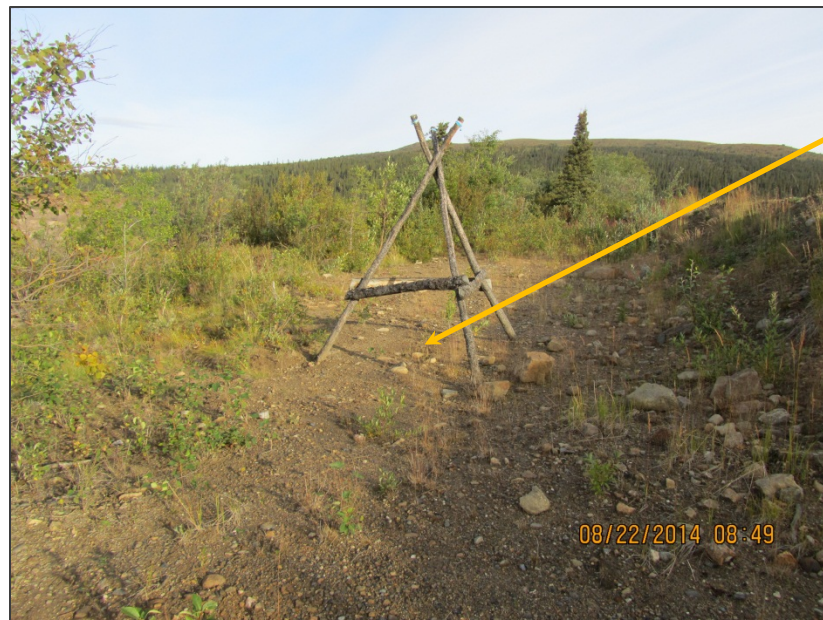
15342
STRUCTURE IN GOOD CONDITION

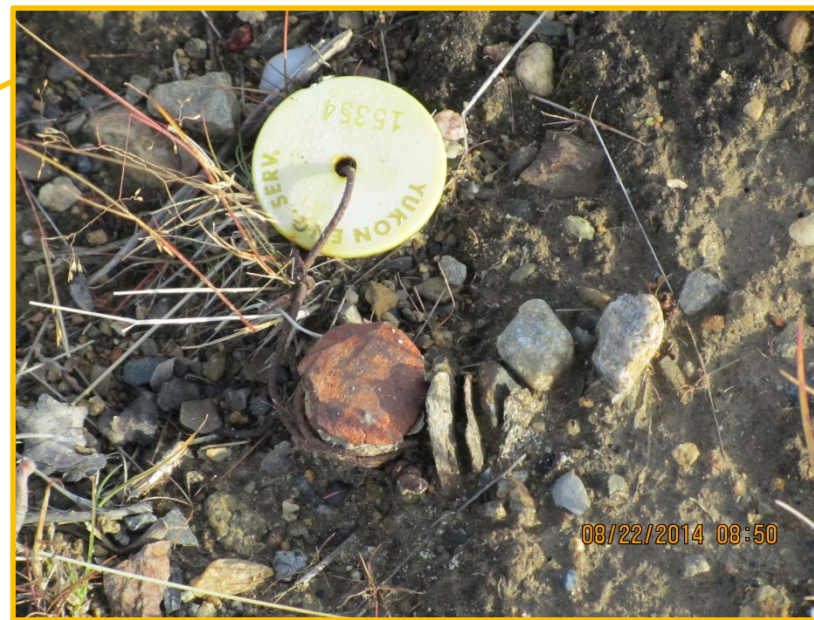
15342
PIN AND TAG IN GOOD CONDITION

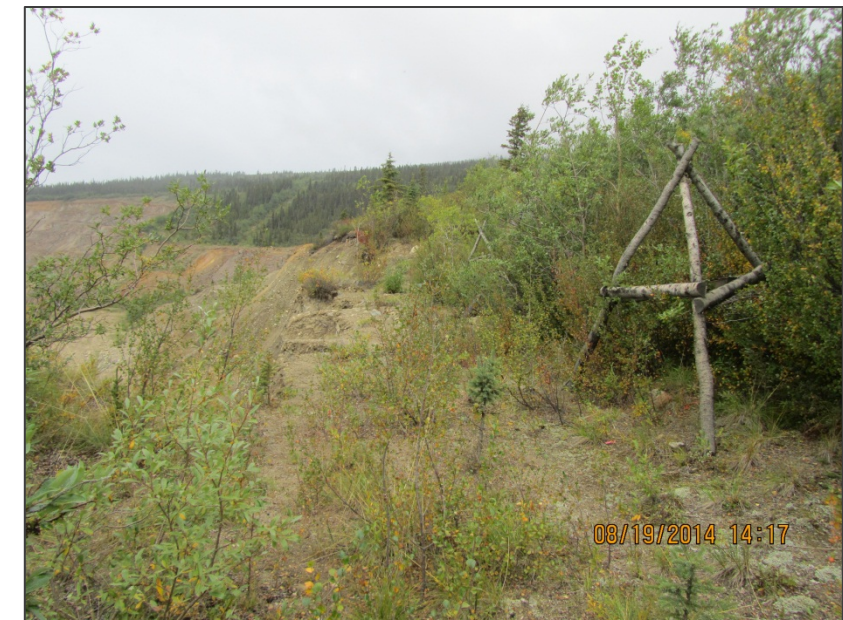
15357
PIN AND TAG IN GOOD CONDITION

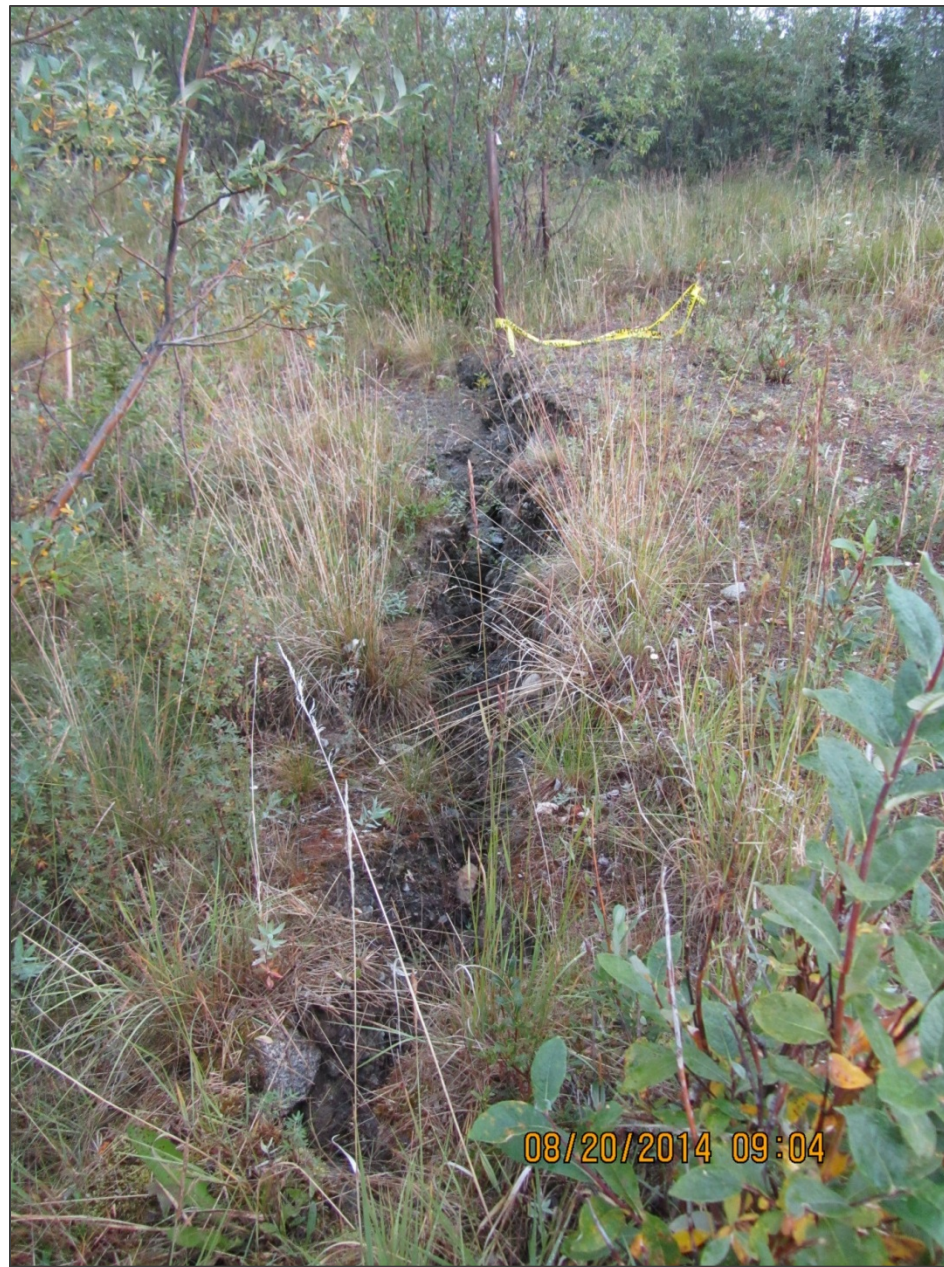
CRACK IN 2014

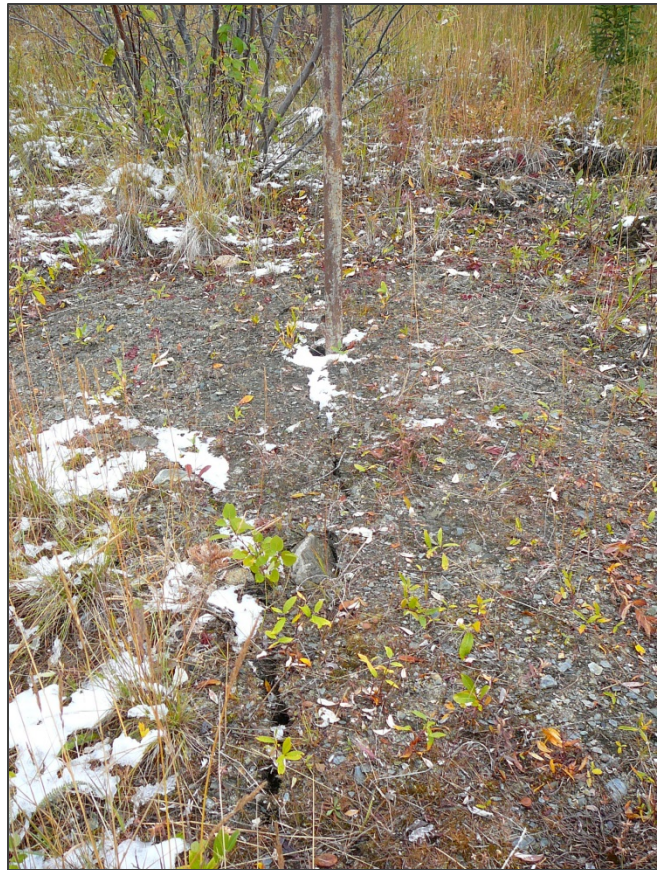
CRACK IN 2012

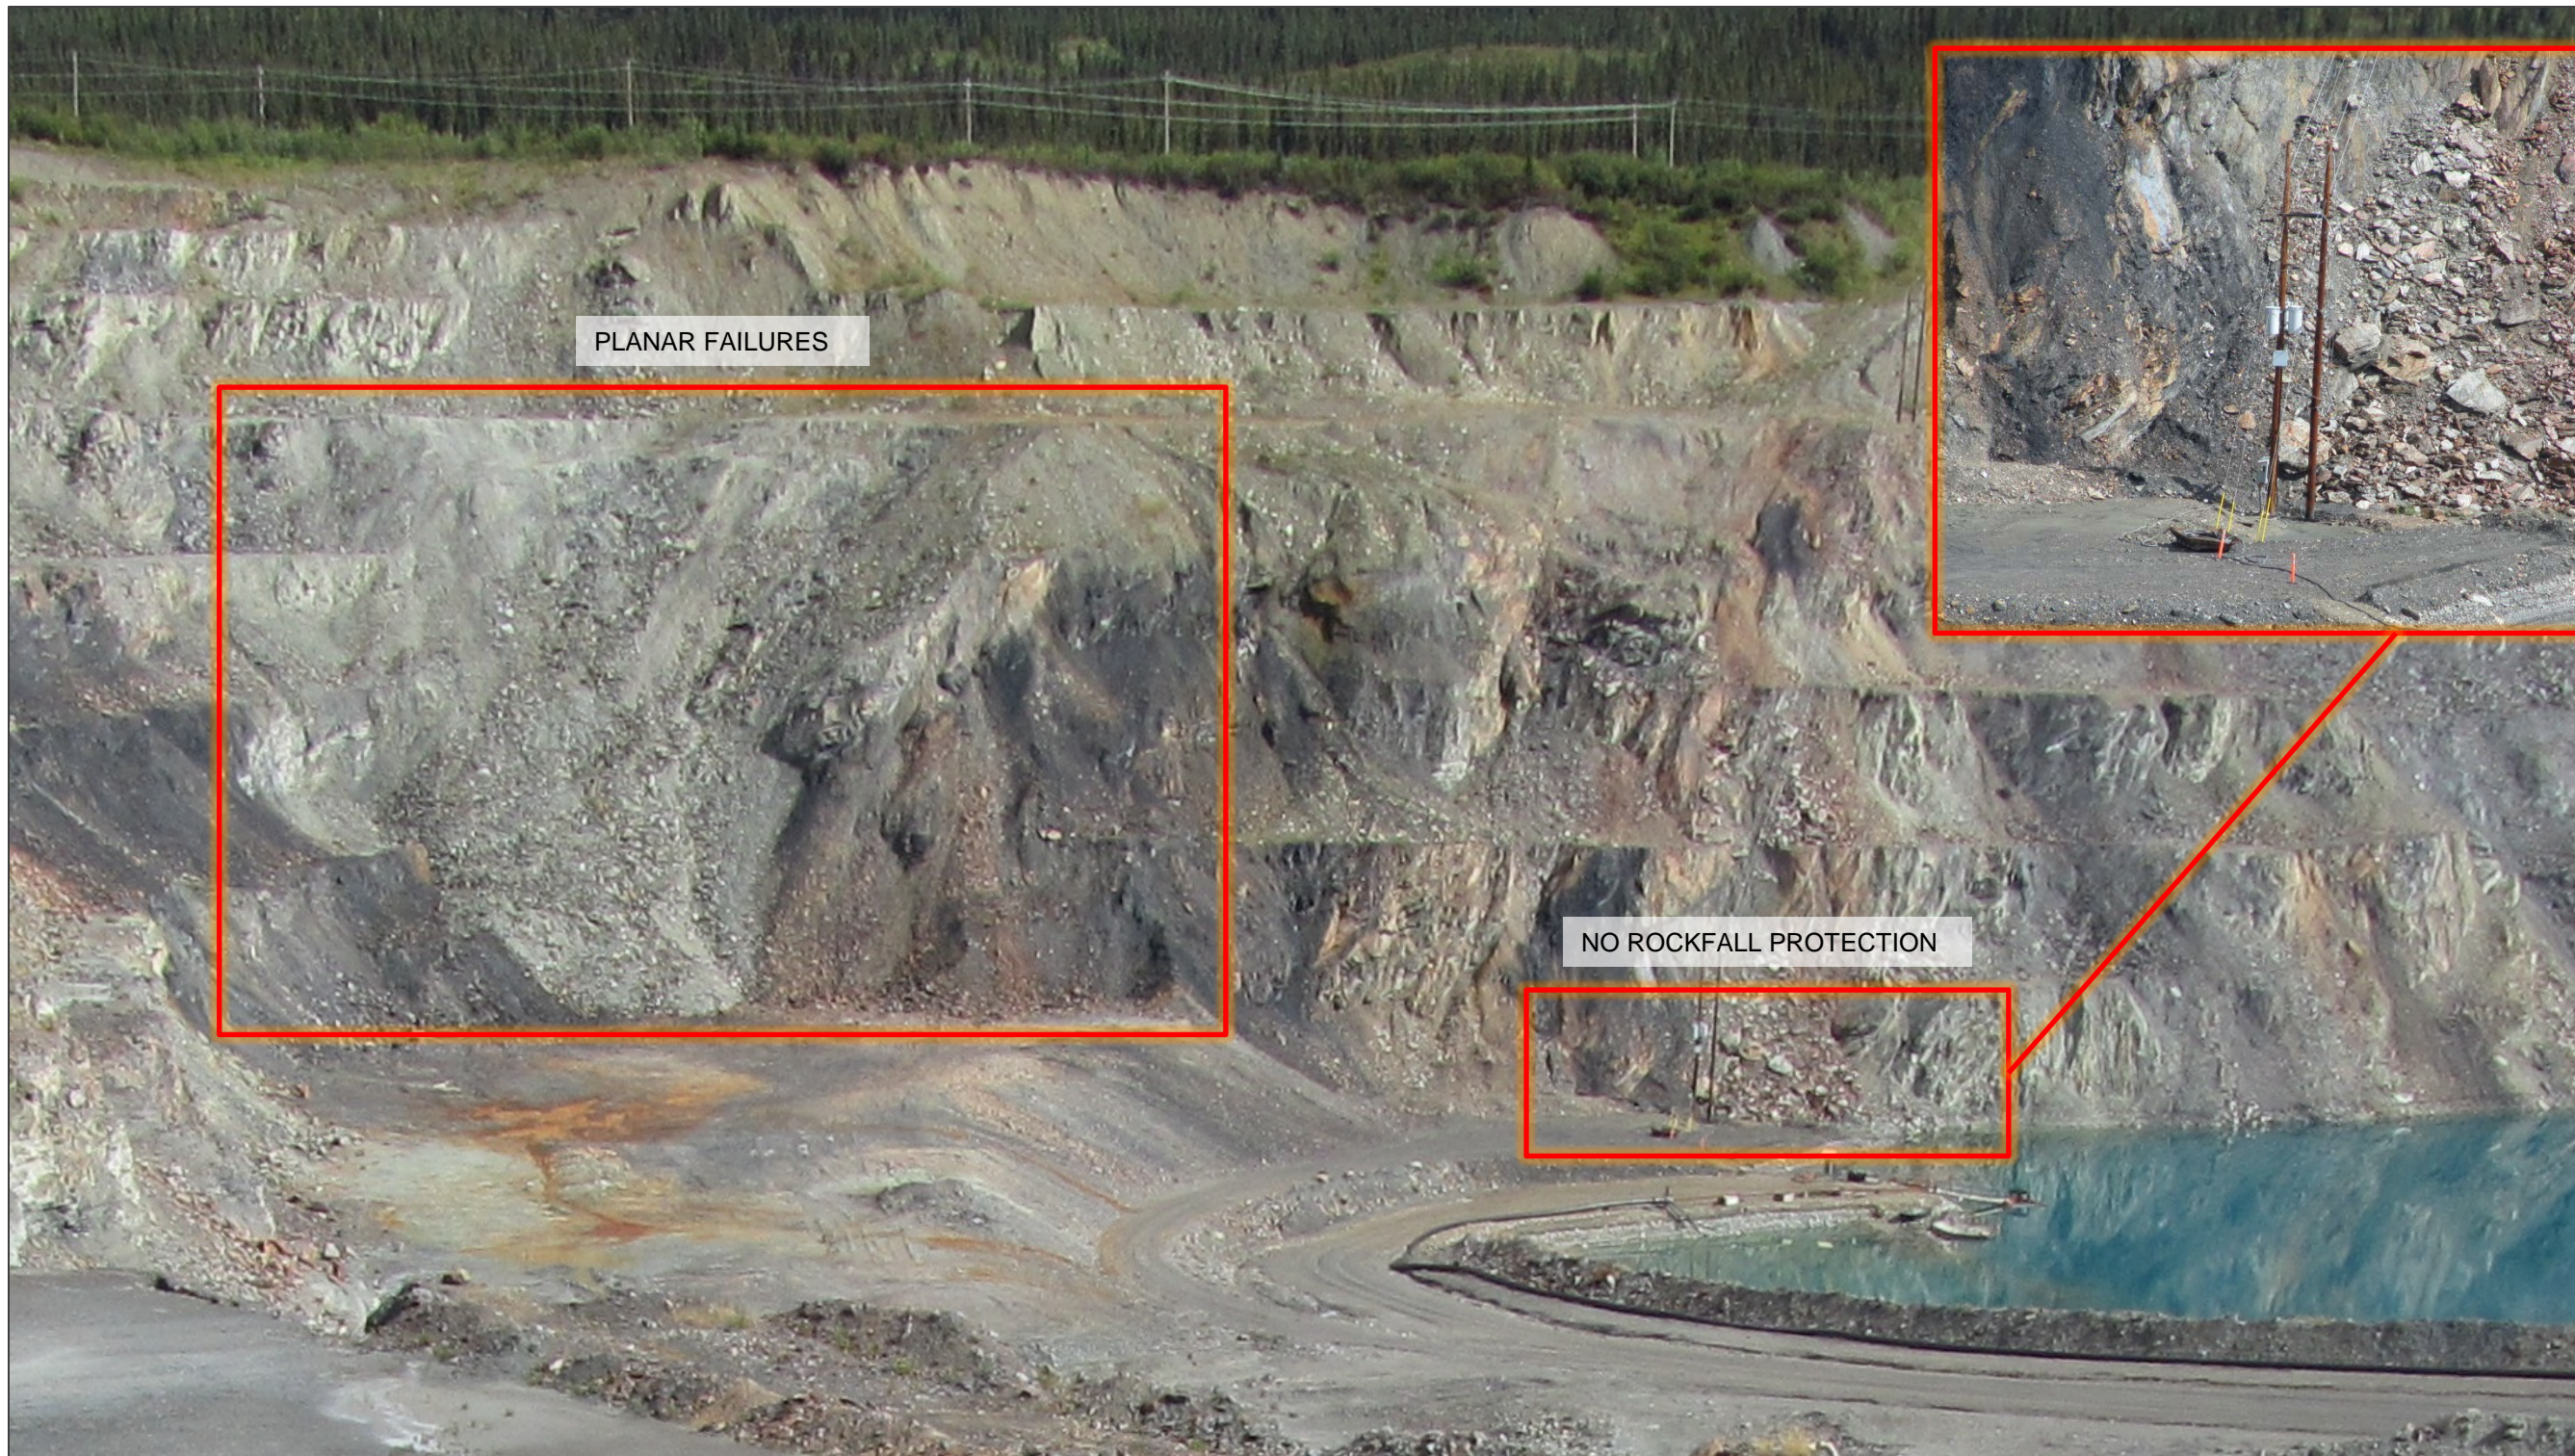
PLANAR FAILURES

NO ROCKFALL PROTECTION

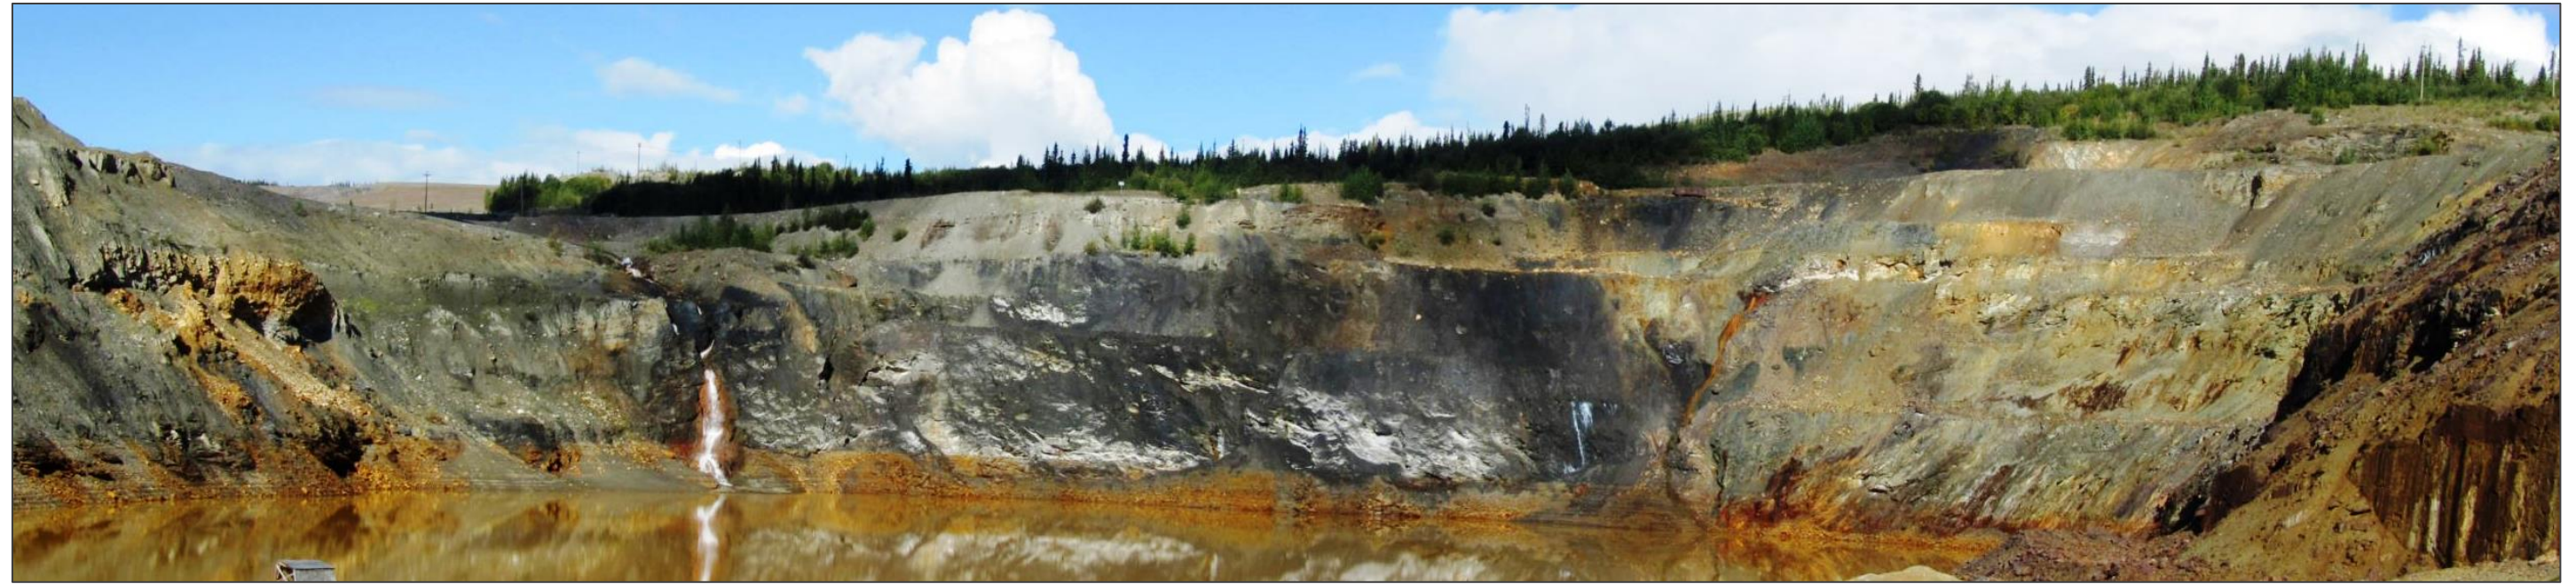
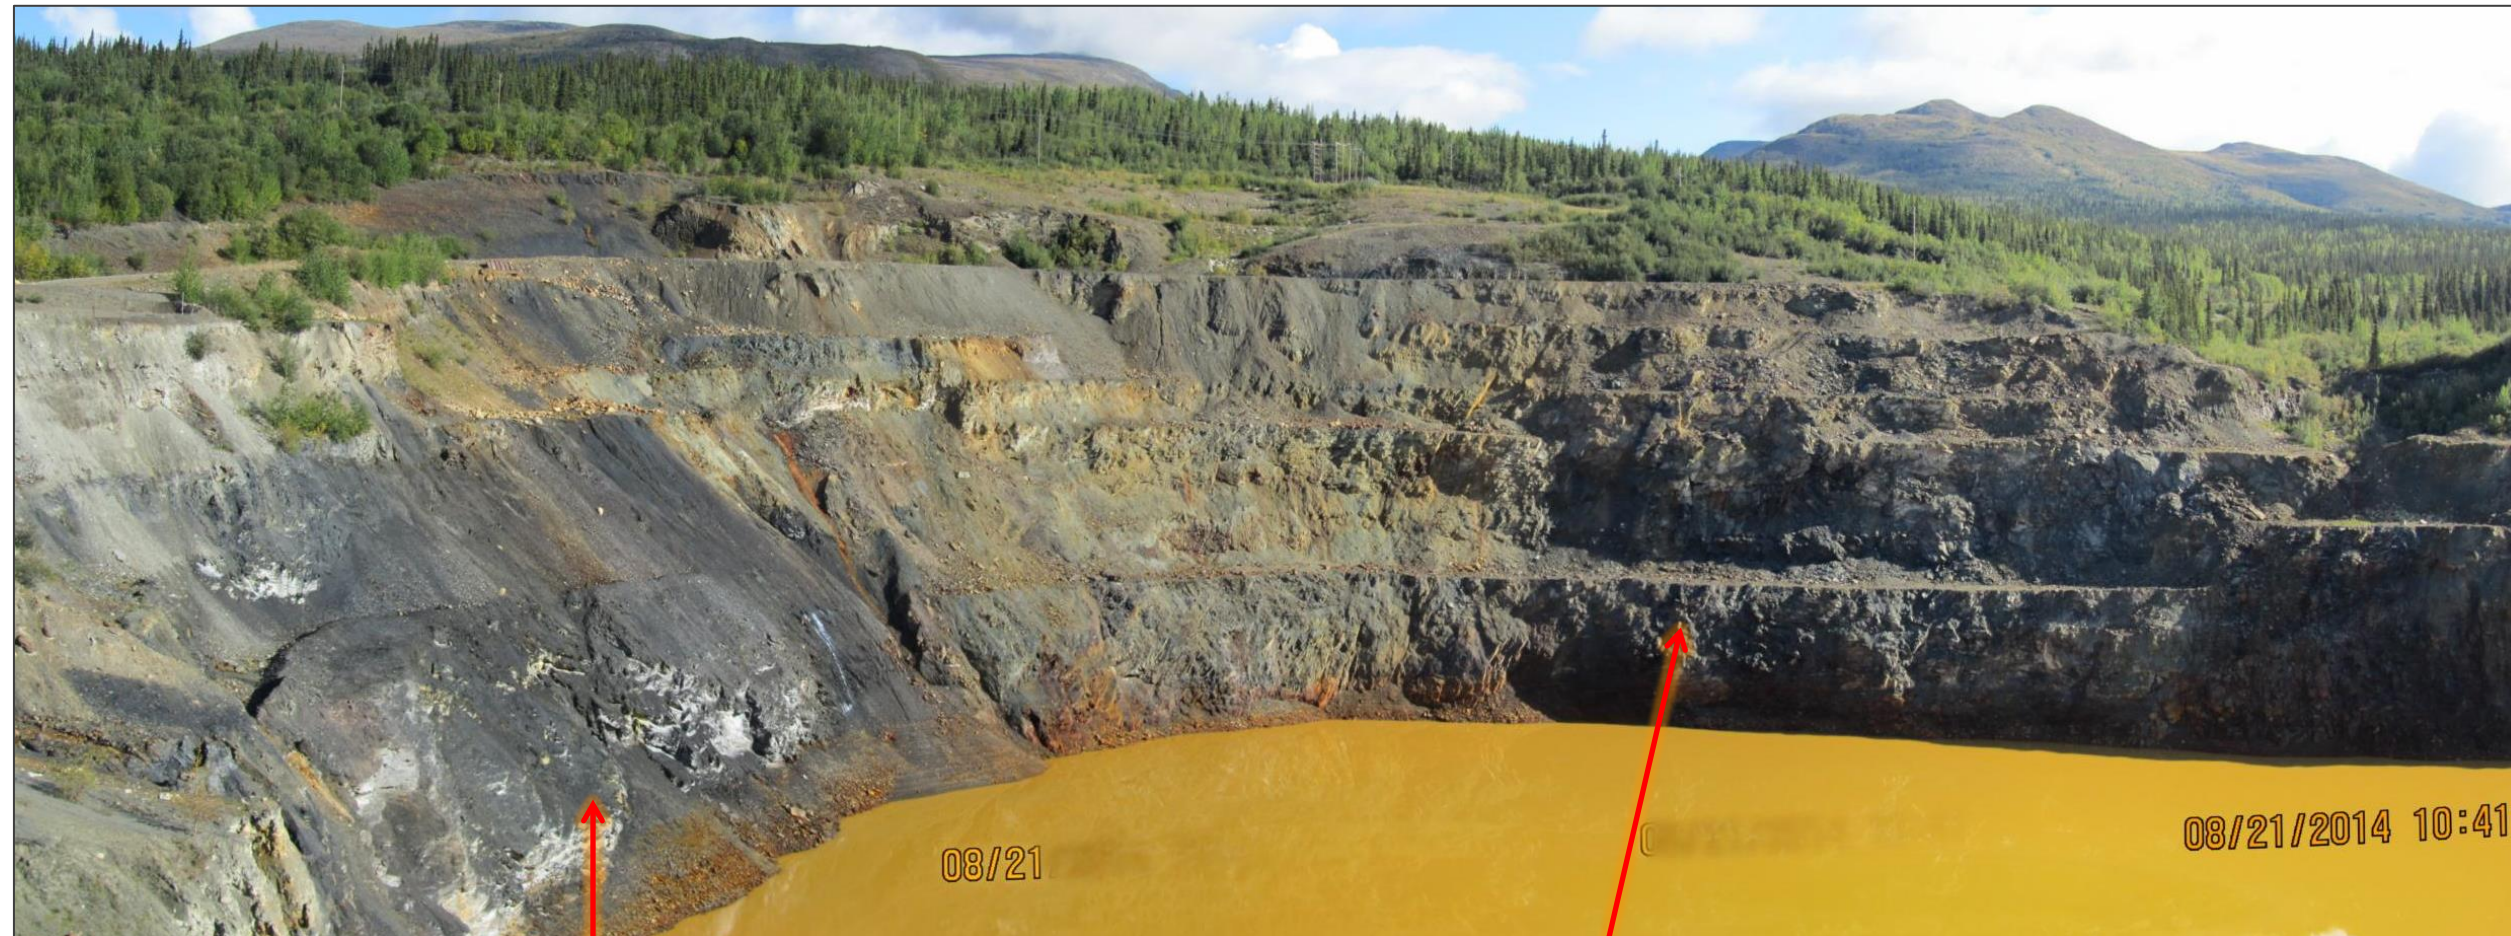
REV	DATE	FIGURE DESCRIPTION	JUR	JUR	AVC	AVC
0	16/SEP/14					
PROJECT			DRW	DES	CHK	R/W
FARO MINE COMPLEX 2014 PIT SLOPE INSPECTION			1410944/8000			
TITLE			NORTH WALL			
			FIGURE No. C1

TALUS SLOPE IN WEAK, GRAPHITIC SCHIST

BENCHES INTACT IN MORE COMPETENT SCHIST

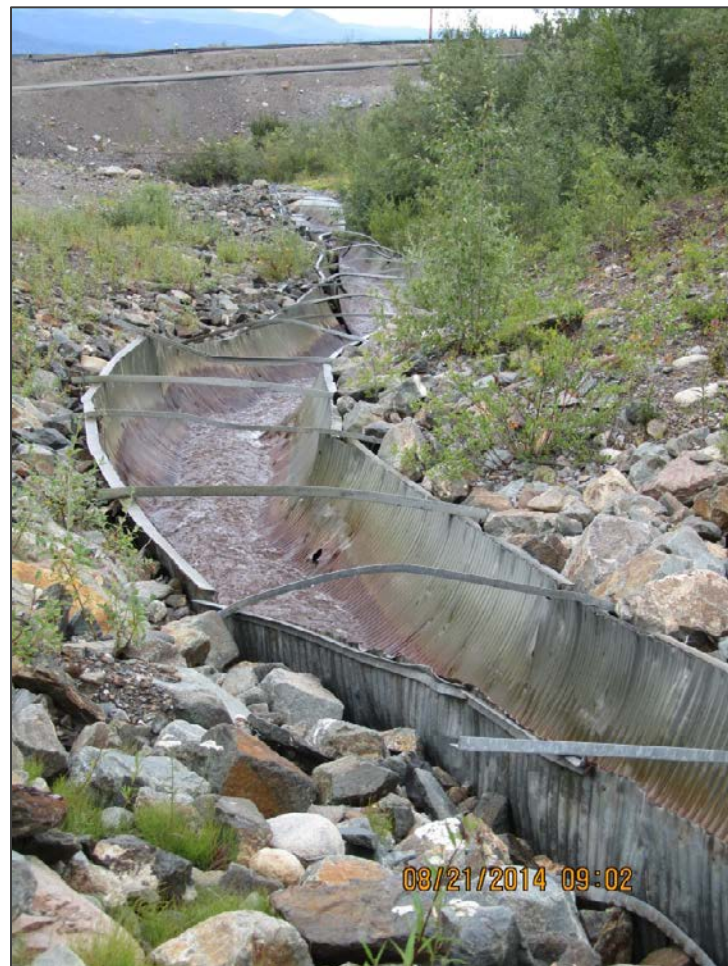
CONDITION OF VANGORDA FLUME

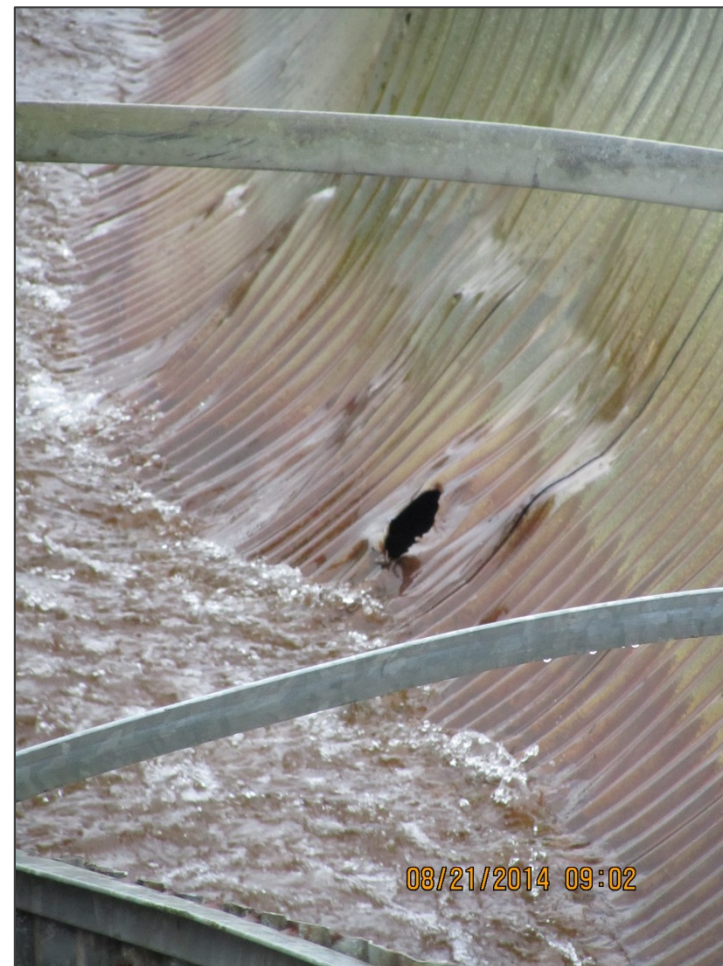
TEAR IN VANGORDA FLUME
