## FARO MINE COMPLEX

# 2015 Pit Slope Stability Review

**Reference Number: 1410944-007-R-Rev0-2015**

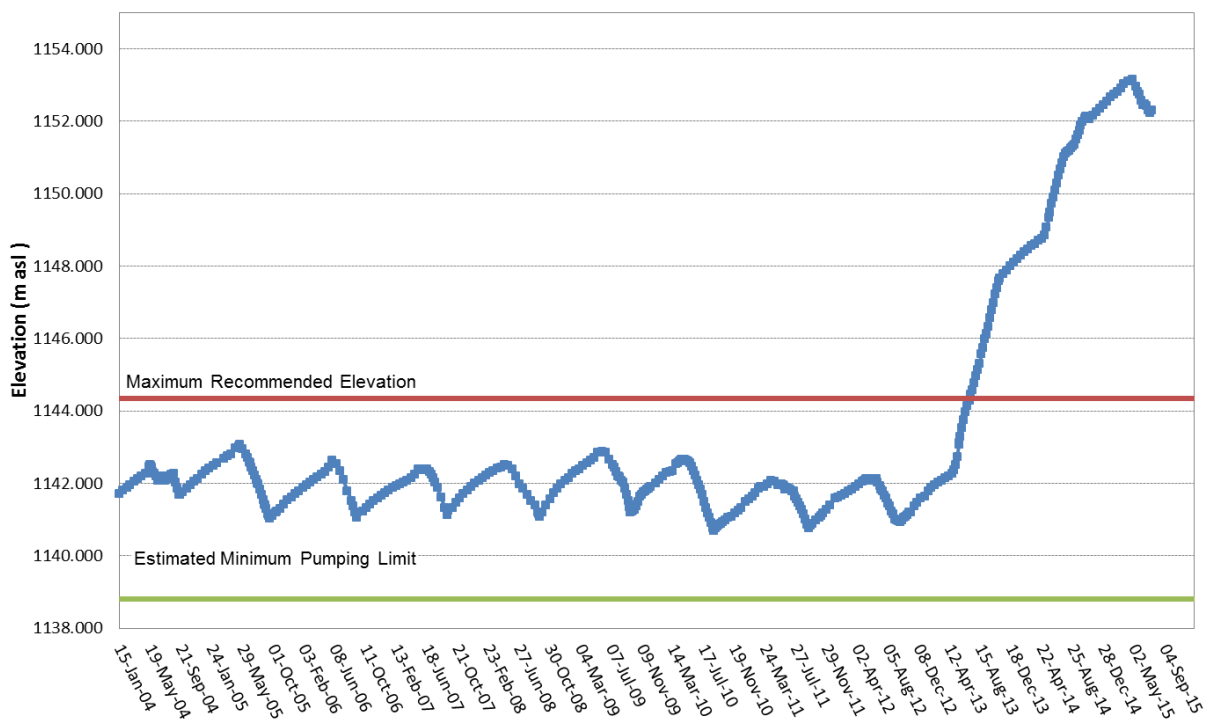
Plate 3: Faro Pit Lake Levels to July 13, 2015

Water level data for the Faro Pit were provided by YG. Plate 3 shows the fluctuations in the Faro Pit lake level from January 2004 to July 2015. The pit lake levels have historically fluctuated between 1,141 and 1,143 masl. However, in July 2013 pit lake levels rose beyond the maximum recommended elevation of 1,144 masl due to suspension of water treatment because of safety issues with the plant. After that time, the water elevation continued to rise to a high of 1,153 metres in April 2015, with periods of intermittent pumping. In April 2015, regular pumping resumed and the pit lake level is being lowered.

As of July 13, 2015, the pit lake level is at approximately 1,152 masl, which is 8 metres above the maximum recommended elevation of 1,144 masl, and 2 metres above the estimated elevation of the lowest contact between overburden and bedrock at approximately 1,150 masl (Klohn Crippen Berger 2014). YG has indicated that has resolved the water treatment issue and intends to pump the pit lake back down to appropriate levels as soon as practicable.

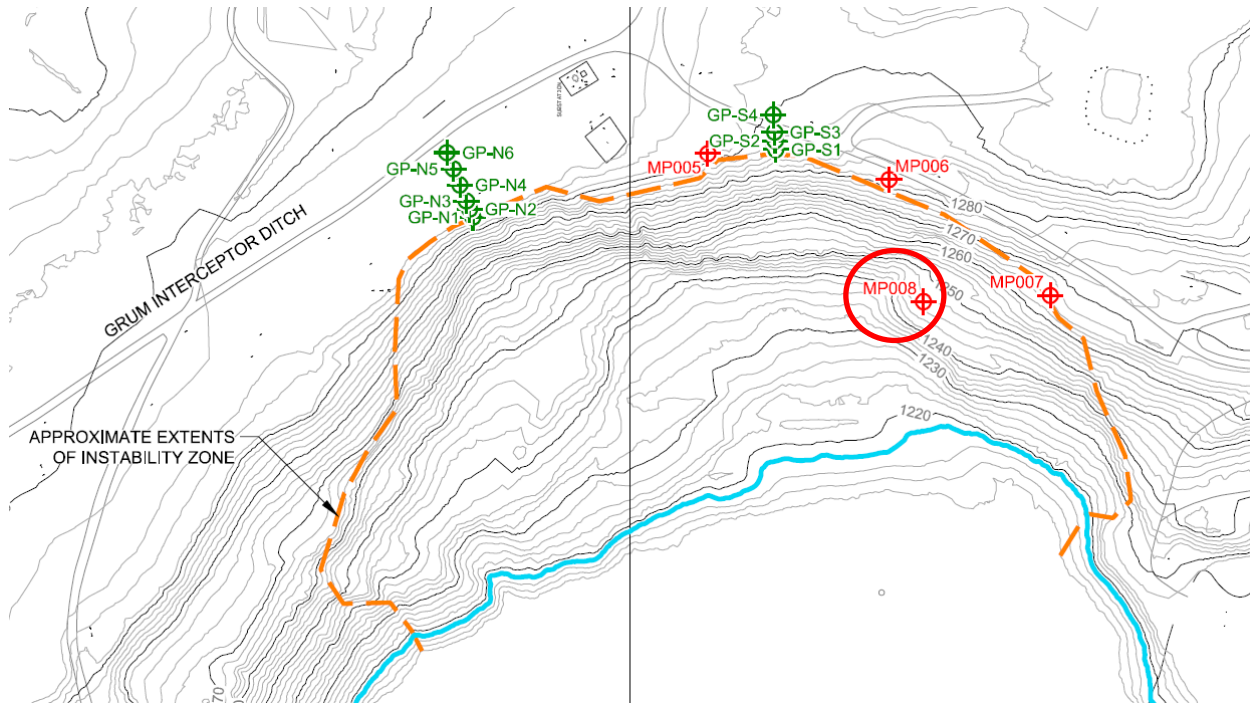
Plate 4: Grum Pit Monitoring Point MP008 Location

The vertical downward displacement of monitoring point MP008 is on the order of 850 mm, which represents a drop of 686 mm since 2014. In addition, the horizontal displacement is on the order of 478 mm, which represents an increase in horizontal displacement of approximately 380 mm since 2014. The wander plot indicates a displacement trend toward the northwest, at an azimuth of 289 degrees. This monitoring point is the only monitoring point located on the slope of the failure debris, rather than at the crest of the east wall (Plate 4). The photograph comparison indicates that there is slumping occurring in this area (Figure B-3) and it appears that monitoring point MP008 is reflecting real ongoing displacement confirming the visual assessment of this part of the instability zone.

As with the Faro Pit monitoring points, we recommend that slope distance measurements be taken each year by the survey contractor of the four Grum monitoring points.

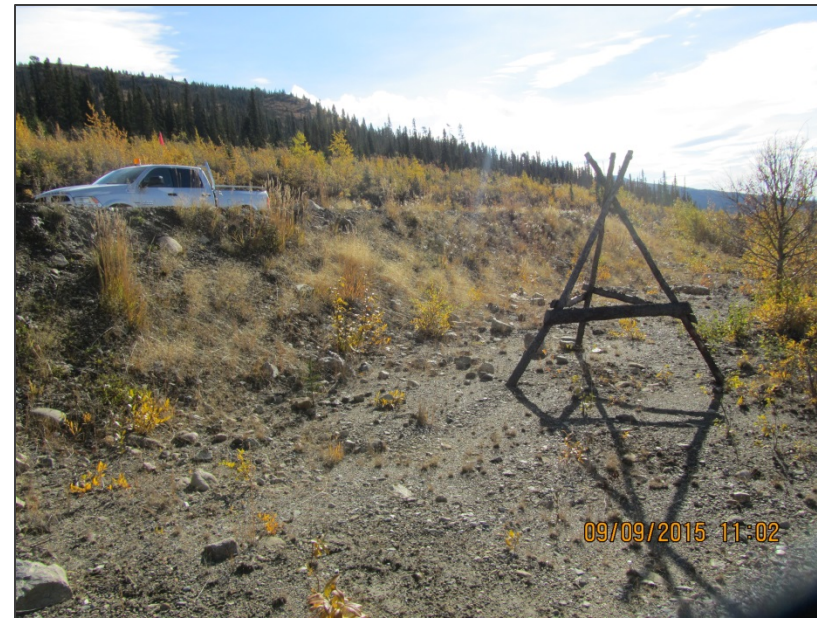
- The monitoring pins and regression pins that were observed appear to be in poor to good condition (Figure A-6). These are discussed further in Section 3.4.2 of this report.

15354  
PIN AND TAG IN GOOD CONDITION

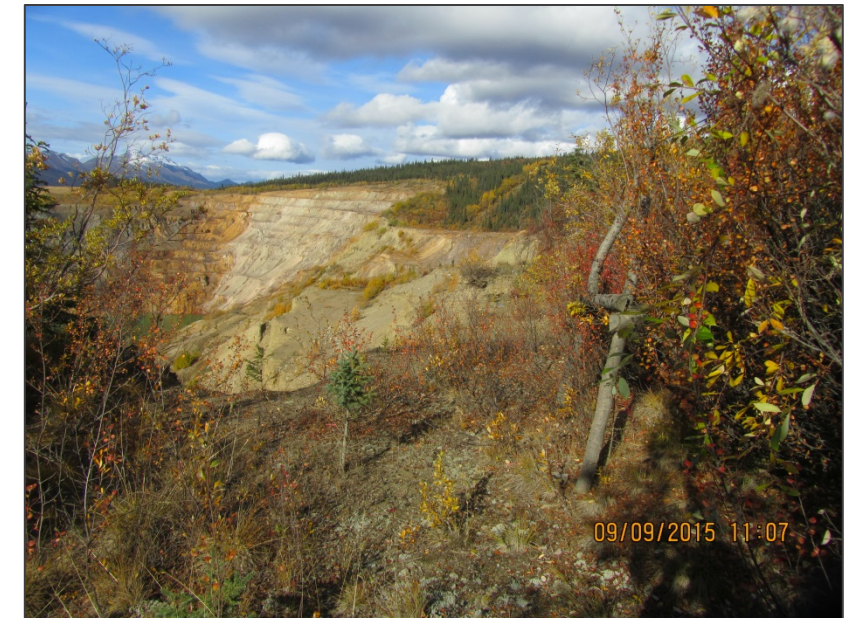
15737  
PIN AND TAG IN GOOD CONDITION

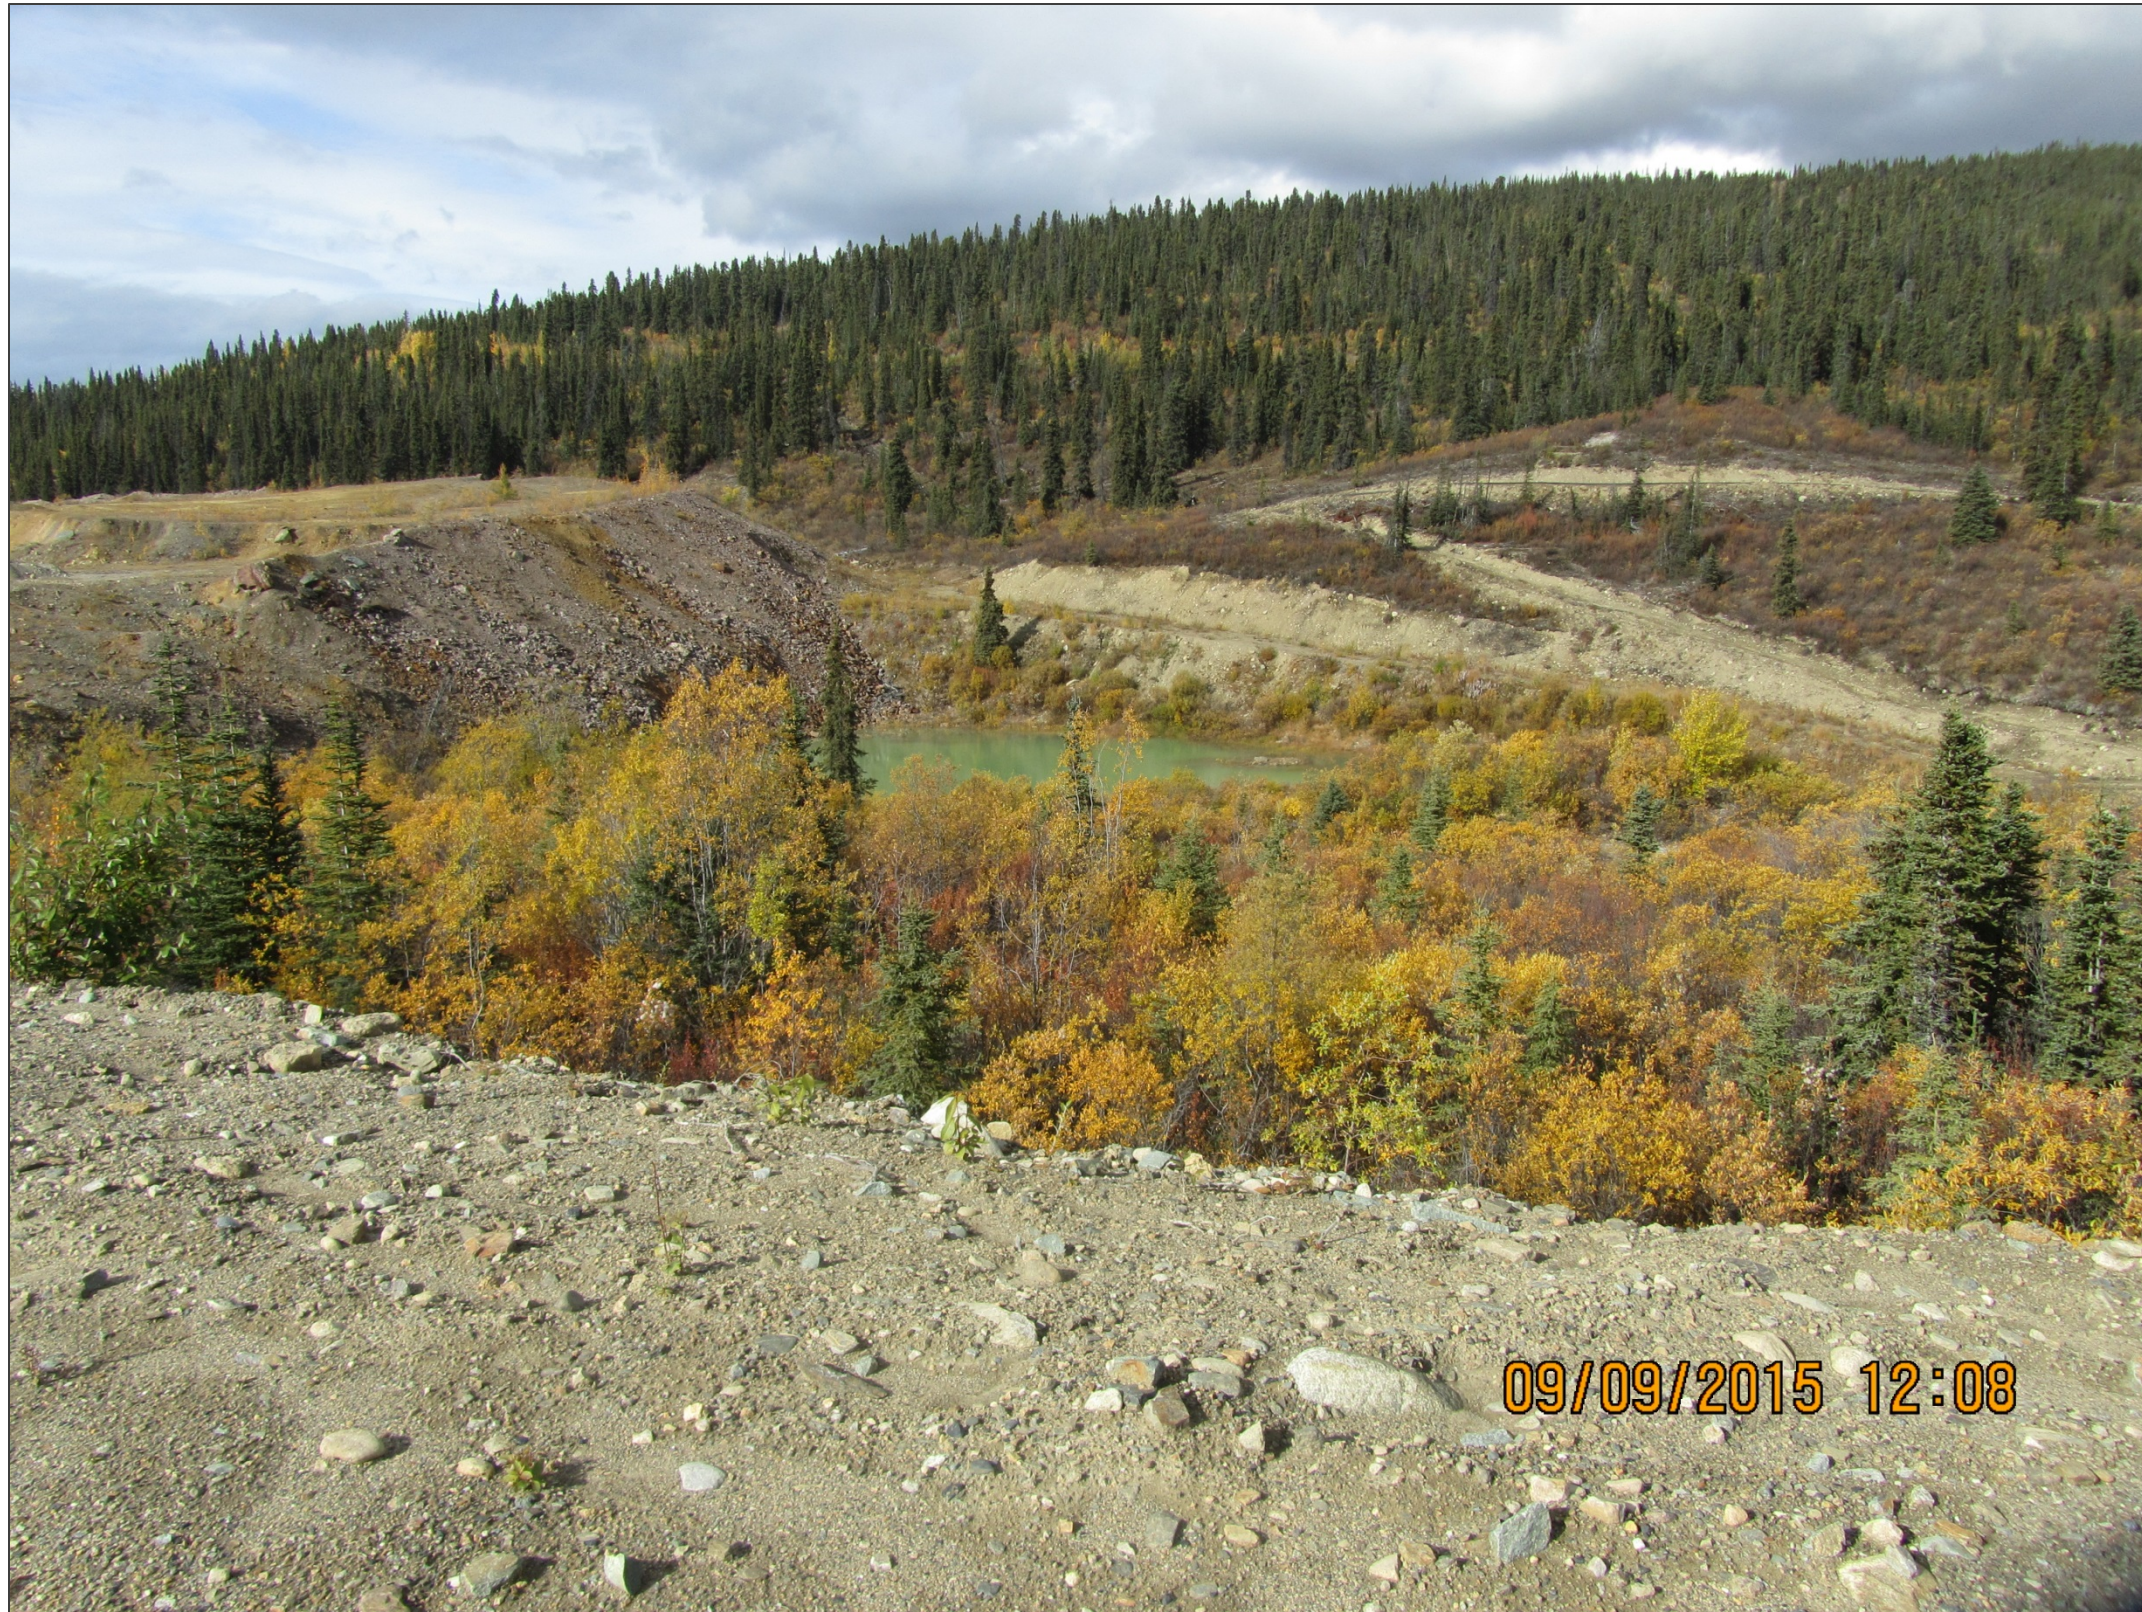
- There is ponded water behind the small dam (Figure A-9) in the northeast corner of the pit at the crest, as was previously observed and reported. It appears that this water is seeping into the slope and reappearing in the slope face as seepage to the north of the North Instability Zone (Figure A-8, top photograph), but does not appear to be impacting the slope in terms of stability.

PONDED WATER BEHIND FARO VALLEY WASTE DUMP, VIEW LOOKING NORTH FROM ROAD ON NORTHEAST SIDE OF FARO PIT

- Water is ponding behind the waste dump platform in the Faro Valley Rock Dump in the northwest corner of the pit (Figure A-9). We understand that the water is pumped every spring to maximize the storage capacity in case of a failure of the Faro Creek Diversion, and that this is included in the Emergency Response Plan for the Faro Creek Diversion. The water level in this pond should continue to be visually monitored in the spring and fall, and should be pumped again in the fall if water levels are high. A pump should be available for emergency pumping.

- In addition, the pond level and the integrity of the waste dump platform that is containing the pond should be assessed by a geotechnical engineer. The toe of the platform on the downstream side should be inspected and assessed to ensure that it will not fail due to the water ponding behind the platform.

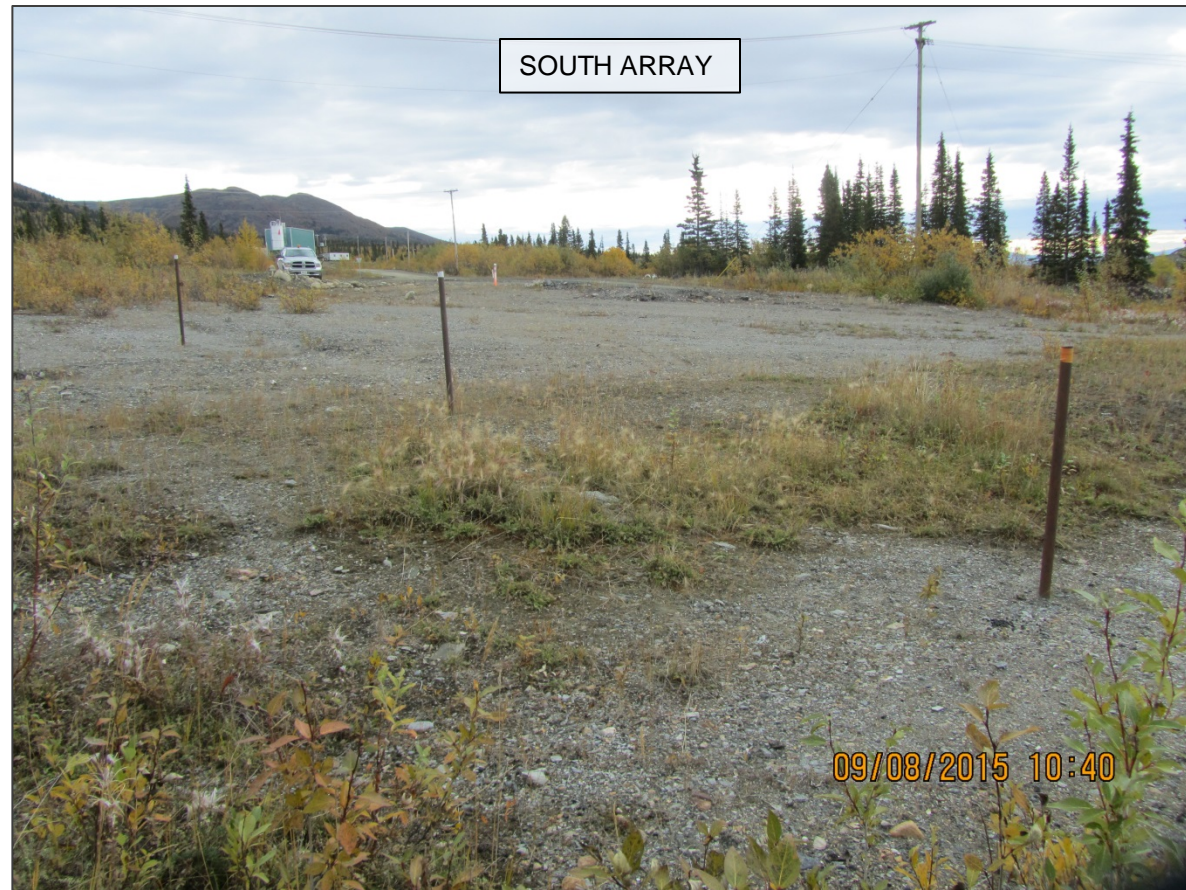
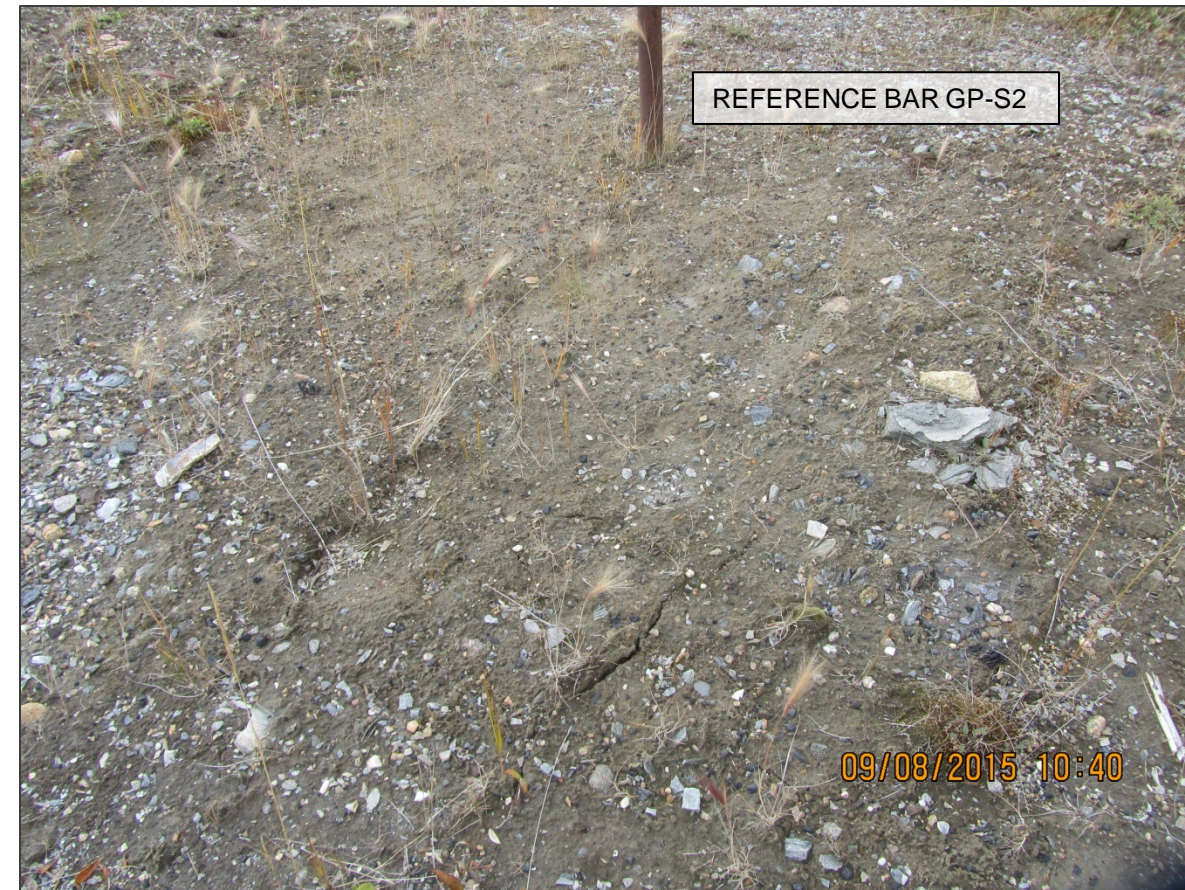
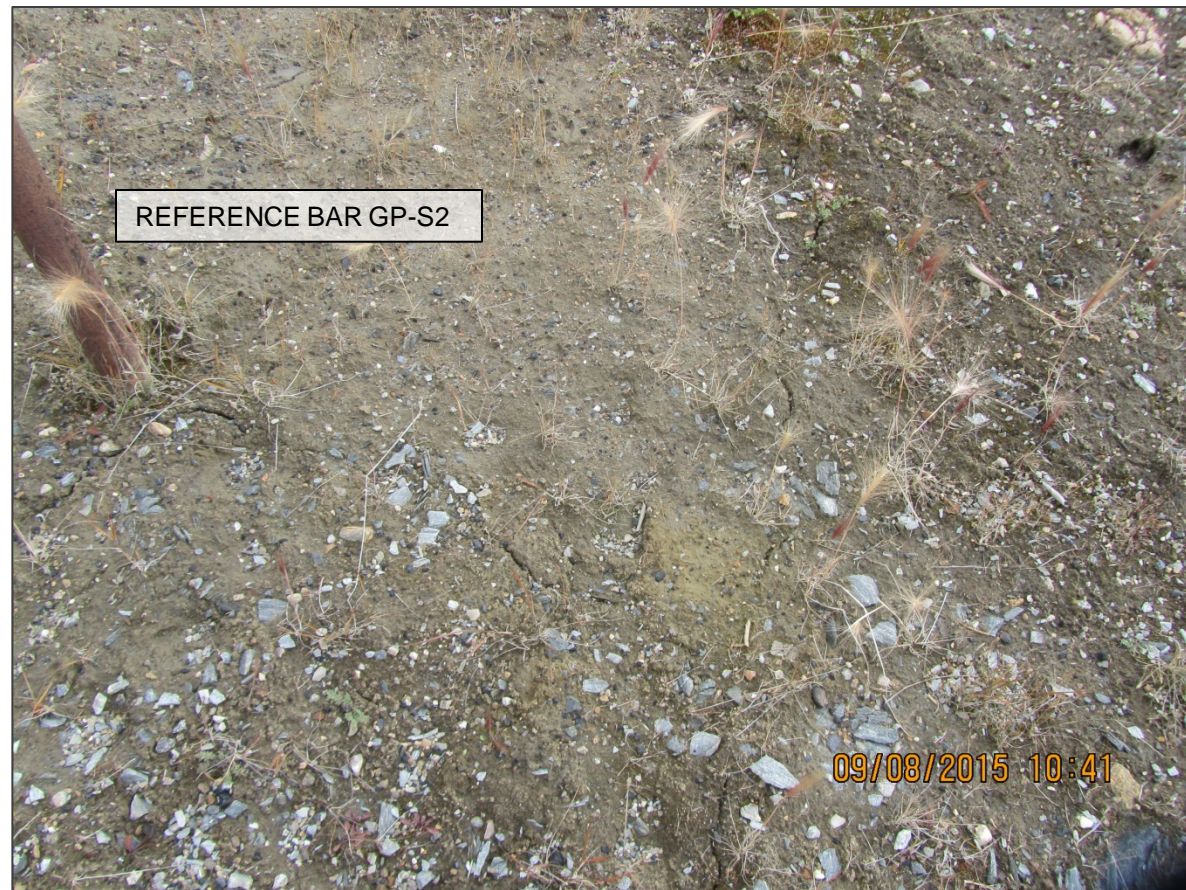
0	29/SEP15	FIGURE	JJR	JJR	AVC	AVC
REV	DATE	DESCRIPTION	DRW	DES	CHK	RVW
PROJECT		1410944/2015				
TITLE		FARO MINE COMPLEX 2015 PIT SLOPE STABILITY REVIEW				
TITLE		GRUM PIT SOUTH SIDE OF INSTABILITY ZONE				
FIGURE No.		B-3

SMALL CRACKS NEAR GP-S2 AT SOUTH ARRAY

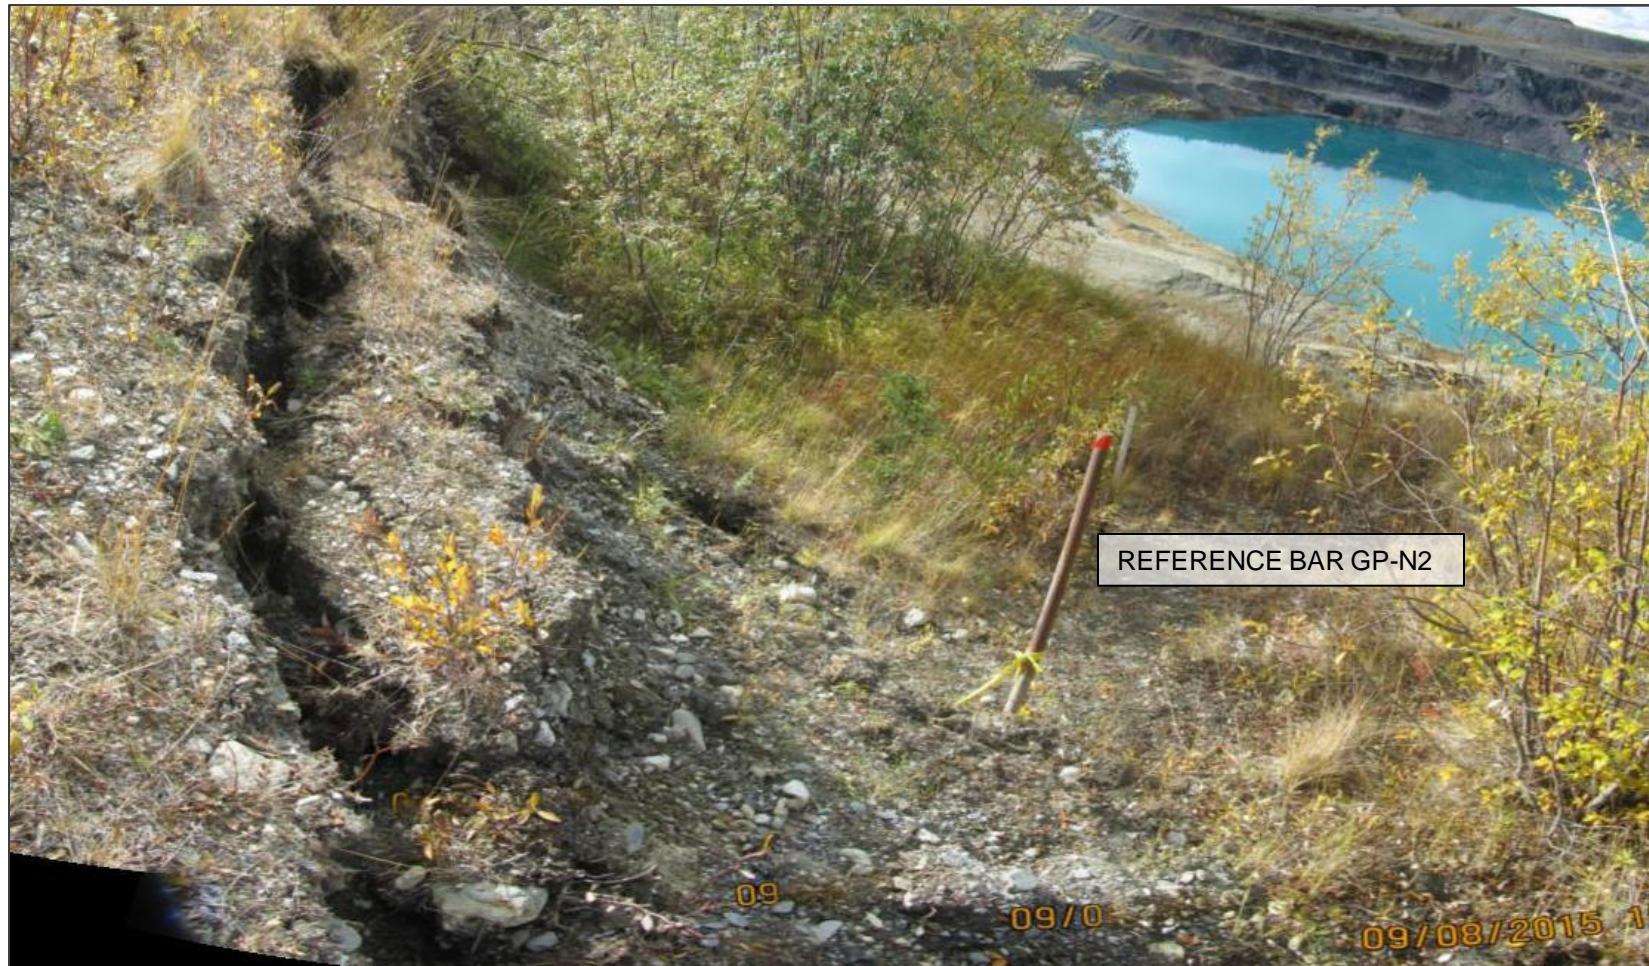
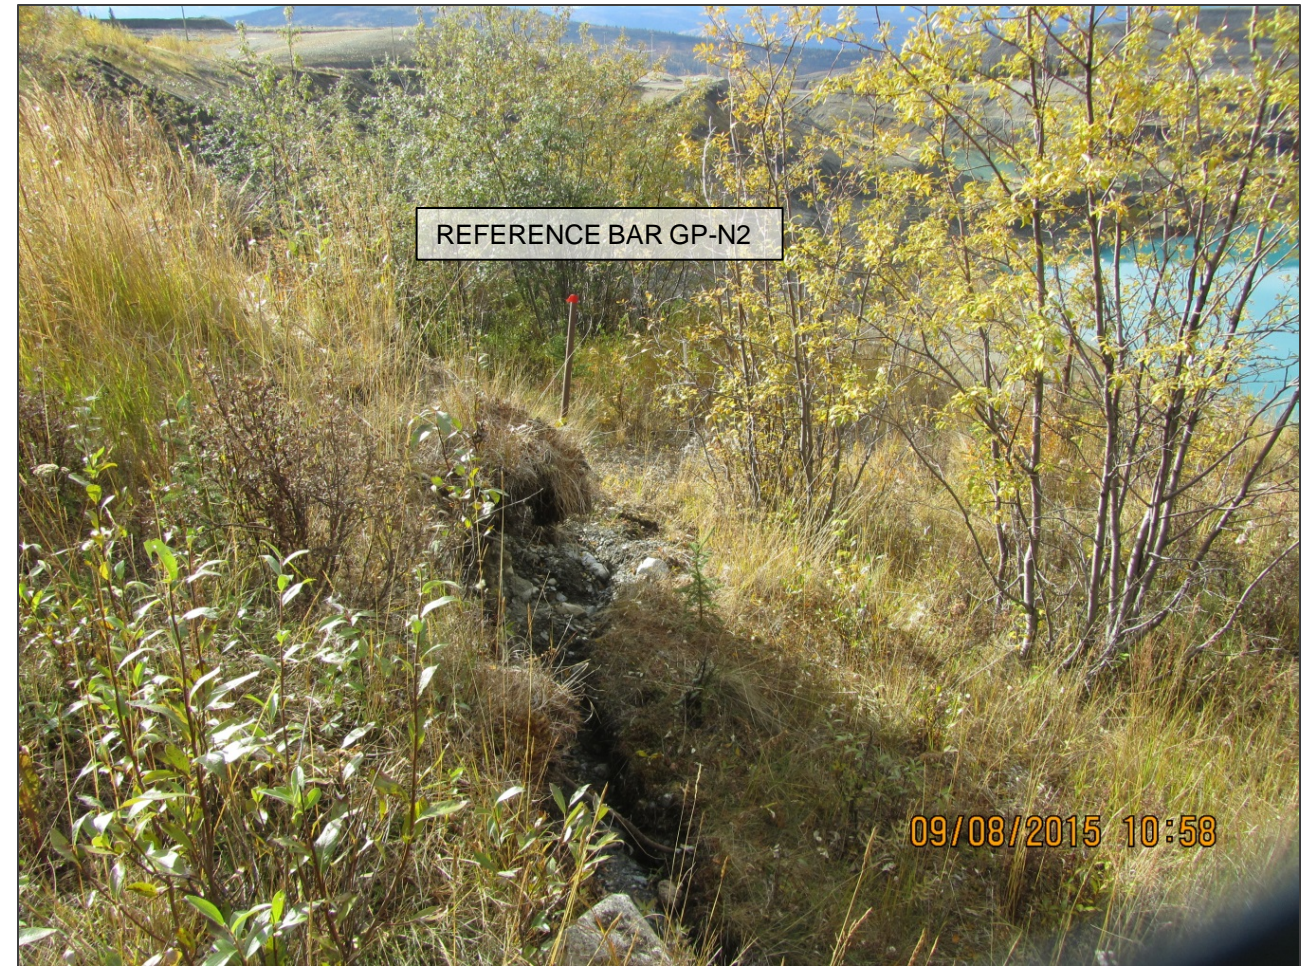
CRACKS AND SLUMPED BLOCK AT NORTH ARRAY, CREST OF EAST WALL, VIEWS LOOKING SOUTHWEST

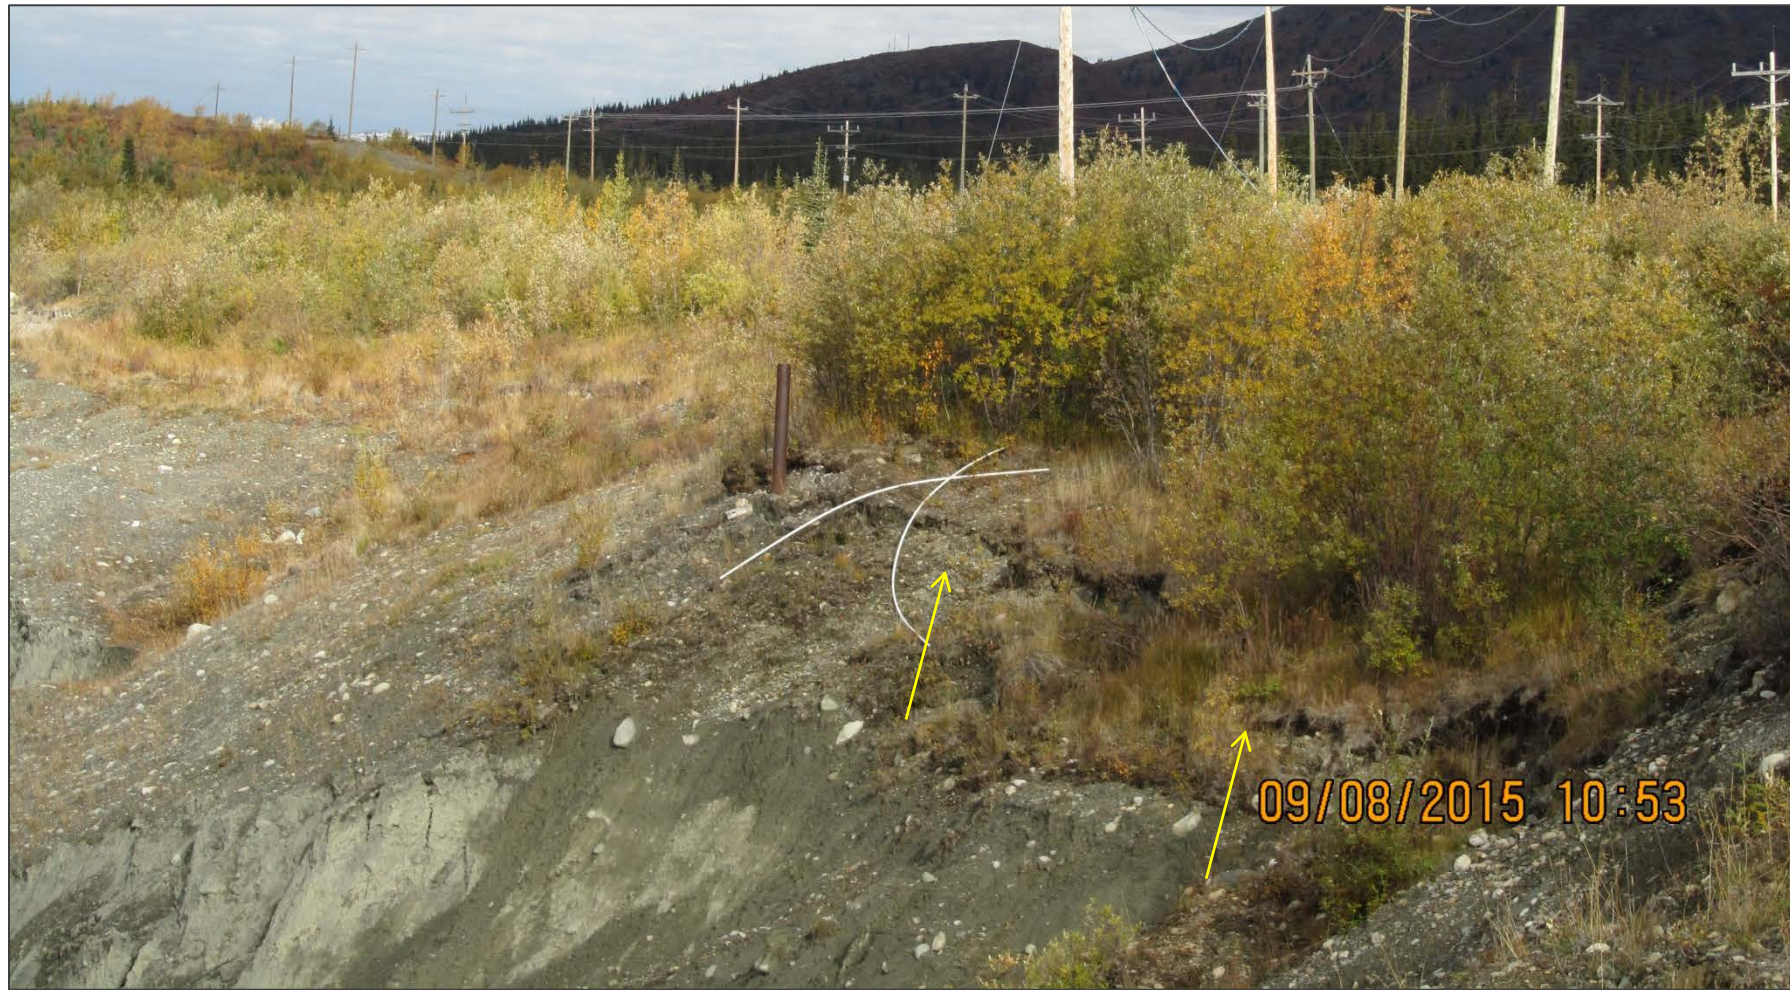
SECOND SET OF CRACKS LOWER DOWN ON CREST OF EAST WALL NEAR NORTH ARRAY, VIEW LOOKING NORTH

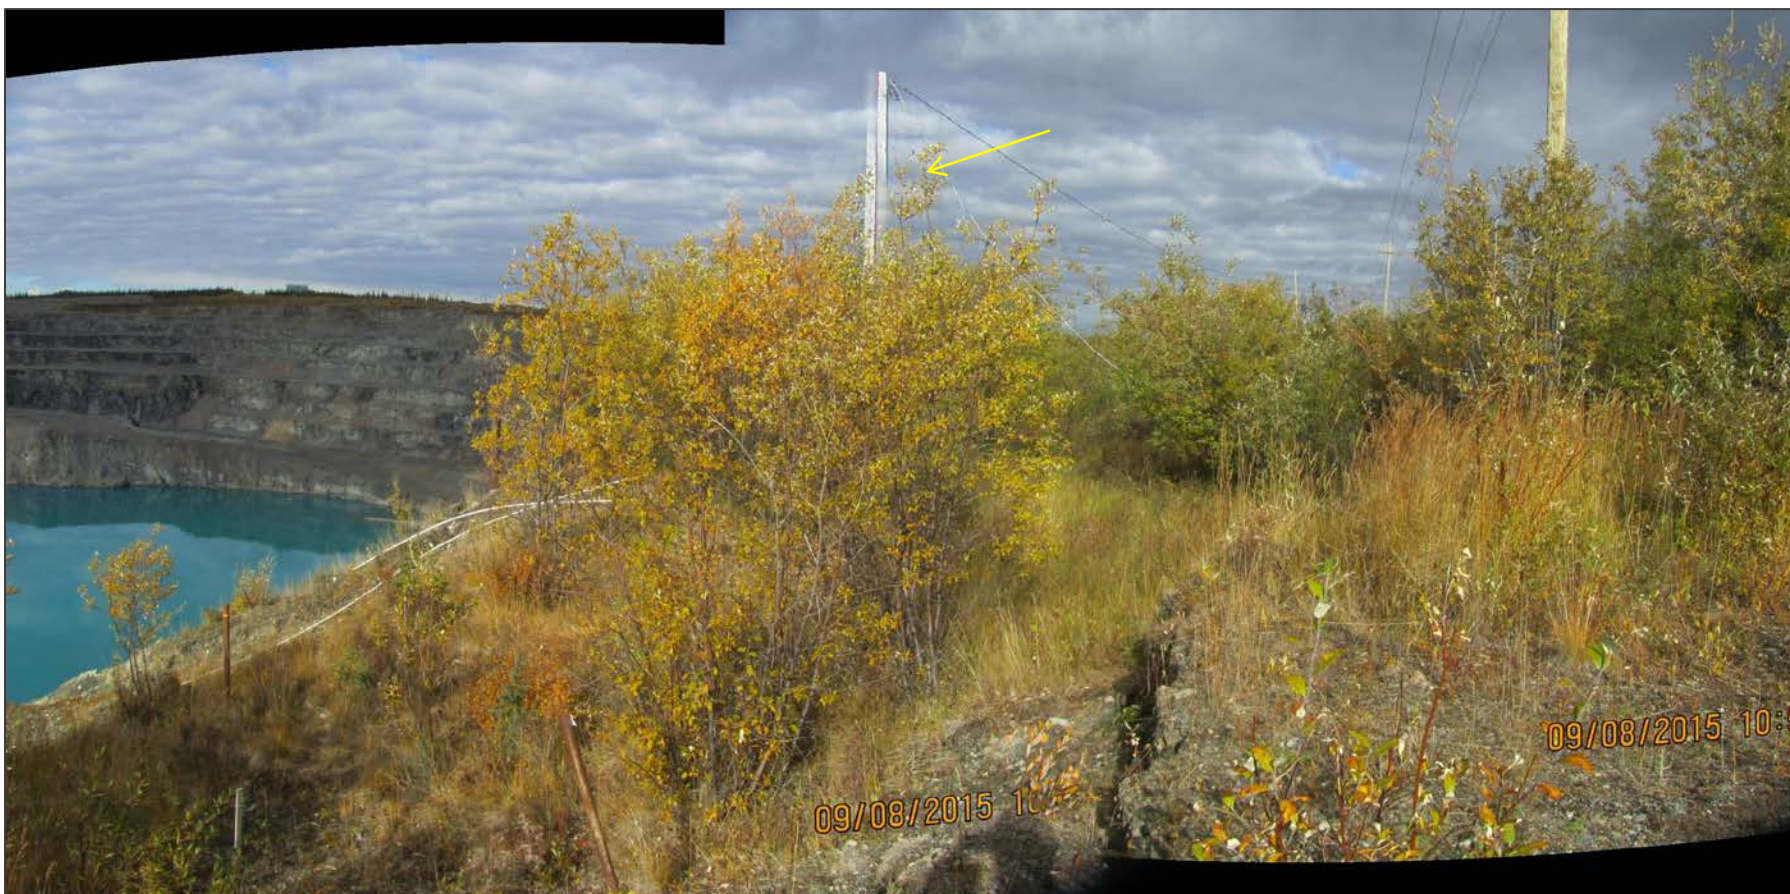
POWER POLE ON DROPPED SIDE OF SLUMP BLOCK, EAST WALL, VIEW LOOKING NORTH

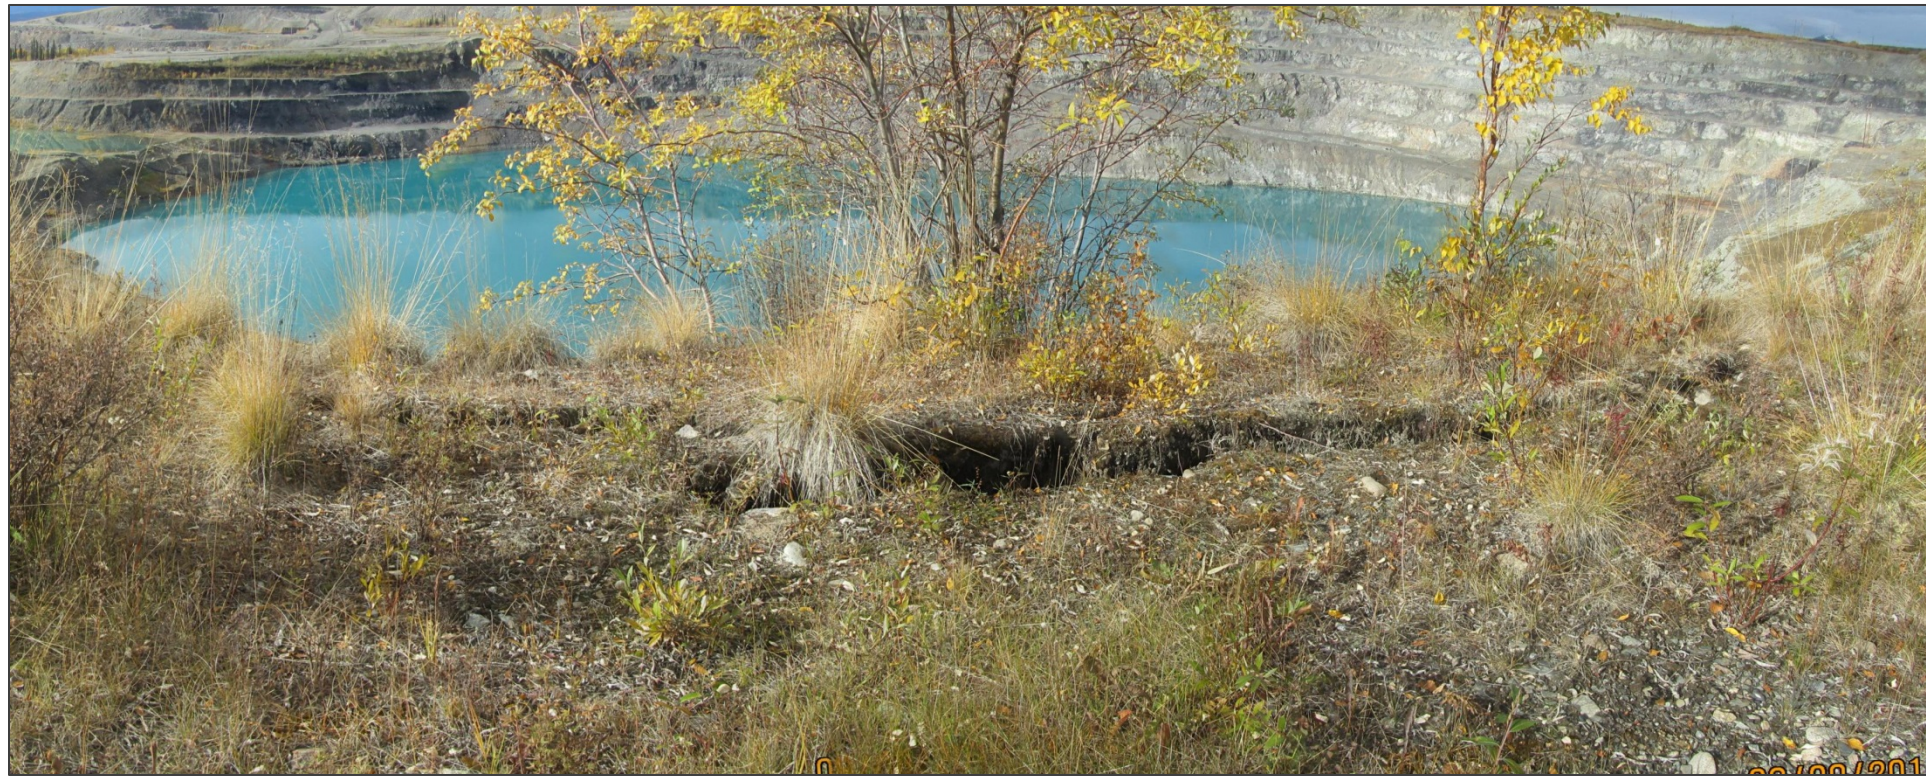
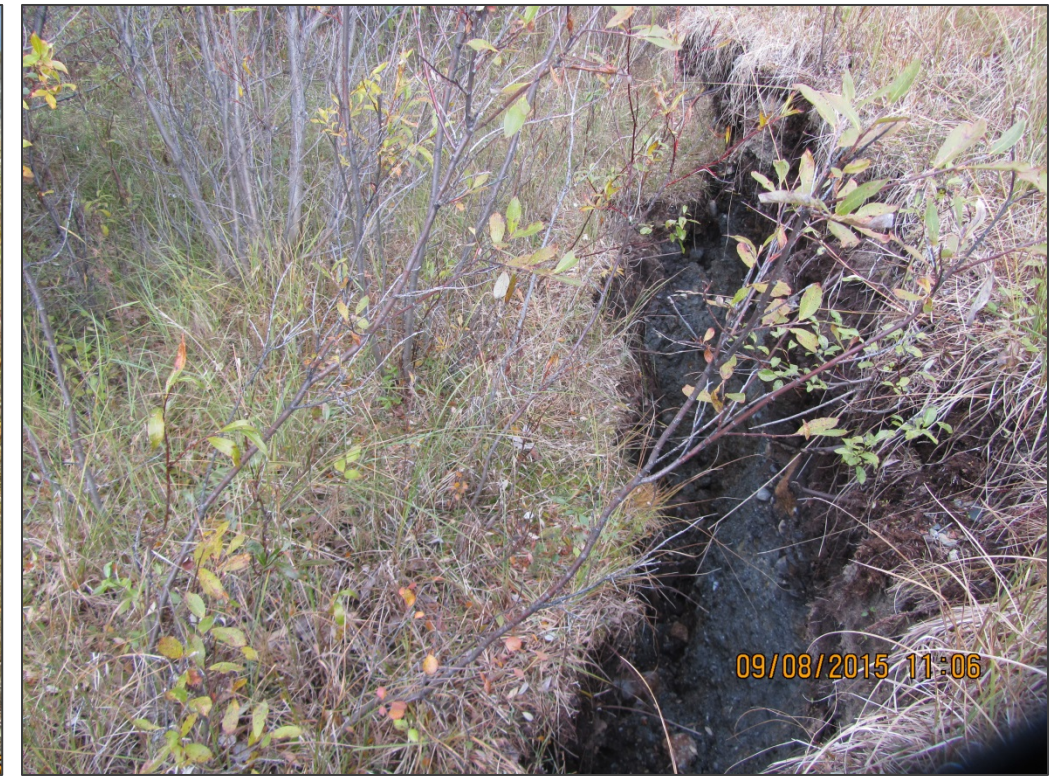
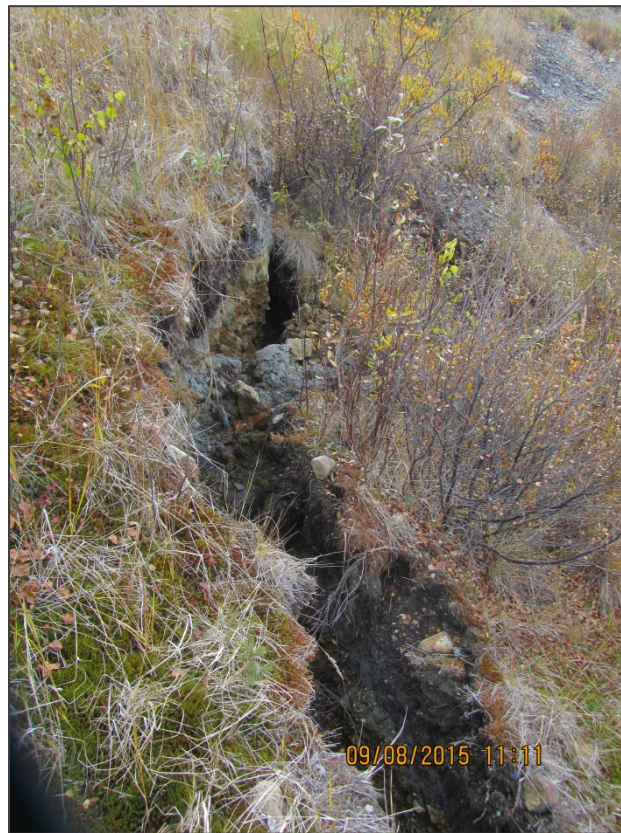
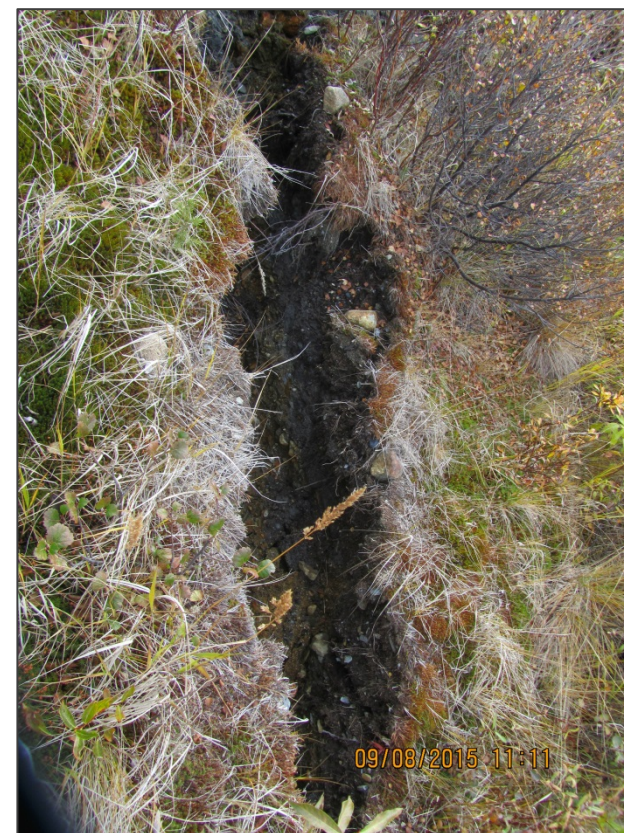
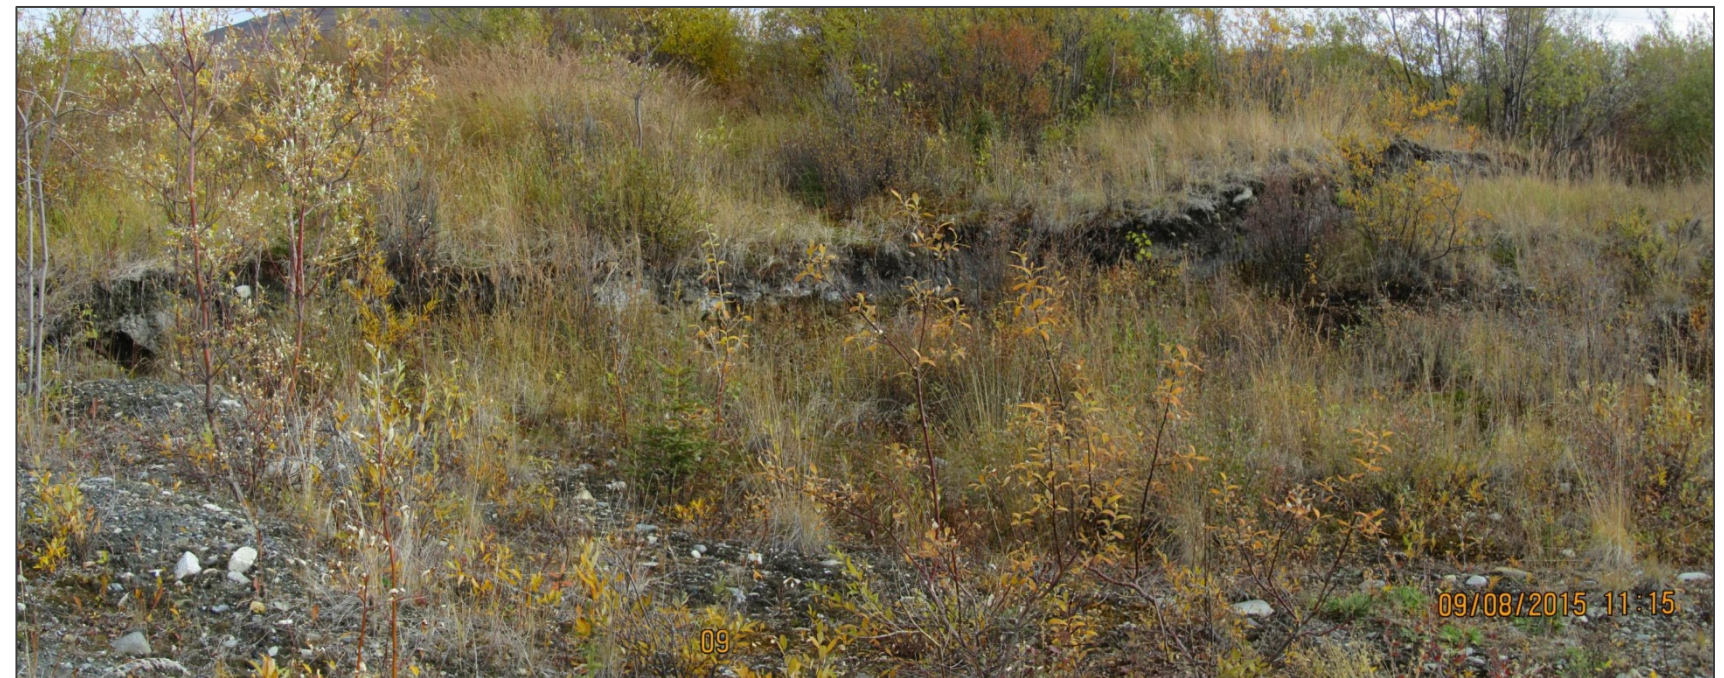
REV	DATE	FIGURE DESCRIPTION	JUR	JUR	AVC	AVC
0	29/SEP15					
PROJECT			1410944/2015			
TITLE			FARO MINE COMPLEX 2015 PIT SLOPE STABILITY REVIEW			
TITLE			CRACKS IN TILL BEHIND CREST OF EAST WALL			
FIGURE No.			B-9

CRACKS CONTINUE TO THE NORTH OF NORTH ARRAY,  
BEHIND THE CREST OF THE EAST WALL
