## FARO MINE COMPLEX

# 2015 Pit Slope Stability Review

**Reference Number: 1410944-007-R-Rev0-2015**

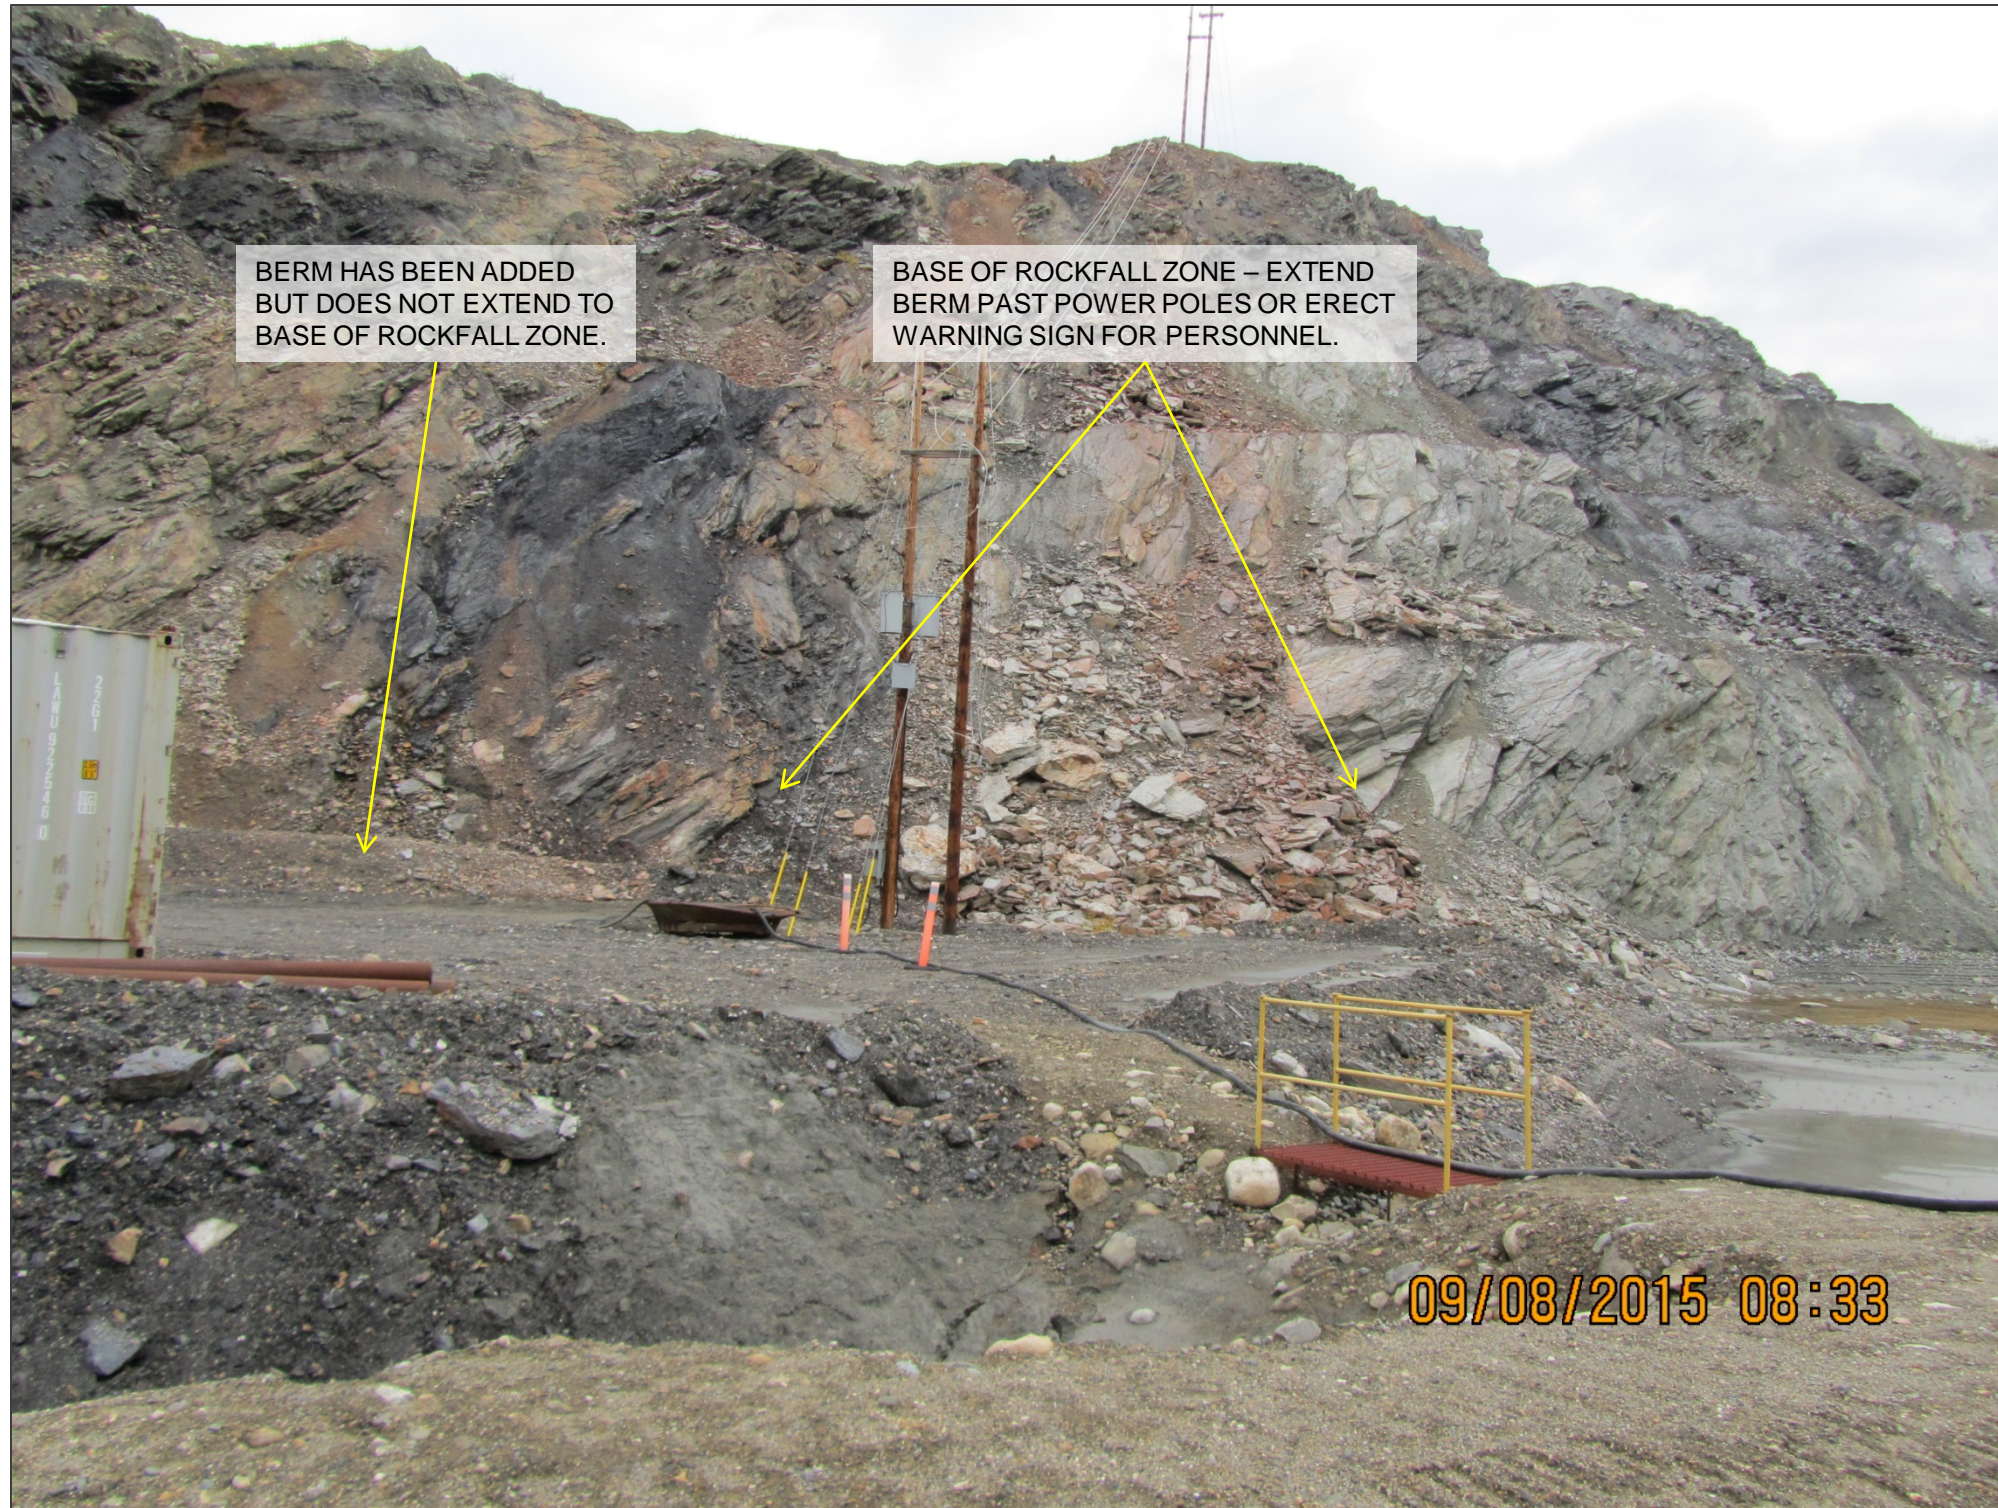
BERM HAS BEEN ADDED BUT DOES NOT EXTEND TO BASE OF ROCKFALL ZONE.

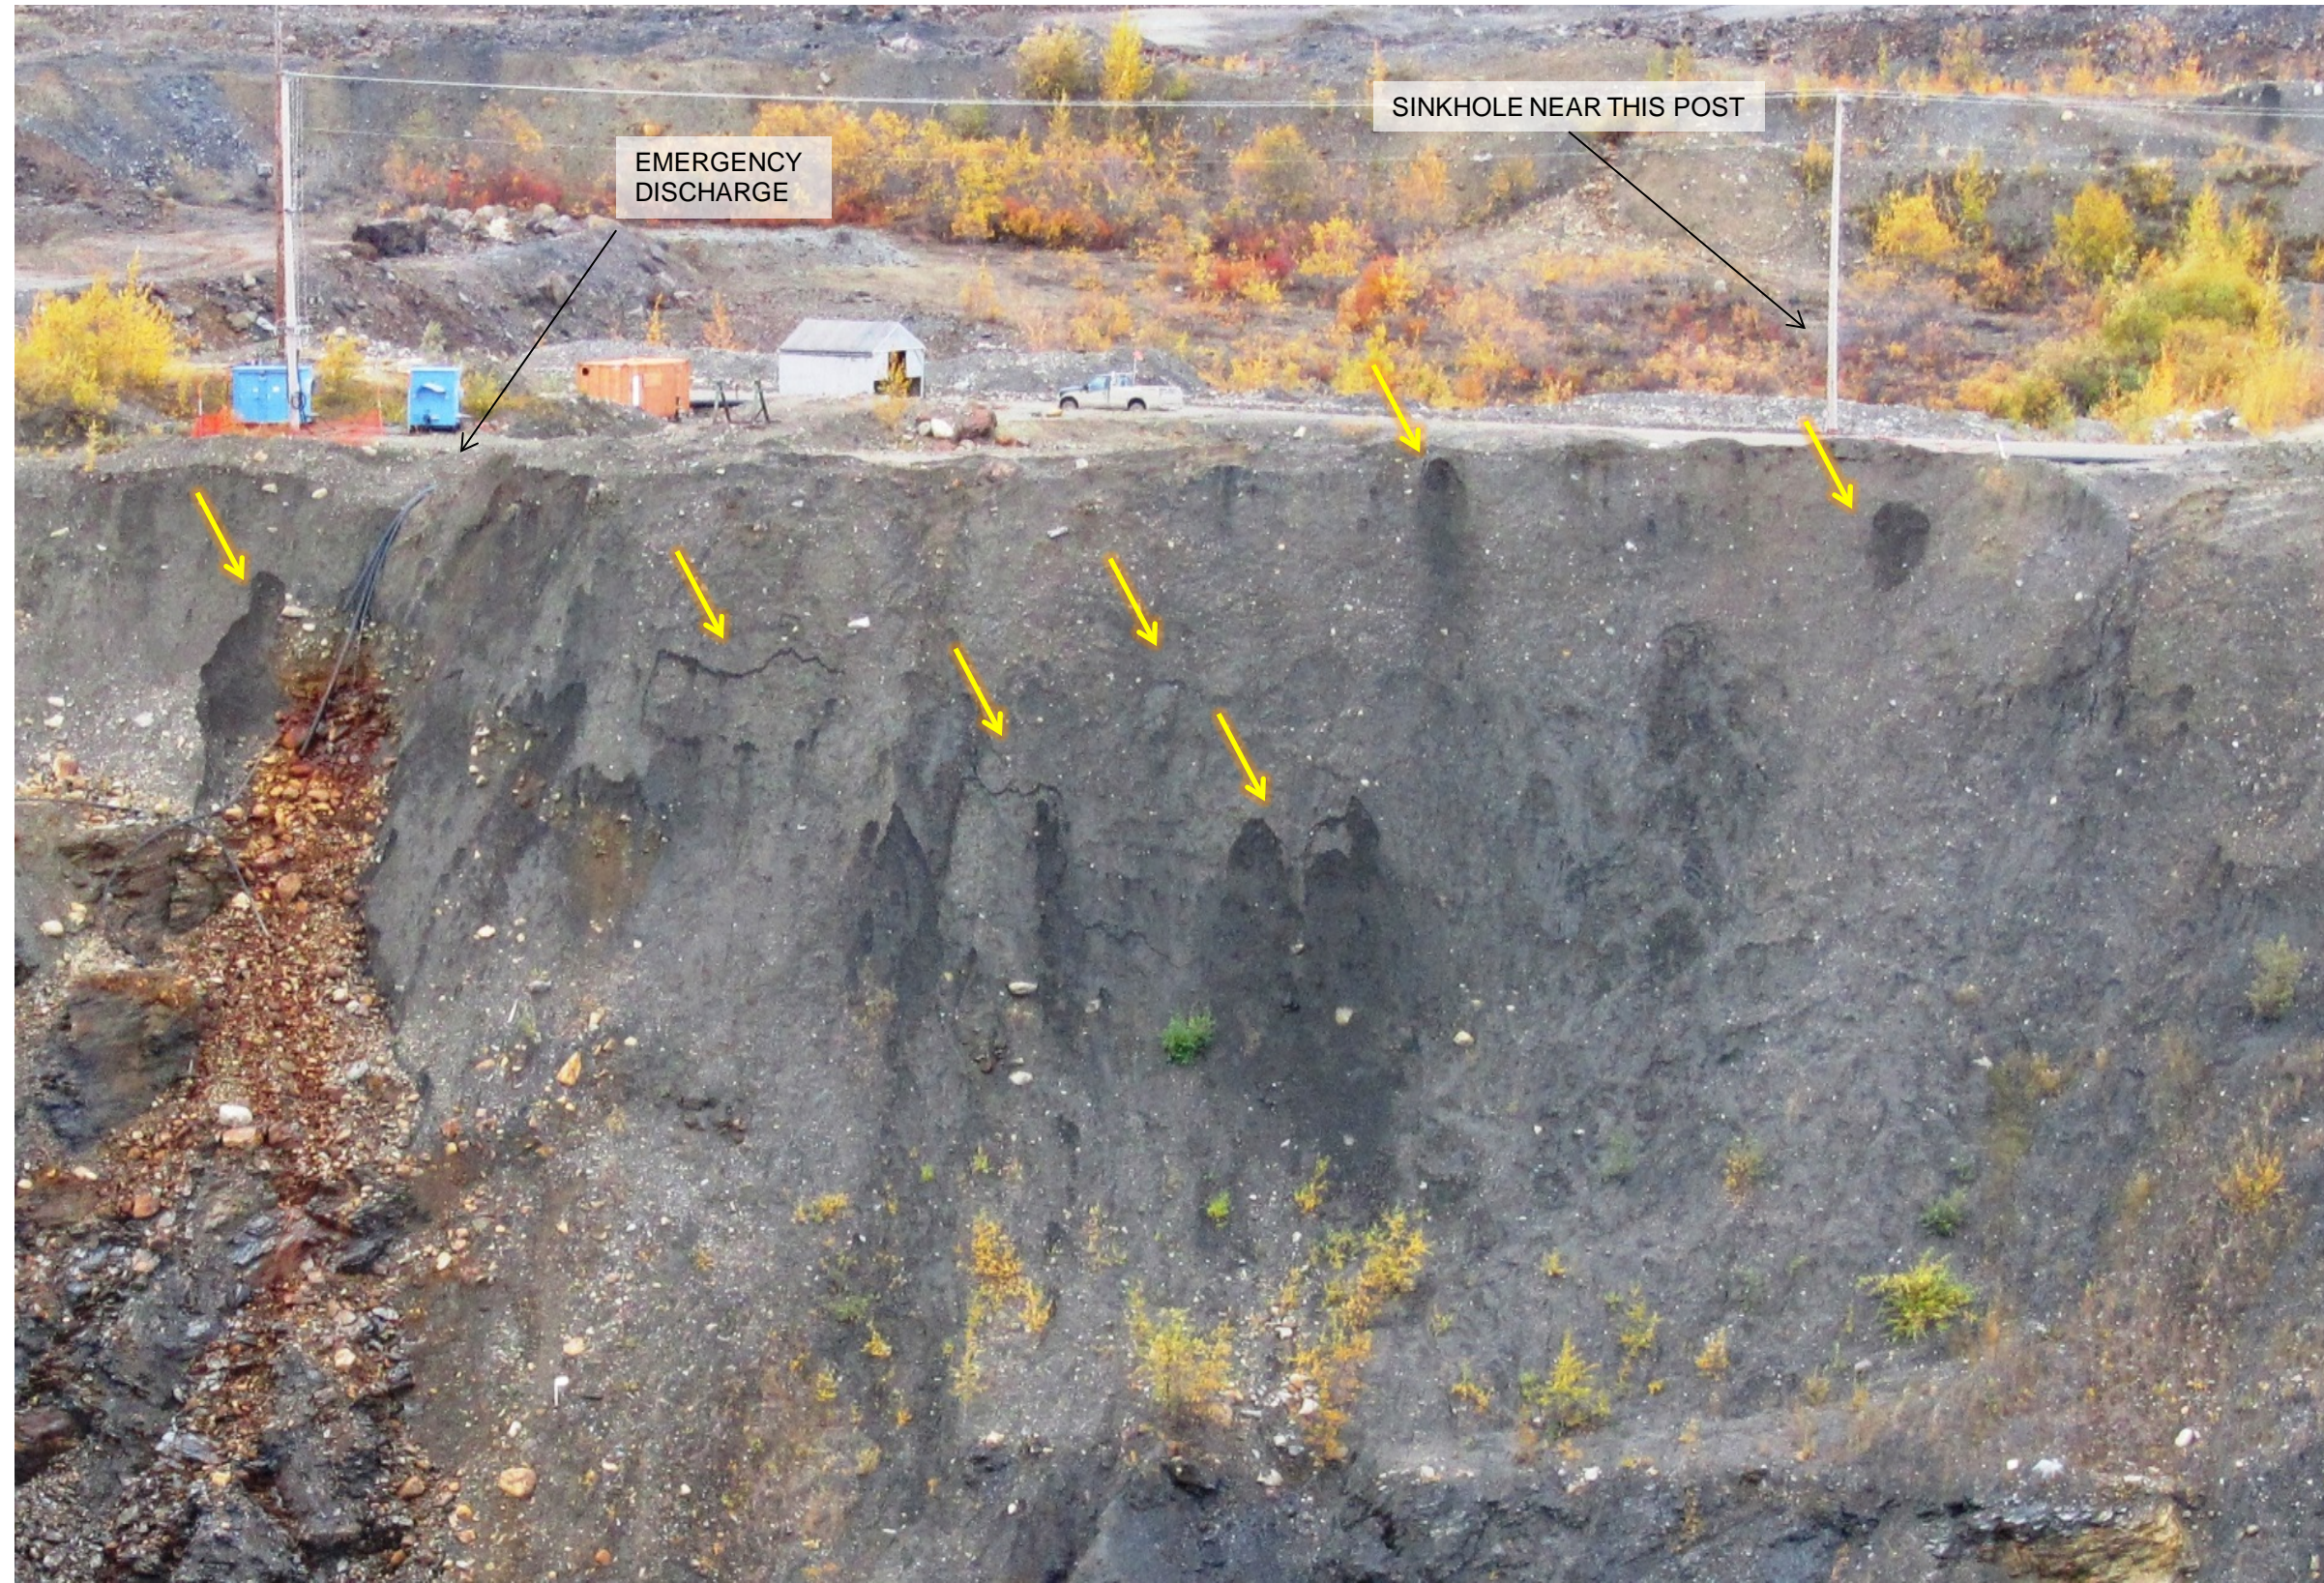
SOUTH SIDE OF UPPER WEST WALL, VIEW LOOKING WEST  
YELLOW ARROWS INDICATE CRACKS OR SLUMPED AREAS

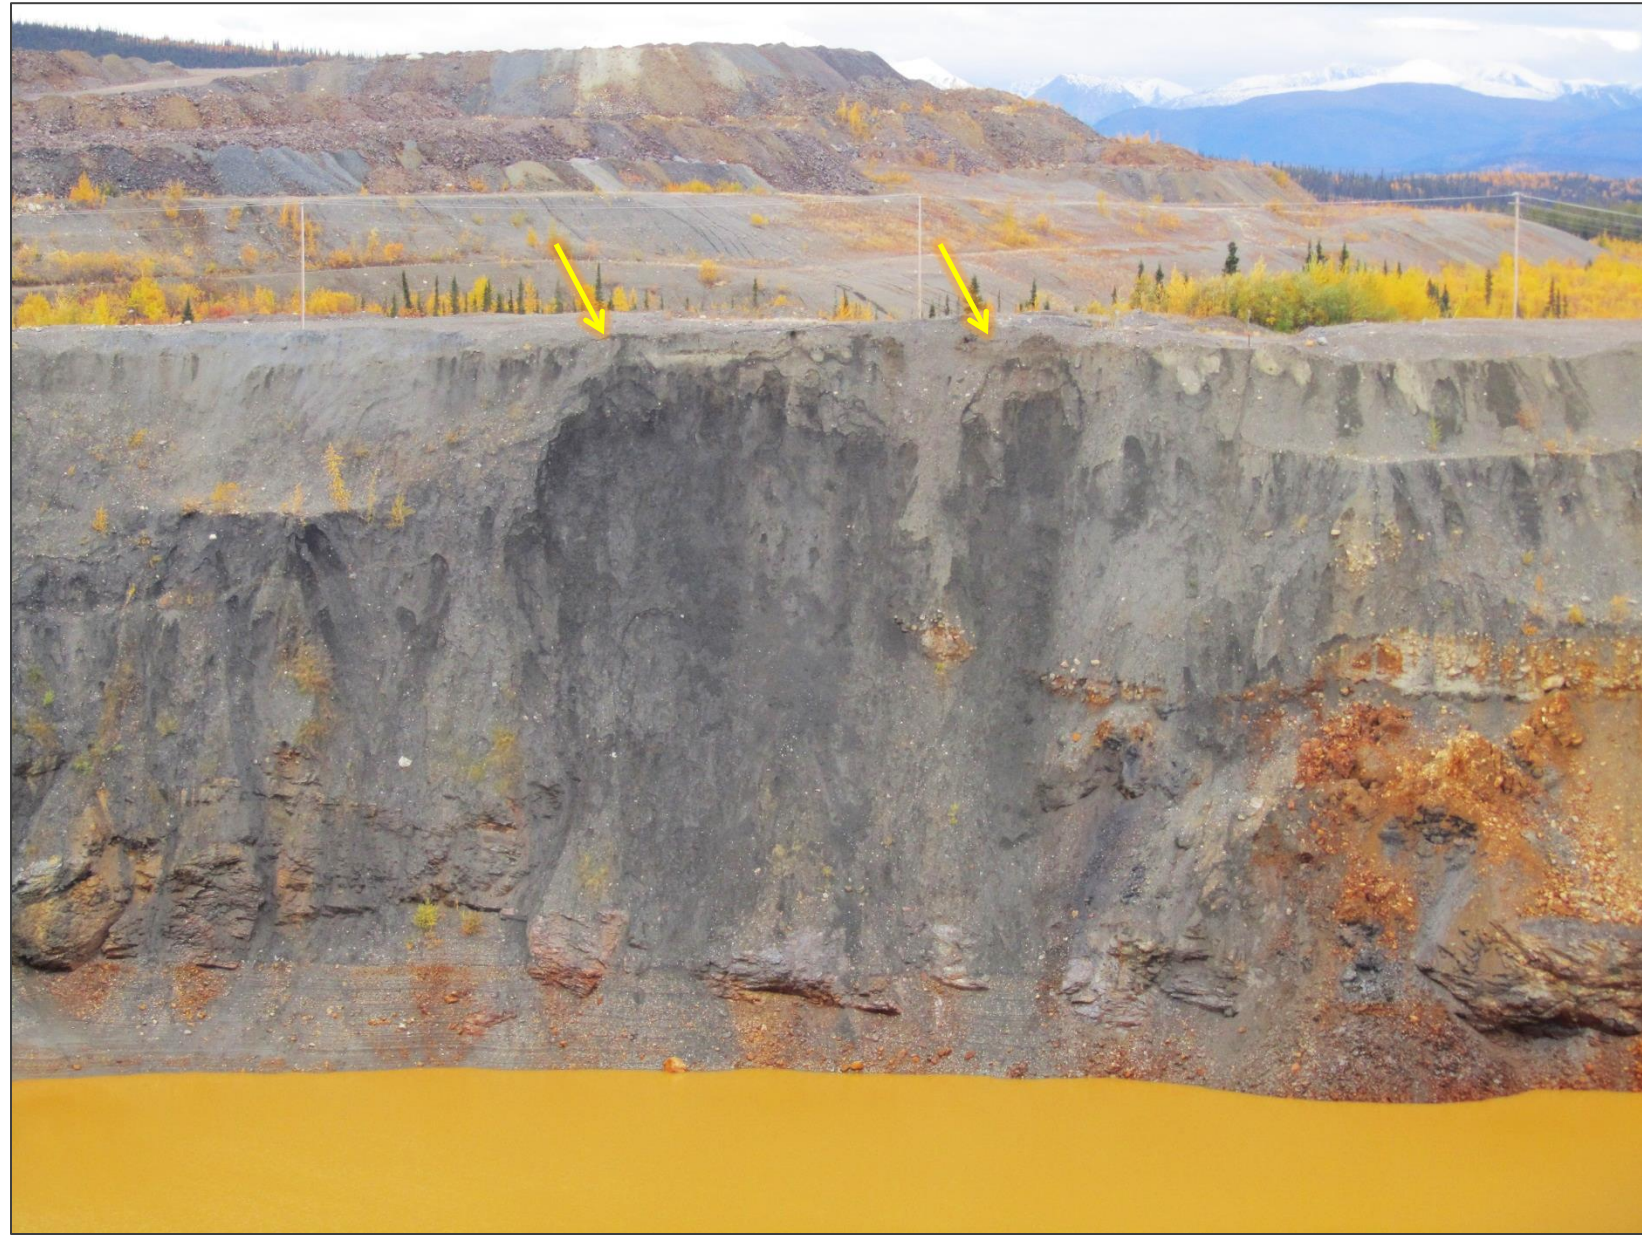
NORTH SIDE OF WEST WALL, VIEW LOOKING WEST  
ARROWS INDICATE RECENTLY SLUMPED AREAS

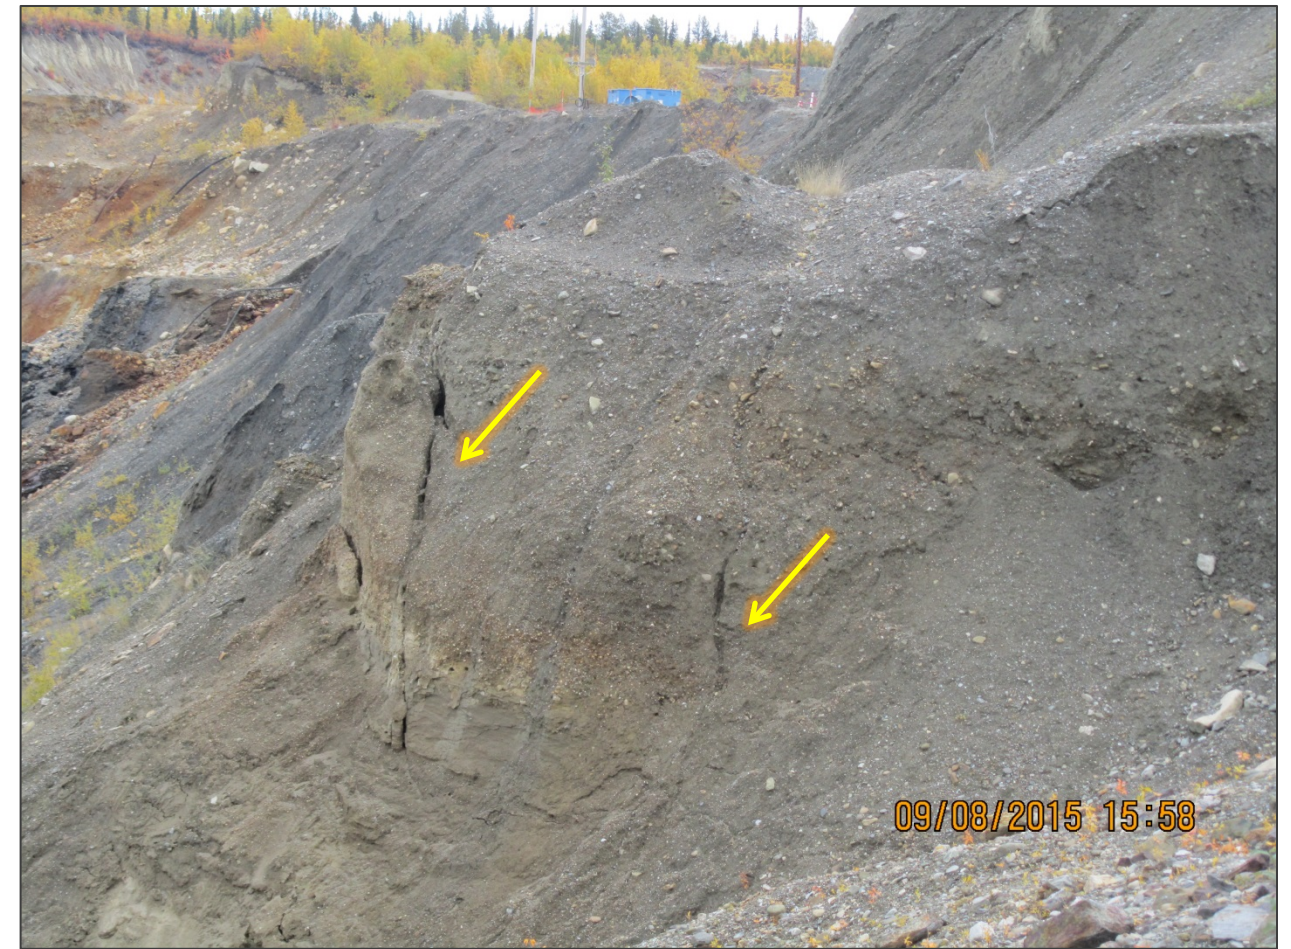
NORTH SIDE OF WEST WALL, VIEW LOOKING SOUTH FROM CREST  
ARROWS INDICATE CRACKS
